**Water Quality Remediation Plan
Dish Mill Brook Tributary**

BURKE MOUNTAIN RESORT

Prepared for **Burke Mountain Resort**
East Burke, Vermont

Prepared by **VHB Pioneer**
7056 U.S. Route 7
North Ferrisburgh, VT 05473

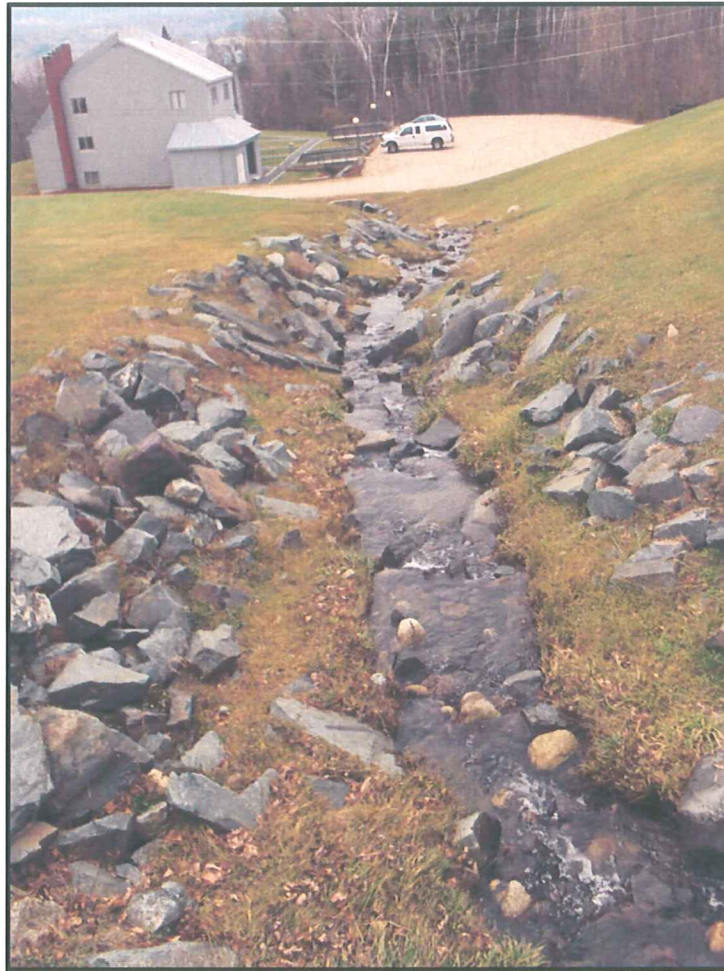
Figure 2. Photograph of reach B looking downstream, upstream of a condominium development.

with a riparian planting plan would improve the structure and function of the channel.

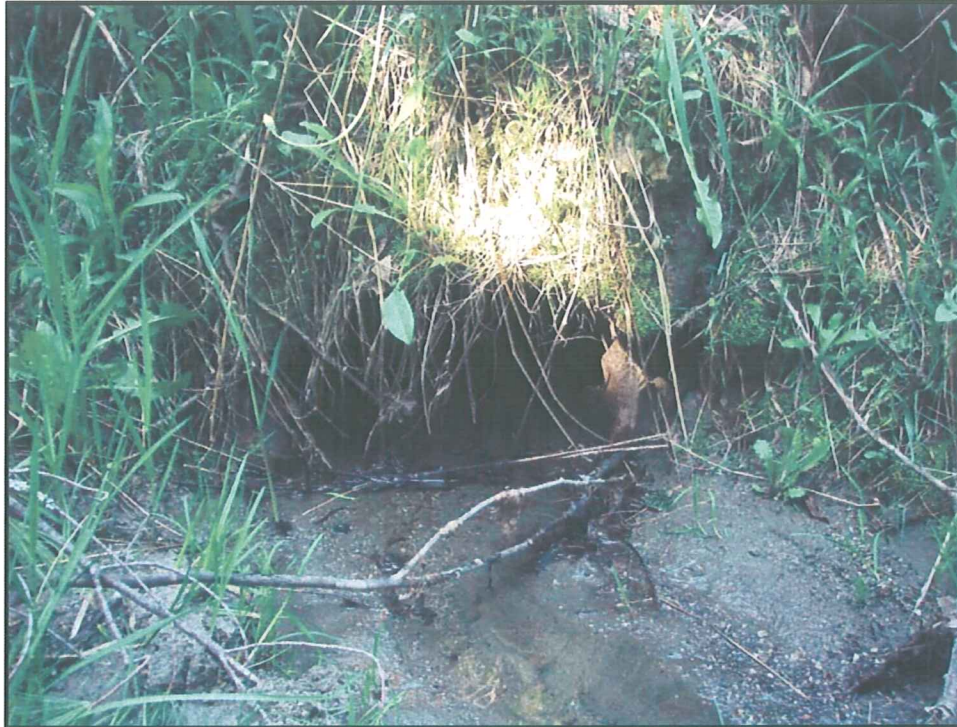
The BCA identified five culverts that were obstructed on the upstream end by sediment. Five culverts were identified that had a two foot drop on the downstream end, and one with a six foot drop on the downstream end. Four culverts were identified as having downstream banks that were substantially higher than the upstream bank heights. Three culverts were observed as having high bank erosion (see Table 5).

Photograph 1: C-03 (Inlet) – Excessive Sediment Obstruction

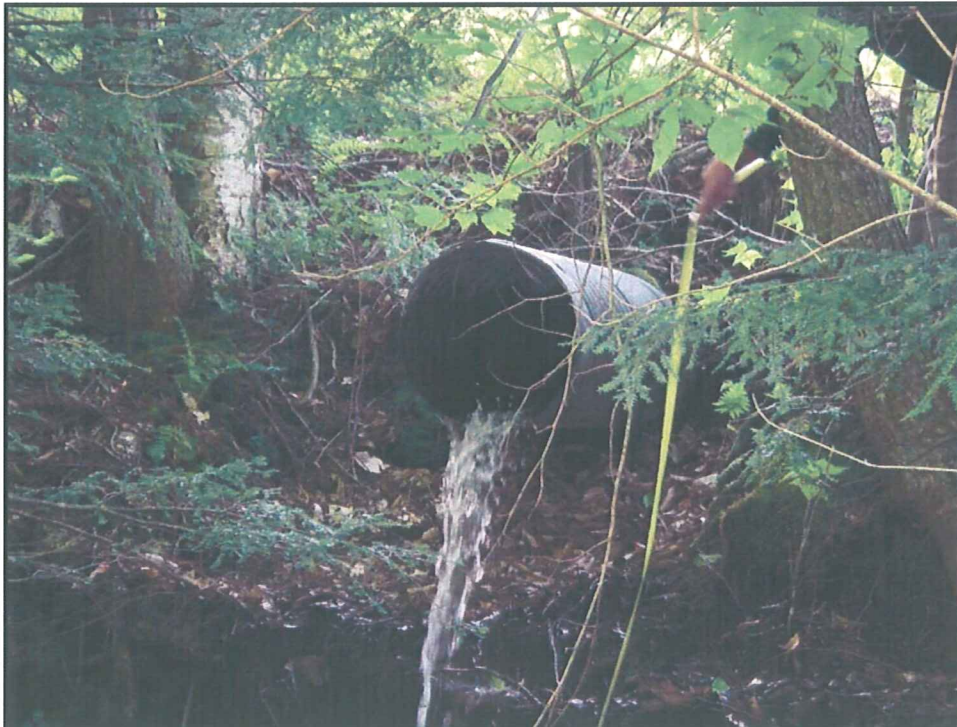
Photograph 2: C-07 (Outlet) – Six foot Outlet Drop

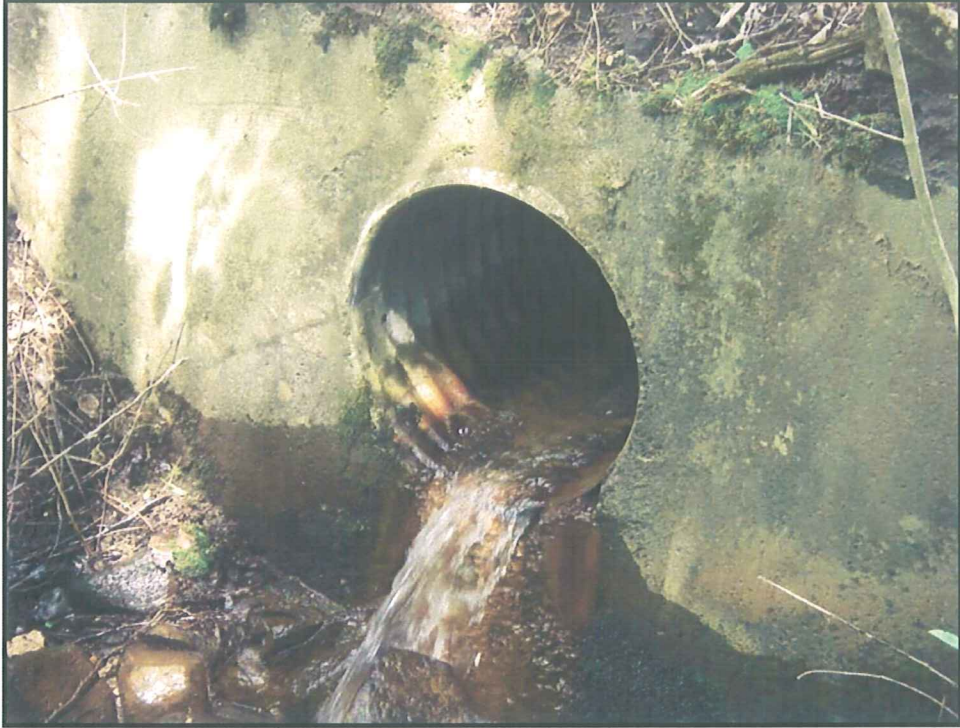
Photograph 3: C-19 (Outlet) – Two foot or Greater Outlet Drop

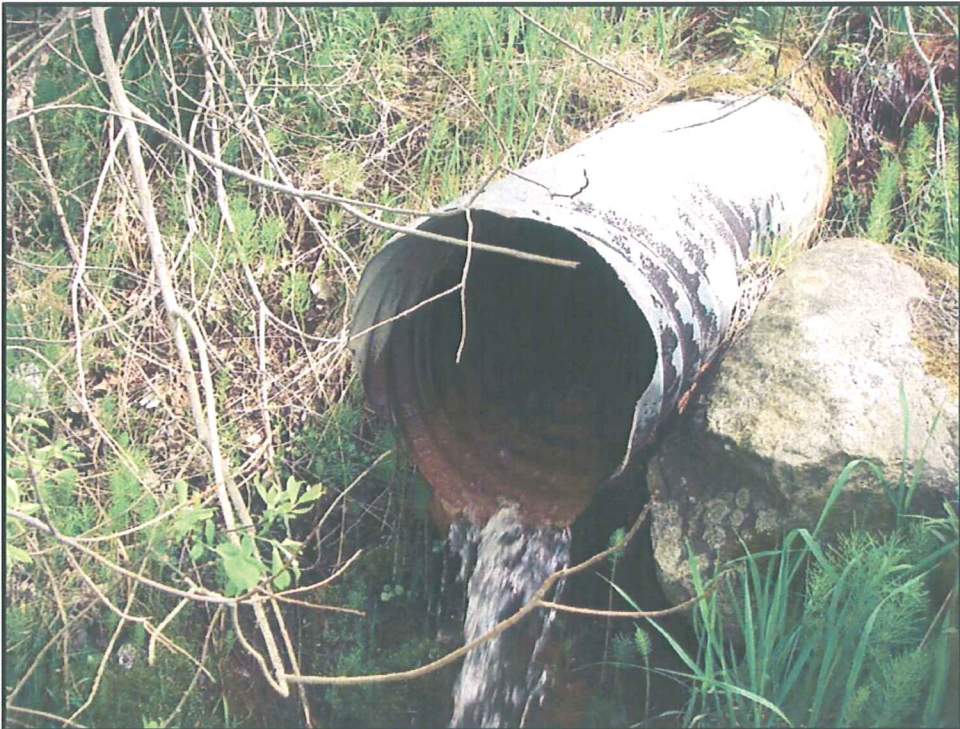
Photograph 4: C-20 (Outlet) – Two foot or Greater Outlet Drop
