# Deer Brook Gully Restoration Town of Georgia, Vermont

**17-084**

**Stone Environmental, Inc.**  
535 Stone Cutters Way  
Montpelier / VT 05602  
gbolin@stone-env.com  
603.273.9253

# Deer Brook Gully Restoration, Town of Georgia, Vermont

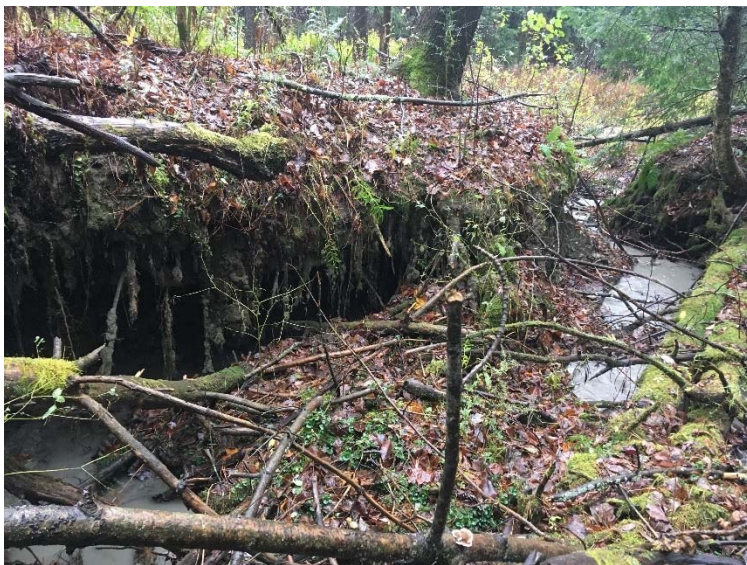
Three upland buildings are located within 20-30 feet of the gully limits, with one (Interstate Auto) less than 10 feet from a failing slope. Armoring and fill along the gully edge was observed on Interstate Auto's property, and a substantial amount of fill was observed along the northern upland portion of the gully (and appeared to be failing at the toe of material placement). Trash was observed at the head of the gully and in the channel, consisting of 55-gallon drums, scrap metal, and other large items. Many trees have fallen over, likely due to bank slope failures and small landslides. Many of the downed trees were identified as eastern hemlock, with some hardwood trees also down and spanning the channel. Approximately 40-50% of the downed trees appeared to be recent falls (within the last 1-2 years), with no signs of rot or weathering.

Runoff was flowing in the gully channel during the visit and the water was gray in color. Within the lower banks and slopes of the gully, it generally appears that there are a few inches of topsoil/soil (4-8") above a soft, gray clay. The channel bed contained 6-8" of fine, gray, silt- to clay-textured sediments. The banks and slopes showed multiple slope failures and slides, and erosion of the upper soil layer with exposed gray clay in some locations. Undercut banks were observed further downstream, indicating that the channel continues to adjust its cross-sectional area to accommodate increase in flows. At the confluence of Deer Brook, a contrast between the gray colored gully discharge and brown flow in the brook was easily discernable. is a photo of the gully channel looking downstream, at an undercut bank and illustrating the sediment and debris that have collected in the channel.

*Figure 3. Failing gully bank, with accumulated sediment and debris in the channel in foreground; gray-colored runoff in background.*

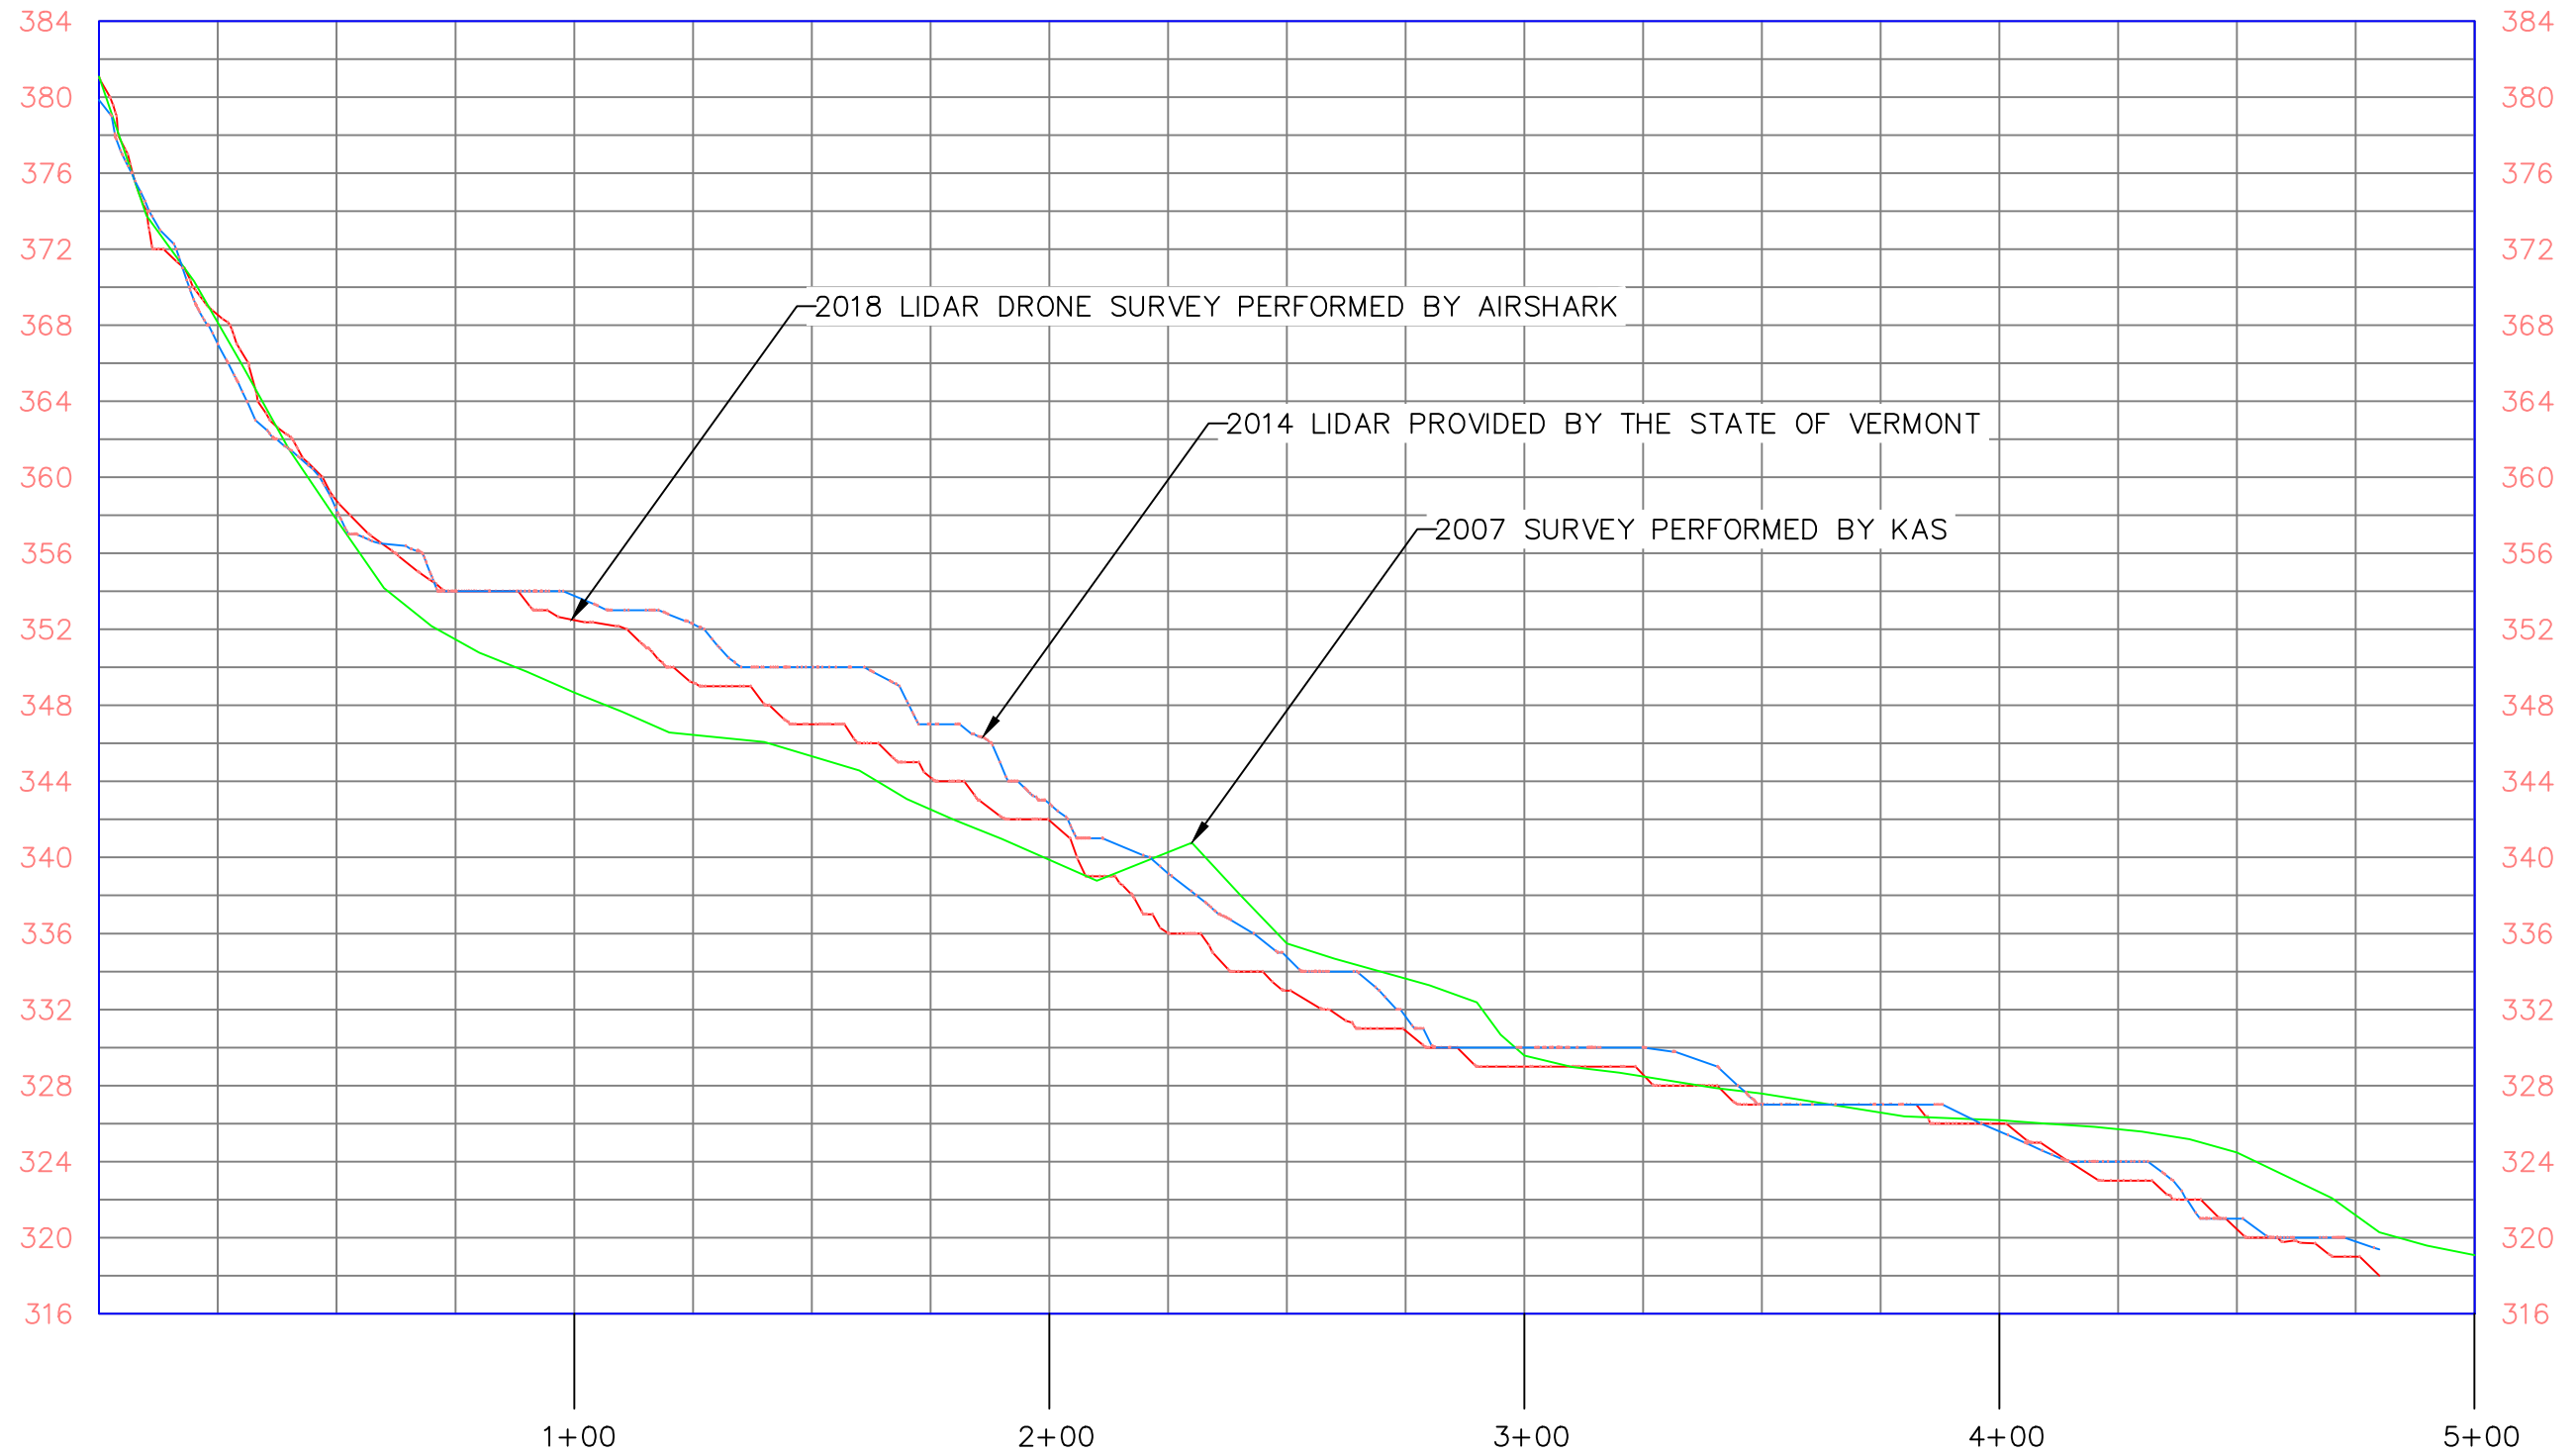
# THALWEG PROFILE

Additionally, Figure 4 provides a plot of the longitudinal profile (along the gully channel centerline) relative to the 2018 AirShark survey, the 2014 state LiDAR data, and the profile provided in the ESPC 2007 study. The purpose of this plot is to assess the stability of the channel bed over time. A comparison between the 2018 and 2014 data shows that a portion of the channel has potentially incised, or cut down, 1-4' over that time period (understanding that the state LiDAR data most likely has an accuracy range of 0-0.5'). It should be noted that while the 2018 and 2014 data sets reference the same vertical datum (NAVD88), the ESPC profile was not collected on a datum, and is therefore not directly comparable to the other data sets. It is included in the plot for illustrative purposes only.

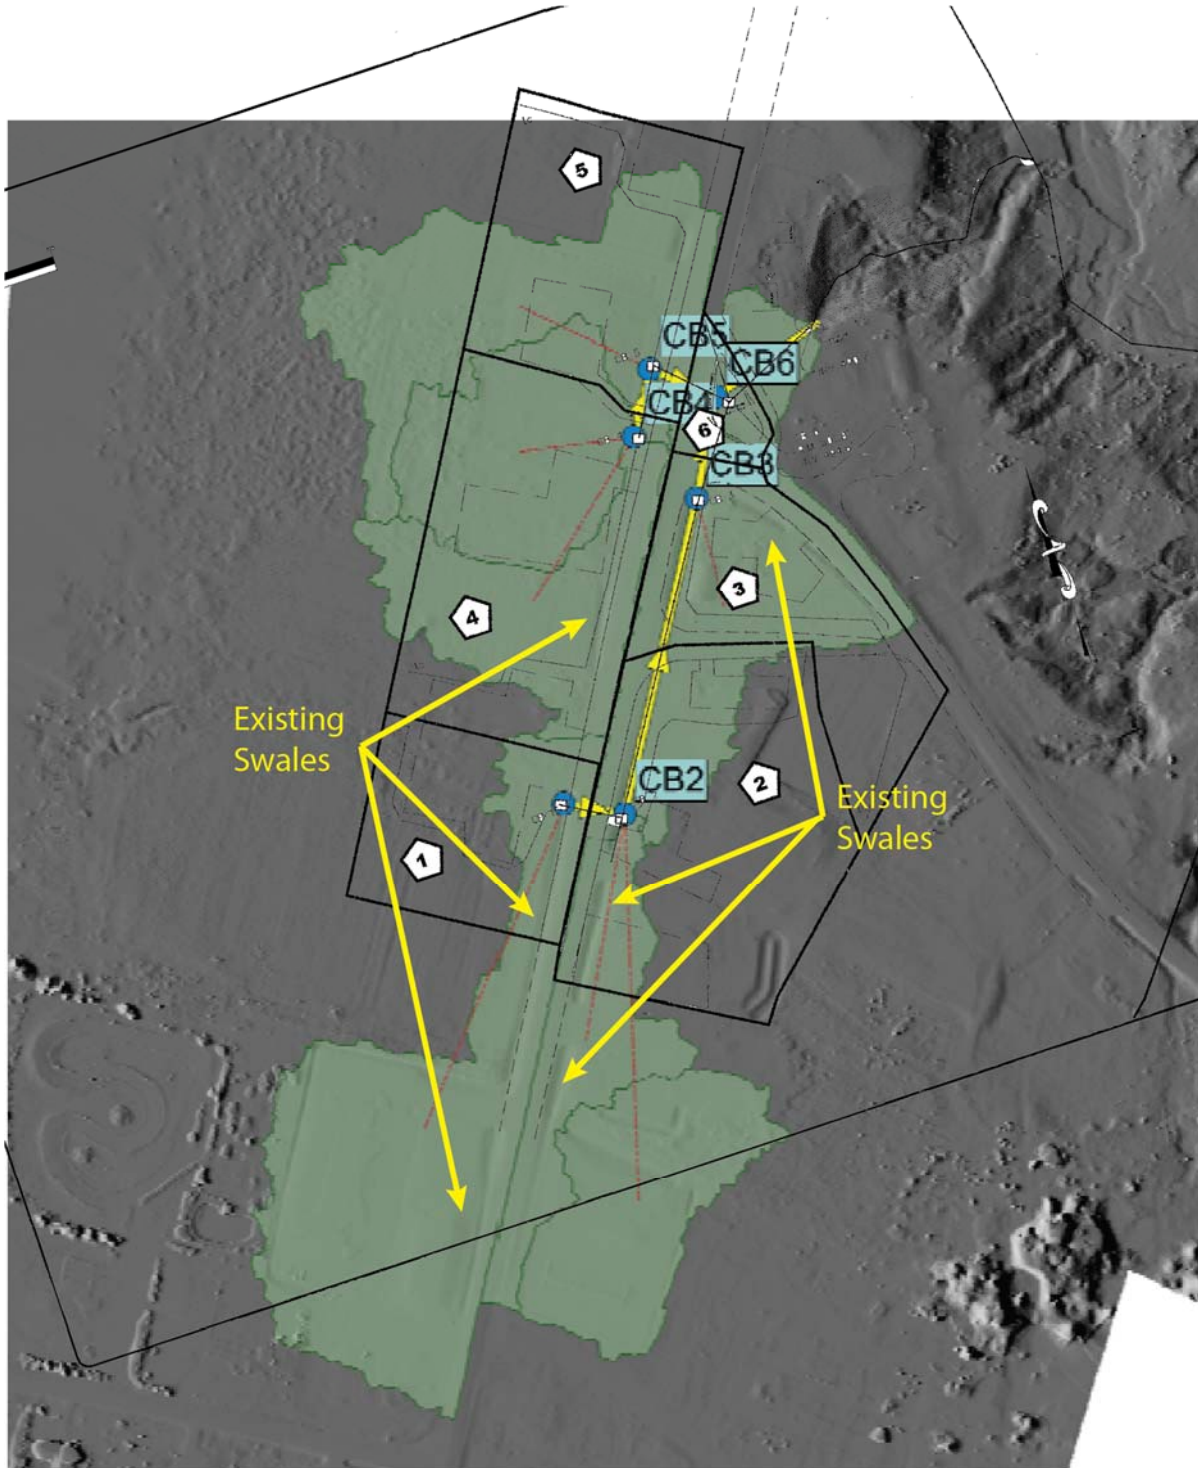
Preliminary modeling indicates that the existing piping system is undersized, which may contribute to the degraded condition observed at the gully head (discussed further in Section 2.3.2). The swales are thought to be providing significant storage capacity during large storm events. A total of six swales exist along U.S. Route 7, and the swales, pipe network, and catch basins are illustrated on Figure 5.

Figure 5 shows a schematic view of the drainage area delineation and existing stormwater infrastructure draining to the gully, developed by ESPC as part of the 2007 study, fitted over an image from Stone's PCSWMM model. The PCSWMM model image shows sub-drainage areas (green), the stormwater infrastructure network including conduits (yellow) and catch basins (blue dots, labeled), the gully outfall (red triangle) and the DTM surface (gray background image).

Figure 5. Gully Watershed Plan depicting drainage area delineations and existing stormwater infrastructure by ESPC, 2007, fitted over Stone's drainage area delineation based on AirShark's 2018 LiDAR topographic survey. Simulated catch basins, stormwater conduit and the gully outfall in PCSWMM model are shown. A total of 6 large swales exist throughout the watershed. Mapping by Stone via PCSWMM, 2018.
