**BLOOD BROOK WATERSHED
CORRIDOR PLAN
NORWICH, VT**

March 27, 2008

Prepared by:
Daniel Ruddell, Elisabeth McLane, Anna Mulligan,
Staff Scientists, and
Ben Machin, Principal
Redstart Consulting

Prepared for:
Two Rivers-Ottawaquechee Regional Commission,
Town of Norwich Conservation Commission, and
Vermont Agency of Natural Resources/
Department of Environmental Conservation
River Management Program

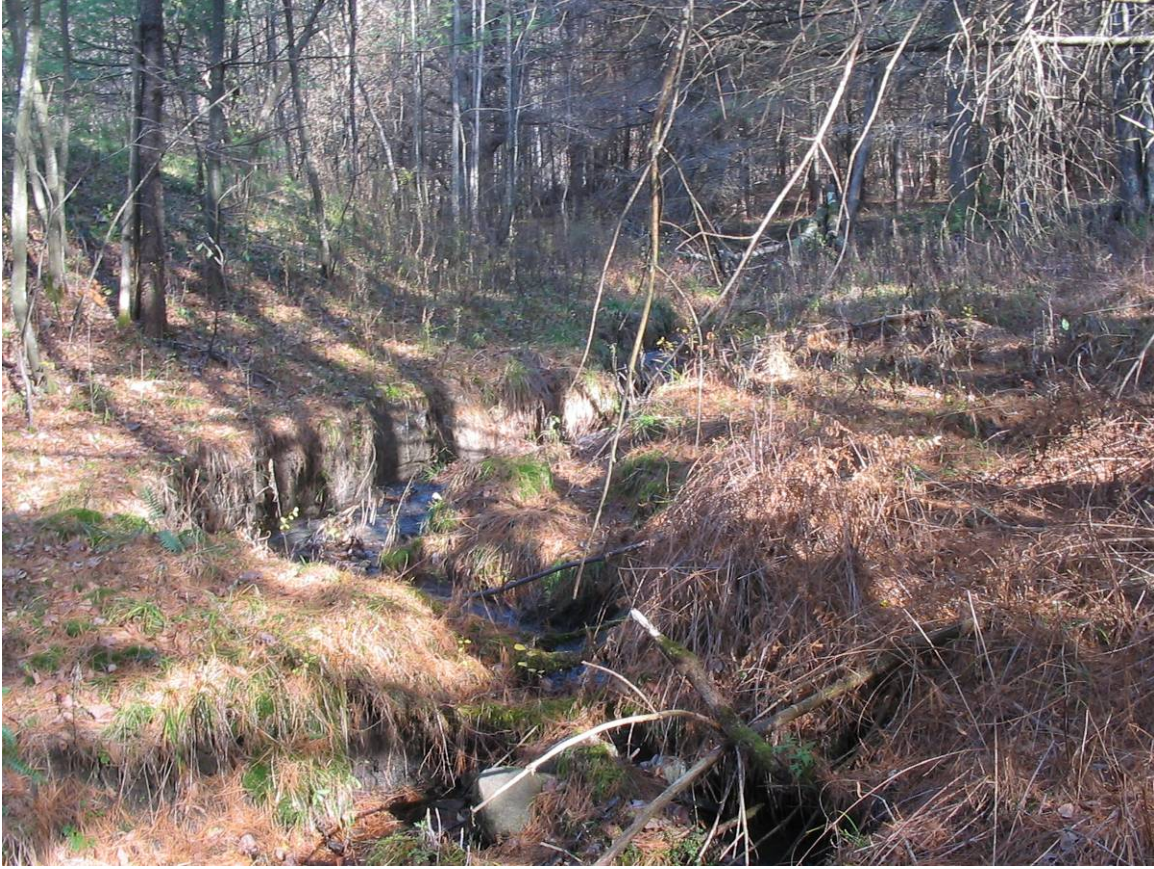
Figure 10. Highly erodible soils on sideslopes above New Boston Brook, like many sedimentary and lacustrine deposits in the Blood Brook watershed, are sensitive to increased stormwater inputs.

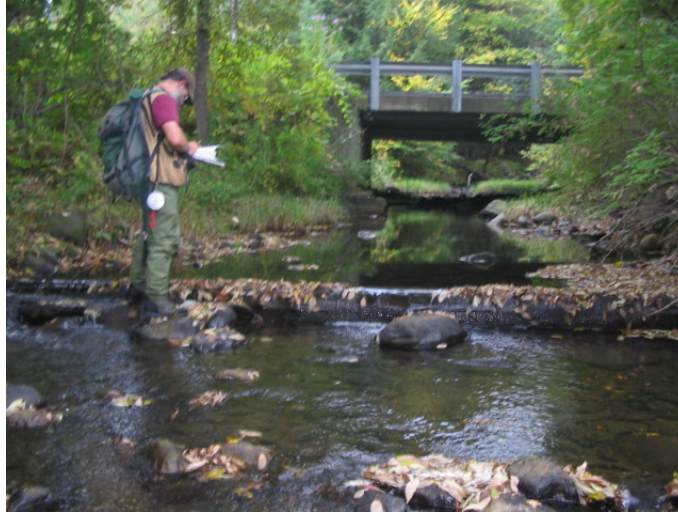
Figure 11. The check dam in this photo was likely installed to limit upstream migration of headcuts and bed degradation below the Norwich Pool impoundment, indicating sensitivity of the stream to the “sediment starving” resulting from retention of sediments above the dam in reach M04-T2.03.

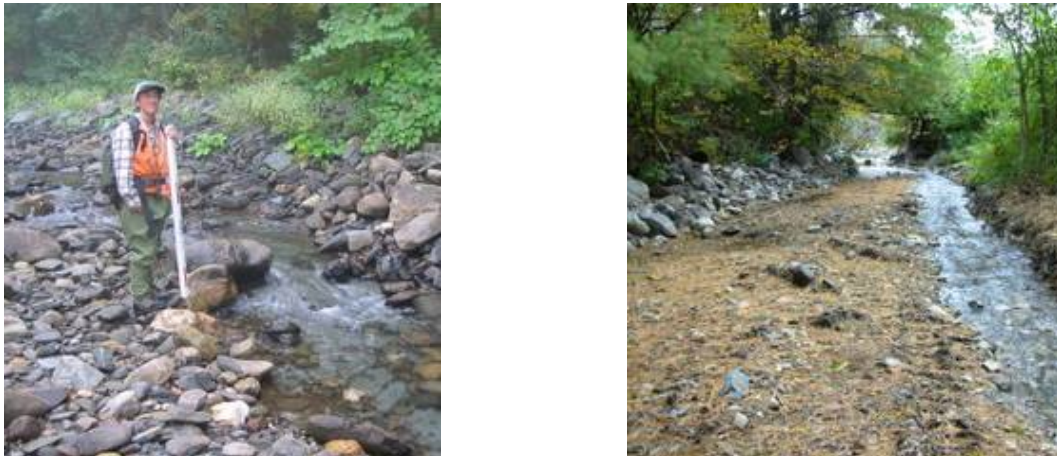
Figure 14. Bulldozing after the 1973 flood pushed windrows of stone from the stream and exposed lodgment till (grey stripe in the bed of the stream at left) in reach M05 and other areas, and more recent channelization has occurred in reach M06 on the Blood Brook mainstem (right).

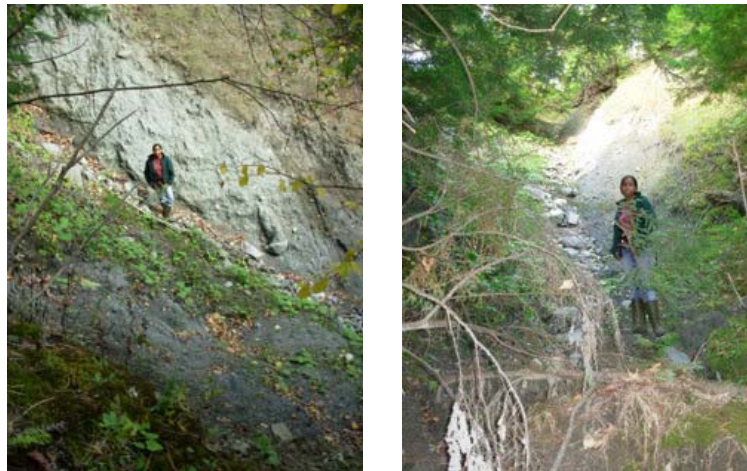
Figure 15. Mass failure/gully along Bragg Brook appears related to a one-time break in a water line upslope of the stream, which contributed to channel slope increases through downcutting and localized slope and depth decreases through significant deposition.

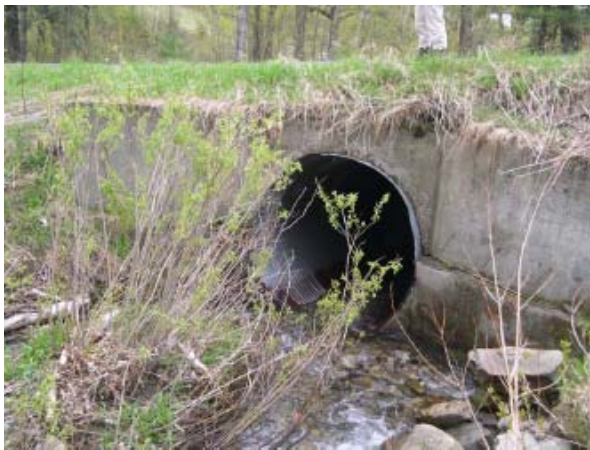
Figure 16. Cumulative deposition now obstructing a culvert at Old Orchard Ln. indicates the culvert is not sized adequately to transport sediment as well as water at high flows (photo courtesy of TRORC 2006).

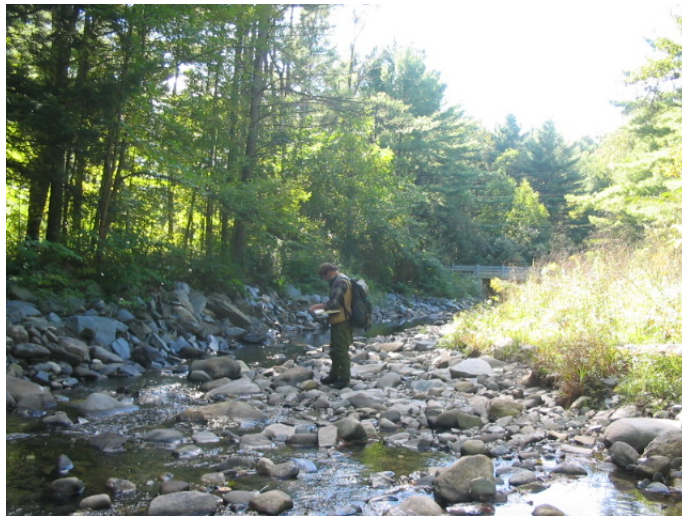
Figure 21. Windrowing of stone along reach M05 is not technically considered bank armoring, but frequent presence, along with a very broad valley, incision ratio of 1.25, and extensive erosion and mass failures elsewhere in segment M05A led to sediment regime reclassification from Coarse Equilibrium and Fine Deposition to Fine Source and Transport and Coarse Deposition. In segment M05B there was additional bank armoring present and less coarse deposition, and the sediment regime was classed as Unconfined Source and Transport.

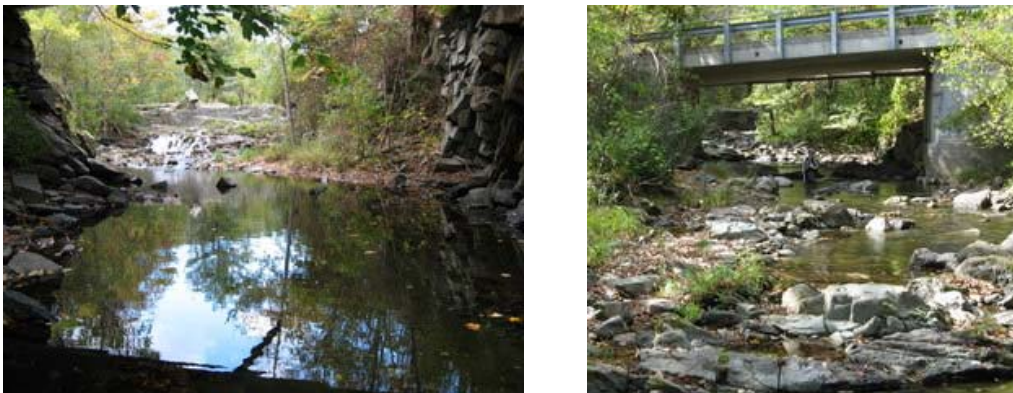
Figure 26. The bridges at Elm St. (left) and Hopson Rd. (right) were built near the locations of waterfalls. Substantial bedrock outcrops at these locations increase stream stability and limit channel adjustments but also create channel and floodplain obstructions that could increase the possibility of channel avulsion in a flood or ice jam.

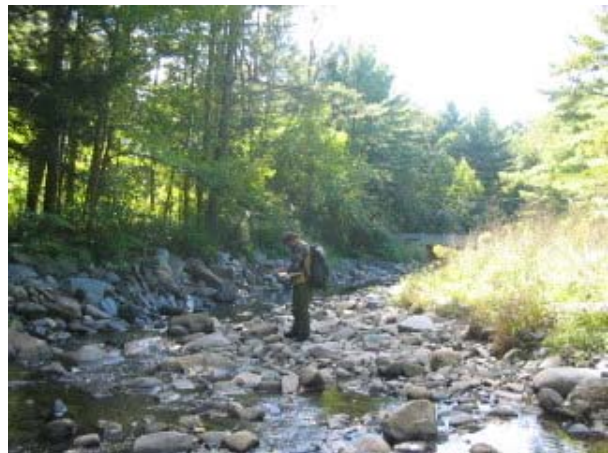
Figure 29. Windrowed stone pushed from the stream channel after the 1973 flood effectively functions as a berm on both sides of the stream in portions of segment M05A.

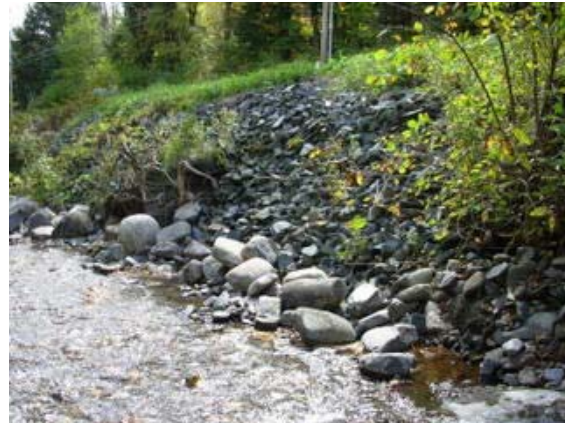
Figure 32. Road encroachment in reach M06 sometimes confines the stream sufficiently to change both the valley confinement type and stream type (C to B) over short distances.

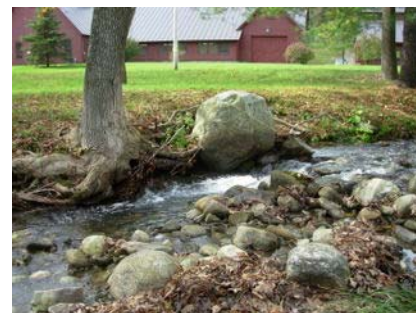
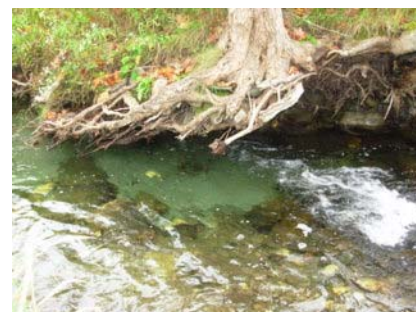
Figure 36. Lack of buffers, headcuts, undercut banks and exposed lodgment till were all noted in Reach M07.

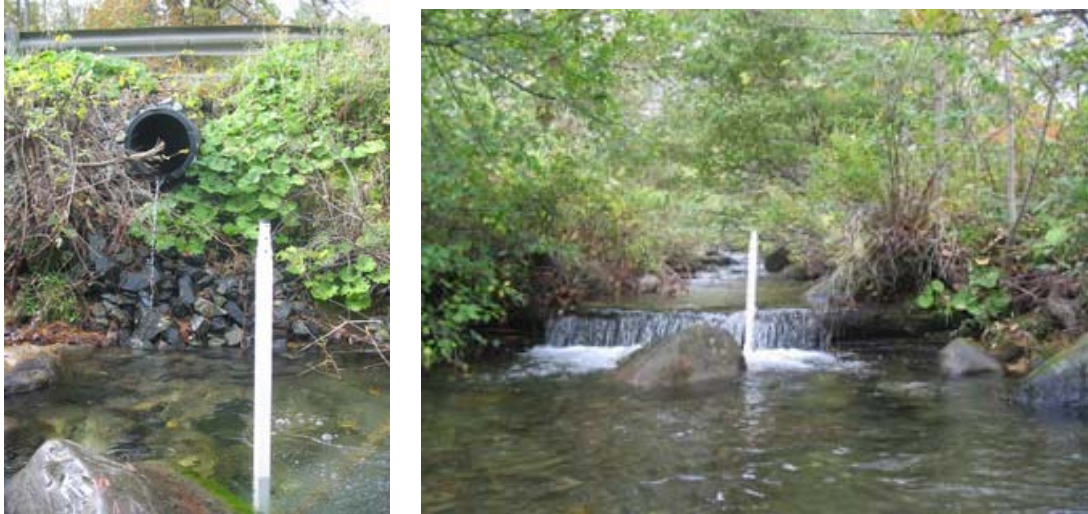
Figure 40. An elevated pipe carrying overflow from a pond above the floodplain daylights on the steep banks below Turnpike Rd. in segment M08A (left). Degradation of erodible bed materials below this outfall has formed a 3-foot-deep pool, and concern about upstream migration of this downcutting may be a primary reason for installation of a check dam just upstream of this point (right).

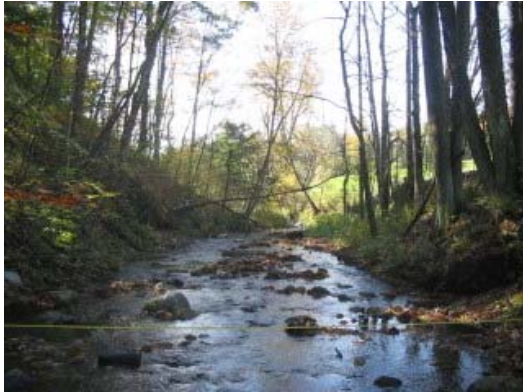
Figure 41. Long-term maintenance of the stream against the valley wall in segment M08B has contributed to sufficient downcutting, causing stream entrenchment and loss of floodplain access.

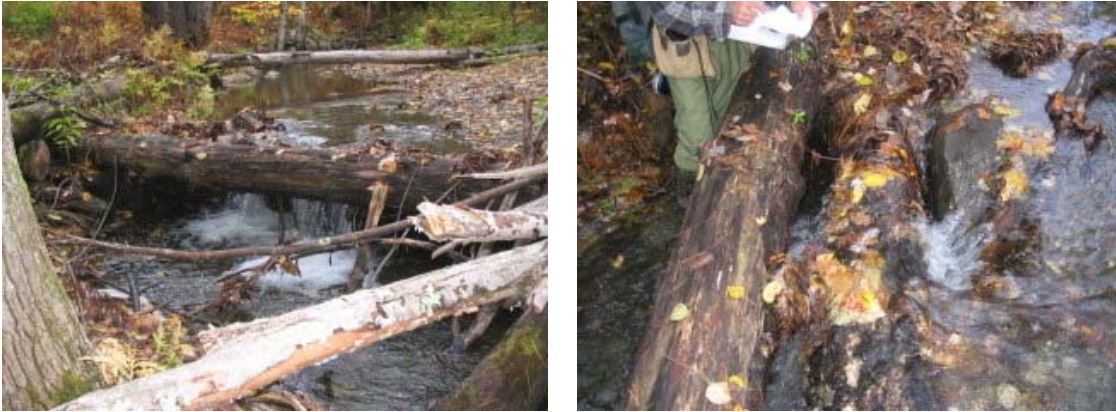
Figure 43. A log dam in segment M08C (left) that appears to have been installed as part of a stream ford to access a log landing has been eroded and is now forming an active headcut with the potential to migrate upstream rapidly (right).

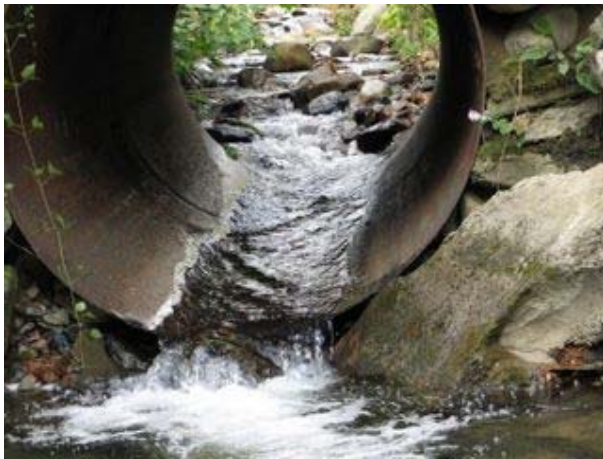
Figure 44. Indications of scour undermining this culvert make the possibility of upstream migration of headcuts a concern for structural integrity. Sediment deposition above – not as heavy at this culvert as some others in the study – indicates a structure may not be adequately sized to transport sediment as well as water at bankfull flows.

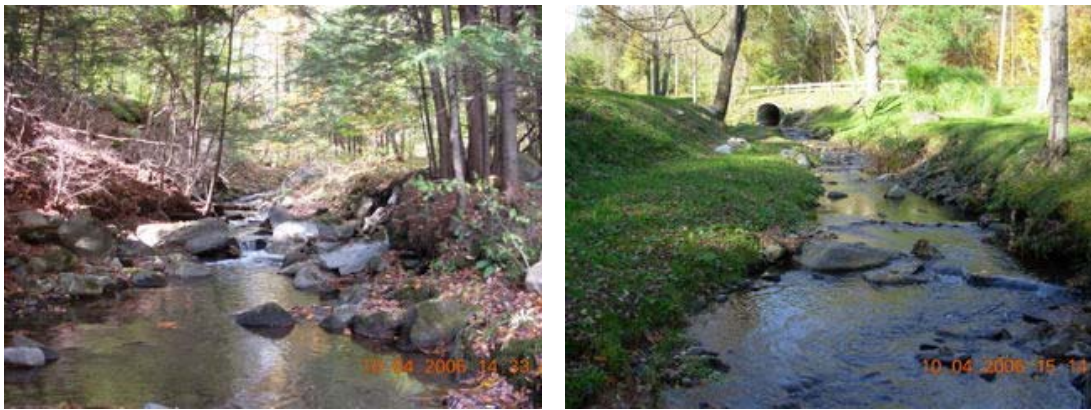
Figure 46. Segment M09A was noticeably incised, limiting access to historic floodplain.

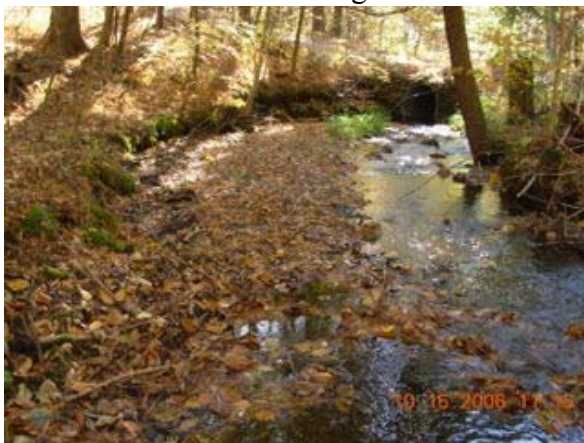
Figure 47. Substantial deposition above an undersized culvert in segment M09A has begun to obstruct the inlet. Such a situation provides sediment storage and flow attenuation, but it increases risks of outflanking and erosion hazards..... 96

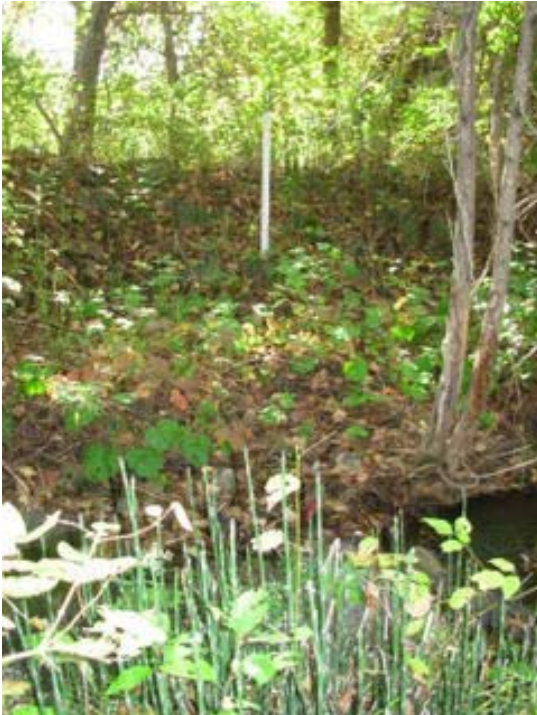
Figure 50. A high berm on the left bank of segment M03-T1.01A prevents the stream from accessing the floodplain.

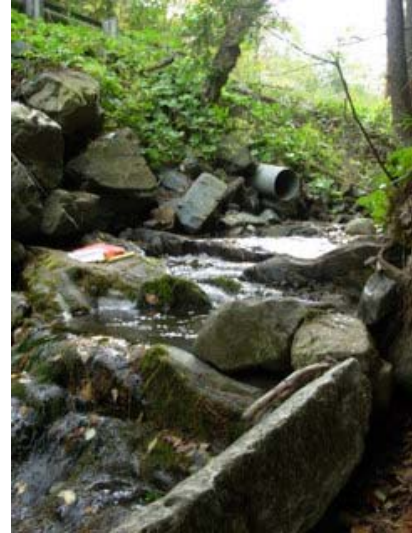
Figure 53. Road encroachment and channel constrictions such as this culvert in segment M03-T1.02B can combine to create localized increases in stream power and decreases in sediment load that increase the likelihood of downcutting processes.

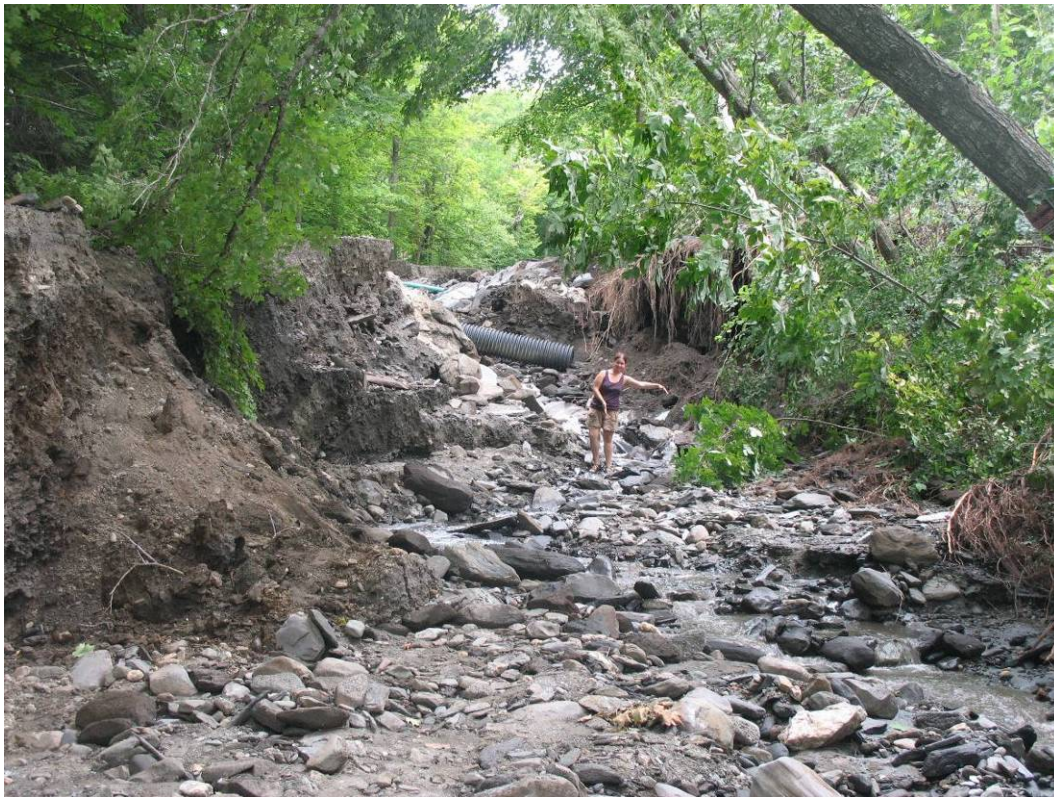
Figure 55. This road was taken out by a small, unnamed tributary of Ayers Brook in Randolph, Vermont, when the stream avulsed and cut a new channel in an intense thunderstorm during July 2007. The woman at the center of the photo is indicating the post-flood width of the stream by her armspan.

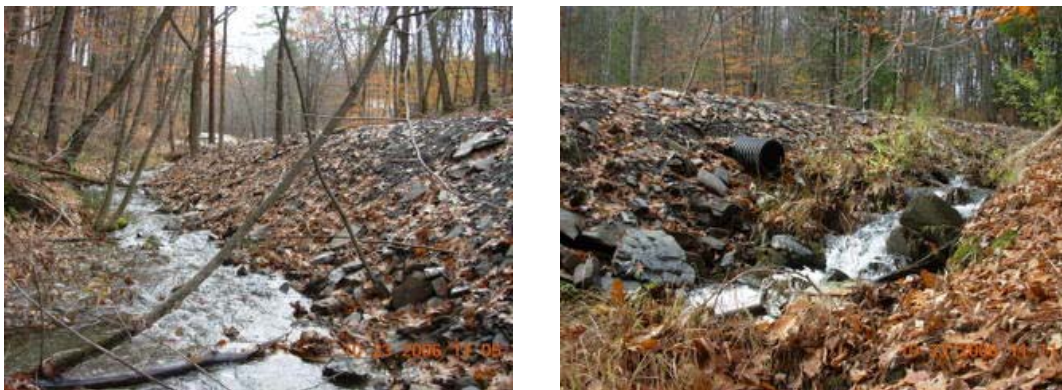
Figure 57. Encroachments along more than 20% of segment M03-T1.03A contribute to an increase in stream power.

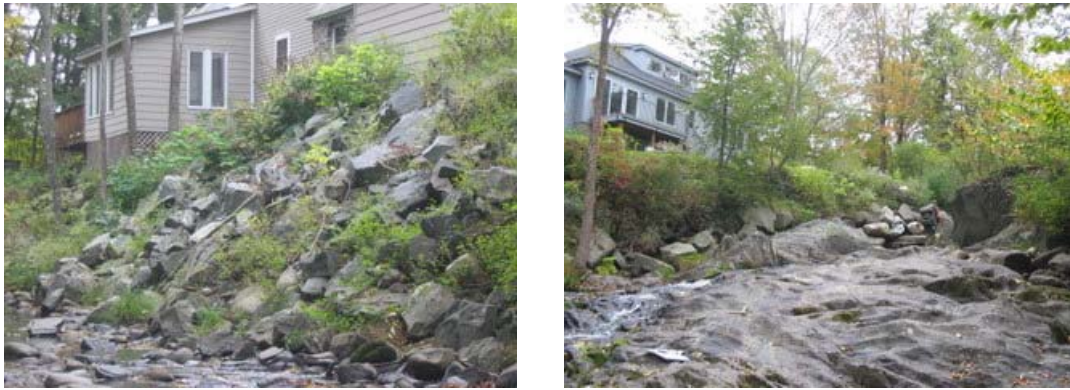
Figure 59. Corridor encroachments come right to the stream bank in segment M04-T2.01A.

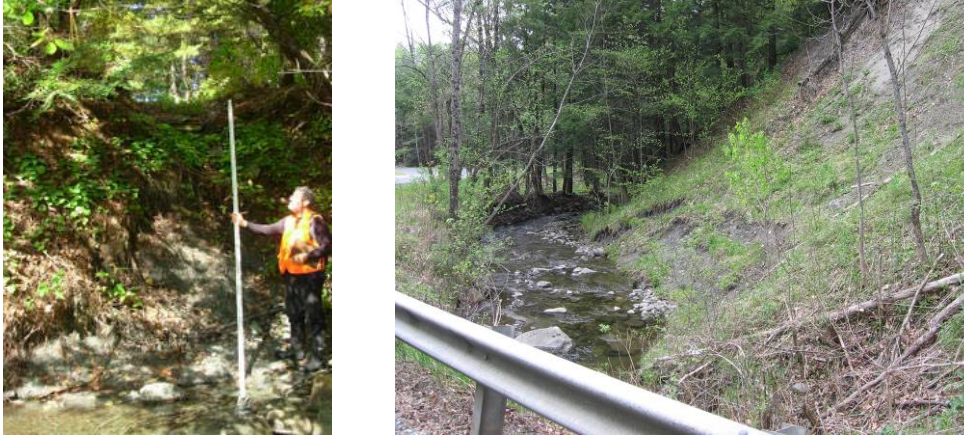
Figure 61. (Left) Norwich Conservation Commission volunteer Jonathan Frishtick extends a measuring rod near bank erosion located just above a headcut in the downstream portion of New Boston Brook.
