**Phase 1
Stream Geomorphic Assessment
Blood Brook Watershed
Norwich, Vermont**

**Prepared by
The Two Rivers-Ottawaquechee Regional Commission
September 2006**

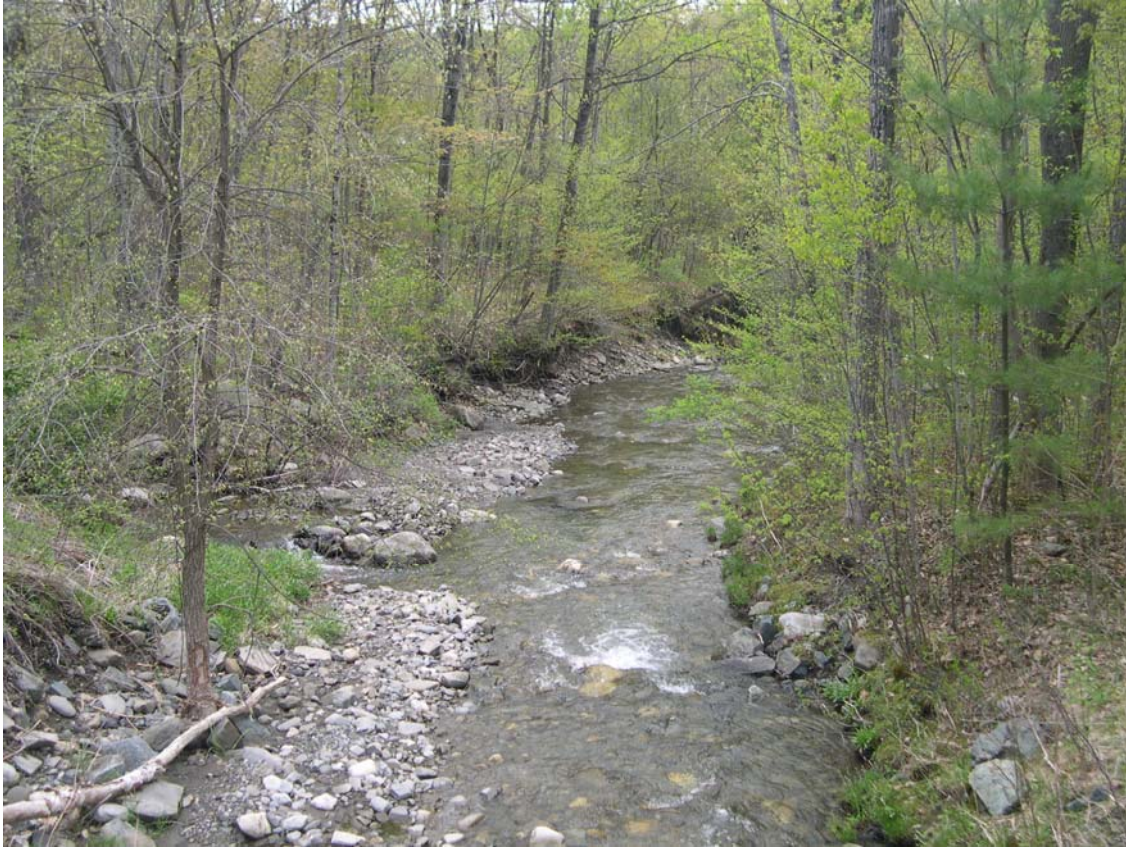
Figure 2 – Typical Bank Erosion in the Blood Brook Watershed at confluence of Beaver Meadow Brook and Mainstem

A 35' bank failure was visible just below Sun Lion Drive on M05 and two smaller 20' failures were visible along the Crooked Half Mile on the first reach of New Boston Brook (M05-T3.01). M05 is heavily armored above the bridge just above Sun Lion Drive and is experiencing significant erosion above the confluence with Charles Brown Brook at a dog leg. Agricultural field bank erosion was visible along M03 with bank erosion heights at 8' near US 5 in the dog leg and floodplain forest area and along an abandoned hay field just above this area. At the next sets of fields that are still being actively hayed below Hopson Rd and Brookside Drive, the bank heights were approximately 2' to 3'. M06 had high banks on the especially on the right side and is more confined than M07 and M05 as it approaches the confluence with New Boston Brook. This reach is experiencing bank erosion along the steep valley walls and before stream crossing structures.

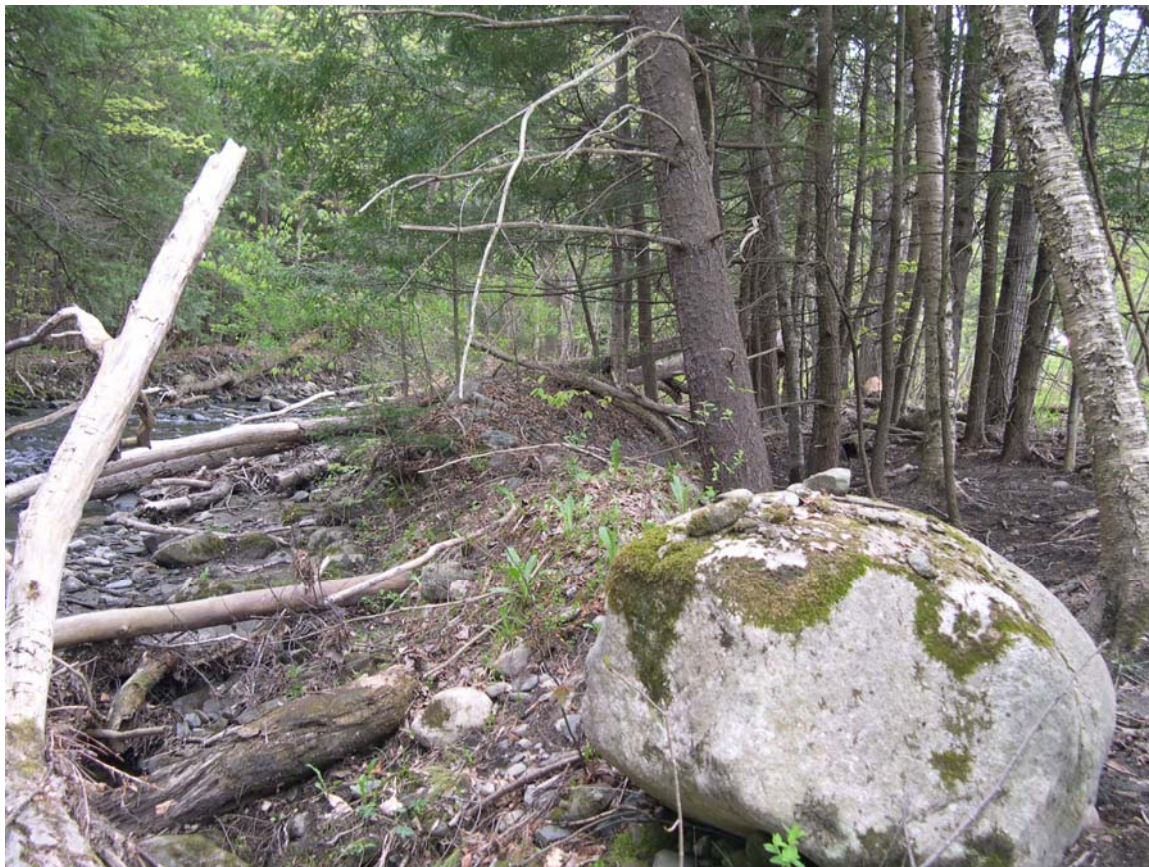
Figure 3 – Berm at base of Charles Brown Brook at Brigham Hill

Reaches where berms, roads, railroads or improved paths were located along 20 percent or more of the river corridor were given impacted ratings of *high*. Eleven of the 25 studied reaches received an impact rating of *high* for berms and roads due to the location of state and town roads and driveways within the watershed. Turnpike Road imposes a *high* impact along six out of nine reaches on the main stem. Town roads run along three other tributaries and were found to cause a *high* impact along several reaches.

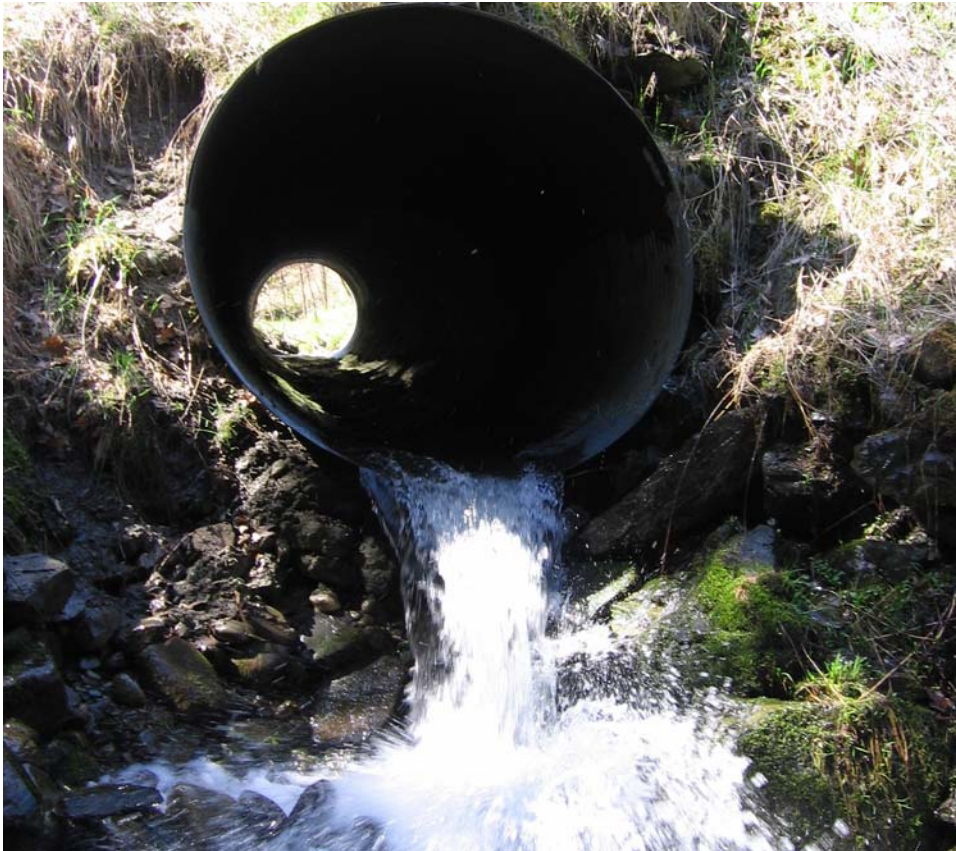
Figure 4 – Perched Outlet Poor Installation on Bragg Hill Road

Culverts that are not installed at or slightly below the stream grade block organism passage. Organisms cannot pass through these culverts because of they cannot access the outlet and then they may not be able to travel up the bare culvert bottom. Erosion or scour at the inlet and outlet can occur at these culverts if the culverts were installed above grade because the water backs up at the inlet and cascades out the outlet. Aggradation or sedimentation can also occur upstream of the culvert resulting in debris jams.

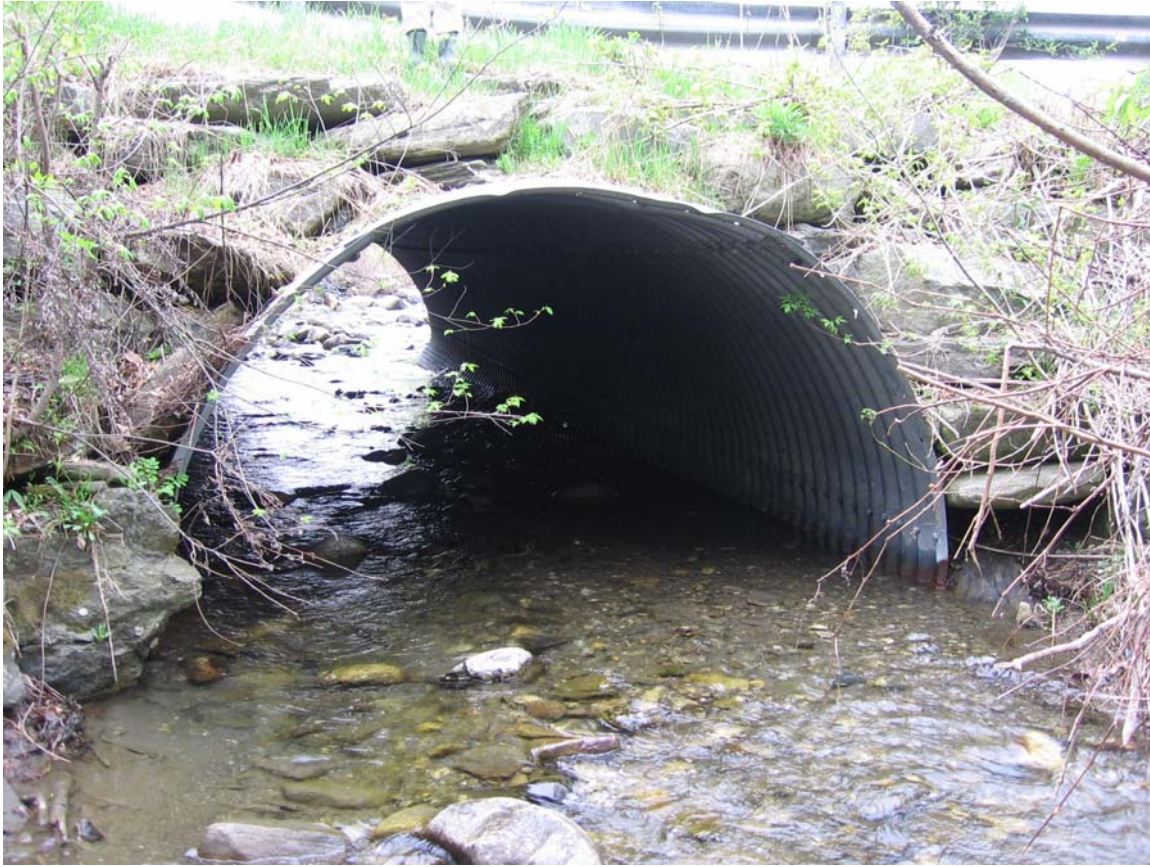
Culverts that are installed at grade allow sediment and debris to pass through more readily than above grade culverts resulting in less erosion and debris jams. Organisms can negotiate these culverts because of the deposits inside the structure.

Figure 5 – Natural bed, at grade, Turnpike Road & Upper Turnpike intersection

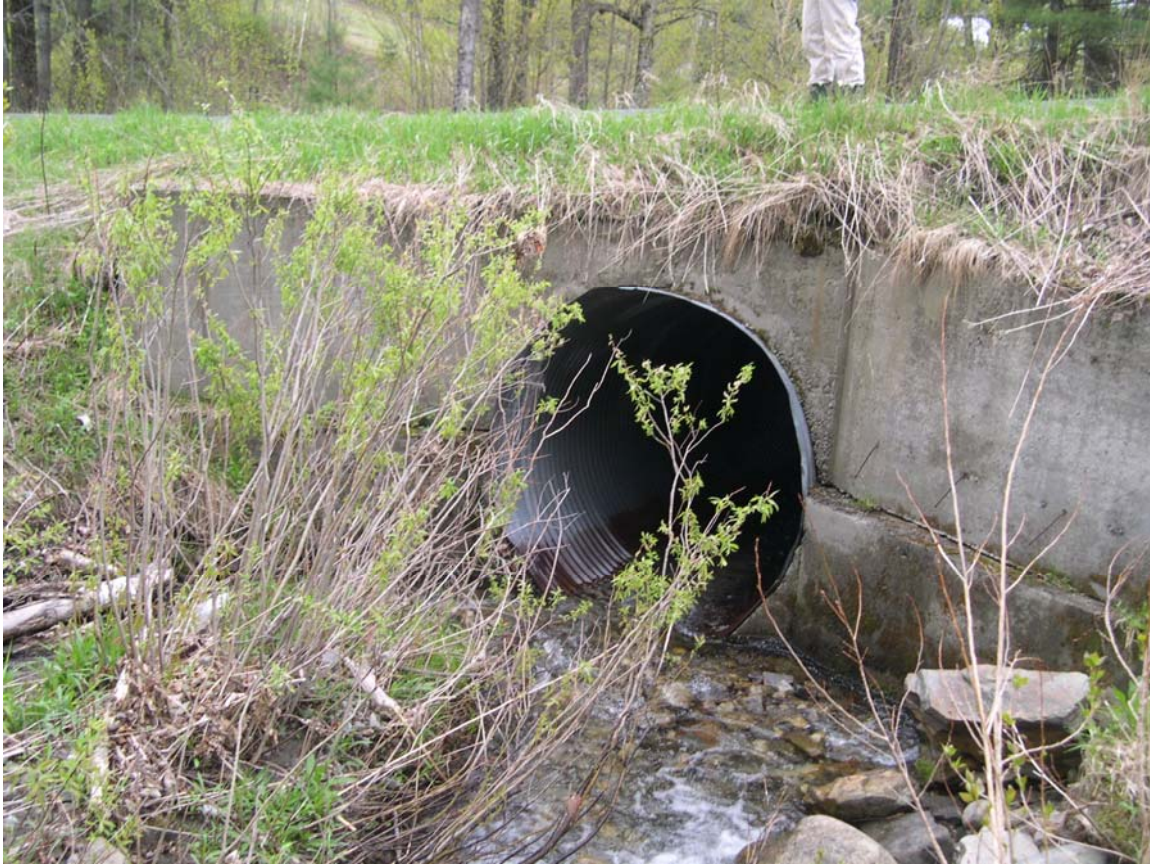
Figure 6 – Sediment Transport Impeded at Old Orchard Lane on mainstem

This private culvert on Old Orchard Lane is 29% of the bankfull width. This culvert is impeding the natural movement of sediment. The mid-channel bar immediately upstream of the inlet illustrates that deposition is occurring.

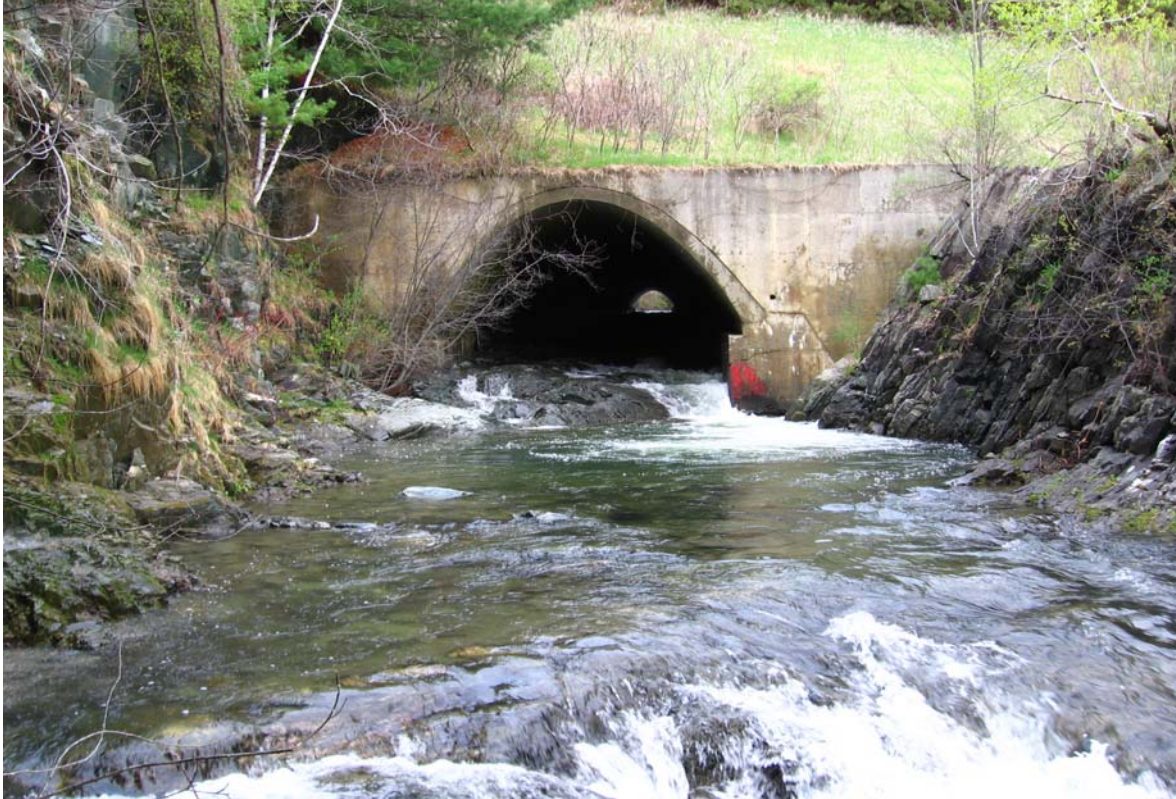
It is the opinion of TRORC that this issue is less critical to evaluation of structures in this watershed. Bedrock grade controls at the outlet of the arch at the mouth of Blood Brook (20009147214112) and at the nearby Elm Street bridge (101411004314111) are so steep, that it would be almost impossible for aquatic organisms to make it upstream

from there (see photo below). Further, since the arch at the mouth of the watershed is 700' long and has an extremely ledgy bottom, most aquatic creatures will not be driven to attempt passage of this structure. Based on this information, we believe the only aquatic organisms that use this watershed are local residents, not in-migrants.

Figure 7 – I-91 Concrete Arch at Mouth of Blood Brook
