**Phase 2 Stream Geomorphic Assessment  
Blood Brook Watershed  
Town of Norwich  
Windsor County, Vermont**

February 27, 2007

Prepared by:  
Daniel Ruddell, Elisabeth McLane, Staff Scientists, and  
Ben Machin, Principal  
Redstart Consulting

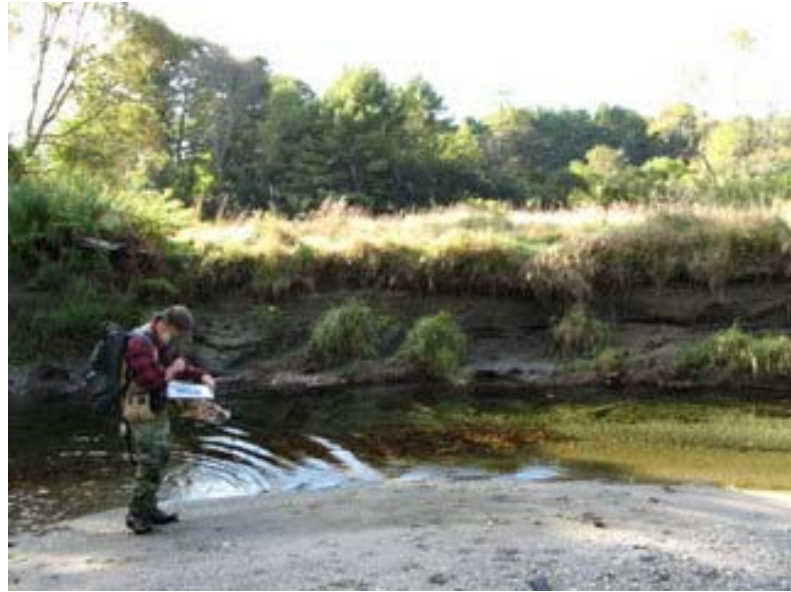
Hay fields represented the dominant land use in the right bank riparian corridor, and buffer width on this side was predominantly 51-100 ft. but dropped to less than 5 ft in portions of the segment. This was most notable on 100 ft of the outside bend leading to the dogleg in this segment (Fig. 4). Due to the non-cohesive nature of the bank materials in this section, this area was identified as a potential neck-cutoff and is strongly recommended for river corridor protection and buffer revegetation.

**Figure 4. Eroding banks at the head of a bend entering the dogleg in segment M03A.**

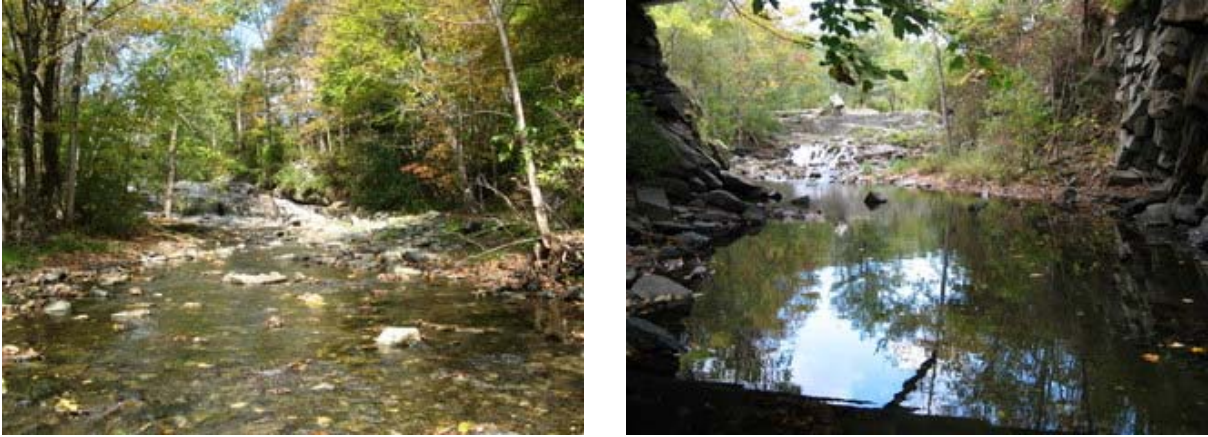
**Figure 5. Waterfalls at Elm St in the lower end of segment M03-B consist of a series of falls, ledge, and bedrock grade controls important to the stability of the stream in this segment.**

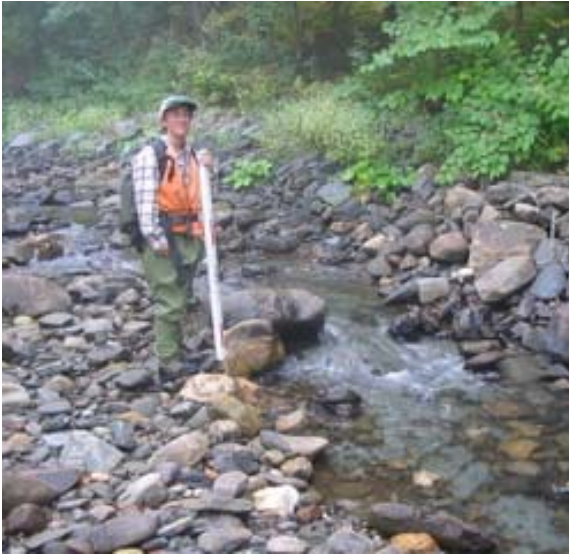
Recounts of local flood history indicate that bulldozing was extensive from this reach up the Blood Brook mainstem into segment M09A following the 1973 flood. This was evidenced in the field in this reach by a frequent lack of bed protection and exposure of lodgement till (Fig. 8), along with windrows of stone (sometimes used as riprap or berms) ranging from cobble to boulder size along both banks, and a likely access point for a bulldozer in the downstream section.

**Figure 8. Sections of the Blood Brook mainstem and Charles Brown Brook were bulldozed after a flood in 1973. Windrows of stone pushed from the stream are mixed with additional riprap in this portion of M05-B. The grey stripe in the bed of the stream is exposed lodgment till with no bed protection.**

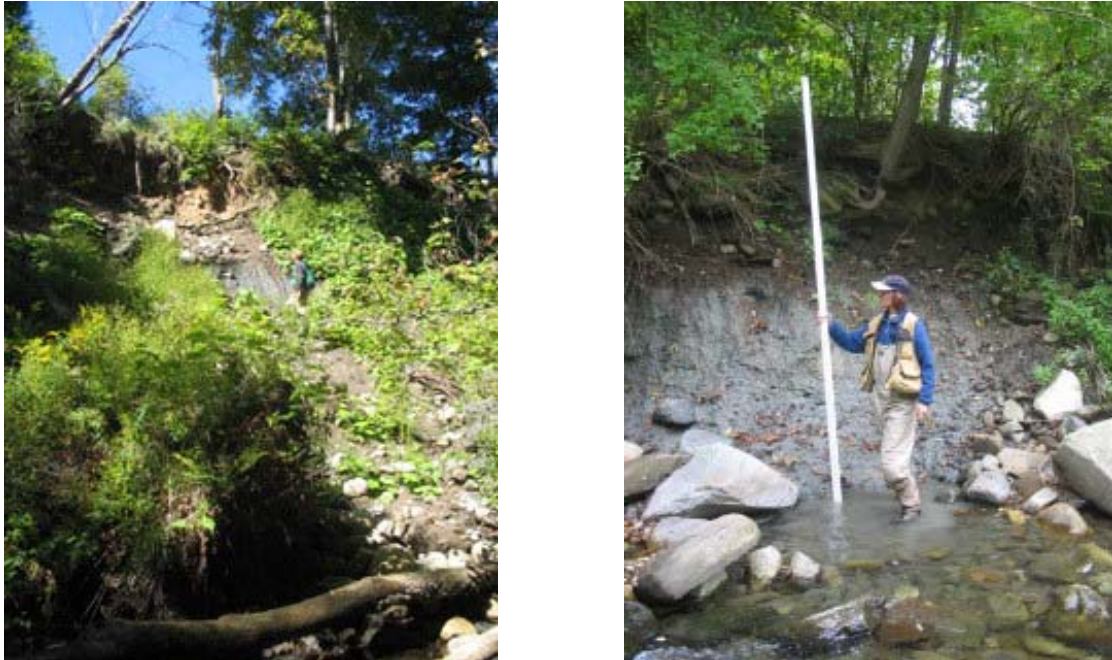
Erosion was extensive, with roughly 40% of the left bank eroded to an average of 4 ft in height and an additional 45% of the segment ripped up on this side. Roughly 10-15% of the right bank was eroded, with 15% ripped up. Erosion included areas of significant bank failure where the bank was composed of non-cohesive gravel and silt substrates, or underlain by lodgement till or clay (Fig. 9).

**Figure 9. Mass failure in M05A (left) and bank failure in M05B (right) are indicative of channel adjustment processes in Reach M05.**

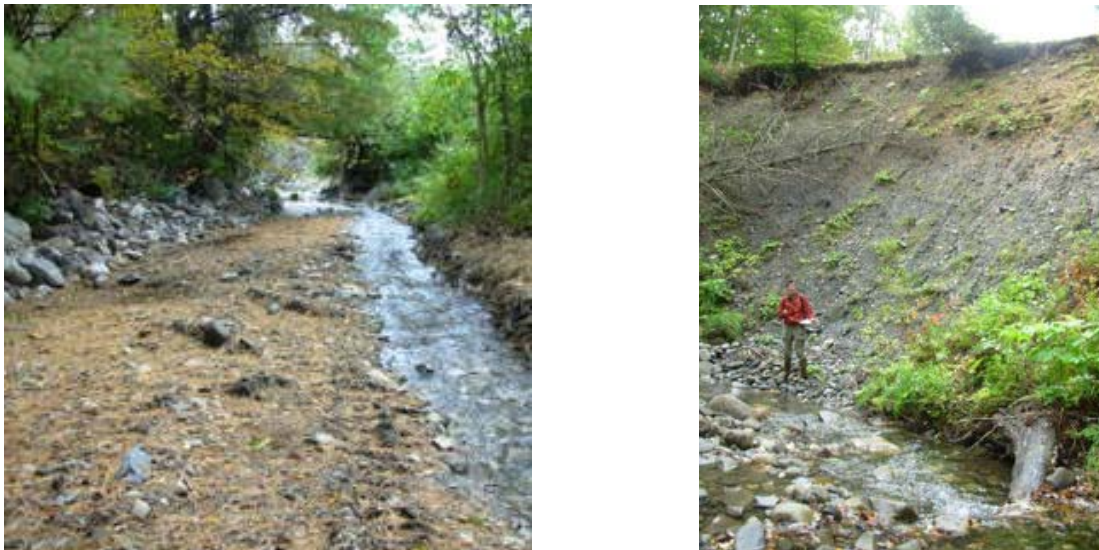
**Figure 10. Recent dredging (left) and mass failure (right) in Reach M06.**

*Potential project identification Reach M06:* This reach would particularly benefit from efforts to reduce channel constrictions by upgrading culverts and bridges to accommodate annual high bankfull flows and sediment transport. The constrictions are worth special consideration in corridor planning because they are likely to have a future impact on the integrity of the road infrastructure. This reach should be a high priority for inclusion in stream corridor protection planning that would identify areas where the stream can be allowed to access floodplain and find other ways to accommodate the adjustment processes that Blood Brook is currently undergoing. In addition, dredging may contribute to downcutting processes in this reach and measures for arresting upstream migration of headcuts may need to be considered.

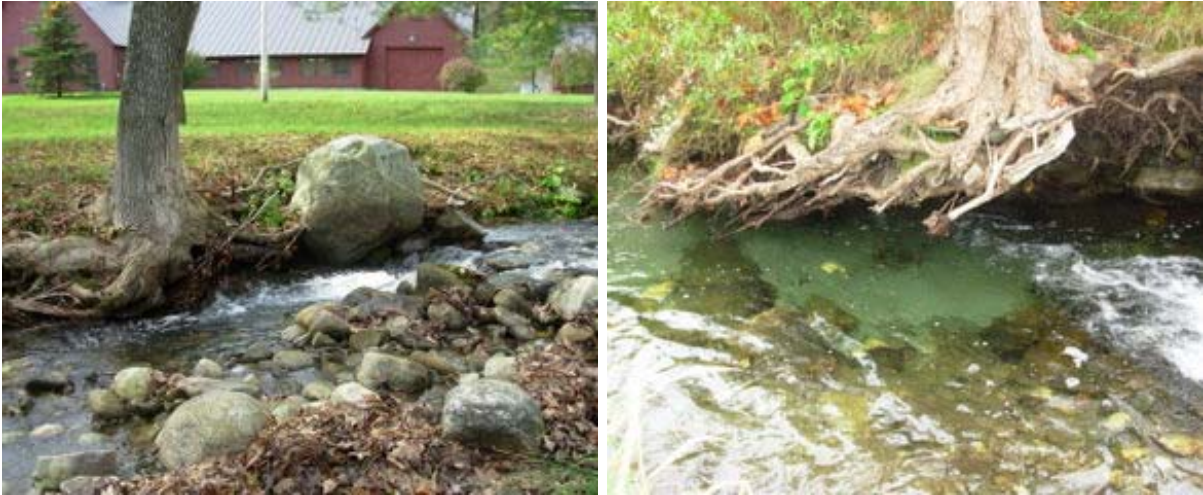
**Figure 13. Lack of buffers, headcuts, undercut banks and exposed lodgment till were all noted in Reach M07.**

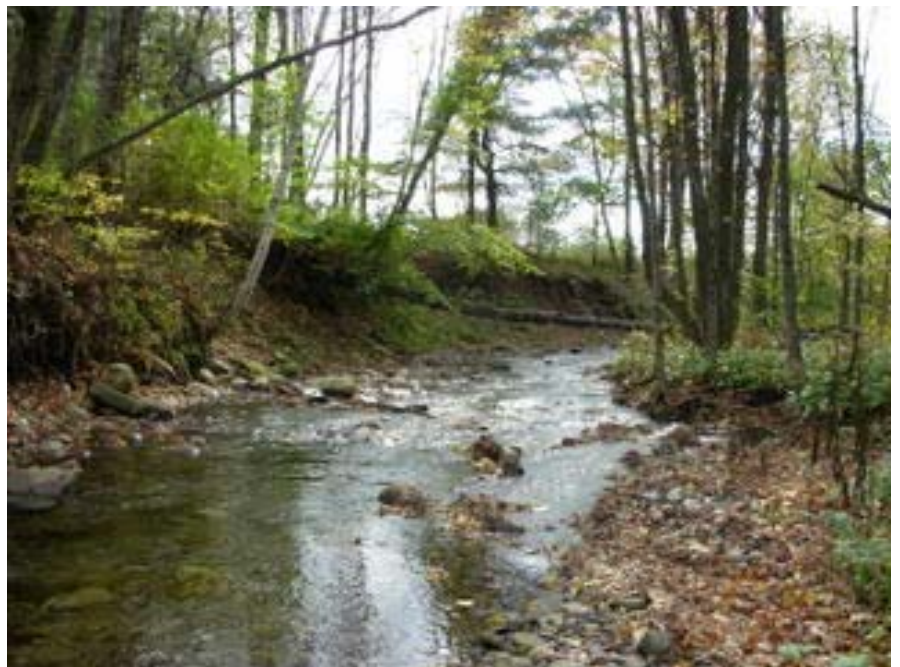
**Figure 14. An opportunity may exist to access some additional floodplain on the right bank of the stream in M07B to help relieve pressure on the left bank at high flows.**

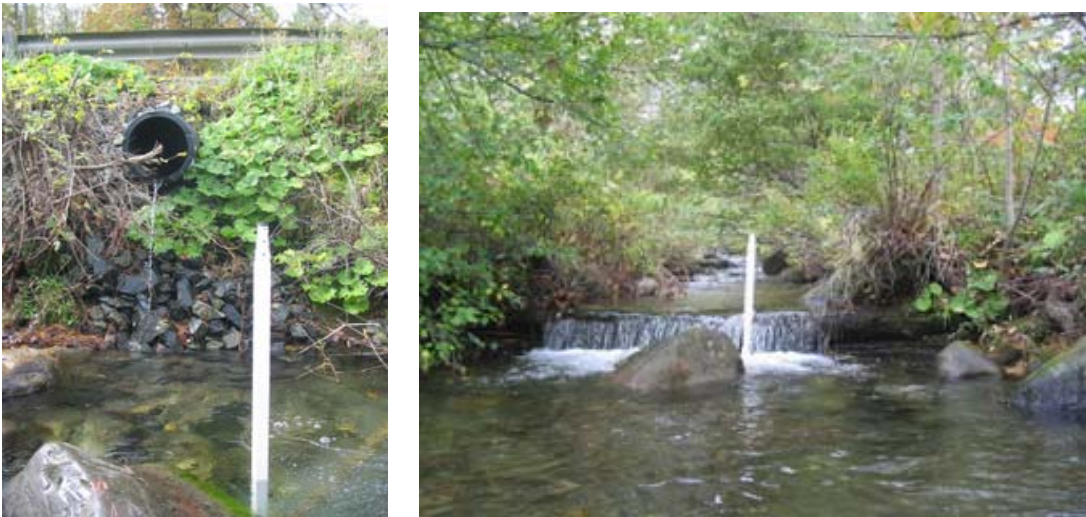
**Figure 16. An elevated pipe carrying overflow from a pond above the floodplain daylights on the steep banks below Turnpike Rd. in segment M08-A (left). Degradation of erodible bed materials below this outfall has formed a 3 ft. deep pool, and concern about upstream migration of this downcutting may be a primary reason for installation of a check dam just upstream of this point (right).**

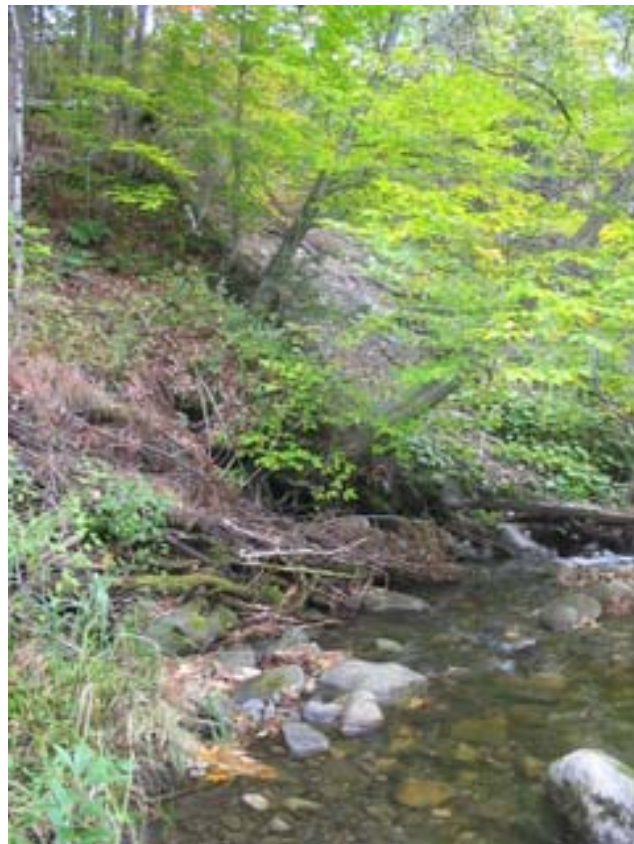
**Figure 17. Brush in the foreground was placed just upstream of a 25-ft. mass failure (background) at a hard bend in segment M08B on Blood Brook, where the stream meets the left valley wall.**

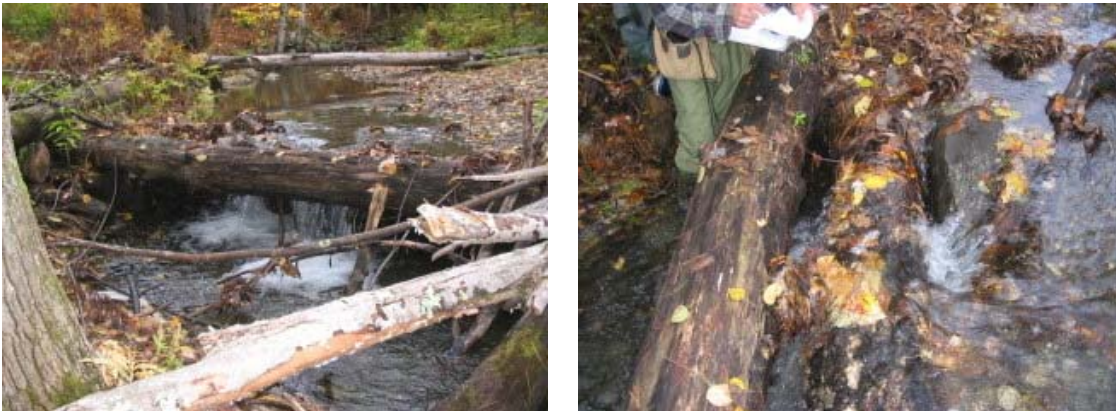
**Figure 18. A log dam in segment M08-C (left) that appears to have been installed as part of a stream ford to access a log landing has been eroded and is now forming an active headcut with the potential to migrate upstream rapidly (right).**

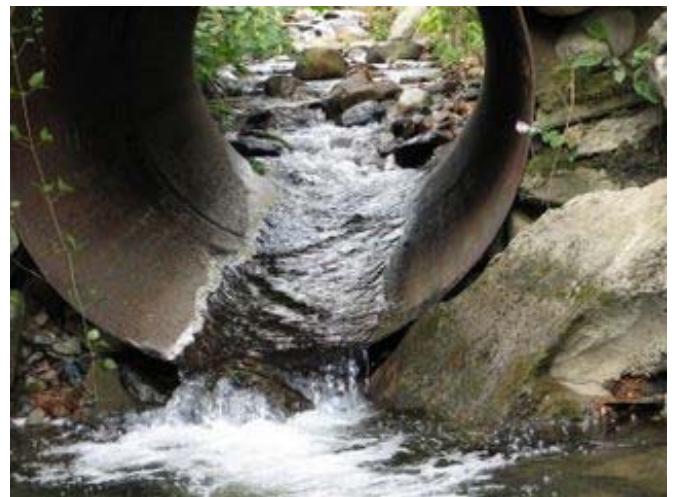
The perpendicular orientation of the driveways and road above the culverts in this segment present floodprone constrictions that, in conjunction with their close proximity to Turnpike Rd., would make this area a concern in a flood event. Soils in this area are highly erodible, although much of the banks are riprapped. The significant amount of riprap and berming in this segment will increase the likelihood of continued bed degradation. The presence of active headcutting in the next downstream segment suggests that high flow events could cause these cuts to migrate upstream rapidly, and the structural integrity of some of these culverts could be a concern in such a scenario (Fig. 19).

**Figure 19. Indications of scour undermining this culvert make the possibility of upstream migration of headcuts a concern for structural integrity. Sediment deposition above, not as heavy at this culvert as some others in the study, indicates a structure may not be adequately sized to transport sediment as well as water at bankfull flows.**

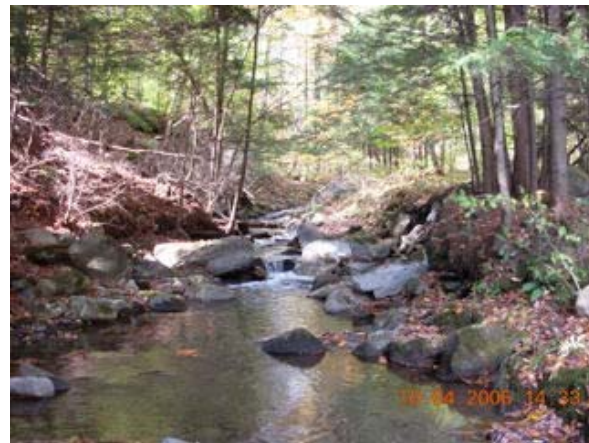
**Figure 20. M09A was noticeably incised, limiting access to historic floodplain.**

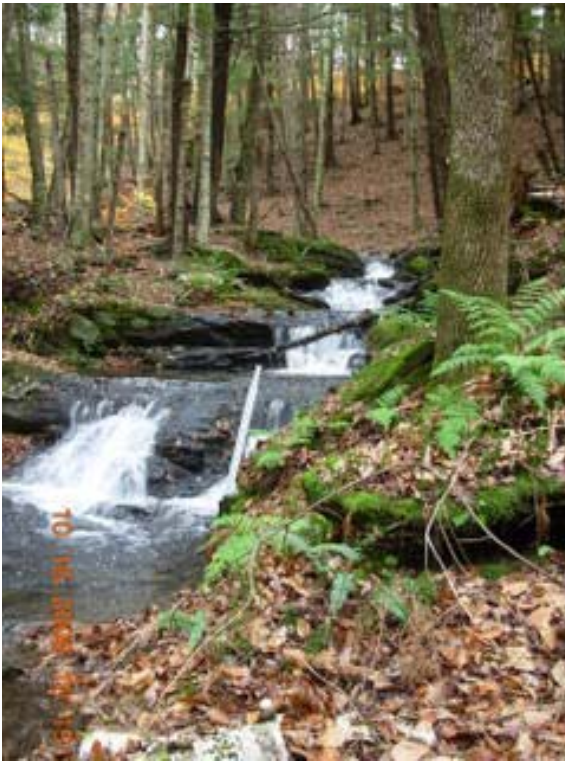
Segment M09B was rated in good condition on rapid geomorphic and reference on rapid habitat assessment scores, and offers a benchmark in this watershed for helping analyze meander geometry of the stream in a healthy condition, as well as excellent possibilities for protecting the relatively intact corridor from encroachment and development to avoid potential future landuse conflicts and erosion hazards. The presence of bedrock and ledge grade controls naturally limits upstream migration of bed degradation processes (Fig. 22).

**Figure 22. Segment M09B was rated in good condition on the Rapid Geomorphic and reference on the Rapid Habitat Assessment in Phase 2.**

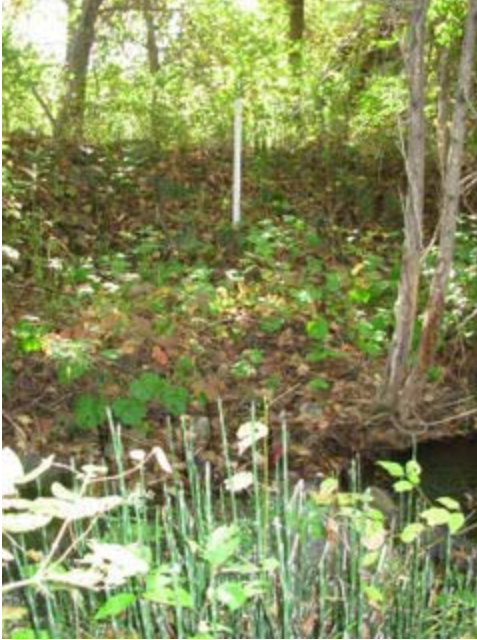
The lower segment (M03-T1.01A) was characterized by significant human manipulation and development, particularly on the left bank where a 790 foot berm prevents the stream from reaching its floodplain even in very high water (Fig. 24). A small housing development was located approximately mid-segment on this left bank. The right bank was characterized by steep slopes with a couple houses that only slightly impact the stream belt-width corridor.

**Figure 24. Berm on left bank of segment M03-T1.01A prevents stream from accessing the floodplain.**

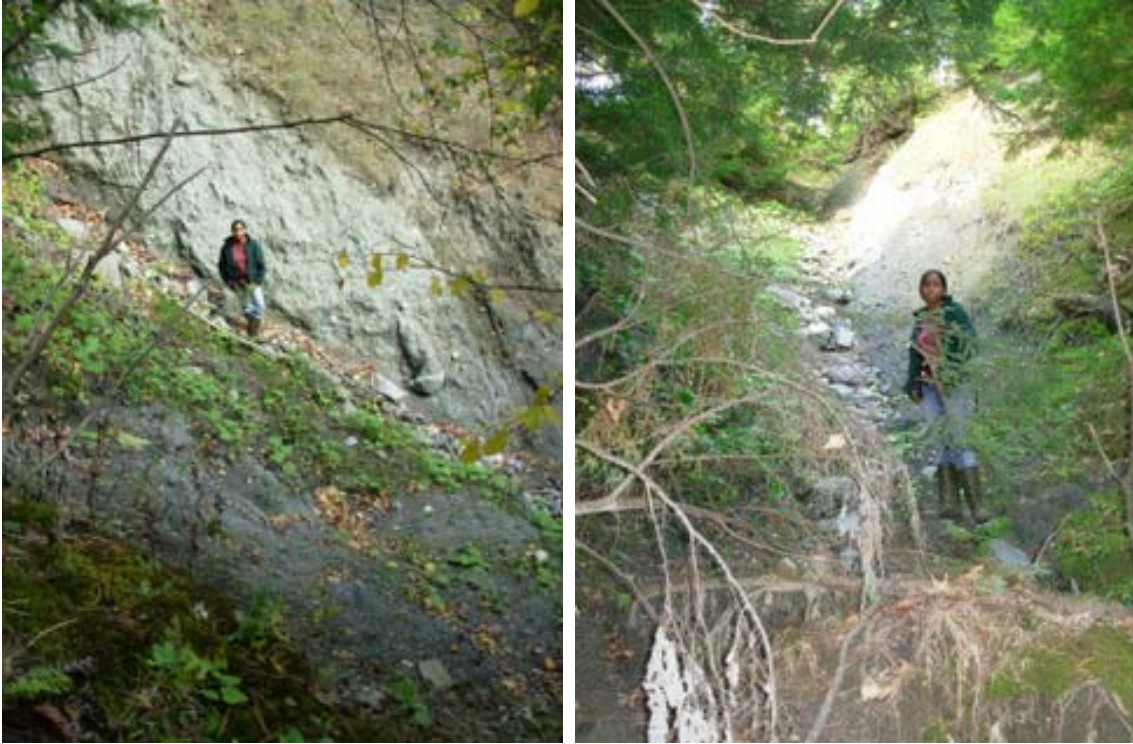
The lower segment (M03-T1.02 A) was dominated by ledge grade control and was largely in reference condition except for sediment inputs from mass failures on its steep left corridor. These mass failures appear related to a one-time break in a water line leading from town wells near the Connecticut River to a 3 million gallon holding tank on Dutton Hill Road, upslope of this reach, in the late 1970s (pers. comms., Andy Hodgdon, Norwich Road Foreman, December 2006 and January 2007). This area of erosion could also be termed a gully. It extended upslope 70 feet, and was approximately 15-20 feet deep (Fig. 26).

**Figure 26. Mass failure/gully in M03-T1.02A appears related to a one-time break in a water line upslope of the stream near Dutton Hill Road.**

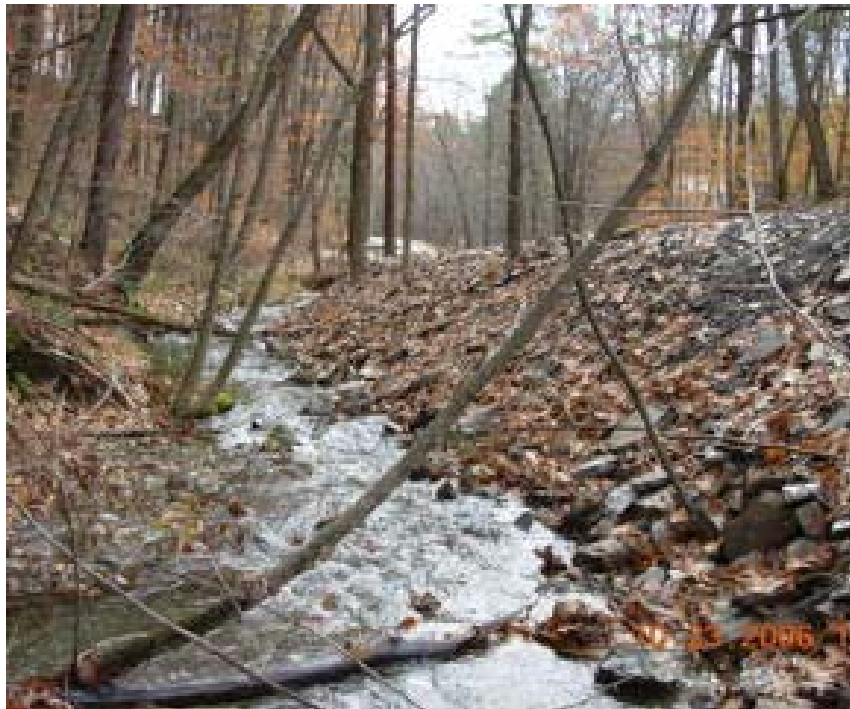
**Figure 28. M03-T1.03A, similar to many of the reaches assessed in the Phase 2 study of the Blood Brook watershed, was characterized by human development and frequent road encroachment.**

*Potential project identification – Reach M03-T1.03:* Potential projects for this reach are concentrated on the lower segment. A river corridor protection strategy that would allow vegetation to re-establish boundary conditions that can create resistance to stream power, particularly in areas where buffers are inadequate, is highly recommended. Road encroachment was an issue in several areas of the reach (Fig. 28), and the reader is again referred to the general discussion of infrastructure protection and development of a stream corridor protection plan included in Section 7 – Recommendations within the main body of this Blood Brook Watershed Phase 2 report.

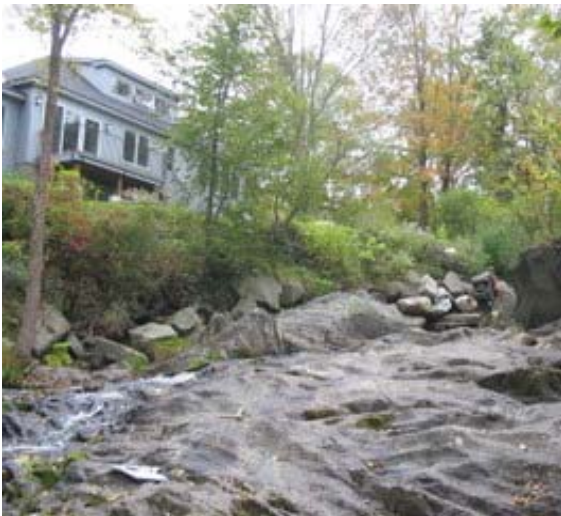
**Figure 30. Segment M04-T2.01A was marked by corridor encroachment and waterfall, ledge and bedrock grade control that contributes to limiting bed degradation.**

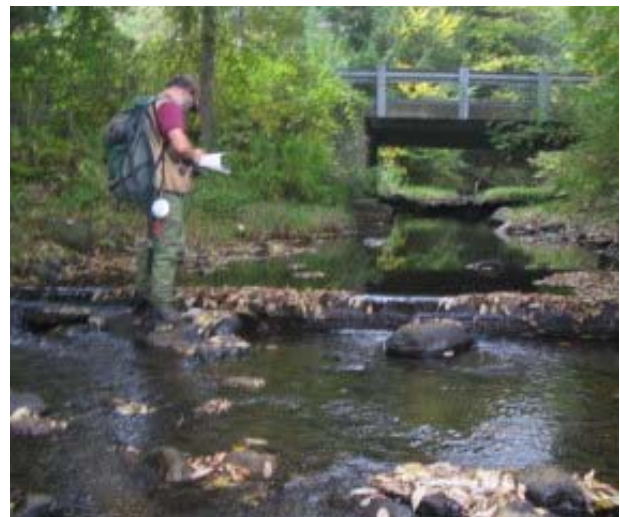
The upper segment (M04-T2.01B) had better buffers, but evidenced road encroachment, store and release damming of the “Norwich Pool” upstream, lack of natural grade controls (Fig. 31). This segment was bulldozed following the 1973 flood (pers. comms., former selectboard member Linda Cook, August 2006 and Town Road Foreman Andy Hodgdon, December 2006). It was deemed a C channel dominated by cobble substrates, also in a plane bed channel structure. There was one bridge in this reach, located in the downstream segment.

**Figure 31. Segment M04-T2.01B had better buffers but lacked the bedrock grade controls present downstream in this reach. The check dam in this photo may have been installed to limit upstream migration of headcuts and bed degradation.**

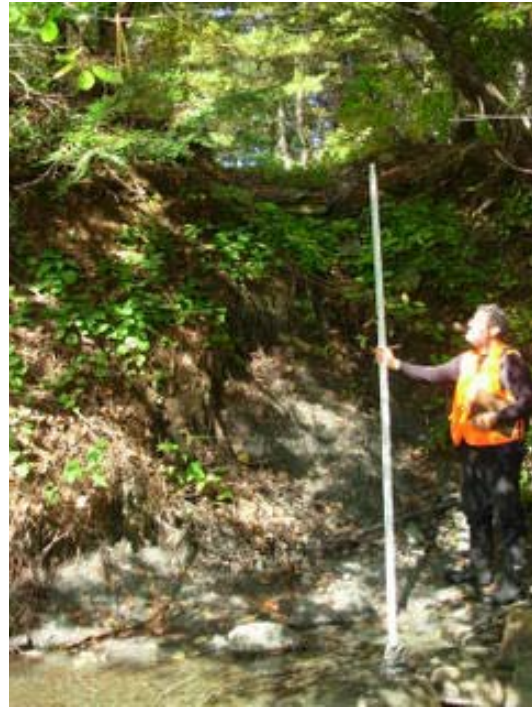
**Figure 33. Norwich Conservation Commission volunteer Jonathan Frishtick extends a measuring rod near bank erosion located just above a headcut in the stream.**

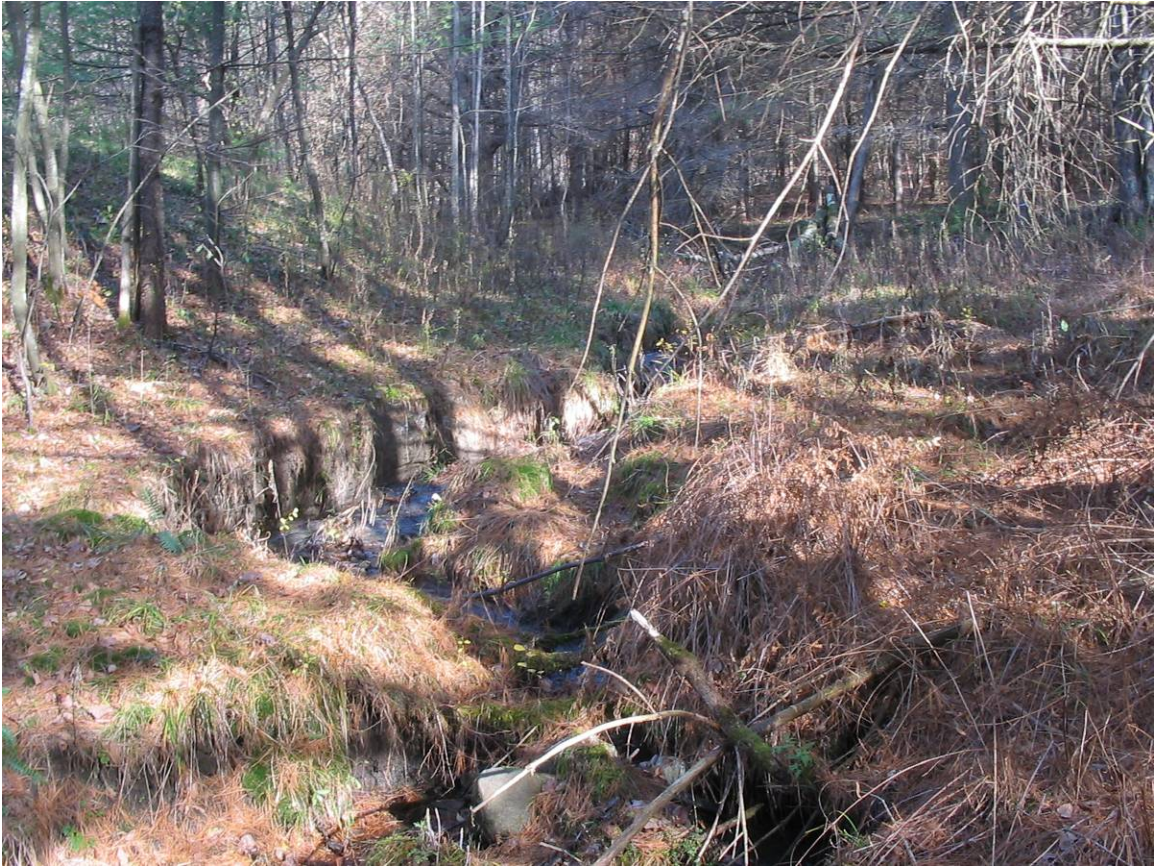
**Figure 36. Highly erodible soils on sideslopes above Reach M05-T3.04, like many sedimentary deposits in the Blood Brook watershed, are sensitive to increased stormwater inputs.**
