# Mill River

## Phase 2 Stream Geomorphic Assessment

### Rutland County, Vermont

December 31, 2007

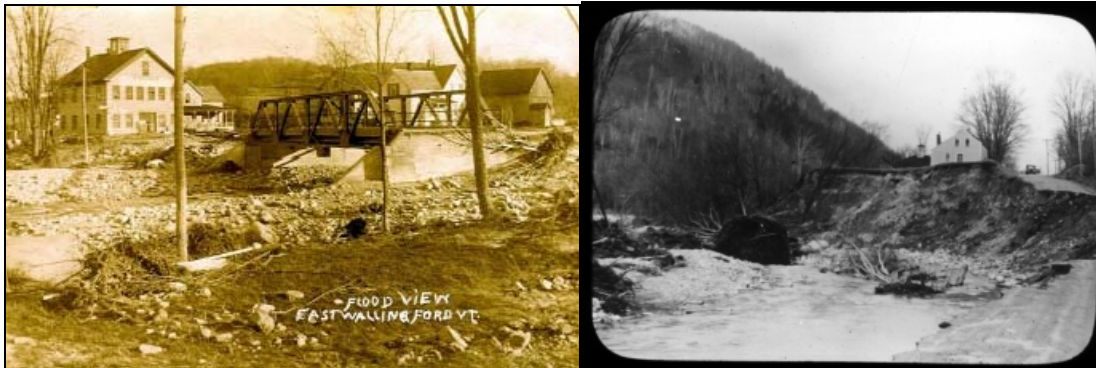
**Figure 3:** These image shows damage from the 1927 flood. Left image is looking towards the intersection of Route 104 and Route 155 (Reach M10) in East Wallingford. Right image is of route 103 washout in Cuttingsville near reach M06/M07.

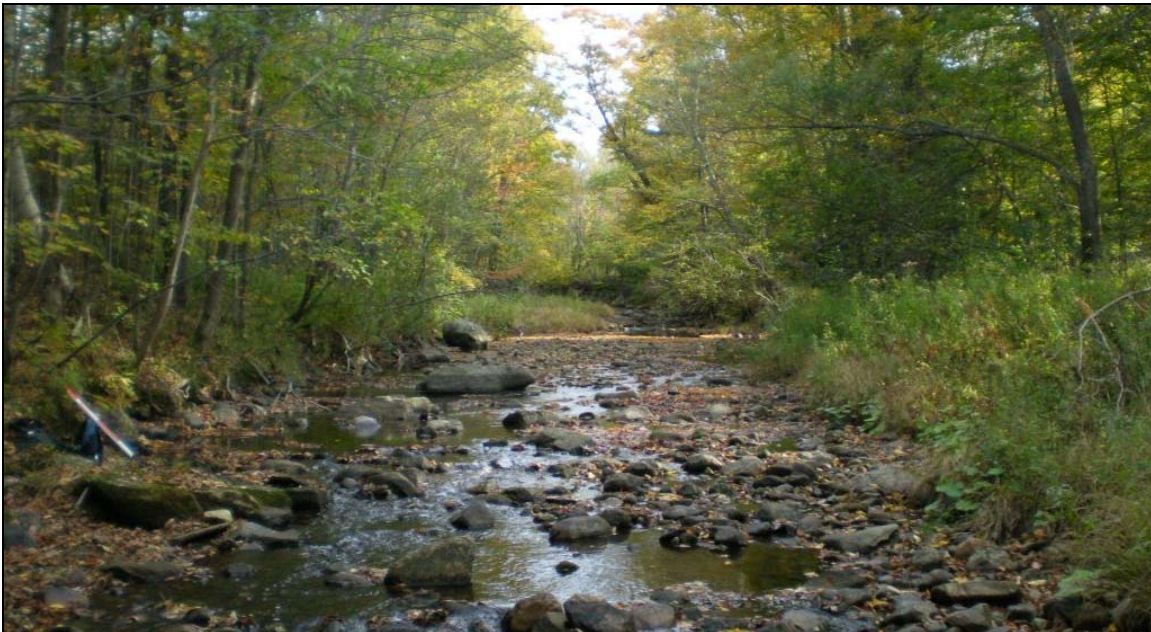
**Figure 7. Reach M15 has been historically straightened. It is an incised channel with a planebed form that is currently undergoing minor channel widening and planform adjustment.**

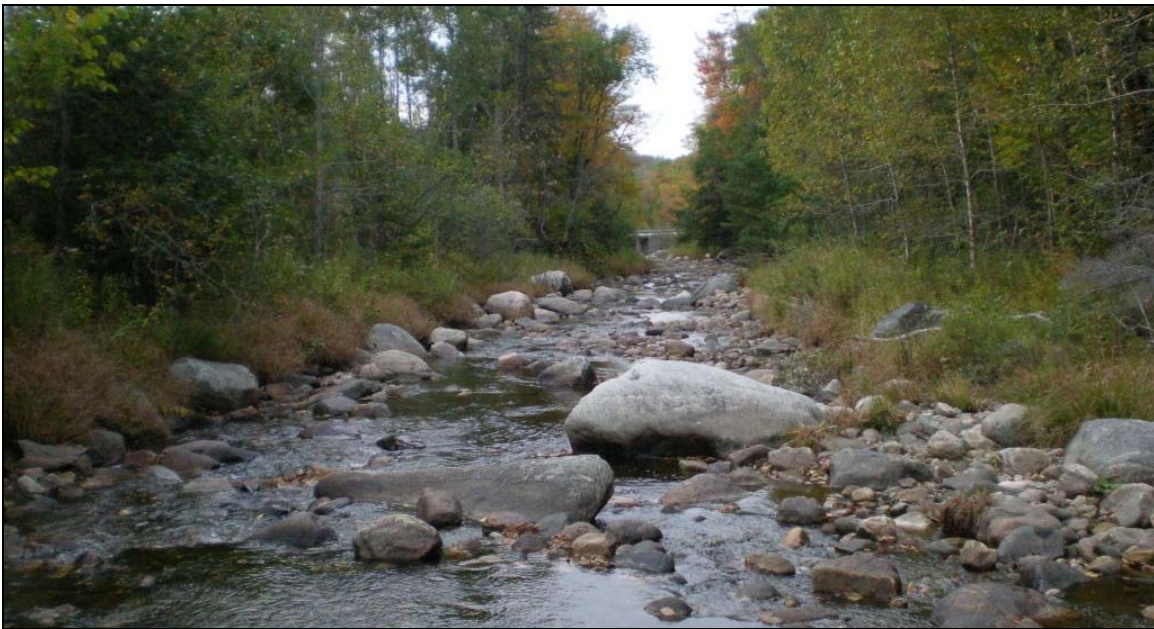
just upstream from the Barlow Road Bridge indicating a level of historic sinuosity has been lost. Deep incision was observed (measured ratio of 3). A stream type departure has ensued from a C-type channel to a B-type plane bed with a significantly reduced capacity to attenuate water and sediment due to the disconnection with the floodplain. Extensive widening and minor planform adjustments are occurring in the reach as the channel works to recover from the high level of incision.

Also of note in this reach, a large delta exists at the Meadow Brook confluence. The brook appears to be contributing coarse and fine sediment to the system as a result of tributary rejuvenation and possible other adjustments upstream. In regards to land use in the M14 corridor a single residence exists on the left bank. With much of the corridor still void of trees and undeveloped this reach may be suitable for an active geomorphic restoration project and/or buffer restoration efforts on the left bank.

**Figure 8. M14 has been historically straightened and is now has a plane bed form. Widening and planform adjustment are actively occurring.**

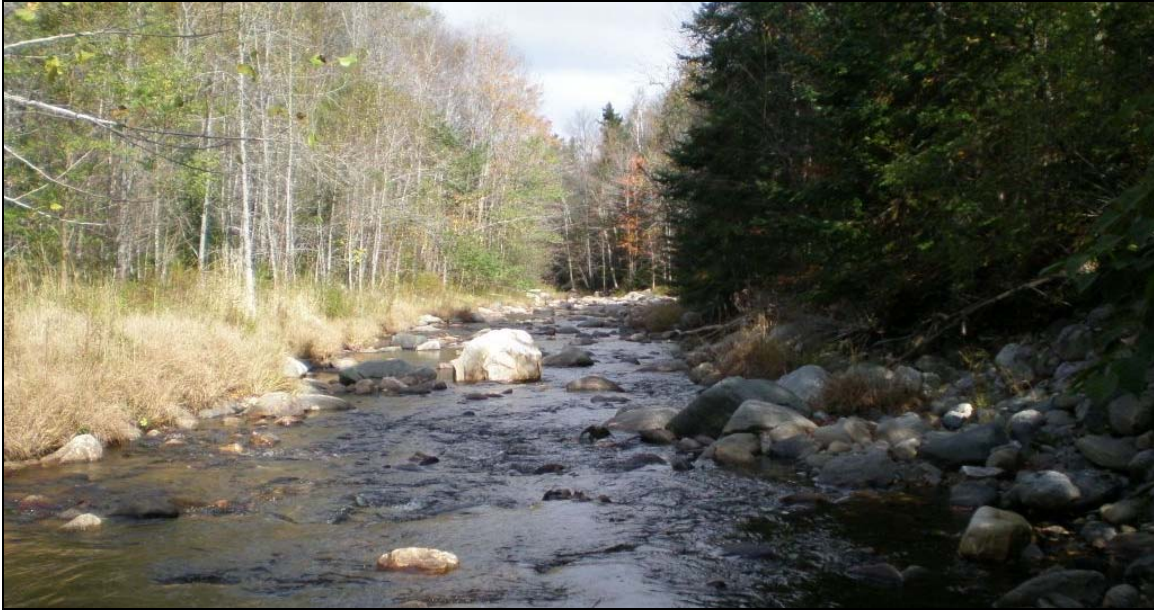
In regards to the observed stream condition, the channel was found to be slightly incised. Some minor widening has occurred. Extreme adjustments are unlikely in this reach due to the stable tendencies of B3 planebed streams.

**Figure 9.** M13-B is a B3 planebed segment by reference.

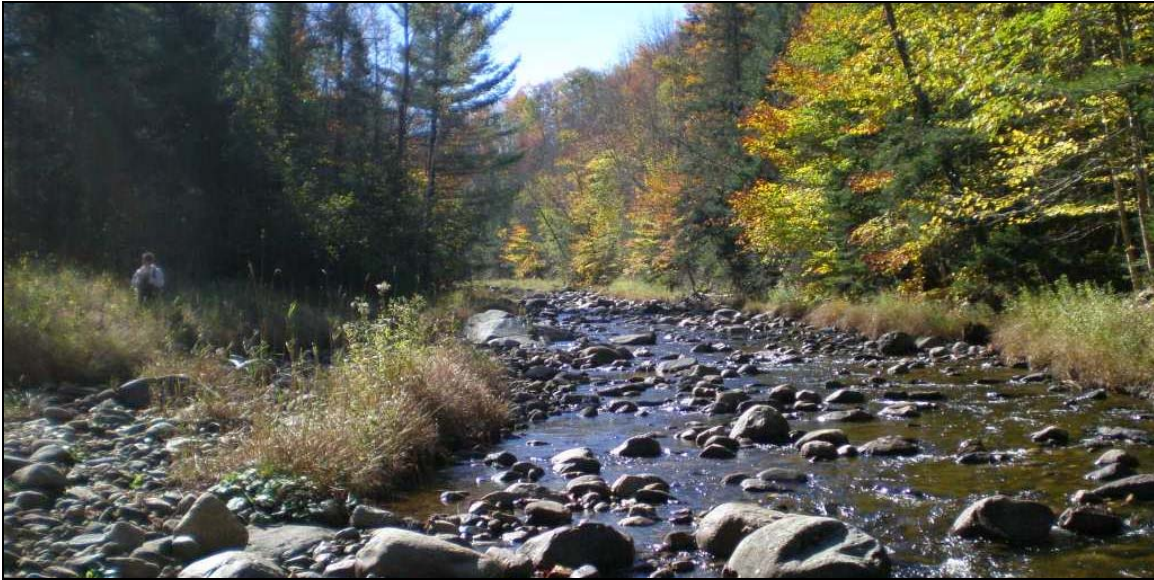
Mill River segment M13-A is a short segment located in a broad valley. Historic channel incision has led to minor channel widening and major channel planform adjustments. Despite a high degree of incision the stream has remained a C-type channel dominated by gravel substrates (Figure 10). The river is adjusting laterally through several flood chutes and has stored a significant amount of gravel in a large point bar. The well forested buffer in this corridor is an asset for the river as are the floodchutes and wetlands that will store some water and sediment during a large runoff event.

**Figure 10. M13-A is a C type channel that is undergoing planform adjustment and minor widening.**

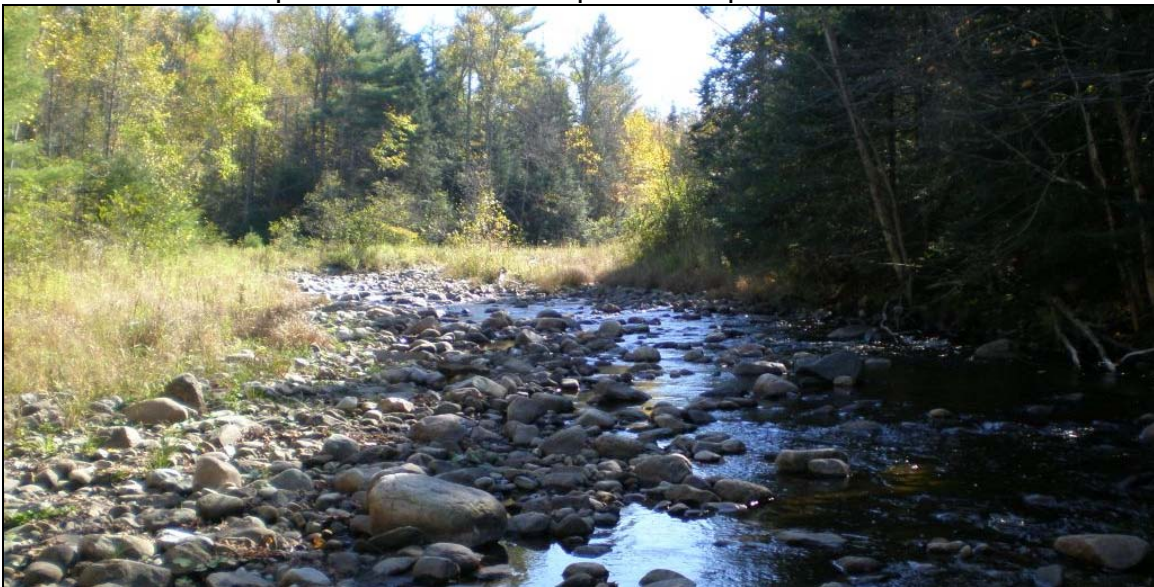
Mill River reach M12 begins upstream from Fowler Brook Road in the town of Mount Holly. This is a C channel that flows through a well forested corridor in a broad valley (Figure 11). Historic incision has led to a great degree of instability in the channel. There were numerous active flood chutes documented as well as new gravel bars indicating both planform adjustment and aggradation as the channel works to redevelop floodplain. Channel widening was also considered a major active adjustment process. This reach may be both a source and sink of sediment and flood waters and will become more of a resource for the watershed as the channel evolution processes continue to improve floodplain access.

**Figure 11. M12 has incised historically. Major planform adjustment, widening, and minor aggradation were observed.**

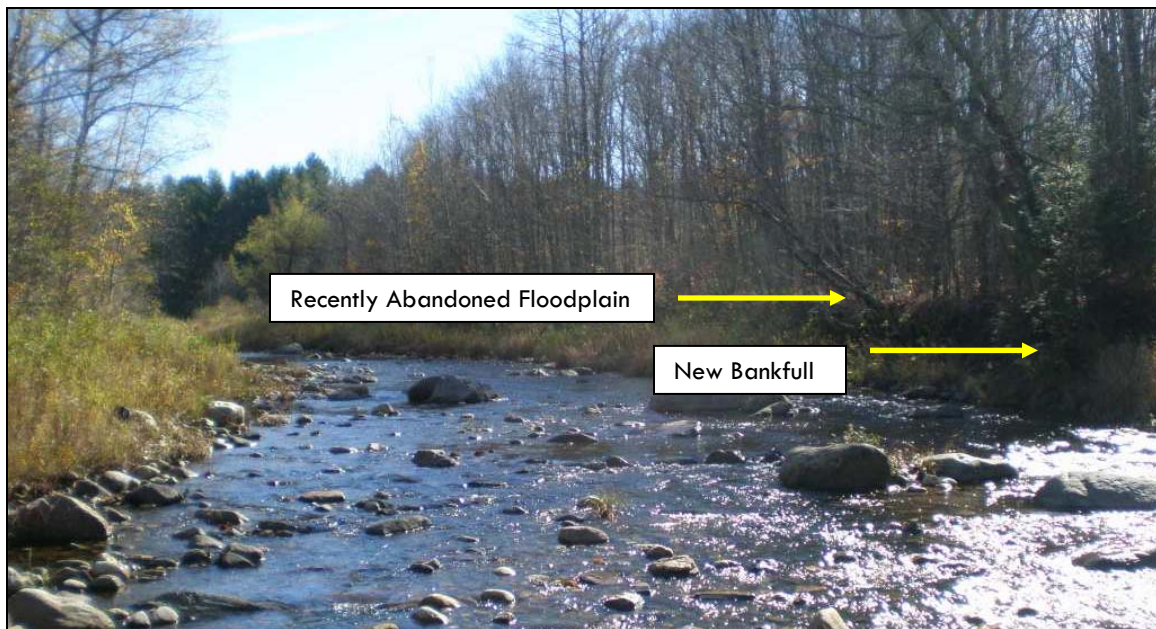
A high degree of channel incision has caused a departure from a C-type channel to a B plane bed (Figure 12). These channel alterations have caused a significant loss of sediment and floodwater attenuation in an important area upstream of East Wallingford and Cuttingsville Villages.

Figure 12. M11-B has been historically straightened. Currently undergoing major planform, widening, and aggradation adjustments.

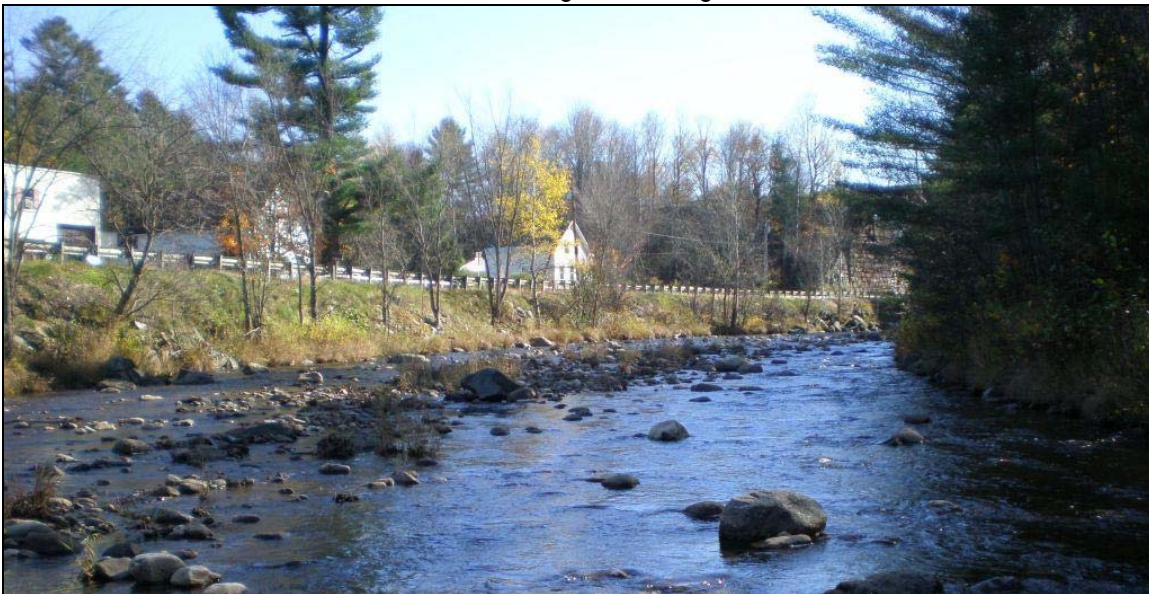
Mill River segment M11-A is one of two reaches that run through the Village of East Wallingford. Due to the relative location of the village to the river, extensive channel straightening, armoring, and dredging have altered this channel, likely in response to past flood events. These alterations have transformed riffle-pool system in a broad valley into a F-type stream with a plane bed form lacking in habitat as well as floodwater and sediment storage capabilities. Vermont Route 155 and commercial and residential development have significantly encroached on the channel (Figure 13). The bridge at the downstream end of the reach appears to be a debris/ice jam potential hazard - it already has held enough sediment behind the middle pier for a fully vegetated mid-channel bar to form. In addition a railroad bridge crossing which funnels both a road and the river underneath appears to be limiting sediment transport. The upstream aggradation the bridge is causing may be increasing an erosion issue on pasture land on the left bank of M11-B. Opportunities to increase conveyance of water and sediment underneath these bridges may be appropriate projects to reduce fluvial erosion hazard in East Wallingford Village.

**Figure 13.** M11-A flows through East Wallingford Village and has a high degree of incision due to channel straightening and dredging.

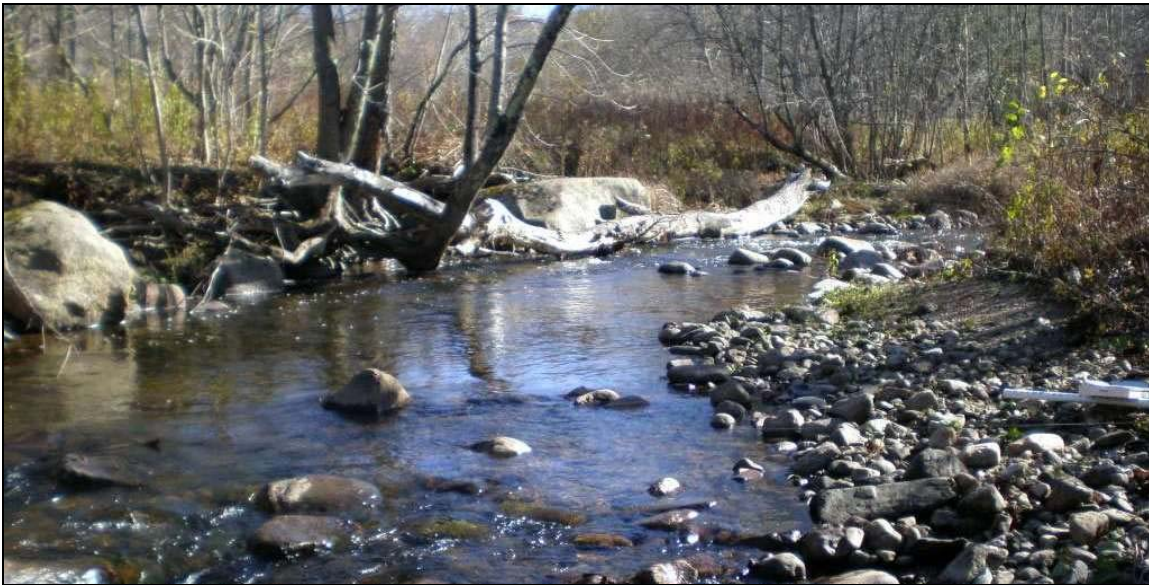
It has undergone major historic incision, however, is actively working to redevelop floodplain and has a fairly well developed riffle-pool bedform that looks to be providing good habitat with several deep pools. Active planform adjustment has led to the development of small gravel bars and a juvenile floodplain in some areas (Figure 14). Continued planform, widening, and aggradation adjustments are expected. Preventing further development of the floodplain of this reach will be an important step to ensure that floodwaters and sediment storage capacity is retained in this reach.

**Figure 14.** T2.01-B has historically incised, however is undergoing major planform adjustment as a new floodplain bench is developed.

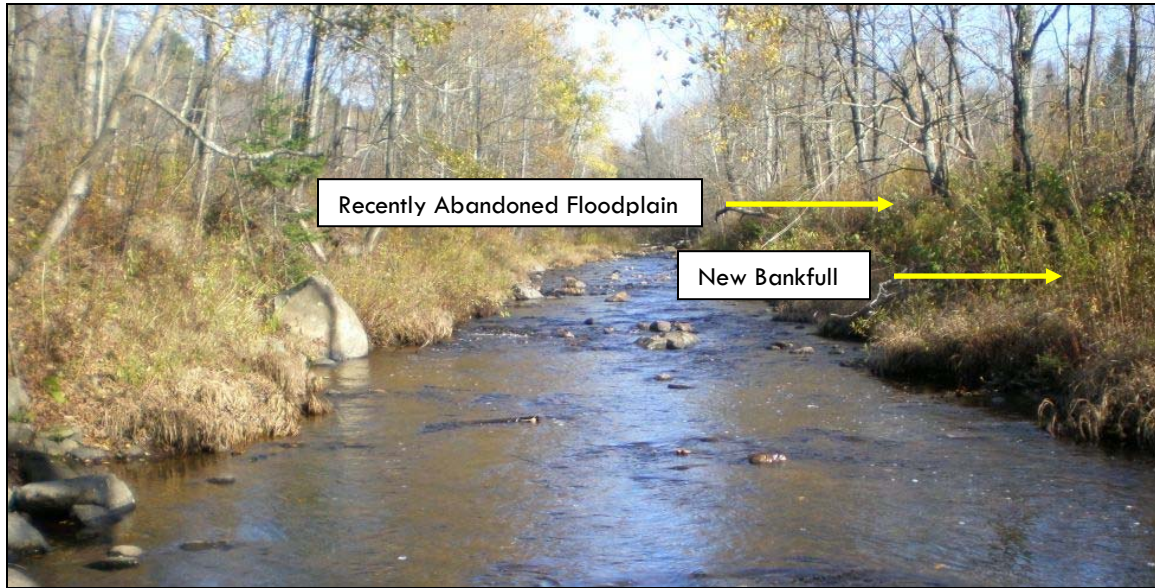
Tributary segment T2.01-A has seen extensive historic channel straightening and armoring (Figure 15). There is also evidence of dredging and windrowing just above the Route 140-East Bridge. The right side of the floodplain has been filled almost entirely by Routes 140 and 103 which create the top of the right bank. On the left side of the channel the riparian buffer has been cleared down to a thin strip of vegetation along the top of the bank. Agricultural land use dominates the left corridor while commercial and residential land use dominates the right corridor. Cross section analysis indicates that a stream type departure has occurred from a C-type channel to an F-type stream due to a high grade of incision.

**Figure 15. T2.01-A has been historically straightened and is now has a plane bed system that is disconnected from its floodplain.**

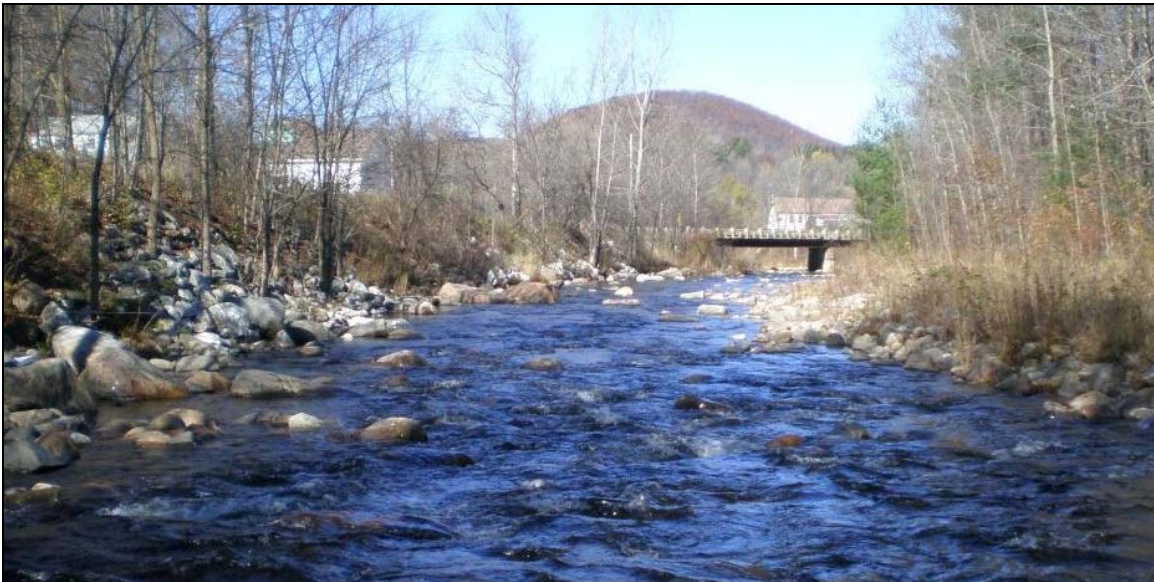
Mill River reach M10 flows through East Wallingford Village. The reach begins just below the Route 140 Bridge at the confluence with tributary T2.01 and continues downstream for 2369 feet. This short reach has been highly managed in order to maintain its location and minimize flooding in the Village. RRD observed evidence of channel straightening and armoring (Figure 17). The high incision ratio has caused a stream type departure from a C-type channel which historically flowed through a forested broad valley to a B-type plane bed system that has a high degree of floodplain development. Due to the significant investment in infrastructure within this reach the Mill River is likely to be maintained near its current configuration. Deteriorating bridge conditions on Village Street may provide an opportunity for redesigning access to the Village and or at least allowing better sediment and water transport under the bridge (which is currently holding sediment in its mid-pier and may create debris jam and flooding under the right conditions).

**Figure 17.** M10 has been historically straightened. There is a high degree of bank armoring within the reach.

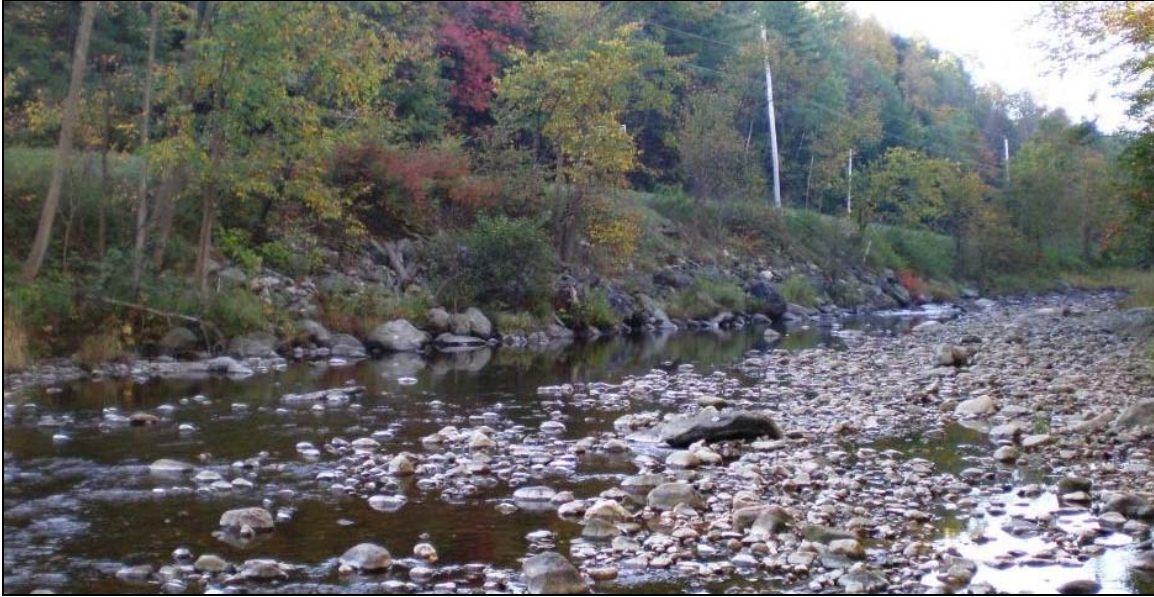
Although development pressure is not as significant as in the reach upstream, Mill River reach M09 has been impacted predominately by VT Route 103 which has changed the valley width from broad to narrow. In order to protect the roadway and a few structures located within the river corridor, extensive berming and channel armoring has occurred (Figure 18). Berming and straightening has increased the erosive forces in the channel leading to a high degree of incision (ratio of 1.8) and a stream type departure from a C riffle-pool channel to a B plane bed system. Adjusting to this incision, the stream has undergone extreme channel widening. Extensive channel management (riprap, dredging, straightening) has prevented the channel from developing new floodplain and storing sediment.

**Figure 18.** The valley width of M09 has been decreased due to encroachment from VT Route 103. The channel has undergone extreme widening.

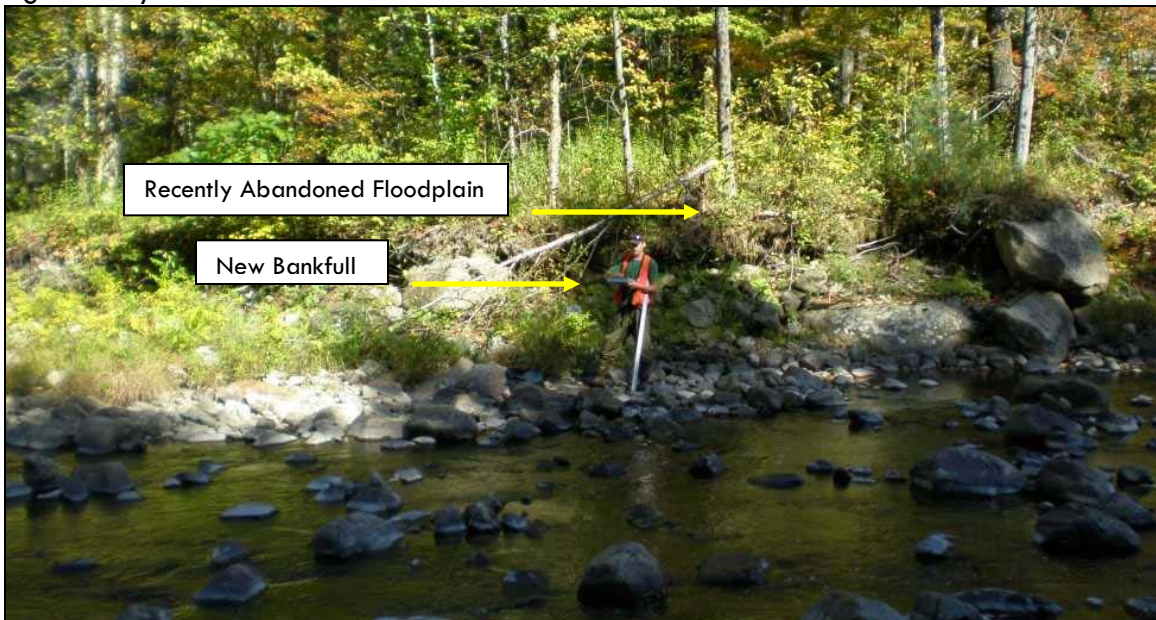
Mill River reach M08 is a short reach in a semi-confined valley that has been further confined by Vermont Route 103. Despite a high degree of historic channel incision (Figure 19) the stream remains a C-type channel with access to floodplain during only the largest events. Although there is no stream type departure or bedform change (planebed by reference) the stream is nearly an F-type channel due to the high degree of incision. As a result of the incision the current sediment and floodwater storage capability of this reach has been significantly reduced.

**Figure 19.** M08 is a short reach that has limited floodplain access due to streambed degradation.

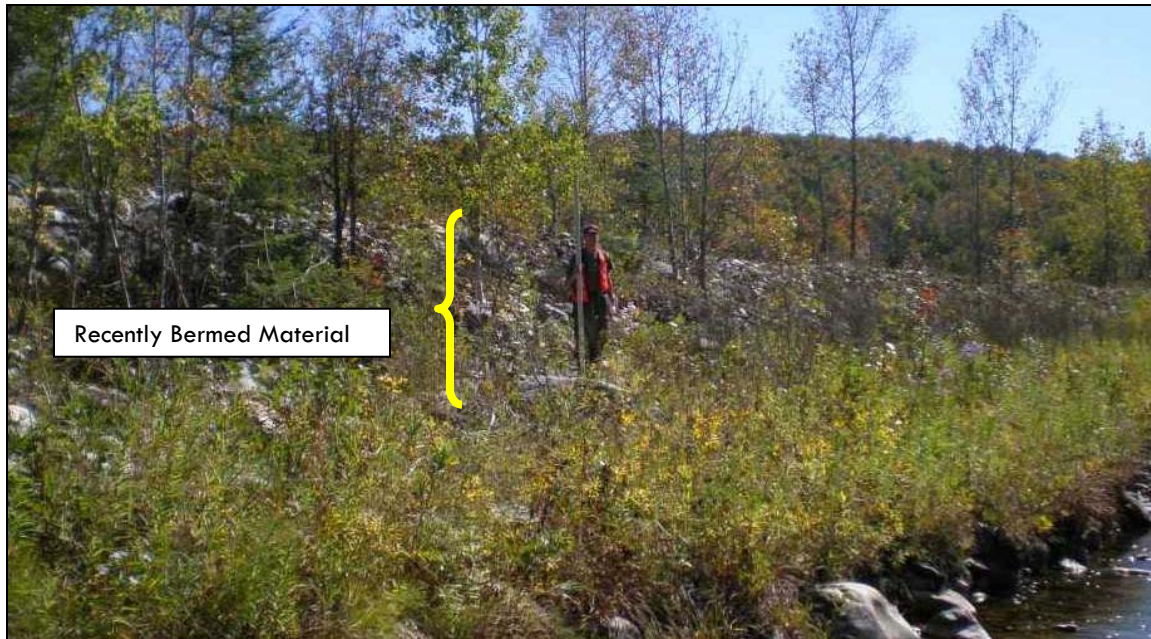
Mill River reach M07 is a very short reach that appears to have been straightened up against the left valley wall in order to increase cultivatable land. Significant berming has occurred on the right bank in order to prevent flooding (Figure 20). Incision and channel widening in response to these channel management activities have led to a stream type departure from a C channel to a F-type channel and loss of bedform from riffle-pool to plane bed system.

Figure 20. M07 has seen significant berming on the right bank causing a significant loss of floodplain access.

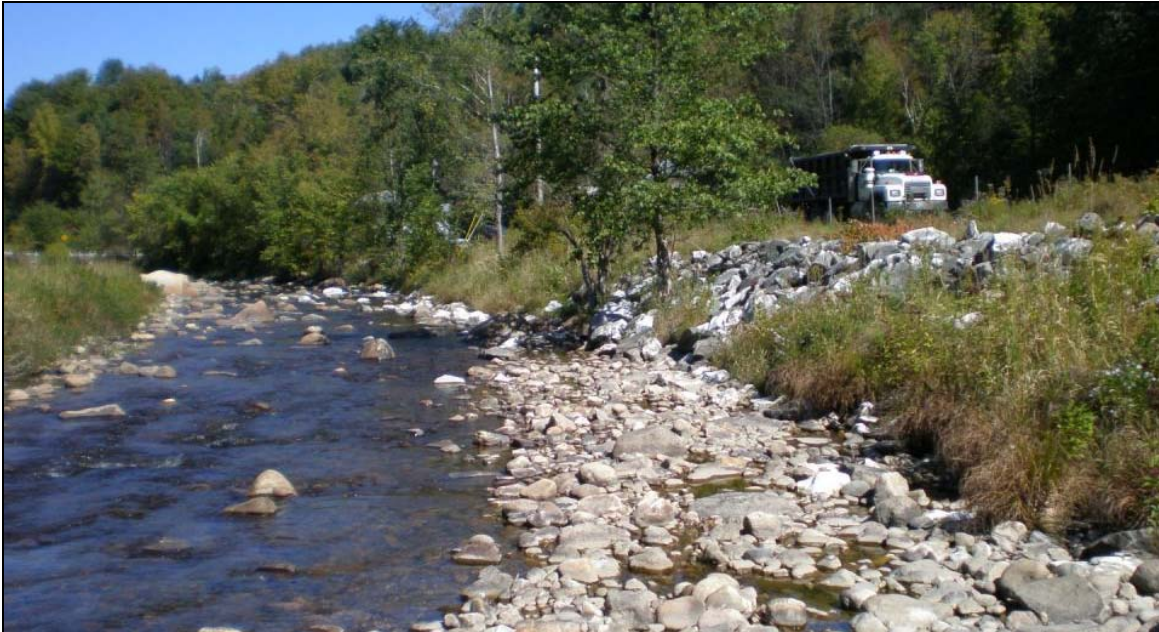
Mill River reach M06 runs directly through Cuttingsville Village with a great deal of human alteration, both historic and recent. Channel straightening, berming, dredging, armoring, and windrowing were all observed. Additionally much of the floodplain has been filled by development and roads (Figure 21) increasing stormwater inputs into the system. It appears that the stream may have been straightened and relocated up against the left valley wall through much of the reach. A high degree of incision (1.8 ratio) was observed with major channel widening and planform adjustments currently occurring. Although there was some evidence of juvenile floodplain creation most of the reach still lacks significant floodplain benches. Some opportunities for channel adjustment and floodplain reconnection still exist in this reach.

**Figure 21. M06 flows through Cuttingsville and has been significantly impacted by channel straightening, armoring, berming, and floodplain development.**

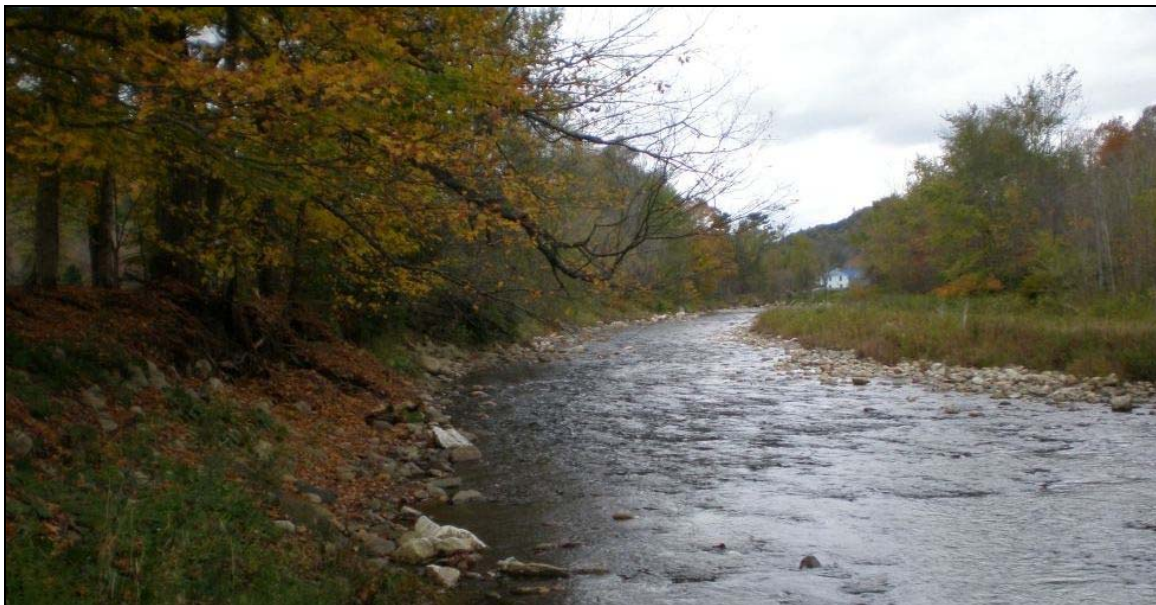
M05-B, as with many segments upstream, is heavily influenced by recent and historic channel management activities including berming, armoring, dredging and windrowing. Floodplain encroachment from VT 103 and residences and commercial development along with significant channel straightening have led to an incised stream that has departed from a reference C riffle-pool system (Figure 23). The B-type channel that now exists has less capacity to attenuate floodwaters and sediment and is a plane bed system with low quality habitat. A berm at the upstream end of the reach has prevented access to a major flood chute. Active major widening is occurring in response to channel incision. The planform and widening adjustments are limited by the valley wall, armoring, and dredging. Although there are significant corridor encroachments, some limited floodplain connectivity may be able to be restored in this reach in areas where structures are not currently located.

**Figure 23.** M05-B has been significantly altered through channel straightening, berming, armoring, and floodplain encroachment.

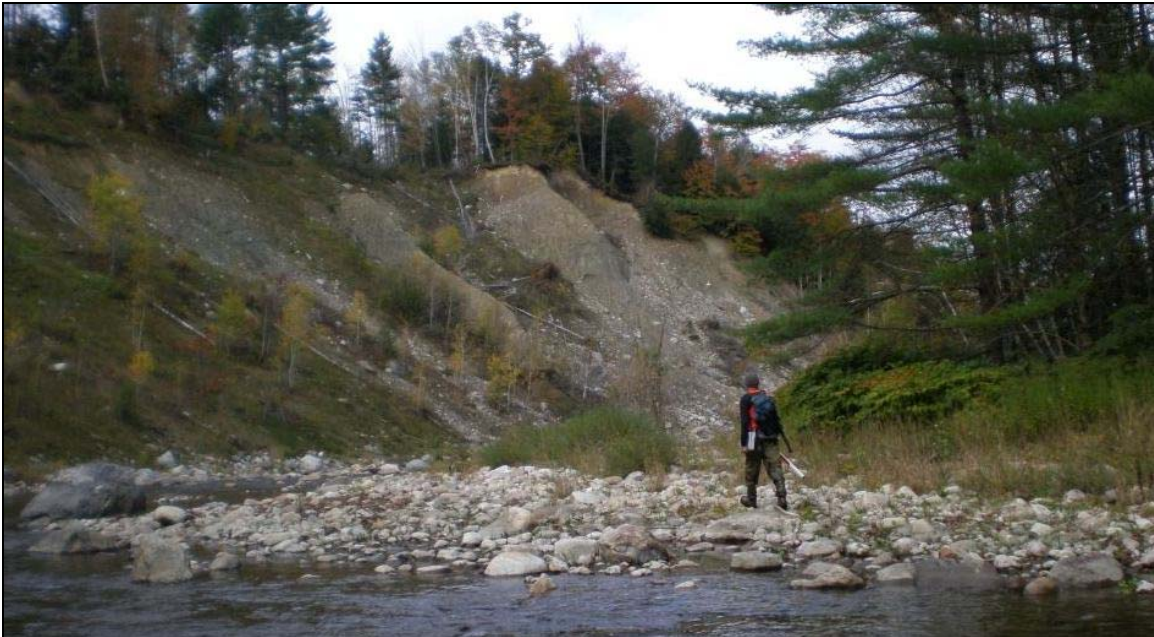
Mill River segment M05-A flows through a well forested corridor. Limited encroachment by the railroad track has impacted the right corridor. The channel has incised enough to abandon an old floodplain and begin to develop a juvenile floodplain. The degree of channel incision is low enough so that the stream remains unentrenched and able to store flood waters during the largest events. A large mass failure within this reach is a source of fine sediment and gravels to the downstream system (Figure 24). This sediment appears to be

assisting the stream in rebuilding bars and floodplain downstream. Several large flood chutes exist in the stream corridor indicating planform adjustment.

**Figure 24.** A large mass failure on the left bank is providing some sediment recruitment to help rebuild bars in the incised Mill River reach M05-A.

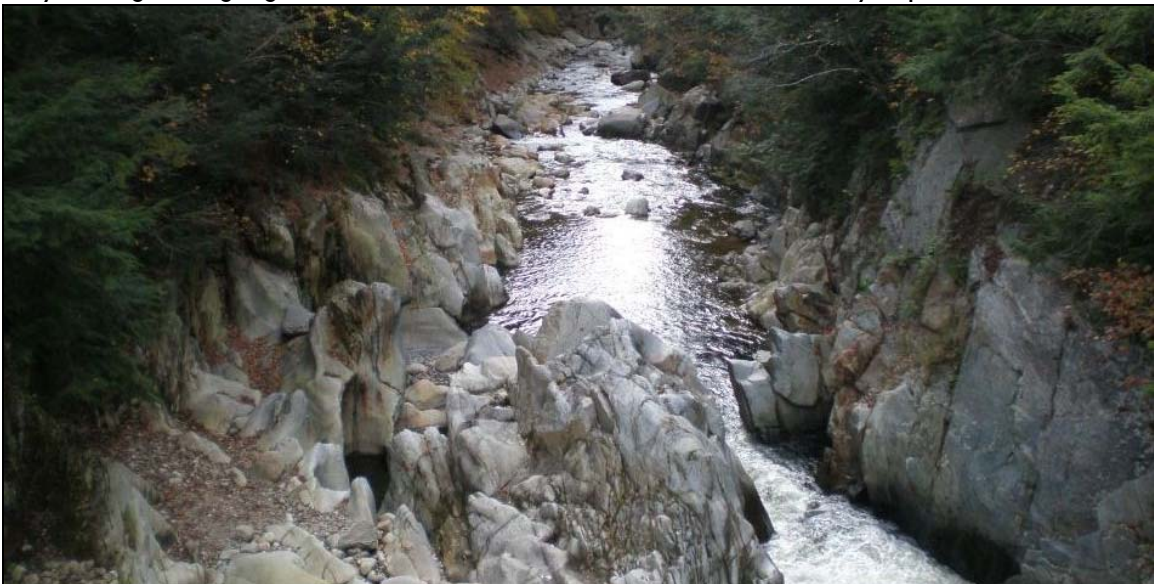
Mill River reach M04 encompasses the Upper Clarendon Gorge (Figure 25). The gorge begins at a sharp southwestward bend in the river where a Long Trail suspension bridge hangs from the bedrock cliffs on each side. The Mill River cuts through the Dalton Formation (a cambrian dolomite/conglomerate), the Mount Holly Gneiss, and the Cheshire Quartzite on its way through the gorge. Due to the bedrock this reach received only a partial Phase 2.

**Figure 25.** M04 consists of the Upper Clarendon Gorge.

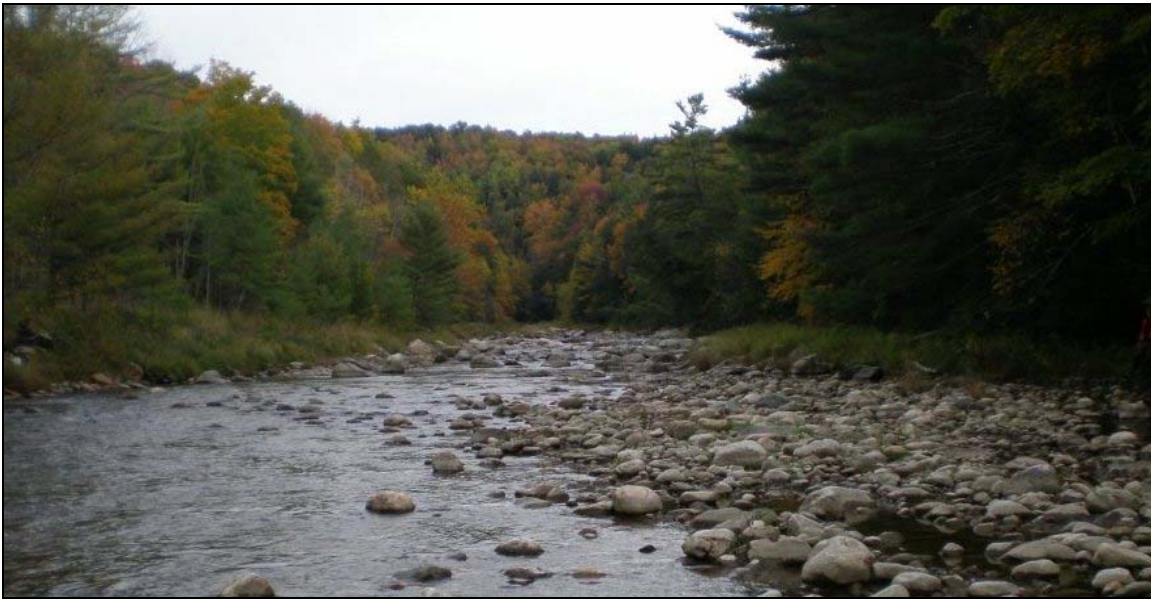
This segment is located between the Upper Clarendon Gorge (a bedrock controlled section) and the bedrock controlled segment at the former Kingsley Mill site. Channel incision observed here may be a result of the river working back through sediments that were stored when there was a mill dam, or due to a sediment imbalance upstream. The Mill was in operation from 1882 until 1935. There are residences encroaching on the river corridor on the left bank, and land was cleared for agriculture on the right of the corridor. This reach was observed to be a B-type channel with a planebed form dominated by gravel substrates (Figure 27). This is expected to be the reference stream type despite major channel widening.

Figure 27. M03-C is a short plane bed segment between two bedrock grade controls.

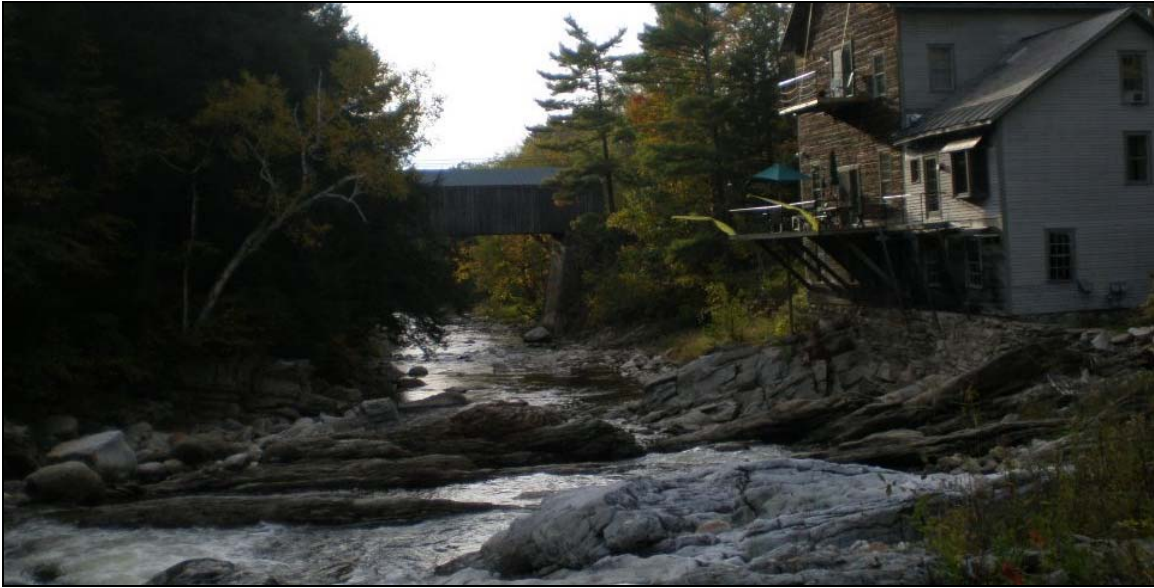
Segment M03-B is a short bedrock controlled segment that includes the former Kingsley Mill dam site (Figure 28). Bedrock grade control and bedrock on most of the banks limited this segment to receiving only a partial Phase 2 assessment. Although some residential development has affected the riparian buffer, in general the bedrock has created a stable geomorphic condition in this segment.

**Figure 28. M03-B is a bedrock controlled segment at the site of the former Kingsley Mill.**

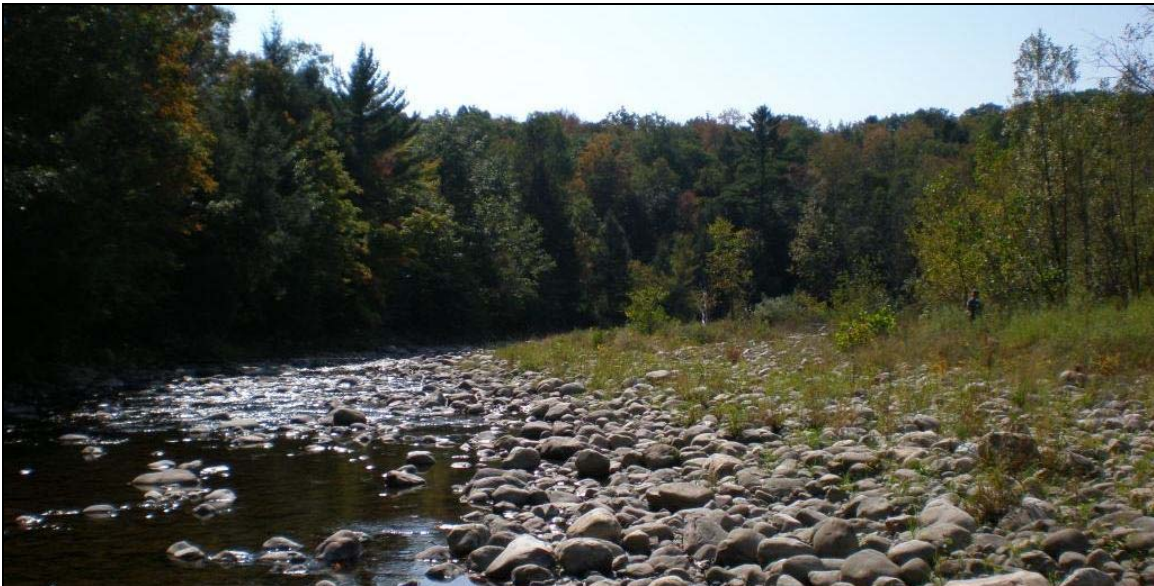
Mill River segment M03-A is also located between two bedrock grade controlled segments. Although this segment is slightly incised, it seems to be an area of sediment and floodwater attenuation, having large gravel bars, accessible floodplains and a forested buffer greater than 100 feet on both sides (Figure 29). As a result of the incision there is evidence of widening that has occurred in this segment. Minor planform and aggradation were observed as the stream rebuilds floodplain on both the left and right banks. This area will likely continue to be an important area in the lower Mill River watershed for sediment and floodwater attenuation.

**Figure 29. M03-A is bordered by a forested buffer. Large bars of unvegetated sediment indicate recent adjustments in the channel.**

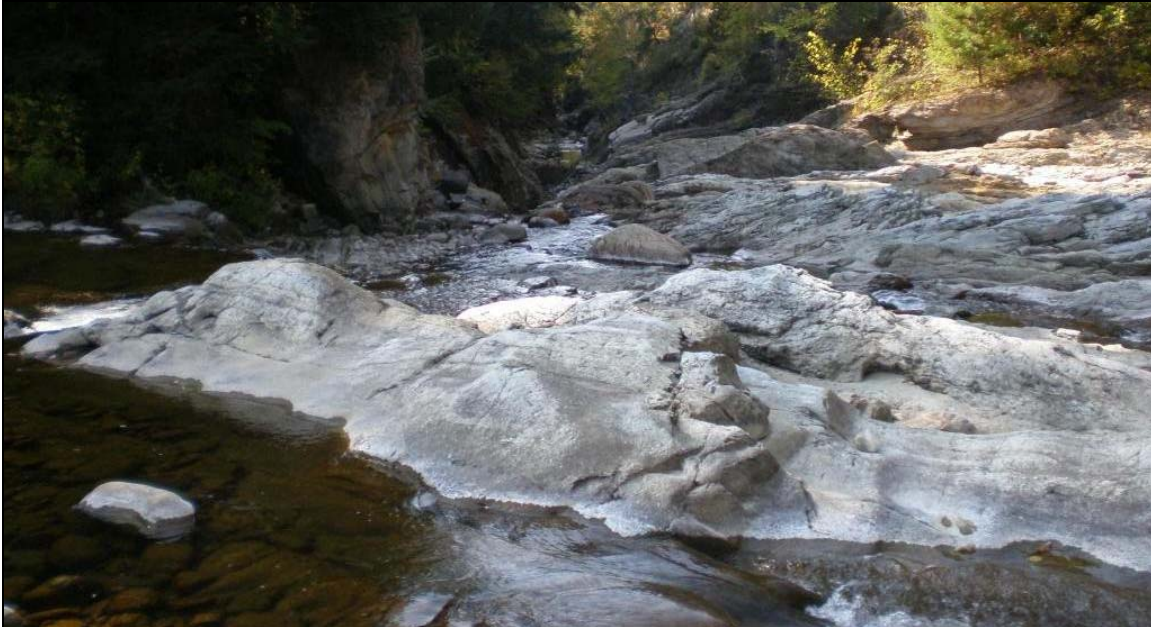
Mill River reach M02 consists of the Lower Clarendon Gorge (Figure 30). The gorge is carved through the Cambrian Dalton formation and Cheshire Quartzite (Van Diver 1987). The Dalton formation lies on Precambrian rocks of the Green Mountain core at the upstream end of the gorge. Only a partial assessment was conducted for this reach due to the bedrock controlled channel.

Figure 30. M02 is the Lower Clarendon Gorge in Clarendon.

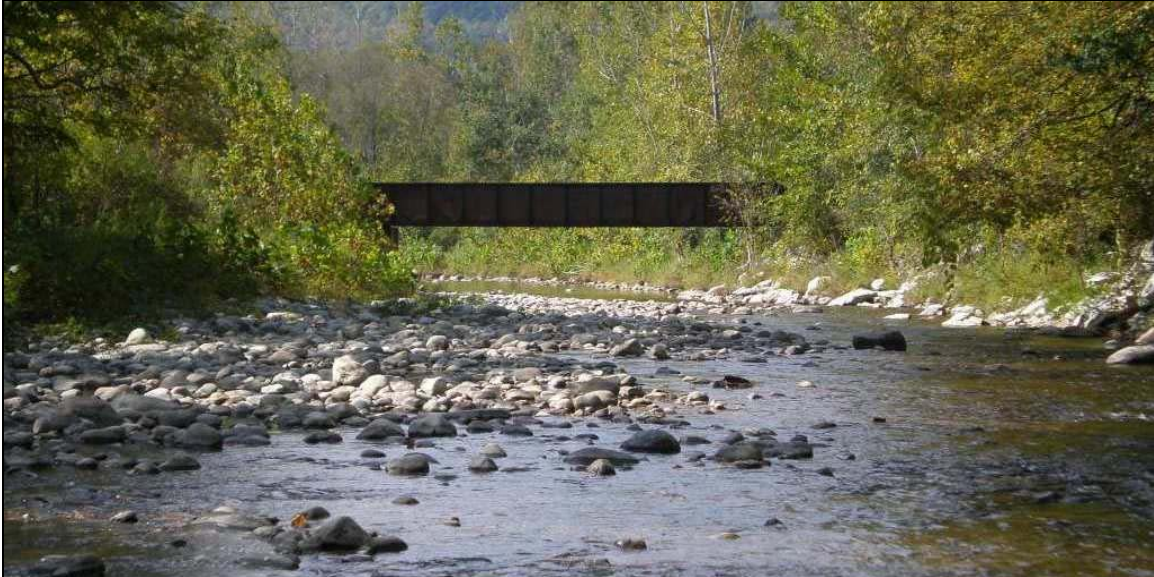
Mill River segment M01-B is a C-type channel by reference in a very broad valley. Significant channel management in the form of straightening, dredging, berming, and armoring has significantly altered the channel dimensions and entrenchment of this segment. The current incision ratio was observed to be 1.8 indicating that both berming and bed degradation have affected the nature of the channel. A landowner whose family has managed much of the surrounding land recounts the 1973 flood that washed out the railroad bridge. He noted that there was significant dredging of the stream channel after the 1973

flood between the railroad bridge and Route 7. He also noted that in the 1950's the area below the railroad bridge was dredged for gravel to help build Route 103. Field observers from RRD and VTANR recorded that the channel has become a plane bed cobble dominated channel as a result of increased stream power (Figure 31).

**Figure 31. M01-B has been significantly impacted by channel straightening, berming, dredging, and armoring.**

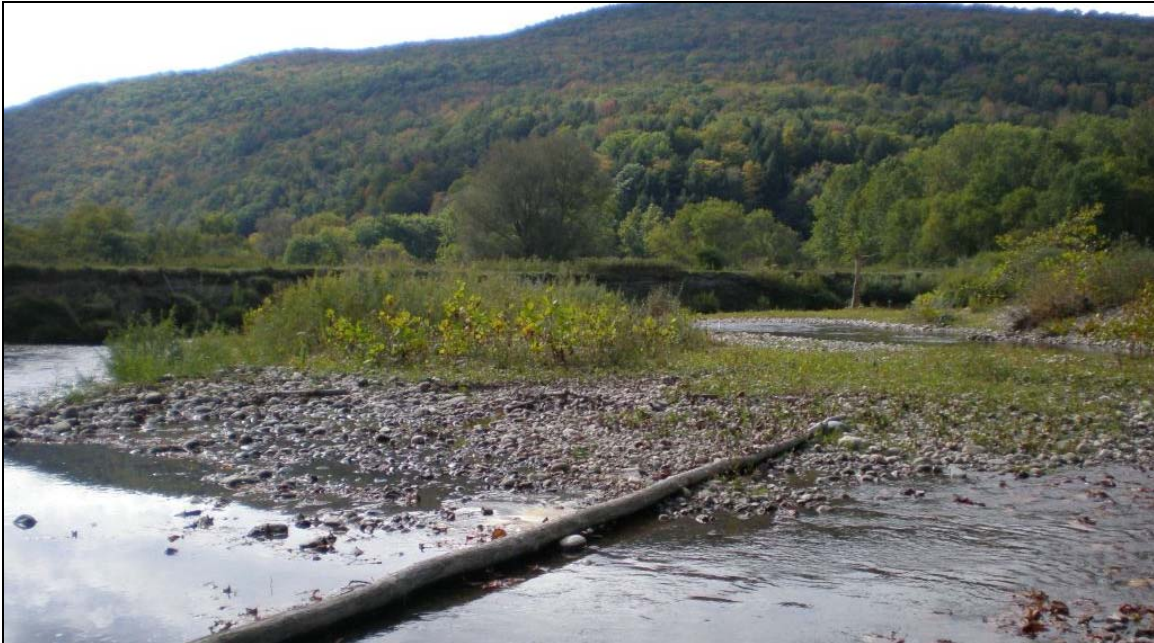
M01-A is the lowest reach of the Mill River. This segment is located at a highly dynamic zone where floodwaters and sediment coming down from the relatively steep Green Mountain hillsides are released in the flat valley bottom of the Otter Creek. Scientists from RRD and VTANR observed a high degree of bank erosion and channel adjustment in this segment (Figure 32). The steambank material are composed of silts and clay near the confluence with the Otter Creek and the bank height increases significantly which is likely due to the influence of the Otter Creek. There is plenty of woody debris recruitment in this reach as the river migrates laterally pulling in trees. Although some areas are in need of a healthier riparian buffer, the habitat in this reach overall looks to provide good depth cover and structure. It is certain that continued investment in channel management will be necessary in order to keep the channel in its relative location, however this area is highly dynamic and should be expected to always be undergoing extreme adjustment, especially during flood events as the river reacts to changes in sediment transport and hydrology in the watershed upstream.

**Figure 32. M01-A is a gravel dominated reach near the confluence with the Otter Creek. Agricultural land use dominates the corridor. The river is undergoing extreme planform adjustment and major widening and aggradation.**

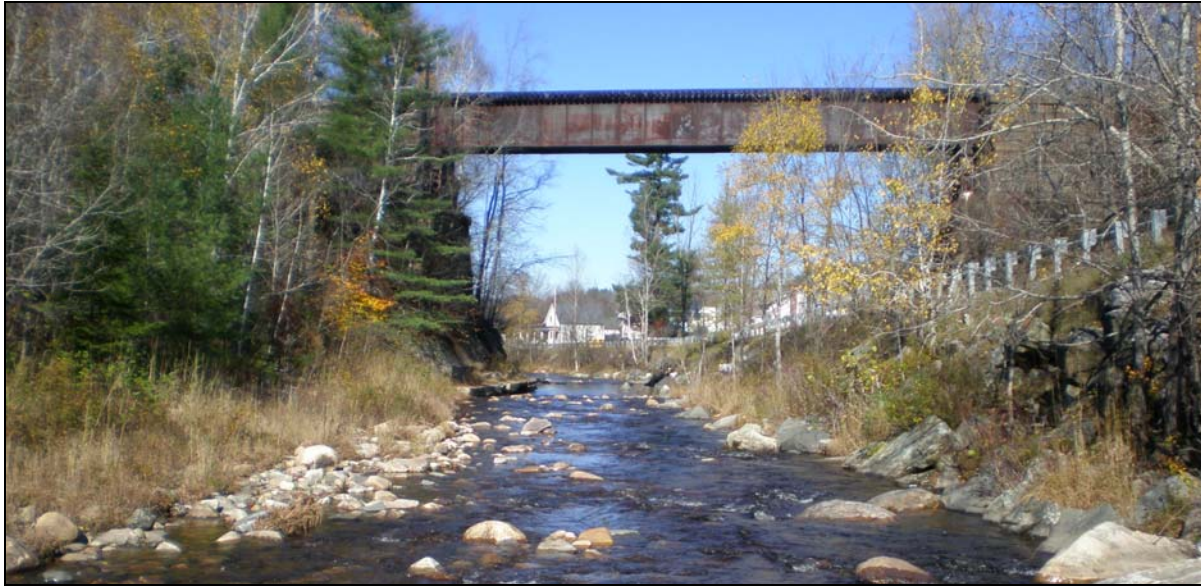
During the Phase 2 Assessment a number of channel and floodplain constricting bridge and culverts were observed to be considerably narrower than the existing bankfull width, subsequently causing instability in the river (Table 2). In particular need of replacement based on the problems observed and their percent bankfull width are the Route 155 Bridge in East Wallingford and the Barlow Road Bridge in Mount Holly. Also the two structures located on T2.01 were found to be undersized. From a technical measurement the railroad bridge on M11-A does not appear to be a problem, however, the channel width of the river from bridge abutment to the Route 155 embankment was only 39 feet (70% reference channel width) and should also be considered a problem structure (Figure 33).

**Figure 33: The railroad bridge span on M11-A is adequate for the Mill River, however, location of Route 155 in relation to the bridge and the river creates a channel constriction between the bridge abutment and the road.**
