# Mill River

## Phase 2 Stream Geomorphic Assessment

### Rutland County, Vermont

December 31, 2007

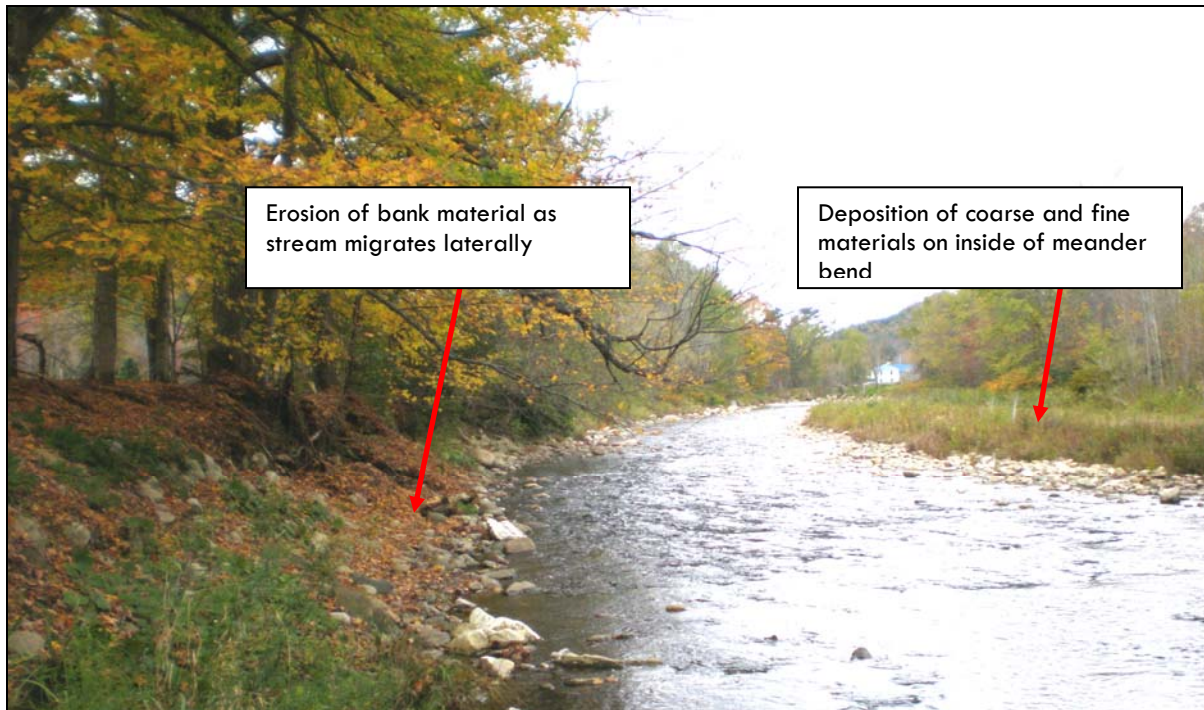
Figure 34: Planform migration associated with floodplain development in the Mill River.
