# Joiner Brook River Corridor Plan

**Bolton, Vermont  
February 21, 2009**

Prepared by: Bear Creek Environmental, LLC

Prepared for: Town of Bolton, Vermont

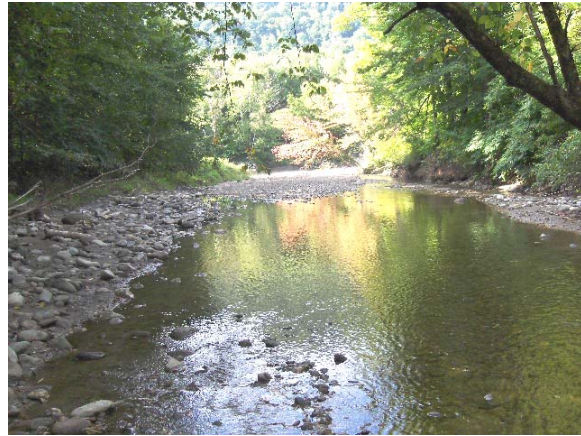
Within Reach R10.S3.01, there was major excavation and site work at the lower end of the brook in the mid to late 1960s. The brook was redirected and "channelized" to the west, when Smilie School was built (to help protect the school from flooding), when the Bolton Valley Access Road was built, and when RT 2 was relocated to allow for Interstate 89 to be constructed through Bolton. After flooding in the early 1970s, the Town of Bolton approved funding to riprap the brook, moving it back toward the east. In addition to installing the boulder riprap, bulldozers were used to create a channel and build up the banks with material from the brook.

**Straightened stream channel in R10.S3.01**

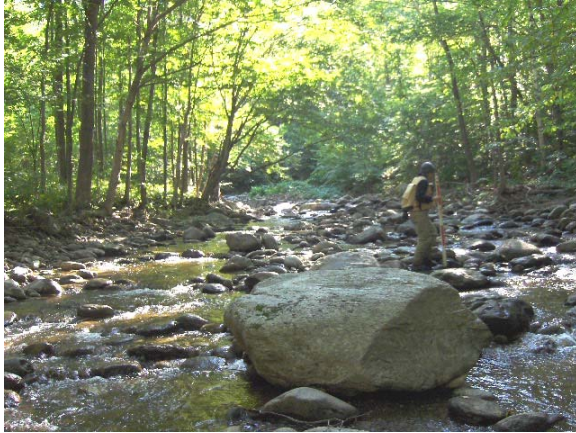
R10.S3.02-A is a Rosgen "C" stream type. The segment transitions as follows: upper is confined with a step-pool bedform; mid is unconfined with a riffle-pool bedform; lower is confined with a step-pool bedform. This segment has undergone minor historic incision. There was a silt layer noted on the substrate, which is likely attributed to road runoff. Overall, R10.S3.02-A is in good geomorphic condition with dominant buffers of greater than 100 feet on both sides. The habitat ranked in the fair category due to lack of aquatic organism refuge and multiple channel obstructions.

**Typical stream channel in R10.S3.02-A**

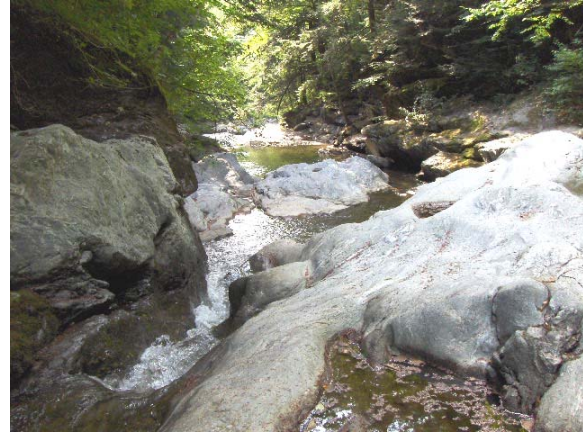
S3.02-B was only partially assessed because it is a bedrock gorge and the field team could not walk the entire length of the segment. This segment has multiple waterfalls that have total heights in the range of 19 to 45 feet. There were also multiple large pools. R10.S3.02-B is in reference condition with the exception of the lack of a buffer on the right bank near the top of the segment.

**Bedrock gorge in R10.S3.02-B**

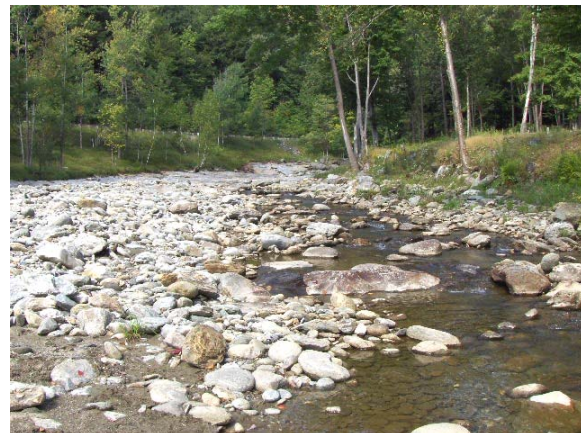
Segment R10.S3.02-C is steeper than R10.S3.02-A, and also has larger substrate. This segment is a Rosgen “C” channel, though the entrenchment ratio closely borders a “B” channel. The habitat scored is in fair condition due to limited aquatic organism refuge, channel morphology, and lack of large woody debris. There are generally adequate buffers on both sides, though there are some minor areas where the buffer could be improved. This segment is in good geomorphic condition having undergone some minor historic incision and the planform is currently undergoing some minor adjustment.

**Area of reduced riparian buffer in R10.S3.02-C**

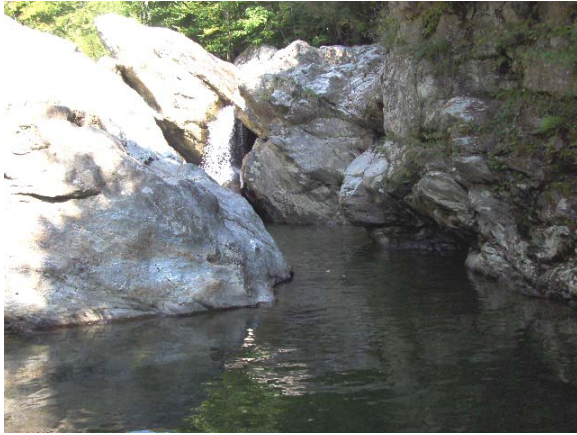
R10.S3.02-D was only partially assessed because it is a bedrock gorge. This segment has multiple waterfalls and large pools. Joiner Brook runs relatively close to the road in this location. A few stormwater inputs via road ditches and overland flow were mapped in this segment. R10.S3.02-D is in good condition with dominant buffers of greater than 100 feet on both sides.

**Bedrock gorge and waterfall in R10.S3.02-D**

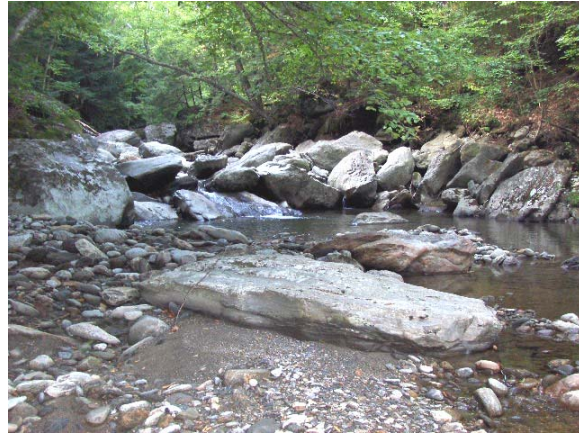
R10.S3.02-E alternates between a "F" Rosgen stream type and a "B" Rosgen stream type by reference. This segment is in fair geomorphic condition and it is experiencing major aggradation and planform adjustment, particularly in areas where the valley wall opens up and is not continuous with banks. This segment has 18 stormwater road ditches impacting flow status and contributing sediment to Joiner Brook during runoff events. The habitat is also fair in this segment due to limited refuge habitat and many channel obstructions. R10.S3.02-E has dominant buffers of greater than 100 feet on both banks.

**Typical channel in R10.S3.02-E**

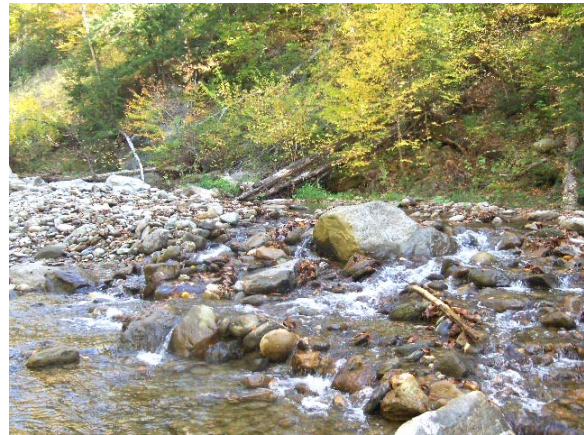
R10.S3.03-A is a Rosgen “C” channel in fair geomorphic condition with lots of exposed substrate. This segment is located to the east of the Bolton Valley Access Road and it is undergoing major aggradation and planform adjustment, evidenced by numerous mid-channel bars, large side bars and flood chutes. The habitat scored in the good category in this segment which has buffers greater than 100 feet on both sides.

**Major aggradation in R10.S3.03-A**

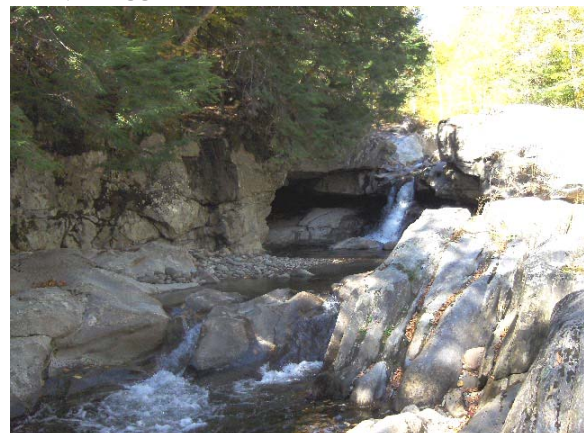
Segment R10.S3.03-B contained multiple bedrock waterfall grade controls. The substrate in the channel that was not bedrock was generally very large. Two cross-sections were surveyed in this segment. The upper cross section, located at the top of the segment upstream of the waterfall grade controls was more incised and had a lower width to depth ratio. The lower cross section was slightly incised and was more representative of the segment. R10.S3.03-B is a “B” stream type

**Multiple waterfalls in R10.S3.03-B**

in fair condition. Aggradation, planform adjustment and historic widening were noted in the riffles located between the waterfalls. The habitat was fair in this segment with limited refuge habitat and multiple channel obstructions (waterfalls). Buffers were greater than 100 feet on both banks.

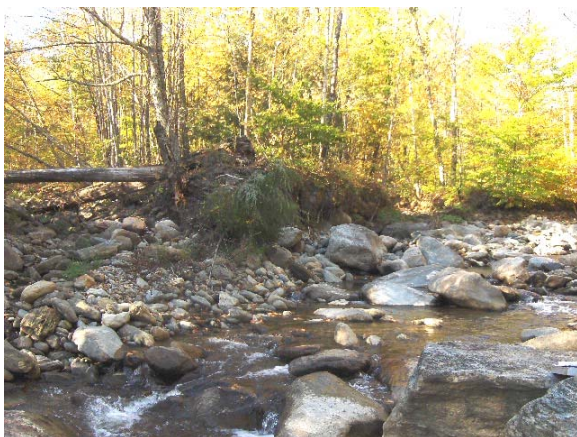
R10.S3.04-A is a Rosgen “C” channel in fair condition. This segment has a reference bedform of planebed, based on the field-measured slope of 3.5 percent. This segment has a historic incision ratio of 1.76, which may be contributing to the planebed features. The slope was lower in segment A than upstream segments (B-D). Segment R10.S3.04-A is very wide with low to moderate bank erosion. Aggradation, widening and planform adjustment were all active processes in this segment, evidenced by mid channel accumulation, active flood chutes and islands, and a high width to depth ratio. The habitat was fair in this segment as a result of the over-wide channel width, and dominant buffers were greater than 100 feet on both banks.

**Active flood chute in R10.S3.04-A**

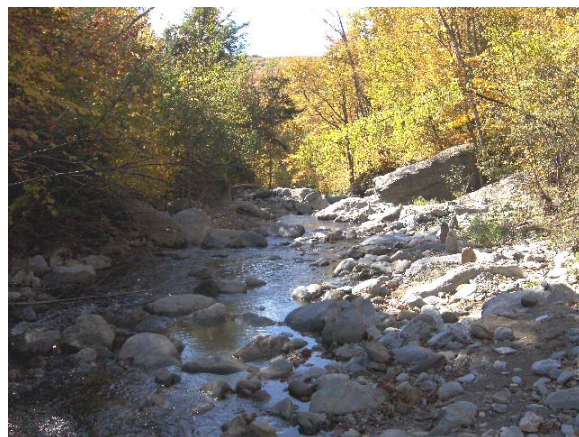
R10.S3.04-B is a “C” stream type in good geomorphic condition with large boulders at the very top of the segment. This segment is not incised and it appears to be holding the elevation of the bed. Active flood chutes indicate major planform adjustment is occurring within the segment. The habitat is fair in segment R10.S3.04-B because of negligible refuge habitat, lack of large woody debris and a high percentage of exposed substrate. There were frequent and deep pools with good cover in this segment.

**Typical channel in R10.S3.04-B**

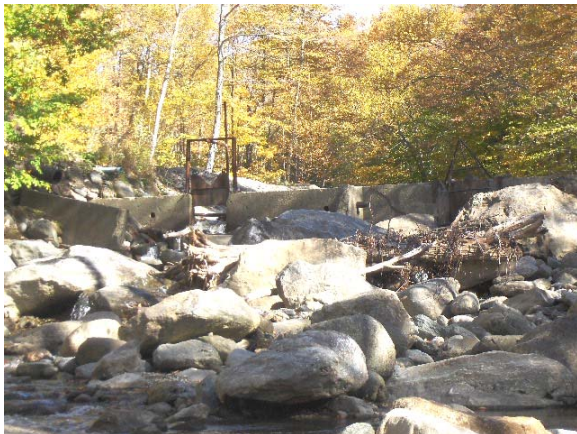
R10.S3.04-C has lost access to its floodplain as a result of historic incision. This segment incised as a result of being sediment starved below a weir. The weir is used by Bolton Valley Resort for snowmaking water withdrawal operations. There are two-4 foot openings on the weir, making it a significant channel constriction. One of the openings is filled with sediment,

and there is extensive sediment buildup both above and below the weir. This segment had one very large mid-channel bar which was created by the channel constriction. R10.S3.04-C has undergone a stream type departure from a reference “C” channel to an existing “F” channel due to historic incision. This segment is in fair geomorphic condition and fair habitat condition. Though the buffers are greater than 100 feet on both banks, the snowmaking weir has caused major alterations to the stream channel and its habitat, including floodplain inaccessibility, bank erosion, major aggradation and widening of the channel, and loss of refuge habitat.

**Snowmaking weir in R10.S3.04-C**

through a widening process to create a floodplain at a lower elevation. Segment R10S3.04-C is located just below Bolton Valley Resort's snowmaking weir and has likely historically incised as a result of being sediment starved due to the weir. The numerous grade controls (see Figure 9) along the entire length of Joiner Brook have likely helped to control incision along the length of the river. Two segments (R10.S3.04-B and R10.S3.04-D) were noted to be in stage I of the "F" stage model indicating these segments are stable and are not significantly aggrading or degrading. A cascade with large boulders at the top of R10.S3.04-B appears to be acting to hold the elevation of the bed. Multiple bedrock grade controls in R10S3.05 are contributing to vertical stability in R10.S3.04-D.

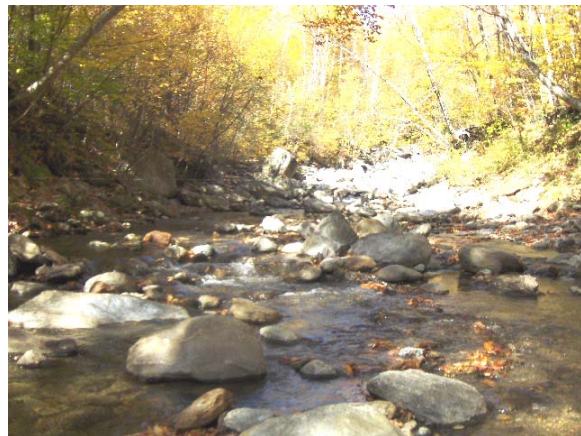
The lower end of segment R10.S3.04-D is just upstream of the weir for Bolton Valley Resort's snowmaking water withdrawal. This segment has some localized impact from the operation of the snowmaking water withdrawal at the lower end. The right bank is unstable and lacks a buffer immediately upstream of the weir. R10.S3.04-D is a Rosgen “C” channel in good geomorphic condition with only localized impact at the lower end of the segment. This segment has fair habitat due to limited refuge habitat, lack of large woody debris and hydrologic characteristics. Dominant buffers are greater than 100 feet on both sides of this segment.

**Typical channel in R10.S3.04-D**

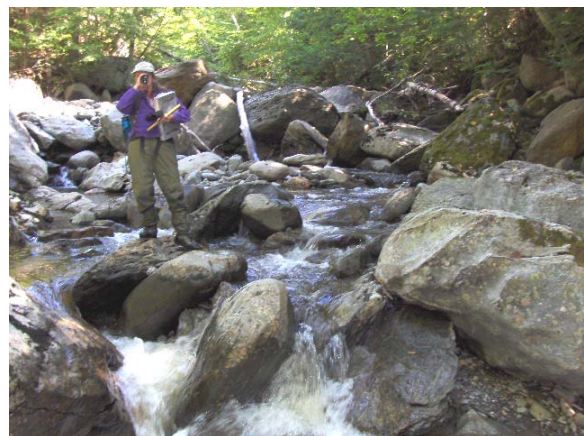
This reach begins just below the “S” curve of the Bolton Valley Access Road, crosses under the road, and continues upstream to the confluence with a tributary on the right bank. A long section of bedrock grade controls dominate the channel with a series of bedrock waterfalls. This reach is a “B” channel in fair condition. It has incised historically and currently aggradation and widening are major processes. This reach has some minor influence from stormwater inputs near the culvert at the Bolton Valley Access Road, but dominant buffers are greater than 100 feet on both sides. The habitat is also fair in this reach because of numerous

**Typical channel in R10.S3.05**

channel obstructions and limited refuge habitat.

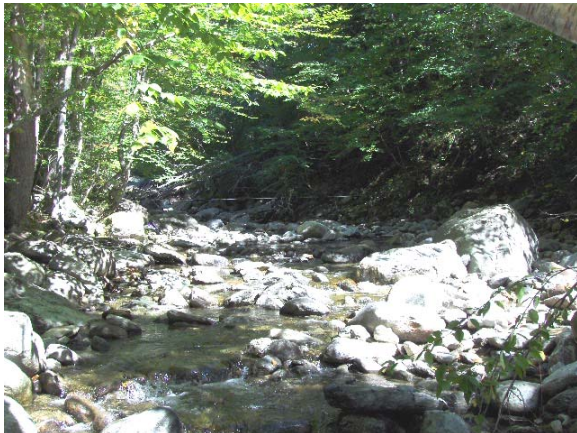
R10.S3.06-A extends for about 2,540 feet to the start of a very confined bedrock gorge. This segment is a Rosgen “B” channel in fair condition. Currently this segment is experiencing major aggradation and widening. The habitat in this segment is also fair as a result of limited refuge habitat and multiple channel obstructions. This segment has dominant buffers of greater than 150 feet.

**Major aggradation in R10.S3.06-A**

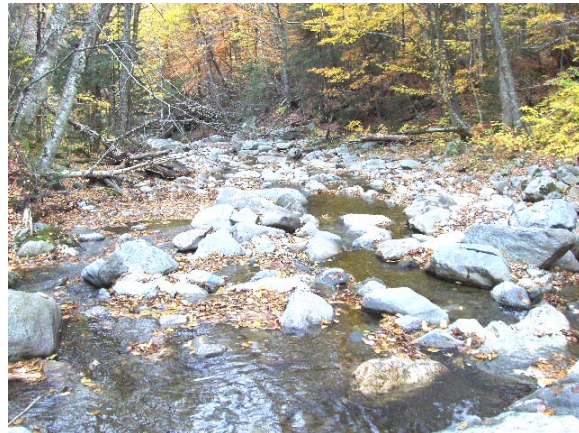
R10.S3.06-C is a “C” channel in fair condition due to current major aggradation and planform adjustment. Planform adjustment was particularly significant process in the downstream end of the segment. This segment has widened historically. The top of reach has a steeper gradient and less planform adjustment. The habitat was in fair condition as well in this segment as a result of limited refuge habitat and many channel obstructions. Buffers are greater than 100 feet on both sides of Joiner Brook in this segment.

**Typical channel in R10.S3.06-C**

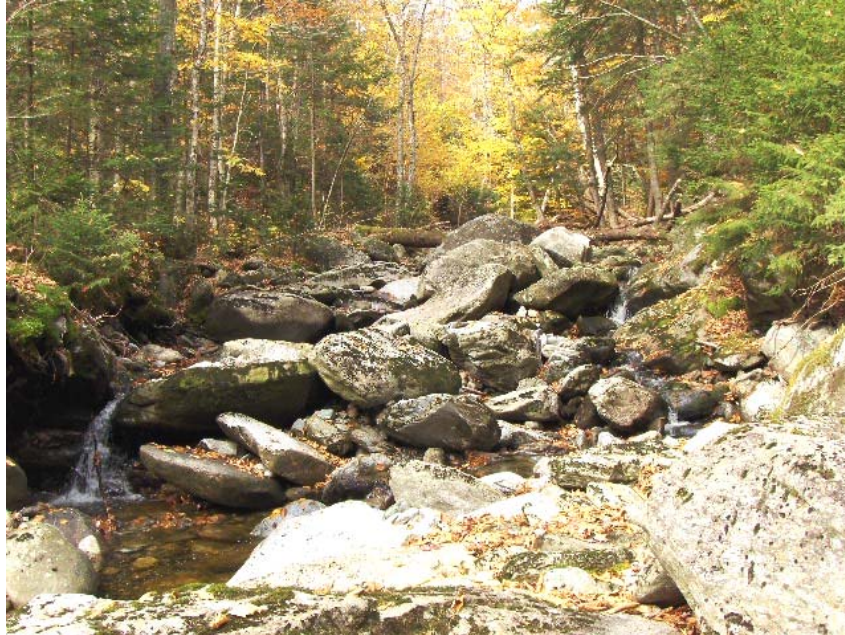
Reach R10.S3.07 begins upstream of the confluence with the tributary near Bolton Valley Resort Village. This reach is very steep and is composed of large boulders with multiple grade controls and waterfalls. This reach was not assessed due to budgetary constraints. It is recommended that this reach be assessed in the future to provide baseline geomorphic and habitat conditions.

**Typical channel at lower end of R10.S3.07**

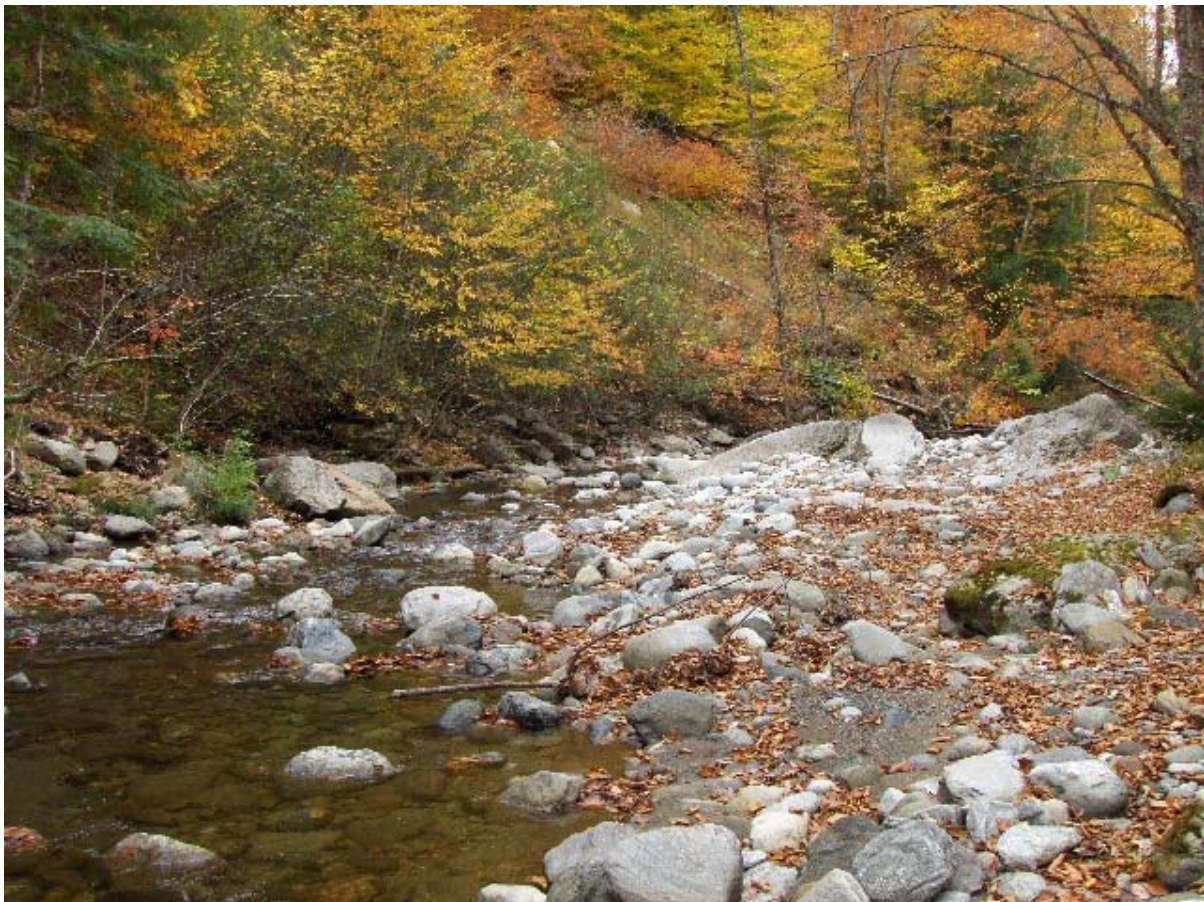
Table 4 shows a comparison of the habitat condition based on the Rapid Habitat Assessment (RHA) and the geomorphic condition based on the Rapid Geomorphic Assessment (RGA). For seven of the segments both the RHA and RGA resulted in fair condition. The RGA was fair while the RHA was good for one segment (R10S3.03-A). This segment was undergoing major planform adjustment and aggradational processes, but had good bed substrate cover, stable banks, good pools, and high quality riparian buffers (see Figure 11) resulting in a higher habitat score.

**Figure 11. Segment R10S3.03-A received a habitat rating of good due to deep pools, stable banks, and a high quality riparian zone.**

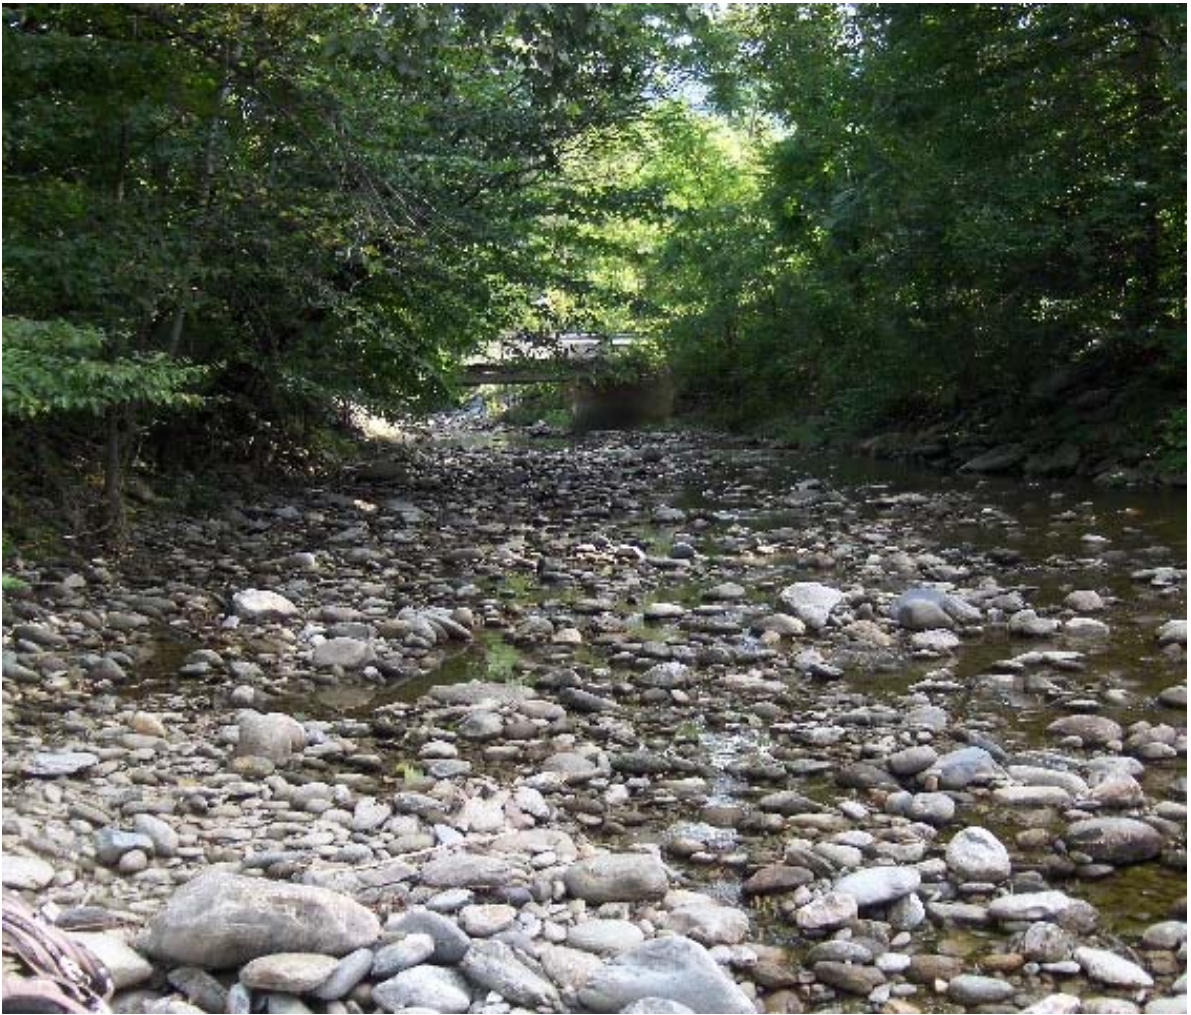
One segment (R10S3.01) had an RGA score of fair and a habitat score of poor. The poor habitat score is attributed to extensive historic channelization and corridor encroachments resulting in lack of pools, poor woody debris cover, reduced bank vegetation and an inadequate riparian buffer (see Figure 12). A high percentage of exposed substrate and a low connectivity score from natural obstructions (waterfalls) also contributed to the poor habitat score for this reach.

**Figure 12. Reach R10S3.01 rated “poor” for habitat. The segment lacked large woody debris, had a high percentage of exposed substrate and a shortage of pools where the channel had been historically straightened.**

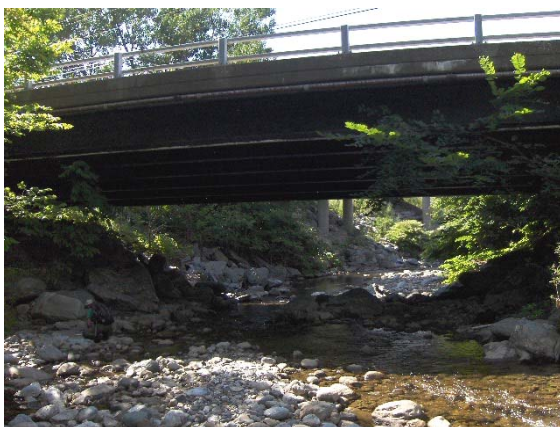
Figure 14. Route 2 bridge with reduced span.

The railroad bridge in reach R10S3.01 and the bridge in reach R10S3.04-A were both found to be partially compatible. Aquatic organism passage is not an issue for bridges, so these two structures were rated as low priority for replacement/retrofit. The Joiner Brook Lane Bridge and the Route 2 Bridge were both found to be mostly incompatible using the screening tool. Both of these bridges received low scores for percent bankfull width, approach angle, erosion and armoring. As shown in Figure 14, rock riprap in the channel and along the sides of the Route 2 structure is causing a channel constriction. The Route 2 Bridge could possibly be retrofitted by removing some of this material to allow for improved sediment transport through the structure. An old culvert sitting in the channel upstream of the Route 2 Bridge could be removed at the time the bridge is retrofitted.

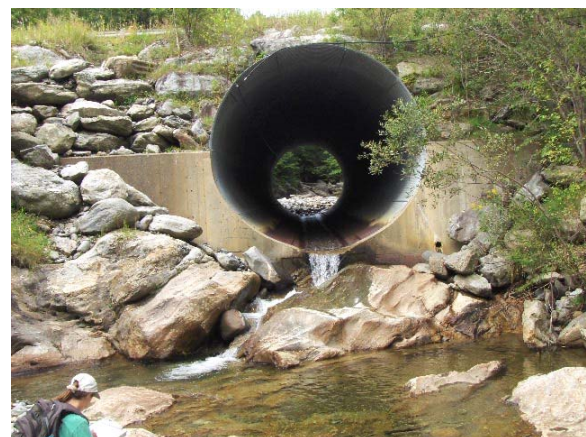
Figure 15. Bolton Valley Access Rd. Culvert

Of the five structures that were assessed, the culvert within reach R10S3.05 that crosses the Bolton Valley Access Road is the highest priority for replacement/retrofit. This culvert is less than 50 percent of the bankfull channel width and a mid-channel bar is located upstream of the structure indicating the structure is undersized. The culvert has a cascade at the outlet thereby reducing aquatic organism passage (see Figure 15). Structures that are moderate or high priority for replacement/retrofit are included in the project identification table in Section 7.
