# **Little River Corridor Plan**

**Stowe, Waterbury, Morristown, Worcester,  
Bolton, Underhill and Cambridge, Vermont**  
**June 28, 2010**

Prepared by:  
Bear Creek Environmental, LLC  
297 East Bear Swamp Road  
Middlesex, Vermont 05602

Prepared for:  
The Lamoille County Planning Commission  
632 LaPorte Road  
Morrisville, VT 05661

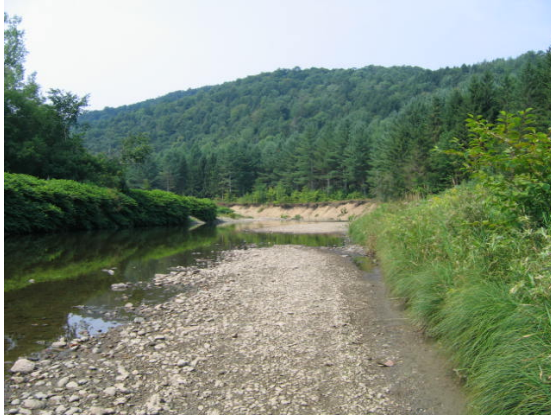
**Figure 7.1. Large side bar and mass failure in Segment M06-B**

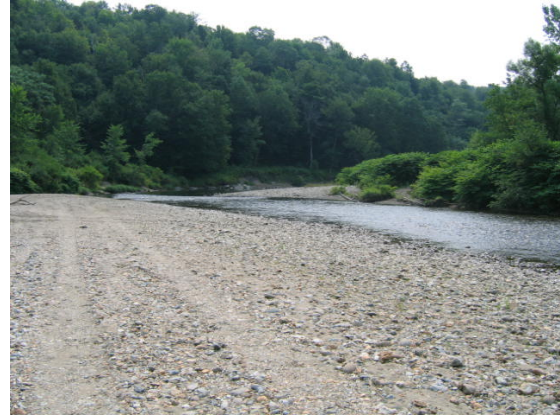
**Figure 7.2. Another large side bar in Segment M06-B**

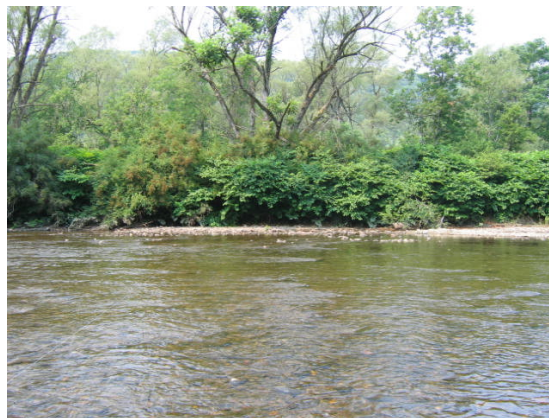
Segment M06-B is a “C” gravel dominated segment. The rapid geomorphic assessment (RGA) scored in the “fair” category due to the major historic degradation, major widening and aggradation, and minor planform adjustment. The reference channel width is 92 feet, but the bankfull width in the cross section was measured as 133 feet (Figure 7.3) indicating that the segment is over widened. The large depositional features are a result of the over widened channel. The rapid habitat assessment (RHA) rated in the “fair” category mostly due to deposition in the channel, channel straightening, and bank erosion.

**Figure 7.3. Typical wide cross section in M06-B**

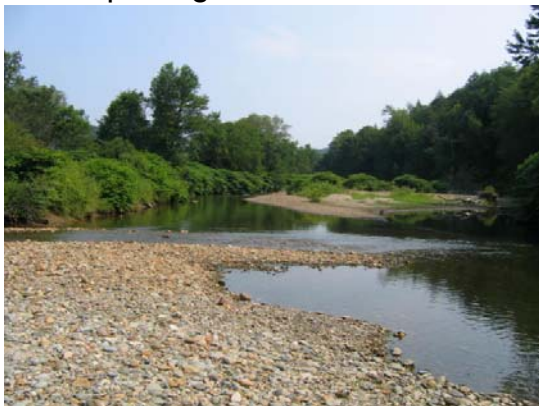
The presence of a mid-channel bar, point bars and large side bars indicates that M07 is also depositional (Figure 7.4). Erosion is also common along both banks. The dominant buffer width on both sides of the channel is greater than 100 feet in width; however, about one-quarter of the west bank has buffers less than 25 feet (Figure 7.5). These areas of minimal buffer are associated with hay fields. Streamside plantings are recommended to augment current planting efforts on lands within the Mount Mansfield State Forest.

**Figure 7.4. Depositional features and wide channel in M07**

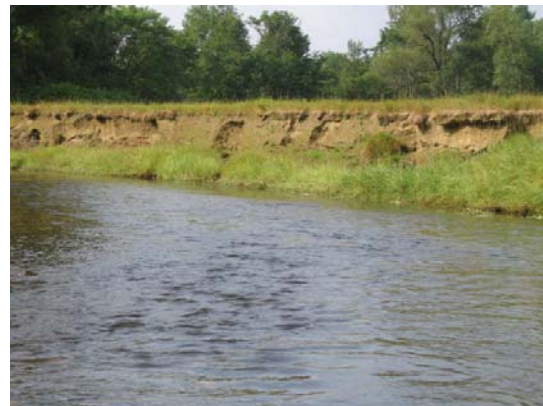
**Figure 7.5. Reach M07 has a significant lack of buffer contributing to bank failure.**

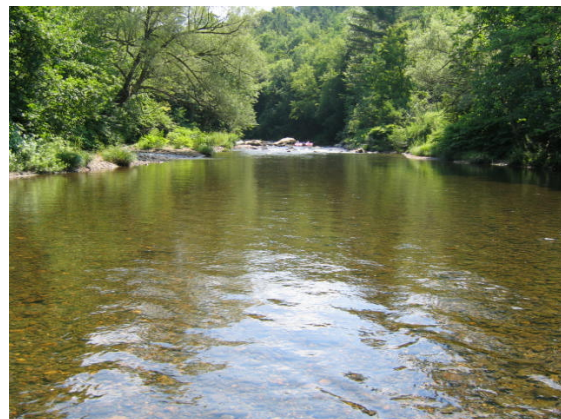
Reach M08 has experienced a stream type departure from a gravel dominated “C” stream to an “F” stream type due to the extreme historic incision. The RGA rated in the “fair” category due to major widening and minor aggradation and planform adjustment. There are three steep riffles, some mid-channel bars and many side bars in M08 indicating that it is depositional. Pools have been filled in with sediment with the bed profile dominated by runs (Figure 7.6). The RHA also scored in the “fair” category as a result of extensive channel straightening, embedded bed substrate, unstable banks, and reduced riparian buffer. This reach would benefit from buffer restoration.

**Figure 7.6. Long run in Reach M08**

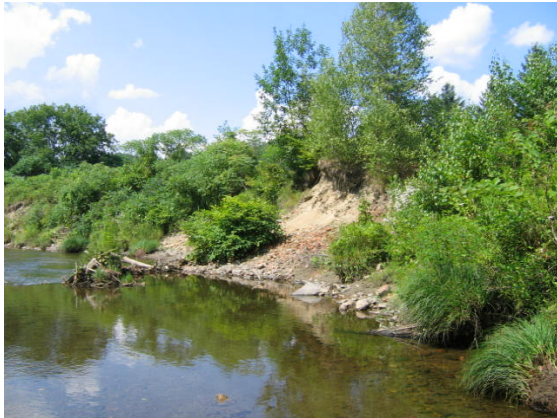
**Figure 7.7. Bank erosion along M09**

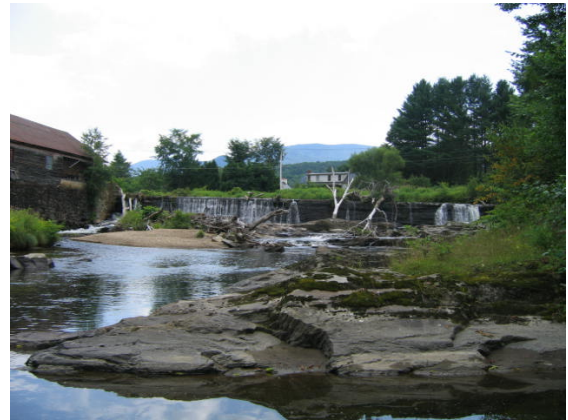
**Figure 7.10. Moscow Mills Dam**

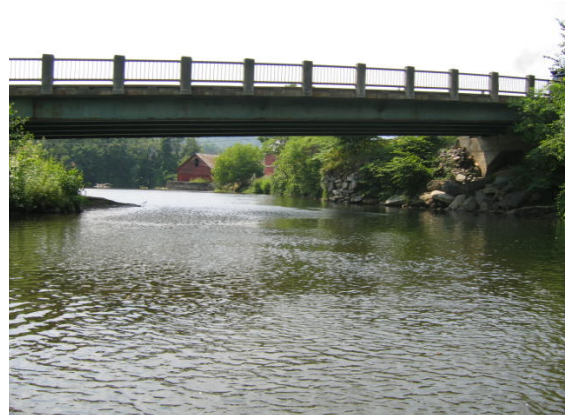
**Figure 7.11. Bridge at Moscow Road in Reach M11**

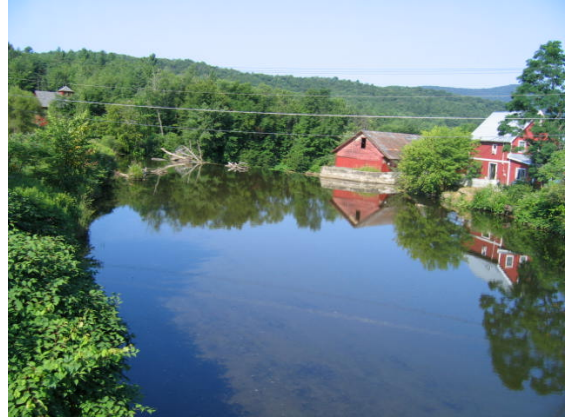
The Moscow Mills dam is located within reach M11 about 300 feet downstream of the Moscow Road crossing. According to Tom Jackman, the dam is listed in the National Register of historic places and is Stowe's only functioning hydro plant. The dam is about 20 feet high and is built on bedrock. The natural flow regime of the Little River is modified by the hydroelectric operations, and the dam is an issue in terms of aquatic organism passage and sediment transport. Sediment is retained above the dam (Figure 7.12) and the downstream reach, M10, has historically incised in response to the channel being sediment starved.

**Figure 7.12. Moscow Mills Dam in Reach M11**

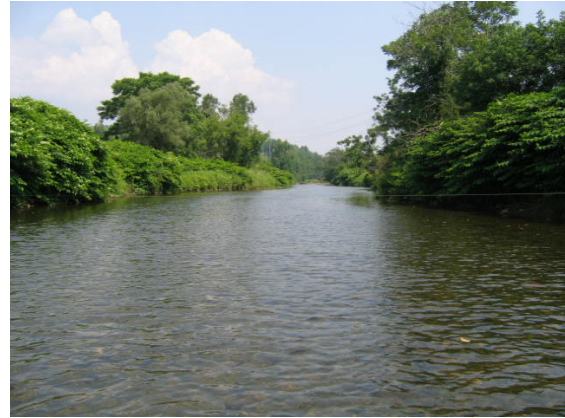
**Figure 7.13 Lack of bedform features in Segment M12-A**

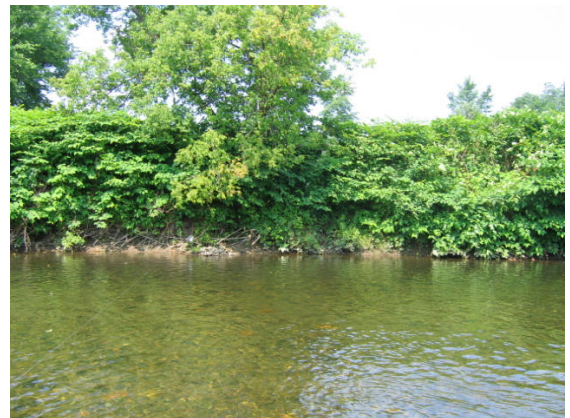
**Figure 7.14. Invasive vegetation on the banks of Segment M12-A**

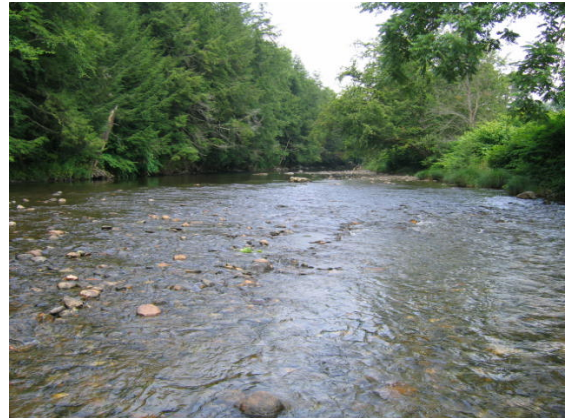
**Figure 7.15. Typical straightened channel in M12-B**

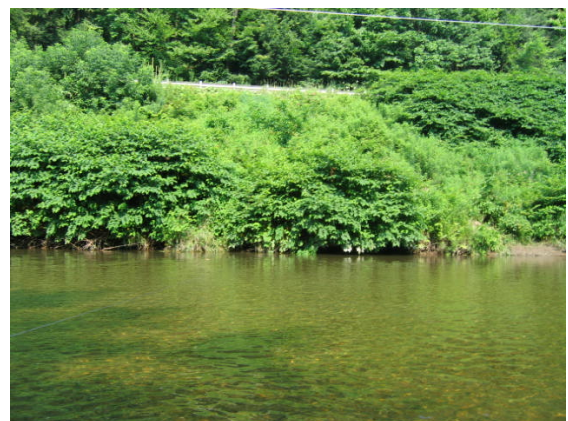
**Figure 7.16. Elevated River Road along Reach M13**

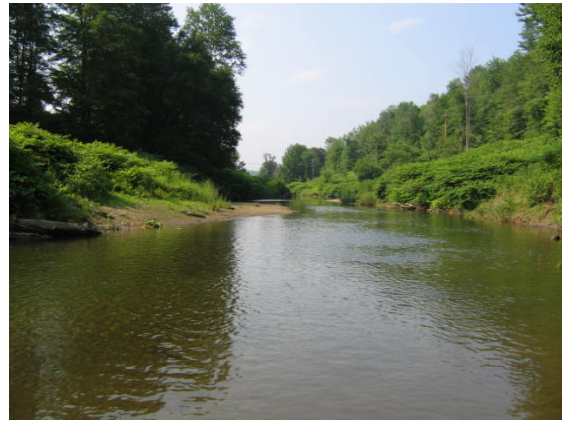
Most of the west bank within M13 has a riparian buffer width of 26 to 50 feet. On the east side of the river, the buffer width is predominantly 51 to 100 feet. Invasive vegetation is very common along banks and dominant within both buffers (Figure 7.17). Erosion is prevalent on both banks (about 50 percent on both sides) as a result of the poor root structure offered by the invasive vegetation. The dominant and subdominant land use within the west corridor is shrub/sapling and forest, respectively. The eastern corridor is dominated by crops and also contains forest.

**Figure 7.17. Invasive vegetation within both buffers in M13**

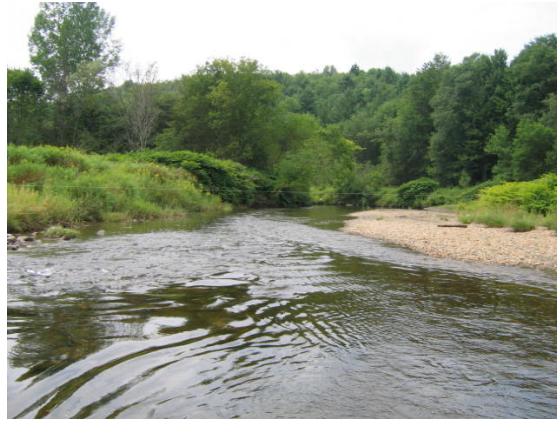
**Figure 7.18. Typical channel in M14-A**

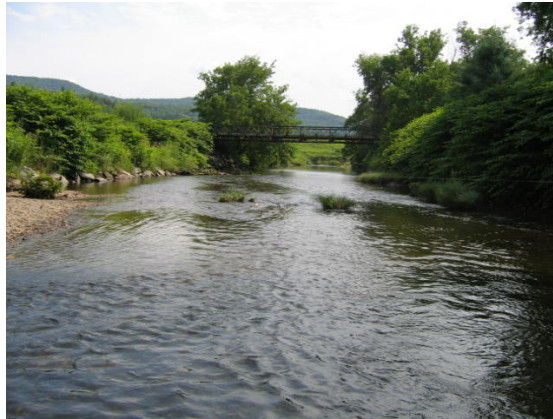
**Figure 7.19. Typical channel in M14-B**

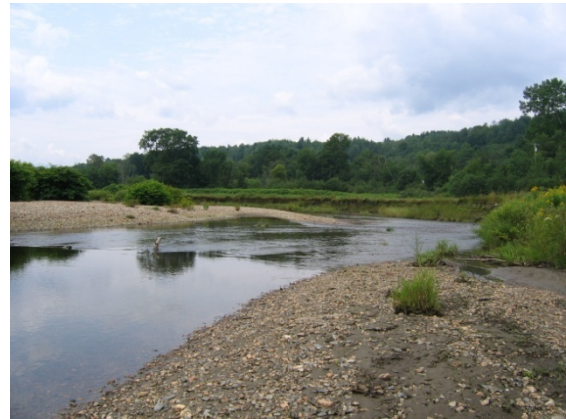
Deposition along Segment M14-C is much more pervasive than in other segments in M14 (Figure 7.20). This deposition has affected the reach enough to cause diagonal bars and steep riffles to form. There are also eight large point bars and four side bars. Channel planform has changed in M14-C as shown by the presence of an island, flood chute and a channel avulsion. Both the RGA and the RHA scored in the “fair” category. The RGA was fair as a result of major historic degradation, aggradation, widening, and planform adjustment. Numerous depositional features, exposed substrate, unstable banks, lack of bank vegetation and riparian buffer, and channel straightening resulted in the decreased quality of habitat in segment M14-C.

**Figure 7.20. Large point bars, bank erosion and lack of buffer in segment M14-C**

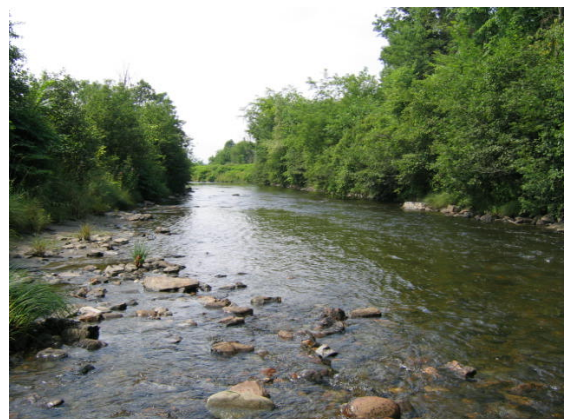
The entire length of the west side has a buffer width of less than 25 feet and the east side’s buffer is 26 to 50 feet wide. Invasive vegetation is dominant on both stream banks and subdominant in both buffers. Dominant buffer vegetation on both sides is comprised of deciduous trees. The land use in the corridor is predominantly residential within both corridors.

**Figure 7.21. Straightened section of segment M14-D**

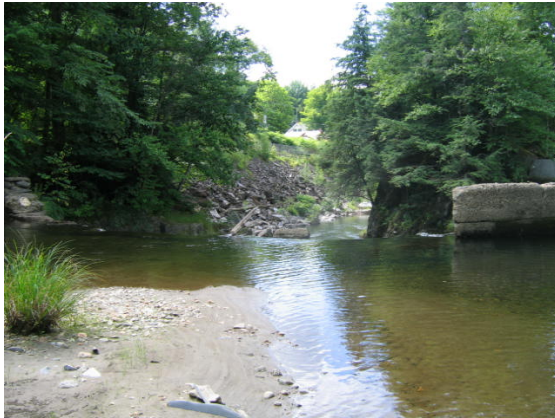
**Figure 7.22. Old dam grade control is constricting channel and causing sediment deposition upstream in M15-A.**

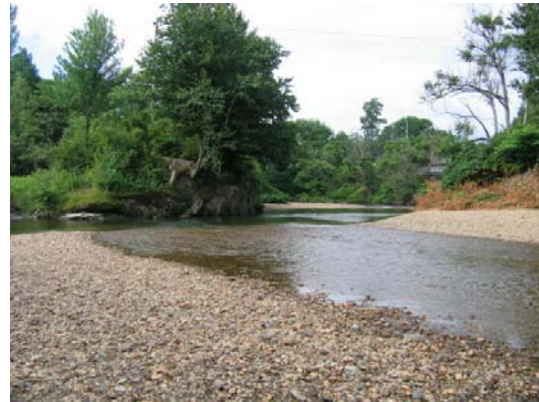
**Figure 7.26. Large point bars within Segment M15-D**

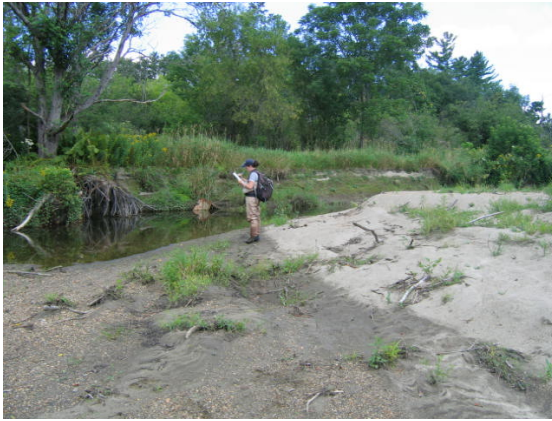
**Figure 7.28. The large sand point bar reflects the major aggradation in M16-C.**

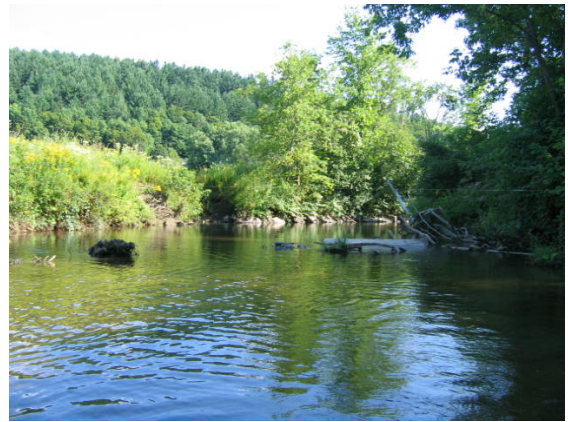
**Figure 7.29. Beaver dam influence in M16-B**

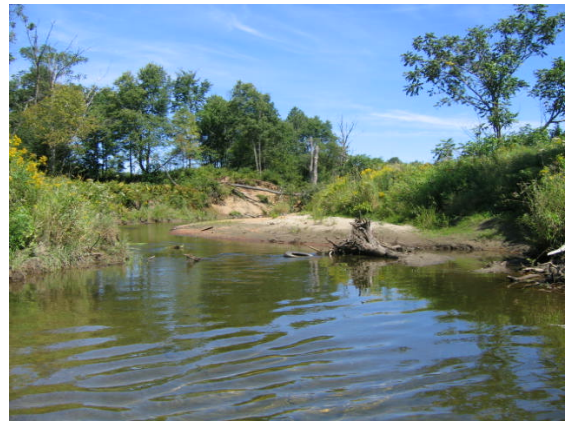
**Figure 7.30. Bank erosion and point bar in M17**

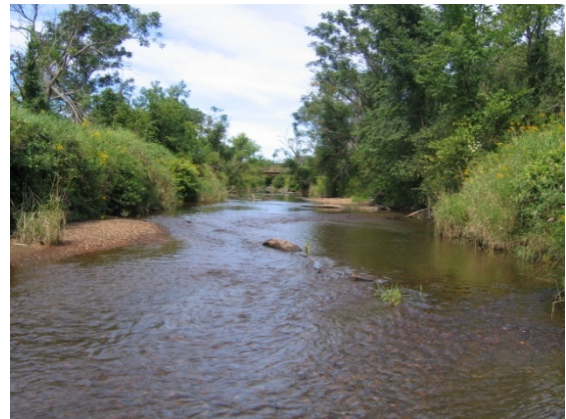
**Figure 7.32. Straightened section of M18-B**

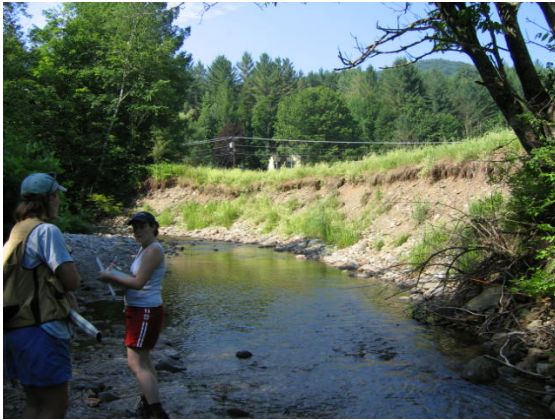
**Figure 7.37. Lack of buffer along western bank causing bank failure in Reach T4.01**

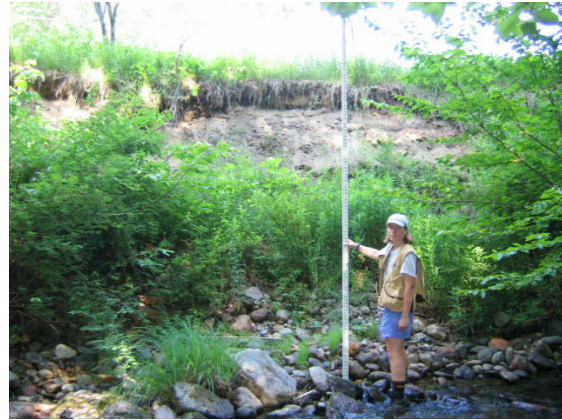
**Figure 7.38. Mass failure 12 feet high along western bank in Reach T4.01**

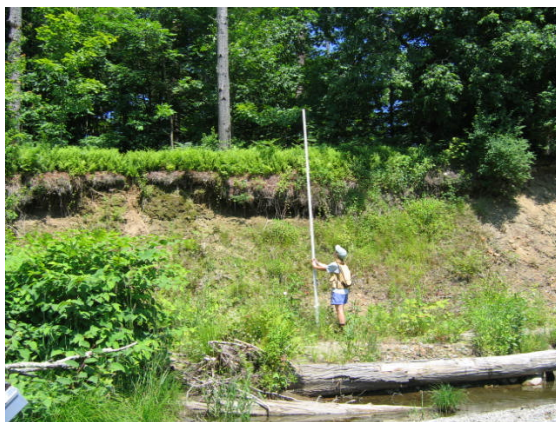
**Figure 7.39. Mass failure 20 feet high along eastern bank in Reach T4.01**

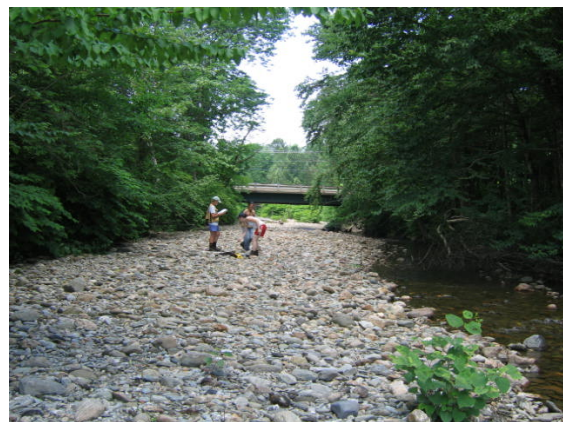
**Figure 7.40. Major aggradation shown by very large side bar in Reach T4.01**

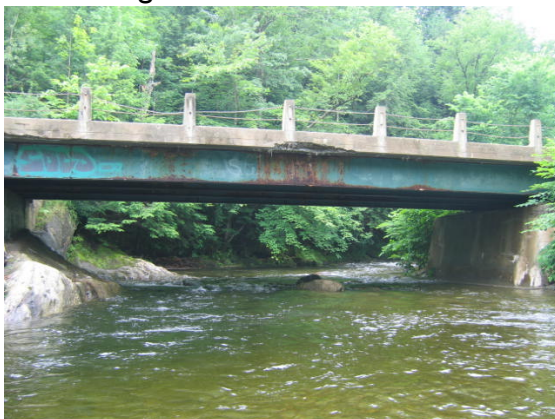
| Stream Name | Reach/ Segment Number | Road Name | Structure Type | Percent Bankfull Channel Width <sup>1</sup> | Aquatic Organism Passage (AOP) | Geomorphic Compatibility | Phase 2 Constriction Notes | Priority for Replacement or Retrofit |
|---|---|---|---|---|---|---|---|---|
| | T4.02 | Nebraska Valley Road | Bridge | 79% <sup>2</sup> | NA | Partially Compatible | Deposition above, scour above and below, alignment (bridge appears to be in poor condition) | Moderate |

**Figure 7.41. Bridge crossing of Nebraska Valley Road constricting Reach T4.02**

### **Bridge Replacement**

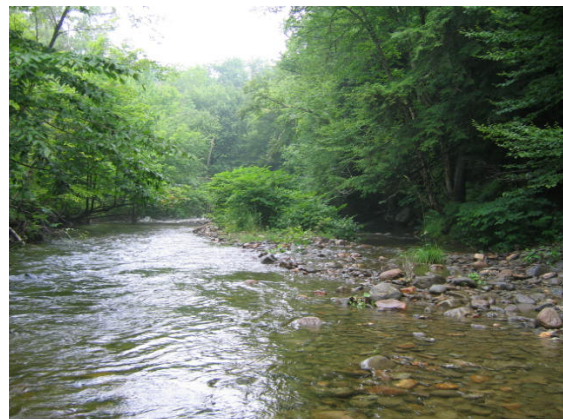
**Figure 7.42. Island with diagonal bar and steep riffle along Reach T4.02**

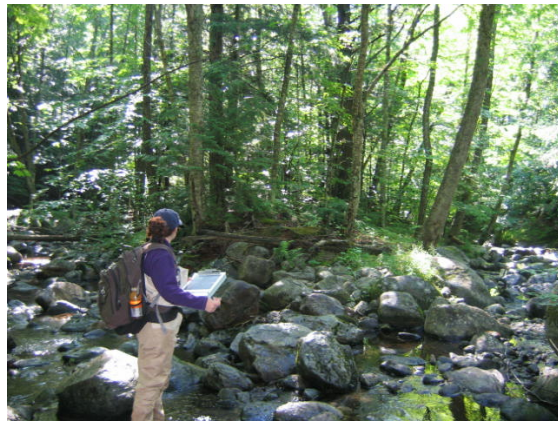
**Figure 7.46. One of many islands showing major planform adjustment in Reach T4.04**

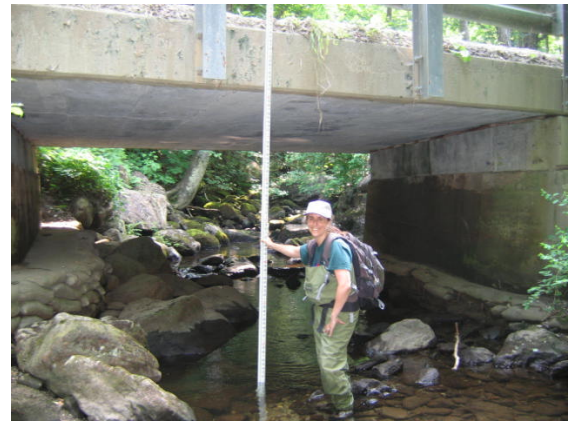
**Figure 7.48. Constricting bridge at Nebraska Valley Road in Reach T4.05**

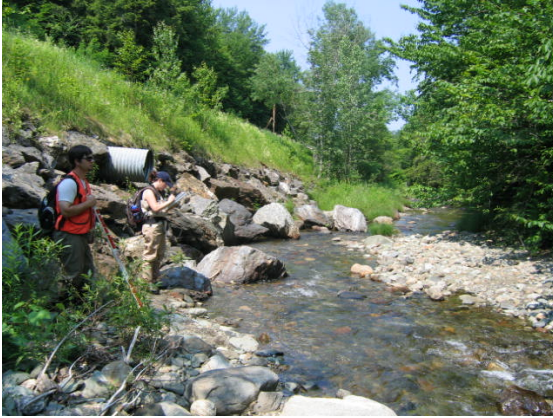
**Figure 7.53. Rip-rap armoring, lack of buffer, and stormwater input in Segment T6.03-B**

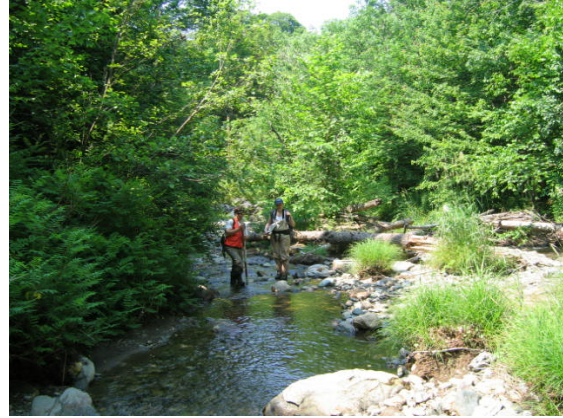
**Figure 7.54. Major aggradation in Segment T6.03-C**

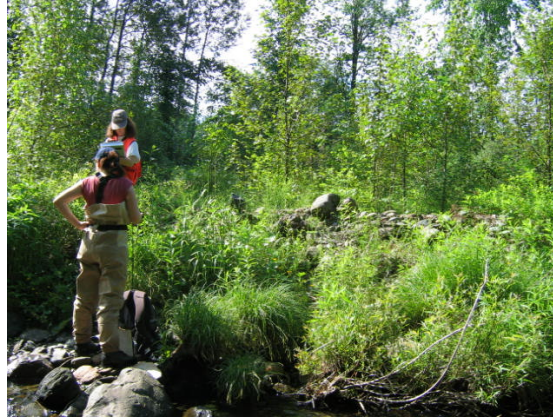
**Figure 7.55. Berm with fill preventing floodplain access in Reach T6.04**

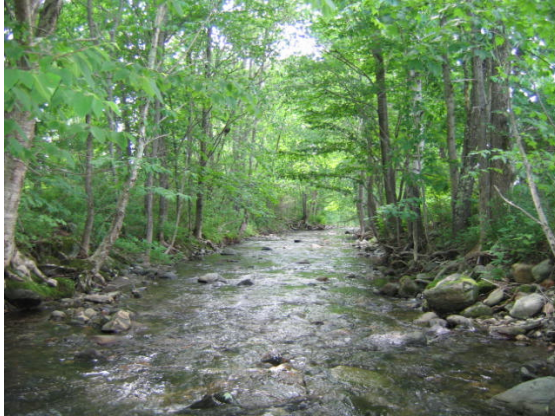
**Figure 7.56. Straightened section of Reach T6.05**

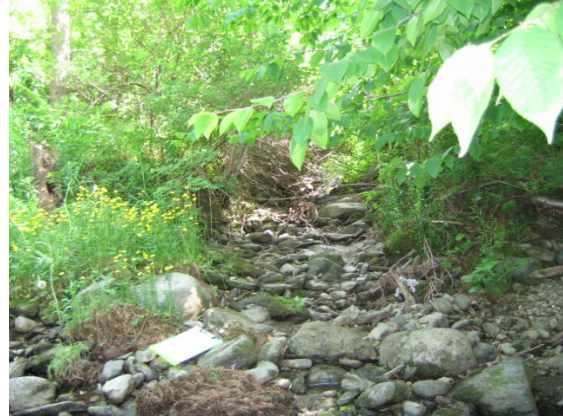
**Figure 7.57. A rejuvenating tributary indicates that T6.05 has incised**

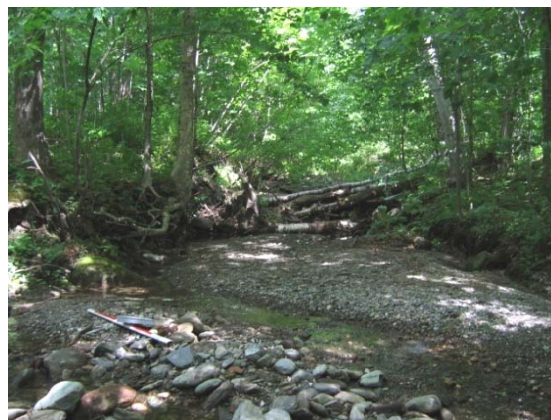
**Figure 7.60. Outlet of channel avulsion in Segment T6.06-A**

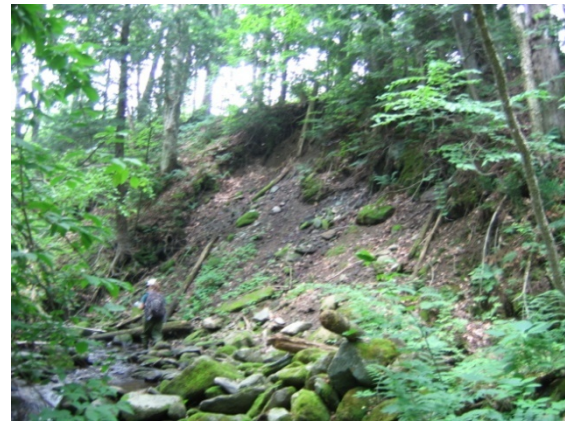
**Figure 7.62. Mass failure in T6.07**

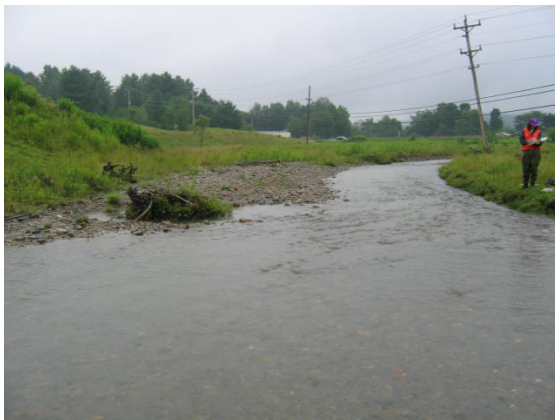
**Figure 7.63 Over widened channel in cross section of T8.01-B**

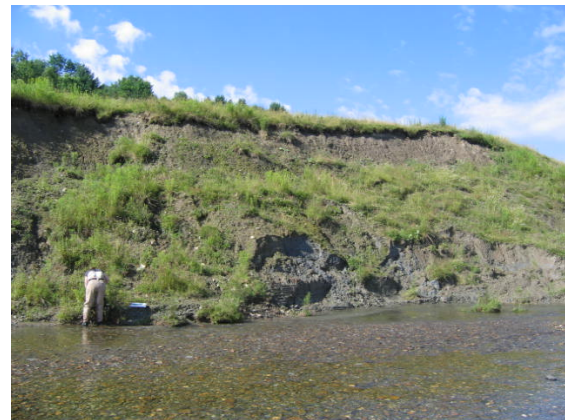
**Figure 7.64. Mass failure acting as a major sediment source in Moss Glen Brook in T8.01-B**

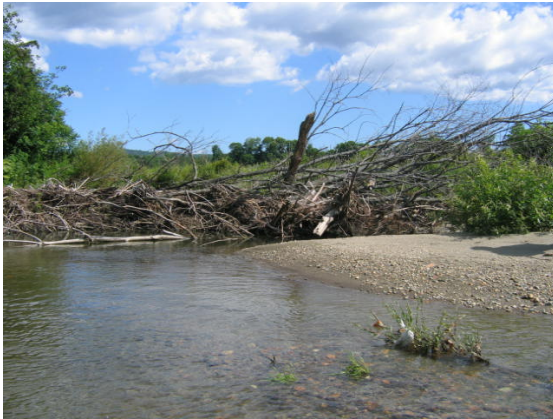
**Figure 7.65. Beaver dam causing deposition in T8.01-A**

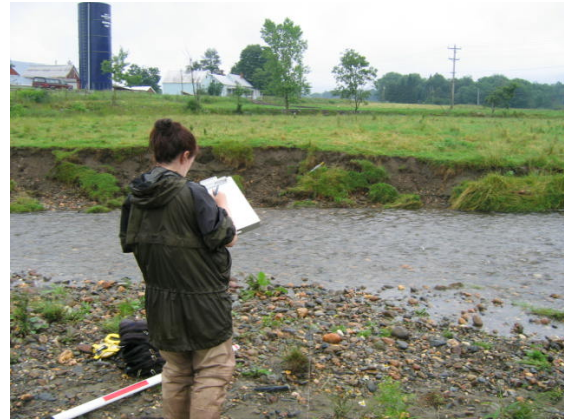
**Figure 7.66. Lack of buffer and severe bank erosion in cow pasture area in T8.01-B**

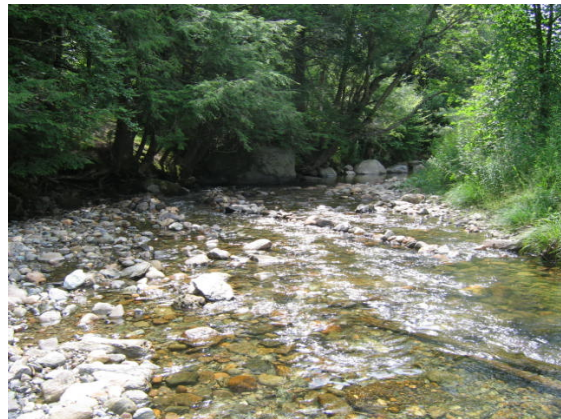
**Figure 7.67. Straightened section of segment T8.02-B**

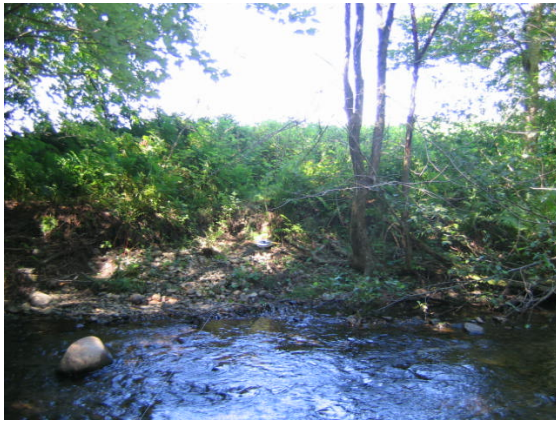
**Figure 7.68. Lack of buffer in Reach T8.03**

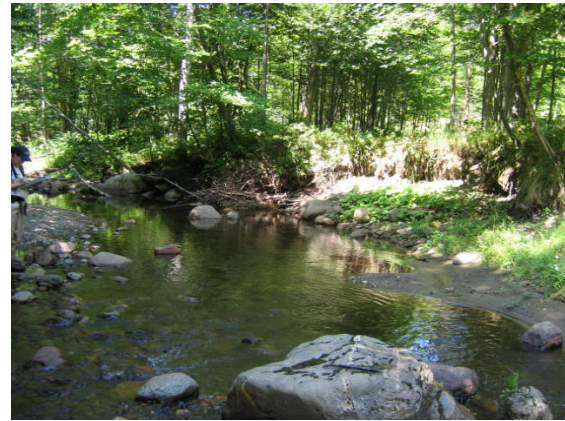
**Figure 7.69. Bank erosion on northern bank in Reach T8.03**
