**Phase 2 Stream Geomorphic Assessment  
Black River Watershed  
Rutland & Windsor Counties, Vermont**

**Addendum 1: Patch Brook & Buffalo Brook Tributaries  
Towns of Plymouth, Reading, Mount Holly, Ludlow**

**October 2010**

**South Mountain Research & Consulting**

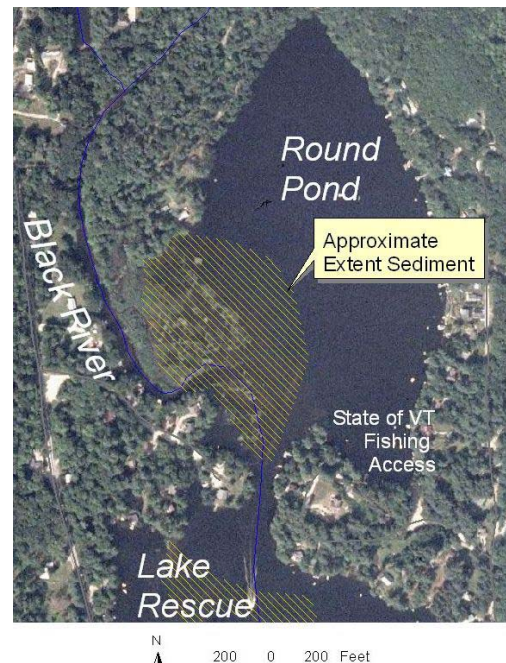
Phase 2 stream geomorphic assessments of the Patch Brook and Buffalo Brook were undertaken at the request of the Lake Rescue Association, in cooperation with SWCRPC. In recent decades, residents in the vicinity of Lake Rescue have noted increasing volumes of sediment in a northern embayment of Lake Rescue known locally as Round Pond. Anecdotally, the aerial extent and thickness of these sand and silt deposits has increased markedly since the flood of June 1973 (Figure 1). Patch Brook enters the Black River downstream of Echo Lake and approximately 0.6 mile upstream of Round Pond (Figure 2). A growing sediment delta has also been noted at Camp Plymouth State Park where the Buffalo Brook joins Echo Lake, approximately 1.2 miles upstream of Round Pond. This delta was observed to increase in size coincident with a June 2006 flood which impacted the Buffalo Brook tributary following sudden breaching of a dam at Reading Pond.

Figure 1. *Approximate location of sediment accumulation in Round Pond*

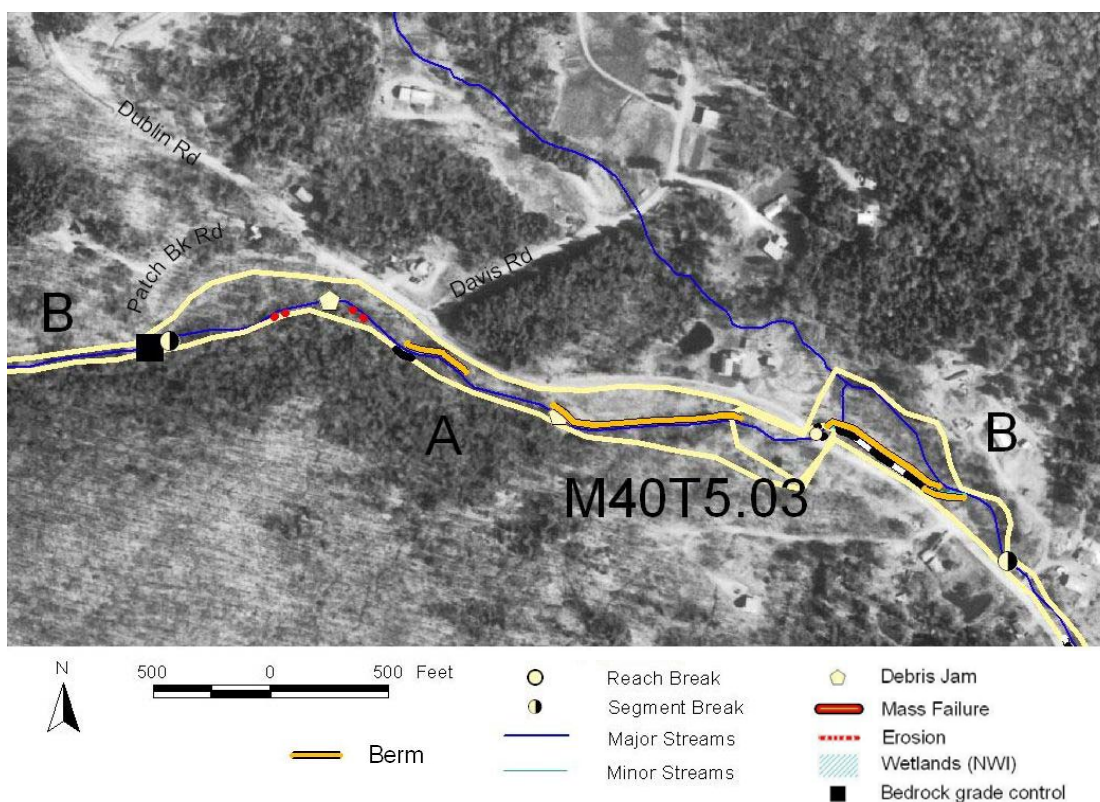
In general, downstream of the Patch Brook Road / Dublin Road intersection, the Patch Brook is incised and entrenched below high terraces of glaciofluvial sediments – in part as a result of an extensive history of channel management including straightening, berming, armoring, inferred dredging, historic mill dam impoundments, and flow diversions. The upstream extent of historic incision is marked by a bedrock grade control (waterfall) at the segment break between M40T5.03-B and M40T5.03-A (Figure 6). At the lower end of reach M40T5.03, the natural valley confinement transitions from Semi-Confined to Broad, as the channel flows from glacial till deposits to glaciofluvial sediments. Increased lateral adjustment of the channel would be expected at such a transition. Instead the channel has been extensively managed in this location in response to past flood events (e.g., 1973, 1936/38, 1927) and to protect adjacent roads and residences. A high berm has been constructed along the left bank in two sections; these berms and the linear planform of the channel suggest a history of channelization with windrowing. The channel is now pinned along the right valley wall and is incised below the adjacent floodplain.

Figure 6. Features encountered along M40T5.03-A and upstream end of M40T5.02 (Segment B), 10 September 2009. (Pale yellow line indicates human-modified valley wall).

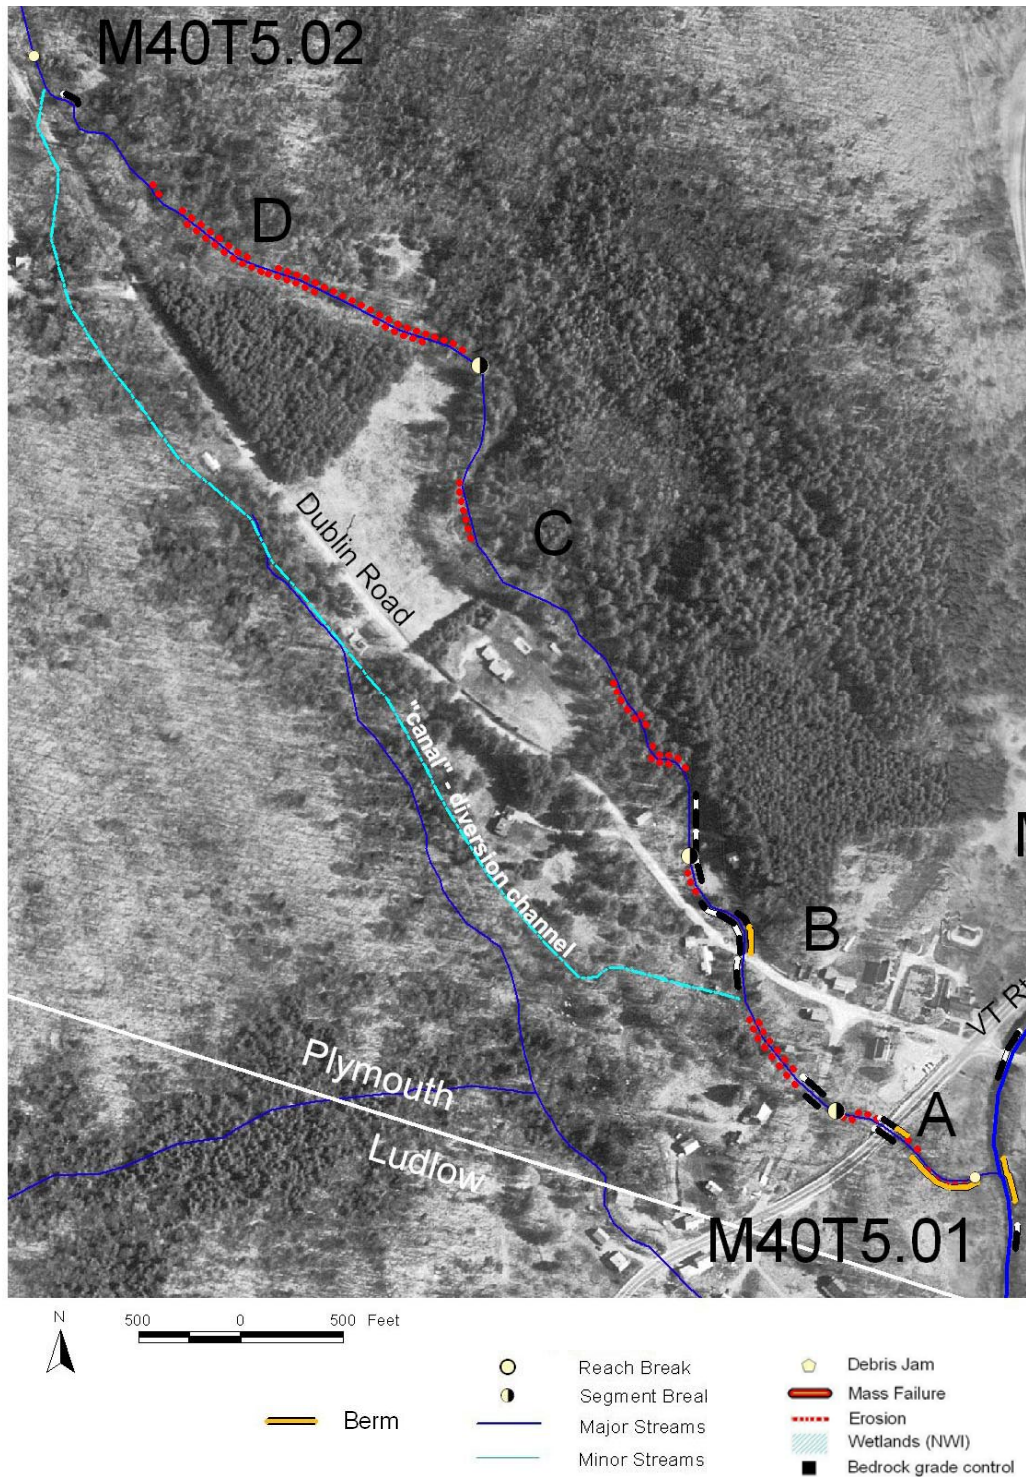
Figure 7. Diversion channel leading from the upstream end of reach M40T5.01 under Dublin Road, to the west of residential homes, and returning to the Patch Brook channel downstream of the Dublin Road bridge crossing.

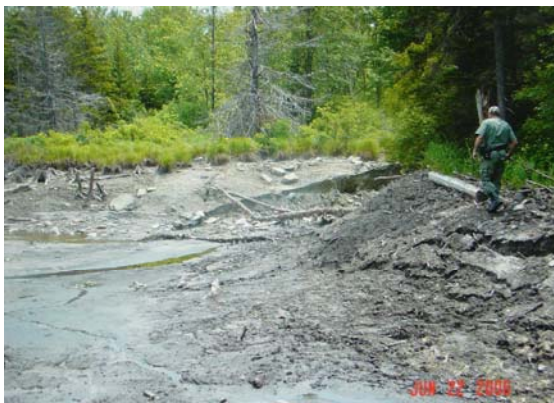
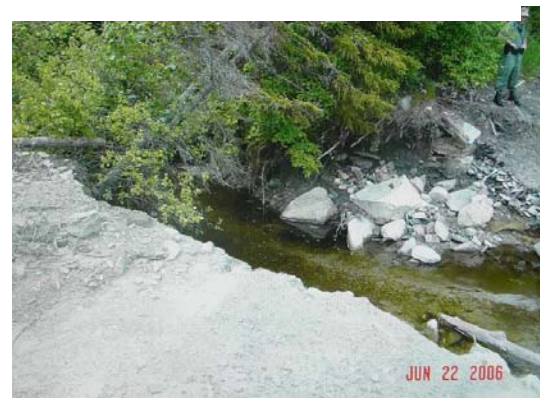
The sudden breaching of Reading Pond dam resulted in a significant volume of water being released to the Reading Pond Brook and lower reaches of the Buffalo Brook. As observed in September of 2009, the southern shore line of Reading Pond is now located more than 700 feet to the north of its former position. The aerial extent of this pond has been reduced by approximately 10 acres (Figures 10-a & -b). It is likely that volumes of fine and coarse sediments were released from behind the dam as the pond drained (Figures 10-c, 10-d, 10-e). Today, the southern extent of the former pond has begun to revegetate (Figure 10-f).

(c) breached dam, 22 June 2006 (Source: VTDEC).

(d) breached dam, 22 June 2006 (Source: VTDEC).

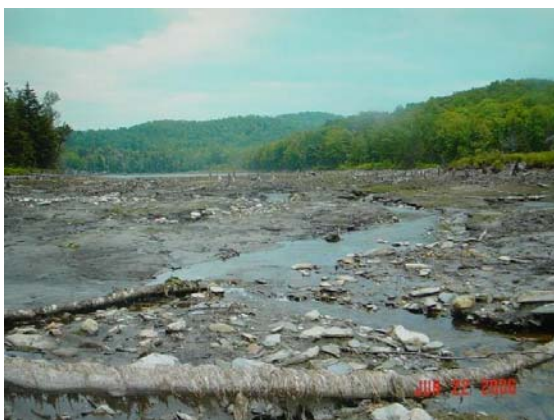
(e) view upstream from breached dam, 22 June 2006 (Source: VTDEC).

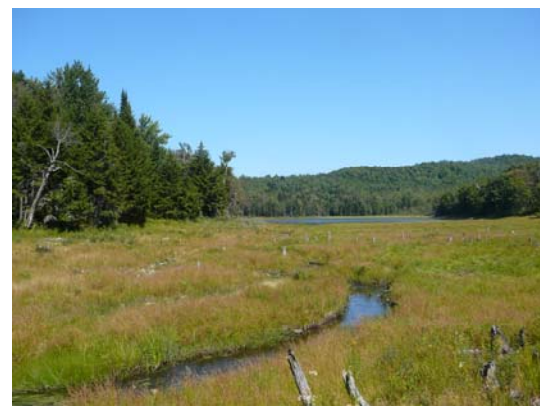
(f) view upstream from breached dam, 4 September 2009

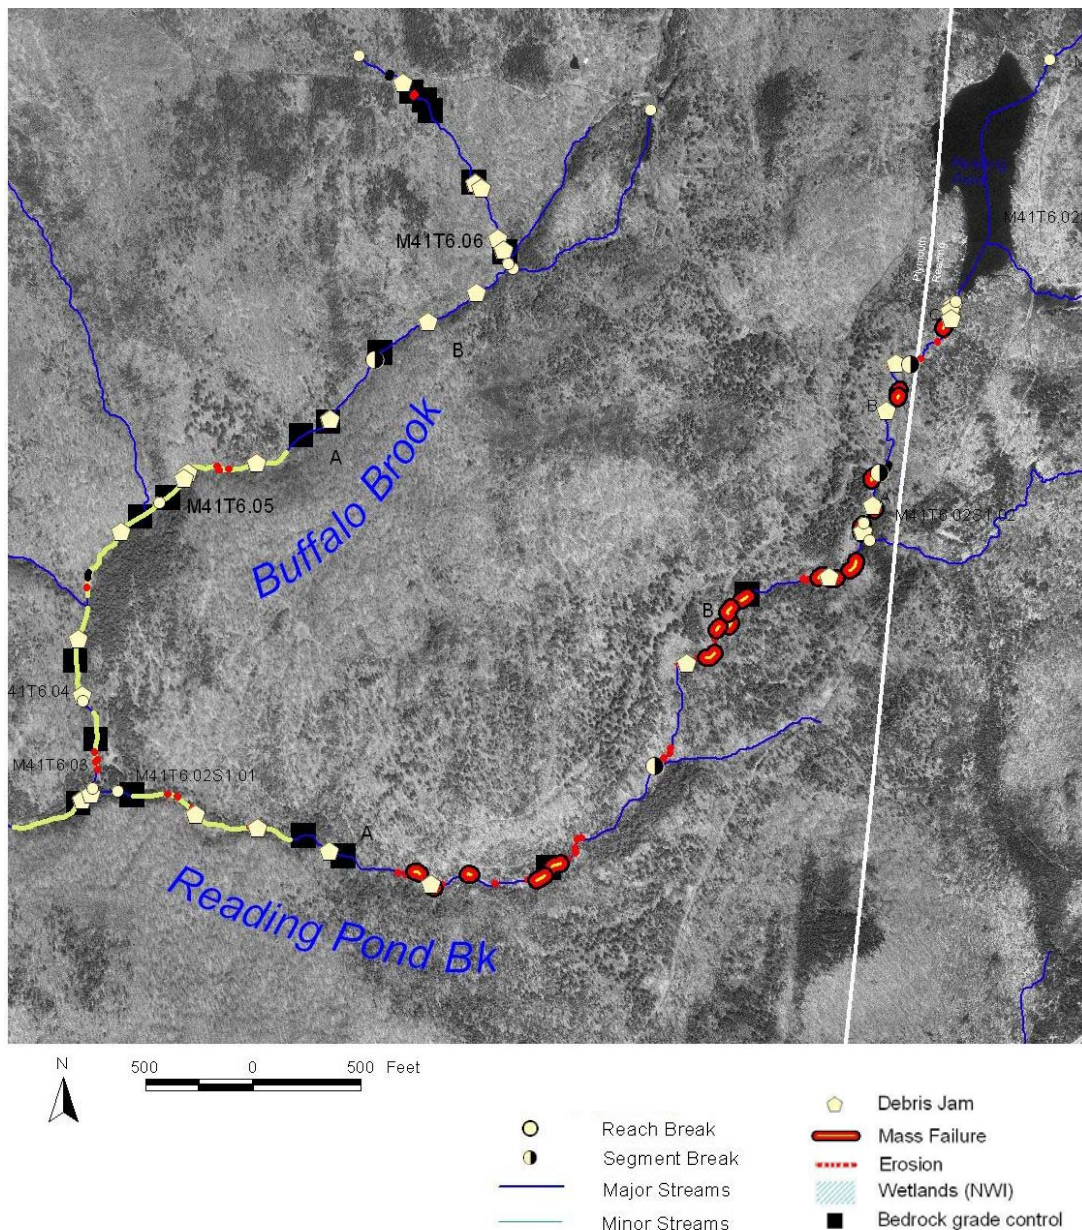
abandoned) joins the narrow stream valley, a degree of historic (or post-glacial) incision below discontinuous stream terraces is evident, along with signs of moderate planform adjustment (flood chutes) and localized widening. Intermediate reach M41T6.04 is vertically and laterally stable. At reach M41T6.03, just above the confluence of Reading Pond Brook, there is a local accumulation of glaciofluvial sediments, and the channel has become historically (or post-glacially) entrenched below high terraces of unconsolidated sediments. Incision may reflect a tributary rejuvenation process extending upstream in the reach from historically-incised lower reaches of the Buffalo Brook.

Figure 12. Observed features on upper reaches of Buffalo Brook and Reading Pond Brook. Pale green line indicates length of channel with abandoned forest road within one channel width to either side of stream.

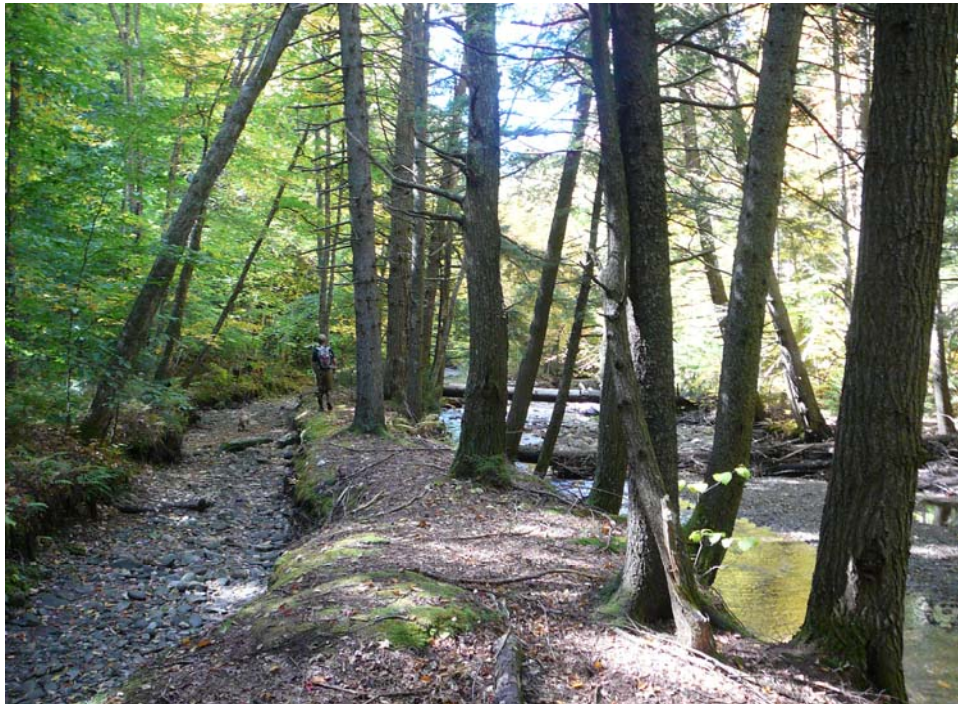
Downstream of the confluence with Reading Pond Brook, the Buffalo Brook channel is characterized by historic (or post-glacial) incision, with localized aggradation, widening and planform adjustments (flood chutes, bifurcations) at sites of debris jams, or log steps. A forest road follows the channel for nearly the entire length down to a short bedrock gorge above Camp Plymouth State Park. Frequently, the channel has avulsed to erode a portion of the road bed or occupy the road as a flood chute during higher water. In this manner, the road bed has served as a source of sediments to downstream reaches (Figure 13).

*Figure 13. View downstream, recent avulsion along the former path of the forest road in LB corridor, Segment B, M41T6.02, Buffalo Brook, 24 September 2009*

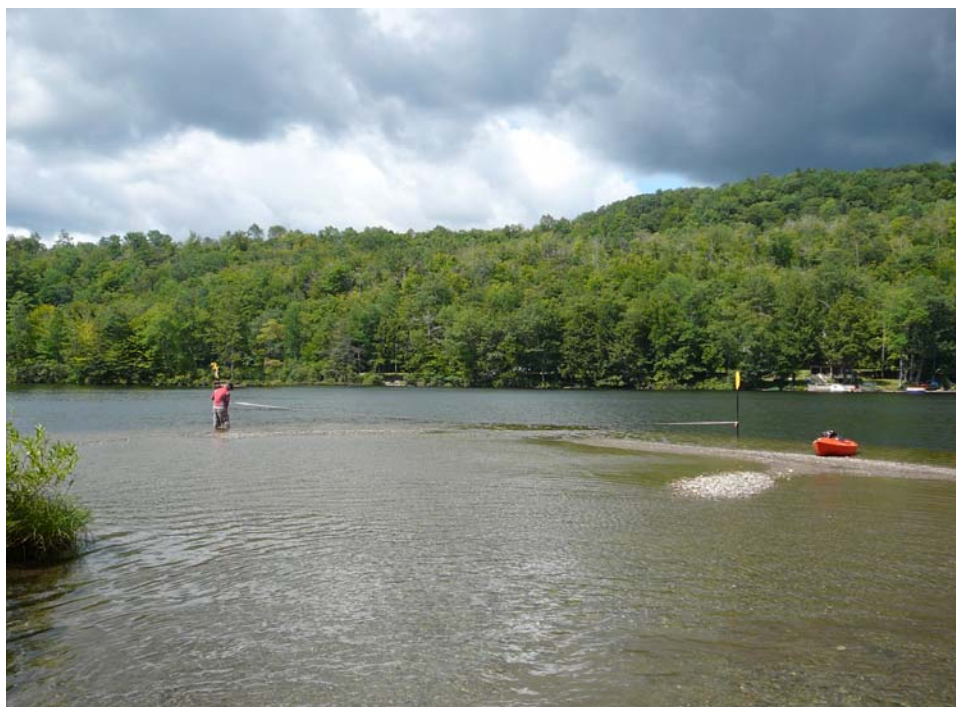
Some lateral adjustments are occurring in the lower segment of M41T6.01 through the state park. A large sediment delta has accumulated – particularly since the June 2006 flood – in Echo Lake at the confluence of Buffalo Brook (Figure 14).

*Figure 14. View downstream to delta of fine gravels and sands which extends out into Echo Lake from the mouth of Buffalo Brook, reach M41T6.01, Segment A, 7 August 2009. Kayak paddles mark approximate lateral extent of deposits.*

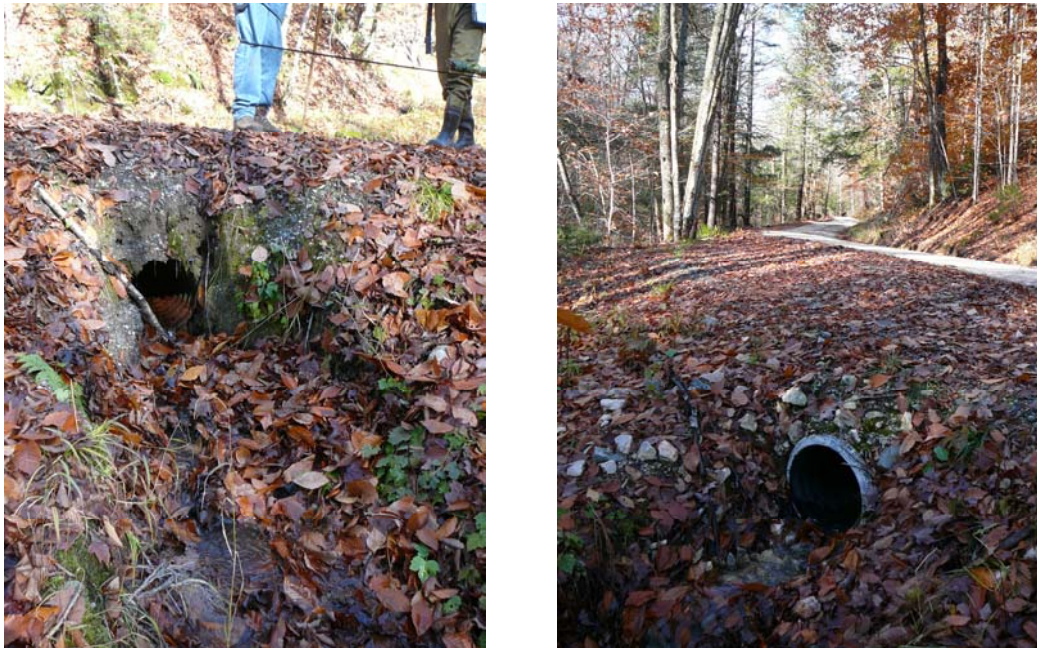
- In the Patch Brook watershed, reach M40T5.03 shares a narrow, steep valley with the gravel Patch Brook Road. Road ditches were prevalent along the uphill (north) side of the road. These ditches receive not only stormwater runoff but also tributary drainage off slopes to the north. At least 21 cross culverts were indexed along a channel length of 1.4 miles. Often, fine sand and gravels obstructed culvert inlets and culvert outlets were unstable (no headers). Road sediment was observed directly entering the channel at the outlet of several culverts. A few additional locations of direct sediment runoff by overland flow were indexed along the reach. No turn-outs or check dams were observed along the road ditches, although it should be noted that physical space to install and maintain such structures is limited in this narrow valley.

*Figure 15. Examples of stormwater inputs to the Patch Brook reach M40T5.03 Segment B; 29 October 2009*

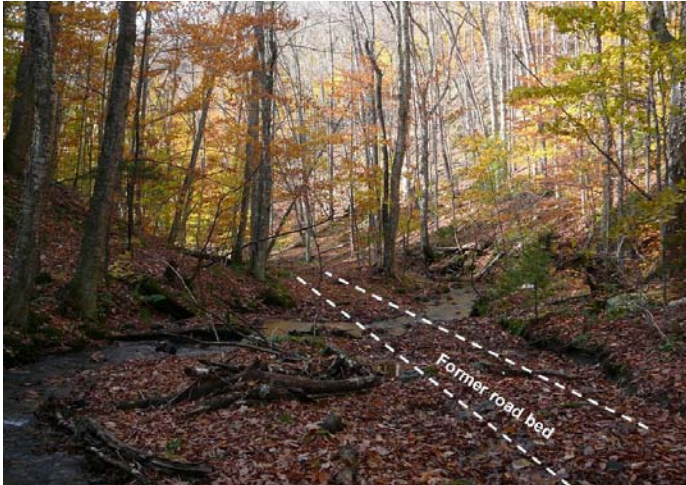
- In the Buffalo Brook watershed, an abandoned road network shares a narrow valley with the stream channel in several reaches of the Buffalo Brook and Reading Pond Brook. In some locations evidence of the road has been eroded away as the stream has avulsed to flow in the path of the road. In other locations, the former road grade has been eroded to form a flood chute (Figure 16). As stormwater flows are concentrated along the road grade, sediments are eroded, and "sunken road" segments, or "dug-ways", have been created (see previous Figure 13).

Figure 16. View downstream, river crossing old road bed, which now functions as a flood chute during higher-flow conditions upstream of the crossing, Segment A, reach M41T6.05, Buffalo Brook, 22 October 2009

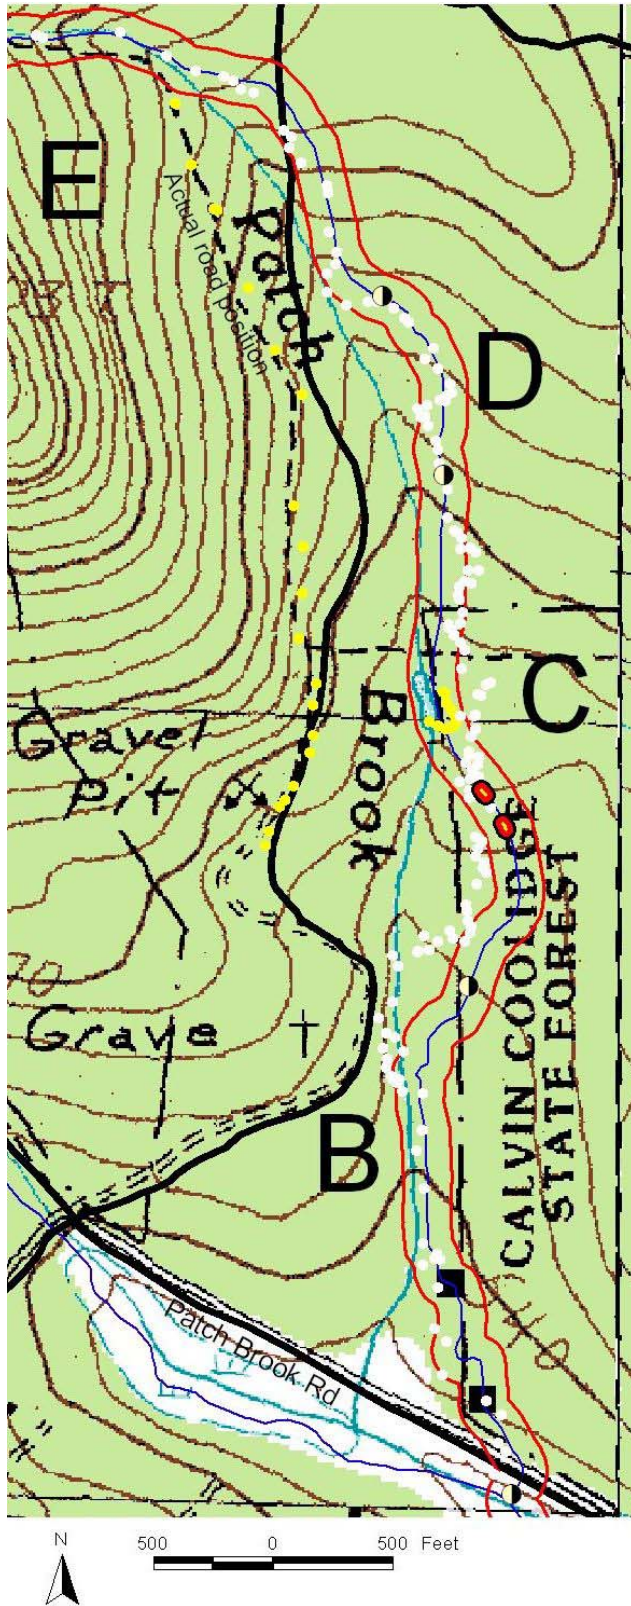
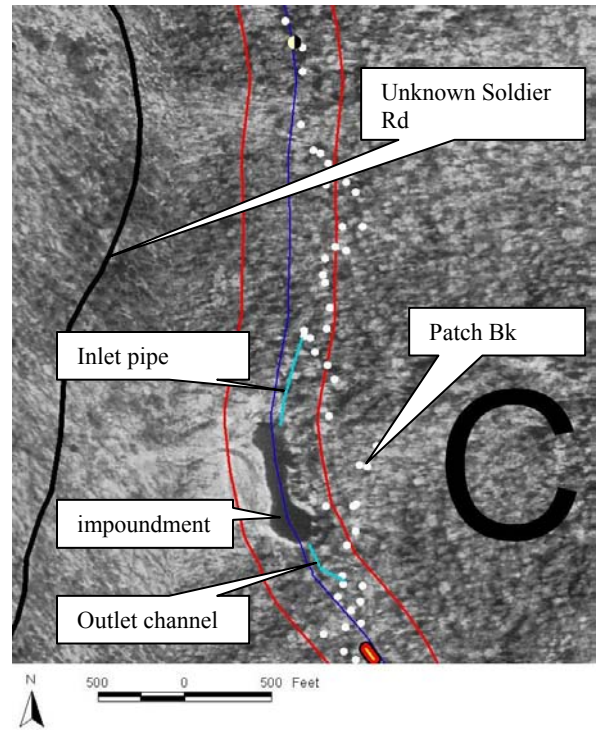
Figure 1b. Actual position of Patch Brook channel (indicated by white dots = waypoints from 2009 assessment) passes 50 to 100 ft east of impoundment.

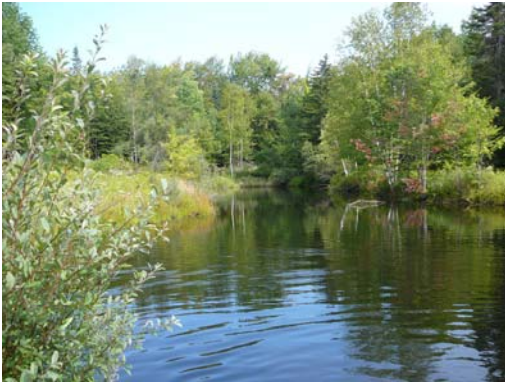
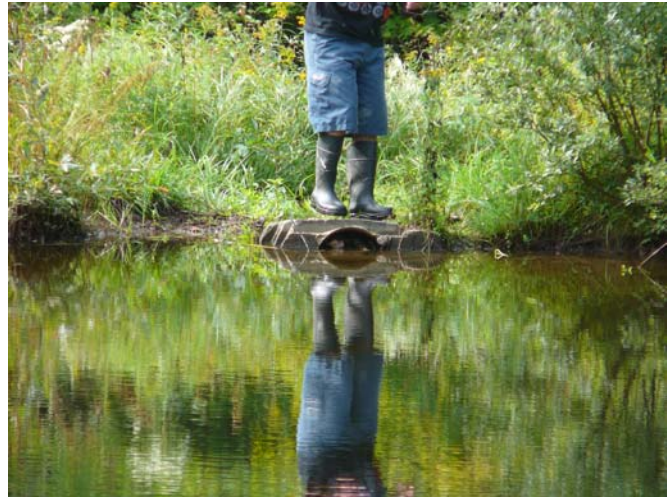
*Figure 4. Impoundment west of Patch Brook reach M40T5.04 Segment C, Patch Brook; 3 September 2009. (a) view upstream (north) from dam; (b) view south to culvert outlet.*

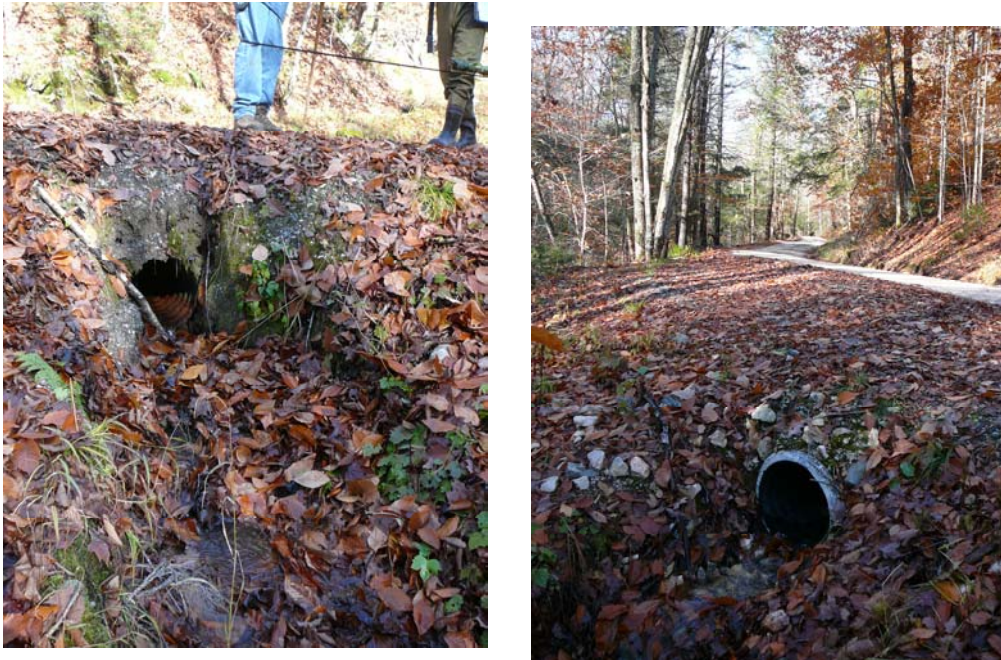
*Figure 9. Stormwater inputs to Patch Brook, M40T5.03 Segment B, from Patch Brook Road; 29 October 2009. (a) cross culverts without headers are sites of road sediment runoff to the channel; (b) sections of the road are graded to drain directly to the channel.*

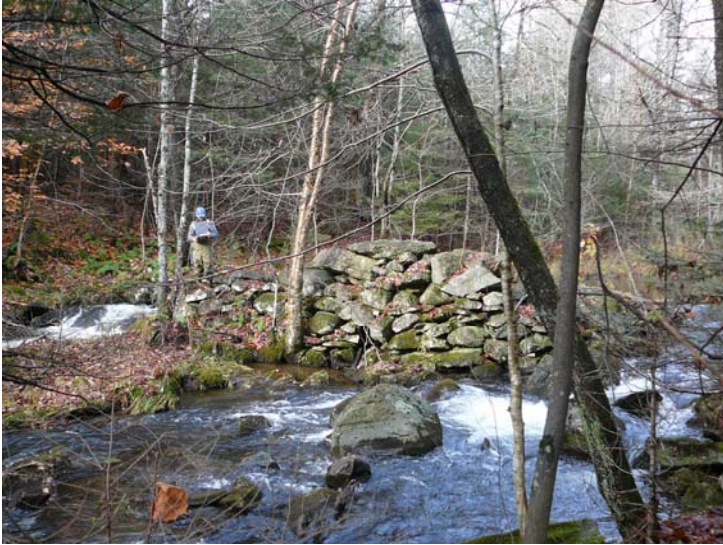
*Figure 10. Remnants of breached dam at bifurcation in Patch Brook channel. View upstream, M40T5.03 Segment B, Patch Brook; 29 October 2009*

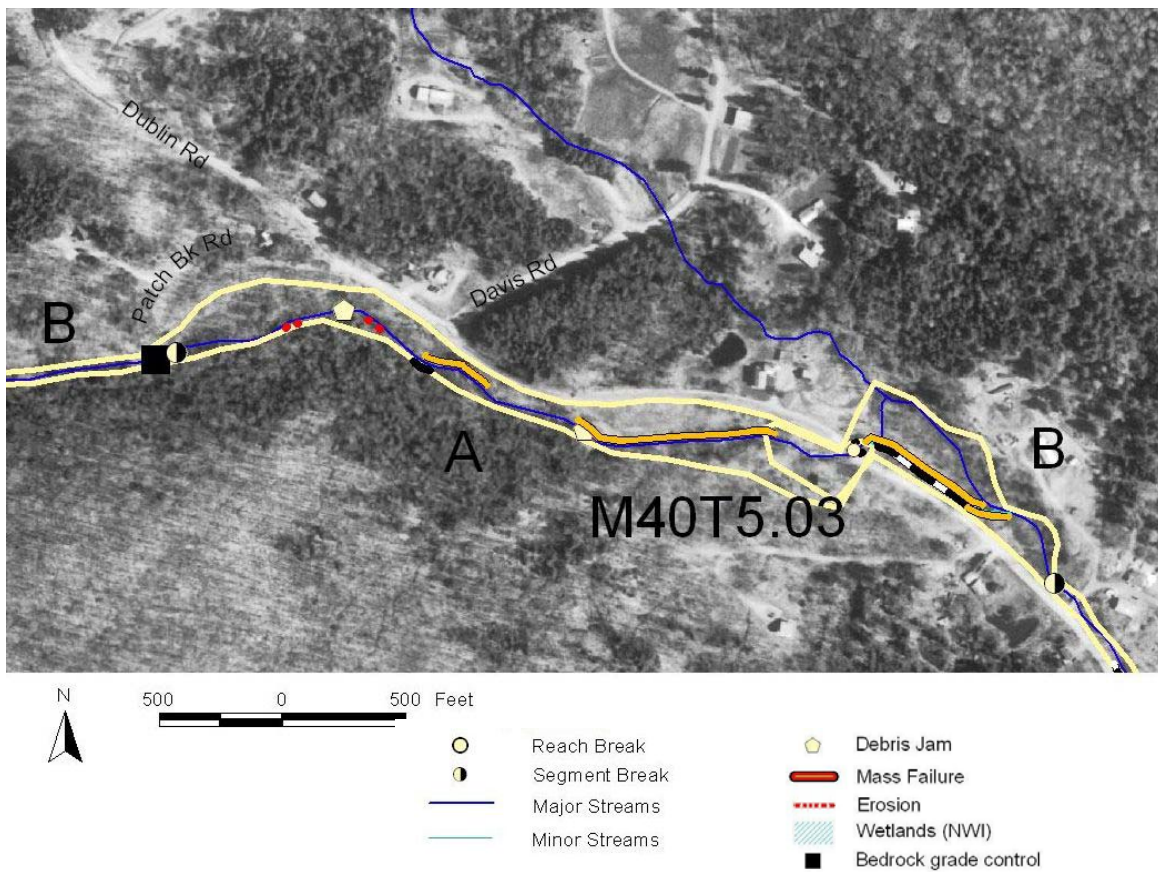
Figure 11. Features encountered along M40T5.03-A and upstream end of M40T5.02 (Segment B), 10 September 2009. (Yellow line indicates human-modified valley wall).

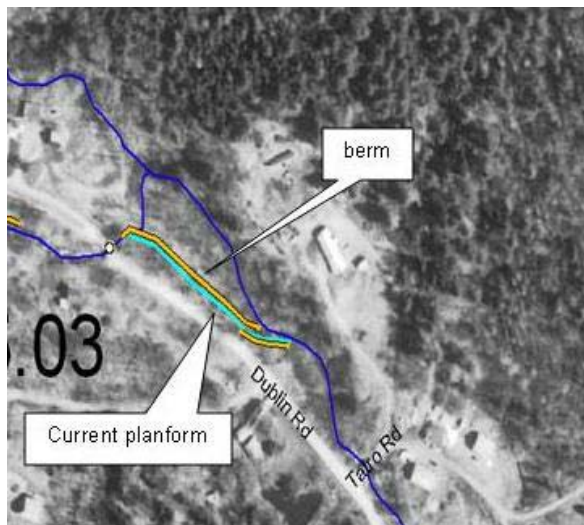
Figure 12. Section of Patch Brook (M40T5.02-B) has been channelized and bermed along Dublin Road.

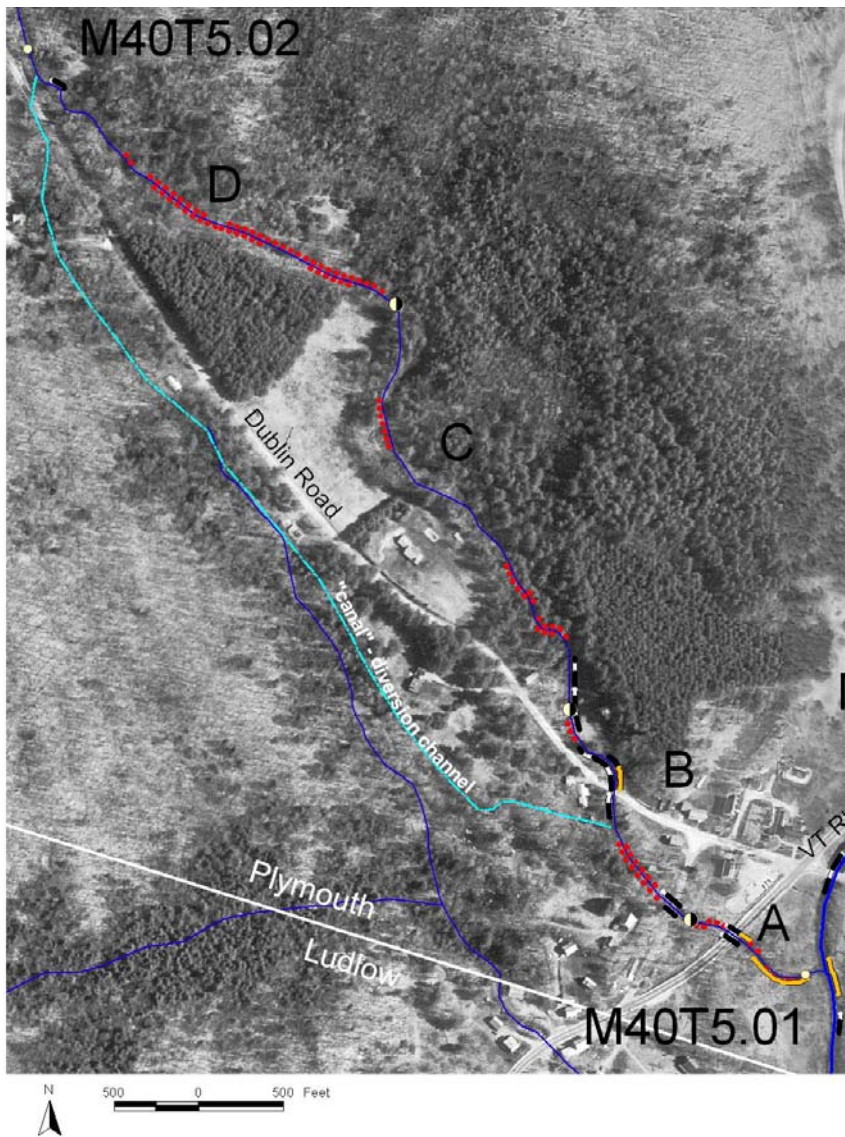
Figure 13.  
 Diversion channel leading from the upstream end of reach M40T5.01 under Dublin Road, to the west of residential homes, and returning to the Patch Brook channel downstream of the Dublin Road bridge crossing.

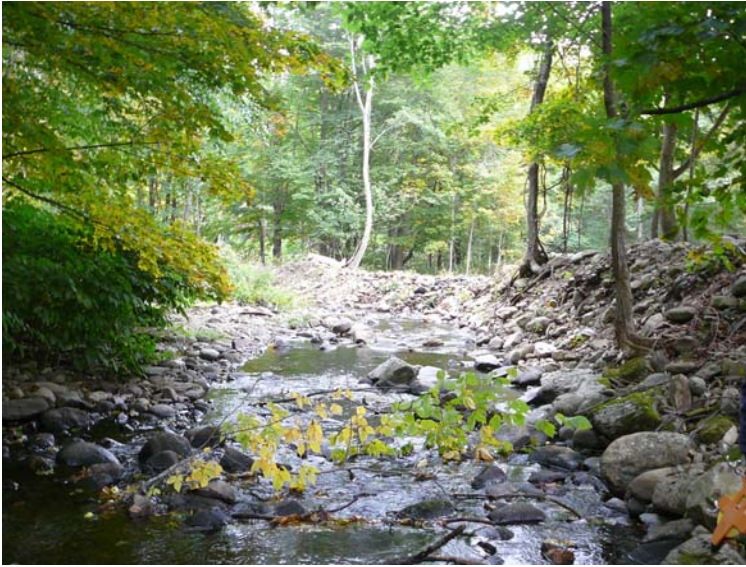
*Figure 17.  
View downstream from  
cross section site to  
right-bank berms,  
M40T5.01 Segment A,  
Patch Brook;  
18 September 2009.*

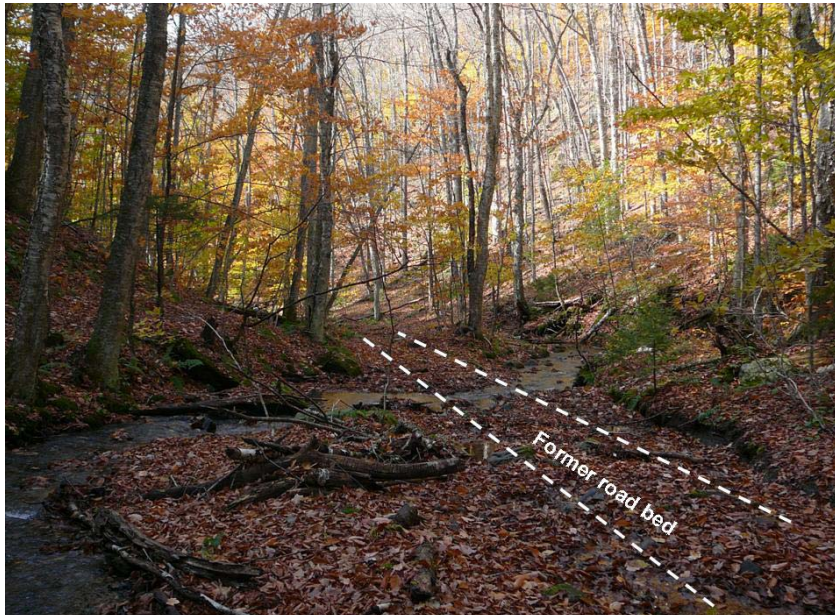
*Figure 20. View downstream, river crossing old road bed, which now functions as a flood chute during higher-flow conditions upstream of the crossing, Segment A, reach M41T6.05, Buffalo Brook, 22 October 2009*

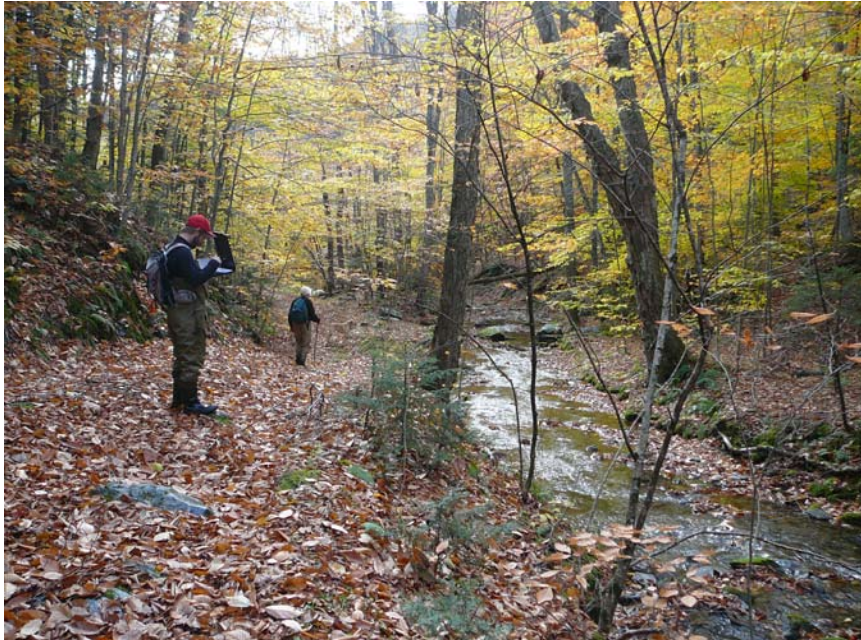
*Figure 21. View downstream, old road bed follows the channel, crossing three times within the reach, with most traces eroded in a bifurcation of the channel near the downstream end of the reach, M41T6.04, Buffalo Brook, 22 October 2009*

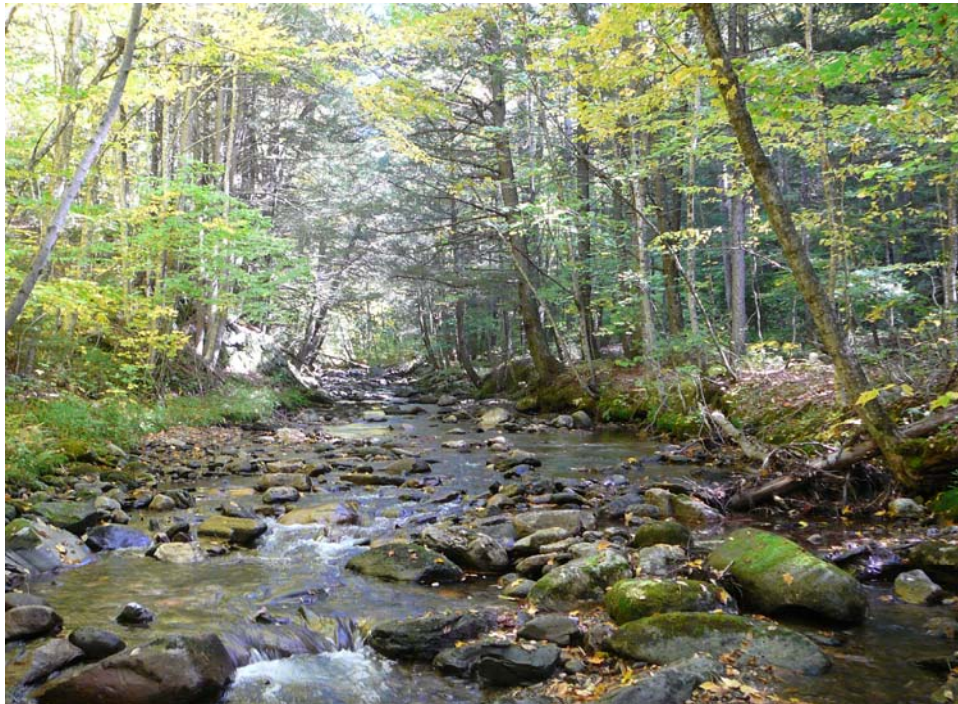
*Figure 22. View upstream, forest road is located on LB terrace (picture right) beyond the tree buffer, valley wall is coincident with RB (picture left); plane bed channel form; historically incised, historic widening indicated by curvilinear trees, Segment B, M41T6.02, Buffalo Brook, 24 September 2009*

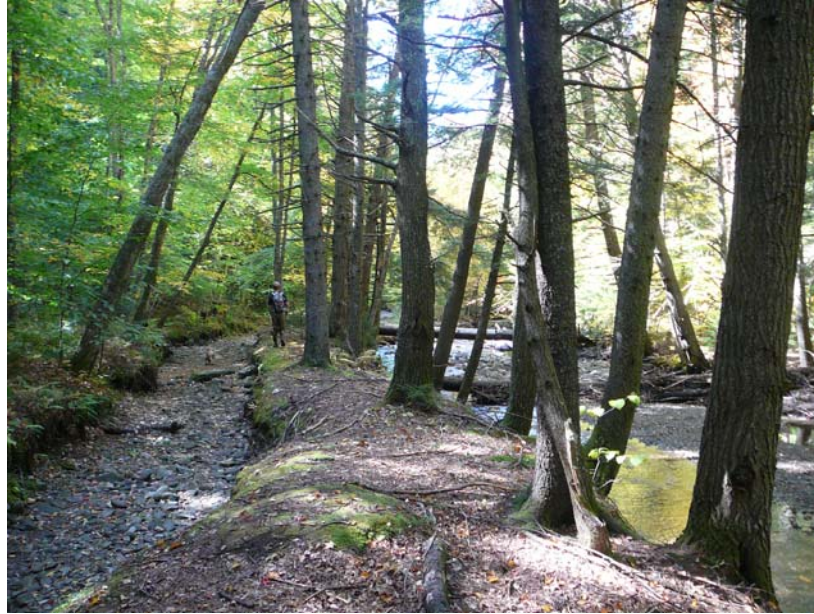
*Figure 23. View downstream, recent avulsion along the former path of the forest road in LB corridor, Segment B, M41T6.02, Buffalo Brook, 24 September 2009*

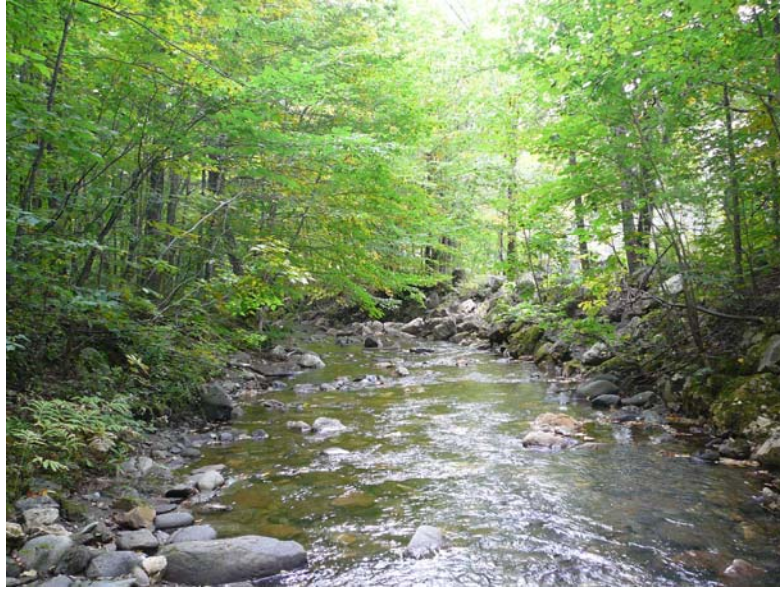
Figure 25. View downstream, berms along right bank (to protect Camp Plymouth State Park cabins) and left bank, Segment B, M41T6.01, Buffalo Brook, 18 September 2009

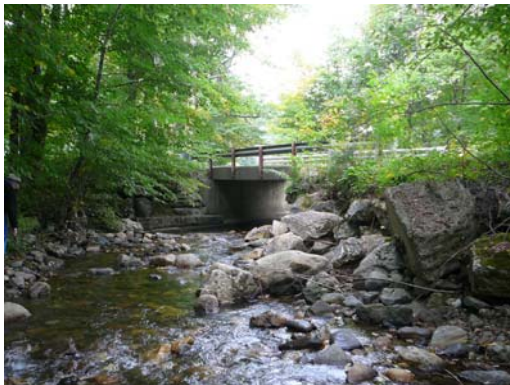
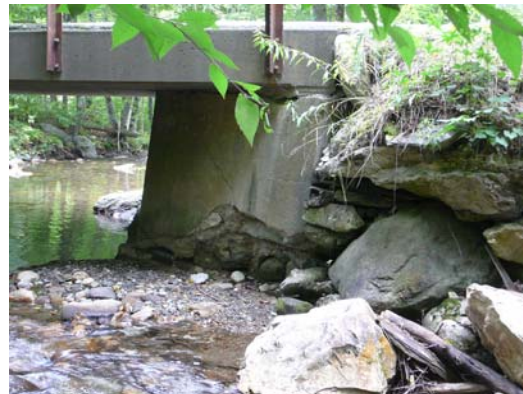
Figure 26. Scout Camp Road bridge, Segment B, M41T6.01, Buffalo Brook, 18 September 2009. (a) View downstream, to sharp approach angle, sediment accumulation at the inlet, armored banks, stepped footers on LB abutment. (b) spalling, cracking and apparent dislodging of right bank abutment.

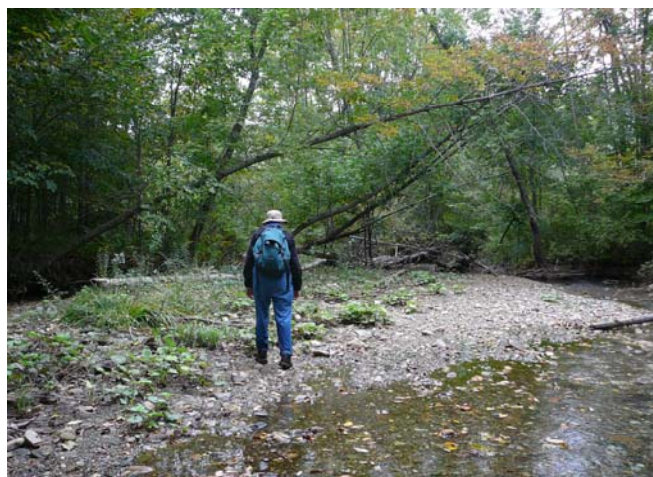
*Figure 27. View downstream, berms along right bank (to protect Camp Plymouth State Park cabins) and left bank, Segment B, M41T6.01, Buffalo Brook, 18 September 2009*

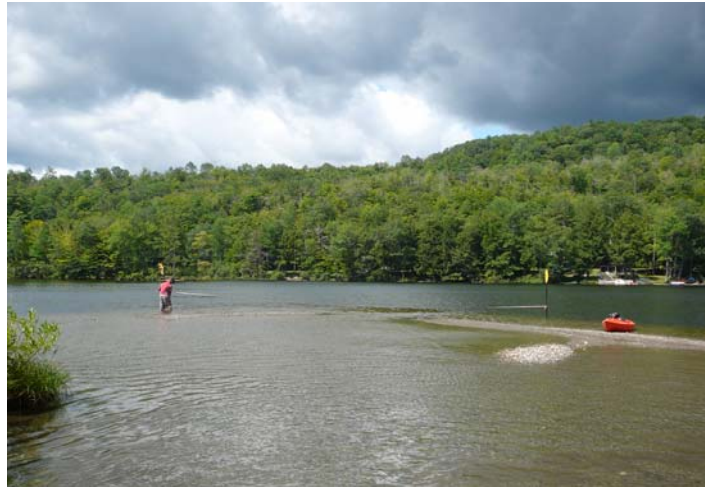
*Figure 28. View downstream to delta of fine gravels which extends out into Echo Lake from the mouth of Buffalo Brook, reach M41T6.01, Segment A, 7 August 2009. Kayak paddles mark approximate lateral extent of deposits.*

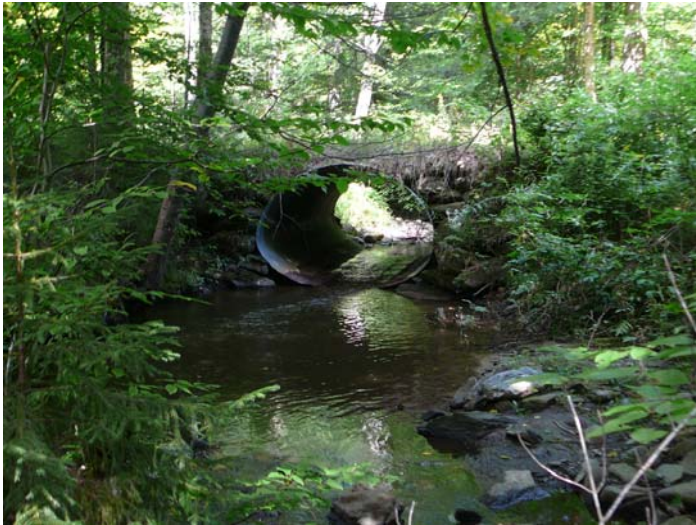
*Figure 29. View upstream, to bankfull constricting culvert crossing under Reading Pond Road, Segment B, M41T6.02S1.02, Reading Pond Brook, 4 September 2009.*
