**Restoring Water Quality in the Lake Memphremagog Basin:  
River Corridor Plan for the Black River**

**Melissa Dyer, Jayson Benoit, and Matt Goclowski**

**March 2011**

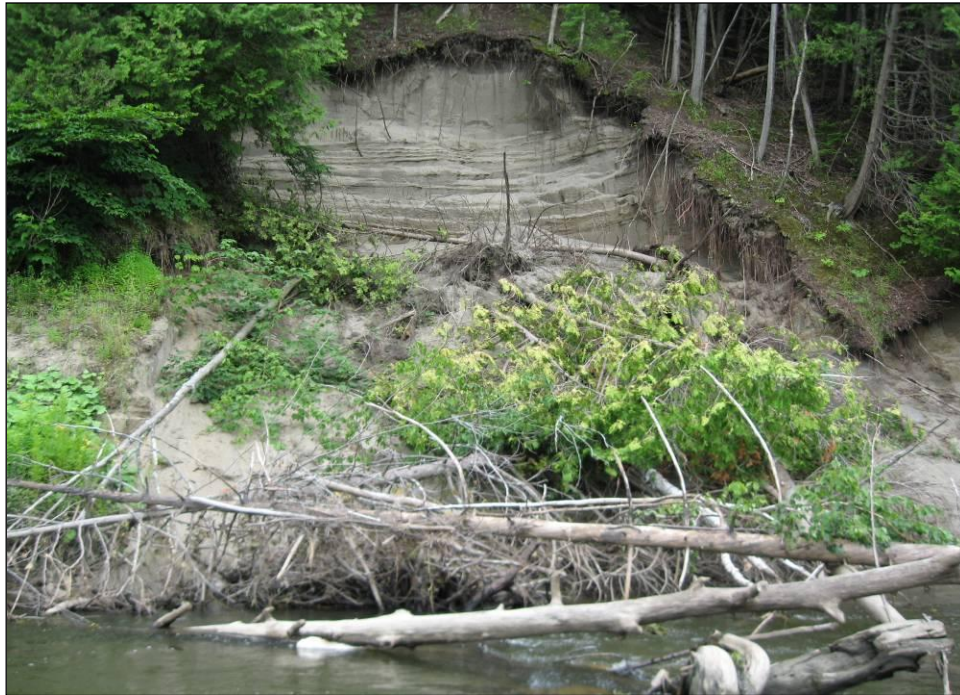
**Figure 10.** Example of a mass failure site, located along Reach M16.

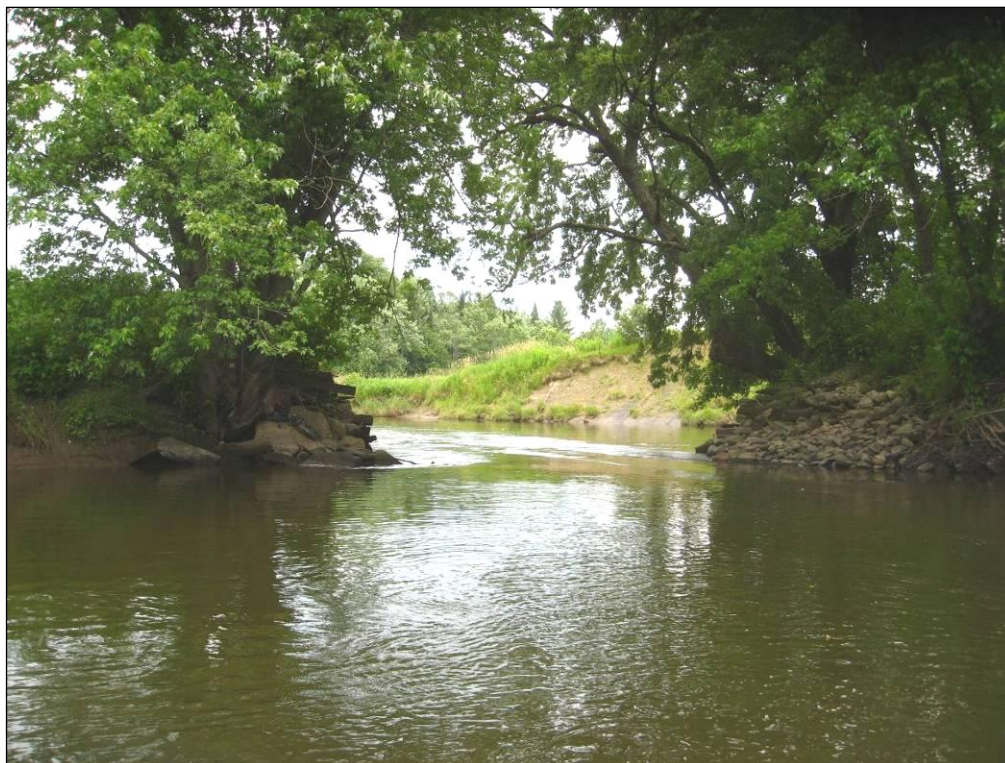
**Figure 11:** Old abutment on Reach M16. Note narrow constriction, upstream scour pool, and resulting erosion downstream.

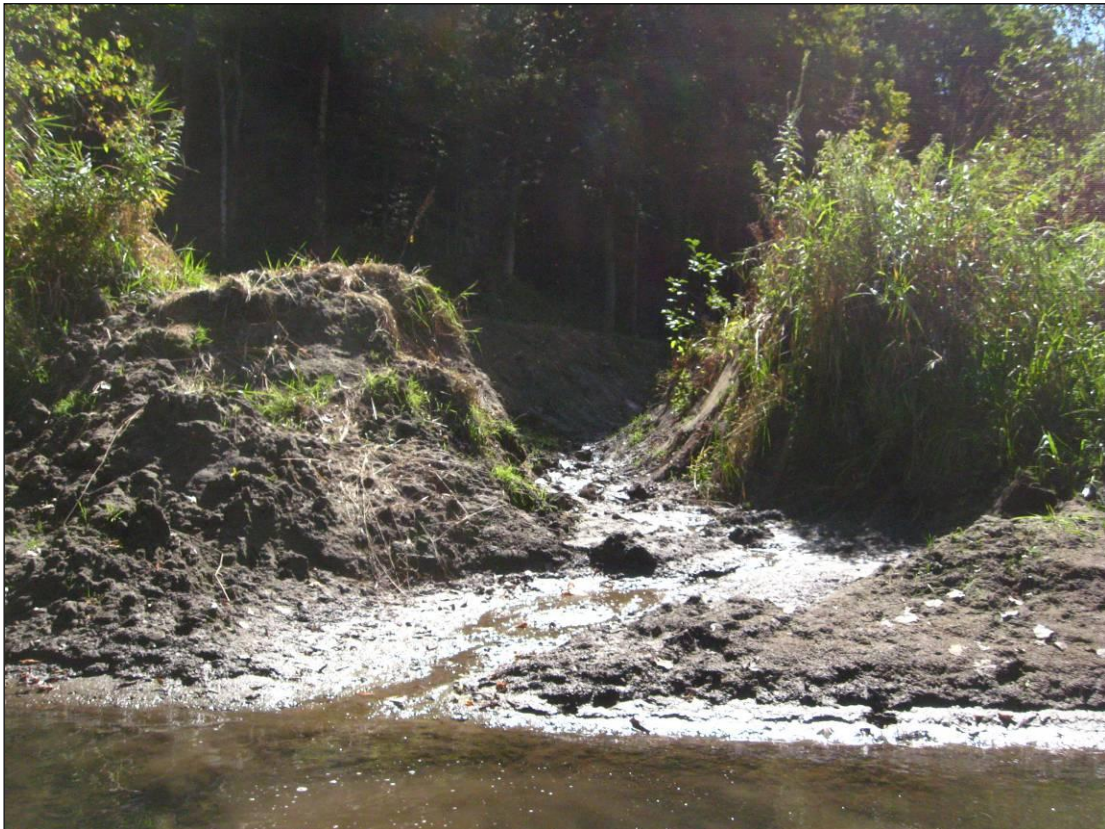
We noted two freshly-dug ditches from Hi-Acres Road draining directly into the Black River (Figure 15). These ditches were discharging silt into the river (during a dry period). A good management approach would be to **encourage road crews and landowners to use erosion control techniques**, such as seeding, erosion matting, or gravel along new ditches, particularly those that are dug through silty soils.

*Figure 15. Freshly-dug road ditch emptying into Reach M03.*

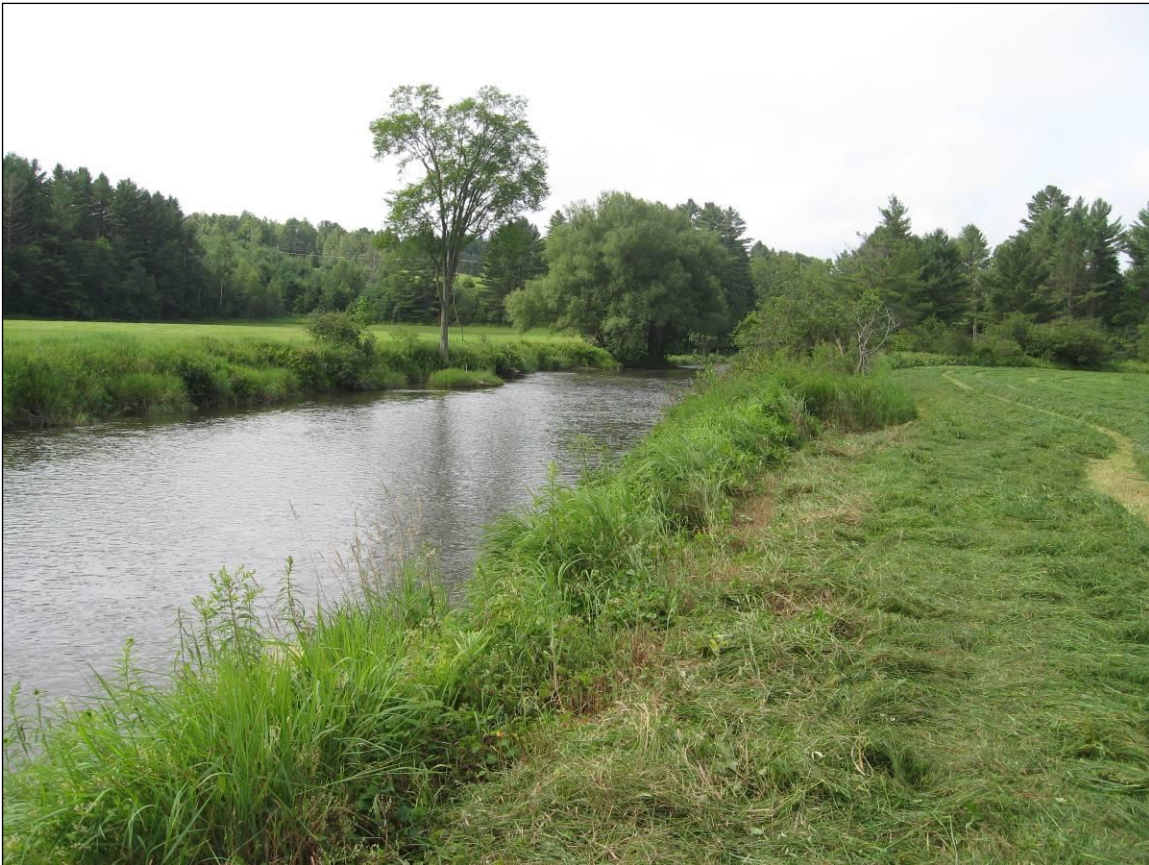
Habitat is only in fair condition due to alterations of the channel planform and alterations to the riparian corridor. The historic straightening of this channel has created a uniform stream bed in the upstream half of the reach, and pools were not observed until after the cross section location. Approximately 1,700 feet of riverbank also lacks a riparian buffer (Figure 19), and in the areas where mowing is not adjacent to the riverbank, only herbaceous vegetation is present. As a result, some benefits provided by woody vegetation are absent, such as ample woody debris in the channel and shade and cover along the riverbanks. Additionally, scattered purple loosestrife plants are found in this reach, as well as garbage thrown from Route 14. Management priorities in reach M05 include **re-establishing the riparian buffer through plantings of native trees and shrubs** and **removal of the invasive plants and garbage**.

*Figure 19. Hay fields along Reach M05 ( facing upstream).*

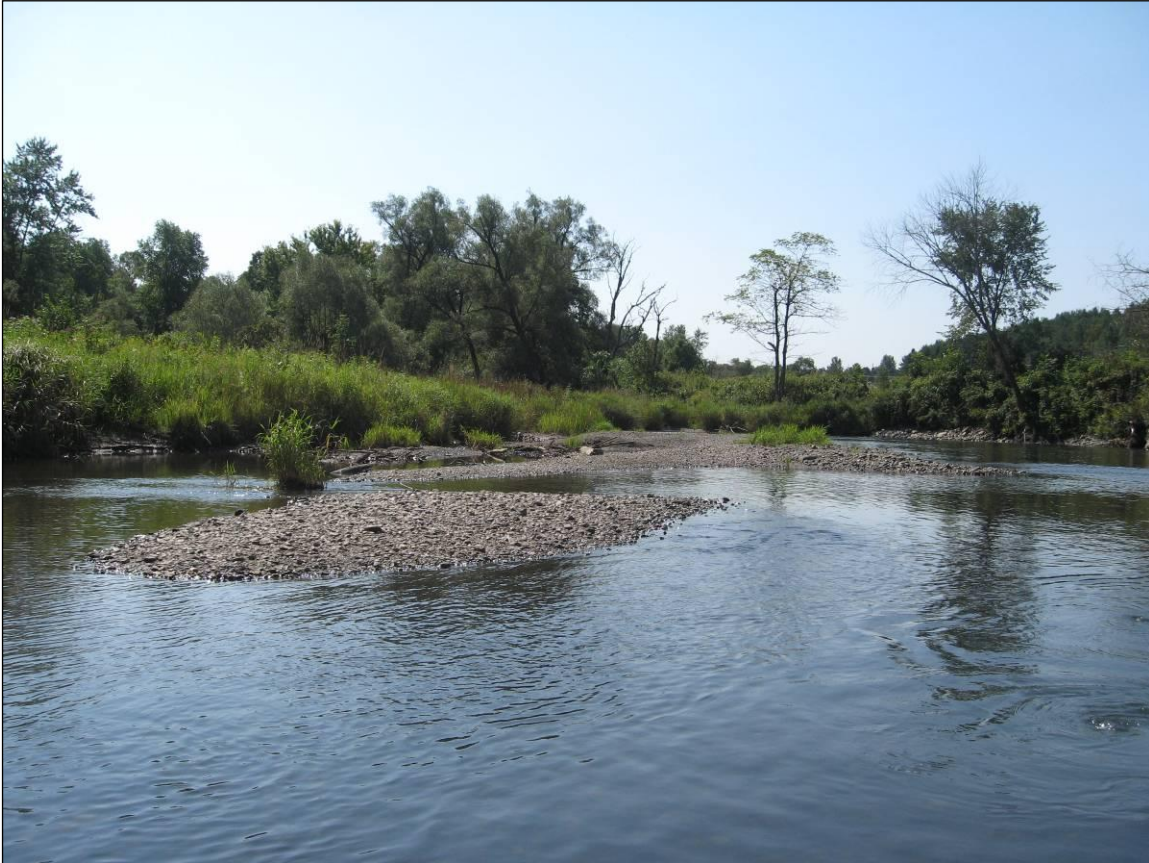
**Figure 26.** *Sediment deposition along Reach M12.*

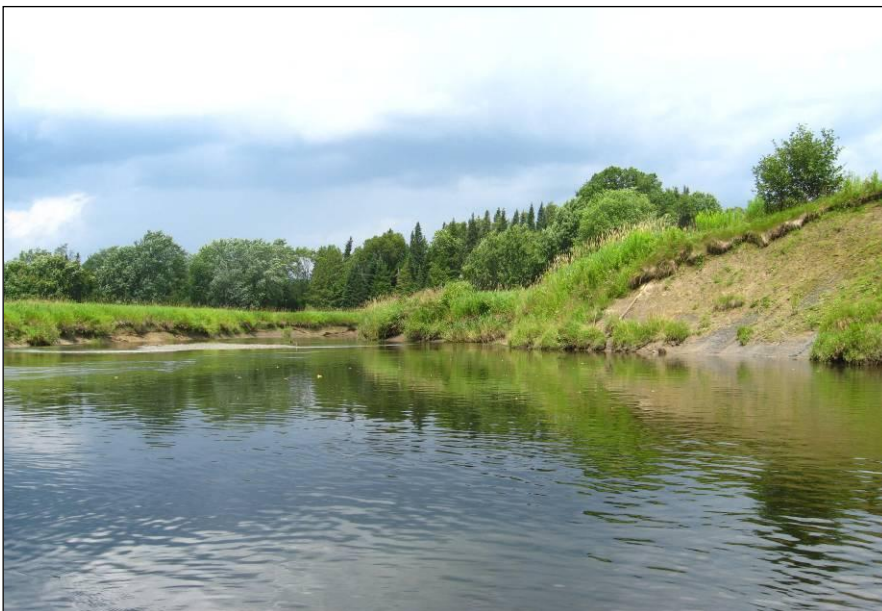
**Figure 29.** Wide scour pool, eroding riverbanks, and mid-channel deposition downstream of an old abutment on Reach M16.

A mix of passive and active restoration is needed for this reach. As mentioned previously, a **passive restoration** approach would be useful along the straightened portion of the reach, where fields are fallow and scattered shrubs and trees are already present along the riverbank. **Corridor easements** would make passive restoration more economically feasible, while also allowing the river the time and space to regain its natural meanders. Active restoration through a **buffer planting is needed** along the meandering portions further downstream where more active erosion is occurring and where the riverbanks only contain herbaceous vegetation. Also, a large patch of **tartarian honeysuckle** was found just below the straightened section and **should be removed** to prevent its further spread along the bare riverbanks downstream. Combined, these approaches will re-establish the forested wetlands and connect the habitat upstream of the Lord's Creek confluence with the extensive and high-quality habitat located upstream.

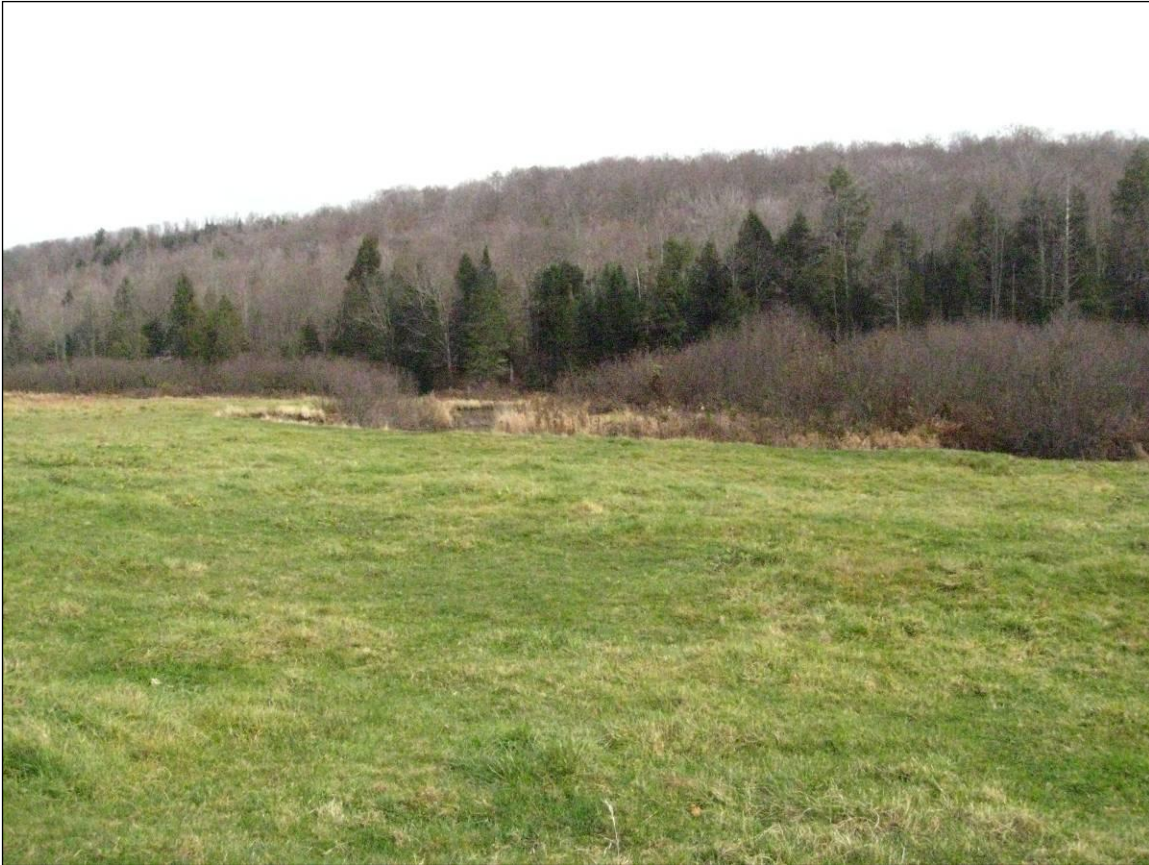
**Figure 31.** The pastured left corridor along Reach M23. The natural alluvial shrub wetland is visible along the right corridor, bordered by mixed forest.

here it has gouged deep pools into the riverbed. **Improved fencing is needed along the left corridor**, as cattle are currently accessing the river and having clear detrimental effects on the riverbank vegetation and stability.

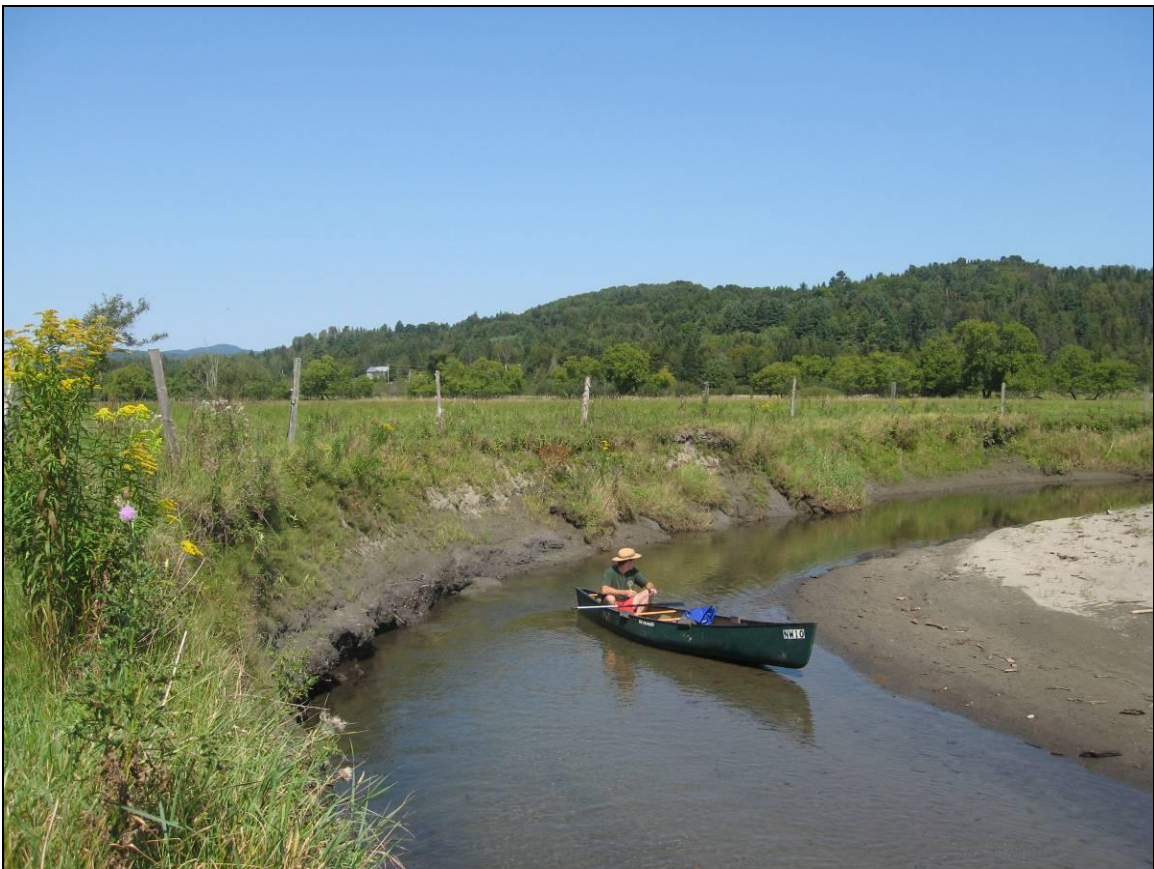
less than 5 feet of buffer (Figure 34). The non-forested areas not highlighted in yellow only contain an herbaceous buffer. Because of these conditions, the corridor lacks cover for wildlife, vegetation to shade the river, and woody vegetation to stabilize the riverbanks. There is also a fair amount of sediment deposition in the reach as evidenced by the many sand bars observed and the soft, newly-deposited sediments present on the streambed. Compared with the remainder of the river, **this reach is a top priority for restoration**. Fencing exists along both sides of the riverbanks, but is in disrepair and falling into the river as the banks erode. Cattle are able to access the river where the fencing has failed. **Restoration of this reach is recommended and should include upgraded or repaired fences as well as plantings of native trees and shrubs along all un-vegetated or grassy riverbanks**, as seed sources in the area are limited. Restoration of this area also would connect well with an existing restoration site located upstream, and the existing natural forests and wetlands downstream.

*Figure 34 Unbuffered stream bank along Reach M29.*

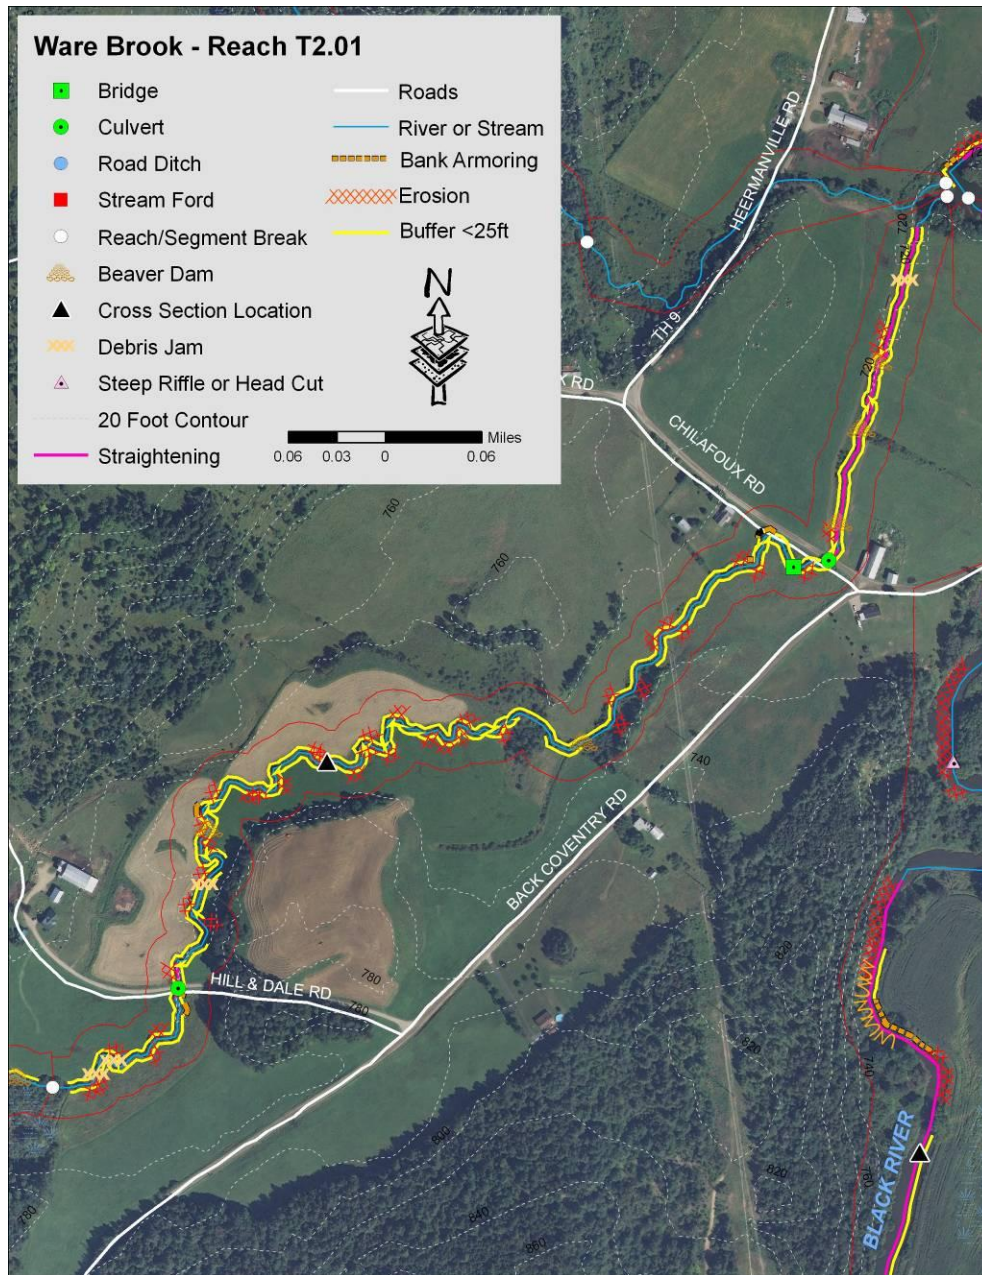
Two culverts are present in the reach, one at Hill and Dale Road and one at Chilafoux Road. Both are channel constrictions but they do not appear to have a major detrimental impact on the stream at this time. There is also a VAST snowmobile bridge just upstream of Chilafoux Road that has washed off of its footers. The bridge is still supported by the river banks but it is likely to fail in the near future. **The bridge is unsafe and should be repaired and repositioned on its footers or removed.**

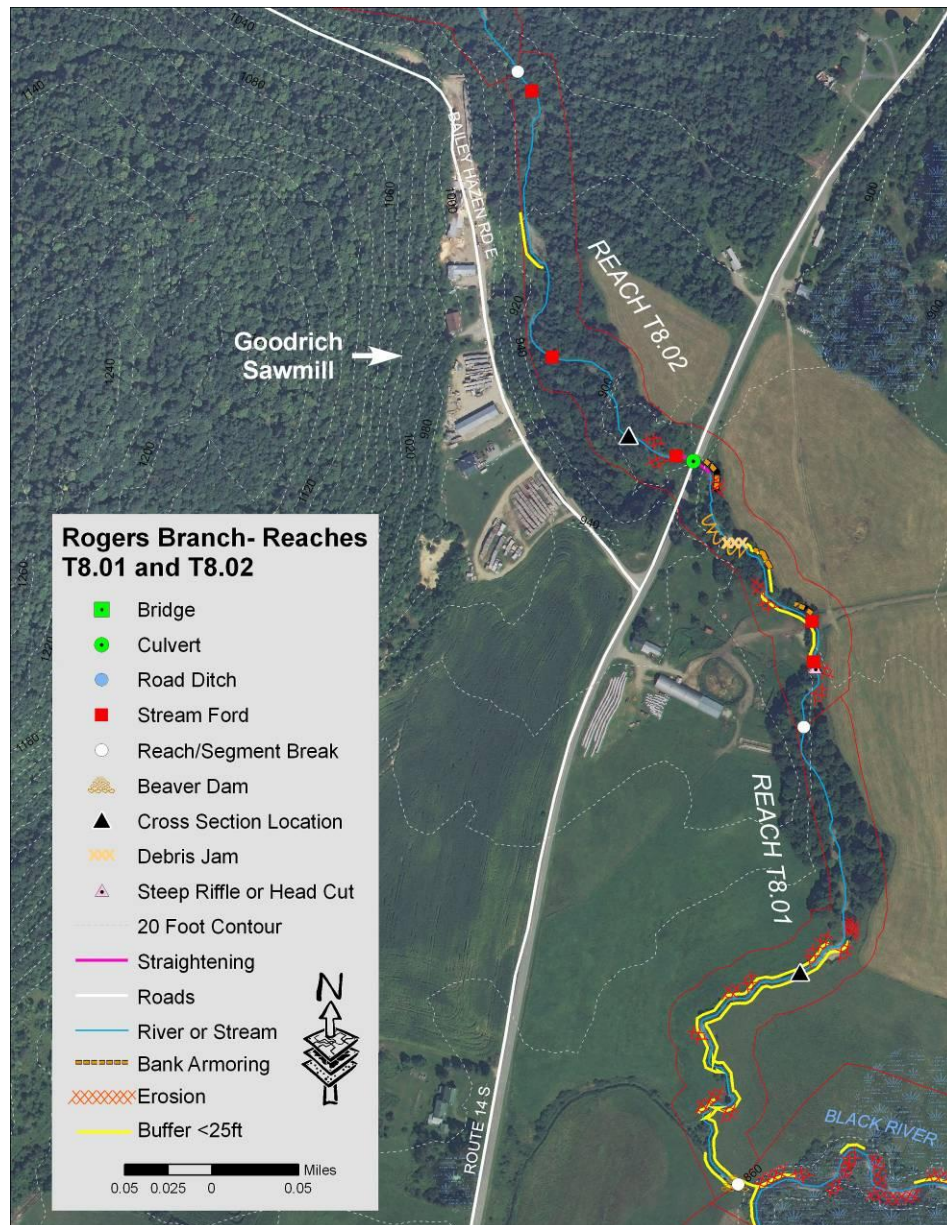
Reach T8.01 includes the 1,890 foot section of stream from the confluence with the Black River to a point 950 feet downstream of Route 14. The majority of the reach is unbuffered as it passes through active pasture and hayfield, though a small forested area encompasses most of the corridor near the upstream end of the reach. In the unbuffered section, most outside bends are actively eroding and large point bars have developed on the inside bends. A **buffer planting project** in this area would help to stabilize the stream banks and to mitigate sediment and nutrient inputs from the adjacent fields and should be considered a high priority. As a farm parcel, this site may also be a good match for a federal cost share program such as CREP. A small snowmobile bridge in serious disrepair is located near the lower end of the reach and is tilted and sagging into the stream. Beavers previously built a dam beneath the bridge, which appears to have caused the stream to overtop the bridge during times of high water. **This bridge should be repaired or removed.**
