# **TWEED RIVER WATERSHED CORRIDOR PLAN**

## **WHITE RIVER PARTNERSHIP**

April 18, 2008

Prepared by:  
Daniel Ruddell, Elisabeth McLane, Anna Mulligan,  
Staff Scientists, and  
Ben Machin, Principal  
Redstart Consulting

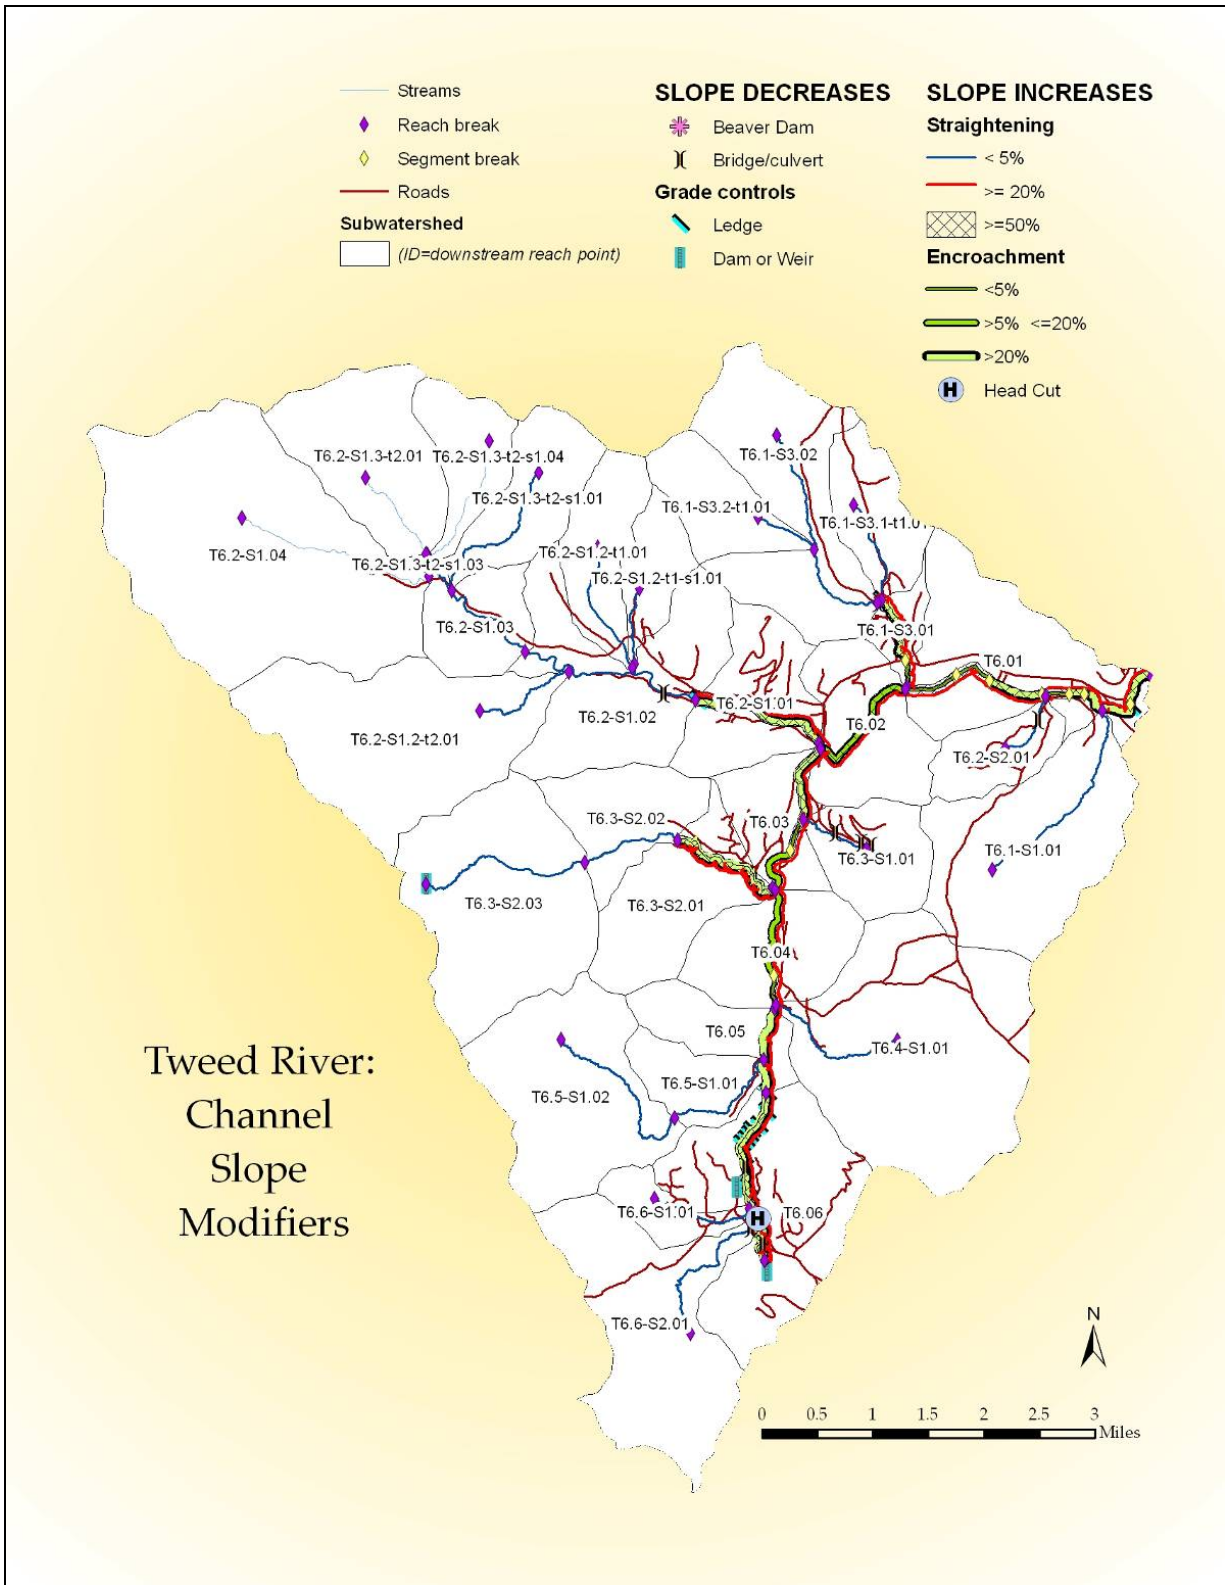
Figure 10. Reach-scale stressors: Channel slope modifiers map for the Tweed River watershed.

Only one active headcut was noted in Phase 2 assessment, relatively high in the watershed (Reach T6.06, Fig. 10). Considered in conjunction with historical incision noted in all reaches in Phase 2 assessment, it is likely that downcutting (and accompanying increase in slope) has migrated up through the watershed over time. Only the lowest reach in each of Guernsey Brook, the West Branch, and Townsend Brook were assessed in Phase 2 (when head cuts would be documented, as opposed to Phase 1 which would not note their presence). It is conceivable that downcutting processes may be more active currently higher in the watershed. In areas where this process is contributing large amounts of sediment to the transport regime, this can lead to large deposits when flows slow down at areas of decreased slope such as undersized culverts, bedrock constrictions, and ledge grade controls, or sediment deposits left previously, and can increase the likelihood of flood chute access, channel avulsions, and similar stream migrations in high flows. This is discussed further in the next section on channel depth modifiers.

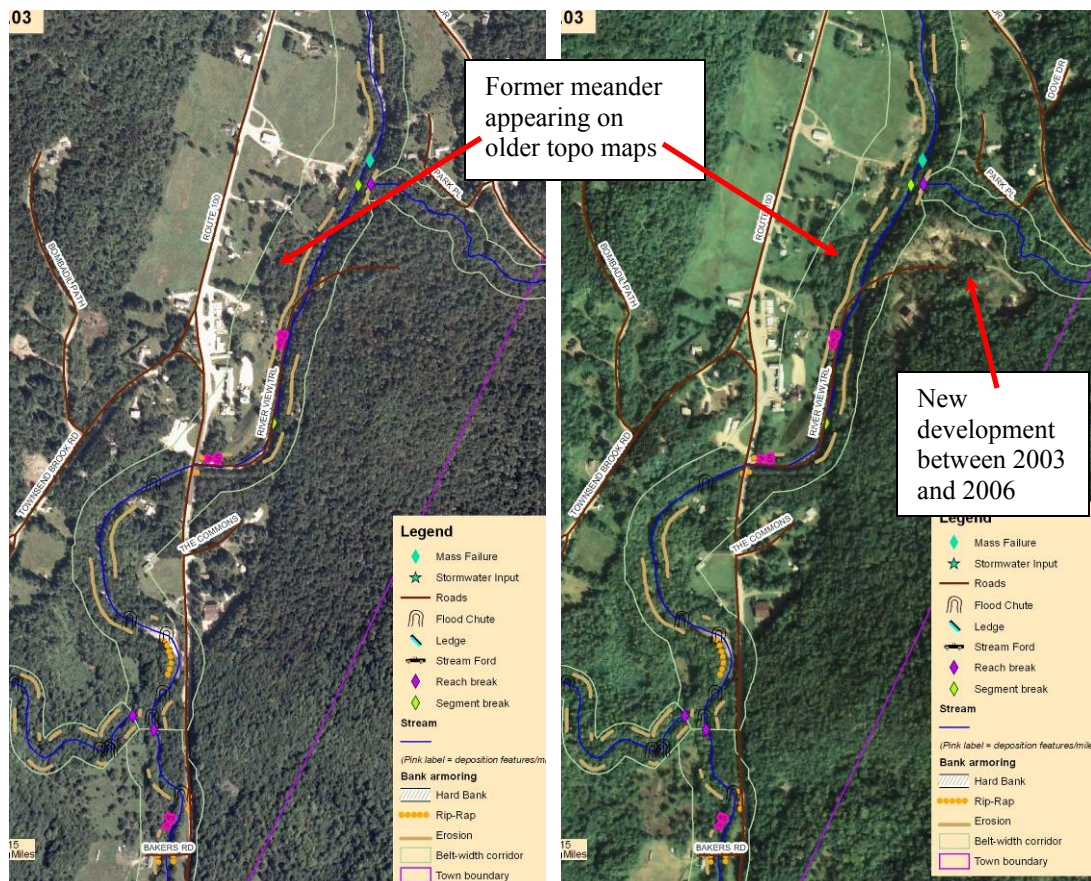
Segment T6.03B was the shortest of the three segments delineated in this reach during Phase 2, covering roughly 1565 ft (0.30 mi) in the midportion of the reach. This segment is straightened along its entire length and showed extensive erosion along both banks. Dominant buffer widths were <25 ft on the left bank. On the right bank, the steep valley wall against which the river is pinned is largely wooded, but dominant buffer widths were recorded at 50–100 ft, largely due to encroachment from a road leading to a number of house lots that have been developed on this valley wall between 2003 and 2006 (Fig. 22).

**Figure 22. Aerial photography from 2003 (left) and 2006 (right) indicates new development on the steep valley wall southeast of the confluence of the Tweed mainstem and an unnamed tributary in the upper right corner of these photos. Phase 2 field notes and older topographic maps (Fig. 31) indicate a former island and meander just west of this location. Restoring this meander could provide sediment attenuation and help diffuse increased stream power contributing to lateral bank instability in this area.**
