# Upper & Middle White River Watershed Corridor Plan

Barnard, Hancock, Pittsfield, Rochester, and  
Stockbridge, Vermont  
July 15, 2015

Prepared by:  
Bear Creek Environmental, LLC  
149 State Street, Suite 3  
Montpelier, Vermont 05602

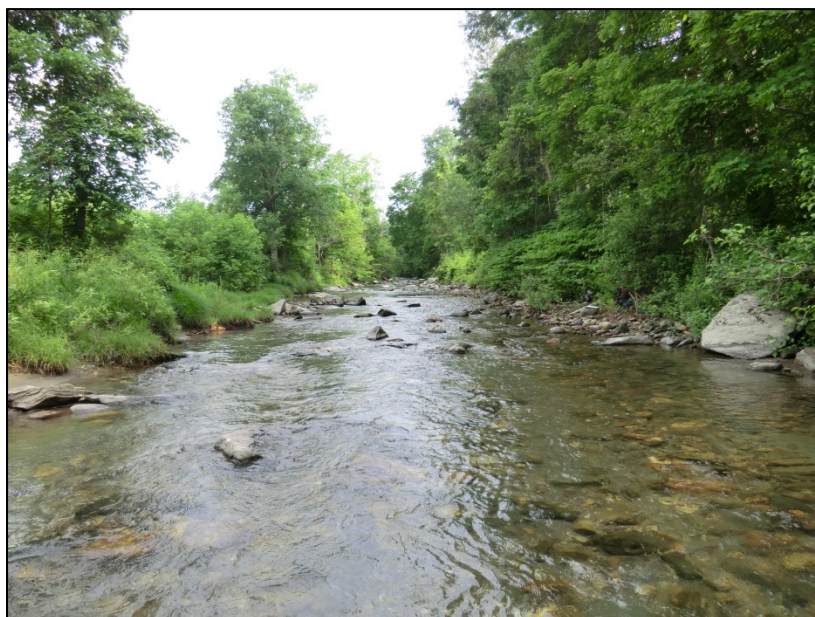
This segment begins at the reach point and continues upstream for 2,300 feet to where the Creek becomes extremely aggradational. Locust Creek has been historically straightened along Route 12 and the western *valley wall* for the majority of this segment. Extensive channel straightening in this area caused severe historic incision and led to a stream type departure and loss of floodplain access. Agricultural fields exist to the east of the creek and armoring is abundant on both banks, limiting channel widening and lateral migration. This segment's riffle-pool bedform is not well defined and borders on a featureless, plane bed system. T3.02-A is in **fair** geomorphic condition primarily due to extreme historic incision. The segment is also in **fair** habitat condition due to the lack of diverse bed features and well vegetated riparian buffers.

**Figure 5.5.** Stream channel has been extensively straightened in T3.02-A and lacks a diversity of bed features.

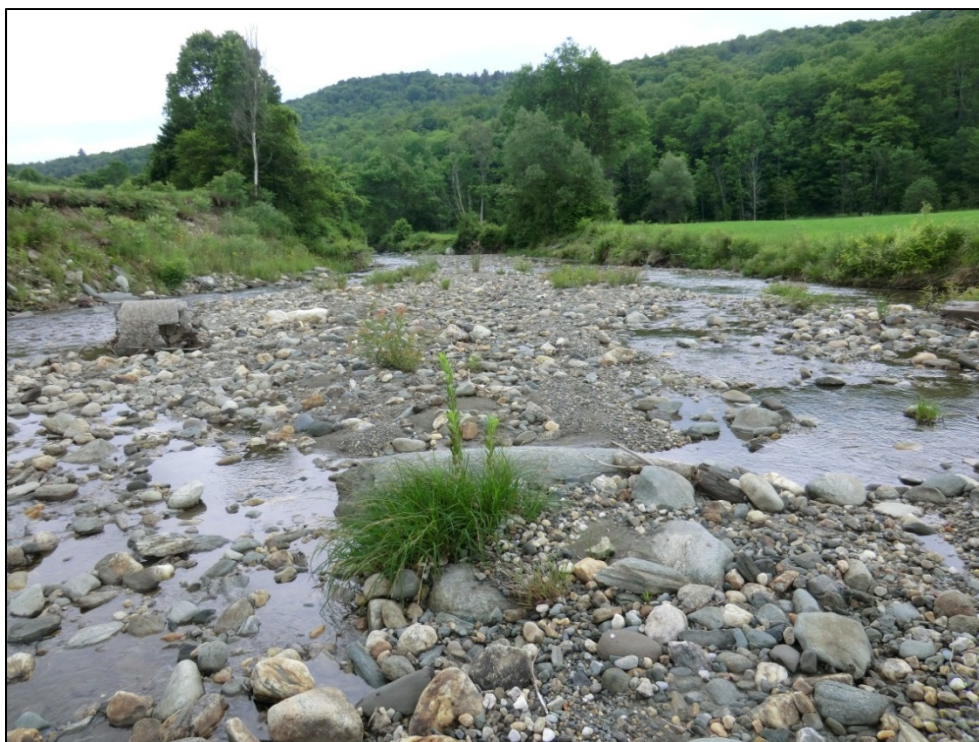
This segment begins where Locust Creek becomes extremely aggradational and more sinuous than segment A. It continues upstream for 8,000 feet to just below the confluence of Pond Brook. T3.02-B is characterized by abundant deposition and an overly-wide channel. This segment has a lower channel slope and wider valley than the reaches above it. Because of this, large amounts of sediment were deposited here during Tropical Storm Irene. This aggradation has caused major channel widening and planform adjustment. Numerous flood chutes cross very large bars, and one channel *avulsion* is present on the inside of a meander bend. T3.02-B underwent moderate historic incision, but retains good floodplain access for most of the segment. Large bars are forming a juvenile floodplain in some areas. Channel windrowing took place post-Irene in small sections throughout this segment, and associated berms are restricting floodplain access in these areas. This segment is in **poor** geomorphic condition due to the aforementioned adjustments and processes. T3.02-B is in **fair** habitat condition due to its channel morphology, a lack of large woody debris, and impacted riparian buffers.

**Figure 5.6.** T3.02-B is very aggradational and has majorly widened.

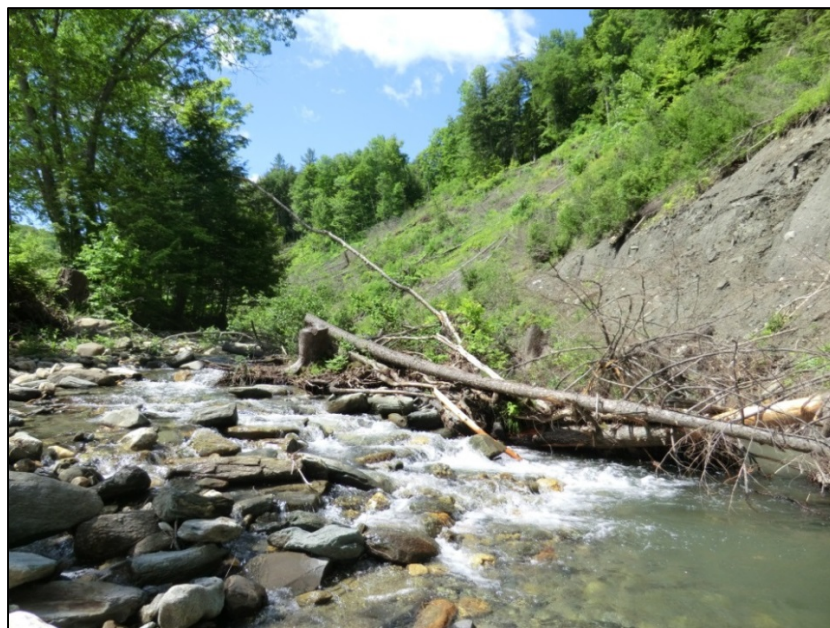
This segment begins just below the Route 12 Bridge between Mount Hunger Road and Chateauguay Road and continues upstream for approximately 1,700 feet to just above Town of Barnard Highway Department. T3.03-A can be characterized by extreme active incision and major historic and recent channel alteration. Chateauguay Road was built into the river valley years ago and severely encroaches upon Locust Creek. Historic straightening along the road caused channel incision within this segment. Additionally, the downstream end of this segment, which aggraded during Irene, was dredged and windrowed post-flood. This lowering of the streambed sparked further channel downcutting, as evidenced by two active headcuts within the segment. Floodplain access has been lost throughout this segment, and a stream type departure has occurred. Due to significant active adjustment, as well as historic and recent channel alteration, T3.03-A is in **fair** geomorphic condition. This segment is also in **fair** habitat condition due to a lack of diverse bed features, limited woody debris, and altered channel morphology.

**Figure 5.8.** One of two active headcuts present in T3.03-A.

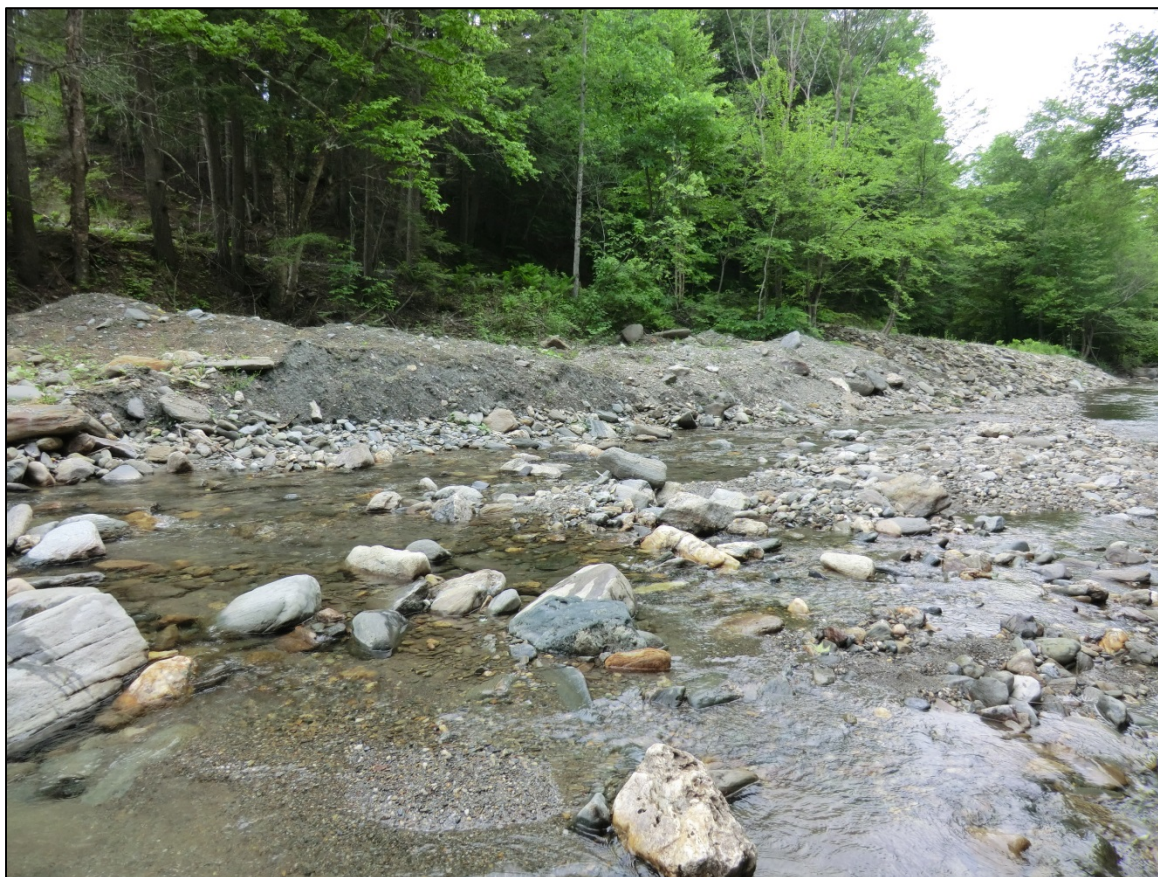
This segment is located along Chateauguay Road, beginning just above the Barnard Highway Department and continuing upstream 3,500 feet to approximately a half mile north of the intersection of Chateauguay Road and Mount Hunger Road. Locust Creek was historically straightened along its eastern valley wall and Chateauguay Road. This led to severe historic channel incision, a stream type departure, and loss of some floodplain access. During Tropical Storm Irene, sections of the creek aggraded and widened significantly, causing major damage to Chateauguay Road. When road repairs occurred, the stream channel was windrowed and bermed in many locations. Due to historic and recent channel alterations, T3.03-B is in **fair** geomorphic condition and **fair** habitat condition.

**Figure 5.9.** Chateauguay Road washed out during TSI in T3.03-B and post-flood work involved windrowing.

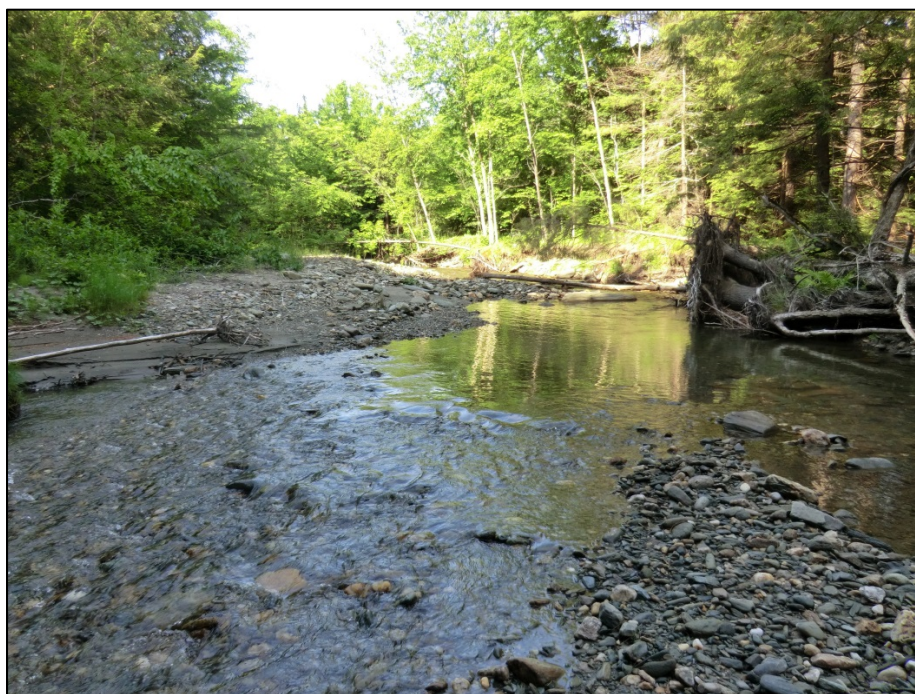
The downstream-most segment on reach four of Locust Creek begins at the downstream reach break and continues upstream for 4,500 feet to just below the West Road Bridge. It flows through a broad river valley mostly through forested land. This segment is undergoing major adjustment both vertically and horizontally. The stream channel historically incised throughout most of this segment, resulting in a stream type departure and loss of floodplain access. Aggradation is a major process as the creek builds large bars, and has caused the channel to widen significantly. These depositional features are forming a juvenile floodplain. Major planform adjustment is also occurring in this segment as water flows around depositional features. Five mass failures are present as well as extensive bank erosion. T3.04-A is in **poor** geomorphic condition due to all of these adjustments. Despite having well vegetated riparian buffers in many areas, habitat condition is **fair** due to changes in channel morphology and unstable river banks.

**Figure 5.10.** Major aggradation is occurring in T3.04-A.

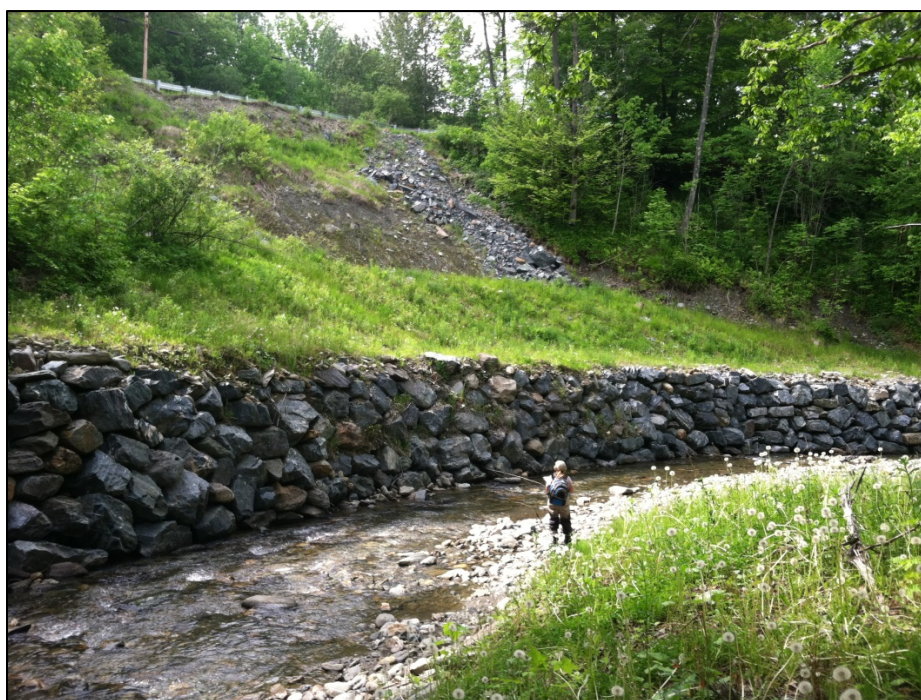
The middle segment on reach four of Locust Creek is approximately 4,400 feet in length, beginning just downstream of the West Road Bridge and continuing upstream to about 1,000 feet downstream of the next Chateauguay Road bridge. T3.04-B appears to have undergone major aggradation during Tropical Storm Irene. Approximately half of this segment was windrowed to remove this aggradation from the channel during post-Irene recovery work. A large mass failure occurred along Chateauguay Road within this segment during Irene, which was heavily armored during repair. Severe historic channel incision has occurred in this segment, most likely due to extensive straightening along Chateauguay Road. Active incision was also observed during the assessment due to the presence of one headcut moving upstream through the segment. Bank erosion is severe on both banks despite abundant armoring. Planform adjustment is occurring as the Creek carves flood chutes over large bars, which are forming and/or have formed a juvenile floodplain in areas that have not been subjected to windrowing. Major adjustments coupled with extensive channel alteration have caused T3.04-B to be in **poor** geomorphic condition. Due to unstable river banks, poor riparian buffers, and channel alterations, habitat conditions in this segment are **fair**.

**Figure 5.11.** Bank instability is common in T3.04-B, as is bank armoring.

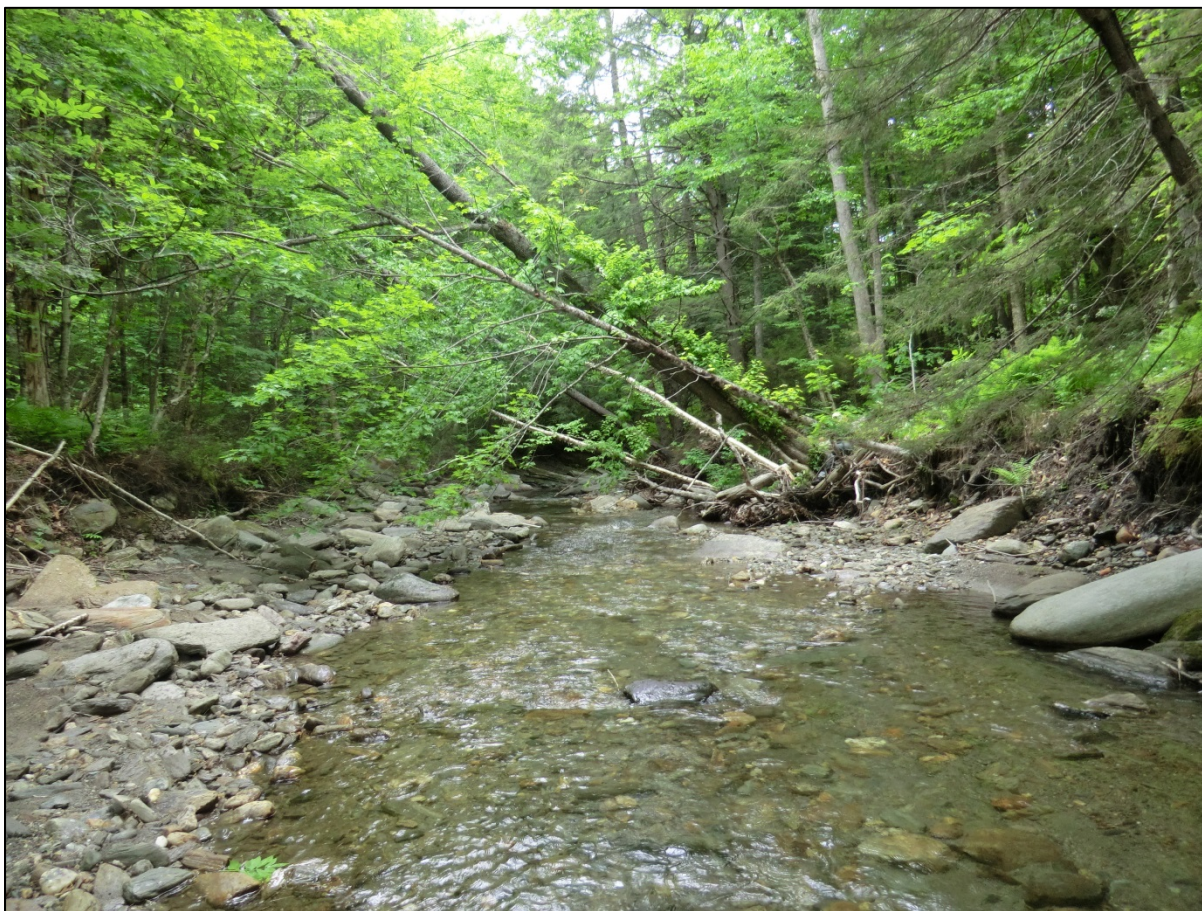
Segment B of reach 5 on Locust Creek also flows through a narrow valley. It begins just below the TH 46 Bridge and continues upstream to 3,000 feet just above the next Chateauguay Road Bridge. Similarly to downstream segments, this segment has incised significantly, which has led to loss of floodplain access and stream type departure. A headcut exists directly below the segment, which threatens further incision. T3.05-B is beginning the widening process, and bank erosion is prevalent. Four mass failures are also present in this segment and are sources of sediment for the Creek. Small sections within this segment have a narrower river valley where there is naturally very little floodplain access. The riparian buffers are well forested in T3.05-B. The segment is in **fair** geomorphic condition due to historic incision and **good** habitat condition as a result of diverse bed features.

**Figure 5.14.** T3.05-B has well forested buffers but abundant bank erosion.

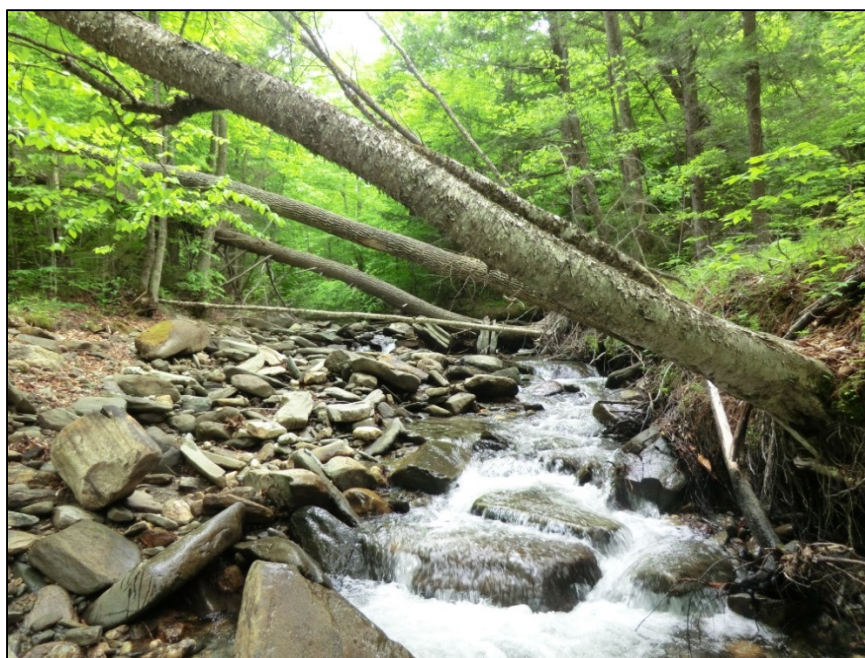
Segment D on reach five of Locust Creek begins at the upstream end of the windrowed section in segment C and continues upstream for 3,300 feet to below the Chateauguay Road Bridge near 4411 Chateauguay Road. Sections toward the bottom of this segment were historically straightened along Chateauguay Road, which likely contributed to the channel incision observed throughout the segment. Channel windrowing occurred in sections of stream that directly abut Chateauguay Road where deposition occurred during the flood. These recent channel alterations have caused further downcutting within T3.05-D, as evidenced by the presence of four active headcuts moving upstream through the segment. Bank erosion is almost continuous along both banks, and four mass failures are further contributing to bank instability and adding fine sediment to the channel. Short sections within this segment are flatter and have more aggradation and planform change than others. Historic and recent incision has led to a loss of some floodplain access and a stream type departure. Overall, T3.05-D is in **fair** geomorphic condition as a result of the downcutting of the stream channel. Habitat conditions in this segment, however, are **good** due to abundant large woody debris in the channel, well vegetated riparian buffers, and a well-defined bedform that provides ample pool and riffle habitat.

**Figure 5.16.** One of four headcuts in T3.05-D contributing to channel incision and instability.

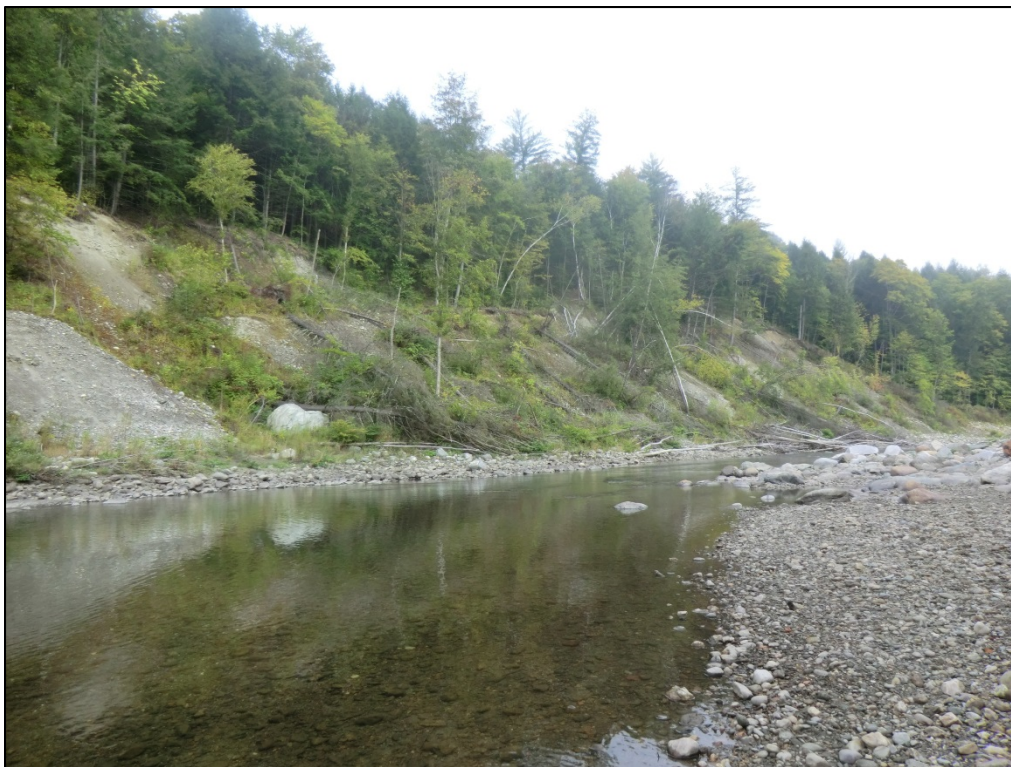
The downstream-most segment on R16 begins at Stockbridge Central School and continues upstream approximately 2,300 feet to the Blackmer Boulevard Bridge. The White River valley is wooded and largely undisturbed throughout R16-A. Human impacts are minimal, and localized in the vicinity of the Blackmer Boulevard Bridge. This segment has undergone moderate historic incision, but retains its reference stream type and access to its floodplain. The White River is in the process of widening in this location, which has led to extensive bank erosion and two large mass failures. R16-A is in **fair** geomorphic condition as a result of historic incision and active widening. It is also in **fair** habitat condition due to lacking pool features, refuge areas, and general in-stream cover for fish.

**Figure 5.22.** Widening has caused mass failures and bank erosion along the White River in R16-A.

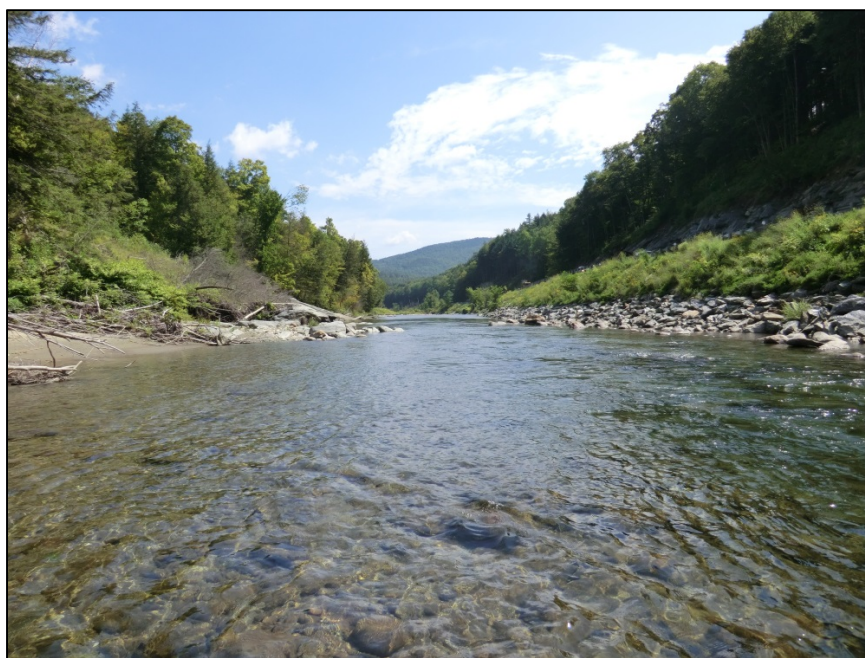
The upstream-most reach on R16 of the White River begins in the vicinity of Hunt Farm Road and continues upstream about 3,100 feet to where the river no longer flows directly along Route 107. The entirety of R16-C was channelized along Route 107 historically and again recently after Tropical Storm Irene. Floodwaters from TSI caused the White River to wash out the Route 107 embankment and one lane of the road throughout most of R16-C. During post-flood recovery, extensive gravel mining occurred in R16-C to obtain material with which to rebuild the road. Route 107 is a significant encroachment, which has created a very narrow and deep channel in this location. The river aggraded and widened substantially during Irene, but was narrowed and directed toward the north valley wall during post-flood work. Extensive armoring due to Route 107 on the south bank and the valley wall on the north bank are preventing the river from widening once more. It may continue to downcut because it is unable to widen. Irene floodwaters also caused two large mass failures along the northern bank of the river, which are extremely silty and an evident source of fine sediment. Historic and recent channel alterations and associated incision have resulted in R16-C being in **fair** geomorphic condition. The segment is also in **fair** habitat condition due to its loss of bedform and conversion to a featureless plane bed system.

**Figure 5.24.** Route 107 is a significant encroachment in R16-C, creating a deep, narrow channel.

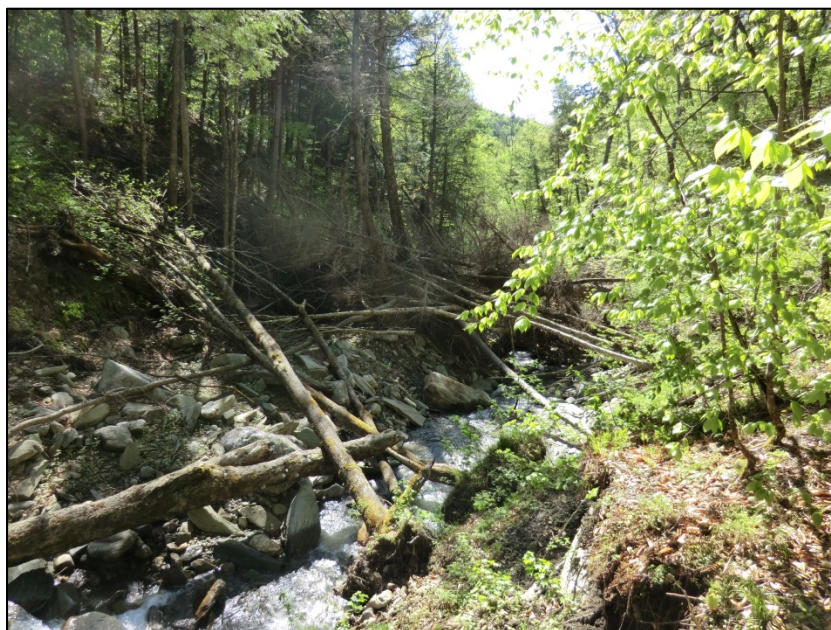
Segment B on reach one of Little Stony Brook flows through a narrow valley above the Route 107 Bridge. Human impacts within this segment are very minimal and include corridor encroachment by a driveway at the downstream end of the segment. An abandoned logging road runs along the brook in areas, and may be contributing increased stormwater. A large rusted tank is present in the stream channel where a culvert under the abandoned trail has blown out. The valley walls are frequently adjacent to the stream channel within this segment and are very steep and comprised of wet sandy soils underlain by glacial till. These conditions have caused the formation of continuous mass failures along both valley walls (nineteen in total). These mass failures are a major source of fine sediment for Little Stony Brook. The brook's substrate particle distribution indicates an excess of fine sediment in the channel, and pools are filled in. The mass failures also contribute large amounts of woody debris to the channel, which is causing aggradation and planform change. Severe historic channel incision has led to a loss of floodplain access and a stream type departure. Little Stony Brook is in the process of widening. All of the aforementioned factors have caused R15-S1.01-B to be in **fair** geomorphic condition. Despite abundant woody debris, a lack of human impacts, and well forested buffers, this segment is in **fair** habitat condition due to unstable banks and an excess of fine sediment in the channel.

**Figure 5.27.** Continuous mass failures are contributing woody debris and sediment to R15-S1.01-B.

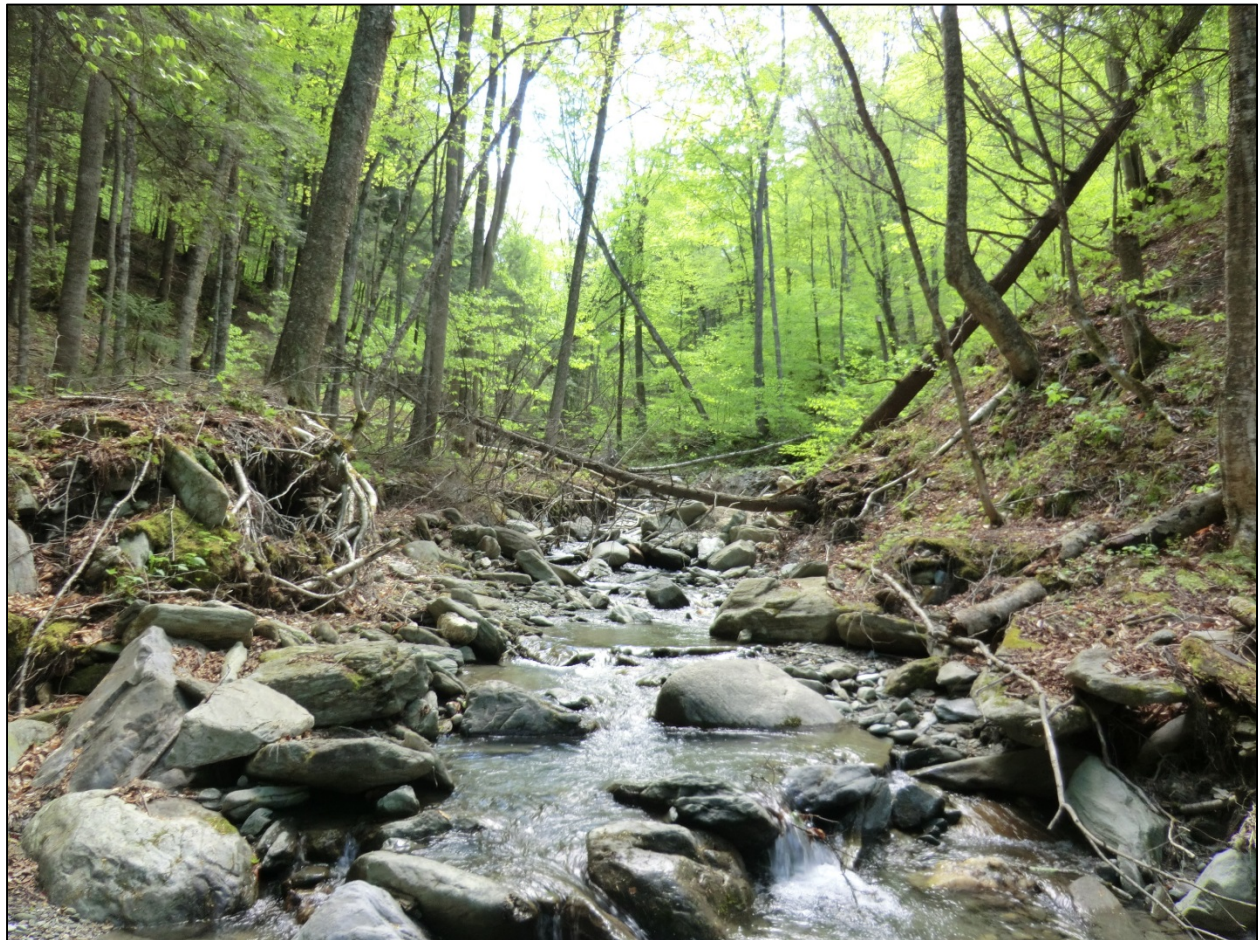
The upper-most segment on Little Stony Brook included in this study was not fully assessed due to its remote location and lack of human impacts. It flows through a vast expanse of forested land with no nearby development. Qualitative observations taken from the downstream end of this segment suggest that it is very similar to segment B in terms of stream type and geomorphic condition. It appears to have undergone historic incision and a stream type departure.

**Figure 5.28.** The upper segment on reach one of Little Stony Brook was not fully assessed, but appears to be very similar to segment B.

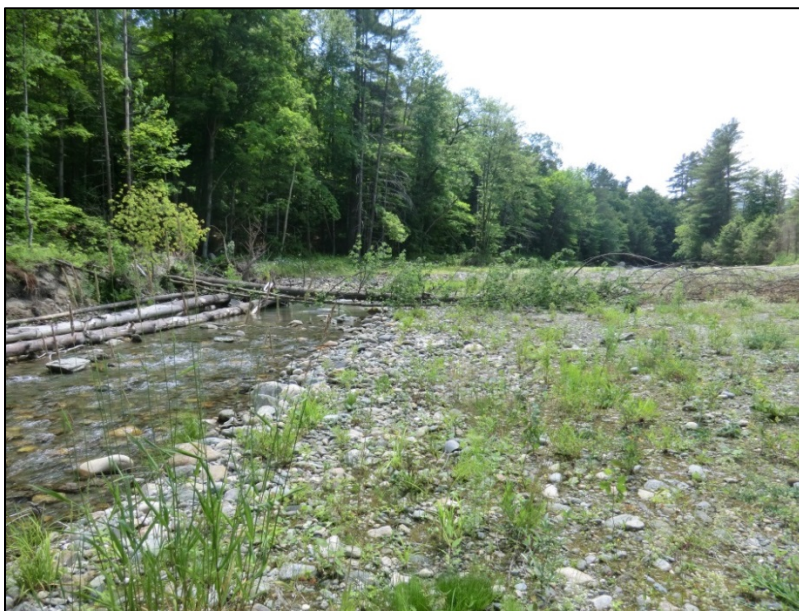
The downstream segment on reach three experienced significant historic incision, and continues to incise via headcutting. T5.03-A is an area where major deposition of material occurred during Irene, creating very large bars. Significant widening has occurred throughout the segment, causing frequent bank erosion and mass failures. Several sections within T5.03-A were windrowed and/or dredged post-Irene, removing deposited material from the channel and creating berms to restrict floodplain access. An alluvial fan is present toward the downstream end of the segment where the channel slope drops and extreme aggradation is present. Planform has been altered by recent channel work in T5.03-A, and adjustment is actively occurring. Depositional features are building a juvenile floodplain within this segment. Due to the geomorphic processes at work in T5.03-A, as well as recent channel alteration, the segment is in **poor** geomorphic condition. Unstable river banks, poor riparian buffers, and impacted bedform and morphology are causing habitat to be in **fair** condition in T5.03-A.

**Figure 5.32.** T5.03-A has undergone major deposition and widening.

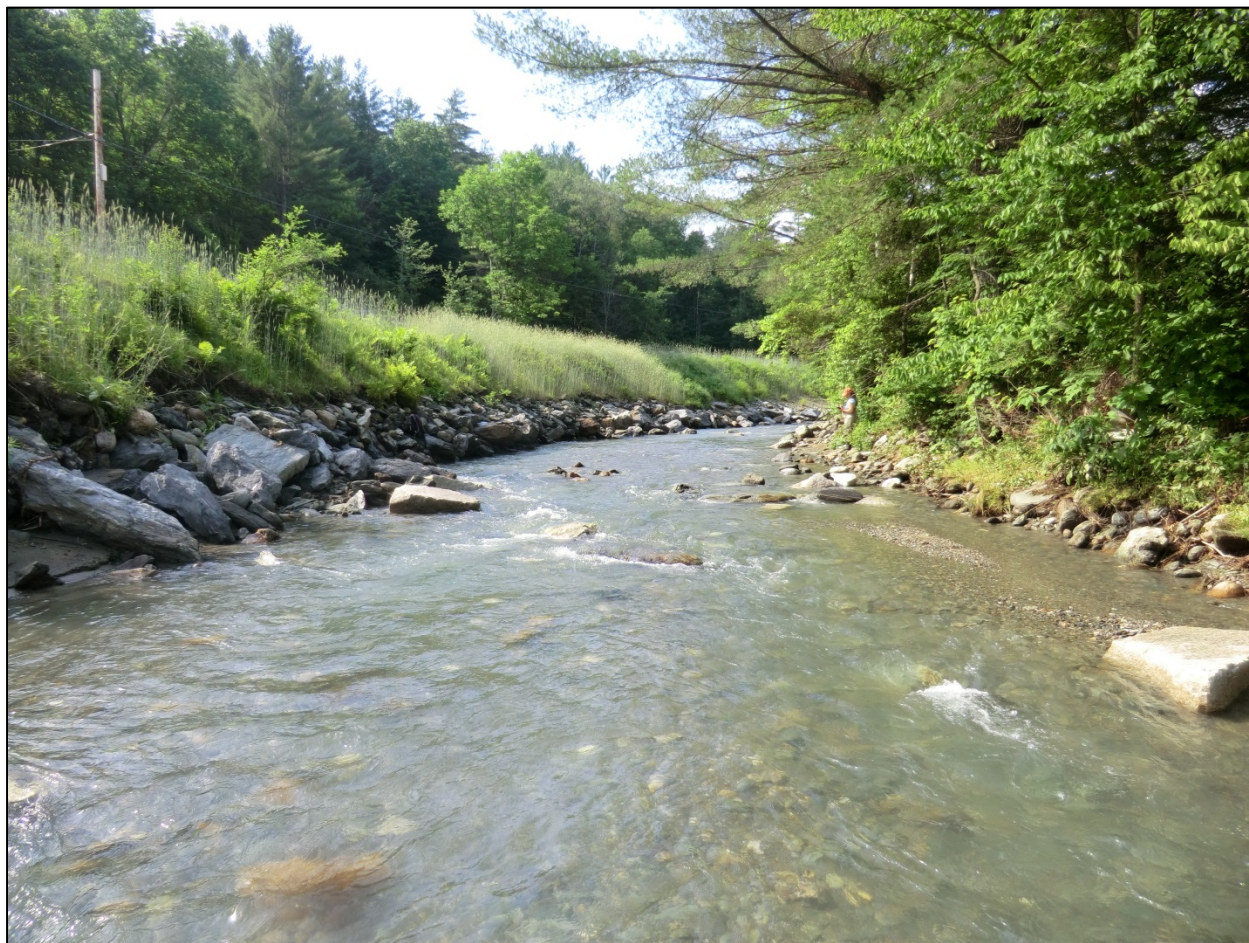
The upstream segment on T5.03 is approximately 1,400 feet long, ending just upstream of the Fletcher Brook confluence. Segment B was historically straightened for its entirety along Stony Brook Road. Moderate historic incision occurred here as a result of this straightening. Stony Brook is narrow in this section, in part due to riprap that may be preventing widening. A short section was windrowed post-Irene. T5.03-B is in **fair** geomorphic condition due to past channel alterations and incision. Lacking woody debris, altered planform, and disturbed banks and buffers have caused T5.03-B to be in in **fair** habitat condition.

**Figure 5.33.** T5.03-B is extensively encroached upon by Stony Brook Road, creating a narrow channel.

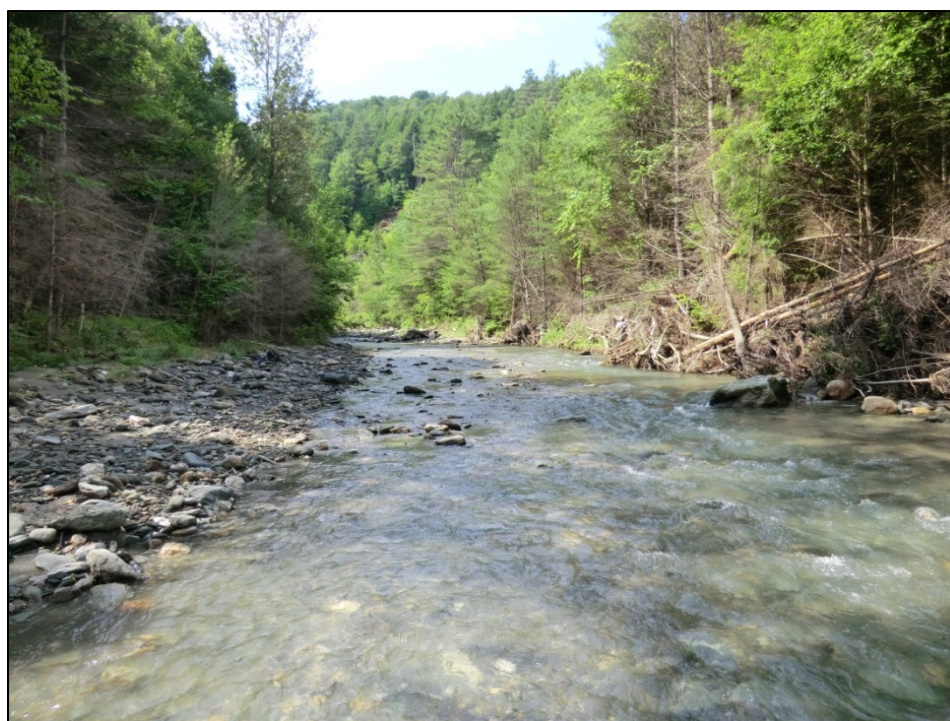
The downstream segment on reach four of Stony Brook is characterized by a wide channel with abundant deposition. The downstream third of this segment was likely historically straightened along the eastern valley wall to create agricultural land. Historic incision followed, causing a stream type departure and loss of floodplain access. In this segment, the stream channel has widened significantly, and is in the process of building large bars. Bank erosion is common along both banks as the channel continues to widen. Two large mass failures along the western valley wall are contributing fine sediment to the stream channel within T5.04-A. Due to significant channel incision and widening, this segment is in **fair** geomorphic condition. It is also in **fair** habitat condition because woody debris is lacking within the channel, pool habitat is lacking, and stream banks are unstable.

**Figure 5.34.** T5.04-A has widened and is actively aggrading.

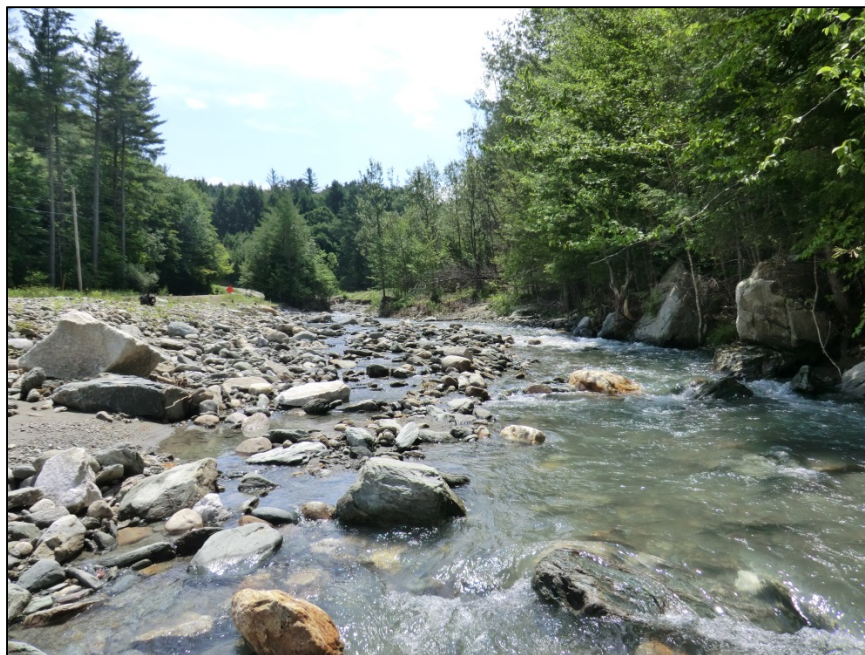
Segment B on reach four of Stony Brook begins just upstream of 2730 Stony Brook Road and continues upstream for 4,200 feet to 3494 Stony Brook Road. This segment is less incised than segment A and has not widened as much. Moderate historic incision occurred within segment B likely as a result of some straightening along Stony Brook Road, and has caused a stream type departure and partial loss of floodplain access. T5.04-B is currently in the process of widening to achieve equilibrium once more. Some sections of the segment widened significantly and underwent major planform change during Tropical Storm Irene. Just downstream of the confluence of Davis Hill Brook, Stony Brook avulsed, cutting a new channel on the eastern bank. In the process of doing so, the brook washed away a camp and flowed down Stony Brook Road. The camp was destroyed, as was a segment of the road. In post-flood recovery work, the brook was rerouted to its old course, and the new channel was filled in. The road was repaired but the camp was not rebuilt. Mass failures are abundant within T5.04-B, primarily occurring along the western valley wall. Bank erosion is also widespread due to channel widening, and armoring is present in areas where the brook flows along the road. This segment is in **fair** geomorphic condition as a result of major recent adjustments and channel work. It is also in **fair** habitat condition, with lacking riparian buffers and impacted channel morphology.

**Figure 5.35.** Stony Brook avulsed and destroyed a camp and Stony Brook Road in T5.04-B (left side of photo).

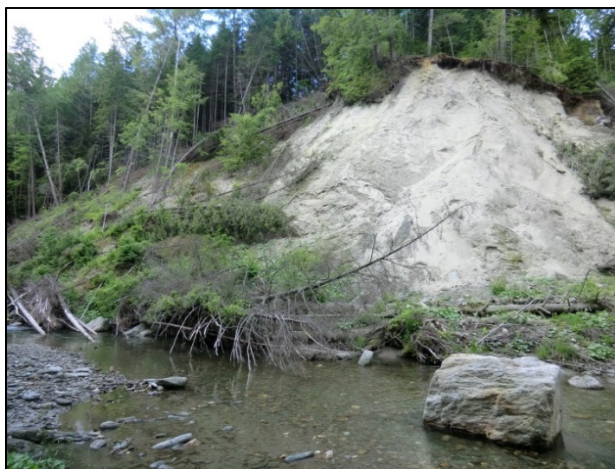
The downstream segment on reach five of Stony Brook is naturally confined between Driscolls Road and Stony Brook Road. It extends from the reach break upstream approximately 2,400 feet to where the river valley widens significantly. A section of the segment was historically straightened along Driscolls Road, which has contributed to the severe historic incision observed during the assessment. Major widening has also occurred in T5.05-A, most of which likely happened during Tropical Storm Irene. The valley walls in this segment are very steep and unstable, which has led to the formation of nine mass failures. Many of these mass failures have occurred along Stony Brook Road and Driscolls Road, putting them at risk of future damage. In two locations, mass failures occurred along Stony Brook Road during Irene, washing out the road and requiring large amounts of embankment armoring post-flood. For most of the segment, aggradation is minor, however, at the bottom of T5.05-A, a bedrock pinch point has created a sediment plug with localized aggradation. The Driscolls Road Bridge over Stony Brook is a significant channel constriction and was damaged by TSI floodwaters. Historic incision has resulted in a loss of floodplain access in T5.05-A and a stream type departure. In combination with widening, this segment is in **fair** geomorphic condition. Habitat condition is also **fair** as a result of unstable banks, impacted buffers, and an over-widened channel.

**Figure 5.36.** One of many large mass failures contributing sediment to Stony Brook in T5.05-A.

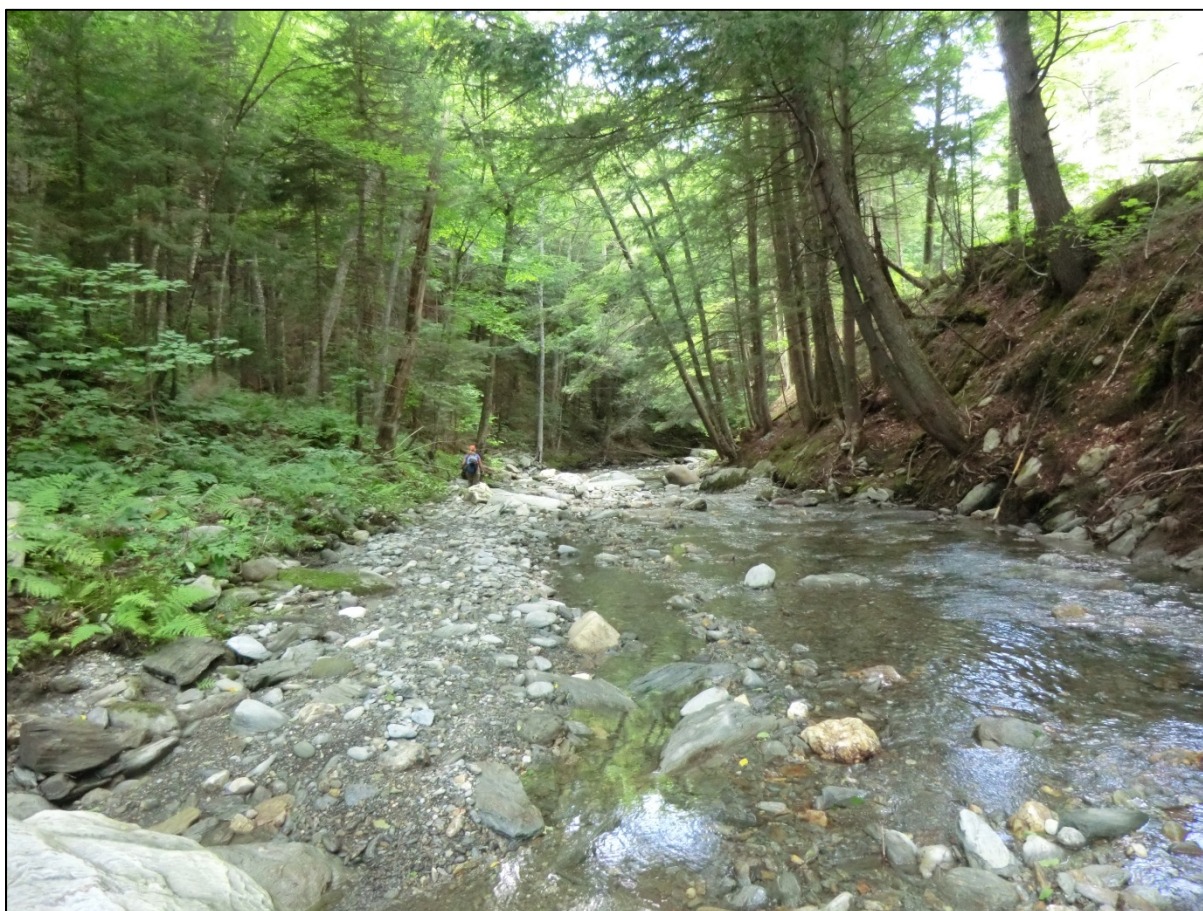
This segment flows through a narrow valley and has a steeper channel slope than segment A. T5.06-B spans approximately 2,000 feet in the vicinity of 5095 Stony Brook Road. It has incised only slightly and has not widened for the majority of the segment. Some sections are more incised and/or wider, but these are not dominant. A short portion of this segment was windrowed post-Irene in the vicinity of the Stony Brook Road Bridge. Three mass failures exist within T5.06-B and erosion is scattered throughout. Bank armoring is minimal and limited to the vicinity of the bridge. T5.06-B is in **fair** geomorphic condition as a result of minor aggradation and planform adjustment. It is in **good** habitat condition because of a well-defined riffle-pool bedform, ample woody debris cover, and good hydrologic characteristics.

Figure 5.39. T5.06-B flows through a narrow valley is not very incised.

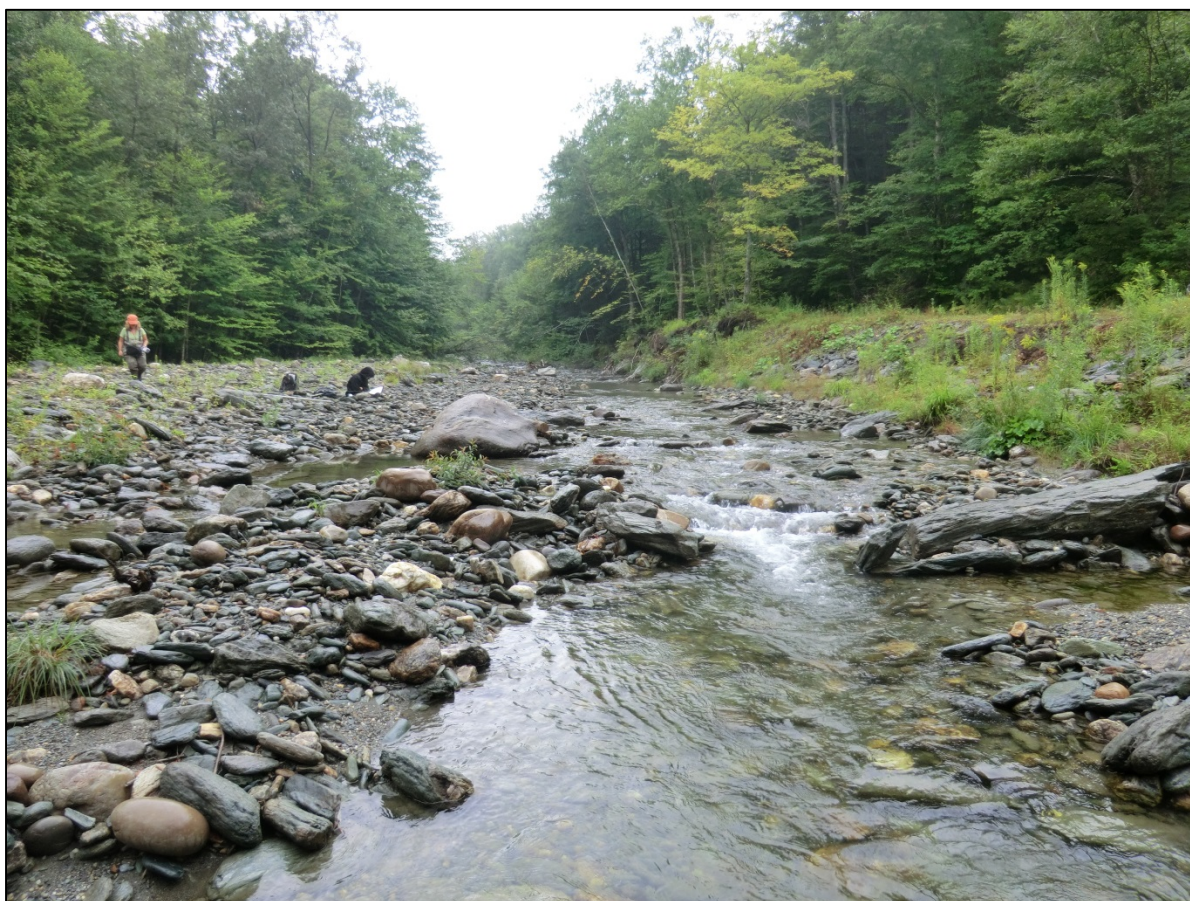
Segment C on reach T5.06 is similar to segment A. It is 900 feet in length and is an extremely wide, aggradational section. This segment has incised slightly, but retains good floodplain access. Floodwaters from Tropical Storm Irene deposited large amounts of material in T5.06-C, which has caused severe channel widening. Deposition is causing braiding of flows in one location. Channel widening has resulted in abundant bank erosion in T5.06-C. Flood chutes cross large bars in this segment, which are in the process of forming a juvenile floodplain. T5.06-C is in **poor** geomorphic condition due to historic and active adjustment processes. Poorly formed bed features, unstable banks, and lacking woody debris contribute to the segment's **fair** habitat condition.

**Figure 5.40.** Aggradation and widening are two major processes that have occurred in T5.06-C.

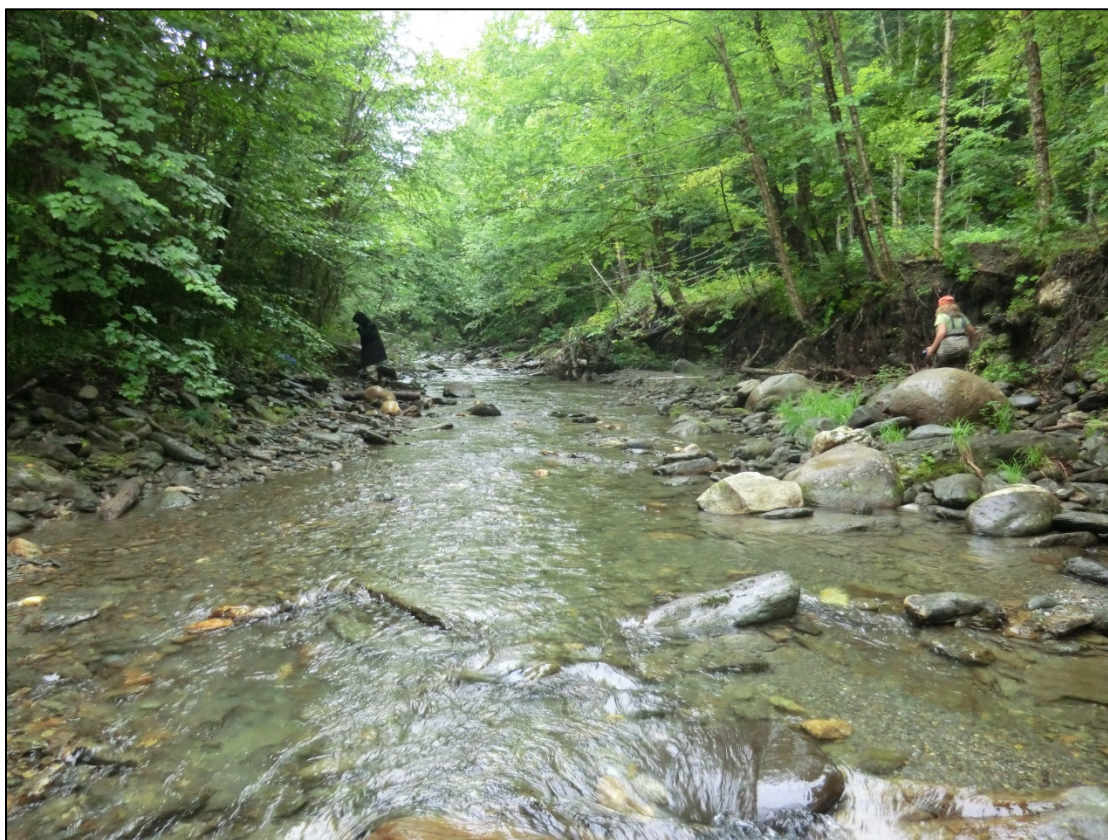
This segment flows directly along Stony Brook Road for approximately 1,000 feet. T5.06-D has undergone moderate historic incision, likely due to the placement of Stony Brook Road within the river valley. Stony Brook is beginning to widen in this segment, and bank erosion is scattered. Incision has resulted in a stream type departure and loss of floodplain access within T5.06-D. One bedrock grade control is present, which may have a localized effect on deterring future downcutting. Aggradation and planform adjustment are not actively occurring within T5.06-D. Historic channel degradation and current widening have caused this segment to be in **fair** geomorphic condition. T5.06-D is also in **fair** habitat condition due to lacking woody debris cover and impacted channel morphology.

**Figure 5.41.** T5.06-D has incised historically and is beginning the widening process.

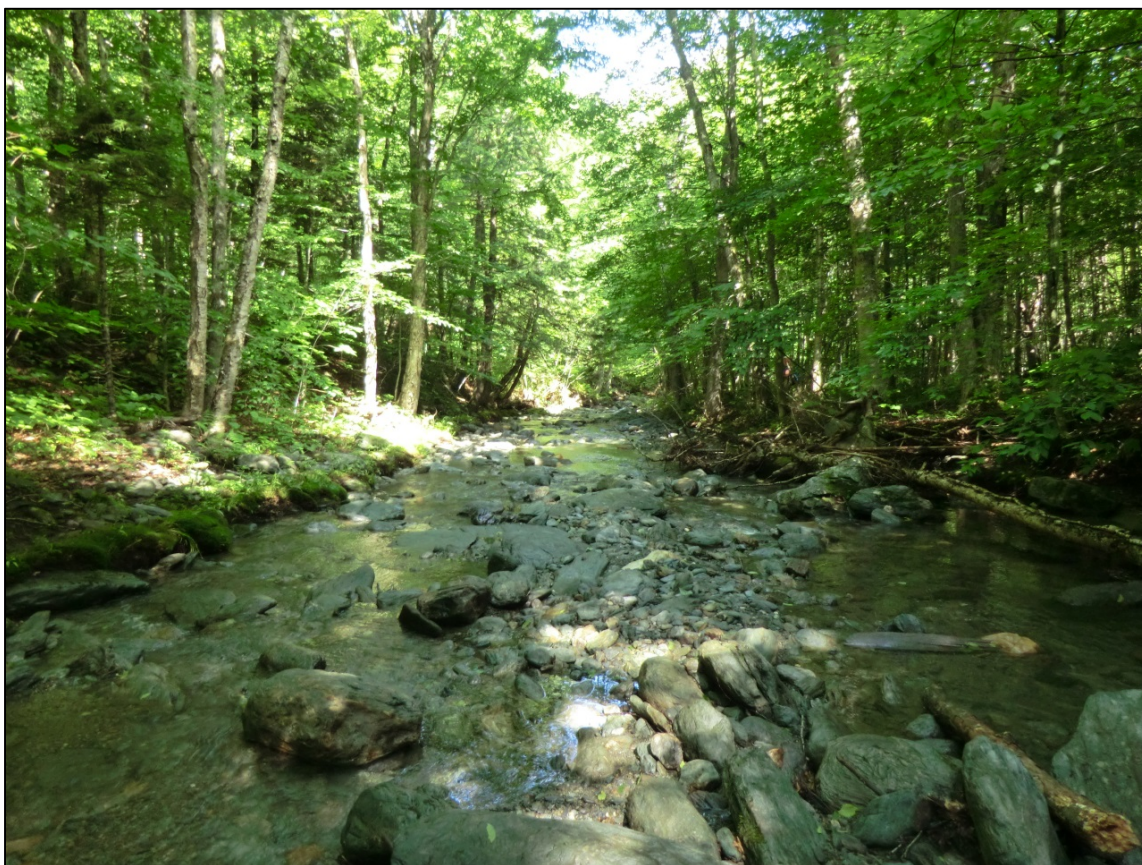
Segment E on reach six is the upstream-most segment on Stony Brook included in this assessment. It is in very stable condition and has not incised. Two bedrock grade controls provide vertical stability to this segment. Stony Brook road encroaches upon the brook for the majority of the segment, but it does not appear to be having significant impacts on the brook. Stormwater inputs from Stony Brook Road are abundant in this segment, and could be delivering sediment to the brook. T5.06-E is in **good** geomorphic condition due to its stability and lack of active adjustment. It is also in **good** habitat condition as a result of diverse bed features and minimal human impacts.

**Figure 5.42.** T5.06-E is very stable and has good floodplain access.
