# Upper & Middle White River Watershed Corridor Plan

Barnard, Hancock, Pittsfield, Rochester, and  
Stockbridge, Vermont  
July 15, 2015

Prepared by:  
Bear Creek Environmental, LLC  
149 State Street, Suite 3  
Montpelier, Vermont 05602

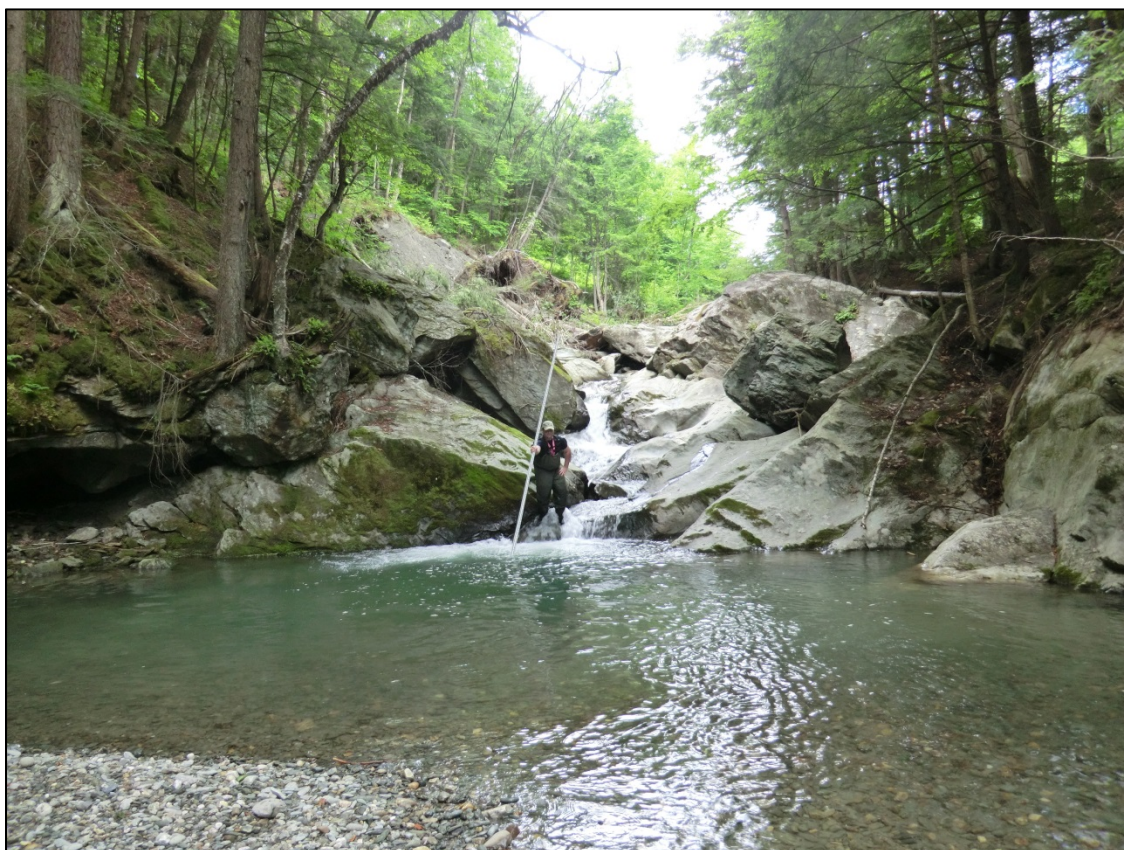
Segment B on reach one of Fletcher Brook flows through a narrow valley from above the alluvial fan in segment A upstream 2,200 feet to near 231 Blanchard Road. Bedrock grade controls are present throughout this segment, and a short bedrock gorge exists at the downstream end. Moderate channel incision has occurred in between these grade controls. Short areas of the segment were historically straightened along Fletcher Brook Road, but mostly planform is natural. Six mass failures are present along the southern valley wall. Fletcher Brook Road washed out in at least one location during Irene within this segment. Road rebuilding and armoring led to a narrowing of the channel in areas. Aggradation is present immediately upstream of grade controls but is not a major process. Historic channel incision has caused T5.3-S1.01-B to be in **fair** geomorphic condition. Habitat is also in **fair** condition due to unstable banks and a lack of large pools.

**Figure 5.44.** Many bedrock grade controls are present within T5.3-S1.01-B.

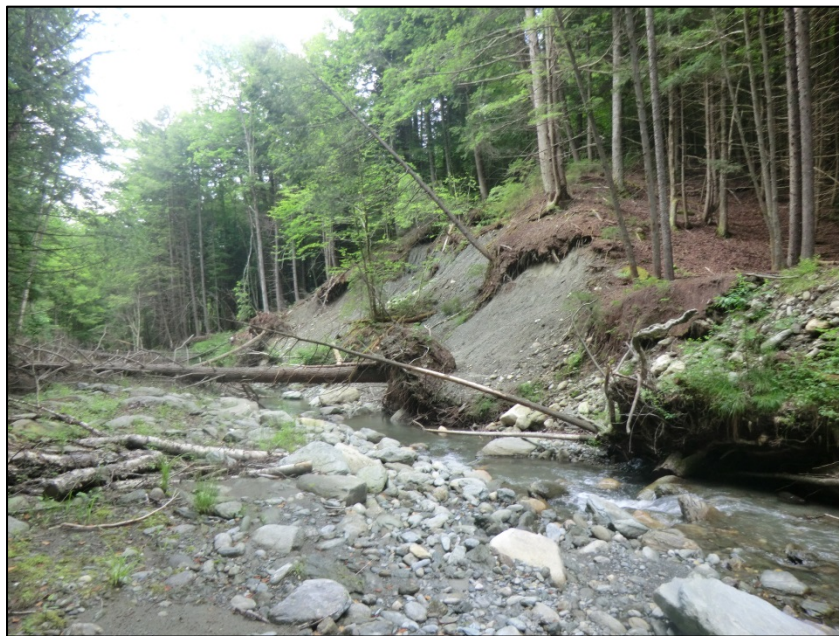
This segment is approximately 5,600 feet in length, flowing through a narrow valley from above Spiegel Road to below Blanchard Road. There are several areas in segment C that were historically straightened along Fletcher Brook Road, which likely led to major historic incision. T5.3-S1.01-C has lost access to its floodplain and undergone a stream type departure. The channel has also experienced major widening and aggradation, and is currently building a juvenile floodplain on large bars. High flows in Fletcher Brook during Irene caused damage to Fletcher Brook Road in numerous locations in T5.3-S1.01-C. During road repair, short sections of the brook were windrowed in the vicinity of damage locations. Bank erosion is nearly continuous along both banks of Fletcher Brook, which can be attributed to the major widening that has occurred. Mass failures are abundant, and are contributing fine sediment and large woody debris to the brook. Debris jams are common in segment C due to these woody debris inputs, and are causing planform change in areas. At the upstream end of the segment, major aggradation occurred during Irene, causing the brook to avulse and cut a new channel over its western bank. T5.3-S1.01-C is in **fair** geomorphic condition due to historic and recent channel adjustment. It is also in **fair** habitat condition due to unstable banks and an overly-wide channel.

Figure 5.45. Mass failures and large depositional features are common in T5.3-S1.01-C.

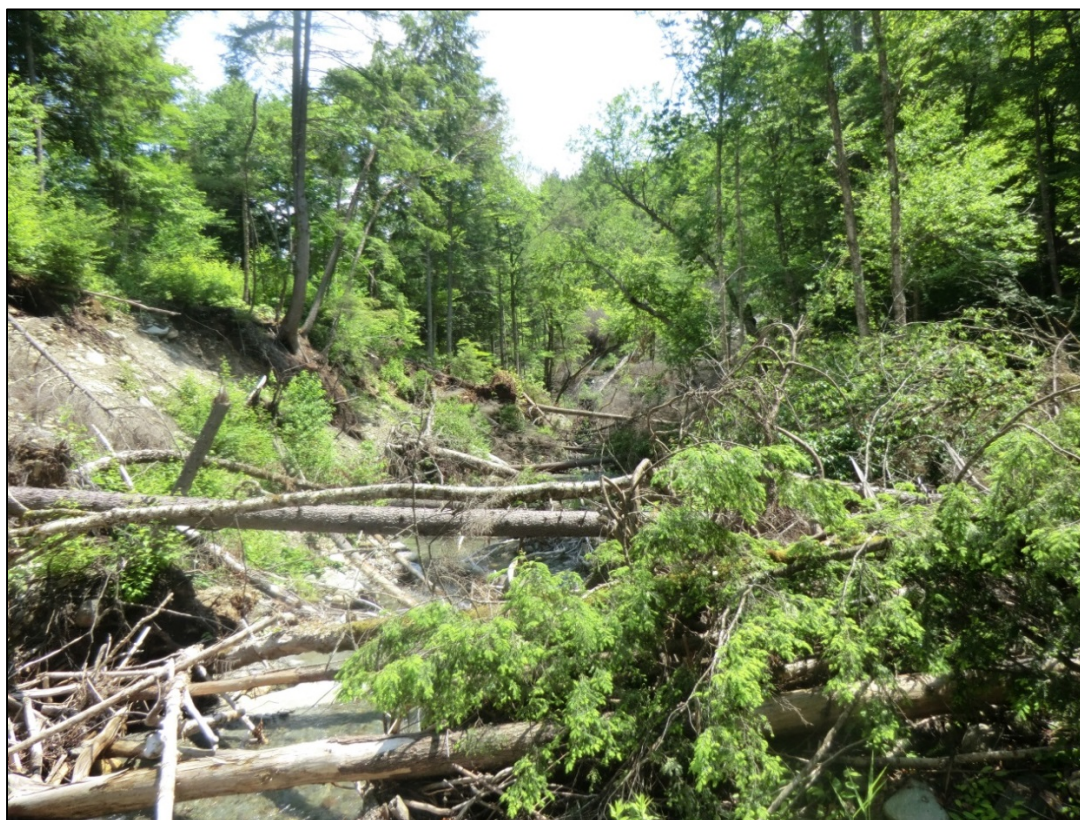
The upstream-most segment included in the assessment of Fletcher Brook begins near 135 Spiegel Road and continues upstream for 2,700 feet to the reach break. This segment has not been subjected to any straightening along Fletcher Brook Road and retains its natural planform. Despite this, the brook has undergone moderate historic incision in this segment and is currently widening. A short bedrock gorge is present in the middle of this segment, which is holding the grade and likely reducing further incision. Bank erosion is nearly continuous throughout the segment and large mass failures are common. The mass failures are sources of sediment and woody debris for the brook, and have led to the formation of numerous debris jams. Minor planform adjustment is occurring in the vicinity of these jams. T5.3-S1.01-D is in **fair** geomorphic condition due to historic incision and active widening. Habitat is in **good** condition, as the brook has an abundance of woody debris that is creating plunge pools and in-stream cover, well vegetated buffers, and diverse bed features.

**Figure 5.46.** Woody debris from the valley walls lines Fletcher Brook in T5.3-S1.01-D.

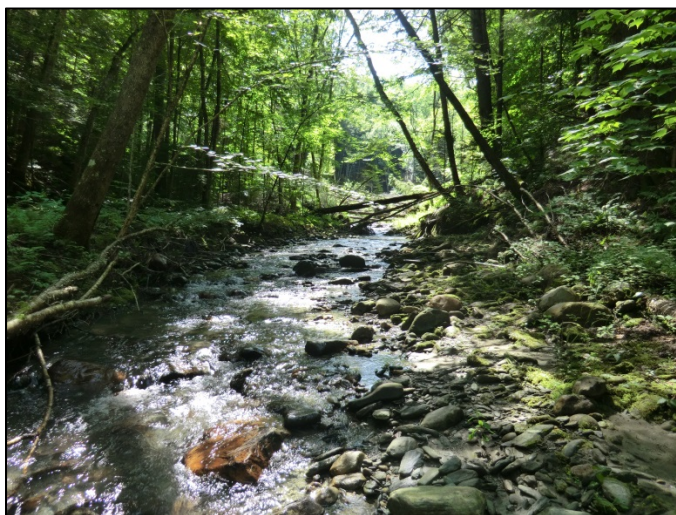
The downstream-most segment on Bartlett Brook is approximately 3,000 feet in length, beginning at the mouth of the brook and continuing upstream to where the stream becomes inaccessible due to woody debris in the channel. T6.1-S1.01-A flows through a broad valley and is currently in very stable condition. The brook has incised slightly, which could be due to channel alteration on the Tweed River just below the confluence. Saturated soils on the valley walls have led to the formation of several mass failures, which are contributing sediment and woody debris to the channel. Debris jams are abundant, and are causing minor planform adjustment and some bank erosion. The brook has good floodplain access in this area. T6.1-S1.01 is in **good** geomorphic condition because channel adjustment is minimal. The brook is also in **good** habitat condition in this location as a result of ample woody debris and good bed cover.

**Figure 5.47.** T6.1-S1.01-A is geomorphically stable and has good floodplain access.

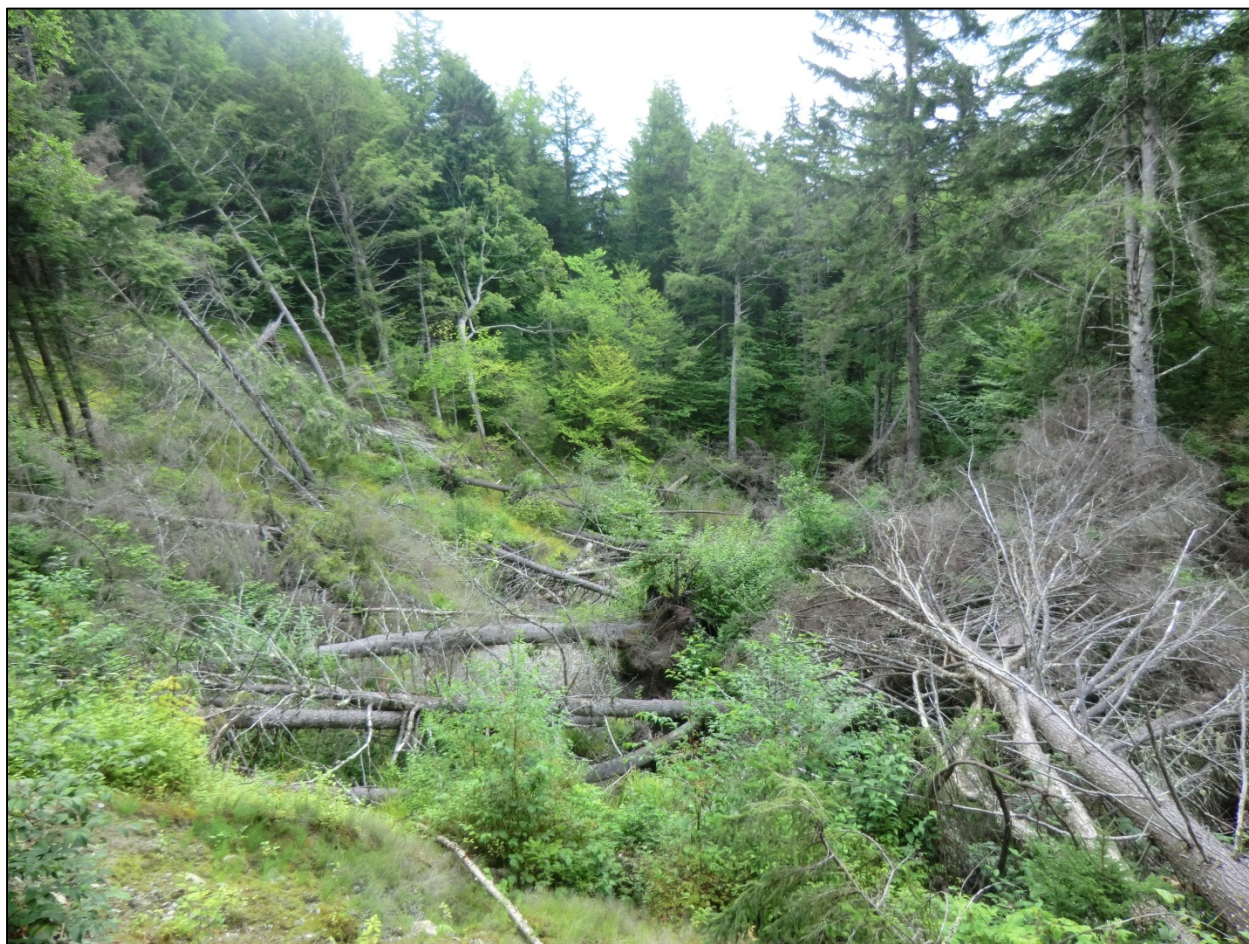
Segment B on reach one of Bartlett Brook is approximately 1,600 feet in length. This segment could not be fully assessed because access to the channel was not possible. Enormous mass failures line the valley walls of the brook. Bank erosion is severe and abundant. The unstable banks in T6.1-S1.01-B have contributed a large amount of woody debris to the stream channel, making it inaccessible. Qualitative observations were taken throughout this segment. It is estimated to be in **fair** geomorphic condition.

**Figure 5.48.** Woody debris in the channel in T6.1-S1.01-B made it inaccessible for assessment.

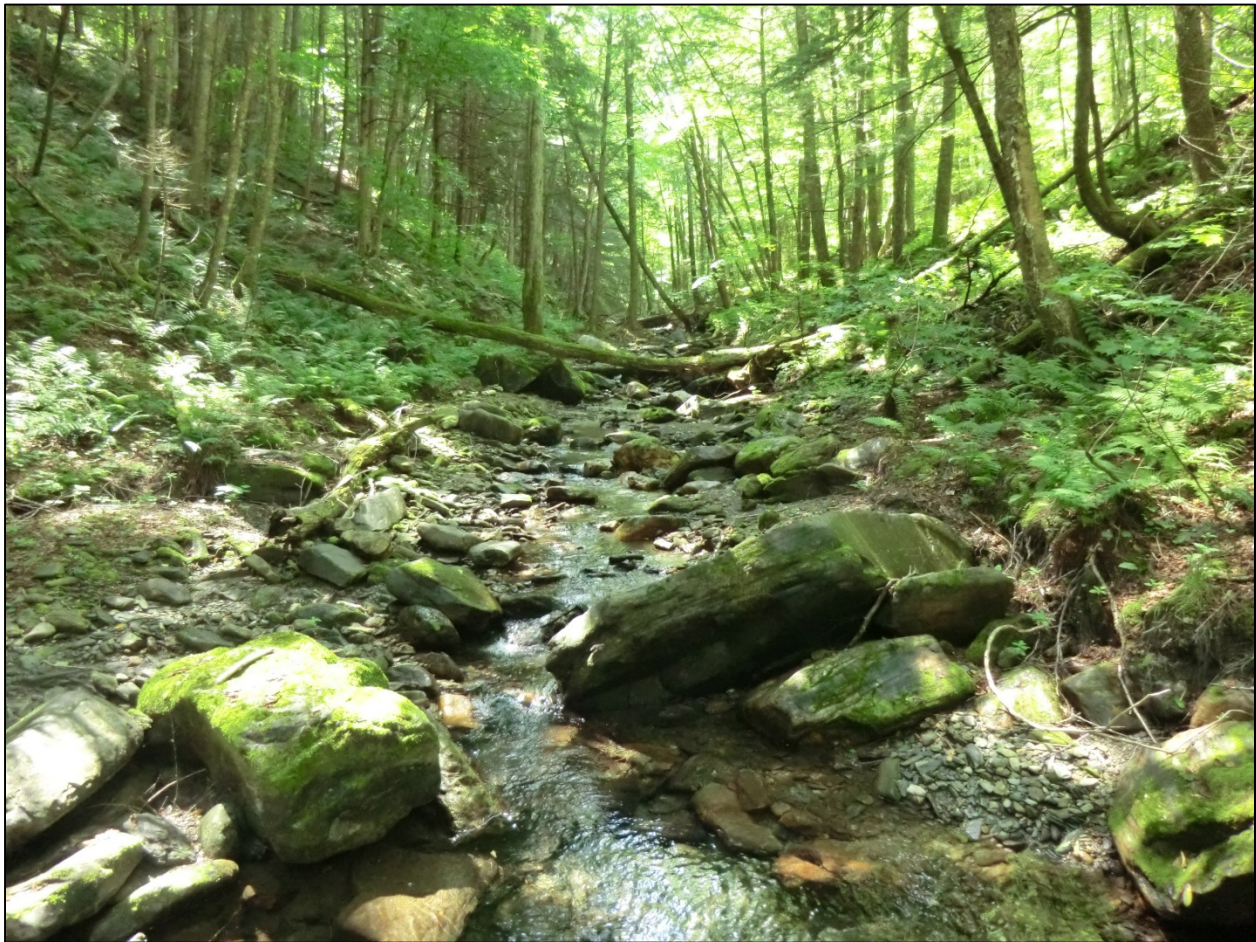
The upstream-most portion of Bartlett Brook included in this study was not fully assessed due to its remote location, lack of human impacts, and stable condition. The segment is approximately 2,000 feet in length. Qualitative observations were taken at the downstream end of the segment to characterize it. The brook is very stable in this location and appears to be in [reference](#) geomorphic condition with a step-pool bedform.

**Figure 5.50.** T6.1-S1.01-D was not fully assessed, but is in very stable condition.

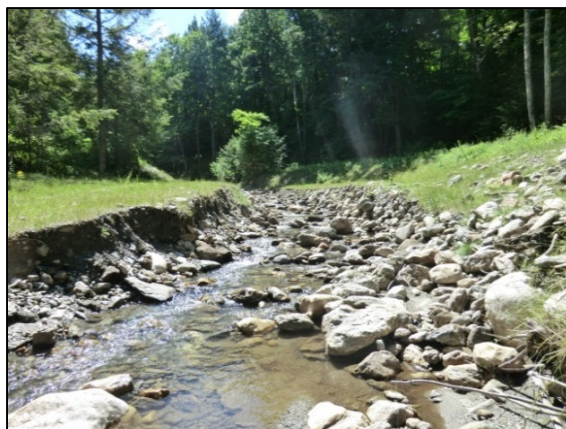
**Figure 5.51.** T6.4-S1.01-A was subjected to windrowing and dredging post-Irene.

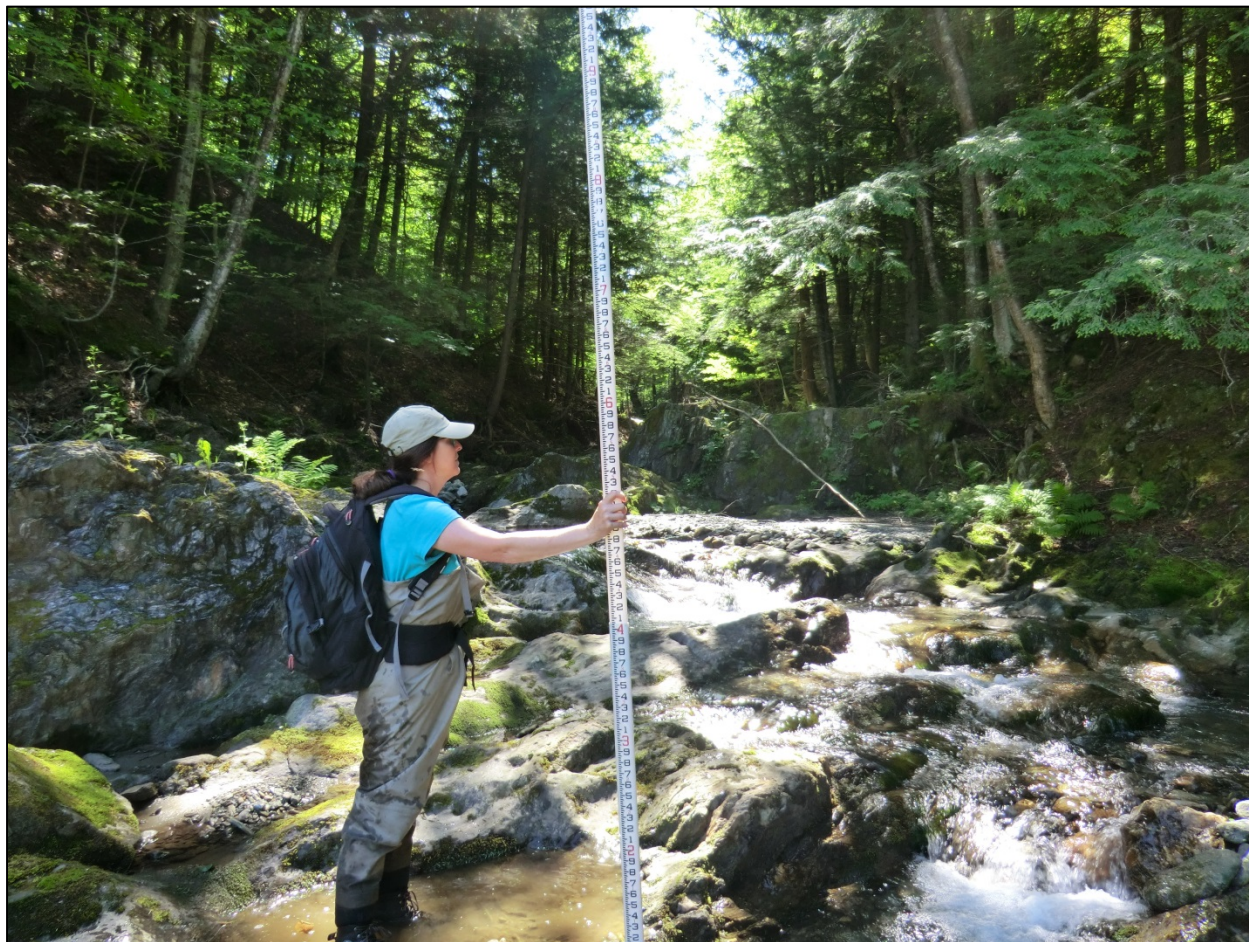
**Figure 5.52.** T6.4-S1.01-B was not fully assessed due to the presence of a bedrock gorge.

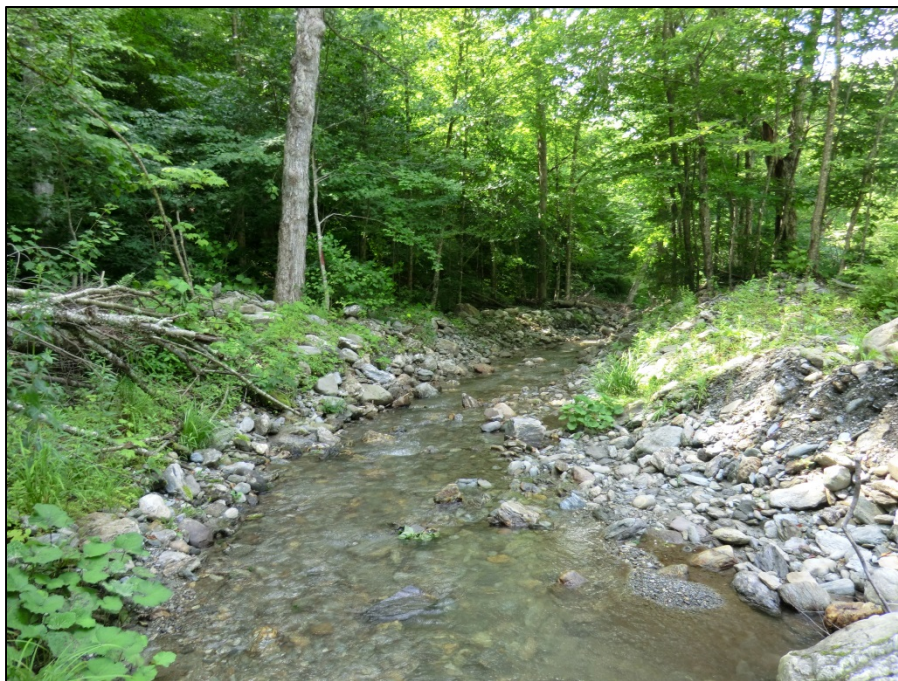
**Figure 5.53.** T6.4-S1.01-C was subjected to extensive windrowing and berming post-Irene.

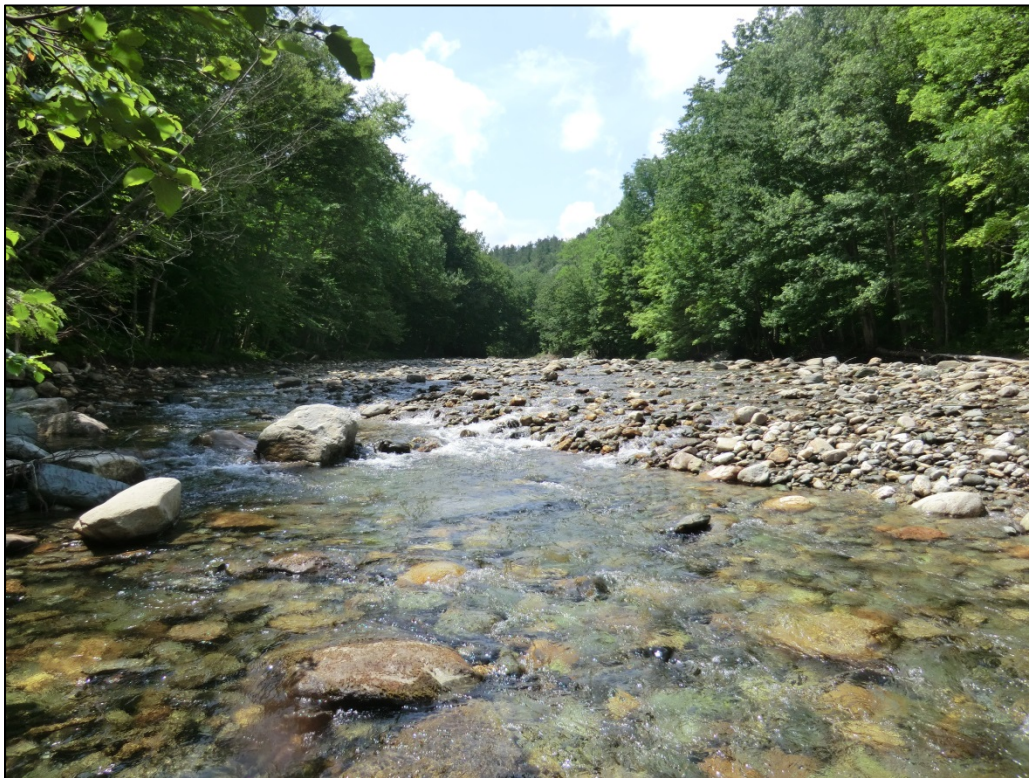
**Figure 5.55.** The West Branch has widened and is adjusting planform in T7.01-B.

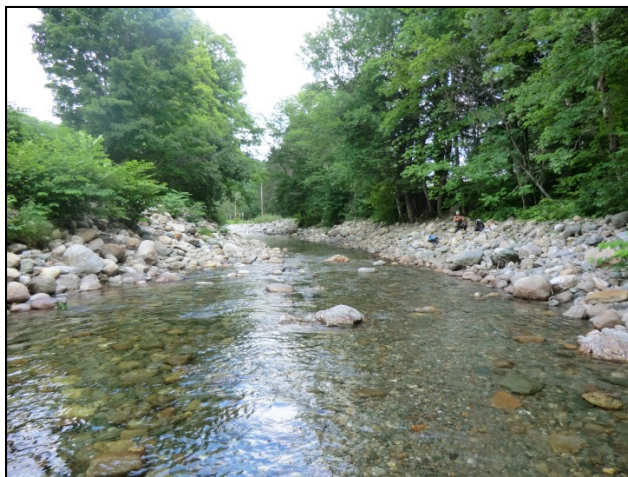
**Figure 5.61.** T8.01-A was extensively windrowed post-Irene.

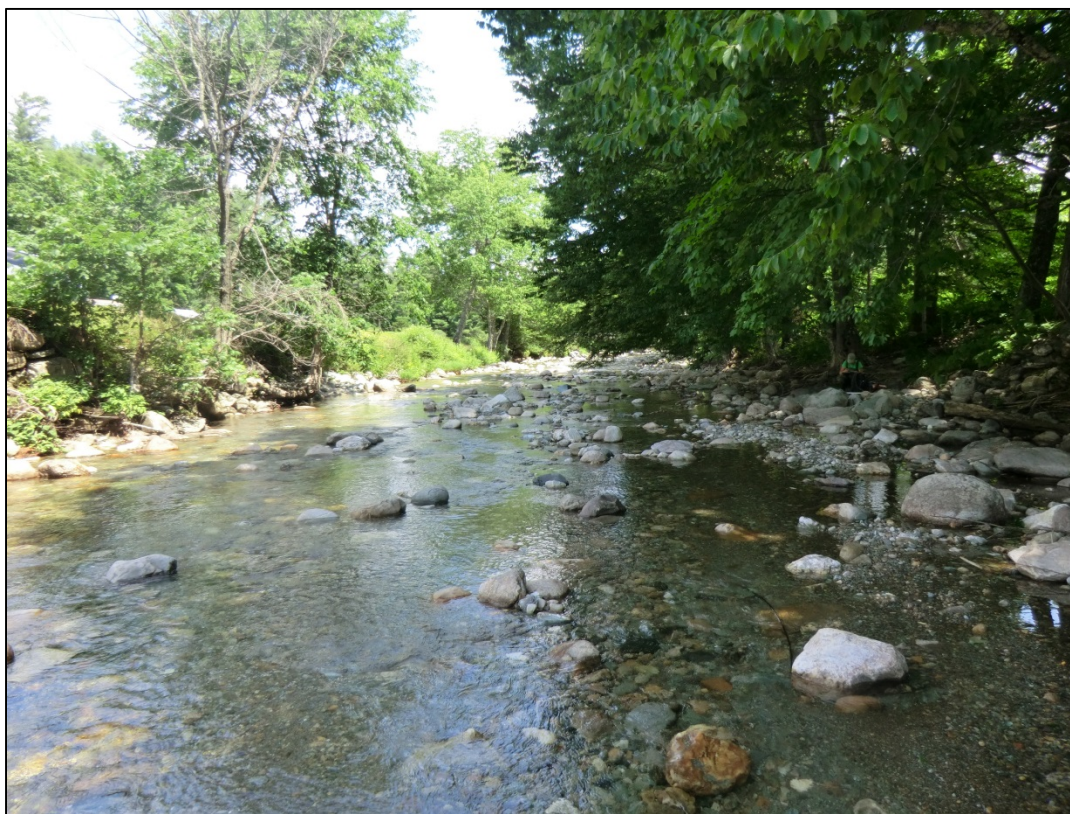
**Figure 5.65.** The river was straightened along Route 125 for all of T8.02-B.

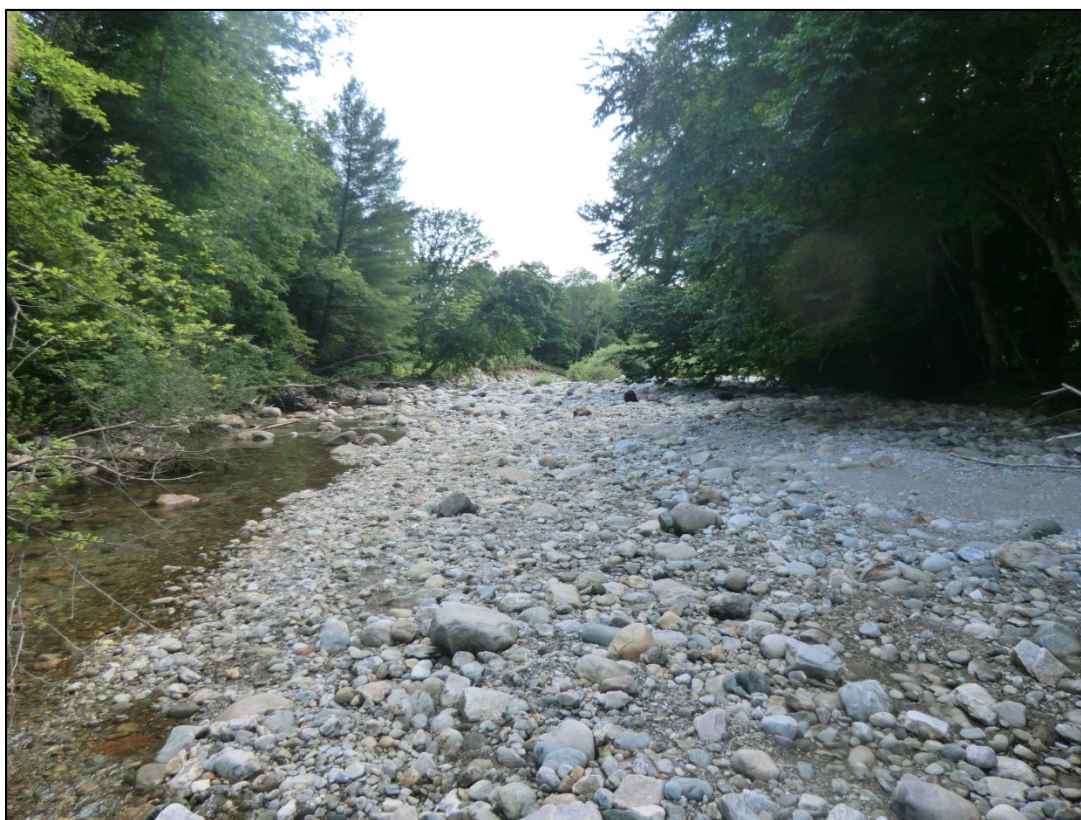
**Figure 5.66.** Major aggradation and a wide channel are characteristic of T8.02-C.

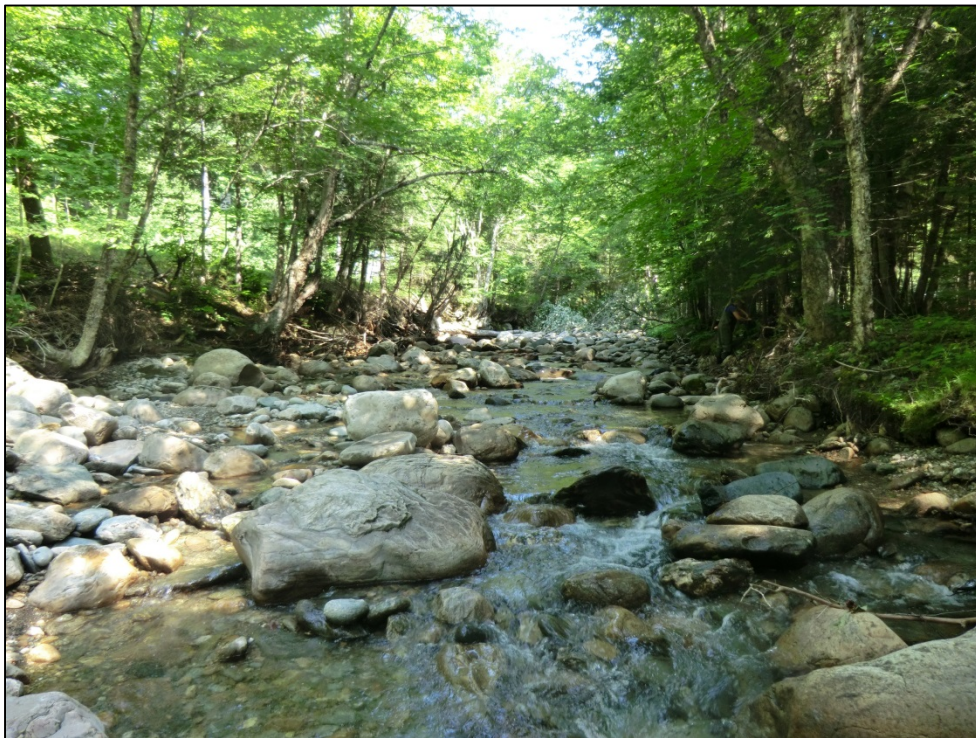
**Figure 5.68.** Much of T8.03-A was historically straightened along Texas Falls Road.
