# **Winhall River Watershed Corridor Plan**

**Winhall, Jamaica, & Londonderry, Vermont**  
**October 27, 2014**

Prepared by:  
Bear Creek Environmental, LLC  
149 State Street, Suite 3  
Montpelier, Vermont 05602

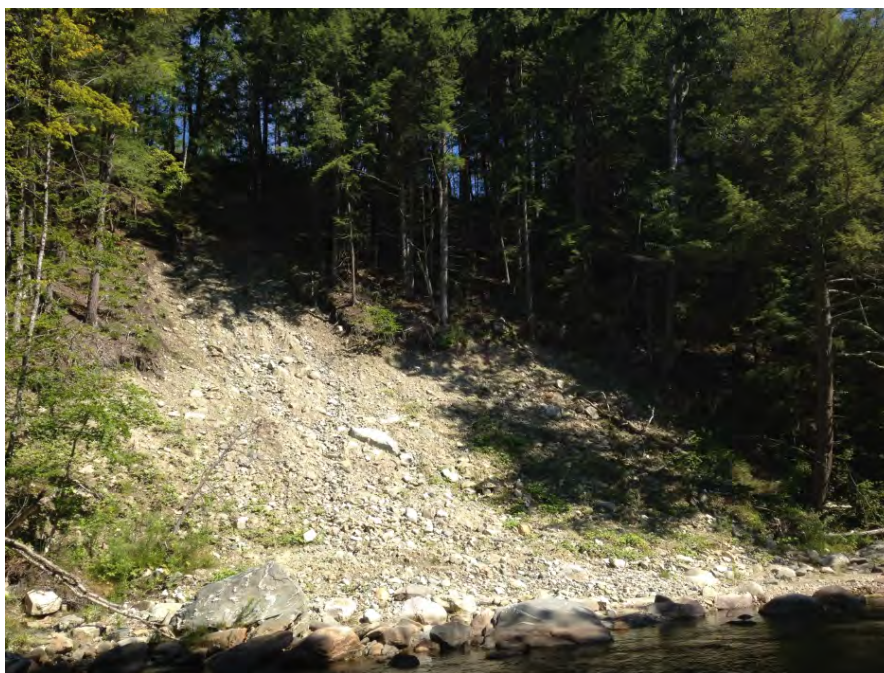
This segment begins just upstream of the TH52 bridge and continues upstream almost 4,400 feet to where a bedrock gorge begins. Characterized by a semi-confined valley and a riffle-pool bedform, the segment has historically incised slightly, but the presence of several grade controls upstream is limiting the channel's vertical adjustment. T11.02-A has an "F" stream type, which indicates that it has very little floodplain access. Several mass failures are present along the northern valley wall, and stormwater inputs from Cohen Road abound on the southern river bank. Major aggradation is currently occurring in the segment, creating large diagonal bars with steep riffles. Planform adjustment is evidenced by several flood chutes throughout the segment. Overall, it is in **fair** geomorphic condition. Habitat condition is also **fair** due to impacted buffers along Cohen Road and lacking bank vegetation.

**Figure 5.4.** One of many mass failures present in T11.01-A.

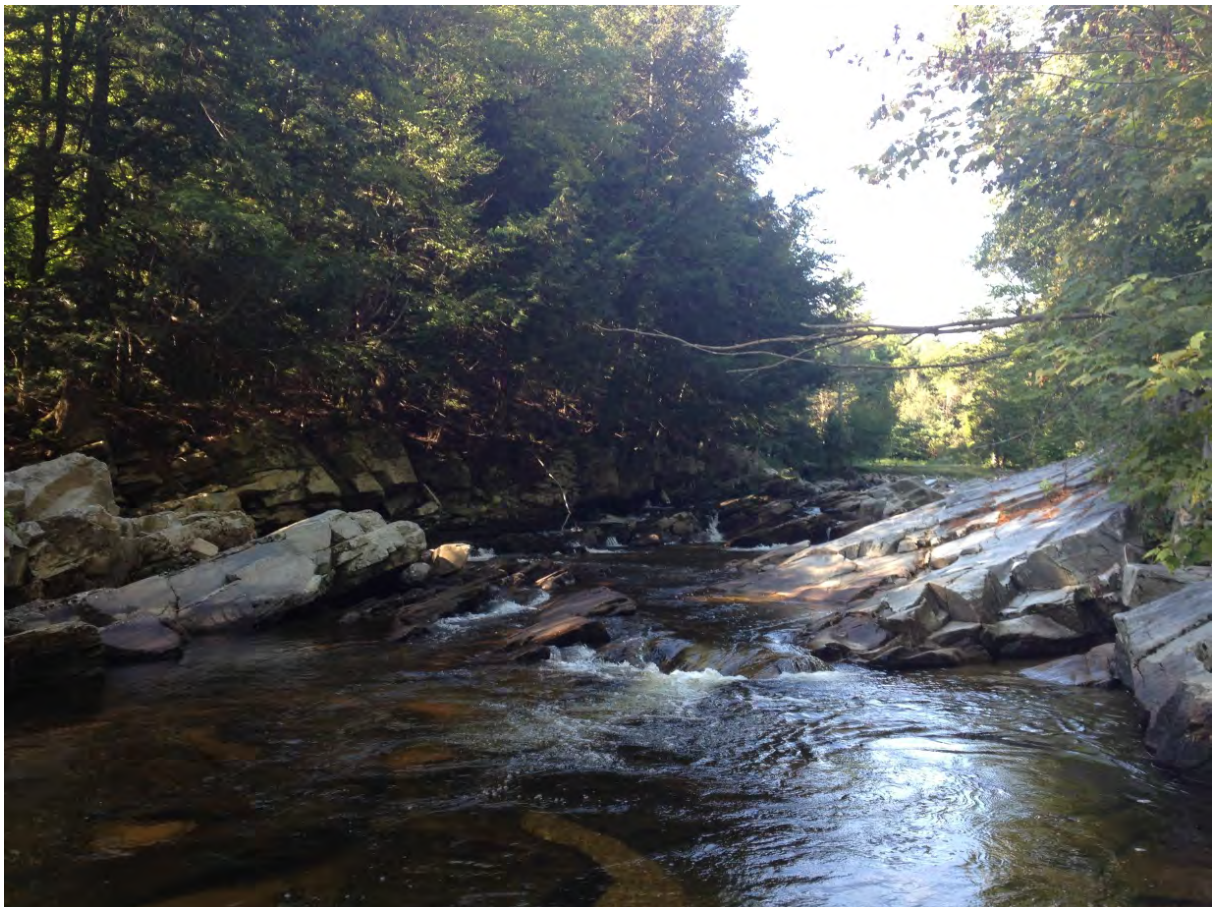
This segment is located within a bedrock gorge in a narrowly confined valley. Several bedrock grade controls are present in the segment, which prevent stream channel adjustment. The segment begins approximately 1,000 feet downstream of the Cohen Road stream crossing and continues upstream 500 feet to the reach break. T11.01-B was not fully assessed due to the presence of the bedrock gorge. Administrative judgment was used to determine reference and existing stream type, bed material, and bedform. Overall, the segment is in good geomorphic condition due to the stability of the bedrock grade controls.

**Figure 5.6.** T11.02-B is located within a bedrock gorge.

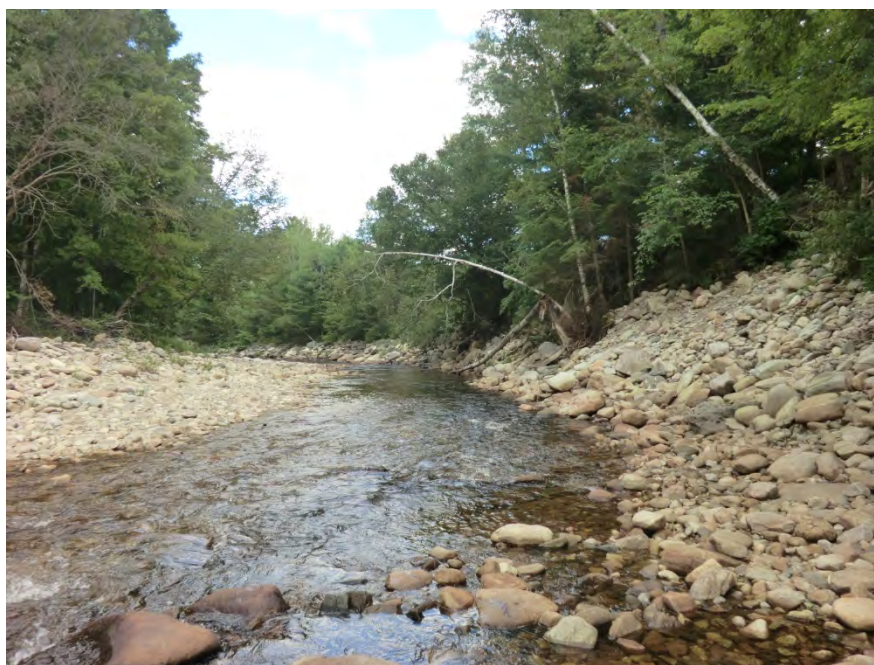
This segment flows through a very broad valley from just below the Goodaleville Road crossing to 1,500 feet upstream where the valley narrows. It is characterized by extensive straightening with windrowing along Goodaleville Road. The channel was historically straightened along the road, but windrowed post-TSI likely to protect the road. Extreme historic incision has caused a stream type departure and loss of floodplain access in T11.03-A. Bank revetments are nearly continuous along the southern bank of the river and also present along the north bank. Widening has occurred in the segment and rip rap is limiting further widening in some areas. Channel alterations have caused the river to lose its riffle-pool bedform in this segment in exchange for a plane bed, featureless channel. Many diagonal bars are present in this reach. Historic and recent channel alterations have created geomorphic instability in T11.03-A, placing it in **poor** geomorphic condition. The loss of bedform in this segment, as well as a lack of LWD, and poor banks and buffers have placed T11.03-A in **fair** habitat condition.

**Figure 5.7.** T11.03-A was windrowed extensively post-Irene.

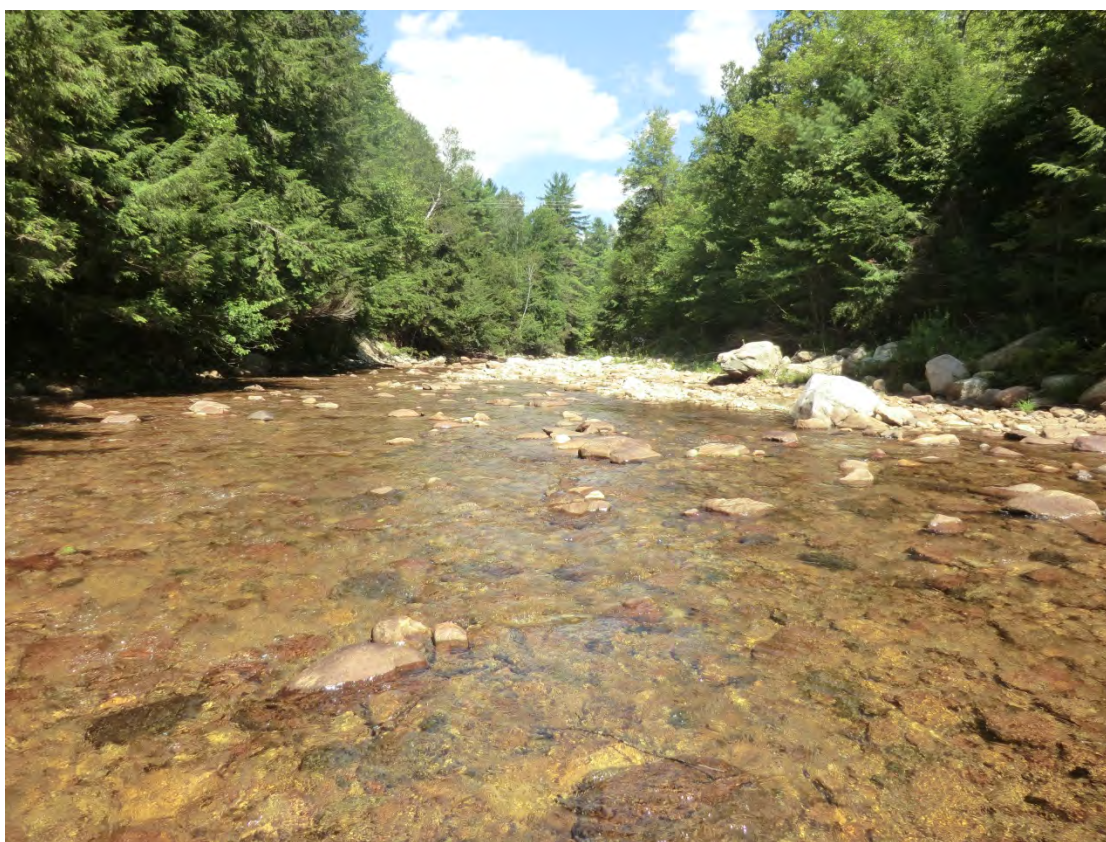
This segment is located along Goodaleville Road where the river valley narrows. The majority of the segment was historically straightened along the road, and a portion was recently windrowed post-Irene. The high incision ratio in T11.03-B alludes to major historic incision. Despite this incision, the segment overall has intact floodplain access. These alterations have, however, caused a riffle-pool reference bedform to be converted to plane bed. Erosion abounds along both banks, as does rip rap along Goodaleville Road. One mass failure is present along the north bank of the river. Several diagonal bars with steep riffles indicate that the segment has majorly aggraded. Due to the aforementioned impacts and processes, T11.03-B is in **fair** geomorphic condition. The segment lacks a diversity of bed features and does not provide good cover for aquatic biota. Coupled with historic and recent channel alterations as well as impacted buffers, T11.03-B is in **fair** habitat condition.

**Figure 5.8.** A featureless plane bed channel dominates in T11.03-B.

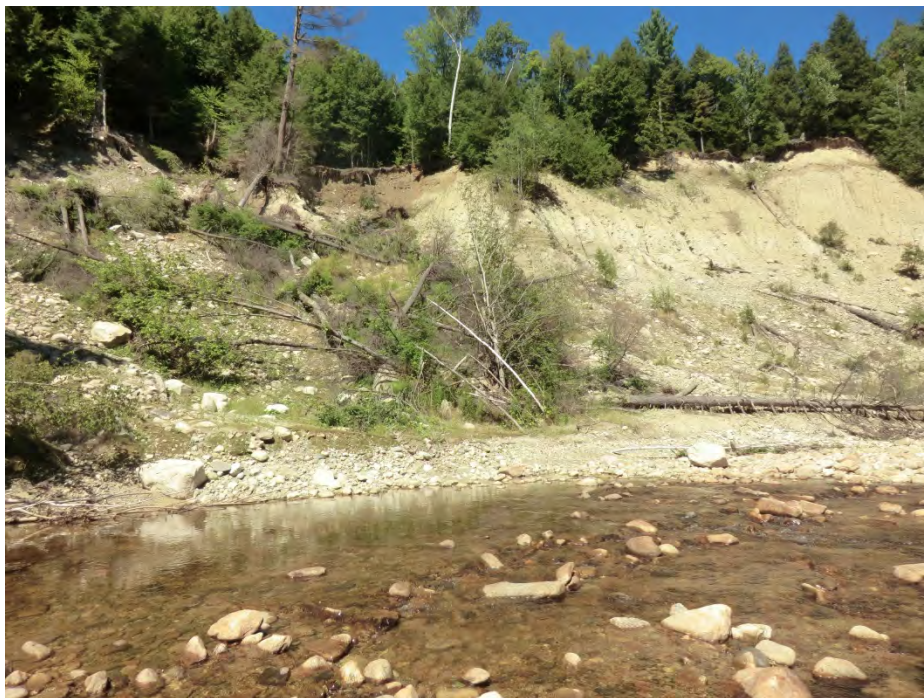
This reach was not split into any segments during assessment. T11.04 begins just downstream of the Route 100 stream crossing and continues upstream to just above the confluence of a major tributary, Red Brook, with the Winhall River. The channel flows through a very broad valley by reference, but due to the presence of Vermont Route 30 encroaching upon the river corridor, the existing valley type is broad. T11.04 has a dominant bedform of braided, with riffle-pool subdominant. The channel was historically straightened along Rt. 30, which led to historic incision. Recent channel work post-Irene involved channel windrowing in some areas of the reach. Rip rap is abundant where the river flows along Rt. 30, and seven mass failures are present throughout the reach. Bank erosion is severe and buffers have been majorly impacted. Aggradation is extreme in this reach, with huge bars creating a braided channel throughout. Widening and planform adjustment are major processes, as evidenced by abundant bank erosion and numerous flood chutes. The channel is currently building a juvenile floodplain through its very large bars. Due to these factors, reach T11.04 is in **poor** geomorphic condition. The braided nature of the channel has created abundant refuge areas for fish, but the impacted banks and buffers and channel alterations have created **fair** habitat conditions in this reach.

**Figure 5.10.** One of seven large mass failures in T11.04.

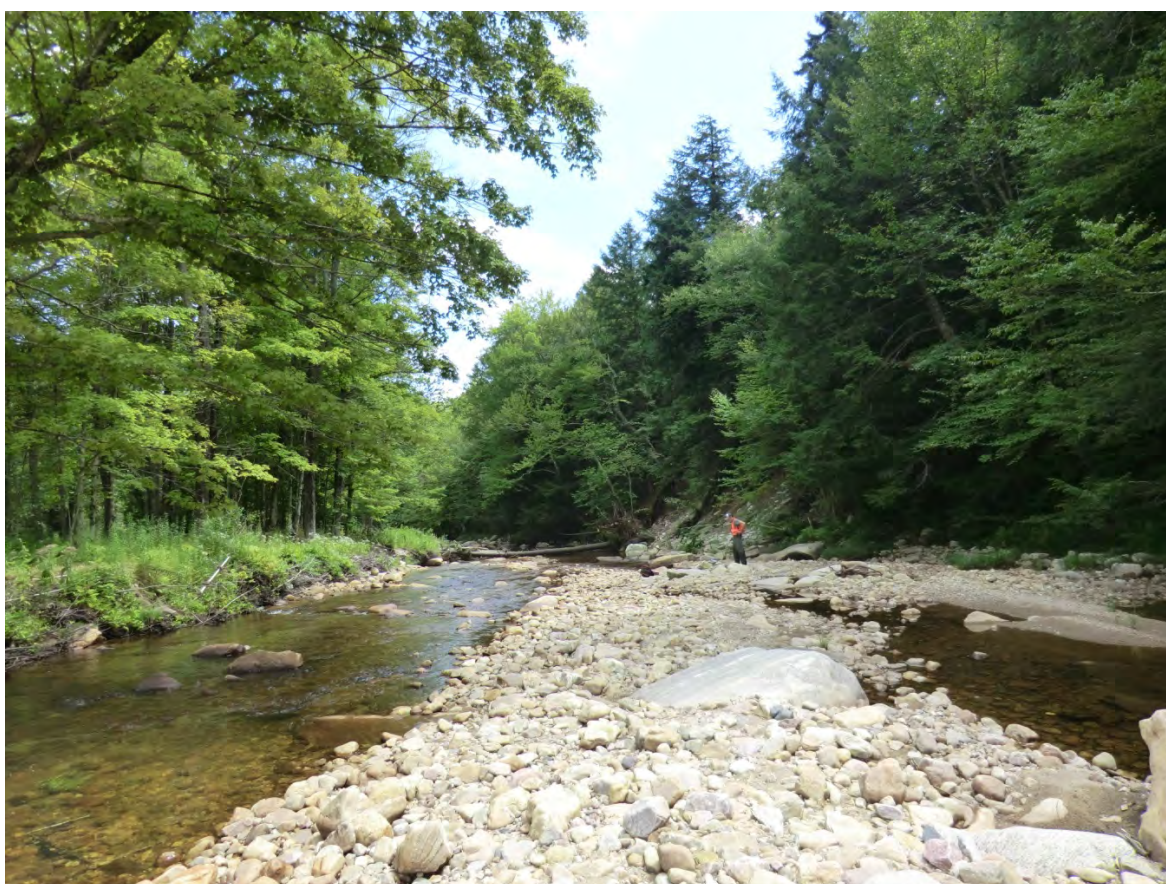
This segment begins where the river flows away from Rt. 30 and the existing valley type changes to very broad. T11.05-B is characterized by a riffle-pool bedform and unconfined valley. The channel exhibits minor incision, which is likely historic, and has not been straightened extensively. One small headcut is present in this segment. Despite the minor incision, T11.05-B has good floodplain access overall. Major aggradation is currently occurring in T11.05-B and large bars are beginning to form a juvenile floodplain. The stream channel has widened, and is beginning to move laterally without impediment from bank armoring and revetments. Due to the channel adjustments occurring in T11.05-B, it is in **fair** geomorphic condition. Unstable river banks with extensive erosion, as well as impacted riparian buffers, are also creating **fair** habitat conditions in this segment.

**Figure 5.12.** T11.05-B is undergoing major aggradation, but has good floodplain access.

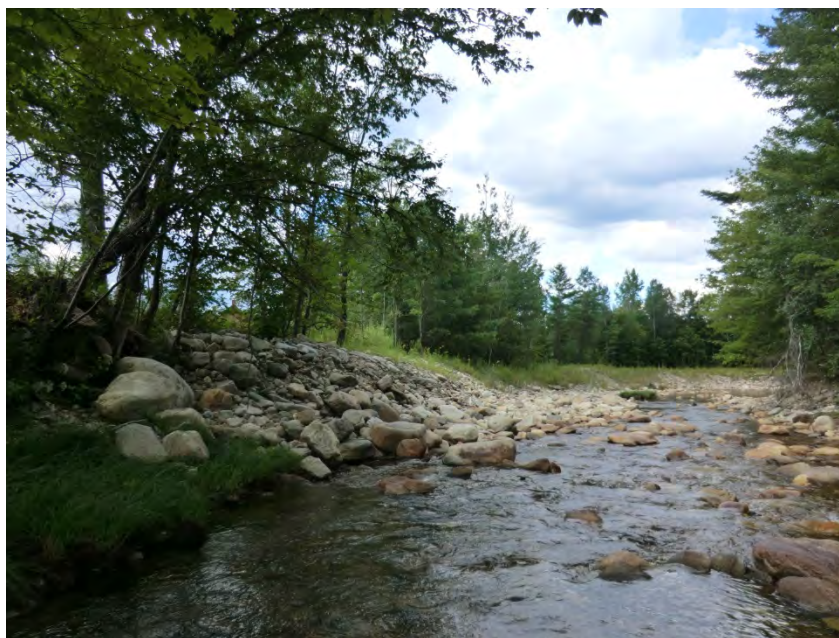
The downstream segment in T11.06 begins behind Homestead Landscaping just below the stream crossing at Lower Taylor Hill Road. This segment has a very broad valley by reference, however due to the presence of VT Rt. 30 and Kendall Farm Rd in the river corridor, the existing valley is broad. T11.06-A was historically straightened along Kendall Farm Rd and recently straightened and windrowed extensively after Tropical Storm Irene. These channel alterations have caused a loss of riffle-pool bedform and conversion to plane bed. A stream type departure has occurred in T11.06-A due to historic incision and floodplain access has largely been lost. It appears that aggradation occurred in this segment during TSI, but it was excavated to create large berms during post-flood channel work. T11.06-A is in **fair** geomorphic condition due to extensive channel alteration that has led to loss of floodplain access and bedform. The segment is also in **fair** habitat condition due to the aforementioned factors, as well as a lack of LWD and poor riparian buffers.

**Figure 5.13.** T11.06-A was windrowed extensively during post-TSI channel work and has lost its bedform.

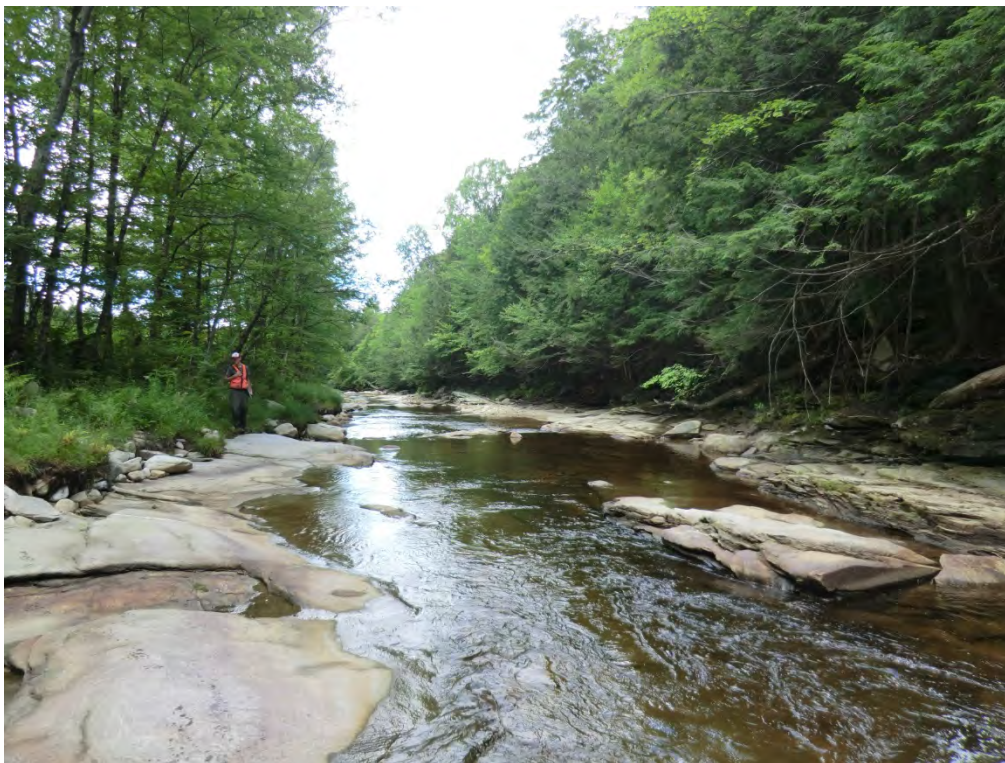
This segment begins where the river valley narrows and bedrock appears on the streambed. T11.06-B was historically straightened along Kendall Farm Road and historically incised down to bedrock. Recent windrowing and berming post-TSI have further entrenched the stream channel in this segment and severely limited floodplain access, causing a stream type departure. The presence of one large bedrock grade control spanning almost the entire segment is limiting further channel incision. The placement of Kendall Farm Road has also caused a broad river valley by reference to become semi-confined. Erosion is present along both banks, and the eastern bank in particular may be susceptible to severe erosion in the future due to increased stream power in this segment. T11.06-B is in **fair** geomorphic condition due to the aforementioned details. The bedrock in the stream channel has created large pools and refuge areas, however overall, this segment is in **fair** habitat condition due to the lack of LWD, loss of bedform, and poor bank and buffer vegetation.

**Figure 5.14.** The stream channel in T11.06-B has incised to bedrock and lost its riffle-pool bedform.

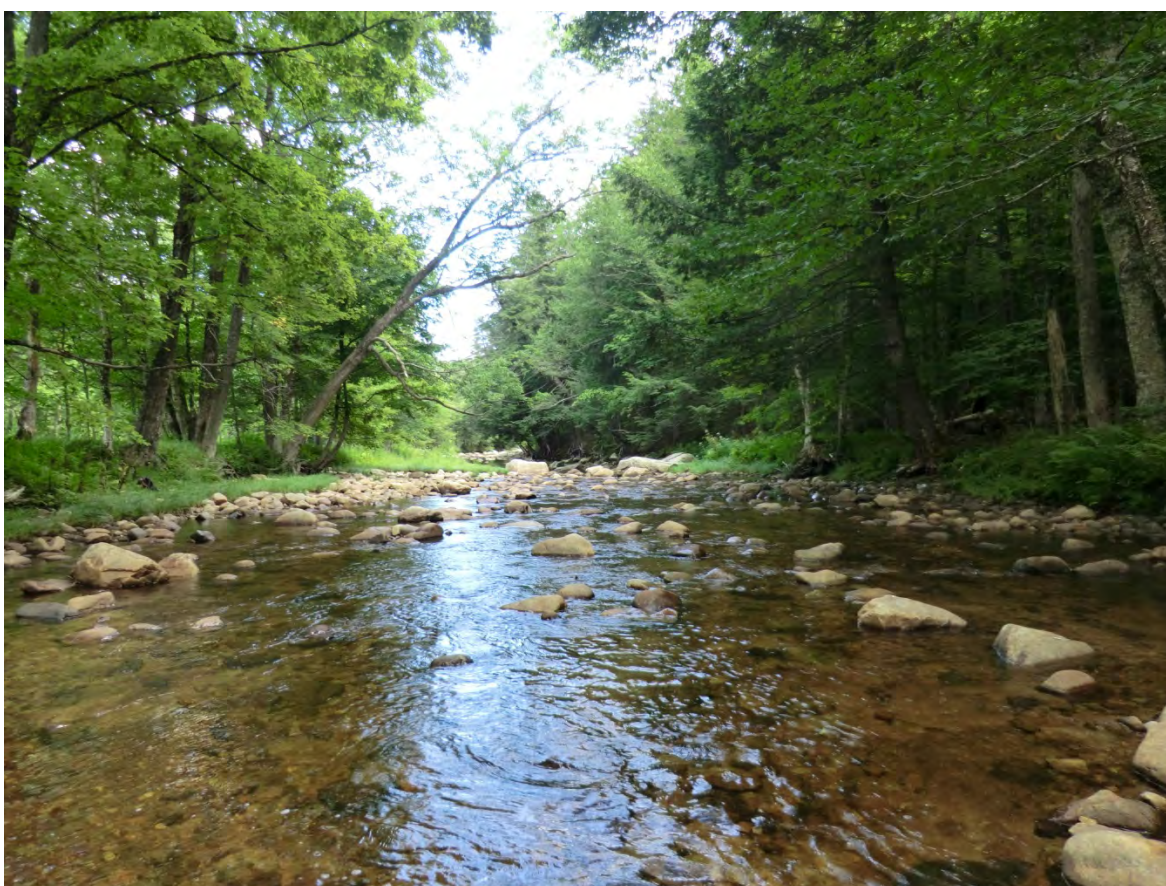
This segment begins just downstream of Rocky Dell Road and continues upstream to just above Hunker Road. T11.07-B overall has good floodplain access and has only experienced minor historic incision due to straightening along Kendall Farm Road. Bank erosion abounds in T11.07-B and one very large mass failure is present along the valley wall. A berm exists in the area with the mass failure, but its origin is unknown and it may be natural piling of sediment. T11.07-B is very aggradational, with bars and sedimented riffles common. The riparian buffer along the north bank of the stream has been impacted due to Kendall Farm Road and agricultural fields that abut the river. Overall, T11.07-B is in **fair** geomorphic condition due to historic incision and recent aggradation. This segment's habitat condition is also **fair** due to poor bank and buffer conditions and changes in channel morphology.

**Figure 5.16.** The Winhall River has good floodplain access in T11.07-B.

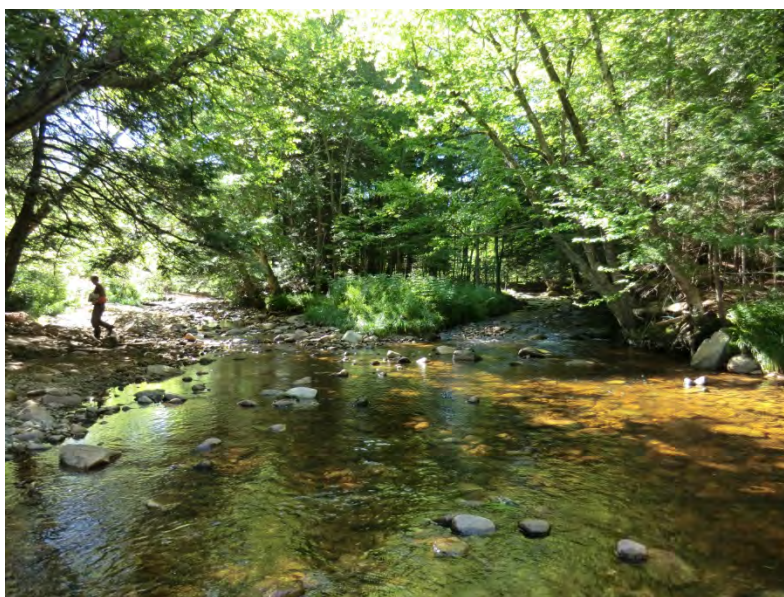
This segment begins just upstream of Hunker Road and continues to just below the stream crossing at Lightfoot Camp Road. T11.08-A is characterized by the presence of an *alluvial fan*, which exists due to a decrease in channel slope and increase in valley width. The river is *braided* throughout this segment, and several different threads of the channel exist even under low flow conditions. Nine channel avulsions were noted during assessment, as were numerous flood chutes. The braided nature of this segment was likely exacerbated during TSI. It appears that a major aggradation and a large debris jam formed during the flood, causing the river to abandon its channel and cut several new ones in the floodplain. Bank erosion abounds in the new channels formed due to the braiding. Riparian buffers are impacted mostly as a result of agricultural activities in the northern side of the river corridor. The channel has incised in this segment, but floodplain access remains intact. Because of the major aggradation and changes in channel planform that have occurred in T11.08-A, the segment is in **poor** geomorphic condition. The formation of multiple channels has created bed features that provide habitat for aquatic biota. LWD is common in this segment, providing increased cover for these organisms. Due to these factors, T11.08-A is in **good** habitat condition.

**Figure 5.17.** Braiding is common in T11.08-A due to the presence of an alluvial fan.

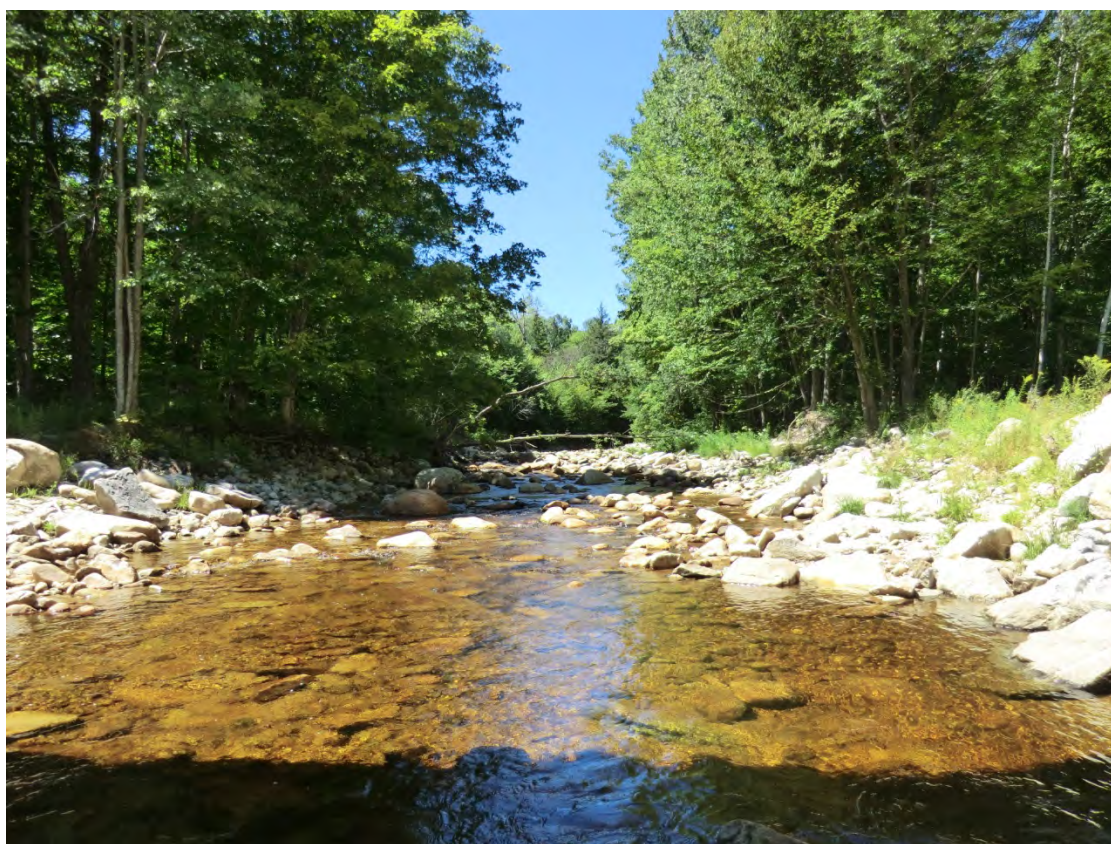
This segment begins just below the Lightfoot Camp Road stream crossing and continues upstream to past the cul-de-sac on Kendall Farm Road. T11.08-B flows through a very broad valley by reference that has been altered to a narrow valley due to the presence of Kendall Farm Road. The segment is characterized by a riffle-pool bedform and extensive historic and recent channel berming and windrowing. The placement of Kendall Farm Road and aforementioned berms led to historic channel incision and a stream type departure. The channel is widening and changing planform as evidenced by bank erosion and multiple flood chutes. There is a wetland across the road from the river that was likely historically accessed by the stream, but the road now impedes this access. Due to historic incision and current lateral adjustments, T11.08-B is in in **fair** geomorphic condition. Despite this, there is good instream cover and refuge for organisms, placing the segment in **good** habitat condition.

**Figure 5.18.** T11.08-B historically incised, forming a “B” channel with limited floodplain access.

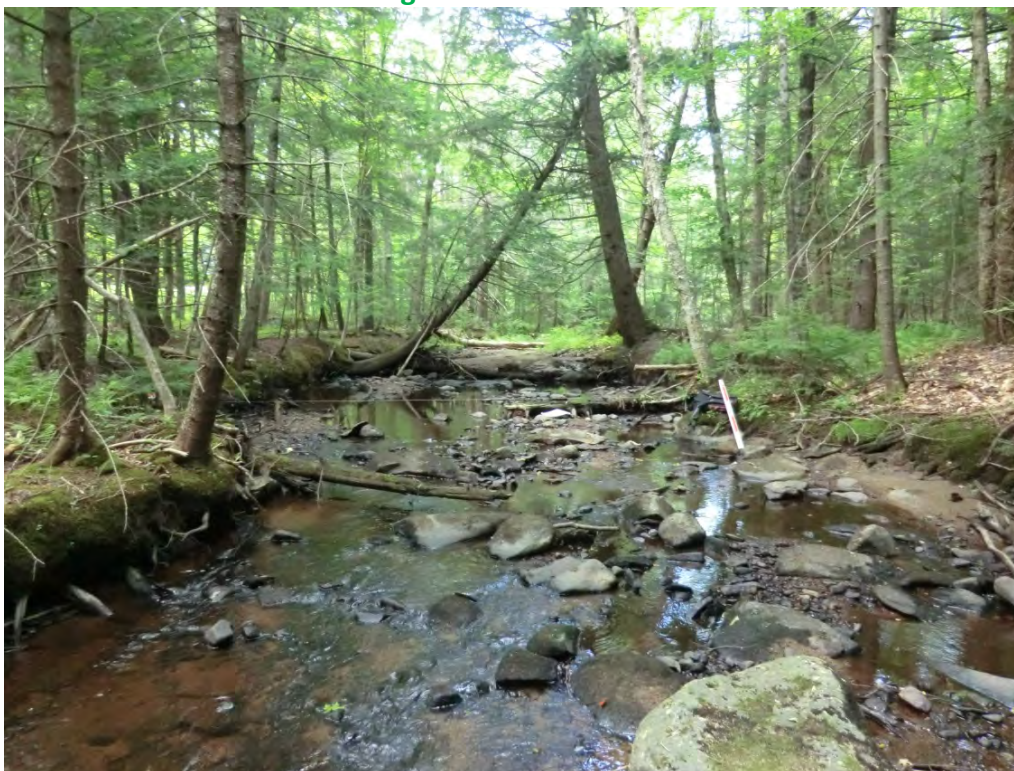
This segment begins about 1,800 feet upstream of the River Road stream crossing and ends just below the upstream-most crossing at Raspberry Hill Road. Directly upstream of this reach is an on-stream pond at Strattonwald Recreation Club. Despite the presence of the pond, severe incision was not observed in T11.S3.01-B. Typically, an on-stream pond disrupts sediment transport regimes, and the section of river downstream of it can become sediment starved. This is not the case for T11.S3.01-B. Aggradation is major in this segment, and the source of which is unknown. There are abundant bars in this segment, which could have formed during TSI. Also, numerous debris jams are present, which have formed flood chutes and channel avulsions. These were also likely formed during Irene. Erosion is present on both banks in T11.S3.01-B. The downstream-most Raspberry Hill Road crossing is undersized and causing significant aggradation above and scour below the structure. Overall, the segment is in **fair** geomorphic condition due to channel aggradation, planform adjustment, and slight historic incision. Debris jams provide LWD to the stream for aquatic organism cover, as do undercut banks and plunge pools. These and other features create **good** habitat conditions in T11.S3.01-B.

**Figure 5.20.** T11.S3.01-B has good floodplain access and good cover for aquatic biota.

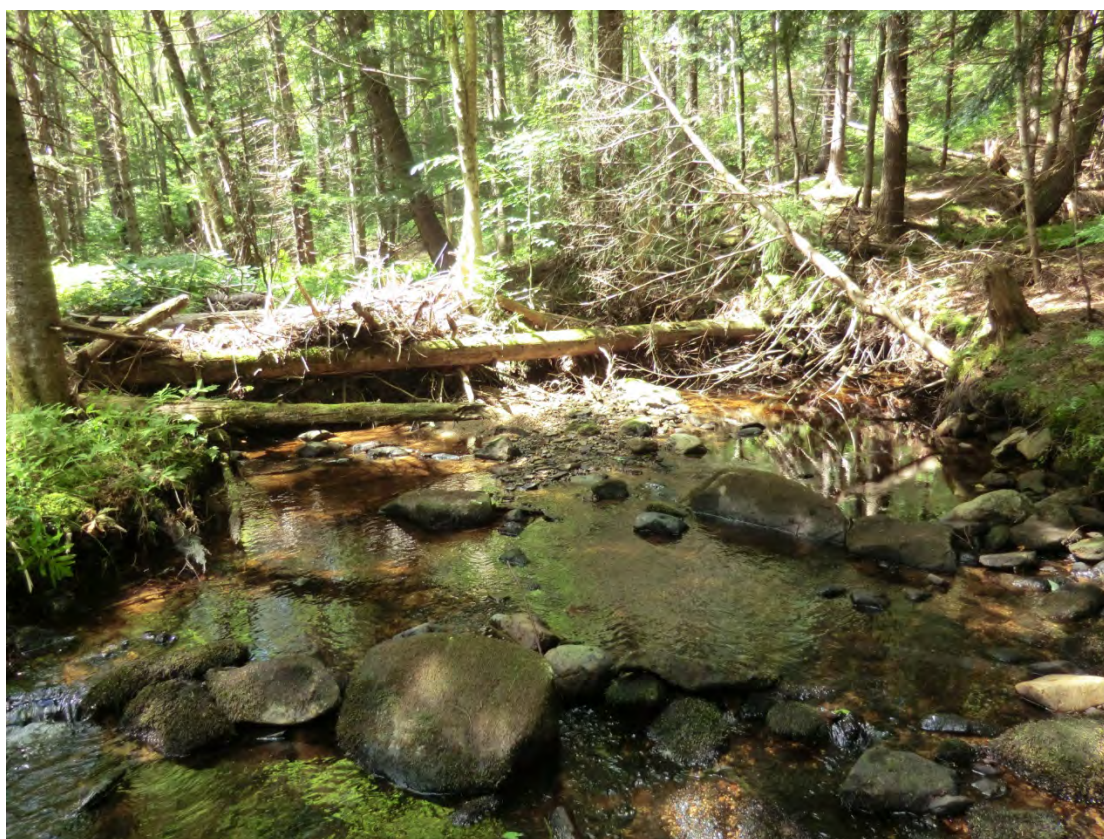
This segment is located above the on-stream pond at Strattonwald Recreation Club and ends approximately 1,100 feet below the Winhall Hollow Road crossing. T11.S3.01-D is characterized by good floodplain access and well forested buffers. This segment flows through the woods, but development encroaches on the river corridor in a few locations. This development also impacts the riparian buffers in areas and contributes stormwater to the stream via gullies. Frequent debris jams have caused channel avulsions and created flood chutes. Where avulsions and flood chutes are not present, the stream channel appears to be very stable and has mossy cobbles and boulders on the bed. There is very little bank erosion present in this segment. T11.S3.01-D is in **good** geomorphic condition due to its lack of incision and erosion and overall channel stability. The segment is also in **good** habitat condition due to abundant LWD, plunge pools, and well vegetated banks and buffers.

**Figure 5.23.** Debris jams are common in T11.S3.01-D and are causing planform adjustment.

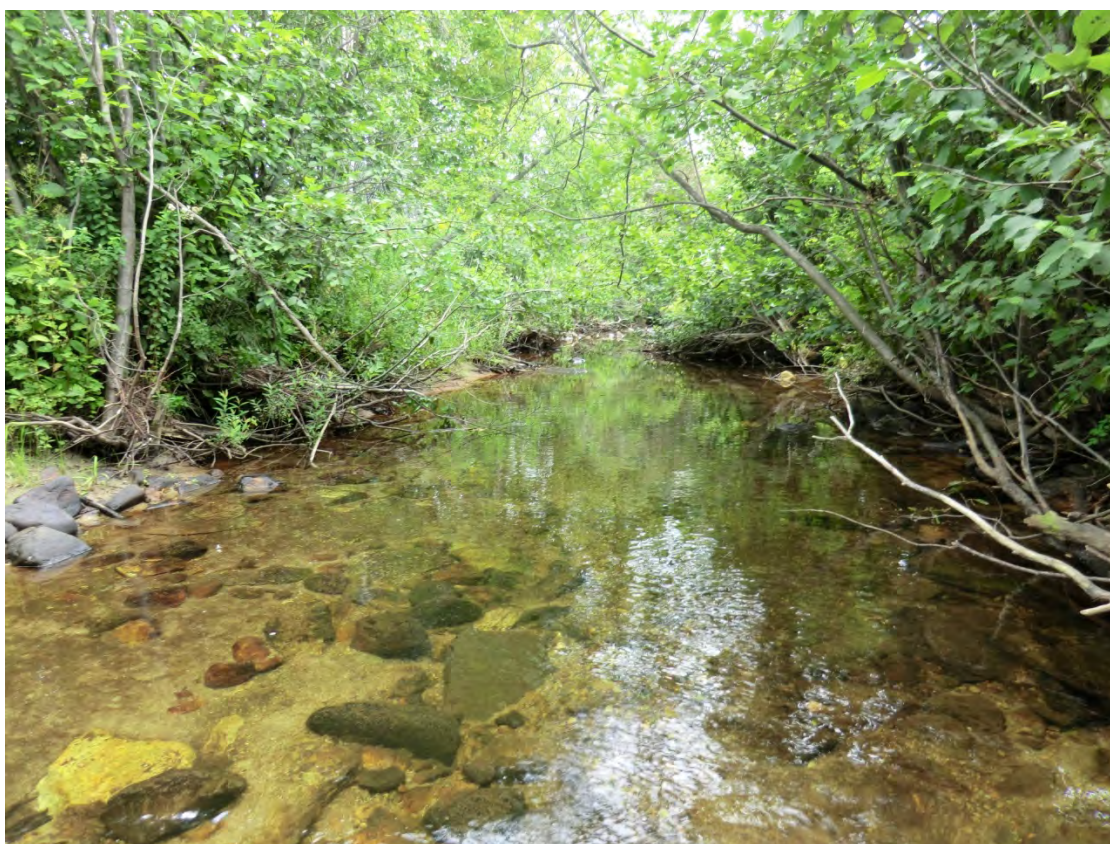
This segment begins just above the confluence with the Winhall River and continues upstream to just below the VT Rt. 30 stream crossing. It was not fully assessed due to limited property access on the north side of the stream. Administrative judgment was used to determine reference and existing stream type, bed material, and bedform. Overall, the segment was placed in fair geomorphic condition based on extensive straightening and stream conditions observed from the segment break.

**Figure 5.25.** T11.S4.01-A has a reference riffle-pool bedform but has likely been converted to plane bed due to channel straightening.

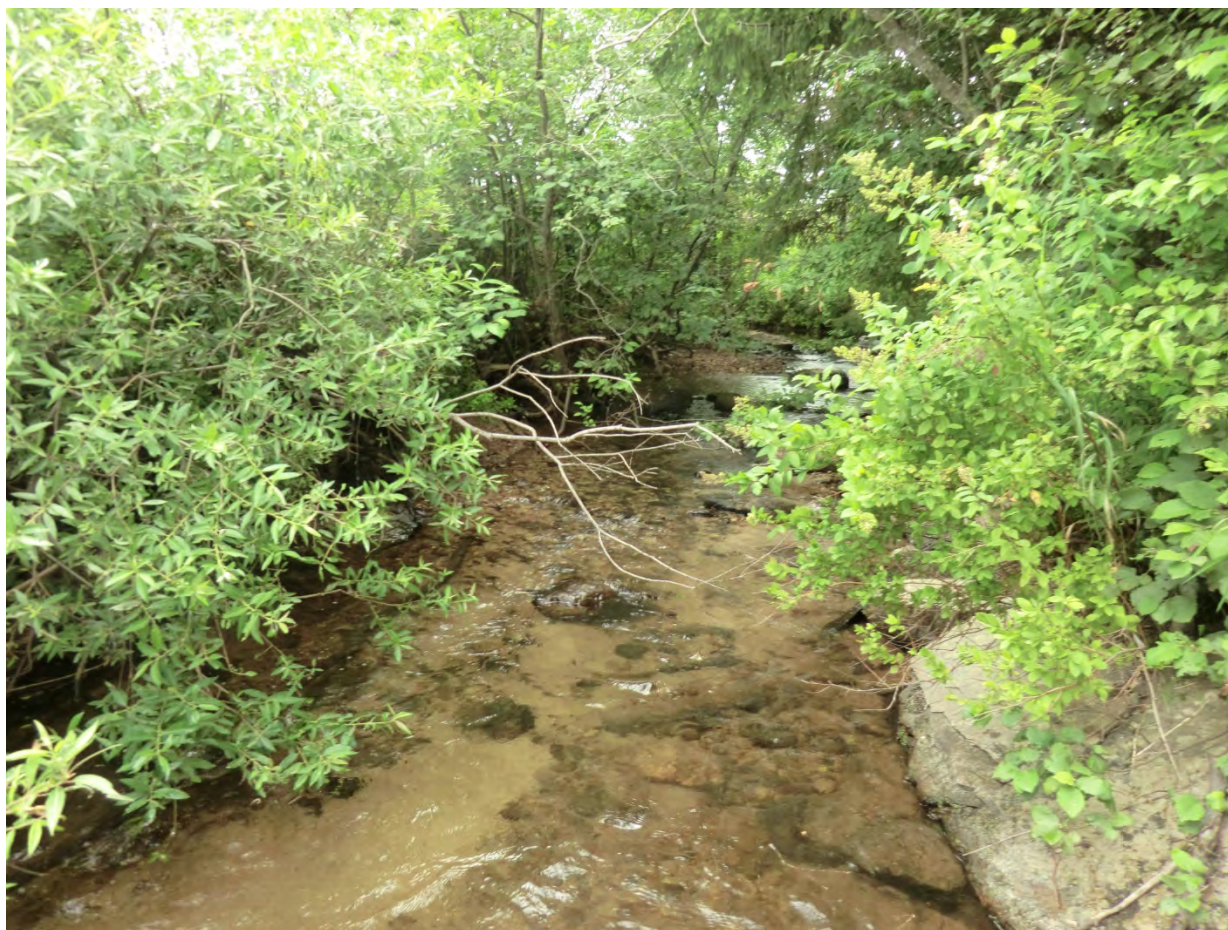
**Figure 5.27.** T11.S4.01-C was not assessed due to limited property access.

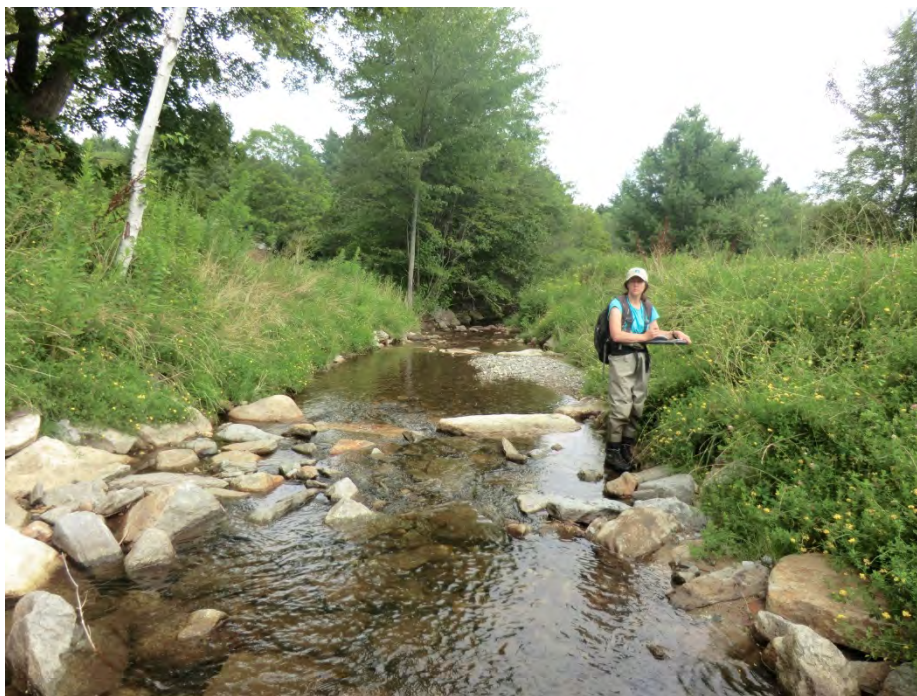
This segment begins just downstream of Goslings Way and ends approximately 500 feet above the Rt. 30 stream crossing. The majority of T11.S4.02-A was historically straightened along Rt. 30, which likely caused extreme historic channel degradation and a stream type departure. Extensive bank revetments are limiting channel widening, though they have been undermined in some areas. Widening has occurred in locations that are not riprapped, as has aggradation and planform adjustment via flood chutes. Development and Rt. 30 encroach upon the river corridor for the majority of T11.S4.02-A. Erosion is frequent along both banks. Tributary 4 has lost its riffle-pool bedform, which has been converted to plane bed. Overall, the segment is in **poor** geomorphic condition due to all of these factors. T11.S4.02-A is in **fair** habitat condition due to its lack of bed features, woody debris, bank and buffer vegetation, and overall cover for aquatic organisms.

**Figure 5.28.** A riffle-pool bedform has been converted to featureless plane bed in T11.S4.02-A.

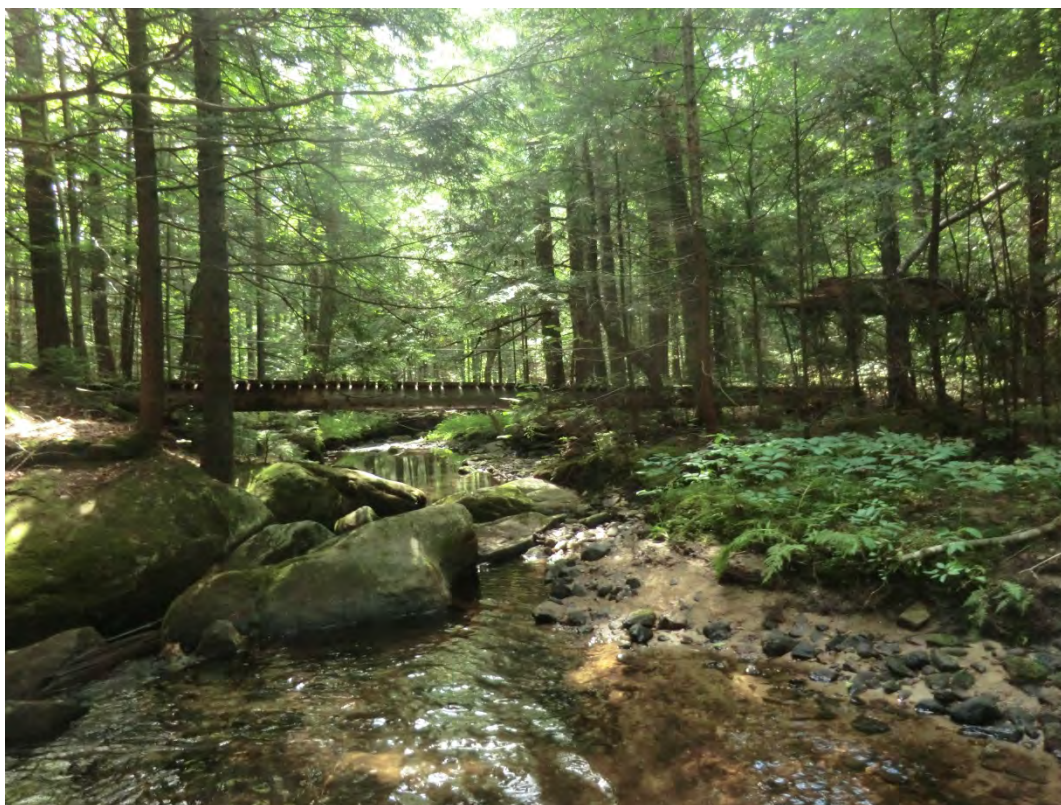
This segment begins approximately 500 feet upstream of the Rt. 30 culvert and continues upstream to where the stream begins flowing directly south and farther away from the road. T11.S4.02-B is not impacted by Rt. 30 as a corridor encroachment as the downstream reaches are. Development is minimal within the corridor, as is channel straightening, and adjacent wetlands abound. Erosion is common, though not extensive, on both banks and there is one mass failure present in this segment. The channel does not appear to be incised; however, aggradation and planform adjustment are occurring. A large amount of fine sediments was noted in this segment, the source of which could be eroding banks and logging activities. There is moss on the stream banks and in the channel in areas, indicating a stable channel. Despite this, the segment is in **fair** geomorphic condition due to the planform changes and aggradation that is occurring. Habitat conditions in T11.S4.02-B are **good** as a result of abundant LWD and cover for aquatic biota and well forested banks and buffers.

**Figure 5.29.** A variety of bed features and forested buffers create good habitat conditions in T11.S4.02-B.

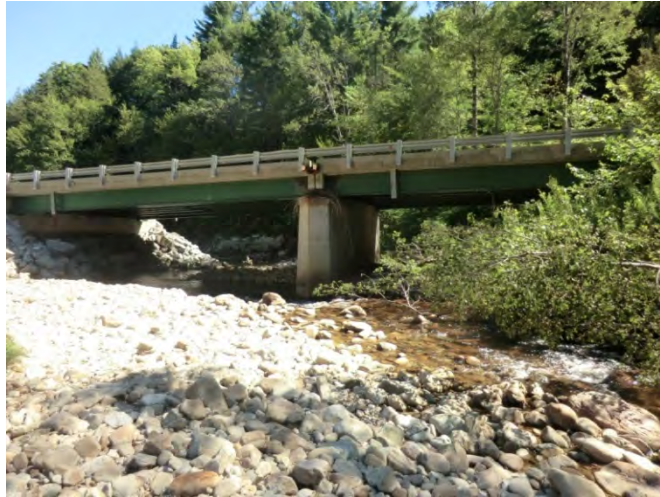
**Figure 5.30.** Rt. 30 bridge with aggradation and alignment problems in T11.04.

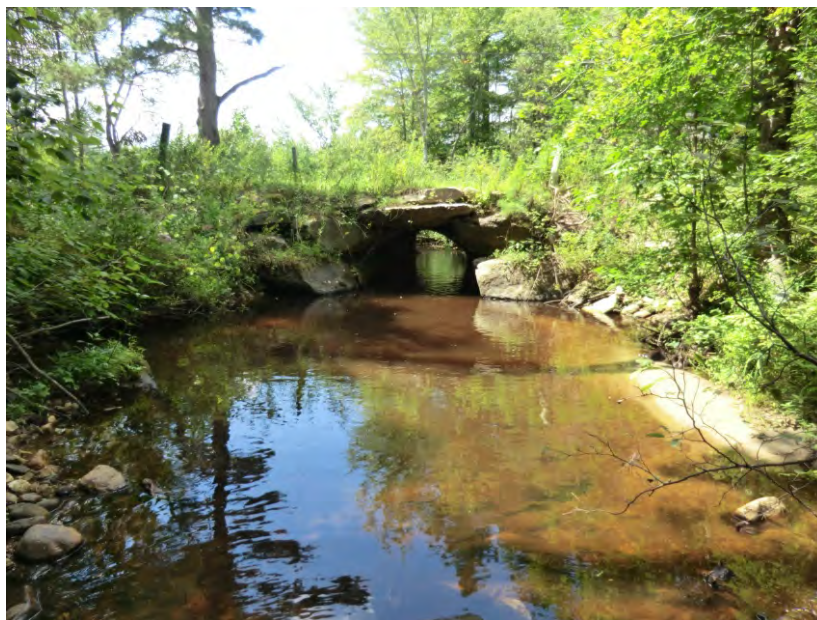
**Figure 5.33.** A culvert under River Road in T11.S3.01-A is very undersized.

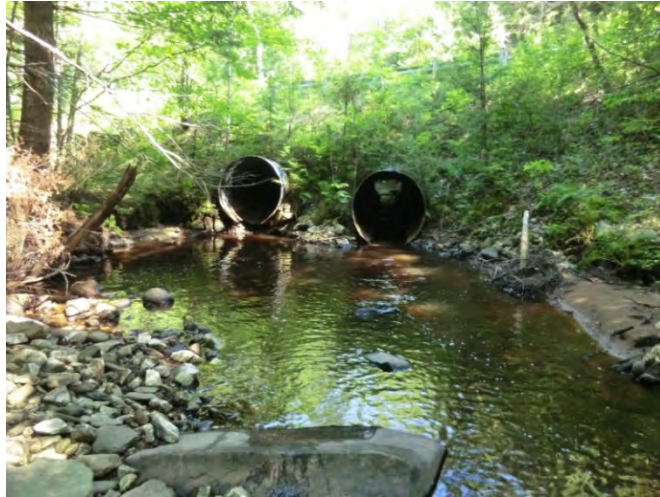
**Figure 5.34.** One culvert captures all baseflow and the other is rusting out at Raspberry Hill in T11.S3.01-B.

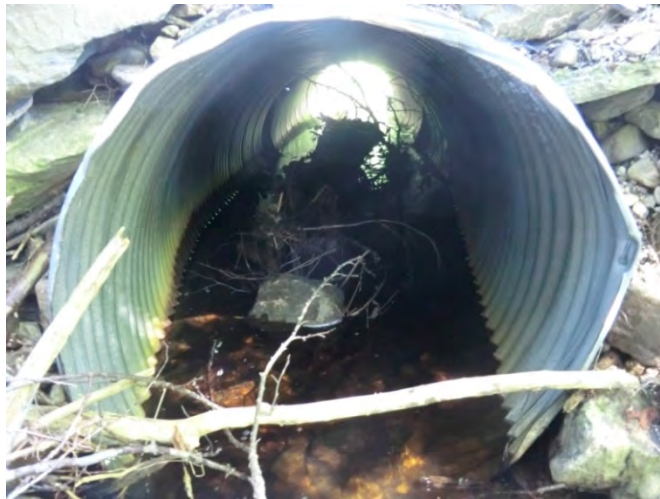
**Figure 5.35.** The culvert on Red Brook under Cranberry Hill Rd is full of woody debris.

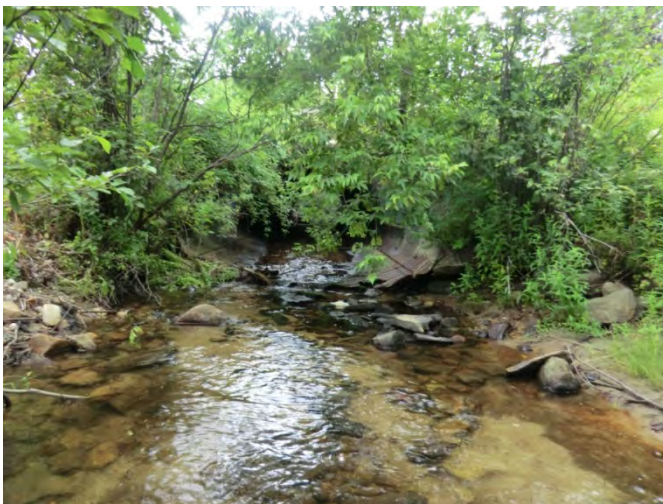
**Figure 5.37.** The bottom of the culvert under Rt. 30 in T11.S4.01-B is rusting out.

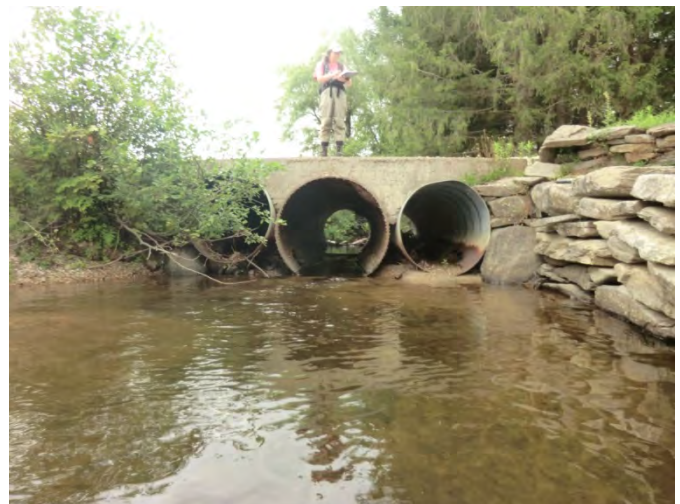
**Figure 5.38.** One of three culverts under Stratton View Rd in T11.S4.01-B is rusted out.

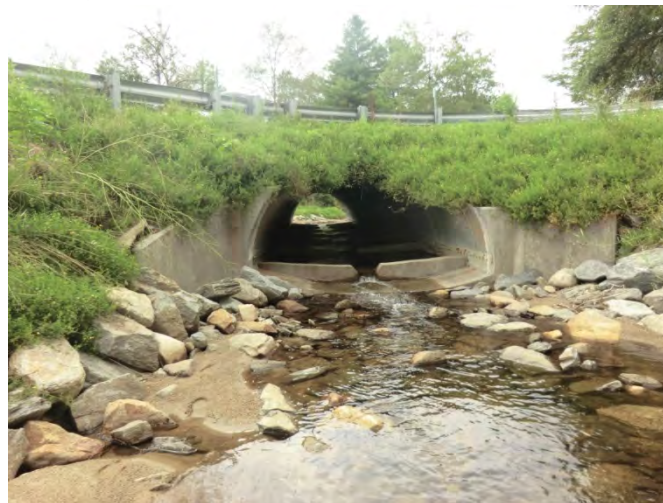
Lastly, a culvert under Rt. 30 in segment T11.S4.02-A has been recommended for replacement with a low priority (Figure 5.39). The culvert is undersized, but is in good condition. Baffles are present throughout the structure and there is a drop of 0.4 feet at the outlet. The structure's alignment with the channel is poor. Deposition is present above the structure and scour below.

**Figure 5.39.** The culvert under Rt. 30 has a small drop at the outlet and baffles throughout.
