# Wardsboro Brook Watershed Corridor Plan

Wardsboro & Jamaica, Vermont  
October 27, 2014

Prepared by:  
Bear Creek Environmental, LLC  
149 State Street, Suite 3  
Montpelier, Vermont 05602

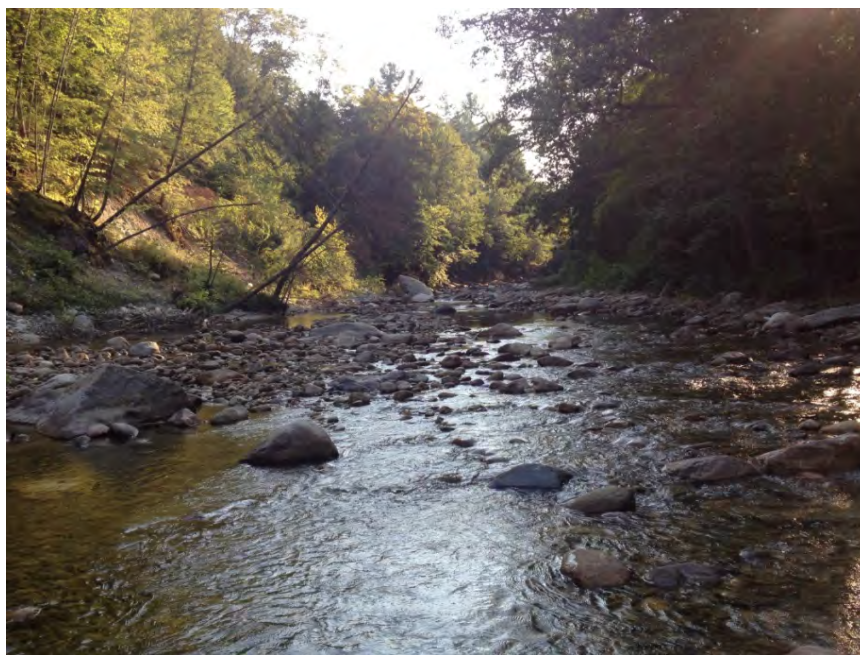
This segment begins at the confluence with the West River and continues approximately 900 feet upstream until the valley narrows. This segment is an *alluvial fan*, where the channel slope drops and the valley opens up as Wardsboro Brook meets the West River. Floodplain access is limited throughout the segment and bedform has been lost. A riffle-pool channel by reference has been converted to featureless plane-bed channel in this segment, as seen in Figure 5.4. This segment is in **fair** geomorphic condition, with major historic degradation, major recent widening, and significant bar formation. The segment is also in **fair** habitat condition due to lack of diverse habitat features and floodplain access, as well as impacted buffers. There is one stream crossing in this segment (Eaton Road), but it is not a channel constriction.

Figure 5.4. Lack of riffle-pool bedform and habitat features in T8.01A.

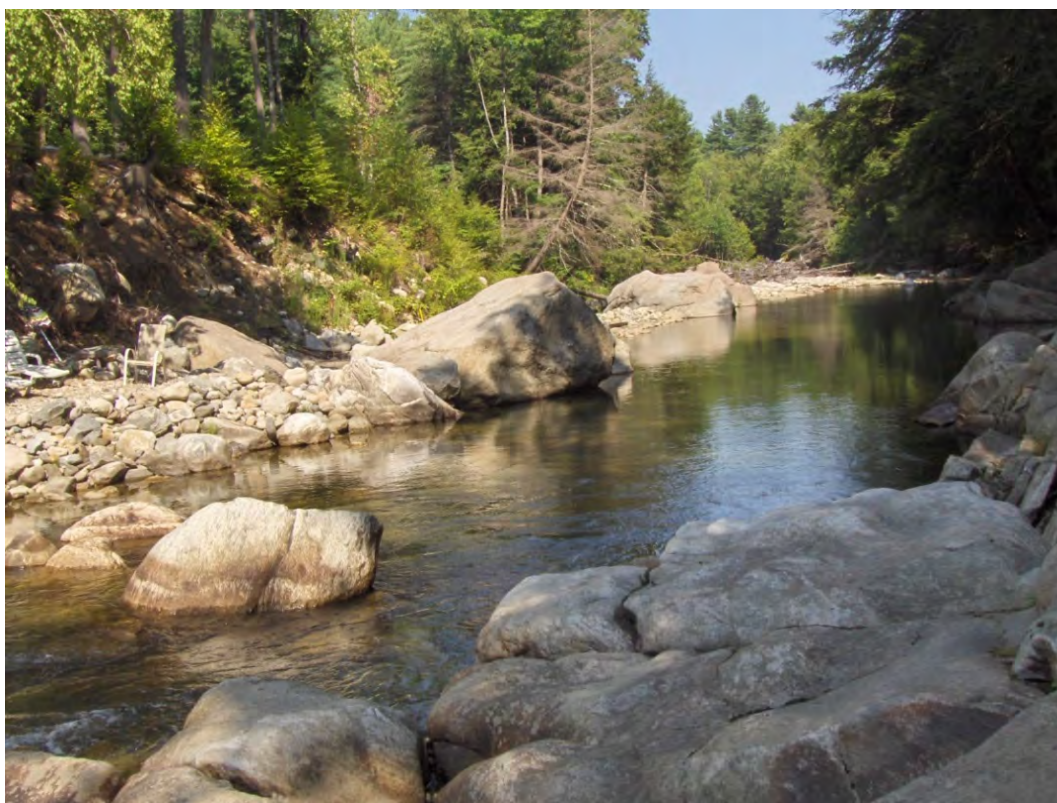
This segment begins where the valley becomes more confined and continues upstream for a half mile until the valley opens up again. It is characterized by a semi-confined valley and a step-pool bed form. At the upstream end of the segment, the brook was straightened along Old Route 8, which led to a loss of bedform and conversion to a plane bed channel in this area. Overall, this segment retains a variety of habitat features, including large pools, refuge areas, undercut banks, and forested buffers. However, erosion and mass failures are common throughout the segment, and are contributing sediment to the brook. This segment is in stage F-IV of the evolution process, and is building a juvenile floodplain through large bar formation. This aggradation and change in channel planform places the segment in **fair** geomorphic condition. This segment is in **good** habitat condition due to its step-pool bedform, refuge areas, undercut banks, and riparian buffers, some of which are shown in Figure 5.5.

**Figure 5.5.** Good habitat features characteristic of segment.

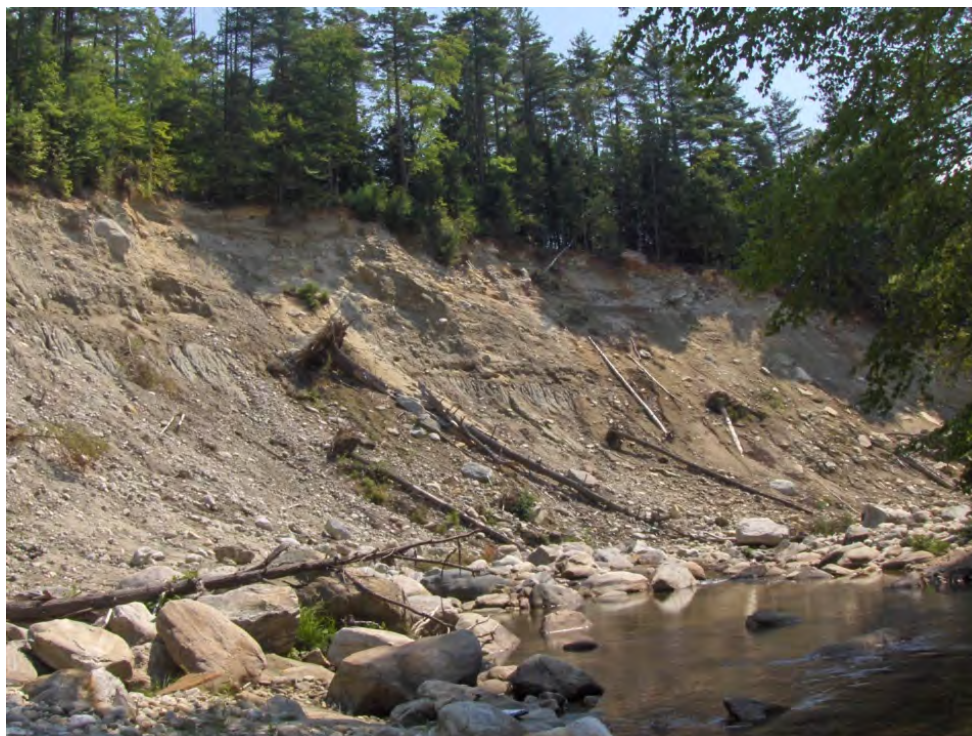
Windrowing and dredging are present in this segment, particularly in areas where the brook is close to the road. Due to these channel alterations, corridor encroachments, and loss of riparian buffer, this segment was placed in **fair** habitat condition. The channel has undergone extreme widening, and is in active planform adjustment, as evidenced by continuous erosion, mass failures, and large flood chutes behind very large bars. Due to these factors, this segment is in **poor** geomorphic condition. An example of the frequent mass failures present in this segment is shown in Figure 5.6.

**Figure 5.6.** One of many mass failures present in this segment.

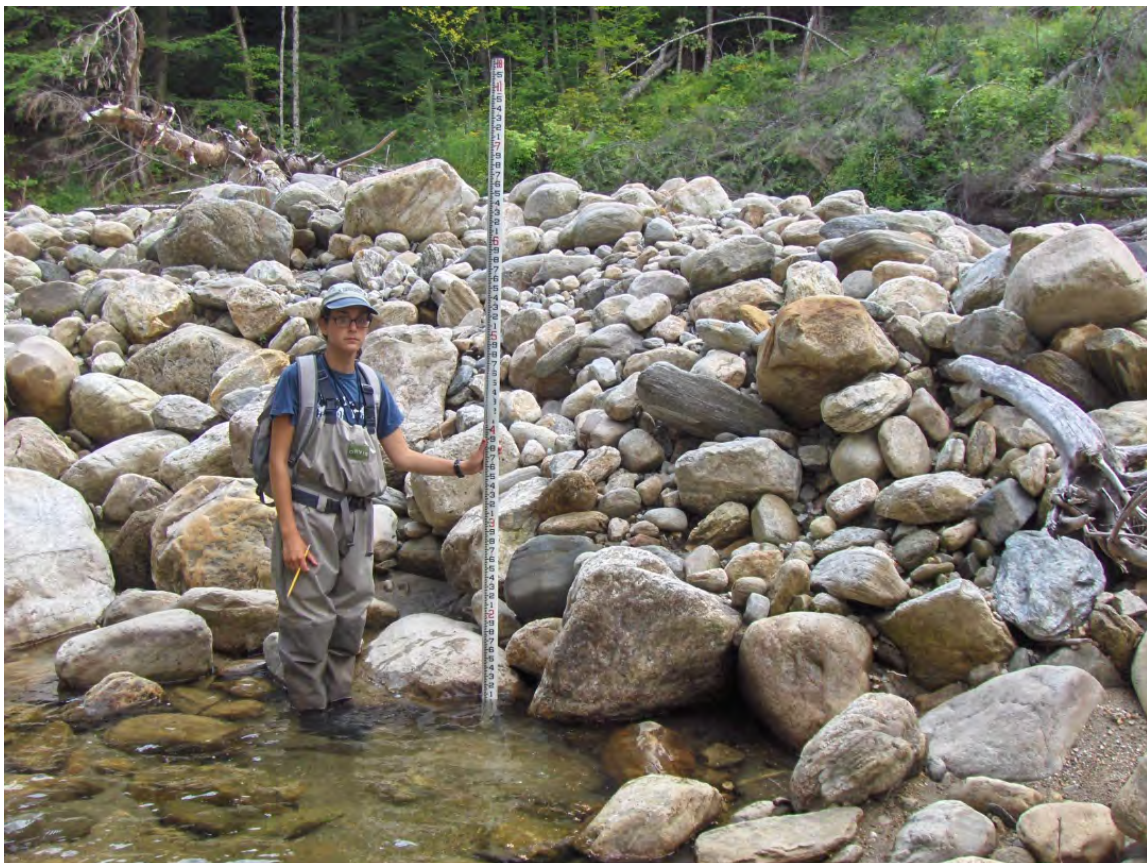
This segment begins where the valley becomes more confined and continues upstream for 1,900 feet to the reach break. The river valley in T8.01-D is semi-confined and the stream channel has undergone major historic and recent degradation. Over half of the reach was straightened along Rt. 100 during its construction. There are two active headcuts present within the segment, as well as some bank armoring and erosion. The brook is currently building a juvenile floodplain as evidenced by very large bars throughout the segment. Planform change is minor in the segment at this time, placing it in **fair** geomorphic condition. T8.01-D is also in **fair** habitat condition due to a lack of large woody debris (LWD) and poor buffers.

**Figure 5.7.** Very large bars are forming a juvenile floodplain in T8.01-D.

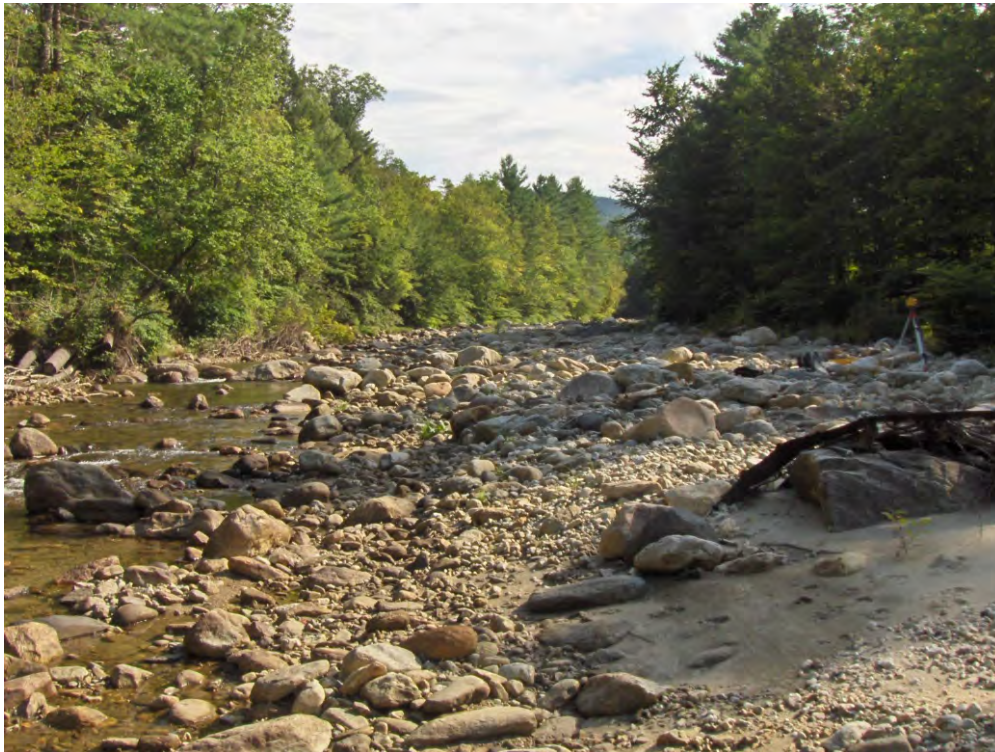
The most downstream segment in T8.02 begins immediately downstream of the Rt. 100 bridge near Pot Luck Lane and continues upstream for almost 2,000 feet to where the stream channel becomes more entrenched. This segment has extensive straightening with windrowing along Rt. 100. The channel historically incised due to the road encroachment. Despite this straightening and channel excavation, the channel has widened significantly and is undergoing major aggradation. This aggradation is developing into a juvenile floodplain. Due to these major and extreme geomorphic processes that are occurring in T8.02-A, the segment is in **poor** geomorphic condition. The segment lacks large woody debris, refuge areas, and undisturbed riparian buffers, placing it in **fair** habitat condition.

**Figure 5.8.** Large bar characteristic of T8.02-A.

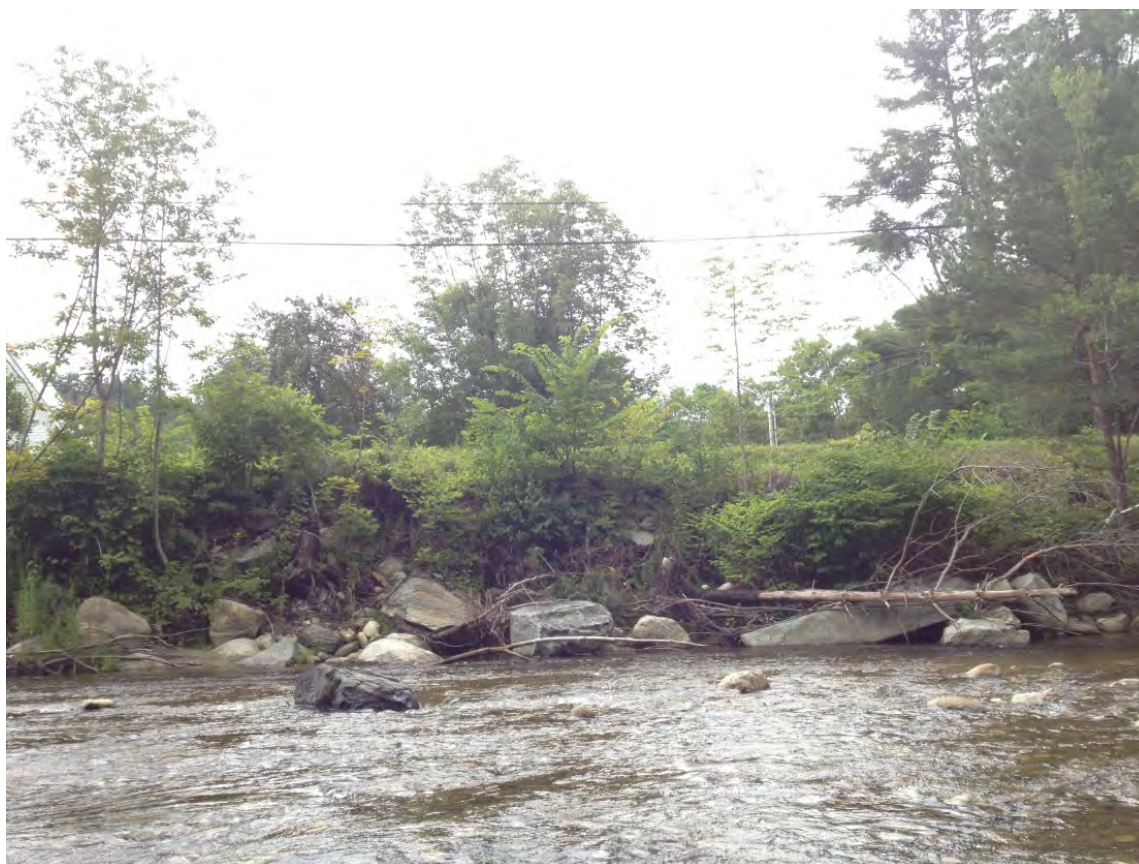
This segment begins just downstream of the intersection of Rt. 100 with Peters Road and ends just upstream of the South Wardsboro Road stream crossing. The valley is broad and has been altered due to the presence of Rt. 100. The segment overall has a riffle-pool bedform, but plane bed is sub dominant where the stream has been straightened along the road. Rip rap is common along the north bank on Rt. 100 road embankments. Historic incision has resulted in a loss of floodplain and a stream type departure. One potential active headcut is present in the segment, and the stream may continue to incise. The stream channel is actively widening. Due to these factors, segment T8.02-B is in **poor** geomorphic condition. Because of the loss of bedform within straightened sections of the segment and the majorly impacted riparian buffer, the segment is in **fair** habitat condition.

**Figure 5.9.** Impacted buffer where segment T8.02-B has been straightened along Rt. 100.

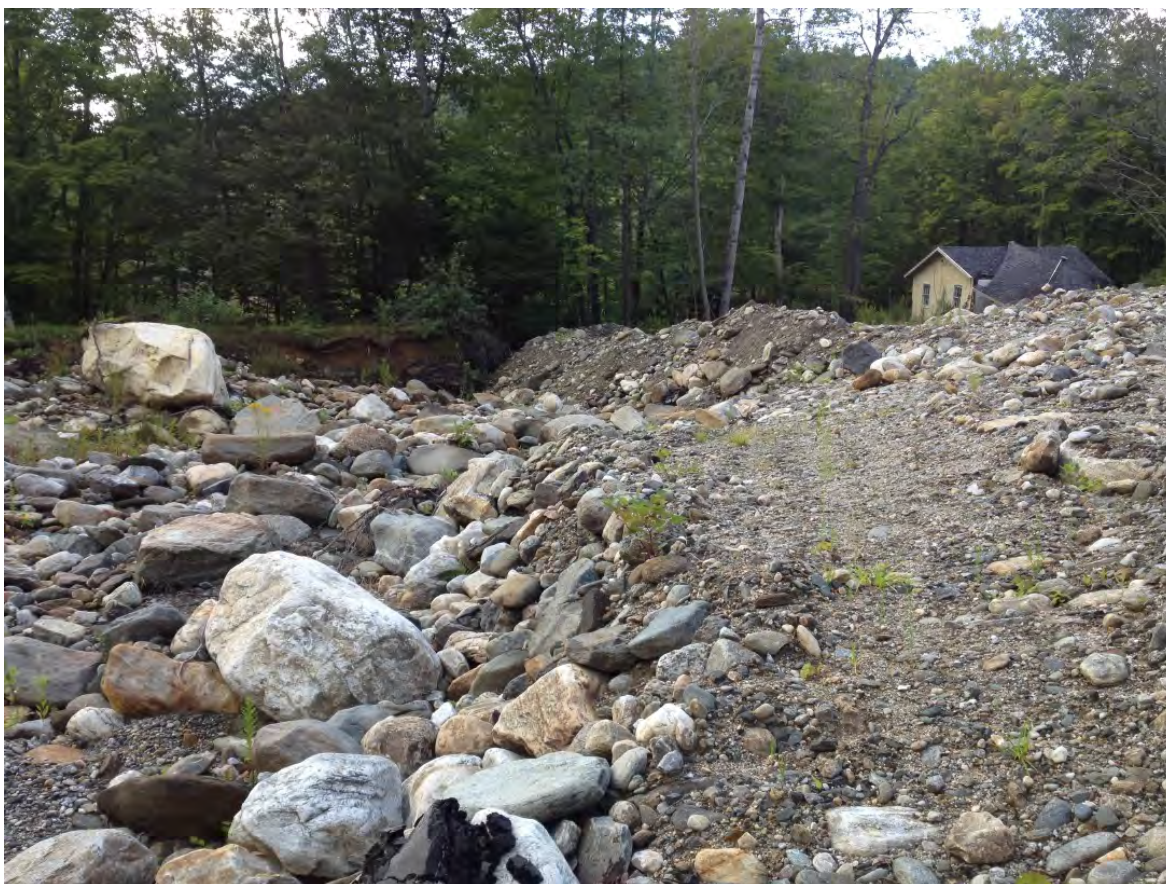
This segment begins just upstream of the South Wardsboro Road bridge where the valley walls open and continues upstream to Mitch Avenue. In this segment, the valley is broad, but a stream type departure has occurred, creating a plane bed channel with limited floodplain access. The entire segment has been straightened and windrowed, and revetments and Japanese knotweed are abundant. The riparian buffers are impacted throughout the segment. Due to all of the aforementioned factors, this segment is in **fair** habitat condition. Historic straightening along Rt. 100 has led to historic incision, and recent windrowing has furthered this channel degradation. The channel has widened toward the bottom of the segment and is beginning to form a juvenile floodplain. Overall, the segment is in **poor** geomorphic condition.

Figure 5.10. Location of three buyouts in T8.02-C

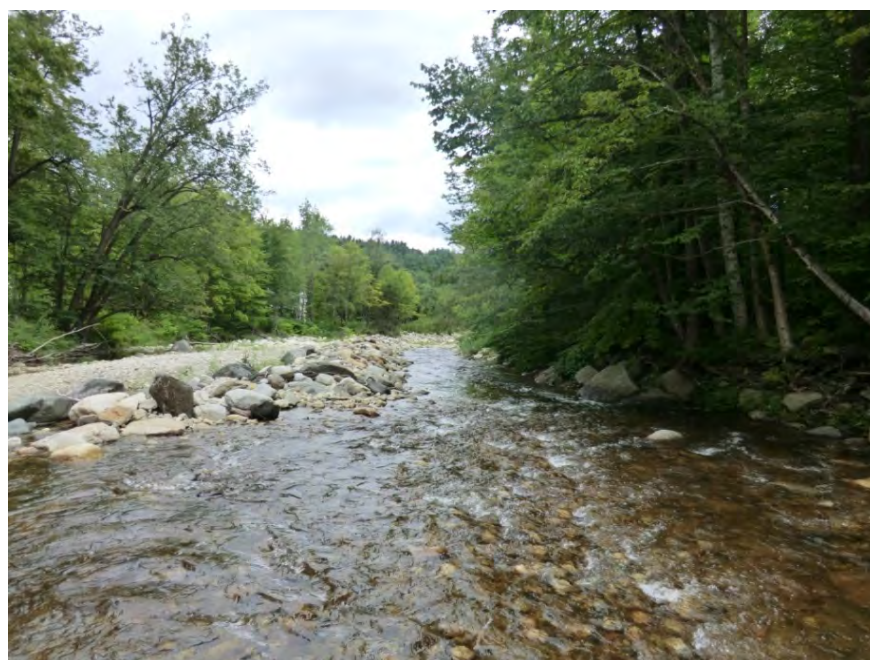
This reach was not split into any segments. T8.03 has a very broad valley by reference, however due to the encroachment of Rt. 100, the existing channel confinement is broad. T8.03 begins where Mitch Avenue enters the river corridor, and continues upstream approximately 9,200 feet where it ends between the Gilfeather Road and Lower Podunk Road stream crossings. Over 75% of this reach has been straightened and windrowed, creating a featureless, plane bed stream channel. Major historic incision led to a stream type departure, and current bed degradation is evidenced by the presence of a headcut in this reach. Massive bars are present, which are likely a result of aggradation that occurred during TSI. Large flood chutes and a channel avulsion were also formed during TSI as the brook underwent major planform adjustment. Erosion is common along the south bank and rip rap along the north. Two large mass failures are present along the south bank. Post-TSI flood work appears to have been aimed at repositioning the stream within its significantly widened channel. This reach is highly geomorphically unstable, resulting in its **poor** geomorphic condition. The reach also has very few features that create good aquatic habitat, so it has been placed in the **fair** category for habitat condition.

**Figure 5.11.** Post-TSI channel work to reposition flow in an over-widened channel.

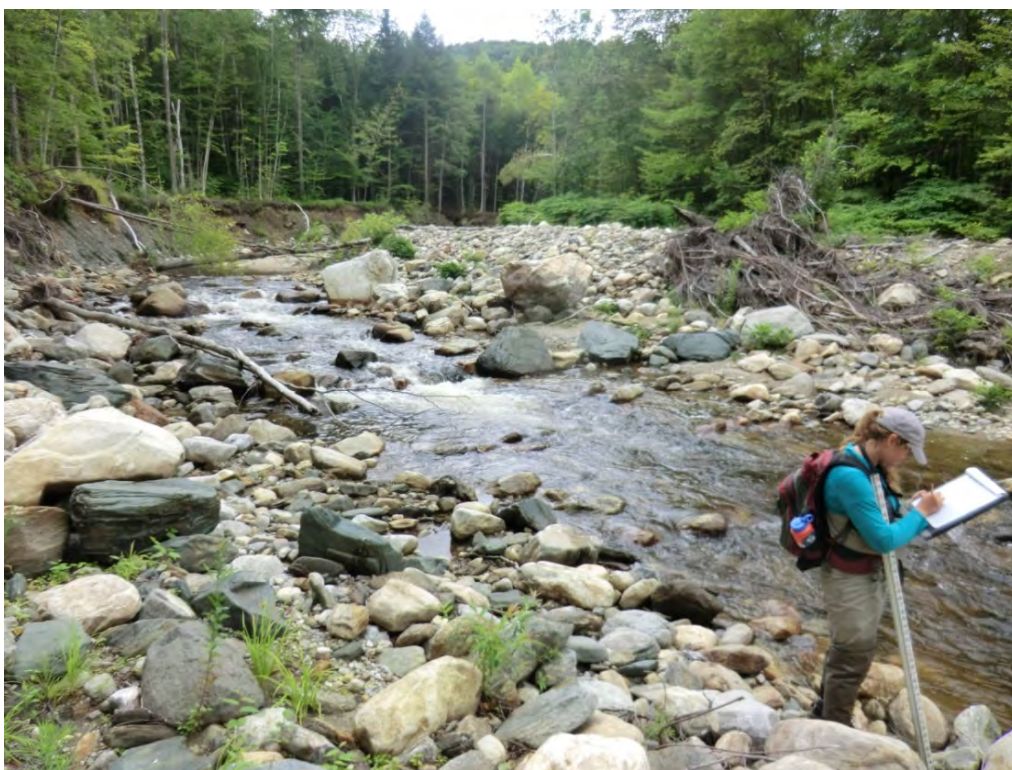
This reach was not split into any segments during assessment. T8.04 begins approximately 3,000 feet upstream of the Gilfeather Road stream crossing and continues just over one mile upstream to where Waite Brook enters Wardsboro Brook just above Lower Podunk Road. This reach has a very broad valley by reference, but Rt. 100 has caused a change in confinement to a narrow valley. The stream in this reach was historically straightened along the road and incised. Recent and historic channel straightening spans over half of the reach, of which a large portion was windrowed post-TSI. This has contributed to a loss of bedform and conversion from riffle-pool to plane bed. Rip rap is common along Rt. 100 on the north bank and erosion on the south bank. There are two headcuts in this reach and one channel avulsion that likely occurred during TSI. Due to the aggradation and planform adjustment that occurred during TSI and is continuing to occur, this reach is in **poor** geomorphic condition. The loss of bedform that has occurred in this reach has also created **fair** habitat conditions.

**Figure 5.12.** Channel avulsion with active headcut and erosion.

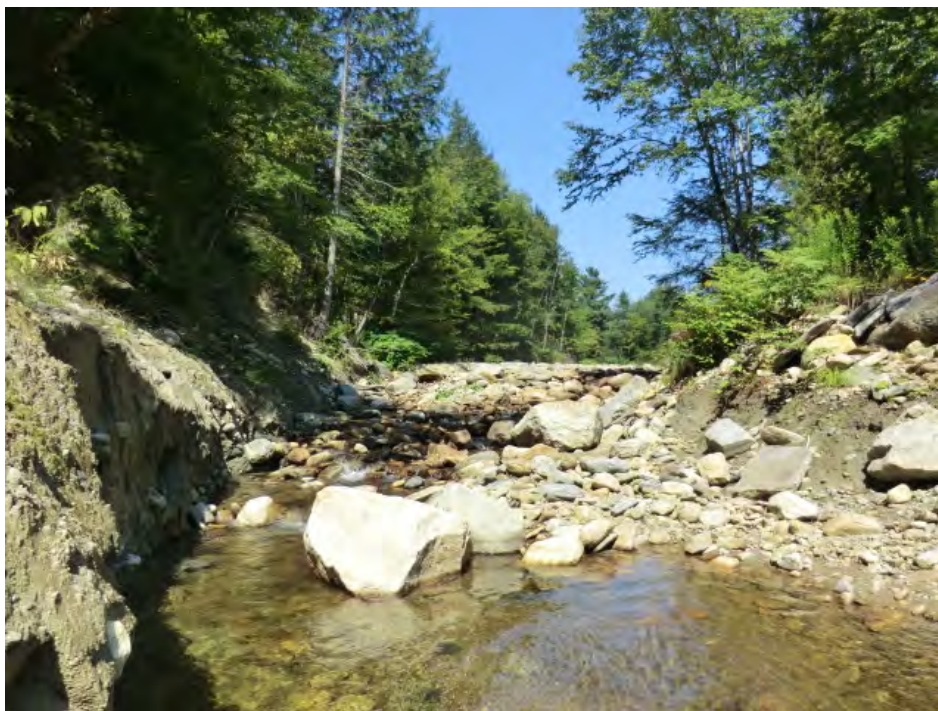
The downstream-most segment begins just upstream of the Lower Podunk Road stream crossing and continues upstream for almost 2,500 feet to where the stream is no longer straightened along Rt. 100. This segment is characterized by major historic and recent incision due partly to a large sediment plug immediately upstream, creating a sediment starved segment. A headcut is present at the top of this segment below the sediment plug. Bank erosion is abundant throughout T8-05A, which is causing many trees to fall into the stream, providing large woody debris. A small amount of windrowing occurred around a house in this segment, but overall, channel straightening has not been significant. There are no revetments present in this segment, but due to flood damage during Irene, it is in **poor** geomorphic condition. The segment is in **fair** habitat condition due to the instability of its banks and flood-damaged channel morphology.

**Figure 5.13.** Headcut below sediment plug and high stream banks in T8.05-A.

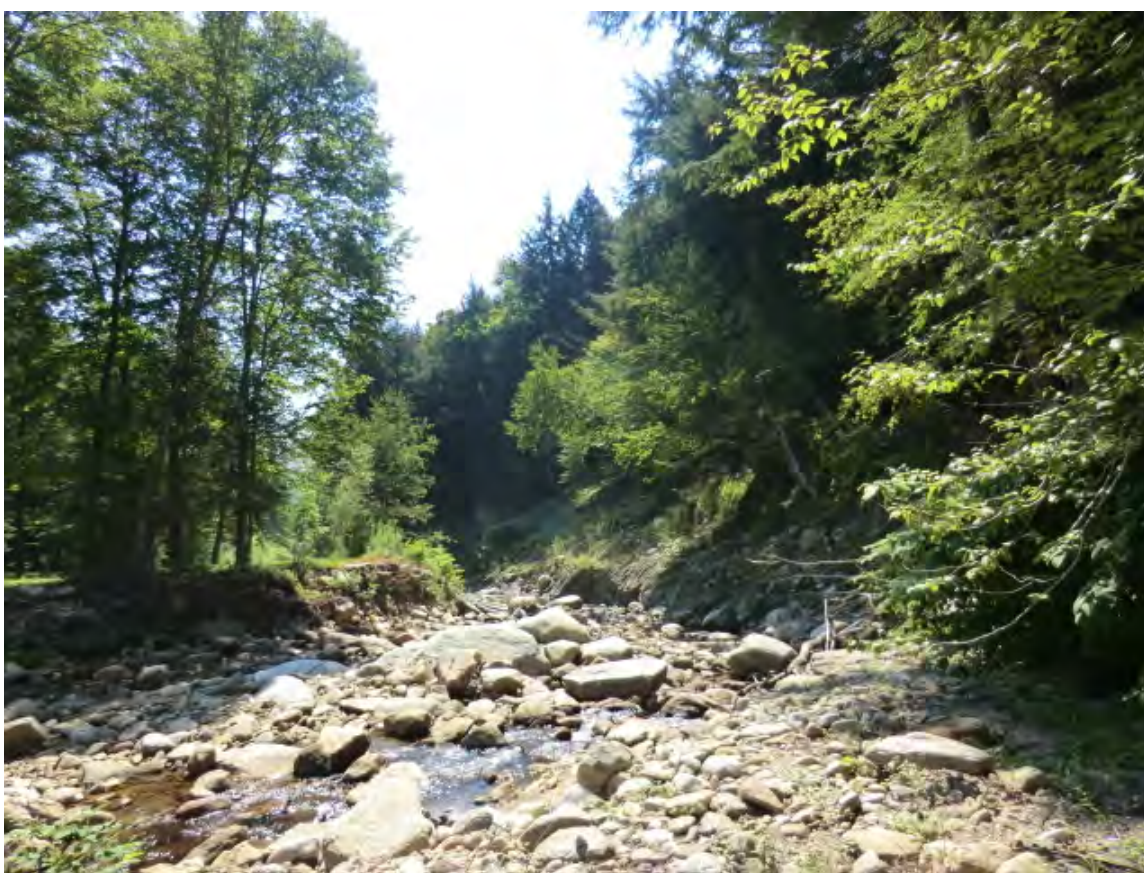
This segment continues upstream for 1,700 feet, meandering away from Rt. 100, and ends where the brook is straightened along the road again. This segment has lower banks than much of the brook and the channel can access its floodplain. It is highly depositional, with aggradation and planform change acting as the major processes in its evolution. The channel is slightly incised and has one avulsion. It is in **fair** geomorphic condition due to these factors, but it has room to adjust without corridor encroachment from Rt. 100. The upstream-most portion of the segment was altered during post-TSI channel work to divert flow away from a house on the north bank using windrowing. There is also a large sediment plug at the downstream end of the segment that is contributing to aggradation. T8.05-B is also in **fair** habitat condition due to its lack of such habitat features as LWD, deep pools, and refuge areas.

**Figure 5.14.** Major aggradation and floodplain access in T8.05-B.

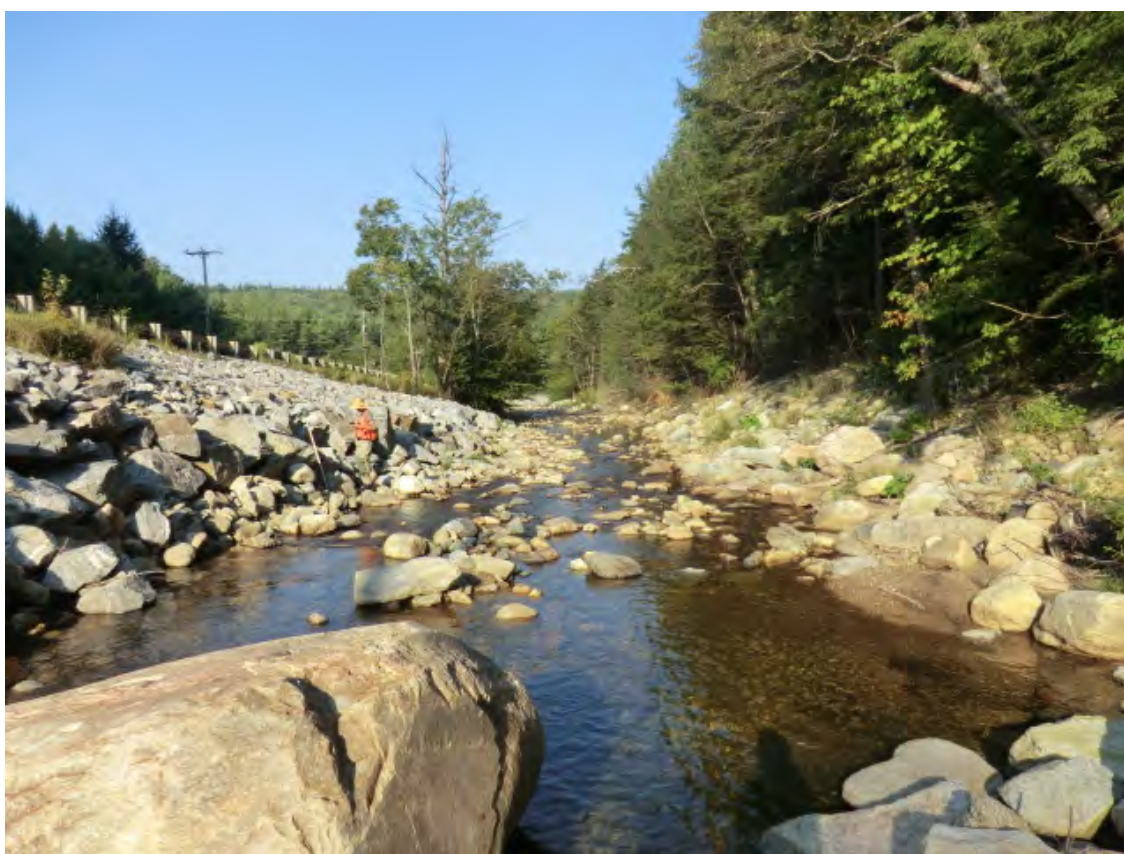
This segment begins where Rt. 100 encroaches upon the brook again and continues upstream for just over 3,200 feet to where Dover Brook enters Wardsboro Brook. T8.05-C is characterized by extensive channel straightening and bank armoring along Rt. 100, which has caused extreme historic incision. The channel has been recently windrowed in many places, activating further channel degradation. There is evidence that the channel widened slightly and adjusted laterally during TSI, however it is currently locked into place by extensive straightening and rip rap. Reference riffle-pool bedform has been lost and replaced with a featureless plane bed channel. Because of these factors, this segment is in **poor** geomorphic condition. Minimal buffers, coupled with a lack of diverse bed features, LWD, and refuge create **fair** habitat conditions in this segment.

**Figure 5.15.** A straight, featureless channel with poor buffers dominates in T8.05-C.

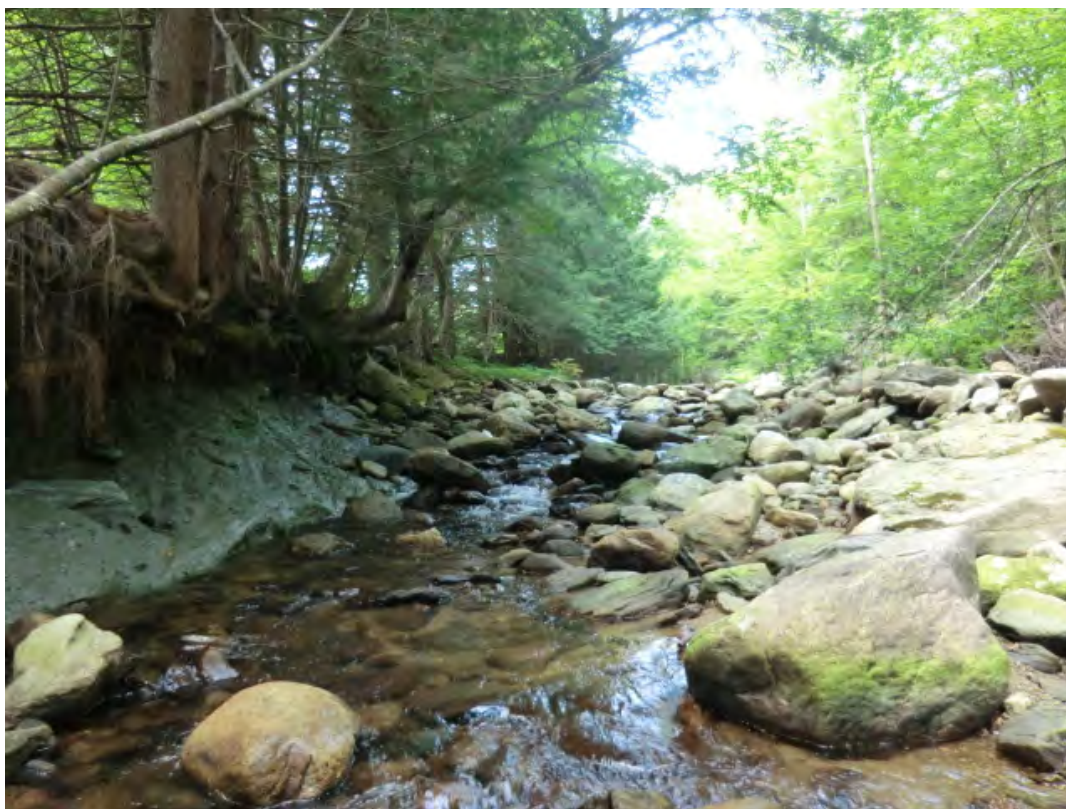
The most downstream segment in T8.06 begins just above the Rt. 100 crossing near Dover Brook and continues upstream for 2,200 feet until just below the Temple Road stream crossing. This segment is characterized by extreme historic and recent channel degradation, as evidenced by a high incision ratio and two active headcuts. This channel degradation has led to an overall loss of channel bedform and a conversion of a riffle-pool stream to plane bed. Rip rap and erosion are both minimal in the segment, and channel straightening is not present. Due to the channel degradation present in this segment, it is in **fair** geomorphic condition. This segment lacked LWD and refuge areas, also placing it in **fair** habitat condition.

**Figure 5.16.** One of two active headcuts in T8.06-A.

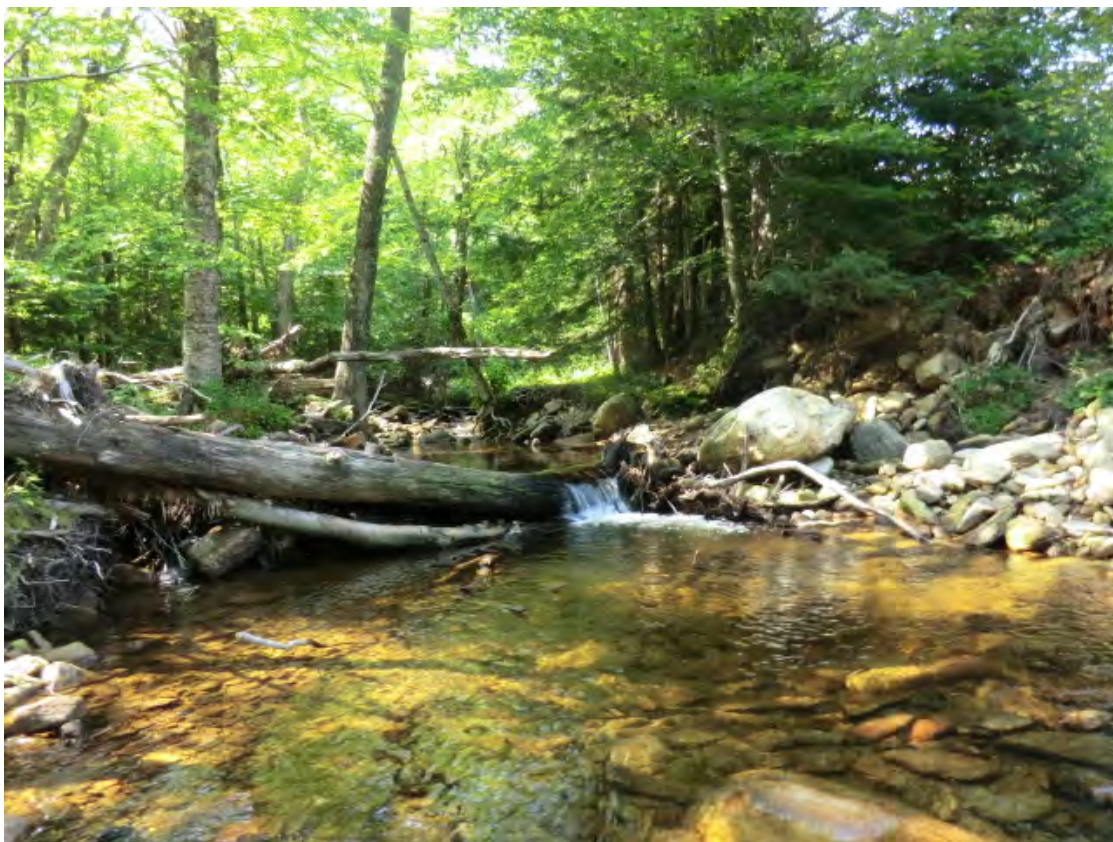
This segment begins just below the Temple Road stream crossing and continues upstream for 2,300 feet to where the brook becomes straightened along Stratton-Arlington Road. T8.06-B is characterized by good floodplain access and abundant depositional features. This segment appears to have undergone aggradation and major planform adjustment during TSI, as evidenced by multiple channel avulsions. Incision in this segment is minor, though one headcut is present. Straightening and post-TSI windrowing are minimal. Due to the planform adjustment that is occurring in this segment, it is in **fair** geomorphic condition. There are many debris jams creating plunge pools and avulsions, providing a diversity of habitat features. For this reason, the segment is in **good** habitat condition.

**Figure 5.17.** Debris jam creating plunge pool for good habitat conditions in T8.06-B.

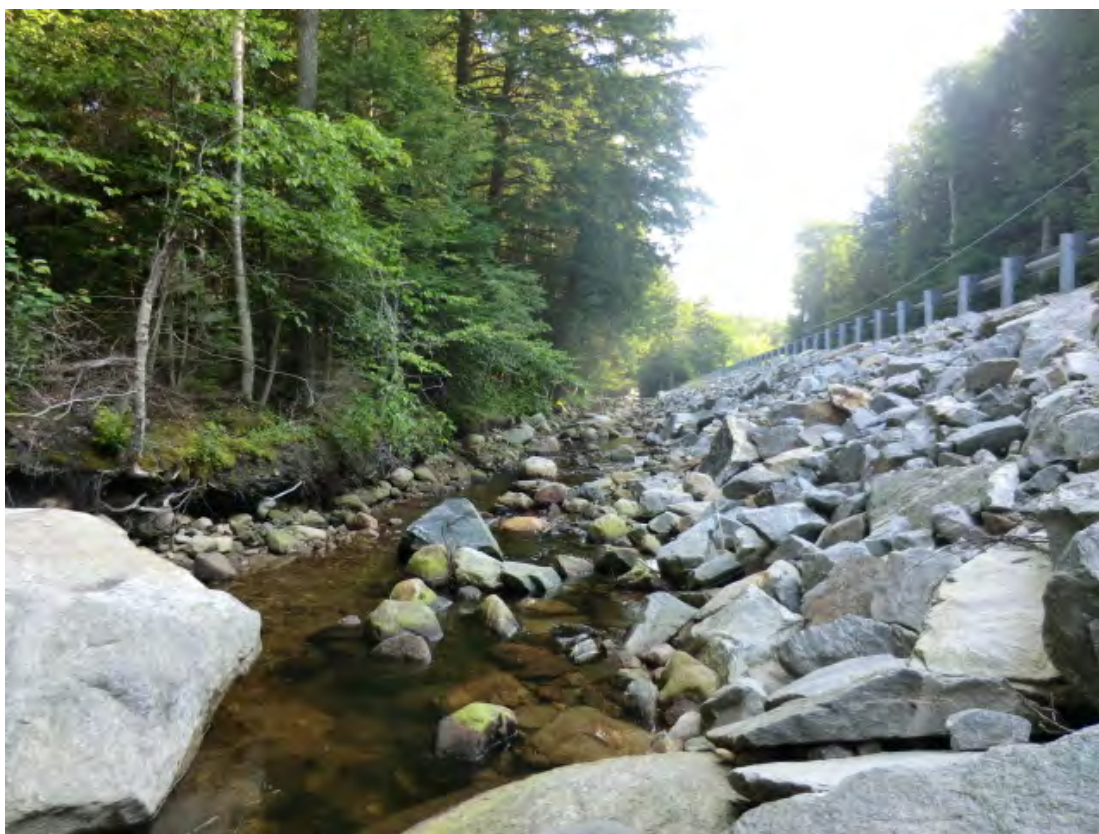
This segment begins where Wardsboro Brook is straightened along Stratton-Arlington Road and continues 2,100 feet upstream to the reach break above the Boardman Loop bridge. This segment has been straightened and rip rapped along Stratton-Arlington Road for nearly all of its extent. This straightening and armoring led to historic channel incision and loss of floodplain access for the entirety of the segment. The channel has largely lost its bed features and was converted from a riffle-pool bedform to plane bed. Channel widening and planform adjustment are limited by the boundary conditions within this segment. Buffers are also in poor condition due to road and development encroachments. Overall, the segment is in **fair** geomorphic condition, as there is evidence of recent channel alteration, channel aggradation, widening, or planform adjustment. Due to its lack of bed features, LWD, refuge, and riparian buffers, T8.06-C is in **fair** habitat condition.

**Figure 5.18.** Straightened and rip rapped along the road, T8.06-C has been converted to a plane bed bedform.

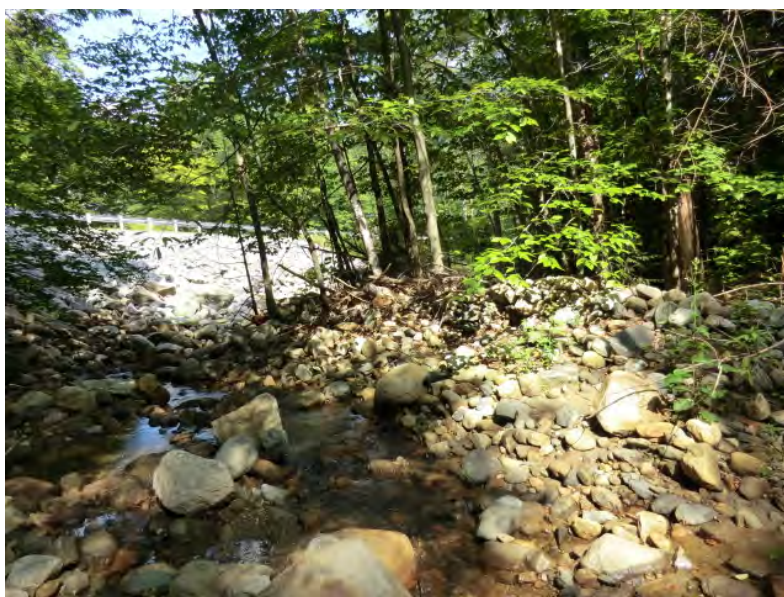
This reach on Dover Brook, a tributary to Wardsboro Brook, was not divided into segments during assessment. The reach begins at the confluence with Wardsboro Brook and continues upstream for 2,500 feet, ending below the Rt. 100 crossing. T8.S3.01 was historically straightened and armored along Rt. 100. The stream has largely lost access to its floodplain and has majorly incised. This reach appears to have aggraded and undergone planform change during TSI, as evidenced by one channel avulsion and five mass failures in this short reach. Post-TSI channel work is present in the form of windrowing in areas where Dover Brook runs along Rt. 100 and private residences. The buffers in this reach are highly impacted by the road and development on both sides of the brook. Erosion is also common in this reach in areas where the banks are not armored or windrowed, indicating slight widening where boundary conditions do not prevent it. Due to the stream's extreme historic degradation and boundary conditions preventing adjustment, this reach is in **poor** geomorphic condition. T8.S3.01 has a very weak riffle-pool bedform and lacks a diversity of bed features. There is also little LWD and few refuge areas, although canopy cover overall is good for the reach. Due to these factors, the reach is in **fair** habitat condition. There is one bridge and one culvert in T8.S3.01; the culvert poses a potential barrier to aquatic organism passage.

Figure 5.19. Windrowing and corridor encroachment of Rt. 100 common in T8.S3.01.

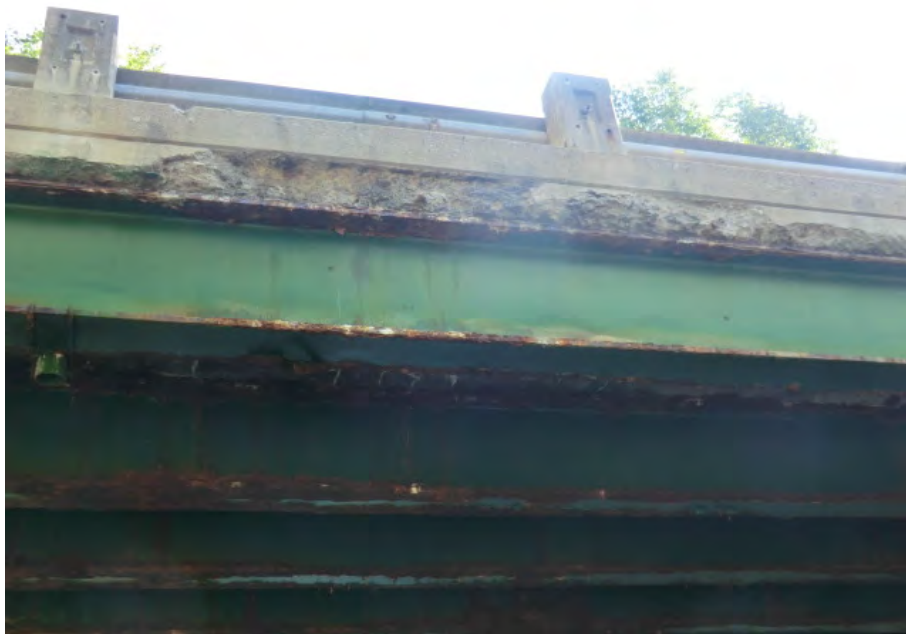
The downstream-most crossing recommended for replacement was a Rt. 100 bridge in T8.05-C. Significant scour around the structure occurred during TSI and the bridge could have been undermined during the next major flow event. The bridge ranked mostly compatible; however, due to its poor condition (cracked abutments, rusting beams, and deteriorating decking) and the potential for the bridge to be undermined, it was recommended for replacement with a moderate priority. According to John Bennett of the Windham Regional Commission, this bridge was replaced by the Vermont Agency of Transportation during 2014.

**Figure 5.20.** Deteriorating decking and rusting beams of Rt. 100 bridge in segment T8.05-C.

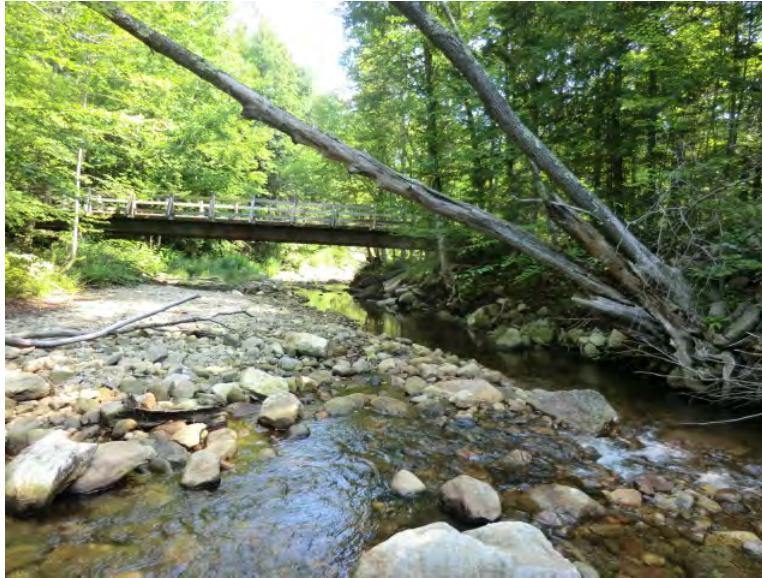
The bridge on Temple Road in segment T8.06-B is ranked as mostly incompatible and is recommended for replacement. This bridge has poor alignment, abutment scour, and was likely overtopped during TSI. Channel avulsions are present directly upstream of the structure.

**Figure 5.21.** Temple Road bridge in segment T8.06-B recommended for replacement.

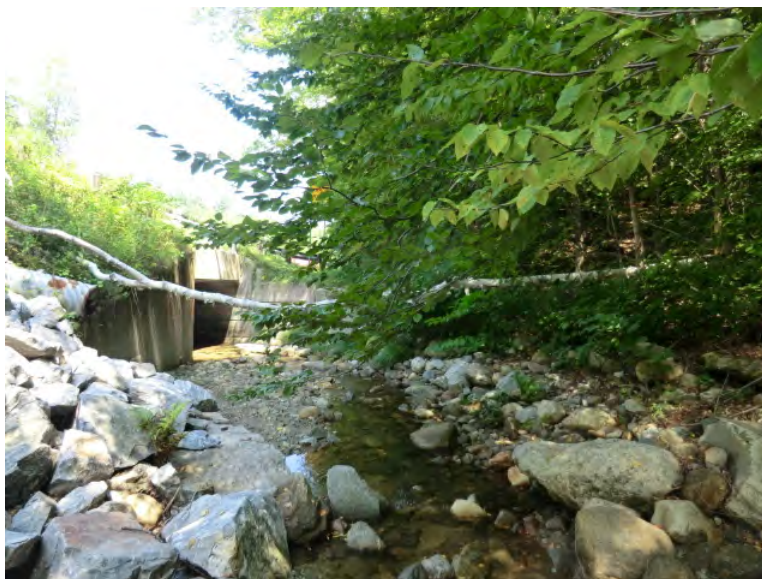
On reach T8.S3.01 of Dover Brook, the most downstream crossing recommended for replacement is the box culvert under Rt. 100 and Cross Road. It is recommended for replacement due to its poor alignment with the channel, reduced aquatic organism passage (AOP), and scour around the structure. Under typical low flows, the depth of water in the culvert is very shallow and it contains no sediment, which could create a barrier for fish and other wildlife.

**Figure 5.22.** Poor alignment of Dover Brook culvert under Rt. 100 and Cross Rd.

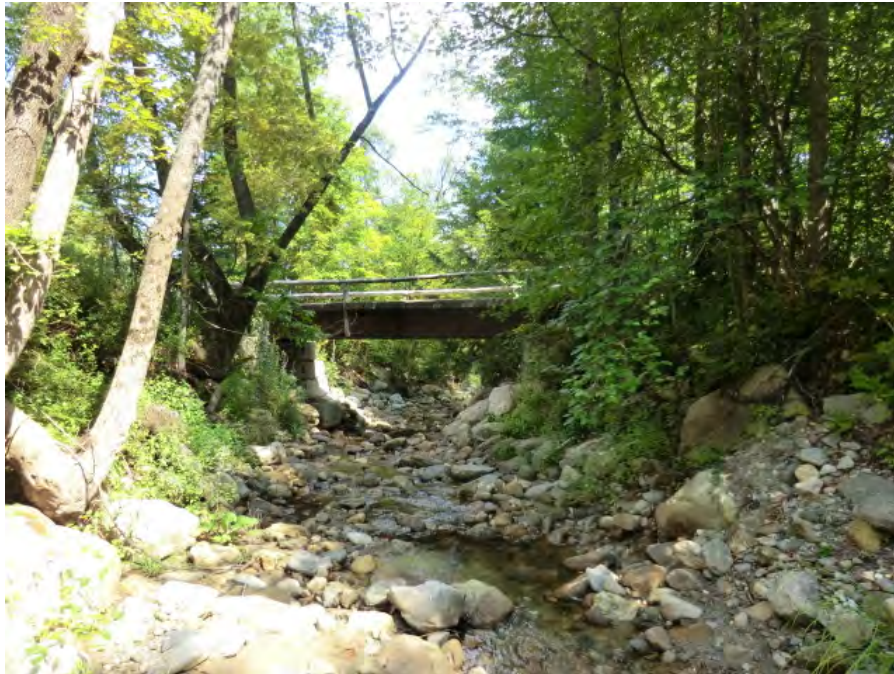
Farther upstream in T8.S3.01, a private driveway bridge is recommended for replacement with a low priority. This structure is a slight channel constriction, and has scour around its footers and failing rip rap.

**Figure 5.23.** Private driveway bridge in T8.S3.01 recommended for replacement.

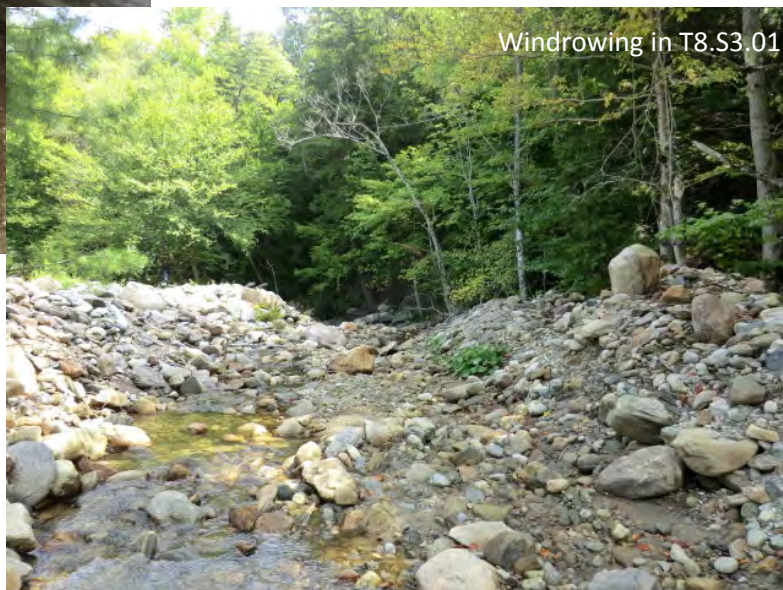
Windrowing in T8.S3.01
