# Saxtons River Phase 1 Stream Geomorphic Assessment Summary

June 26, 2008  
**DRAFT**

**Fitzgerald Environmental Associates, LLC.**

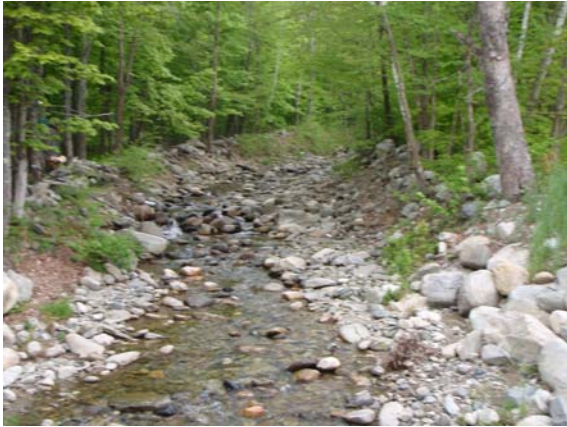
Dredging at these locations has been carried out following past flood events (B. Cahoon, 2008), and berming was evident during the windshield surveys (Figure 7). Another potential location for an alluvial fan has been noted on Mainstem Reach M23 where a sharp change in slope occurs where a steep headwaters channel (M24) meets a wide valley with outwash parent material.

Figure 7. Dredging through alluvial fan in T6-S2.01.

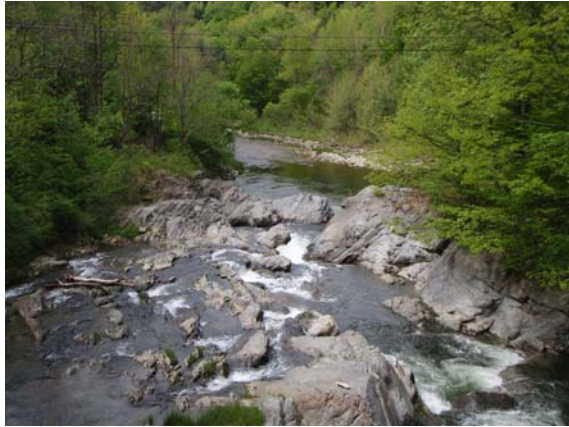
Figure 8. Grade Control in M03.

Four natural grade controls exist along the lower Mainstem in Reaches M01, M03 (Figure 8), and M06. In each of these reaches, these bedrock areas act as controls on vertical stability have caused the historical deposition of alluvium along the channel and valley bottom in the areas upslope of the controls. The grade control in M01 is known as Saxtons River Falls, and is also the site of an historic mill and dam known as Blake and Higgins Dam. Upslope, an unnamed grade control is located at the site of a former covered bridge on Covered Bridge Road. The grade control in upper M03 is known as Twin Falls, and is found just upstream of the Route 121 crossing. The grade control in M06 is found in the center of Saxtons River immediately downstream of the crossing of Westminster Road. A mill dam operated at these falls during the 1800's (UVM, 2008) and has long since been abandoned. Additionally, one human-enhanced grade control is found on lower Bundy Brook (T1.01) and is associated with an abandoned impoundment and small mill.

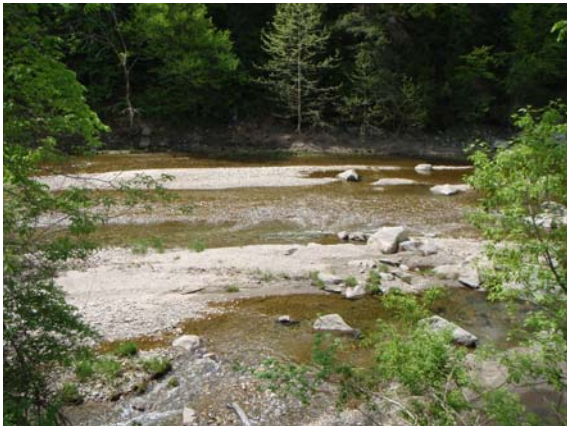
Mainstem: There are two flow regulations on the mainstem that are considered large (e.g., upstream impoundment is wider than channel width) run-of-the-river impoundments that are currently not actively managed to change discharges or volumes. Reach M01 has remnants of a large impoundment behind the old Blake and Higgins Dam that has a high degree of sedimentation upstream (Figure 11). In the upper watershed, M22 has a large impoundment associated with the Lawrence Four Corners Dam (Figure 12). Below the dam and the Route 121 crossing, some channel incision was noted where the channel enters a marshy, alluvial valley where historic straightening has been noted.

Figure 11. Sediment deposition in lower M01.

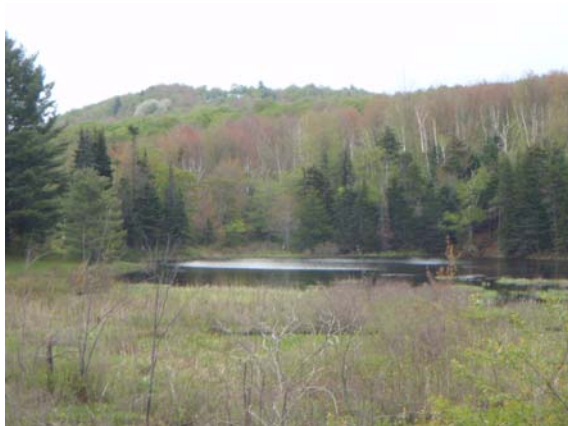
Figure 12. Impoundment in M22.

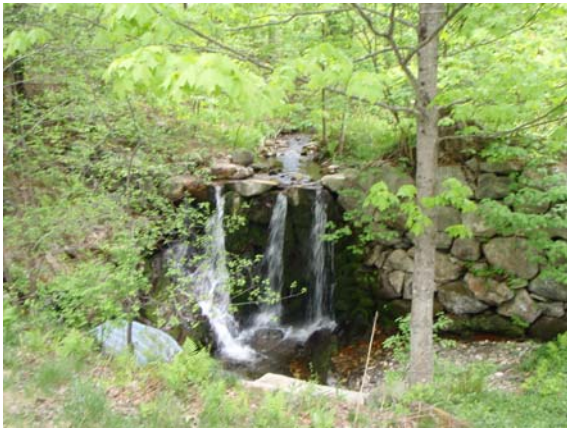
Tributaries: Six flow regulations were noted on the tributary reaches. On Reach M06-S1.01, a large run-of-the-river impoundment associated with Vermont Academy was noted mid-reach. From the field observations it was not clear whether or not water is diverted from this structure for irrigation of the adjacent athletic fields. In lower Reach T1.01 there is small run-of-the-river impoundment associated with an old stone dam (Figure 13). There is significant fine gravel deposition above this feature. In T4.S1.02 there is a large impoundment in the upper reach known as Athens Pond. In the lower section of T5.01, just upstream of the Route 121 crossing, there is a small run-of-the-river

Figure 13. Defunct dam and impoundment in T1.01. Figure 14. Defunct Cambridgeport Mill and Dam.

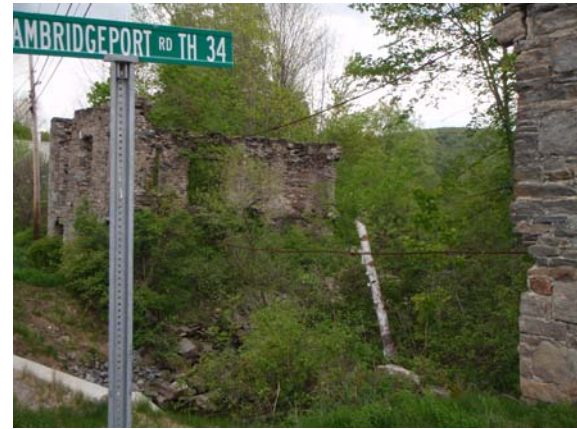
impoundment associated with the partially breached Cambridgeport Dam at the site of an old mill (Figure 14). Upstream in T5.02 there is a large run-of-the-river impoundment that appears to be used as a private swimming pond, however detailed field observations were not possible at this site. On the lowermost reach of the South Branch, Reach T6.01, there is a small run-of-the-river impoundment that may have been historically used for agricultural purposes, however it is currently partially breached. Finally, VTDEC noted a possible water withdrawal associated with the Grafton Ponds Cross Country Ski Center, located on an unassessed tributary to the South Branch (J. Cueto, 2008). However, since this potential withdrawal is not located on an assessed surface water in the SGAT project, it has not been indexed with the FIT.

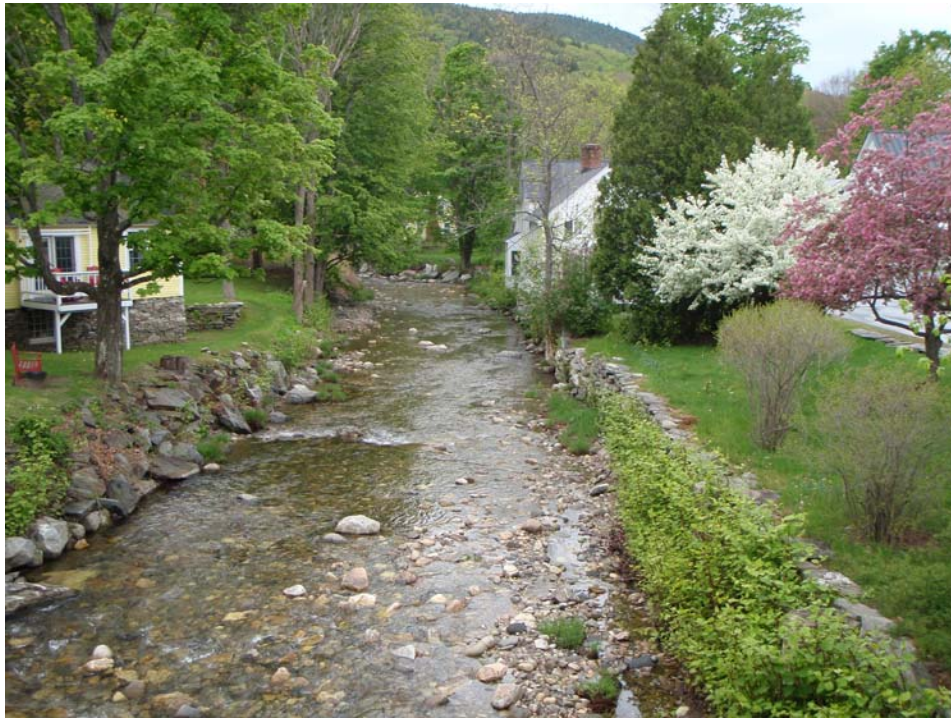
and lateral migration of the channel. These areas included Reaches M03 and M04, where armoring protects Route 121 from bank erosion, and M13 and M14 in the vicinity of Grafton village (Figure 15). Additionally, some armoring was noted along the major tributaries where road embankments have been protected from ongoing bank erosion (e.g., T2.03, T4.01, and T6.02), and where some intensive channel modifications associated with alluvial fans were also noted (e.g., T6.S1.01). The impact of bank armoring on the reach was considered not significant for most reaches, and low for the following reaches where it impacted between 10 and 30% of the reach length: M03, M14, M14-S1.01, and T2.01. No reaches had high impact ratings (armoring impacts greater than 30% of reach length) for this parameter.

Figure 15. Hard bank armoring protecting adjacent properties in M14 in Grafton village.

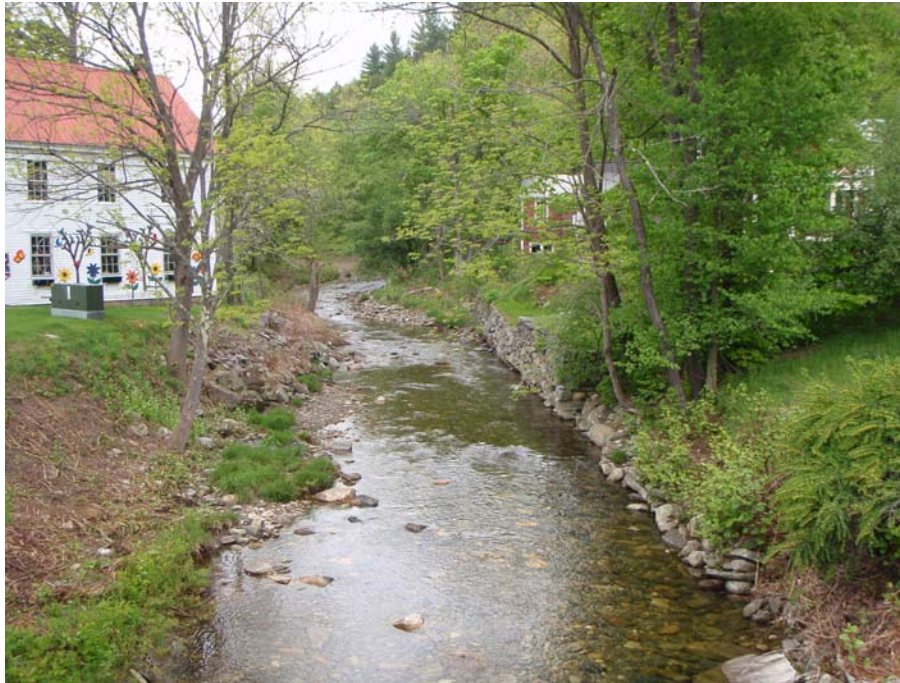
Bellows Falls and Saxtons River villages, and in the upper watershed around Grafton Village (Figure 17). Mainstem and subtributary reaches with high corridor development impact ratings associated with villages included: M01, M03, M04, M05, M06, M06-S1.01, M07, M14, and M14-S1.01. Some tributary reaches are impacted by low-density residential development along secondary roads. These reaches included T2.03, T4.02, and T4.S1.01.

Figure 17. Corridor encroachment in Grafton Village in Reach M14.

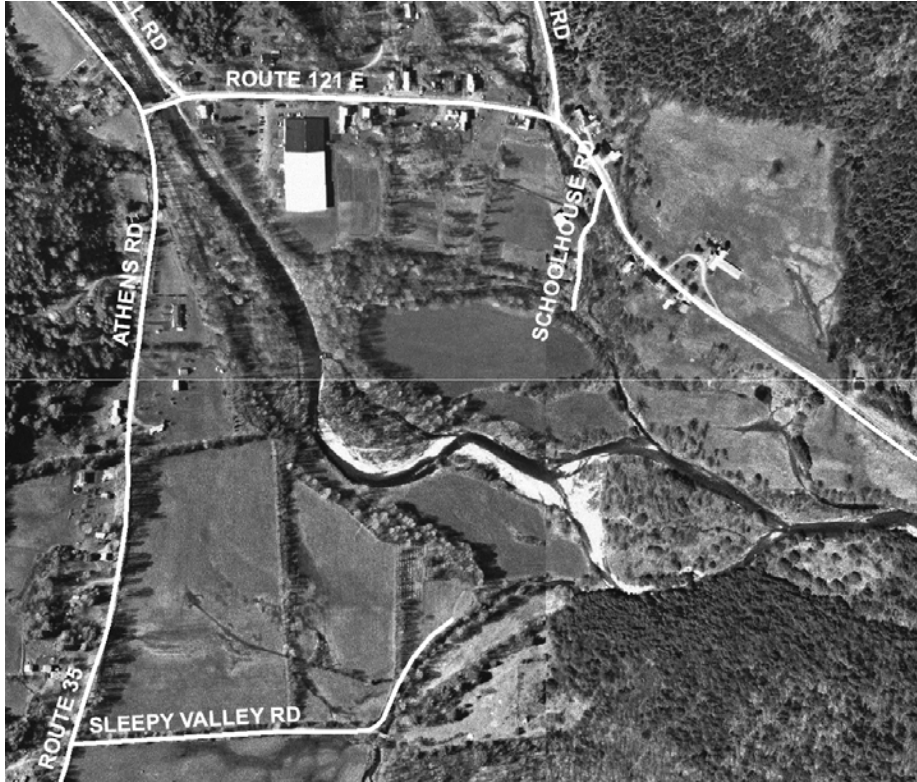
Figure 18. High degree of depositional features and migration in Reach M09 at the confluence with Bull Creek (T4) as seen in the 1990 aerial photography.

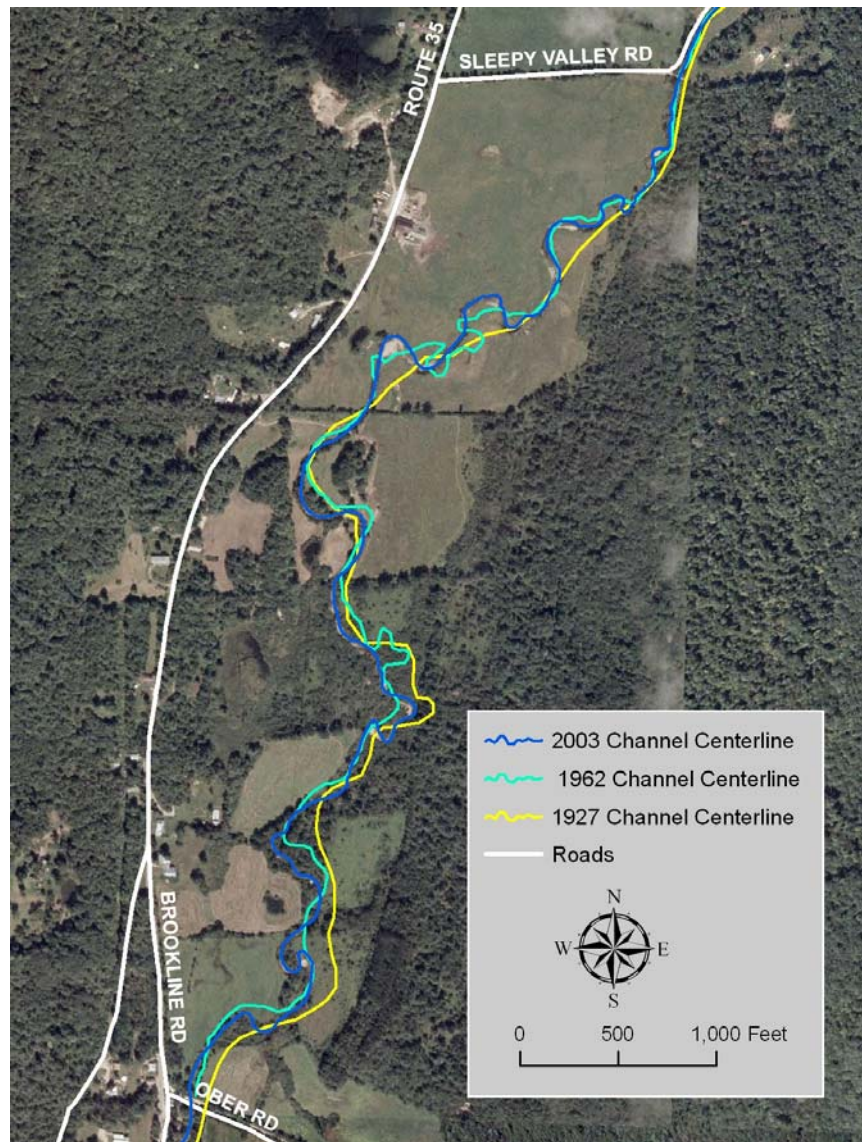
Figure 19. Redevelopment of a sinuous planform following straightening in the lowermost reach on Bull Creek (T4.01) prior to the confluence with the mainstem.
