**Phase II Stream Geomorphic Assessment  
Moose River; Essex and Caledonia Counties  
Concord and St. Johnsbury, Vermont**

**Final Report  
August 2009**

Tamara Colten-Stevens  
Essex County Natural Resources Conservation District

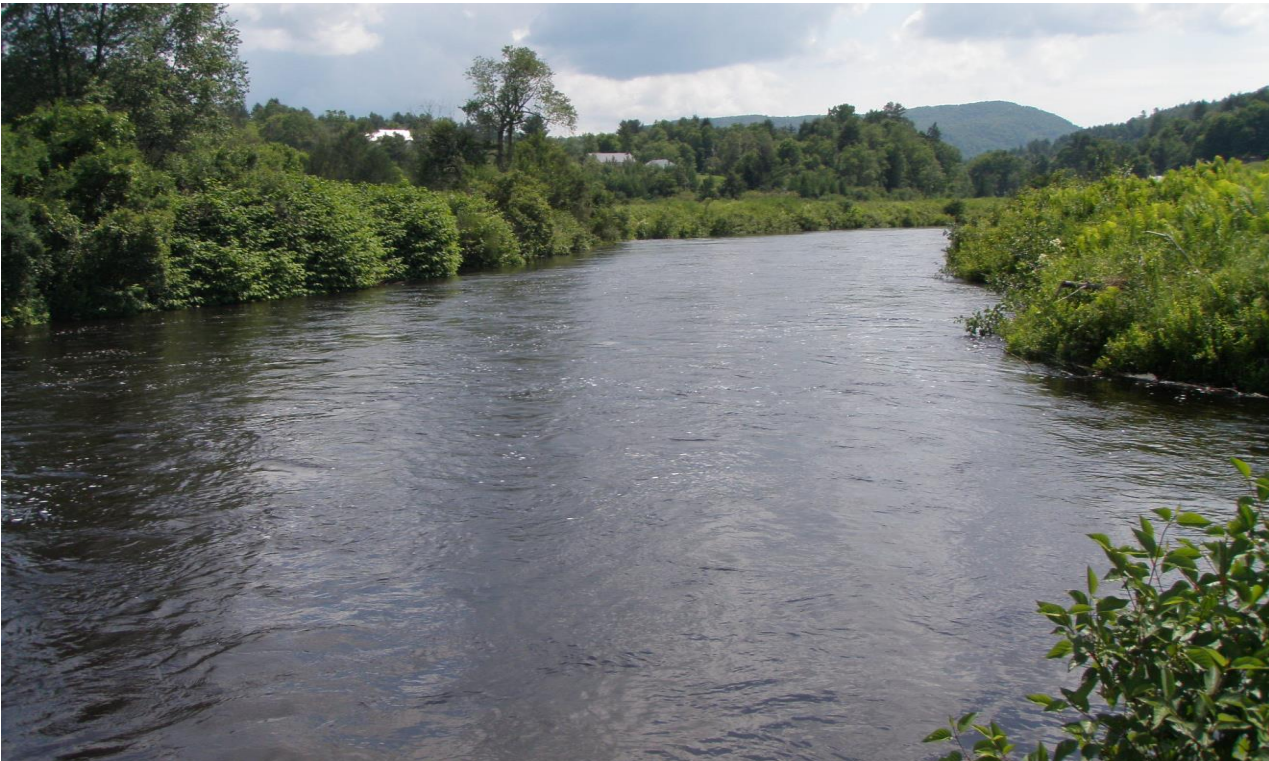
Reach M07 is the most southerly of the Phase II assessed main stem reaches, flowing above East St. Johnsbury for 1,747’. With a valley width of an estimated 715’ and flat hillside slopes on both of the reach banks, this reach was classified as broad in confinement. Stream type was determined as an F3 with the results of the channel cross section and pebble count. The dominant substrate was found to

be cobble (33%), though course gravels (29%) and boulders (27%) followed closely behind. Only one mid channel bar was documented in this reach. An incision ratio of 1.86 and a high entrenchment value of 1.14 suggest there is poor access to the floodplain in this reach. There was no erosion noted on either bank. Both the right and left banks' riparian corridors were dominated by pasture, with no sub-dominant land use present. Very narrow buffers (<25') of shrubs, herbs and invasive plant species (notably *Polygonum cuspidatum*; Japanese Knotweed) were observed.

**Photo 1. Reach M07 was observed to be a broad, F3 stream with limited buffering and pastures along both its banks.**

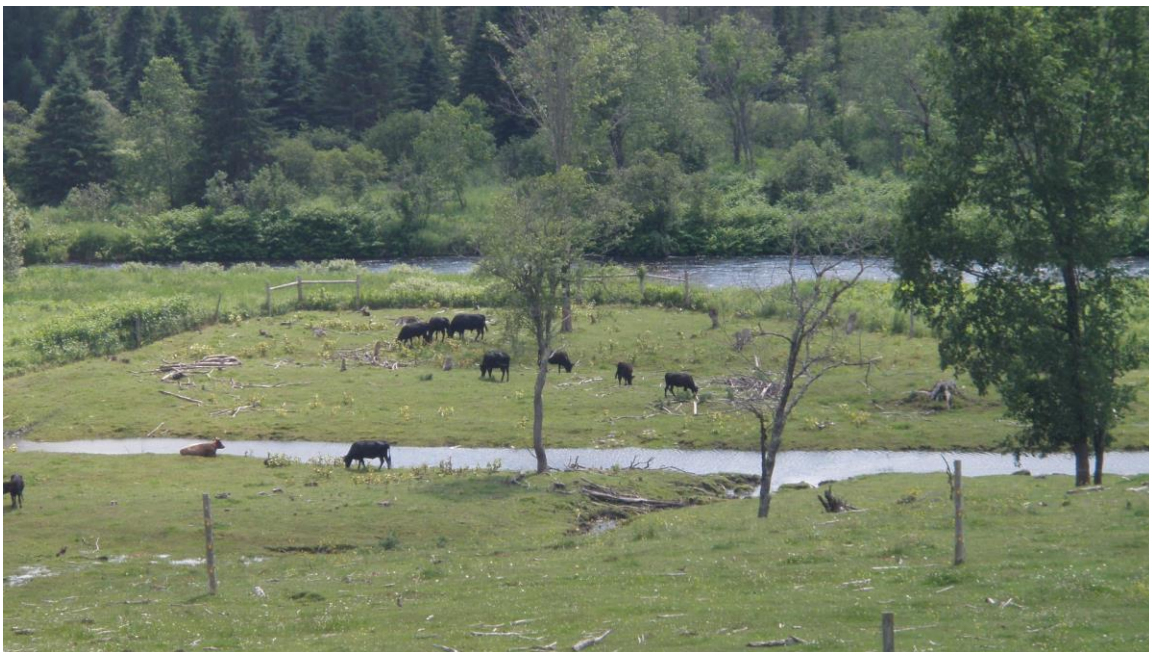
A longer reach than M07 (3,444'), the stream in M08 flowed faster and in a narrower channel. The reach was determined to be a narrowly confined F3 stream type, with a valley width of 163' and a bankfull width of 98'. The substrate composition was found to be similar to the M07 (cobbles, 37%; course gravel, 27%; and boulder 23%) with sedimented riffle types observed. Storage bars were present, though not numerous, with one side bar and one small island noted. An incision ratio of

1.79 and a high entrenchment value (1.04) suggest this section of stream has fair access to its floodplain. Seventy-six feet of erosion was noted on the right bank and rock rip rap was recorded for a total of 391' along the right bank. Corridor encroachments included 3,250' of road (Rte. 2) along the right bank and 615' of railroad to the left. The riparian corridor in M08 was dominated by shrubs and saplings on both banks, with no sub-dominant vegetative type observed. The riparian buffer on both banks was found to be 26-50' in width in most areas with shrubs and saplings dominating and herbaceous plants sub-dominant in vegetation. Minimal springs and seeps were observed as were adjacent wetlands.

**Photo 2. In Reach M08, cows were observed grazing up to the right bank of the stream. Additional fencing to keep them out of the river and installation of a riparian buffer would be recommended.**

Recommendations of the Essex County Natural Resources Conservation District would be for the establishment of forested riparian buffers in coordination with landowners and the Towns of St. Johnsbury and Concord in Reaches M7, M9, M10 and M13. In addition, fencing and installation of riparian buffer, where necessary, is recommended for Reach M08 below Concord Village, where cows can be observed grazing up to the bank of the stream.

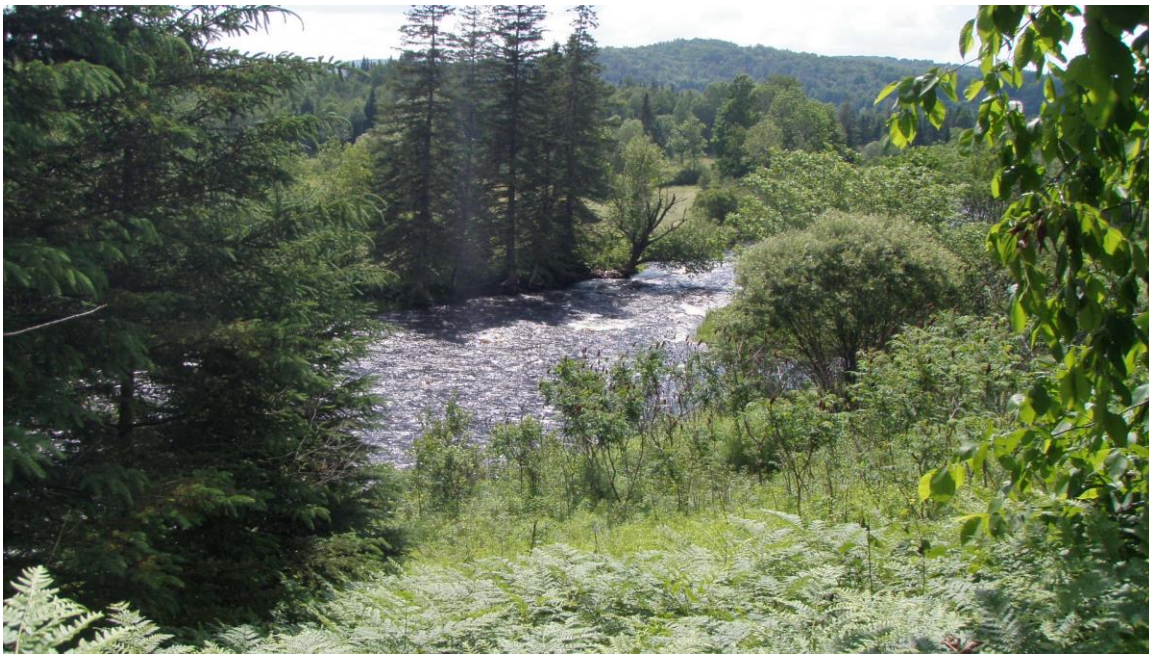
The fairly high incision ratio of 1.54 and a moderate entrenchment value of 1.92 suggest the stream has moderate to good access to its floodplain. The banks of M09 had a boulder/cobble upper material and a lower gravel material type that experienced great amounts of erosion. Four-hundred (400) feet of erosion at 4.5' in height was measured on the right bank and 405' of erosion at five (5) feet in height was measured on the left. Rip rap was found in limited lengths on both the right (145') and left (64') banks. Corridor encroachments were present for much of the reach, with the railroad following the river for 13,113' and Rte. 2 for 334'. Two (2) old railroad abutments were observed in M09, one on either bank, with channel and floodprone constriction noted due to the right bank abutment's presence. The riparian corridor on both banks was dominated by 'crop' (corn). The riparian buffer, where present, consisted of shrubs and saplings with invasives (*P. cuspidatum*) sub-dominant on both banks. On the right bank the buffer was measured to be 0-25' for 8,278' and the left bank; 6,614'. Abundant springs and seeps were noted as were two (2) storm water inputs.

**Photo 3. Though riparian buffers were substantial at the top of Reach M09, 8,278' of the right bank and 6,614' of the left had just 0-25' of vegetation.**

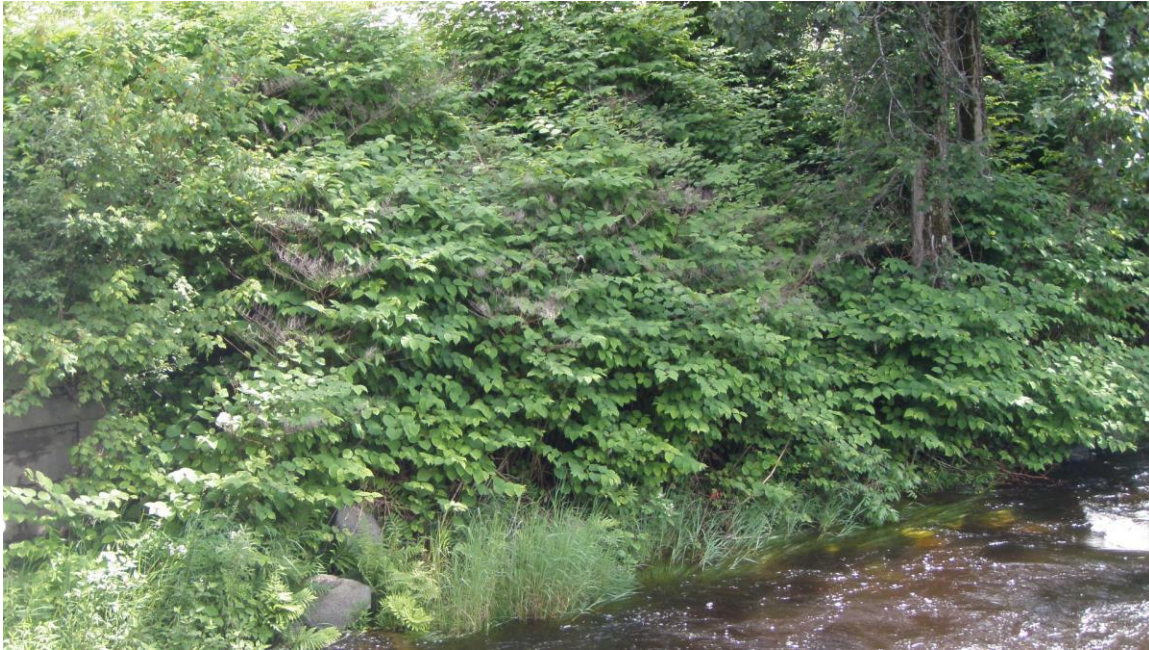
**Photo 4. Japanese Knotweed (*P. cuspidatum*) grew abundantly in many of the reaches riparian buffers.**

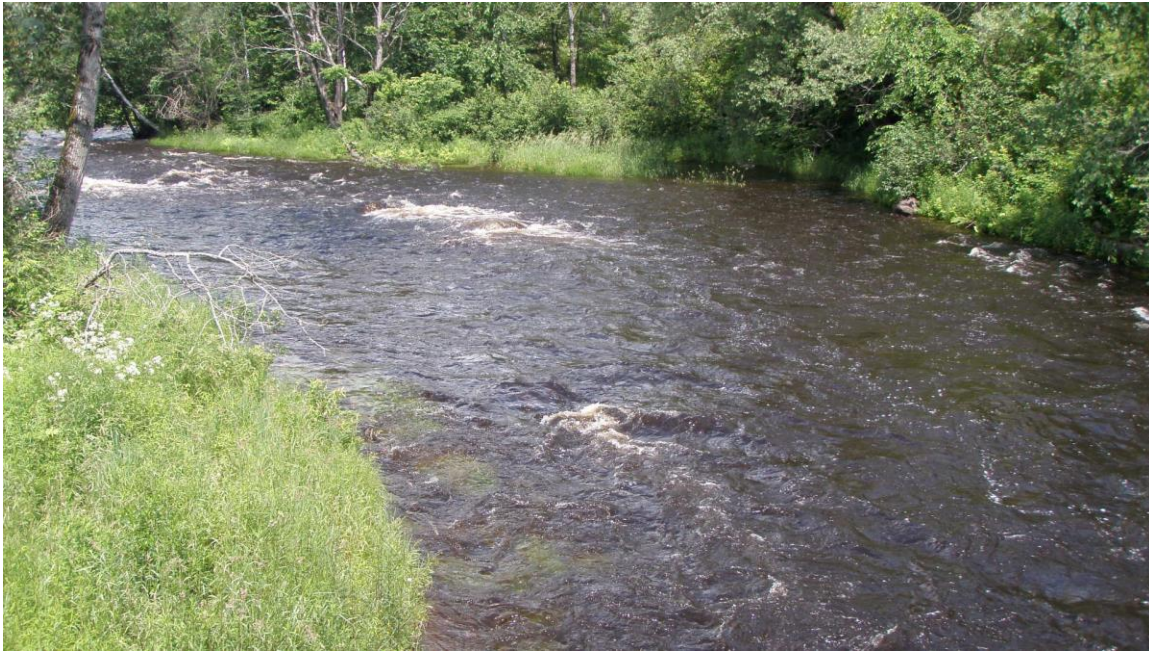
Flowing 2,608' just downstream of the Town of Concord, reach M10 was classified as a semi-confined C3 stream type. Cobble once again was the dominant substrate observed during the pebble count (55%) with the bed and bar average largest particles measured at 96.6 mm and 104.0 mm respectively. Storage bars were abundant, with six (6) side bars, one (1) point bar and ten (10) islands observed. The incision ratio of 1.63, little to no entrenchment (4.78) and a high w/d ratio (39.37) suggest this reach's stream has moderate access to its floodplain. The dominantly undercut banks were sandy in texture although erosion was not as widespread as expected (a mere 12' on the right and 356' on the left). Revetments were not noted on either bank. The riparian corridor was dominated by shrubs and saplings on the right bank (with pasture sub-dominant) and crops dominant on the left. The sub-dominant vegetation for the left bank riparian corridor was shrubs and saplings. The near bank vegetational types of both banks were invasives and herbaceous vegetation, both with poor buffers of 0-25' in width. Springs and seeps were noted as abundant, with minimal adjacent wetlands observed.

**Photo 5. Storage bars including side bars, point bars and islands were abundant in Reach M10.**

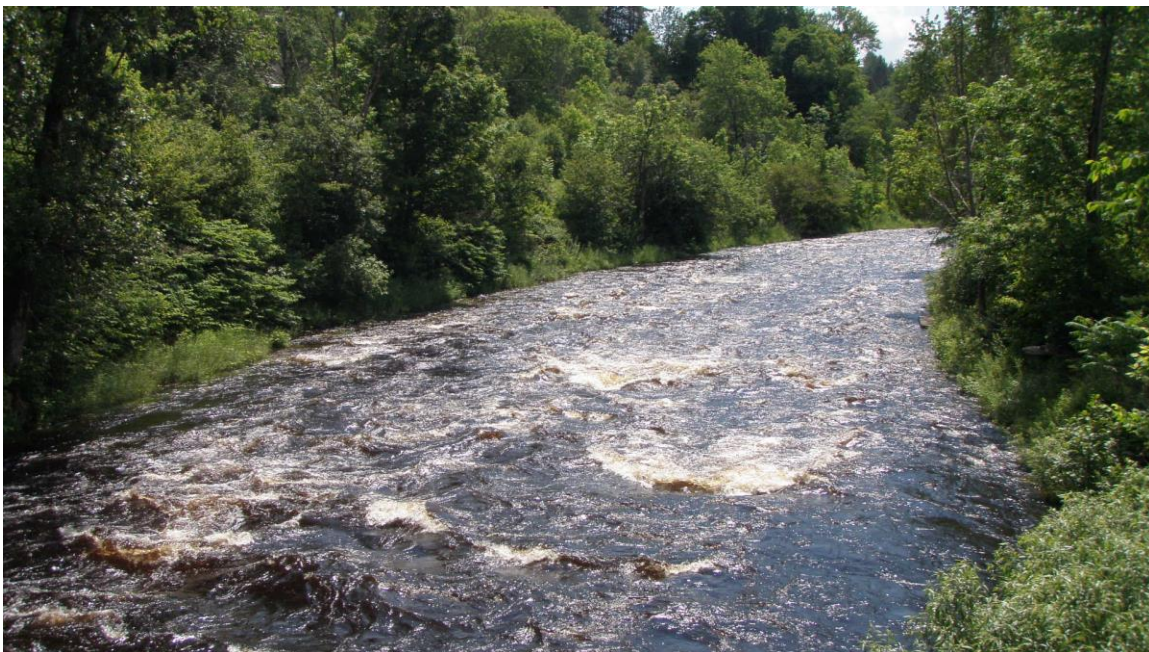
**Photo 6. Reach M11, just above the Town of Concord.**

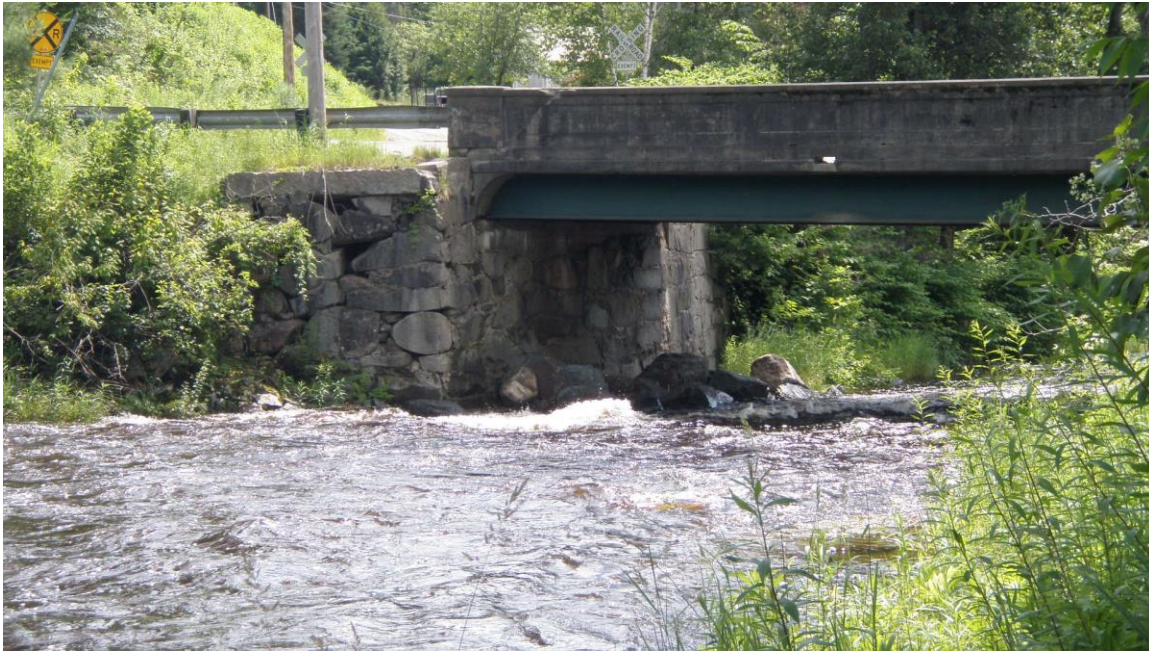
Erosion was not observed on either of the stream's banks, though rock rip rap was measured on both the right and left banks (838' and 57' respectively). Corridor encroachment included 3,307' of Rte. 2 and 57' of railroad. The riparian corridor was dominated by forest on both sides of the river, with a sub-dominant of hay on the left. The buffer width on both banks was impressive with 51-100' in width on the right and >100' (with a sub-dominant of 26-50') on the left. The near bank vegetation type for the right bank was shrub and sapling, with herbaceous dominant on the left. Springs and seeps were noted as minimal with no adjacent wetlands present. One (1) bridge (Fournier Bridge) was observed in M12A (48' in width). Channel and floodprone constriction with deposition above the bridge was determined a problem at this site. A grade control of ledge (1.5' in height) was documented just below this bridge.

**Photo 7. The bridge at the bottom of Reach M12A.**

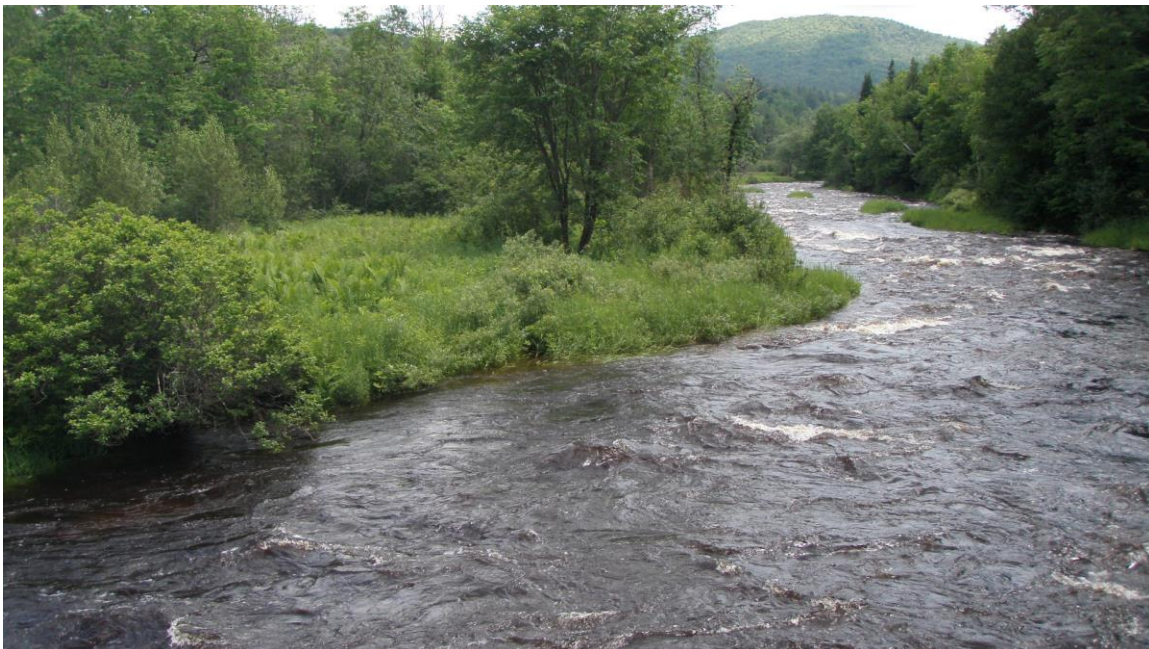
**Photo 8. A large number of woody debris, necessary for fish habitat, was noted on the multiple thread of Reach M12A.**

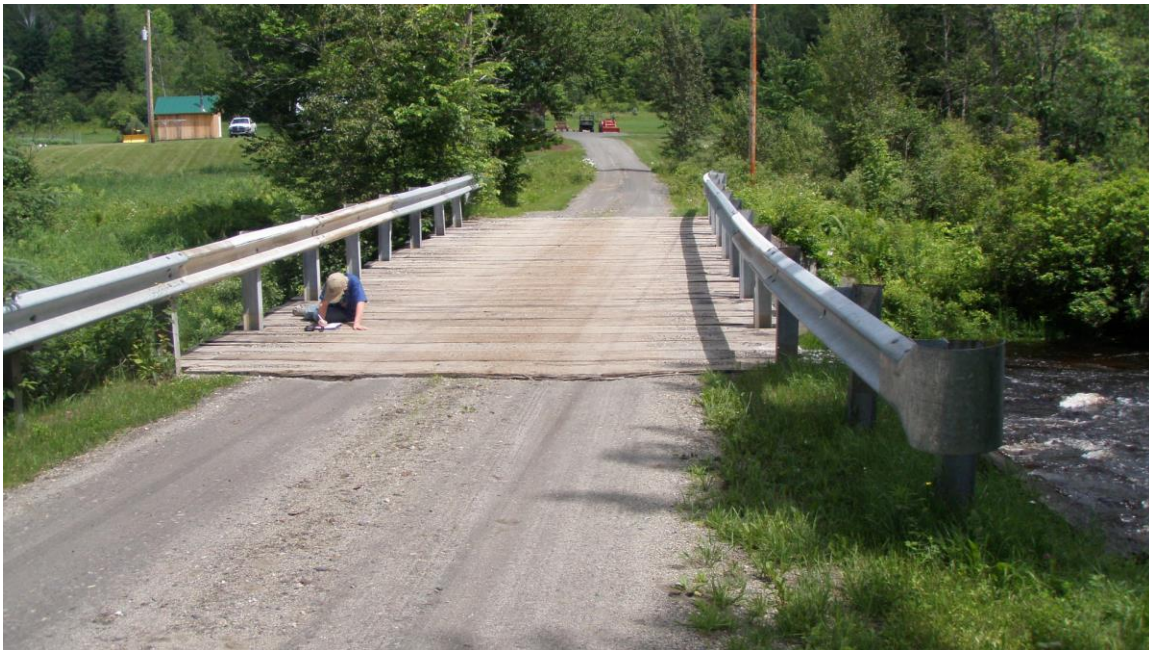
**Photo 9. Fournier Bridge. Dividing Reaches M12B and M12A.**

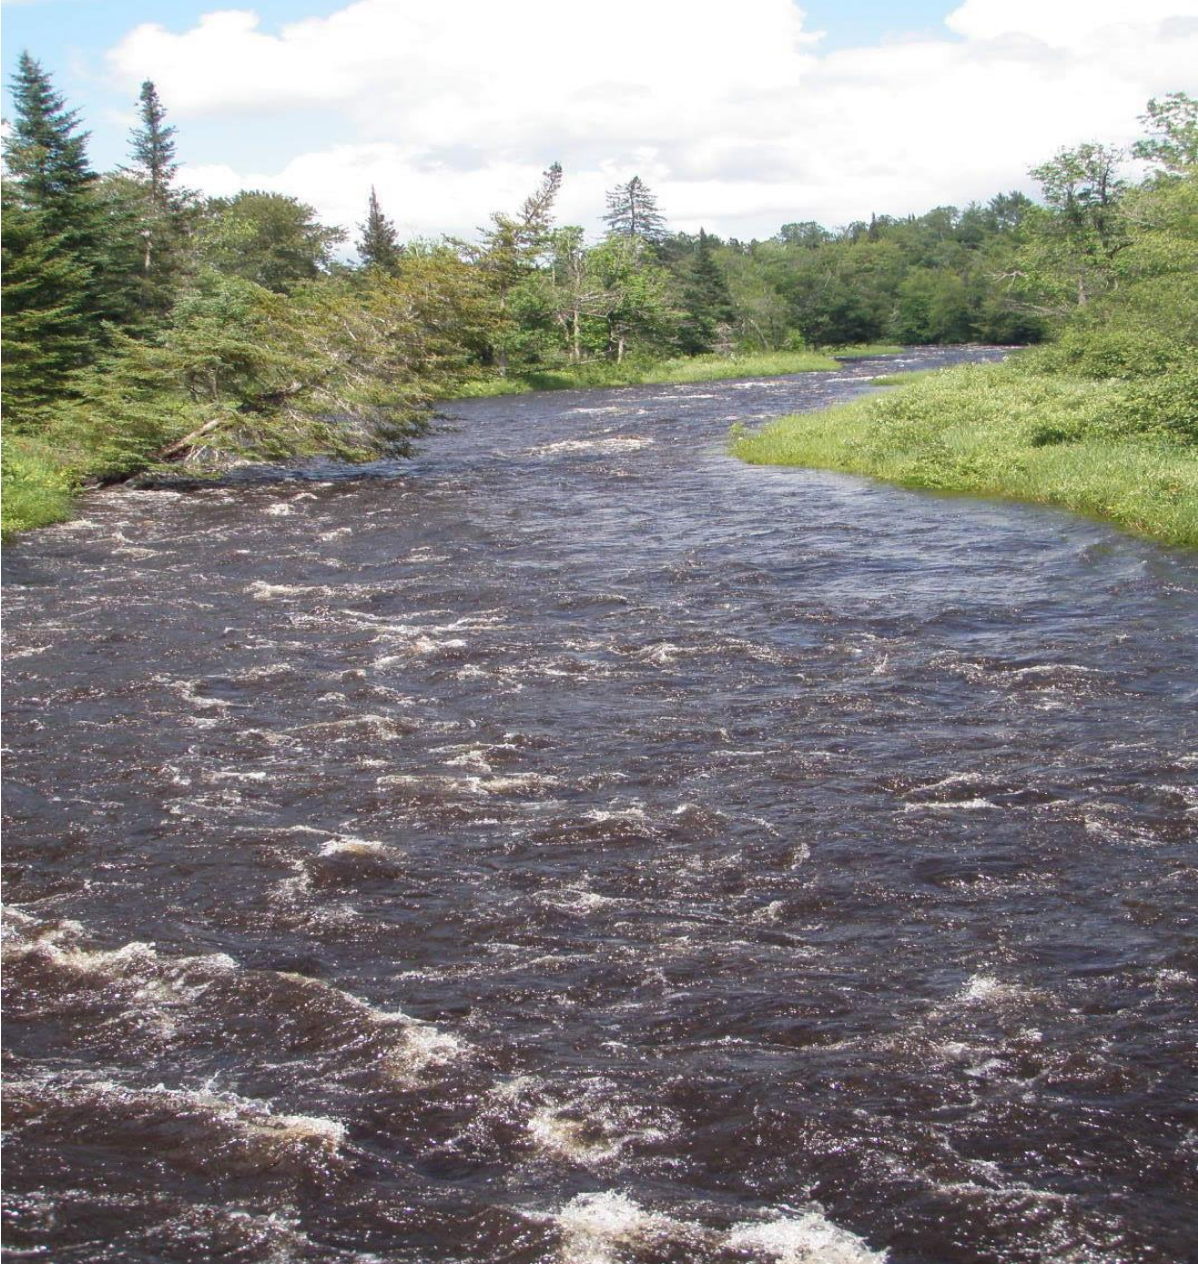
M12B ran 2,423' upstream of the Fournier Bridge. M12B was determined to be a very broad B3 plane bed stream with good access to its floodplain in most locations. The pebble count determined that cobble was again the dominant substrate present, at 46%. Storage bars were present, with one (1) mid channel bar, two (2) side bars and five (5) islands present. Three (3) flood chutes were noted. Moderately to good access to its floodplain is suggested with an incision of 1.26 and entrenchment of 1.22. Erosion was non-existent on the right bank and minimal (67') on the left bank. Rock rip rap was noted along 87' of the left bank. Both the right and left banks of M12B had a riparian corridor dominated by forest with riparian buffers of greater than 100' in width. Both banks were dominated by coniferous trees and sub-dominated by shrubs and saplings. Springs and seeps were noted as minimal, with minimal adjacent wetlands observed. Beaver activity was noted though no dams were present. While no constrictions were present, ledge of 2' in total height was observed just below the channel cross section location.

**Photo 10. Reach M12B had good access to its floodplain in most locations.**

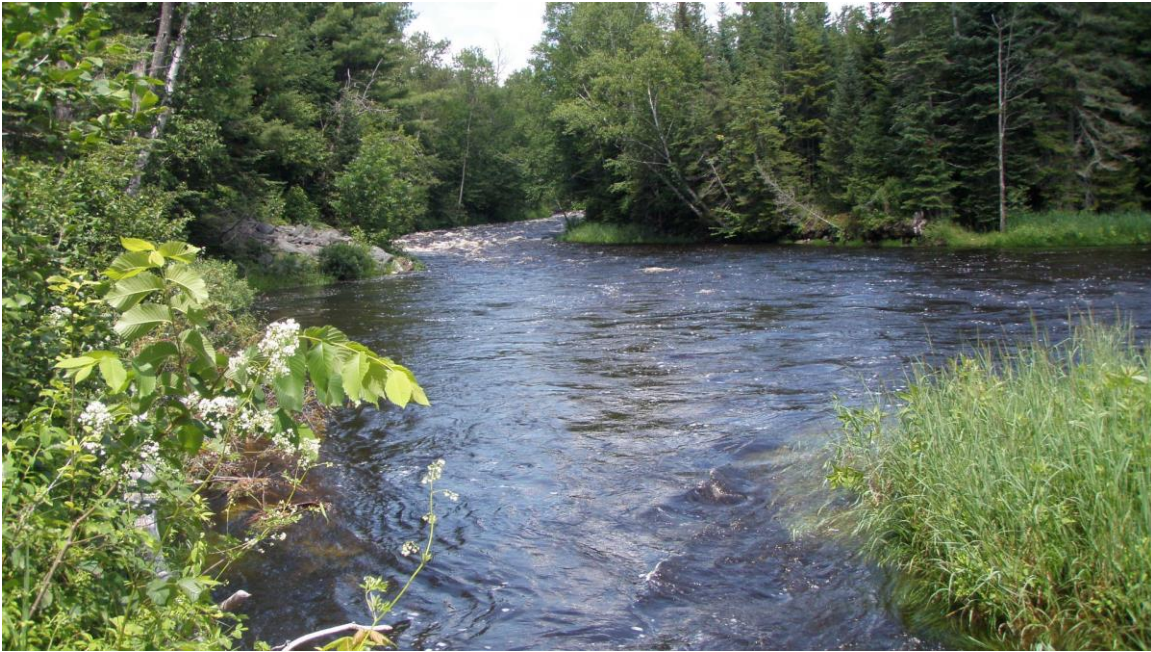
M13B flowed for 4,122' with a bankfull width of 93' at the channel cross section location. The segment was classified as a broad C3 step pool. The waters of M13B were fast flowing and deep (5.8' maximum depth at the channel cross section location) so a complete pebble count for substrate composition was not performed. Sixty-two (62) pebbles were counted, revealing a dominantly cobble stream (25% of 62) followed by boulders (18% of 62). The incision ratio of 1.53 and little to no entrenchment (4.28) suggest this stream has fair access to its floodplain. Erosion was present to a lesser degree on both banks (210' on the right; 282' on the left) with no noted revetments. The riparian corridor in M13B was dominated by residential development on the right bank (sub-dominant crop) and crops on the left bank (sub-dominant shrubs and saplings). The riparian buffers of herbaceous, sub-dominated by shrubs and saplings was minimal, with 0-25' in width dominating. Springs and seeps were minimal and minimal adjacent wetlands were noted.

**Photo 11. The waters of Reach M13 were deep and fast moving.**
