Bear Creek **Environmental**

Phase I Stream Geomorphic Assessment
Neshobe River
Town of Goshen
Addison County, Vermont

DRAFT

June 10, 2004

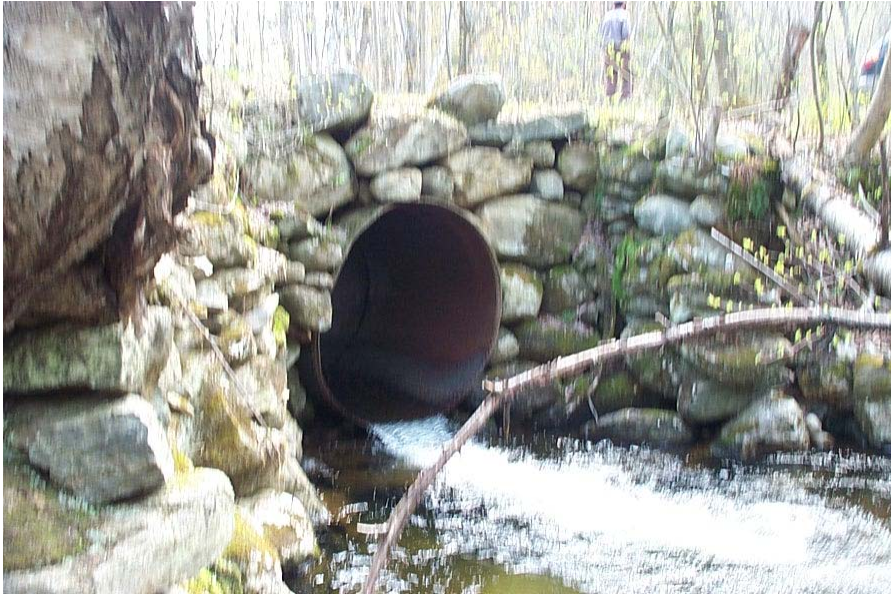
Figure 4. Undersized culvert located in Reach M05.

1. Minimize future flood damage by improving culvert/bridge widths. If additional funds are available it may make sense to conduct a Bridge and Culvert Assessment using the protocols recommended by the Vermont Agency of Natural Resources. The condition information contained in the Town of Goshen's bridge and culvert survey could be cross referenced with the ANR Bridge and Culvert Assessment to prioritize the replacement of bridge and culverts with the Town of Goshen.

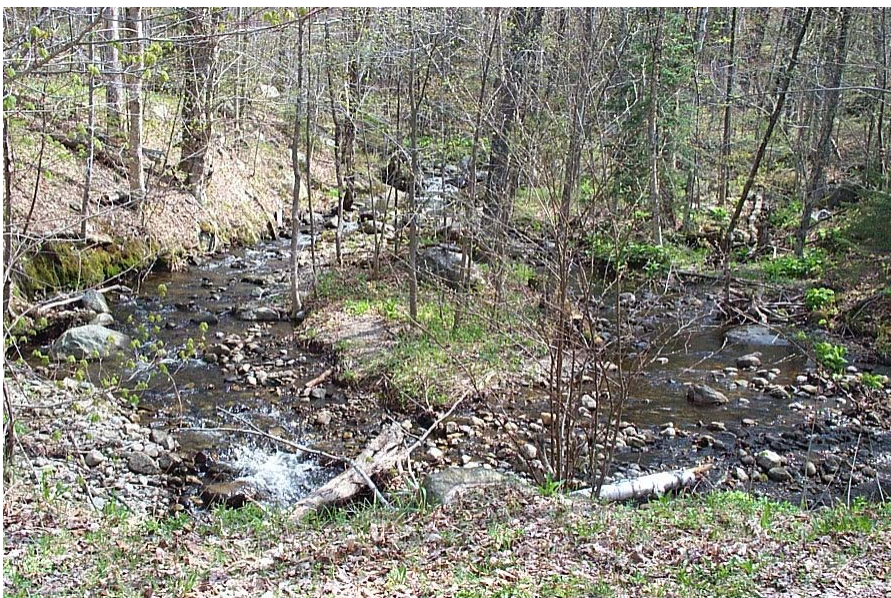
evaluated by determining the percentage of the reach length that is channelized, has split flow, or makes a sharp “S” bend upstream or downstream of bridges or culverts. With the exception of reach M05 and reach T1.03, the impact from bridge and culverts on stream dimension, pattern or profile appeared to be not significant. A vegetated mid-channel bar was noted in reach M05 above an undersized culvert crossing a forest service road. In reach T1.03, above a bridge, a vegetated mid channel bar was noted.

Figure 5. Mid channel bar created as a result of the undersized culvert shown in Figure 4.

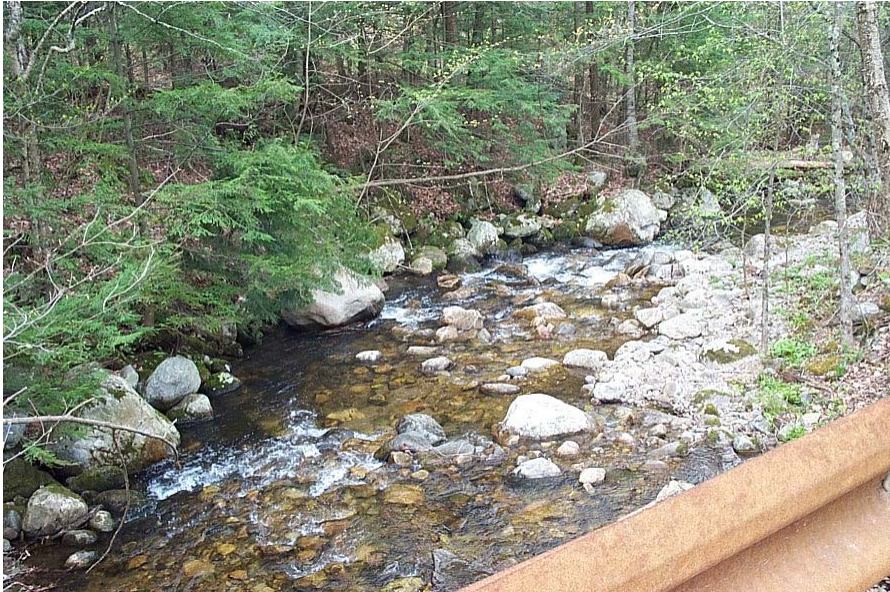
Figure 6. Looking downstream into reach M02 at large native boulders providing good bank armoring

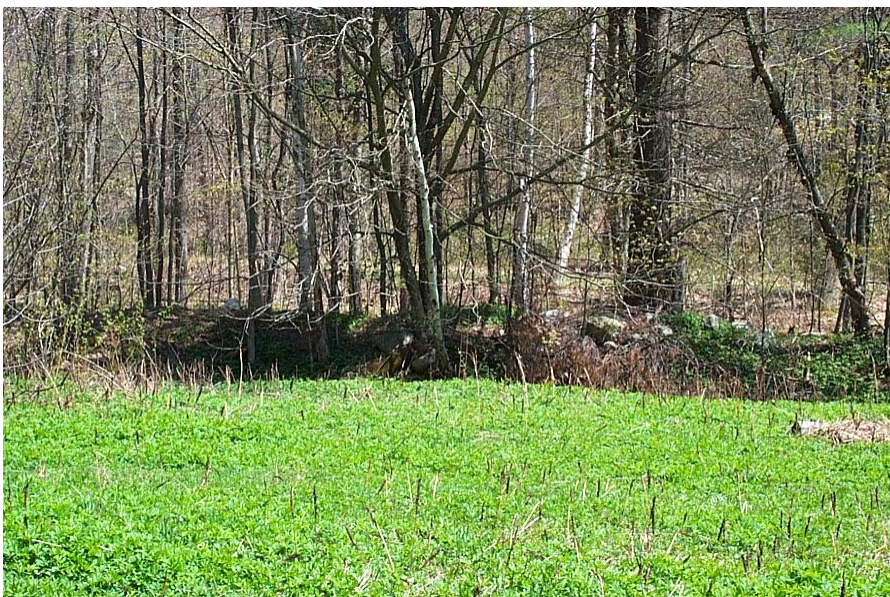
The windshield survey showed evidence of windrowing in two of the reaches within the village of Goshen (see Figure 7). The reaches where berms had been constructed along the channel were T1.04 and S1.01. These berms may have been constructed to protect farm land, roads or houses located adjacent to the North Branch of the Neshobe or Gould Brook within the Village of Goshen. According to Fred Nicholson, historic straightening and channelization dates back to the 1940s. Channel modification projects also occurred in southern Vermont following high flow events in the 1970s.

Figure 7. Historic berms along right bank of reach T1.04 (North Branch of the Neshobe River). The stream channel was over wide in this location and had some minor bank erosion along the right bank. The channel dredging which took place at the time the berms were constructed likely contributed to this wide channel. The channel appeared to be in the process of rebuilding its floodplain.
