**Restoring Water Quality in the Lake Memphremagog Basin:
River Corridor Plan for the Barton and Johns Rivers**

Melissa Dyer
December 19, 2008

Final Report for the 2007-2008 River Corridor Grant

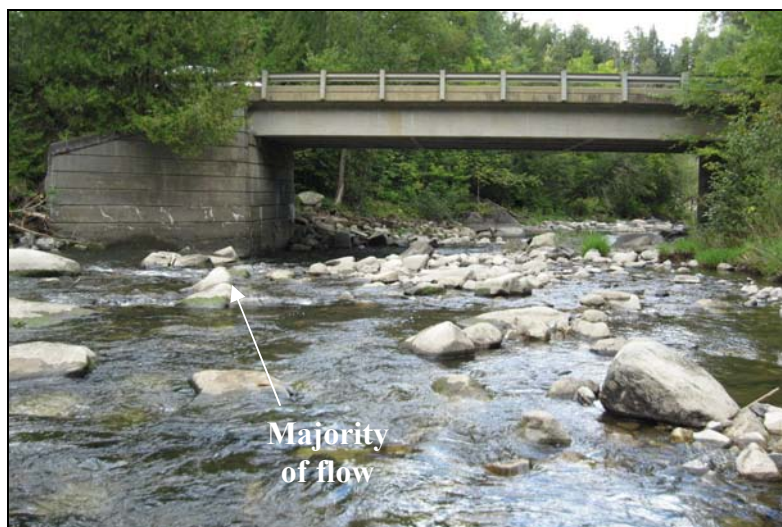
Figure 9: Example of sediment deposition upstream of bridge on Willoughby River Reach T3.

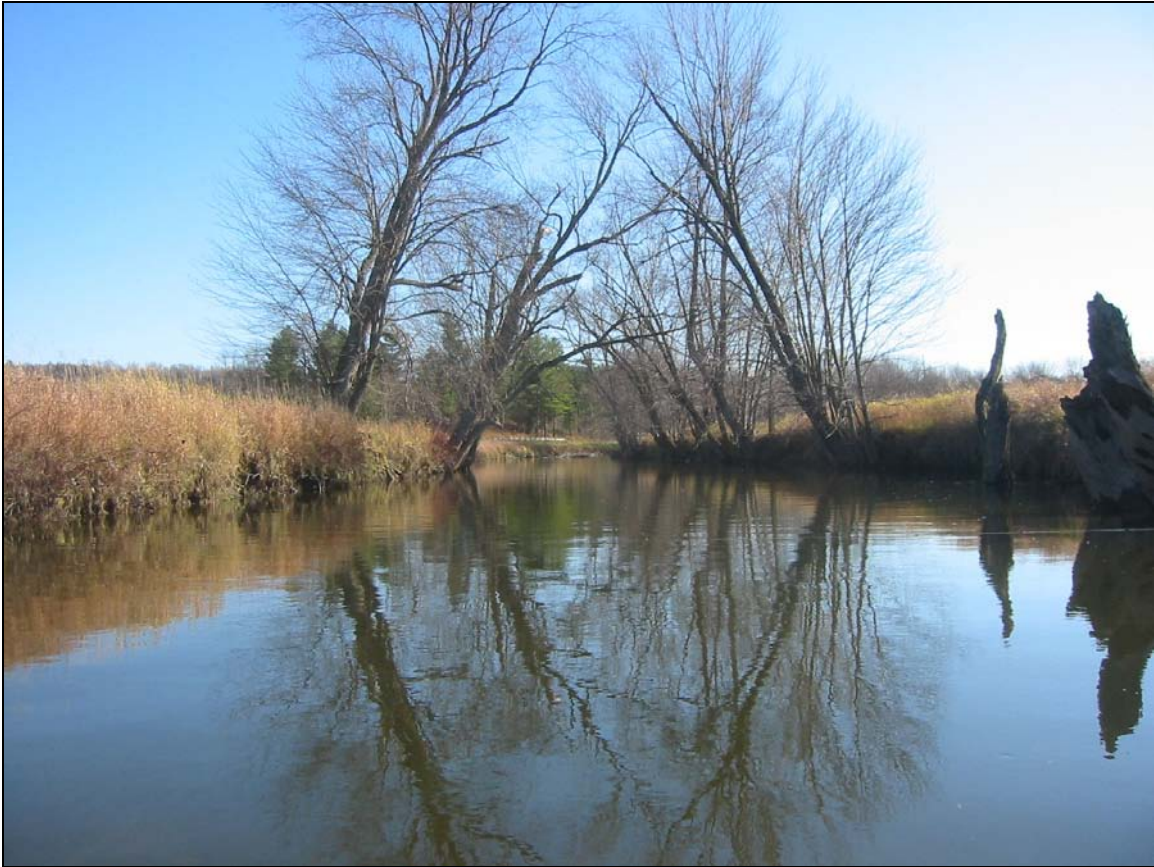
Figure 14: Leaning trees on reach M03A. Riparian vegetation is uncommon along this section.

Most of the riparian corridor is classified as wetland in the Vermont Significant Wetland Inventory; however the landscape is dominated by old fields. The northern half lies in the South Bay WMA. This segment is an excellent candidate for buffer plantings, particularly because seed sources along the large western bend are sparse and the re-establishment of woody vegetation may take a long time. Tree and willow plantings would greatly speed up natural re-vegetation as well as stabilizing some of the eroding banks and improving wildlife habitat.

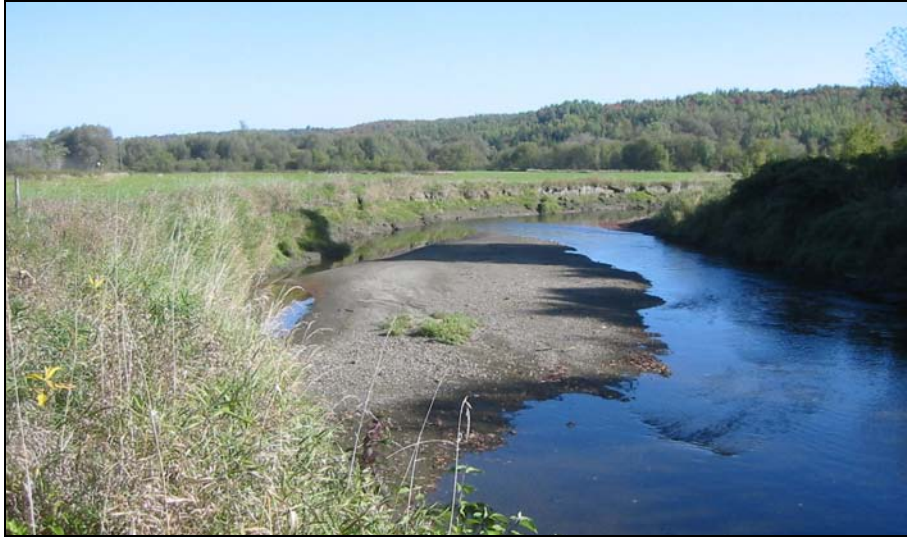
The land along the left bank is mowed to the river’s edge, leaving no vegetated buffer to keep 12’ high banks from eroding into the channel (Figure 17). We anticipate this reach to be dynamic in the future, and recommend that the existing hayfield be reduced or retired within the river corridor to accommodate changes in the river planform. Additionally we recommend planting a wide buffer (>50’) of native trees found in the area such as willow, silver maple, and ash to protect the riverbanks and improve wildlife habitat.

Figure 18. Haying and eroding banks along the river's edge near the Barton /Willoughby River confluence.

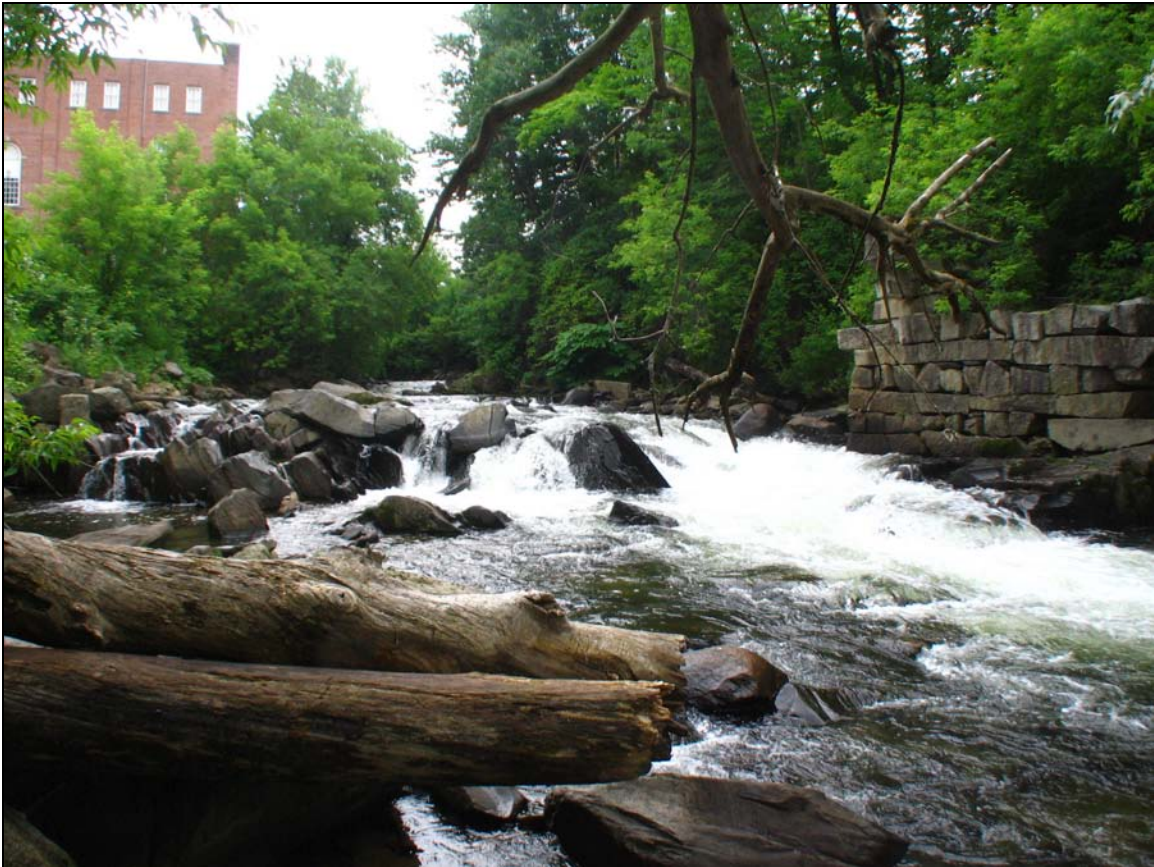
Figure 20: Bedrock ledge and old mill foundation along Reach M04A.

Because most of the river corridor is already developed, options to improve river morphology and habitat conditions are limited. Willow plantings and tree revetments were implemented on the upstream portion of this reach by Lake Region High School teacher Greg Hennemuth several years ago and have stabilized those banks well.

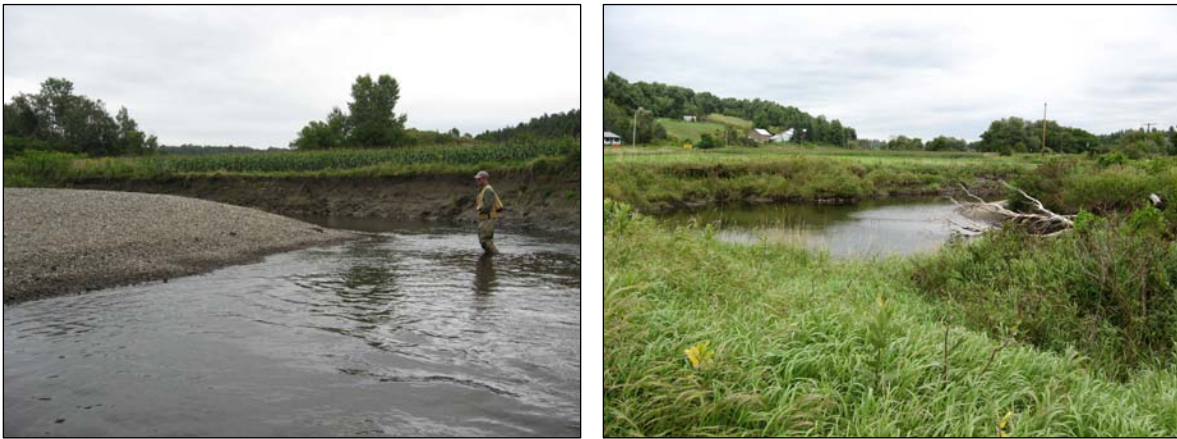
accommodate its sediment load. One meander bend just south of Boudreau Lane, immediately upstream of the railroad crossing, will likely be cut off within the next few years, changing the sediment/flow regime downstream.

Figure 22: Erosion and deposition (left); Slumping banks and herbaceous buffer along Reach M05A (right).

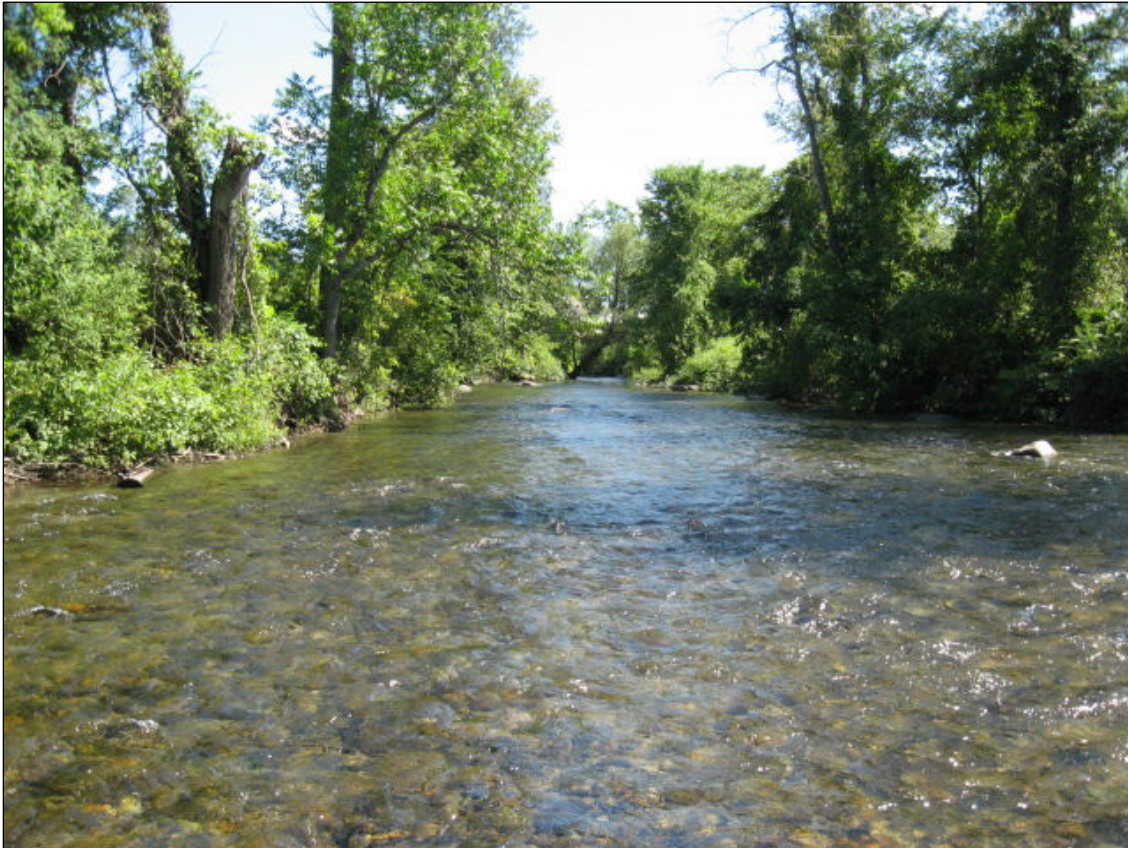
Figure 24: The mostly forested riverbanks along Reach M05B.

Like M05A, reach M05B's corridor is almost entirely devoted to agricultural use and lacks a wide riparian buffer for most of its length (Figure 23). However, M05B appears much more stable and is not incised like many of the Barton River reaches. Bank erosion is much less frequent. Most banks are covered in woody vegetation which stabilizes the banks well (Figure 24), but riparian habitat is limited. Ideally, mowing should cease within 50' of the river in order to improve habitat conditions.

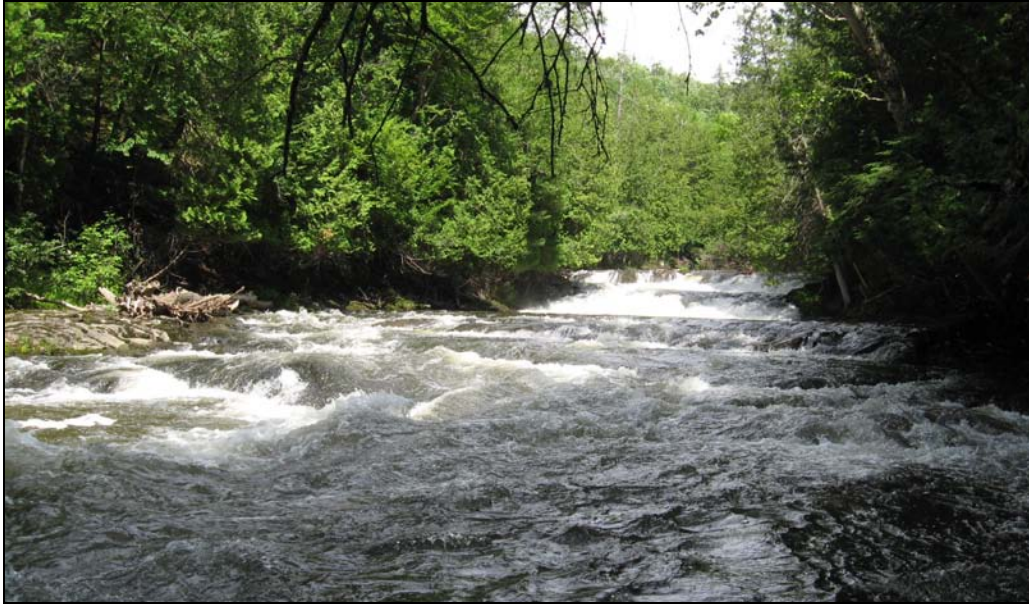
Figure 26: One of many bedrock ledges located in Reach M07.

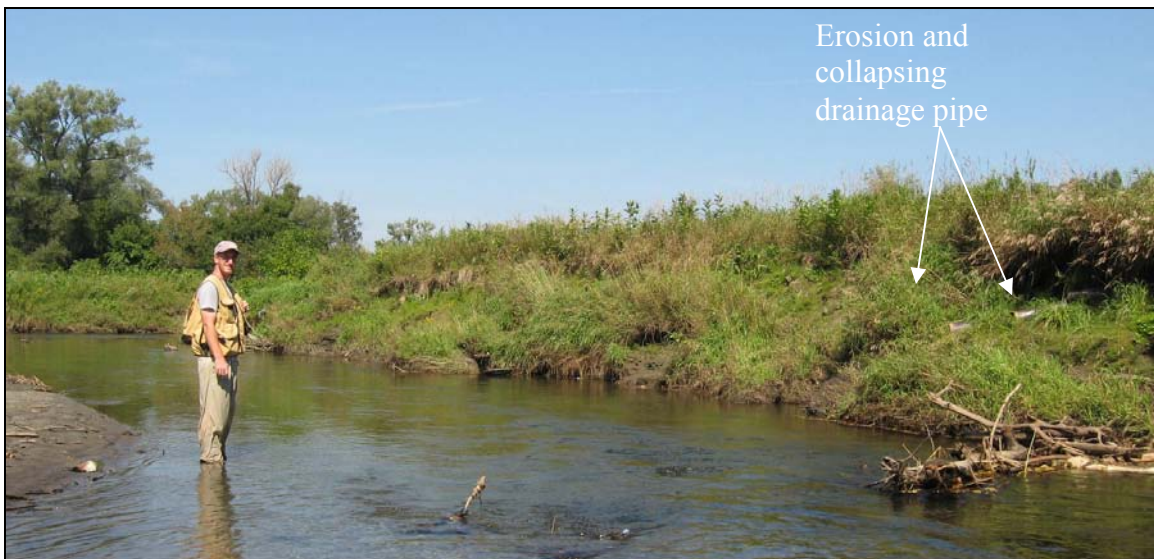
Figure 28: Extensive erosion in this area of Reach M08 has caused several sections of a drainage pipe to collapse.

Fencing the entire corridor (which is also the entire floodplain) and establishing a forested buffer is recommended along this reach. This will greatly improve water quality, as most of the corridor is pasture and cattle are accessing the river. Portions of the reach are migrating (Figure 28), while others are fixed in place by rip-rap. An active restoration approach could include removal of the rip-rap to help the river establish an equilibrium state.

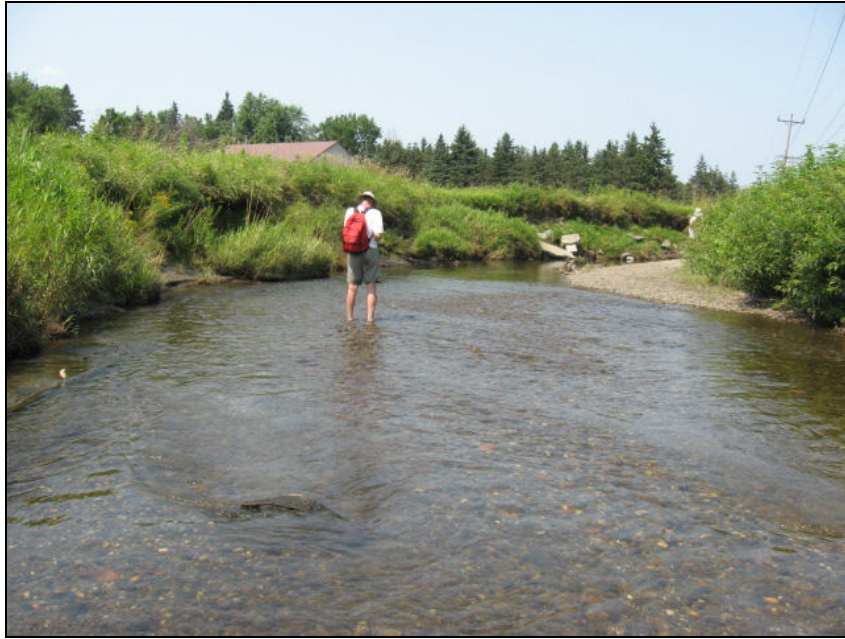
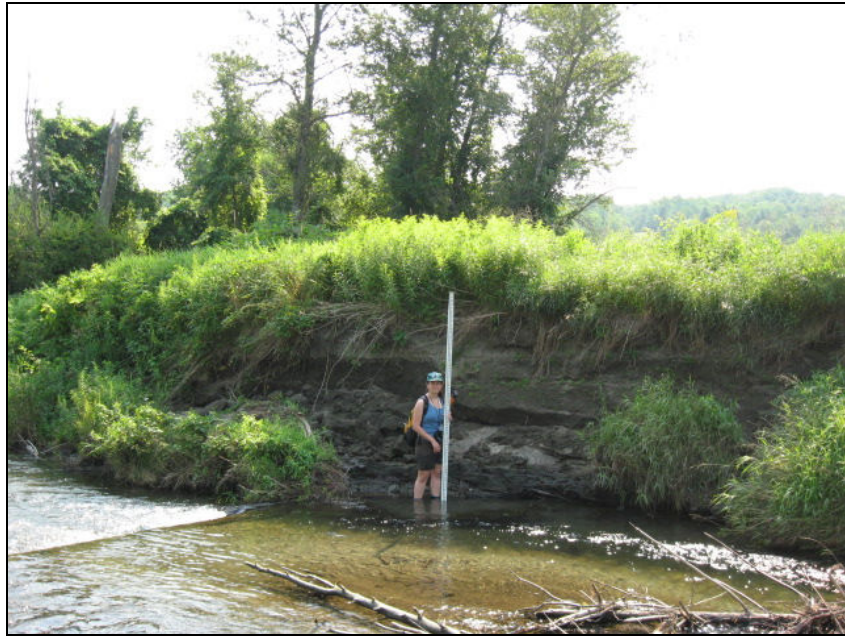
Figure 30: Eroding banks along reach M09

Establishment of a wide strip of natural woody vegetation along the left corridor will be necessary to improve habitat and water quality conditions along this reach. It should be kept in mind that the river will likely transition to a more meandering planform in future decades. The area in the vicinity of Roaring Brook will probably always be dynamic as it reacts to the sediment and flows originating from that tributary; development and agricultural practices should be kept as far from this area as possible.

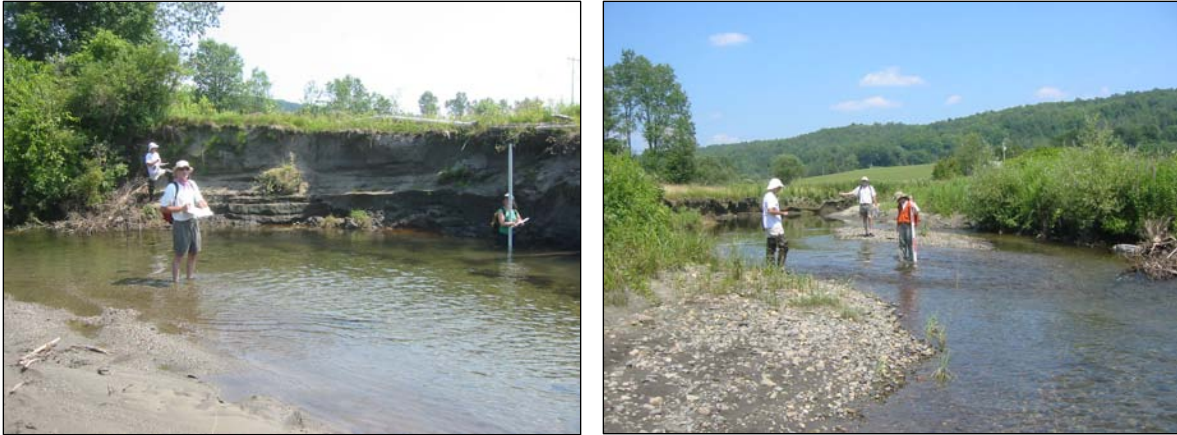
Figure 33: Erosion and deposition along Reach M11.

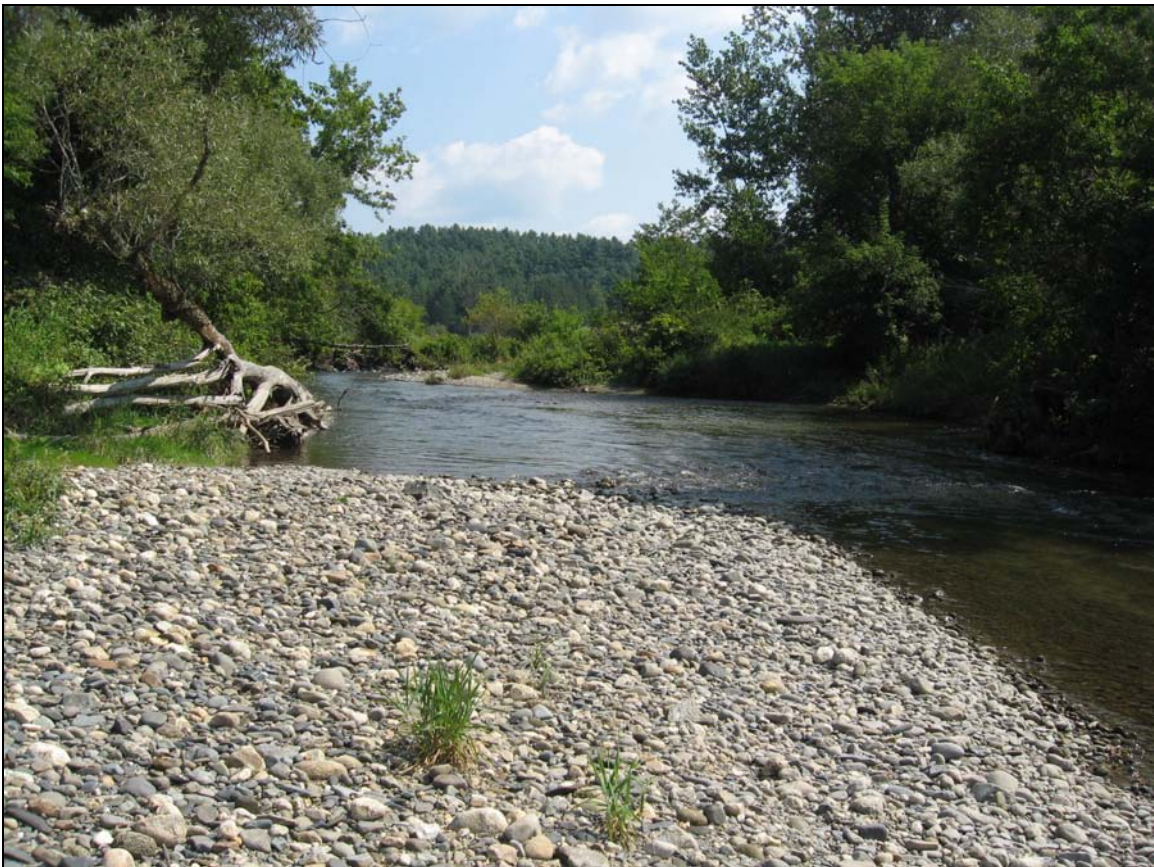
Figure 35: Gravel bars along Willoughby River reach T3.01B.

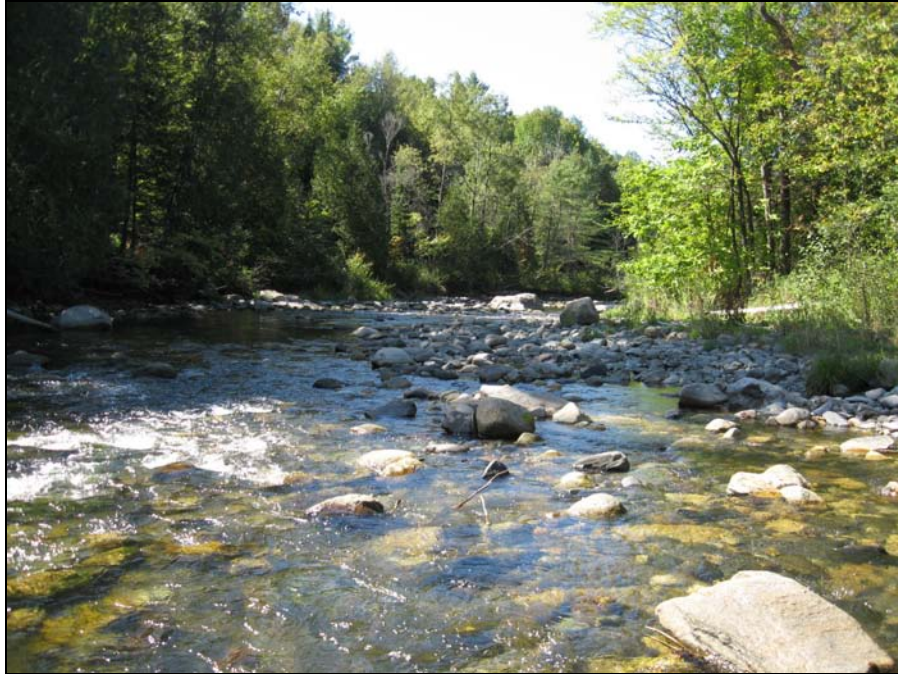
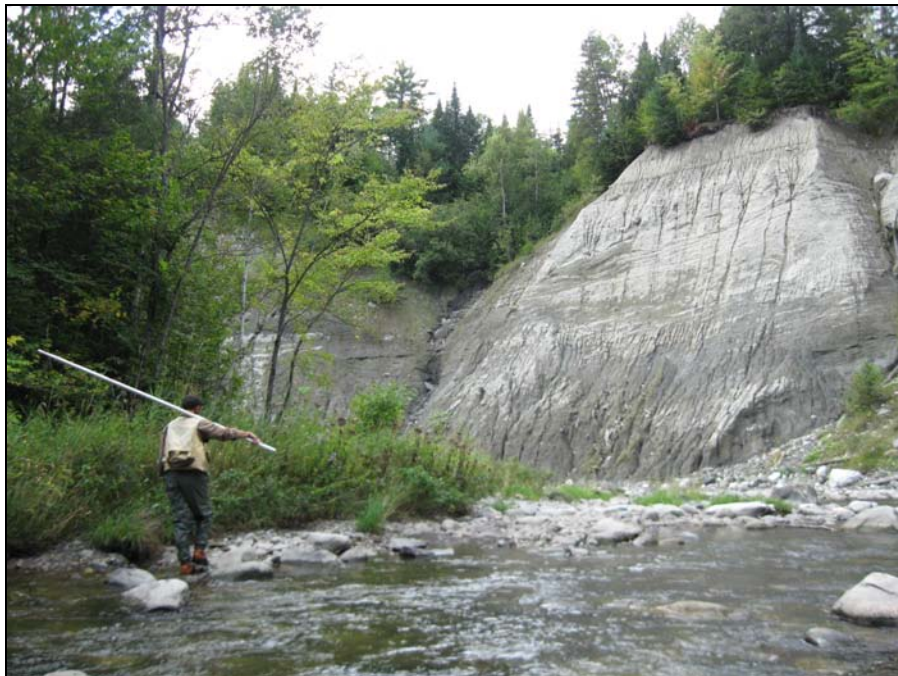
Figure 38: Typical section of the Willoughby River (Reach T3.03, above); One of several mass failure sites on the Willoughby River (Reach T3.04, below).

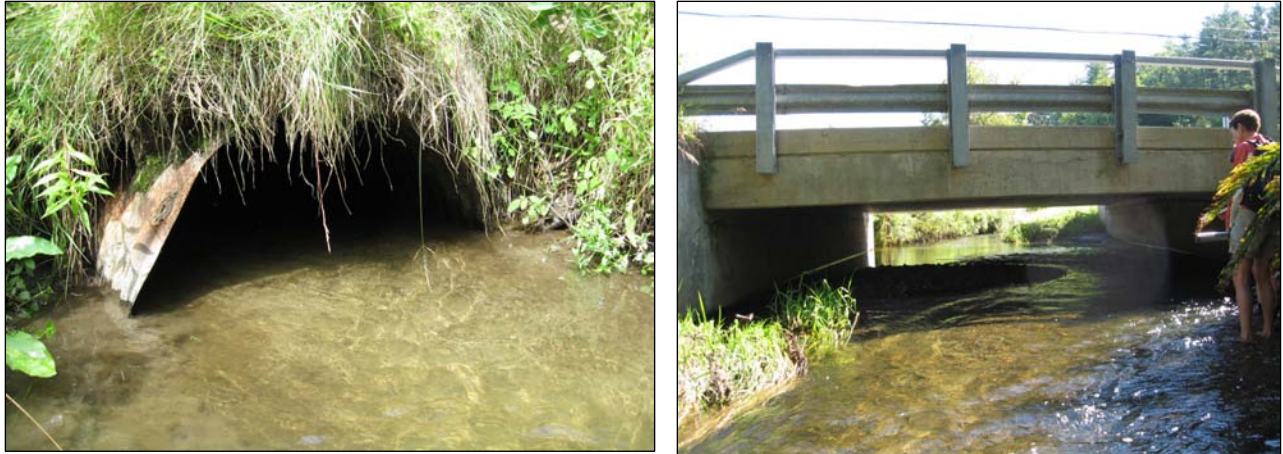
Figure 43: Sediment accumulation downstream of culvert on Reach T1.01; deposition beneath bridge on M05.

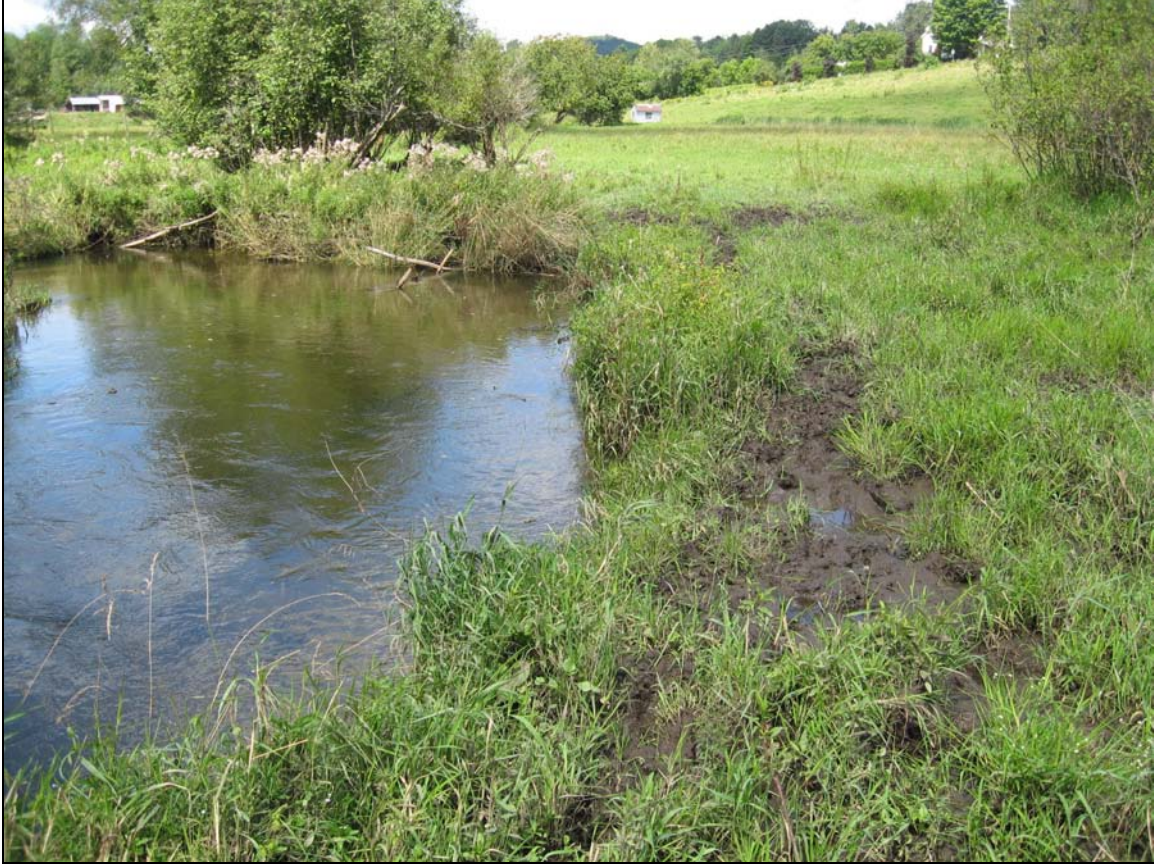
Figure 47: Evidence of cattle accessing the Johns River along Reach M04.

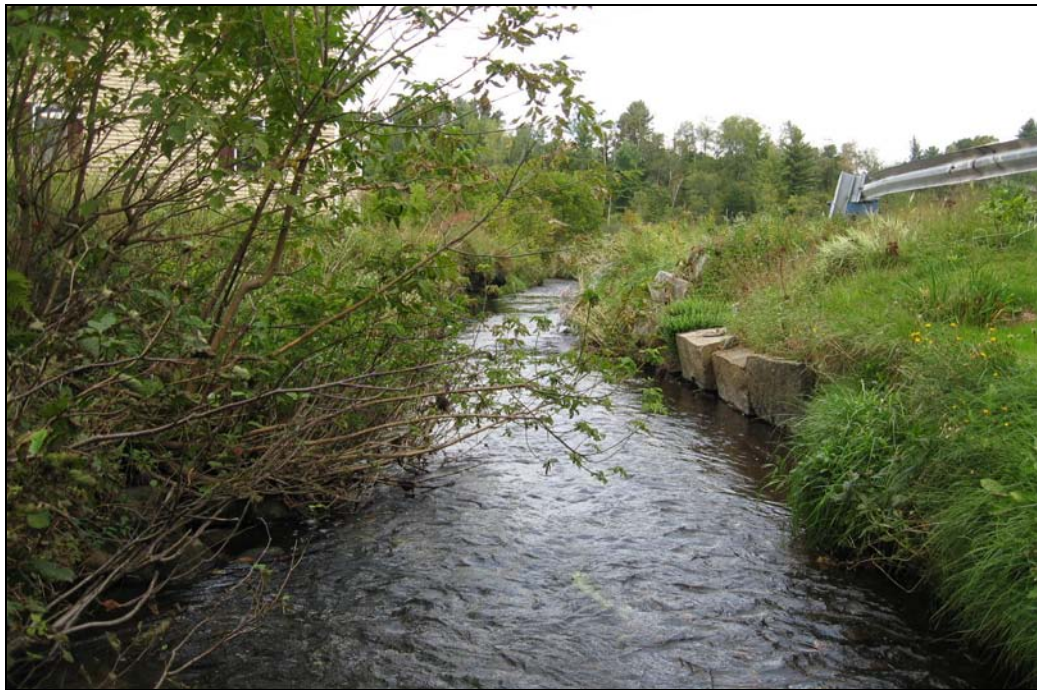
Figure 49: Reach M05 near Darling Hill Road.
