# **Elmore Branch River Corridor Plan**

**Wolcott and Elmore, Vermont**  
**October 30, 2009**

Bear Creek Environmental, LLC

The Lamoille County Planning Commission

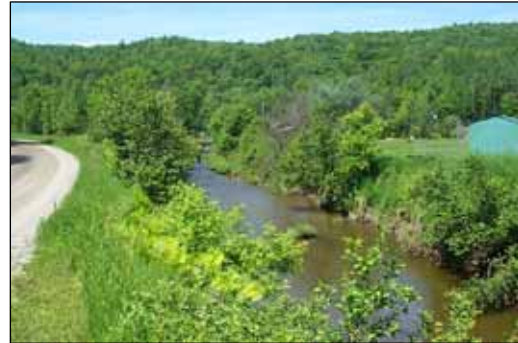
The buffer is narrow on both sides (<5 feet in width). Shrubs and saplings are the dominant vegetation type.

Segment T01-A has undergone a stream type departure from a C channel to a B channel due to historic incision and floodplain encroachment. The measured incision ratio was calculated to be 2.0, suggesting a high degree of incision and loss of floodplain access along this reach. The incision along this segment may be related to extensive channel straightening that seems to have occurred throughout this segment and/or degradation that has occurred in the mainstem of the Lamoille River. Lateral adjustment of the channel in response to this straightening has likely been limited due to extensive armoring of the streambanks. Active adjustment has been limited to only minor widening in this section due to extensive riprap. Approximately 15 percent of the north bank and 35 percent of the south bank has been armored. Sediment storage included only two small bars. The lack of bars in a reference "C" channel is indicative of a segment that has been straightened. The bedform recorded for this section was a plane bed indicating that the incision has resulted in a loss of pool habitat.

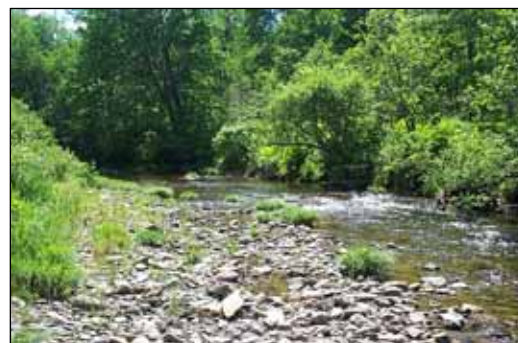
From a major waterfall at the end of reach T02, Elmore Branch segment T01-B continues downstream for 1277 feet to a series of bedrock ledges. This upper segment of reach T01 is a "C" type channel. There is evidence of historic incision

through this segment; however, the reach has rebuilt a juvenile floodplain through major widening and minor planform and aggradation adjustments.

The bedform recorded for this section was a weak riffle-pool indicating that the incision has resulted in a loss of pool habitat. Forest and residential development were noted to be the dominant land use within the riparian corridor of segment T01-B. The buffer was over 100 feet wide on both sides. Shrubs and saplings were the dominant vegetation type.

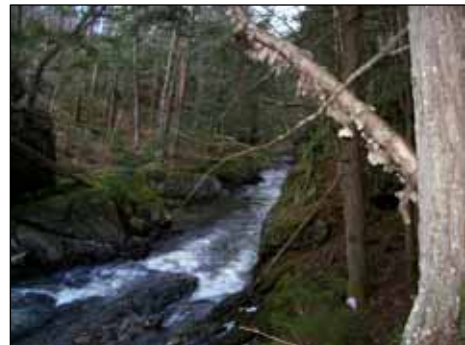
Elmore Branch reach T02 is a 1387 foot long reach that is a very stable bedrock controlled “F” channel. Due to the very stable nature of this stream type, this reach was not assessed for geomorphic condition or habitat quality. The surrounding land use of this reach is also predominately forest.

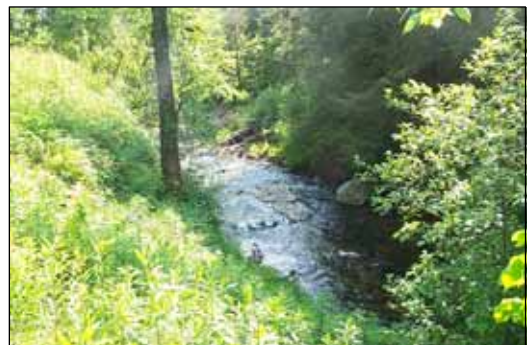
**Reach T03**  
**Protect River Corridor**

Elmore Branch reach T03 is an 1193 foot long reach that is a very stable bedrock controlled “F” channel. This reach was not assessed for geomorphic condition or habitat quality. The riparian corridor of the surrounding landscape is predominately forest.

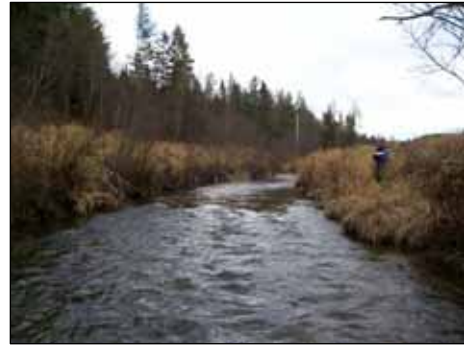
### **Reach T04**

Elmore Branch reach T04 begins at a large waterfall and continues downstream for 3334 feet to where the valley confinement and stream type of the Elmore Branch change. Bank material in this reach was a cohesive mix of silt, clay, and sand. The channel was determined to be a "C" stream type with a riffle-pool bedform. Despite extensive channel straightening through this reach, the river does not appear to have incised. Grade controls at the bottom and top of the reach have likely prevented incision. The stream is, however, undergoing minor widening and major planform adjustment as a result of the increased slope of the channel. Moderate to high scour and erosion at the base of both banks was observed within riffle sections in locations that had not been armored and lacked a high quality buffer of trees and shrubs. It is likely that pasture land (or other agricultural activities) once dominated the surrounding river corridor. The riparian and near bank vegetation is still dominated by herbaceous species rather than woody species.

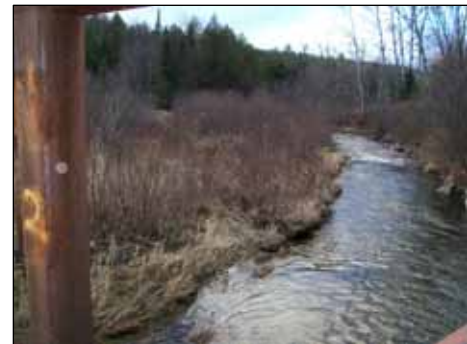
### **Reach T05**

Elmore Branch reach T05 begins downstream of a bedrock dominated section of stream and ends at a large waterfall. This reach is a "C" riffle pool type stream channel by reference and flows through a narrow valley. The major impact affecting the river corridor in this reach is the encroachment of the Elmore Road on the right bank. There was evidence of riprap in the channel that had once been armoring the banks. Some channel straightening and bank armoring may have caused the loss of the riffle-pool bedform, as the reach was found to be a planebed system. Despite these impacts, the reach was found to be in good geomorphic condition exhibiting only minor widening and planform adjustment.

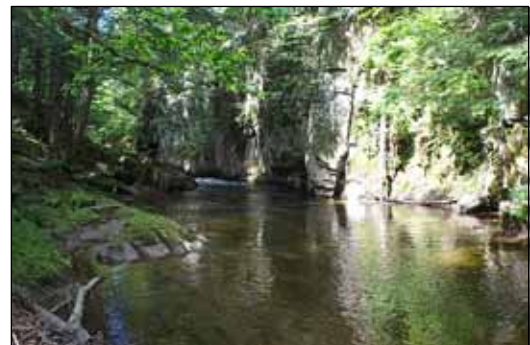
Elmore Branch segment T07-A is a 1031 foot long bedrock gorge with excellent geomorphic stability. Encroachment of the river corridor through this reach was minimal and in all cases has not affected the stability of the stream channel. Due to the very stable nature of this stream type, this reach was not assessed for geomorphic condition or habitat quality.

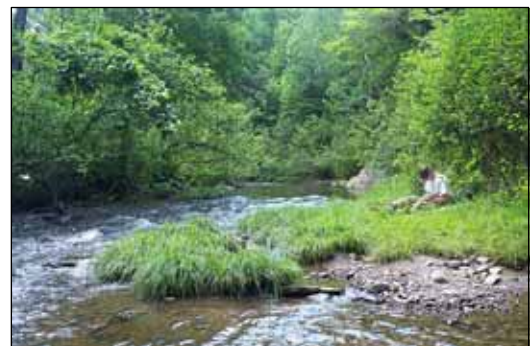
#### **Segment T07-B**

Elmore Branch segment T07-B is 422 feet in length. This short segment encompasses a transition zone between the reference “C” channel found in reach T08 and the bedrock gorge of segment T07-A that begins immediately downstream. The segment was found to be a “B” stream that had departed from a reference “C” channel. High terraces indicated that the stream has undergone some incision (the incision ratio was 2.4). This incision may be related to excessive aggradation that may occur at the entrance to the bedrock gorge where the stream may be cutting back through this deposition. The segment showed only minor signs of channel aggradation, widening, and planform adjustment likely associated with excess sediment from major bank erosion in upstream reaches as well as from channel adjustment associated with the historic incision. Buffer conditions on both sides of the stream channel were dominated by mixed trees and shrub saplings.

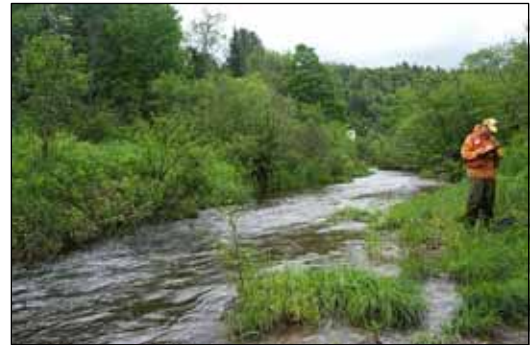
**Reach T08**  
**Protect River Corridor**

Elmore Branch reach T08 is 1911 feet long and begins at the confluence of a tributary downstream of Symonds Mill Road. Land use within the stream corridor was found to be influenced by clearing for hay. Some channel straightening was also noted along this reach as was historic channel incision. The floodplain is mostly old field and wetland with no structures. A juvenile floodplain has developed along much of reach as the stream has been building bars and narrowing. The reach was found to be undergoing major aggradation and planform adjustment. The reference and existing stream type for this reach is "C".

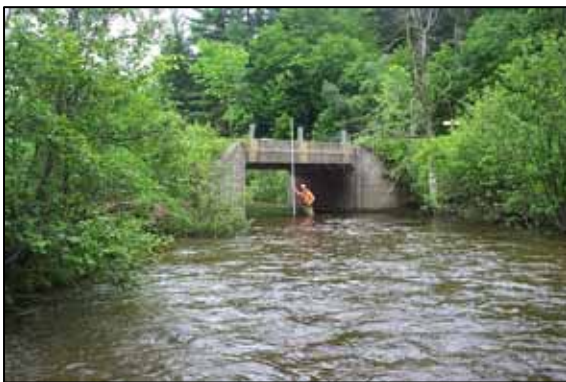
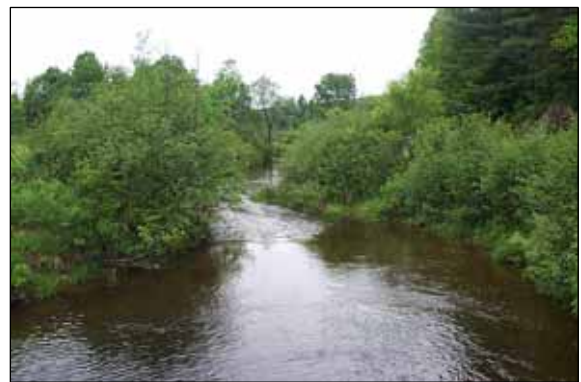
**Reach T09**  
**Replace Undersized Bridge**  
**Improve Riparian Buffer**

There are three bridges on the Elmore Branch in the Phase 2 study area. The bridge on Symonds Mill Road just before it meets East Elmore Road impacts sediment movement and is a bit undersized. According to LCPC, this bridge failed in a flood in 1995 and is in danger of failing again due to upstream sediment deposition and poor location and alignment. This reach also has some sediment storage in the form of point and side bars, and the most significant erosion on the entire river with erosion spanning fifty feet long by twenty feet high. This bank failure was located about 2000 feet upstream of the bridge on Symonds Road. During the Phase 2 Assessment conducted by BCE and LCPC, the undersized bridge with poor alignment at Symonds Mill Road was identified as creating sediment transport problems (see Table 5). This bridge has a span of 49 percent of the bankfull width is recommended for replacement. No significant sediment transport or alignment problems were noted at the other three stream crossings during the Phase 2 assessment.

Elmore Branch reach T09 is 450 feet long. The reach begins at the confluence of an unnamed tributary, flows under the Symonds Mill Road and ends at the confluence of another unnamed tributary. The banks are mostly lined with alder; there is a road on the east bank and an old field on the west. The dominant buffer width on the west bank is less than 25 feet. The lowest tributary is undergoing major rejuvenation; however that is not affecting this reach. Reach T09 had evidence of historic channel straightening and incision. It was found to be undergoing minor widening and planform adjustment. The reference and existing stream type for this reach is "C". The bridge at Symonds Mill Road is undersized and is poorly aligned and is recommended for replacement.

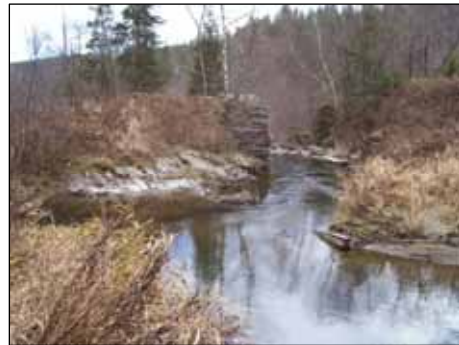
Elmore Branch segment T10-A flows through a narrow bedrock gorge. Two historic mill dam sites were found within this segment. Due to bedrock control that was found through most of this reach, only a partial assessment was conducted in accordance with ANR assessment protocols. Some erosion of the stream banks were noted in several locations, indicating the channel had undergone some localized widening in this reach. The reference stream type for this segment is a "B" channel dominated by bedrock. Due to the width and steep bank, the existing stream type appeared to be an "F" channel.

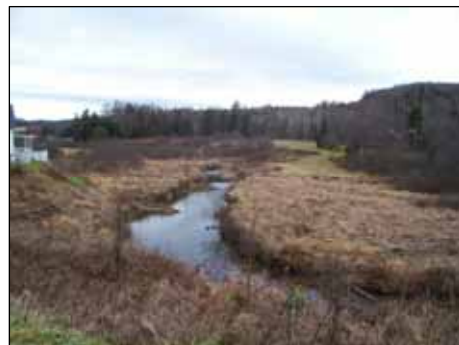
### **Segment T10-B**

Elmore Branch segment T10-B flows through a very broad valley that may have been partially flooded by historic mill dams in segment T10-A. These dams may have caused years of sediment build up (aggradation) to occur. It appears that the stream has eroded its channel (incised) and is possibly still cutting through this sediment buildup. The upper portion of the segment has been straightened historically, likely for agricultural purposes. The reference stream type for this segment is a "C4" channel that is a slightly entrenched, meandering, gravel dominated, riffle-pool channel with a well developed floodplain. Despite some areas of poor floodplain access, the stream was found to be a "C" channel through most of the reach. Continued minor adjustment within this reach will likely occur until the channel has reached an equilibrium slope, planform, dimension, and access to a seasonal floodplain.

#### **Protect River Corridor** **Improve Riparian Buffer** **Evaluate Localized Incision**
