# Dishmill Brook Watershed River Corridor Plan Burke, Vermont February 12, 2014

Prepared by:  
Bear Creek Environmental, LLC  
149 State Street, Suite 3  
Montpelier, Vermont 05602

Prepared under contract to:  
Caledonia County Natural Resources Conservation District  
481 Summer Street, Suite 202  
St. Johnsbury, Vermont 05819

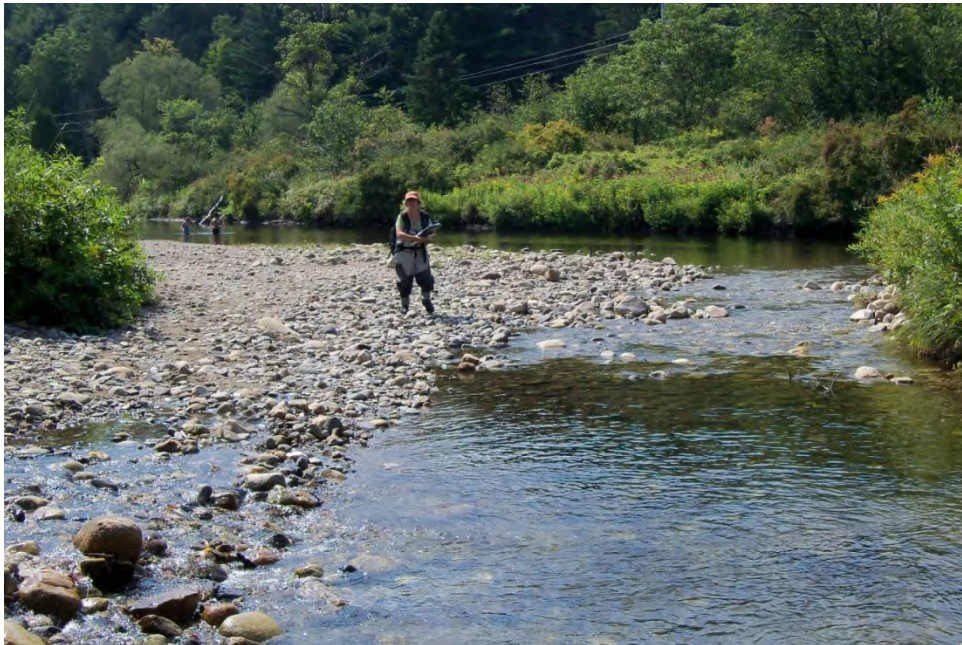
**Figure 5.3.** Confluence of Dishmill Brook and East Branch Passumpsic River.

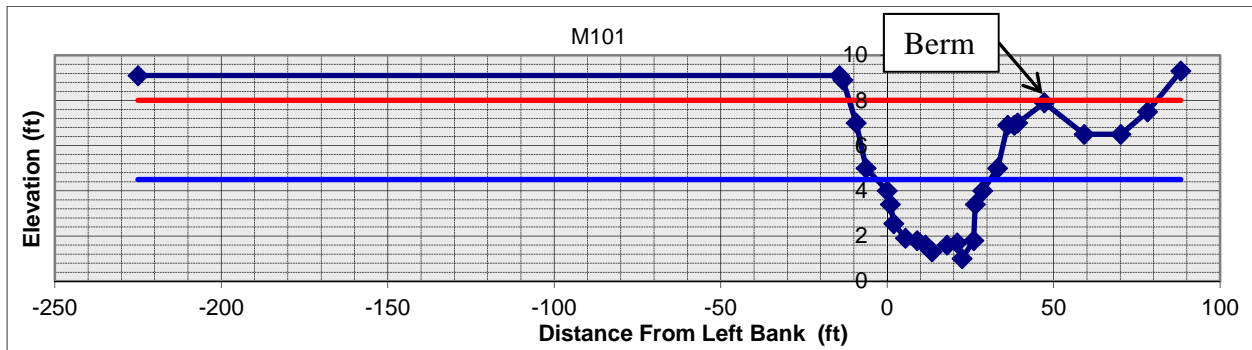
M101-A is in **fair** geomorphic condition. This segment differs from the upstream segments in that it is very unstable due to loss of floodplain access through berming (Figure 5.4). The abundant infrastructure in the river corridor and the disconnection of the channel from its floodplain due to berming has led to major channel **incision** and a stream type departure from a “C” stream to a “B” stream. The channel is not widening due to the extensive armoring on the banks.

**Figure 5.4.** Cross section of M101-A showing berm preventing floodplain access.

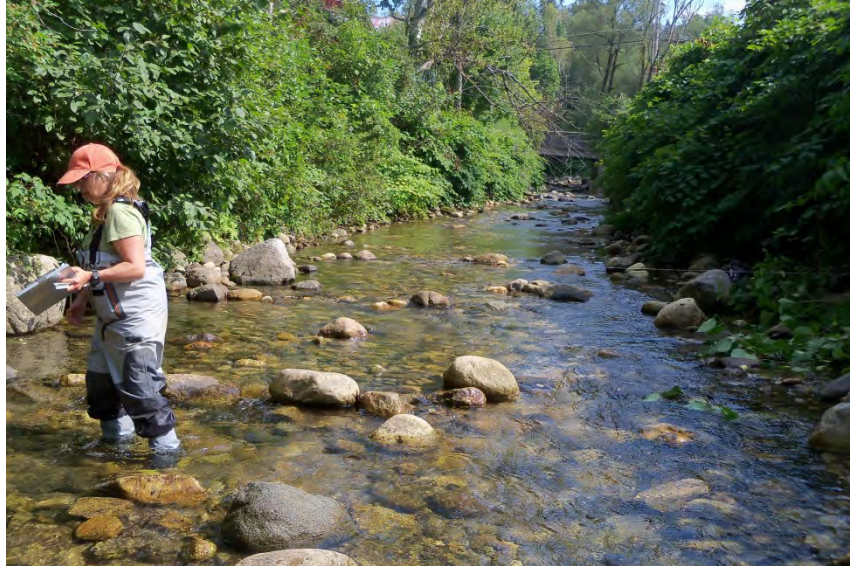
M101-A is in **poor** habitat condition due to its limited pools and large woody debris, abundant fines and invasive plants (Figure 5.5), compromised channel morphology, and poor bank and buffer vegetation.

Figure 5.5 Abundant Japanese knotweed on both banks in M101-A.

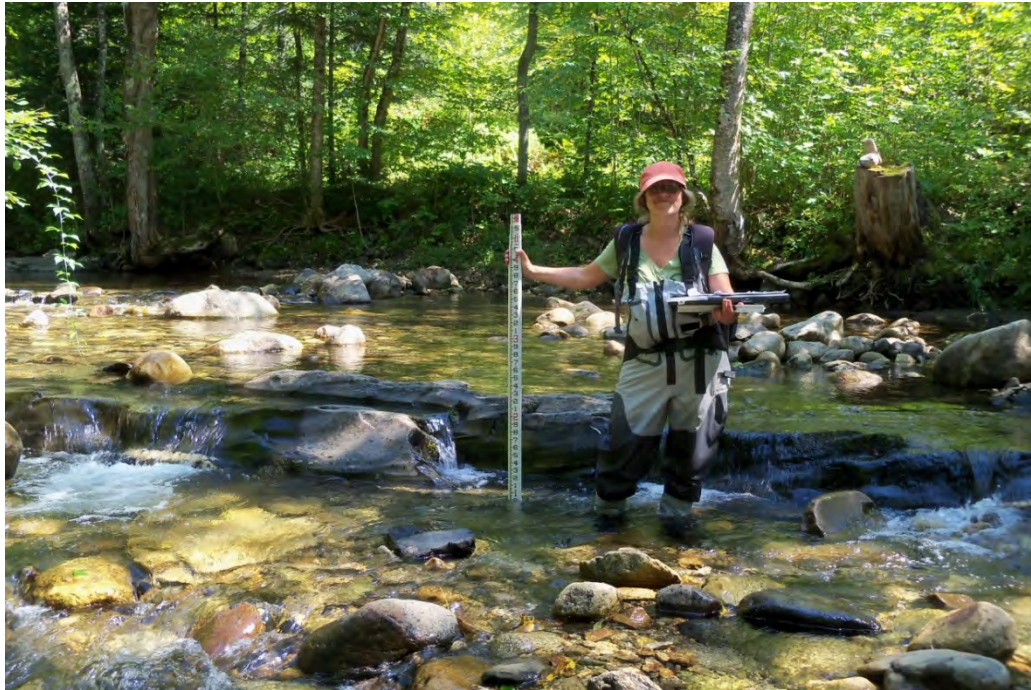
Figure 5.6. Ledge grade control in M101-B.

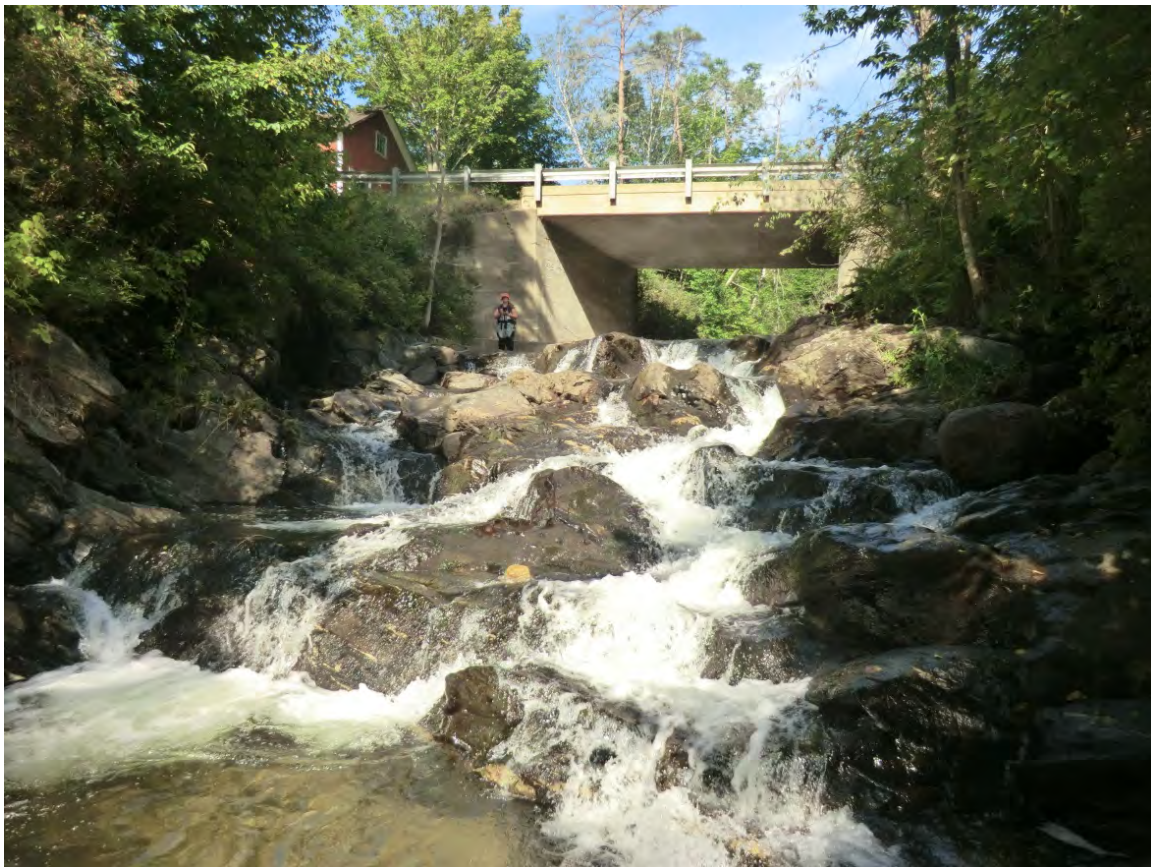
**Figure 5.7.** Ledge grade control just below Kirby Road in M102-A.

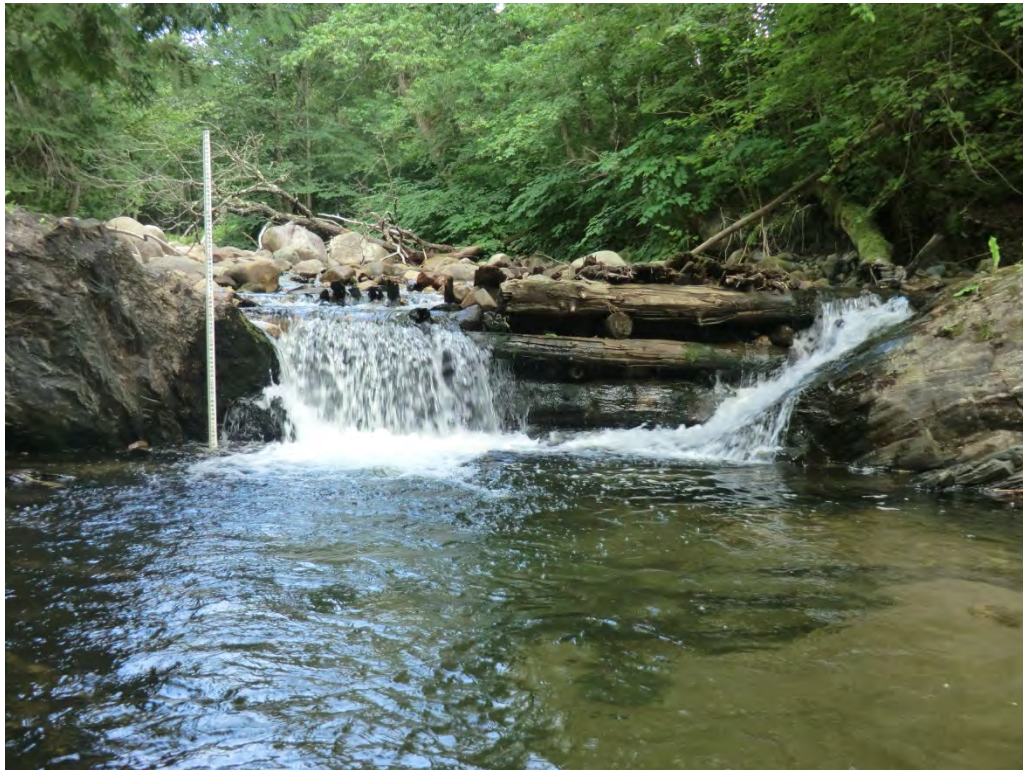
Figure 5.8. Old dam with logs in channel causing scour downstream in M102-A.

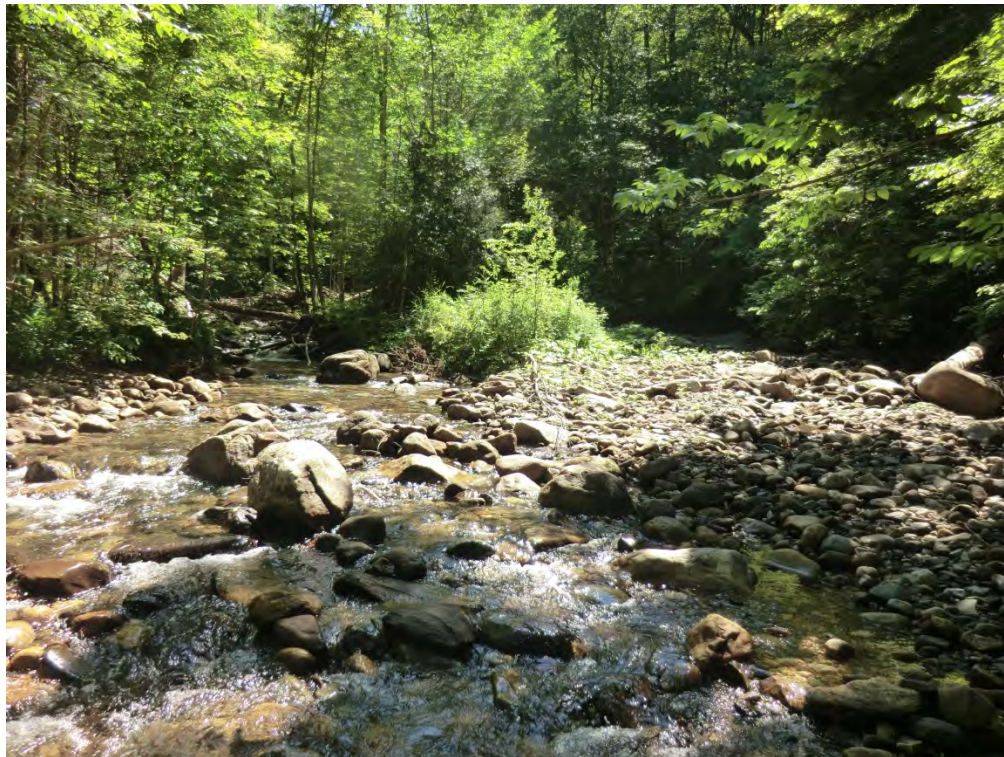
M102-B is in **good** geomorphic condition with major **aggradation** as the main process that is a result of a decrease in slope from the upstream transport reach. The major aggradation has led to minor widening and planform change. At the upstream end of the segment, the brook has cut off its original course (*avulsion*) and is now flowing in a new channel (Figure 5.9). Gullies in this segment are contributing excess material to the channel as well causing an increase in sediment load (Figure 5.10). M102-B is in **good** habitat condition due to many factors including but not limited to good refuge habitat, abundant large woody debris and pools, good substrate cover and predominantly well vegetated banks and buffers.

**Figure 5.9.** Channel avulsion in M102-B with associated aggradation.

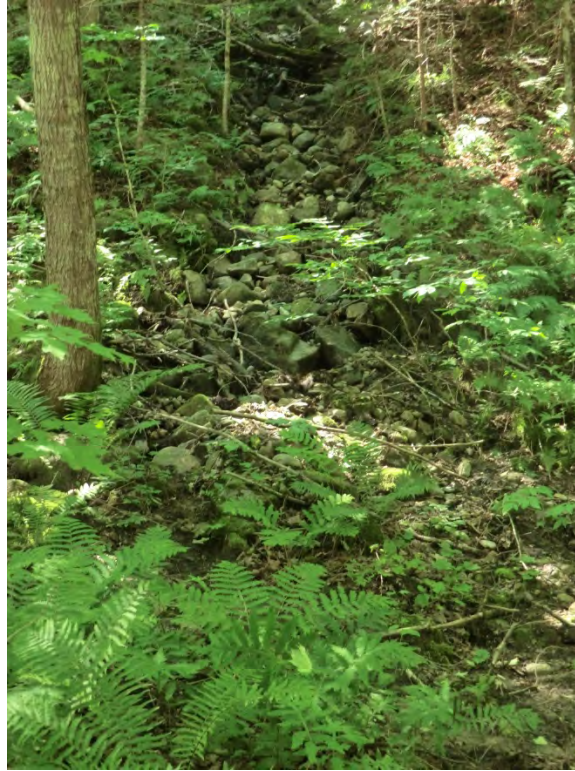
Figure 5.10. Gully on valley wall contributing sediment to channel in M102-B.

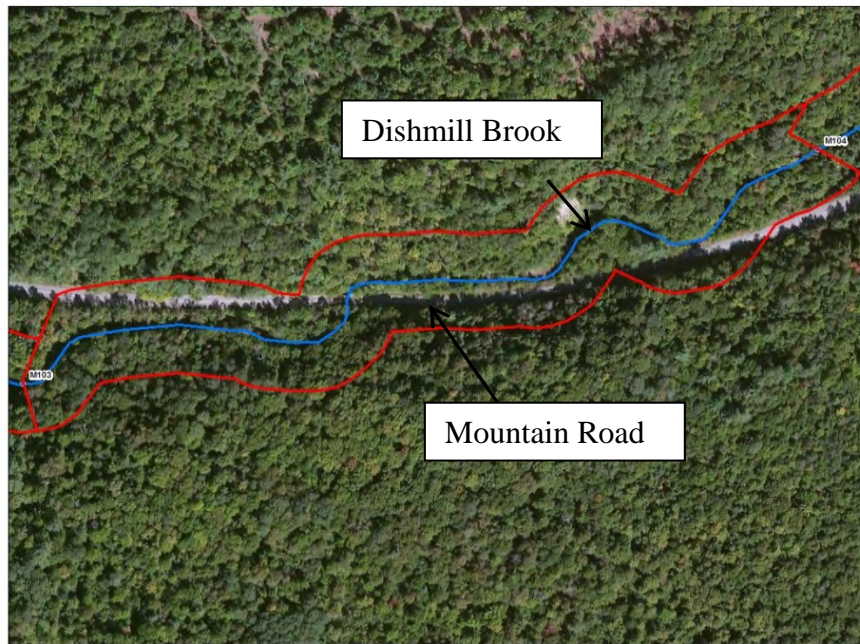
**Figure 5.11.** Road encroachment of Mountain Road on Reach M103.

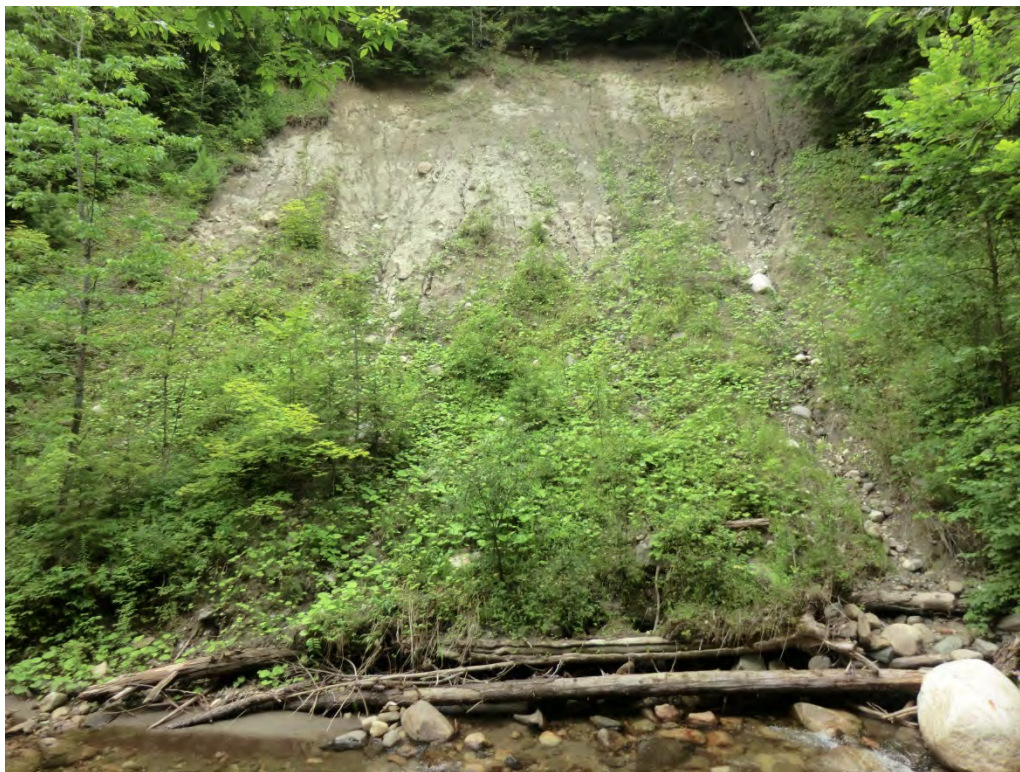
**Figure 5.12.** Mass failure on the northern bank in reach M103.

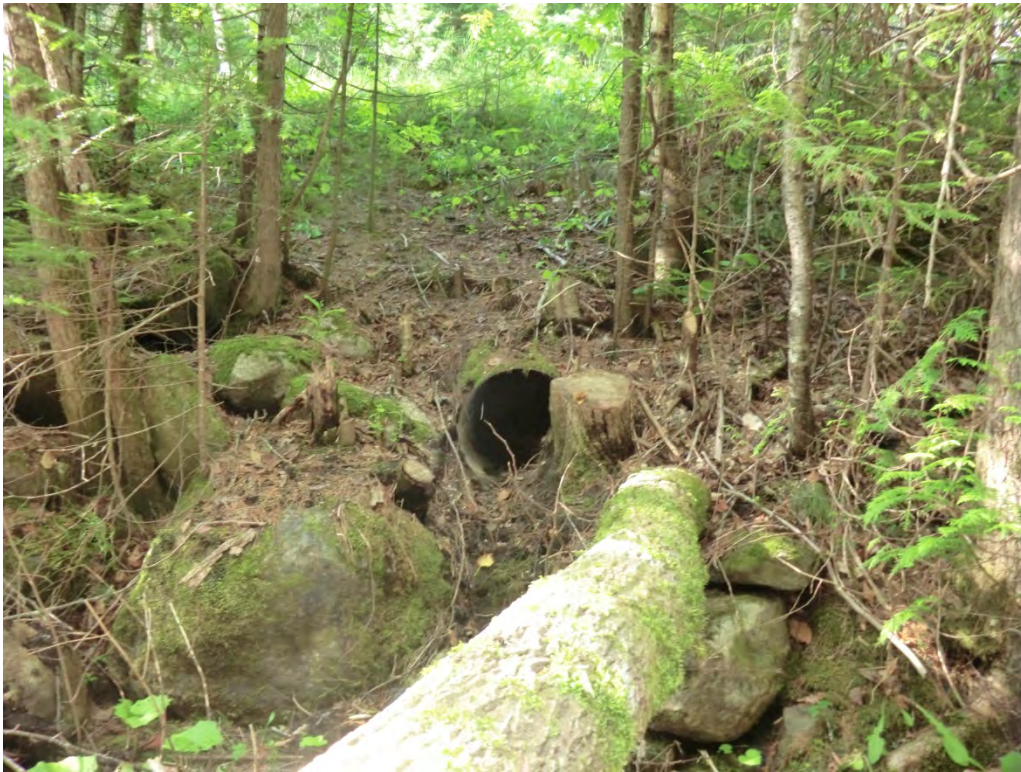
**Figure 5.13.** Stormwater drainage pipe contributing sediment to Dishmill Brook in M103.

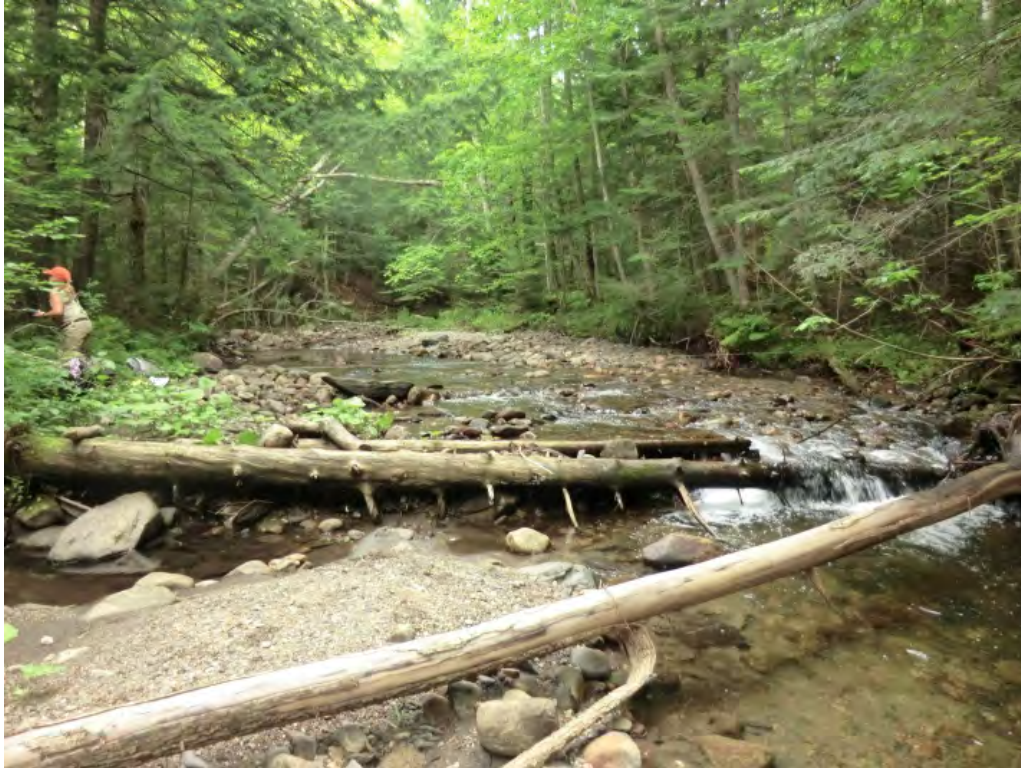
**Figure 5.14.** Increased sediment storage in M104 from debris in channel.

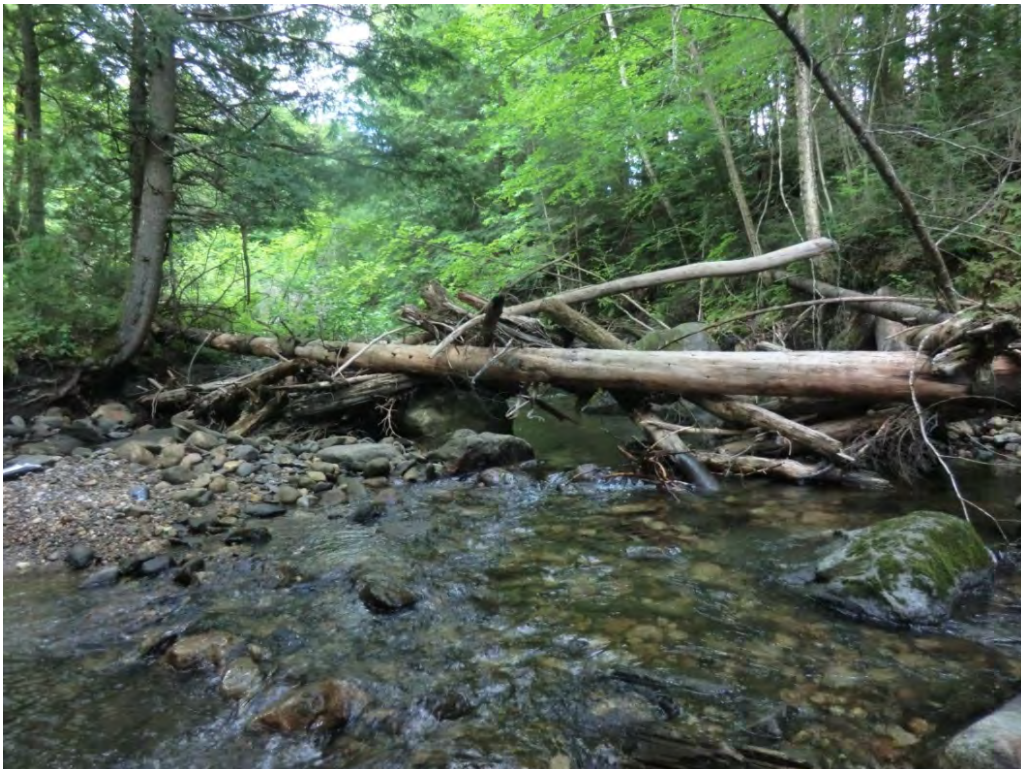
**Figure 5.15.** Debris jam in M104.

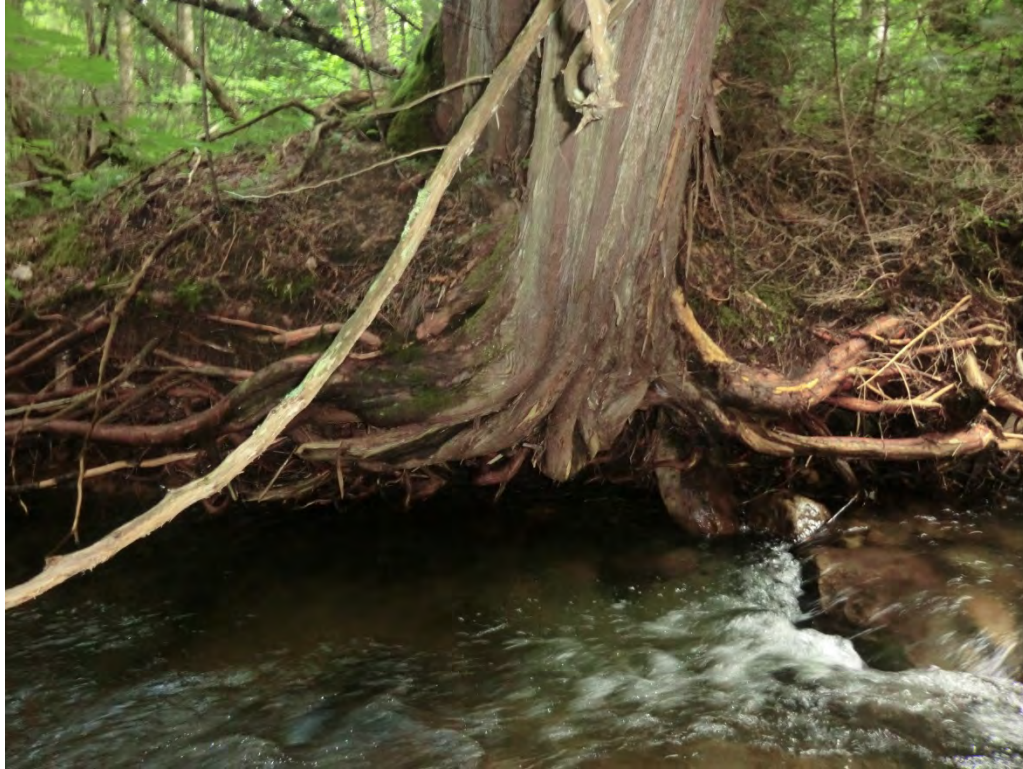
Figure 5.16. Undercut bank and deep pool in M104.

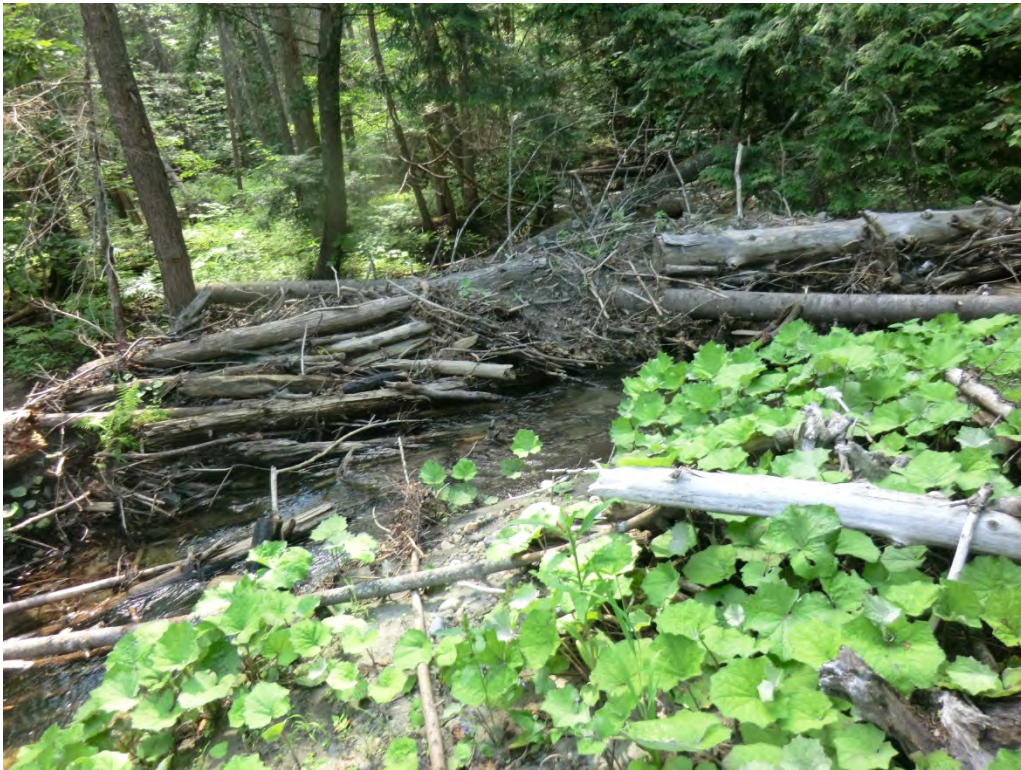
**Figure 5.17.** Large debris jam in M105-A.

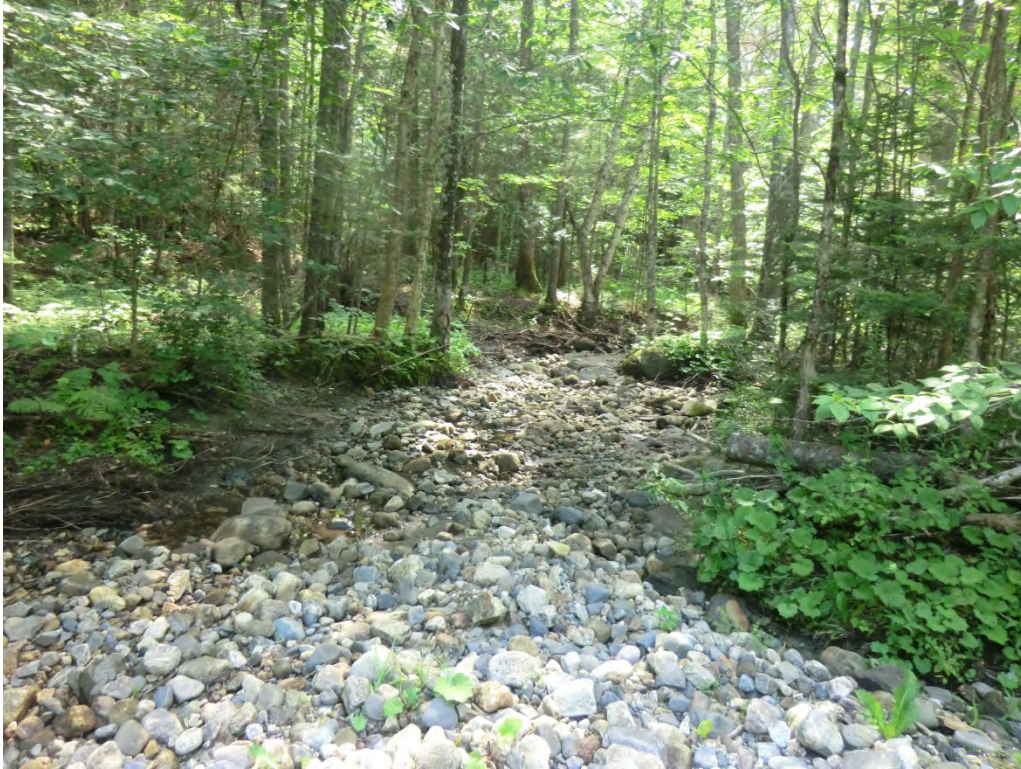
**Figure 5.18.** Abandoned channel in M105-A from influence of debris jam.

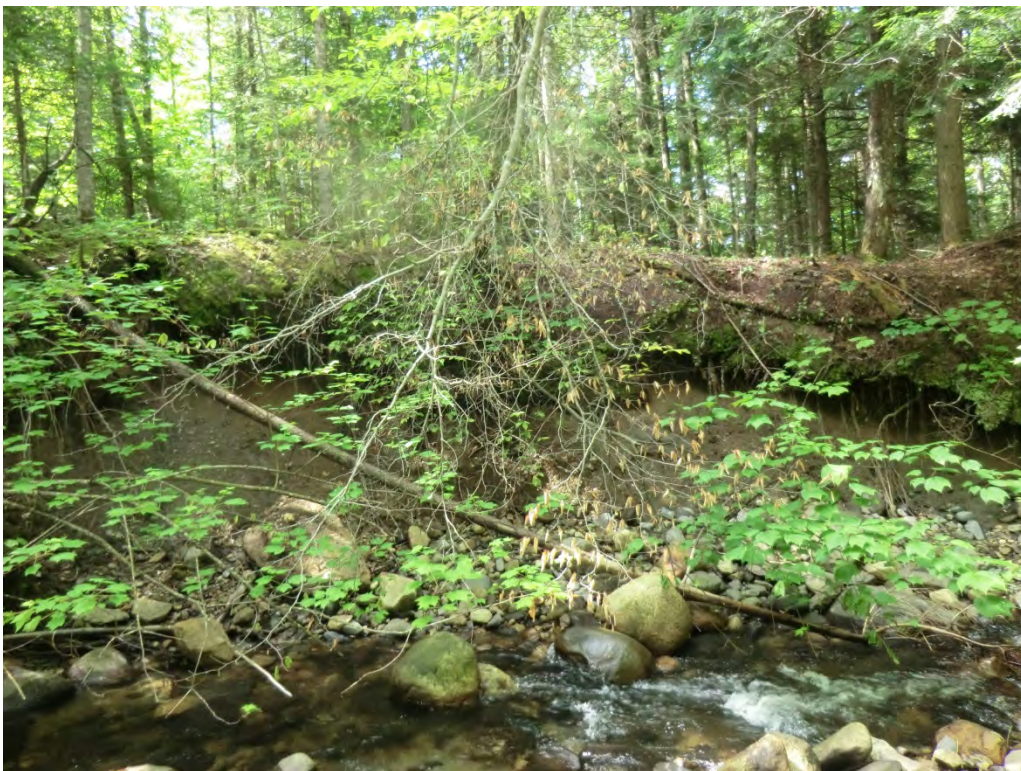
**Figure 5.19.** Mass failure in M105-A contributing sediment to Dishmill Brook.

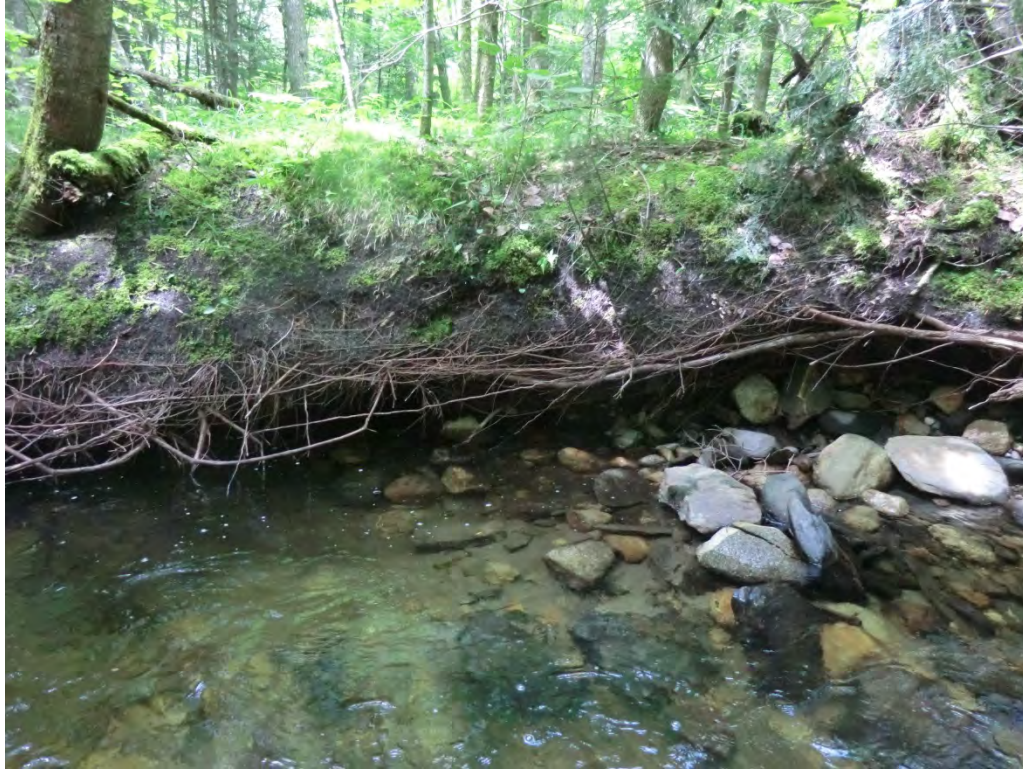
**Figure 5.20.** Undercut bank providing habitat in M105-A.

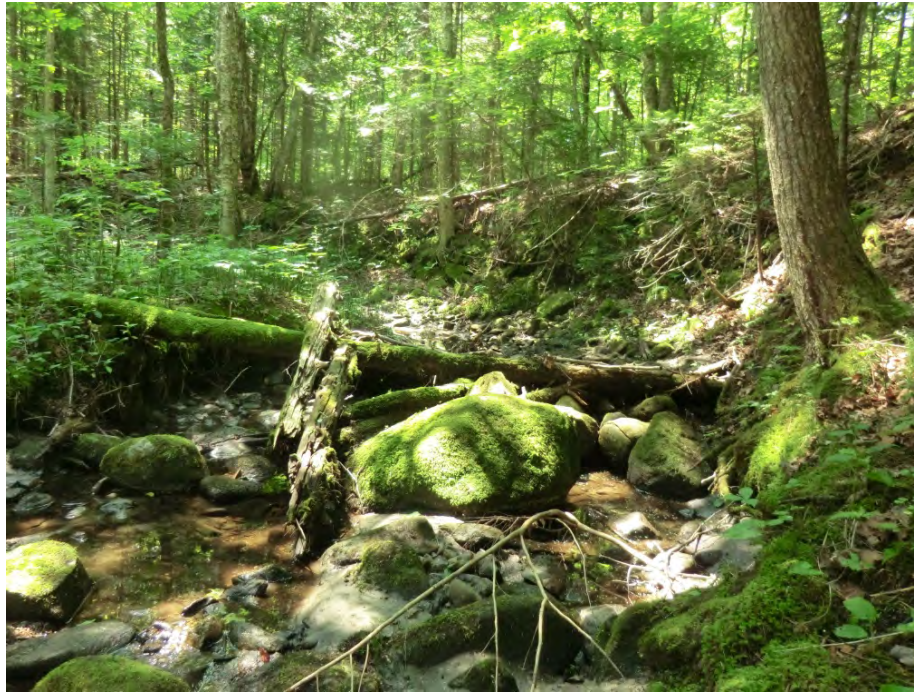
**Figure 5.21.** Old channel at avulsion location in M105-B.

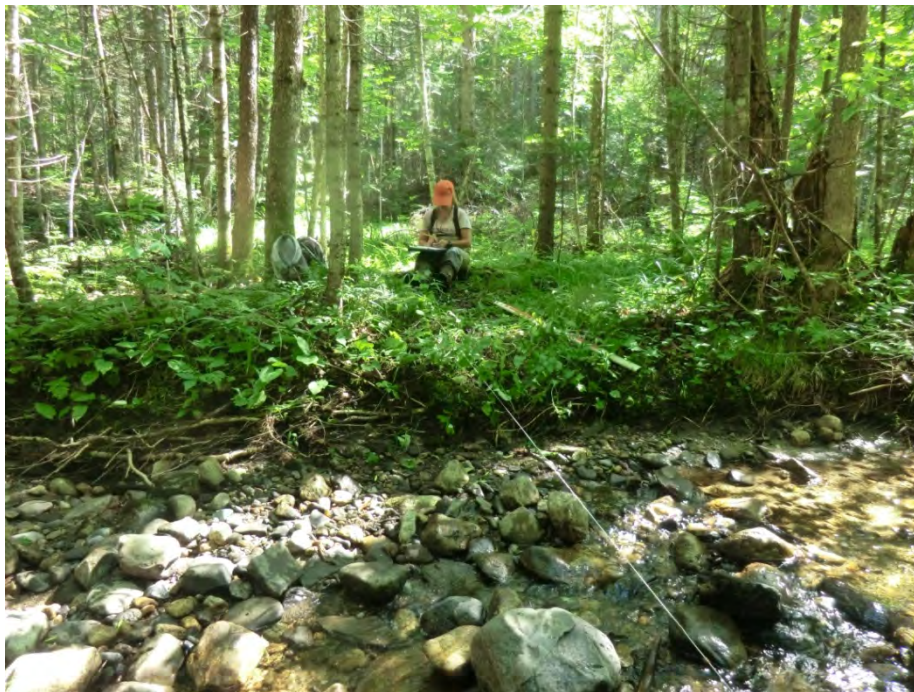
**Figure 5.22.** Well vegetated banks and buffers and floodplain access in M105-B.

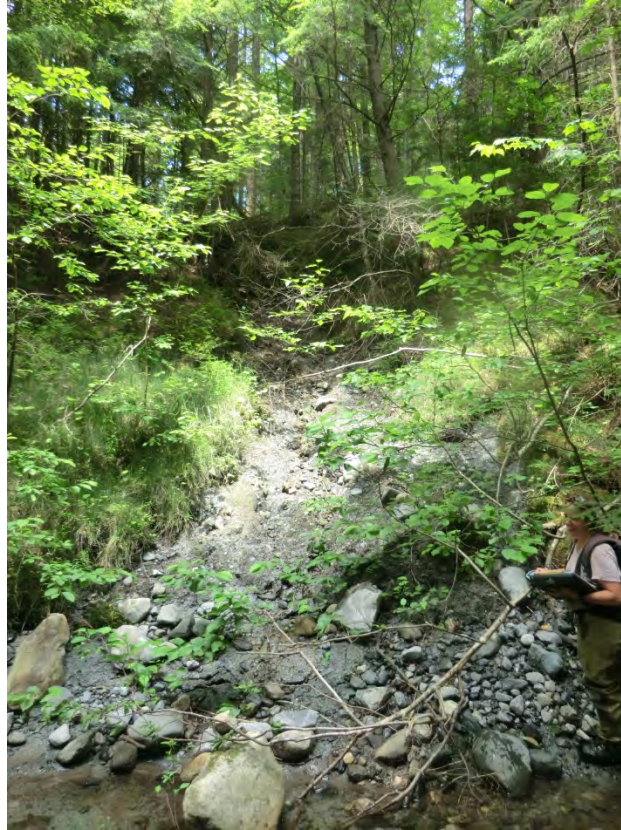
Figure 5.23. Mass failure with clay in lower bank and bed in M105-B.

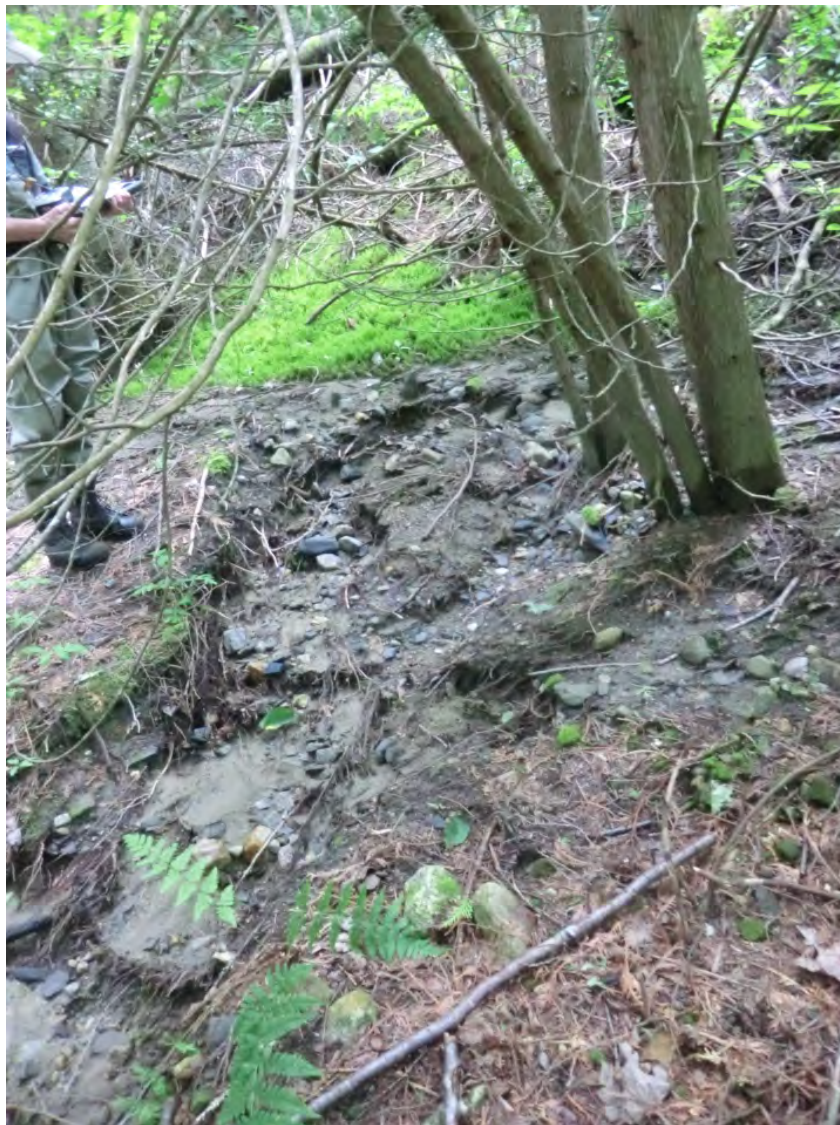
**Figure 5.24.** Sediment laden overland flow from the southern side of reach T1.01.

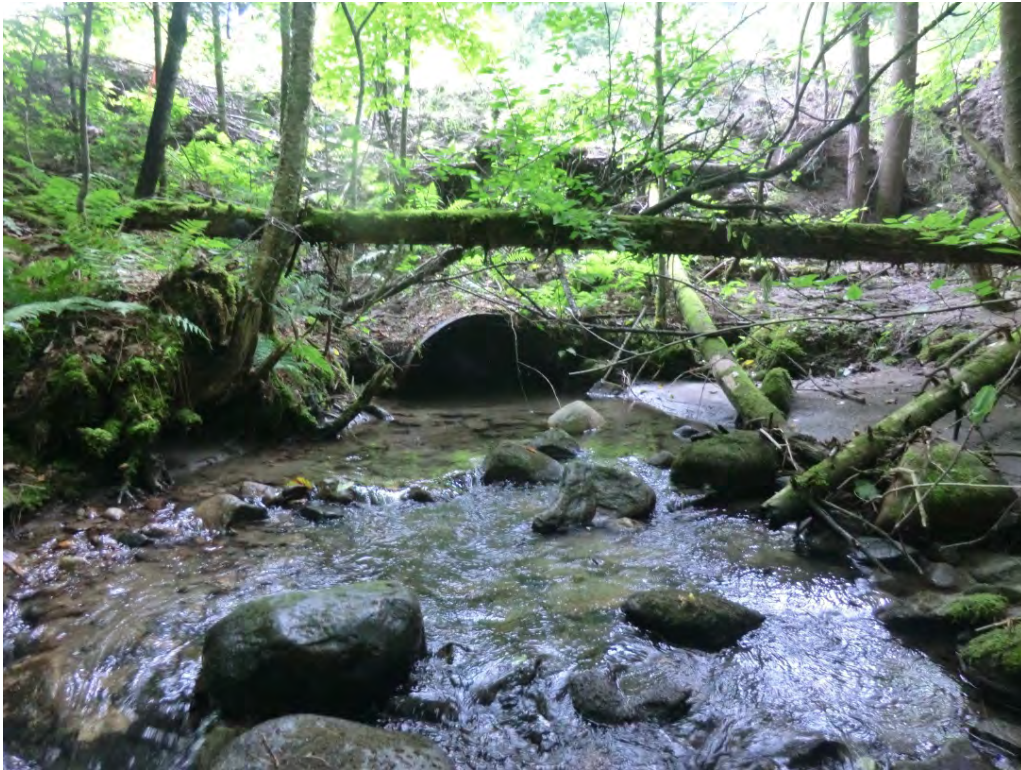
**Figure 5.25.** Stormwater input from trail just upstream of reach T1.01.

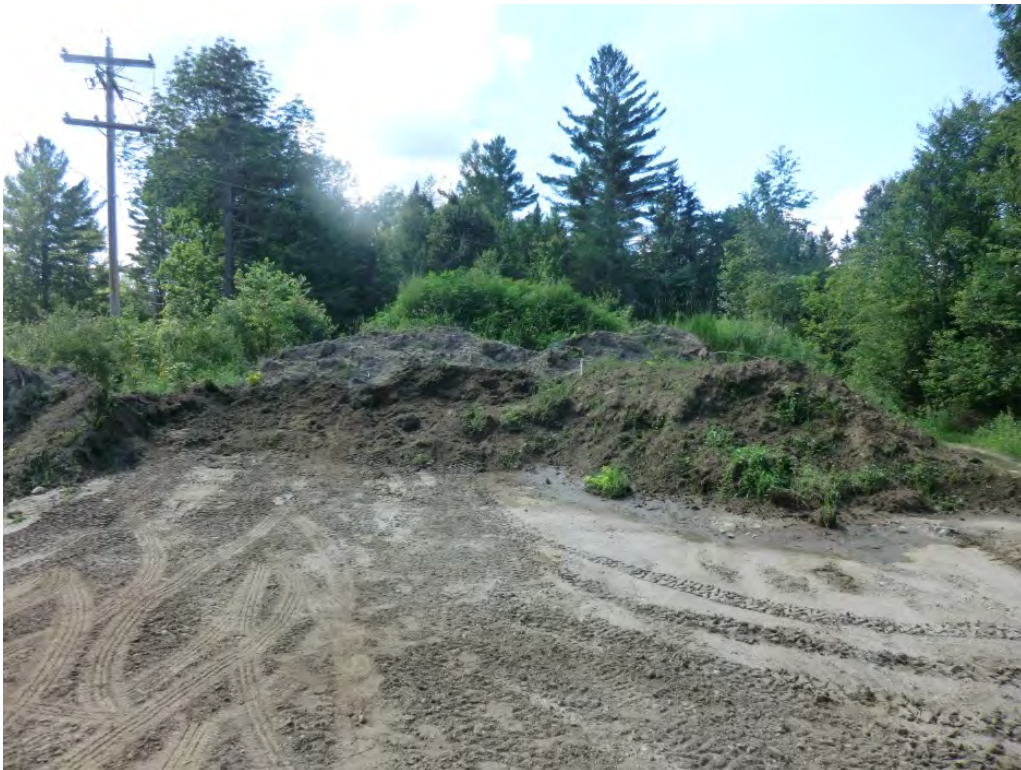
**Figure 5.26.** Sand piles at southern end of trail which crosses Tributary 1 just upstream of reach T1.01.

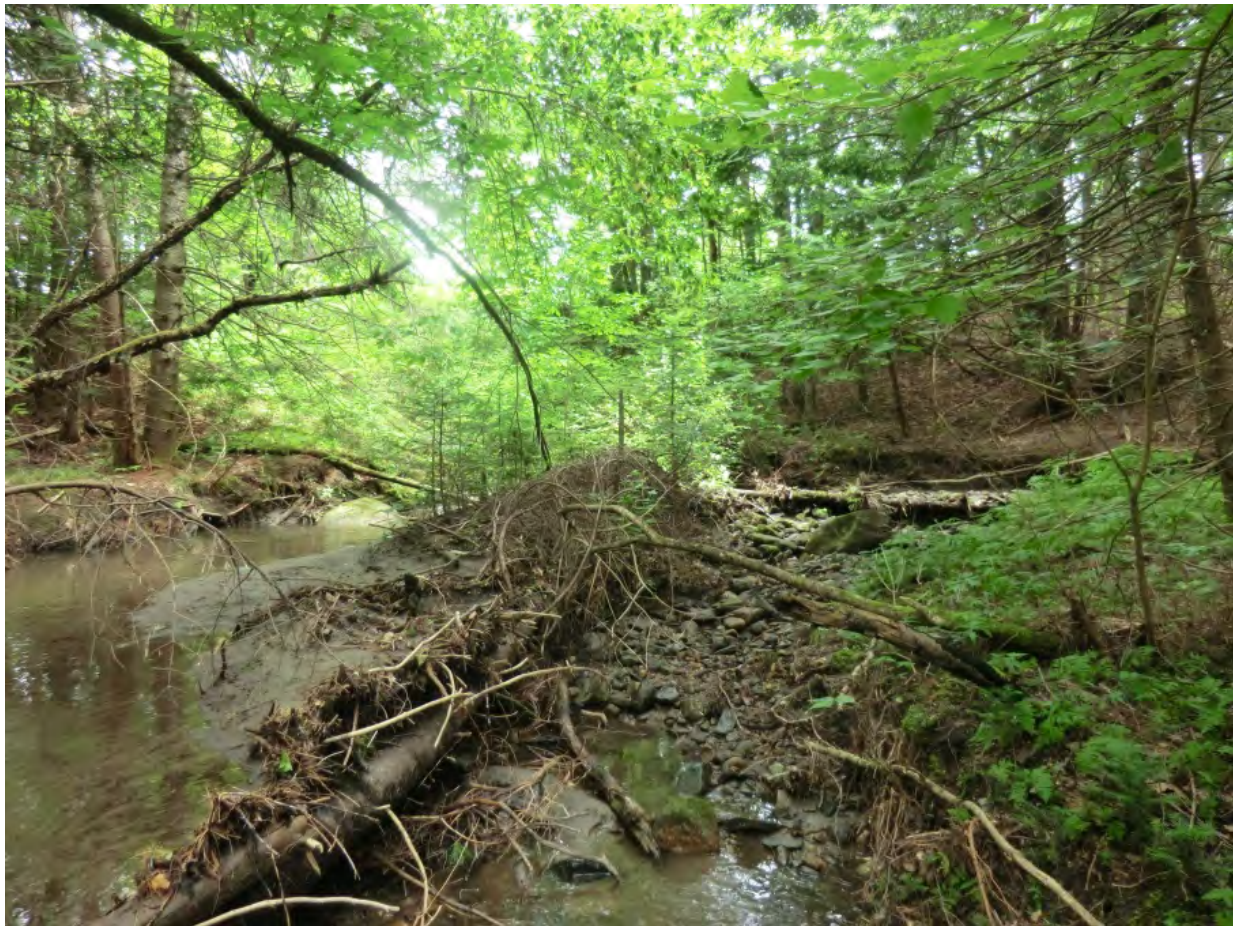
**Figure 5.27.** Debris jam and channel *bifurcation* in T1.01.

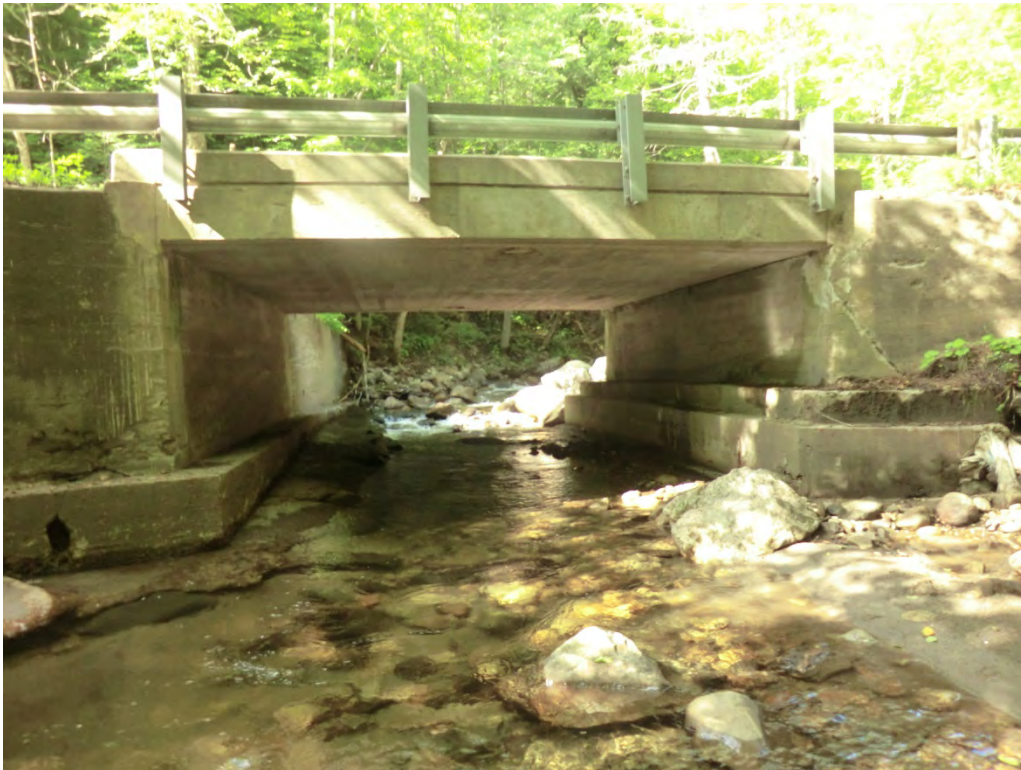
**Figure 5.29.** Undersized structure at Mountain Road crossing causing geomorphic instability in M103.

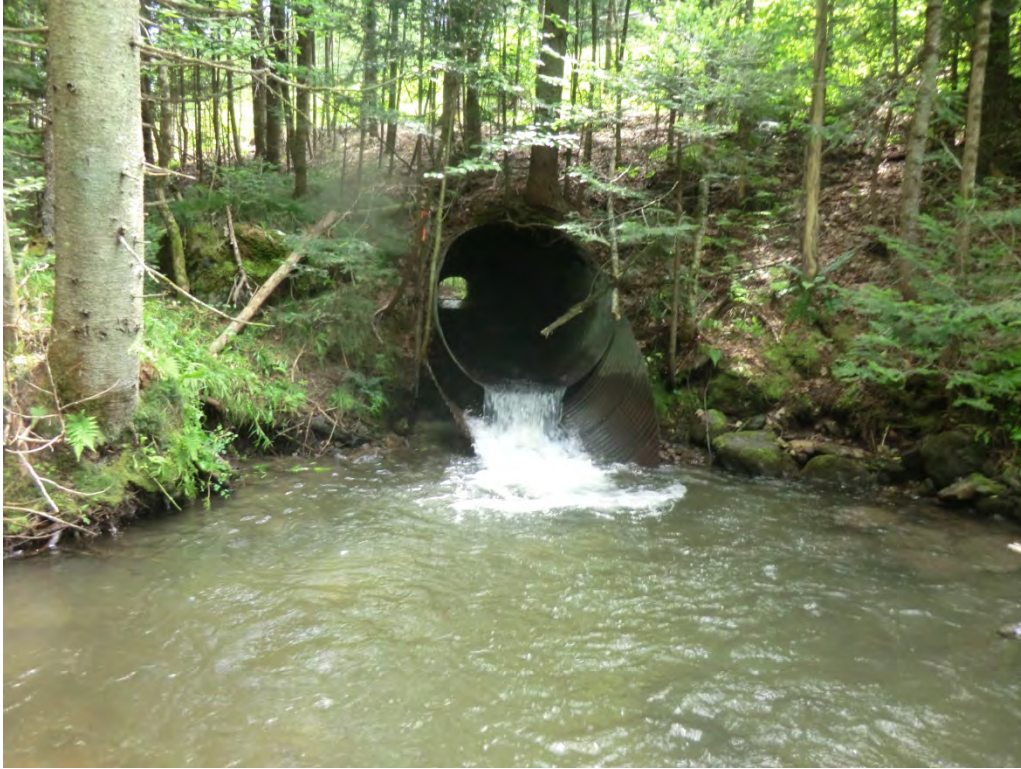
**Figure 5.30.** Undersized culvert causing potential fish passage issue with culvert apron falling off in T1.01.

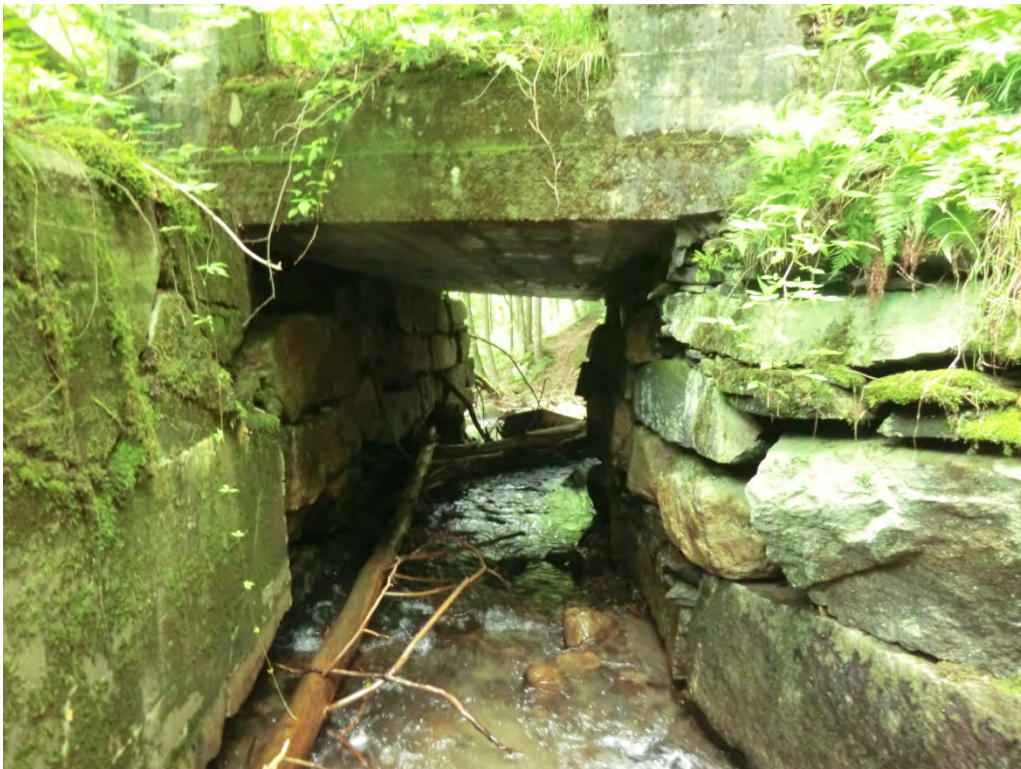
**Figure 5.31.** Channel constriction at trail crossing in reach T1.01.

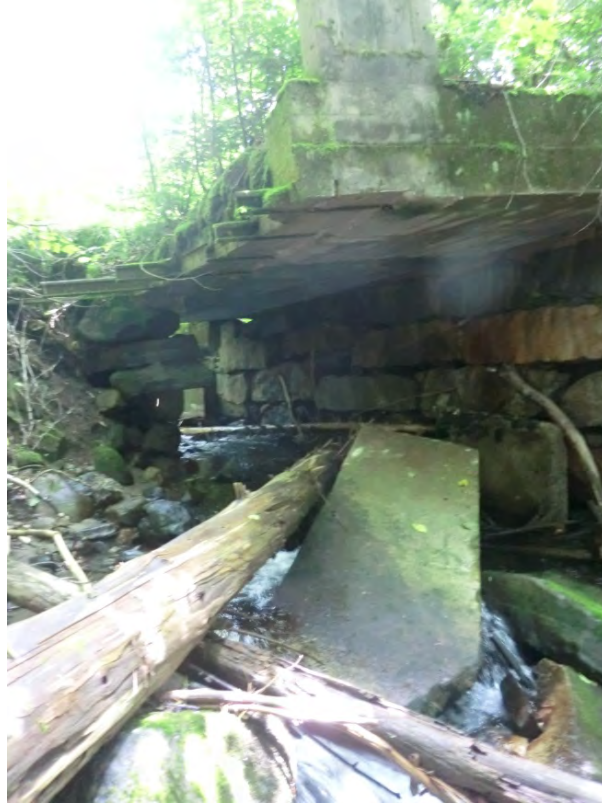
Figure 5.32. Bridge failure at trail crossing in T1.01.

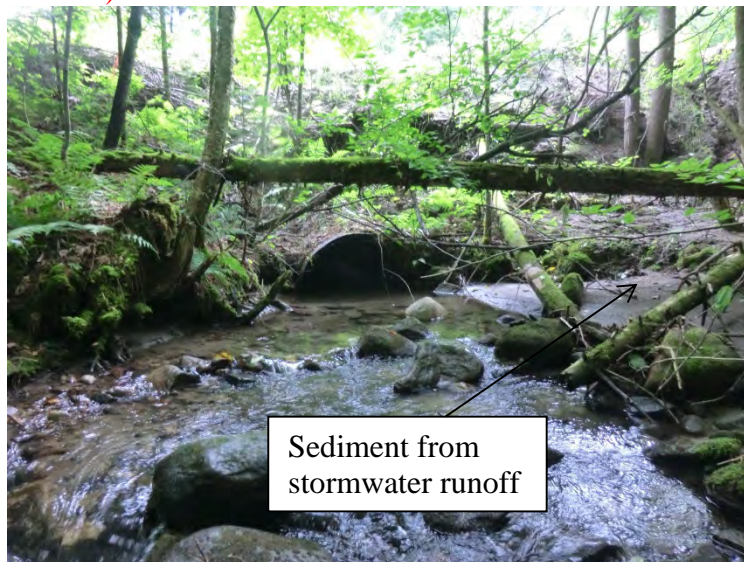
As mentioned above in the explanation for aggradation being a major process, sediment is definitely entering the stream via stormwater runoff as observed at the crossing just upstream of the top reach break. There is a trail crossing here and stormwater runoff around the culvert is causing sediment to enter (see photo below).

Stormwater runoff off of trail crossing by culvert in T1.02

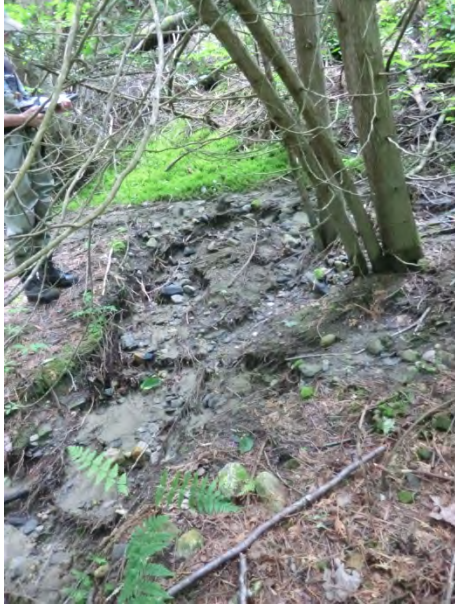
Overland stormwater runoff in T1.01

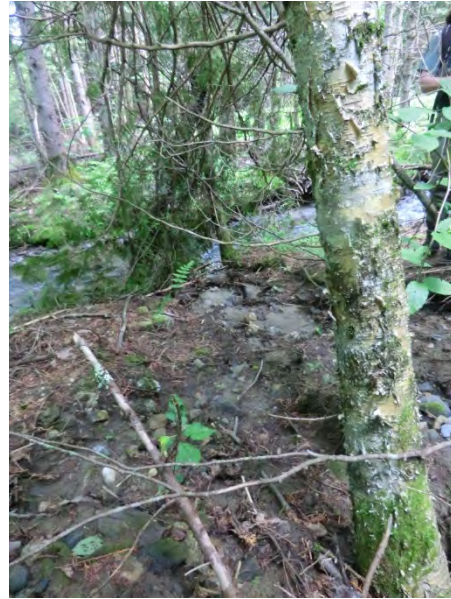
Overland stormwater runoff making its way to stream
