# Stream Geomorphic Assessment of City Stream and Bolles Brook *Woodford, VT*

## **FINAL REPORT** *December 2007*

**Bennington County Conservation District**

**GOMEZ AND SULLIVAN**  
Engineers, P.C.

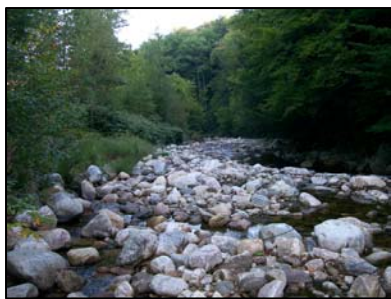
##### M06T3.05S1.01A

Segment M06T3.05S1.01A (S1.01A) of City Stream is a reference C3b step-pool stream that has degraded to a type B3. It is semi-confined (CR=3.7) in its valley, which is generally defined by a steep mountainside on the right and Route 9 on the left. The segment is approximately 2,377 feet long and has a slope of about 2.5%. Encroachments such as berms, roads, and development impact much of its length (52%, 28%, and 35%, respectively). Berms in this segment are generally engineered structures reinforced with concrete and rock slab facing. A few braided areas and flood chutes are present. Both a head cut and a steep riffle (slightly downstream) were observed in the field. The segment is moderately entrenched (ER=1.61) with a high width/depth ratio (W/D=31.3). The incision ratio (IR) based on the recently abandoned floodplain (RAF) is 2.39, but the presence of a berm leads to a human-elevated floodplain (HEF) IR of 3.98. Banks and buffers are relatively well-vegetated with mixed trees and saplings. The segment received an RHA rating of “good” and an RGA rating of “fair.” Because the stream has lost access to the majority of its floodplain, through both bed degradation and floodplain build-up in the form of berms, but is starting to widen, it was

determined to be in Stage III of the CEM. The major adjustment process is degradation. Due to the stream type departure (from C to B), the stream sensitivity is high.

| Stream | Segment ID | RGA Score | RGA Condition | Stream Type Departure | Evolution Stage | Adjustment Processes | Sensitivity |
|---|---|---|---|---|---|---|---|
| City Stream | M06T3.05S1.01A | 0.60 | Fair | Yes | III | Degradation | High |

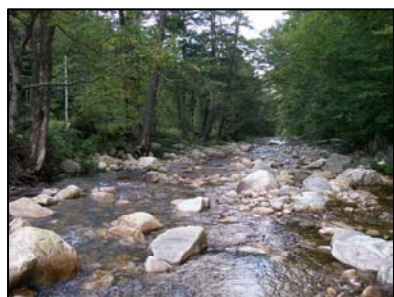
#### M06T3.05S1.01B

Segment M06T3.05S1.01B (S1.01B) of City Stream is a reference C3b step-pool stream that has degraded to a type F3. The segment is approximately 1,346 feet long and has a slope of about 1.5%. It was segmented from Segment A because its entire length appears to be straightened, and it is narrowly confined (CR=1.4) by a steep mountainside on the right and Route 9 on the left. The left bank, which is essentially the road embankment, is eroded in areas and reinforced with rip-rap in others. A head cut and a bedrock constriction were observed in the field. This segment is entrenched (ER=1.15) with a high W/D ratio (26.9). The IR, based on an RAF at the top of the left bank, is 2.40. The right bank is relatively well-vegetated with mixed trees and saplings, whereas the left bank consists mainly of herbaceous and shrub/sapling vegetation. The segment received an RHA rating of “good.” The RGA condition was modified from “fair” to “poor” due to a stream type departure from C to F. Because the stream has lost access to the majority of its floodplain through bed degradation and floodplain build-up (berms), but is starting to widen, it was determined to be in Stage III of the CEM. The major adjustment processes are degradation and widening, and the stream is extremely sensitive.

| Stream | Segment ID | RGA Score | RGA Condition | Stream Type Departure | Evolution Stage | Adjustment Processes | Sensitivity |
|---|---|---|---|---|---|---|---|
| | M06T3.05S1.01B | 0.51 | Poor* | Yes | III | Degradation and Widening | Extreme |

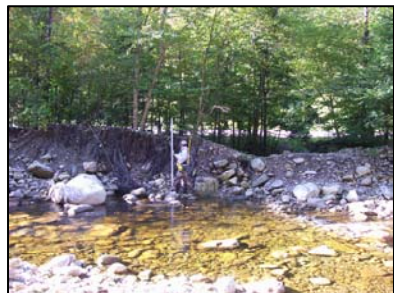
#### M06T3.05S1.01C

Segment M06T3.05S1.01C (S1.01C) of City Stream is a reference C3b step-pool stream that has degraded to a type B3. It is approximately 3,924 feet long and has a slope of about 3.1%. It was segmented because its valley, although narrow (CR=4.4), is relatively wider than that of Segment B and is only encroached by the road for approximately half (45%) of its length. The left bank and buffer vegetation is also more developed, with mixed trees and shrubs/saplings. Similar to Segment A, this segment is characterized by berms on the left side, and even has a section with a double berm (one on the bank and one set back 50-150 feet). The cross-section for the segment was taken through the double berm to capture this representative feature. The valley is defined by Route 9 on the left and the steep mountainside (which is sometimes set back from the bank up to 100 feet due to RAFs or terraces) on the right. There are several sections of erosion on both banks, and a small mass failure on the right. The left bank is reinforced with rip-rap near the downstream and upstream edges of the segment (where the road is closest to the stream). A steep riffle, flood chute, and several stormwater inputs were also observed. The segment is moderately entrenched (ER=1.64) and has a moderate W/D ratio (24.6). The IR based on the RAF behind the first berm is 1.39, but the presence of the berm leads to a human-elevated IR of 4.19. The segment received an RHA rating of “good” and an RGA rating of “fair.” The major adjustment processes are degradation, widening, and planform adjustment. Due to the stream type departure from C to B, the stream sensitivity is high. Because the stream has lost access to the majority of its floodplain through bed degradation and floodplain build-up (berms), but is starting to widen and adjust planform as well, it was determined to be in Stage III of the CEM.

| Stream | Segment ID | RGA Score | RGA Condition | Stream Type Departure | Evolution Stage | Adjustment Processes | Sensitivity |
|---|---|---|---|---|---|---|---|
| | M06T3.05S1.01C | 0.48 | Fair | Yes | III | Degradation, Widening, and Planform | High |

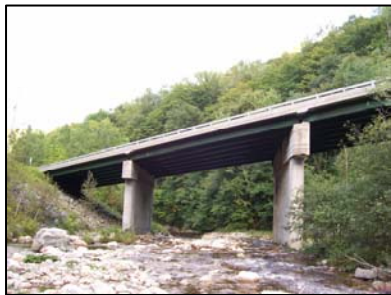
#### M06T3.05S1.02A

Segment M06T3.05S1.02A (S1.02A) of City Stream is a reference B2 step-pool stream that has degraded to a type F3. The segment is approximately 1,073 feet long and has a slope of about 1.9%. It is narrowly confined (CR=1.2) in its artificial valley of steep, high (>20 feet) road embankments on both sides—Route 9 on the right and Notch Road (old Route 9) on the left. The embankments are reinforced with rip-rap for much of the segment, particularly under/near the Route 9 bridge and on the right bank upstream of the bridge. The bank and buffer vegetation is therefore sparse and of the herbaceous and shrub/sapling type. The segment is entrenched

| Stream | Segment ID | RGA Score | RGA Condition | Stream Type Departure | Evolution Stage | Adjustment Processes | Sensitivity |
|---|---|---|---|---|---|---|---|
| | M06T3.05S1.02A | 0.43 | Fair | Yes | III-IV | Aggradation and Widening after Historic Degradation | Extreme |

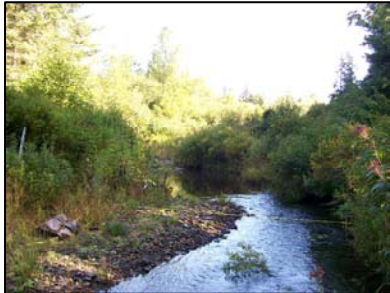
#### M06T3.05S1.04B

Segment M06T3.05S1.04B (S1.04B) of City Stream is distinguished from Segment A (a bedrock gorge) by a marked decrease in slope (to approximately  $0.9\%$ ), an opening of the canopy and transition from mixed forest to herbaceous vegetation, and a shift in bed material from bedrock and boulders to gravel, sand, and silt. The reference stream type for the reach is C4 riffle-pool, but this segment has degraded to a type F4. The segment is approximately 1,112 feet long. Its valley is very broad ( $CR=43.3$ ), and is defined by Route 9 on the right and the natural and artificial grades of Prospect Mountain ski area on the left.

| Stream | Segment ID | RGA Score | RGA Condition | Stream Type Departure | Evolution Stage | Adjustment Processes | Sensitivity |
|---|---|---|---|---|---|---|---|
| | M06T3.05S1.04B | 0.64 | Fair | Yes | II | Degradation | Extreme |

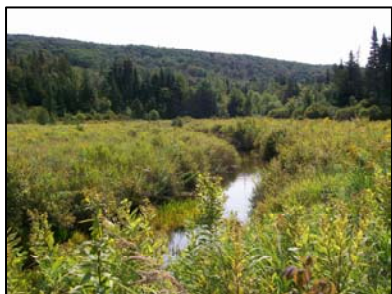
#### M06T3.05S1.04D

Segment M06T3.05S1.04D (S1.04D) of City Stream was segmented because Segment C is an impoundment that was not assessed. The reference stream type for the reach is C4 riffle-pool, but this segment has degraded to a type F4. The segment is approximately 1,957 feet long with a slope of about 0.8%. Its valley is very broad (CR=64.3), and is defined by Route 9 on the right and the natural and artificial grades of Greenwood Campground on the left. The W/D ratio is low (14.6). Recent beaver activity near bottom of the segment has resulted in a dam and small impoundment about 165 feet from the culvert. The

upper limit of the segment is marked by the dam that impounds Bugbee Mill Pond (reach S1.05). The majority of the channel is nearly featureless, but a system of riffles, pools, and runs forms near the top of the segment. In this upper section, a gravel storage lot with piles of sand, stone, and other materials on the right bank and a newly cut dirt road just off the left bank are likely contributing to the numerous fine sediment deposits found in the channel nearby and further downstream. Vertical banks on both sides flatten out to a wide floodplain covered with meadow-type herbaceous and shrub vegetation. However, the stream was classified as entrenched (ER=1.33) because the floodprone height did not quite reach the elevation of the floodplain. This is likely due to a major adjustment process of degradation, and a CEM Stage of II. The IR based on this RAF elevation is 2.26. Due to the stream type departure, the stream sensitivity is extreme. The segment received a fair RGA rating and a good RHA rating.

| Stream | Segment ID | RGA Score | RGA Condition | Stream Type Departure | Evolution Stage | Adjustment Processes | Sensitivity |
|---|---|---|---|---|---|---|---|
| | M06T3.05S1.04D | 0.59 | Fair | Yes | II | Degradation | Extreme |

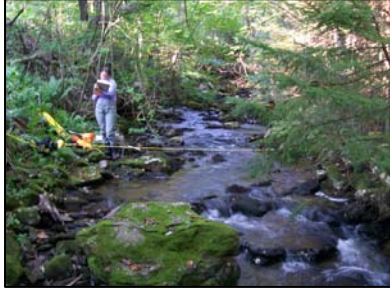
#### M06T3.05S1.06

Reach M06T3.05S1.06 (S1.06) of City Stream is a reference D4b braided stream that was field-verified to be a type D4b. While the majority of the reach is braided, its upper portion where the stream is close to Route 9 has been channelized and straightened. The stream passes through a culvert and two bridges in this upper section. The valley is very broad (CR=43.3), and is generally defined by Route 9 on the right and natural slopes on the left. The reach is approximately 2,260 feet long and has a slope of about 3.3%. The downstream end of the reach begins in the wetland complex above Bugbee Mill Pond, and

a small dam on a private pond marks the upstream end. Route 9 and patches of development encroach 21% and 14% of the river corridor, respectively. Both stream banks along the majority of the reach are heavily buffered with shrub/sapling vegetation, although larger trees are dominant towards the middle of the reach and near the cross-section. Snags, debris jams, and large woody debris were prevalent. A steep riffle, ledges, and flood chutes were also observed. Old stone fences/bridge abutments/dams have constricted and impacted the stream in two locations. The stream generally has access to a floodplain on one or both sides of the stream, with the exception of the channelized upper section. The reach is moderately entrenched (ER=2.13) with a moderate W/D ratio (17.1). The IR is 1.60. The reach received RHA and RGA ratings of “good.” The reach was determined to be in Stage IV of the CEM, and is mostly adjusting in planform. The stream sensitivity is extreme, which is typical for braided stream types in any condition.

| Stream | Segment ID | Sensitivity | Stream Type Group | Existing Stream Type | Natural Valley Type | Departure from Equilibrium | FEH Rating | |
|---|---|---|---|---|---|---|---|---|
| | M06T3.05S1.06 | Extreme | 10 | D4b | Very Broad | Reference Condition | EX | 10 |

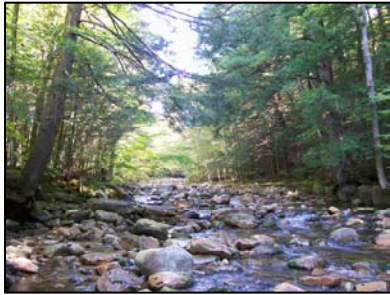
#### M06T3.05B

Segment M06T3.05B (T3.05B) of Bolles Brook is a reference B3 step-pool stream that was found to be a B3c. It was segmented from Segment A because it is less encroached by development and has more floodplain access. The stream is still encroached by Harbour Road, for 74% of this segment. The segment is approximately 2,242 feet long with a slope of about 1.8%. Its natural valley is broad (CR=9.6) but, even though Harbour Road is not a truly confining feature, it will certainly continue to have a confining effect on the stream as long as it is maintained. The valley is defined by the mountain slope behind Harbour Road and the residential development on the right, and by a steep bedrock wall and high terrace near the bank on the left. An old railroad grade is present on top of the high terrace on the left. The left bank is a relatively flat or slightly sloping floodplain up to Harbour Road, but the stream has lost access to most of this feature. The IR based on this feature is 1.80. The stream is moderately entrenched (ER=1.57) with a high W/D ratio (29.7). Three steep riffles, two flood chutes and a braided area were observed. Old concrete slabs found along the bank and broken in the channel near the middle of the segment are causing left bank erosion and creating a grade control. More old concrete slabs (possibly from an old bridge) under the Harbour Road bridge in this segment are also creating a grade control and causing downstream deposition. Mixed trees and saplings cover both banks fairly well. The segment received an RHA score of “good” and an RGA score of “fair.” Because the stream has lost access to the majority of its floodplain, but has widened and is reworking through aggradation, it was determined to be in Stage IV of the CEM, with the major adjustment processes being widening and aggradation. The stream sensitivity is high.

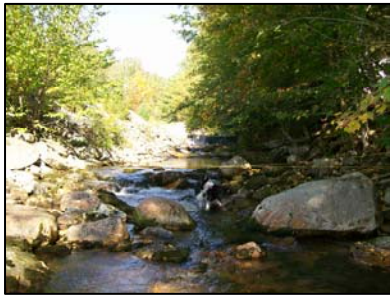
#### M06T3.05C

Segment M06T3.05C (T3.05C) of Bolles Brook is a reference B3 step-pool stream that was also found to be a B3c. It was segmented from Segment B because it is highly channelized, has less adequate bank/buffer vegetation, and is closely encroached by development and Harbour Road for its entire length. The segment is approximately 1,163 feet long with a slope of about 1.7%. Its natural valley is very broad (CR=14.3) but, even though Harbour Road is not a truly confining feature, it will certainly continue to have a confining effect on the stream as long as it is maintained. The valley is defined by a mountain slope behind Harbour Road and the residential development on the right, and by a steep mountainside that angles in to meet the stream at a bedrock wall near the top of the segment on the left. The stream has lost access to most of its floodplain due to residential and road fill, as well as natural bedrock. The human-elevated IR based on the right top of bank is 2.89. The stream is moderately entrenched (ER=1.85) with the lowest W/D ratio (12.2) of all the segments assessed. Near the top of the segment, just below the bridge, is a small dam and water withdrawal that supplies the town with drinking water. The small impoundment between the dam and the bridge was recently dredged in September. The right bank of this segment is steep, high, and armored with rip-rap for about half of its length. The left bank is flatter towards the bottom of the segment, but becomes a bedrock wall towards the top. Bank and buffer vegetation is mostly shrub/sapling, with more herbaceous vegetation on the right. Near the top of the segment, there is no vegetation on the rip-rapped bank, and the only buffer between the bank and the road is a mowed lawn. Because of this, the RHA score of 0.65 was adjusted from “good” to “fair.” The RGA score was also “fair.” Because the stream has lost access to the majority of its floodplain through

residential and road fill, it was determined to be in Stage II of the CEM, with the major adjustment process being degradation. The stream sensitivity is high.

| Stream | Segment ID | RGA Score | RGA Condition | Stream Type Departure | Evolution Stage | Adjustment Processes | Sensitivity |
|---|---|---|---|---|---|---|---|
| | M06T3.05C | 0.60 | Fair | No | II | Degradation | High |

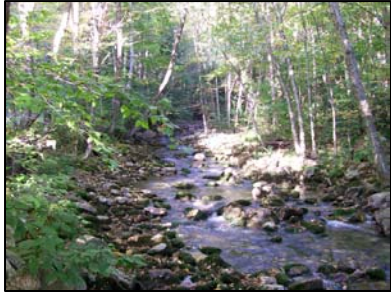
#### M06T3.06

Reach M06T3.06 (T3.06) of Bolles Brook is a reference D3b braided stream that was field-verified to have the same existing stream type. It is approximately 5,734 feet long with a slope of about 3.4%. Its natural valley is very broad (CR=16.4), and it is only encroached by Harbour Road for 34% of its length. The valley is defined by steep mountain slopes on both sides. This reach is extensively braided, with multiple active channels as well as flood chutes and abandoned channels crisscrossing the floodplain along most of its length. Only two small areas of erosion were observed. A short section of an old berm or railroad grade was found between the left bank and Harbour Road. The cross-section was taken near the top of the reach, where there is one channel with flowing water, an adjacent stagnant channel that is currently blocked by a debris jam, and two abandoned channels or seepage channels on the right floodplain. At this location, the ER was 3.96 and the W/D ratio was 16.4. The IR, based on an RAF on top of the right bank, is 1.98. Both corridors are heavily forested for most of this reach. The reach received RHA and RGA ratings of “good.” The reach was determined to be in Stage IV of the CEM, and is mostly adjusting in planform. The stream sensitivity is extreme.

| Stream | Segment ID | Sensitivity | Stream Type Group | Existing Stream Type | Natural Valley Type | Departure from Equilibrium | FEH Rating | |
|---|---|---|---|---|---|---|---|---|
| | M06T3.06 | Extreme | 10 | D3b | Very Broad | Reference Condition | EX | 10 |

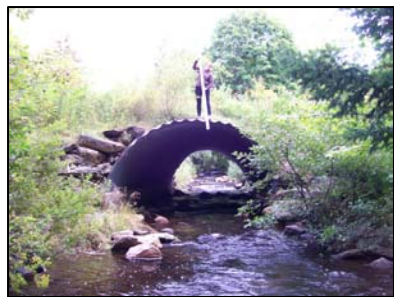
### S1.03 City Stream Road Arch

This structure is a small arch near the top of reach S1.03 of City Stream, just off Route 9 on City Stream Road (gravel). With a width 59% of the channel width, this structure acts as both a channel and floodplain confinement. Shrub/sapling vegetation lines both upstream and downstream banks, more densely on the left side. The arch seems to be in relatively good condition with a low potential to fail, although it does confine the stream somewhat.

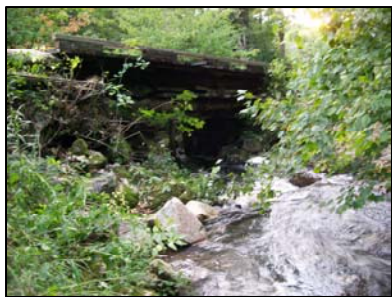
#### S1.04A Driveway Bridge

This structure is a small wooden bridge across a driveway just upstream at the break between reaches S1.03 and S1.04 of City Stream. A new bridge with steel beams and a timber deck was recently built over top of the old, failing bridge by its private owner. The bridge is located at the base of a bedrock gorge at a bend in the stream, and the effect of the high stream power is evidenced by failing bank armoring on the upstream side of the bridge. The banks and buffers are well-forested in all directions. Now that the bridge has been reinforced and rebuilt, it appears to

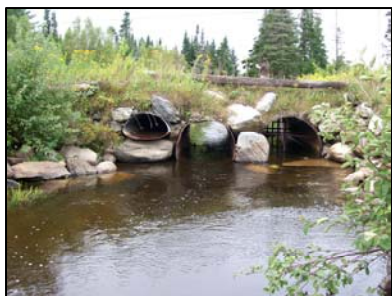
#### S1.04D Prospect Access Culvert

This structure is a culvert across a gravel access road at the base of Prospect Mountain ski area, located at the break between segments S1.04C and S1.04D of City Stream. The combined width of the two culverts is 53% of the channel width. An overflow pipe is also present. Below the culvert, the entire length of segment S1.01C is impounded by a beaver dam at its downstream end. A relatively new beaver dam about 165 feet upstream of the culvert has created a small impoundment in segment S1.01D as well. A potential problem for this structure

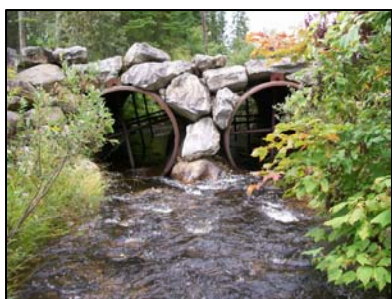
#### S1.04D Greenwood Drive Culvert

This culvert is located just below the outlet of Bugbee Mill Pond near the top of segment S1.04D on Greenwood Drive. It has two openings with a combined width 67% of the channel width. Herbaceous and shrub vegetation lines both banks, although just downstream a new dirt road is being cut on the left and a gravel lot is on the right. Both of these developments are contributing to heavy sediment runoff and deposition in the channel downstream. The structure itself appears to be in good condition with little potential to fail, although it does confine the stream.

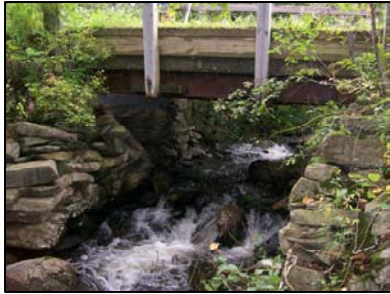
### S1.06 Driveway Bridge

This bridge is located on a driveway just off Route 9 in reach S1.06 of City Stream. Although the structure span is as wide as the channel, large stone abutments beneath the bridge confine the stream. Shrub/sapling vegetation lines both banks, more extensively in the left corridor. The stone abutments do not appear to be in the best condition and could possibly fail during a flood event.

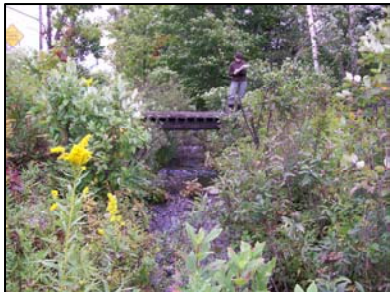
### S1.06 Snowmobile Trail Bridge

This bridge is on a snowmobile trail that crosses Route 9 in reach S1.06 of City Stream. The bridge's light timber deck, with a span 300% of the channel width, does not appear to confine the stream. Rip-rap armoring is intact. The left bank is buffered with shrub/sapling vegetation, whereas the right is the Route 9 embankment. The structure seems to be in good condition with a low potential to fail or impact the stream.

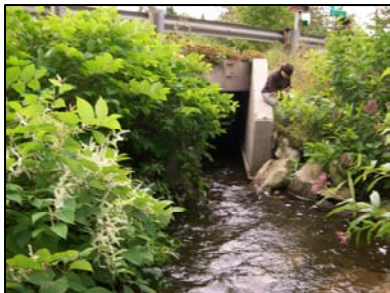
### S1.06 Route 9 Culvert

This structure is a culvert across Route 9 near the upper end of reach S1.06 of City Stream. The structure is skewed to the roadway to accommodate the sharp angle of the stream. With a width of only 3.2 feet (18% of the channel width), this culvert is the most confining structure assessed on either City Stream or Bolles Brook. The stream is highly channelized in this area, especially above the culvert where concrete wingwalls extend upstream. Still, the structure seems to be in good condition with little potential to fail. It is likely that the small dam and impoundment just upstream of the culvert (at the reach break) provide some flow regulation to protect the structure.

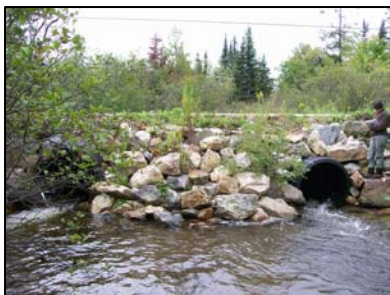
### S1.07 Evergreen Lane Culvert

The most upstream structure on City Stream is a culvert across Evergreen Lane below Woodford Lake (Big Pond) on reach S1.07. Two corrugated plastic culverts have a combined width that is 48% of the channel width. Shrub/sapling vegetation lines the banks in both directions. The structure seems to be in good condition with a low potential to fail or impact the stream, although it does confine the stream.

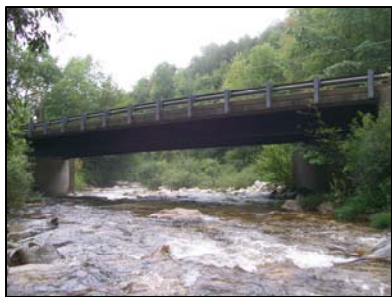
### T3.05B Harbour Road Bridge

The most downstream structure on Bolles Brook is the second bridge on Harbour Road, just above the segment break between T3.05A and T3.05B. With a span 300% of the channel width, this bridge does not appear to confine the stream, but does create a floodplain confinement. The stream is relatively straight approaching the bridge, but passes through the bridge at an angle and bends to the left just downstream, where a small mass failure has occurred on the right bank. Shrub/sapling vegetation and mixed trees provide buffer in both directions. A potential problem is the presence of multiple large concrete slabs, possibly from an old bridge, in the channel underneath the structure. These slabs have created a steep grade control and may be partially responsible for the large sediment deposits downstream (which may also be due to the entrance of a tributary). Otherwise, the bridge is in relatively good condition, with a low potential to fail or impact the stream.

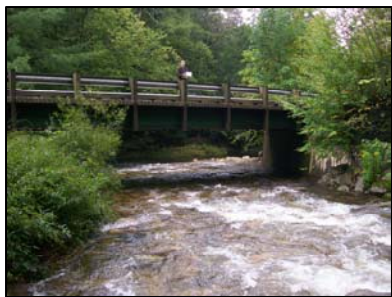
### T3.05C Harbour Road Bridge

This structure is the third bridge on Harbour Road, near the top of segment T3.05C of Bolles Brook. It is located just above the small dam and drinking water withdrawal. Just upstream of the bridge, a tributary (Bickford Hollow Brook) enters Bolles Brook. The stream makes 90-degree bends just above and below the bridge. A bedrock wall on the outside of the downstream bend has likely prevented bank erosion. Above the bridge, Bolles Brook is extensively braided, whereas downstream it has been channelized. Although the span of the bridge is 133% of the stream width, the concrete abutments act as a channel and floodplain confinement. The small impoundment between the bridge and the dam was recently dredged in September 2007. Overall, the bridge itself is in relatively good condition, with a low potential to fail or impact the stream.

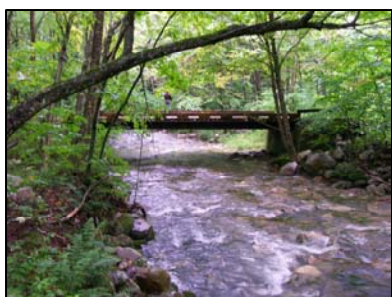
### T3.06 National Forest Road Bridge

The most upstream structure on Bolles Brook is a timber bridge near the top of reach T3.06 on the Green Mountain National Forest dirt road that continues from Harbour Road. This bridge spans approximately the same width as the channel, and does not seem to confine the stream. Mixed forest vegetation provides adequate buffer on both sides. The bridge is in good condition with a low potential to fail or impact the stream.

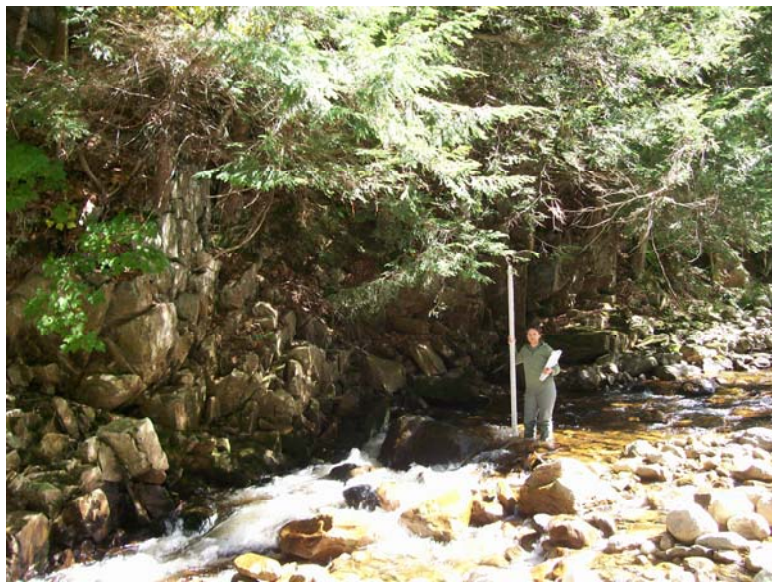
| <b>View:</b> US | <b>Description:</b> Close-up of bedrock wall and steep riffle | | | <b>View:</b> DS | <b>Description:</b> Left bank erosion along Rt. 9 | | |

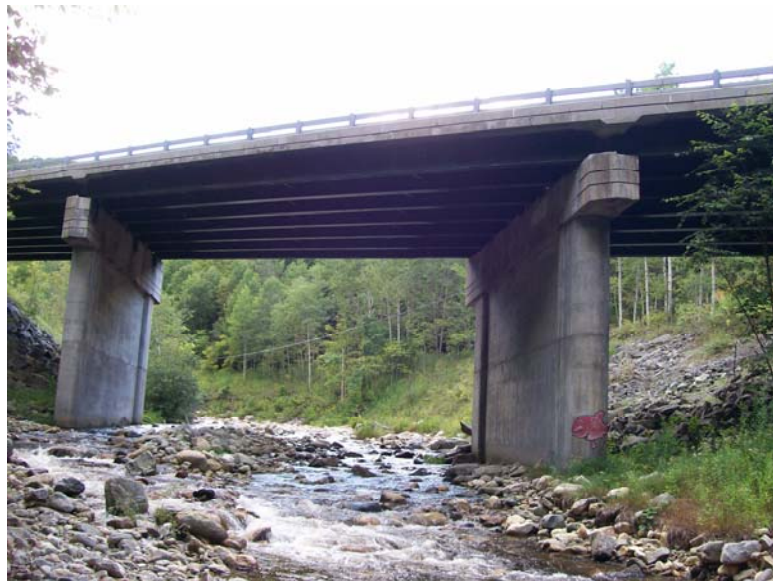
| Segment ID: S1.02A | | Photo #: 100_0919 | | Date: 9/12/2007 | |

| View: US | | Description: Deposition under Rt. 9 bridge | | | |

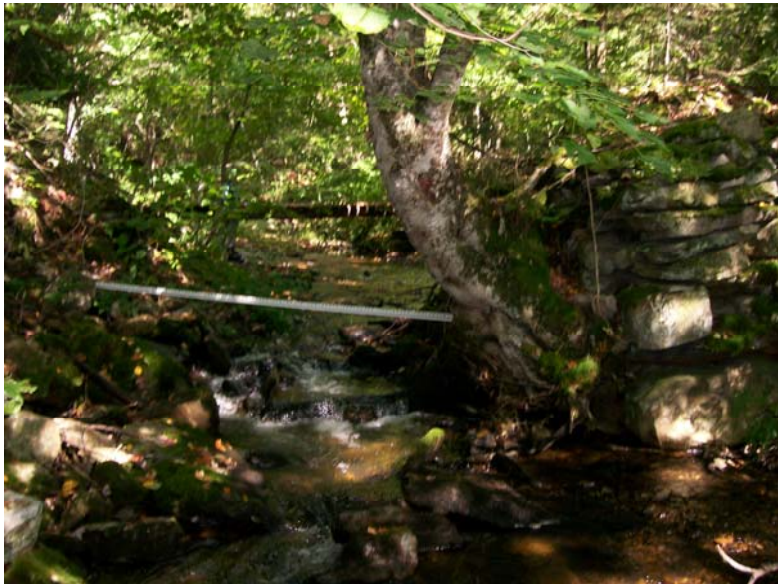
| Segment ID: S1.06 | | Photo #: 100_0937 | | Date: 9/13/2007 | |

| View: US | | Description: Old stone fence causing channel constriction | | | |

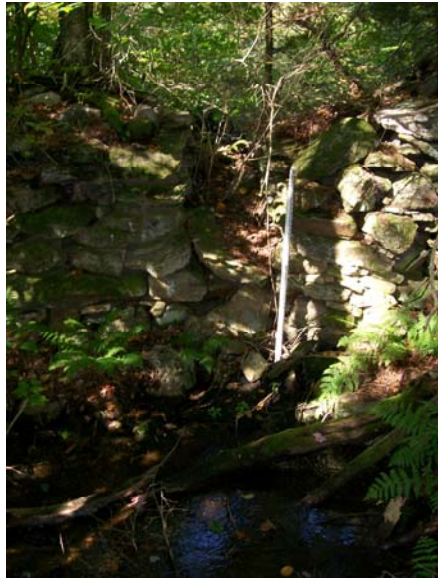
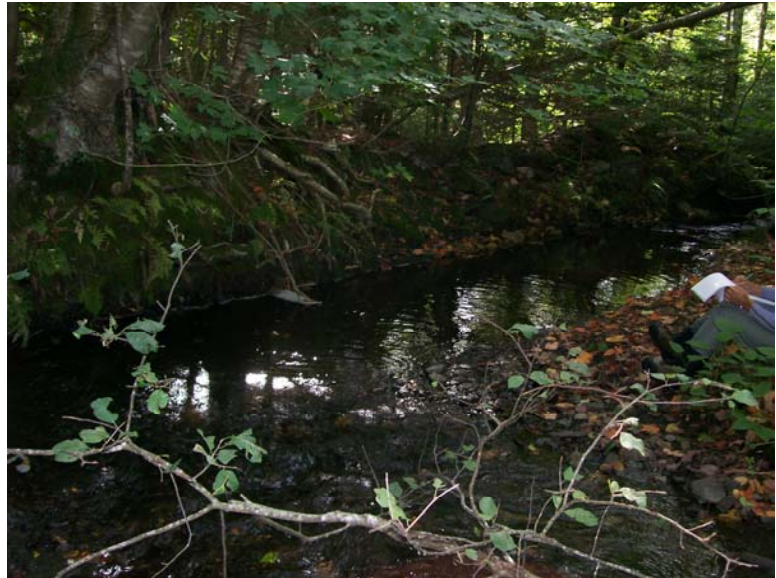
| <b>View:</b> US | <b>Description:</b> Old stone fence/dam causing channel constriction | | | <b>View:</b> DS | <b>Description:</b> Channel caused by old stone fence/dam | | |
