Crosby Brook Phase 2 Stream Geomorphic Assessment Summary

July 21, 2008

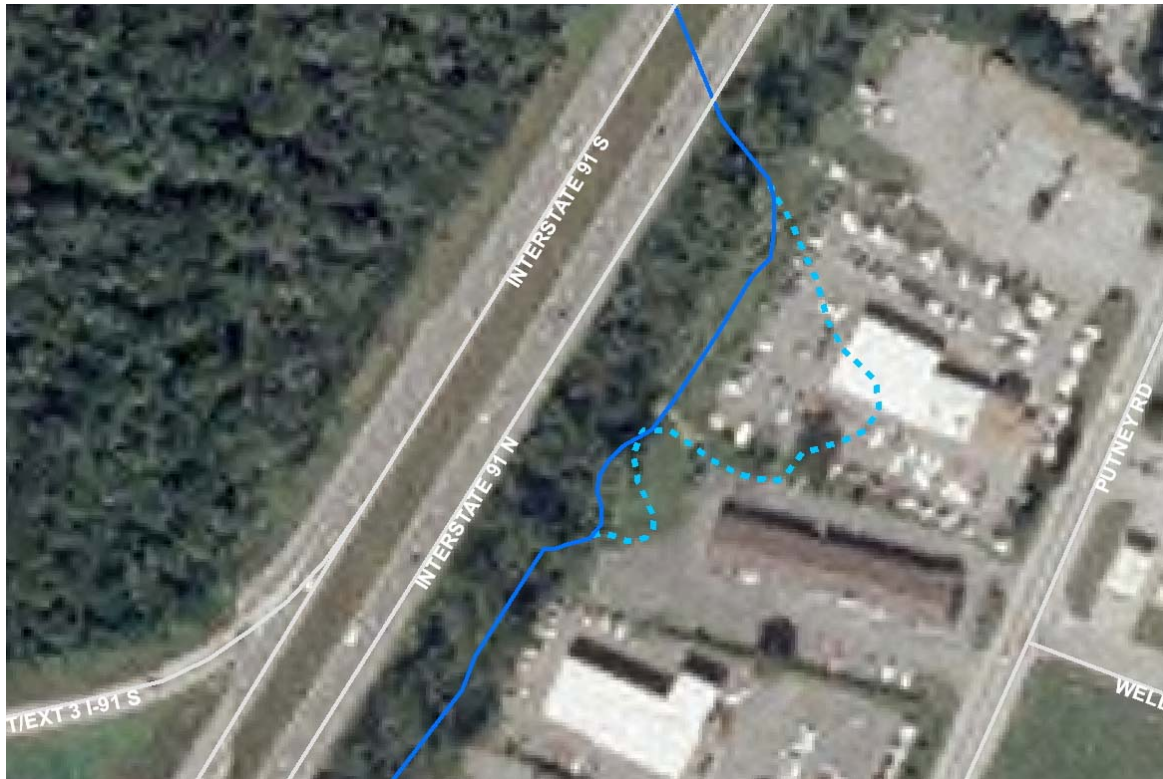
Figure 6. Area of straightening to accommodate increased commercial development. The 1962 channel location is shown as dashed blue and the current location is solid blue.

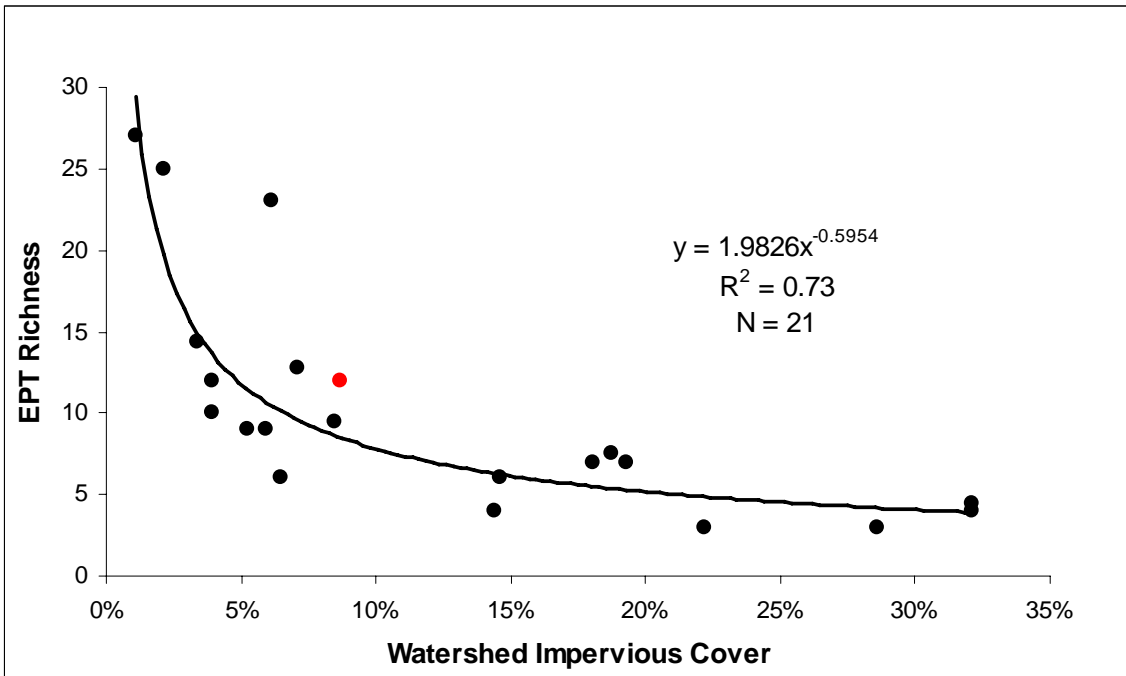
Figure 7. Response of sensitive macroinvertebrates to impervious cover for study sites in Chittenden County (Fitzgerald 2007). Crosby Brook data point (VTDEC, 2005) for Reach M01 shown in red.

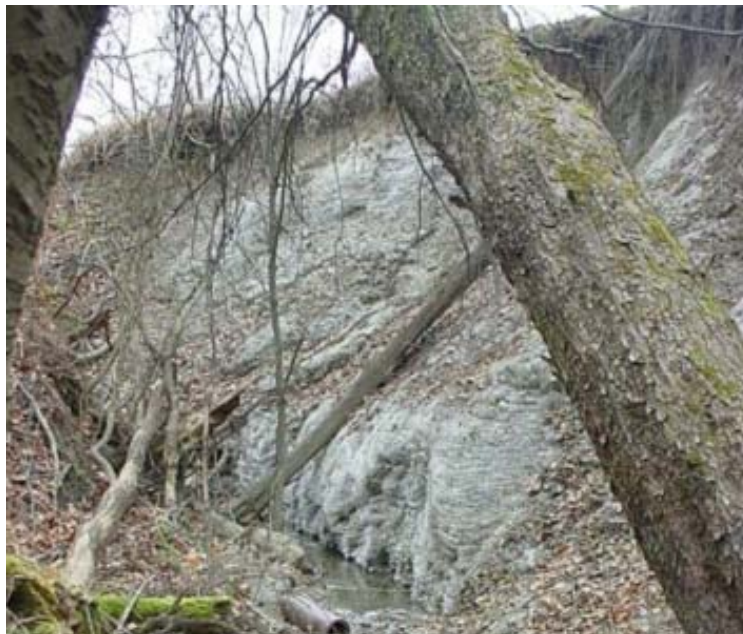
Figure 9. Gully on Pepsi Property draining to lower Reach M03.

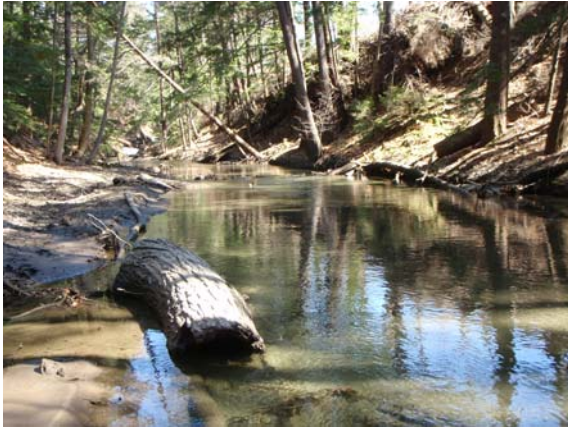
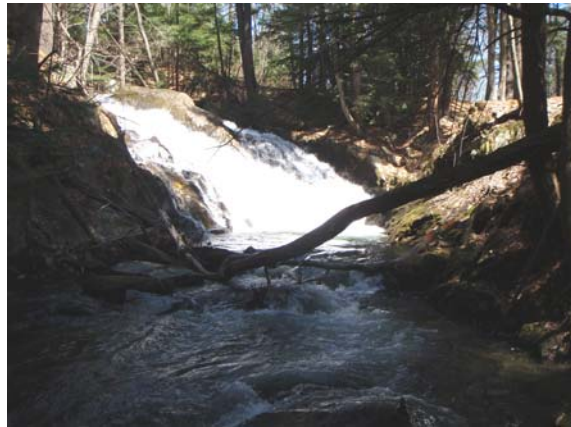
Figure 12. Fine sediment deposition in lower M01-A Figure 13. Large grade control in middle of M01-A

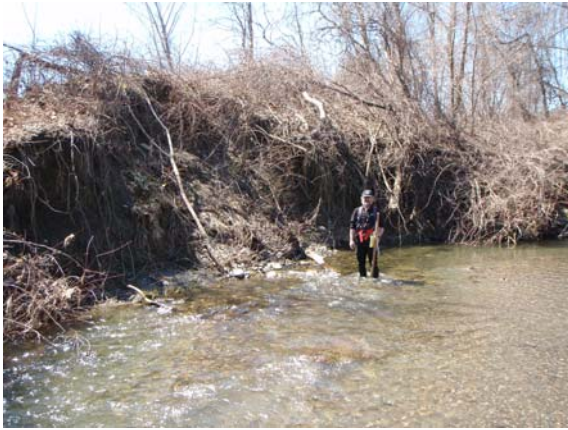
Figure 14. Mass failure in lower M01-B

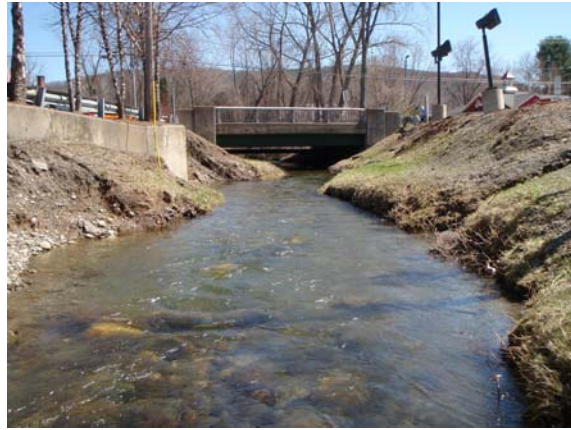
Figure 15. M01-B above Route 5 crossing.

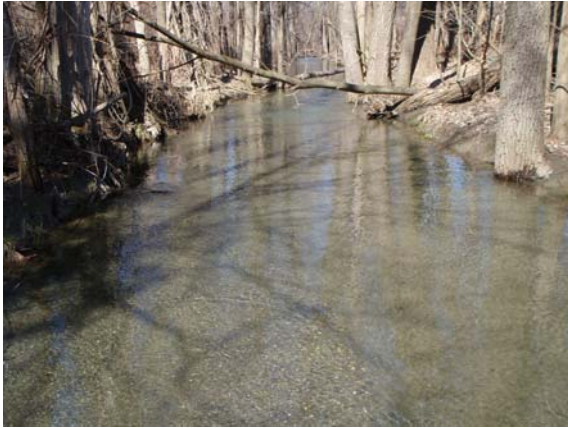
Figure 16. Plane bed morphology in lower M02

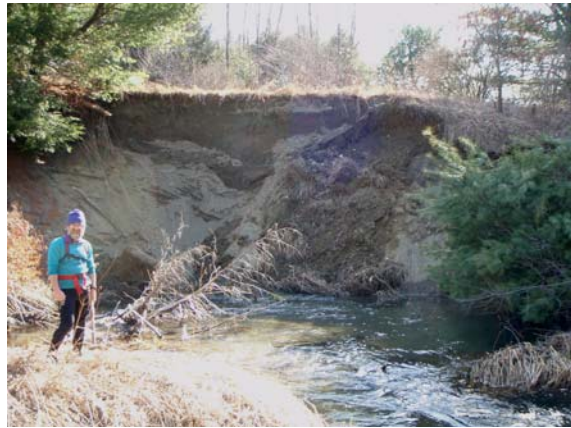
Figure 17. Large mass failure in upper M02

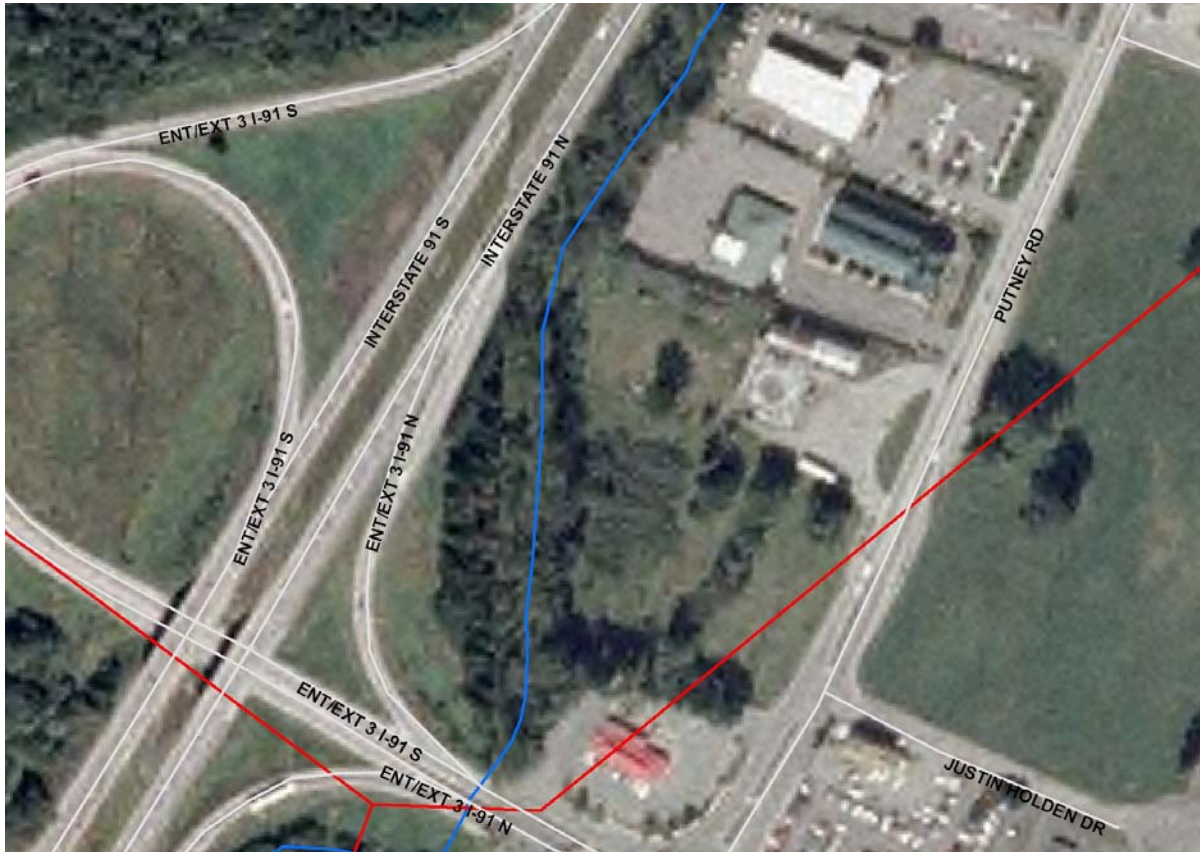
Figure 18. Undeveloped corridor in lower M02 immediately upstream of the Exit 3 ramp.

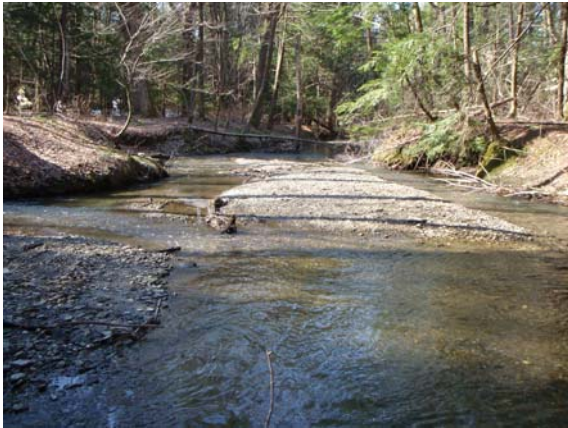
Figure 19. Aggradation and widening in lower M03.

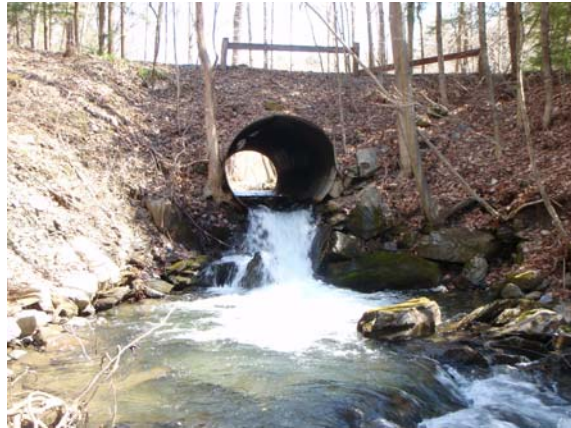
Figure 20. Perched culvert beneath Ryan Road.

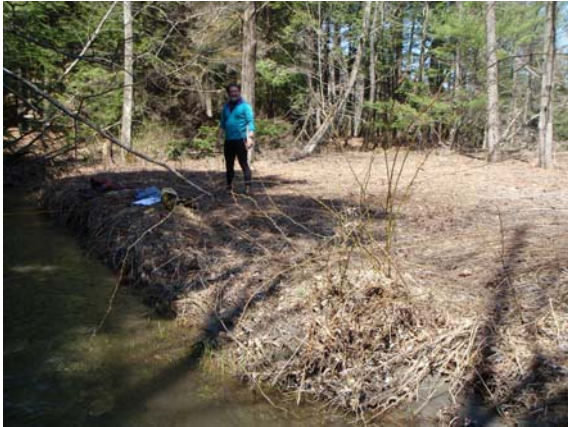
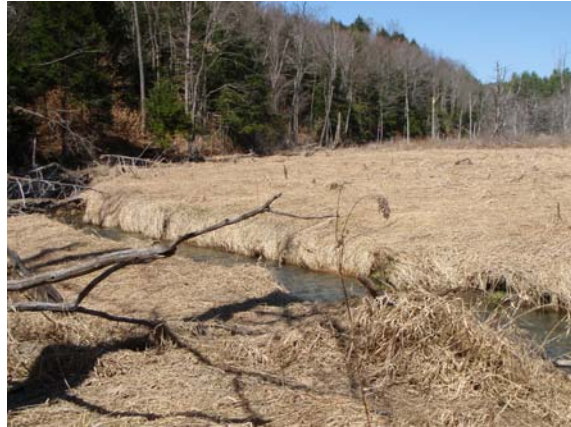
Figure 21. Accessible floodplain mid-reach in M03. Figure 22. Old beaver impoundment in upper M04.

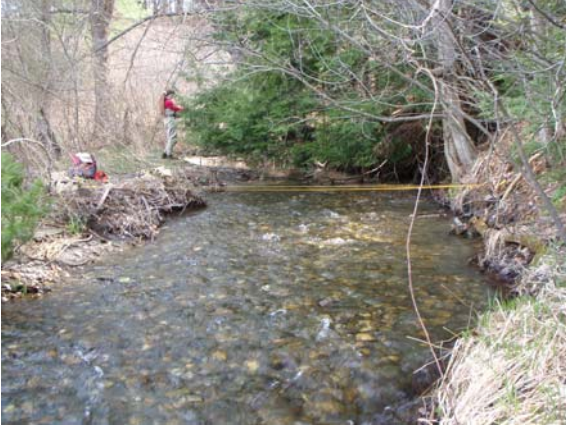
Figure 23. Cross-section mid-reach in M05.

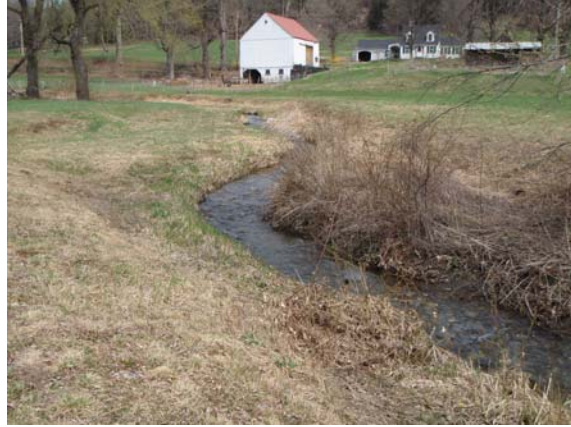
Figure 24. Lack of riparian buffer in upper M05.

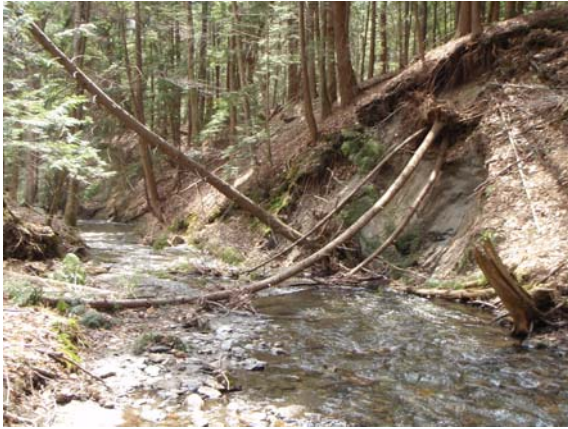
Figure 25. Mass failure in Segment M06-A.

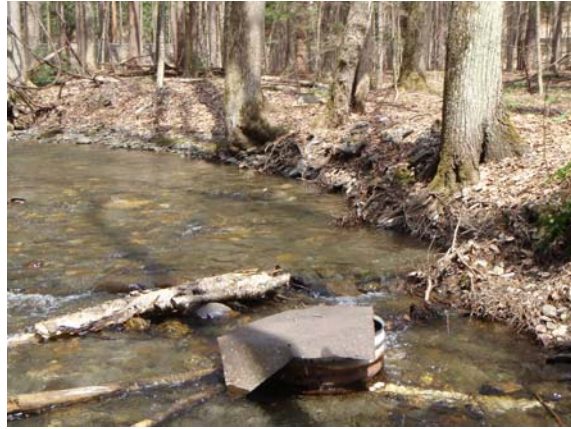
Figure 26. Cistern pond diversion in M06-A.

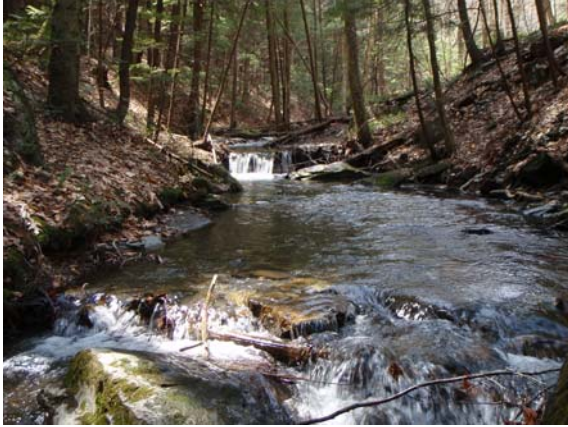
Figure 27. Step-pool bedform in M06-B.

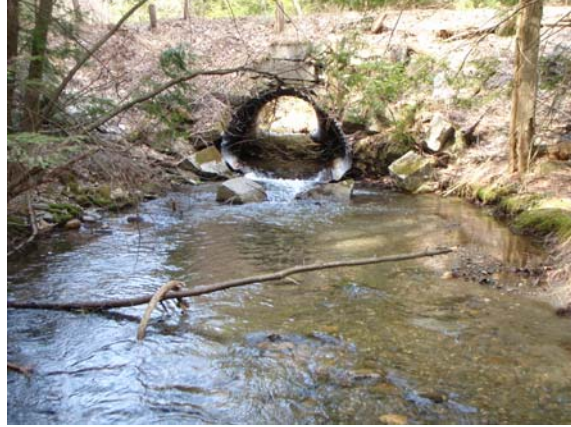
Figure 28. Houghton Road culvert in upper M06-B

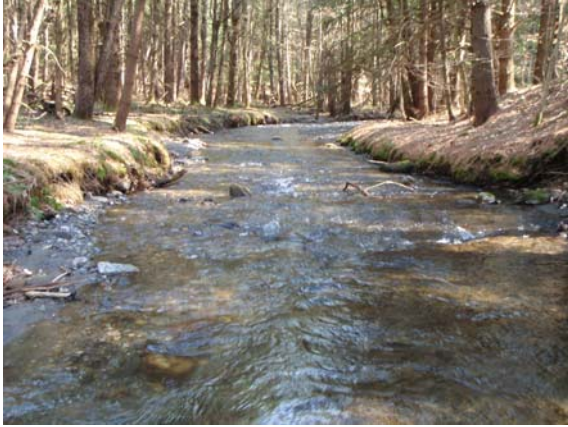
Figure 29. C-type geometry in M06-C.

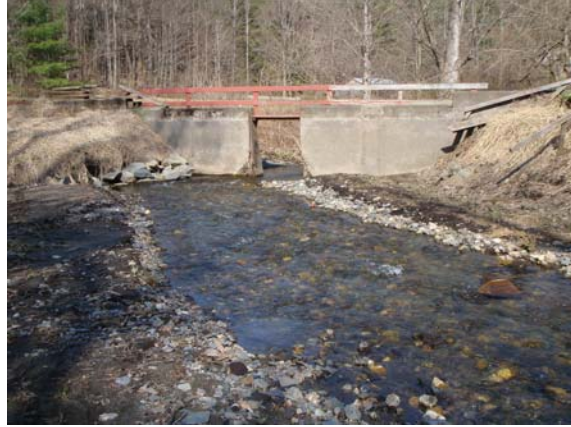
Figure 30. Dam and sluice gate in upper M06-C.

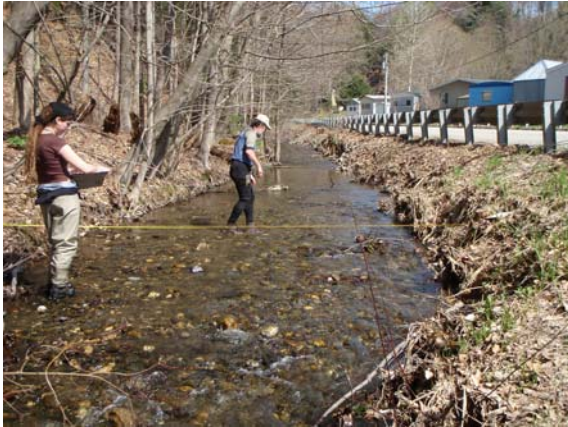
Figure 31. F-type geometry in upper T1.01.

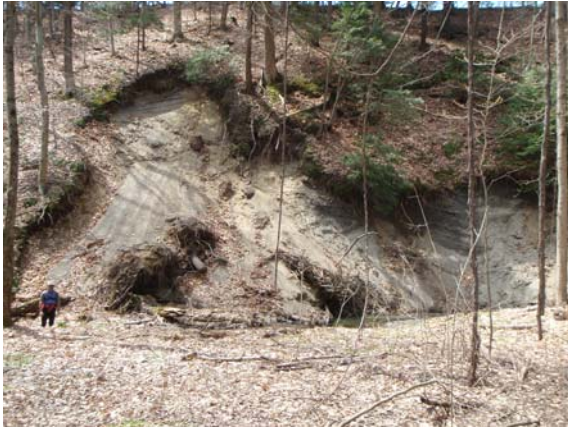
Figure 33. Large mass failure in upper T1.02-A.

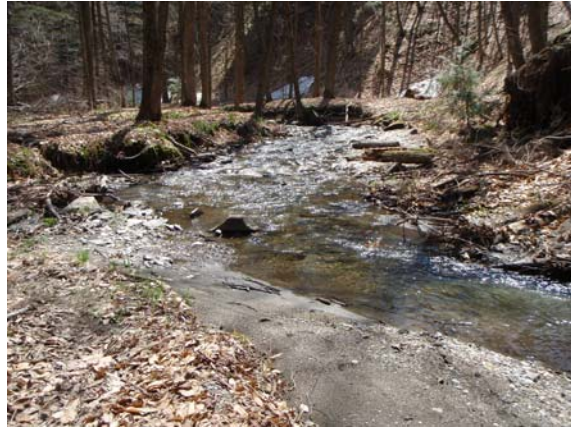
Figure 34. Bank erosion mid-segment T1.01-A.

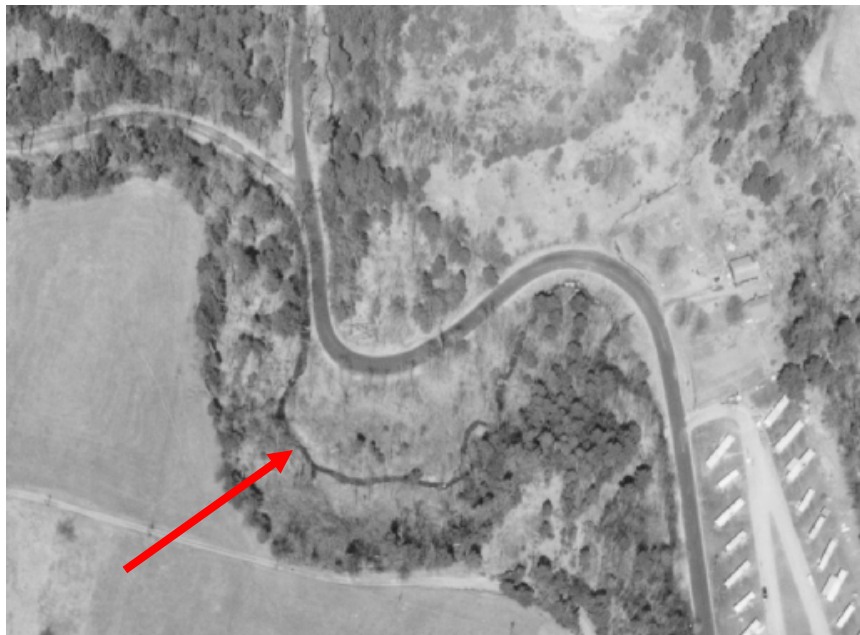
Figure 35. 1962 aerial photograph of T1.02-A. Red arrow points to current site of mass failure.

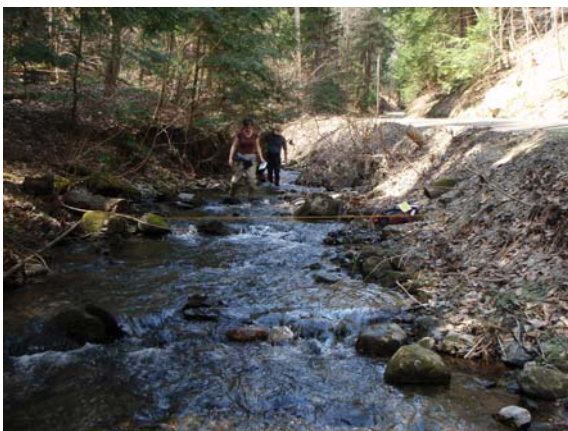
Figure 36. F-type geometry in T1.02-B.

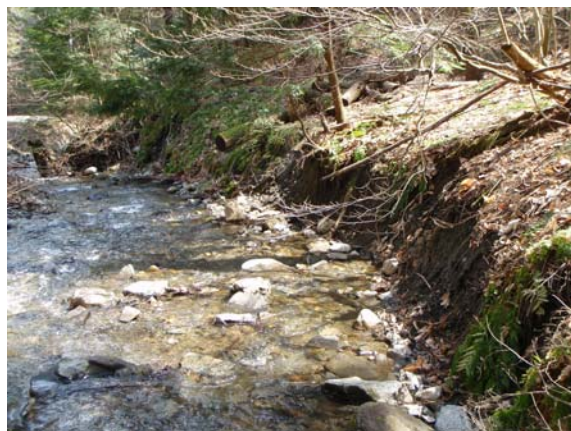
Figure 37. Bank erosion in lower T1.02-B.

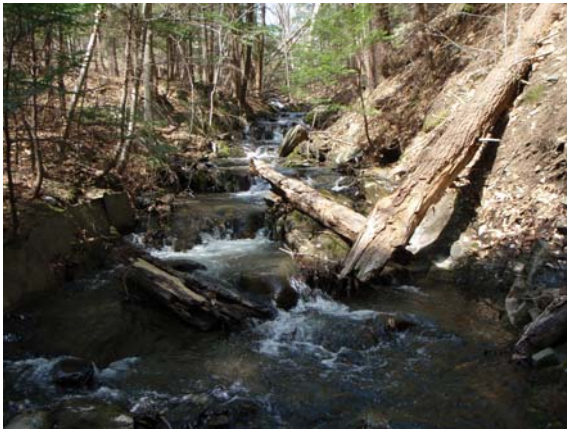
Figure 38. Step-pool bedform in T1.02-C.

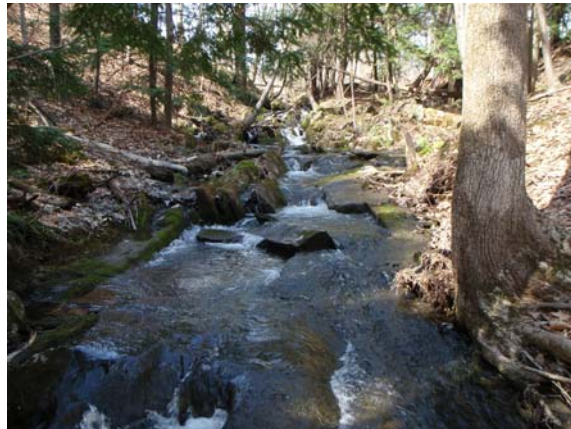
Figure 39. Bedrock grade controls in upper T1.02-C.

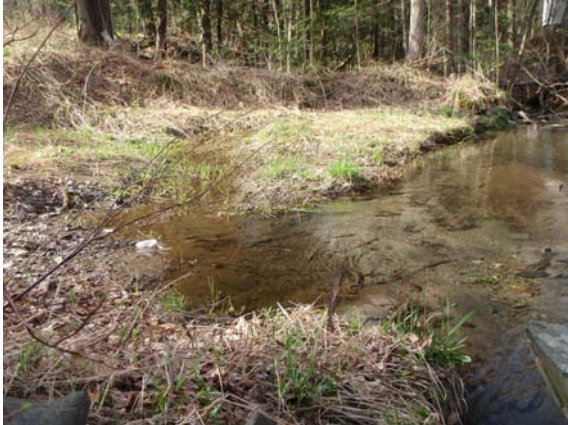
Figure 40. Old impoundment in lower T1.02-D

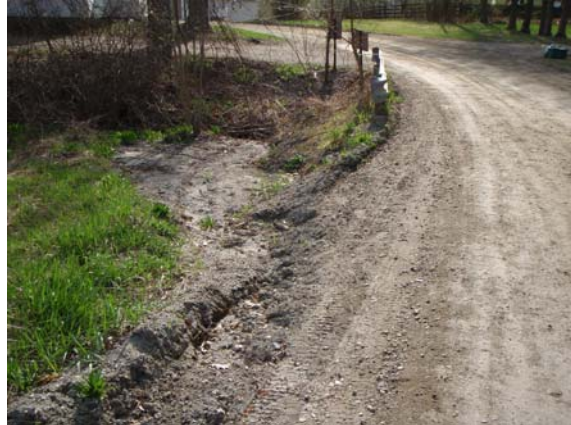
Figure 41. Sediment source from Dickinson Road.

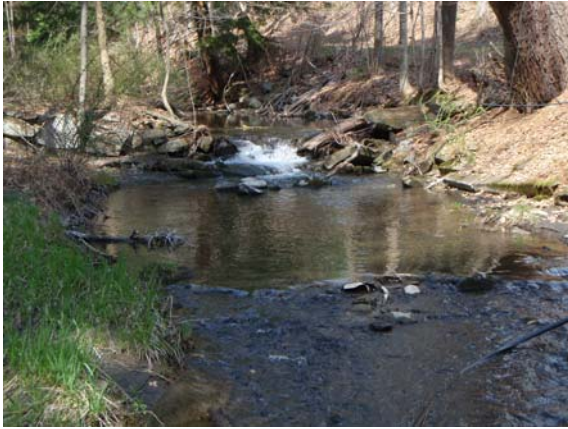
Figure 42. Old dam in lower T1.02-E.

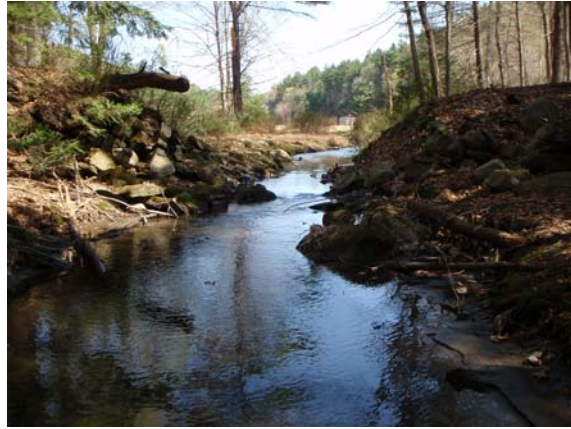
Figure 43. Reach break at T1.03.

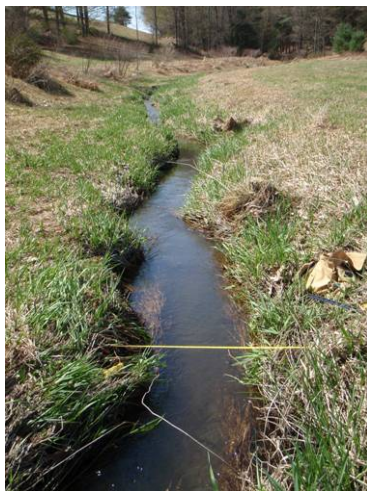
Figure 44. Cross section in T1.03.

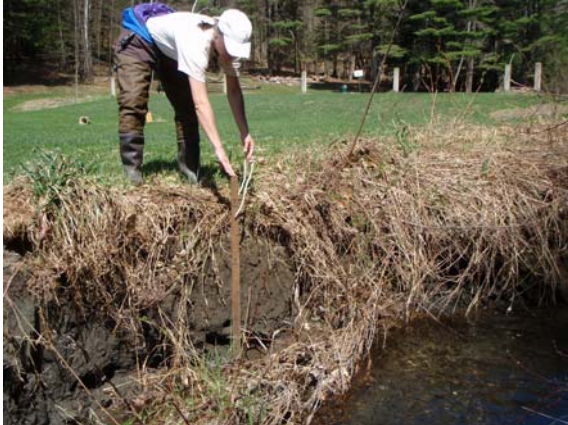
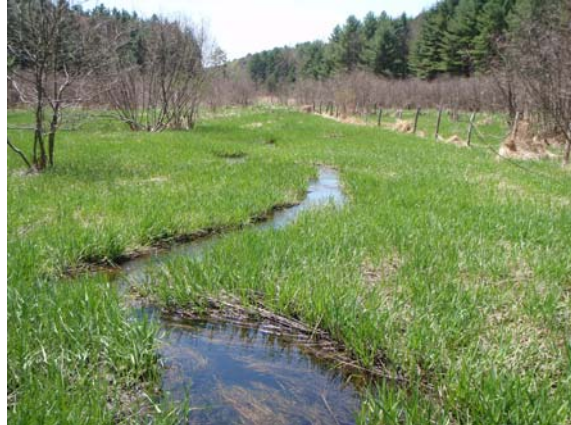
Figure 45. Bank erosion mid-reach below a crossing. Figure 46. Herbaceous buffer in upper T1.03.

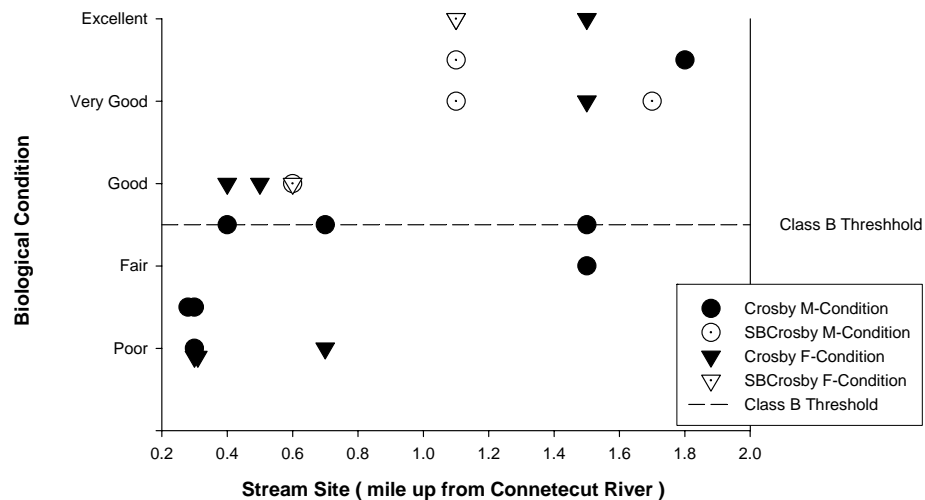
The lower part of the watershed starting from CB 0.7 down to CB 0.3, and SBC 0.1 are generally degraded compared to the upper watershed sites. Based on the assemblage characteristics, and habitat observations temperature, sediment/silt, and stream channel straightening appear to be the most likely stressors to various degrees at each individual site. Finally, it is clear that the lowest site 0.3 has been consistently assessed as fair to poor by both assemblages for three consecutive years. The assemblage characteristics and habitat observations at this site point strongly toward temperature and sediment/silt, as the primary stressors.
