Wild Branch Corridor Plan

Wolcott, Craftsbury and Eden, Vermont

March 18, 2010

Wild Branch Corridor Plan Wolcott, Craftsbury and Eden, Vermont

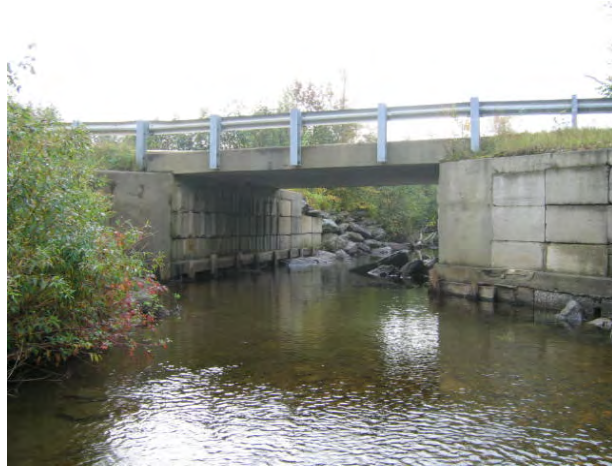
The Hatch Brook Road Bridge is undersized relative to the bankfull channel width and has poor alignment. The deposition above and below the Hatch Brook Road Bridge suggests there is a localized problem with sediment transport in segment T14-C as a result of this stream crossing. This bridge crossing has been rated as high priority for replacement based on cursory information from the Phase 2 geomorphic assessment. A full bridge and culvert assessment using the VANR's protocols is recommended to verify this structure is a high priority for replacement.

Figure 5.6 The Hatch Brook Road Bridge is undersized relative to the bankfull channel width.

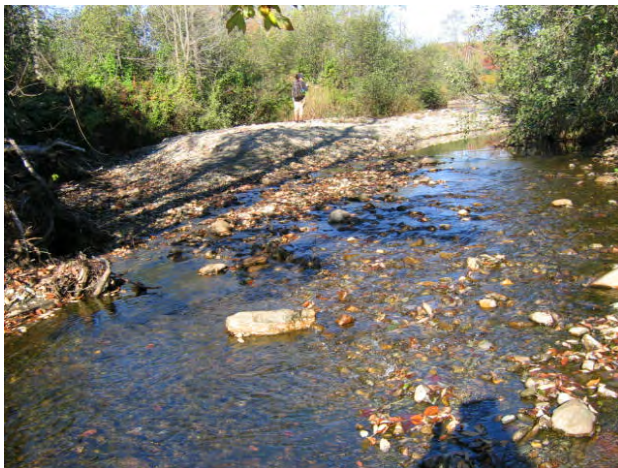
The upper Collinsville Road Bridge in reach T16 has been identified as high priority for replacement because it is causing localized geomorphic instability. The bridge was noted to have poor alignment. Considerable sediment is depositing upstream, within, and downstream of the structure (Figures 5.7 and 5.8).

Figure 5.7 Steep riffle and mid-channel bar showing considerable deposition upstream of Collinsville Road upper stream crossing.

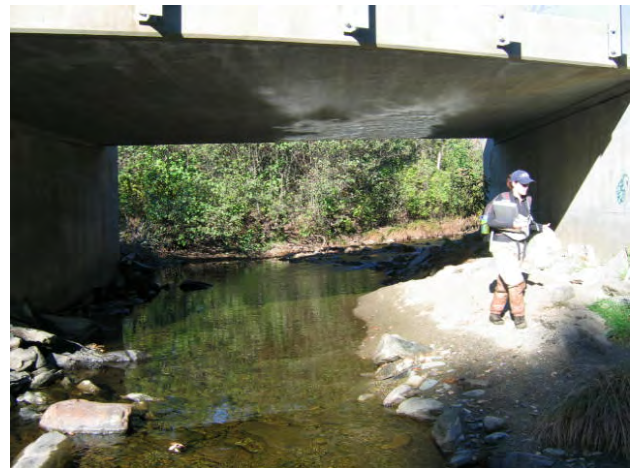
Figure 5.8 Large side bar within and downstream of Collinsville Road upper stream crossing. The alignment of the structure is poor and is causing localized geomorphic instability.

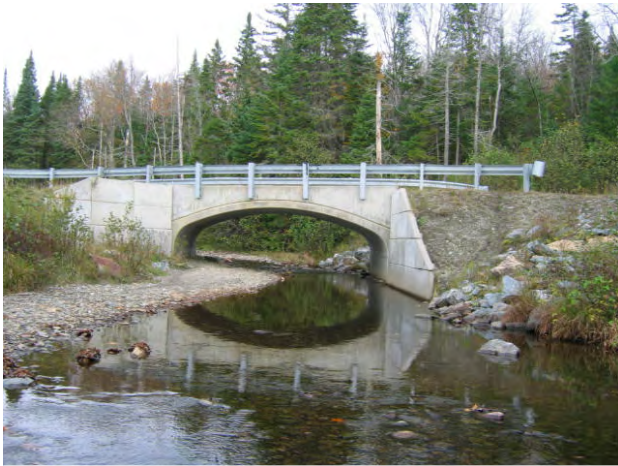
The 24 foot wide Square Road Bridge in segment T19-A was identified as causing localized geomorphic instability during the Phase 2 assessment due to scour and deposition above and below the structure (Figure 5.9) as well as poor alignment (Figure 5.10). The span relative to the bankfull width is 61 percent. This structure is high priority for replacement.

Figure 5.9 Deposition and scour above and below the Square Road Bridge. The bridge has poor alignment.

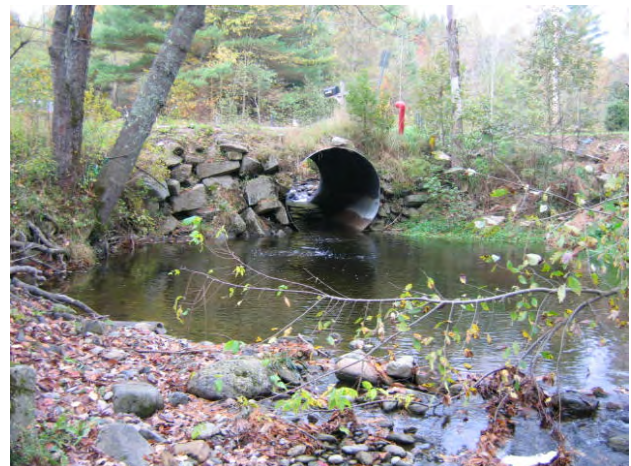
The Brook Road culvert in reach T10.01, located on a major tributary to the Wild Branch, is undersized. The culvert diameter is only 7 feet compared with a measured bankfull width of 24.5 feet (Figure 5.9). The small diameter is causing sediment transport problems including deposition and scour above the structure and a large scour pool immediately below the structure. Undersized bridges and culverts are not designed to accommodate both flow and sediment. During flood events large point bars can consequently deposit upstream of undersized bridges and culverts. During catastrophic flood events crossings can become outflanked, taking out large sections of roads and driveways. Significant sediment discharges to waterways can result. Sedimentation of the river poses water quality and aquatic habitat concerns.

Figure 5.10 This undersized Brook Road stream crossing on a tributary to the Wild Branch is causing significant sediment transport problems as well as reduced aquatic organism passage.

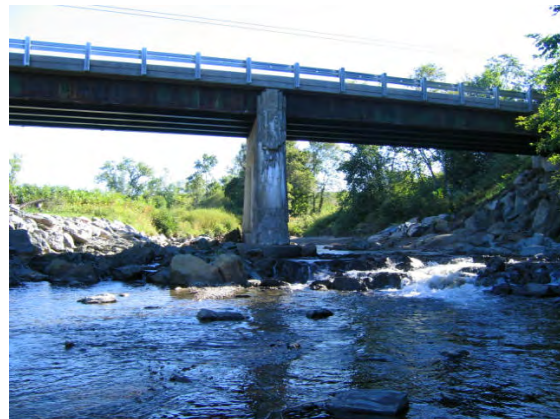
Figure 7.2. Downstream end of Route 15 Bridge showing deposition and ledge grade control within Reach T01

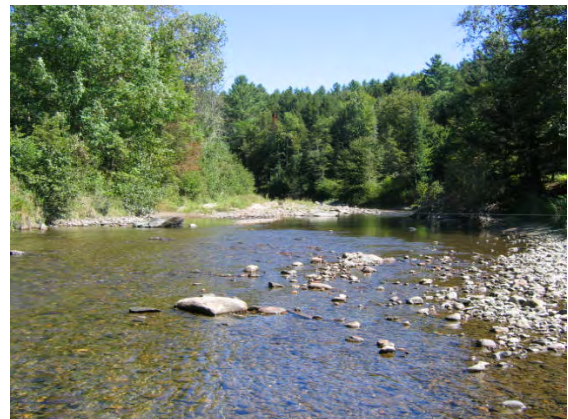
Figure 7.3. Reach T02 has a wide depositional channel in this cross section location.

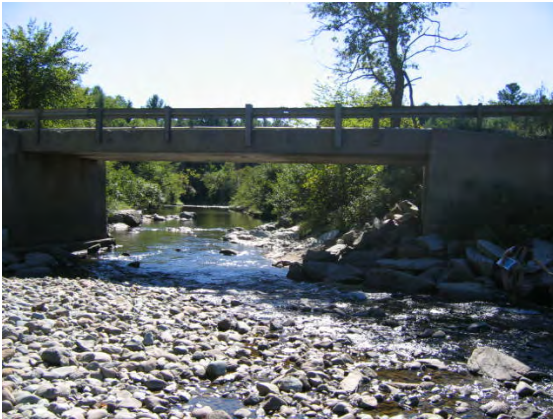
Figure 7.4. Rip rap and hard bank armoring is associated with the Gulf Road Bridge in Reach T03. The bridge is resulting in deposition of sediment.

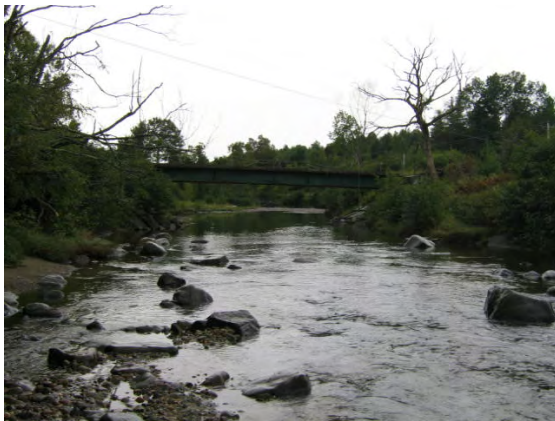
Figure 7.6. The Wild Branch Lane Bridge is a floodprone constriction and not a channel constriction.

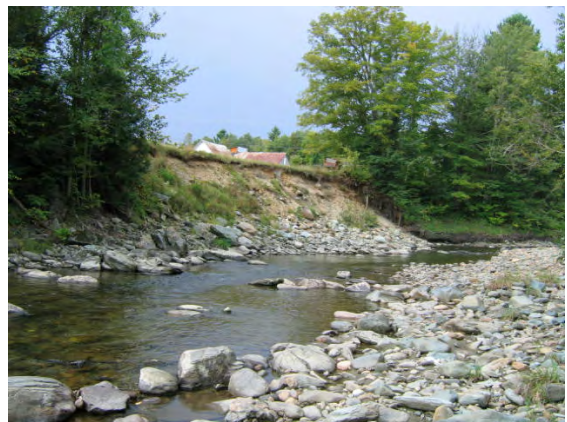
Figure 7.7. A mass failure about 15 feet high is on west bank where the Wild Branch flows away from North Wolcott Road in reach T04.

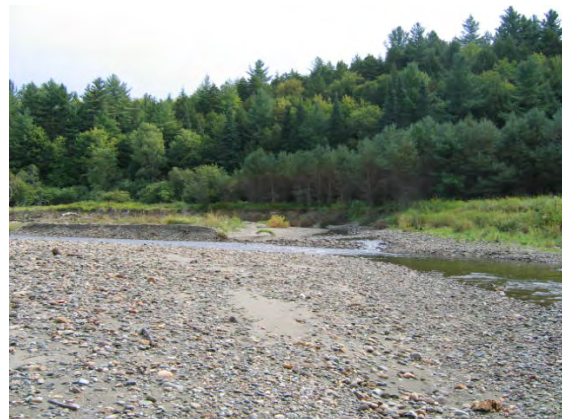
Figure 7.8. Reach T05 has large depositional features with aggradation as the primary process.

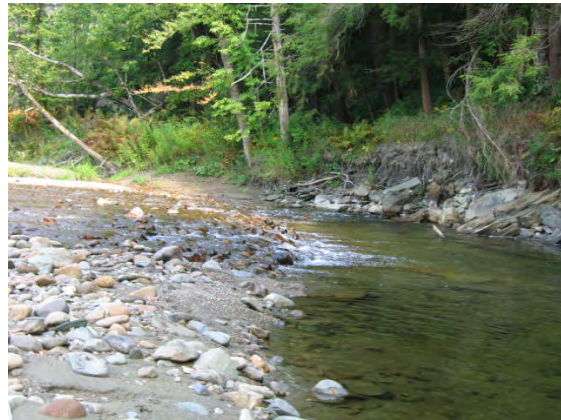
Figure 7.9. Reach T06 has multiple steep riffles and diagonal bars indicating sediment is building up.

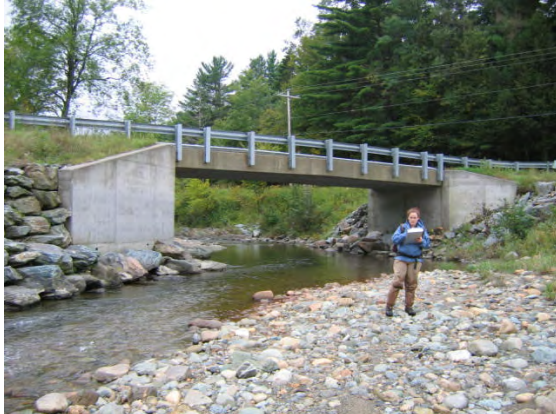
Figure 7.11. Sediment deposition upstream Tamarack Road Bridge. The bridge is undersized relative to the bankfull channel width and has poor alignment.

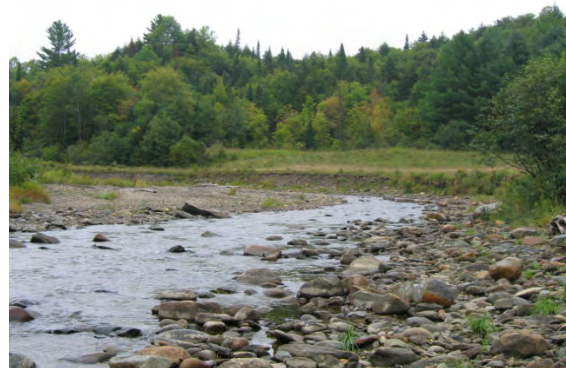
sides. Figure 7.12 shows bank failure on an outer bend where the buffer is less than 25 feet in width.

Figure 7.12. Bank failure on outside bend in reach T08 where the buffer is less than 25 feet in width.

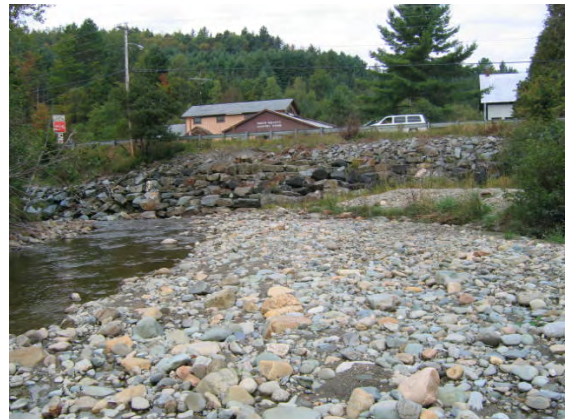
Figure 7.13. Rock riprap along North Wolcott Road in reach T09

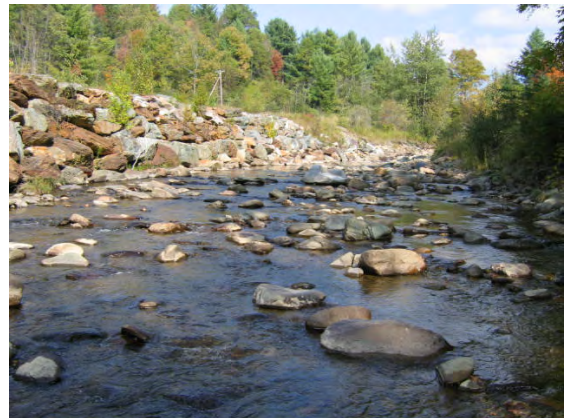
Figure 7.14. Segment T10-A has been extensively straightened and riprapped along the entire length.

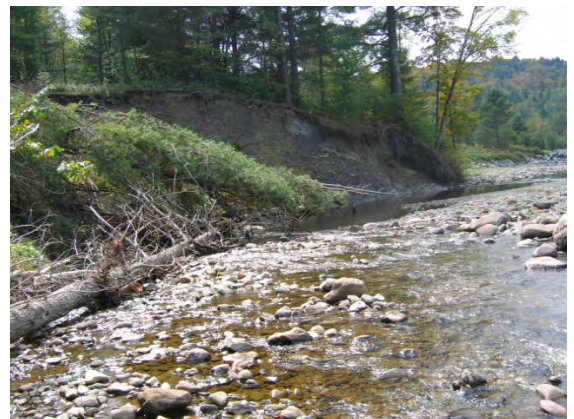
Figure 7.16. A mass failure along the east bank of segment T10-C contains clay soils. A diagonal bar is shown in the foreground of the photo above.

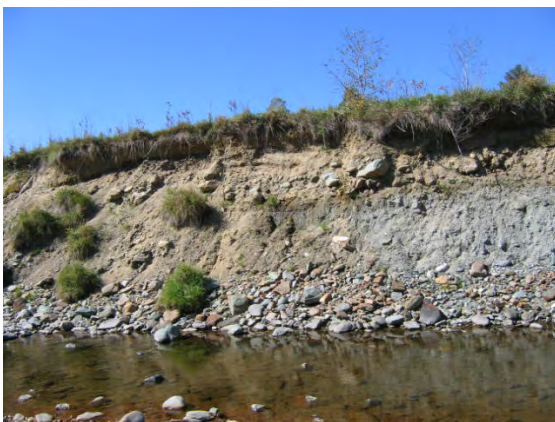
Figure 7.19. A mass failure approximately 15 feet high and 150 feet wide is located along the west bank of reach TII.

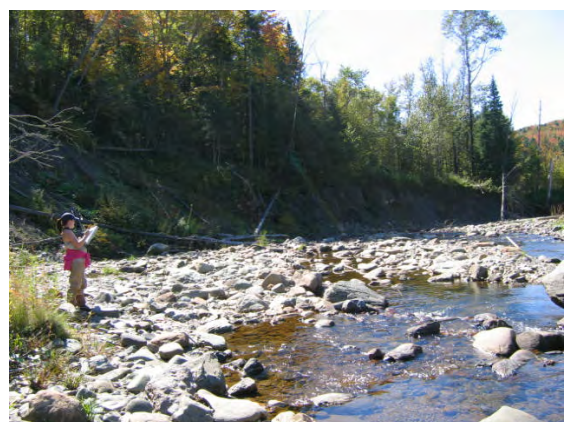
Figure 7.20. Split flow (braiding) is occurring within reach TII.

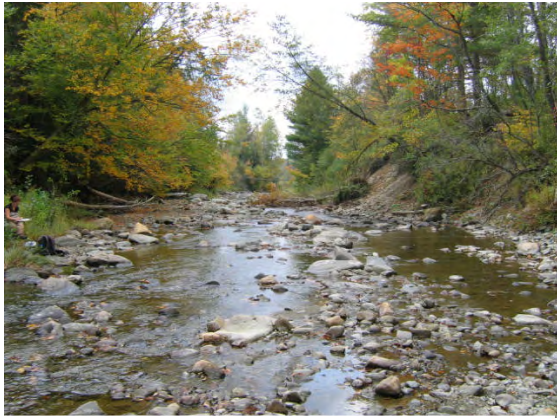
Figure 7.21. Typical incised channel in segment T12-A.

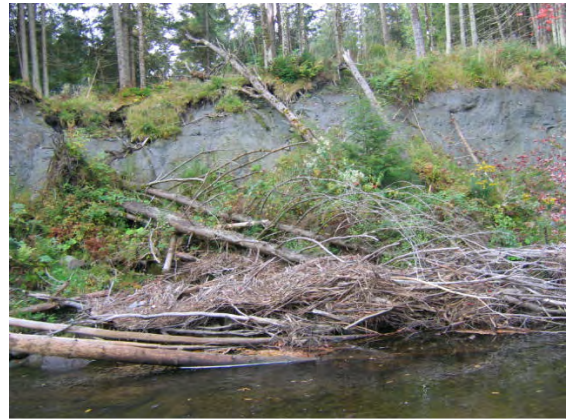
Figure 7.22. Debris jam in front of clay, east bank of T12-B. Mass failures as shown in this photo were common along the east bank.

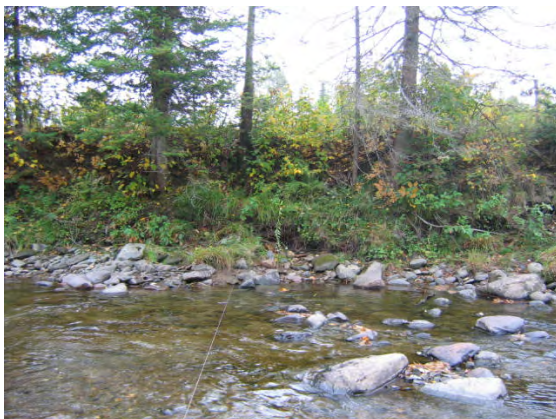
Figure 7.23. The channel in reach T13 is a stream type departure from reference condition.

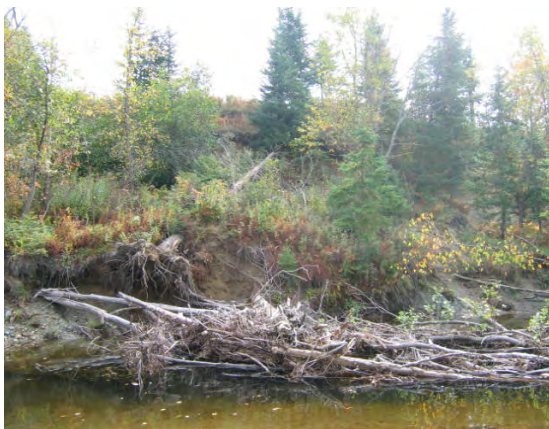
Figure 7.27. The bank erosion in segment T14-C is evidence that the stream channel is widening in response to incision.

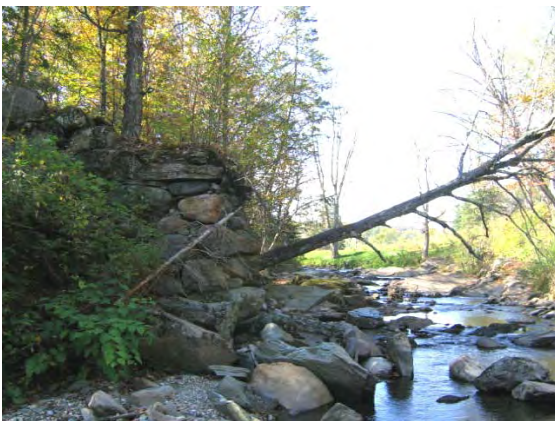
Figure 7.30. Remnants of possible historic dam in segment T15-C.

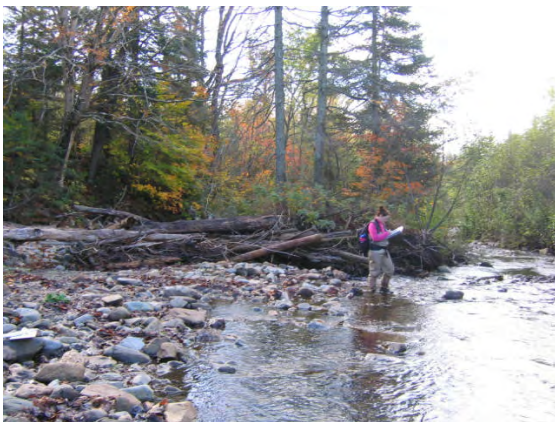
Figure 7.37. A channel avulsion was noted during the Phase 2 assessment near the upper end of reach T18.

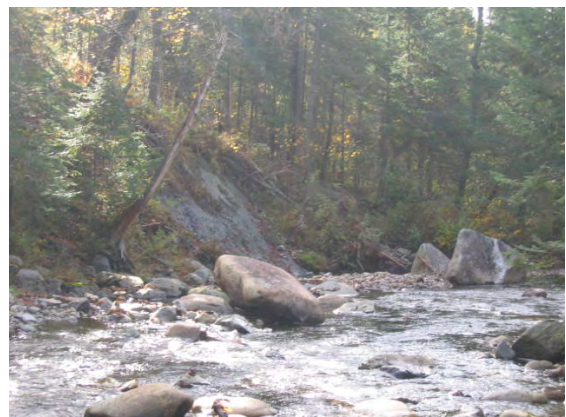
Figure 7.38. Erosion along the east bank. This bank contains clay.

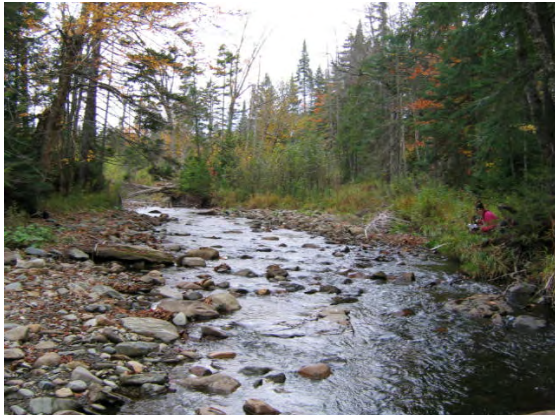
Figure 7.39. Segment T19-A has a high quality buffer. The channel is over wide and bank erosion is common.

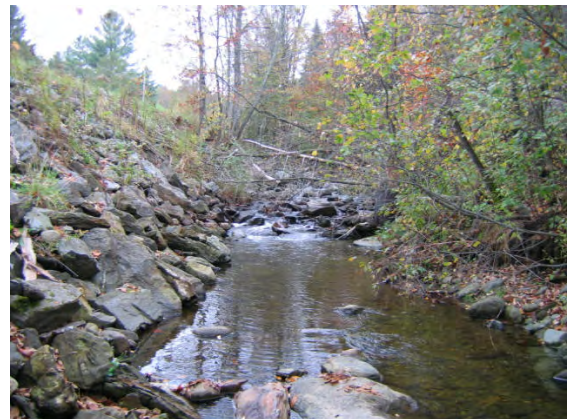
Figure 7.42. A steep riffle is shown upstream of the riprap that is located along Brook Road in Reach T10.01.

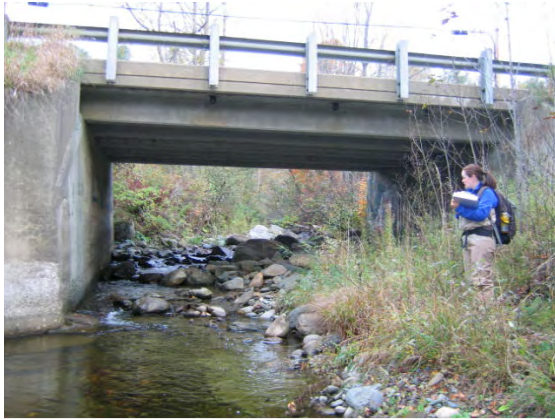
Figure 7.43. Deposition is occurring both upstream and downstream of the North Wolcott Road Bridge. This structure is a moderate priority for replacement.

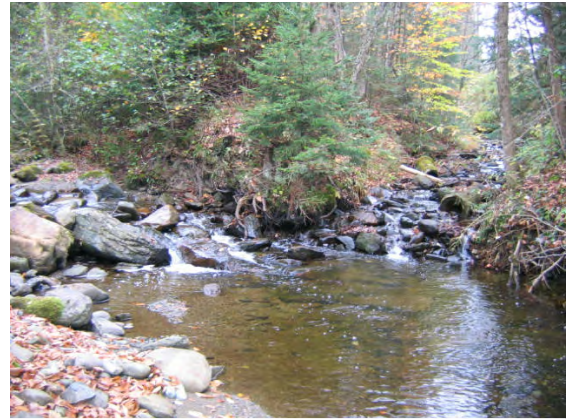
Figure 7.44. A rejuvenating tributary in reach T10.01 indicates the bed of the Wild Branch mainstem has incised.
