# Muddy Brook Phase 1 and 2 Stream Geomorphic Assessment Summary

February 2, 2009

**Fitzgerald Environmental Associates, LLC.**

Vermont River Management Program

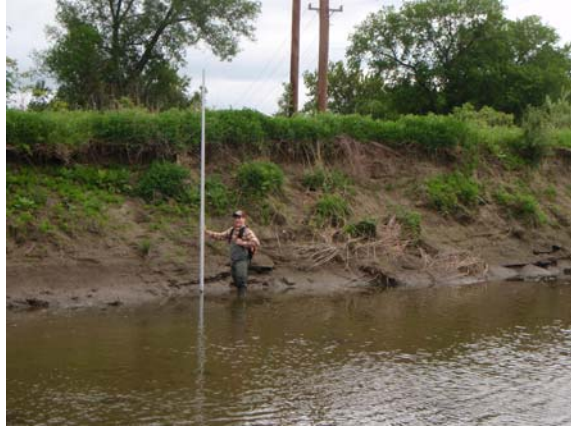
sediment load, because the banks are largely non-cohesive (Figure 14). The low slope of the reach and high sediment load has helped form several prominent point bars with elevations about one-half of the bankfull height. Allen Brook (T1.01) drains an area of over 10 sq. miles and contributes greatly to the observed discharge and width of the first reach.

Figure 14. Bank erosion on the right bank 10'h x 150' l

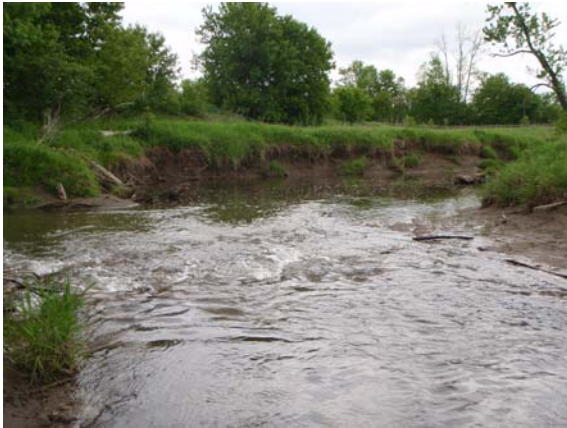
high incision ( $IR = 1.6$ ) was noted at the cross section. The extent of the channel erosion was not limited to the banks; a head cut was observed several hundred feet upstream of the National Guard Avenue channel crossing. There, a more cohesive clay conglomerate provides temporary vertical stability, halting the migration of the 0.5-foot head cut (Figure 15). Three mass failures were also observed on the right banks of the upper-reach where the channel was continuous with valley wall. The soft sand texture of the exposed slope provides little resistance to the power of the channel (Figure 16).

Figure 15. 0.5-foot head cut (picture taken upstream)

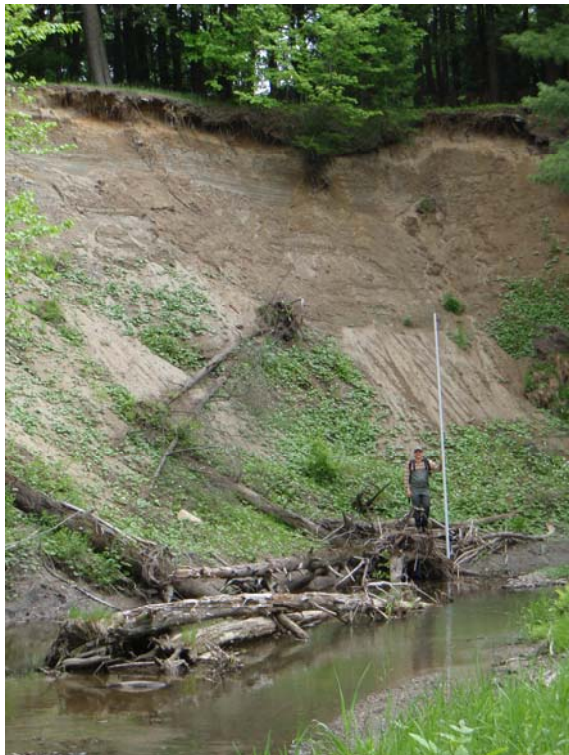
Historically this reach has been straightened, encompassing about 20% of the channel's length. The recent incision and down-cutting have resulted from the increased runoff from upslope urban land use, resulting in increased channel slope. The bank instability observed throughout the channel may also be attributed to beaver activity. Many mature silver maples (*Acer saccharinum*) that were once rooted on the near-channel banks were felled by beavers, and only the stumps remain today. Historically aerial photos from 1937 and 1962 show dense tree cover (albeit limited in width) along the lower part of the reach. Changes in planform from degradation processes and some widening in the upper portion of the reach make this channel unstable and actively incising (CEM stage II; RGA condition "fair"). Given recent and historical changes in morphology the channel is largely disconnected from its floodplain. The channel bed is primarily composed of sand (57%) and silt (21%) substrate. The down-cutting and excess sediment loading has filled deep pools and limited the availability of epifaunal substrate cover. With these features lacking the overall integrity of fish and benthic invertebrate habitat is limited (RHA condition

Figure 16. Mass failure on the right bank 40'h x 70'

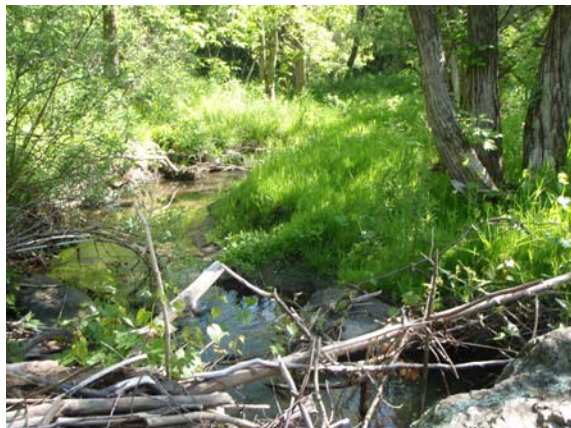
Figure 20. The upstream end of the large floodchute

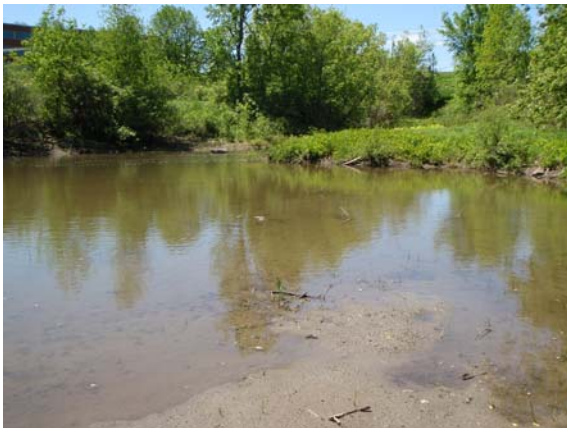
Figure 23. Ponding observed mid-reach

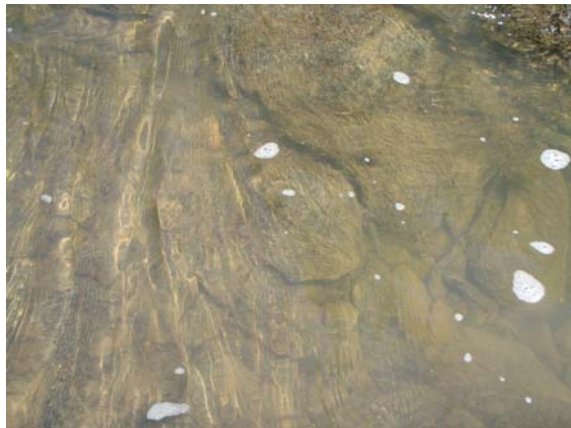
Figure 24. High embeddedness and filamentous algae

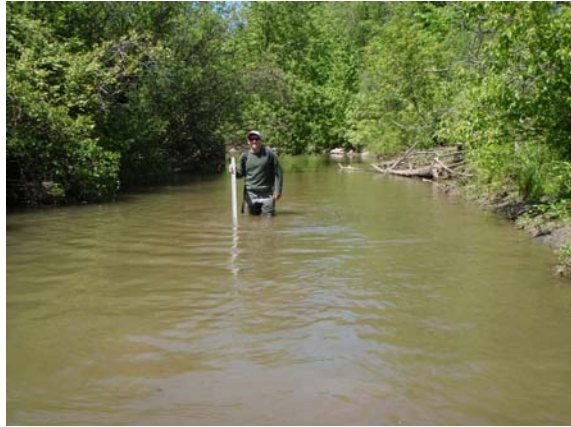
Figure 26. Stream channel that is deep and canal-like

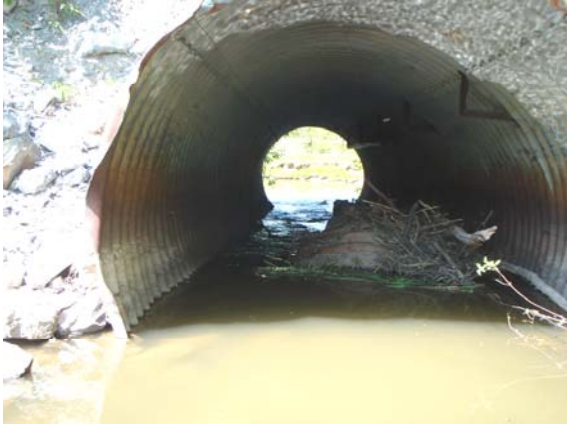
Figure 27. Debris jam inside the undersized culvert

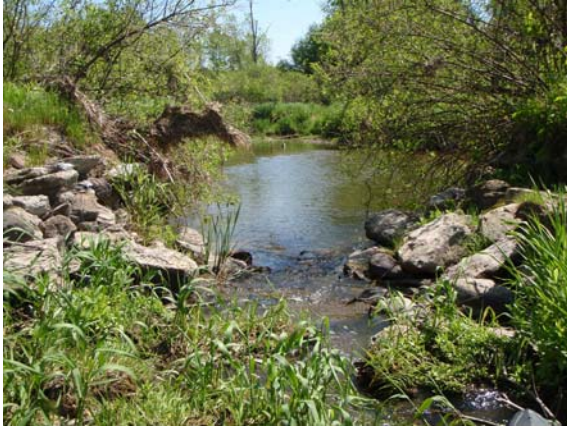
and morphology of this stream type. An old bridge abutment found mid-reach was causing erosion and channel migration (Figure 30). Other areas had minor channel migration that was caused by old beaver dams that have since failed.

Figure 29. Old bridge abutment that has failed.

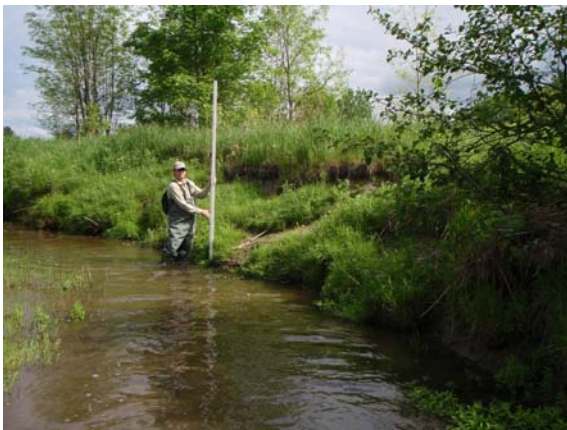
Figure 31. Bank erosion in lower reach.

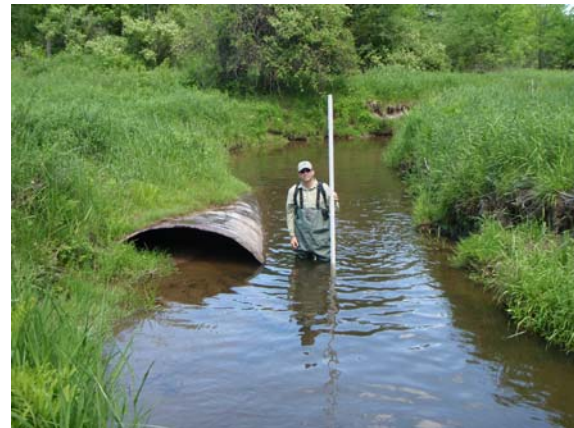
Figure 34 Failed old farm crossing in lower M11-A.

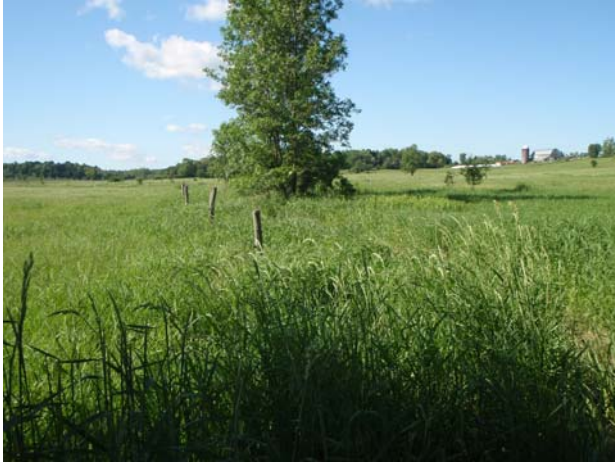
Figure 36. The straightened channel along the fence row

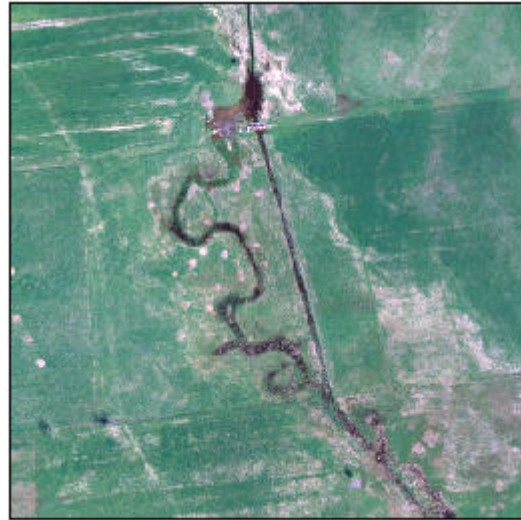
Figure 37. Straightening in M19

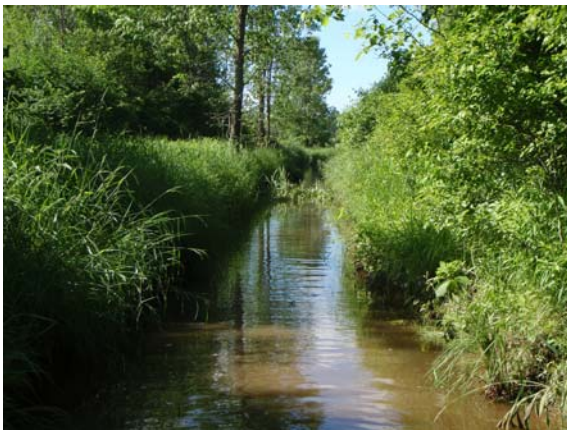
Figure 38. Straightened channel with windrowing

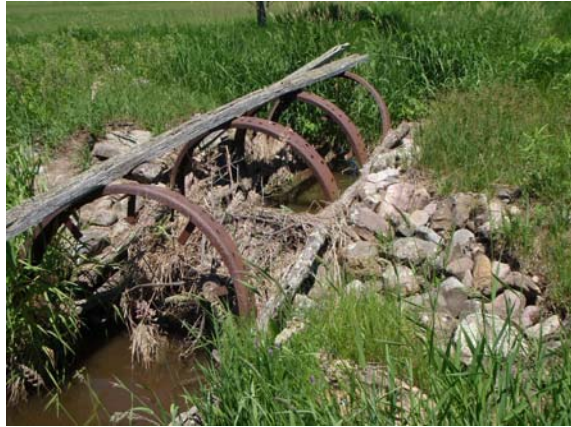
Figure 41. Culvert channel crossing clogged with debris

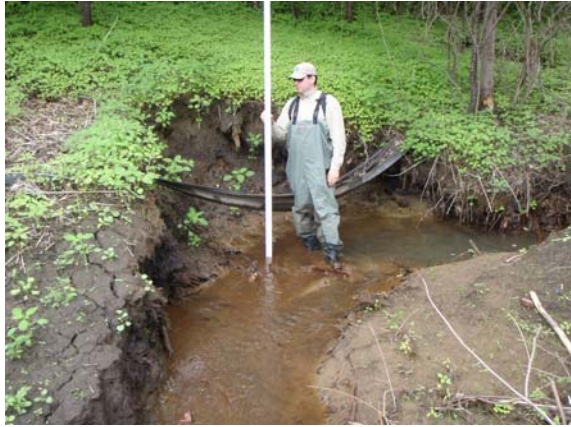
Figure 43 Bank erosion above Marshall Ave. crossing.

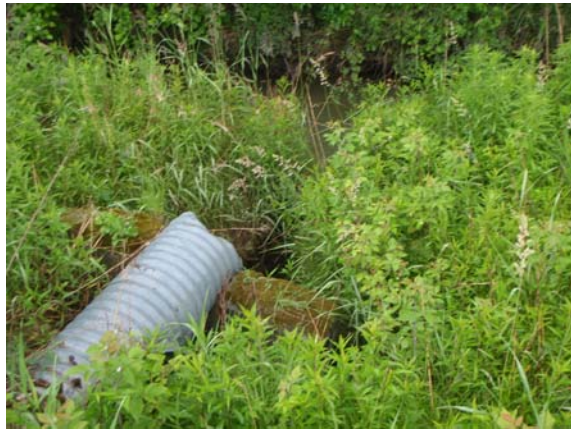
segmented because the bed substrate and channel dimensions change upslope of the road crossing. The segment has a broad valley type, which is partially encroached upon by I-89. The channel geometry is indicative of an E-type channel ( $ER = 7.6$  &  $WDR = 7.0$ ), but scour ( $IR = 1.25$ ) associated with the encroachment and straightening along I-89 has led to plane bed channel morphology (Figure 44). The incision of the channel has been slowed by the presence of clay that is not easily eroded. The segment has experienced some bank erosion on both the left and right banks, and there are two mass failures on the right bank where the channel has slumped material off from the adjacent side slope. Along I-89 a drainage culvert has been scoured out by overland flow coming off the highway (Figure 45). The culvert is held in place by a slab of concrete that has been undermined and the gully has the potential to recede towards the highway in the near future.

Figure 45. Interstate drainage eroding around a culvert

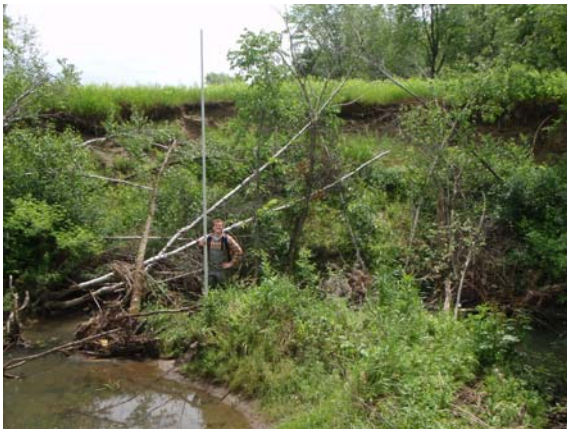
Figure 46. Mass failure on left bank (mid-segment)

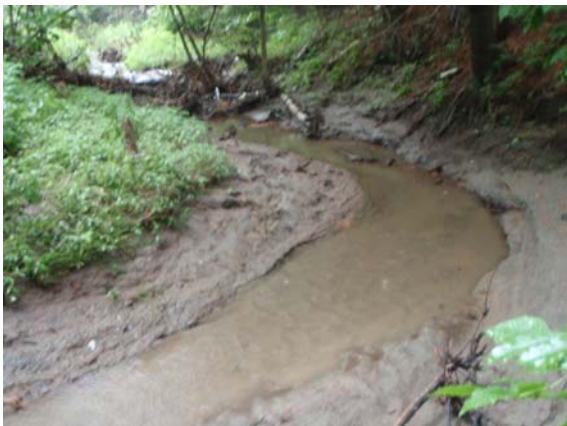
Figure 48. Aggradation of sediment mid-segment

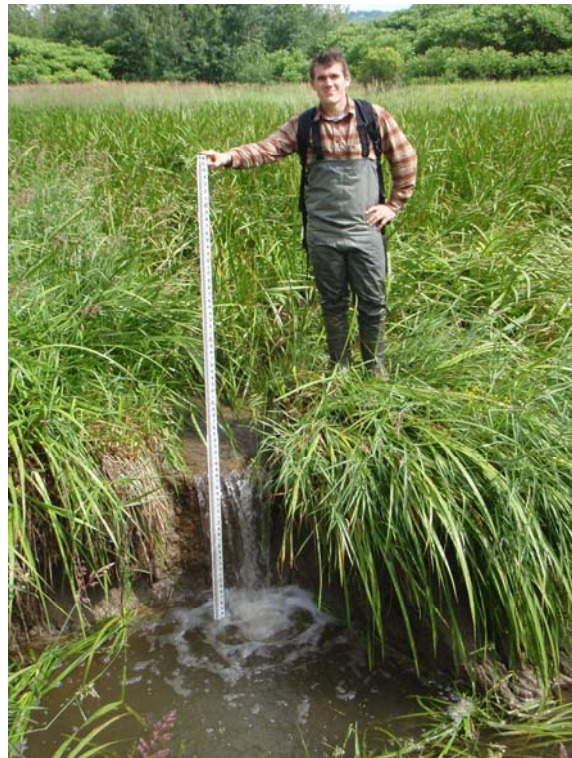
Figure 51. The primary headcut

This segment is actively adjusting to accommodate increased runoff draining from the urban land use upslope. There is no viable habitat in this reach downstream of the primary headcut and limited channelized flow above (RHA condition “poor”). The gully is an excellent example of stage II of the channel evolution process. Degradation, aggradation, widening, and planform changes are all occurring on this segment simultaneously resulting in a “poor” geomorphic condition rating.

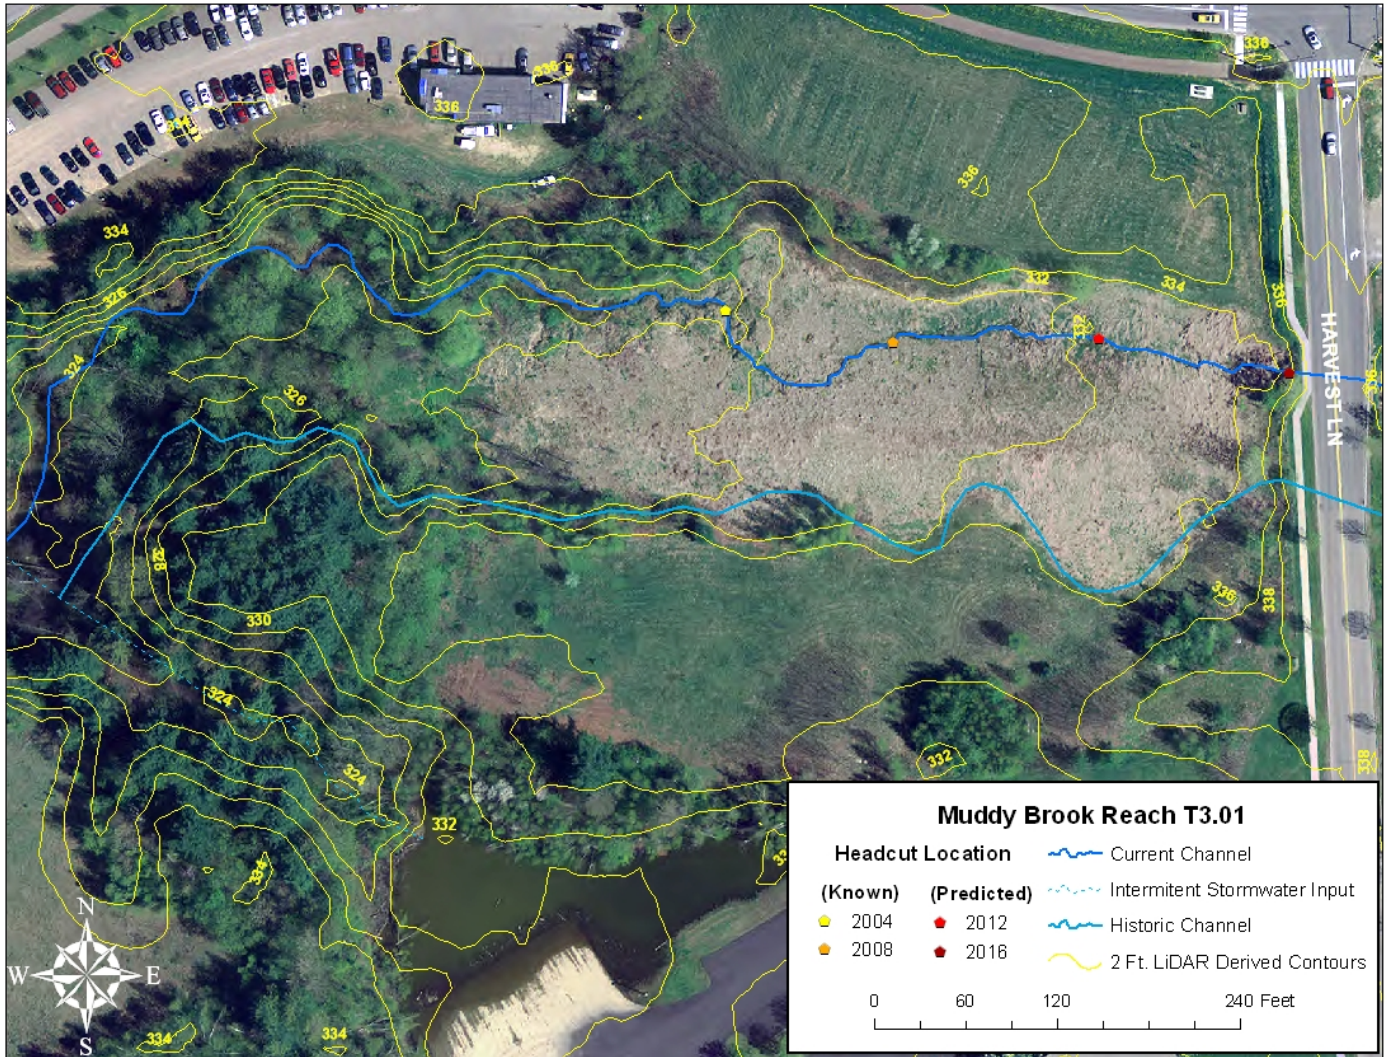
migrated approximately 30 feet a year since 2004, and, if it continues at that rate, could endanger the culvert crossing at Harvest Lane in 5 to 8 years (Figure 52).

Figure 52. Head cut location

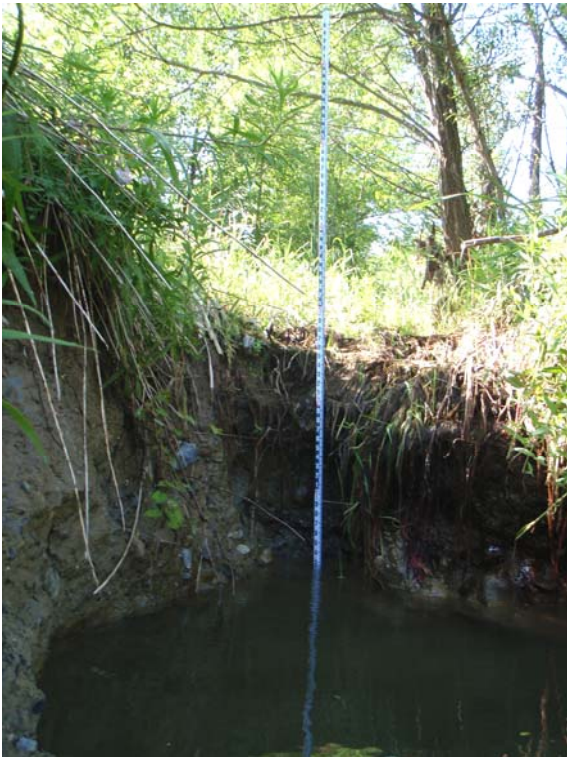
The higher slope observed in this segment combined with the influences from the surrounding development has greatly reduced the stability of the channel (RGA condition “fair”). As the headcut migrates upstream to the crossing of I-89, it is unlikely that the structure or the road would be jeopardized because of the extensive rip-rap protecting the downstream end of the culvert. Currently, the culvert is perched, with about 40 feet of large boulder-sized rocks within the channel and on both banks. The down-cutting of the migrating headcut and the export of sediment is typical of a channel found in stage II of the CEM.

Figure 55. The headcut found mid-segment

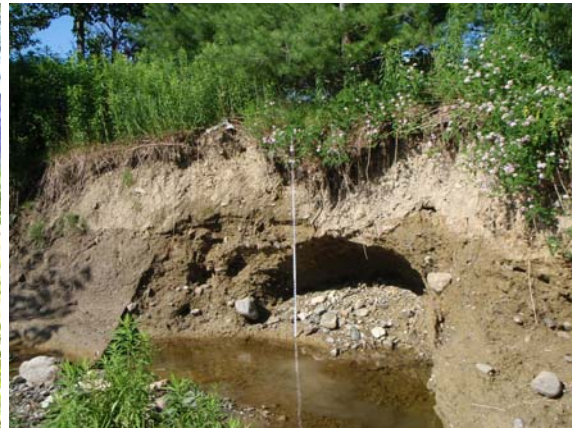
Figure 56. A mass failure observed on the left bank
