Bridge and Culvert Survey

Ompompanoosuc River & Major Tributaries

**Fairlee, Norwich, Thetford, Vershire,
and West Fairlee, Vermont**

**Prepared by
The Two Rivers-Ottawquechee
Regional Commission
Woodstock, Vermont**

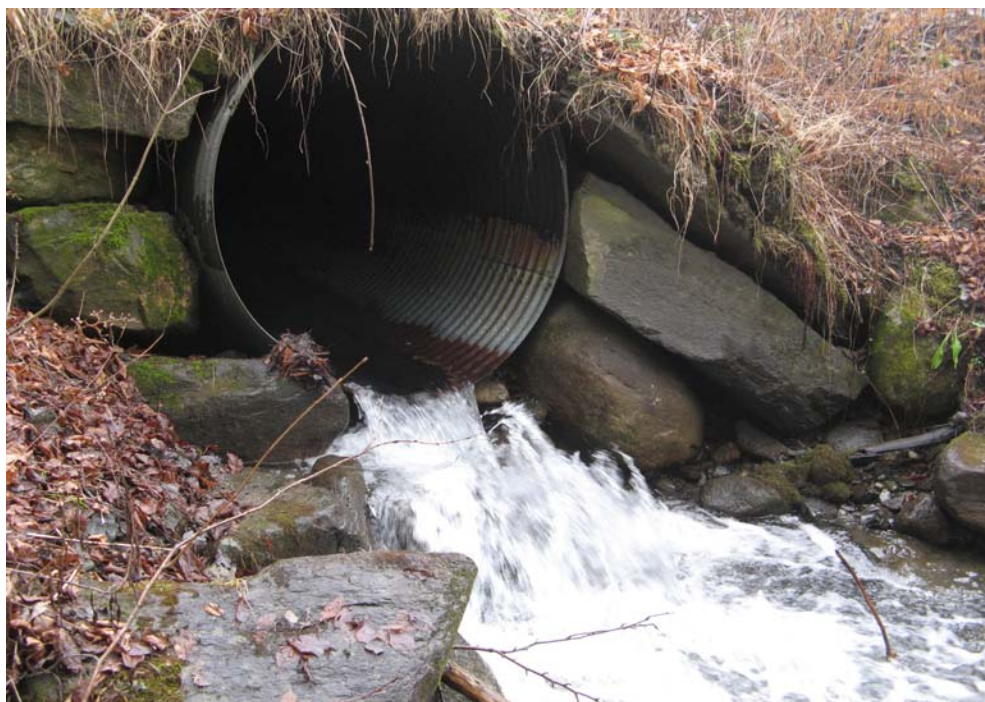
Figure 1– Perched Outlet on Vershire Center Road

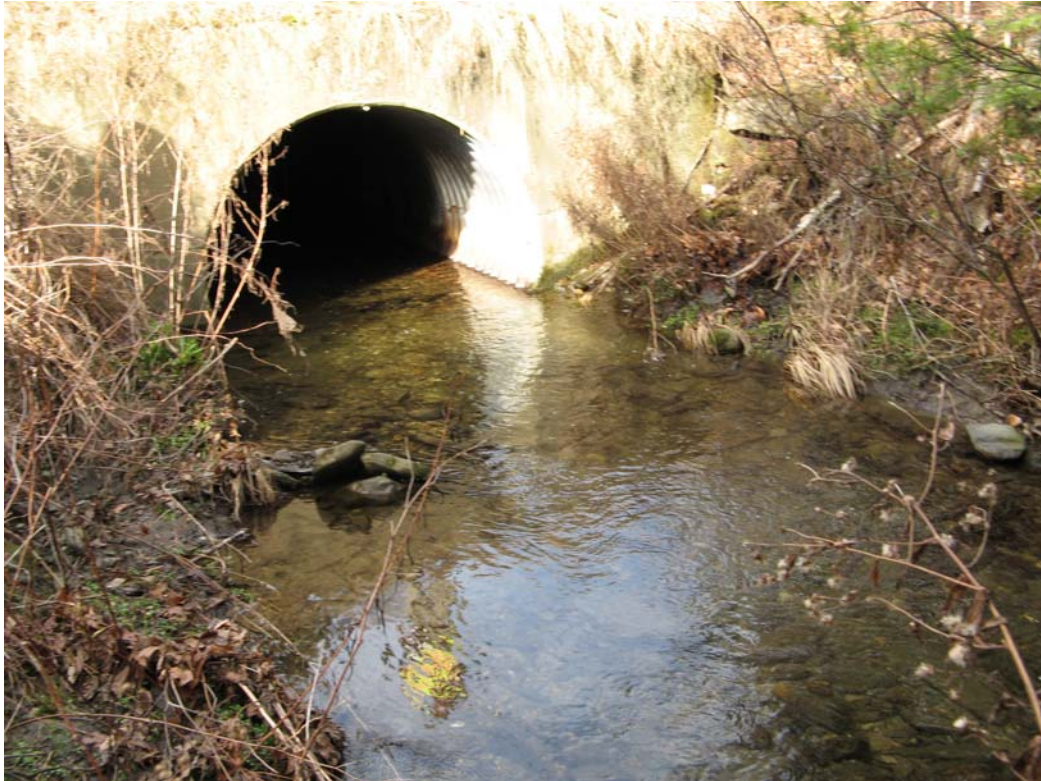
Figure 2 – Natural bed, at grade, Barker Brook in Thetford

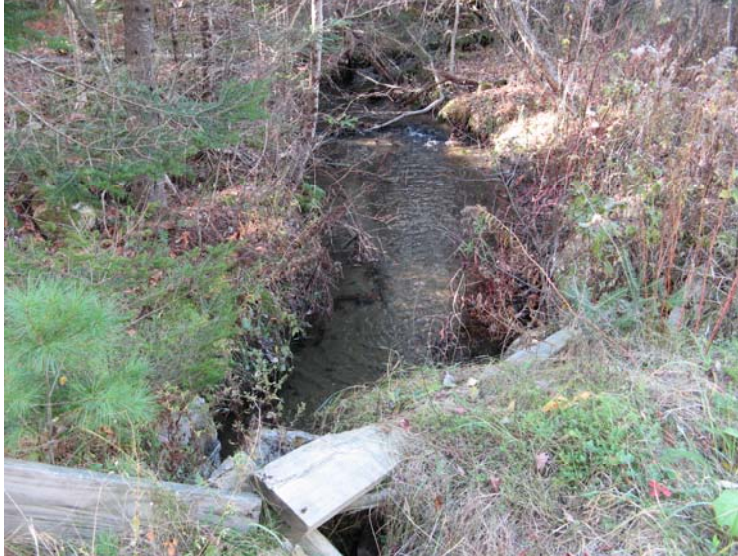
Figure 3 – Beaver Meadow Brook, approaching undersized culvert

Bridges and culverts with channel widths of less than 40 percent of the bankfull width, which significantly impede natural sediment transport, or which block AOP, were placed in Category 1. Category 1 contains structures that have highest priority for replacement, primarily due to geomorphic incompatibility, erosion, scour, or alignment problems. The two photos above illustrate the nature of this problem.

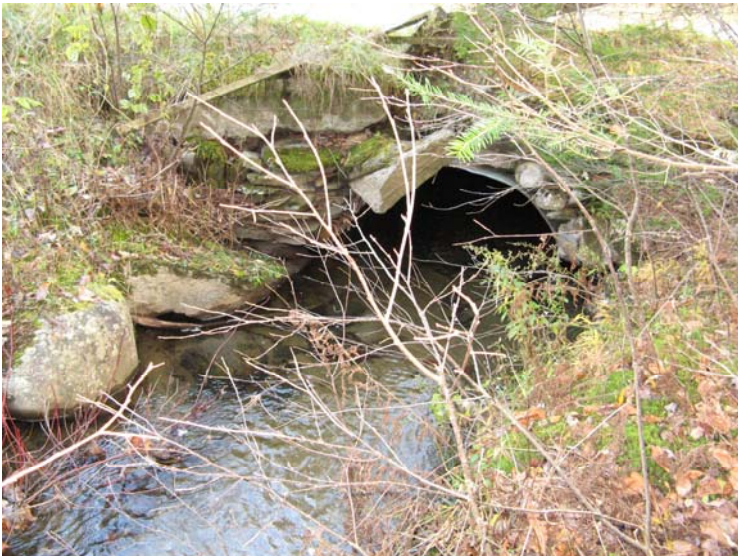
Figure 4 – Inlet to culvert with 25% bankfull width on Beaver Meadow Brook

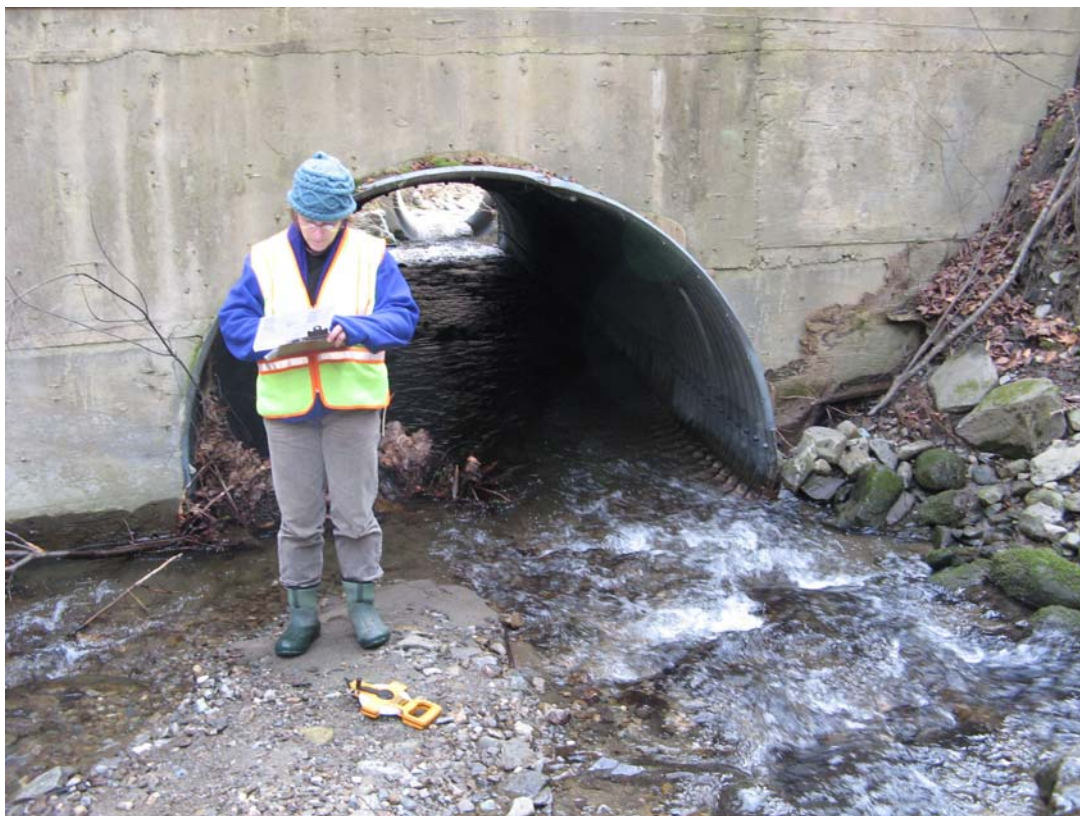
Figure 5 – Double culvert on Barker Brook, Thetford, with midchannel bar

This culvert on Barker Brook in Thetford is 35% of the bankfull width. This culvert is impeding the natural movement of sediment. The mid-channel bar immediately upstream of the inlet illustrates that deposition is occurring.
