# **Ompompanoosuc River Corridor Plan**

**West Fairlee to Thetford, Vermont**

**April 28, 2011**

**Bear Creek Environmental, LLC**

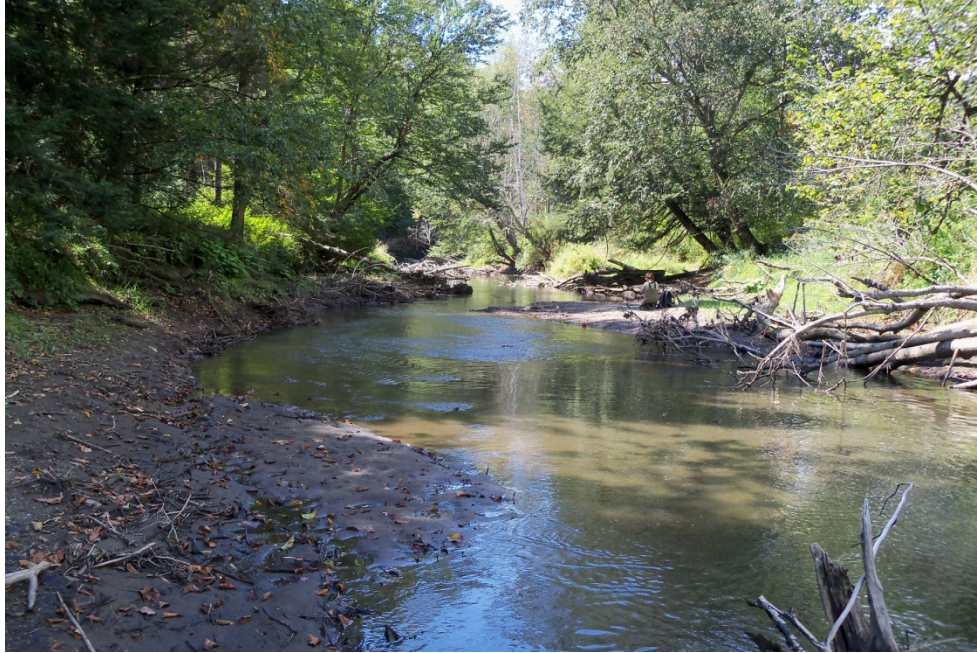
The overall habitat condition in R16 is also “fair”. Reach R16 scored in the reference category for woody debris cover, providing some cover for fish and aquatic organisms; however, there were no undercut banks noted in the entire reach. Stable undercut banks with overhanging vegetation are important for providing low velocity areas for fish to seek cover. Channel widening has led to moderate bank erosion. There are numerous *pools* in R16, but deep pools (over 2.0 feet) are infrequent. Once again, channel widening may be impacting the quality of habitat, by making the channel over wide.

**Figure 4.7** The bed substrate of reach I6 is dominated by sand.

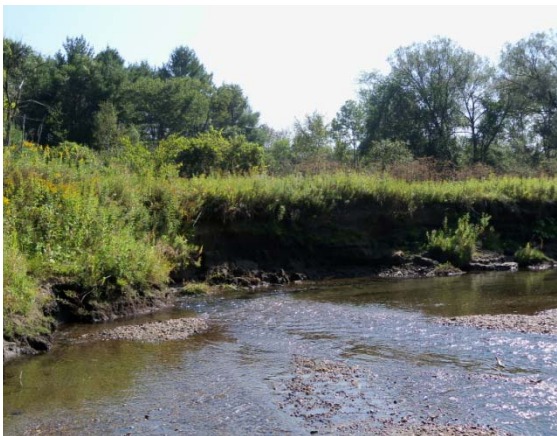
Reach R17 begins just upstream of the confluence with the Lake Fairlee outlet and continues until about 1,300 feet downstream of the Cross Road Bridge. The reach is set in a very broad valley with only minor human-caused change to the valley width from floodplain encroachments, such as houses. The channel exhibits “C” type morphology with a riffle-pool bedform. The valley slope is gentle and the channel substrate is fine, lending this reach to a subdominant bedform of dune-ripple. Clay was noted on the lower banks in some locations. Historic channel incision has led to extreme channel widening resulting in widespread bank erosion (Figure 4.8). The high frequency of debris jams and large bar features (Figure 4.9) are indicative of sediment buildup in the reach. There are two areas of mass failure in the reach that are contributing sediment to the channel. Planform adjustment (i.e. movement of the channel) is apparent from the extensive lateral bank erosion and active flood chutes. The channel is multiple thread in some locations. The overall geomorphic condition of reach R17 is “poor”.

**Figure 4.8** Extensive bank erosion in Reach R17

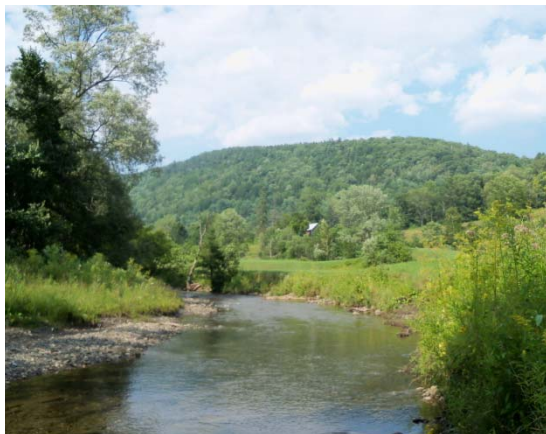
**Figure 4.12** Historically straightened.

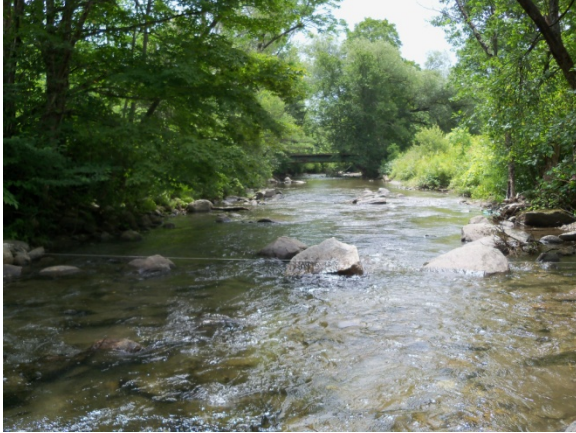
**Figure 4.17** Straightened channel

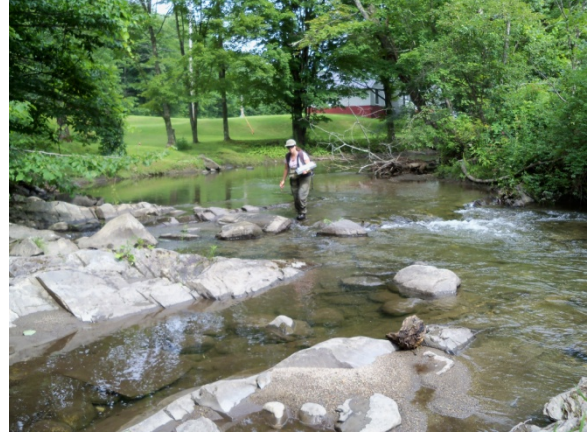
**Figure 4.18** Ledge grade control in R20-A

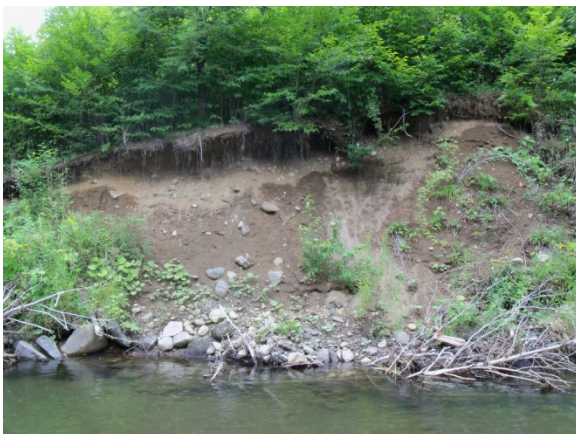
Segment R20-B has also been extensively straightened, leading to geomorphic instability and habitat degradation. The channel may have incised down to the elevation of three areas with channel spanning ledge that is at grade with the water surface under low flow conditions. The channel is a “C” by reference, and the cross section measurement indicated is near the cut-off between a “C” and a “B” channel. Route 113 is decreasing the available valley width. Even with this encroachment, the valley type is still broad. The channel evolution stage is best characterized as early widening. Historic channel degradation has caused widening and the channel is aggrading (filling in with sediment) through the presence of small diagonal bars. Upstream bank erosion and a mass failure (Figure 4.19) on the east side of the channel are sources of sediment in R20-B. Figure 4.20 shows bank erosion on the west bank and an old automobile near the upper end of R20-B, in the vicinity of Route 113. Riprap is preventing further planform adjustment and widening. The overall geomorphic condition is “fair”.

**Figure 4.19** Mass failure on east bank

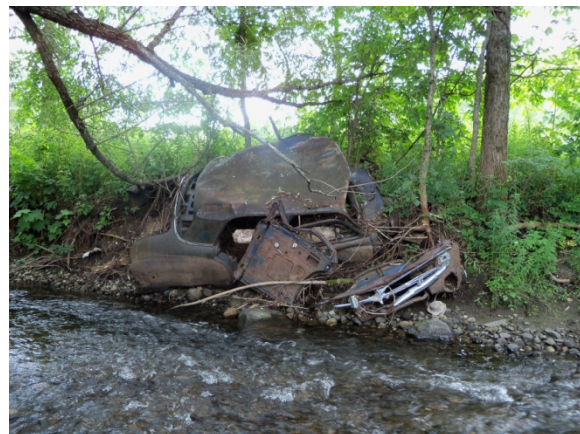
**Figure 4.20** Bank erosion and old automobile

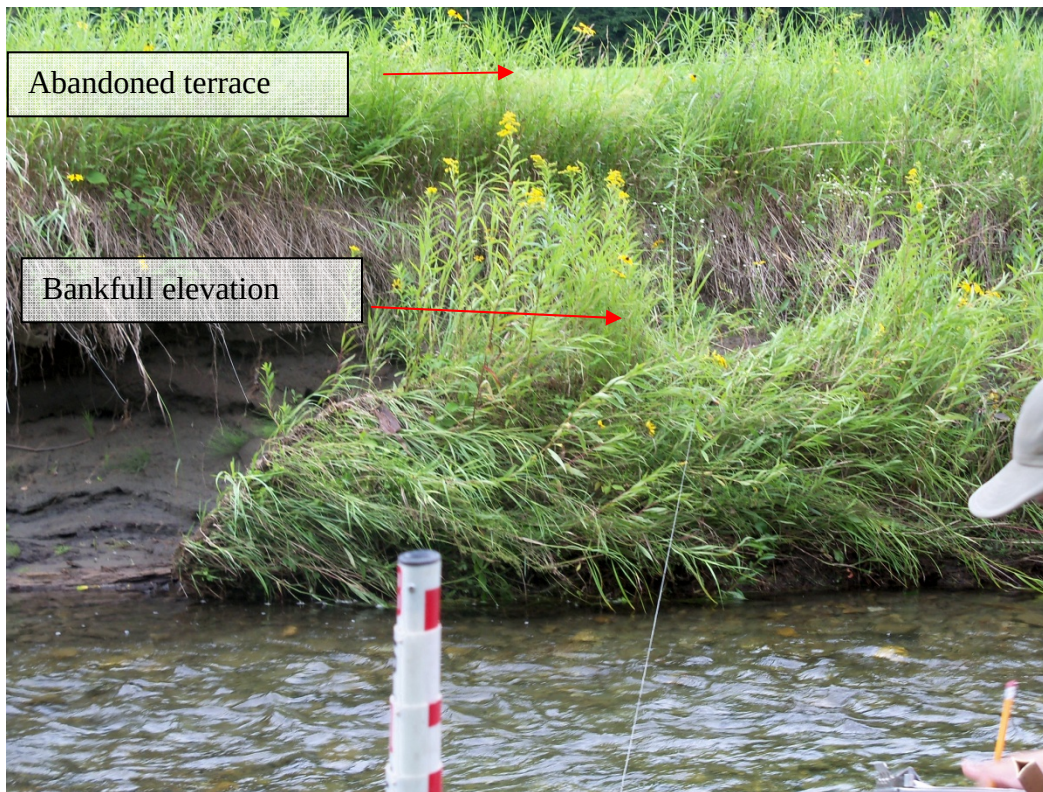
**Figure 4.22** Cross section measurement in segment R21-A, showing incised channel.

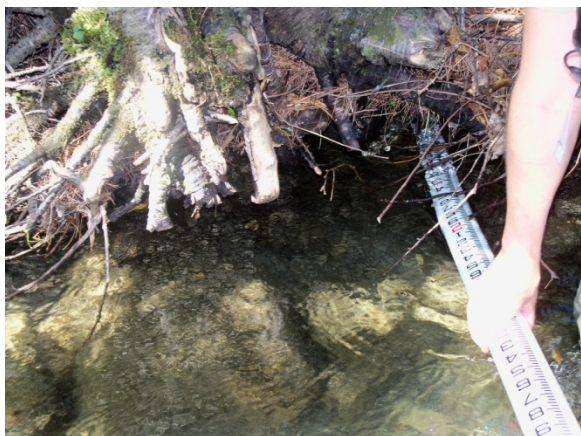
The overall habitat condition of R2I-B is also “fair”. The lack of wide, high quality riparian buffers and channel straightening are contributing to habitat degradation. Based on observations during the Phase 2 assessment, it is strongly suspected that the upper end of R2I-B may have been straightened and windrowed. *Windrowing* is the pushing of gravel up from the stream bed onto the top of either bank as part of the straightening of a river. The entire length of segment R2I-B has been straightened, and this has resulted in a loss of high quality pools. The number of pools per mile is within the expected range, but these pools lacked deep water habitat of over two feet, which is critical for adult trout and other resident fish species. Given the lack of buffer and the bank erosion, there are only a couple of places that have undercut banks with stable boundaries, such as roots (Figure 4.24). Hay fields are the dominant corridor land use on both sides of the channel, and buffers are generally less than 50 feet in width. Figure 4.25 shows a buffer planting project that was part of a Wildlife Habitat Incentives Program (WHIP) project about three years ago.

**Figure 4.24** Stable undercut bank in segment R21-B

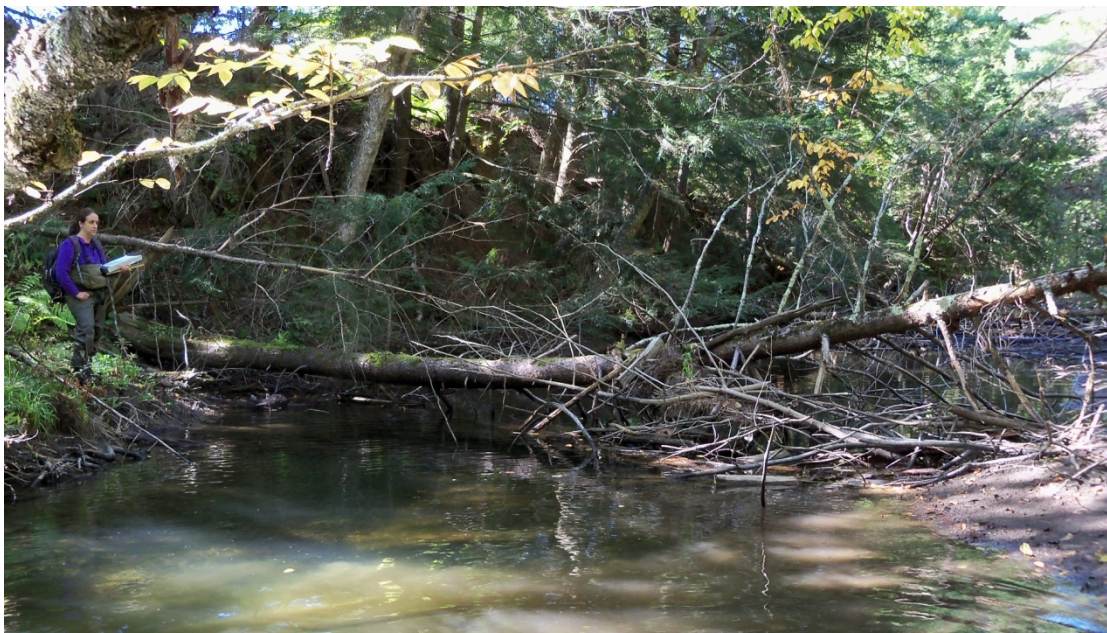
The habitat condition for R16T2.02 is at the high end of the “fair” range. Woody debris cover was outstanding, with logs and debris jams creating cover (Figure 4.27). Coarse particulate organic material (CPOM), which is an important source of food and cover for aquatic insects, was present both in the margins and channel. There is a high percentage of silt (30%) making the substrate less suitable for the colonization by water quality sensitive species and for trout reproduction. Connectivity of habitat scored low, because of the man-made obstruction (Lake Fairlee Dam). The dam is fourteen feet in height and is creating a system obstruction for movement of fish and other aquatic species (Figures 4.28 and 4.29).

**Figure 4.27** Debris jam at reach break between R16T2.02 and R16T2.01

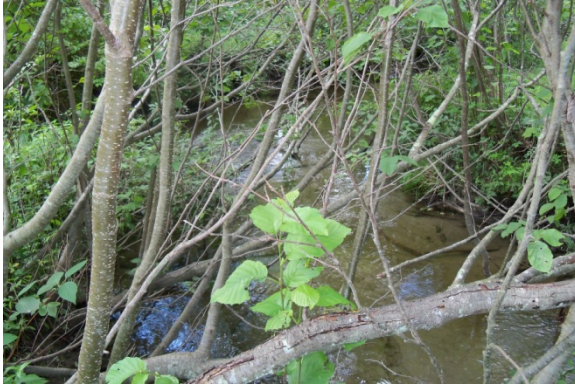
The overall habitat condition in segment R16T2.04-B falls at the low end of the “good” range. The pasture adjacent to the channel has introduced some invasive species, such as Japanese barberry and honeysuckle. In areas that have not been disturbed, alders are providing high quality bank vegetation and good root structure (Figure 4.33). There are very few undercut banks because of the extensive bank erosion. Figure 4.34 shows an undercut bank that is providing cover for resident species. Coarse particulate organic material that is important for food and cover for aquatic insects is common in both the channel and margins. The buffer is reverting back to trees and shrubs in some locations and at some point could provide higher recruitment of large woody debris, which is currently in low supply.

**Figure 4.33** Alders providing good root structure

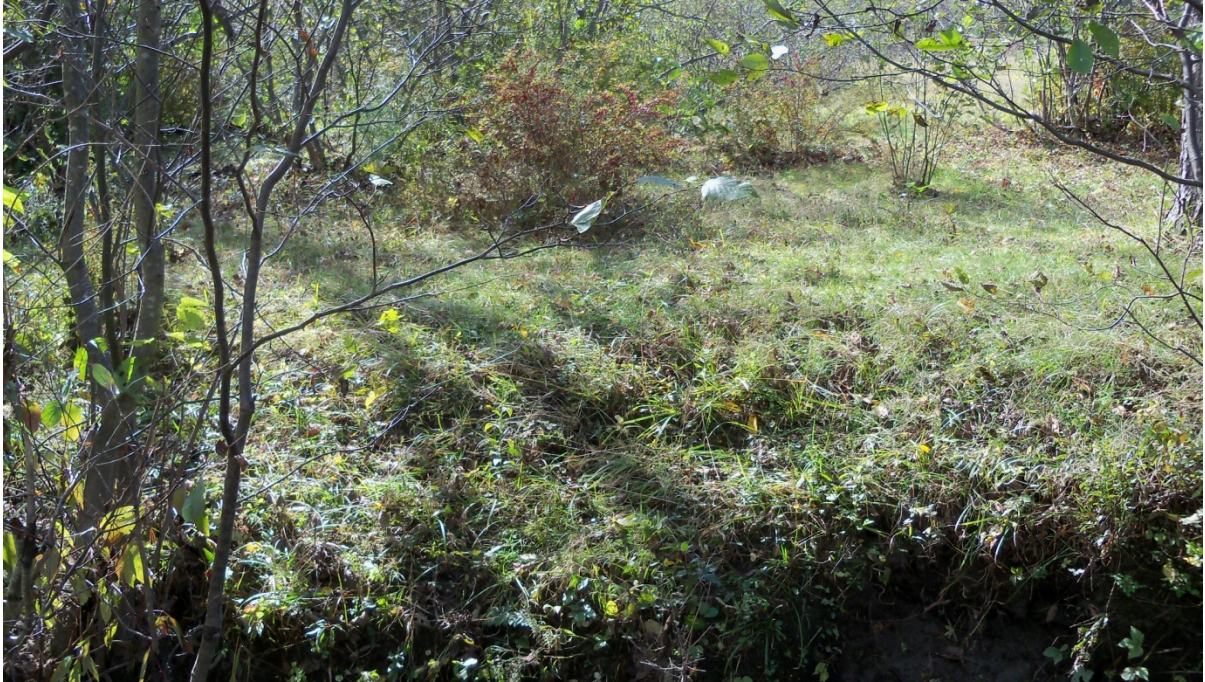
The habitat of segment RI6T2.05-A is “fair”. The stream banks have been impacted by livestock grazing. About 40 percent of the east bank and 60 percent of the west bank have eroded. There are isolated areas (about 10% of the length of the channel) with buffers less than 25 feet in width. Japanese barberry and honey suckle are invasive species that are common in the riparian corridor (Figure 4.35). There is limited habitat diversity in the straightened section in the middle of the reach in the vicinity of a residence.

**Figure 4.35** Lack of buffer along the near bank and invasive plant species in the background in R16T2.05-A

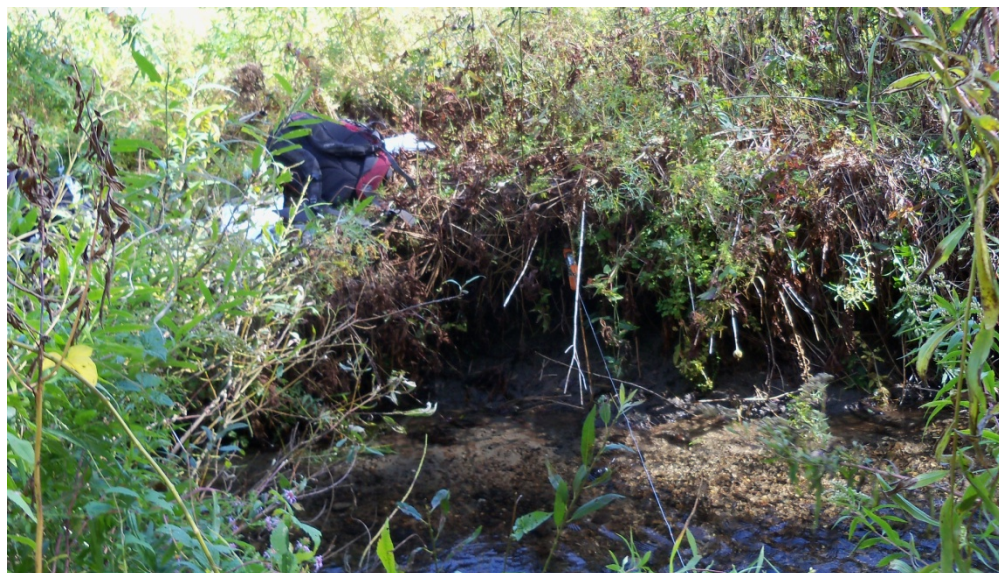
The straightened planform and the narrow buffer on the east side of the channel are factors that are affecting habitat in segment R16T2.05-D. There are frequent pools, but only one pool was over two feet in depth. The lack of sinuosity in the segment is responsible for the marginal pool depths; typically, deep pools form on the outside of meander bends. Small minnows were observed in pool habitat. About 50 percent of both banks are eroded. Pasture is in the east riparian corridor, and buffers are narrow on the east side with the dominant buffer width of less than 25 feet. The west side of the channel has a forested buffer. The habitat condition is “fair”.

**Figure 4.39** Bank erosion indicative of channel widening in segment R16T2.05-D

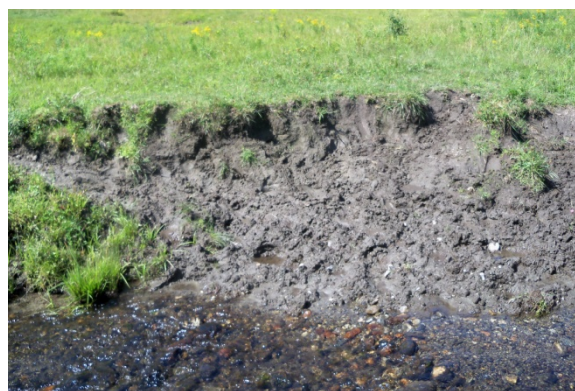
**Figure 4.45** Trampled stream banks from horses

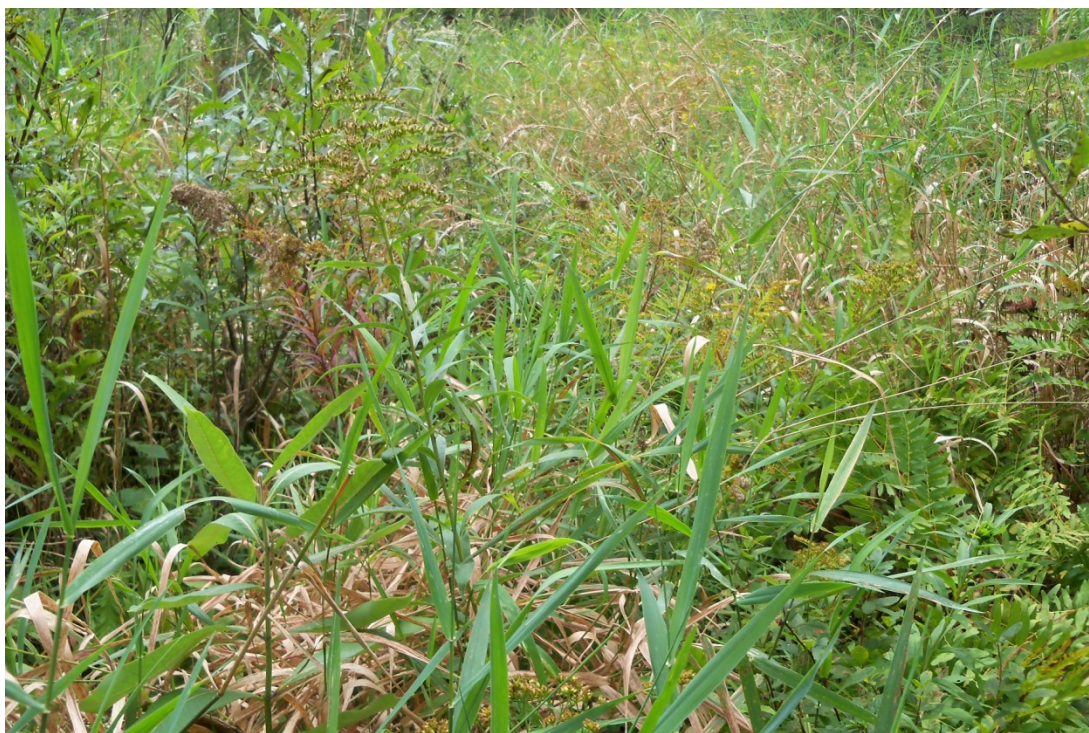
A full Phase 2 assessment of R16T2.06-D, the most upstream segment of Blood Brook, could not be completed because the channel is small and in a wetland setting (Figure 4.50). The valley is very wide and the buffers are expansive.

**Figure 4.50** Wetland in segment R16T2.06-D

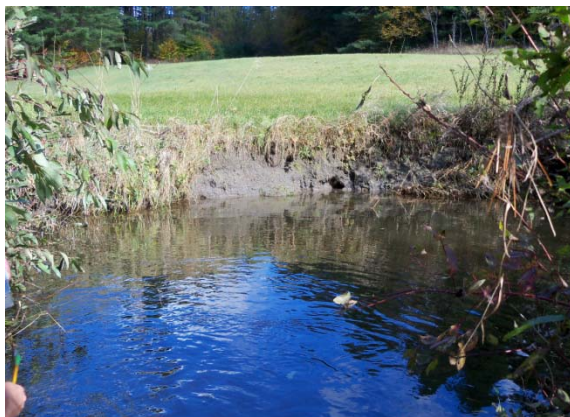
**Figure 4.53** Lack of buffer and bank erosion

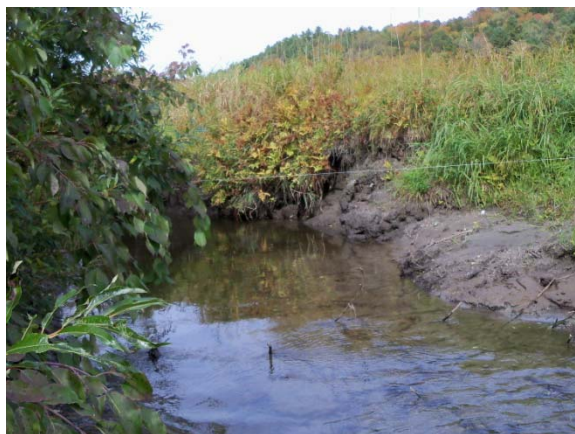
Segment RI6T2.03SI.02-A is about 2750 feet in length. The channel has a reference and existing and stream type of “E”. The dominant substrate material is sand. The bedform is predominantly dune-ripple, yet some portions have distinct riffles and pools. The downstream end of the segment (last 350 feet) is impounded by a beaver dam. Segment A is in “fair” geomorphic condition, and is undergoing major adjustment processes in terms of aggradation, widening, and planform change. The wetland adjacent to the channel on the west side is about one foot higher than the bankfull elevation. An active head cut in clay soils (Figures 4.56 and 4.57) was observed on a small drainage that enters the channel from the west side in the middle of the segment. It is not clear whether the channel historically incised in this segment. Nonetheless, given the extent of the aggradation, widening, and planform adjustment that is occurring, the channel appears to be in the stabilizing stage of the channel evolution model. There is a well defined floodplain on both sides of the channel. Based on the inspection of orthophotos, the channel has moved laterally over time. Planform adjustment is evident in the field from the moderate to high lateral bank erosion on most outside bands, *neck cutoffs* (places where the channel crosses and cuts off a meander), active flood chutes crossing inside of meander bends, and islands. There are numerous bars, which are uncharacteristic of the reference “E” channel. These bars are indicative of aggradation within the channel. Channel widening has occurred, and approximately seventy percent of both banks are eroded (Figure 4.58 and 4.59).

**Figure 4.59** Bank slumping and typical channel

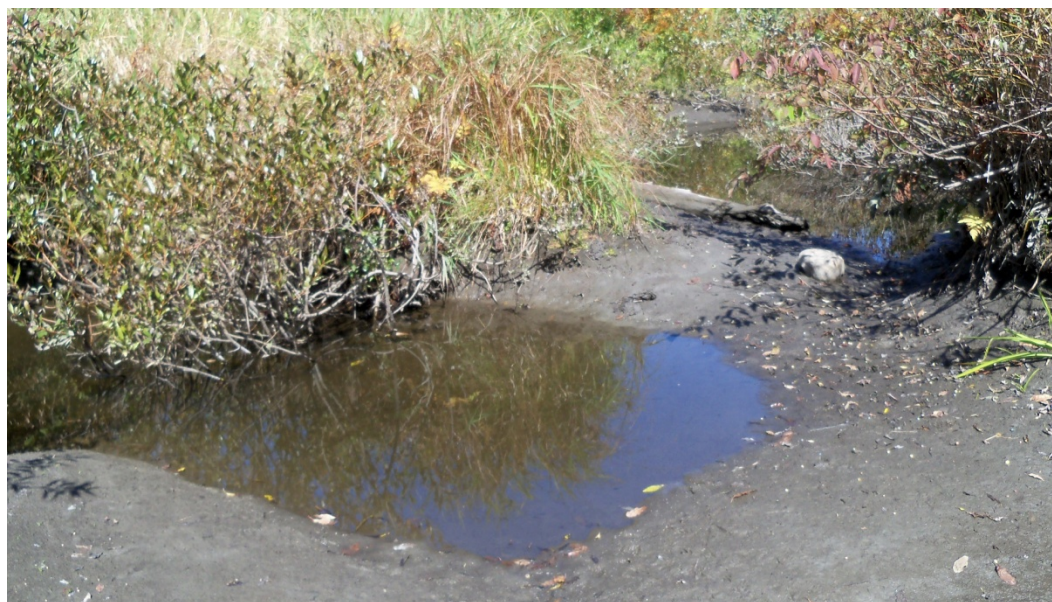
The active geomorphic processes occurring in R16T2.03S1.02-A is also impacting habitat. The overall habitat condition is “fair”. There are few stable undercut banks, most likely due to the extreme bank erosion and the lack of large woody vegetation along the near bank. Woody debris cover is in the fair category due to lack of large woody debris. Most of the woody material is small, and coarse particulate material is in good supply and is present in the channel and along the margins. About one-third of the reach has buffers less than 25 feet in width. Hay fields are the dominant corridor land use on the east side of the channel, while wetland is dominant in the buffer on the west side. The subdominant land use on the west side is pasture. Wetlands in the corridor on the west side are providing out of channel refuge areas (such as the shown in Figure 4.60) that provide safety for aquatic species during high flow events.

**Figure 4.60** High flow refuge area in wetland

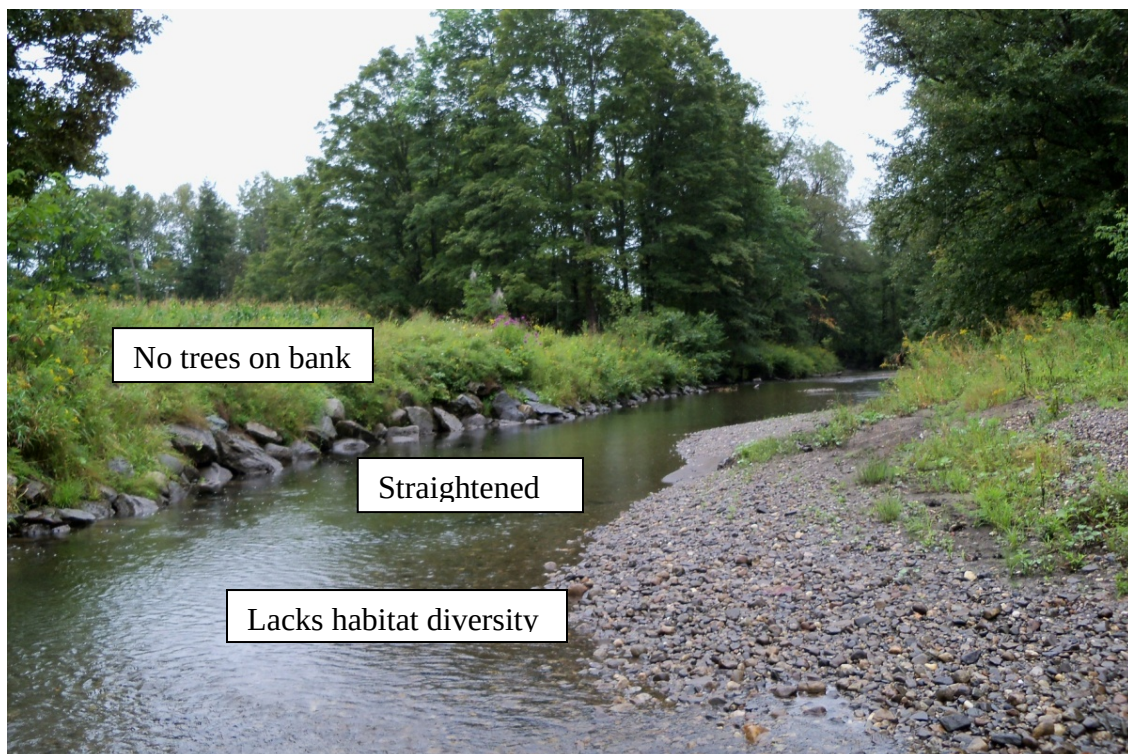
**Figure 4.71.** Segment R18 rated “fair” for habitat. The segment lacked large woody debris, riparian vegetation and was shallow and wide where the channel had been historically straightened.

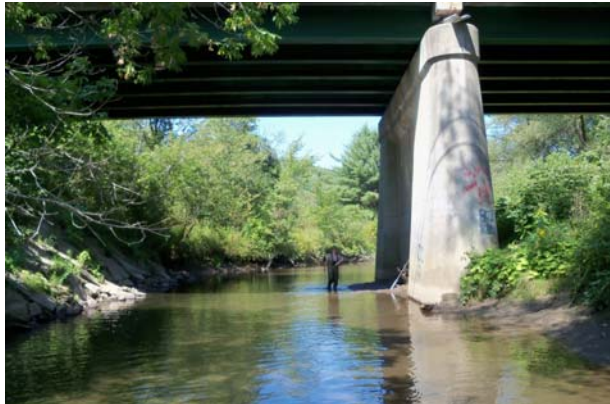
**Figure 4.75.** Center pier of Route 244 Bridge

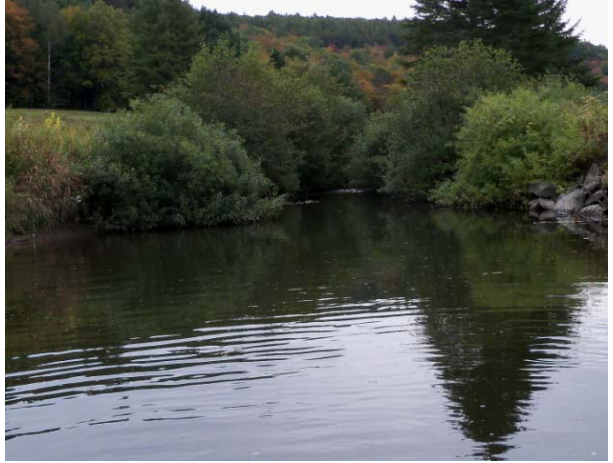
Scour below culvert
