Ompompanoosuc River Corridor Plan

Thetford to Norwich, Vermont

January 10, 2014

Bear Creek Environmental, LLC
149 State Street, Suite 3
Montpelier, Vermont 05602

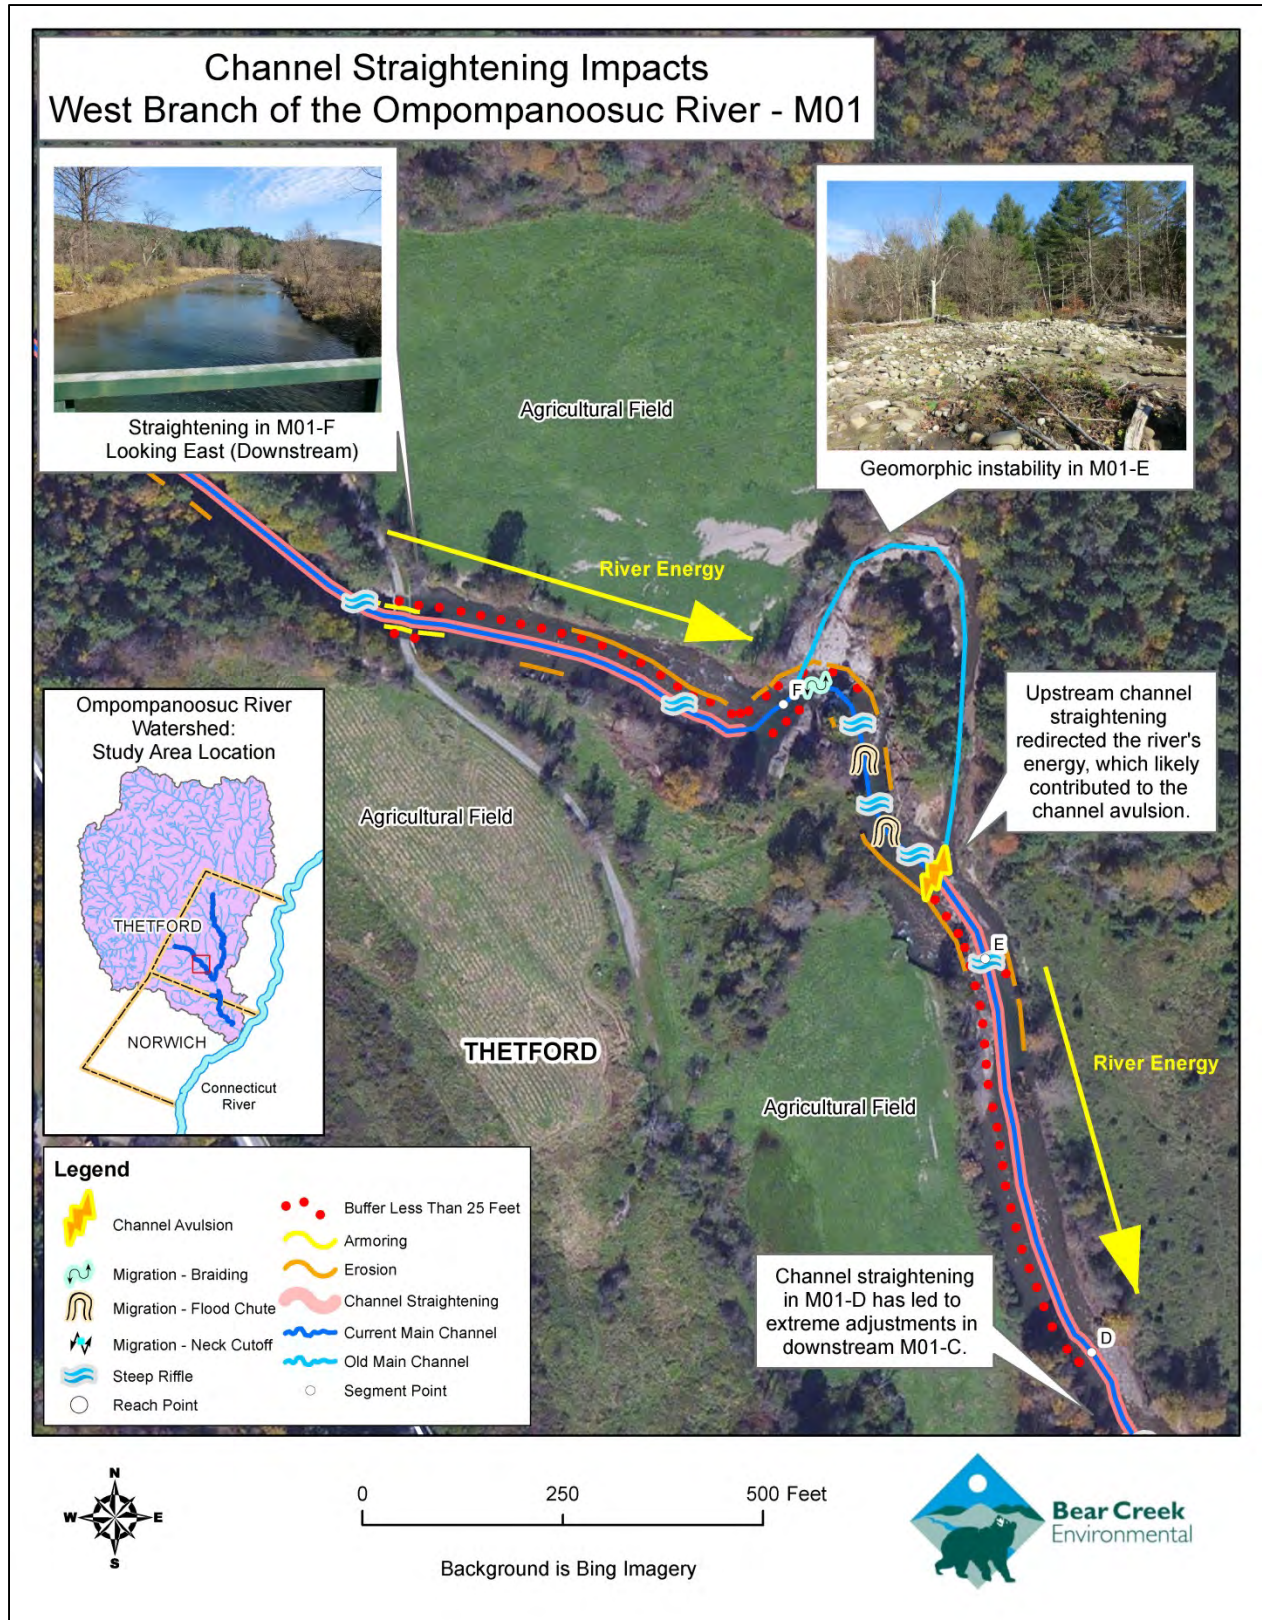
Figure 5.1. Impacts of channel straightening in M01 on the West Branch of the Ompompanoosuc River

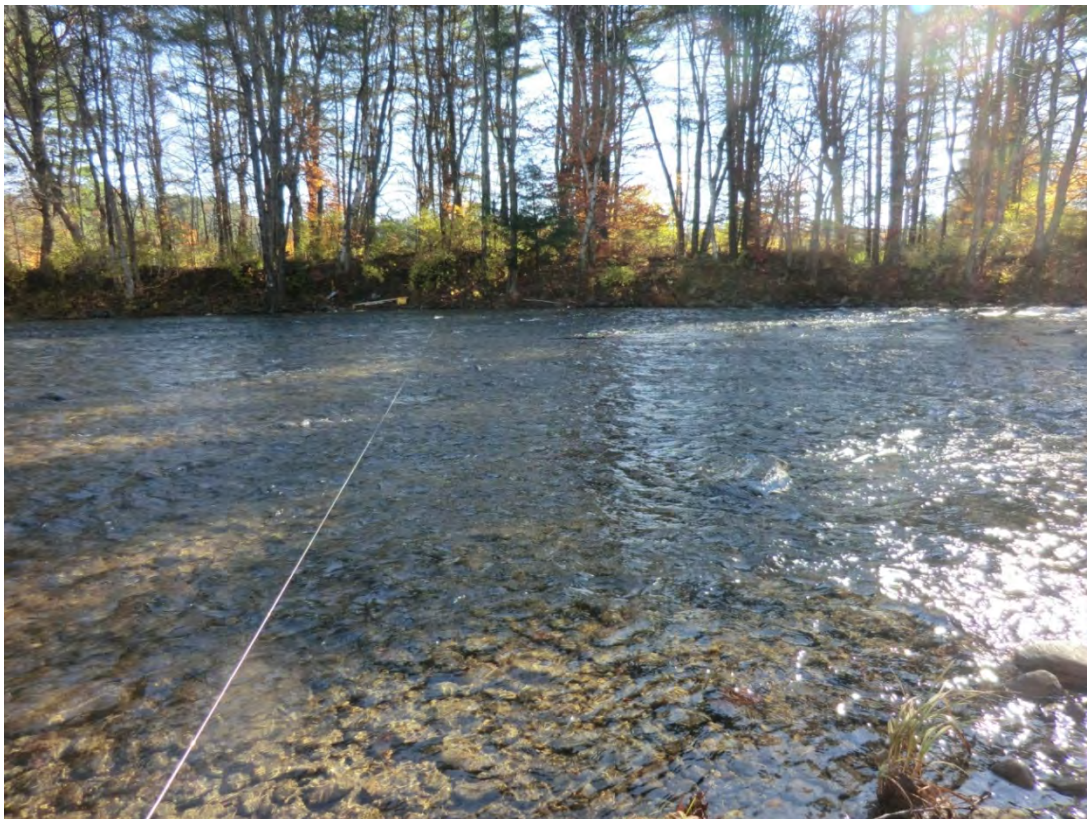
Figure 5.5. High banks in R03-B restrict floodplain access.

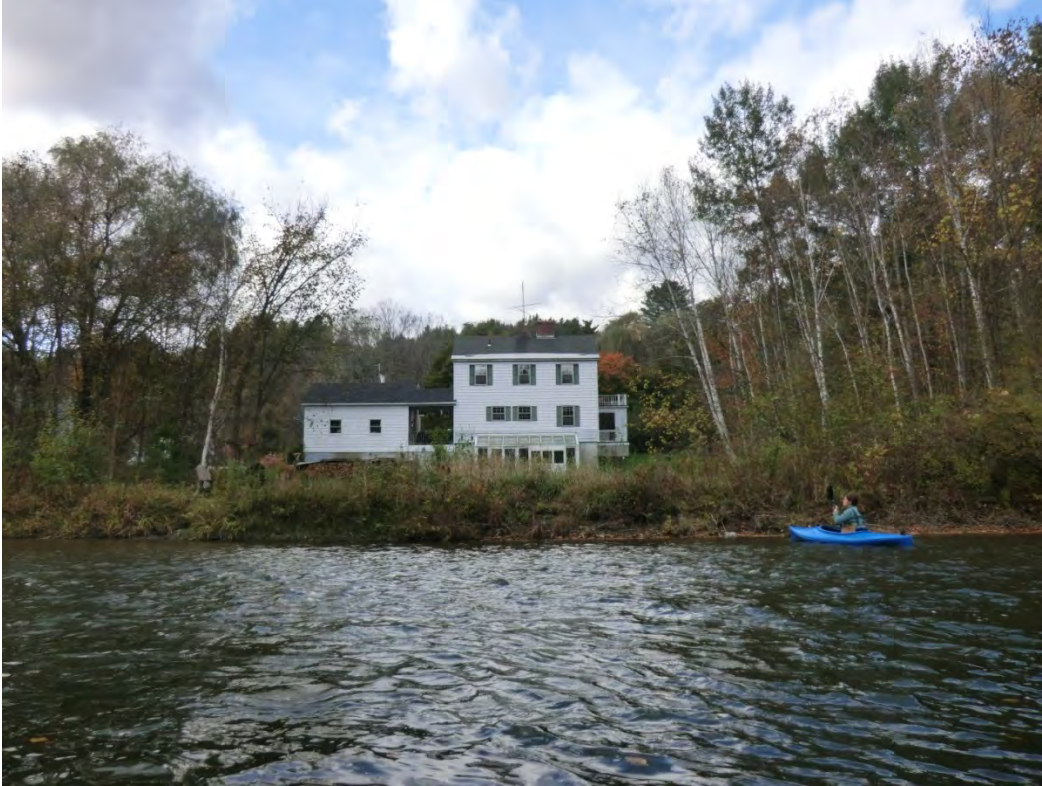
Figure 5.8. The upstream quarter of R05 is in a residential area. This is a property with sparse bank and buffer vegetation and is typical for this portion of the reach.

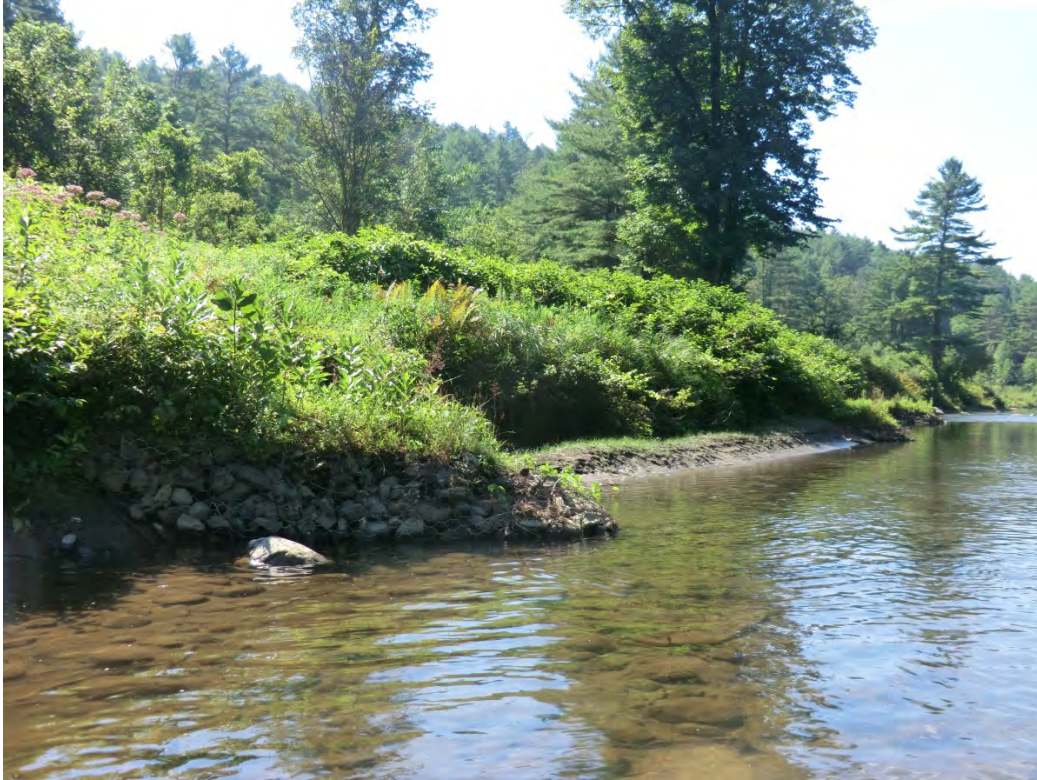
Segment R08-B is in **fair** geomorphic condition with extreme **historic incision** as a result of channel straightening. This has resulted in a loss of some floodplain access and a stream type departure from the reference C stream type to the existing B stream type. **Widening** and **planform adjustment** are major processes occurring as the river responds to the incision. Segment R08-B is in **fair** habitat condition as a result of a limited amount of aquatic organism refuge areas, a lack of adequate bank vegetation, and reduced buffer widths. The reduced buffer widths can mainly be attributed to the presence of Buzzel Bridge Road, which is to the east of the channel.

Figure 5.14. Gabions at the stream edge in segment R08-B likely contributed to historical channel straightening.

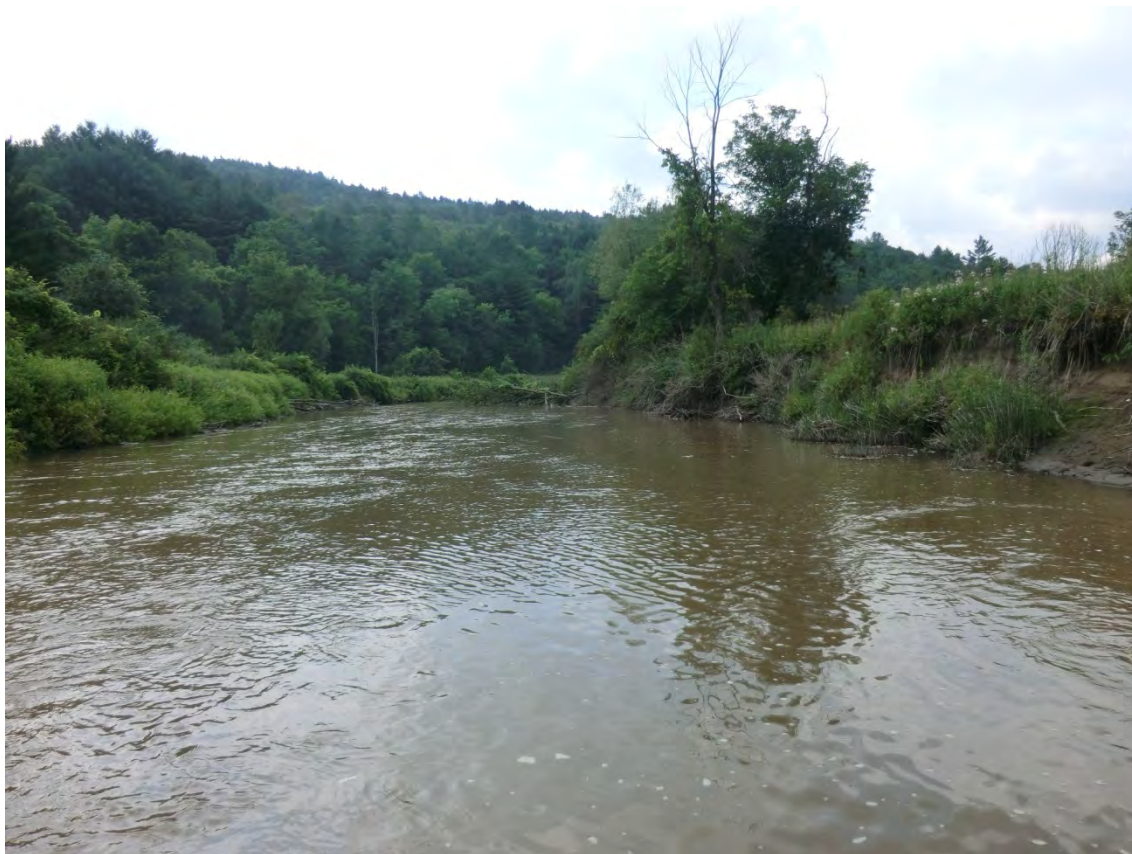
Figure 5.18. Typical eroded banks and limited bank and buffer vegetation in R09.

Reach R09 is in **fair** geomorphic condition and has undergone major **historic incision**. The incision is likely a result of historic channel straightening because of the road in the east corridor and the agricultural field in the west corridor at the upper end of the reach. Minor widening and planform adjustment are occurring in R09. This reach is in **fair** habitat condition as a result of poor bank and buffer vegetation and reduced buffer widths. Large amounts of invasive honeysuckle were present along the banks in this segment (See Figure 5.19).

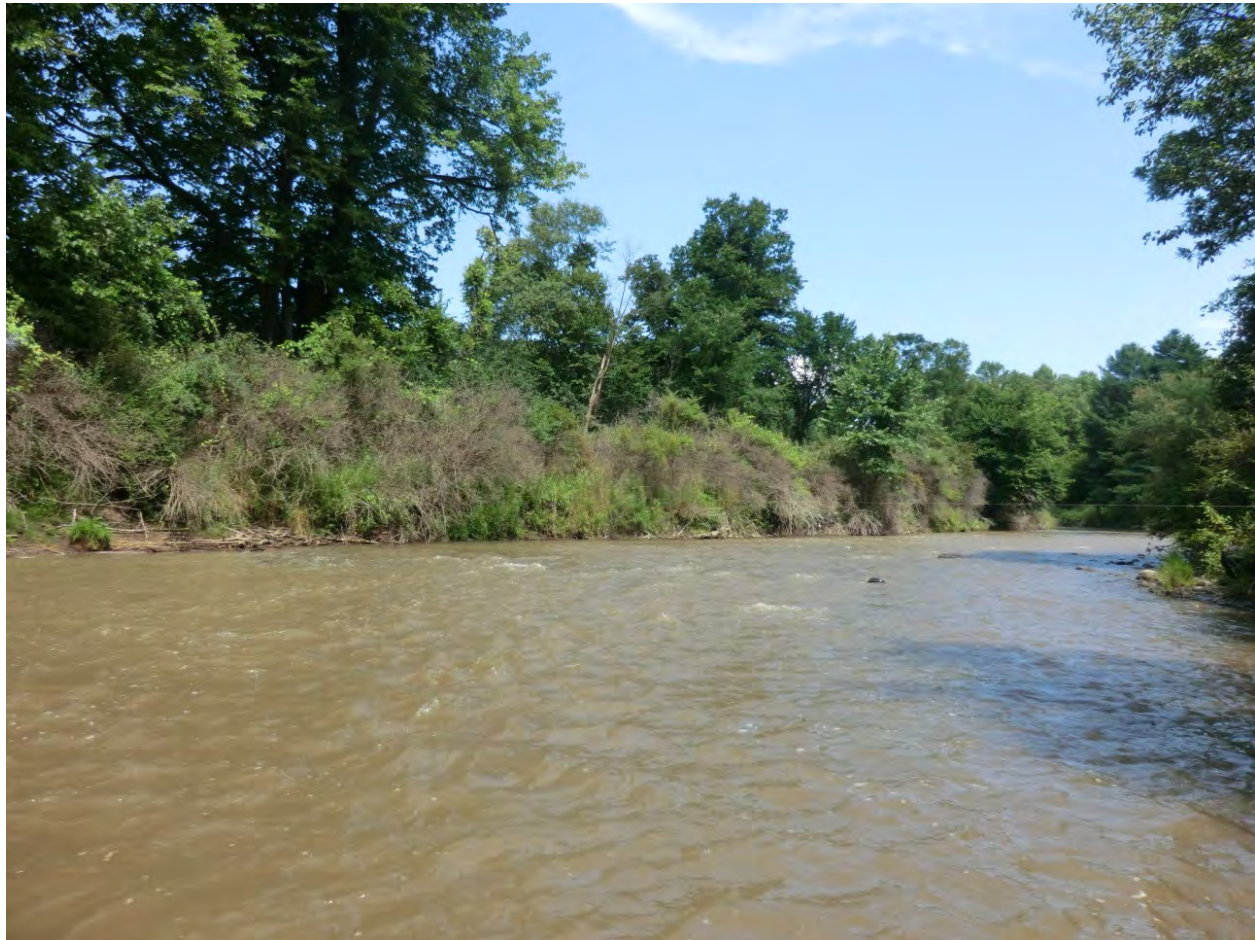
Figure 5.19. Invasive honeysuckle is widespread in R09.

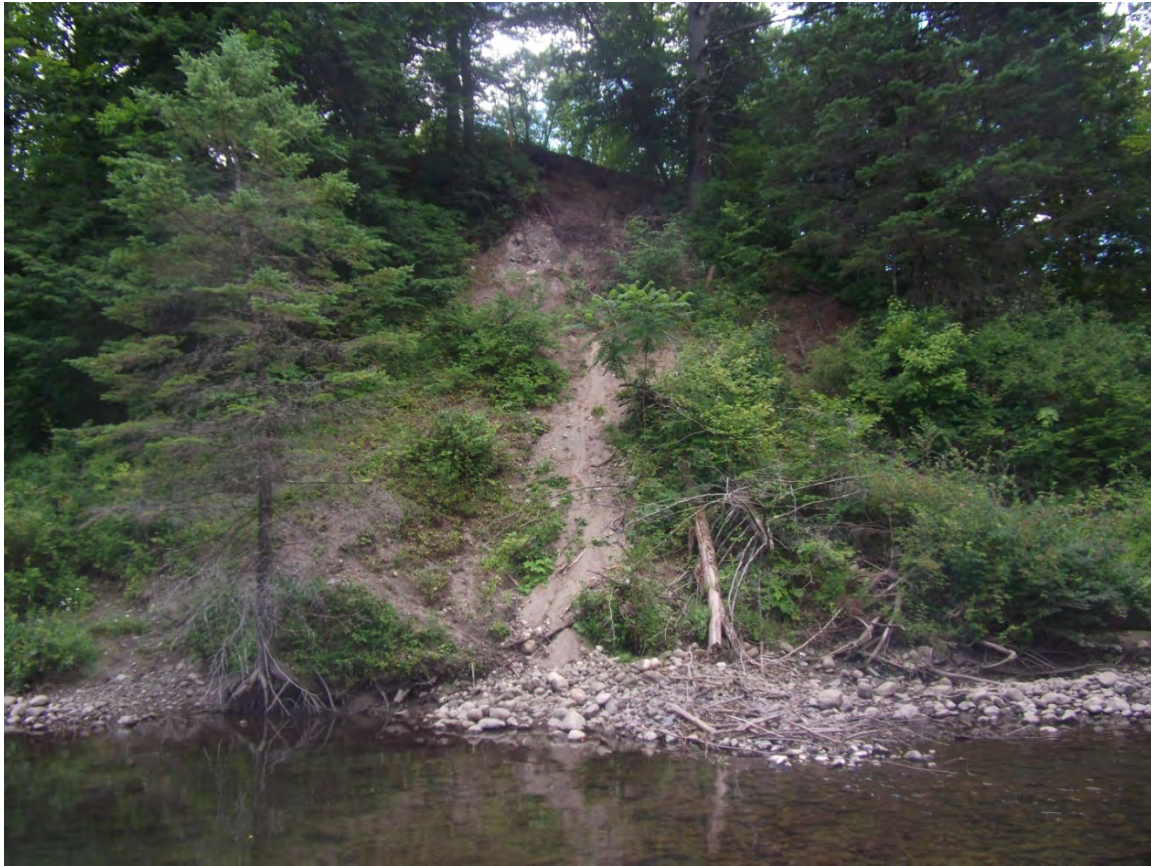
R11-A Data Summary		Reference	Existing
Length: 4,038 ft	Confinement	Broad	Broad
Drainage Area: 61 sq. mi.	Stream Type	C	C
Evolution Stage: F-III	Entrenchment Ratio	> 2.2	13.5
Sensitivity: Very High	Incision Ratio	< 1.2	1.7
	Dominant Bed Material	Gravel	Gravel
	Dominant Bedform	Riffle-Pool	Riffle-Pool
Major Stressors:	Invasive Plants, Erosion, Mass Failure

Figure 5.23. Mass failure on the bank in R11-A.

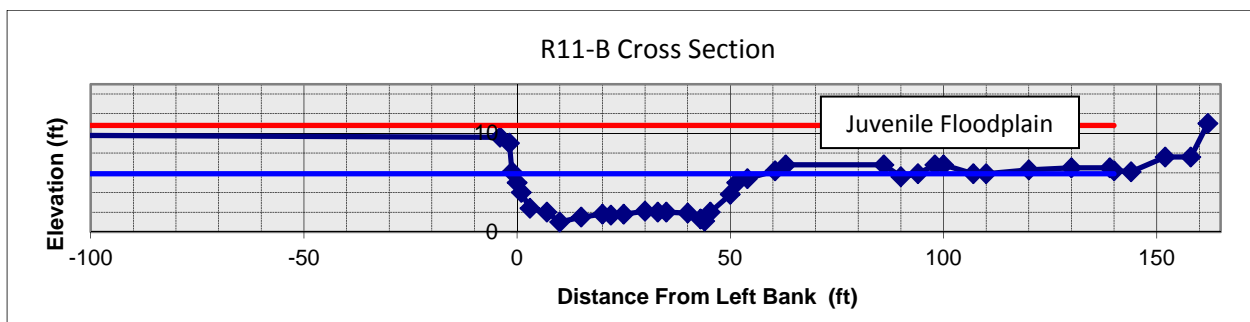
Figure 5.24. Cross section from R11-B indicates that channel is building a new floodplain.

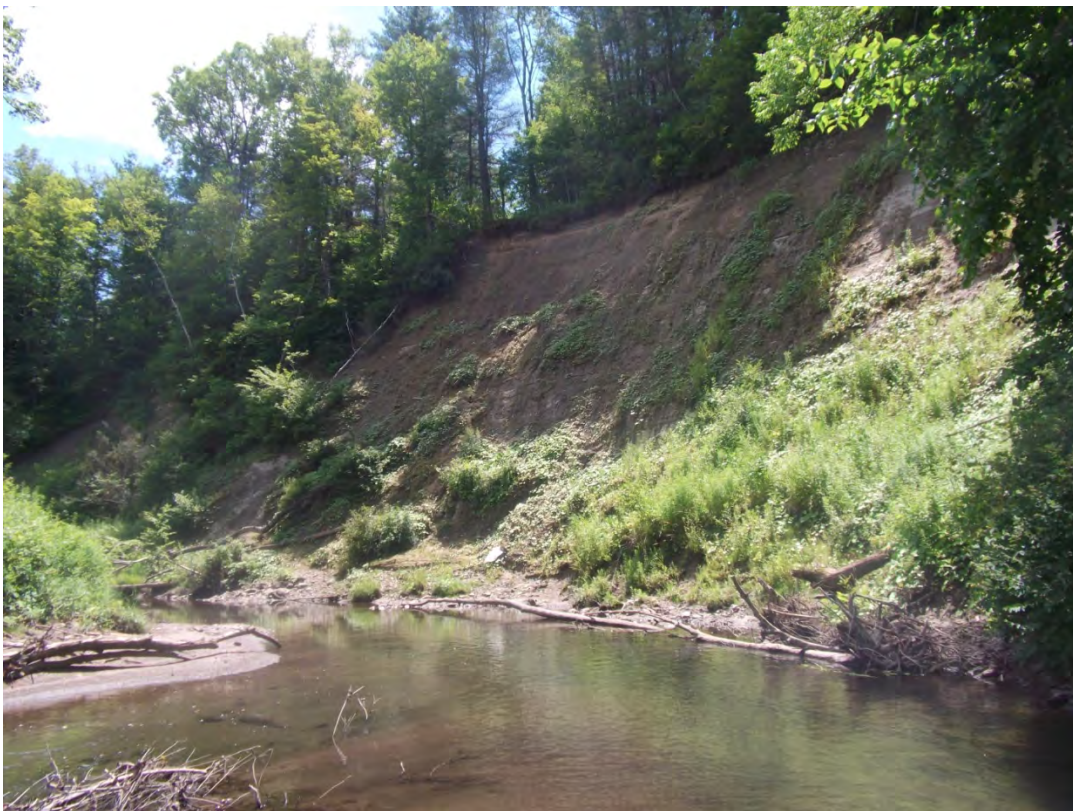
Figure 5.26. Large mass failure on the valley wall.

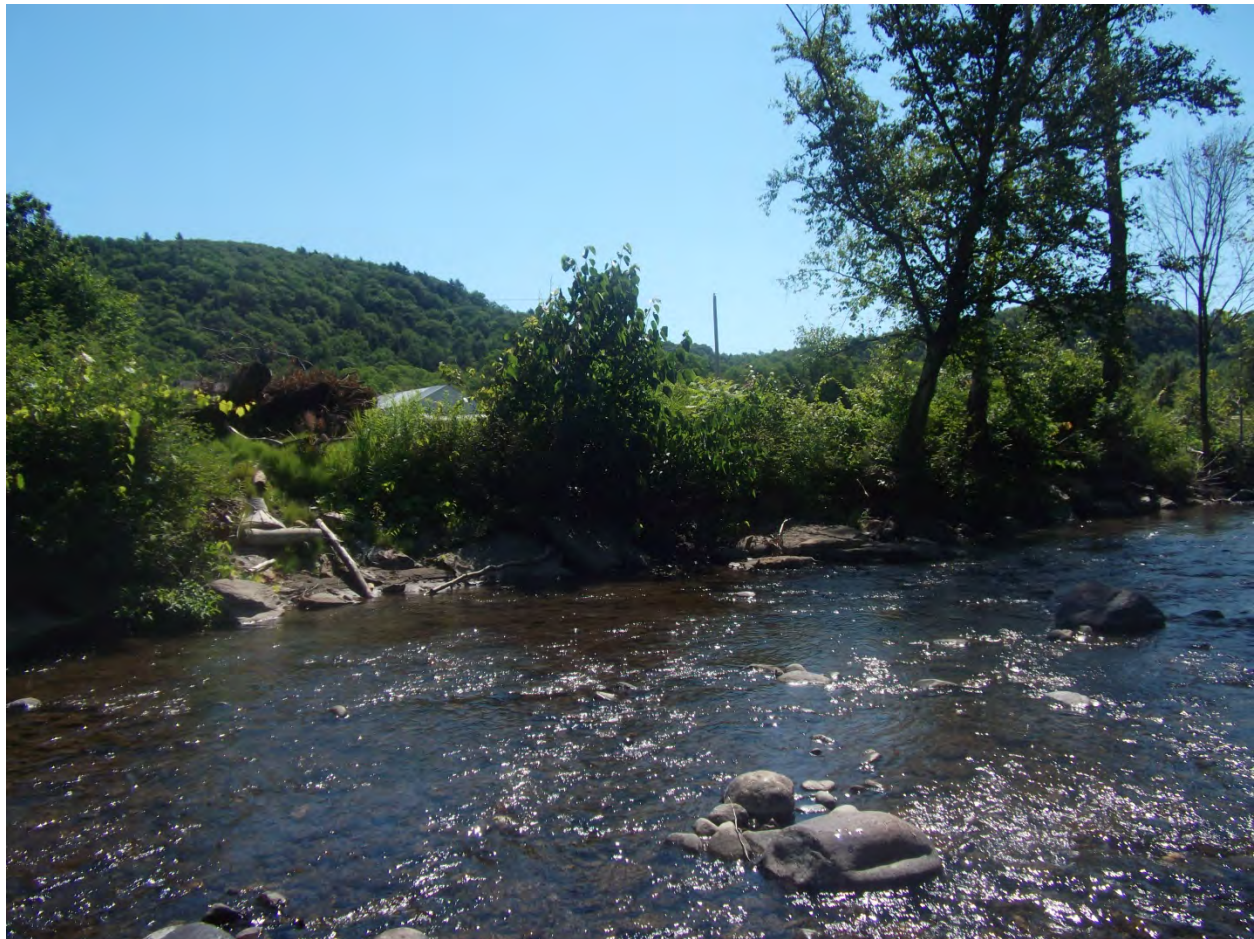
Figure 5.27. Typical area with buffers less than 25 feet wide in R11-C.

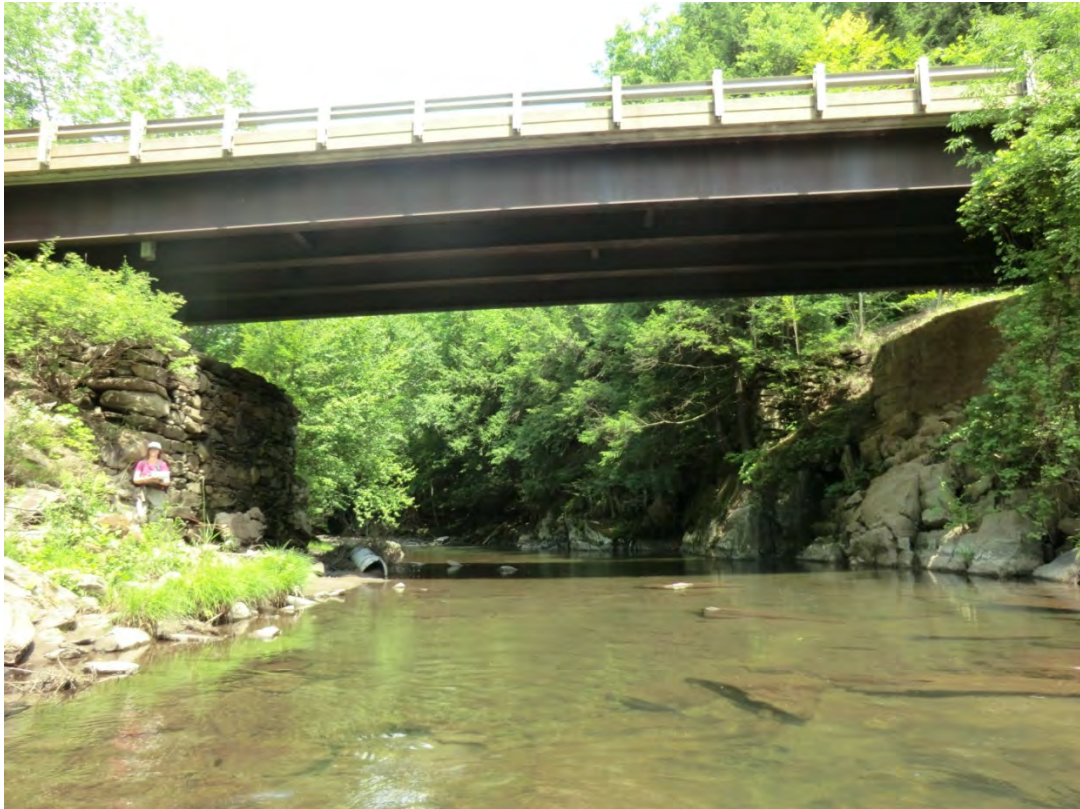
R12-A Data Summary		Reference	Existing
Length: 2,204 ft Drainage Area: 58 sq. mi. Evolution Stage: D-IIc Sensitivity: Moderate	Confinement	Semi-confined	Semi-confined
	Stream Type	B	B
	Entrenchment Ratio	1.4 – 2.2	1.4
	Incision Ratio	< 1.2	1.0
	Dominant Bed Material	Cobble	Cobble
	Dominant Bedform	Riffle-Pool	Riffle-Pool
Major Stressors:		Revetments, Constrictions

Figure 5.29. Old bridge abutment beneath Sawnee Bean Road bridge is causing a channel constriction.

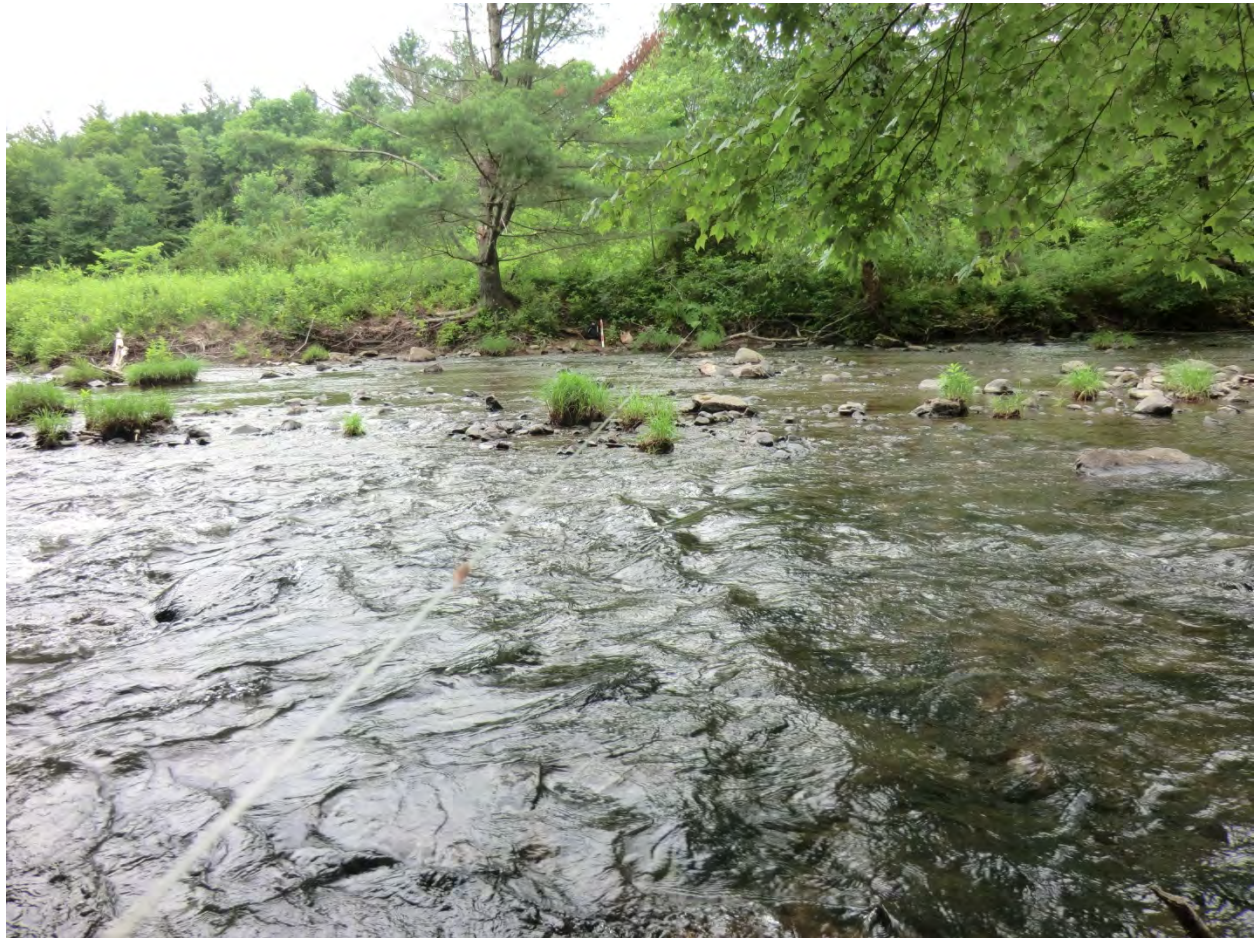
Figure 5.34. Reduced buffer width in western corridor in R14-B.

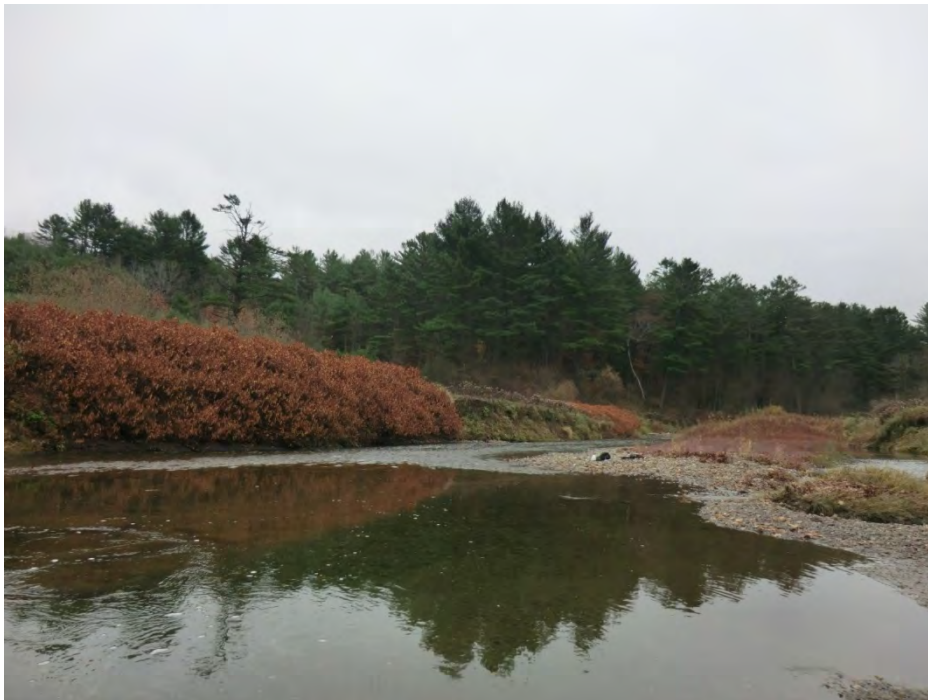
Segment M01-A is in **poor** geomorphic condition. Extreme **historic incision** has led to a loss of floodplain access and stream type departure from a C to an F. **Aggradation** and **widening** are major geomorphic processes occurring, while **planform adjustment** with high lateral erosion is extreme. M01-A is in **fair** habitat condition because of the large presence of invasive plants and an incised channel.

Figure 5.36. High banks with limited floodplain access in M01-A. Japanese knotweed is seen on the east bank.

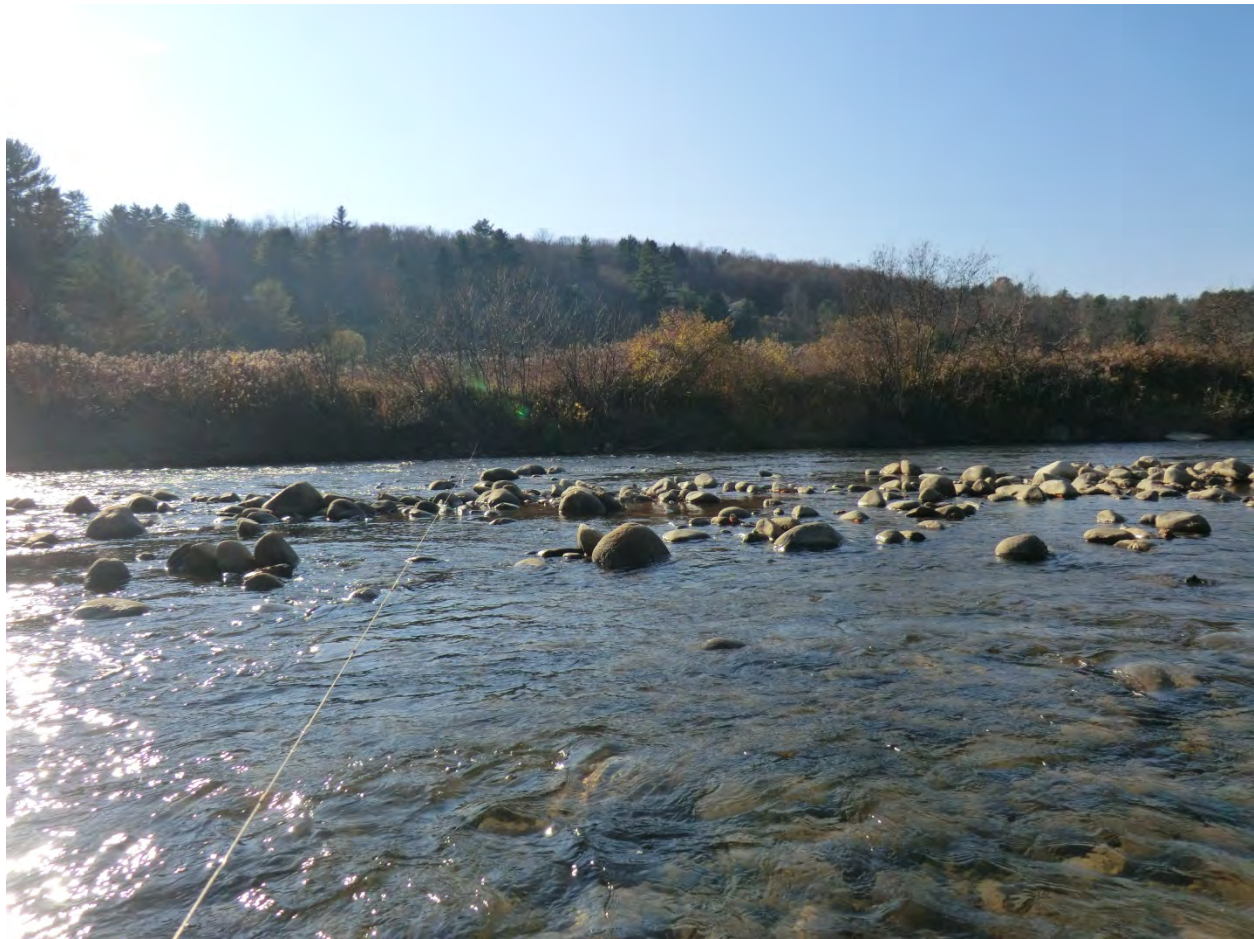
Figure 5.40. High banks in M01-D as a result of historic incision are restricting floodplain access.

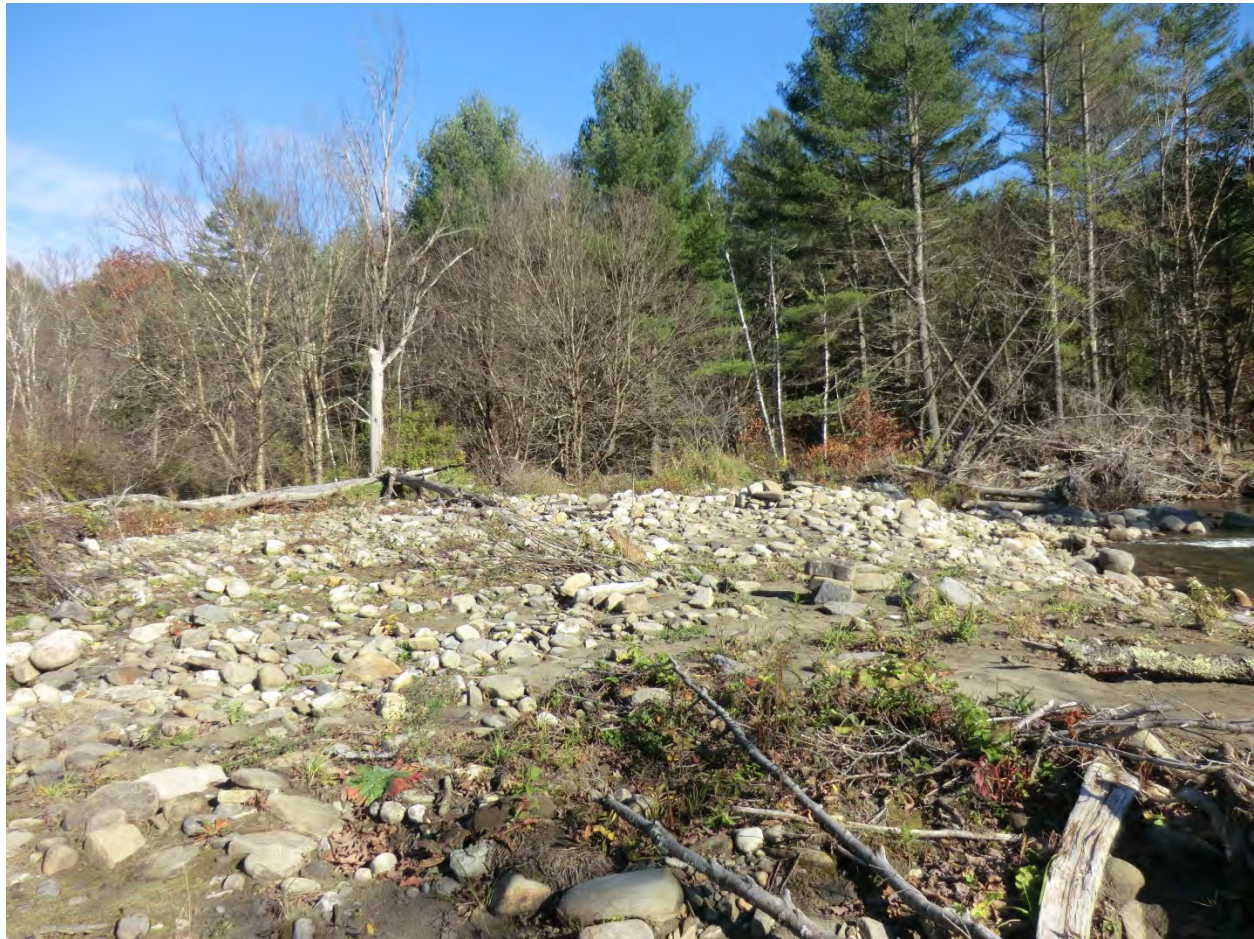
Figure 5.41. A channel avulsion has created this island in M01-E. Major aggradation can be seen here as well.

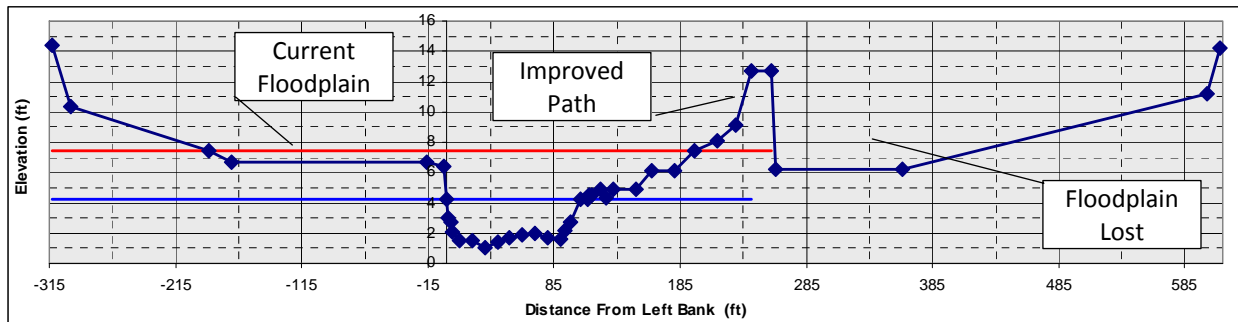
Figure 5.42. The cross section from M01-F shows how the improved path is restricting floodplain access.

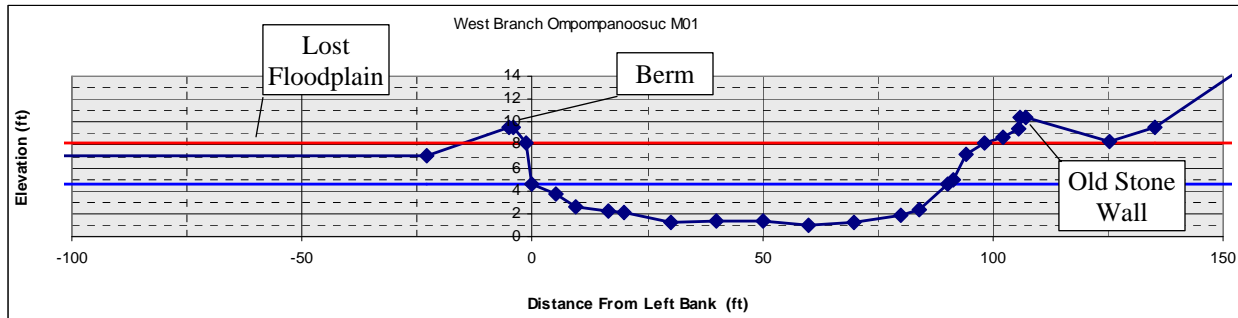
Figure 5.45. Cross section in M01-I shows how the berm on the northern bank is restricting floodplain access.

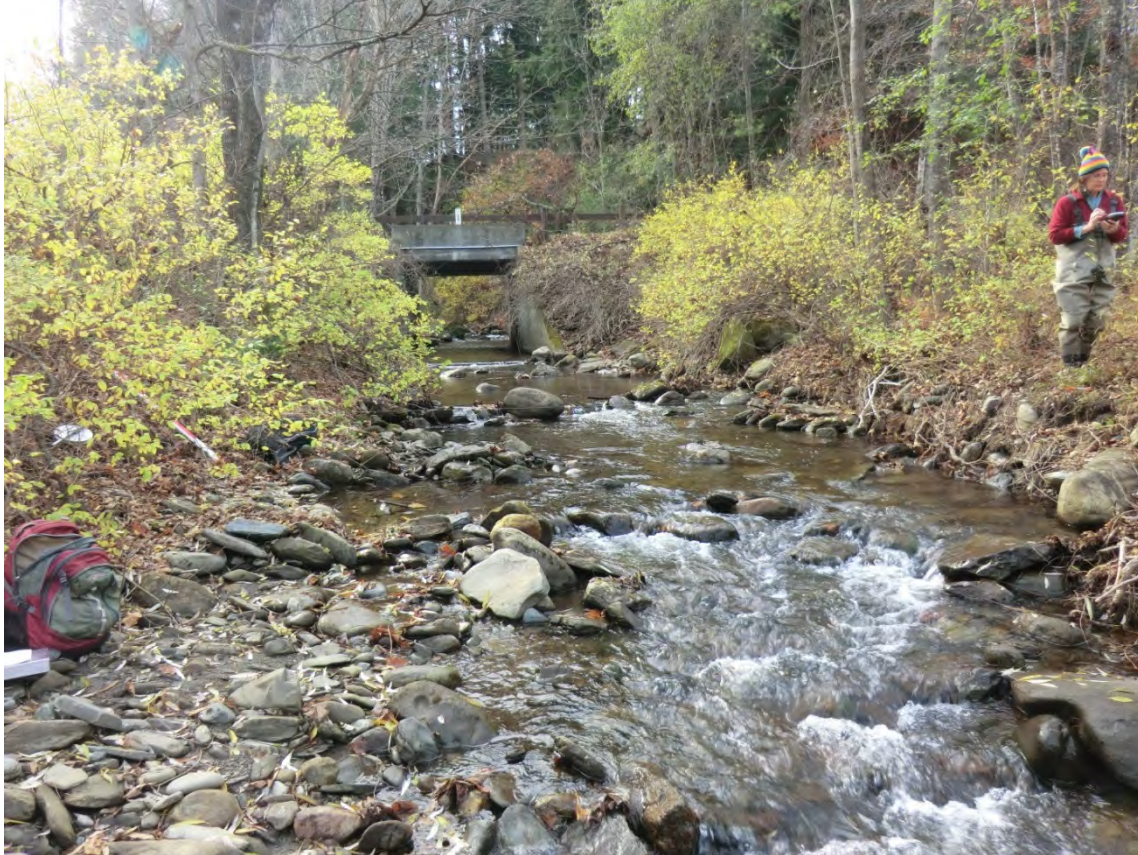
Figure 5.49. Invasive honeysuckle is abundant in R06.S1.02-A.

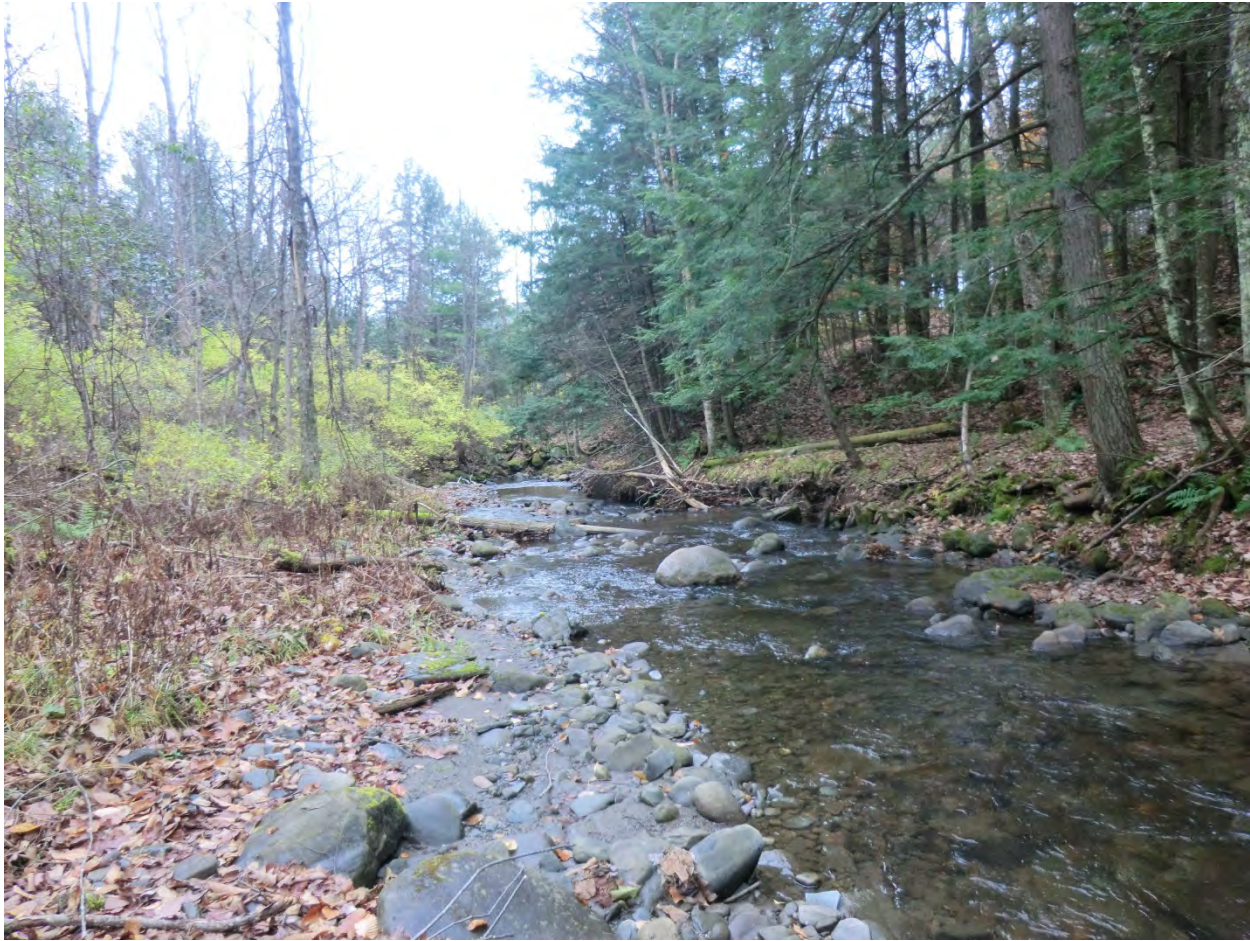
Figure 5.50. Invasive honeysuckle on the left bank in R06.S1.01-B.

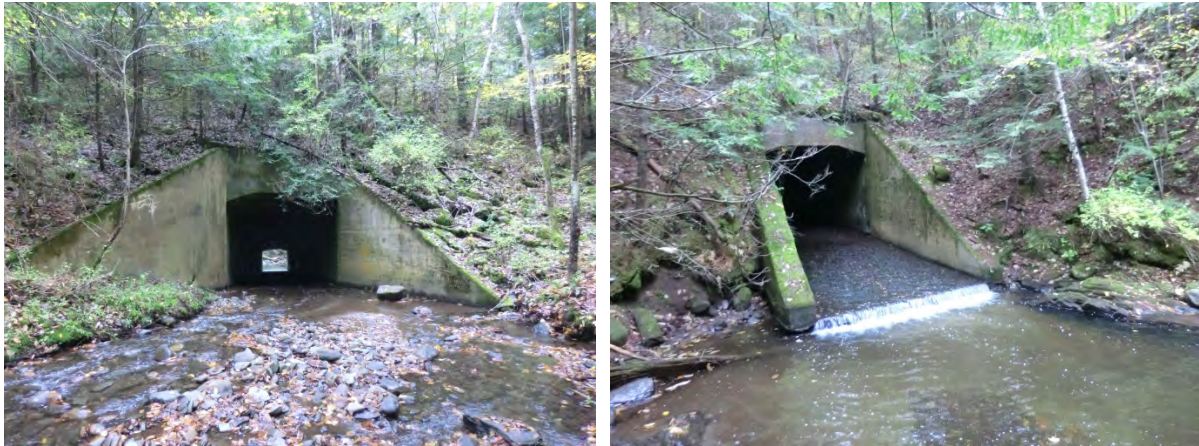
Figure 5.54. The Route 132 box culvert on Avery Brook limits aquatic organism passage.

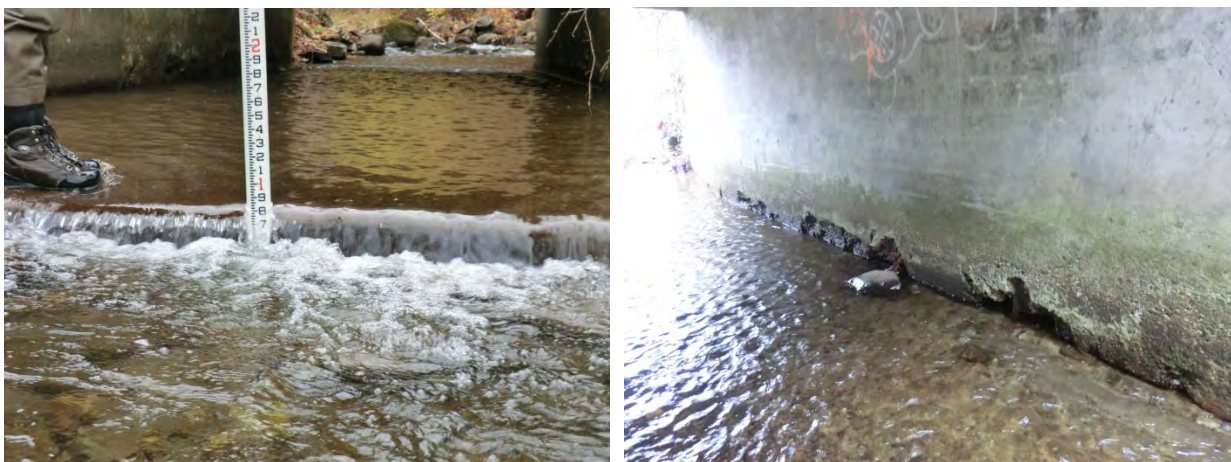
Figure 5.55. The most downstream box culvert on Avery Brook is perched at the downstream end and is deteriorating along the walls inside the structure.

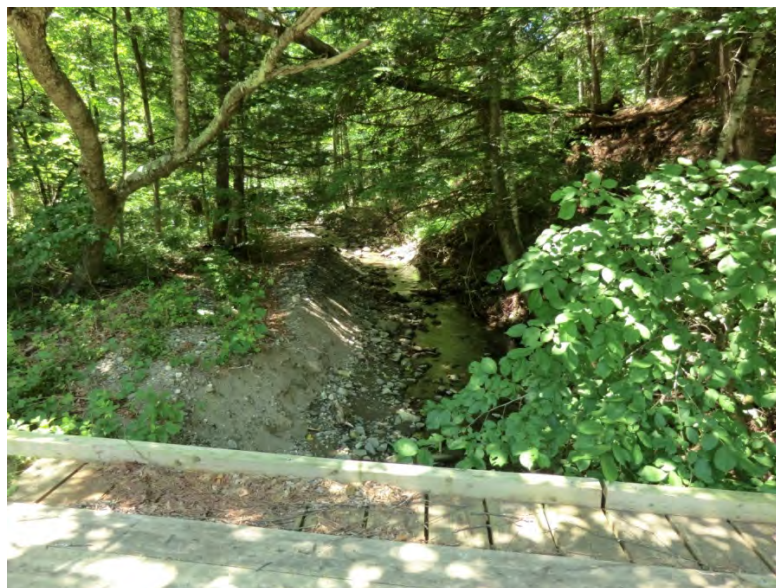
Figure 6.1. Aggradation near the mouth of Barker Brook
