Ottauquechee River Watershed Stream Geomorphic Assessment Bridgewater and Woodstock, Vermont January 29, 2013

Prepared by:
Bear Creek Environmental, LLC
297 East Bear Swamp Road
Middlesex, Vermont 05602

Prepared under contract to:
Two Rivers-Ottauquechee Regional Commission
128 King Farm Road
Woodstock, VT 05901

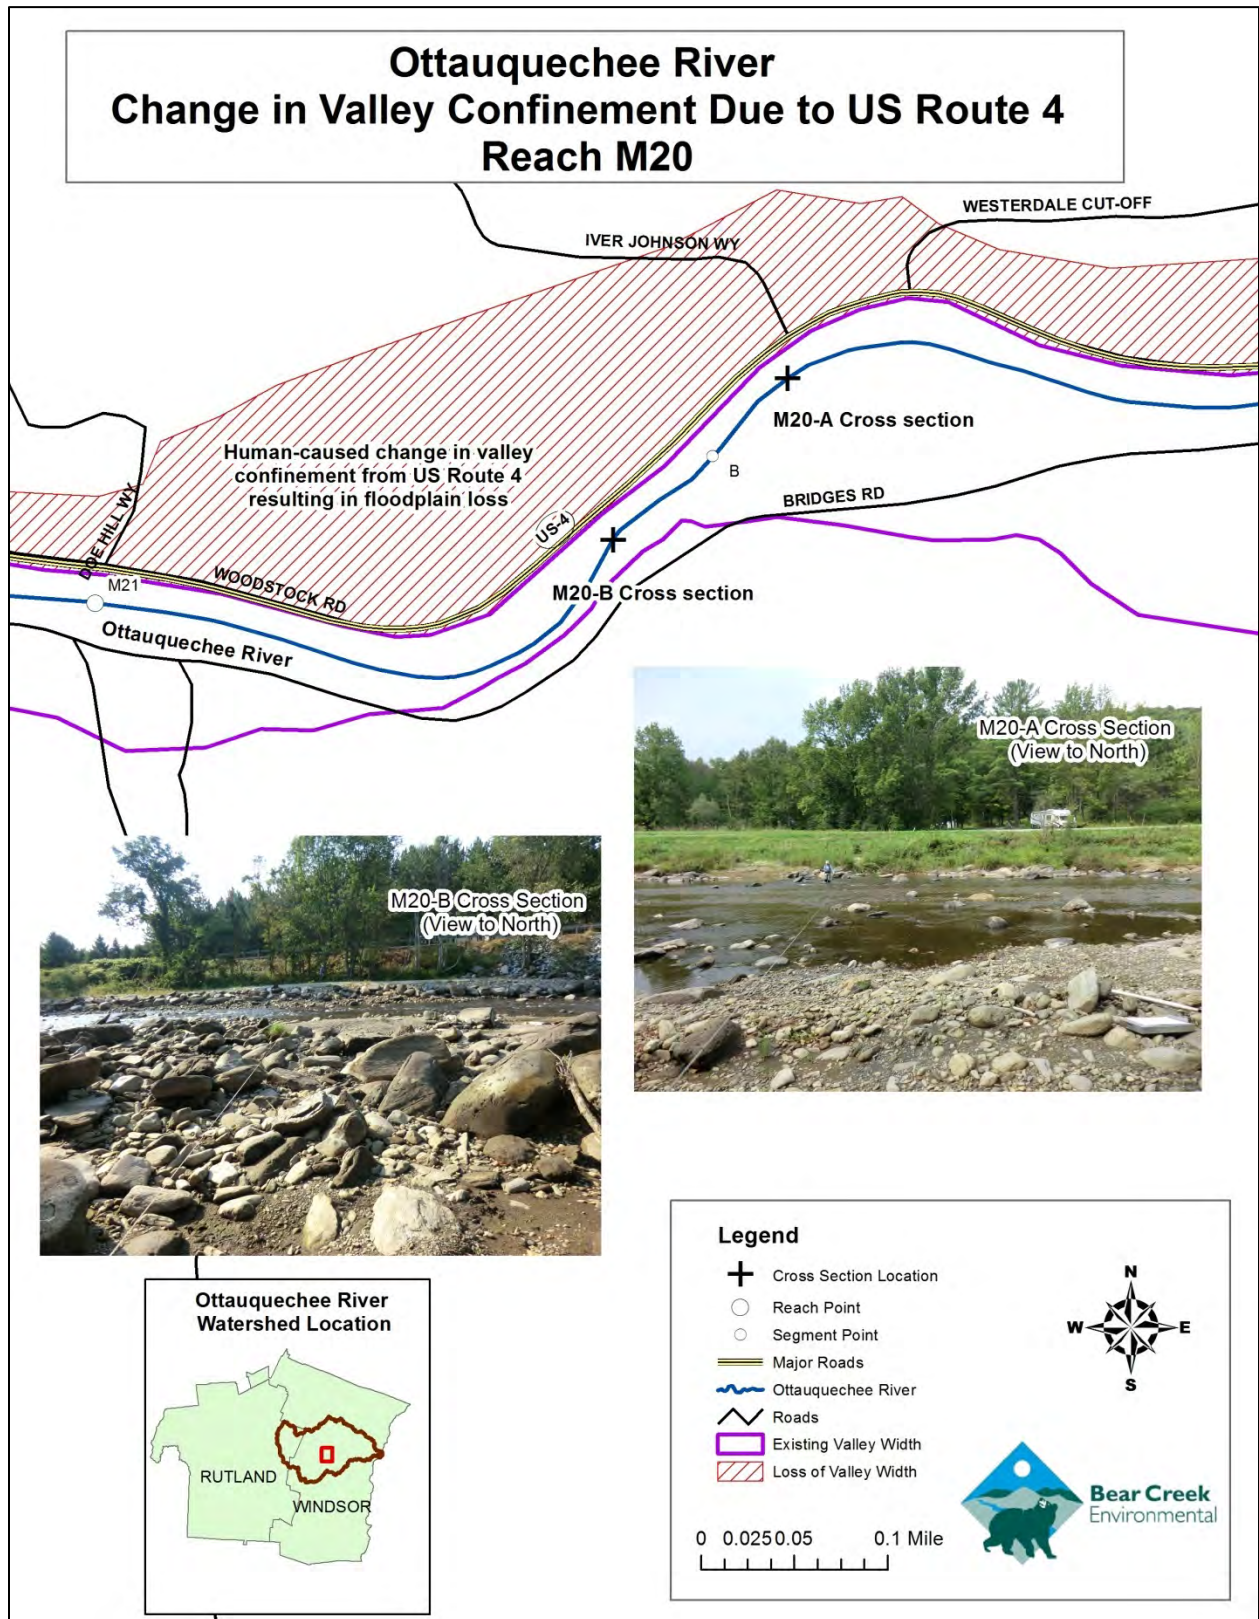
Figure 5.1. Loss of valley width (and floodplain) from US Route 4

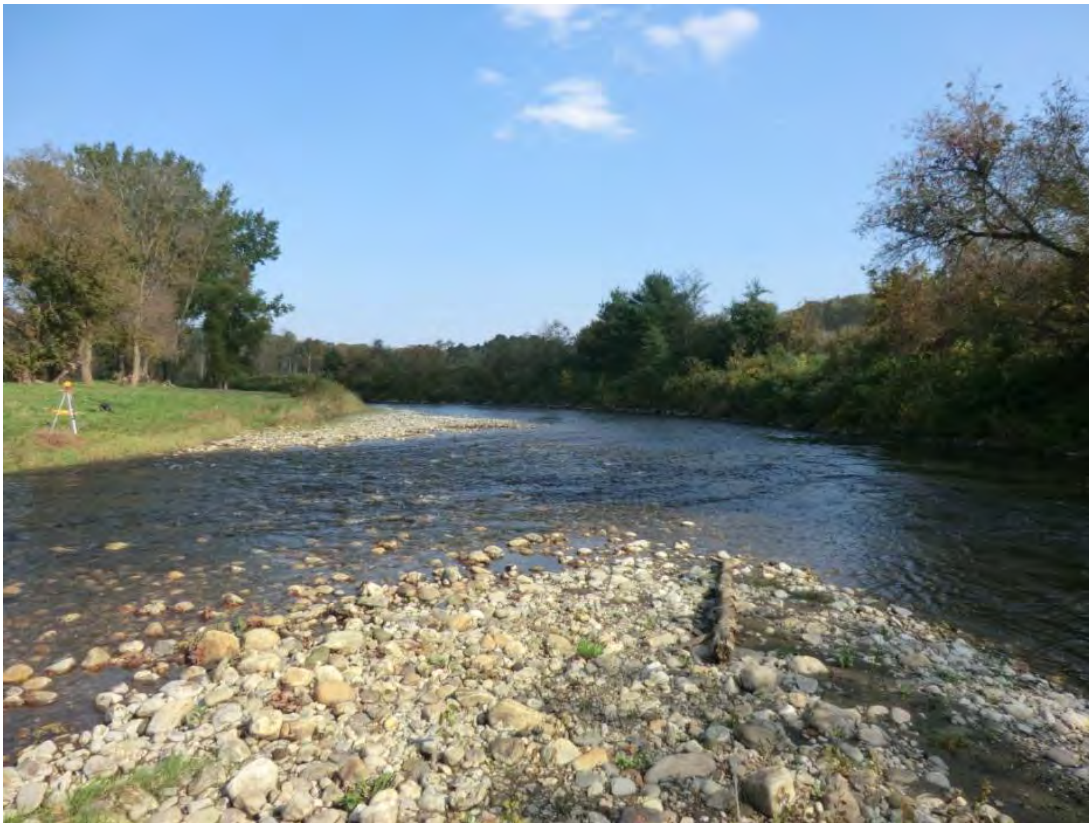
Figure 5.3. Typical low banks, sparse buffer (left bank), and high aggradation in M13.

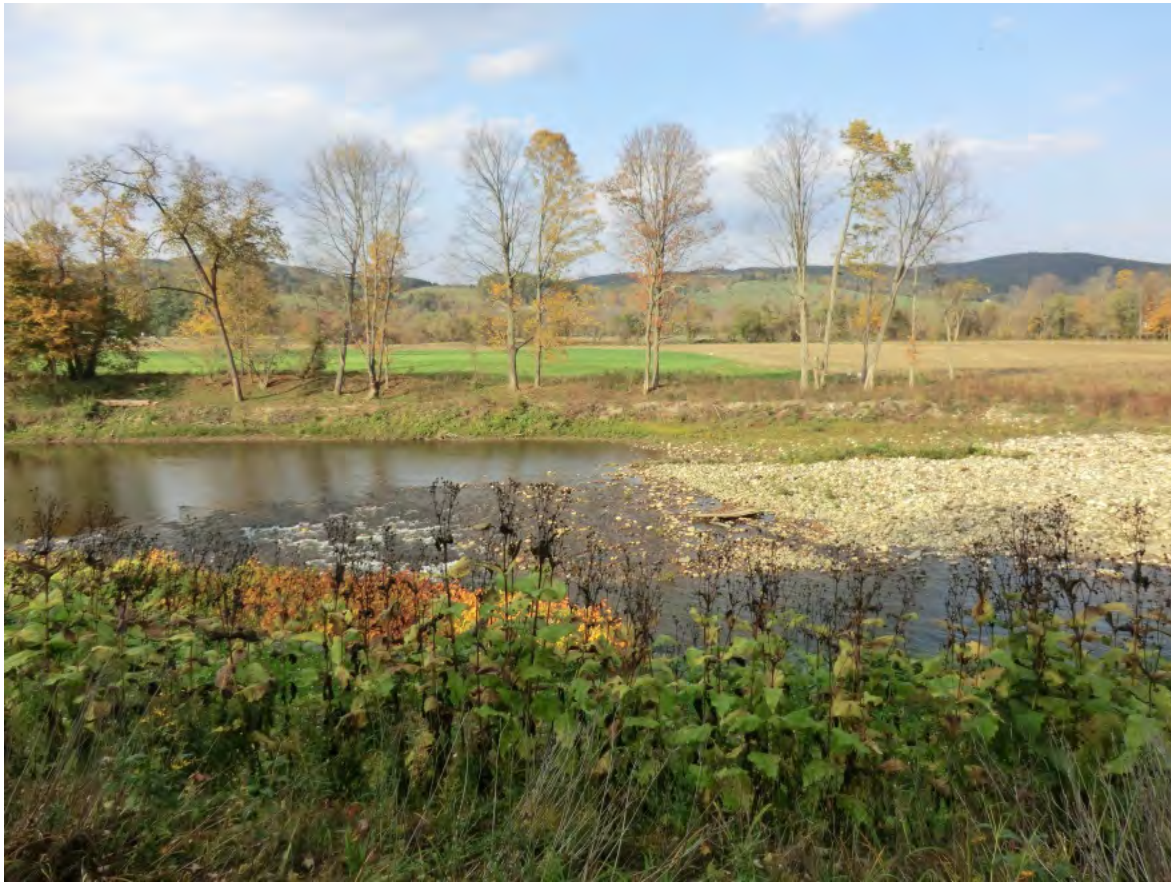
This segment begins where Barnard Brook enters the Ottauquechee and continues 3,800 feet upstream to where the river becomes straight, or directly across from a motel on Woodstock Road. M14-A, accounting for two-thirds of the reach, has good floodplain access while the upstream segment (M14-B) does not have access to its floodplain (Figure 5.4).

Figure 5.4. High banks in M14-B (left) and lower banks in M14-A (right).

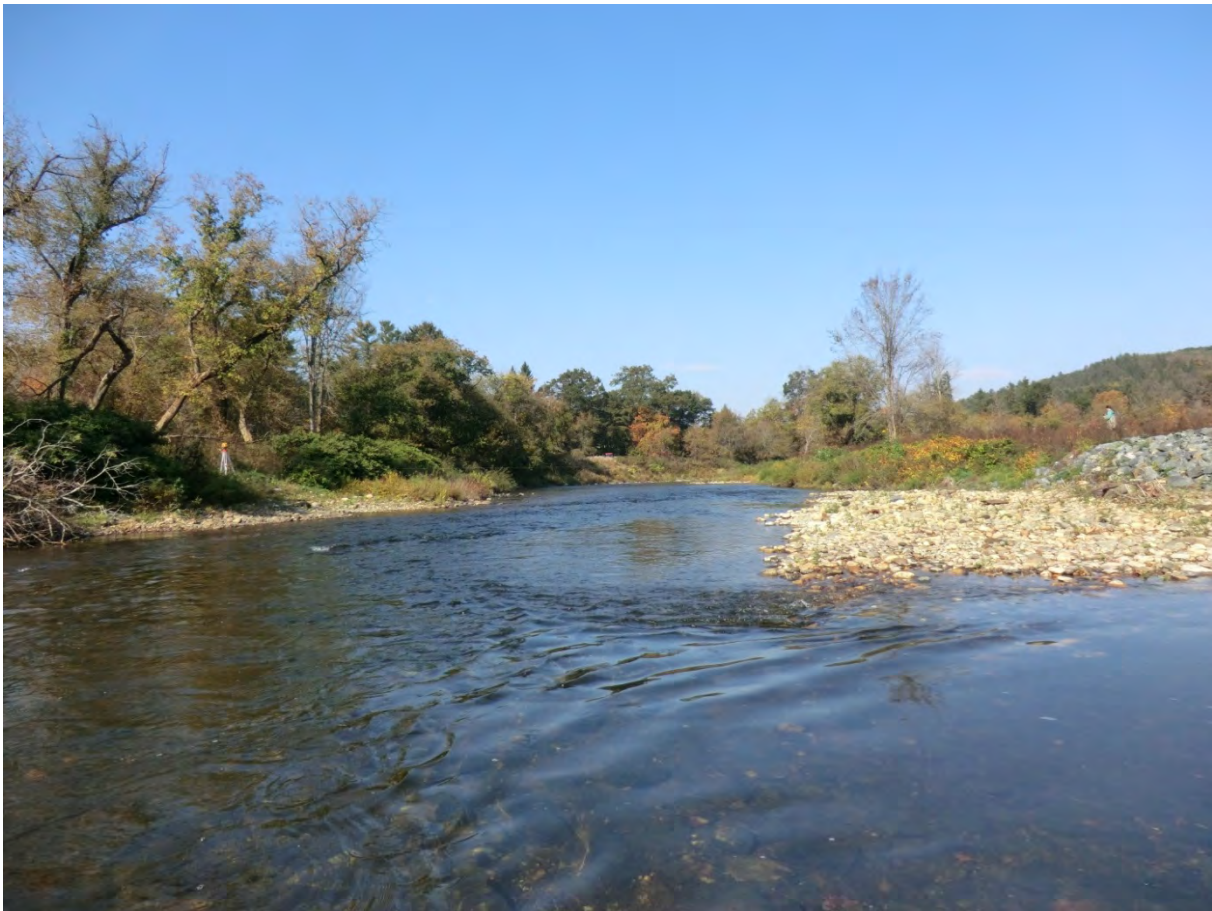
Figure 5.5. Widening and aggradation are occurring in M14-A. Rip rap prevents planform adjustment.

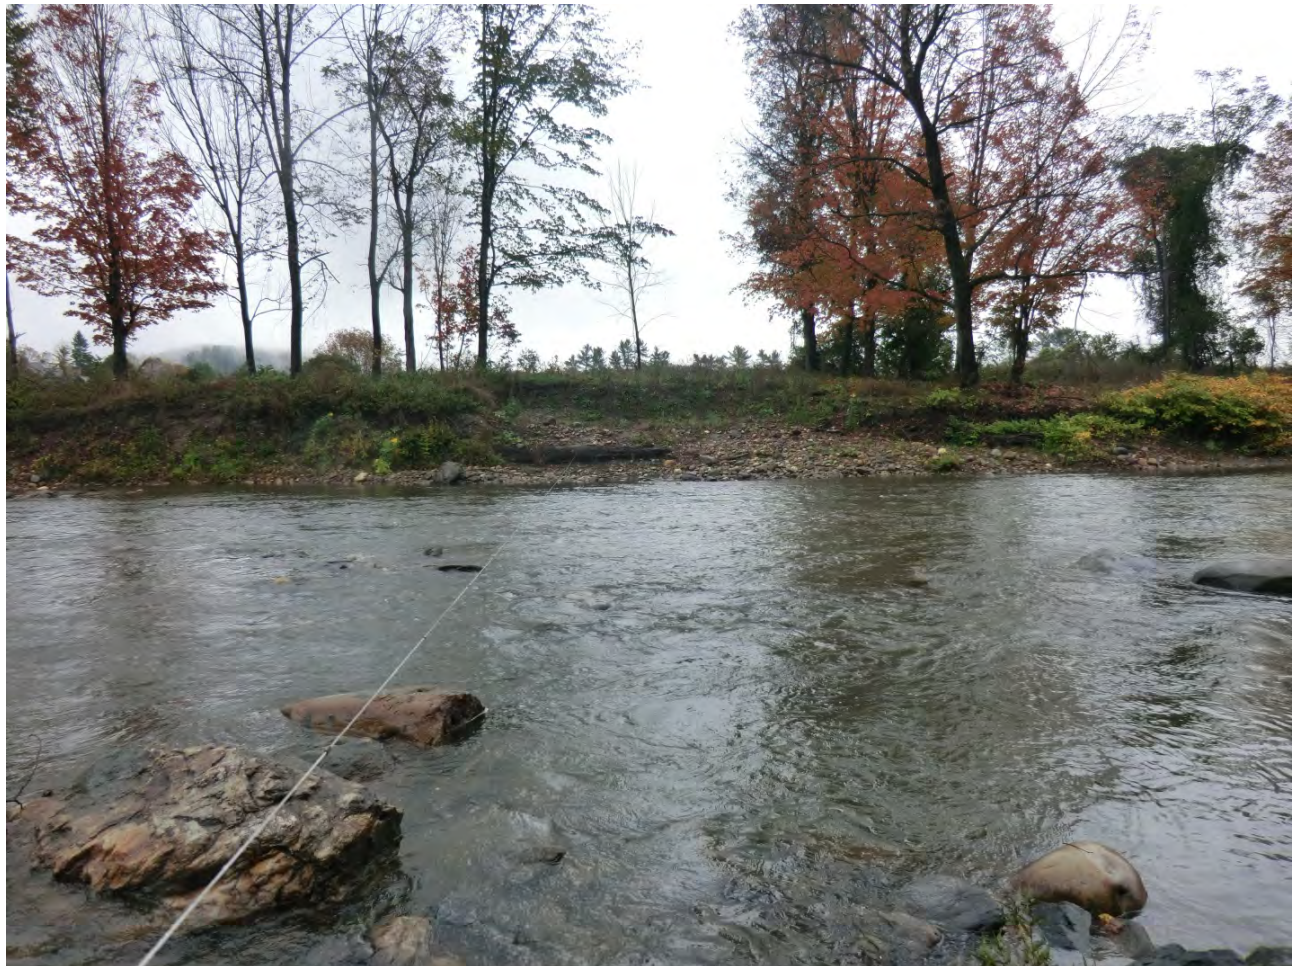
Figure 5.6. High banks in M14-B restrict floodplain access.

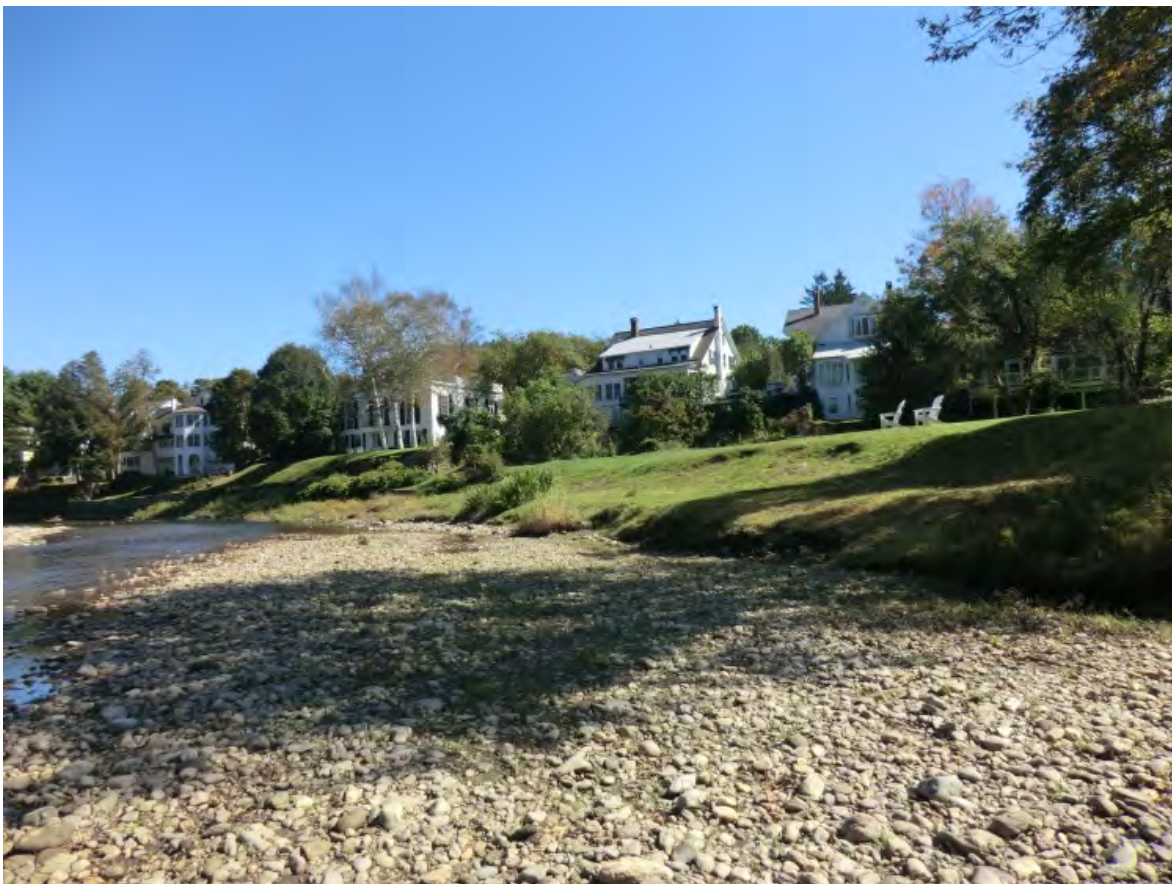
Figure 5.8. Typical aggradation and no buffer area adjacent to the river in M15-B.

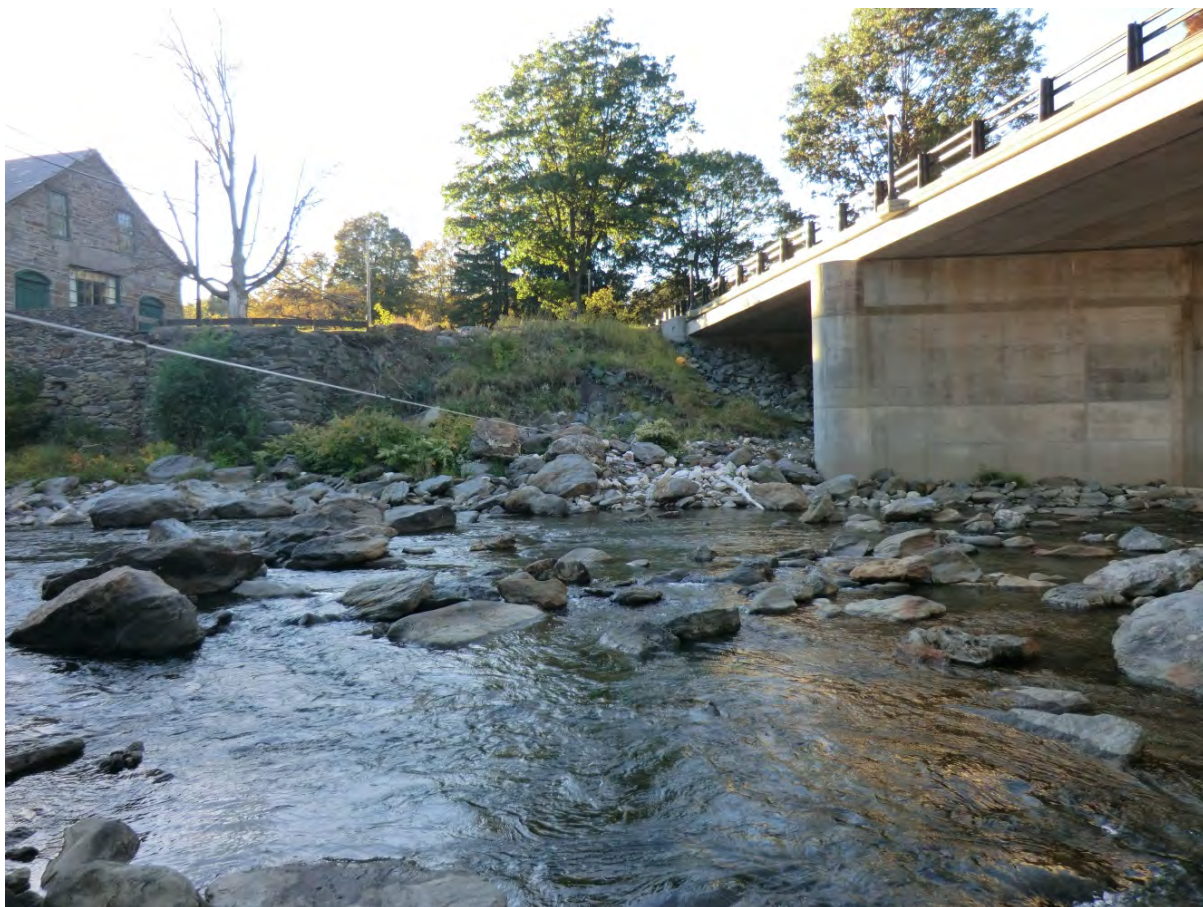
Figure 5.9. Extensive channel straightening seen through rip rap and hard bank armoring.

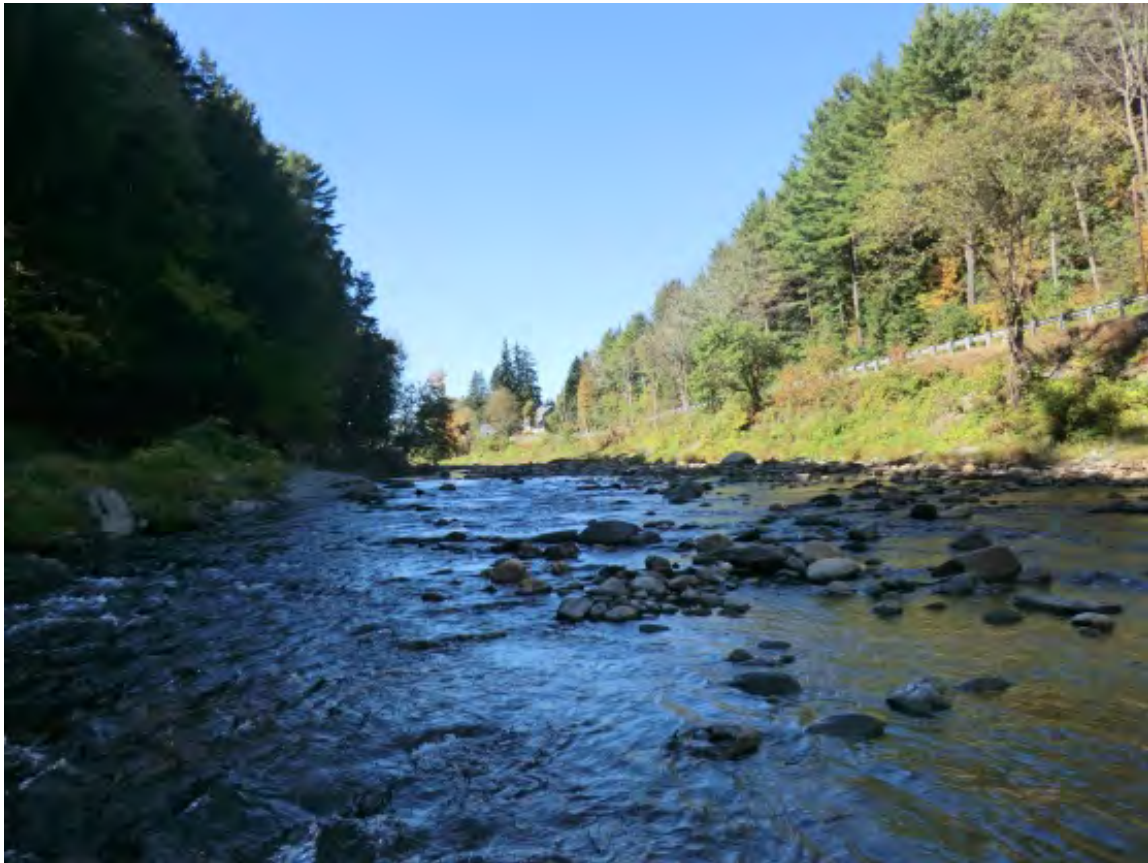
Figure 5.10. Route 4 running along northern edge of M16.

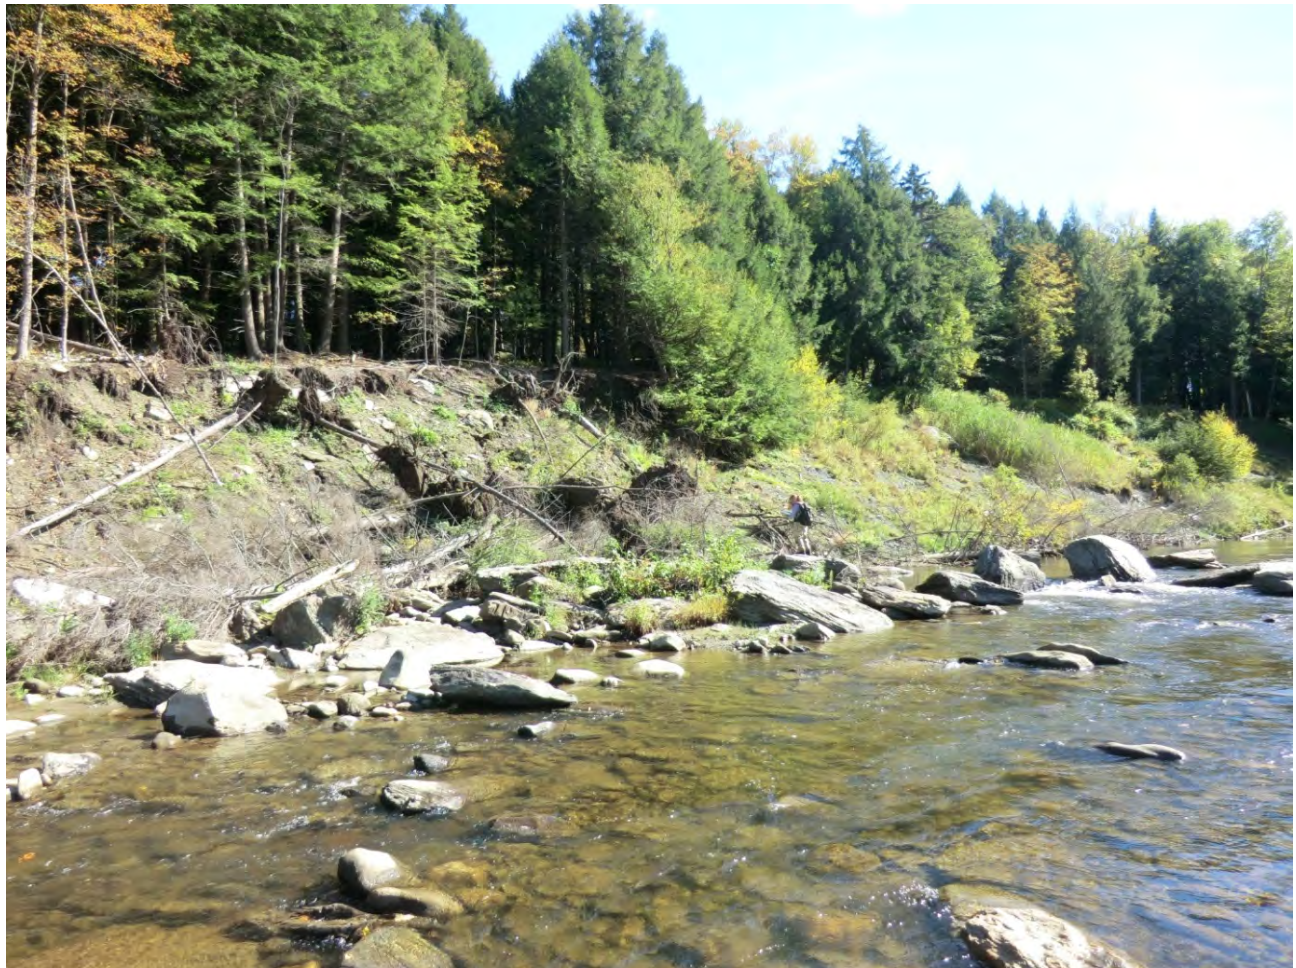
Figure 5.11. Mass failure on the southern bank at downstream end of M17.

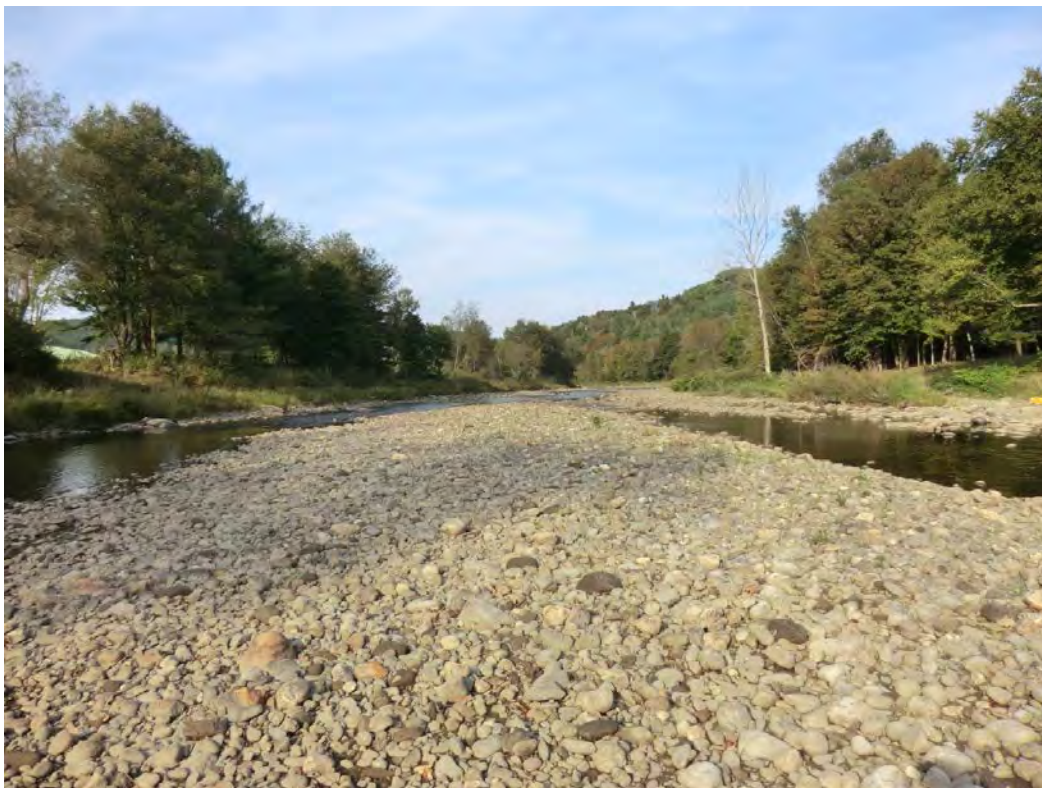
Figure 5.12. Major aggradation in M18-A.

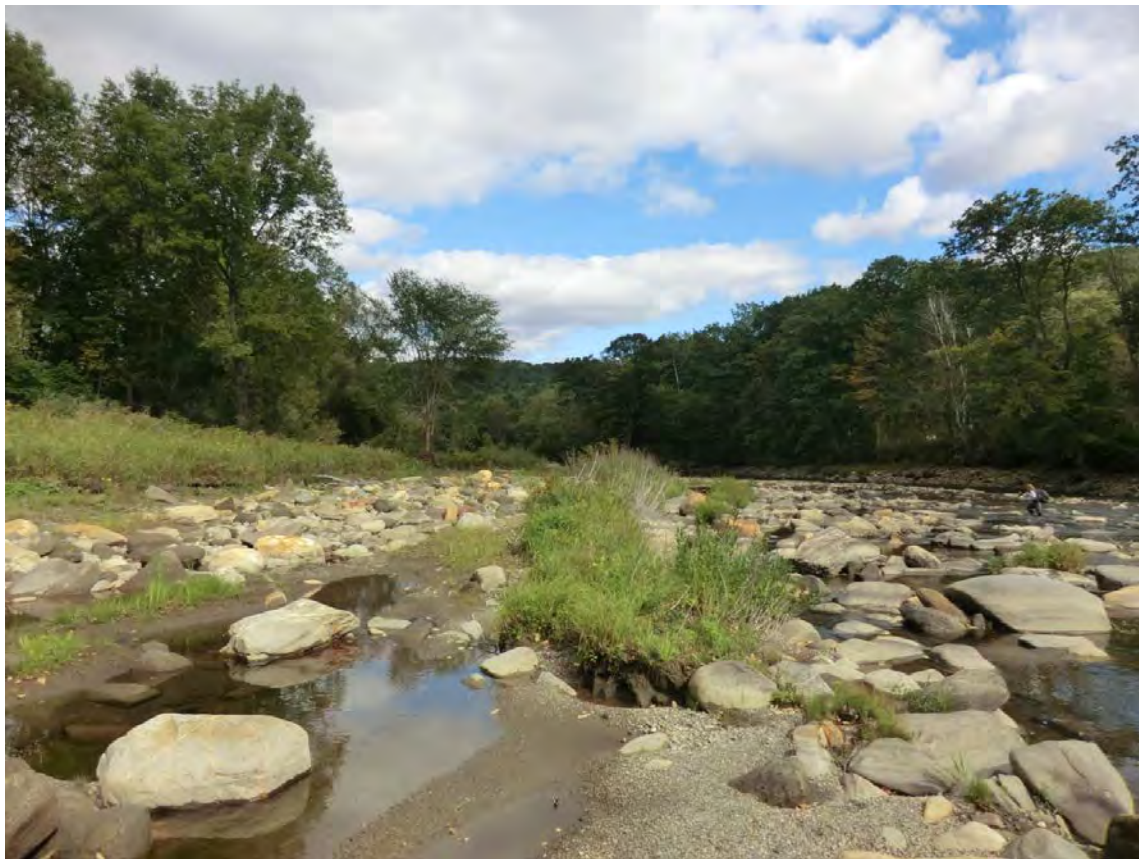
Figure 5.13. M18-B is widening.

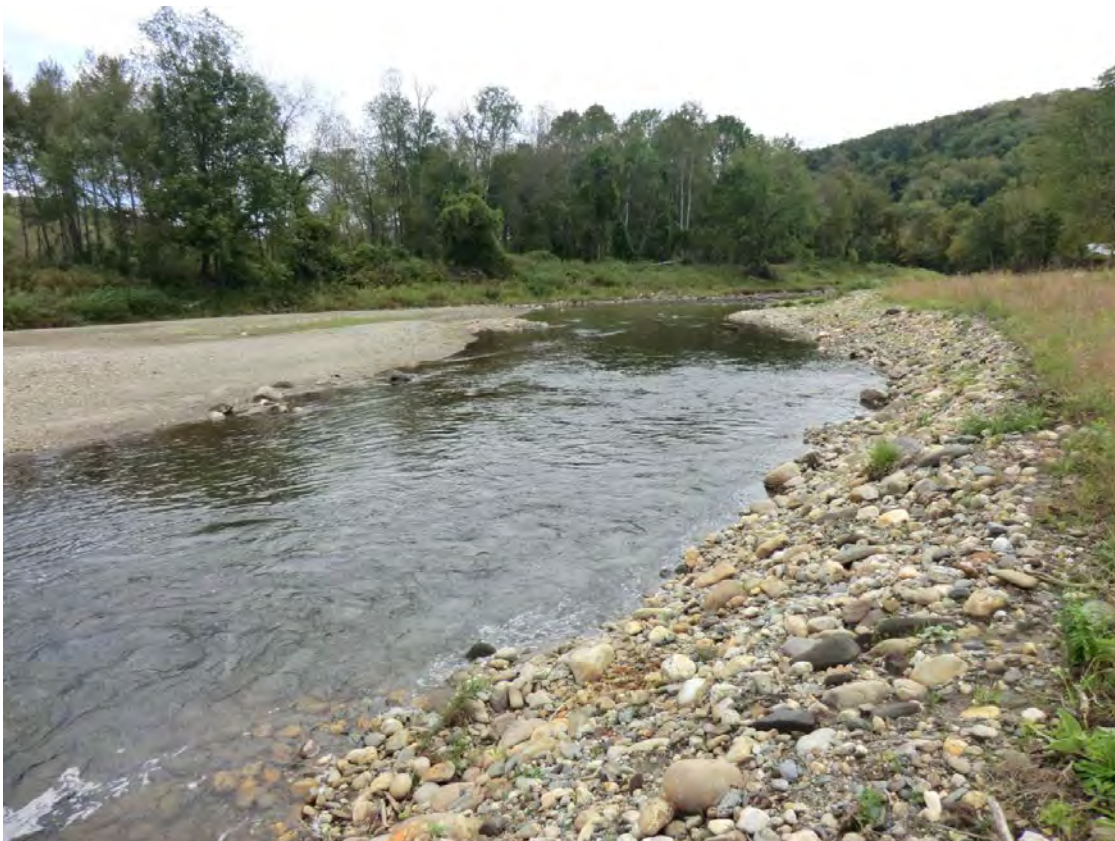
Figure 5.14. Flood work is limiting natural geomorphic processes.

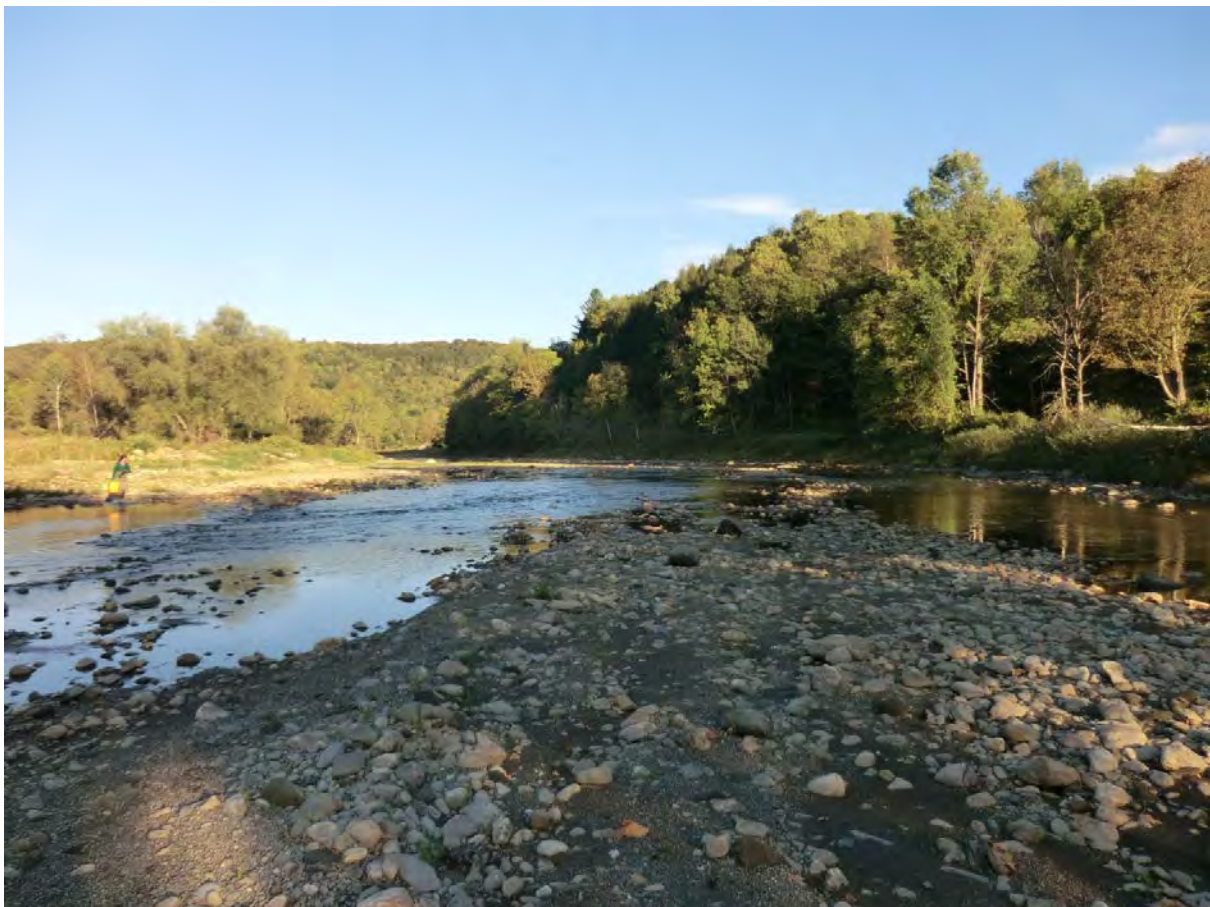
This segment begins where Fletcher Hill Road comes close to the southern bank and continues 1,350 feet upstream to just below the Lincoln Corners Covered Bridge. Fletcher Hill Road runs directly along the entire southern bank of this segment. This segment is in **fair** geomorphic condition with minor **historic incision**. Major **aggradation** and extreme **widening** are the main processes occurring in this segment. The river is building a new floodplain. This segment is in **fair** habitat condition mainly because of a lack of adequate vegetated buffers and large woody debris. Figure 5.15 shows a typical channel in this M19-B.

Figure 5.15. Typical channel in M19-B shows major aggradation and extreme widening.

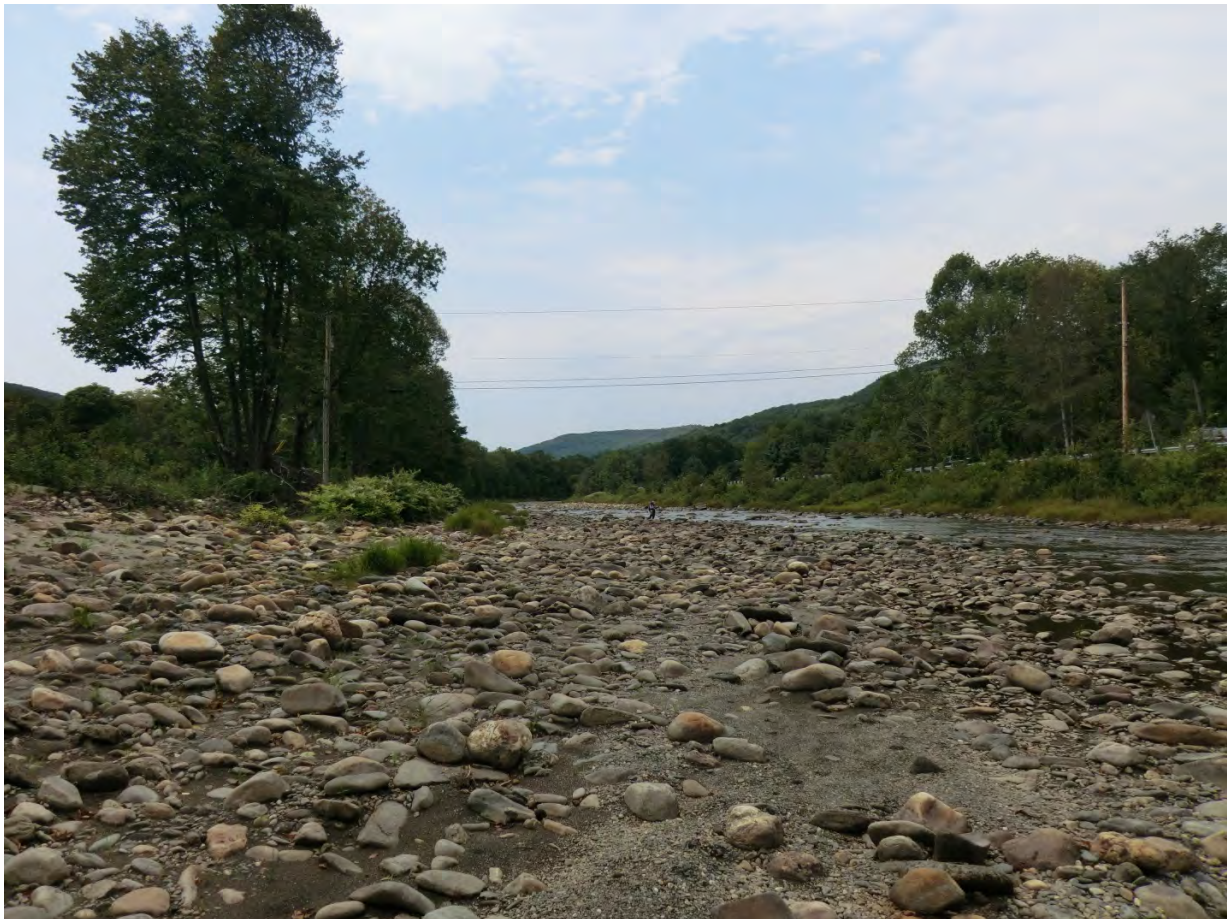
Figure 5.16. M20-A exhibits extreme aggradation.

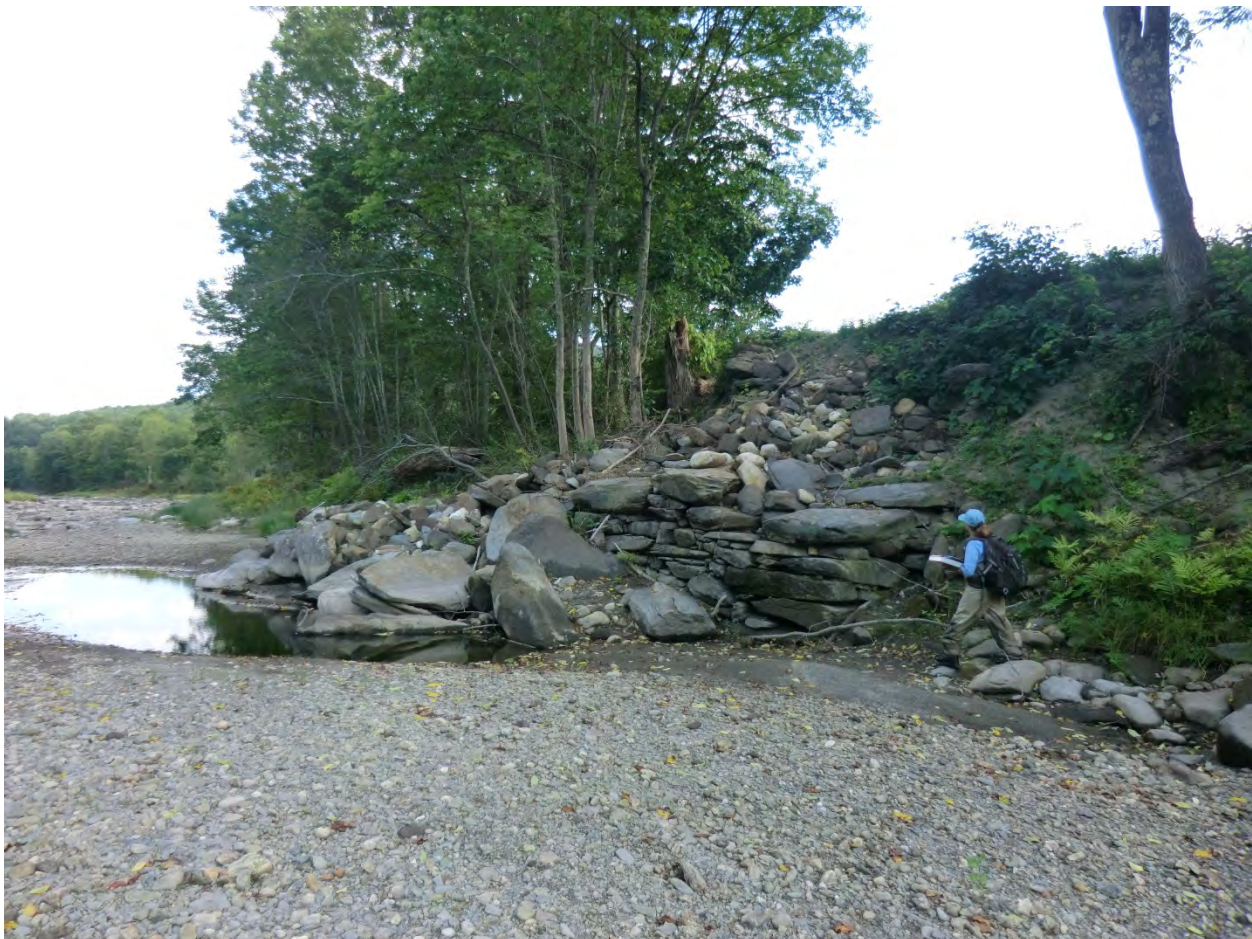
This segment begins approximately where Doe Hill Way intersects Route 4 and continues upstream 1,700 feet along a residential area until the southern bank becomes forested. Route 4 runs directly along the northern bank for the entire length of the segment. There is an old bridge abutment that is constricting the channel and causing additional deposition (See Figure 5.17).

Figure 5.17. Old bridge abutment causing deposition in M21-A.

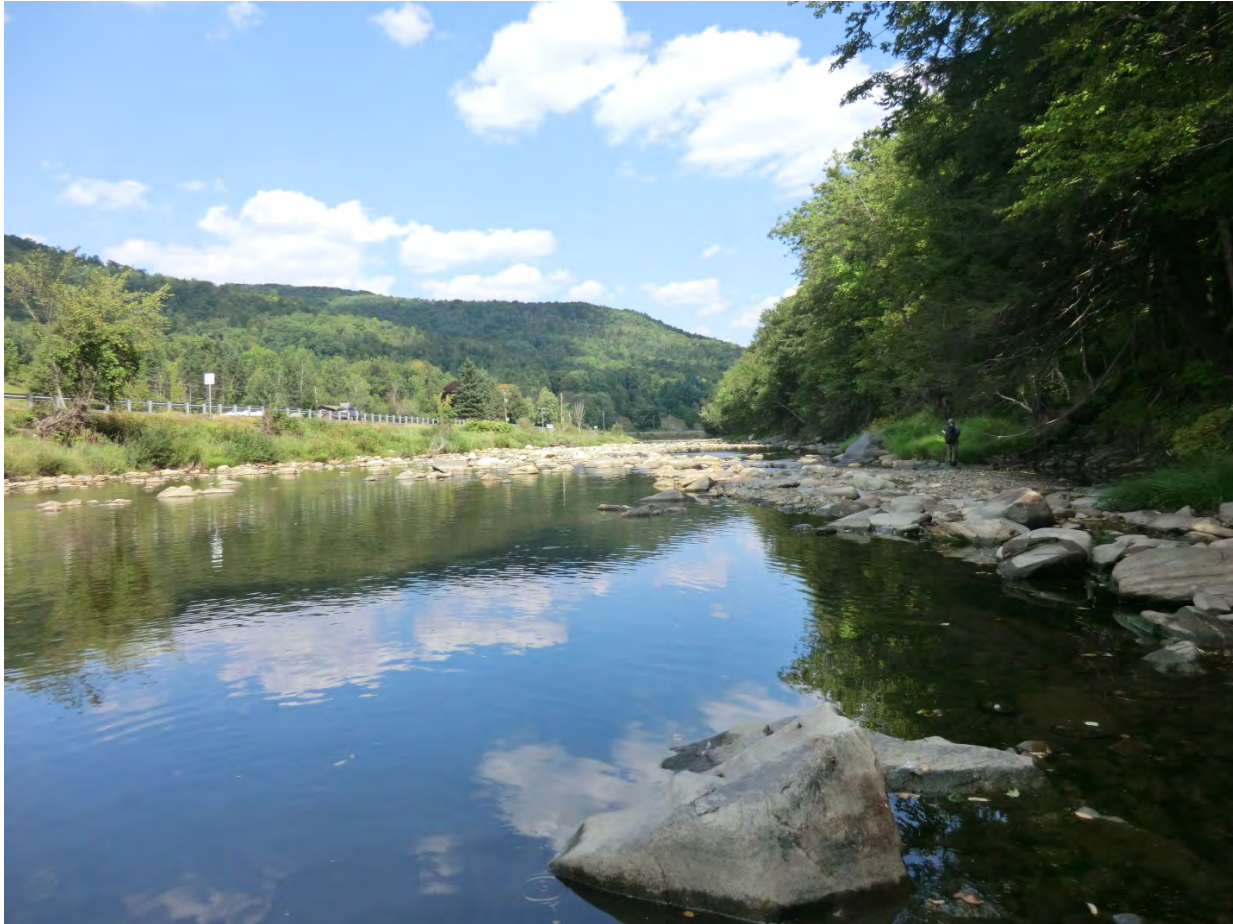
Figure 5.18. Typical channel in M21-B.

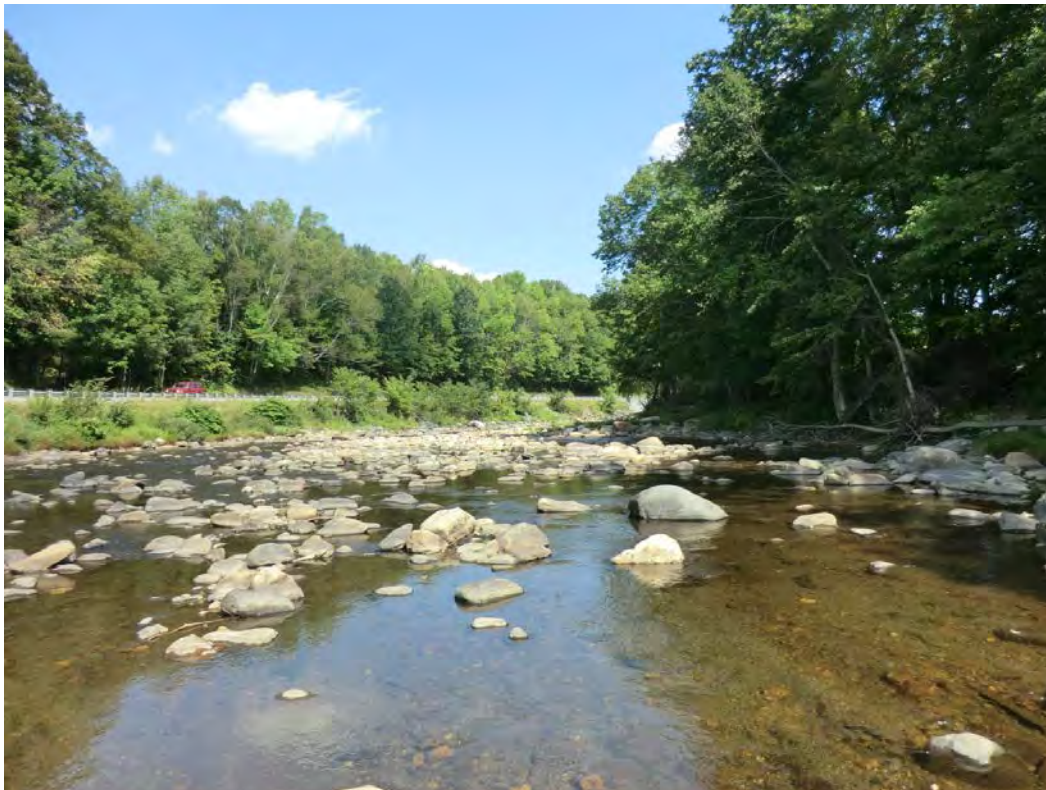
This segment is in **poor** geomorphic condition. Route 4 has cut off access to some of its floodplain and led to **historic incision**, resulting in a stream type departure. Floodplain access is now completely restricted. Major **aggradation, widening, and planform adjustment** are the main processes occurring here as the channel responds to incision. This segment is in **fair** habitat condition because of its lack of adequate vegetated banks and buffers. In addition to that, the largely incised streambed and lack of large woody debris lower the rating.

Figure 5.19. Typical M21-C channel looking downstream.

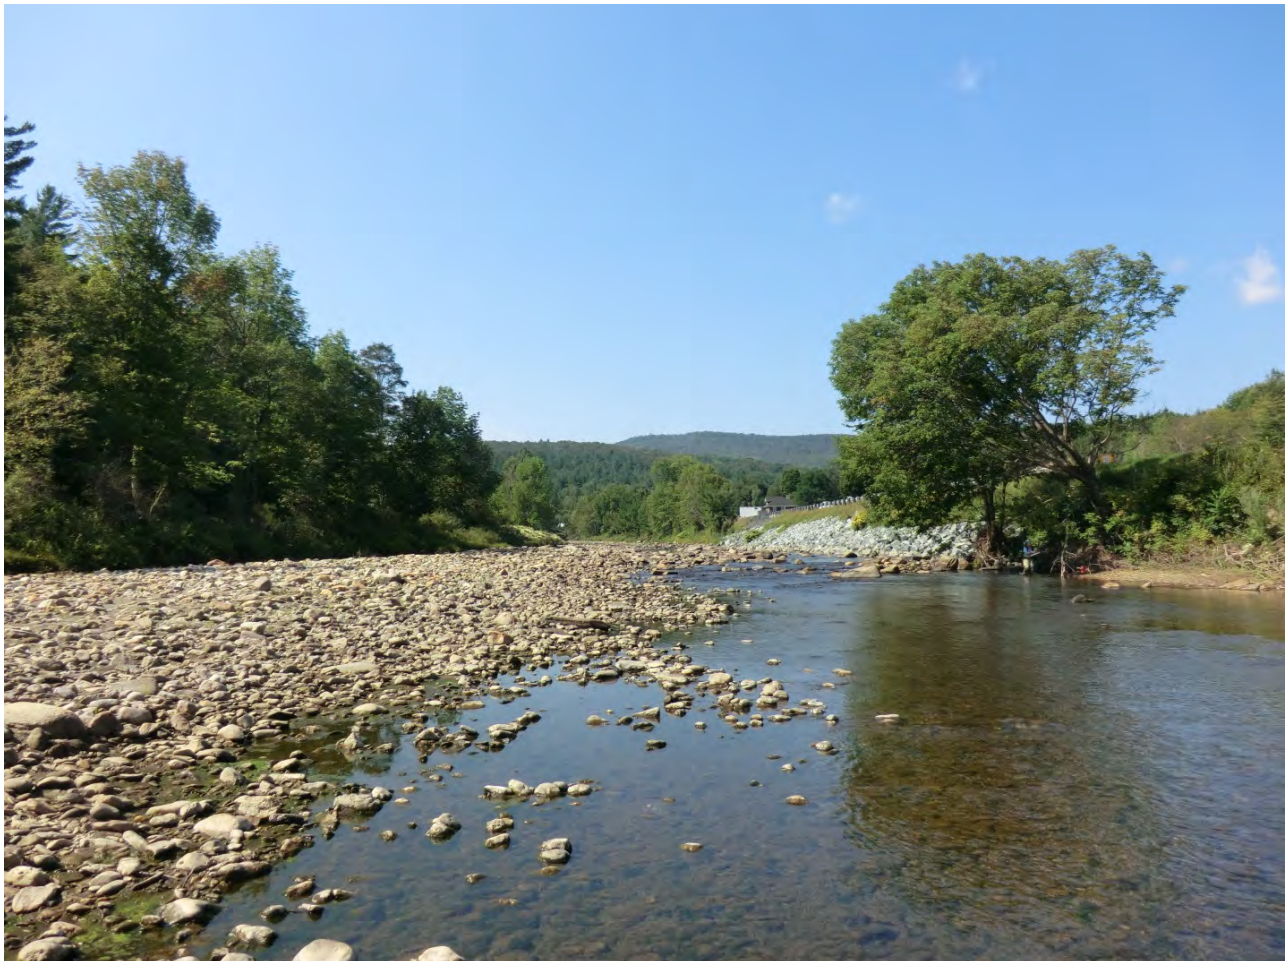
This segment begins where the southern bank changes from cropland back to forest and continues 2,800 feet upstream to the reach break at the confluence with Curtis Hollow Brook. Several storm water inputs were identified in this segment, which are coming from Route 4 and Larry Curtis Road. This segment is in **poor** geomorphic condition. Route 4 has cut off access to some of its floodplain and led to **historic incision**, resulting in a stream type departure. Floodplain access is now completely restricted. Major **aggradation** and **planform adjustment** are the main processes occurring as the channel responds to incision. **Widening** is extreme. This segment is in **fair** habitat condition because of its lack of an adequate vegetated northern bank and buffer. In addition to that, the largely incised streambed and a lack of large woody debris lower the rating. Figure 5.20 shows the major aggradation and lack of buffer.

Figure 5.20. Typical channel in M21-D looking upstream. High aggradation. Lack of adequate buffer along Route 4.

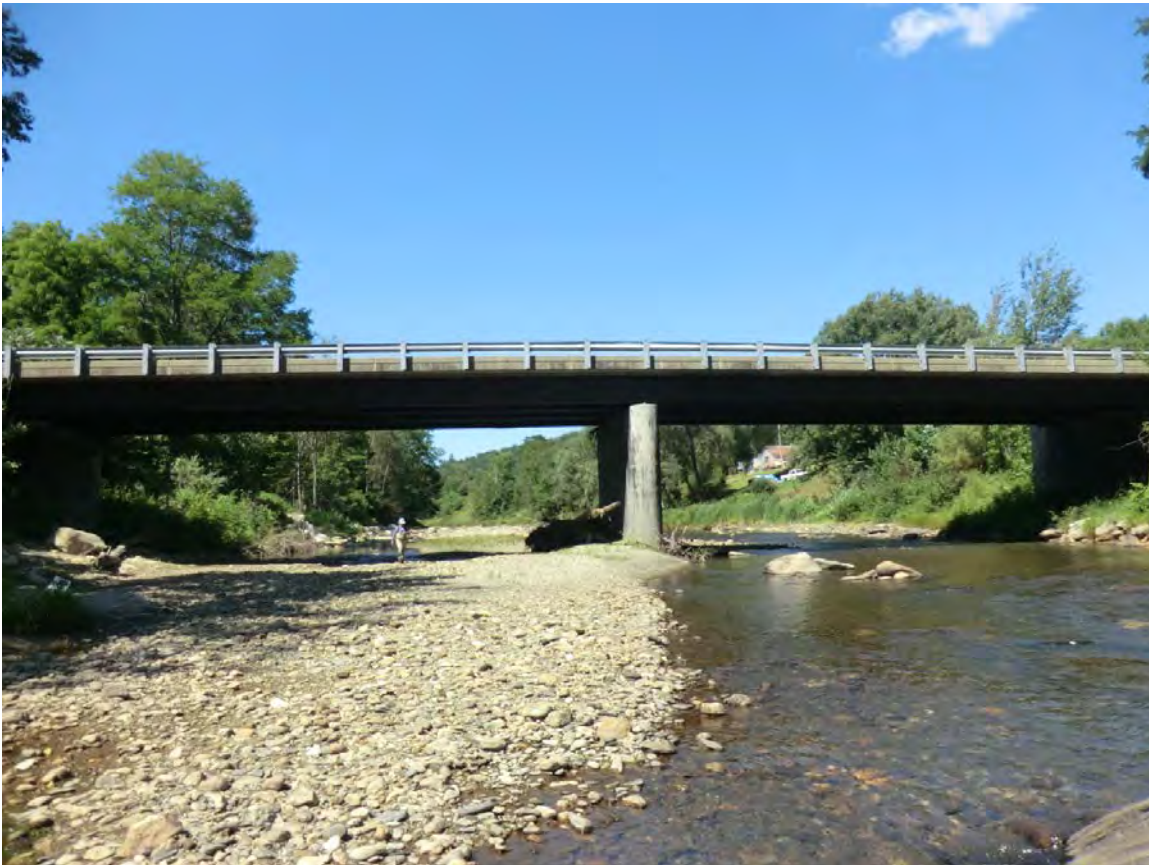
Figure 5.21. Bridgewater Village/Curtis Hollow Road Bridge causing upstream and downstream deposition in M22-A.
