Ottauquechee River Watershed Stream Geomorphic Assessment Bridgewater and Woodstock, Vermont January 29, 2013

Prepared by:
Bear Creek Environmental, LLC
297 East Bear Swamp Road
Middlesex, Vermont 05602

Prepared under contract to:
Two Rivers-Ottauquechee Regional Commission
128 King Farm Road
Woodstock, VT 05901

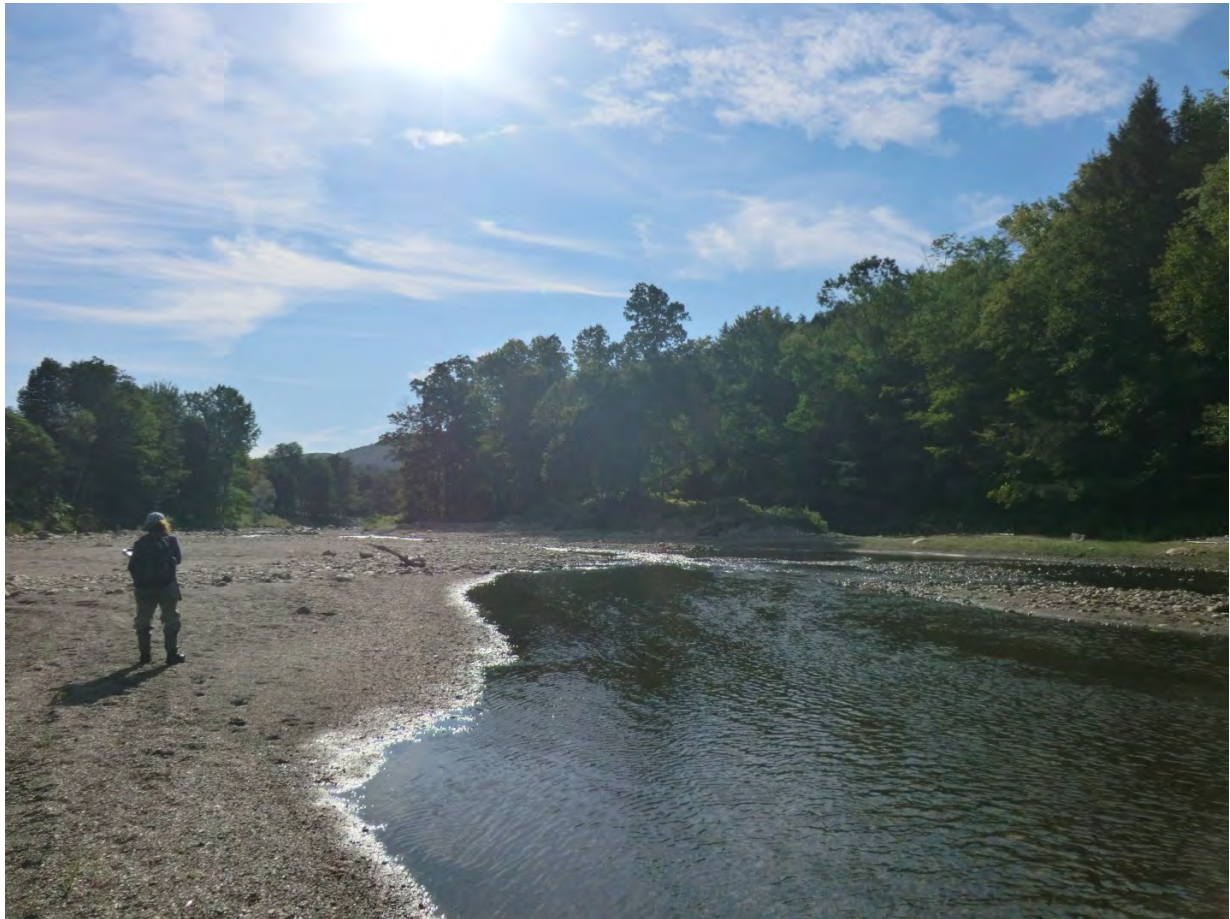
This segment begins just above the Bridgewater Village/Curtis Hollow Road Bridge and continues 4,100 feet upstream to where the river valley narrows and Route 4 becomes continuous with the northern bank. In the upper part of this segment, Route 4 is significantly impacting the valley width, changing the confinement from unconfined to confined. This segment is in **poor** geomorphic condition. Channel alteration has led to extreme **historic incision**, resulting in a stream type departure. Floodplain access is now completely restricted. Major **aggradation, widening, and planform adjustment** are processes occurring here as the channel responds to incision (See Figure 5.23).

Figure 5.23. Extreme aggradation, widening, and planform adjustment in M22-B.

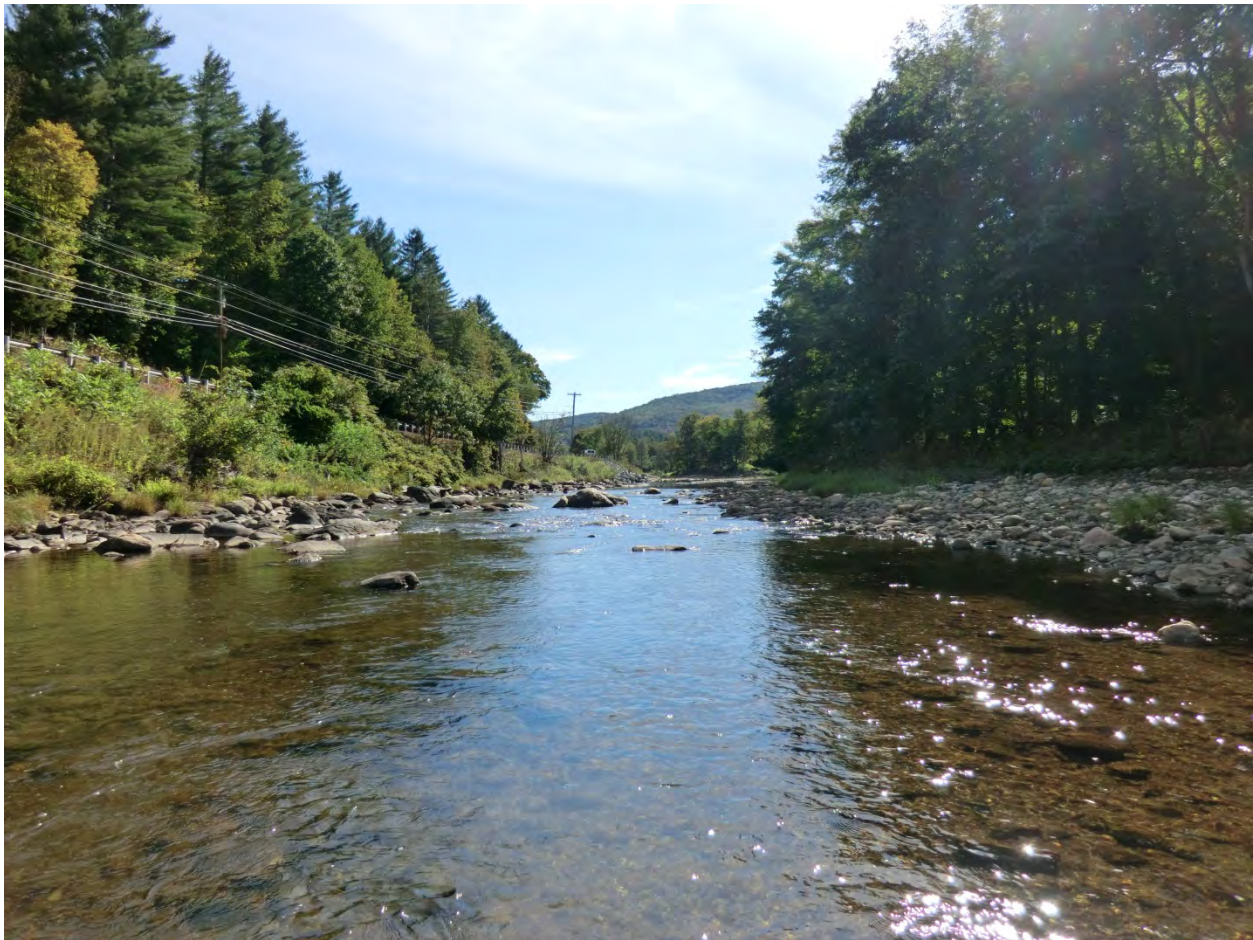
Figure 5.24. Major widening seen in M23-A.

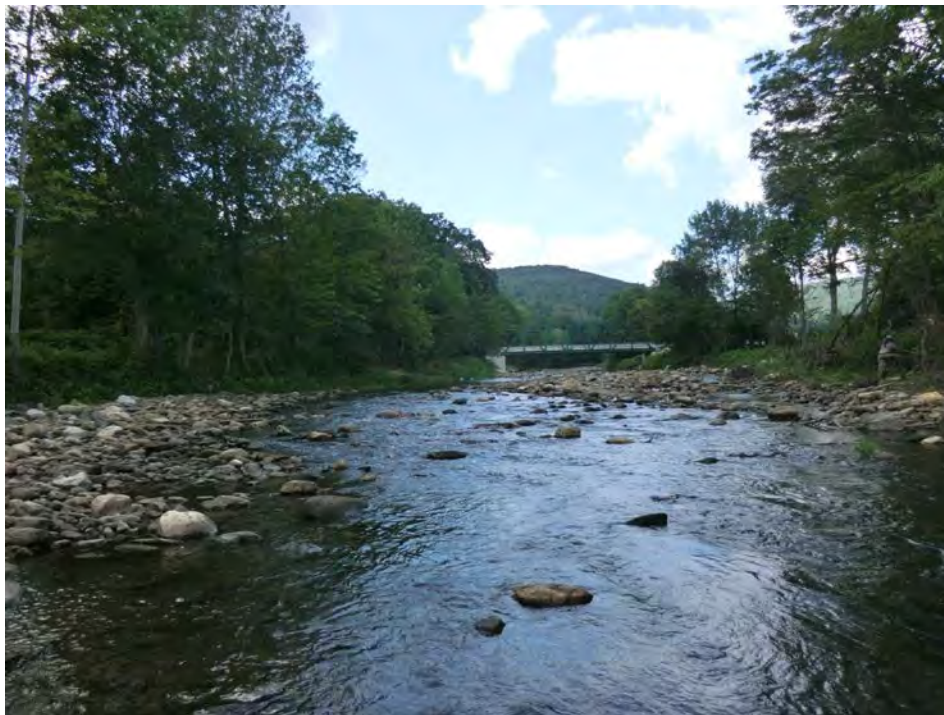
Figure 5.27. Typical channel in M24-A includes major aggradation. Route 100A bridge is upstream.

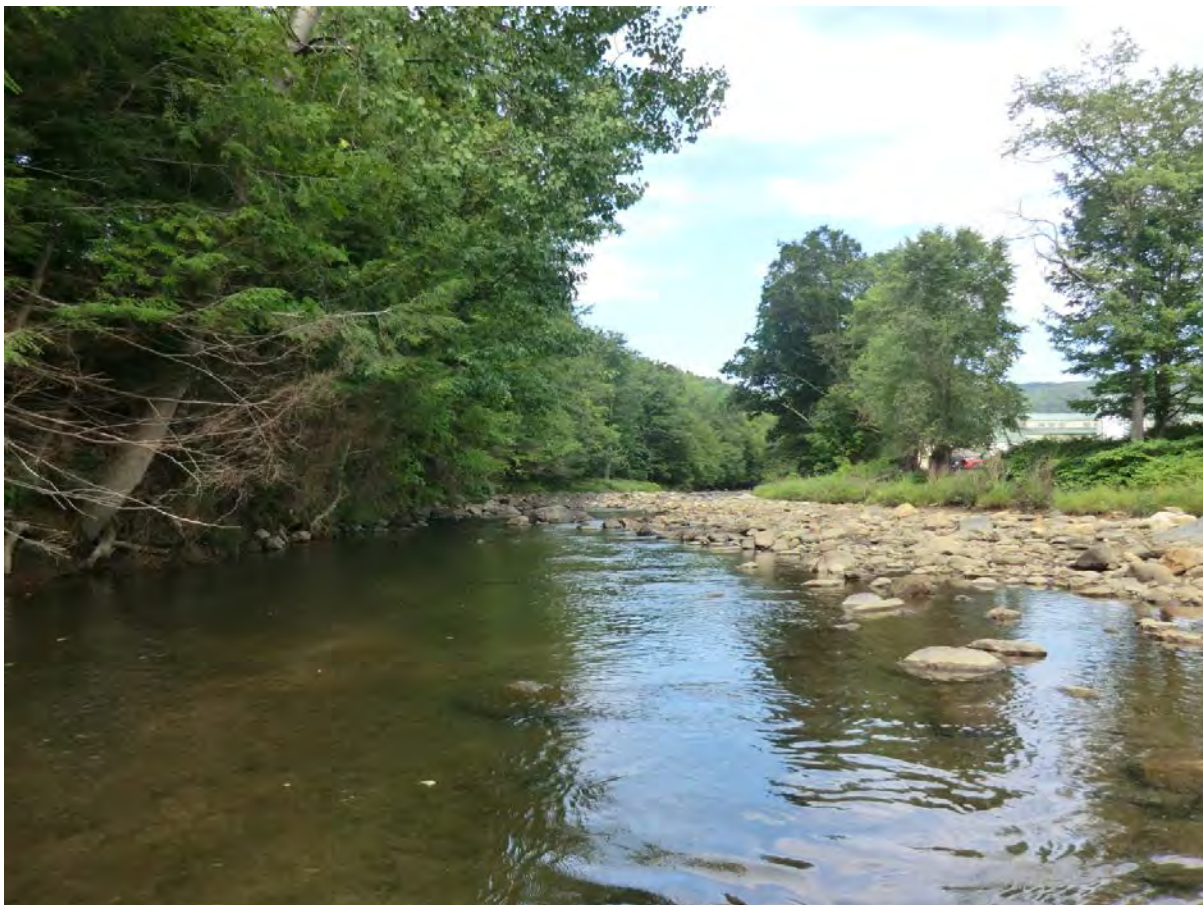
Figure 5.28. Significant aggradation in M24-B. Long Trail Brewery seen beyond the northern bank.

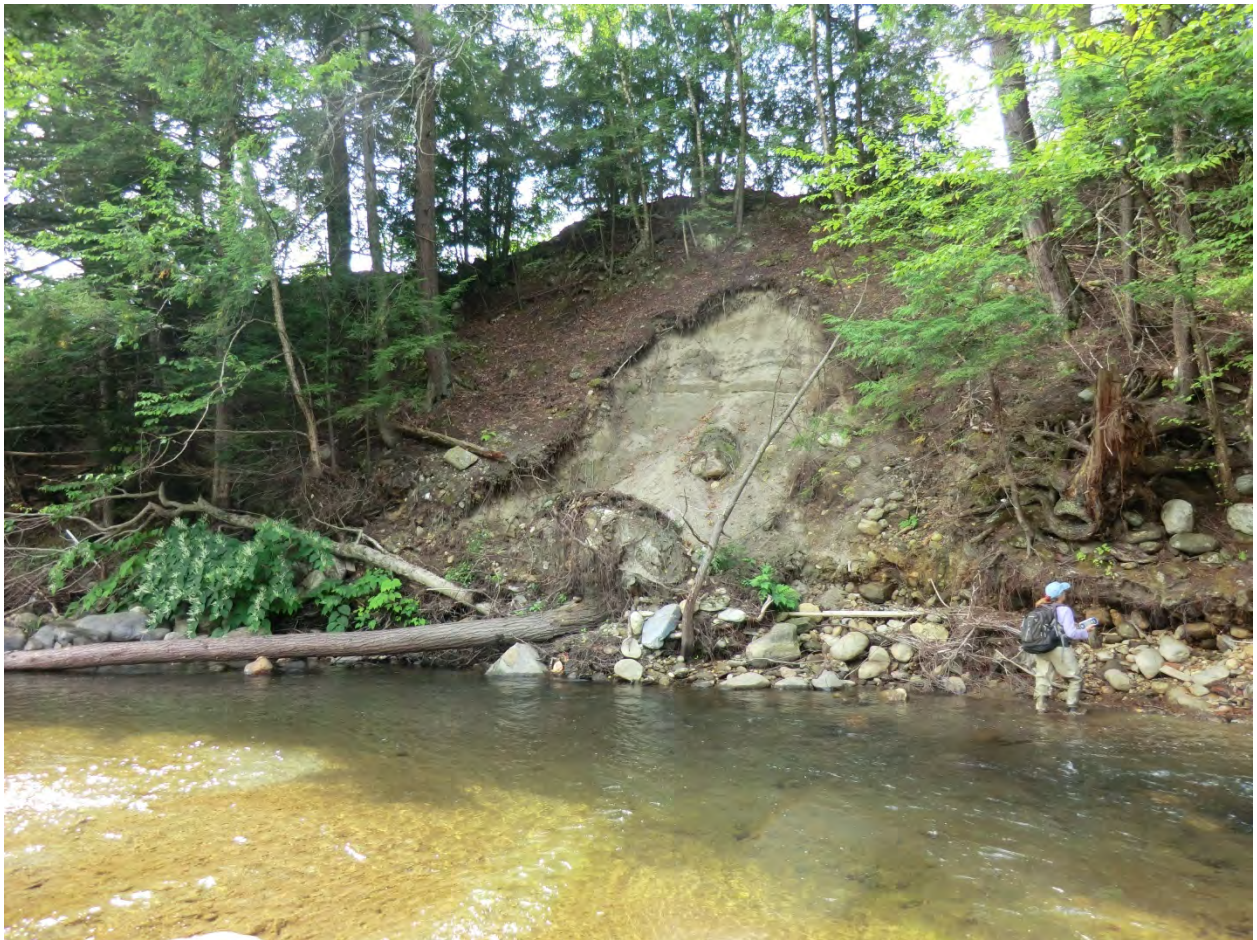
Figure 5.29. Mass failure on southern bank in M24-B.

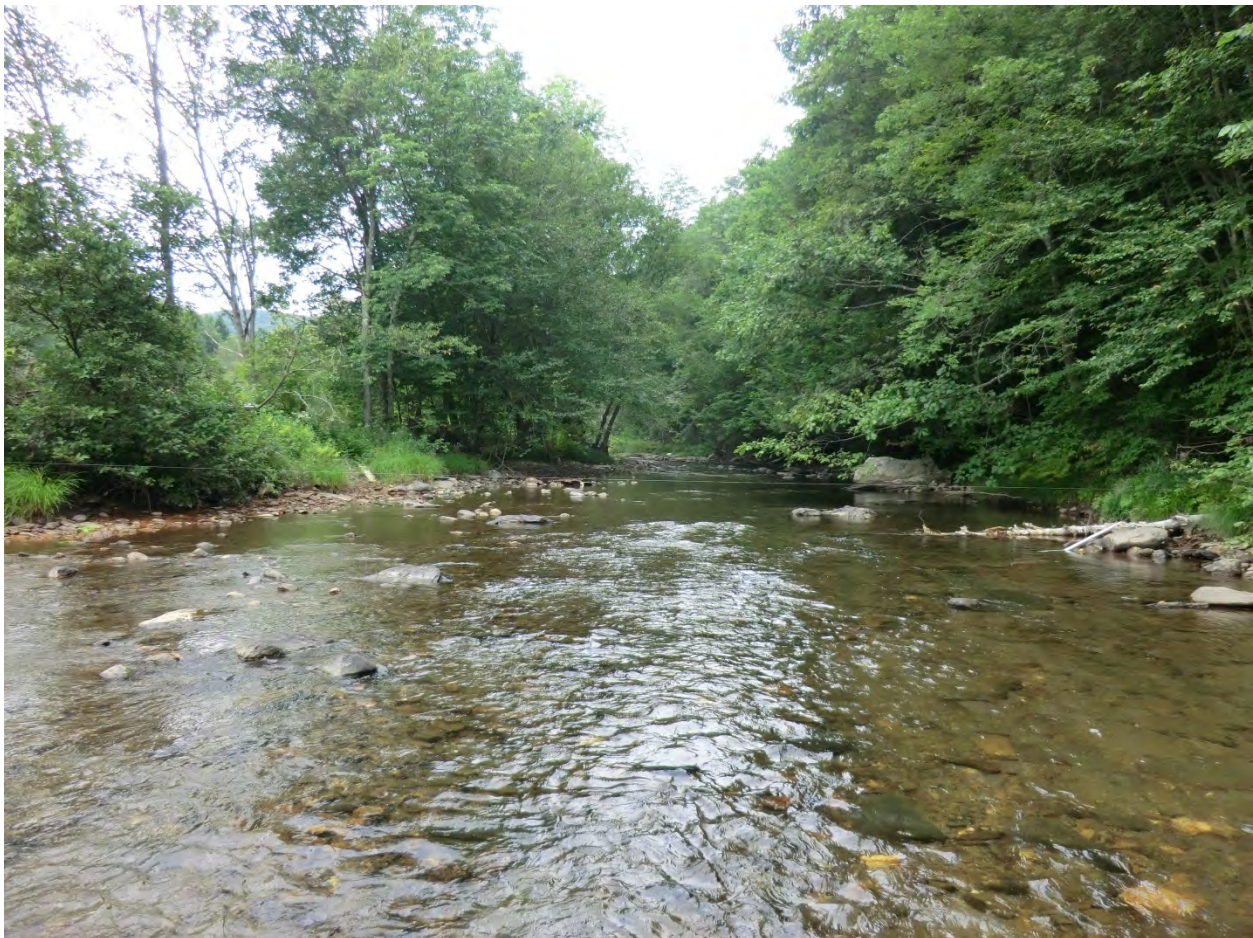
Figure 5.30. Aggradation and incision are minor in M25-A.

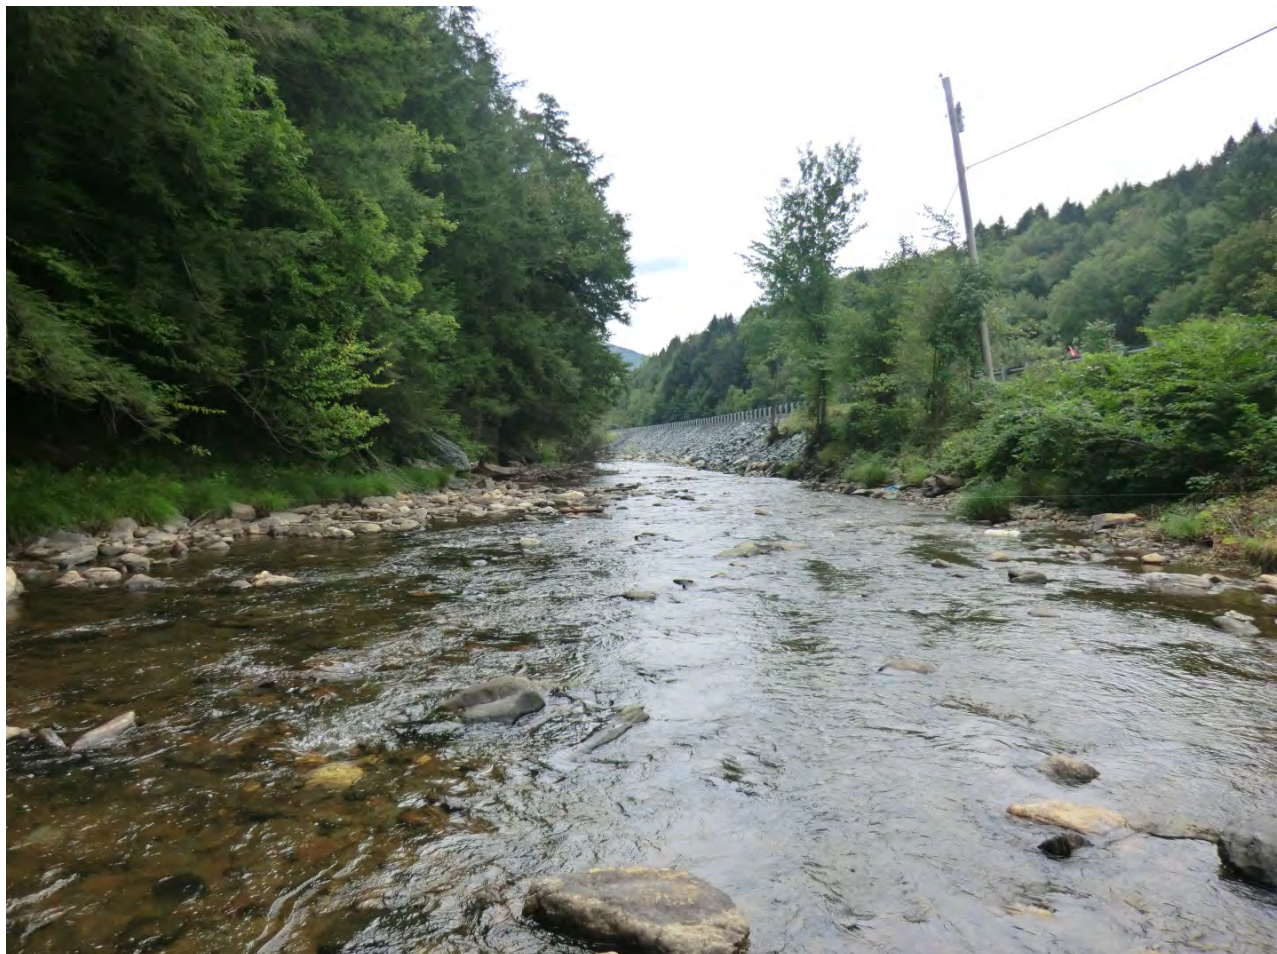
Figure 5.31. Placement of Route 4 significantly altering confinement in M25-B.

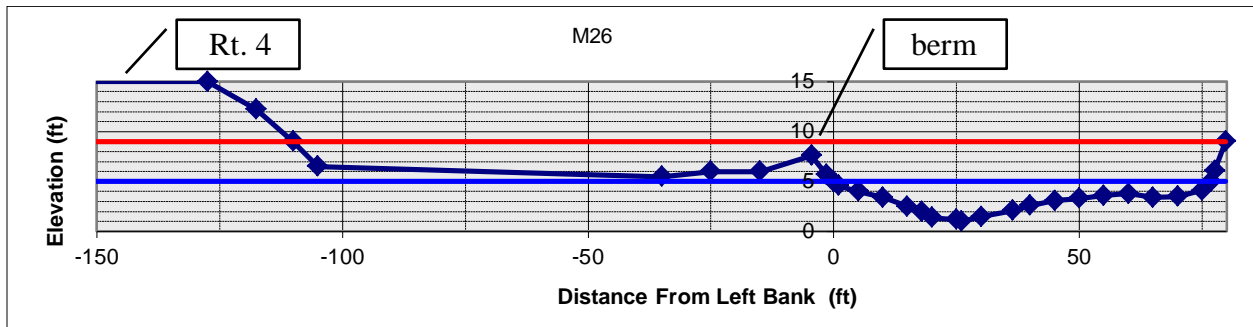
Figure 5.33. M26-A cross section shows the berm on the left bank. A human elevated incision ratio was calculated.

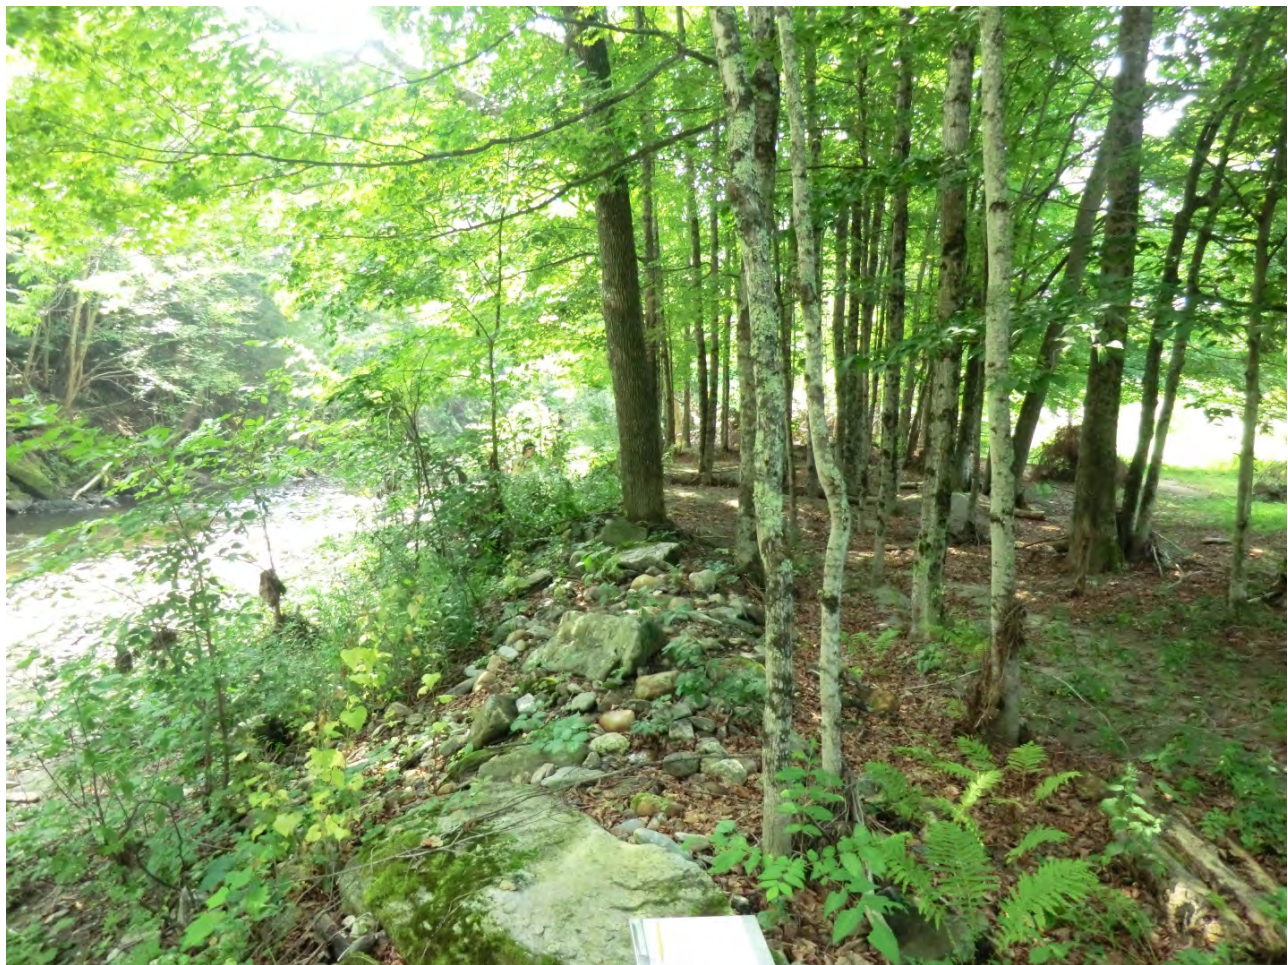
Figure 5.34. Berm along northern bank in M26-A.

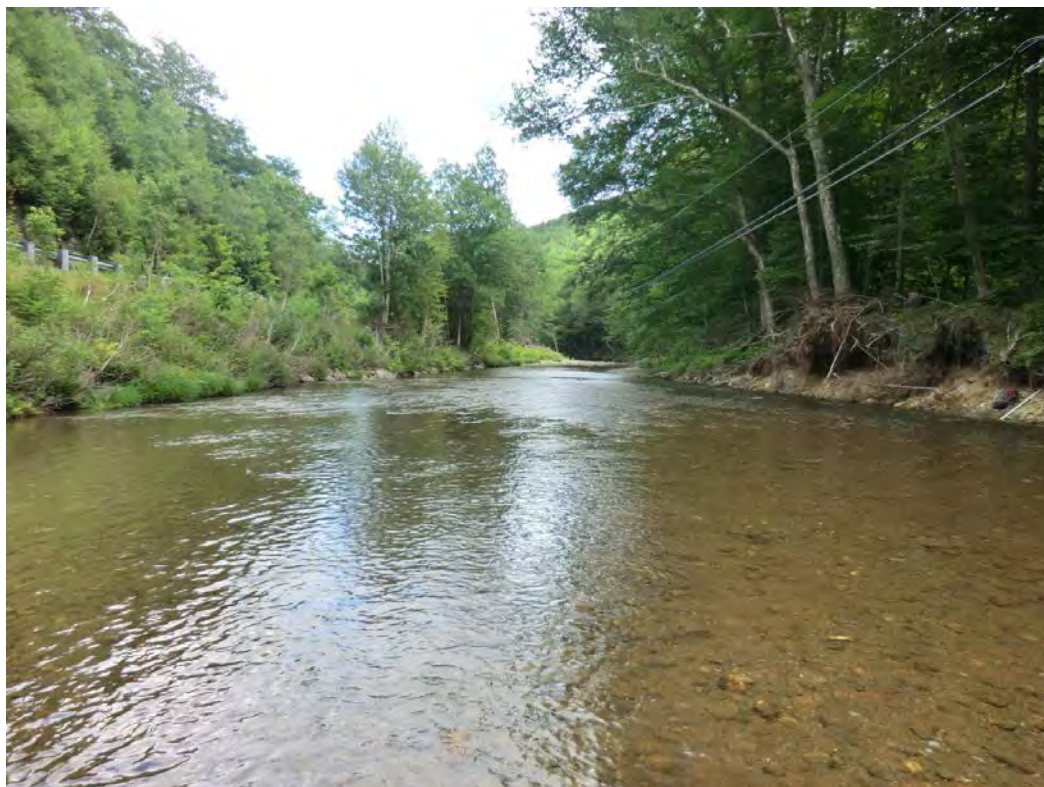
Figure 5.35. Route 4 adjacent to the north and highly eroded southern bank. Plane bed habitat type.

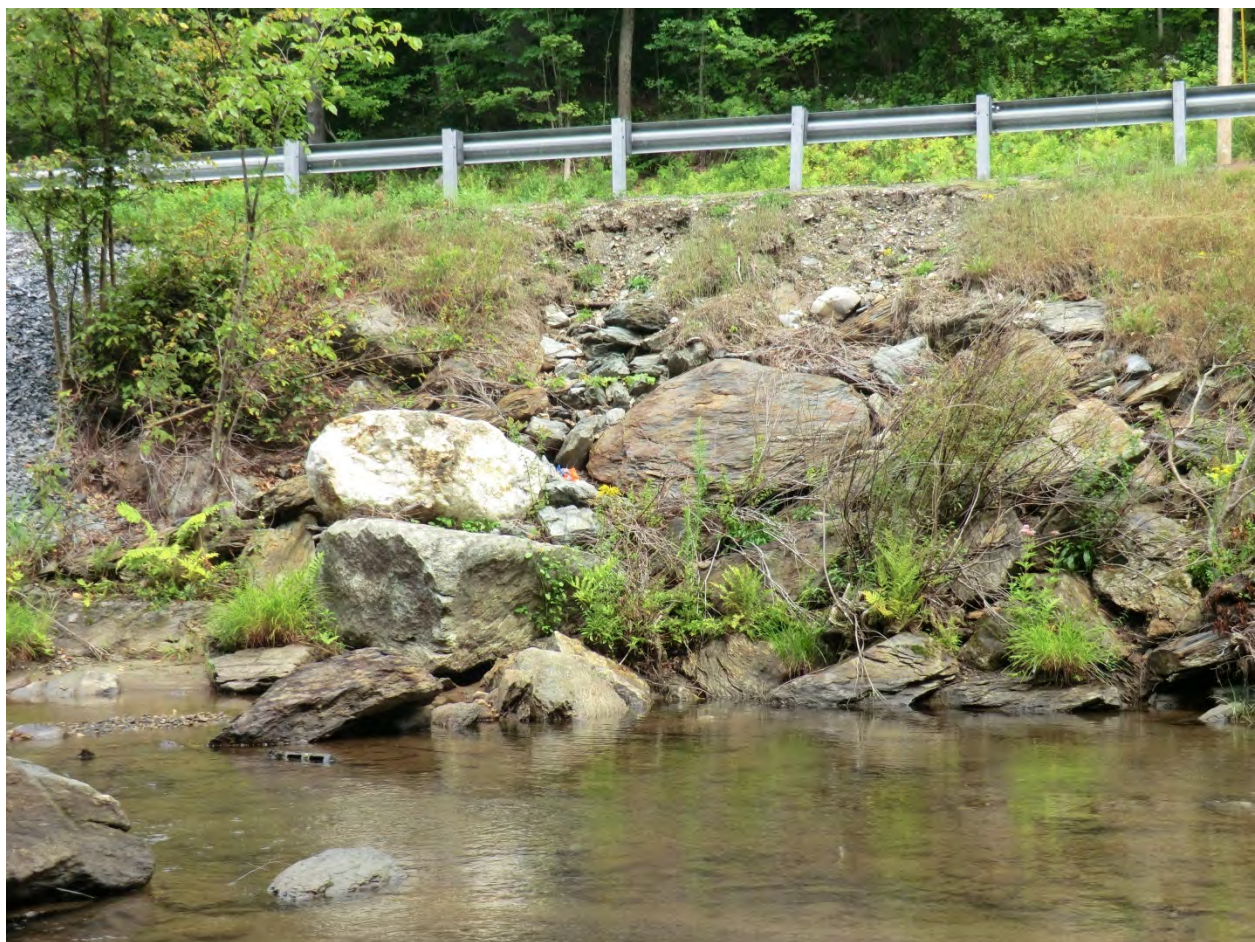
Figure 5.36. Storm water runoff from Route 4 on the northern bank.

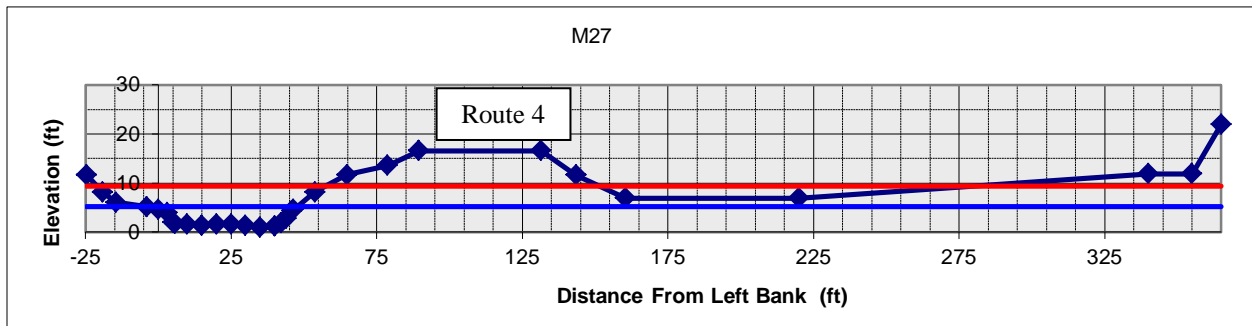
Figure 5.37. Cross section from M27-C shows how Route 4 significantly limits floodplain access.

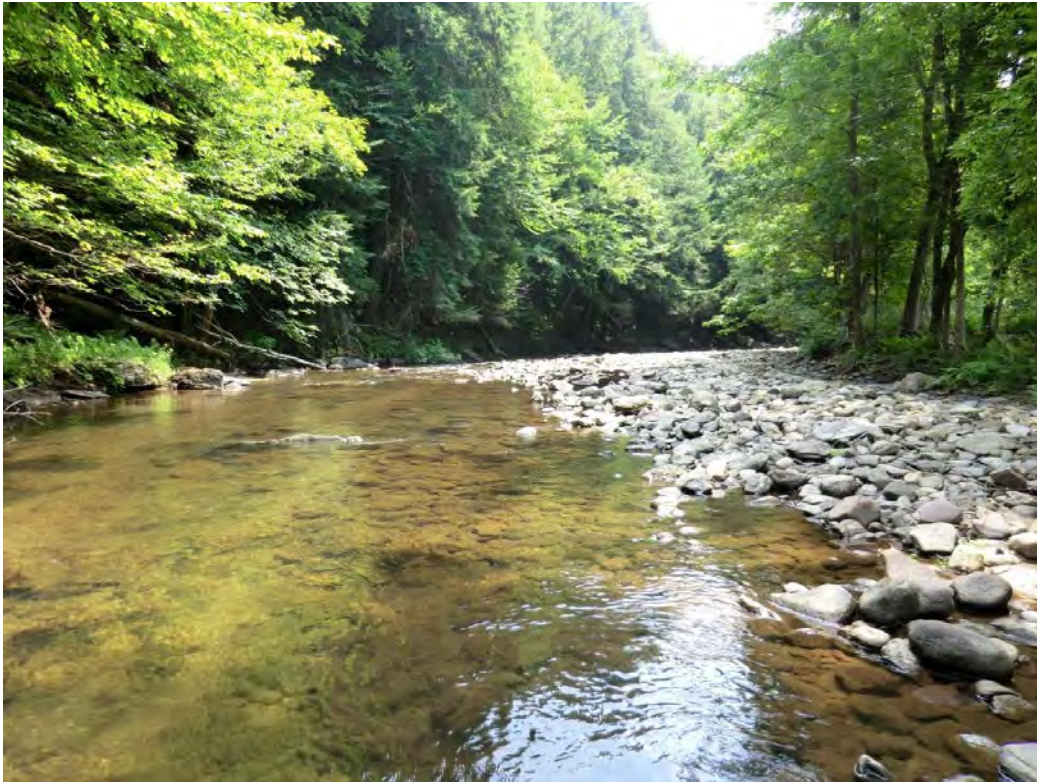
Figure 5.40. Aggradation in M27-D.

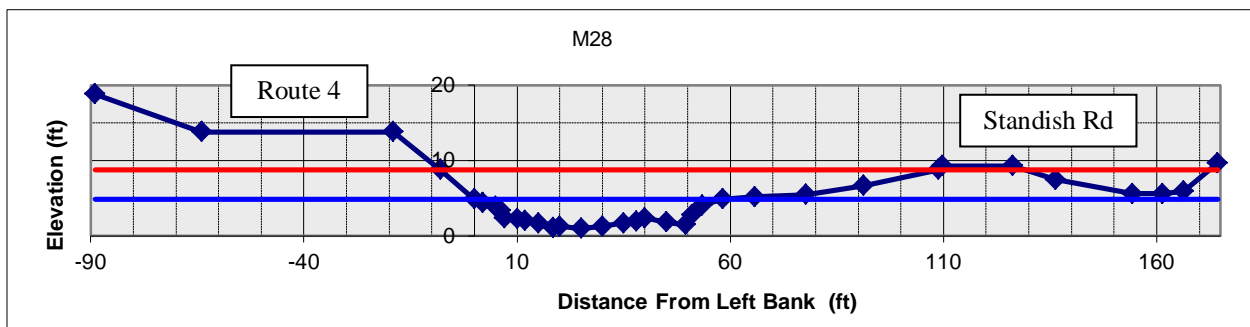
Figure 5.42. Cross section in M28-A shows Route 4 to the left of the channel and old Standish Road to the right. Floodplain access is limited.

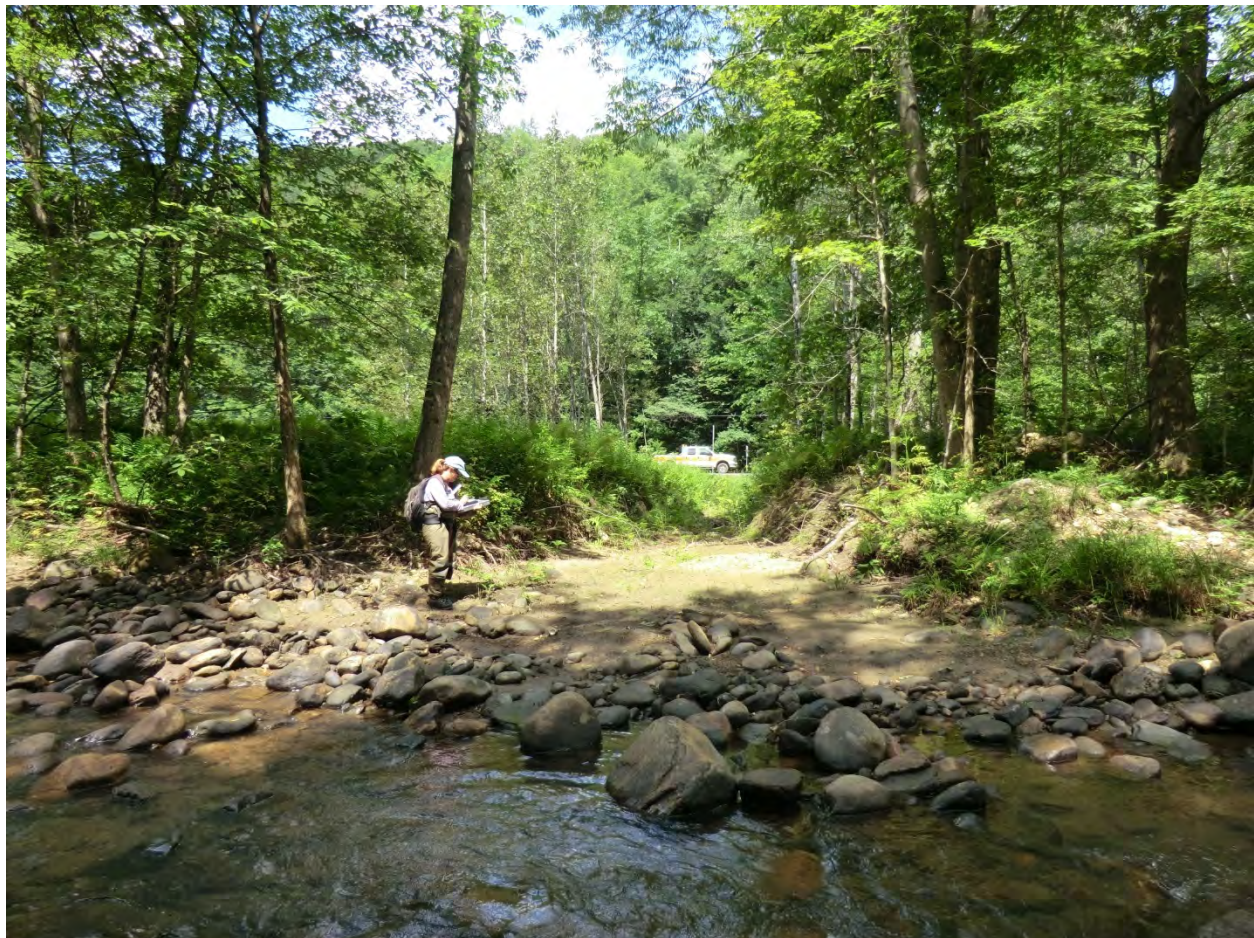
Figure 5.45. Road ditch from Route 4.

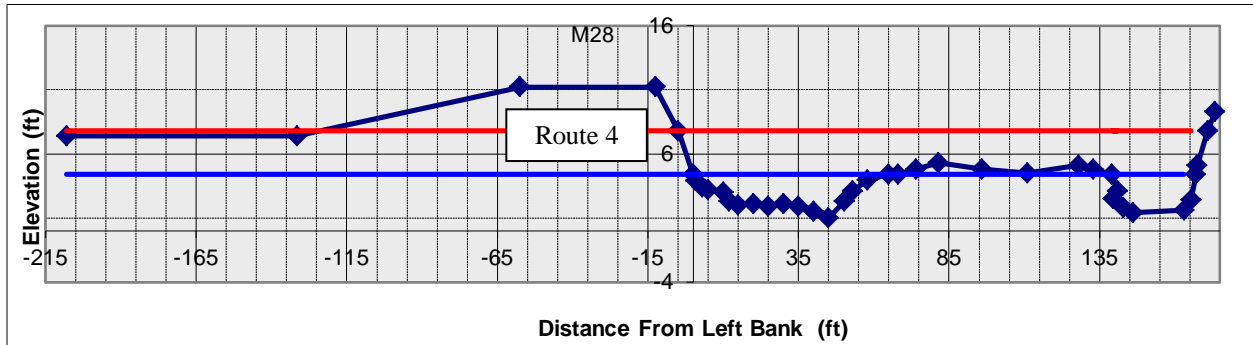
Figure 5.46. Cross section in M28-C shows that Route 4 is cutting off floodplain access. A human elevated incision ratio was calculated.

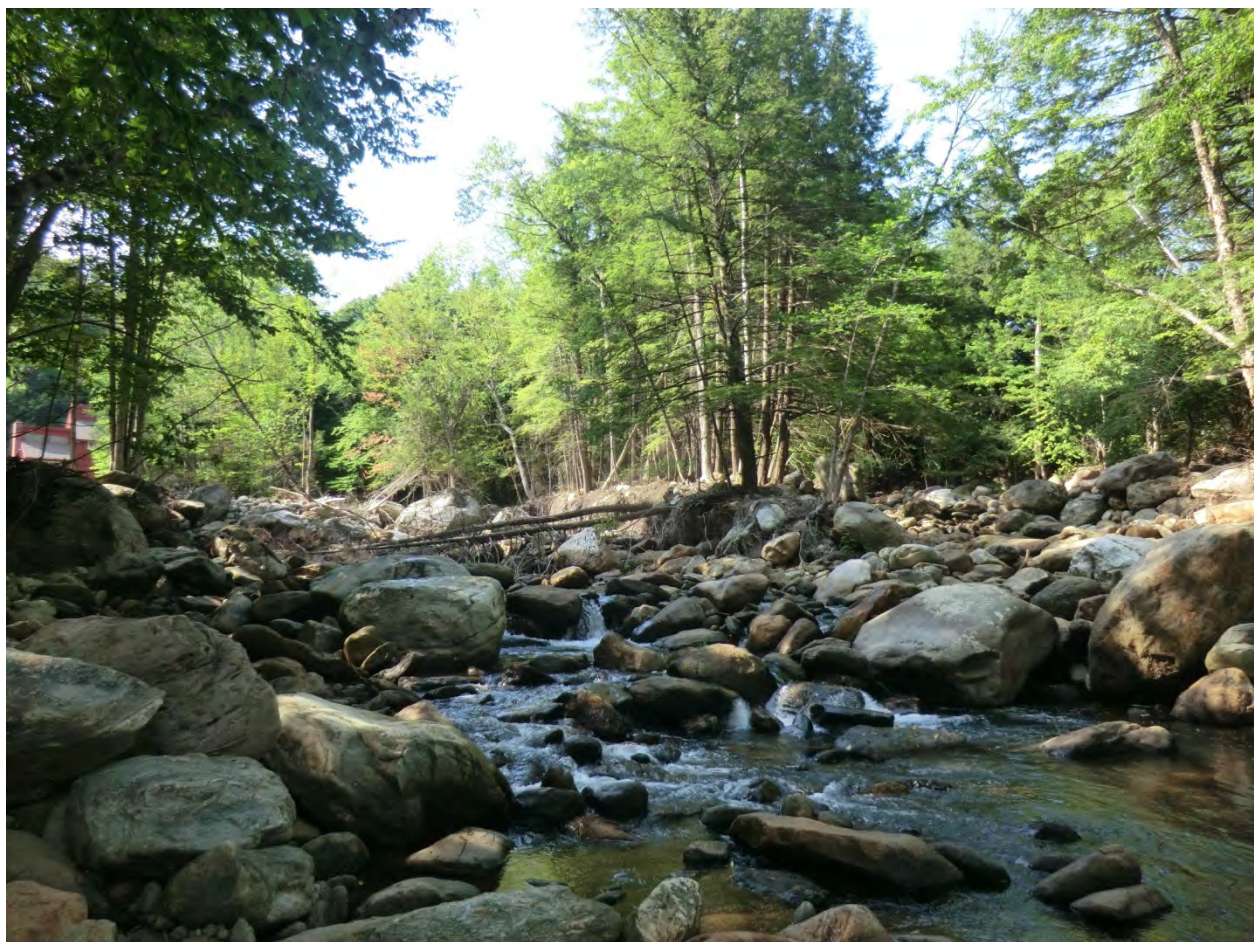
Figure 5.49. Channel avulsion is seen looking upstream in M30-A.

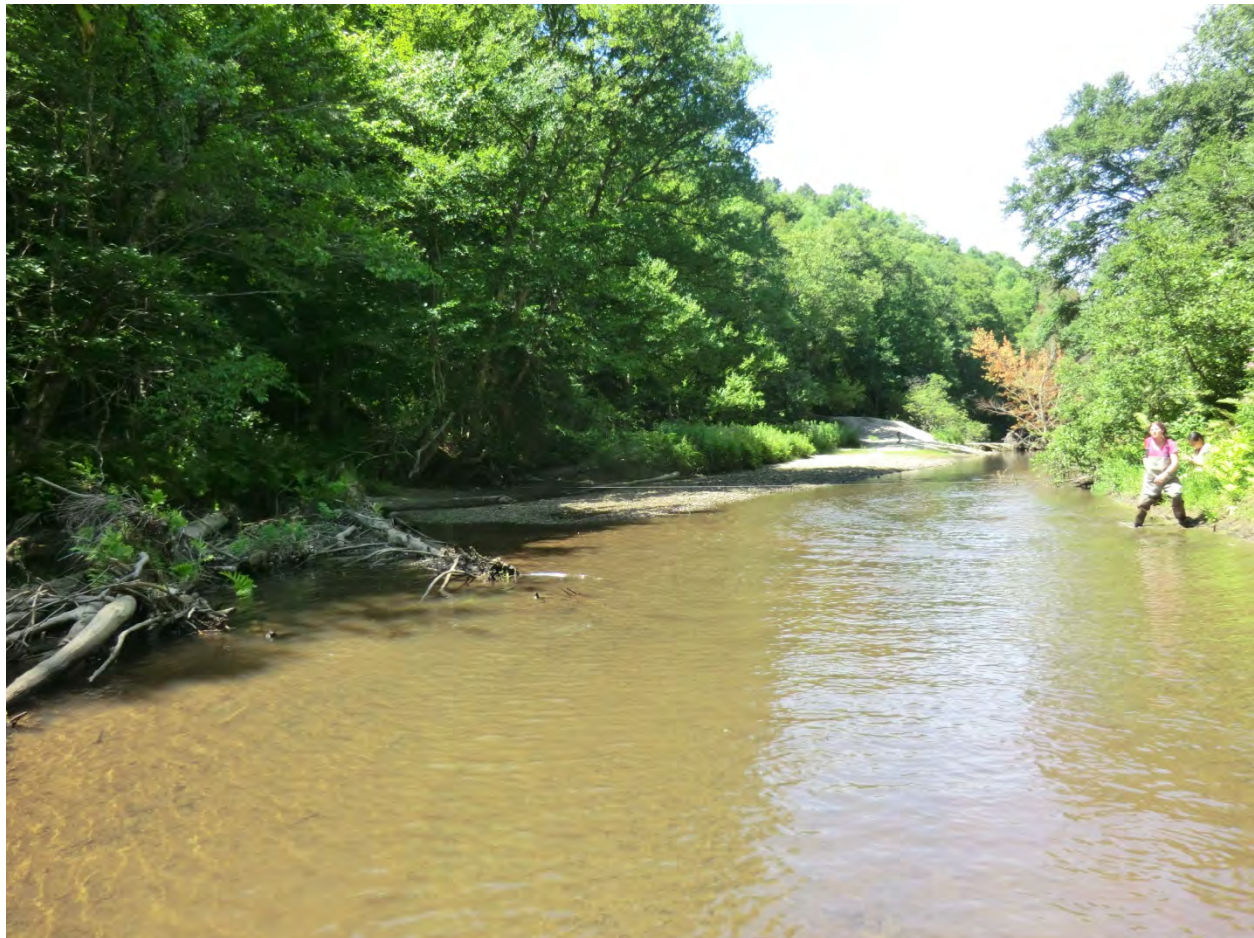
Figure 5.50. M30-C exhibits plane bed features as well as aggradation. Banks and buffers are well-vegetated.

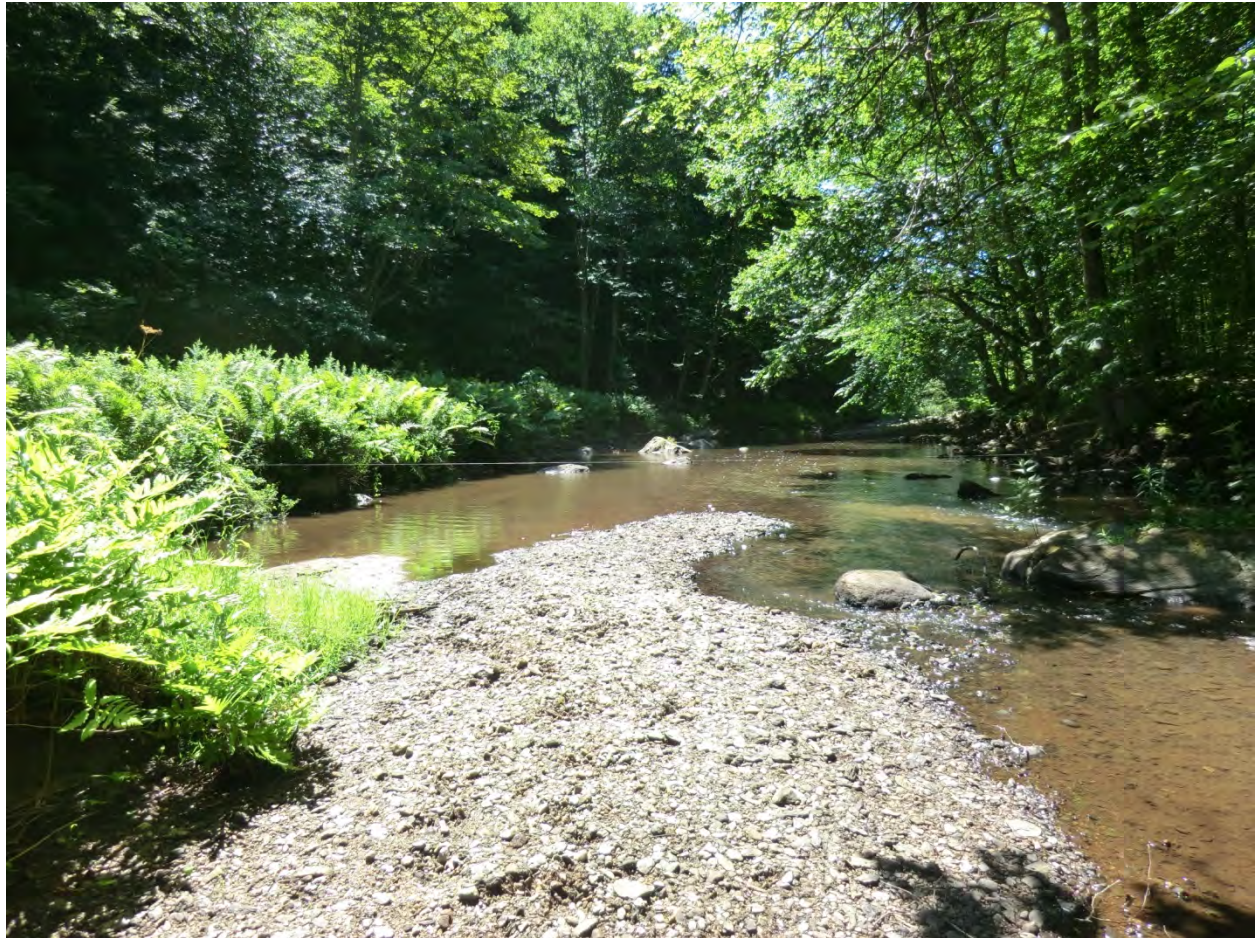
Figure 5.51. Typical channel in M30-D.

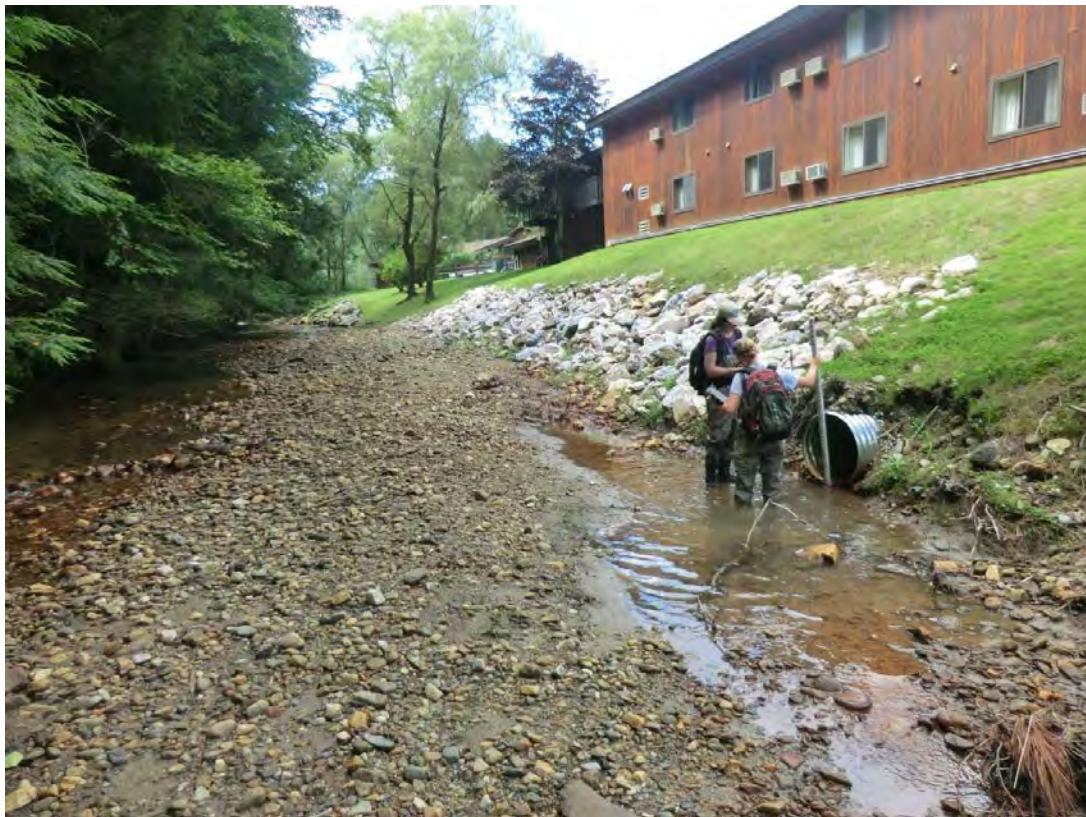
Figure 5.53. Stormwater input in M28T5.01-A. Major aggradation, poor buffer, and riprap are seen here.

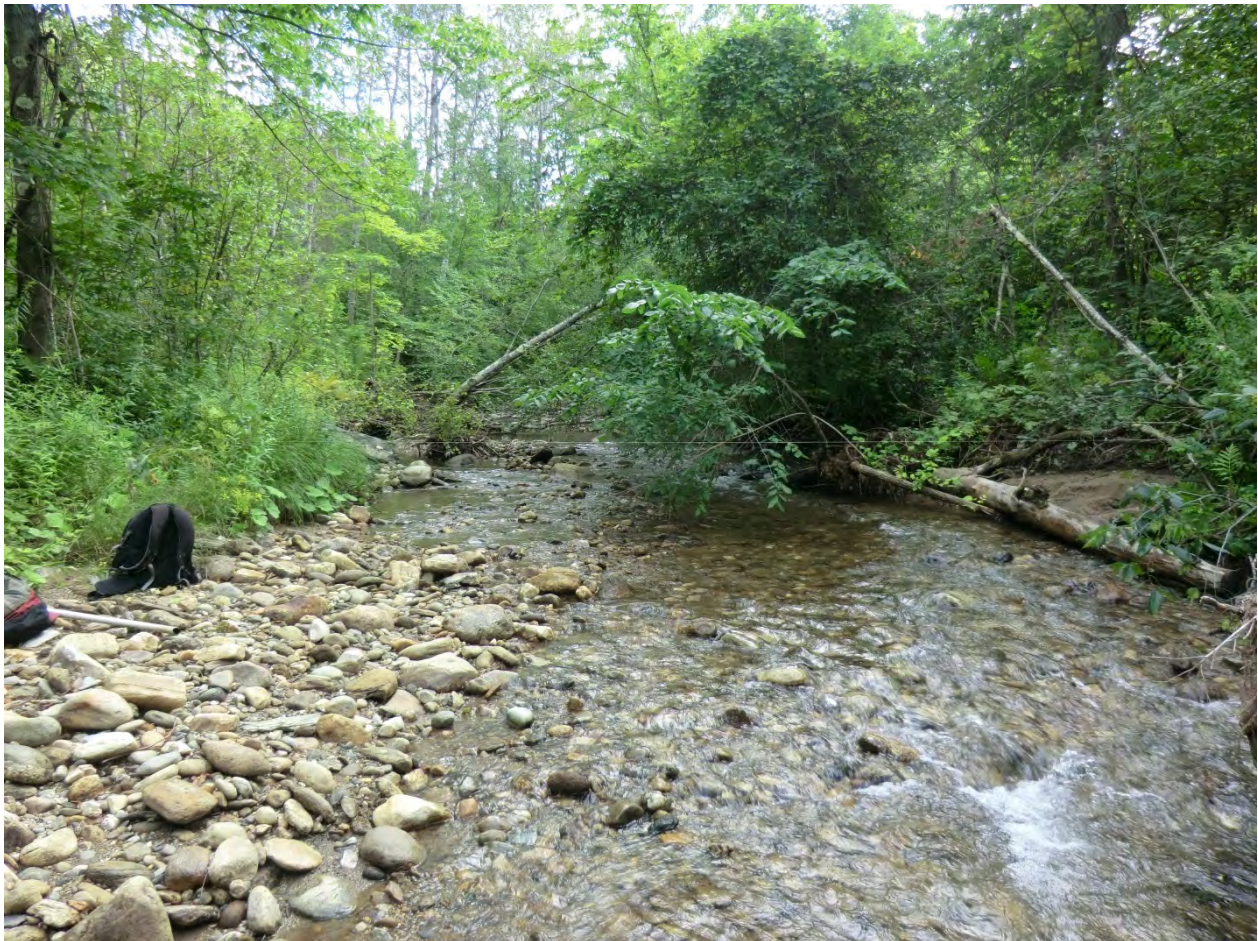
Figure 5.54. A typical channel in M28T5.01-B upstream of the beaver dam. Excellent vegetated banks and buffers.

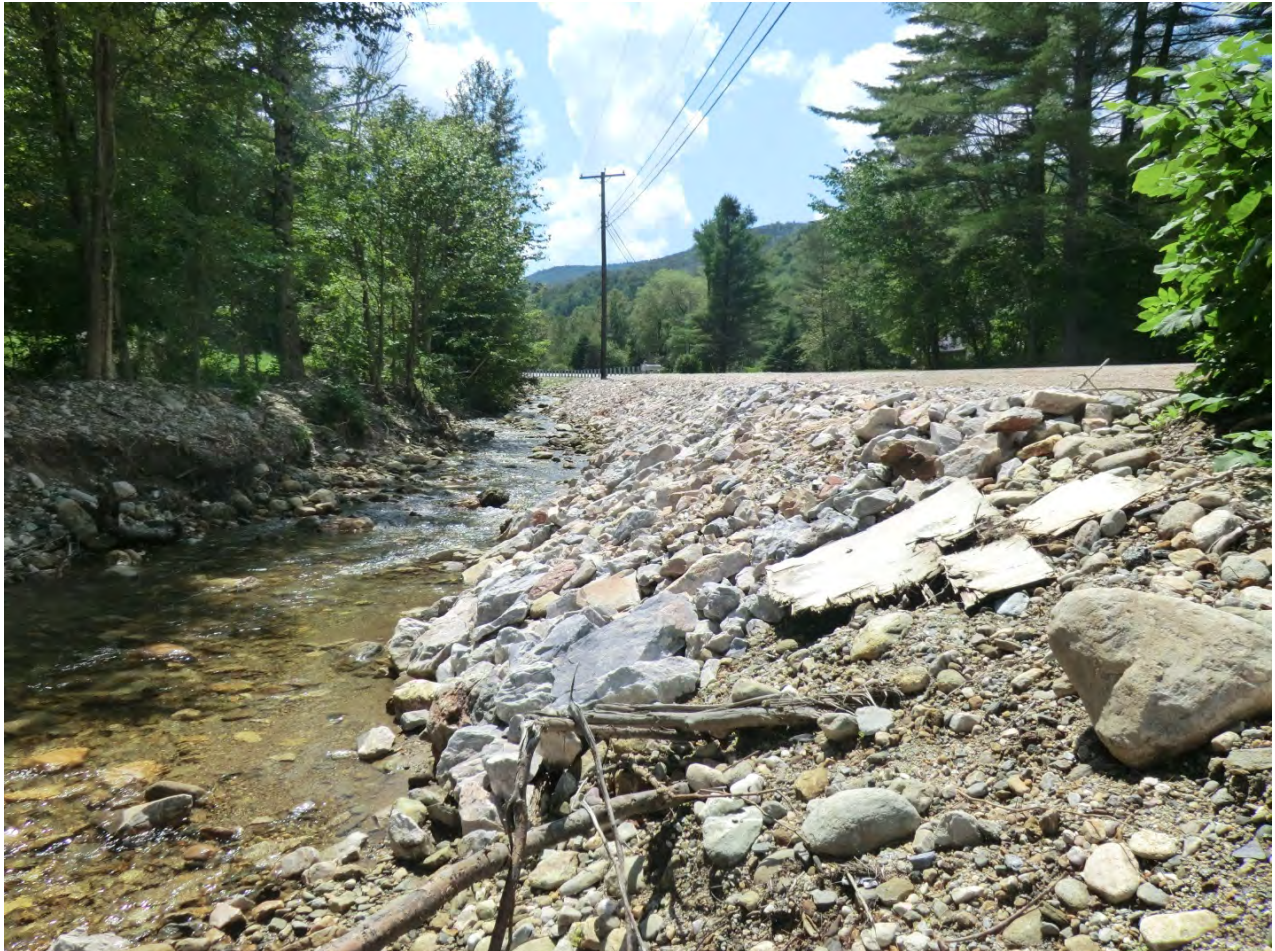
Figure 5.55. Channel straightening along Route 100 in M28T5.01-C.
