Town of Springfield, Vermont

Phase 2 Stream Geomorphic Assessment

Unnamed Tributary to Black River Along Valley Street

September 22, 2017

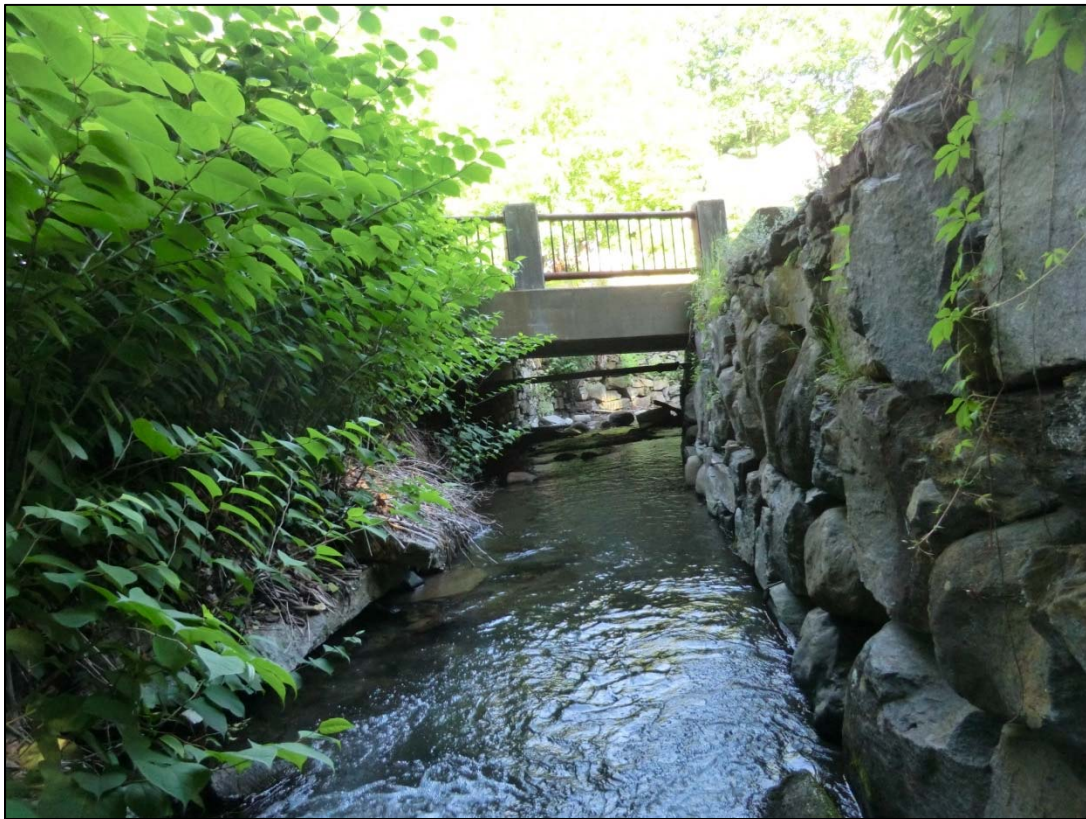
M07S1.01 has been historically channelized and flows in close proximity to businesses and residences. There are two private bridges and two public crossings (Main Street and Valley Street) within this lowest reach. Due to channel encroachments and armoring the stream has been straightened and contained for much of the reach on both sides (Figure 5.1). There are a couple of major stormwater gullies that are on the west valley wall. Although Valley Street results in a reduction in the valley width, the reference and existing valley confinement is very broad.

Figure 5.1. The Stream channel has been extensively straightened in M07S1.01.

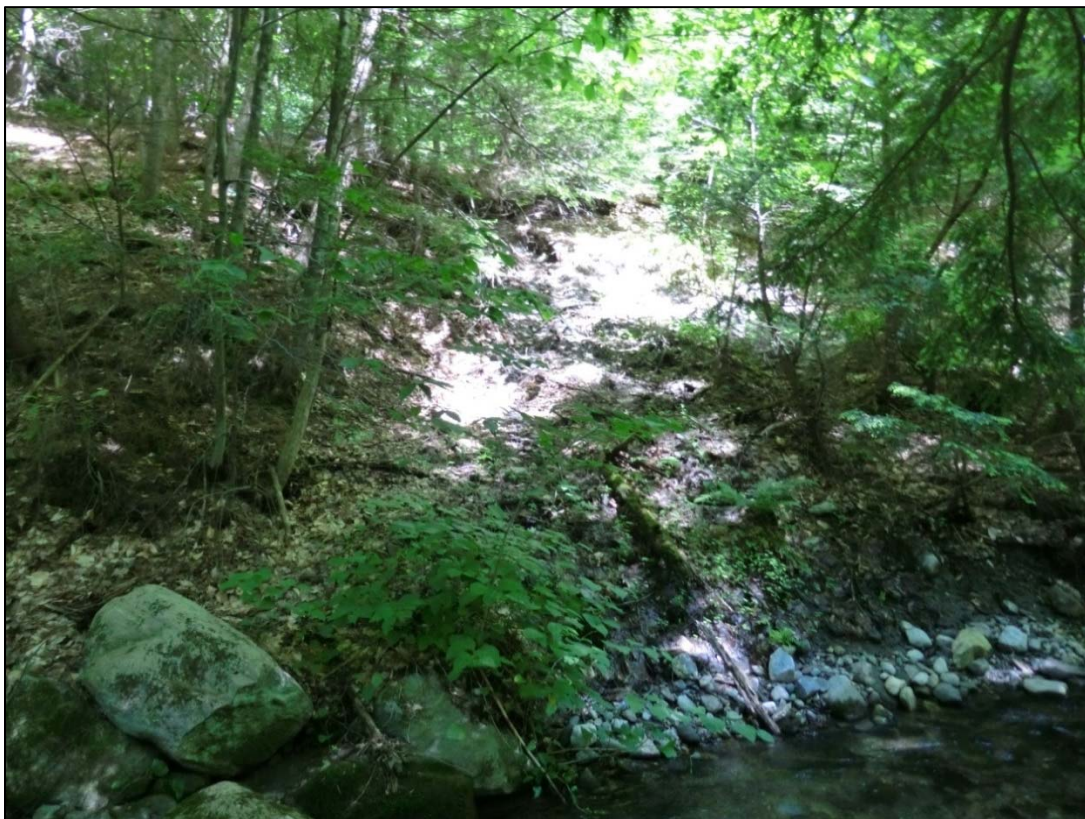
Glacial till was noted to be the material at the bottom of some of the eroded banks and along several of the mass failures that were mapped, indicating channel widening is taking place. There is a channel spanning bedrock grade control in approximately the middle of the reach that is acting to prevent further incision.

Figure 5.2. Mass failure with ground water seep and glacial till on lower bank in M07S1.02-A.

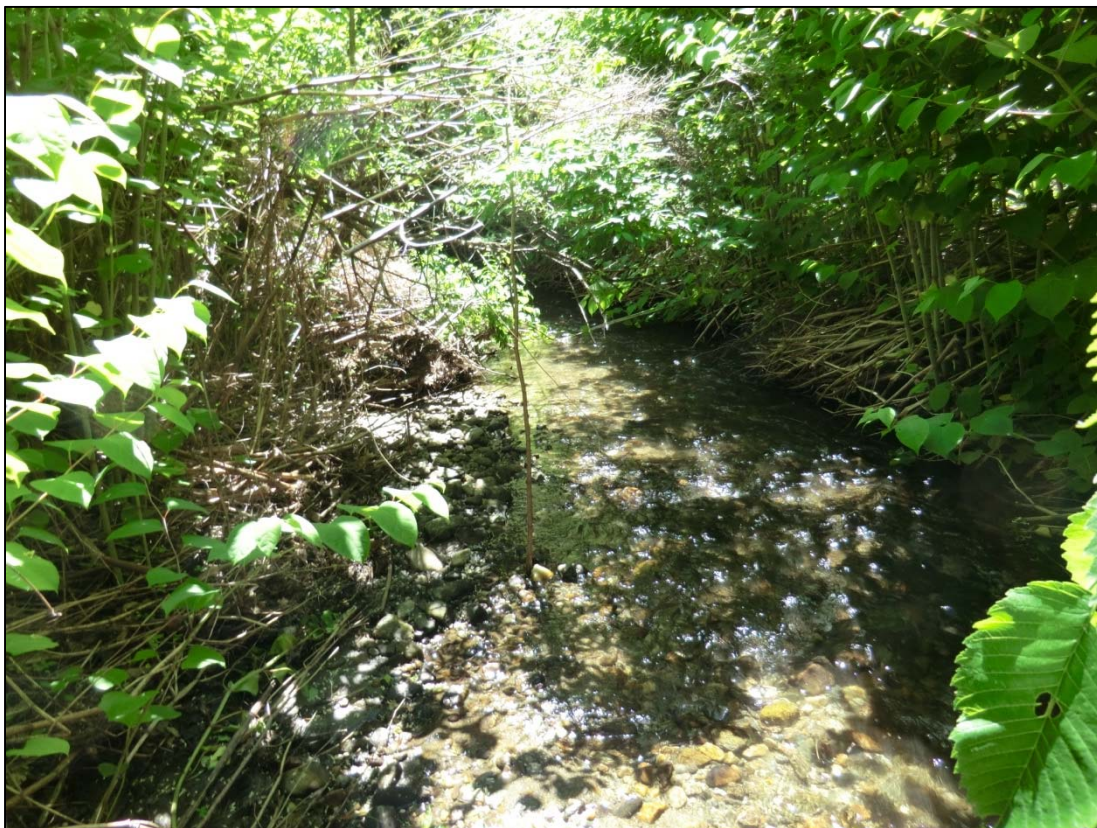
Figure 5.3. Lower banks with gravel bed material and a more sinuous channel characterize M07S1.02-B.

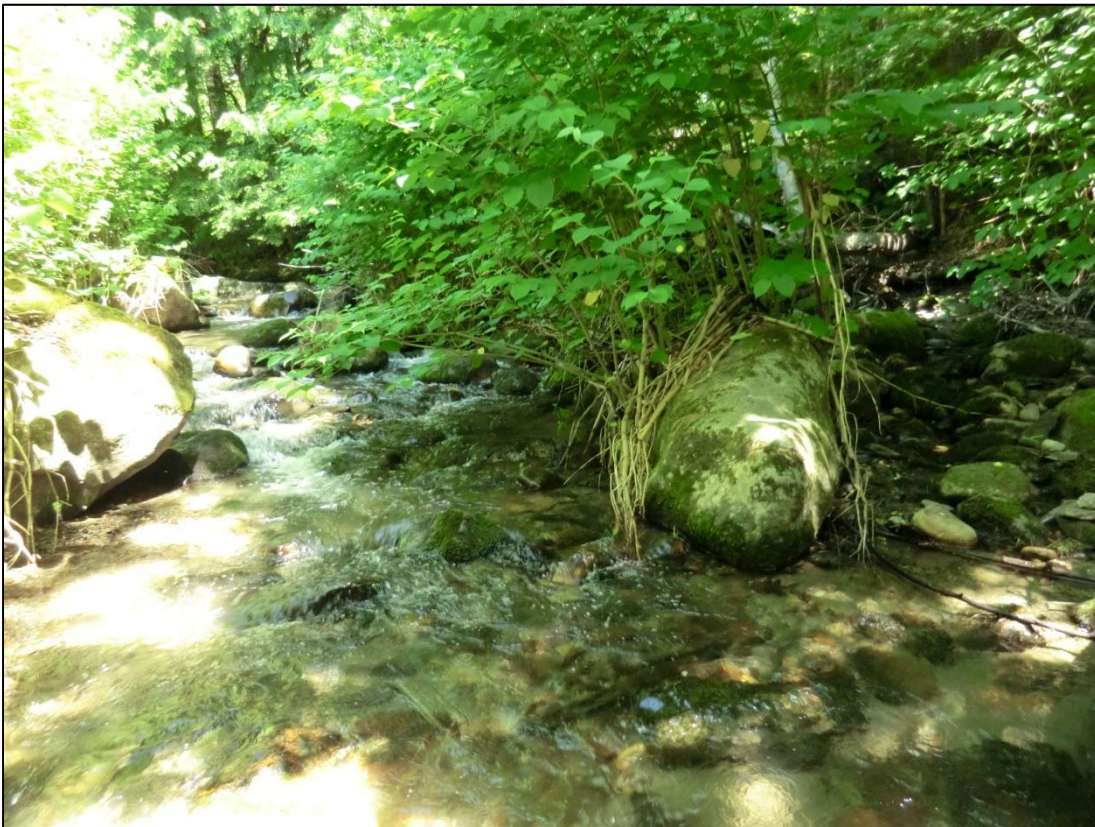
Figure 5.4. Channel upstream of Valley Street arch crossing in segment M07S1.02-C.

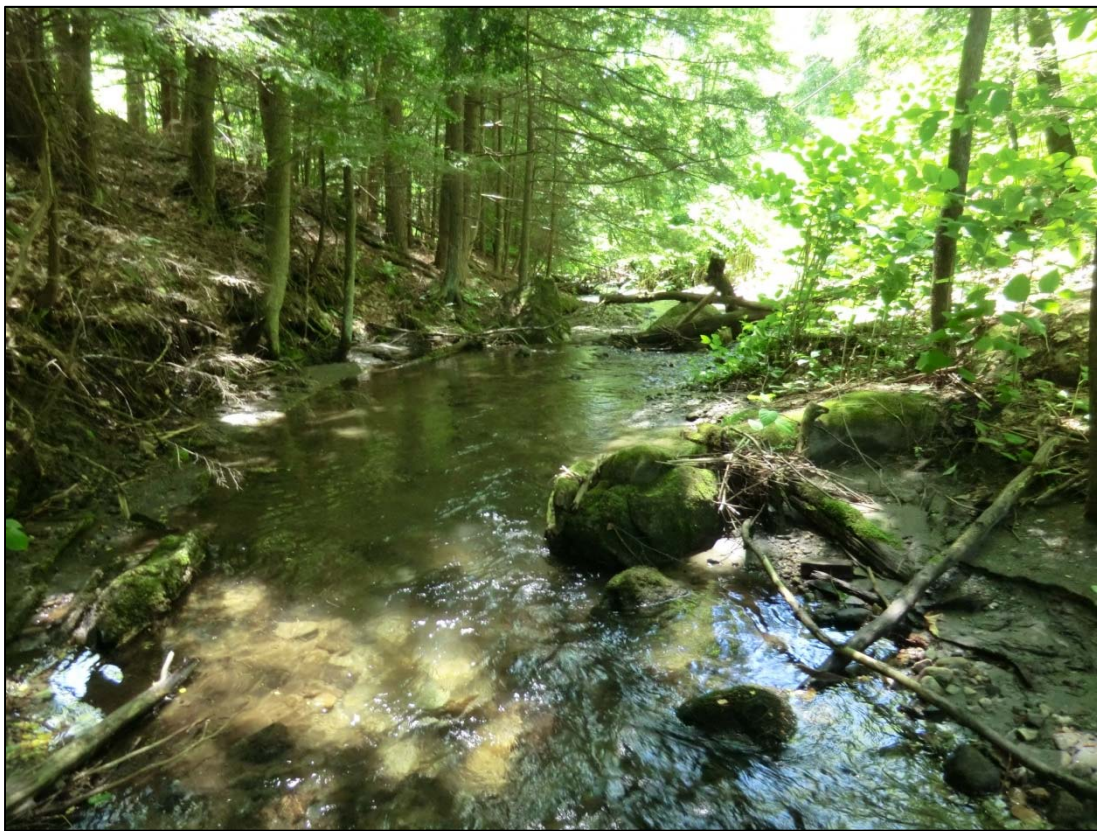
The lower segment of reach M07S1.03 is 320 feet long. Similar to segment M07S1.02-C, M07S1.03-A is entrenched (Figure 5.5) and is trapped between the valley wall and Brook Road. The reference valley width is broad. The close proximity of Brook Road to the western side of the channel converts the valley type to narrow. Segment M07S1.03-A ends at the upstream end of the Brook Road Bridge. The land use immediately adjacent to both sides of the channel is wooded.

Figure 5.5. The Stream channel has been extensively straightened in M07S1.03.

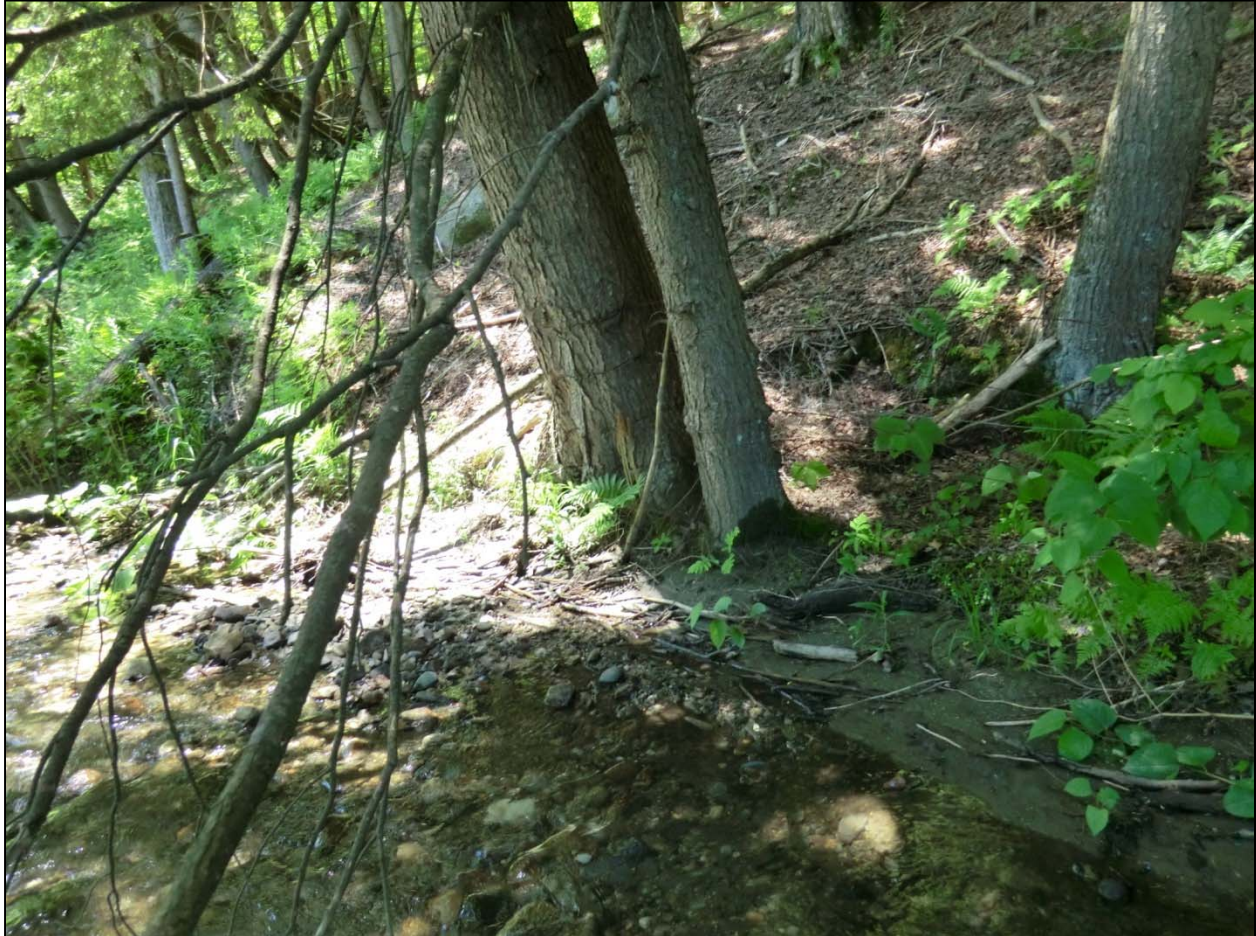
The channel length of the upper segment of reach M07S1.03 is approximately 710 feet. The upper part of the segment has a low width to depth ratio, but then transitions to a wider channel with good floodplain access. This lower section of stream appears to be going through an aggradation process (buildup of sediment), as shown in Figure 5.6.

Figure 5.6. The channel has filled in with material at the lower end of M07S1.03-A.

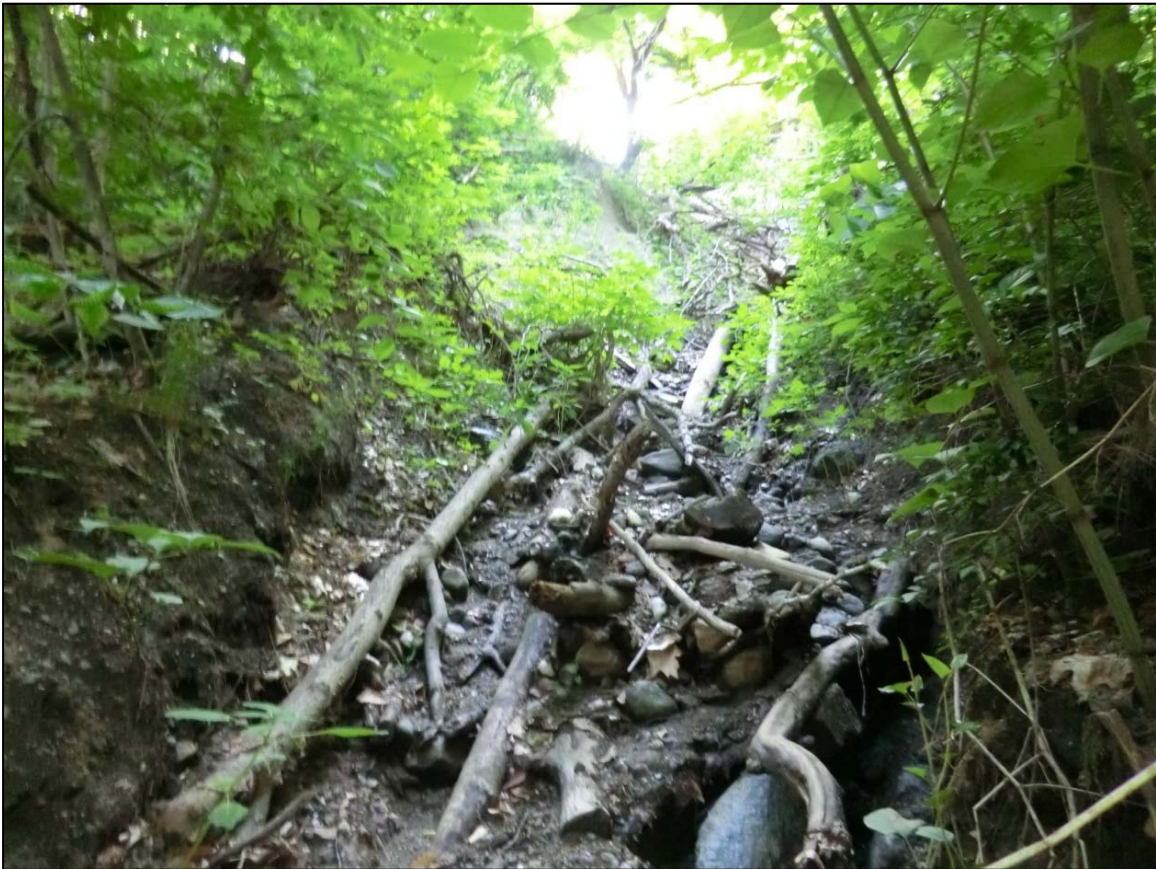
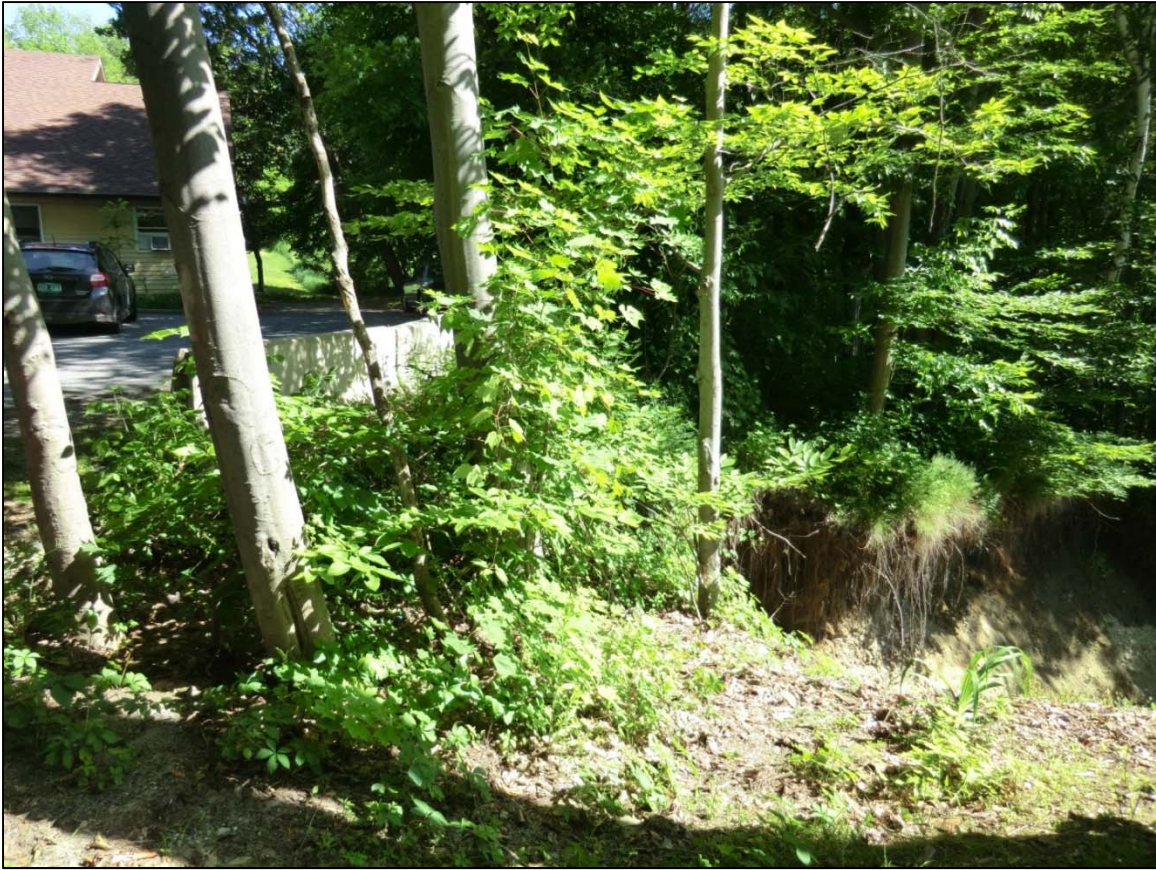
The most downstream gully that has been identified for remediation is located to the west of Valley Street between the junction of Pleasant Street to the south and Common Street to the north. The gully is located to the east of Lincoln Street, and across the brook and to the west of 83 Valley Street. The source of the gully erosion has been attributed to stormwater runoff coming from the Lincoln Street neighborhood (personal communication with Tom Yennerell, Town Manager for Springfield, VT). The gully dimensions are estimated to be approximately 10 feet deep and 150 feet long (Figure 6.1). This gully has led to destabilization of the valley wall, which has put the property of 10 Lincoln Street at risk (Figure 6.1). According to Tom Yennerell, a catch basin was installed near the base of Lincoln Street to collect stormwater and prevent it from running down the valley wall. In 2012, a slope stabilization project using erosion control matting was undertaken by the Vermont Youth Conservation Corps (VYCC). This slope stabilization project has not halted the erosion, and steps need to be taken to stabilize the slope. The erosion at the top of the valley wall is undermining the parking lot at 10 Valley Street (Figure 6.2). In addition to remediating the gully, consideration should be given to a property acquisition to purchase this at-risk property. General information about property acquisition through the Federal Emergency Management Agency (FEMA) is provided below.

Figure 6.1. Gully erosion on west valley wall east of Lincoln Street (Project #1).

Figure 6.2. Severe erosion on valley wall near 10 Lincoln Street (Project #1).

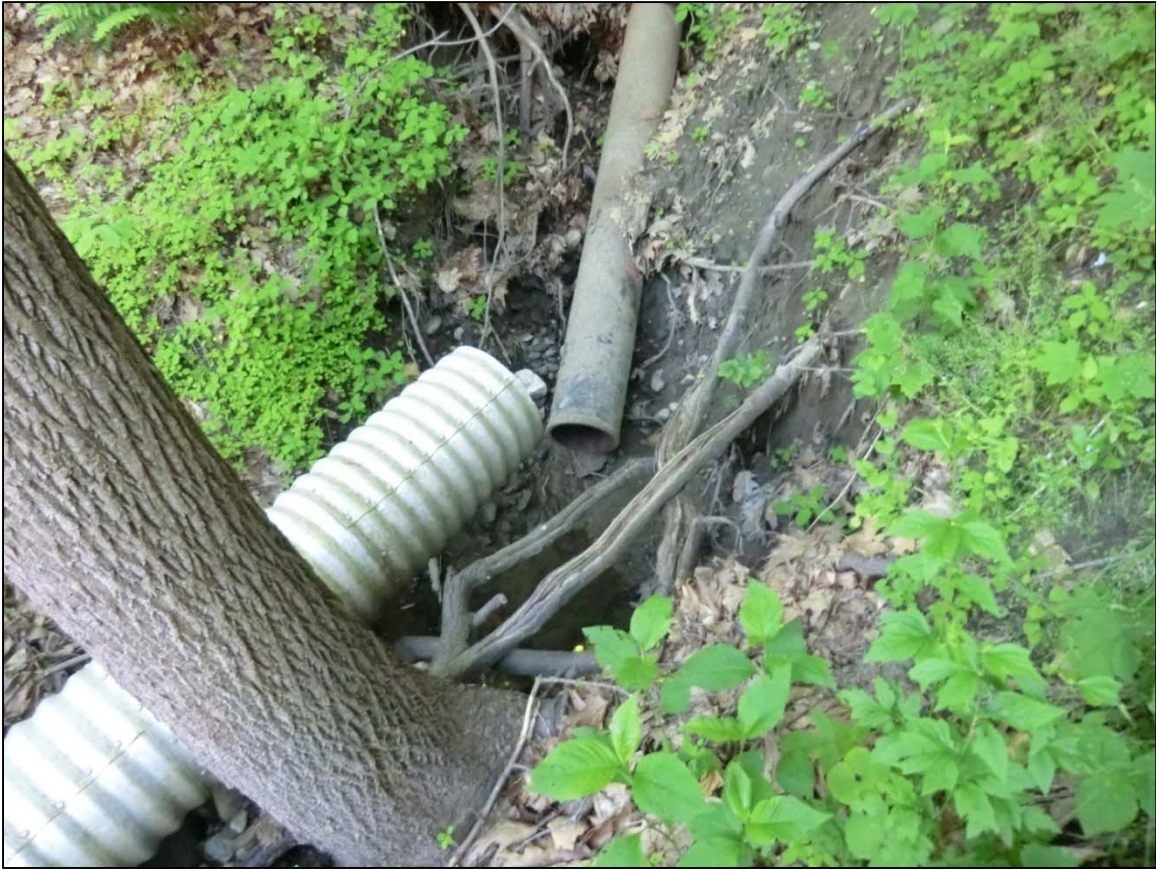
A second gully, located across the brook from 91 Valley Street and near the junction of Valley Street and Common Street, was identified during the stream walkover. The gully was estimated to be about 2 feet deep, 6 feet wide and about 44 feet in length, and appeared to be caused by a broken stormwater pipe (Figure 6.3). Field investigation is recommended to see what actions should be taken to reduce stormwater runoff in this area and/or repair the broken pipe.

Figure 6.3. Broken pipe contributing to gully erosion off of Valley Street (see project #2).

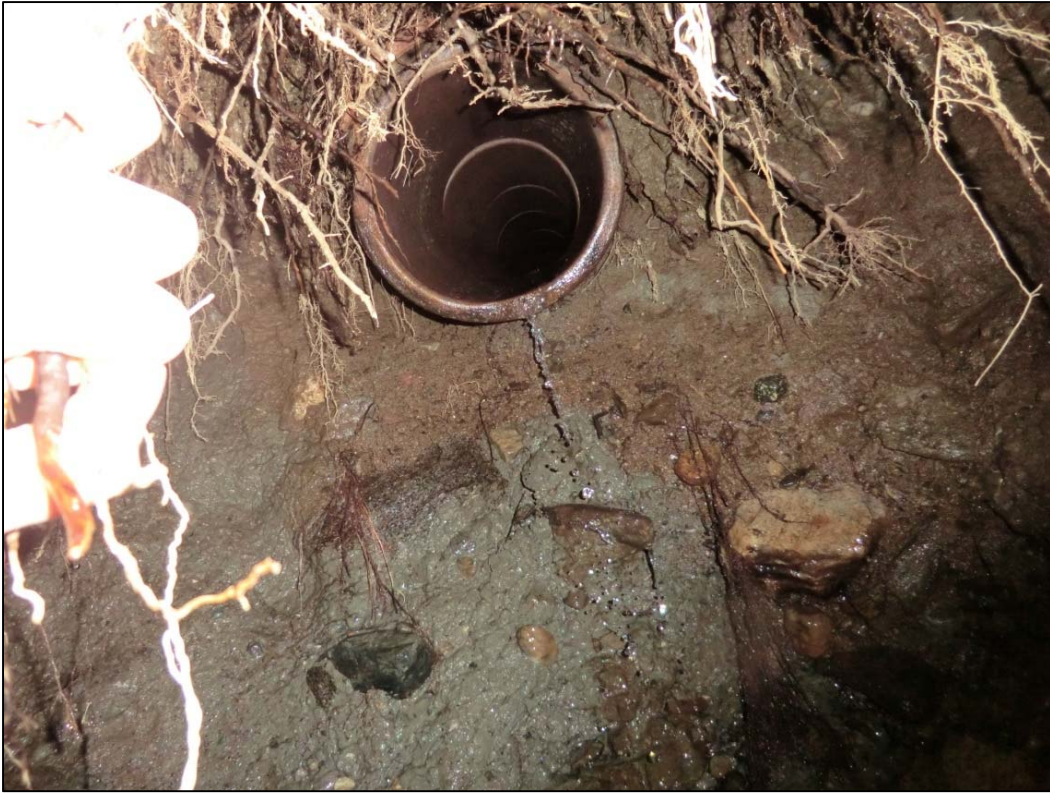
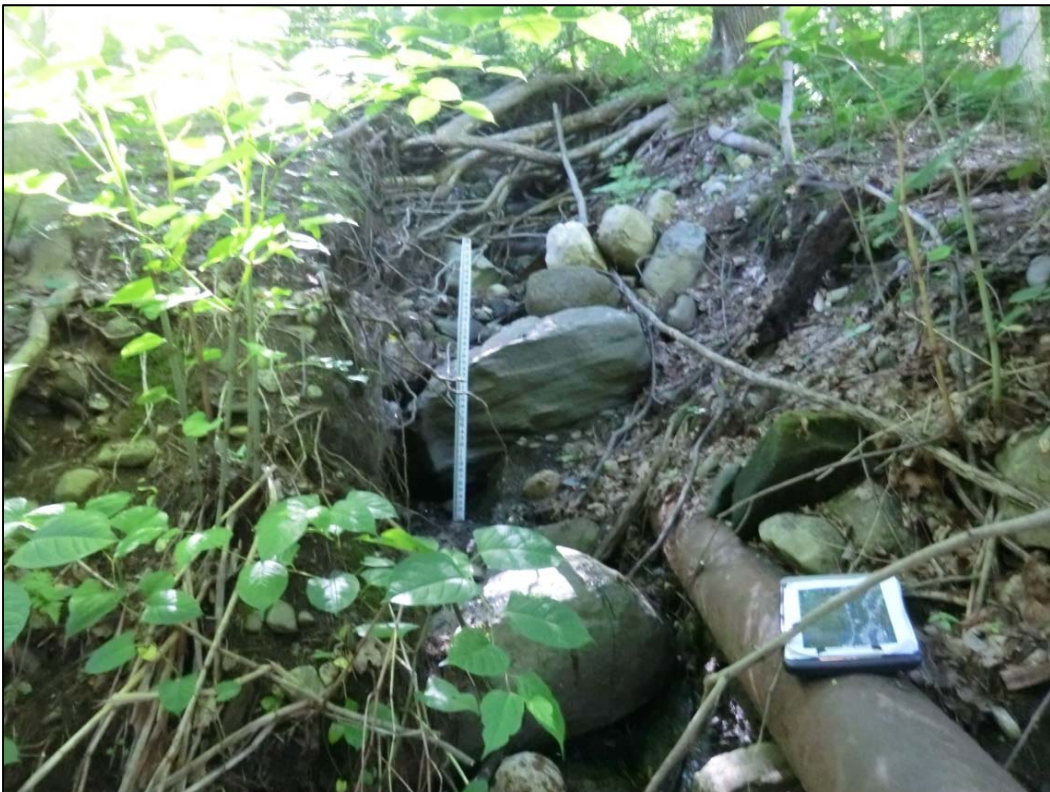
A third gully identified during the stream walkover is about 0.1 miles north of the junction of Valley Street and Common Street. It is located just upstream of a small tributary that enters from the east. This gully also appeared to be caused by a broken stormwater pipe (Figure 6.4). The dimensions of the gully are approximately 4 feet deep, 50 feet long and 12 feet wide (Figure 6.5). Similar to project #2, a field investigation to determine possible actions to reduce stormwater to this area and/or repair the broken pipe is recommended.

Figure 6.4 Broken stormwater pipe that is contributing to gully erosion (Project #3).

Figure 6.5. Gully erosion below broken off stormwater pipe (Project #3).

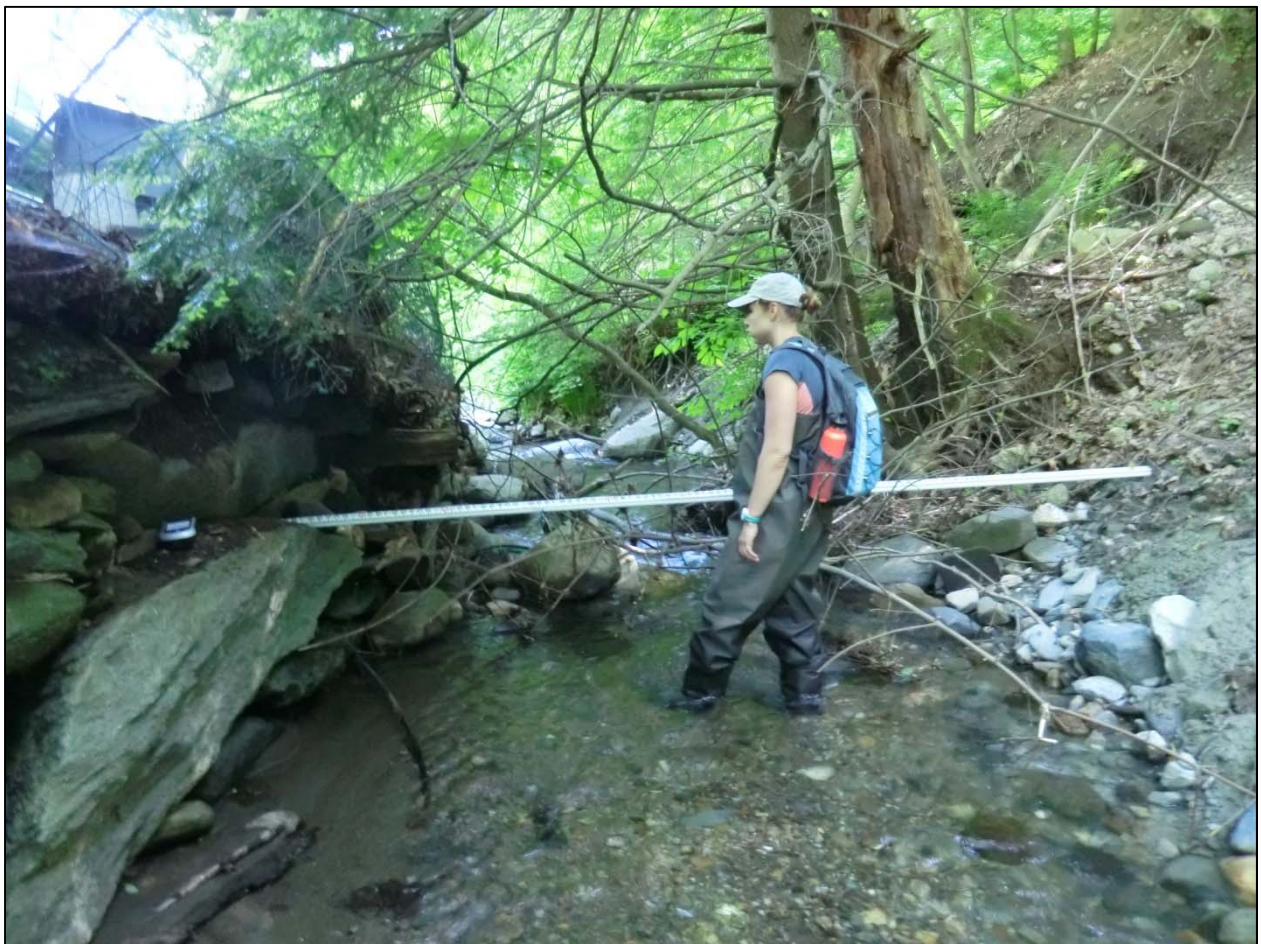
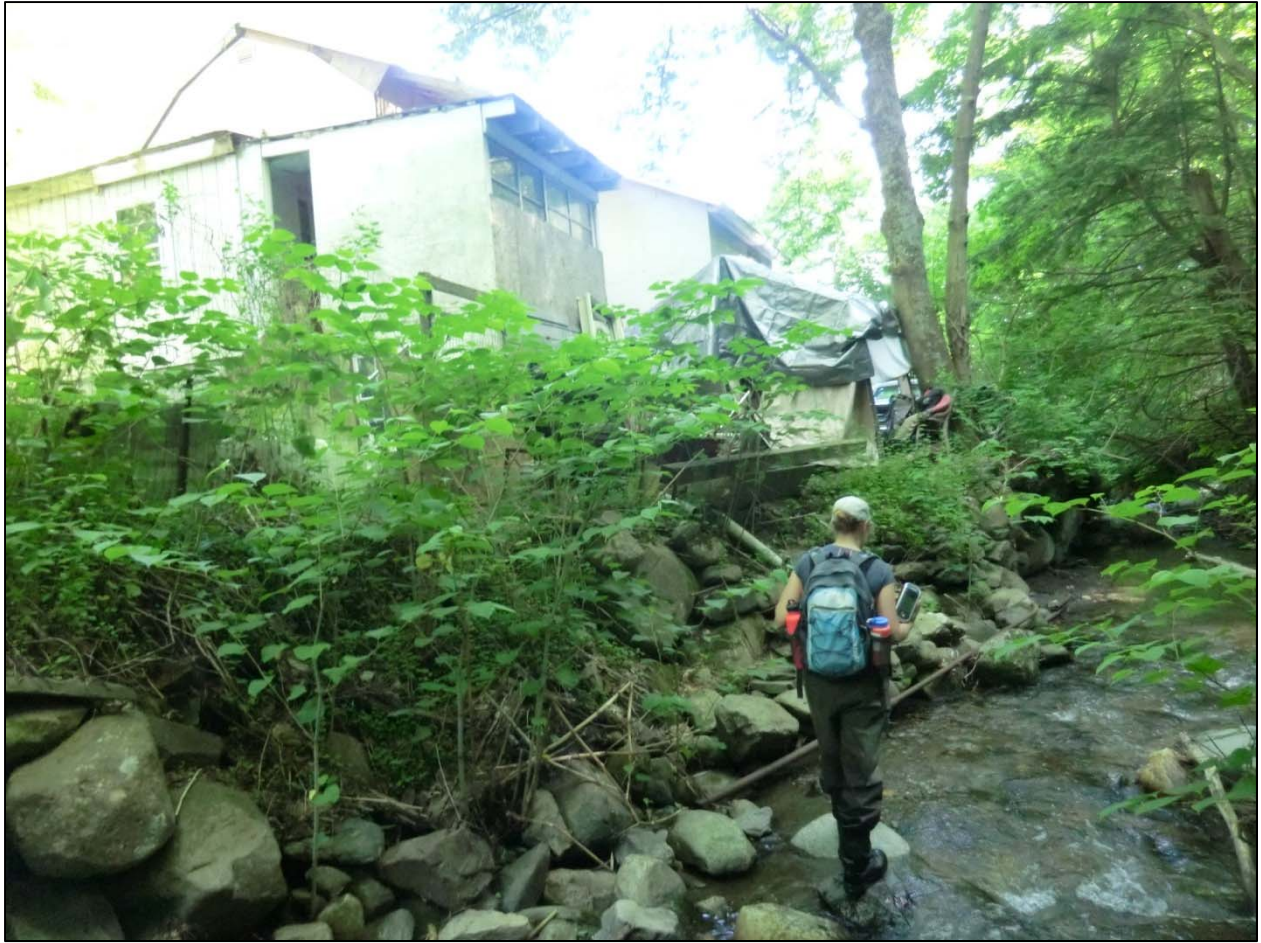
The goal of project #4 is to improve the safety of residents along the brook and to restore the stream channel dimensions. The encroachment from a stone retaining wall and home along the bank of the brook has narrowed the channel width to about 12.5 feet in this location (Figure 6.6). This lack of channel width and floodprone area is resulting in excessive shear stress along the valley wall and is contributing to destabilizing the west valley wall. The house is located directly on the banks of the brook (Figure 6.7), and property acquisition should be considered to improve safety. If a buy-out is pursued, a project could be designed to increase the channel width and possibly restore some needed floodplain.

Figure 6.6. The channel width has been narrowed to 12.5 feet (project #4).

Figure 6.7. House on the banks of the brook that is susceptible to flood damage (Project #4).

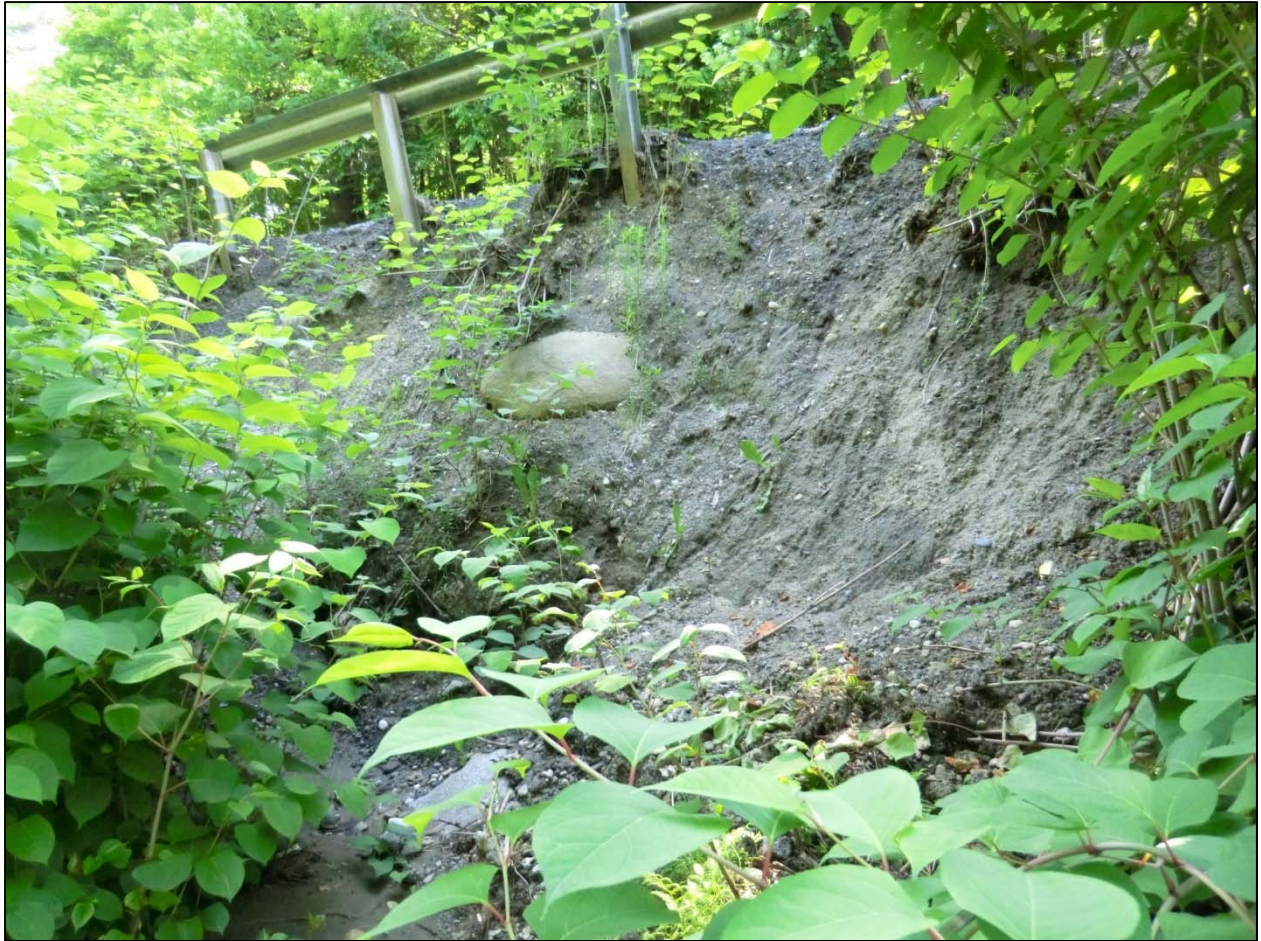
Figure 6.8. Potential washout location along Valley St. adjacent to study brook (Project #5).

As part of project number 5, a road stabilization project adjacent to Valley Street should be investigated (just upstream of the culvert crossing on Valley Street directly west from the intersection of Mark Street and Litchfield Street). As shown in Figure 6.8, the bank below the guard rail is not stable. A stacked toe wall design should be considered here to prevent encroachment out into the river. It is recommended that a Stream Alteration Engineer from the State of Vermont be consulted for the best course of action in this location.

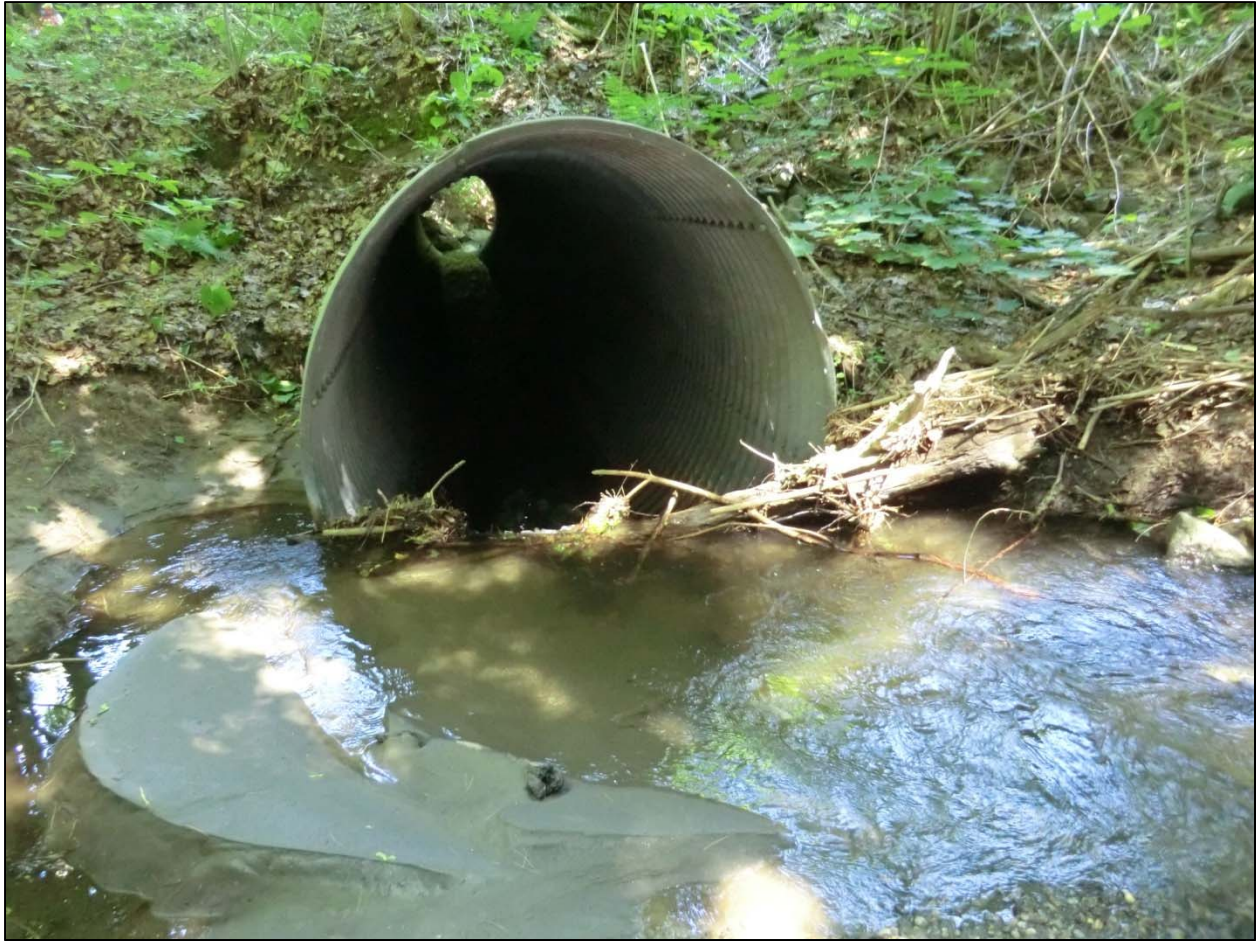
The stream crossing on Valley Street that is located approximately a quarter of a mile south of the junction of Valley Street and Litchfield Street is undersized. This steel corrugated culvert is only 45 percent of the bankfull channel width. Wood debris and sediment were noted to be obstructing the opening of the structure as shown in Figure 6.9. The height and width of the structure was measured to be 9 feet during an October 2015 stream crossing assessment, while the channel width is approximately 20 feet. A structure replacement that has dimensions that are closer to the bankfull channel width is recommended. In addition, a structure that mimics the natural system is recommended to improve water and sediment transport, flood resiliency, and habitat.

Figure 6.9. Undersized culvert on Valley St. is obstructed with sediment and debris (Project #6).

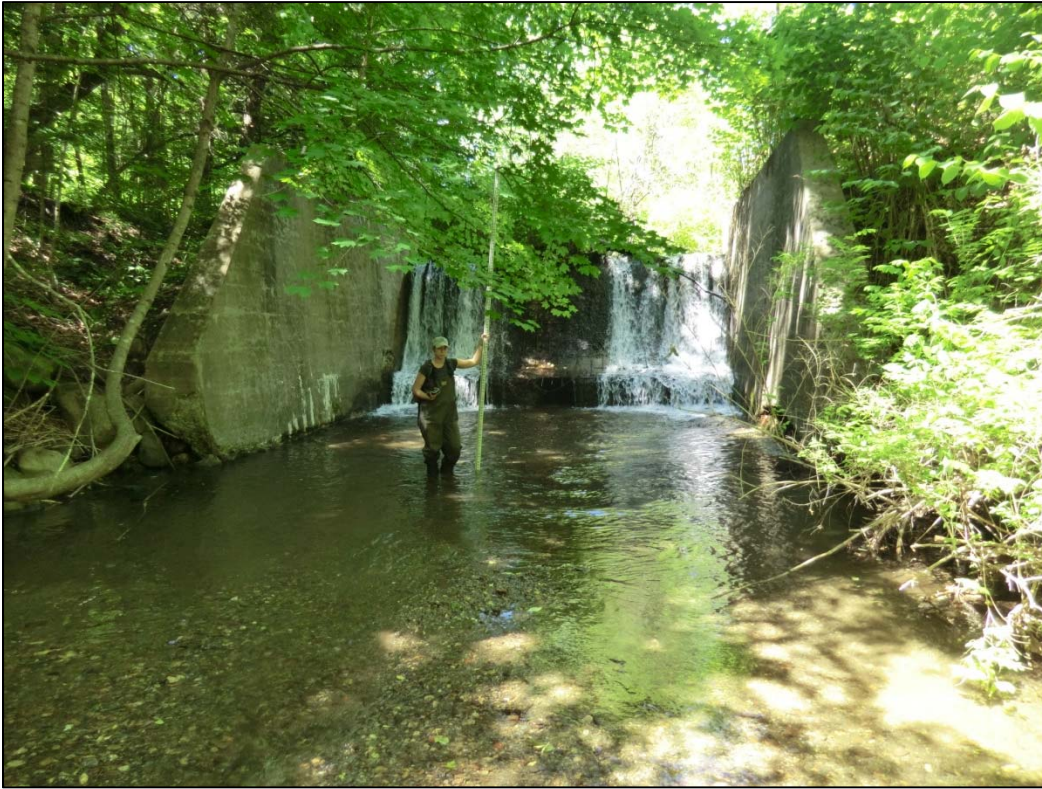
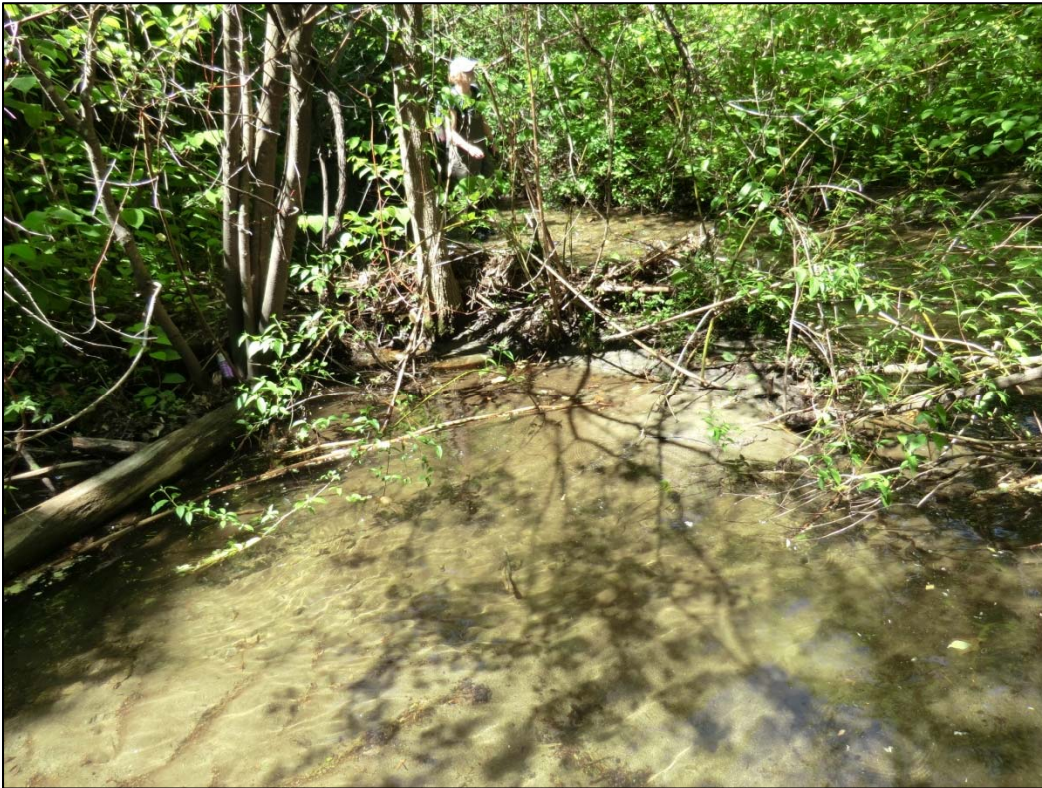
An old dam is located on the brook adjacent to Valley Street about 500 feet south of the junction of Valley Street and Litchfield Street. The dam is approximately 10.6 feet high and is made of concrete (Figure 6.10). As shown in Figure 6.11, sediment has built up above the dam. In an effort to improve sediment transport and aquatic organism passage, a dam removal project could be considered.

Figure 6.10. Old dam made of concrete that is 10.6 feet high.

Figure 6.11. Sediment accumulation behind old dam.
