Malletts Creek & Allen (Petty) Brook Phase 1 & Phase 2 Stream Geomorphic Assessment Summary Report

February 23, 2011

Fitzgerald Environmental Associates, LLC.
316 River Road
Colchester, VT 05446

Chittenden County Regional Planning
Commission
110 West Canal Street, Suite 202
Winooski, VT 05404

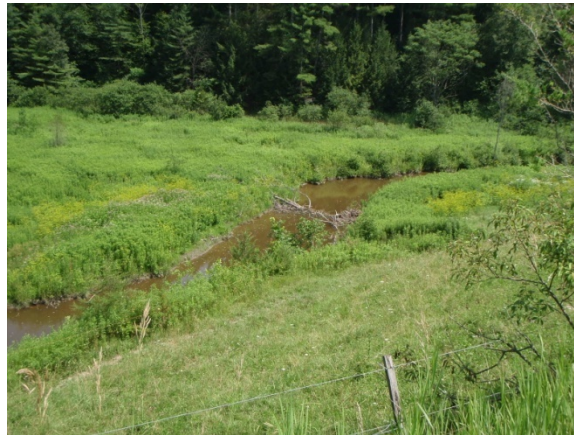
Riparian buffer widths were estimated remotely and verified in the field where possible during the windshield surveys. Areas where the buffer widths were less than 25 feet were mapped remotely and indexed using the FIT. Areas that received high impact scores for the lack of a healthy riparian buffer were those valleys where adjacent lands have been intensively used for agricultural or residential land uses including the presence of roadways (Figure 4.8). Adequate buffer widths are very important to habitat function and in preventing thermal loading to the surface water. A complete summary of land use impact scores from buffers less than 25 feet can be found in Appendix A.

Figure 4.8 A buffer width of less than 25 feet along the right (west) bank of reach M07

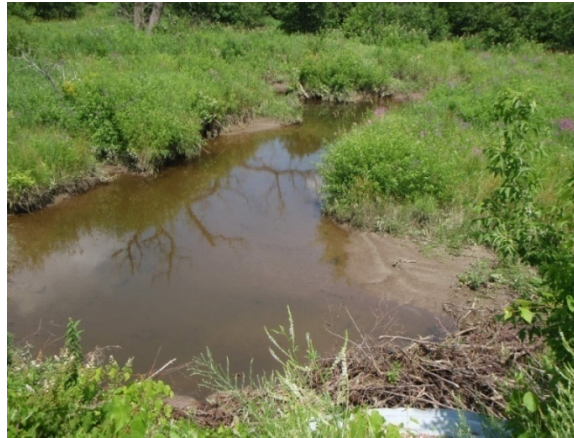
The locations and lengths of bridge and culvert crossings were mapped remotely and were verified in the field where possible. A total of 40 structures were noted on the 51 assessed reaches: 9 bridges, 27 culverts, and 4 unknown structures were observed. Culverts and bridges act as a constriction point to the channel at various flow depths, or inhibit the passage of wildlife if the culvert is improperly constructed. The McMullen Road crossing of M12 has a beaver dam immediately upstream this debris blockage impedes flows and might create problems for the structure in the future (Figure 4.10).

Figure 4.10 Looking upstream at the beaver dam impeding the inlet of the McMullen Rd culvert in reach M12

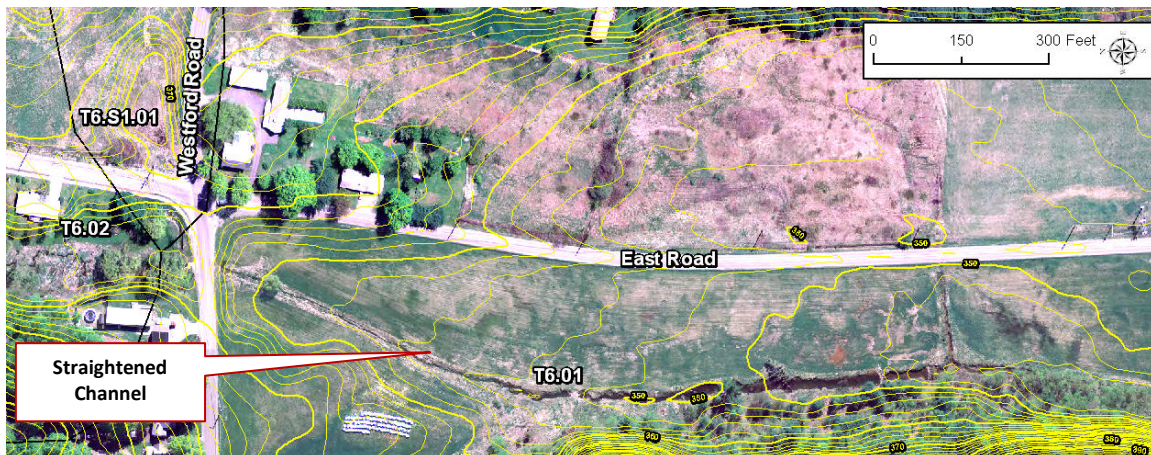
Figure 4.11 Straightening impacts in tributary T6.01 along East Road

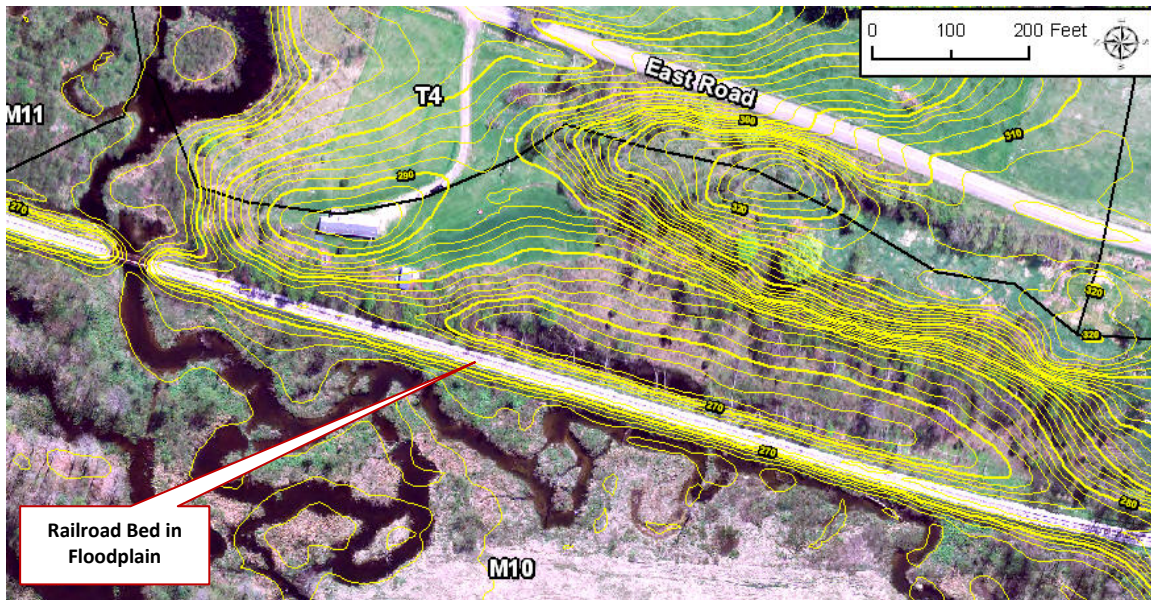
Figure 4.12 Railroad encroachment impacts on reach M10 west of East Road

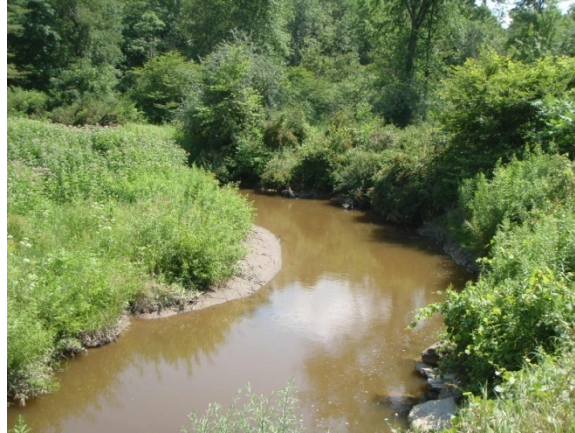
accessibility, several reaches were deemed to have a “low” impact from depositional material and one reach had a “high” impact rating. This reach, M05, had an abundance of sediment on the point bars upstream and downstream of the Juniper Hill Road crossing. Here, the upslope sediment supply greatly exceeds the transport capacity of the channel (Figure 4.13). Additional detailed data about the types of depositional features and their relative impacts for all reaches are found in the reach reports found in Appendix A.

Figure 4.13 Large point bar upstream of Middle Rd crossing of reach M05

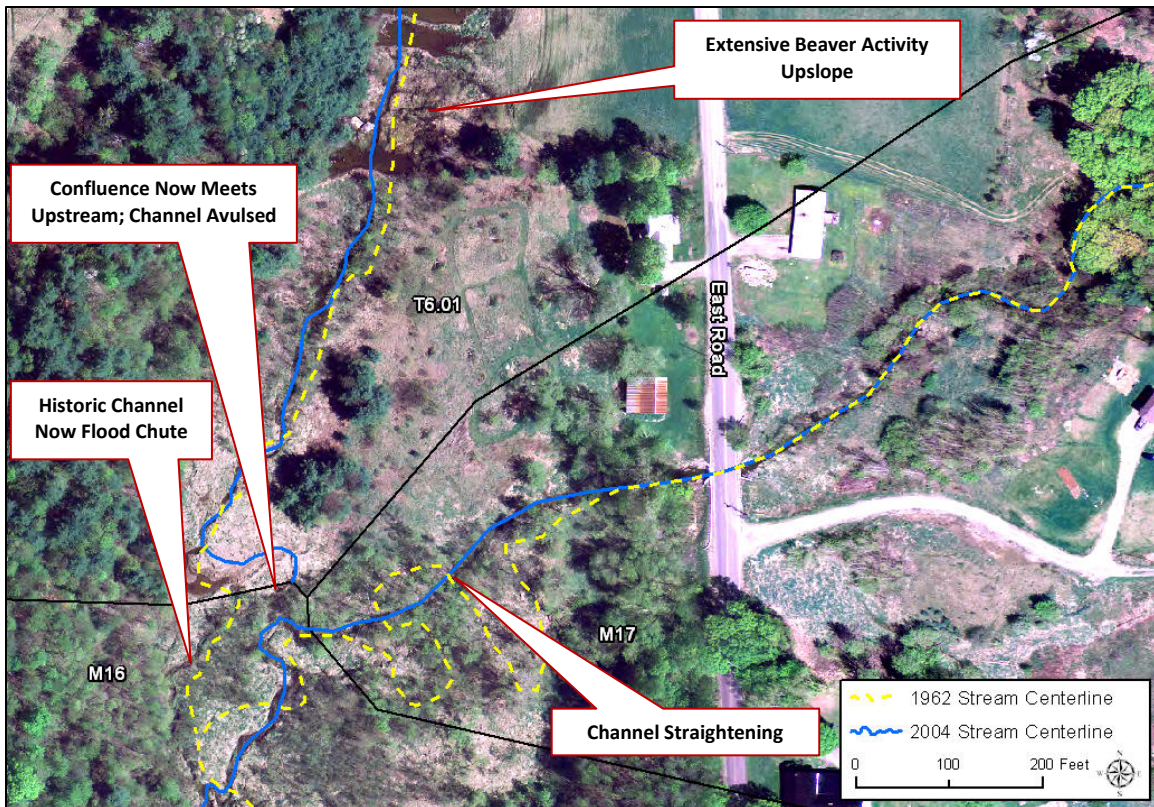
Figure 4.14 Channel straightening and migration at T6 and M17 confluence

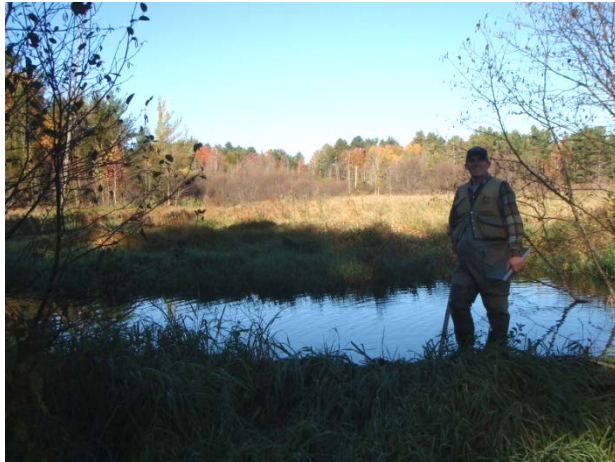
This segment was only assessed for bank and buffer conditions because extensive beaver activity impounds the entire channel length of 2,518 ft (Figure 5.3). The very broad valley and abundance of alders and other fast growing woody species makes this segment ideal for beaver inhabitation (Figure 5.4). Under reference conditions the channel was probably very similar to its current impounded state. Beaver activity greatly increases the time it takes for water to flow downstream, and the dams act as sediment sinks allowing fine silts and sands to settle out and aggrade. The channel is extremely well buffered because of the abundance of wetlands in the wide valley. Professional judgment was used to determine the RGA score as “Good” and E5-type channel morphology with dune-ripple bedform.

Figure 5.3 Large beaver dam at segment break with M14-B

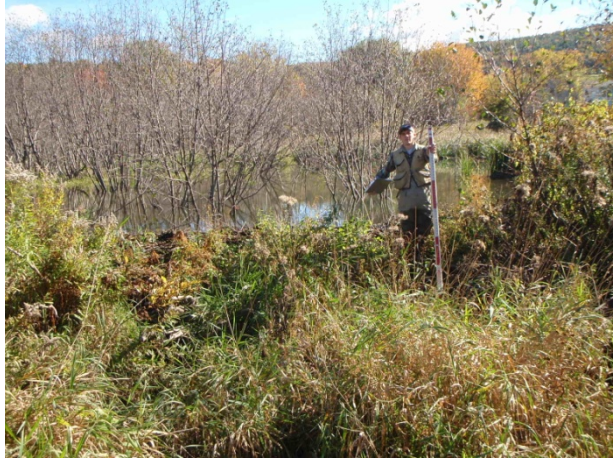
M15-A, like M14-B, is impounded by beaver activity (Figure 5.5). The segment is 671 feet in length and extends from the reach break with M14-B at the confluence with tributary T5.01 and ends approximately 400 feet downstream of the Kingsbury Road crossing. Bank and buffer conditions were surveyed and professional judgment was assigned for the geomorphic condition (RGA score = “Good”). An E5-type channel with dune-ripple bedform would likely occur if the segment was not so heavily impounded.

Figure 5.5 Large beaver dam at downstream end of M15-A

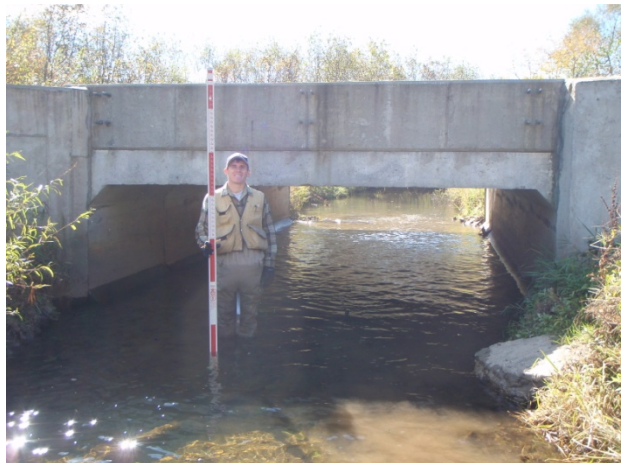
Segment M15-B is 1,487 feet in length with an average channel slope of 0.4%. The segment begins at the end of impoundment and extends up to the reach break with M16 about 850 feet upstream of the Kingsbury Rd crossing where the confinement changes. The valley setting is very broad by reference. The channel exhibits E-type geometry with riffle-pool bedform which is consistent with the reference stream type designation (Figure 5.6). The width-to-depth and entrenchment ratios are 9.5 and 22.3, respectively. No incision was observed at the cross-section location (IR = 1.0), however, some minor incision was observed upstream of the Kingsbury Road crossing. Substrate is slightly coarser in this segment than observed in the reaches below, with fine gravel representing the median substrate type (36%). The Kingsbury Road crossing has been recently replaced and may have previously had some erosion problems (Figure 5.7). Angular fill rock typical of road footings was found in abundance downstream of the road crossing suggesting that the previous crossing may have blown out.

Figure 5.7 Kingsbury Road Crossing inlet looking downstream

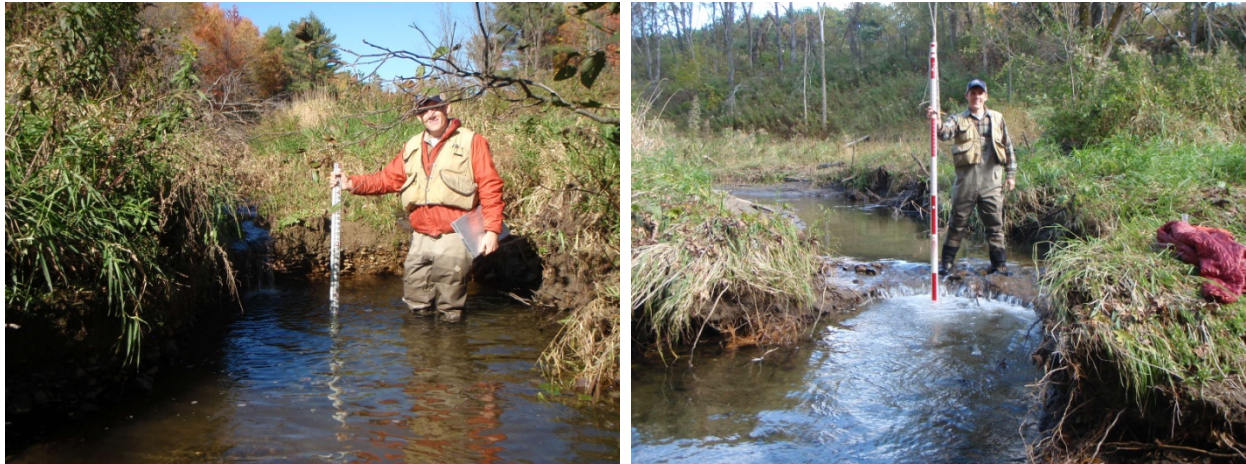
downstream channels. The net effect of sediment aggradation and subsequent degradation as beaver dams come and go effectively neutralizes the adjustment processes observed on this reach (RGA score = "Good"). Stage I of the CEM was chosen because degradation through naturally aggraded, beaver-related substrate is the dominant adjustment process observed. The habitat condition score in M16 is also "Good." Woody debris was abundant (LWDs/Mile = 122), but pools were somewhat limited (Pools/Mile = 25).

Figure 5.10 Two examples of headcuts migrating upstream through sediment aggraded historically by beaver activity

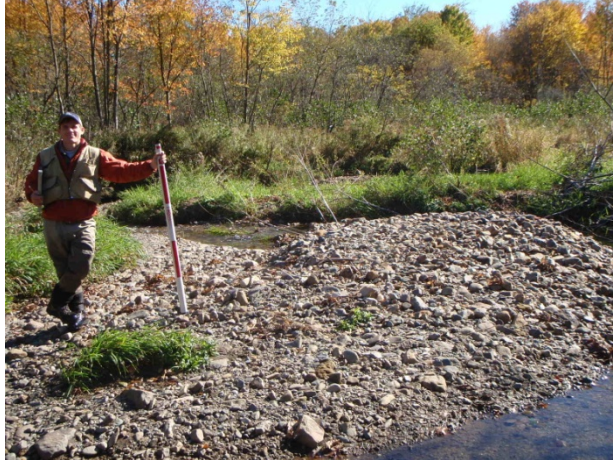
The impacts to the natural planform of the channel have also impacted the habitat condition of this segment. M17-A has limited wood (LWD/Mile = 40), pools (Pools/Mile = 28), and undercut banks (UCB/Mile = 17), which reduced the overall habitat score to “Fair” condition. It is evident in Figure 5.11 that the banks and buffers in the lower portion of the segment have been recovering from previous deforestation. The plant assemblages are typical of old field succession occurring in a wet environment. Boxelder (*Acer negundo*), speckled alder (*Alnus rugosa*), and black willow (*Salix nigra*) are the dominant woody species in the lower segment. The geomorphic condition of M17-A has been reduced as a result of several adjustment processes (RGA score = “Fair”). The straightening which occurred sometime between 1962 and the present likely caused the channel to degrade and down-cut. However, vertical changes in the channel were not observed in the cross-section; only minor incision (IR = 1.1) was noted upstream and downstream. The lack of incision suggests that the bed elevation might be aggrading sediment from upslope. Several large sediment deposits were observed at the upstream end of reach M16, indicative of a high sediment load (Figure 5.13). As more coarse sediment spills into this segment, widening and planform adjustments are likely to recreate a similar sinuous setting as observed in 1962. Stage I of the CEM describes the state of this segment, because no active incision associated with historical straightening was noted. Widening and shifts in planform will likely be more prominent adjustment processes in the future.

Figure 5.13 Sediment deposits at the reach break between M17-A and M16

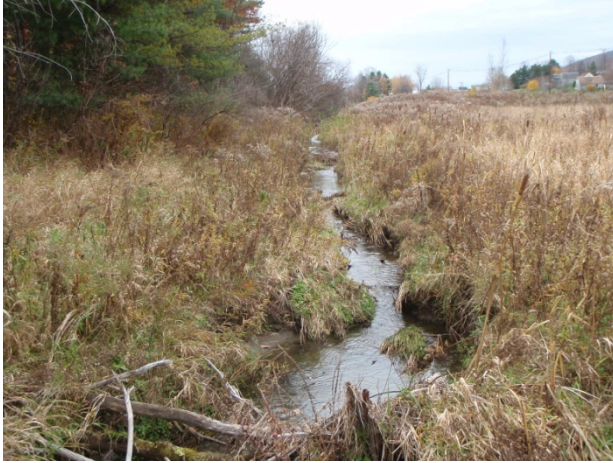
Figure 5.18 Channel atop a breached beaver dam mid-reach

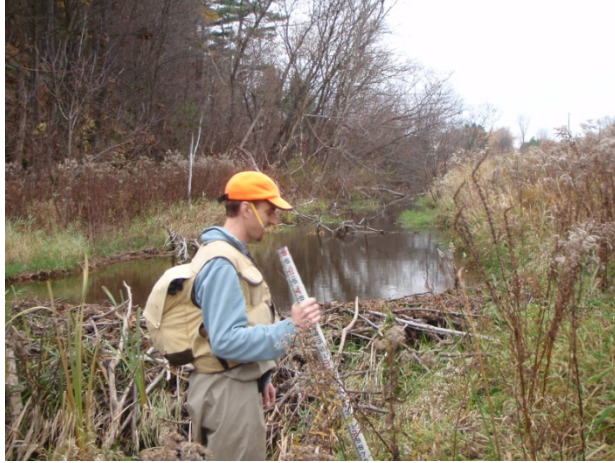
Figure 5.20 Beaver dam at the downstream end of the segment

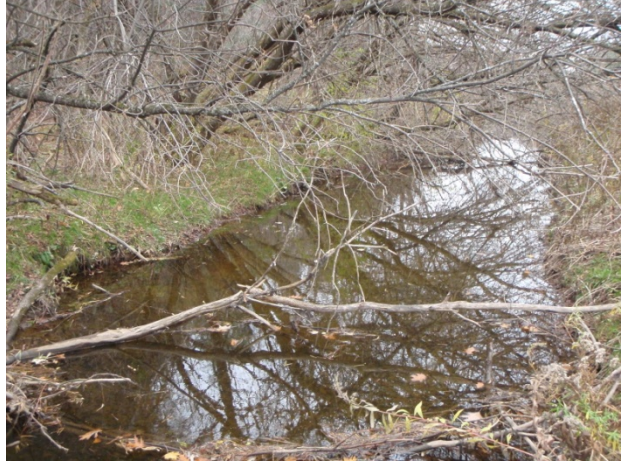
Figure 5.21 Impoundment bound by the extent of dredging

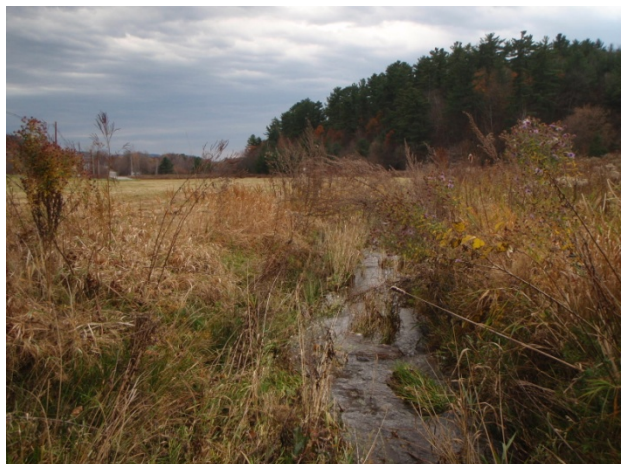
Figure 5.23 Downstream view of floodplain and small headcuts

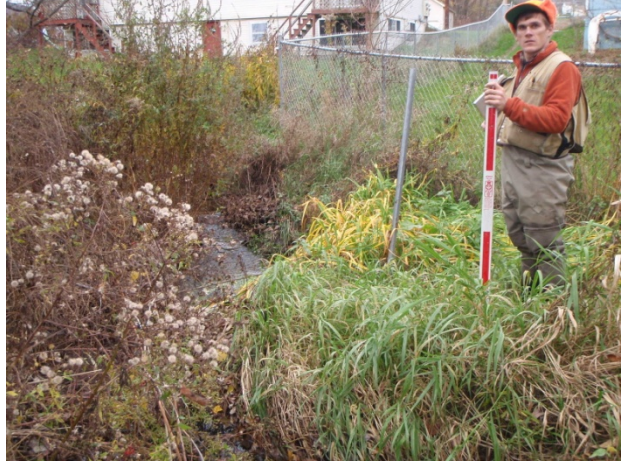
Figure 5.25 Upstream view of channel avulsion

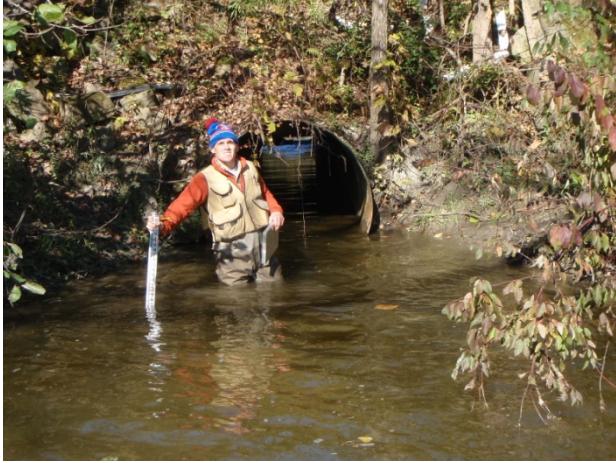
Figure 5.28 Scour pool downstream of the undersized culvert

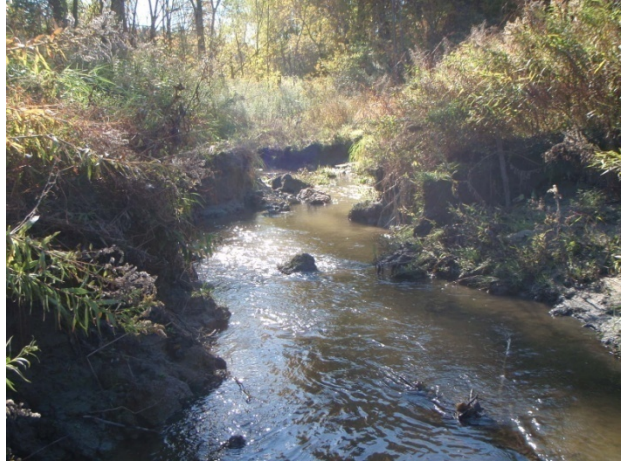
Figure 5.29 Slumping, erosion, and aggradation upstream

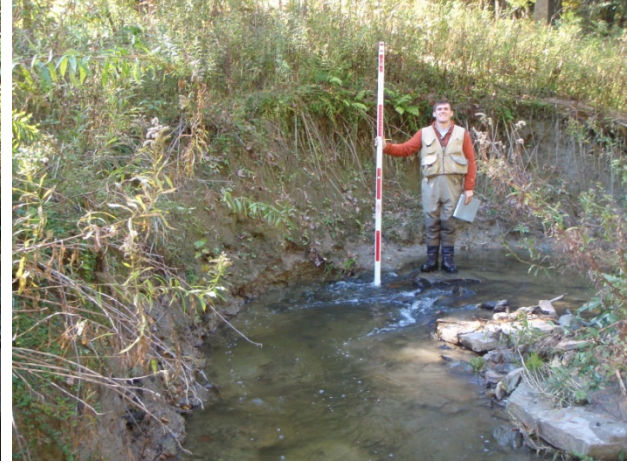
Figure 5.31 A mass failure with exposed varved clays

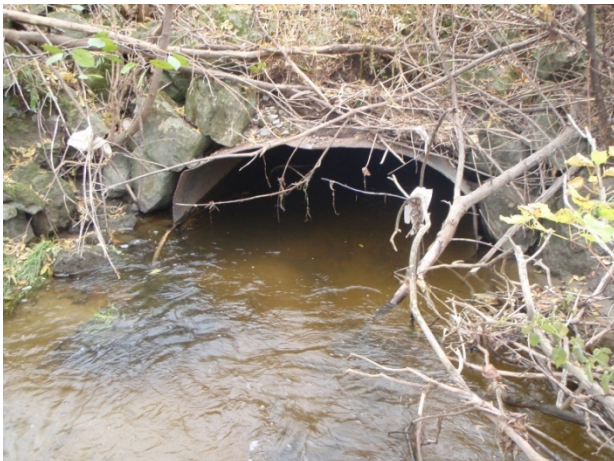
Figure 5.36 Downstream view of Sweeny Farm Rd culvert inlet

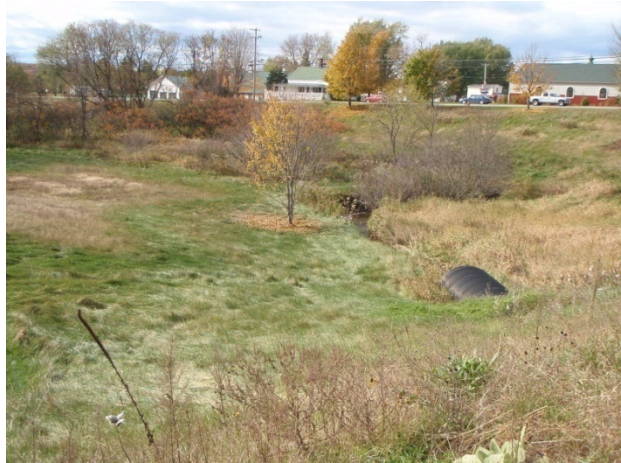
Figure 5.39 Downstream view from atop Allen Bk Drive culvert
