# Lower Passumpsic River Tributaries Phase 1 Stream Geomorphic Assessment Report

September 27, 2013

**Fitzgerald Environmental Associates, LLC.**  
18 Severance Green, Suite 203  
Colchester, VT 05446

**Caledonia Country Natural  
Resources Conservation District**  
481 Summer Street, Suite 202  
St. Johnsbury, VT 05819

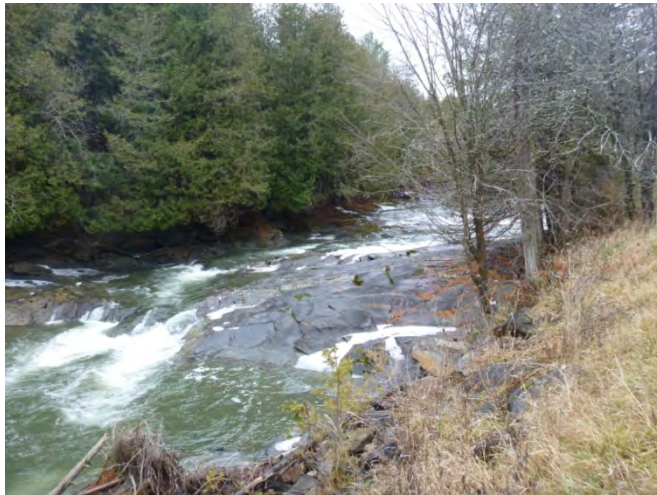
**Figure 7:** Large bedrock cascade in reach T3.06

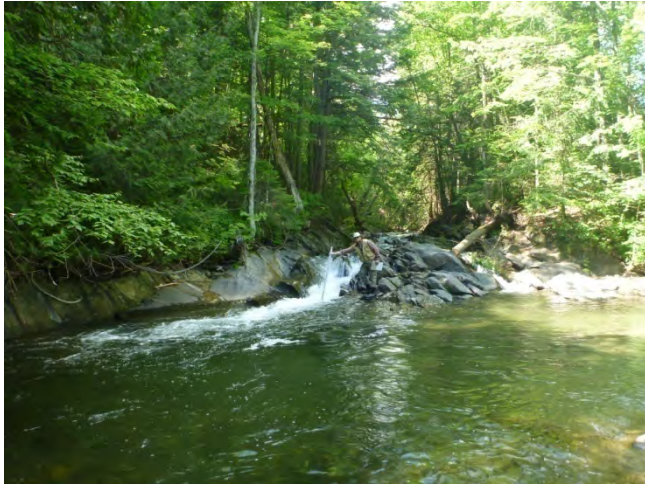
**Figure 8:** Small gorge in T5.04

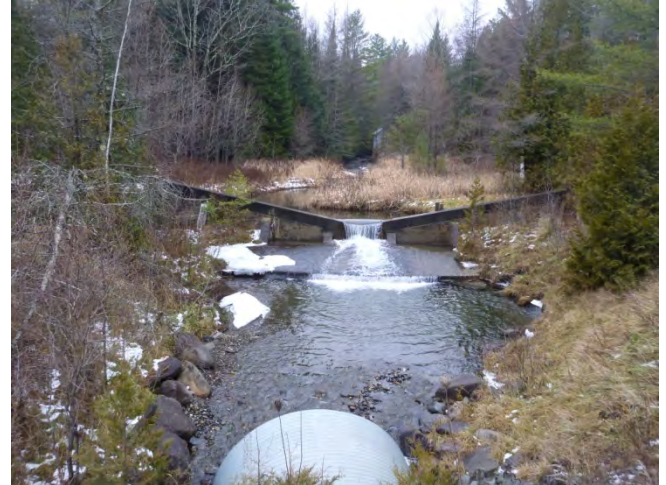
**Figure 9:** Active USGS weir in T3.14

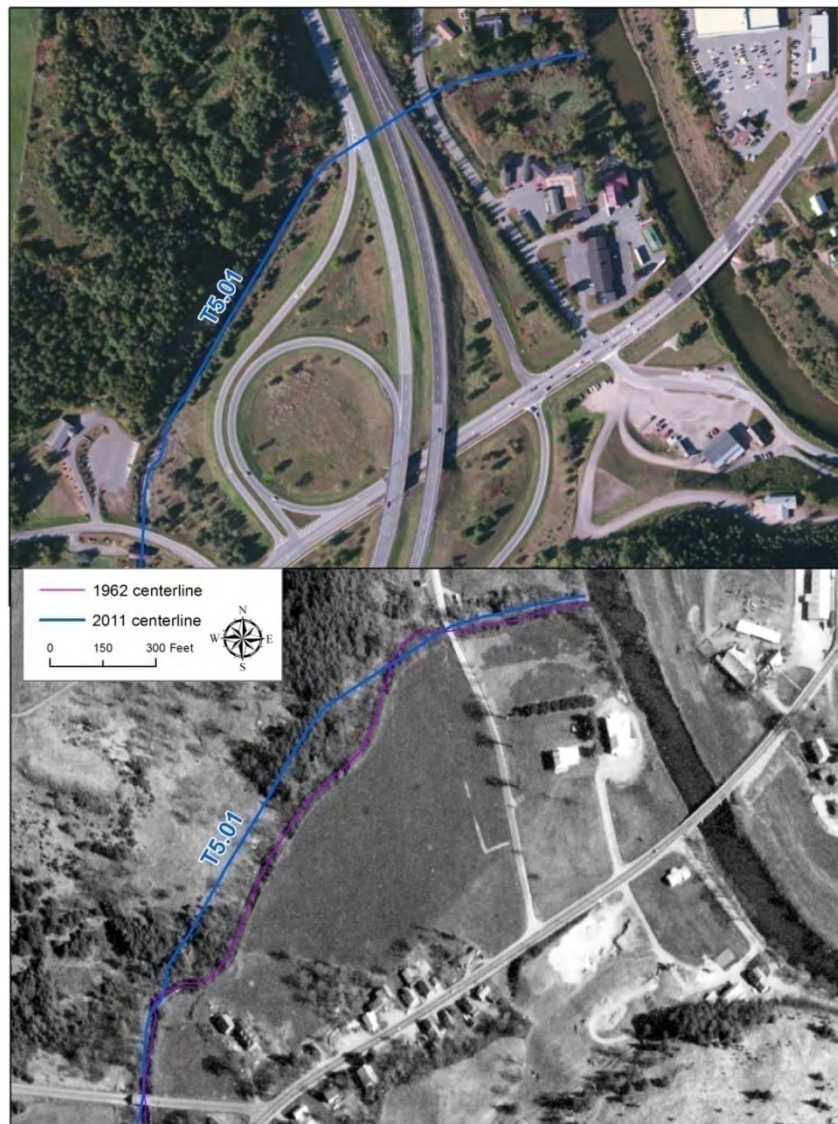
**Figure 10:** Major channel alteration in reach T5.01 visible from 1962 imagery (bottom) to current imagery (top).

Historic land cover data for the reach watershed and corridor scales was reviewed using a series of geo-rectified aerial photos from the study area from 1970's. Agricultural land use has remained relatively consistent within the study area. Minor increases in forest cover as agricultural fields are abandoned is visible in all of the study watersheds. Increased developed lands and transportation corridors are most visible in the Sleepers River and Wheelock Brook watersheds. The construction of the I-91 interchange in Lower Wheelock Brook (T5.01) required the stream to be relocated approximately 100 feet to the northwest (Figure 10).

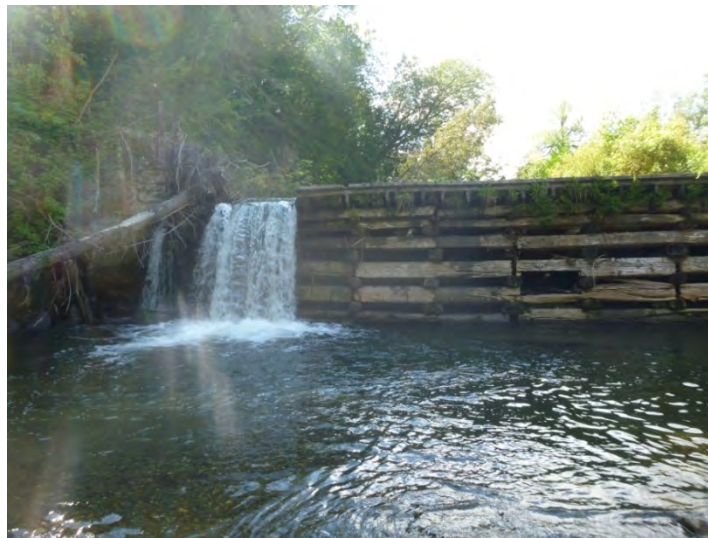
**Figure 12:** Timber crib dam on T3.10

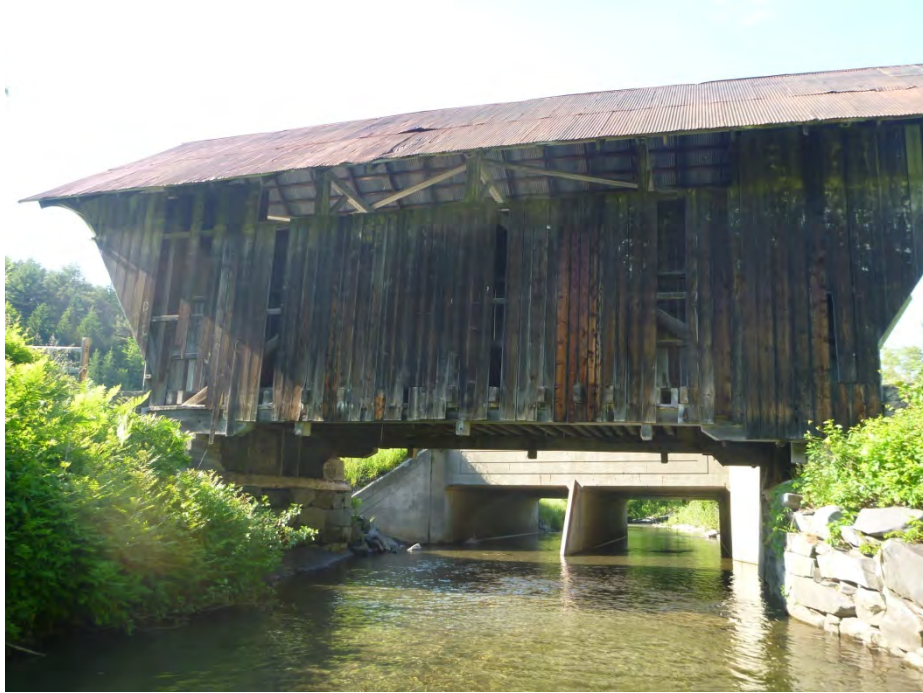
**Figure 13:** Covered bridge and box culverts on T5.02

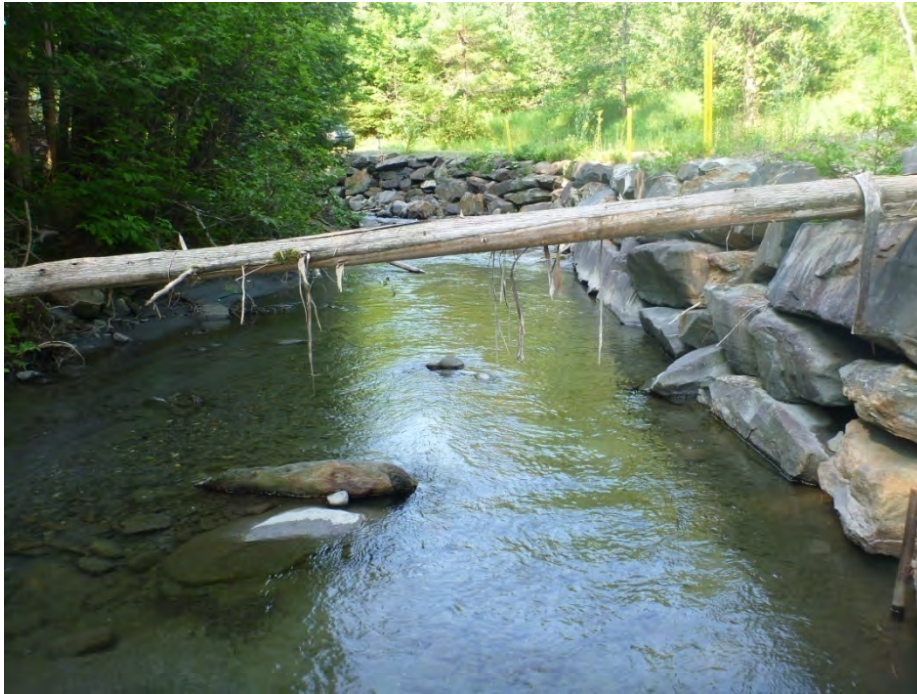
**Figure 14:** Bank armoring along Roy Rd in Reach T3.7S1.02

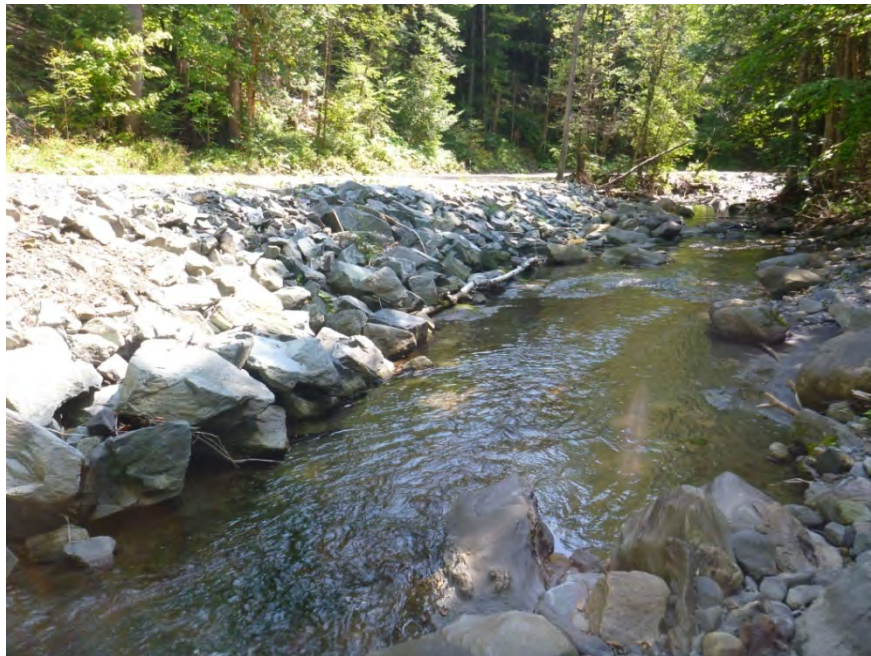
**Figure 15:** Encroachment from Water Andric Road along much of T2.08

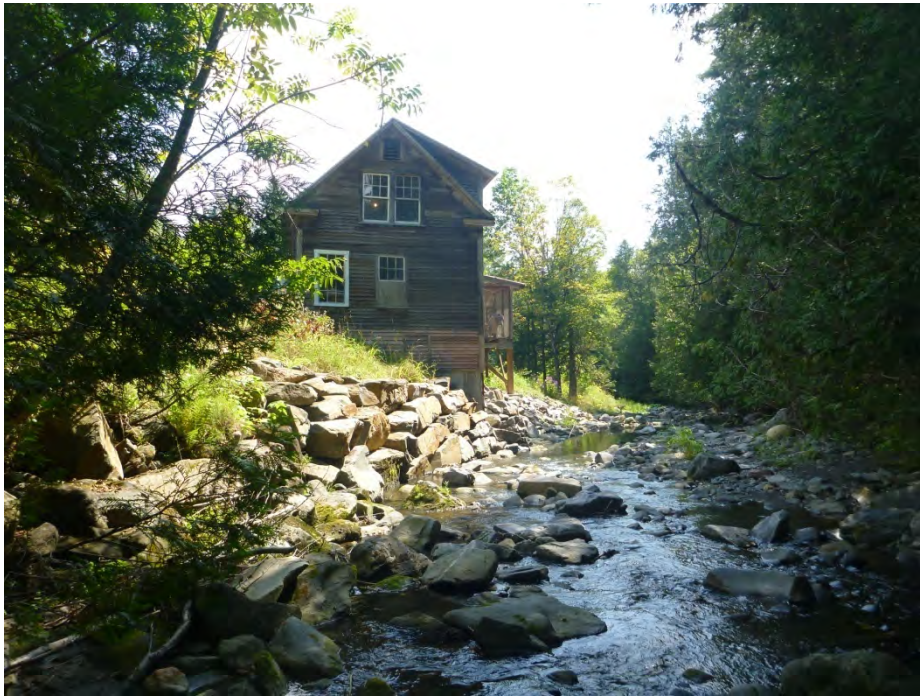
**Figure 17:** Development impacts on Water Andric in Danville, Reach T2.08.

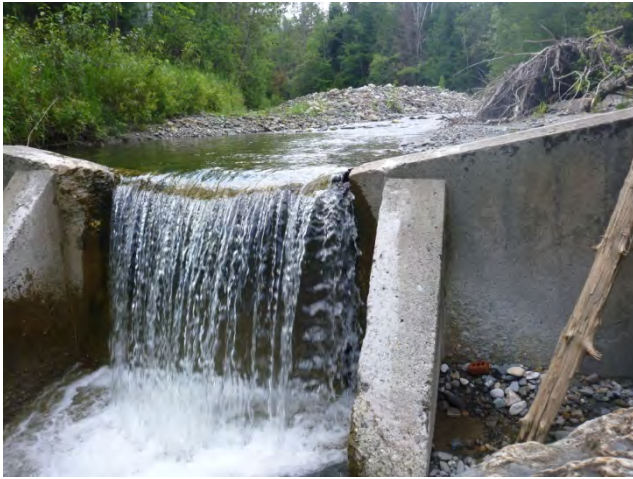
**Figure 18:** Sediment deposition upstream of abandoned USGS weir on T3.10S1.02

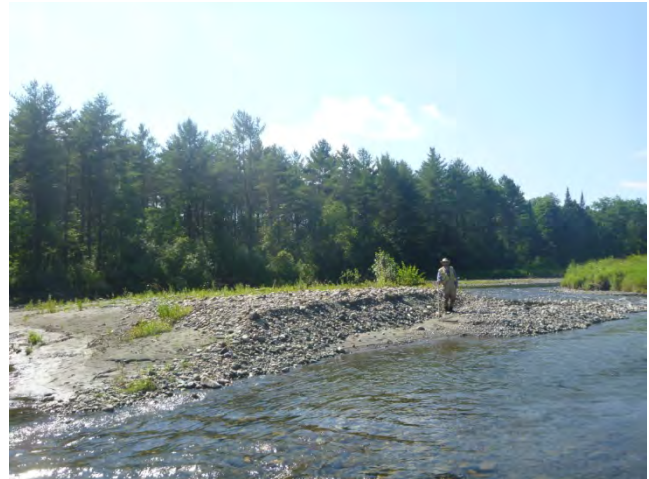
**Figure 19:** Braided channel and alluvial fan on T3.07

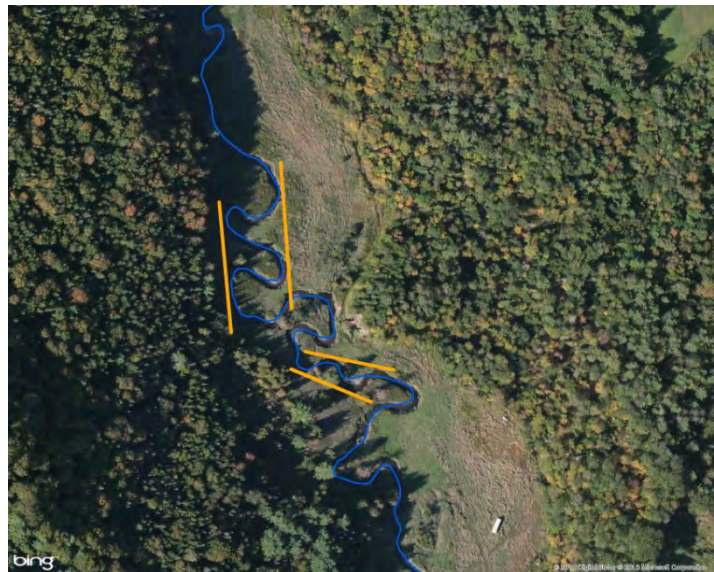
**Figure 20:** Meander geometry assessment on Reach T2.03

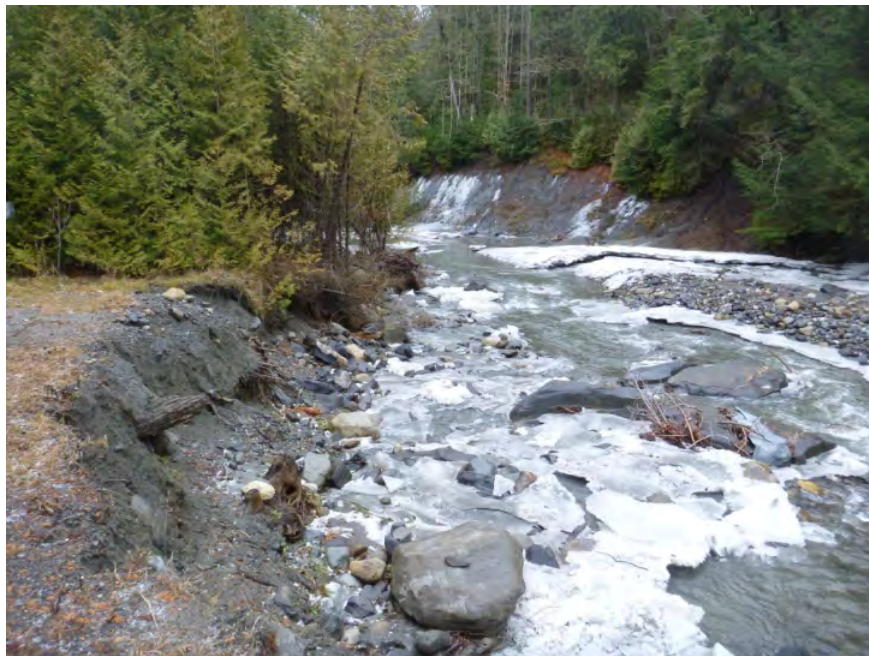
**Figure 21:** Bank erosion and mass failure on T3.09, Sleeper's River in Danville.
