# Brewster River River Corridor Plan

July 31, 2015

Fitzgerald Environmental Associates, LLC.  
18 Severance Green, Suite 203  
Colchester, VT 05446

**Lamoille County Planning Commission**  
PO Box 1637  
52 Portland Street, Second Floor  
Morrisville, VT 05661

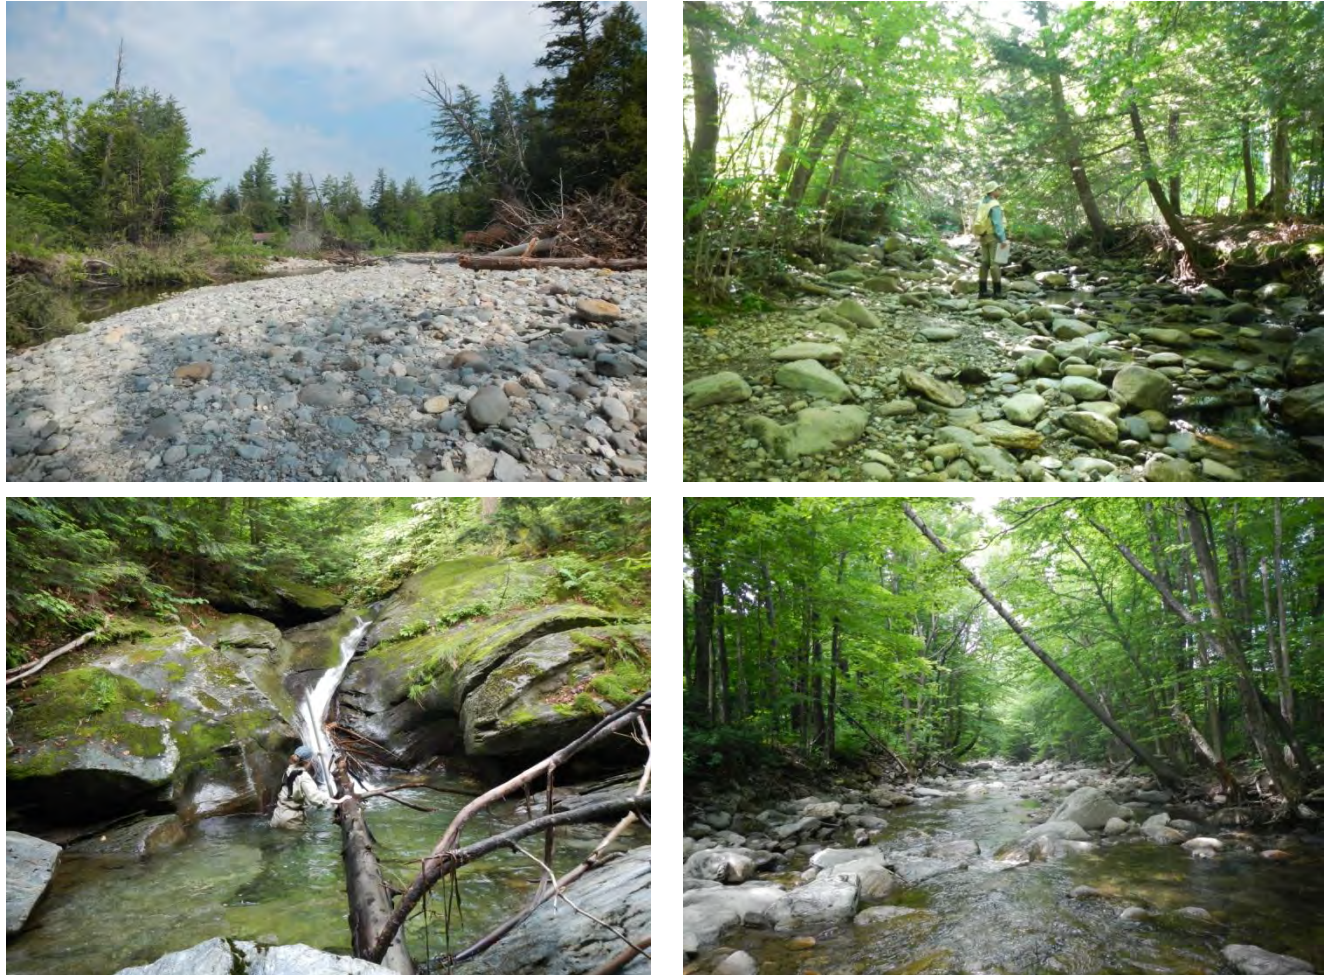
**Figure 2:** Range of channel types and valley settings found within the Phase 2 study area, clockwise from top left: Widening and deposition in an unconfined valley (M06); recent incision with ongoing widening and deposition in a steeper yet unconfined valley (M12.B); recent widening with ongoing incision (T7.01); and steep boulder/bedrock channel in a narrowly confined valley (T7.S4.03).

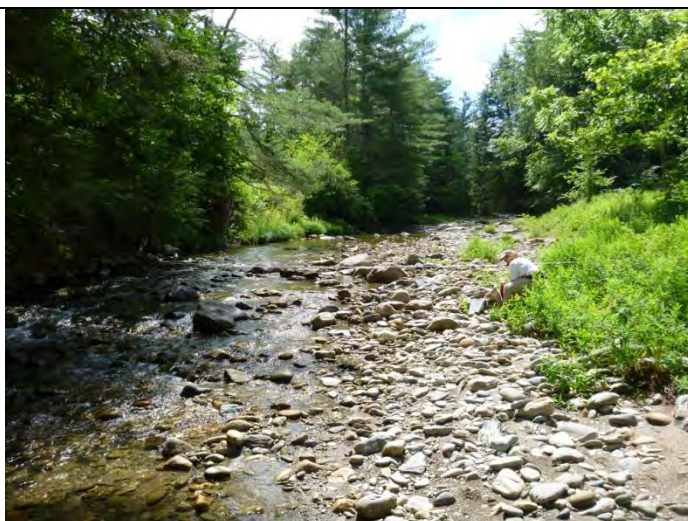
Moderate widening and some planform adjustment at the cross-section

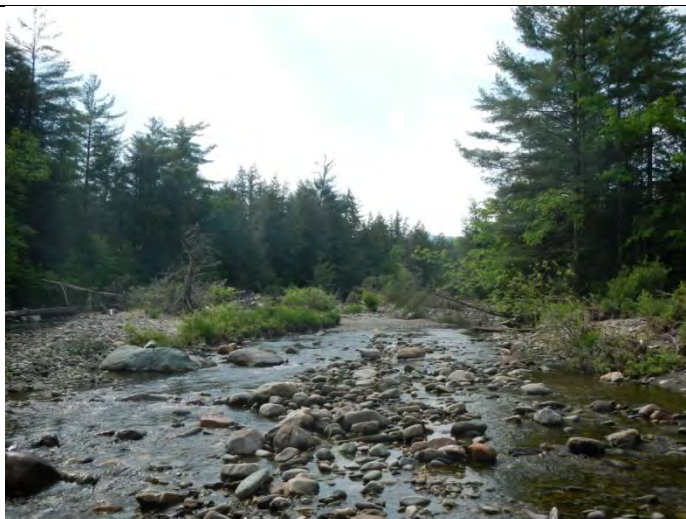
Widened reach with significant deposition from recent flooding

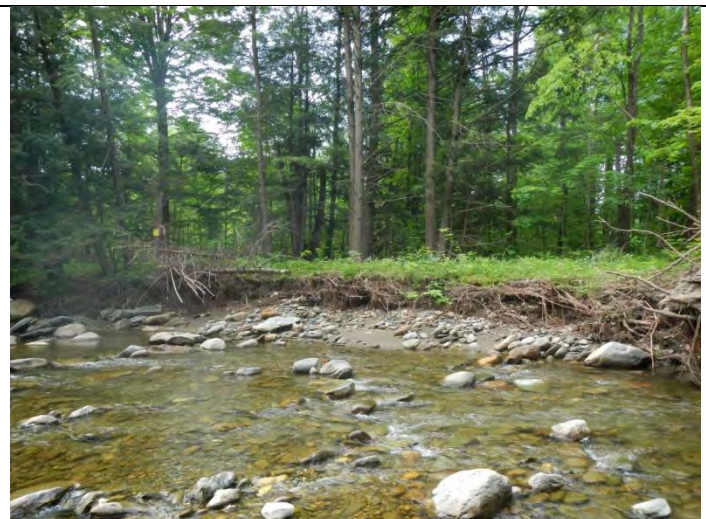
Bank scour observed through most of reach indicating recent widening

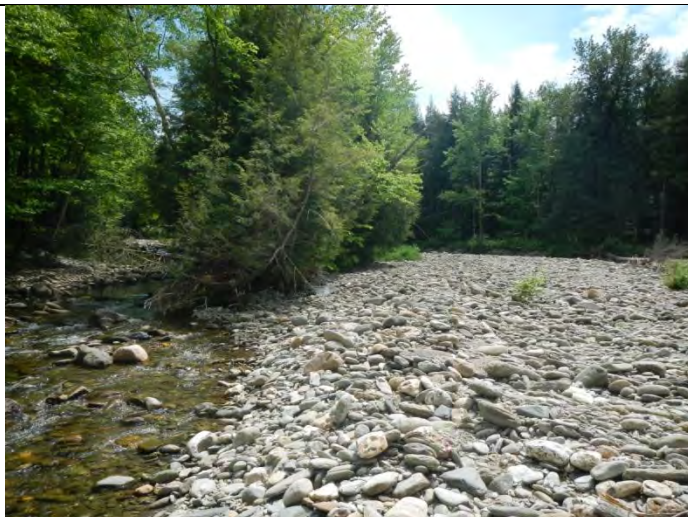
Channel avulsion with a minor headcut and major deposition through historic channel

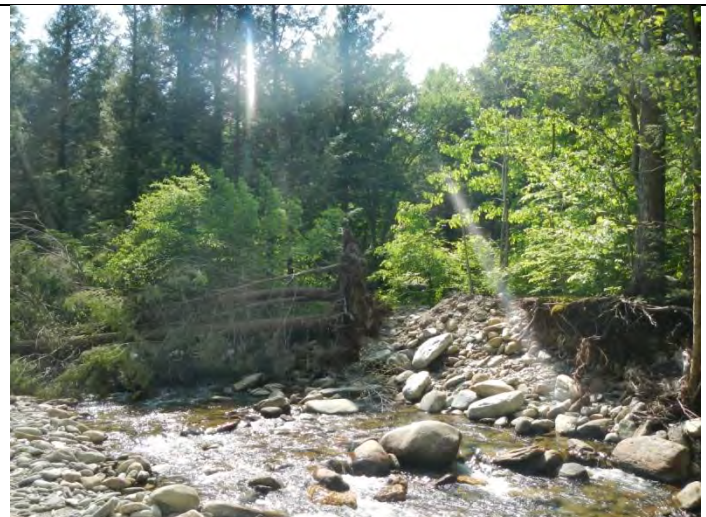
Channel migration causing bank failure on the Austin property

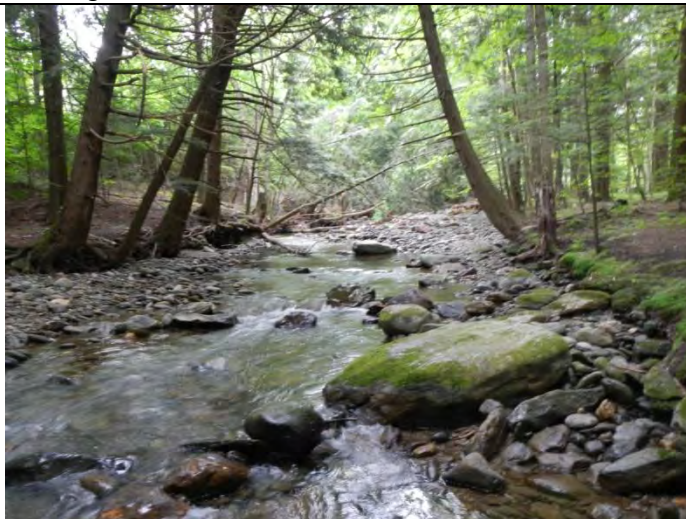
Recently accessed historic channel in upper reach

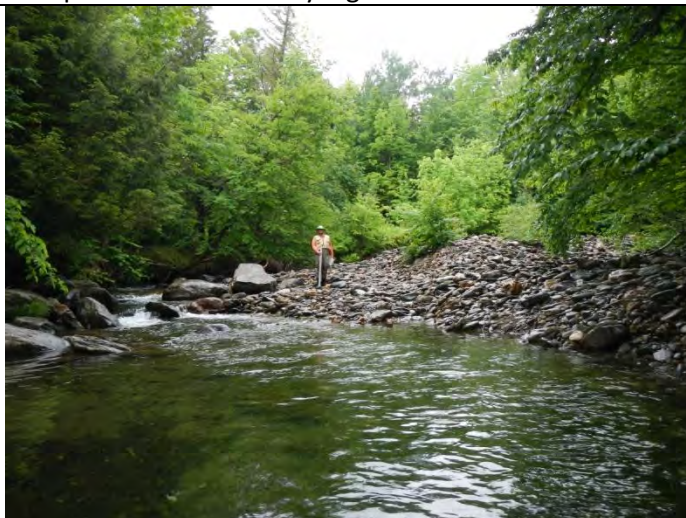
Major deposition upstream of Edwards Rd bridge

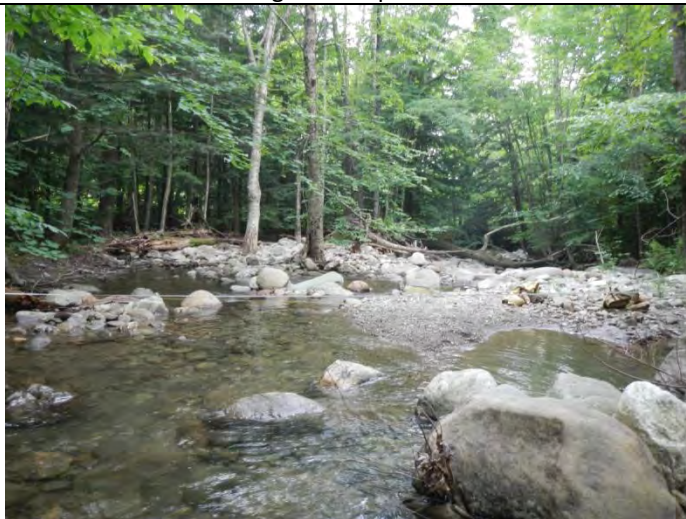
Braiding channel with major deposition

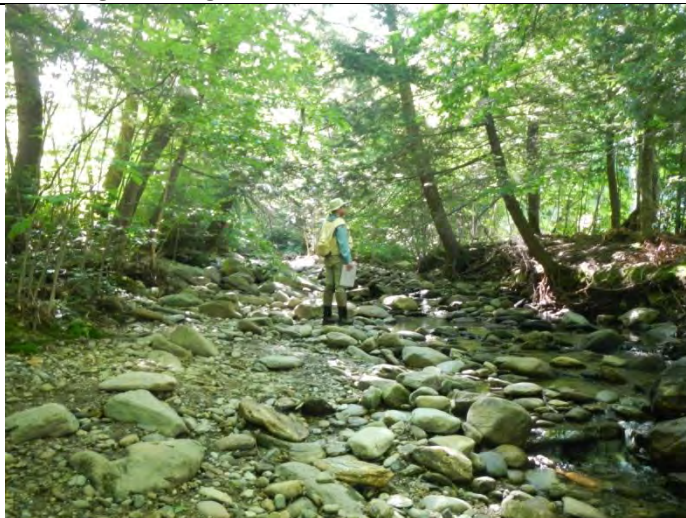
Recent widening and deep incision throughout segment

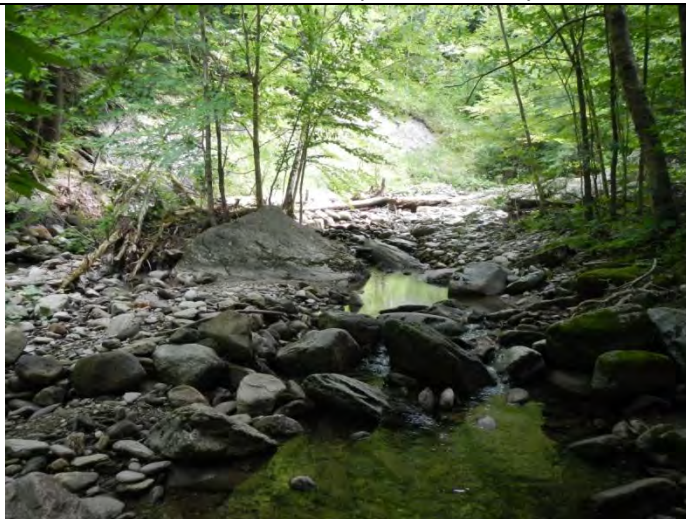
Widening, aggradation, and mass failure

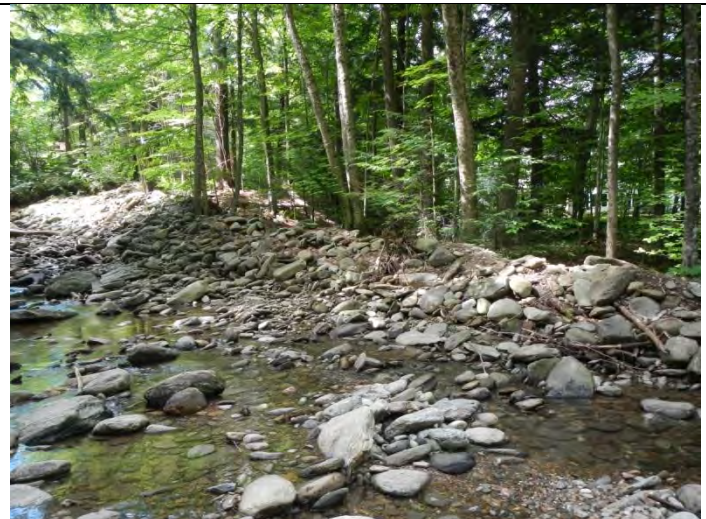
Cobble berm cutting off forested floodplain

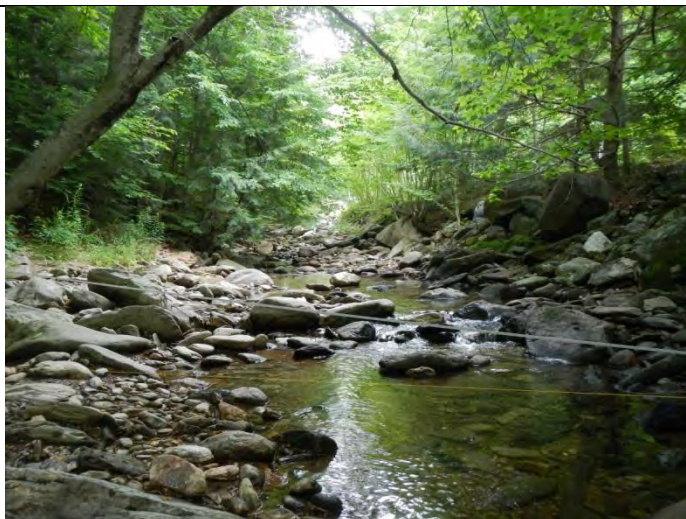
Deep incision throughout reach

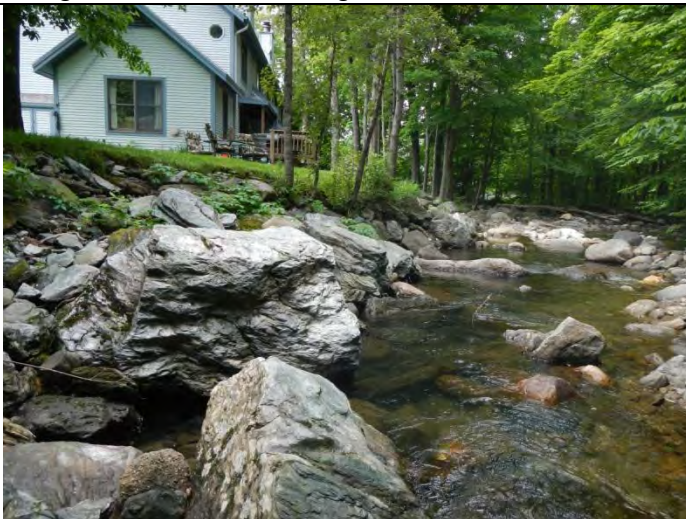
Development and incision with failing bank armor

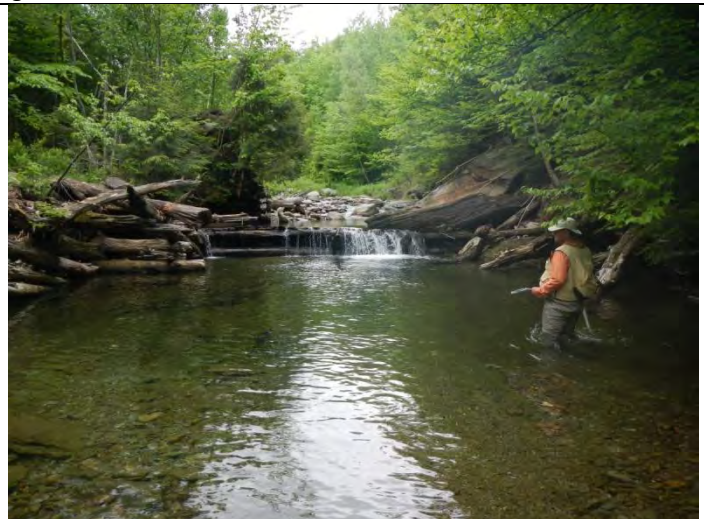
Failing timber crib dam, top of reach

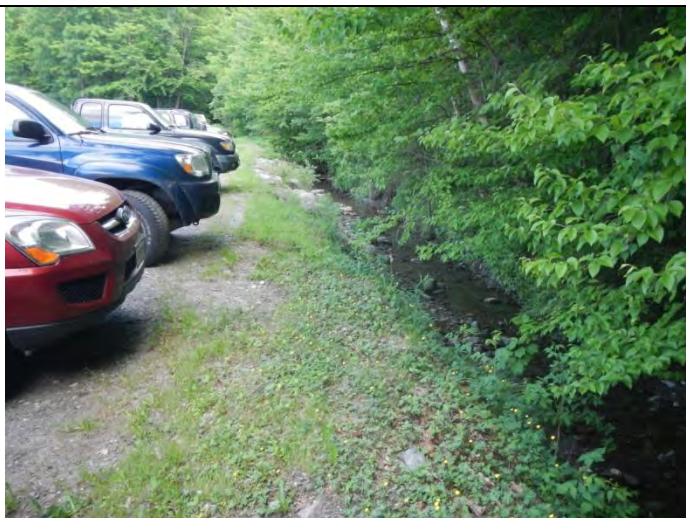
Channelized ditch along parking lot

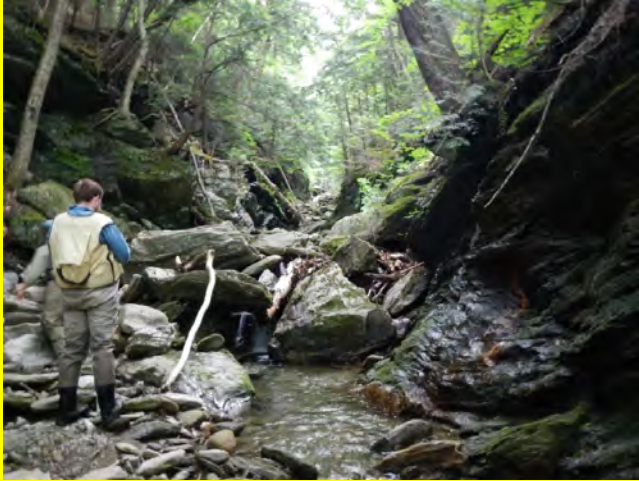
**Figure 6:** Near continuous bedrock grade control on reach T7S4.03.

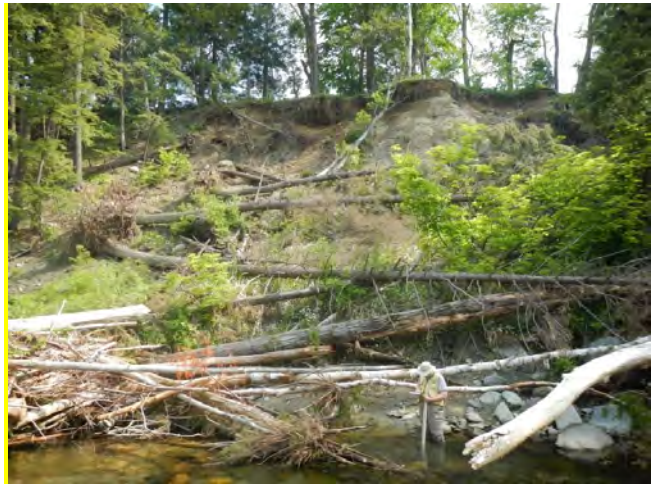
- High bank erosion in segment M12.B
- Large mass failures in segments: M06 (Figure 9), M13, and M14
- Dredging in segments M13 and T7S1.01
- High density of riparian buffer width impacts in segments T7.01 (Figure 10) and T7S1.01

**Figure 9:** Large mass failure on reach M06.

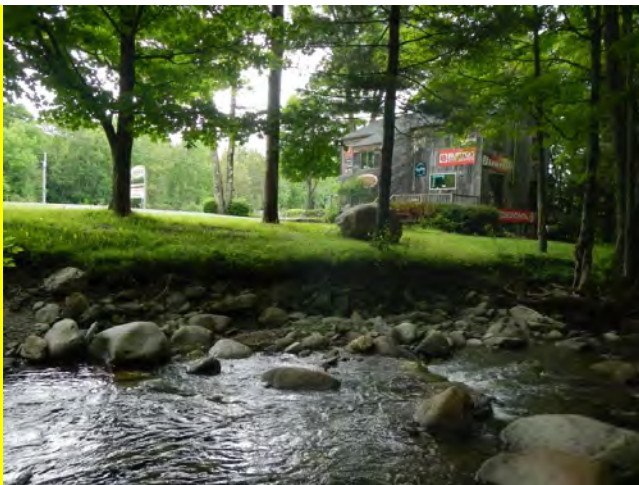
**Figure 10:** Buffer impacts along reach T7.01.

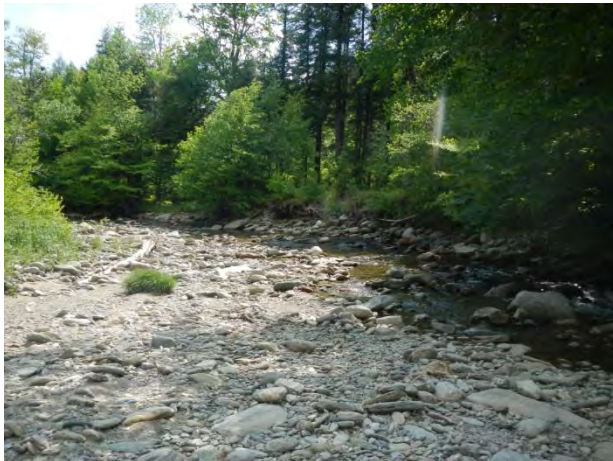
**Figure 1:** Point bar building along the right bank is pushing thalweg into the Austin property.

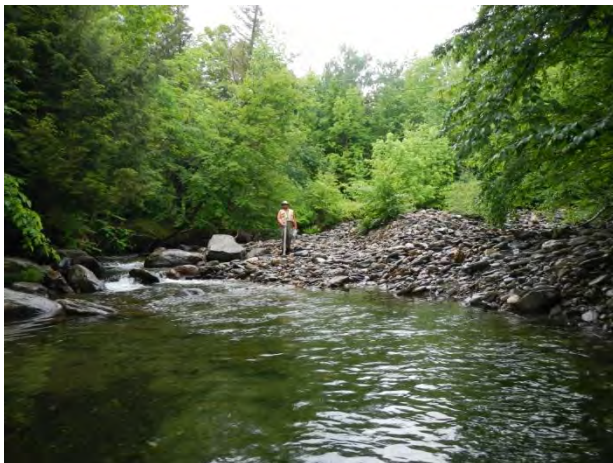
**Figure 7:** Huge cobble bar immediately upstream of the bridge

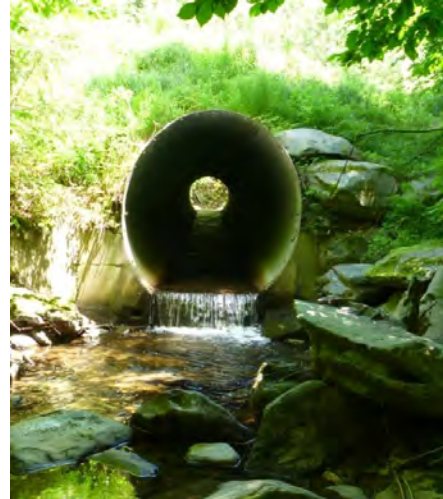
**Figure 14:** Perched culvert beneath lower Canyon Road

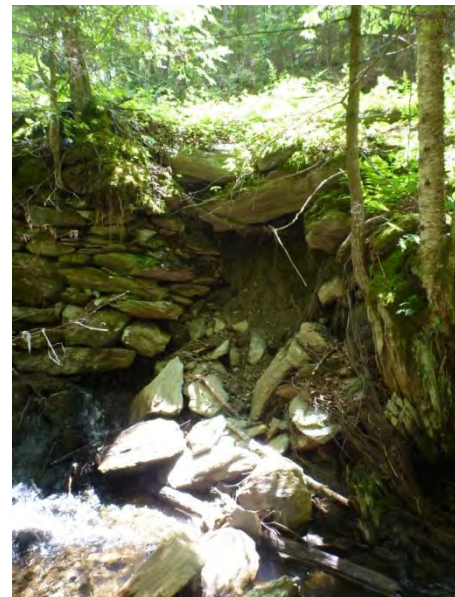
**Figure 15:** Failing stone wall embankment

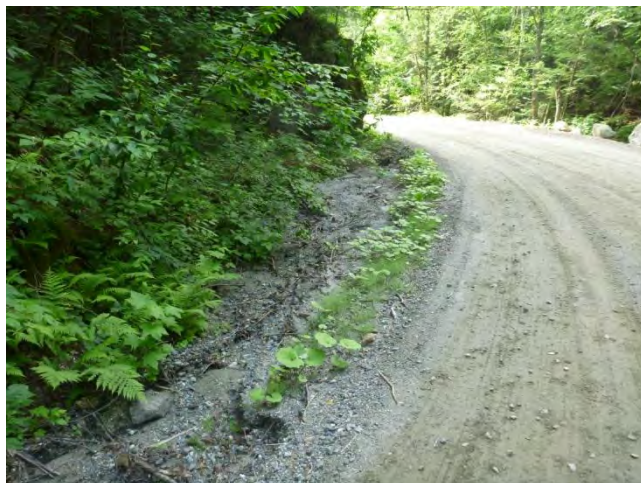
**Figure 20:** Low point along first bend in road approximately 15ft x 30ft
