**Phase 2 Stream Geomorphic Assessment
Upper Otter Creek Watershed**

**Reaches: M22 – M26
Rutland & Clarendon, Rutland County, Vermont**

February 2006

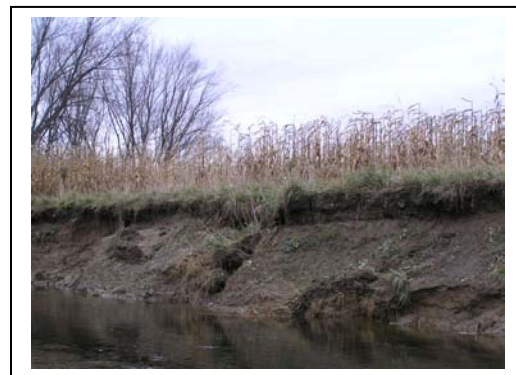
Buffers consisting of mature trees with occasional shrubs were dominantly 5 to 25 feet in width along the five study area reaches. There were intermittent sections of streambank without woody buffers, where active streambank erosion and sloughing were typically noted. Table 4 lists lengths of erosion recorded with a GPS along left bank (LB) and right bank (RB), facing downstream. Erosion is noted by a red stippled line on reach maps in Appendix B.

Figure 7. Bank erosion noted typically along channel sections without tree buffers.

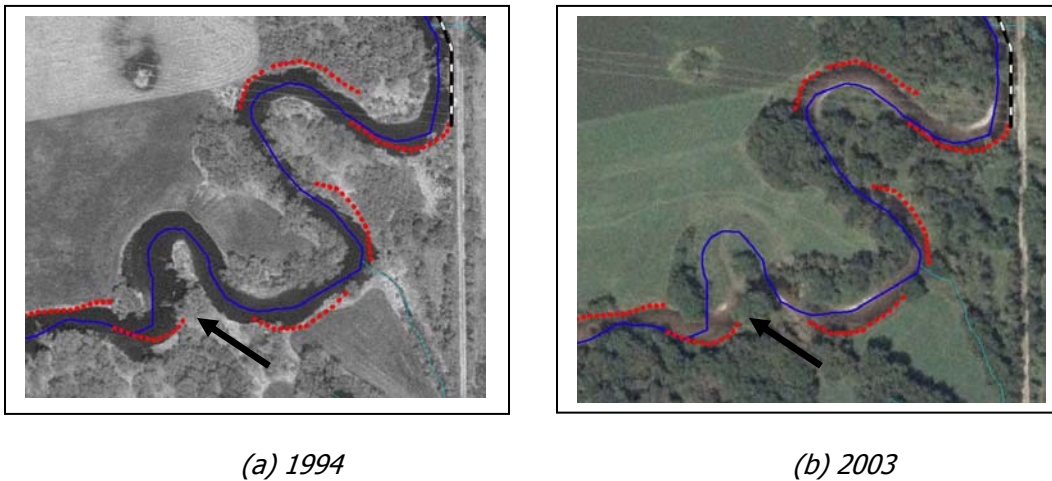
Accelerated meander extension was noted at several locations along the Upper Otter Creek valley, coincident with gaps in the woody riparian buffer. Occasionally, a meander will grow and move until the bend becomes too tortuous for the river to pass through, and the neck of the meander will be cut off in the next flood event (or a series of flood events). Comparison of the 1994 orthophotos with 2003 aerial imagery revealed a few examples of recent and pending neck cutoffs in the study area (see Figure 9). Where possible, these gaps in the buffer can be filled in by tree and shrub plantings. As the shrubs and trees establish themselves, the root systems will hold the erodible alluvial soils along the channel margins and offer roughness elements to slow the erosive power of the river; streambank erosion will be reduced and nutrient and sediment loading to the river will be reduced over the long term.

Figure 9. M24. Site of neck cutoff occurring between 1994 and 2003 (at arrow). (Flow direction is to the northeast – from bottom left to upper right on the images.)

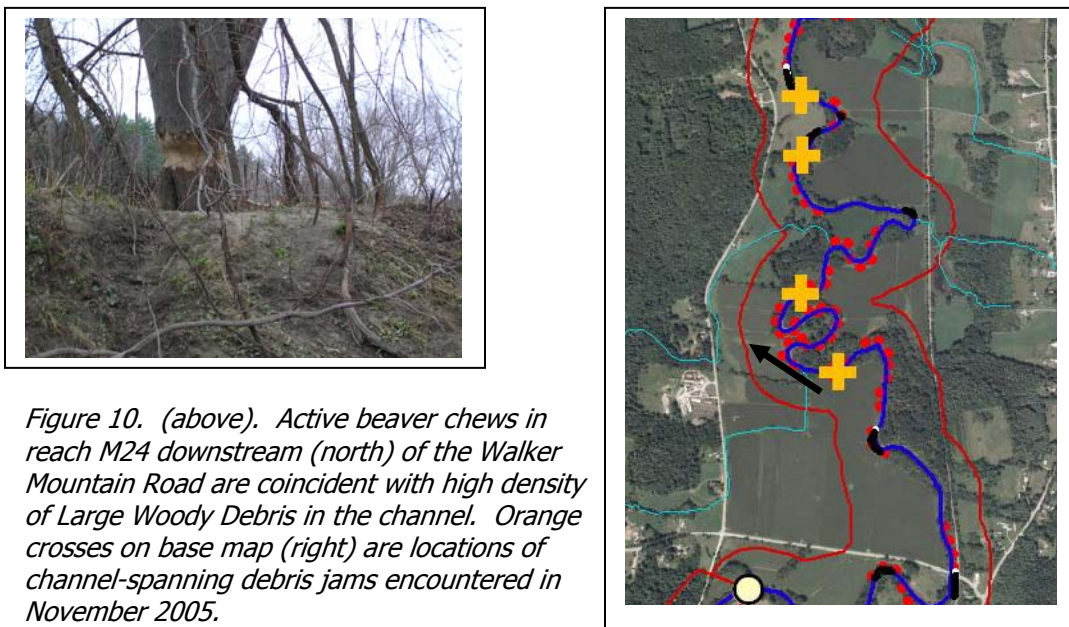
Figure 10. (above). Active beaver chews in reach M24 downstream (north) of the Walker Mountain Road are coincident with high density of Large Woody Debris in the channel. Orange crosses on base map (right) are locations of channel-spanning debris jams encountered in November 2005.

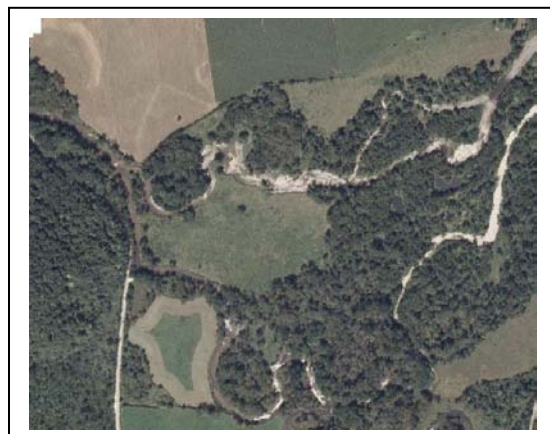
The inherent sensitivity of the geologic setting means that these study reaches are still vulnerable to future sediment or hydrologic changes from upstream and upwatershed sources. Future stressors could easily “tip the balance” for the Otter Creek main stem. Of particular concern is the current geomorphic condition of the Mill River and Cold River tributaries. Excessive sediment contributions and an apparent reduction in sediment transport capacity are noted in the vicinity of the Mill River confluence with the Otter Creek (Figure 11).

Figure 11. Excessive sedimentation in the Mill River near the confluence with Otter Creek in reach M22.

- 4) Phase 1 and 2 geomorphic assessments on the Cold and Mill Rivers should be undertaken to understand the current geomorphic condition and adjustment processes ongoing in these major tributaries. To date, the condition of the Otter Creek main stem in reaches receiving these discharges does not appear to be in significant adjustment. However, the Otter Creek main stem remains highly sensitive to potential changes in or imbalances of sediment and hydrologic loading from these major tributaries.
