Upper Otter Creek

Phase 2 Geomorphic Assessment & Preliminary Restoration Project Identification

Rutland County, Vermont

January 21, 2009

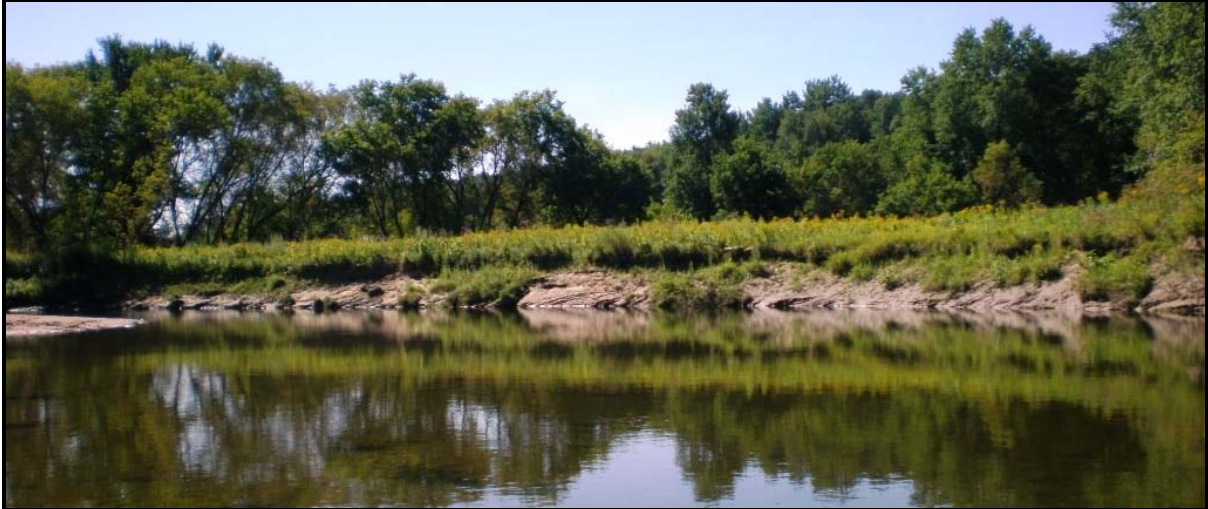
Figure 9: Reaches such as M18 are susceptible to thermal pollution due to lack of shading.

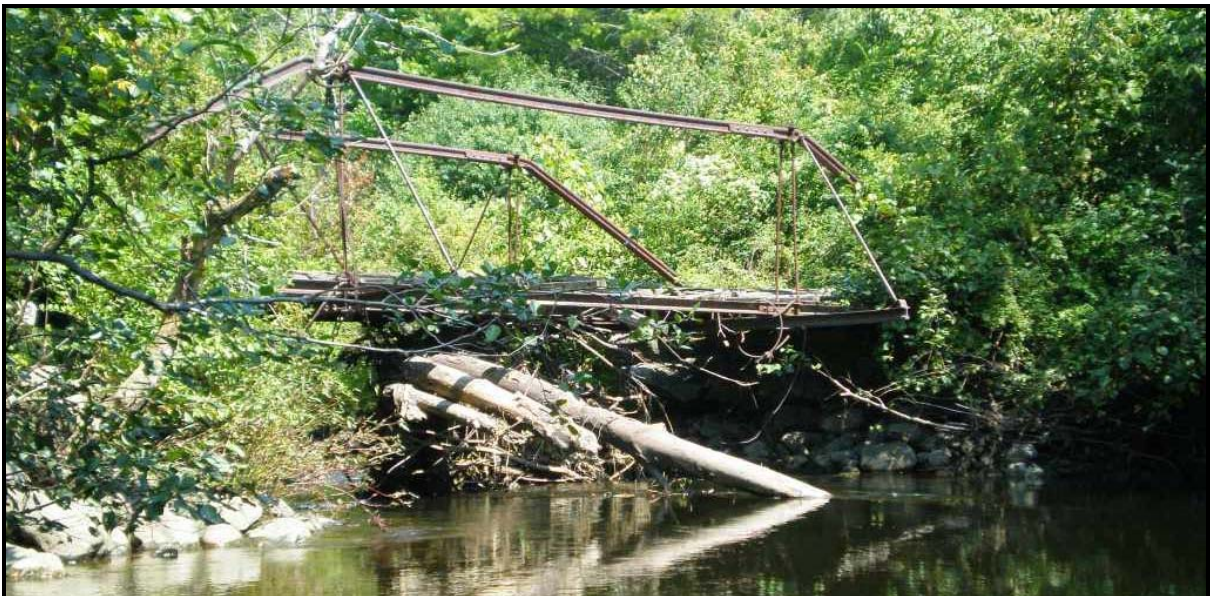
Figure 11: The abandoned bridge (M29) is similar to several nearly abandoned crossings that are likely to cause debris and ice jams and may washout and cause further damage in a future flood.

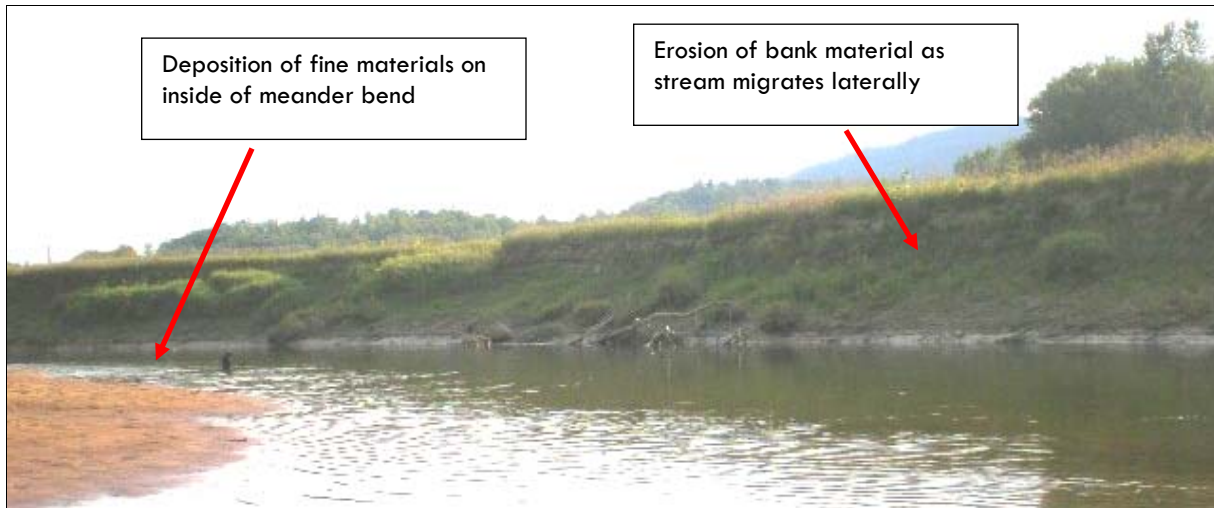
Figure 12: Planform migration associated with historic channel straightening of the Otter Creek.

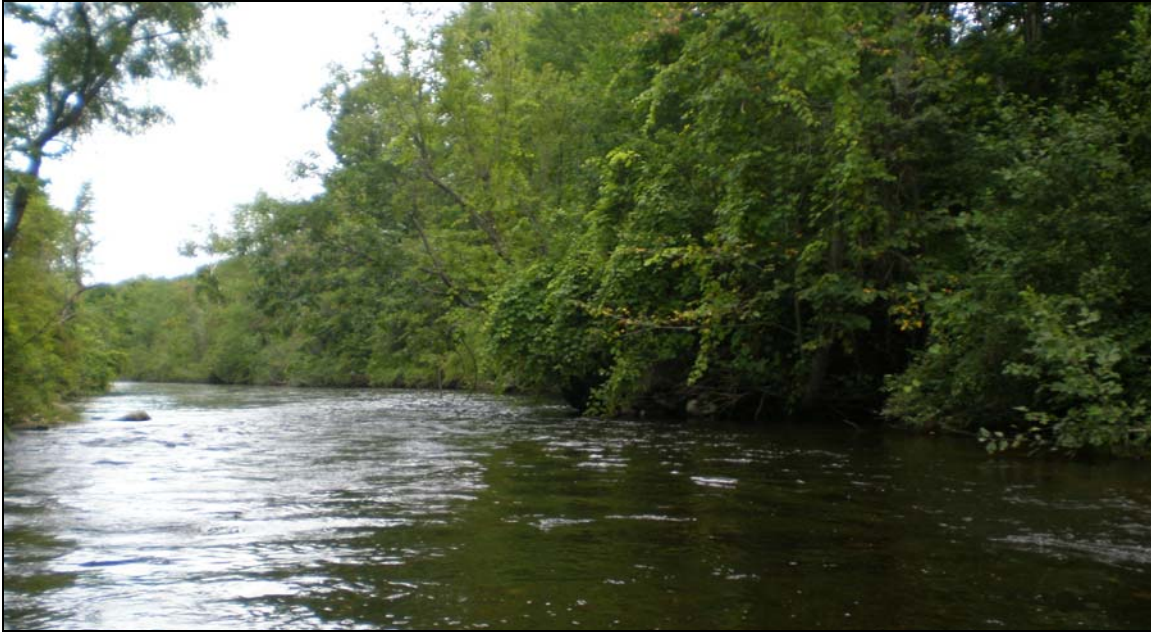
Figure 3. Reach M31 has been historically straightened and is impacted by several old stone bridge abutments and undersized bridges.

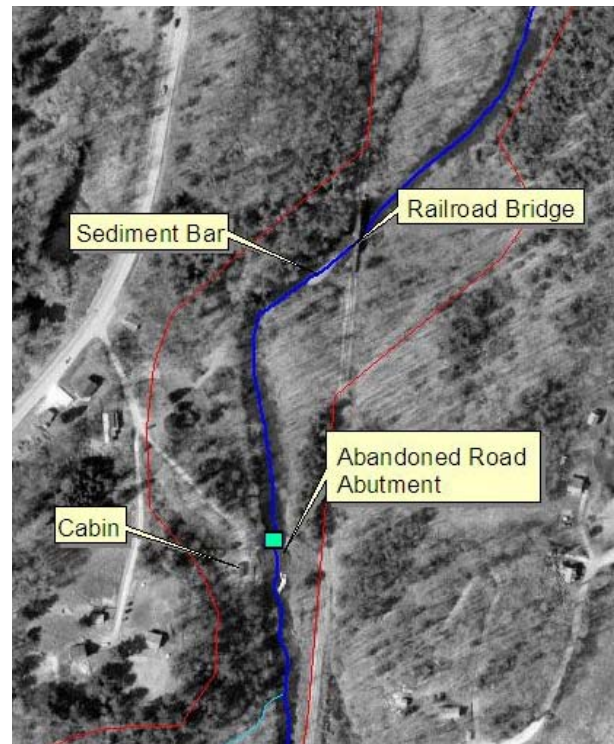
Figure 4: Examples of channel constraints, M30.

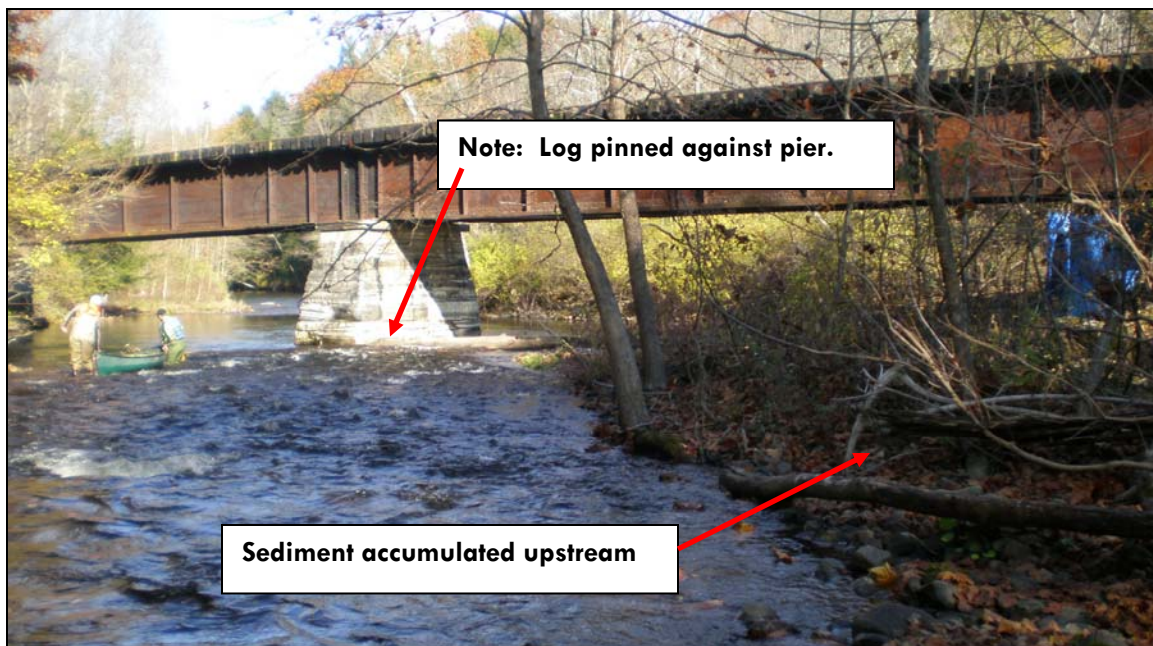
Figure 5. M30 has a steeper channel slope and is a C4 riffle-pool stream by reference. The railroad bridge is one of several disruptive structures.

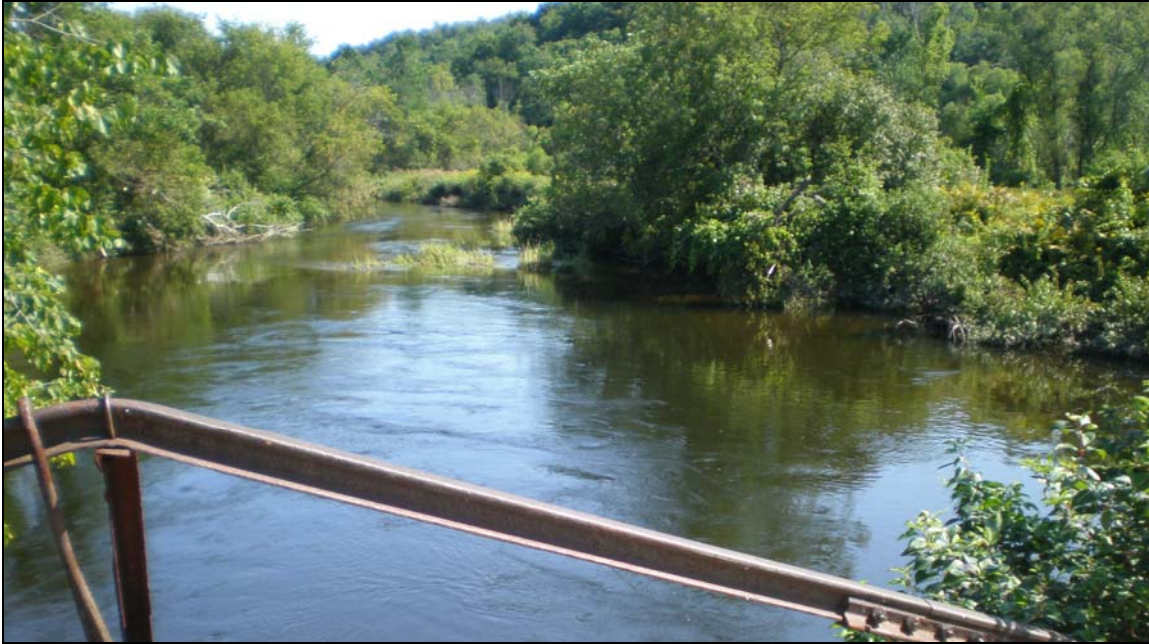
Figure 6. The view of reach M29 from one of several undersized crossing structures. Note the very wide, deep pool that has been scoured just downstream of this structure.

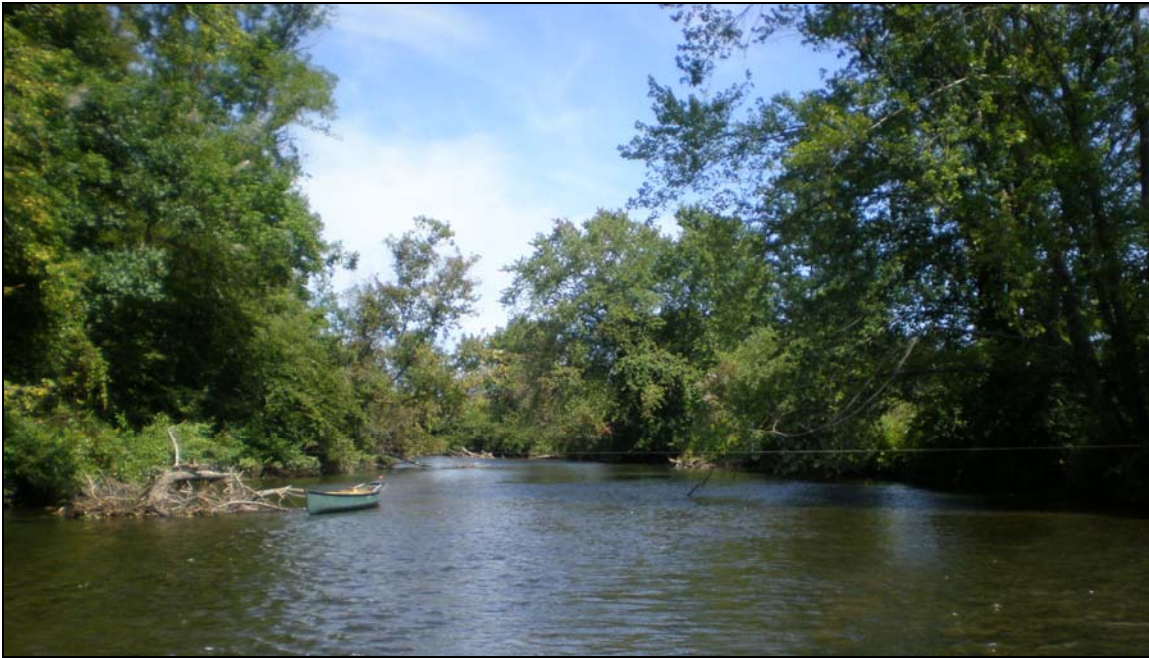
Figure 6. M28 has been significantly straightened leaving a wide, habitat-poor stream.

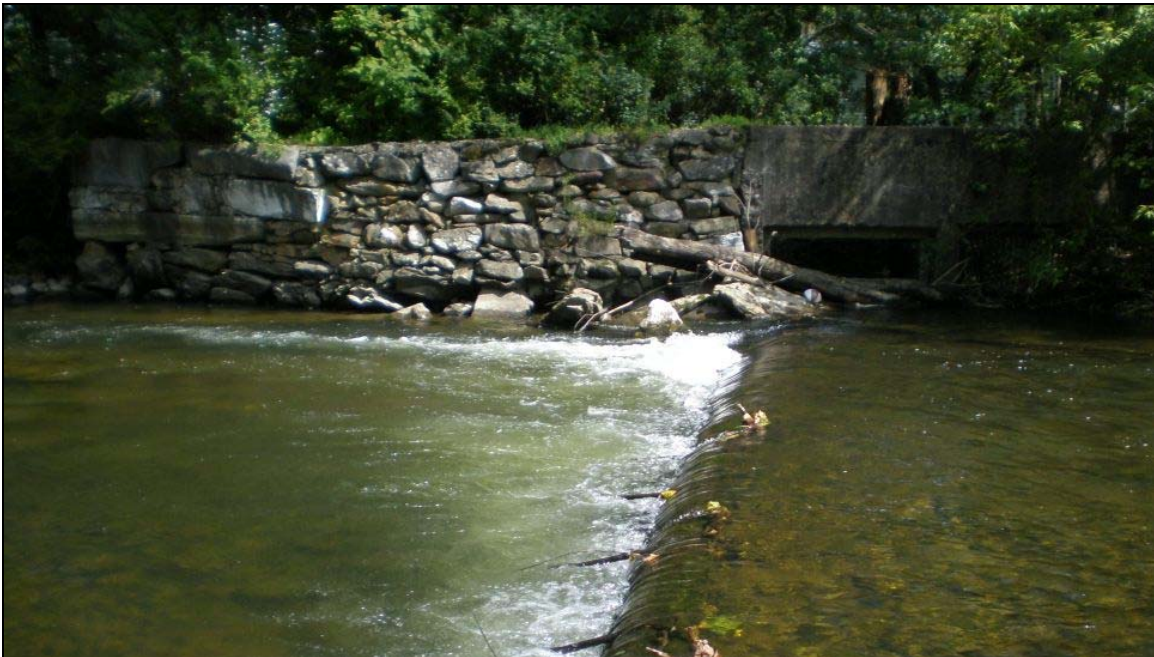
Figure 8. Recent photograph of the lower dam remnants in Wallingford Village reach M27.

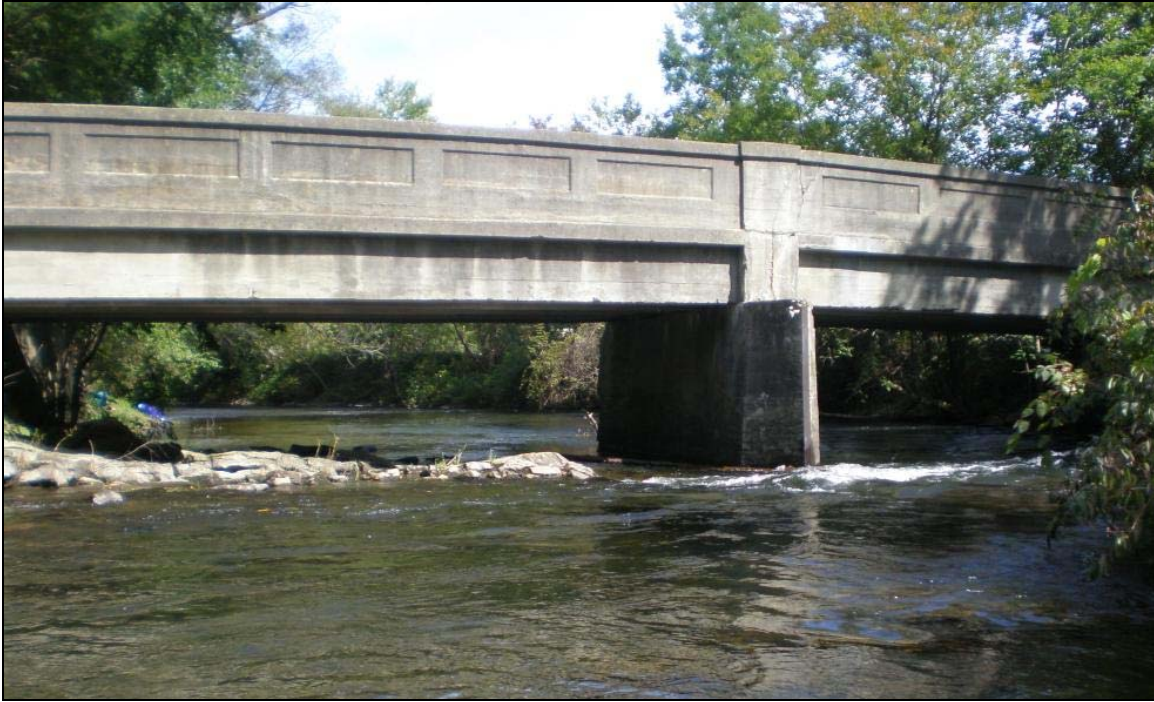
Figure 9. Bedrock and a pier block flow at the Creek Road Bridge on M27.

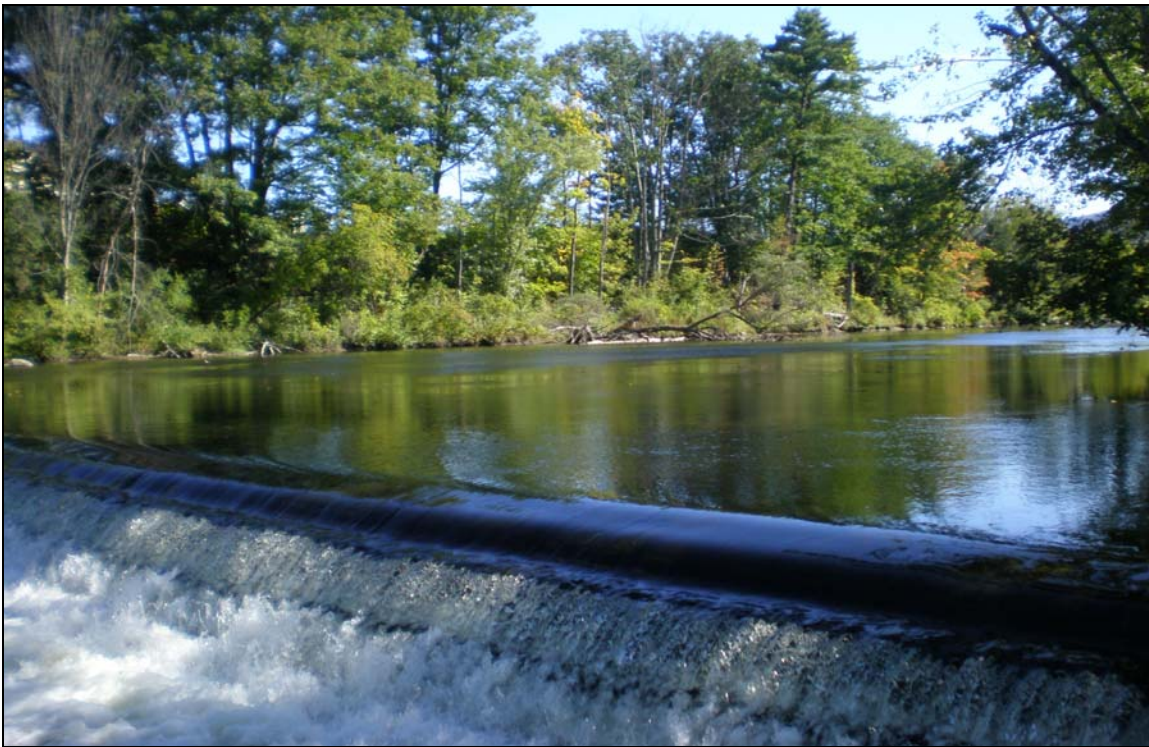
Figure 12. A small concrete dam, Ripley's Mills impedes sediment transport and alters flow at the upstream end of reach M21.

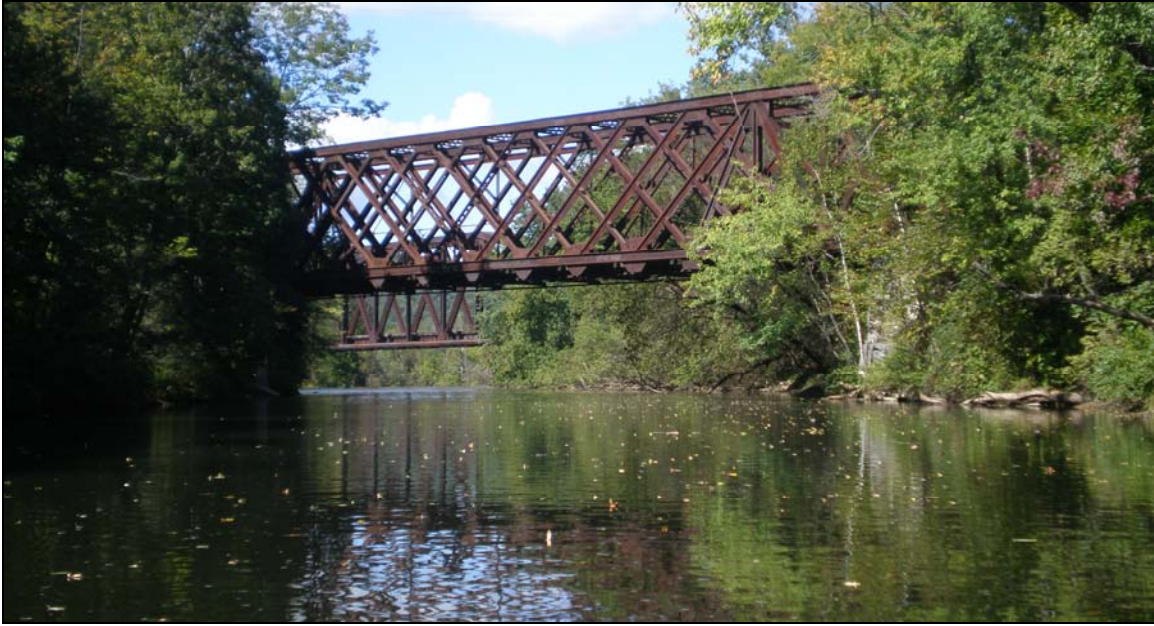
Figure 14. Dual railroad bridge crossings upstream of the Mead Falls and Omya dam which create a backwatered segment with a very low water surface slope.

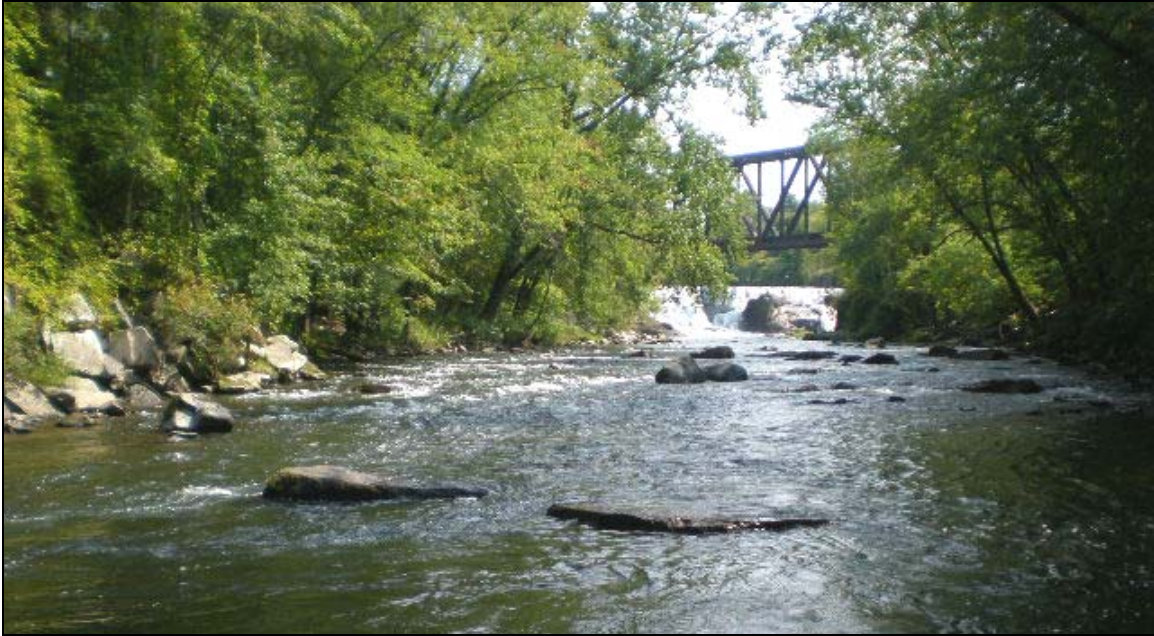
Figure 15. Upper Otter Creek segment M21-A has been altered from a C to a B channel.

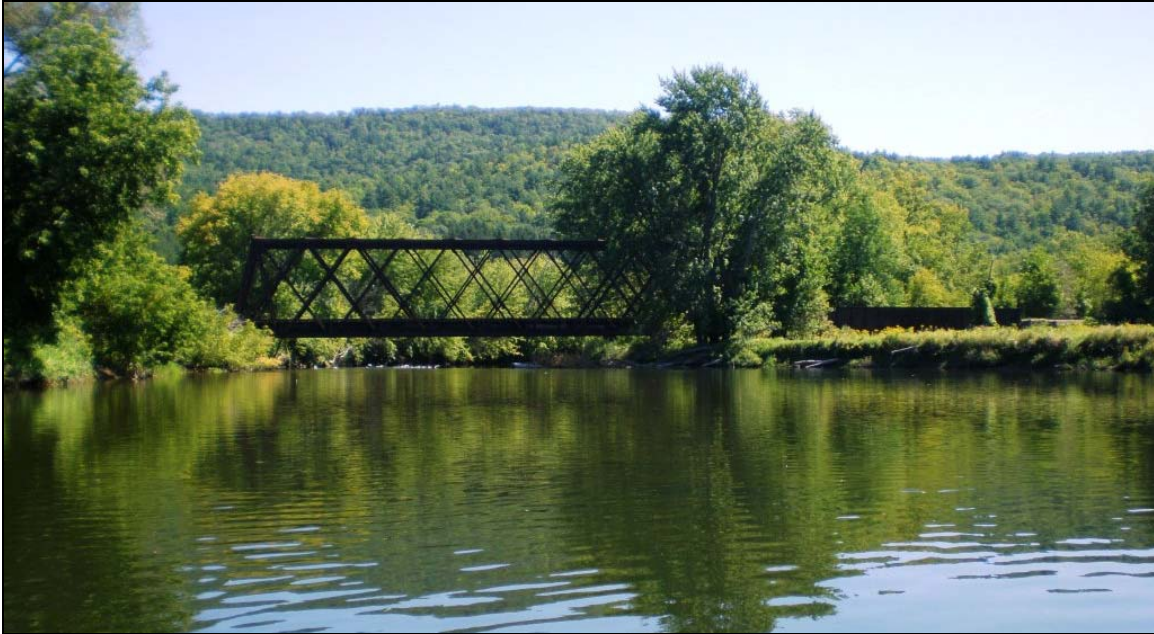
Figure 16. Two major impairments to reach M20; the railroad track and riparian forest removal for agriculture.
