# River Corridor Plan for the East Branch of the North River in Halifax and Whitingham, Vermont

December 21, 2017

Prepared by:

**Fitzgerald Environmental Associates, LLC.**  
18 Severance Green, Suite 203  
Colchester, VT 05446

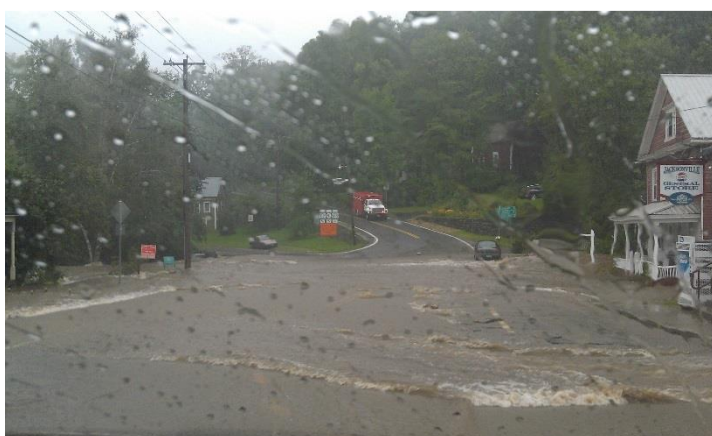
**Figure 1.5:** Floodwaters spilled out of the channel of the East Branch North River and flowed down Route 100 through Jacksonville, VT during Tropical Storm Irene in 2011 (Photo courtesy of G. Havreluk).

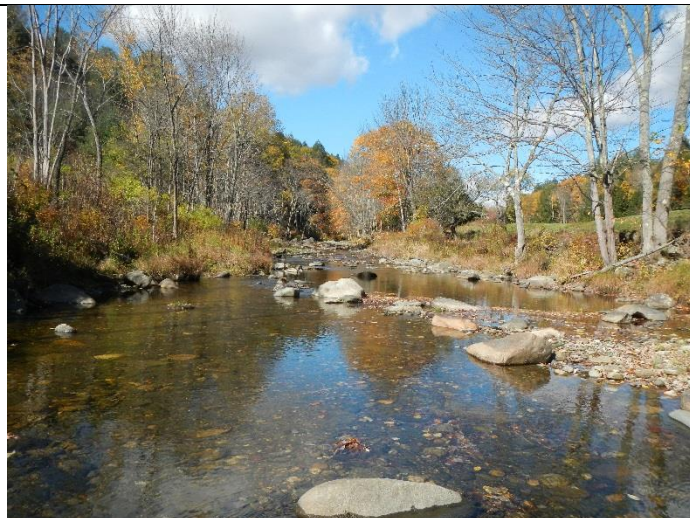
**Reach Highlights:** Historically this reach was incised due to straightening and encroachment along Route 112. A large alluvial fan is located in the upper portion of the reach, downstream of the confluence with Branch Brook. We assessed this reach as Stage II due to channel incision, but widening in some areas suggests it may be transitioning into a stage III reach. The stream departed from a C to a F-type channel due to incision and entrenchment.

Historically incised and straightened F-type channel.

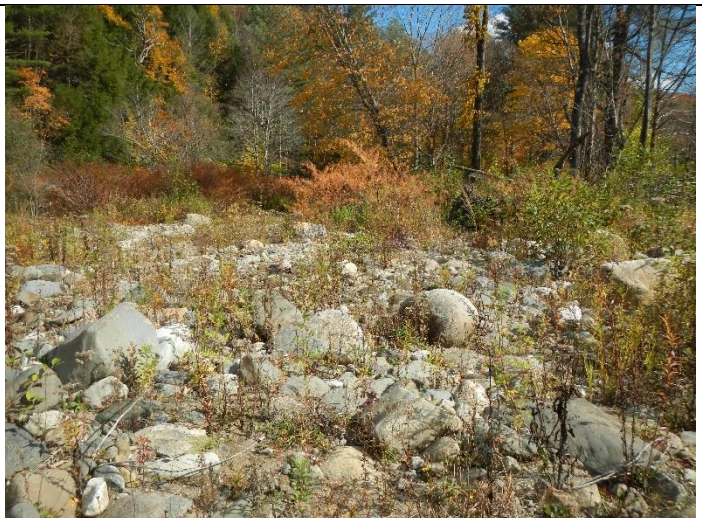
Alluvial fan deposits in the upper portion of the reach.

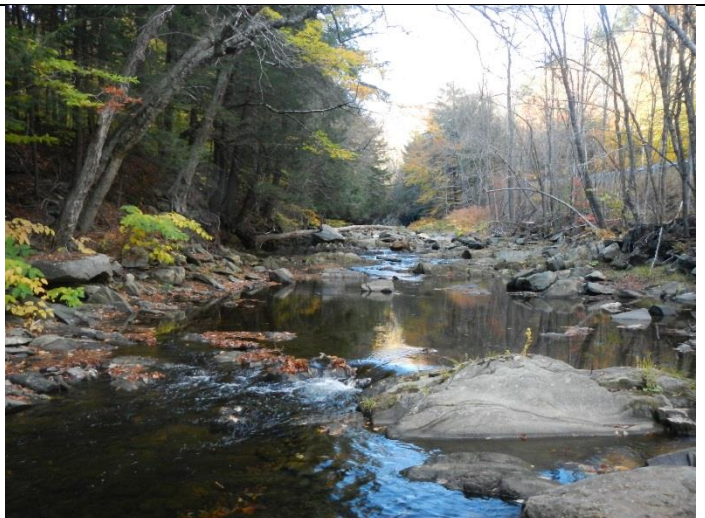
Grade controls in the upper portion of the segment, approaching a bedrock gorge.

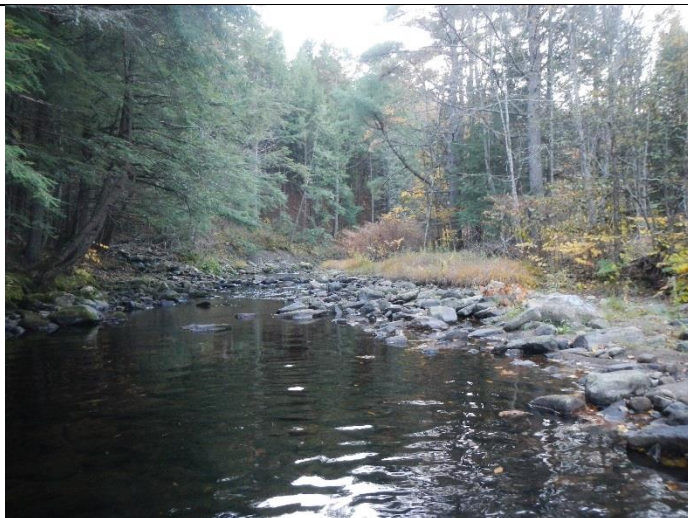
C-type channel with floodplain access.

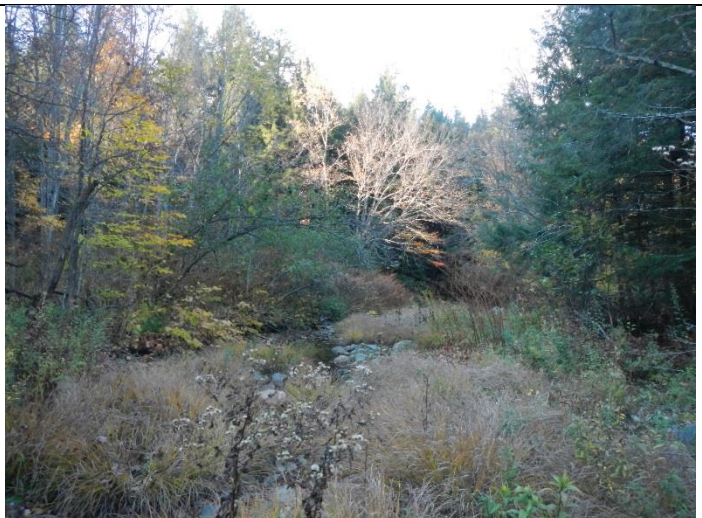
Large flood chute.

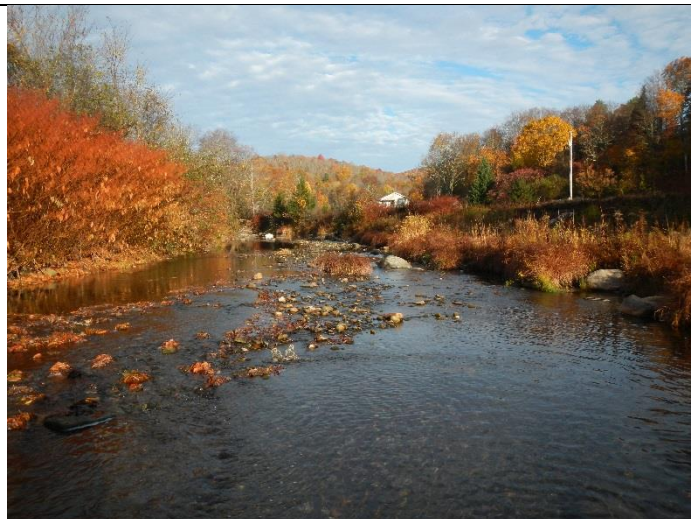
**Reach Highlights:** Historically this segment was incised due to straightening, armoring and encroachment along Route 112, which caused a stream type departure from a C to a F-type channel. We observed evidence of ongoing aggradation and recent widening. We assessed the segment as recently transitioning to Stage III, however widening and planform adjustment potential is limited due to road encroachment.

Segment upstream of beaver activity, with evidence of historic incision.

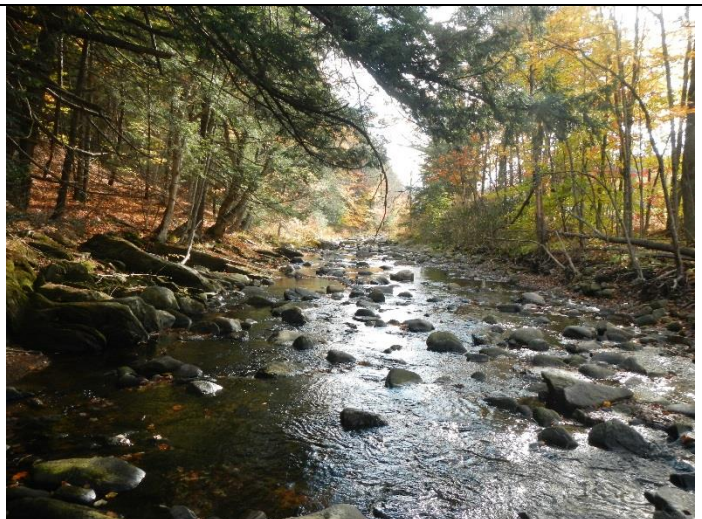
F-type channel near the top of the segment, historically incised due to straightening and encroachment.

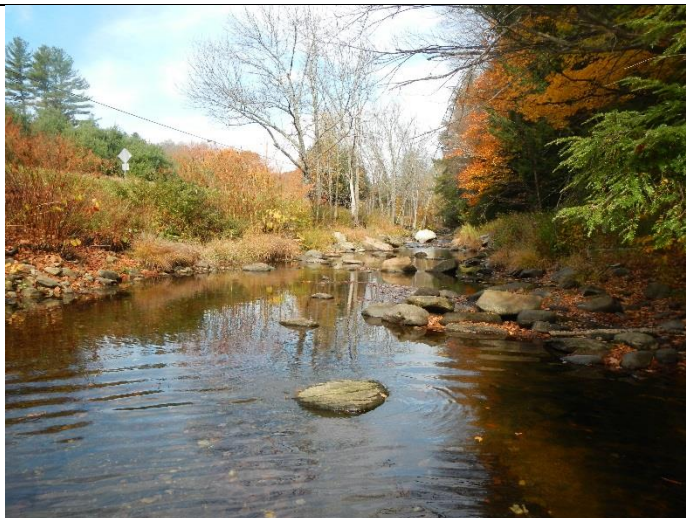
**Reach Highlights:** Historically this reach was incised due to straightening, armoring, and encroachment along Route 112. We assessed this reach as Stage II because incision and entrenchment that caused a stream type departure from a C to a F-type channel. The presence of several large flood chutes and splits in the channel suggest the channel maintains some ability to adjust planform within its valley.

F-type channel due to historic straightening and armoring.

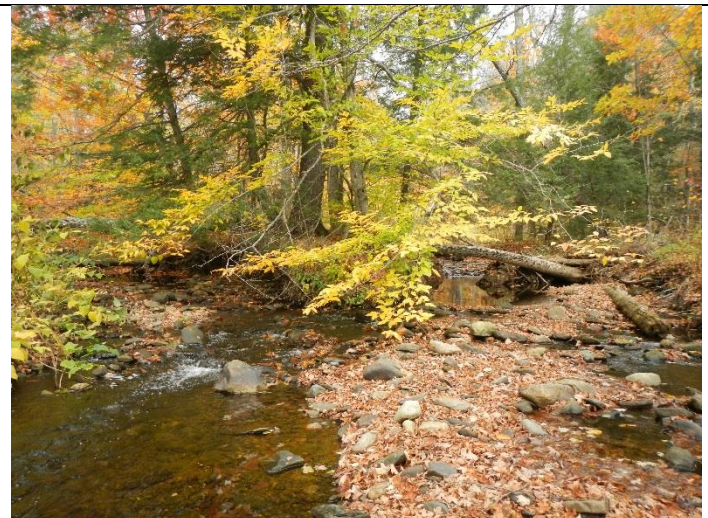
Channels converge downstream of a bifurcation.

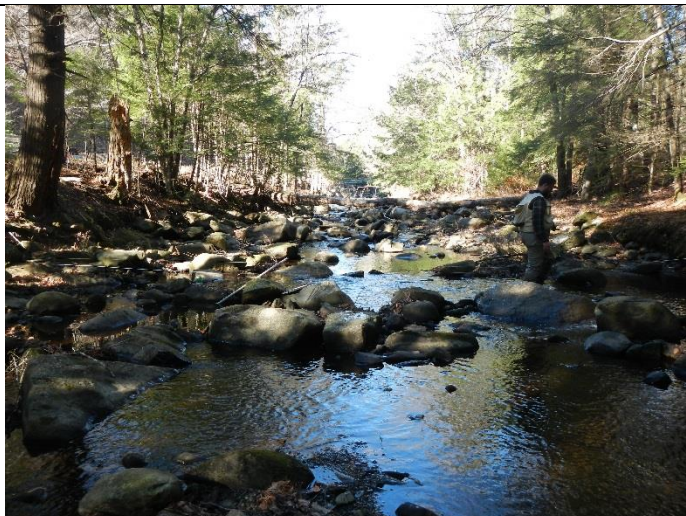
**Reach Highlights:** Historically this reach was incised due to straightening as well as armoring and encroachment along Branch Road. There was some evidence of channel widening with recent bank scour from T.S. Irene. The lower portion of the reach, near the confluence with North River, had several large flood chutes. Processes associated with incision were representative for most the reach and contributed to our assessment of the reach as Stage II.

F-type channel due to straightening and encroachment

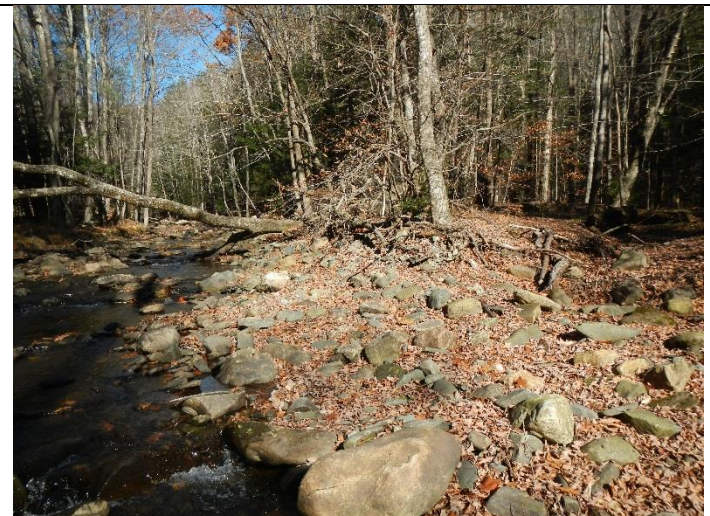
Large flood chute rejoining the channel near the confluence of Branch Brook and the North River.

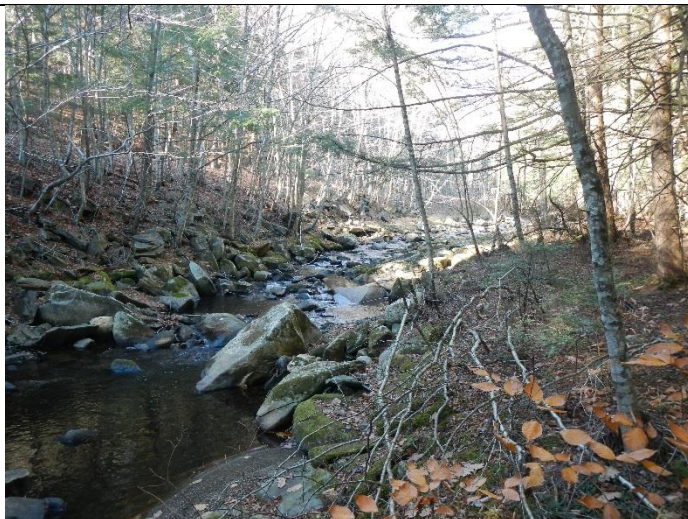
**Reach Highlights:** Historically this reach was incised due to straightening and development, as well as armoring and encroachment along Branch Road. Based on extensive scour we suspect that the channel incised during T.S. Irene. Further incision is very limited due to the presence of numerous grade controls and very large substrate throughout the reach. We observed some evidence of widening however this will be limited due to extensive road armoring and natural armoring along the banks. We assessed the reach as Stage II but it is likely slowly progressing to Stage III.

F-type channel due to straightening and encroachment.

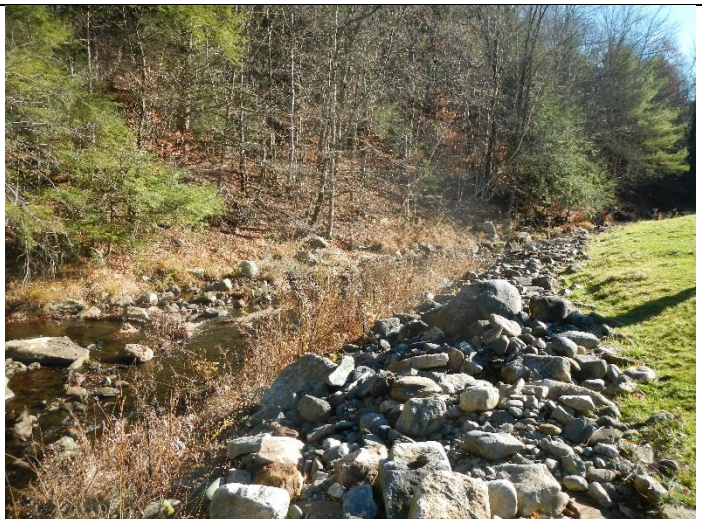
Bank straightening and armoring along cow pasture.

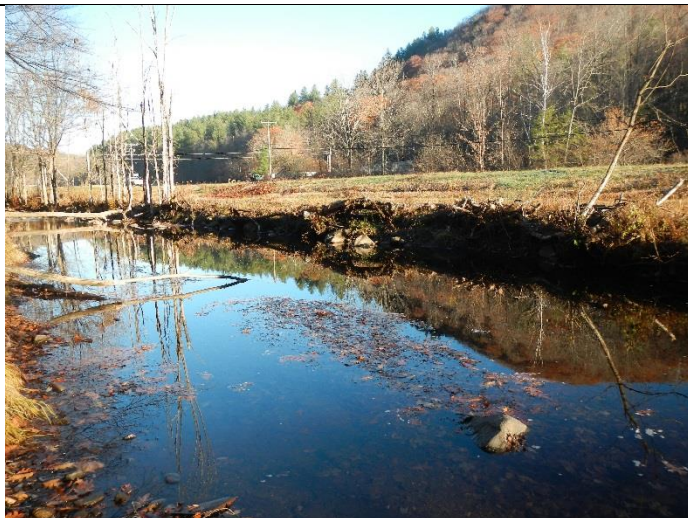
**Reach Highlights:** Historically this reach was incised due to straightening and encroachment along Route 112. We did not see evidence of much widening, aggradation or planform adjustment. Processes associated with incision contributed to our assessment of the reach as Stage II. The stream departed from a C to a B-type channel due to incision and entrenchment.

F-type channel due to historic straightening and encroachment.

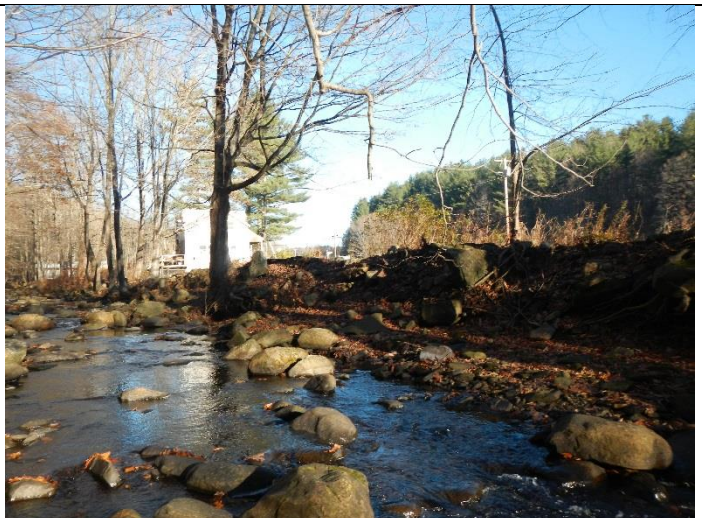
Historically straightened channel with an old berm on the left bank.

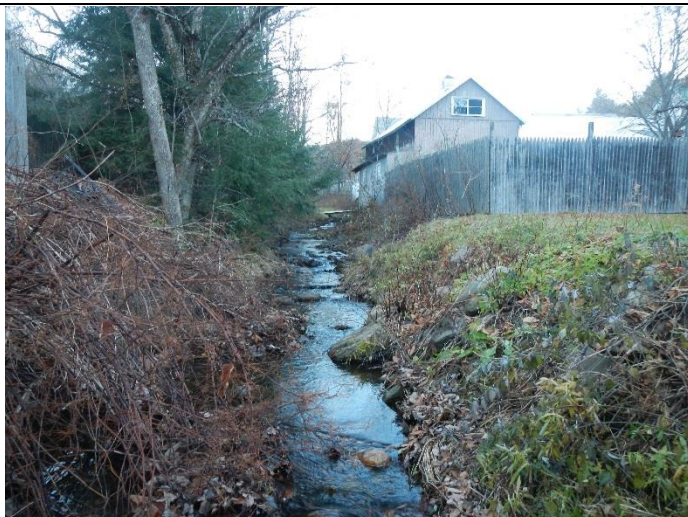
**Reach Highlights:** Historically this segment was incised due to straightening and encroachment along Route 100, as well as extensive armoring through the village of Jacksonville, VT. The armored banks prevent widening and planform adjustment. Extensive straightening has degraded channel bed features resulting in a plane bed stream. Processes associated with incision contributed to our assessment of the segment as Stage II. The stream departed from a C to a F-type channel due to incision and entrenchment.

F-type channel due to historic straightening, encroachment, and armoring.

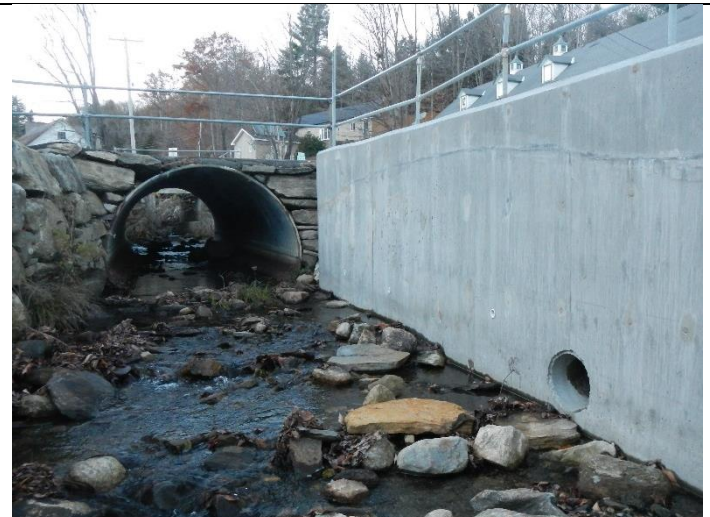
Bank armoring and constrictions at the Whitingham Municipal Complex.

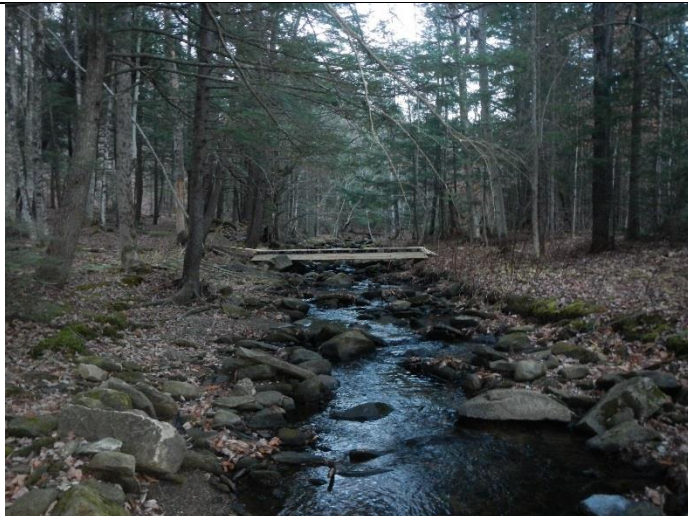
**Reach Highlights:** Historically this segment experienced some encroachment from Route 100. The channel is slightly incised and widened but has retained floodplain access and appears stable. Further incision and widening is limited by the large substrate present along the banks and channel bed. We observed increased sand and gravel through the segment, likely coming from upstream bank erosion or mass failure. The relative stability of the reach following a recent significant flood event supports our assessment as Stage I.

C-type channel in very broad valley.

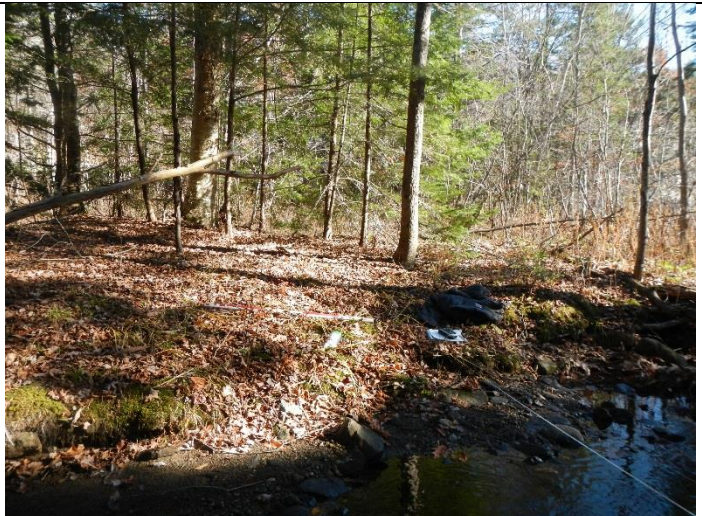
Floodplain access along channel.

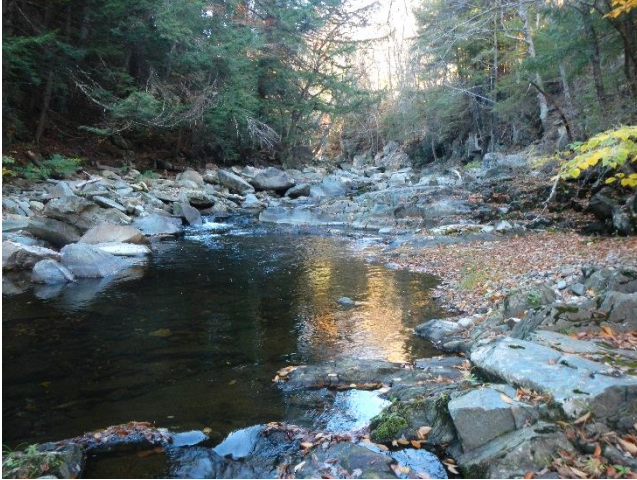
**Figure 4.6:** Grade controls in segment M03.B.

- Areas with numerous natural grade control on segments: M03.B, M03.C, M05, T1.02 (Figures 4.6 and 4.7).
- Beaver dams are located on segments M02, M04.A, M06.A (Figure 4.8) and a small cobble impoundment is located on segment M03.C (Figure 4.9).

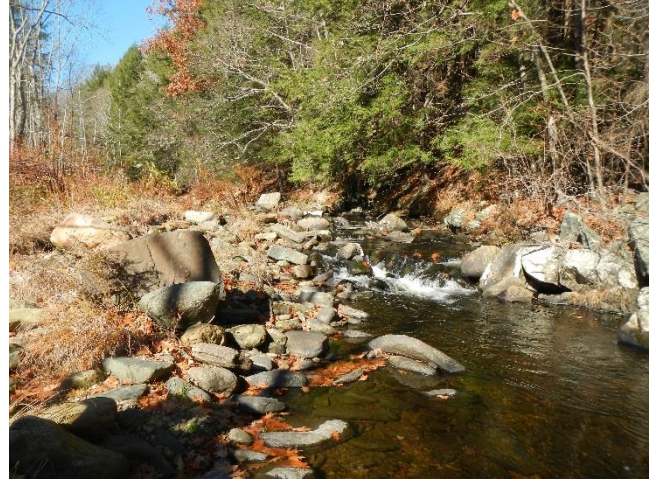
**Figure 4.7:** Grade controls in reach M05.

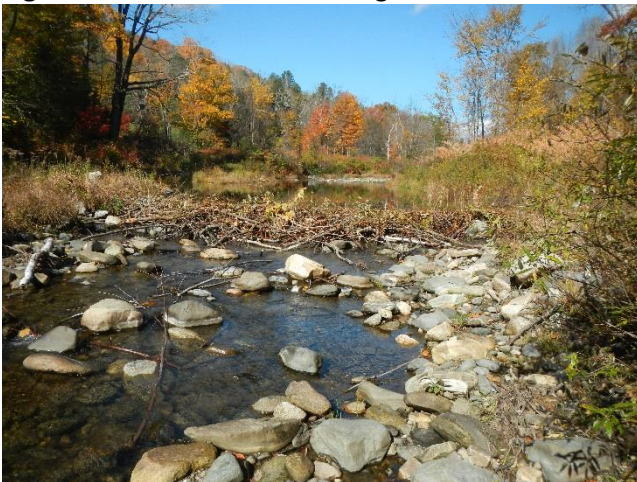
**Figure 4.8:** Beaver dam in reach M02.

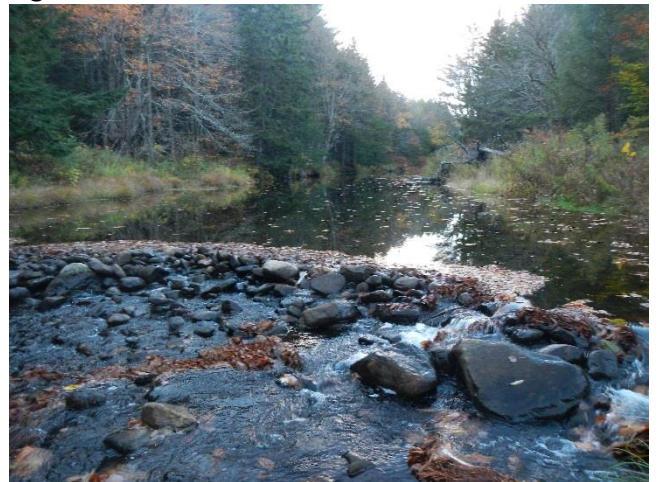
**Figure 4.9:** Small boulder & cobble impoundment in segment M03.C.

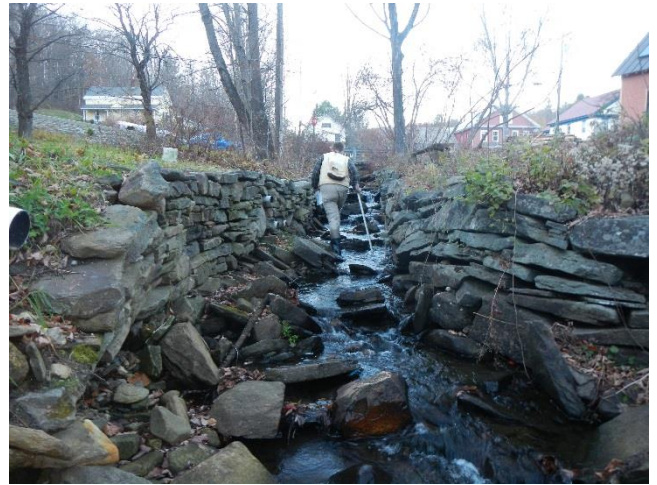
**Figure 4.11:** Extreme bank armoring on segment M07.A.

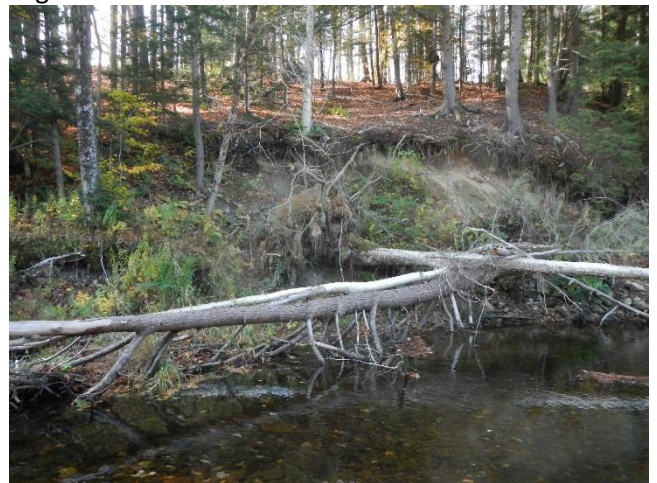
**Figure 4.15:** Mass failure on reach M05.

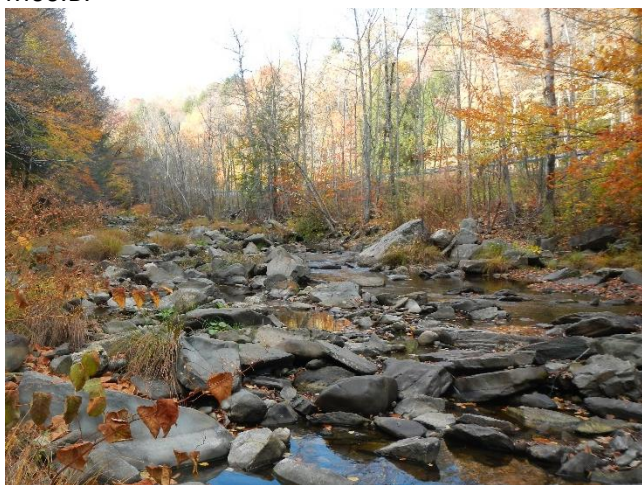
**Figure 4.19:** Extreme encroachment along Route 112 on segment M03.A.

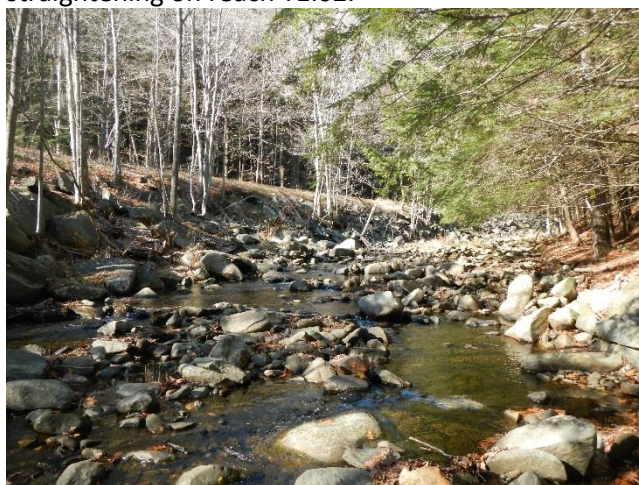
**Figure 4.20:** Extreme encroachment along Branch Road on reach T1.01.

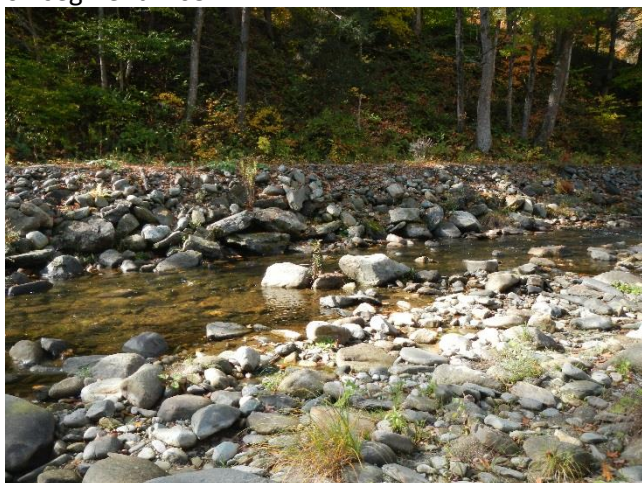
- Dredging in segments: M02, M04.A, M04.B (Figures 4.21 and 4.22).
- High density of riparian buffer width impacts in segments: M02, M03.A, M05, M06.A, M06.B, M07.A, T1.01, T1.02.

**Figure 4.21:** Dredging and windrowing on reach M02.

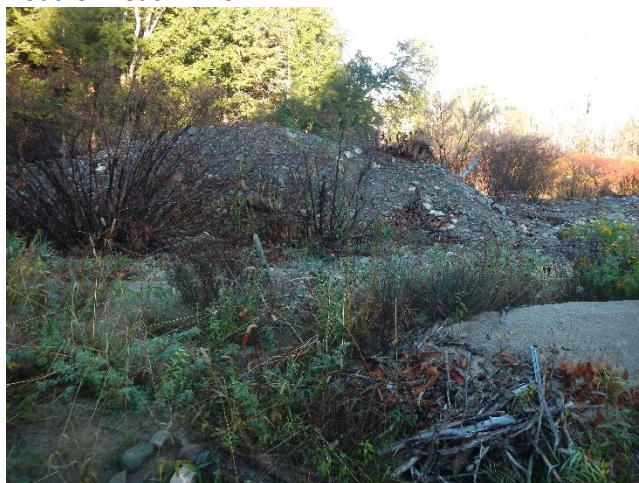
**Figure 4.22:** Dredging spoils on segment M04.A.
