# Phase 2 Stream Geomorphic Assessment Castleton River Watershed – Town of Castleton Rutland County, Vermont

March 2007 (Revised April 2008)

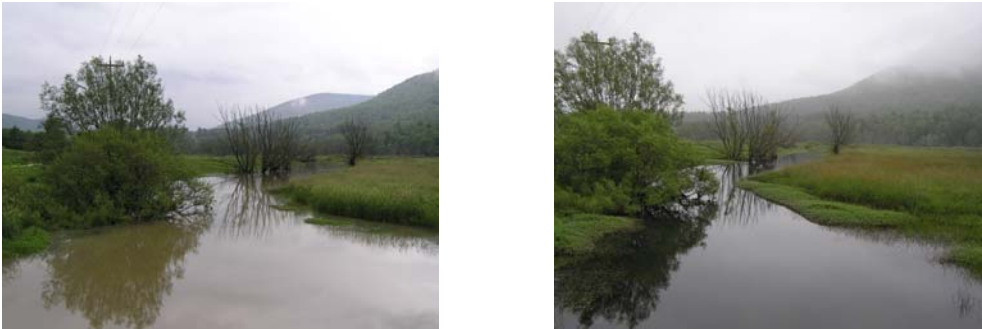
(a) (b)  
*Figure 7. View upstream (southeast) from Birdseye Road crossing at the downstream extent of reach T02.12. (a) 14 June 2005 at near bankfull condition; (b) 30 June 2005 at lower-flow conditions. Turbidity has also cleared as flows subside.*

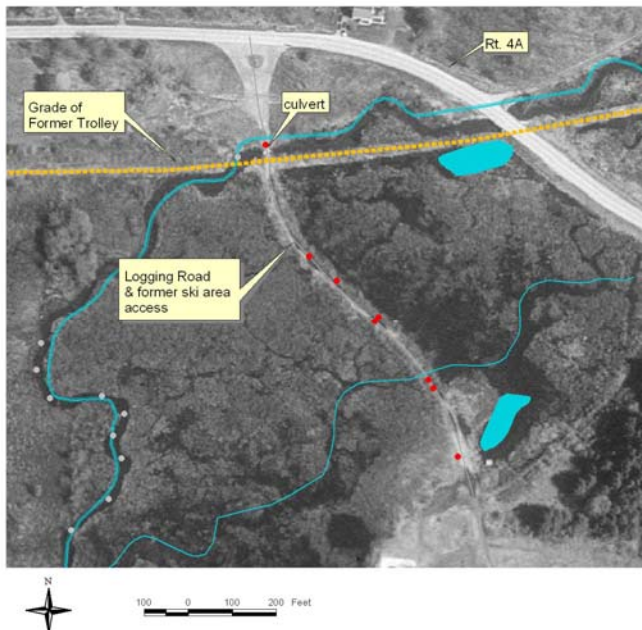
Reach T02.12 is dominated by wetland conditions, with diffuse flows through braided channels. Figure 8 shows several locations noted where flows were breaching the logging road (former ski access road) that crosses the wetlands complex downstream of the Route 4A crossing. The location of the culvert crossing is identified as a dam on the Vermont Dam Inventory (VCGI, 2003) – no construction information for this dam site was offered in the Inventory. The road which crosses the channel and wetlands at this location appears to have been constructed in the early 1960s to provide access to the Birdseye Mountain ski area that operated until the late 1960s or early 1970s (NELSAP, 2007).

*Figure 8. Red dots indicate locations where individual channel flows were crossing the logging road on 30 June 2005.*

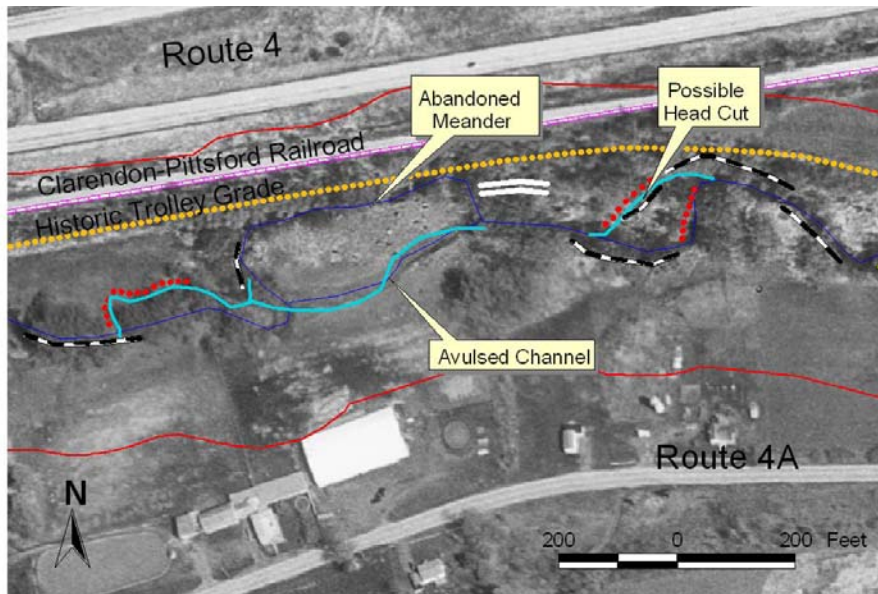
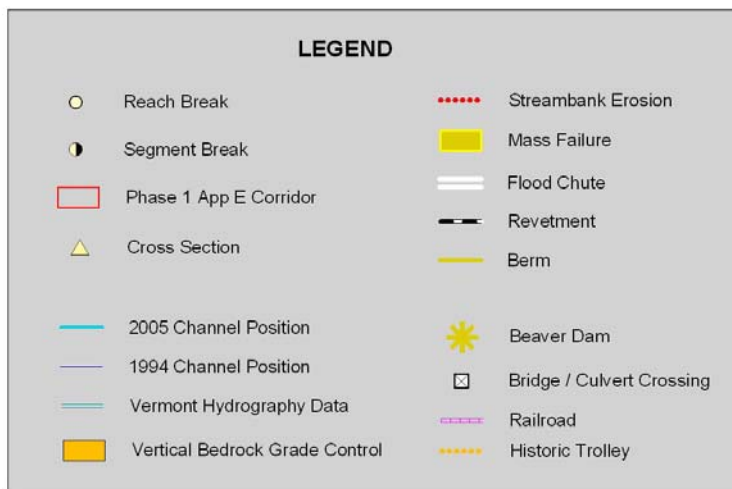
Downstream of Route 4A, at the downstream extent of Segment B near the horse stables, a recent channel avulsion is apparent. The Castleton River has abandoned a meander approximately 600 feet in length to flow approximately 400 feet through active horse pasture (see Figures 9 and 10).

Figure 9. Channel avulsion occurring pre-1994 in which Castleton River abandoned a 600-foot meander to flow along a 400-foot length of channel through horse pasture. The channel was restored to its original planform by the landowner, but had re-avulsed prior to the 2005 assessment of this reach.

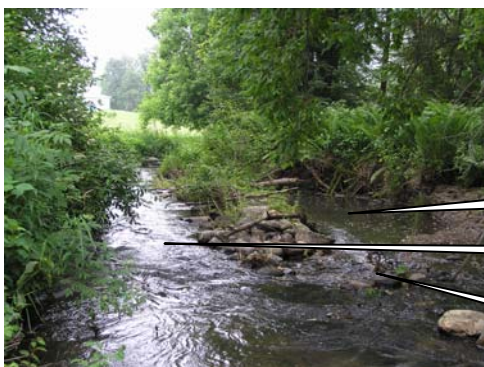
Approximately 250 feet upstream of the avulsion site, the channel is bifurcated in the vicinity of debris jam activity. The right-bank channel had then itself bifurcated to outflank a line of small rip-rap along its right bank. A steep nick point is present, where the river has eroded through a dense, cohesive surface layer of sediment to scour deeply into more erodible sediments beneath. A splitting of flows in this right-bank channel has resulted, as a portion of the flow was observed to be perched above the resistant layer, while the remainder of the flow was over the nick point into an immediately-adjacent scour pool which has eroded below the resistant layer (Figure 11). At first glance, it might appear that this nick point represents a head cut generated by incision from the avulsion site just downstream. However, the lack of an incised condition in the intermediate channel length (between the nick point and the avulsion site) suggests this nick point to be a localized phenomenon. The irregular channel form through this area may simply be the result of the layering of sediments of varying erosion resistance, exacerbated by the upstream sedimentation and downstream scour processes associated with debris jams which have since washed through. Vehicle tracks or other signs of heavy equipment use were not observed in the thickly-vegetated buffers along right and left banks.

Figure 11. Site of nick point and split flows in a right-bank channel at a larger bifurcation of Castleton River main stem, Segment B, Reach T02.11. View downstream, 30 June 2005.

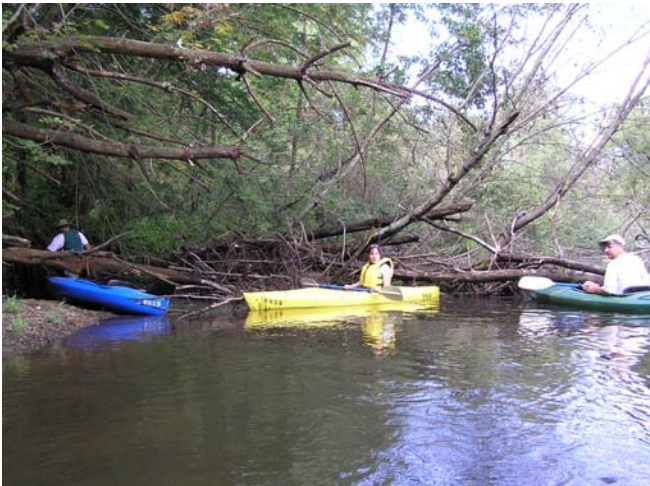
Overall, reach T02.05 is exhibiting minor degrees of adjustment - limited planform adjustment in the form of one recent (post-1994, pre-2003) neck cutoff and one pending neck cutoff associated with debris jam sites. (As with reach T02.06, a substantially different planform is represented on the 1972 USGS topographic maps).

*Figure 13. Fifteen (15) channel-spanning debris jams and 104 Large Woody Debris were recorded for the 1.5-mile length of reach T02.05.*

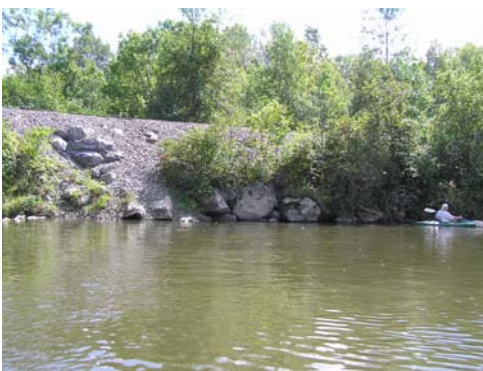
*Figure 14. Length of armorment on left bank (view facing downstream) along the Clarendon-Pittsford railroad, reach T02.04.*

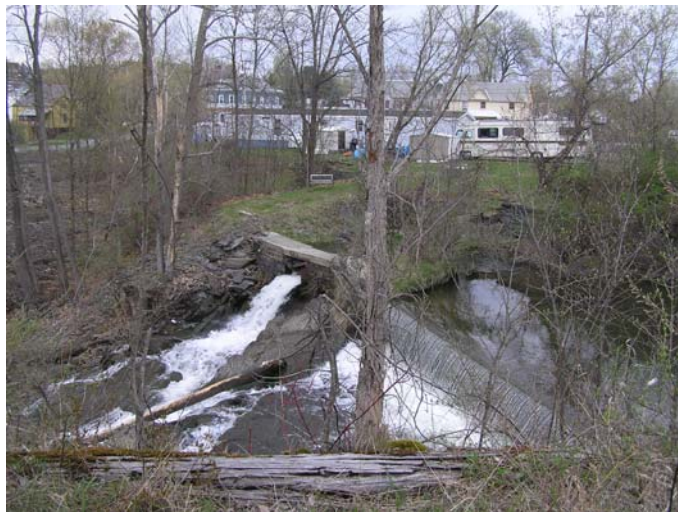
Figure 17a. Dam 2 – Structural Slate Dam, view to north from southern end of dam. Breach evident at north end. 18 May 2005, during moderate to low flows.

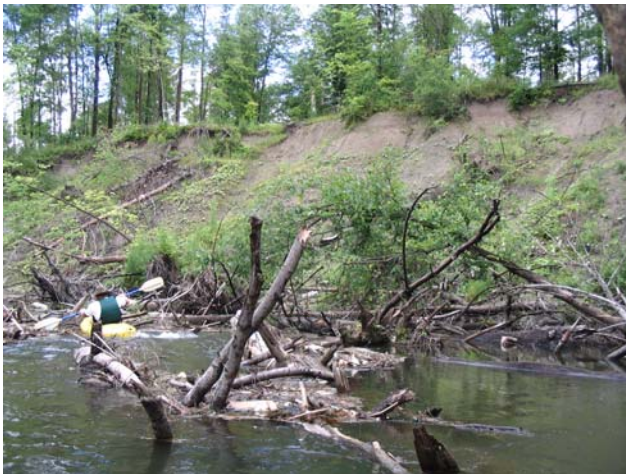
*Figure 21. Downstream of Fair Haven village, the Castleton River has incised downward through deltaic sands and underlying lake silts/clays, over the past several thousand years. These sediments are revealed in 80-foot high streambank exposures, where the river impinges on the valley walls. Reach T02.02. Pictured: Scott Lobdell, kayaking through a large woody debris jam, 13 July 2006.*

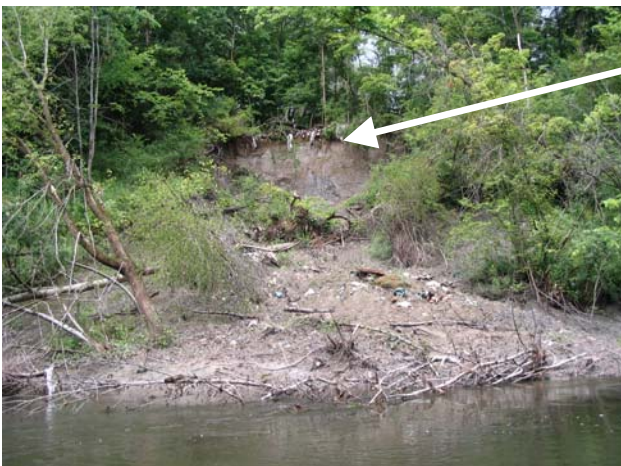
*Figure 22. High bank erosion along the right bank of the Castleton River is exposing household rubbish in the former Fair Haven landfill.*

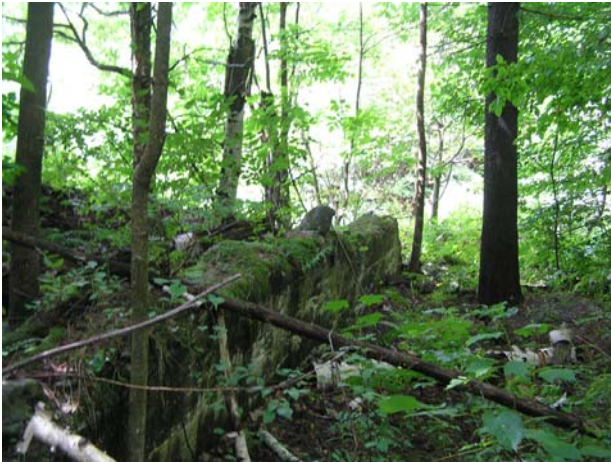
*Figure 26. T02.11-s1.04-A.  
Remnants of vertical concrete  
wall / dam at former reservoir  
site located mid-segment. View  
(to the southwest) from right  
bank corridor toward the channel  
and mill pond.*

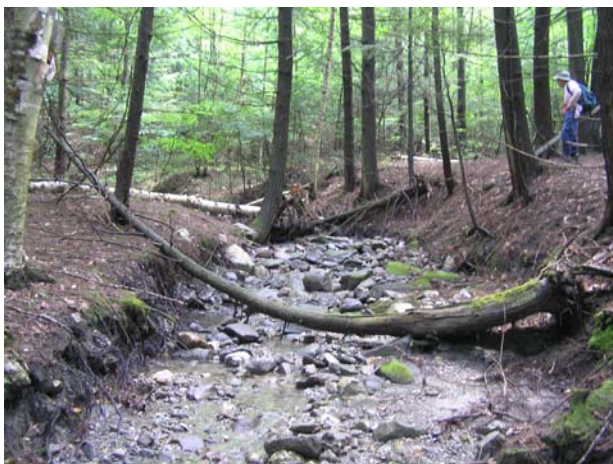
Figure 27. Right bank tributary to Gully Brook exhibiting signs of active incision and widening. (a) View upstream from confluence with Gully Brook reach T02.11-s1.03.

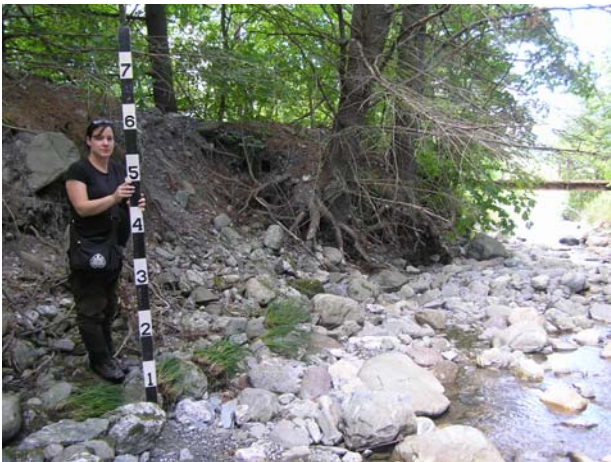
Figure 31. Gravel and cobble berm along left bank of Gully Brook upstream of Woodbury Road bridge crossing. Berm height ranges from 4 to 9 feet above channel thalweg.

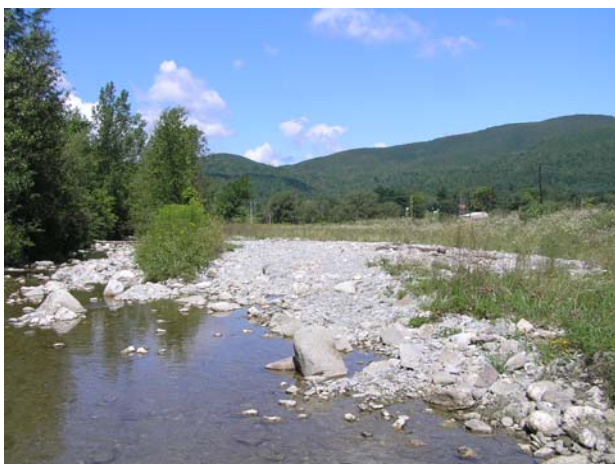
*Figure 33. Deposition of gravels, sands, and silts is active on the newly-constructed floodplain of Gully Brook reach T02.11-s1.01. View downstream from Woodbury Road bridge crossing, 8 August 2006.*

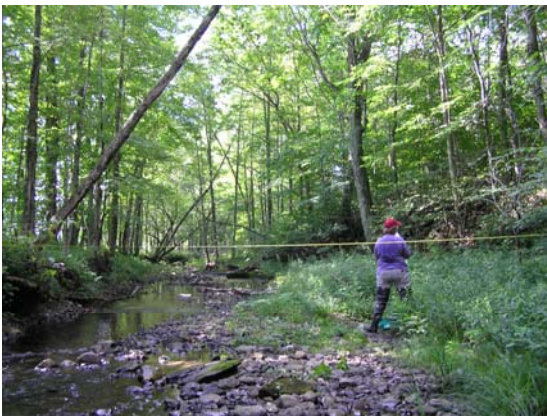
*Figure 36. In Segment T02.09-s1.04-E, North Bretton Brook is incised ( $IR= 2.2$ ) between the bedrock-controlled right valley wall and corn fields along left bank. View downstream, 2 August 2005*

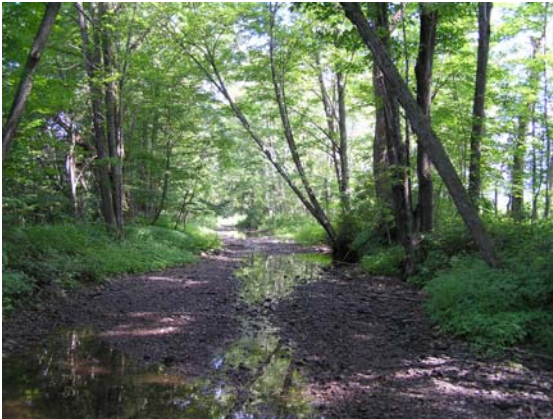
*Figure 37. Approximately 700 feet of dry streambed in channelized, bermed section of T02.09-s1.04, Segment D. View downstream.*

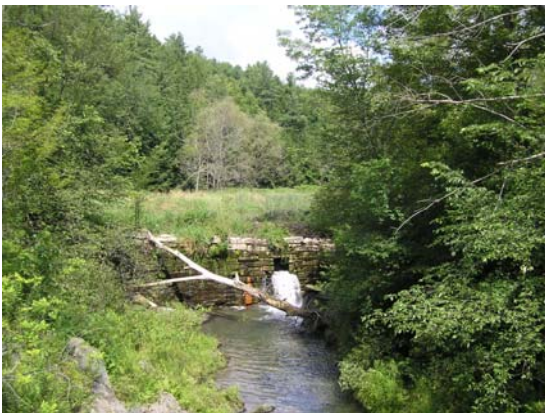
*Figure 38. Pelletier dam is coincident with the downstream reach break for T02.09-s1.02. A wetland (former mill pond) is present upstream of the dam for a distance of approximately 400 feet. View upstream from East Hubbardton Rd bridge crossing.*

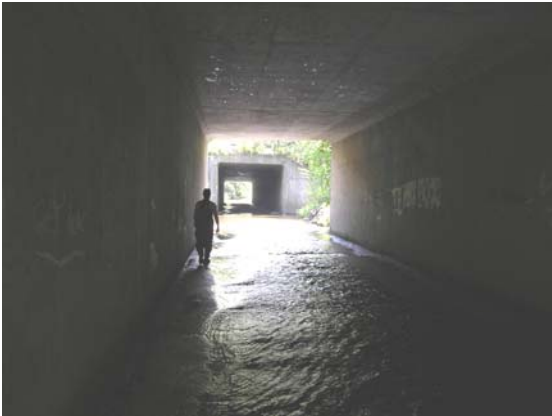
*Figure 40. Route 4 highway box culvert crossing structures. View downstream; foreground is box culvert under exit ramp approximately 90 feet long; background is culvert under Route 4 east-bound and west-bound lanes, approximately 220 feet long.*

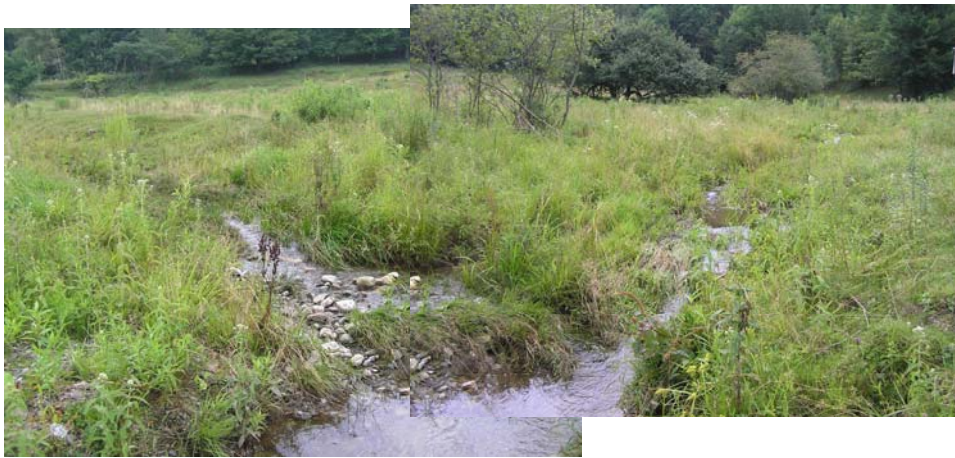
Figure 44. T02.08-s1.05-D. Small "delta" of gravels and sands at confluence of right-bank ephemeral stream channel with Pond Hill Brook. View upstream, 25 July 2006.

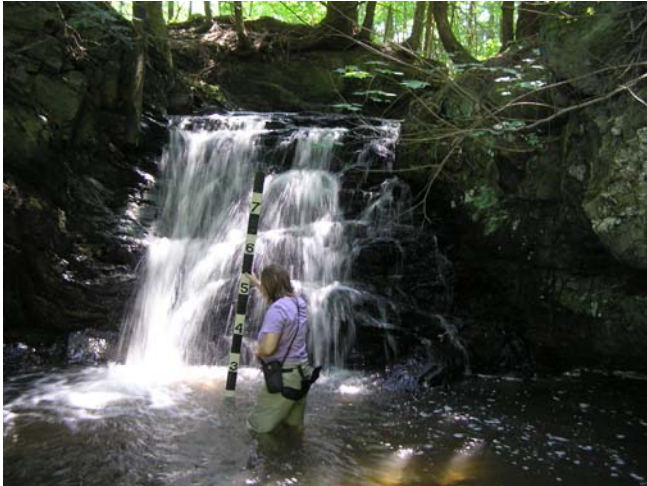
*Figure 49.  
Waterfall in Segment A of T02.08-  
s1.04, as Pond Hill Brook  
transitions from an unconfined  
valley setting back to a narrowly-  
confined steep bedrock channel.*

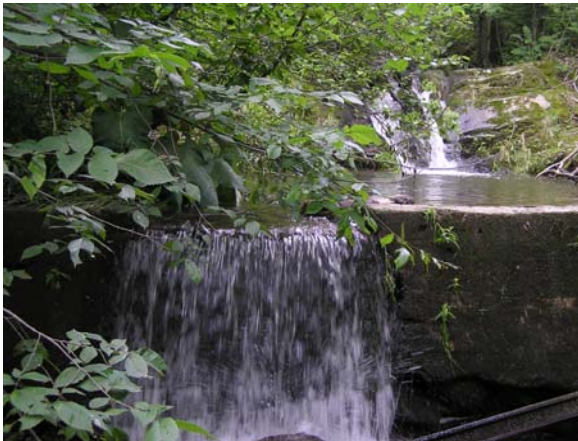
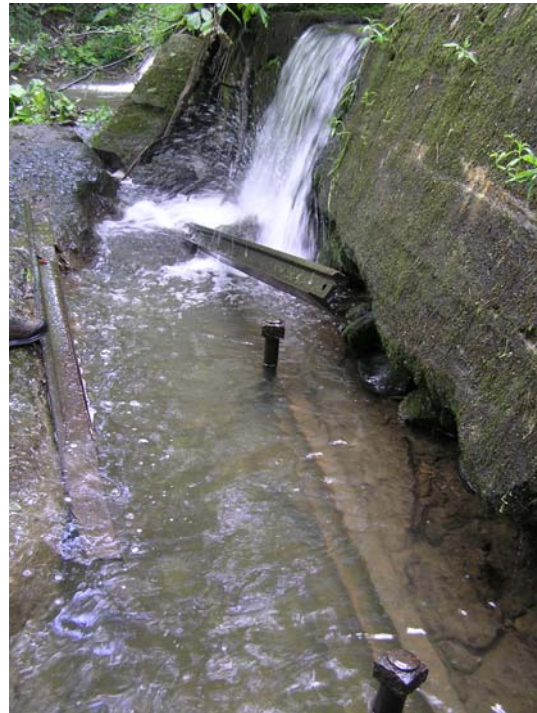
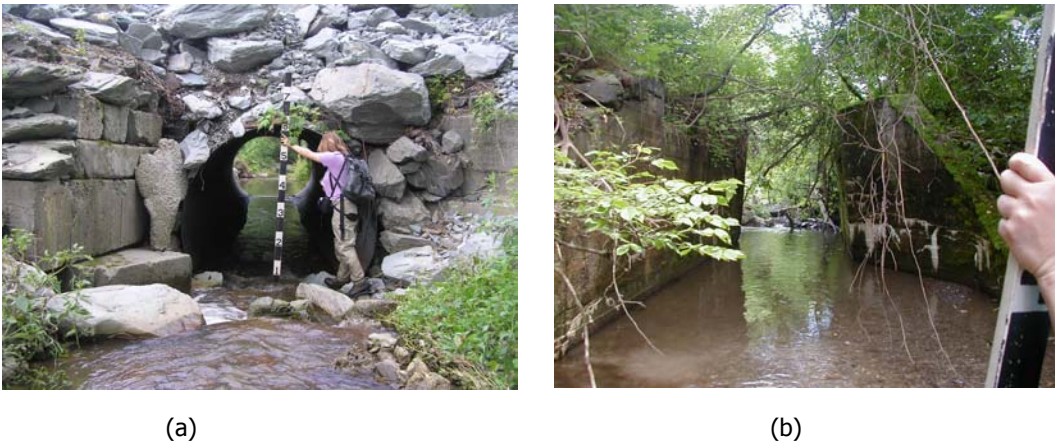
Figure 55. Constriction along reach T02.08-s1.02 of Pond Hill Brook. (a) Culvert crossing for driveway to Hadeka Stone Corporation off Staso Road; view downstream to the culvert inlet. (b) Old abutments approximately 300 feet downstream from culvert crossing; view downstream.

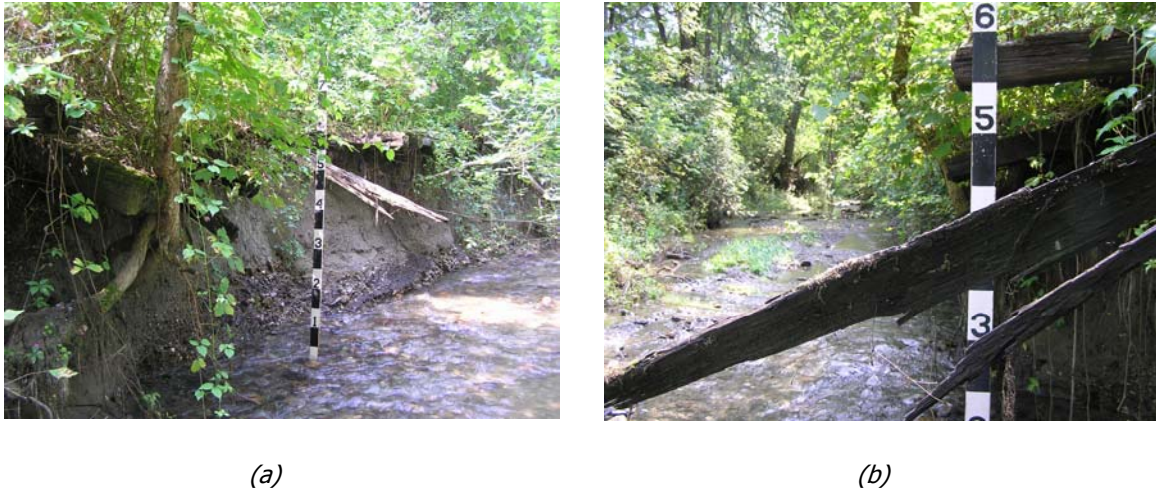
*Figure 58. Pond Hill Brook is regaining sinuosity and building new floodplain through by actively eroding the bed of the abandoned railroad spur leading to the former Staso Milling Company (Segment E of reach T02.08-s1.01). (a) view downstream to left bank; (b) view upstream from left bank, railroad ties are undermined and collapsing into the channel. Viewed 31 July 2006.*
