**FLUVIAL GEOMORPHOLOGY ASSESSMENT:
MIDDLEBURY RIVER WATERSHED
ADDISON COUNTY, VERMONT**

August 2003

Kristen L. Underwood, P.G.

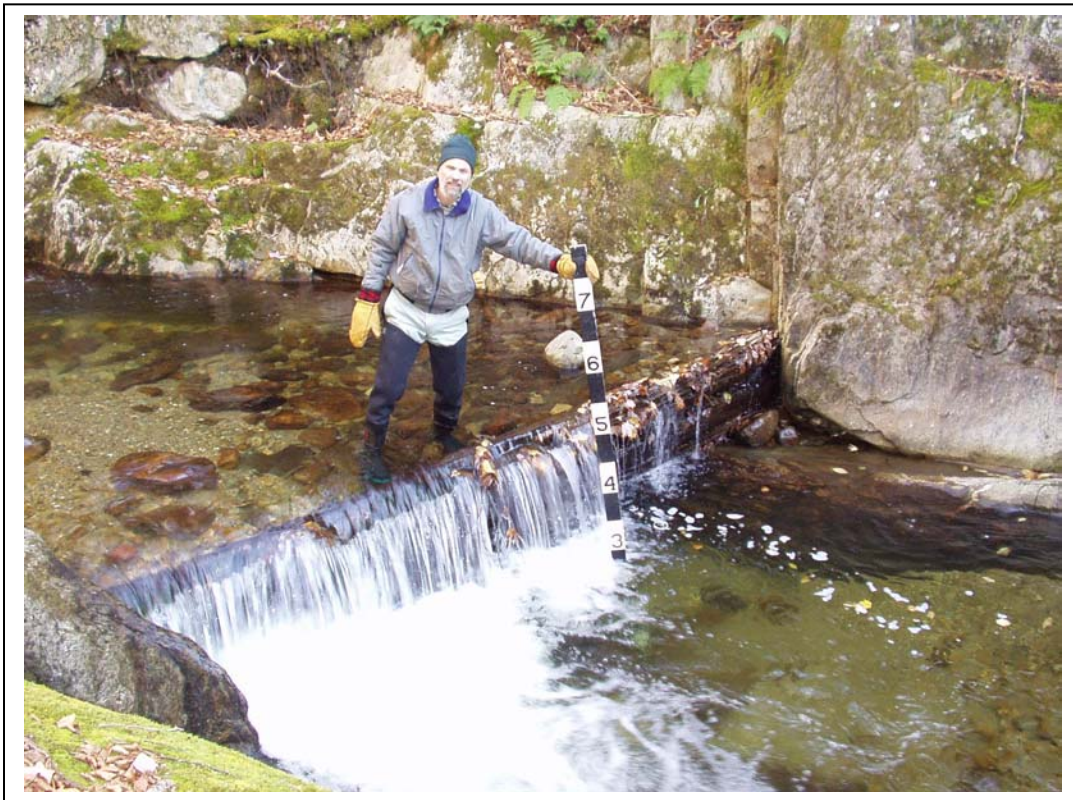
Photo 1. Dam across Middle Branch (Reach M14) in approximate location of D.C. Sherman mill dam noted on 1871 Beers Atlas of Ripton, VT. (Warren King pictured)

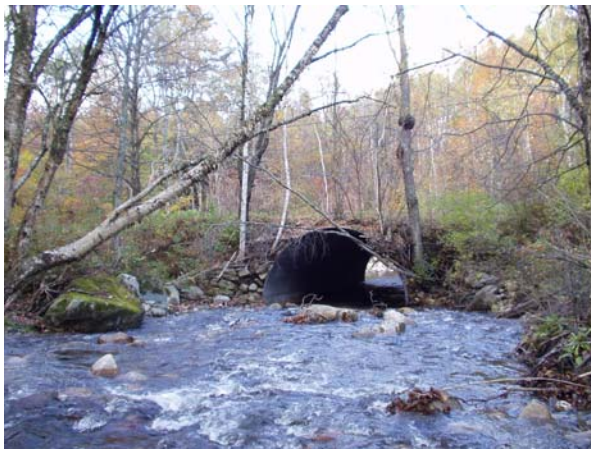
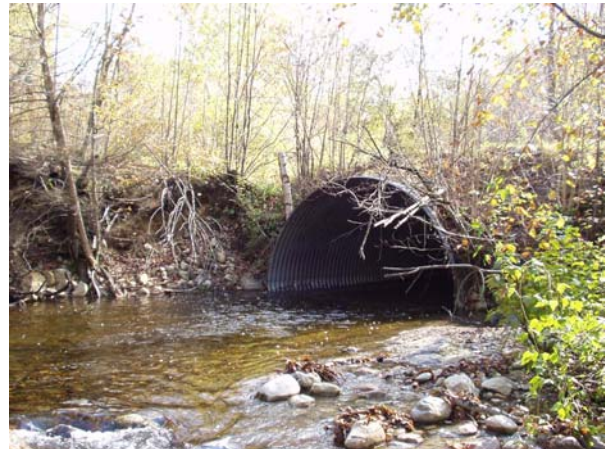
Figure 11. In-stream culvert on Peddlers Bridge Road crossing of Middle Branch, Reach M13 – (a) upstream approach depicts culvert width (16 ft) undersized with respect to the measured bankfull width (40.5 ft) – (b) constriction of flow through the culvert has lead to vertical scour on the downstream end of the culvert, as well as excessive lateral scour along the right bank of the stream channel which has migrated upstream and poses risk to the integrity of the fill material surrounding the culvert.

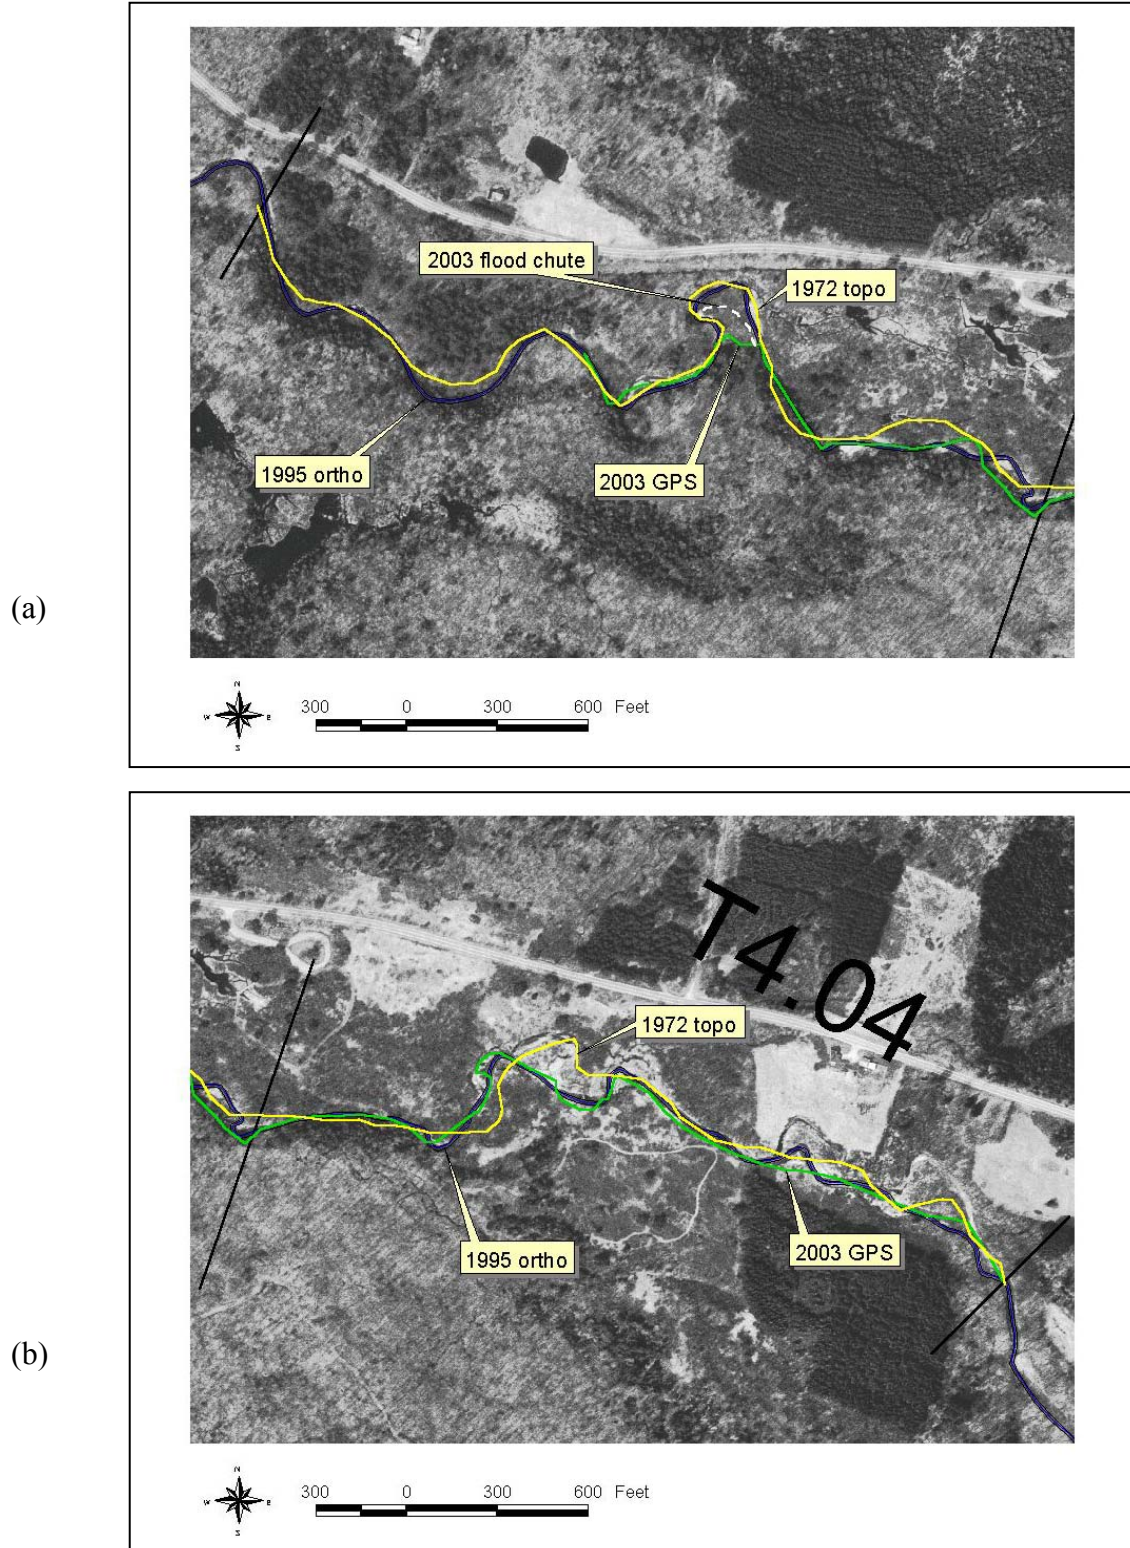
Figure 12. History of lateral channel migration, Reaches T3.03 (a) and T3.04 (b), South Branch, Ripton.

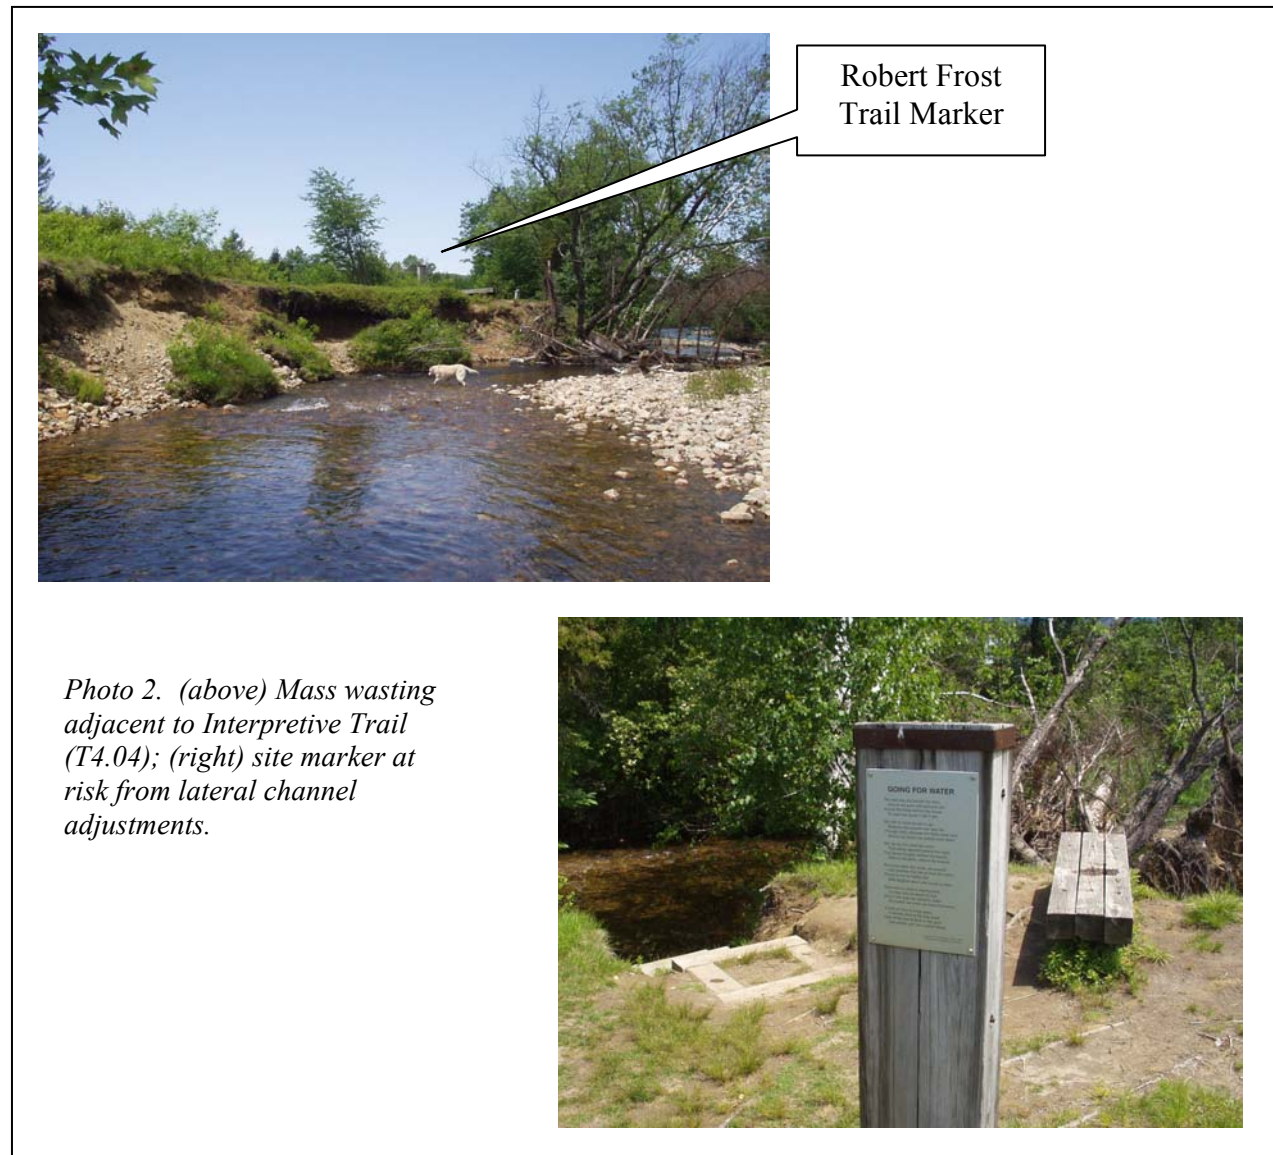
Reaches T4.04 and T4.03 are the subject of a restoration project being undertaken by the Green Mountain National Forest (Beck, 2002). Phase 3 geomorphic assessments were conducted in support of this restoration project as part of this Middlebury River watershed study, and are presented in Section 6.3. Infrastructure including a footpath bridge over the South Branch and site marker stations of the Robert Frost interpretive trail are at risk from lateral and vertical channel migrations through these reaches (Photo 2).

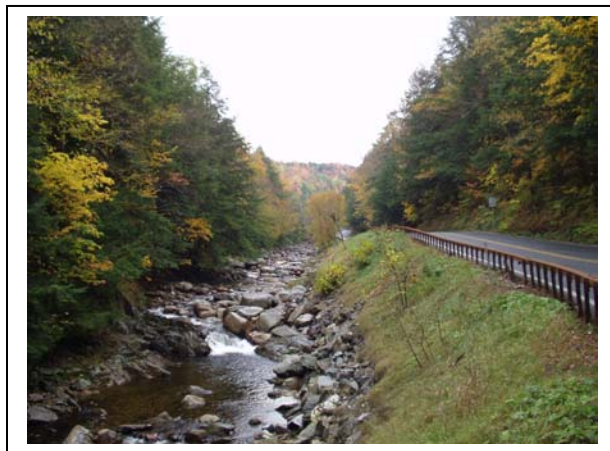
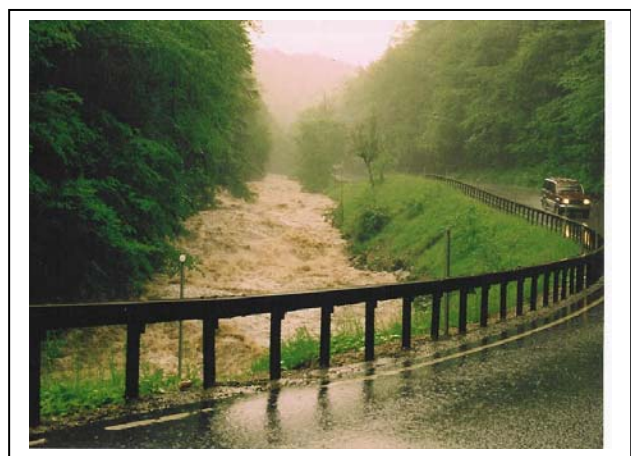
The majority of Reach M11 shares a narrow steep valley with Rt. 125 (Photo 4). Several hundred feet of rip-rap line the left bank of the river along this main road. Culverts convey stormwater runoff and tributaries from the left corridor under Rt. 125 to the stream channel.

Photo 4. Middlebury River along Rt. 125 (Reach M11) at base flow conditions in October 2002 (a) and during flood conditions in June 1996 (b) – view upstream.

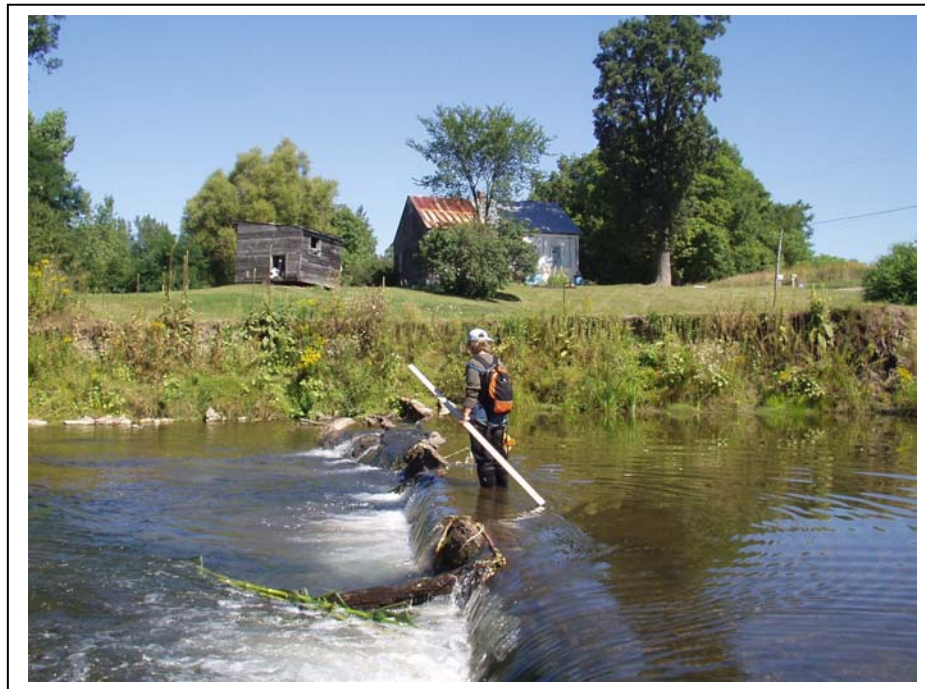
Photo 5. Channel-spanning bedrock exposure west of Shard Villa Road (Reach M03). Such exposures of bedrock provide grade control to the river, preventing the stream from lowering its bed elevation.

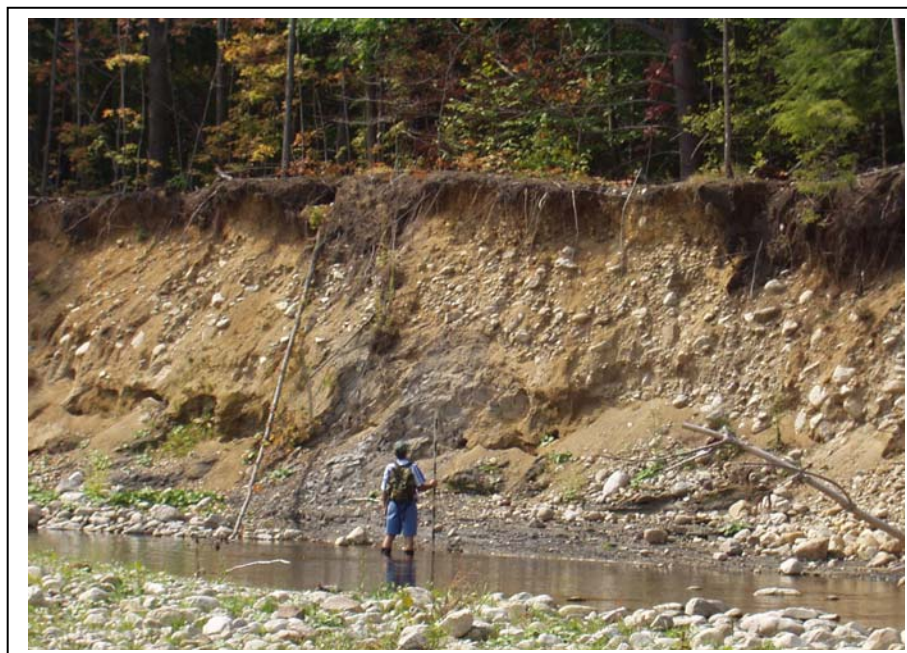
Photo 6. Mass wasting along outside of meander bend at upstream extent of Reach M06. This section of the river is immediately downstream of a long stretch of channel berming and armoring. Stream energies translated through the armored reach are now impacting this downstream river reach.

This mass failure site initiates at the downstream extent of rip-rap along the left bank (facing downstream). This meander has shifted approximately 225 feet in less than 30 years, equating to an average lateral migration rate of 7.5 feet per year. As reviewed on historic aerial photographs and topographic maps, the downstream portion of Reach M06 has also undergone substantial lateral adjustments in the last 30 years (see Figure 13). Particularly following the flood events of 1998 and 2000, the river has undergone substantial channel avulsions.

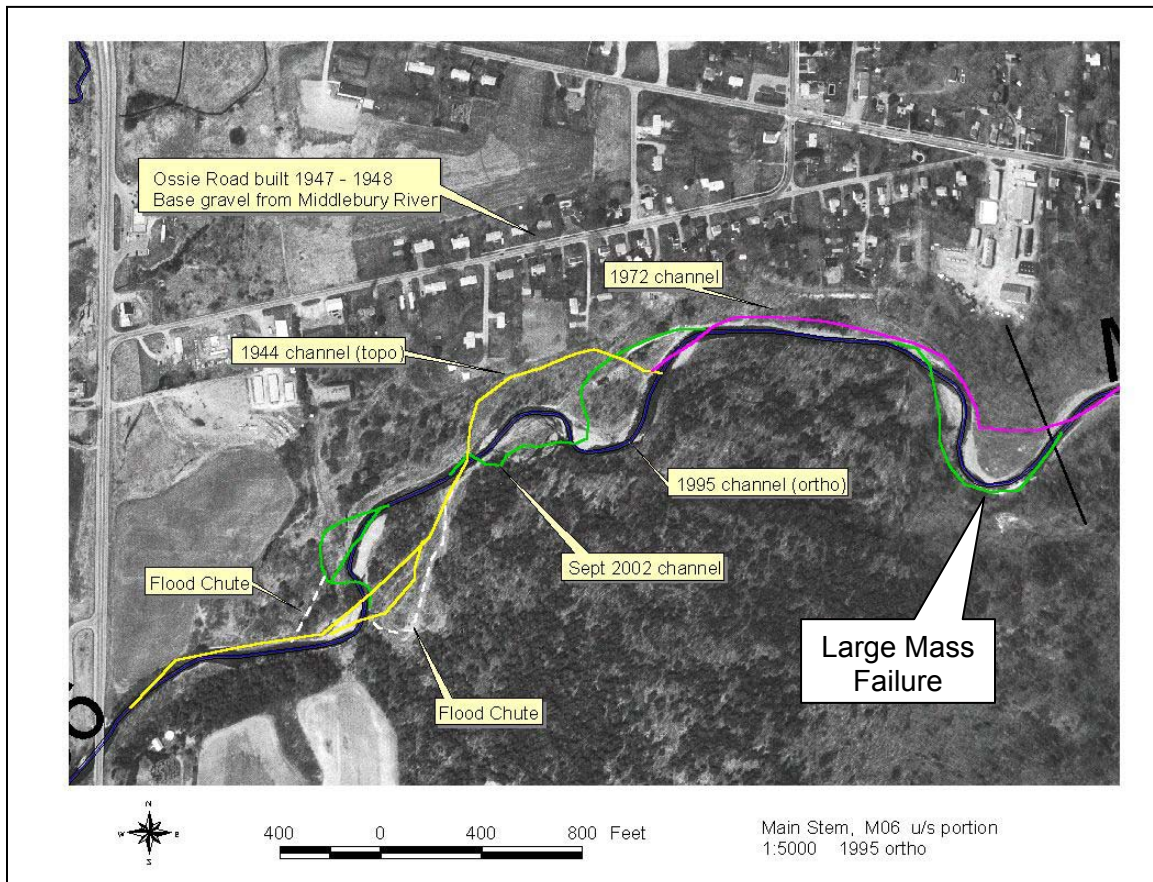
Figure 13. History of lateral channel migration, Reach M06, Main Stem, East Middlebury.

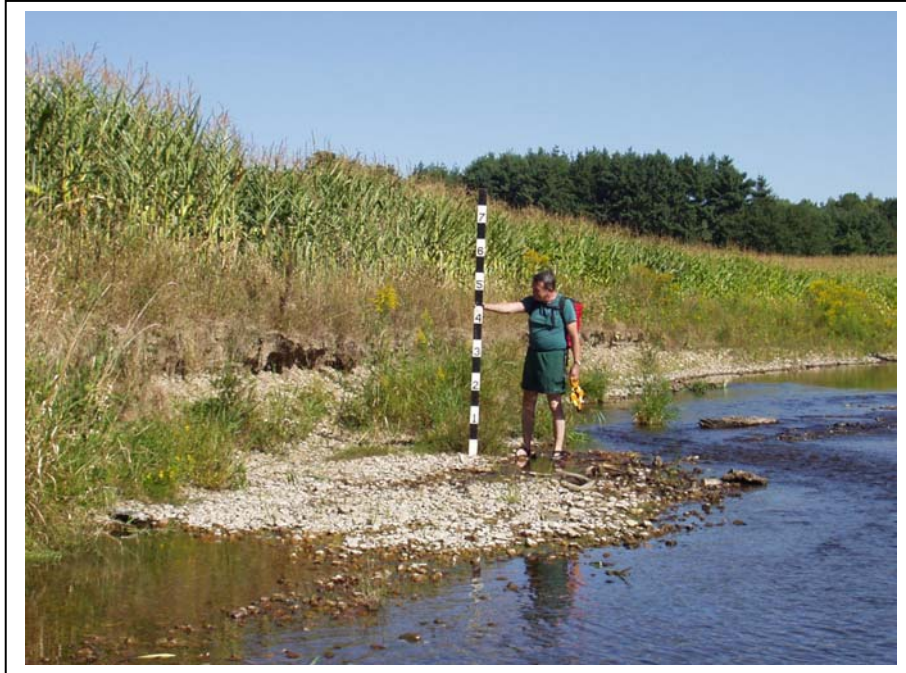
Photo 7. Less than 5-foot riparian buffer along a portion of Reach M04 Buffer is dominated by grasses which provide little root-binding capacity to streambank soils and negligible shade to the river channel.
