**Phase 2 Stream Geomorphic Assessment
New Haven River Watershed
Addison County, Vermont**

September 2004

South Mountain Research & Consulting

Addison County Regional
Planning Commission
79 Court Street
Middlebury, VT 05753
802-388-3141

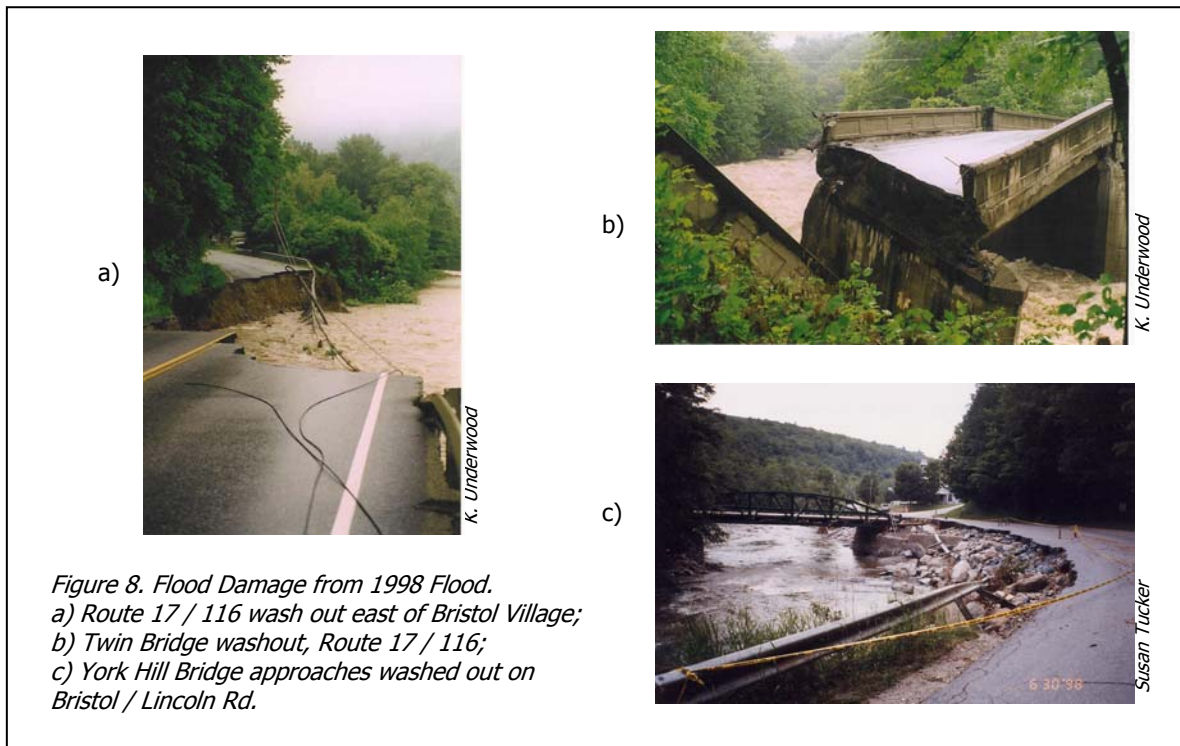
A recent flood in 1998 caused substantial damage to infrastructure (Figure 8). Several riverside homes and developments (e.g., Palmer’s Court mobile home park in South Bristol along reaches M11 and M10) were bought out by FEMA following this flood event. Buyout agreements transferred ownership of these lands to the Town of Bristol and specify no future development, measures which should reduce risks to human health and infrastructure in future flood events.

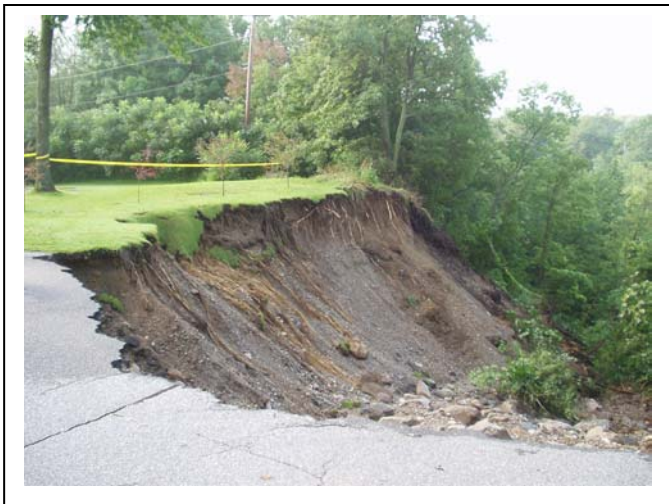
*Figure 9.
Slope failure behind (southwest) of
Merchants Bank along West Street
(Route 17 / 116) in Bristol,
28 August 2004.*

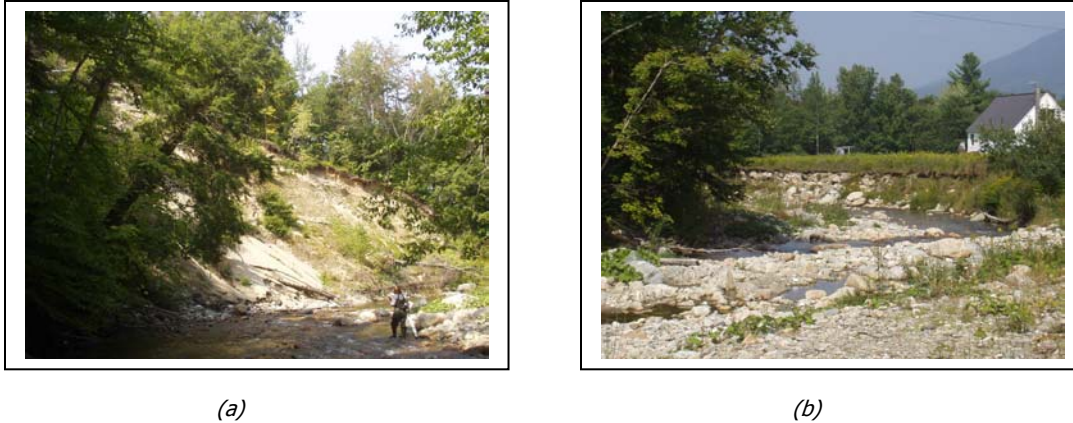
A large mass failure greater than 90 feet in height has developed along the left bank just downstream of the cross section location in reach M25 (Figure 12a and Appendix E). The mass failure post-dates the 1995 orthophotograph. Streambank erosion at the toe of this slope has likely contributed to this slope failure. Land use practices or activities at the top of the slope along County Road may also play a role (e.g., concentrated runoff to these highly erodible soils). Sands and gravels are actively eroding from this mass failure into the channel. Enlarged MCBs and PBs are prevalent through rest of the reach. Approximately 250 feet downstream of the mass failure site, a meander bend is developing along right bank (Figure 12b).

Figure 12. Streambank erosion on reach M25, South Lincoln, VT. (a) Mass failure over 90 feet high on left bank; sands and fine gravels eroding into the channel. (b) Meander migration and right bank erosion approximately 250 feet downstream of the mass failure site.

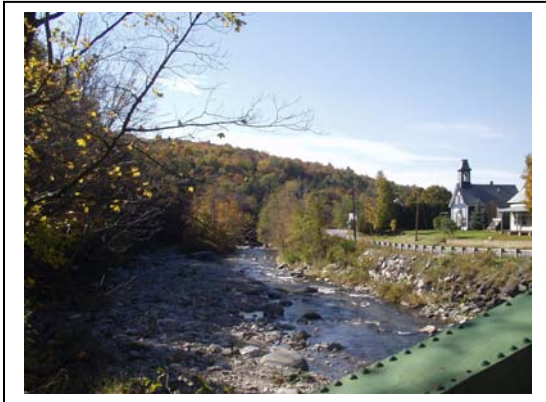
Figure 14. Reach M17 through West Lincoln Village; view downstream from the York Hill Road Bridge.

leaning trees and undercut banks suggest active widening. Noted features are consistent with development of a new floodplain at lower elevation.

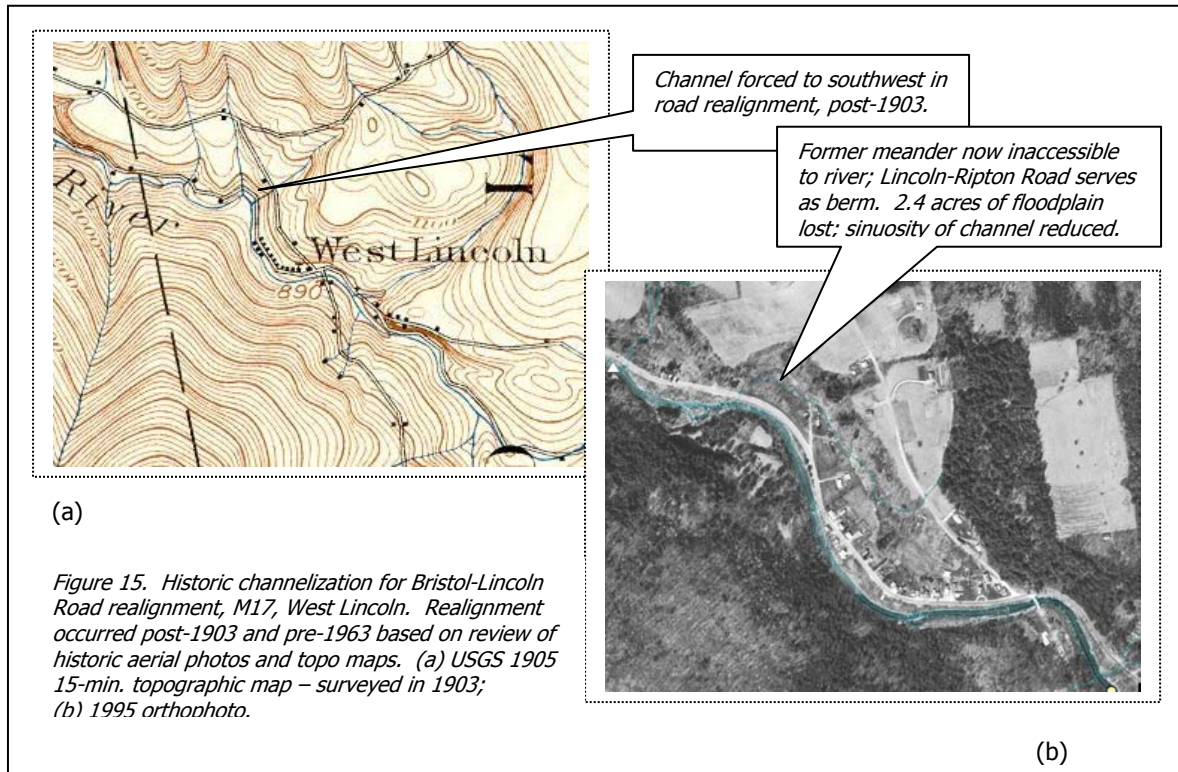
Figure 15. Historic channelization for Bristol-Lincoln Road realignment, M17, West Lincoln. Realignment occurred post-1903 and pre-1963 based on review of historic aerial photos and topo maps. (a) USGS 1905 15-min. topographic map – surveyed in 1903; (b) 1995 orthophoto.

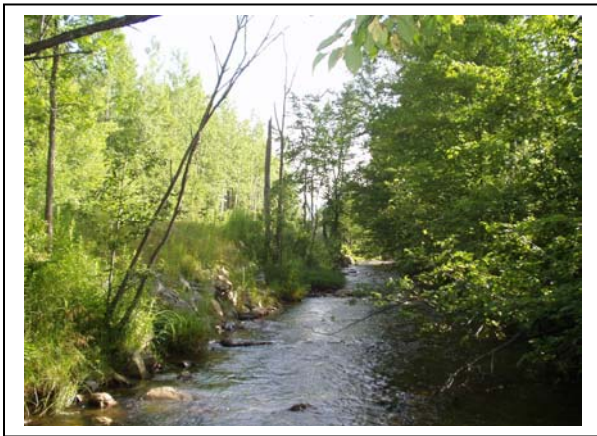
Figure 17 Straightened, armored section of Beaver Meadow channel along Downingsville

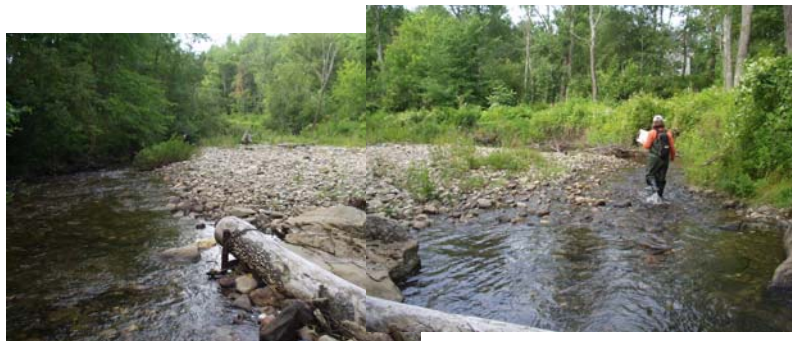
Figure 18. Tree revetment along right bank, reach T4.03. Stream flow has breached the revetment and is bifurcated around a mid-channel bar. High bank slumping and erosion of sands and gravels are evident along the downstream right bank of the right-most (western) channel.

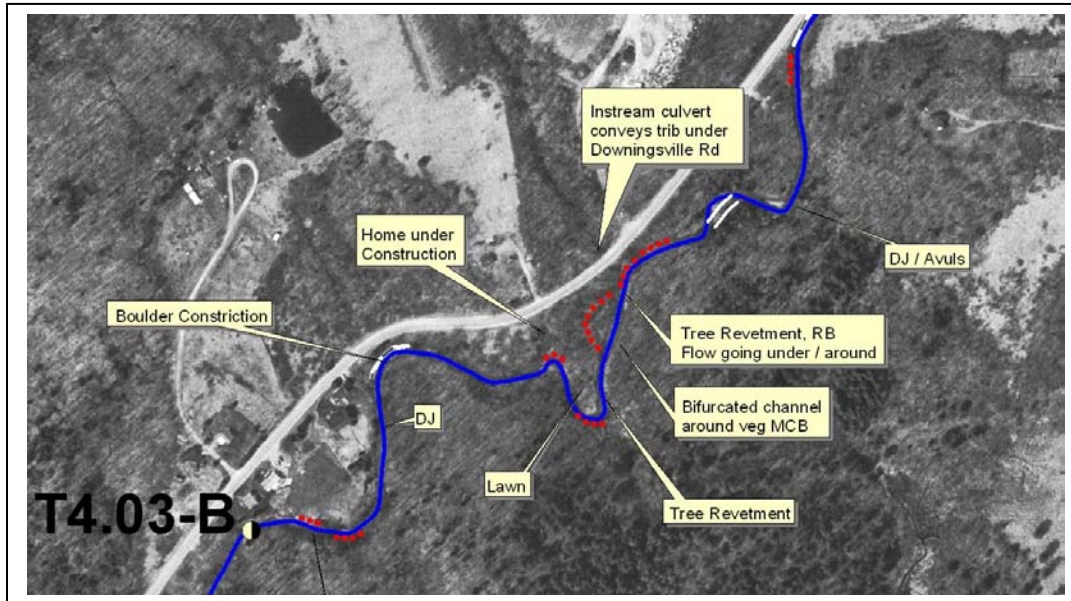
The "peninsula" of land formed by the tight meander bend appears regularly mowed, and woody vegetation has been selectively removed. Tightness of this meander bend, removal of woody vegetation and the upstream occurrence of debris jams and channel avulsions would suggest that this tight meander bend is susceptible to a future neck cut-off. A new residence is in process of construction along the right bank opposite this meander (see Figure 19). The foundation appears to be set on bedrock, however. If so, risks to this structure in the event of avulsion-induced bank failures would be reduced.

Figure 19. Tight meander bend proximal to upstream avulsions and planform adjustments, reach T4.03, Downingsville Road, Lincoln, VT.

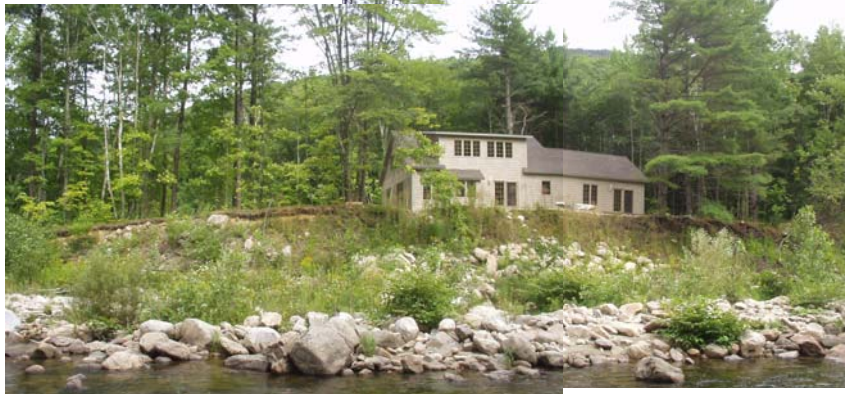
During Phase 2 assessments in July and August 2004, signs of active incision were noted within the upstream section of this reach, including abandoned stream terraces, scour along both streambanks through riffle section accompanied by leaning trees and freshly exposed tree roots. The streambed is incised and has lost connection with its flood plain in all but the higher-magnitude flood flows. Incision is less pronounced as one proceeds downstream and aggradation and widening begin to dominate. Excess sedimentation through the reach is derived from streambank and bed erosion both within the reach, and from upstream reaches and tributaries (Lincoln, Starksboro). Large overwidened sections and mid-channel bar deposits with steep bar faces are prevalent through the reach, causing bifurcation of flows. Immediately adjacent to one of these mid-channel bar systems is a newly-constructed (post-1998) home positioned within 10' laterally of a failing bank of highly-erodible sands and gravels (Figure 26).

Figure 26. Newly-constructed home located within 10 feet of the top of an actively eroding sand and gravel stream bank. Reach M15, right bank. Rockydale, Bristol, VT.

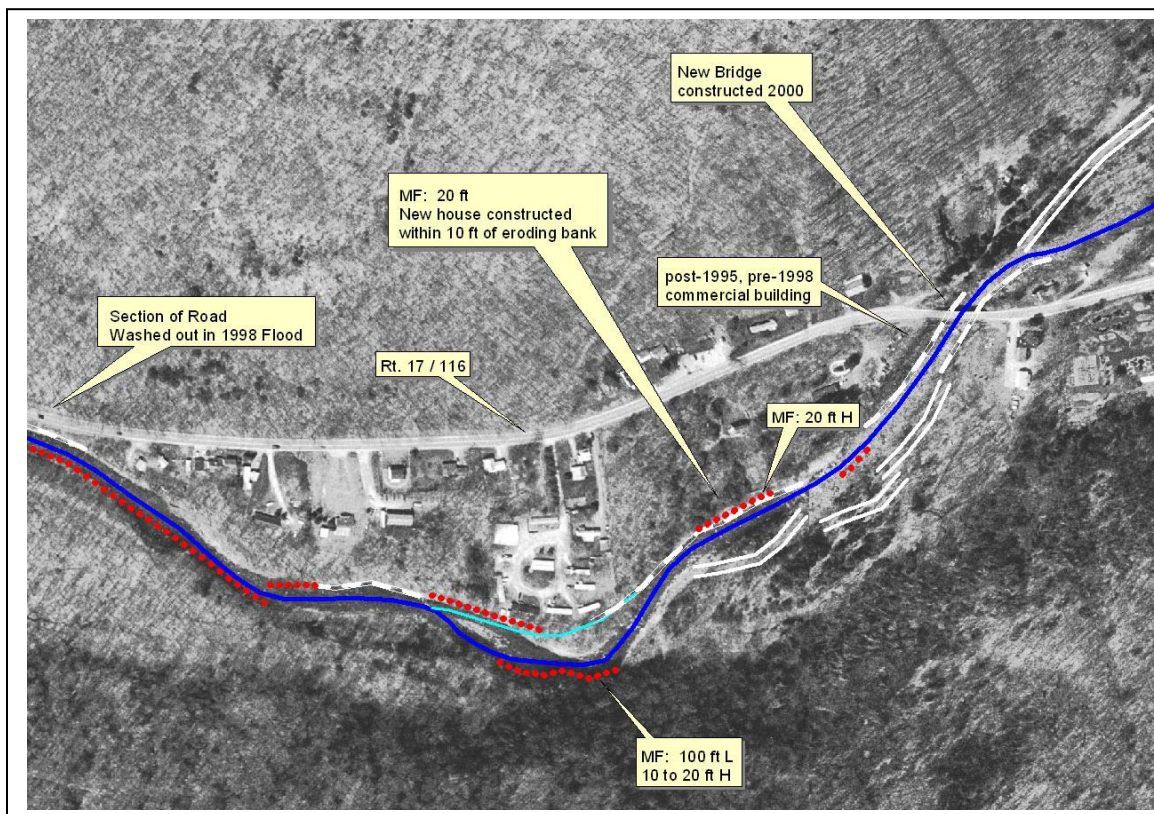
Figure 27. Floodplain encroachment along upstream half of reach M15. Rockydale, Bristol, VT.

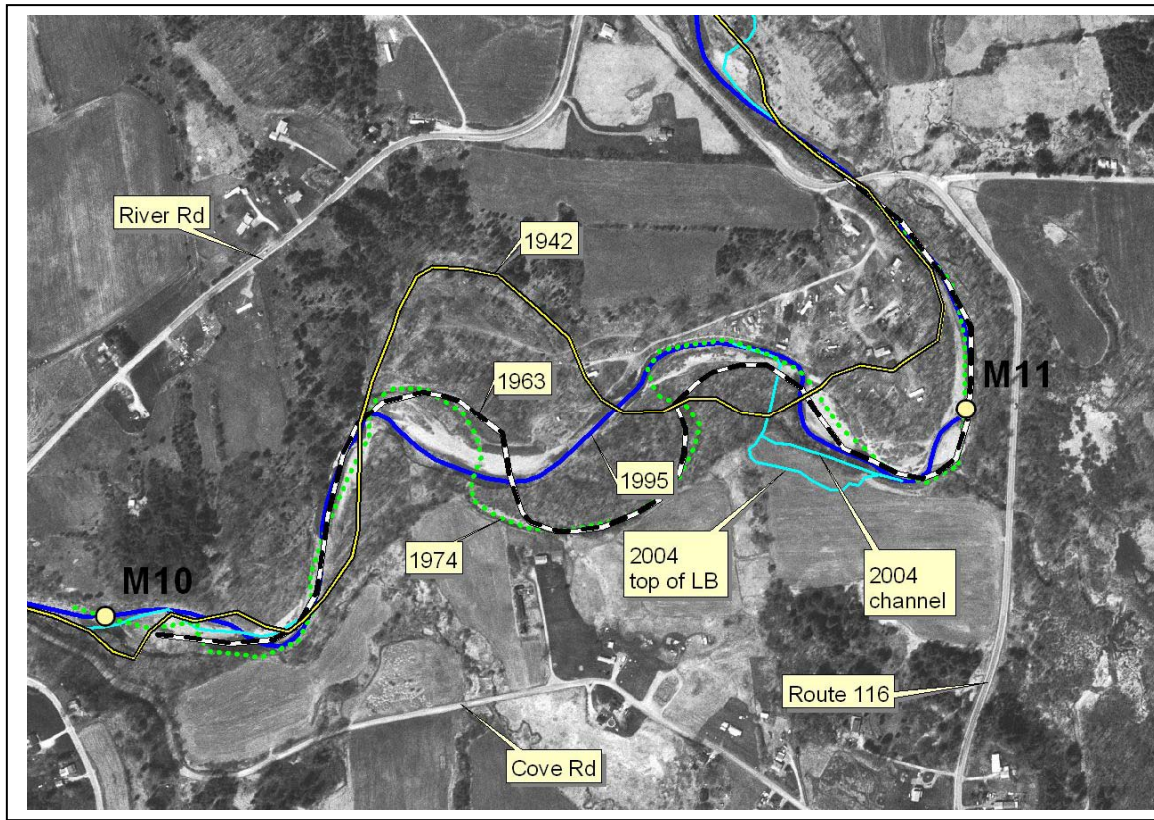
Figure 31. Historic channel migration zone in Reach M10, New Haven River main stem, Bristol, Vermont.

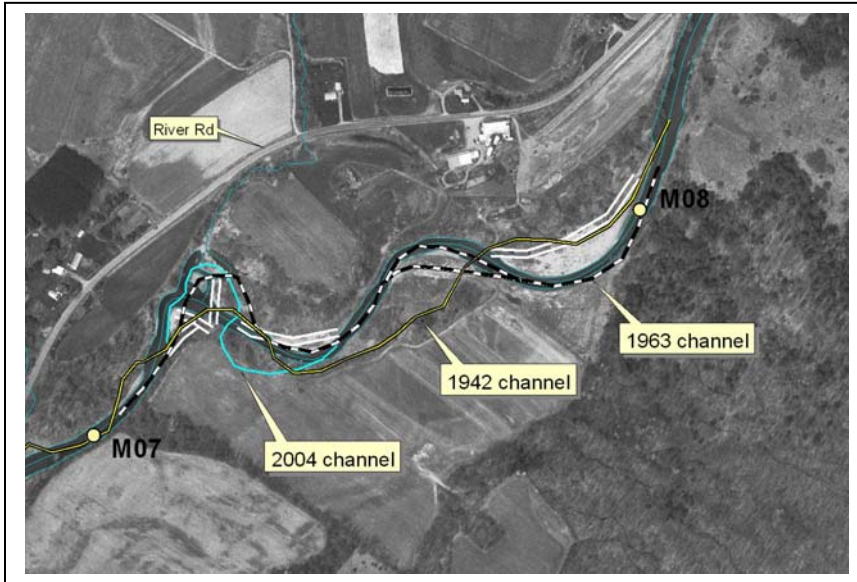
Figure 34. History of planform adjustments (meander migration) in Reach M07 discerned from review of historic aerial photographs.

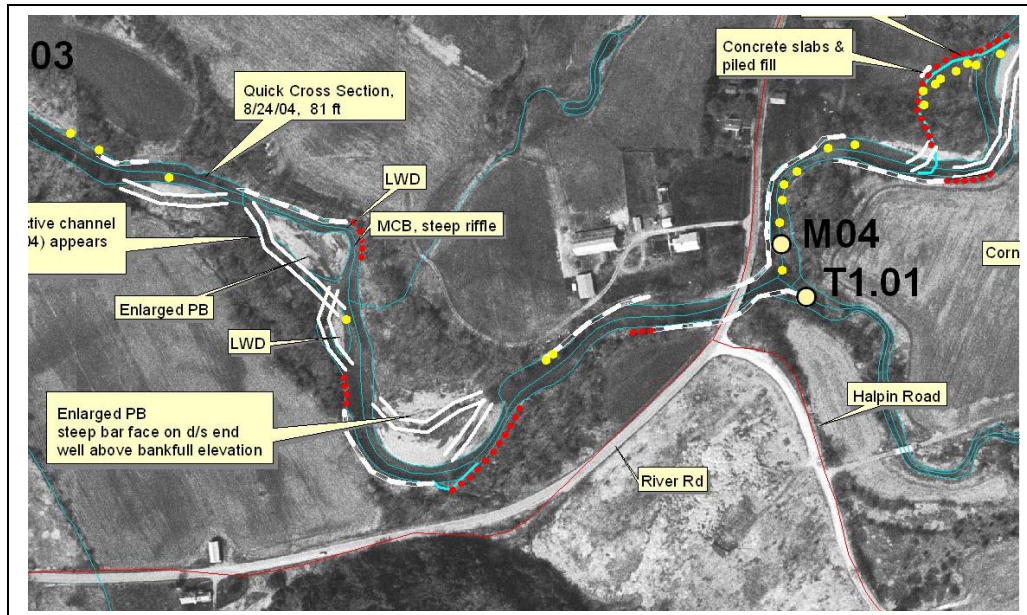
Figure 38. Planform adjustments in reach M03, migrating toward River Road.

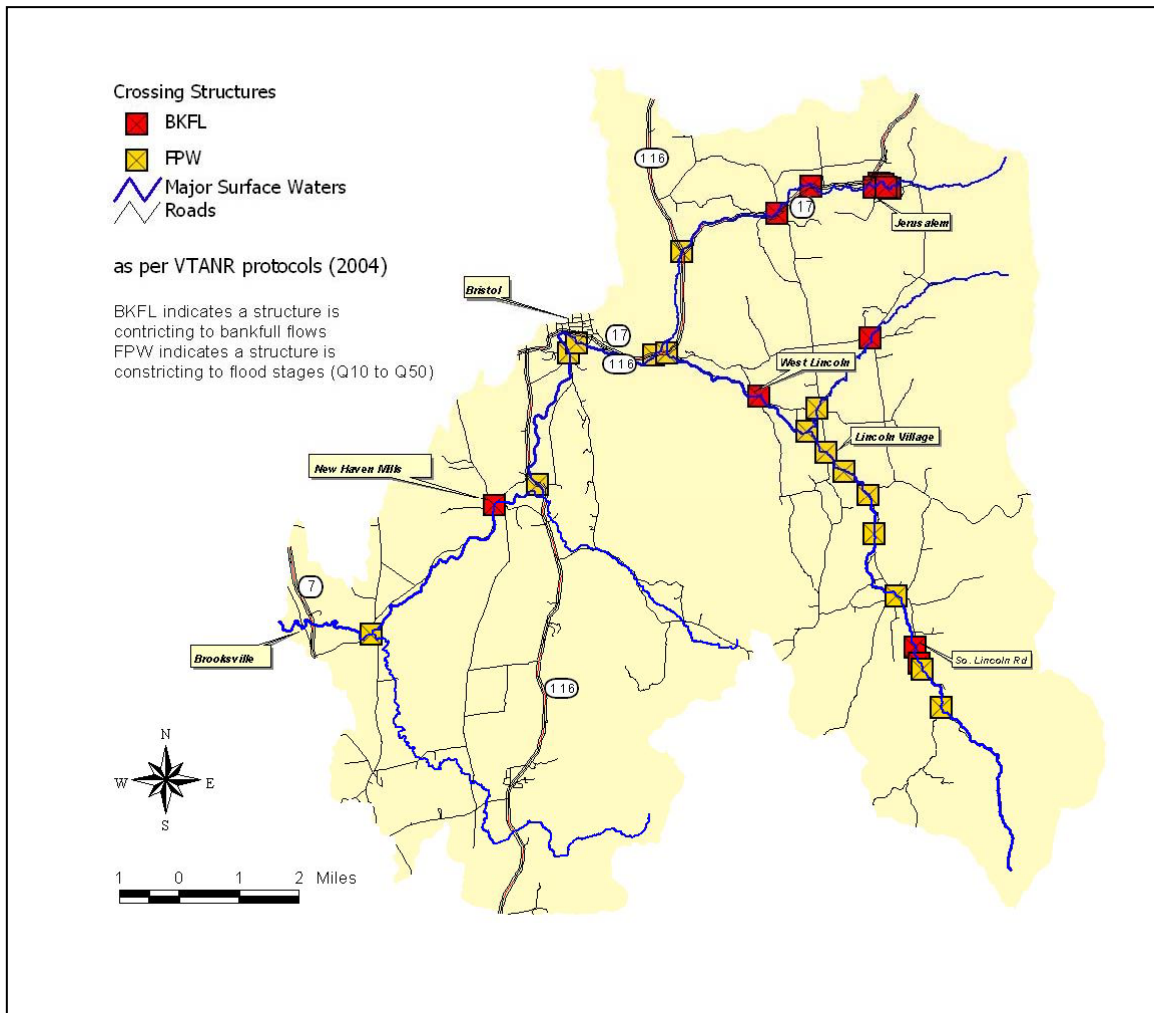
Figure 40. Geomorphic status of major bridge and in-stream culvert crossings. New Haven River watershed, 2004 Phase 2 assessment results.

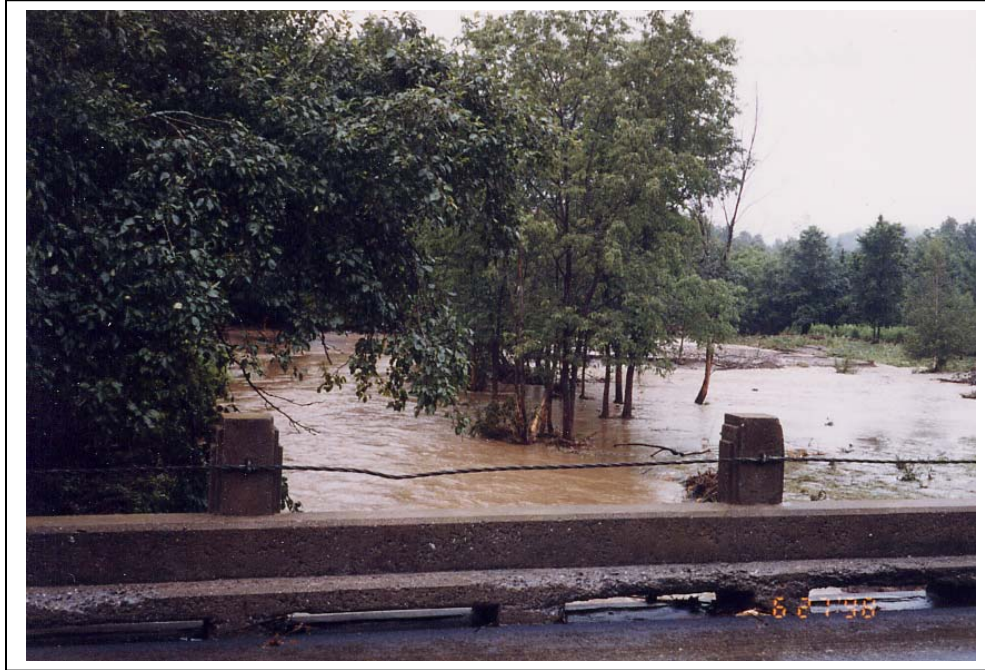
Photo 1. Smith property, Cota Brook crossing on South Lincoln Rd, just upstream from confluence with main stem (M21), 1998 flood.
Susan Tucker collection.

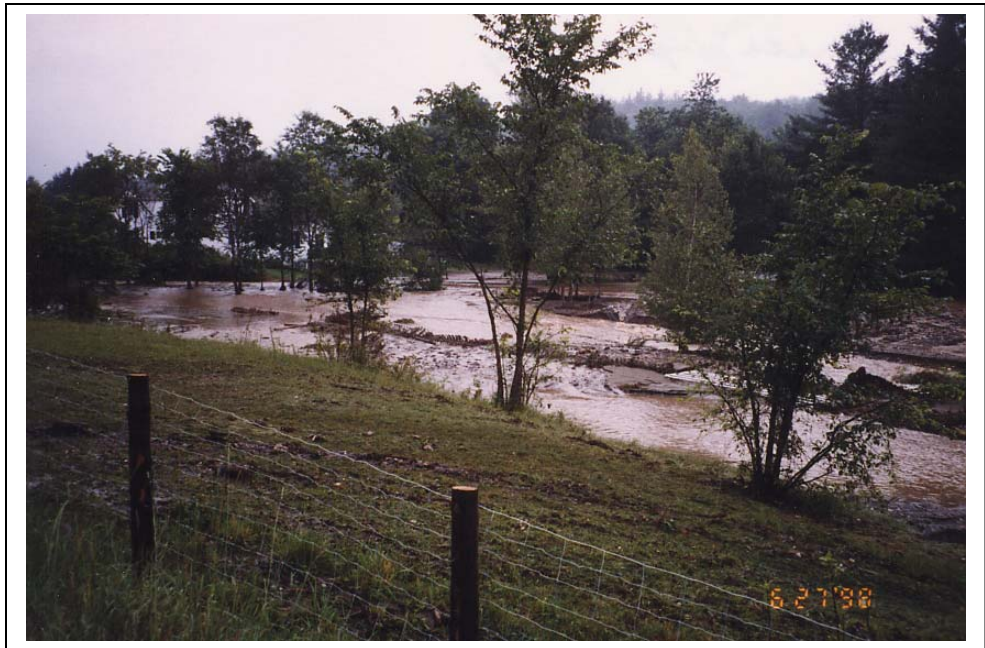
Photo 2. Smith Property inundated by Cota Brook and New Haven main stem (M21), 1998 flood. *Susan Tucker collection.*

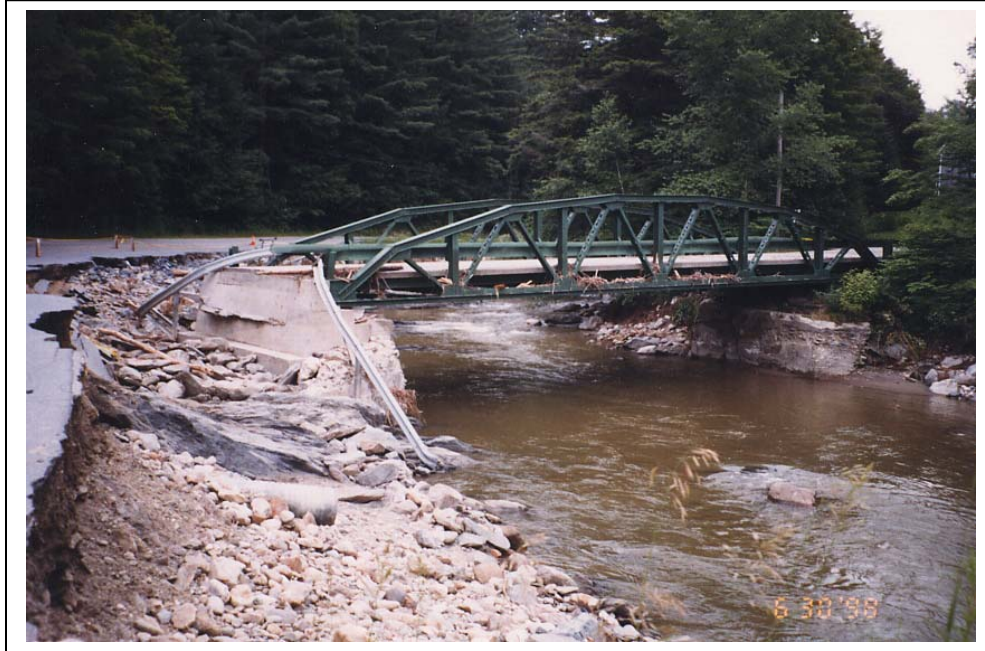
Photo 3. (M17) York Hill Road Bridge, approaches washed out, 1998 flood. View from west.
Susan Tucker collection.

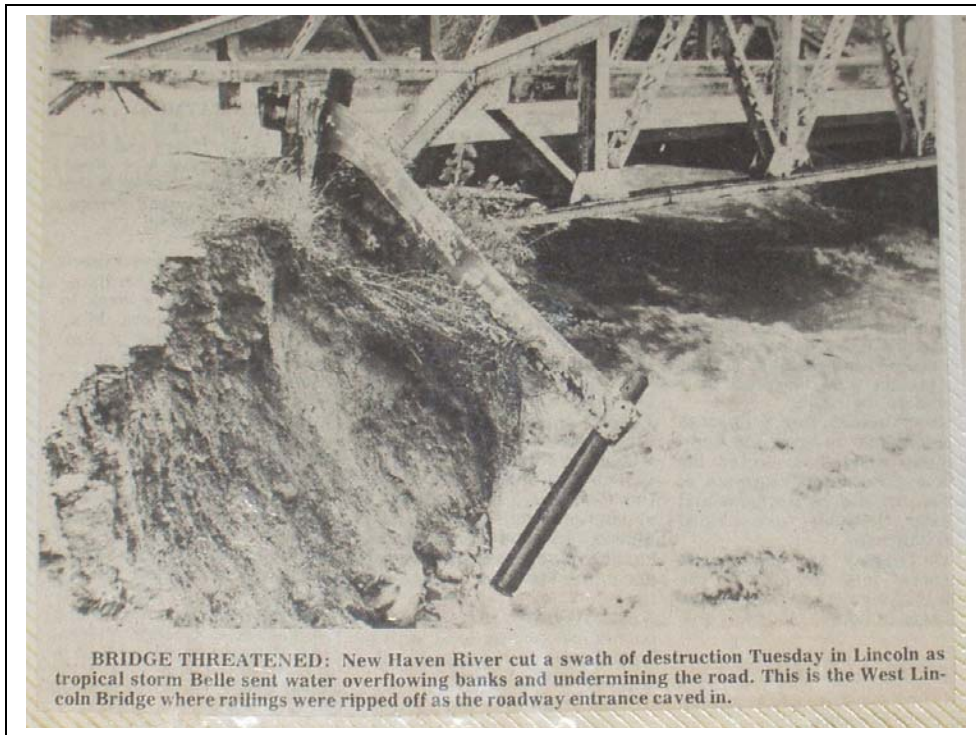
Photo 4. (M17) York Hill Road Bridge, approaches washed out in 1976 flood. View from west.
Addison Independent, 1976.

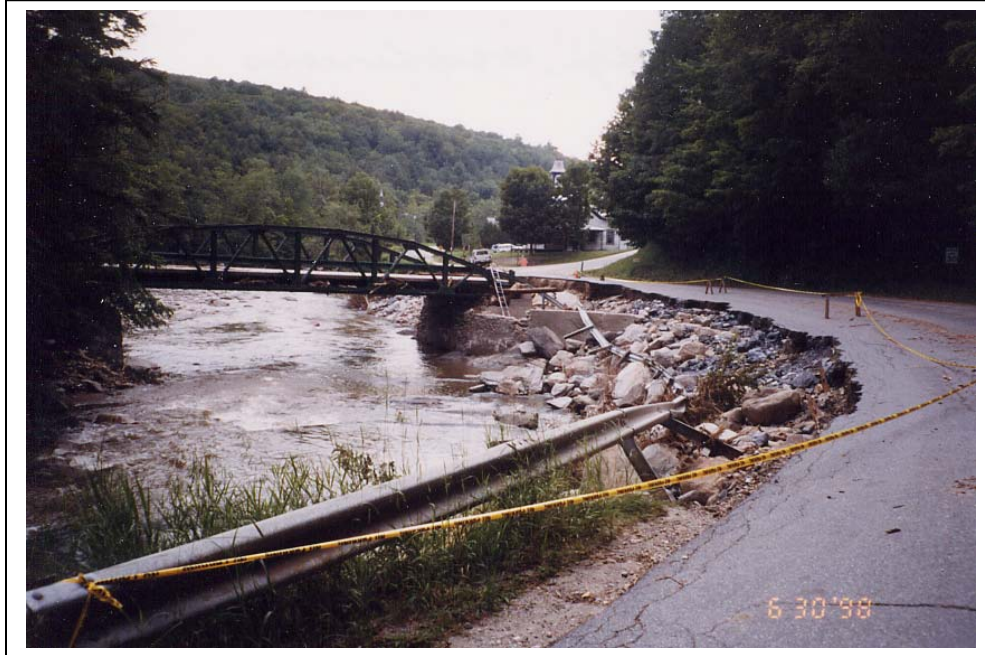
Photo 5. (M17) York Hill Road Bridge, approaches washed out in 1976 flood. View from east.
Addison Independent, 1976.

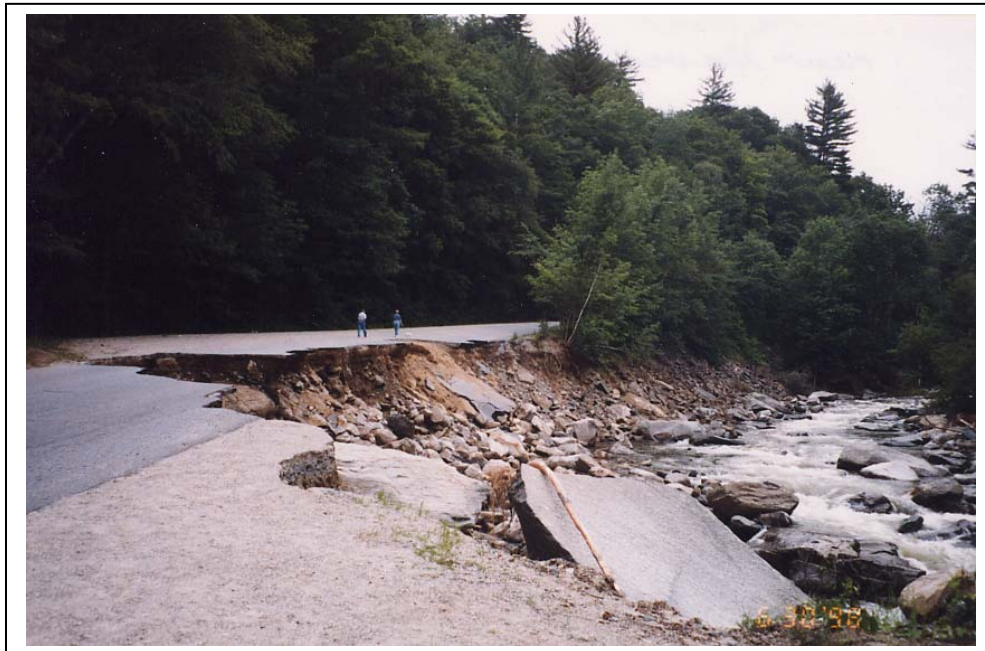
Photo 6. Bristol / Lincoln Road washout, 1998 flood. Just downstream of Bartlett's Falls.
Susan Tucker collection.

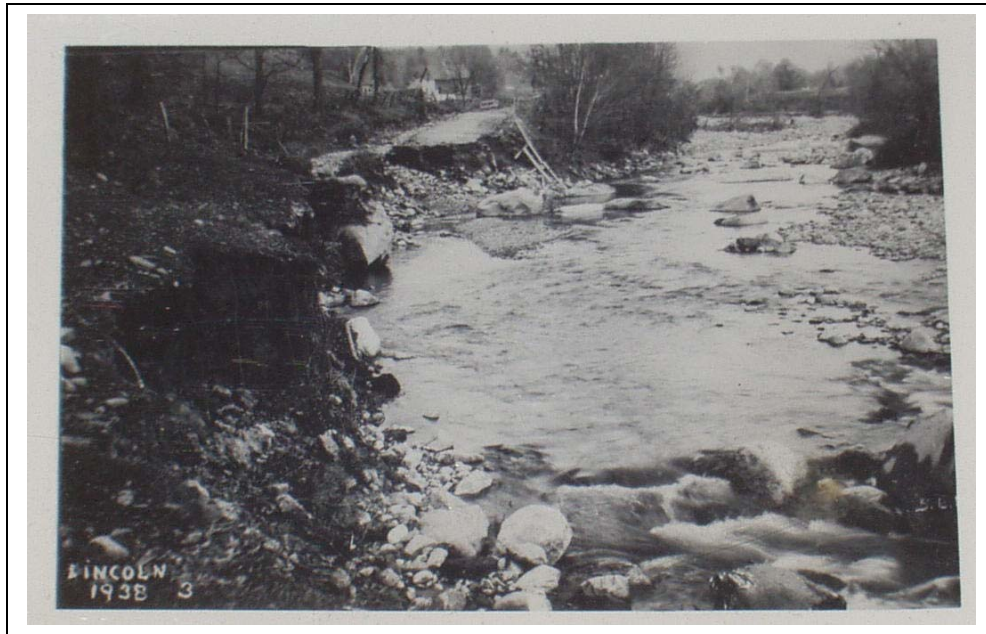
Photo 7. Bristol / Lincoln Road washout, 1938 flood. Just downstream of West Lincoln (M17)?
Lincoln Historical Society collection

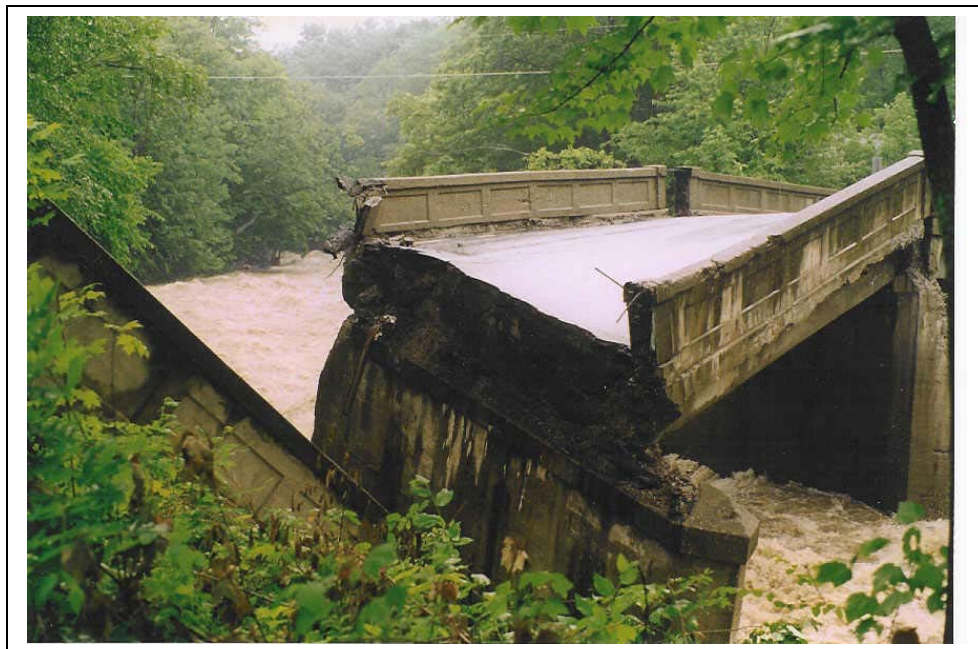
Photo 8. (M15) Route 116 bridge (western of the twin bridges), washed out in 1998 flood.
K. Underwood collection.

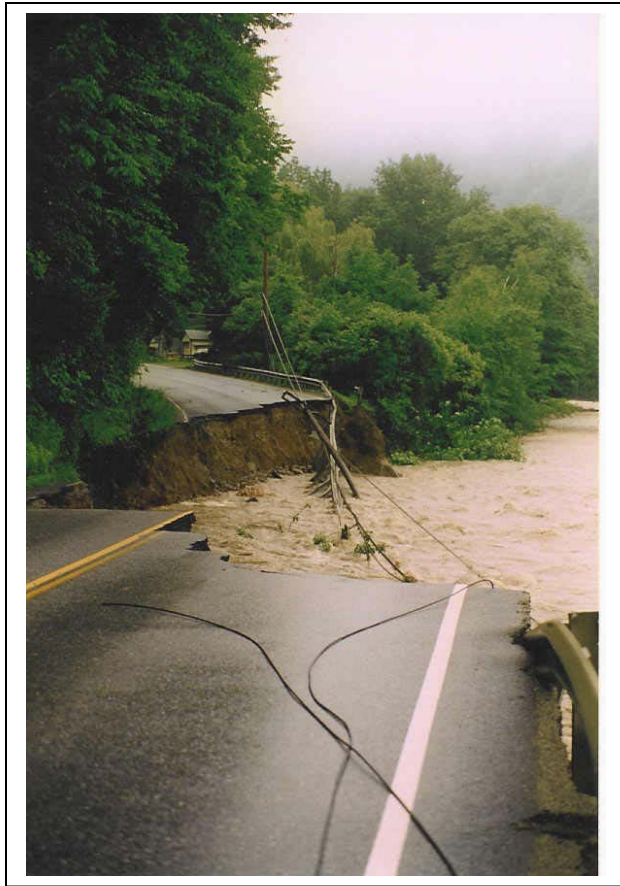
Photo 9. (M15) Route 116 washout, 1998 flood.
K. Underwood collection.

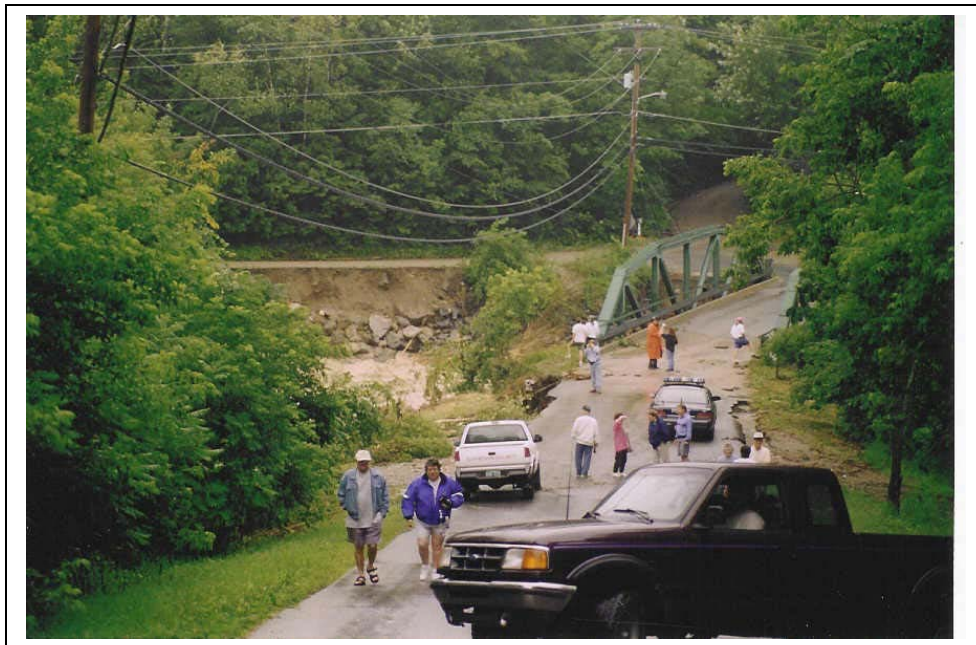
Photo 10. (M14) South Street Bridge approaches eroded, 1998 flood.
K. Underwood collection.

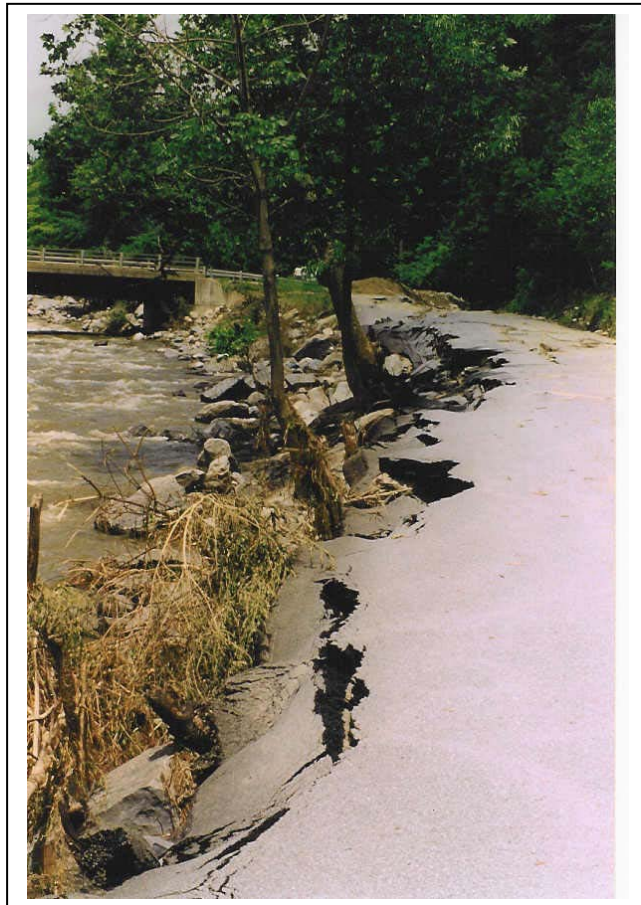
Photo 12. Hewitt Road Bridge outflanked and Notch Road washed out, 1998 flood. *K. Underwood collection.*

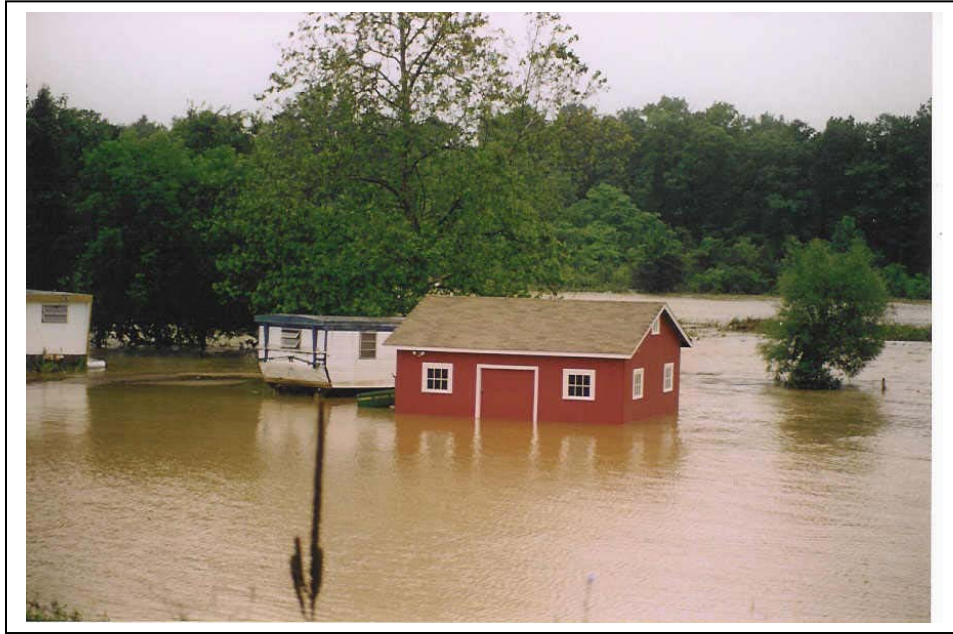
Photo 13. (M11) Draper residence along 116 inundated by flood waters, 1998.
K. Underwood collection.

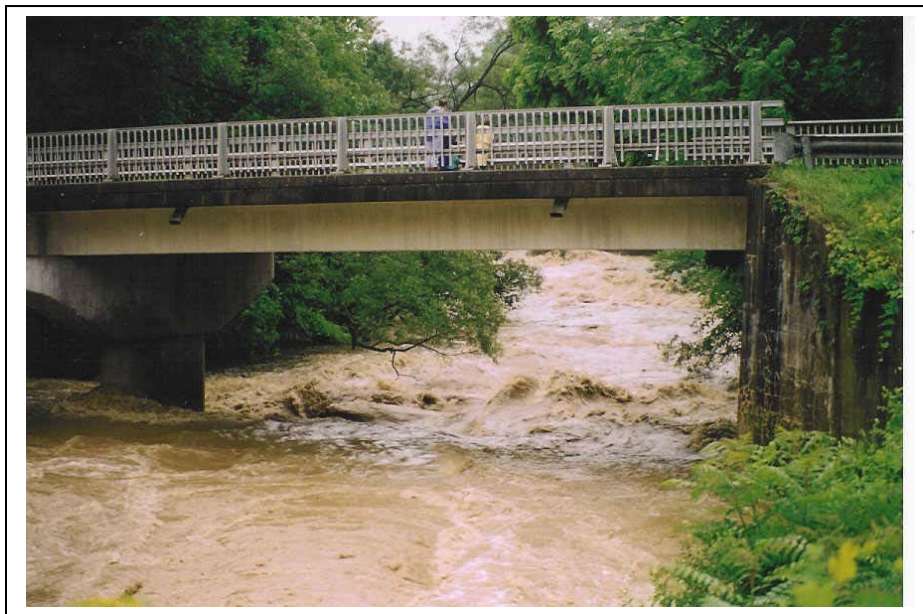
Photo 14. (M09) 1998 flood waters a few hours after peak, 27 June, Munger Street
Bridge crossing, New Haven Mills. *K. Underwood collection.*

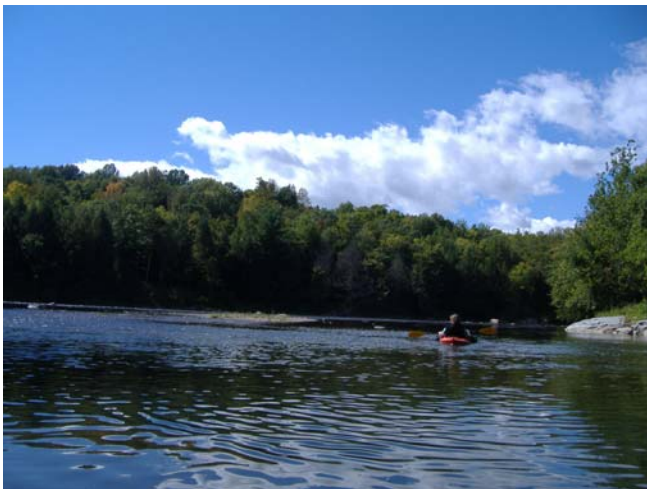
*Figure 10.
Confluence of New Haven
River with Otter Creek;
sediment deposition is evident
at the confluence, slightly left
of picture center.*
