**Phase 2 Stream Geomorphic Assessment
New Haven River Watershed – Addendum
Reaches M01, M02
Town of New Haven, Addison County, Vermont
January 2008 (DRAFT)**

South Mountain Research & Consulting
2852 South 116 Road, Bristol, VT 05443
802-453-3076

Addison County
Regional Planning Commission
14 Seminary Street
Middlebury, VT 05753

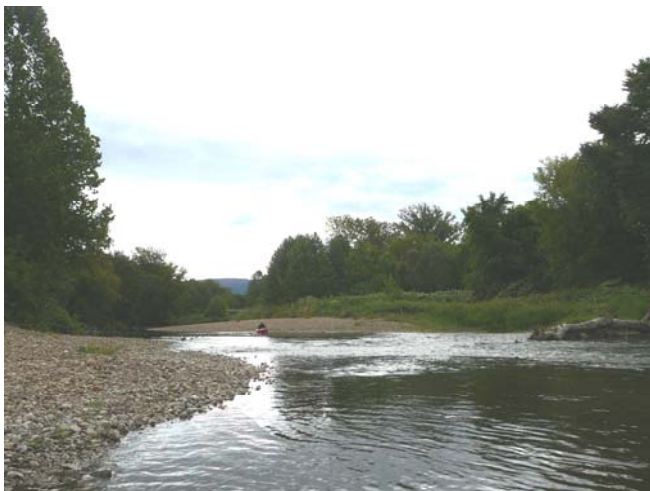
Depositional bars (point bars, side bars, mid-channel bars, transverse bars) are frequent within the reach; some pools are relatively shallow and bar heights are occasionally greater than the one-half bankfull height. Active recruitment of large woody debris ($LWD = 65$) is generating local scour holes, providing variability in velocity/depth patterns and contributing to morphological diversity. At the low to moderate flow stage of the assessment date (9/12/2007), many of the riffle substrates were exposed. Forested buffer widths are moderate to occasionally absent; this fact combined with the large size of the channel and its open canopy result in limited shading for the river. Moderate streambank erosion was noted, related to active meander extension and a recent (post-1995, pre-2003) neck cut-off. Active recruitment of large woody debris and detritus is occurring, providing epifaunal substrates and organic matter for instream habitats. Overall, a "Good" habitat condition rating (0.65) was assigned following the RHA (on the cusp with a "Fair" rating).

Figure 6.
Transverse depositional bars
and point bars are frequent
along Reach M02.

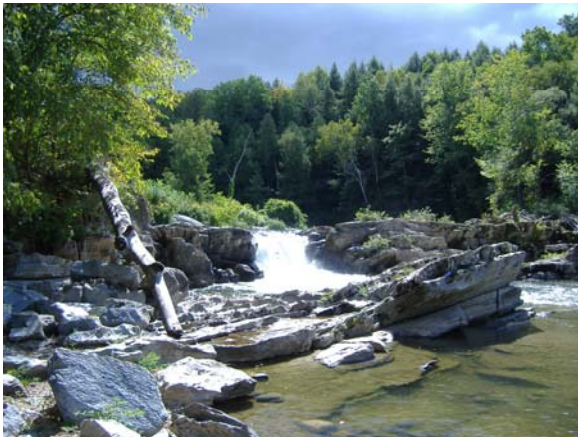
*Figure 8.
Waterfall at top of bedrock
cascade and step/pool section in
the vicinity of historic Brooksville
dam.
Segment M01-B.*

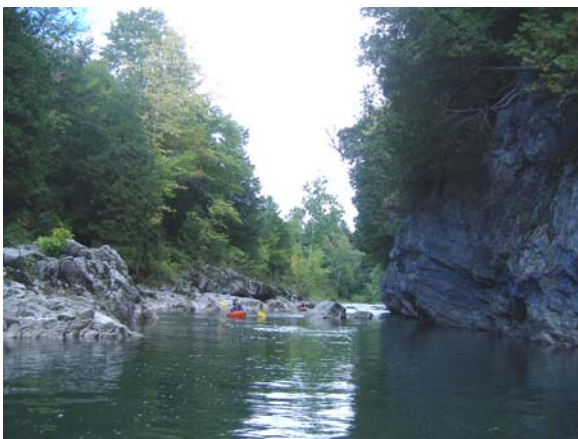
*Figure 9.
Gorge section downstream of
the former Dog Team Tavern.
Segment M01-B.*

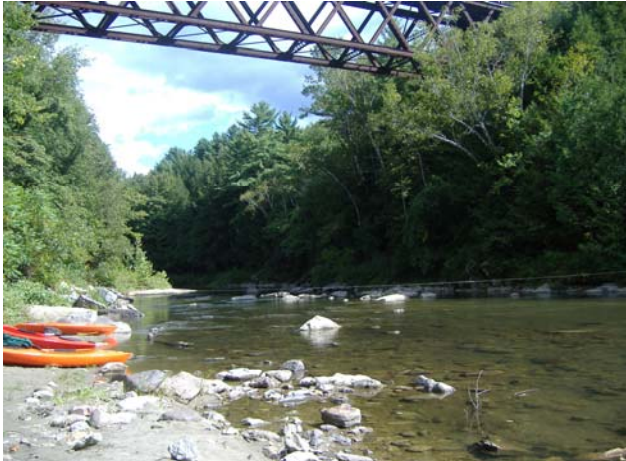
A cross section was completed near the mid-point of Segment A (Figure 11). Measured channel and floodplain dimensions suggest an A4c-riffle/pool stream type, consistent with the reference stream type for the reach. Overall, a riffle/pool bedform was apparent, with two small point bars. A plane-bed form was evident at the upstream extent of the segment where a submerged bedrock "ledge" comprised the channel bed.

*Figure 11.
Riffle cross section site just
downstream of the Vermont
Railway bridge.*

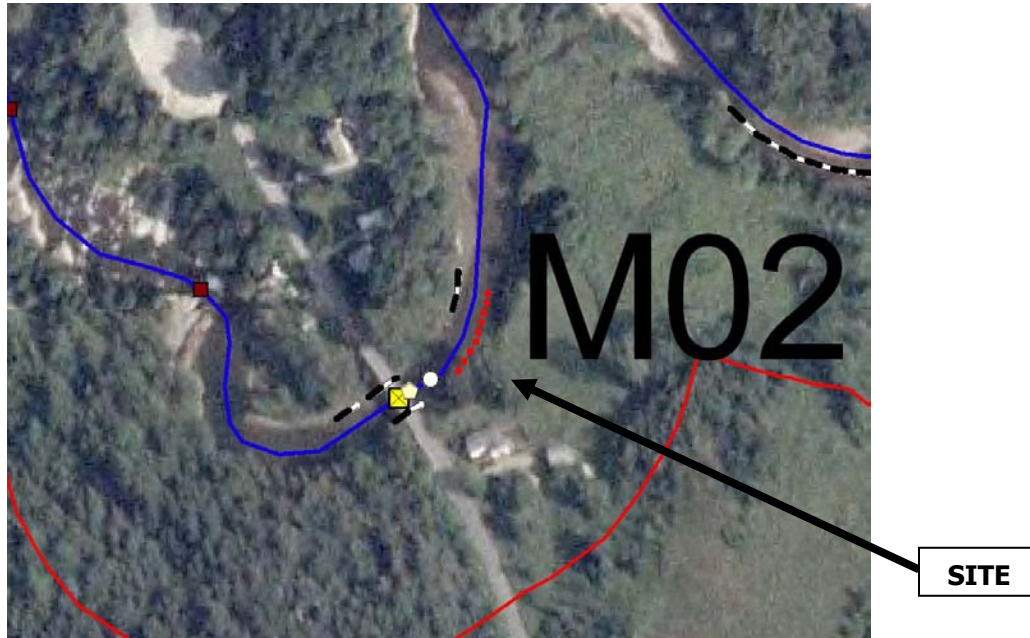
One possible bank stabilization project has been identified for further feasibility assessment along reach M02 at the downstream-most end of the reach along the left bank (see Figures 12 and 13). Landowners at this location have previously contacted the ACRPC with concern for erosion along their bank.

Figure 12. Location of LB erosion adjacent to residence just upstream of Dog Team Road bridge crossing at the reach break between M02 and M01.

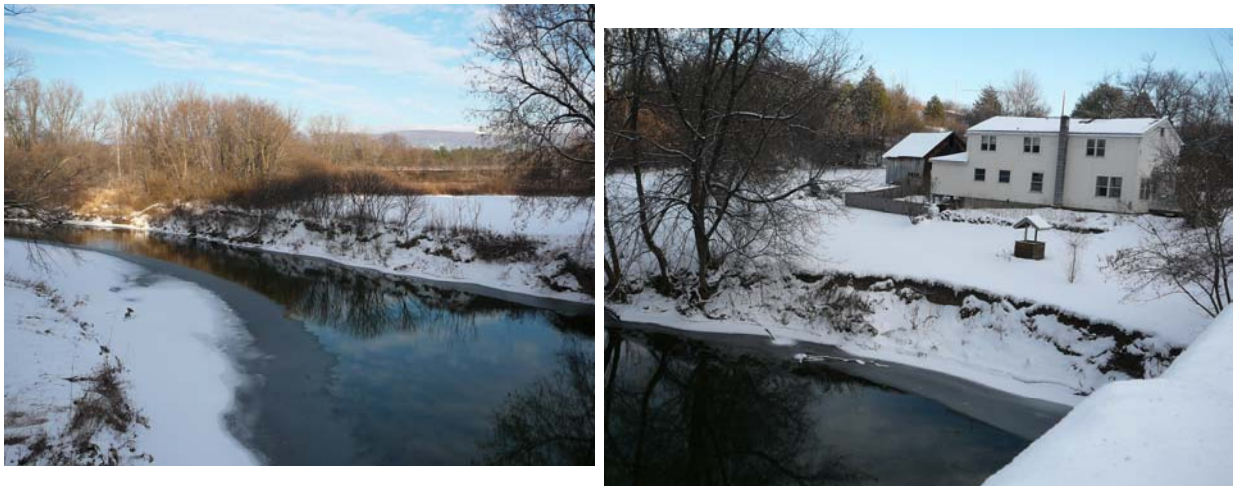
Figure 13. Site of LB erosion upstream of Dog Team Road bridge, reaches M01 and M02. (View upstream from the bridge, 10 December 2007).

The LB is at the outside of a meander bend on approach to the Dog Team Road bridge, and streambank erosion along this bank in recent years has progressed to the southeast. The top of this undercut bank is located within 90 feet of a residence. Erosion could progress downstream to outflank the LB pier and the LB stone-filled spill-through embankment of the Dog Team Road bridge (see Figure 14).

There would appear to be room for establishment of a minimal-width forested buffer between the streambank and the residence at this site, if the bank could be stabilized through some combination of toe armoring or revetments combined with bioengineering along the upper two-thirds of the bank.

Any plans for streambank stabilization at this site should be considered for compatibility with design plans for rehabilitation or replacement of the Dog Team Road bridge. This bridge was constructed in 1927 and has been identified by the town of New Haven as a high-priority bridge in need of rehabilitation or replacement.

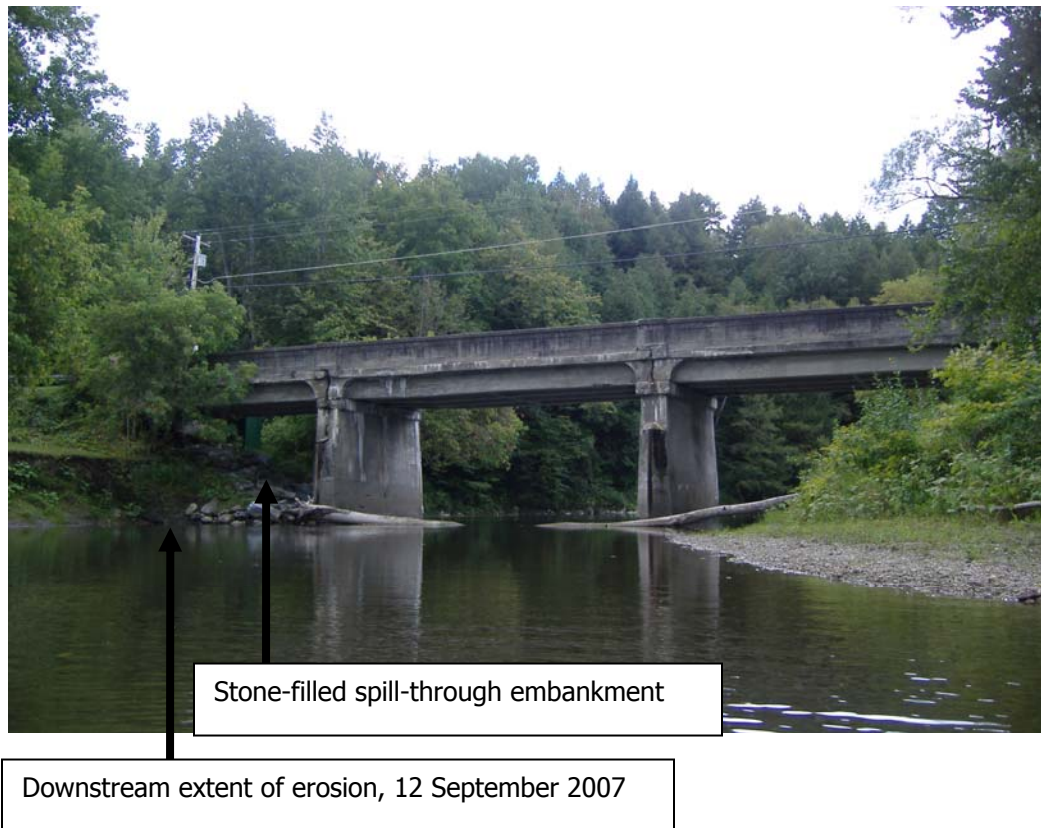
Figure 14. Site of LB erosion upstream of Dog Team Road bridge, reaches M01 and M02. (View downstream to the bridge, 12 September 2007).
