Phase 2 Assessment of the Hungerford Brook Watershed, Franklin County, Vermont 2006

Carmi Consulting

1.0 Summary

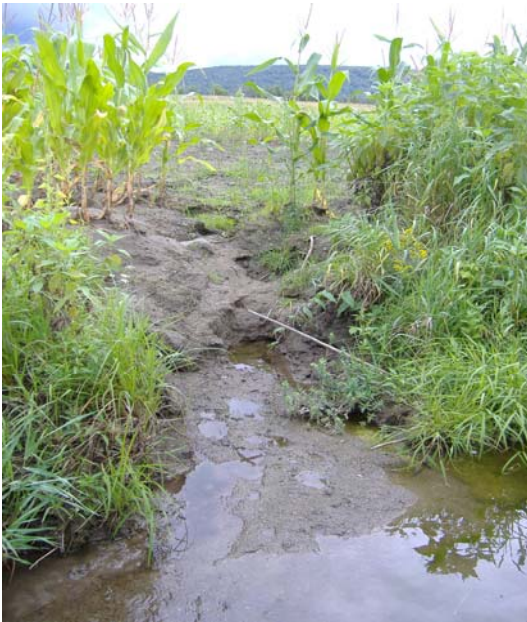
Figure 2 Nutrient Input. M08

Land use in this watershed is agricultural, forested, developed and wetland. Recent increases of housing and commercial development are occurring in several of the upper reaches of the watershed. The Hungerford Brook is located in some of the most highly concentrated agricultural land in the state. Watershed impacts such as direct cattle access, close cropping with mow or absent buffers, channel alteration and run off were observed in this small but significant brook.

Stream bank erosion is a contributing non point source of phosphorus in rivers and streams.

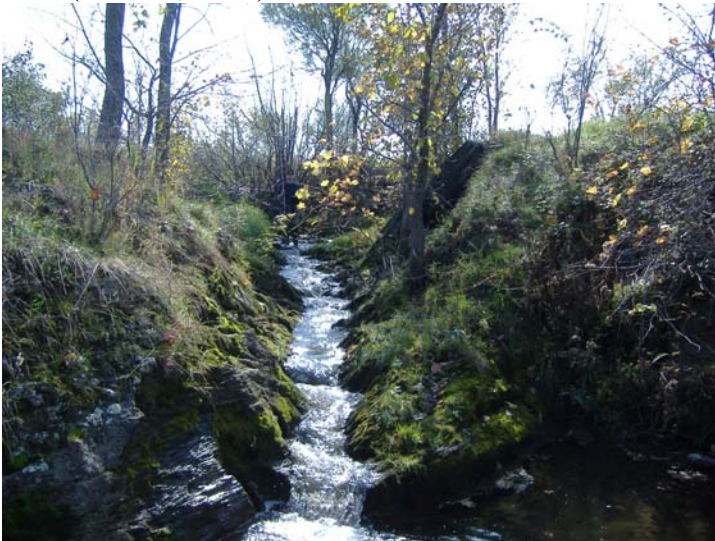
Figure 3 Channel Spanning Bedrock M4T2.03

Frequent bedrock exposures influence the channel position and profile in the watershed. Bedrock exposures along the valley walls control the lateral position of the river channel. Locations of channel-spanning bedrock offer vertical grade control, preventing possible downward erosion of the channel in response to regional or local stressors (at least over the 10- to 100-year time spans on which this study is focused). Within the study area there are several exposures of bedrock (grade controls) along the main stem and tributary channels.

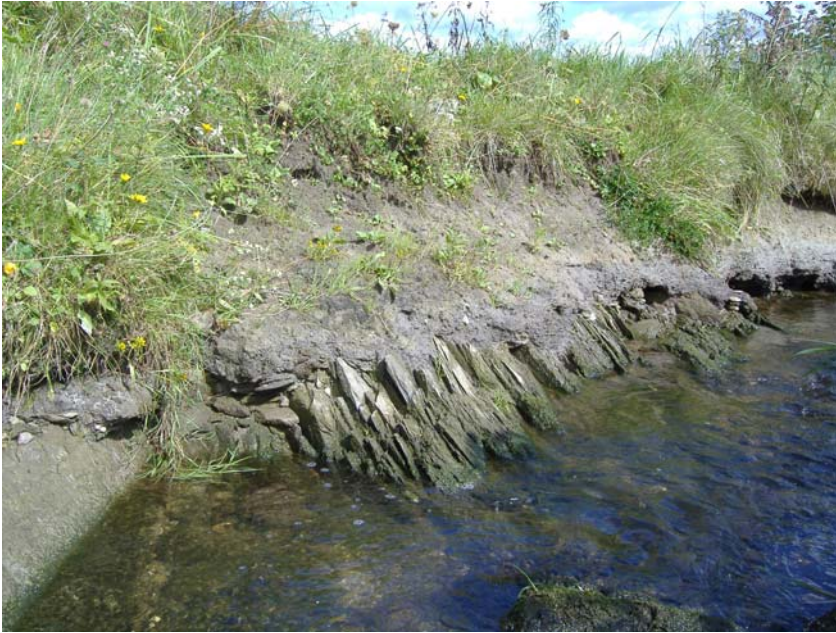
Figure 4 Clay on Bedrock M3T1.03

Glacial and post-glacial events have influenced the surficial sediments and soil types which are present in the Hungerford Brook watershed today. Upland slopes along the eastern and western margins of the watershed are dominated by shallow- to moderate-thickness glacial till deposits overlying bedrock. The mid-portion of the watershed is underlain by silts and clays deposited first in fresh-water Lake Vermont and later in the Champlain Sea. Marine beach gravels from the Champlain Sea have been mapped in the southern portion of the watershed; these sand and gravel deposits form some of the higher-relief terraces in the watershed visible along Route 105, for example. At the downstream end of the watershed, near the confluence with Missisquoi River, the Hungerford Brook cuts through sands and pebbly sands of the Champlain Sea delta deposited by the Missisquoi River over 10,000 years ago (Stewart and MacClintock, 1969; Stewart, 1974; Doll, 1970).

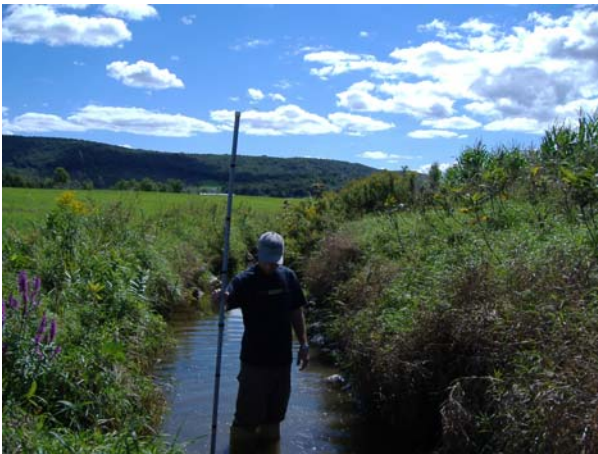
Figure 5 M08B Cross section looking upstream

M08B- M08B is an E type channel with a gravel bottom. The channel is currently incising most likely due to increased hydrologic pressure from straightened/ channelized tributaries. It has not yet undergone a Stream Type Departure however without a more adequate buffer, it is inevitable.

M08B is located in a very broad valley in an agricultural setting. There are corn and hay fields on both the right and left banks for most of the segment. The downstream quarter of the reach flows through pasture with cows accessing the brook. This reach and its tributaries have little to no woody buffer and suffer from extensive historical straightening and ditching.

Increased hydrological pressure was also observed due to increased run off from residential areas and highway surfaces. Loss of wetlands was also apparent.

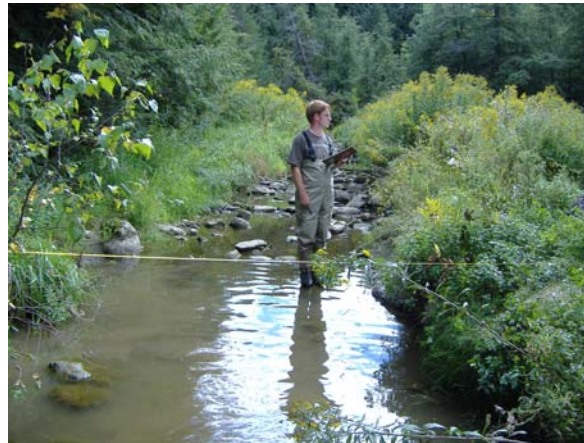
Figure 6 M08A Cross Section looking upstream

Processes caused by upstream channel alteration and stressors were noted in M08A. Large areas of accelerated erosion were observed on both banks. Given the more natural sinuous planform and relatively minor encroachments a greater degree of flood plain connection was expected (Incision ratio of 1.0 or 1.2.) Instead an incision ratio of 1.35 was observed.

Exemplary corridor can be found on the banks of this reach. However due to upstream stressors and increased hydrologic pressure this reach is incising and losing access to its floodplain.

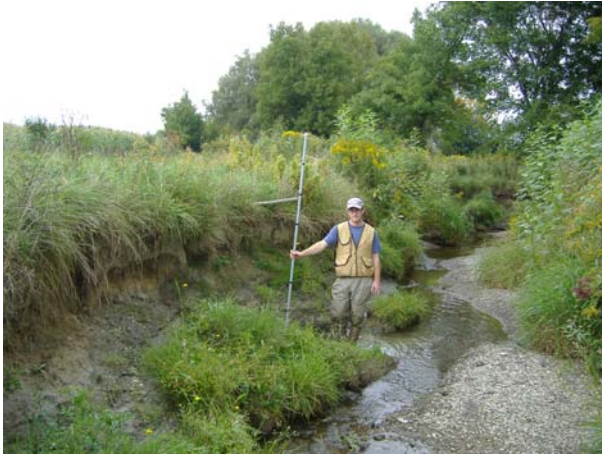
pasture has cows accessing the brook and has little to no woody buffer making it a production zone for sediment and nutrients.

Downstream of the pasture, the brook flows through a farm road culvert and along a corn field on the left bank. Slumping banks are common along this segment as are storm water inputs (tile drains) from agricultural lands.

A headcut was observed in this segment making this reach especially vulnerable to loss of floodplain and a possible stream type departure.

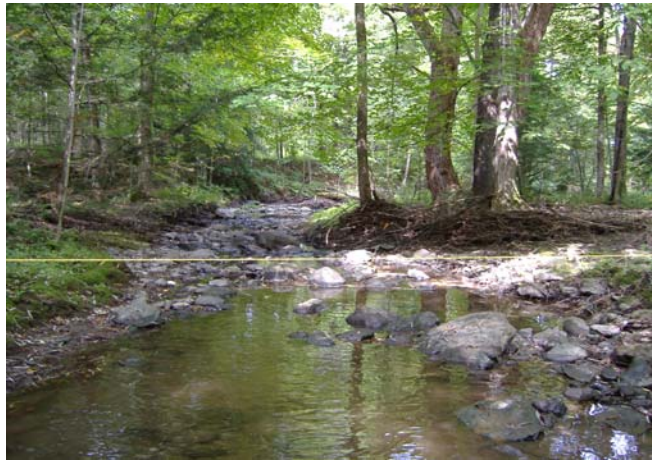
Figure 8 Reference conditions of M07A

M07A has stream banks and riparian buffers in near reference condition for geomorphic and habitat features. A deciduous old growth forest can be found on the left and right banks of this segment. The first debris jam we found was located in this segment and it was the first area we saw large woody debris walking downstream from M08.

A large braided area halfway through the segment clued us in to the sediment load coming from upstream. This reach is working as a sediment attenuation area trapping bed load upstream of its debris jams and bedrock outcrop. This outcrop is channel spanning and offers grade control for the brook.

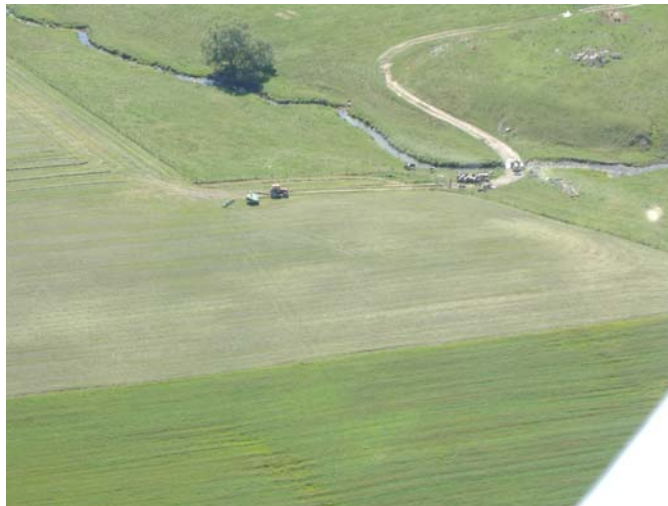
Figure 9 M06 from the air.

M06 starts just upstream of Hazard Road. It flows through pastures for the next 10,000 feet, some with direct access by cattle and some with cattle exclusion. This reach has numerous stressors and is one of the larger production reaches for sediments and nutrients. Due to the lack of woody buffer and direct access by cattle accelerated erosion is quite common.

Erosion is also related to an incision ratio of 1.6. Flood waters are now trapped within the banks rather than overflowing to the floodplain. This causes banks to erode and the bed to lower. This incision ratio could be directly related to the increased magnitudes and peak of flows due to increased tile drainage and/or storm water runoff to upstream reaches and tributaries.

There are three bridges and two culverts on this reach all channel constrictions. Most are old in and desperate need of repair or removal. One bridge in particular had broken in to numerous pieces and now lies across the channel.

A headcut was observed in this reach that threatens to cut off even more of M06's floodplain if not addressed.

Buffers, stream crossings, cattle exclusion and meanders must be reestablished if there is an expectation to reduce on-going sediment and nutrient production and channel adjustment leading to stream bank failure and other damage.

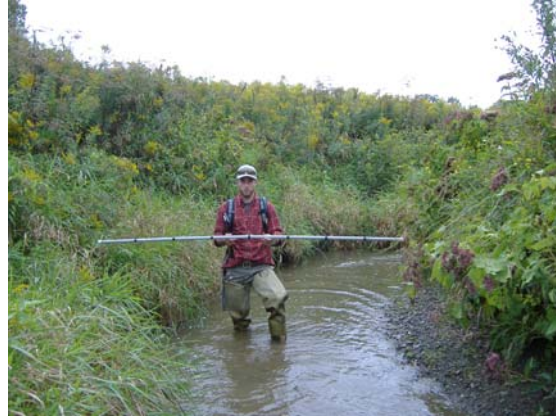
Figure 10 Incised M05

M05 flows from south of the Woods Hill Road to where the main stem meets up with M4T2. This section of the brook flows through a very broad valley and is fairly incised. At the cross section site a 1.82 incision ratio was observed. Abandoned pasture surrounds the corridor and woody buffer is slowly re establishing itself. Some shrubs and deciduous trees can be found inside the corridor.

The town of Swanton has done extensive channel alteration to this area due to the floods that would flow over the Woods Hill Road. Down stream of the road the channel has been dredged and straightened in hopes the high water would dissipate faster. This has caused headcuts to migrate upstream causing very high incision ratios upstream of Woods Hill Road. This has also caused loss of floodplain resulting in more water, with more pressure flowing towards the Woods Hill Road.

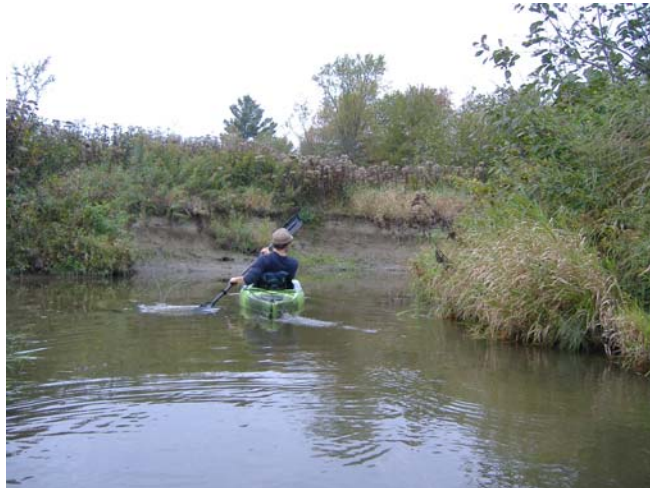
Figure 11 Erosion on a meander bend M04

Erosion was present on some meander bends possibly due to the sinuous nature of this reach. Erosion could also be a result of the changes in hydrology and sediment load found in upstream reaches. Flows that are higher in magnitude and velocity will cause erosion of banks. The bank texture consisted of sand, silt and clay, all easily eroded during high flows.

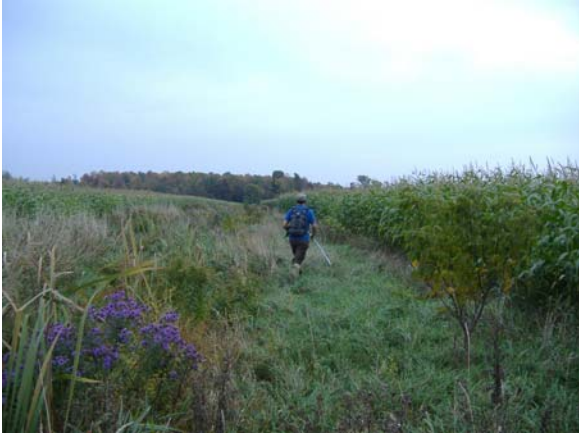
Figure 12 M4T2.04D

This upstream segment of M4T2.04 flows through both corn and hay fields. Extensive channel alteration including dredging and straightening have left this part of the reach with virtually none of its original characteristics. It is a sediment production zone and transport zone moving agricultural runoff and sediments from the corn and hay fields. There is no more than ten feet of herbaceous buffer on either bank. Due to incision during high water most of the flood plain access is lost.

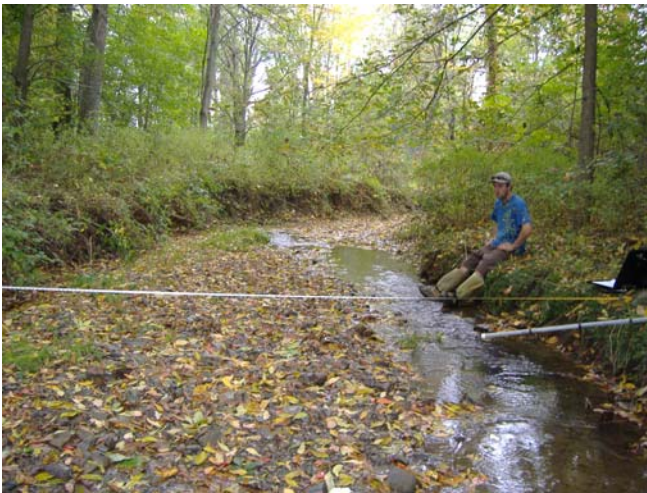
Figure 13 Cross section M4T2.04C

M4T2.04C- M4T2.04C is a B type channel with a gravel bottom. This reach is currently widening and has already undergone a stream type departure (E to B).

Segment C has excellent woody buffer on both banks, excellent meanders, and good bed strata, however because of increased hydrologic pressure and channelization of the upper watershed, this very short segment is in fair state. Much erosion has already undergone to create room to handle the increased cfs.

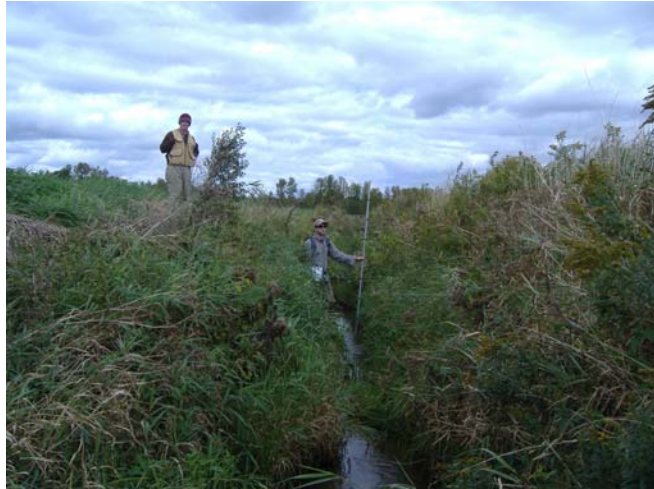
Figure 14 M4T2.04B Downstream of Rail Trail

M4T2.04B flows from Sholan Road to upstream of Viens Road. This segment has little to no woody buffer. It also suffers from channel alterations such as straightening and dredging. Just downstream from Sholan Road the channel flows under the old rail road grade (now known as the “rail trail”.) The channel flows along side the berm for about 800’ before it heads north at a farm road culvert. Downstream of the berm the channel is straightened and incised.

There is crop land on both the right and left banks with only minimal herbaceous buffer. The channel is very straight with no meander bends.

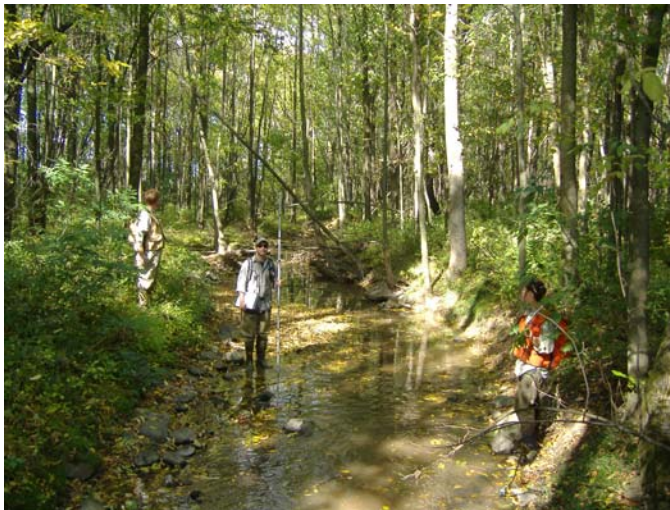
Segment A flows from upstream of the Viens Road to just upstream of the Bushey Road. This segment has excellent buffer with woody vegetation. It has adjacent wetlands and two bedrock outcrops on the bottom portion providing grade control.

Debris jams were observed inside of the stream corridor. There are numerous crossings made for an ATV that have accelerated erosion of some banks. Overall however

this reach is in excellent condition and needs only to be conserved and preserved through land use management. Not one of the bigger sediment production areas in the Hungerford Watershed.

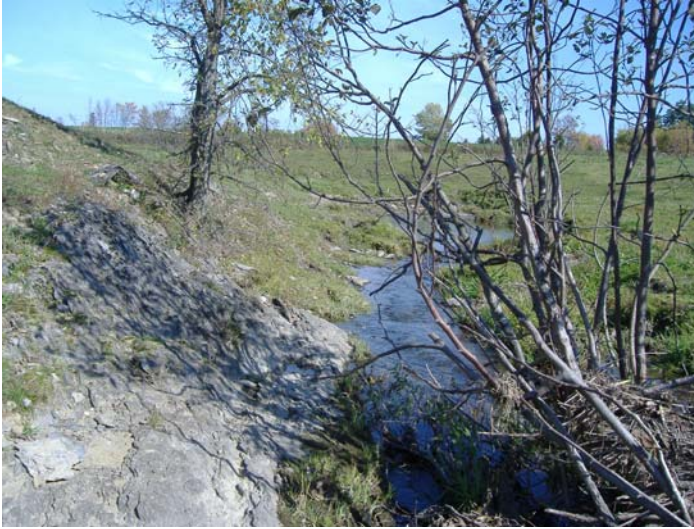
has the most bedrock of all the reaches assessed in the Hungerford Watershed. A total of five outcrops were observed, almost as many as all of the other reaches combined.

M4T2.03 flows through pasture with access to the channel by cattle and horses. Rip-Rap was observed downstream of Bushey Road next to a residence in the corridor

Due to stressors such as lack of woody buffer, vehicle crossings and animal accessibility, this reach has much erosion on its banks. It does however offer grade control for upstream reaches and will reduce the potential for the reach to lose connection with its flood plain.

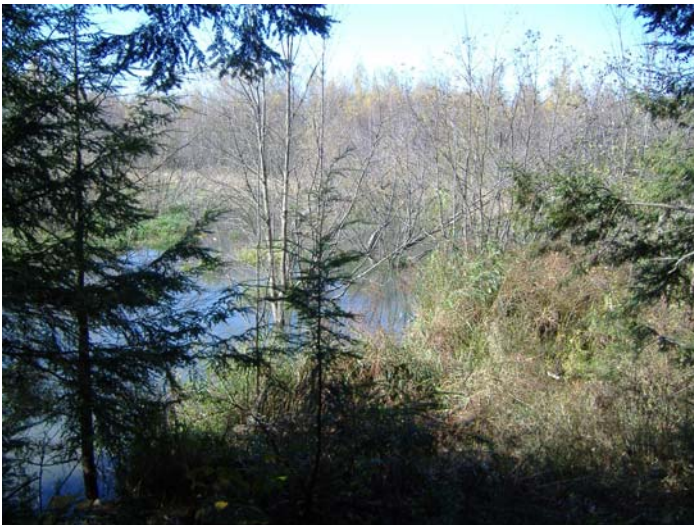
Figure 17 M4T2.02 Beaver activities

M4T2.02 has excellent canopy cover and for most of the reach has 100' or more of woody buffer. Midway down the reach the buffer changes from deciduous/ conifer to alders. Not long after that change was observed the reach became impounded by beavers.

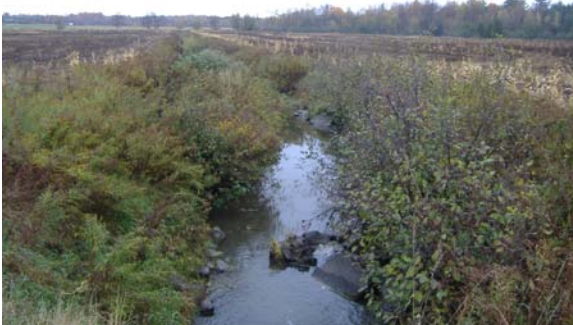
Figure 18 M4T2.01 Downstream of Woods Hill Rd.

This reach joins the main stem of the Hungerford Brook just downstream of the Woods Hill Road. Upstream of Woods Hill Road the reach has 50' of woody buffer on both banks and has not undergone channel alterations. Before M4T2 reaches the road however it has been straightened and dredged. It flows through a culvert underneath the Woods Hill Road and into crop land before joining the main stem (see figure 10.) Less than ten feet of herbaceous buffer surrounds the channel with corn being cultivated on both banks.

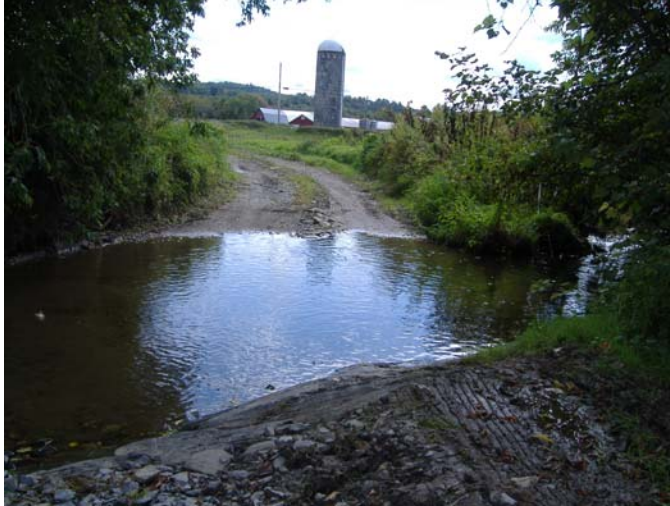
*Figure 19 Vehicle crossing
M3T1.03*

This reach begins just upstream of Rte 105 in Swanton. It ends just downstream of the Swanton/Sheldon town line. Upstream of Rte 105 excellent woody buffer was observed as well as a small bedrock outcrop. On the roadside, within the corridor, Japanese knotweed was spotted, surprisingly the only plant of its kind seen during the whole assessment. Downstream of Rte 105 the brook flows through a pasture where cattle have direct access to the brook. There is no woody buffer in the pasture and most of the banks are undercut.

Possibly due to upstream grade control or the cohesive banks this reach has surprisingly good access to its floodplain.

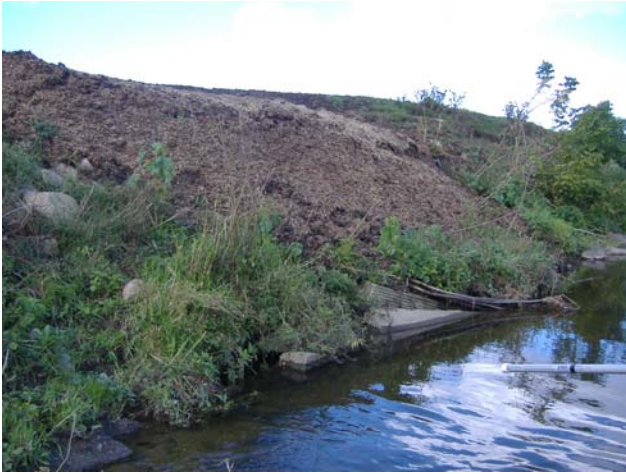
Figure 21 Nutrient source just upstream of Woods Hill Road M3T1.02

Close to Woods Hill Road cattle have access to the brook and much erosion was observed. Before the brook crosses the road it enters a barnyard and loses all buffer and is extremely eroded.

Old feed is dumped into the corridor leaching nutrients directly into the brook. Woody buffer is lost in this short area along Woods Hill Road.

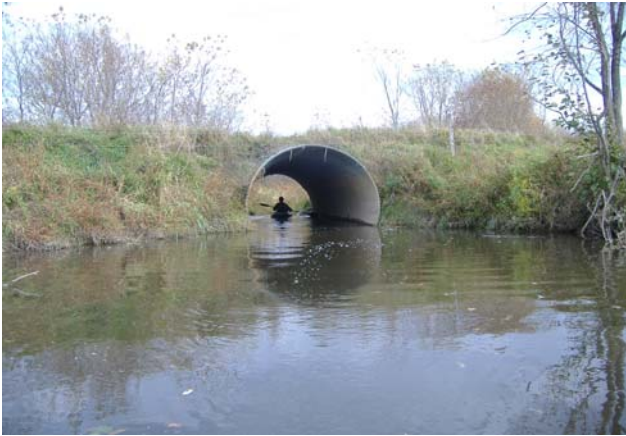
Figure 22 Heald Road culvert M3T1.01

This reach is in stable condition and offers good sediment attenuation zones due to all of the beaver activity. Much of the reach is impounded and gives sediment a chance to settle out before it reaches the main stem.

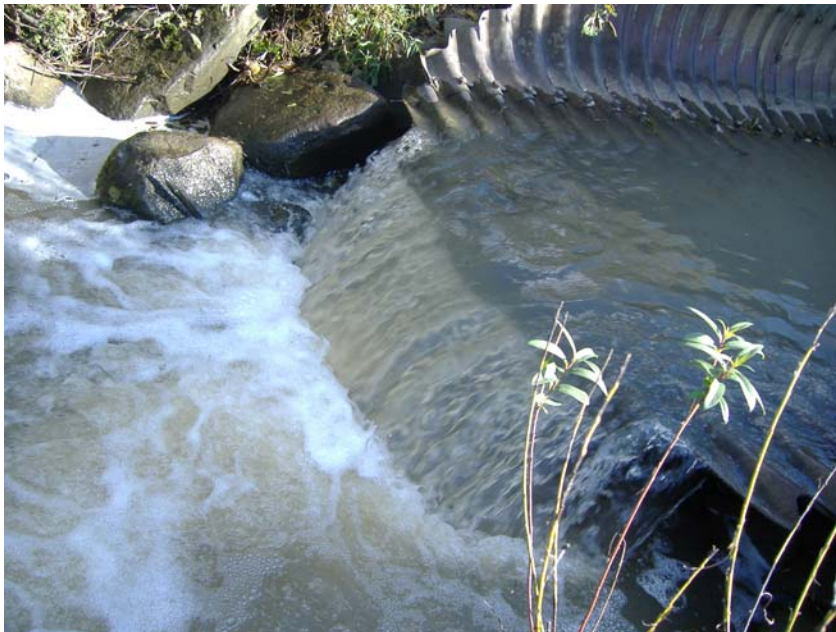
Figure 22 Perched Output M4T2.01

Seven bridge and culvert assessments were completed for the Hungerford Brook Watershed. Of these seven assessments, six were culverts and one was a bridge. Common problems observed at these structures included scour pools above and below, deposition above and below and floodplain and channel constriction.

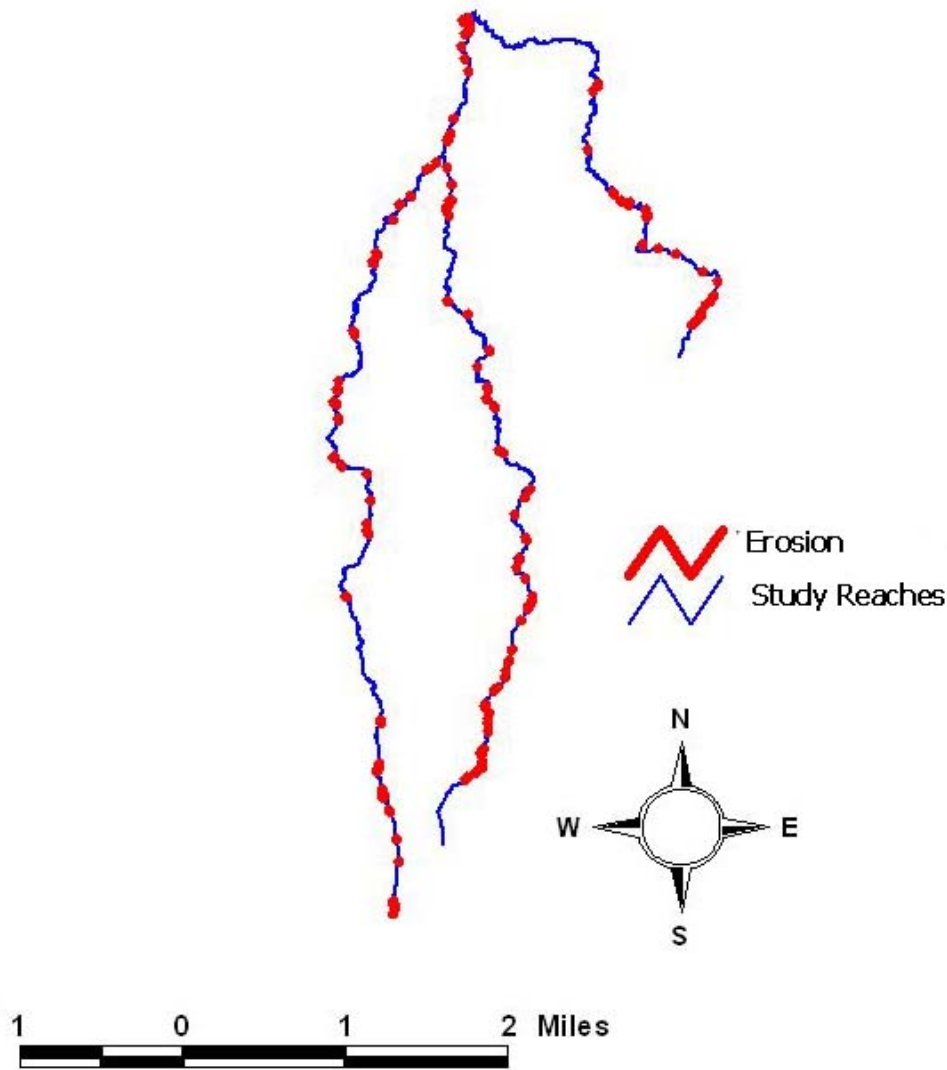
Figure 24 Erosion Map

The following figure (Figure 24) highlights the problem of erosion observed in the Hungerford Brook watershed. Lots of red (erosion) can be seen in the figure. This erosion can be caused by increased hydrologic pressure, direct access by cattle, lack of woody buffer, ATV's, vehicle crossings, undersized crossing structures, and numerous other causes. Erosion is a problem that must be addressed if the Hungerford Brook is to be returned to a state closer to its equilibrium.
