# Upper Winooski River: Plainfield to Montpelier

## River Corridor Management Plan

### Washington County, Vermont

MARCH 31, 2010

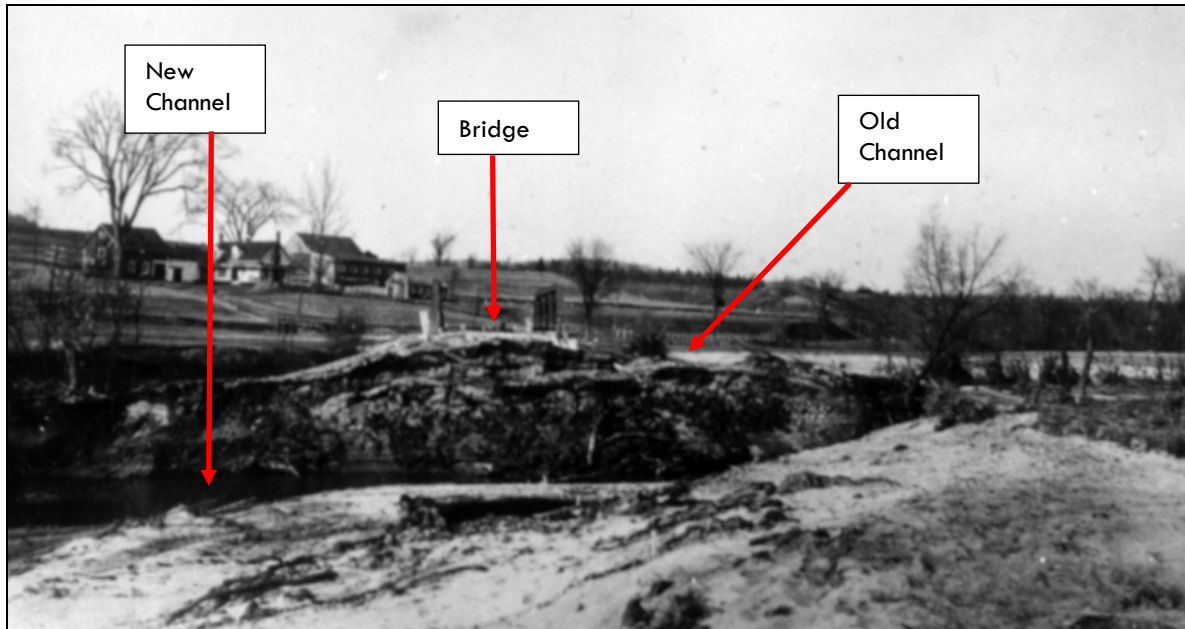
**Figure 7: Land eroded next to bridge on Winooski River between Montpelier and Plainfield where the channel constriction likely caused water to back up and avulse around the structure during the 1927 flood (Source: UVM Landscape Change Program).**

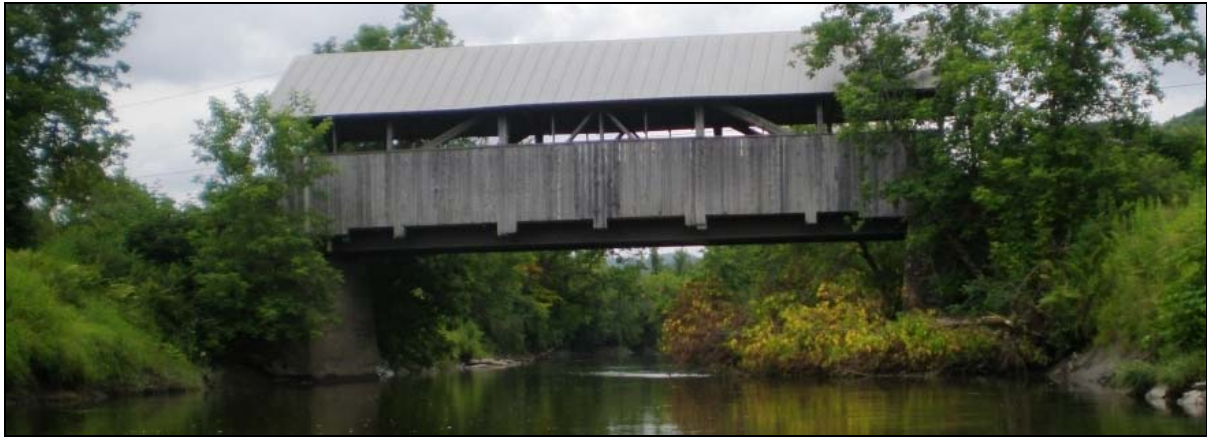
During the Phase 2 Assessment, several bridges and culverts were observed to be considerably narrower than the existing bankfull width, subsequently causing instability in the river (Table 3). In particular need of retrofit, based on the problems observed and their width as a percentage of bankfull width, are the Route 2 bridges spanning reaches R19, R22-A and R25, the railroad bridge at R19, and the Coburn Covered Bridge on R24 (Figure 12).

**Figure 12: The Coburn Covered bridge (R24) was elevated to increase the area through which water can flow. Despite this, the bridge abutments still constrict the channel and upstream and downstream erosion is a result (see fallen tree on right bank).**

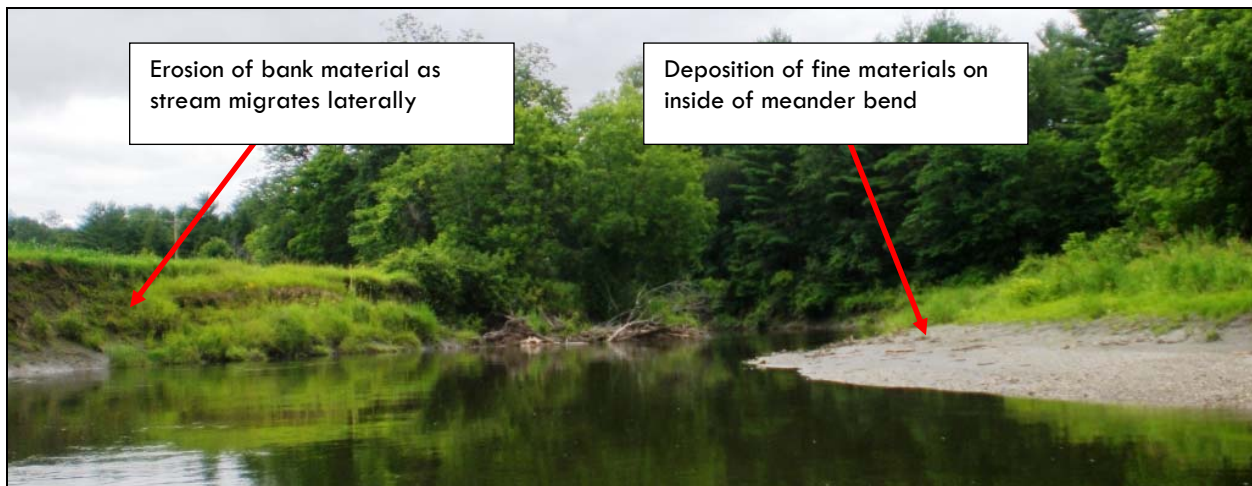
Figure 13: Planform migration as reaction to historic channel straightening (R23) of the Upper Winooski River.

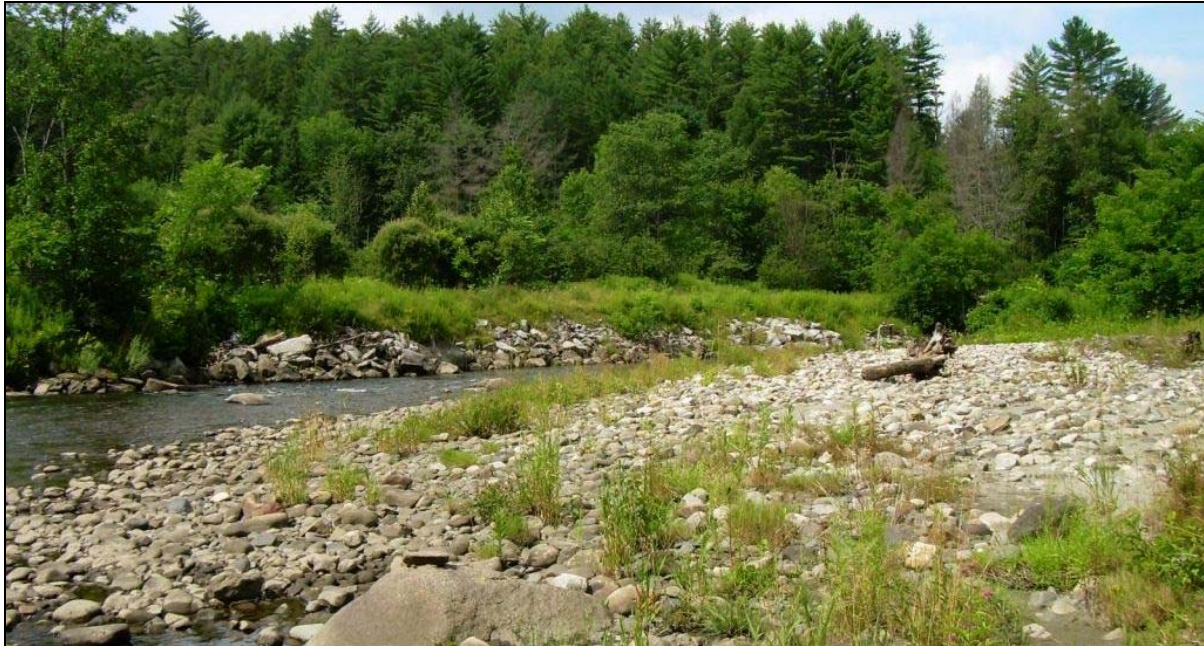
A road on the left bank has severed some potential floodplain access for the river. Riparian buffer removal on the left bank has also occurred in significant amounts. On the right bank some minor encroachment by residential development has occurred, however, overall the buffer is in better condition. The Plainfield Water Treatment facility, located within the river channel corridor is on the left bank next to the recreation fields. Future continued planform adjustment can be expected in this reach as the river works to develop accessible floodplain and to transport sediments arriving from Great Brook.

**Figure 4: Dynamic channel movement in reach R26. New floodplain development and sediment deposition on inside bend (right), erosion and prevention (rip-rap) on left bank.**

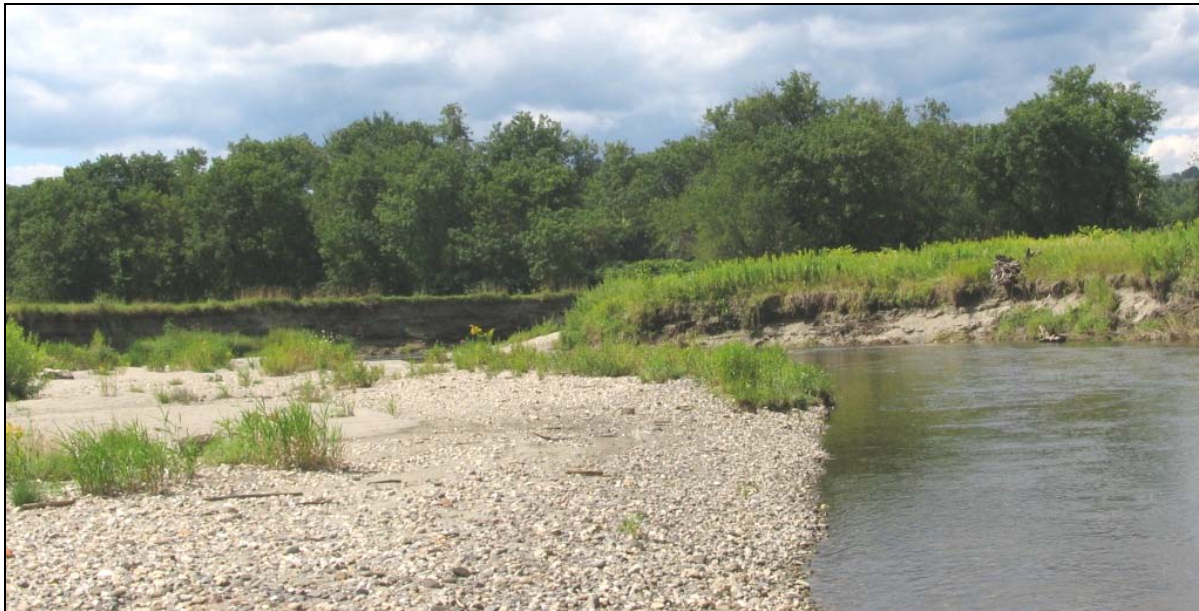
Figure 6: Widening and planform adjustment in Reach R25. Photo credit: Johnson Company

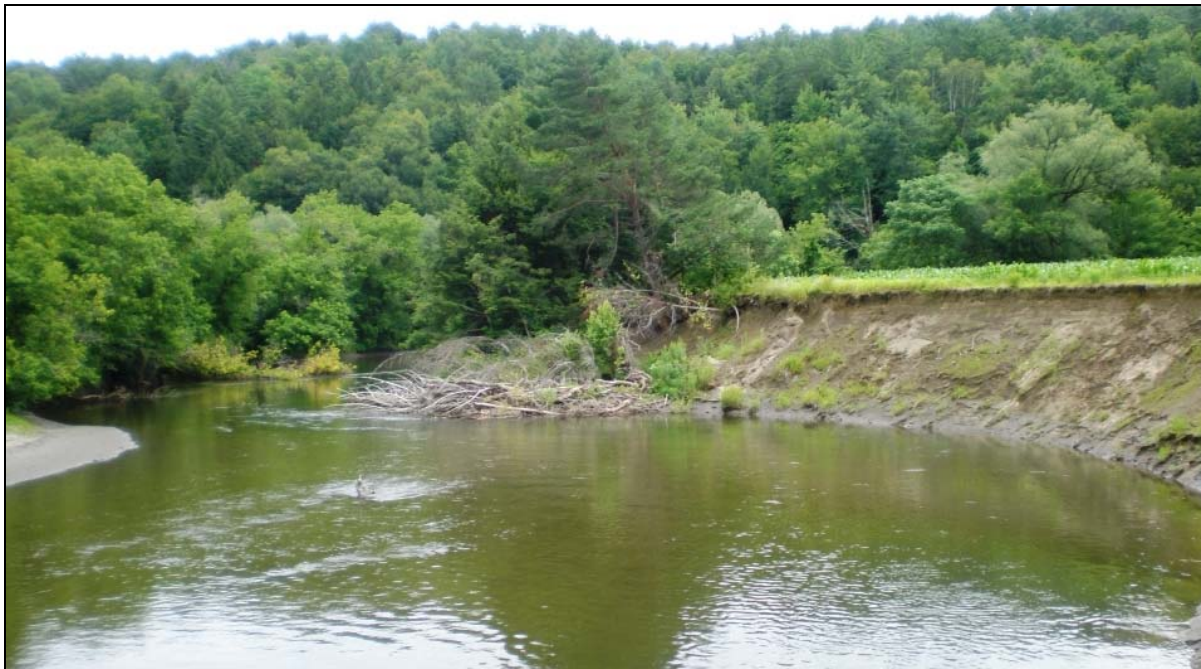
**Figure 9: Significant streambank erosion through alluvial soils in reach R23.**

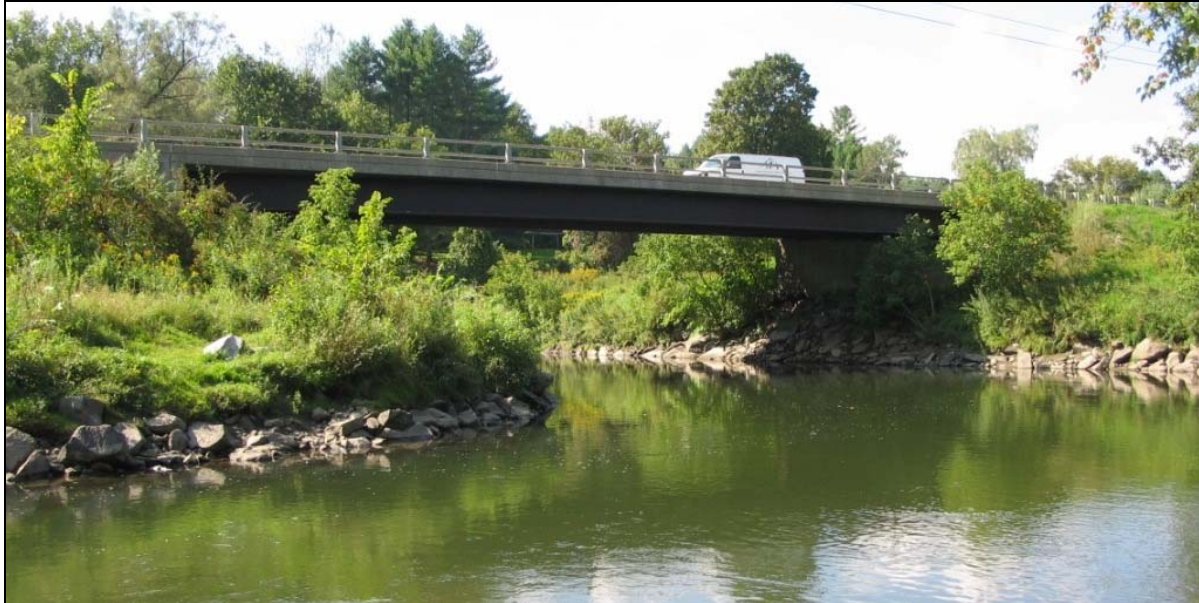
**Figure 12: Route 2 Bridge with difficult alignment, R22-A. Photo credit: Johnson Company**

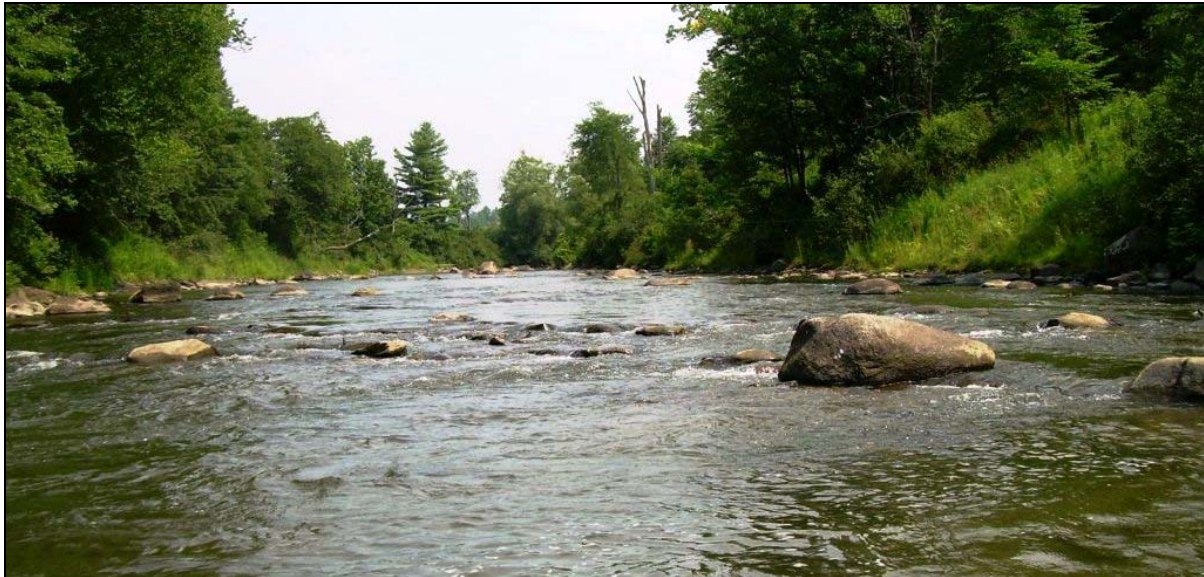
**Figure 14: R21-B flows over boulders and cobbles alongside the old route 2 roadbed which flanks the left bank (right side of photo).**

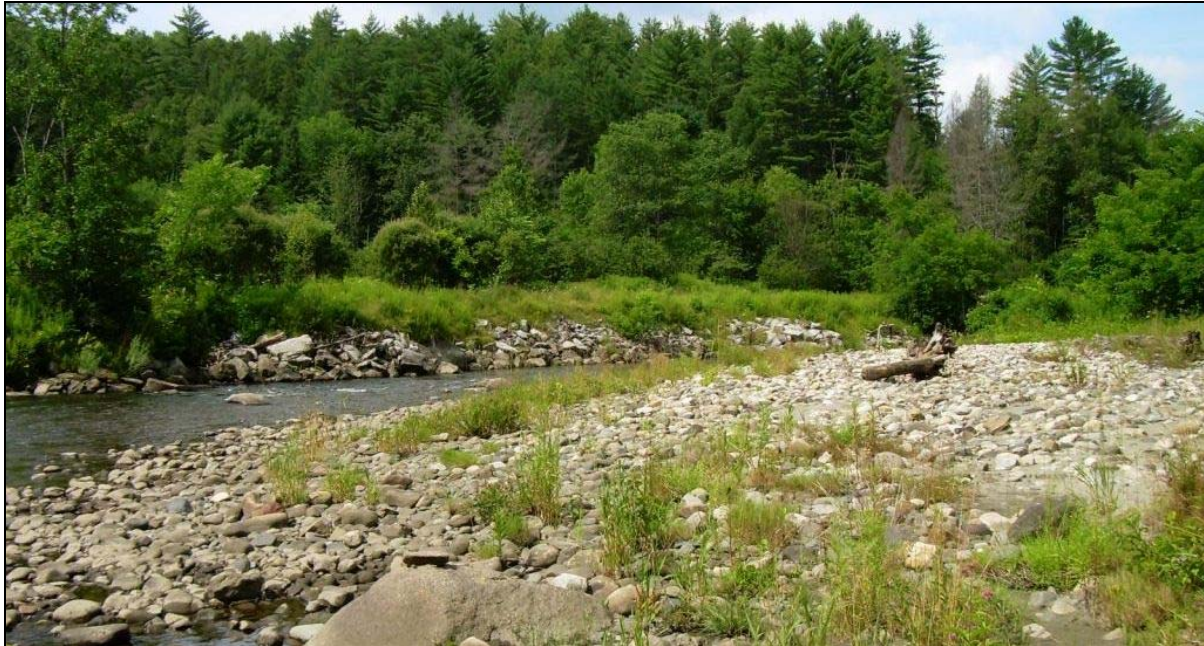
**Figure 4: Dynamic channel movement in reach R26. New floodplain development and sediment deposition on inside bend (right), erosion and prevention (rip-rap) on left bank.**

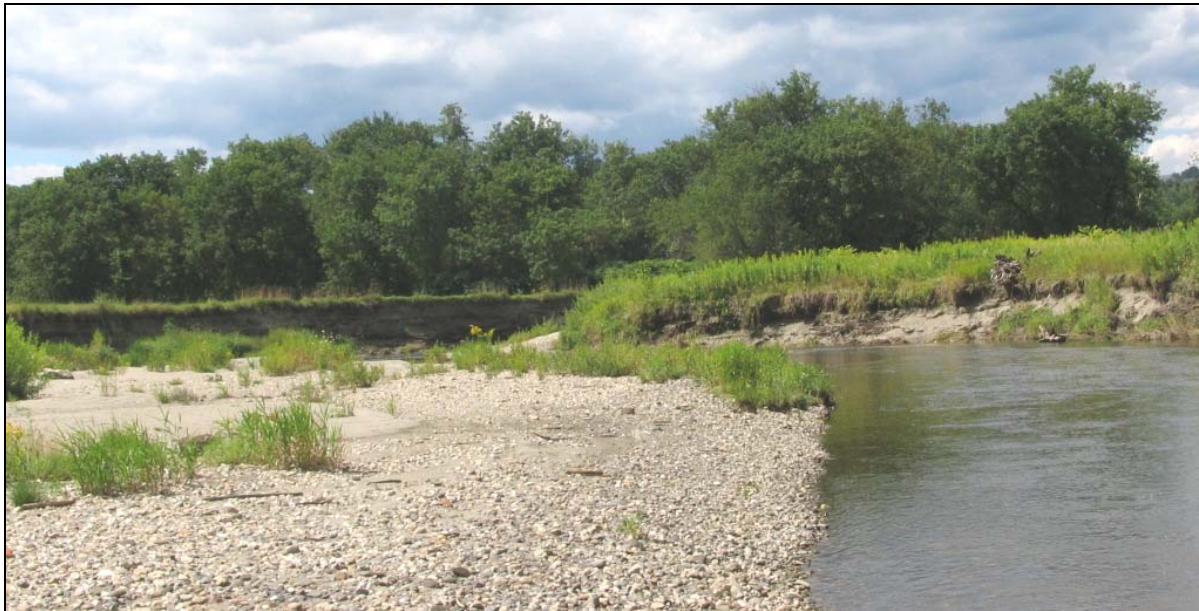
Figure 6: Widening and planform adjustment in Reach R25. Photo credit: Johnson Company

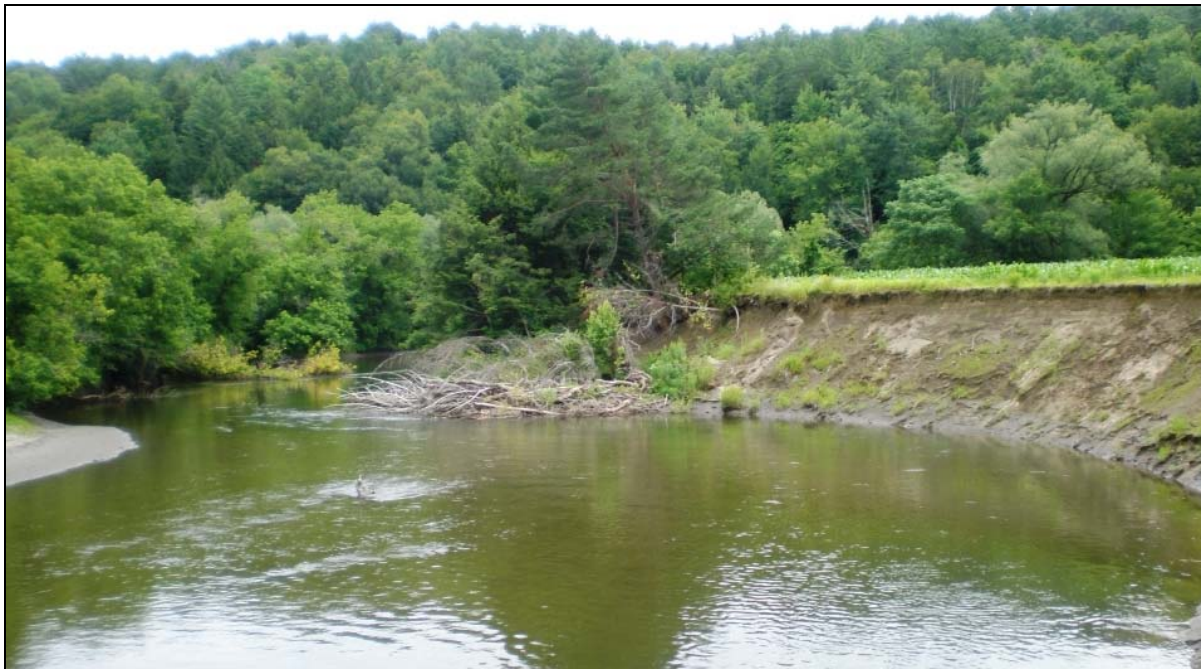
**Figure 9: Significant streambank erosion through alluvial soils in reach R23.**

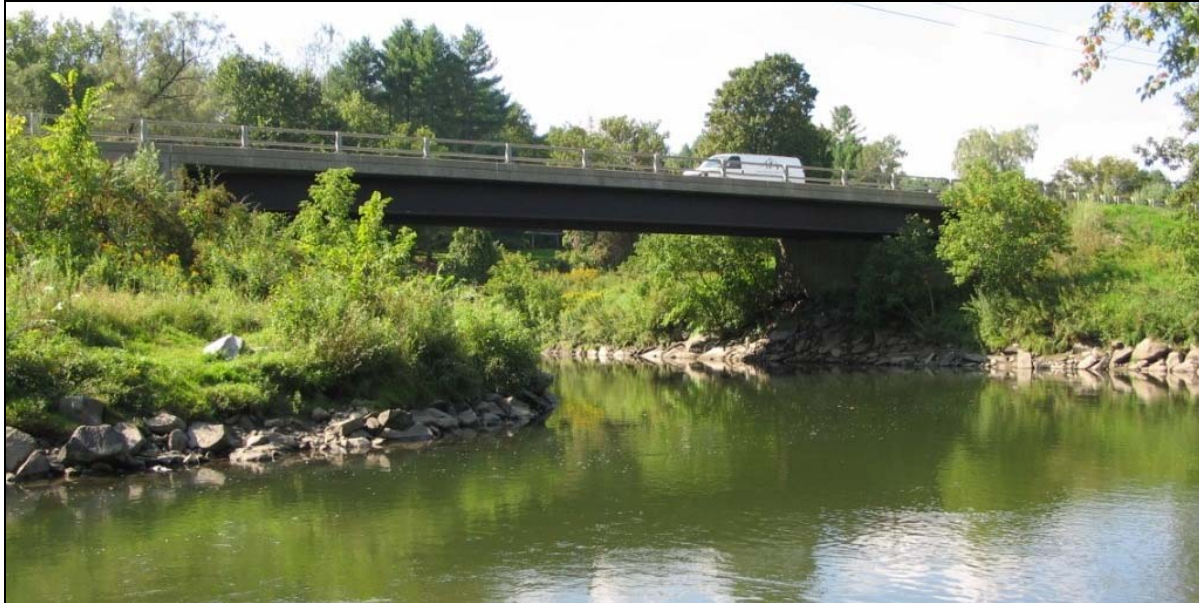
**Figure 12: Route 2 Bridge with difficult alignment, R22-A. Photo credit: Johnson Company**

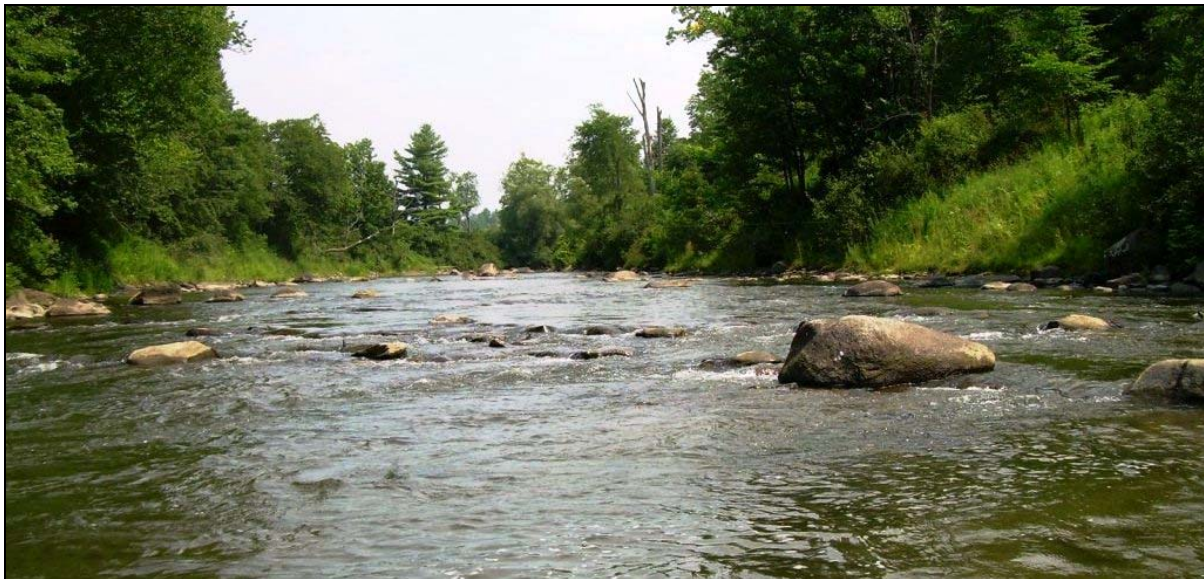
**Figure 14: R21-B flows over boulders and cobbles alongside the old route 2 roadbed which flanks the left bank (right side of photo).**
