# **Phase 2 Stream Geomorphic Assessment Winooski River Watershed Town of Cabot Washington County, Vermont**

Draft Report  
December 6, 2004

Mary Nealon  
Principal/Aquatic Biologist

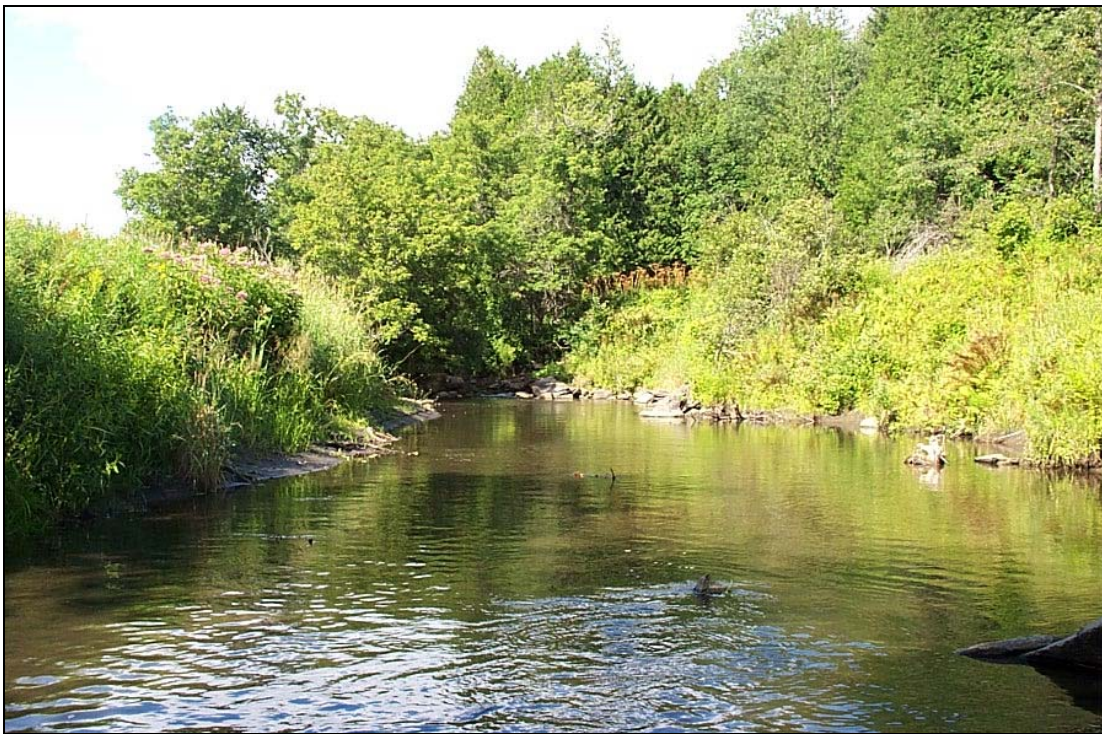
The confinement within segment M02-A is very broad. This segment was classified as a C5 channel based on the channel cross section and the pebble count. The substrate was noted to be soft underfoot and approximately 80 percent of the particles were sand. Much of the segment is dominated by runs, as illustrated in Figure 2. Sediment storage bars included mid channel and point bars. The incision ratio was calculated to be 1.7, suggesting the river has only fair access to the floodplain within this segment.

**Figure 2. M02-A is dominated by run habitat. The substrate was soft underfoot suggesting aggradation is occurring.**

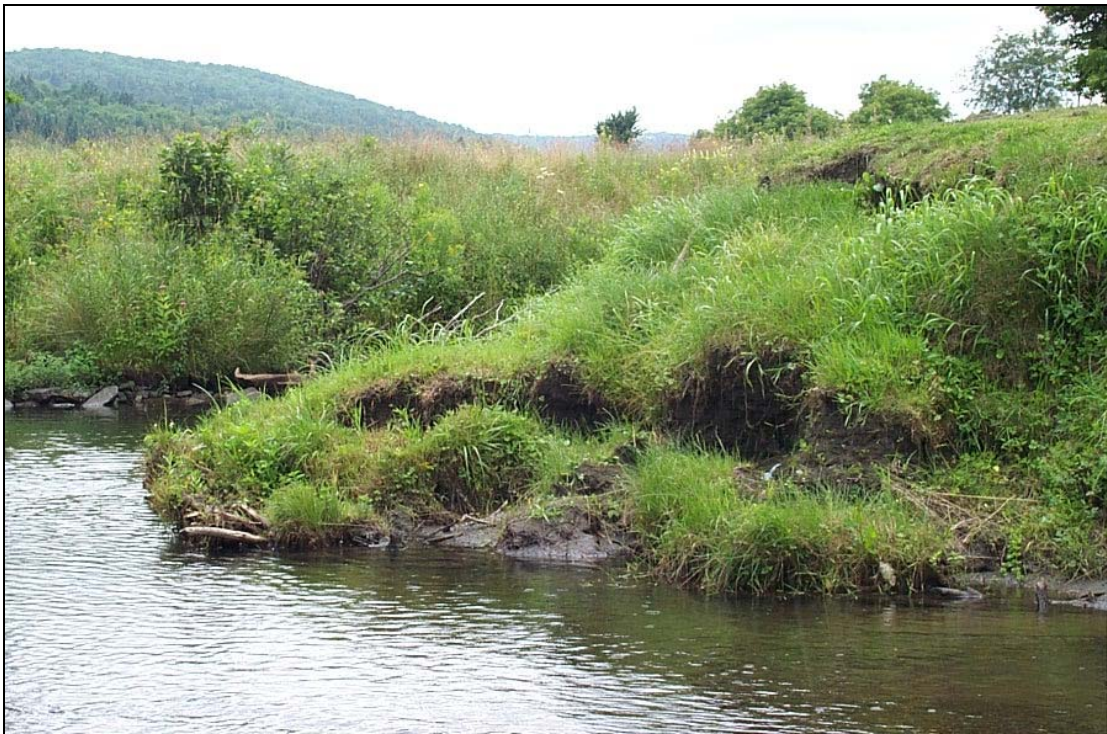
Segment M02-B had a high rate of bank erosion, with erosion noted along approximately 60 percent of the left bank and right bank. The high bank height in this section averaged about five feet. Figure 3, shows bank erosion adjacent to Durant cemetery. During fall 2004, the Cabot Cemetery Commission stabilized approximately 300 feet of the right bank with rock riprap.

**Figure 3. Bank erosion in segment M02-B adjacent to Durant cemetery. The Cabot Cemetery Commission stabilized approximately 300 linear feet of bank with rock riprap during fall 2004.**

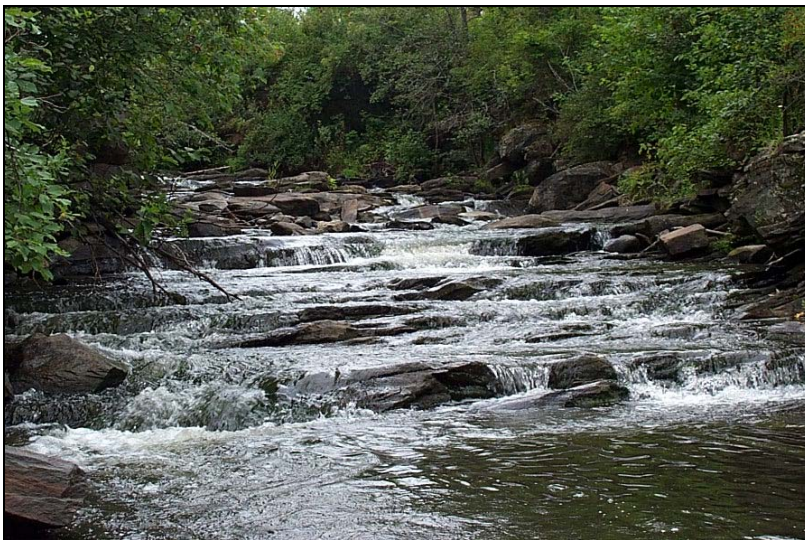
As shown in Figure 4, segment M02-C had a ledge grade control falls at the upper end and a step/pool system at the lower end of this subreach. An old mill site was observed within this segment. Segment M02-C was not included in the Phase 2 study because it is bedrock controlled.

**Figure 4. Segment M02-C is ledge a controlled falls with a step/pool system at the lower end. An old mill was observed within this reach during the Phase 2 walkover.**

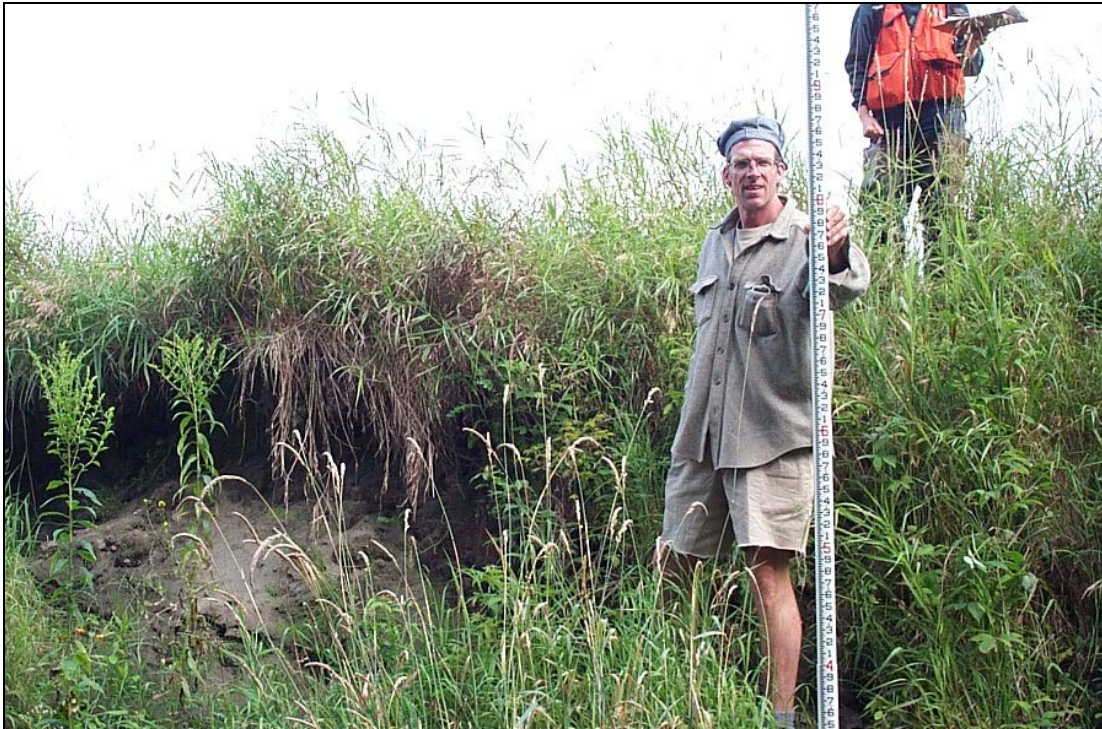
**Figure 5. Charlie Wanzer, high school science teacher in Cabot holds the rod to measure the bank height. The low bank height within this segment was close approximately 8 feet, providing evidence that the Winooski is incised in this location.**

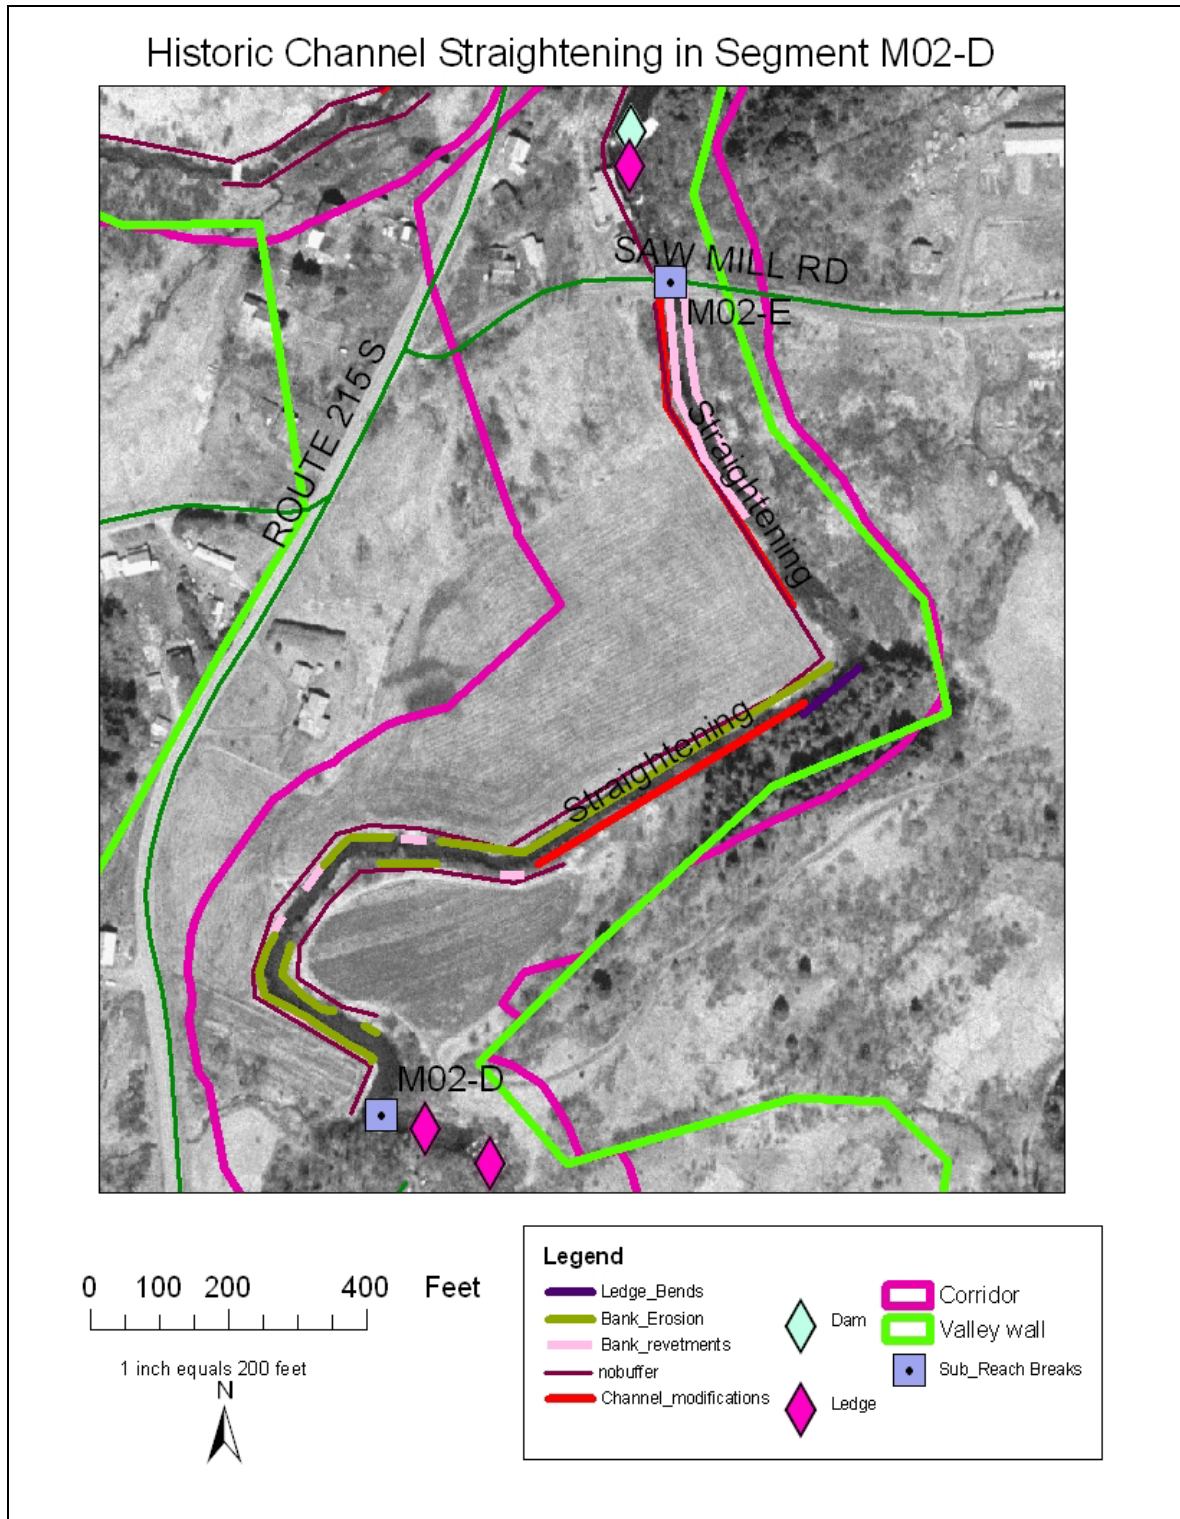
Because of the significant historic channel straightening within this section, the sinuosity is only low. The river is sometimes within one bankfull width of the left valley wall, suggesting the river was relocated at one point at the edge of farm fields. Ledge was noted along the left bank of the large bend within this reach. Bank erosion was recorded to be high (50%) on the right bank where the buffer width was typically less than 5 feet wide. Along the left bank, where the buffer width was generally greater than 100 feet, the bank erosion was only about 13 percent.

**Figure 6. Historic channel straightening within segment M02-D. The reach is bordered by ledge grade control on the downstream end and a dam and ledge grade control on the upstream end.**

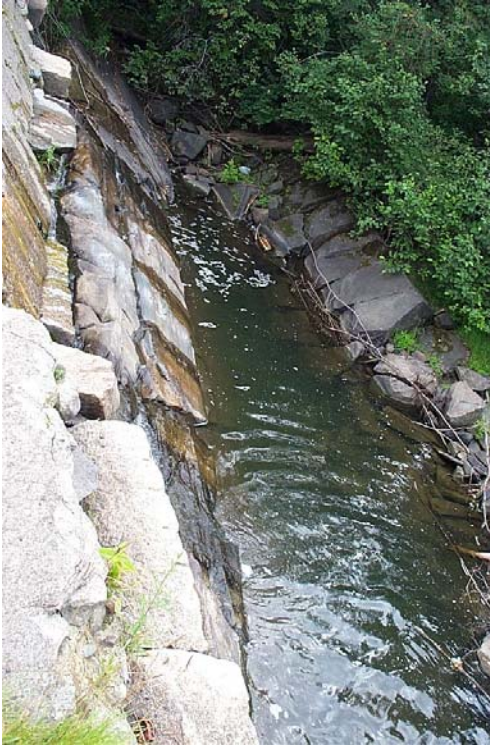
Segment M02-E provides a significant grade control due to the Clark's Saw Mill dam and the bedrock below the dam. Based on records from the Vermont Dam Safety Program, Clark's Saw Mill dam has a length of 135 feet and is 14 feet high. Segment M02-E was not included in the full Phase 2 assessment because it is bedrock controlled.

**Figure 7. Clark's Saw Mill Dam and ledge provide a significant grade control at the upper end of Reach M02.**

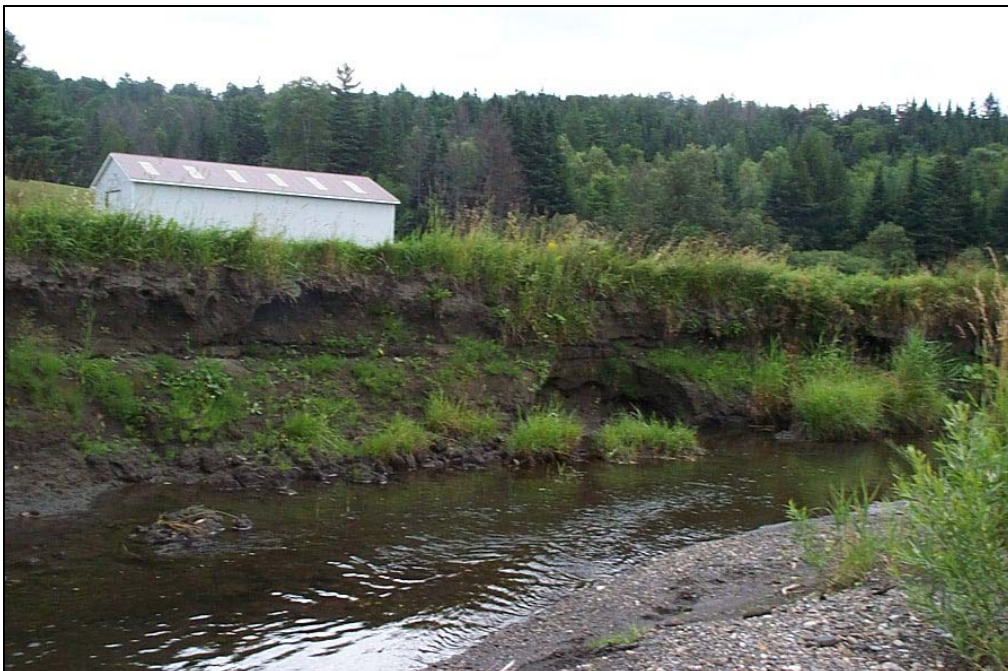
channel. Based on the high bank lateral bank erosion and the historic and active flood chutes, reach M03 appears to be undergoing extreme planform adjustment.

Figure 9. Extensive lateral bank erosion on outside bends in reach M03.

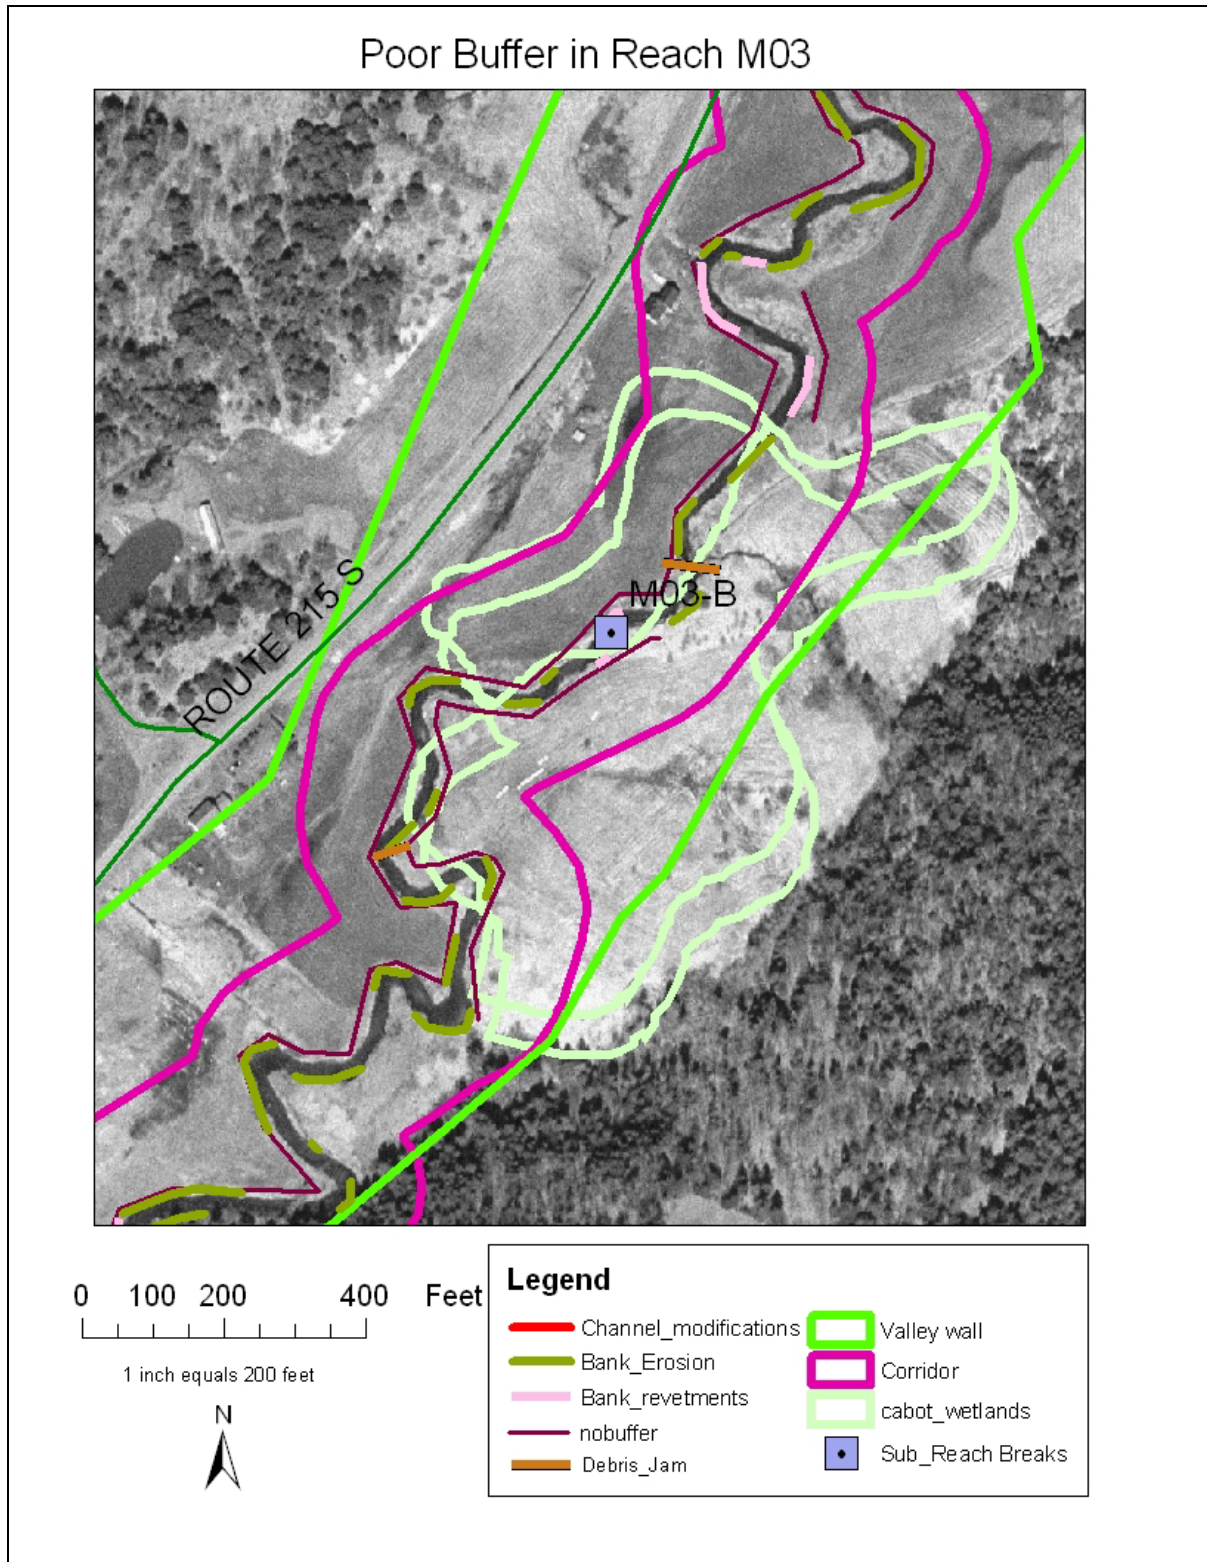
**Figure 10.** The majority of reach M03 has no buffer (<25 feet) on both sides of the channel.

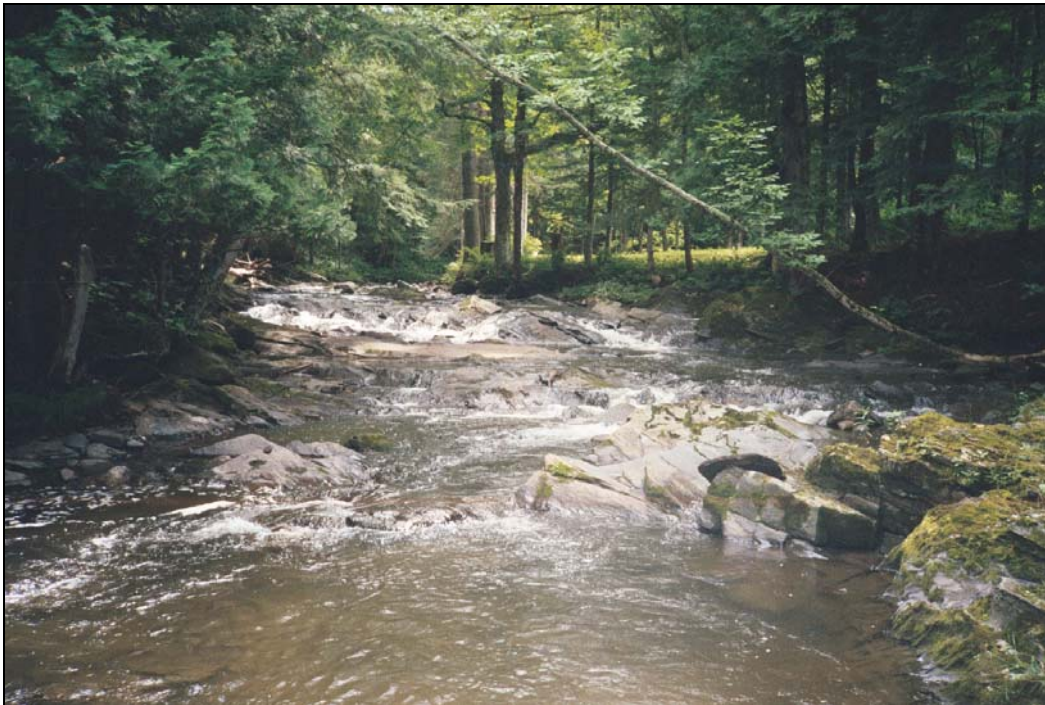
**Figure 11. Ledge grade control section at upstream end of segment M04-A.**

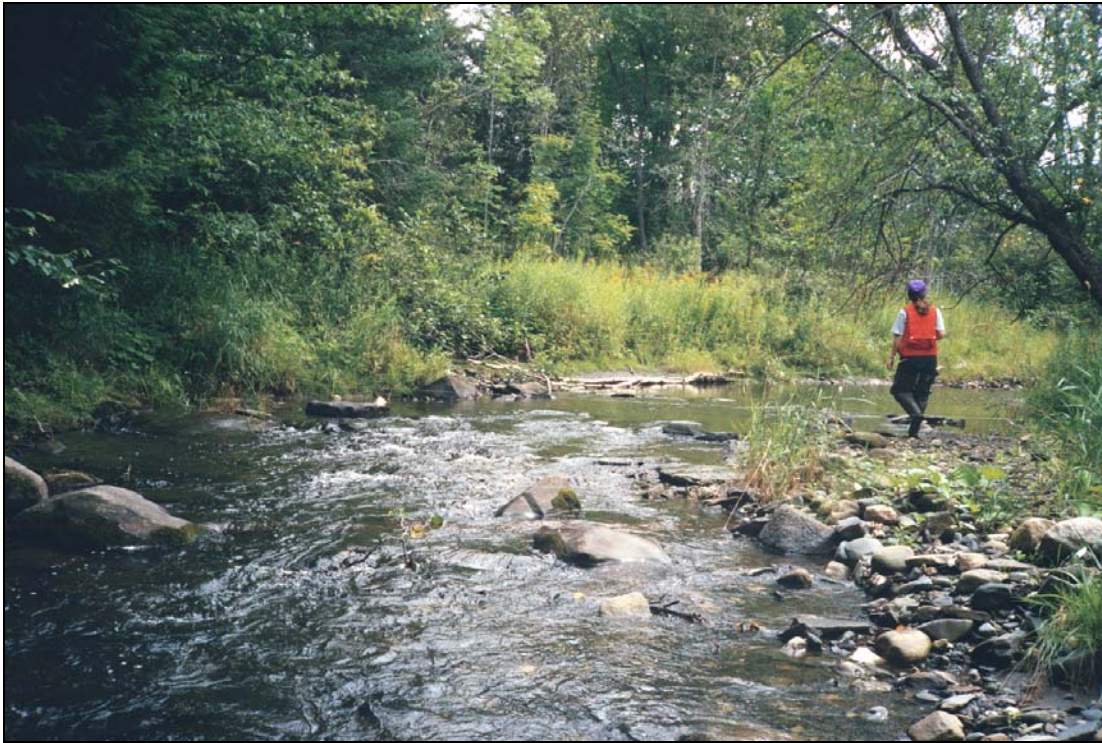
**Figure 12. Good habitat was noted in Reach M04-B. This reach contained a good mix of substrate types and frequent pools.**

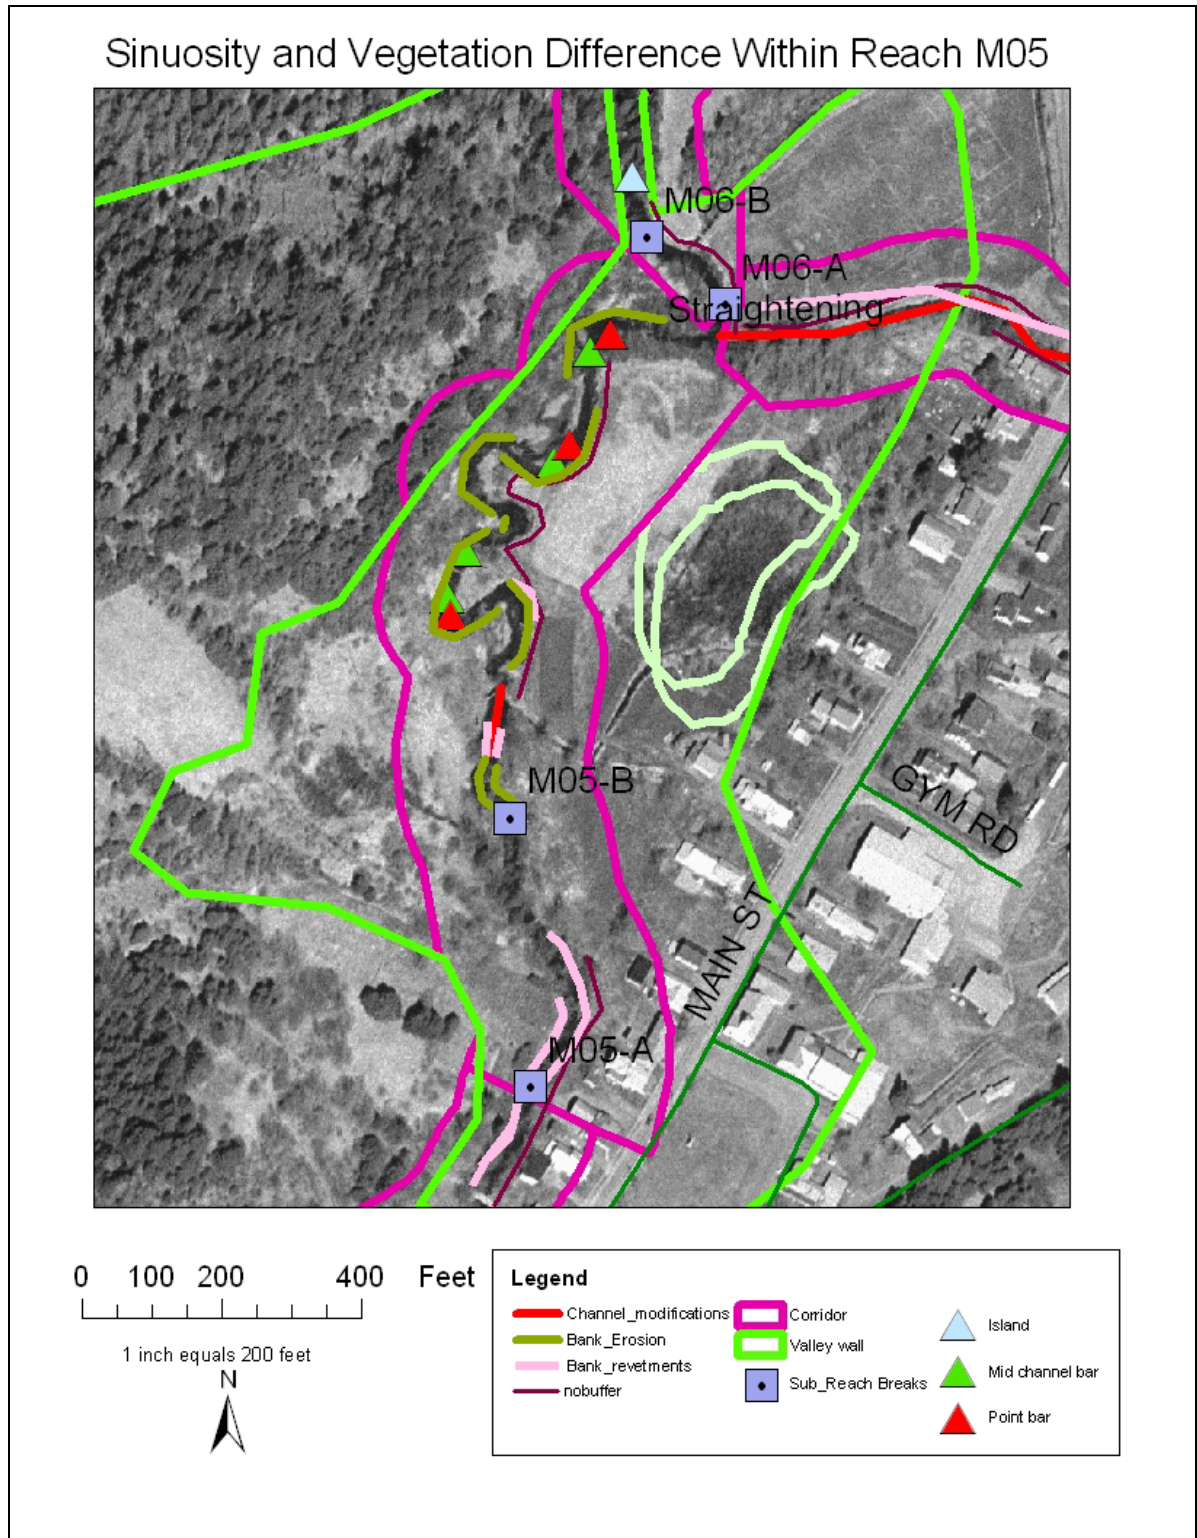
**Figure 13. Reach M05 was split into segments based on differences in sinuosity and vegetation**

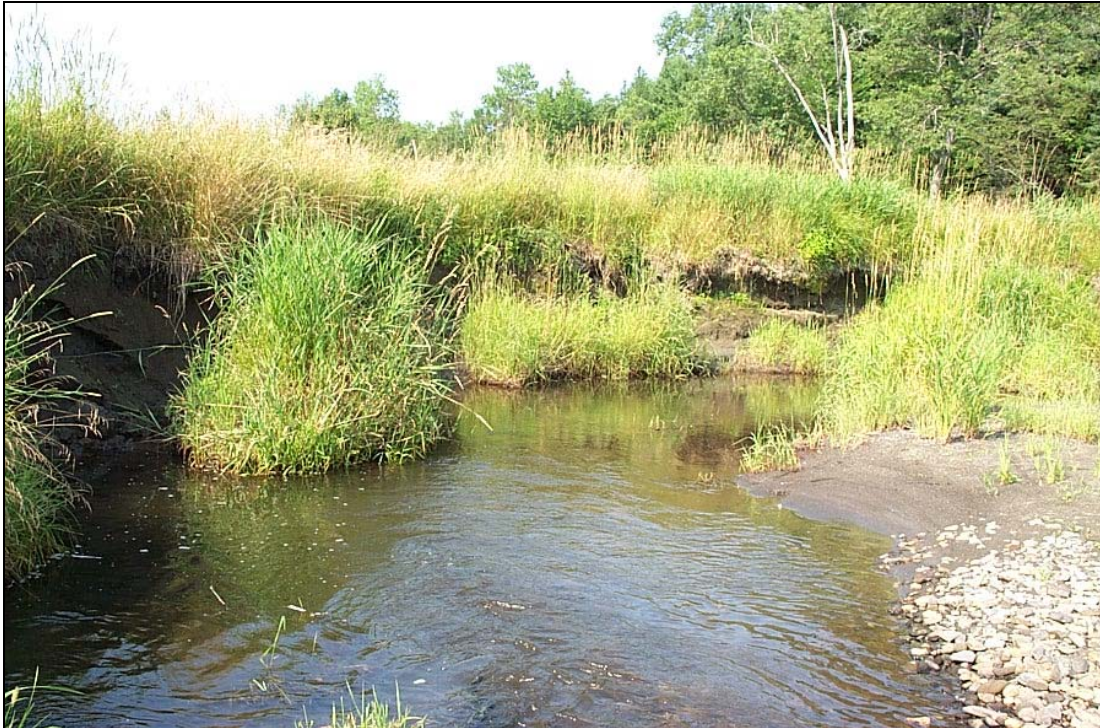
lower segment M05-B typically had shrubs-sapling on the near bank and shrubs-saplings or deciduous trees within the buffer. M05-B was noted to have moderate sinuosity, and M05-A has low sinuosity. Reach M05-B has unvegetated point bars and mid channel bars, and flood chutes, while M05-A has side bars. Significant lateral bank erosion was observed on the outside bends in reach M05-B (see Figure 14).

**Figure 14. Segment M05-B was noted to have extensive lateral bank erosion on the outside bends.**

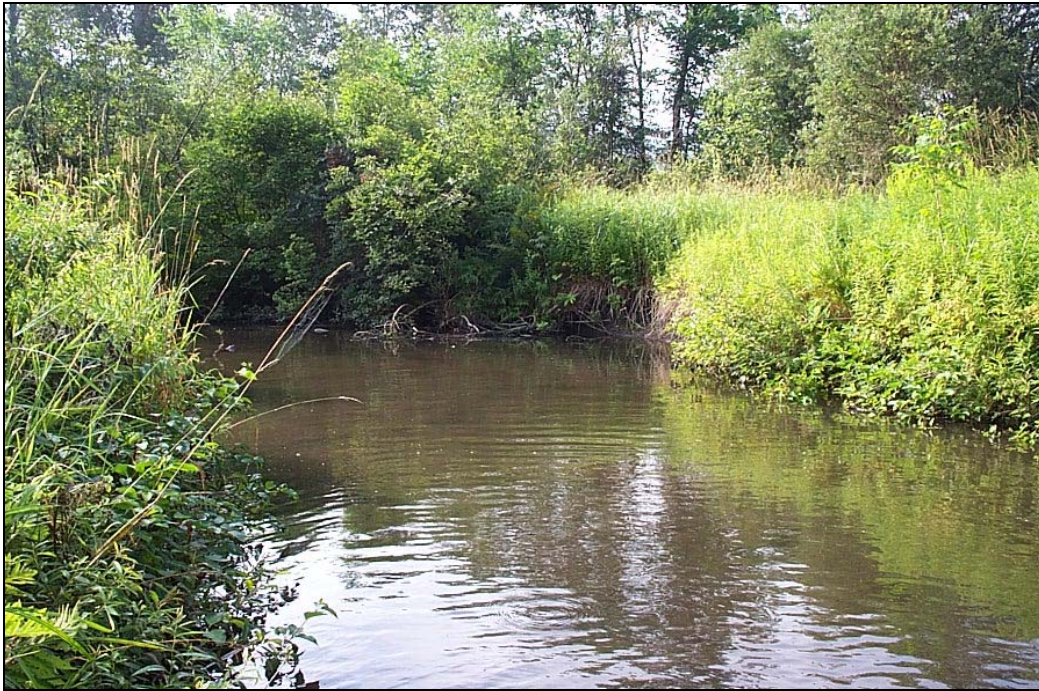
**Figure 15. Reach M06-A is characterized as a low gradient, sand dominated channel.**

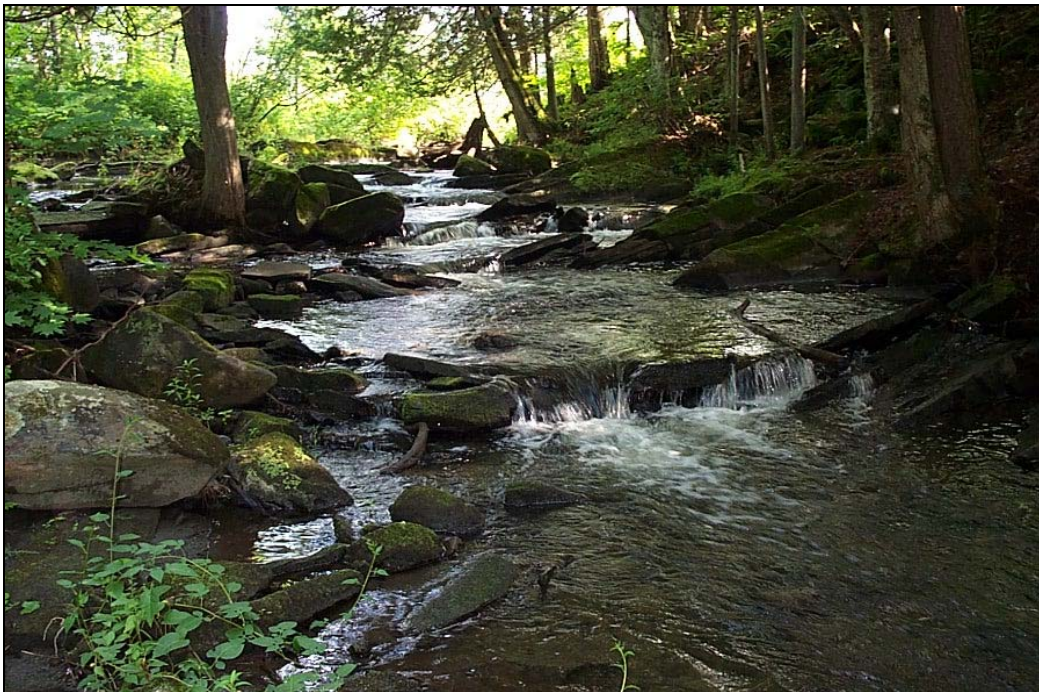
Segment M06-B is a higher gradient, narrowly confined rock gorge as shown in Figure 16.

**Figure 16. Segment M06-B is a narrowly confined, bedrock controlled section of the Upper Winooski River.**

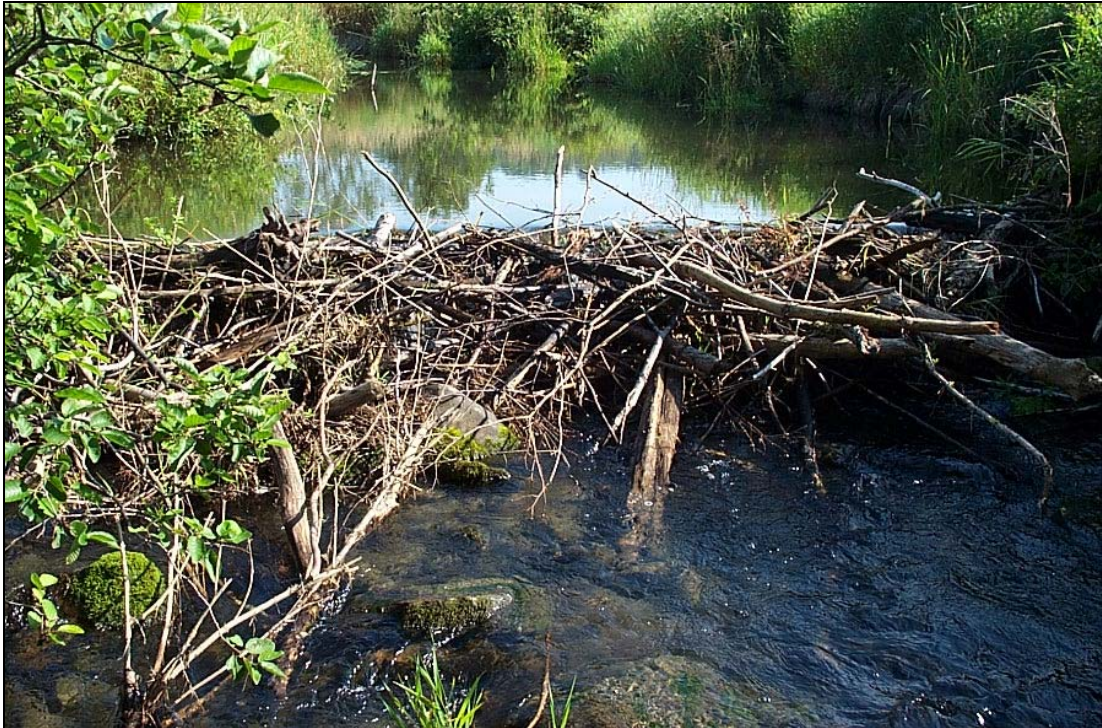
Because this reach is bedrock controlled, a geomorphic assessment of this reach is not warranted. Segment M06-C, located above the bedrock grade control is heavily influenced by two beaver dams (see Figure 17). This area appears to have had extensive beaver influence over a period of time. For this reason, this segment is functioning more like a wetland than a fluvial system. Therefore, a phase 2 assessment of this segment is not appropriate.

**Figure 17. Beaver dams are influencing the Winooski River within Segment M06-C. This segment is acting more like a wetland than a fluvial system.**

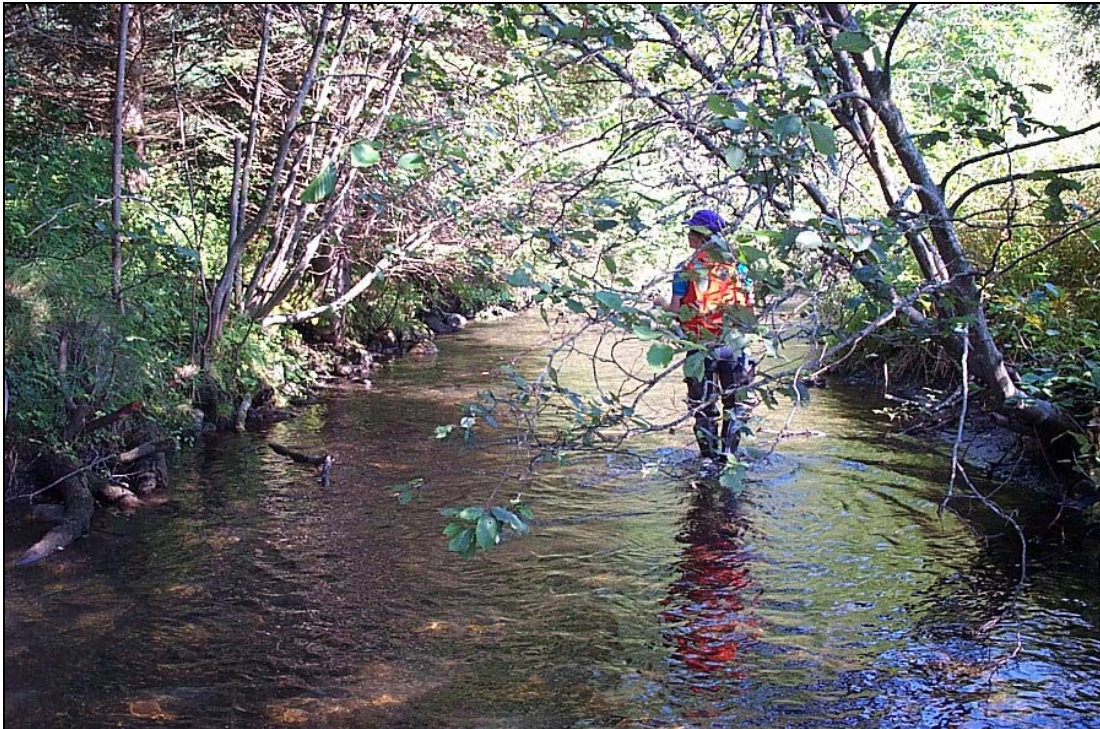
**Figure 18. Segment M06-D has a high quality buffer and near bank vegetation.**

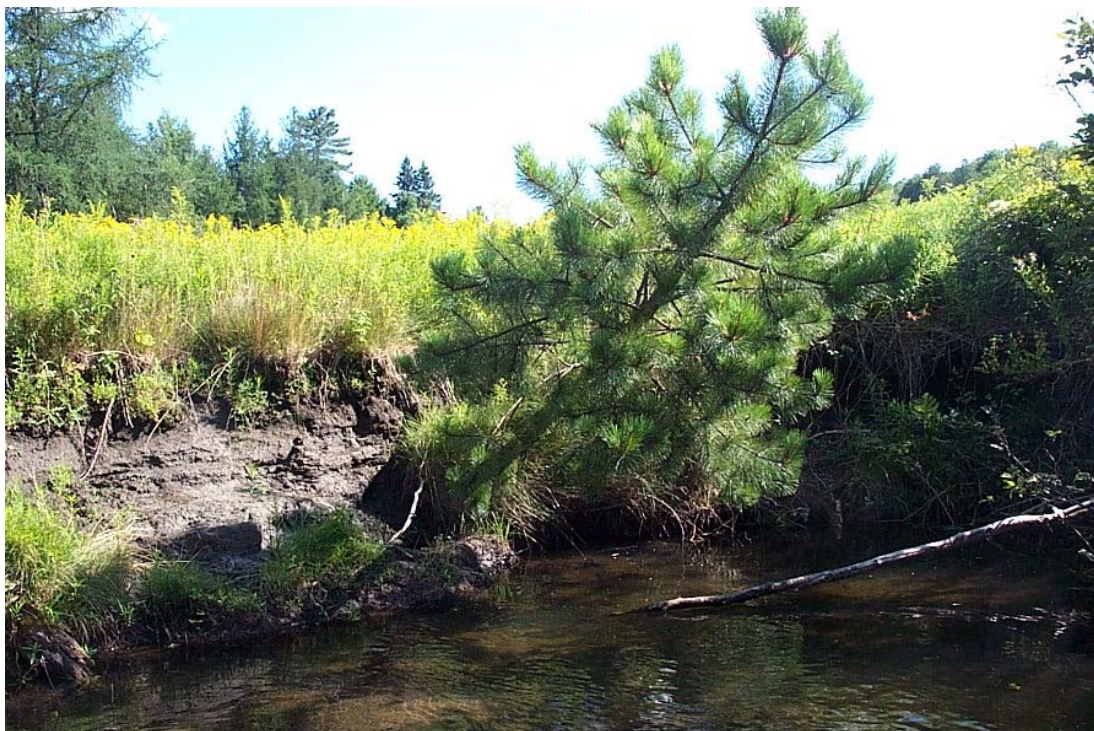
**Figure 19. Reach M07 appears to be undergoing significant lateral migration. There is also some evidence of degradation and channel widening.**

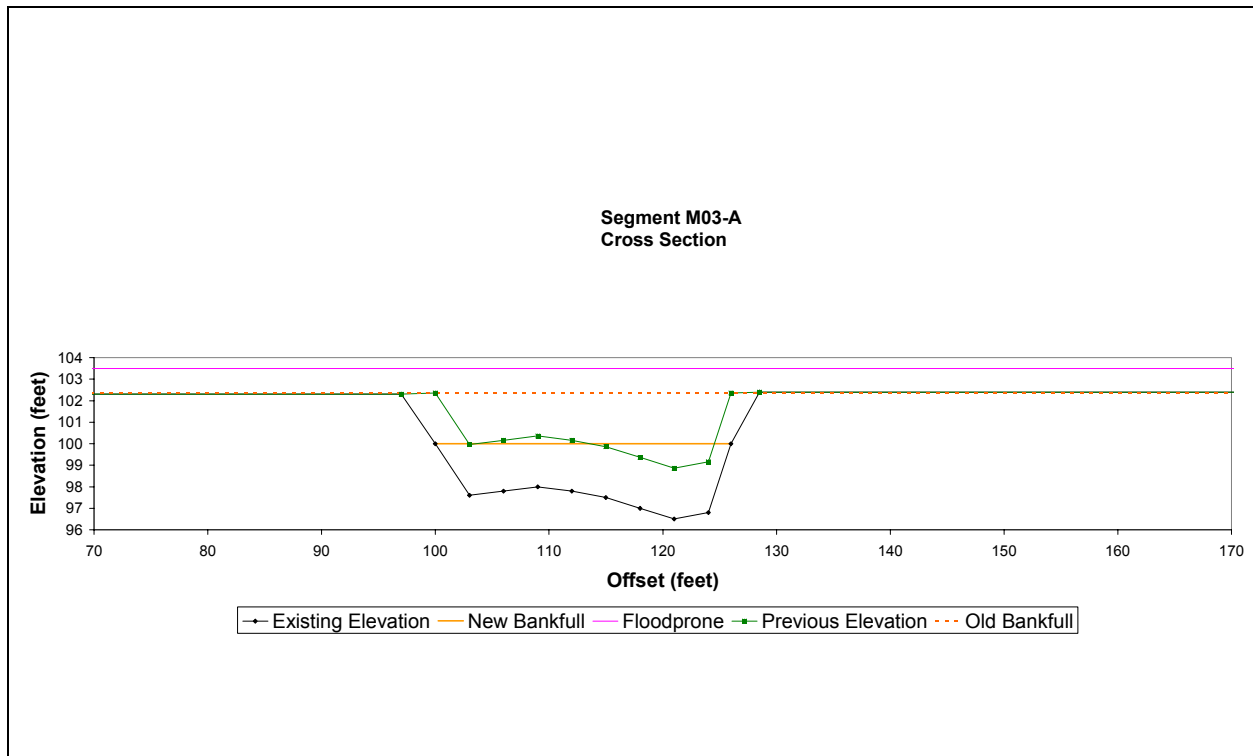
All of the cross sections were found to be incised. The incision ratio ranged from 1.4 to 2.2. Seven of the 12 cross sections were found to have a bankfull elevation that is approximately one mean bankfull depth lower than the top of the low bank. This is illustrated below in Figure 20.

**Figure 20.** The field measurements from cross section M03-A indicate the channel has incised by the mean bankfull depth.
