Moretown, Vermont Phase 2 Stream Geomorphic Assessment & River Corridor Plan

April 20, 2018

Prepared by:
Bear Creek Environmental, LLC
149 State Street, Suite 3
Montpelier, Vermont 05602

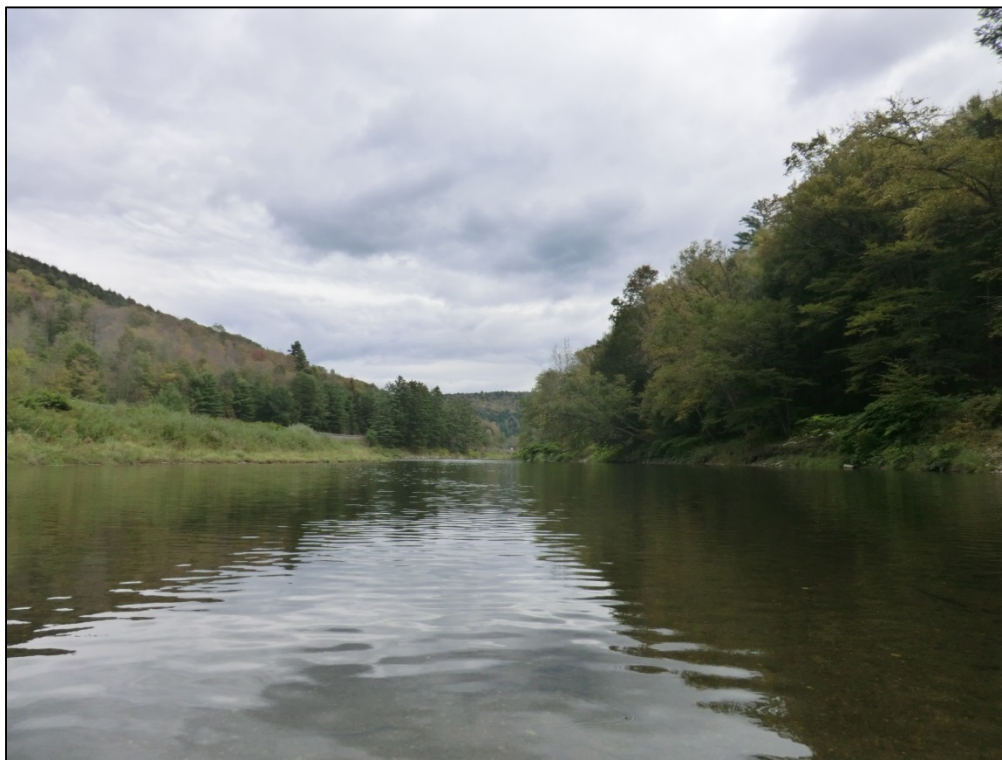
Reach 3 on the Mad River begins at the downstream end at the Moretown No. 8 hydroelectric dam and continues upstream to Kenneth Ward Park (Appendix C, Map 1). The reach is nearly 3,500 feet in length and the river flows along Vermont Route 100B. This reach was not segmented during the assessment. The Mad River in reach M03 is backwatered due to the presence of Moretown Dam No. 8 immediately downstream. For this reason, a full Phase 2 assessment could not be completed for M03. The river flows through a semi-confined valley in this reach. Impacts include a lacking riparian buffer due to the presence of RT 100B and stormwater inputs from the road. Bank armoring is present in some areas along RT 100B. Invasive Japanese knotweed is prevalent on both banks within this reach.

Figure 5.1. M03 looking downstream – impounded.

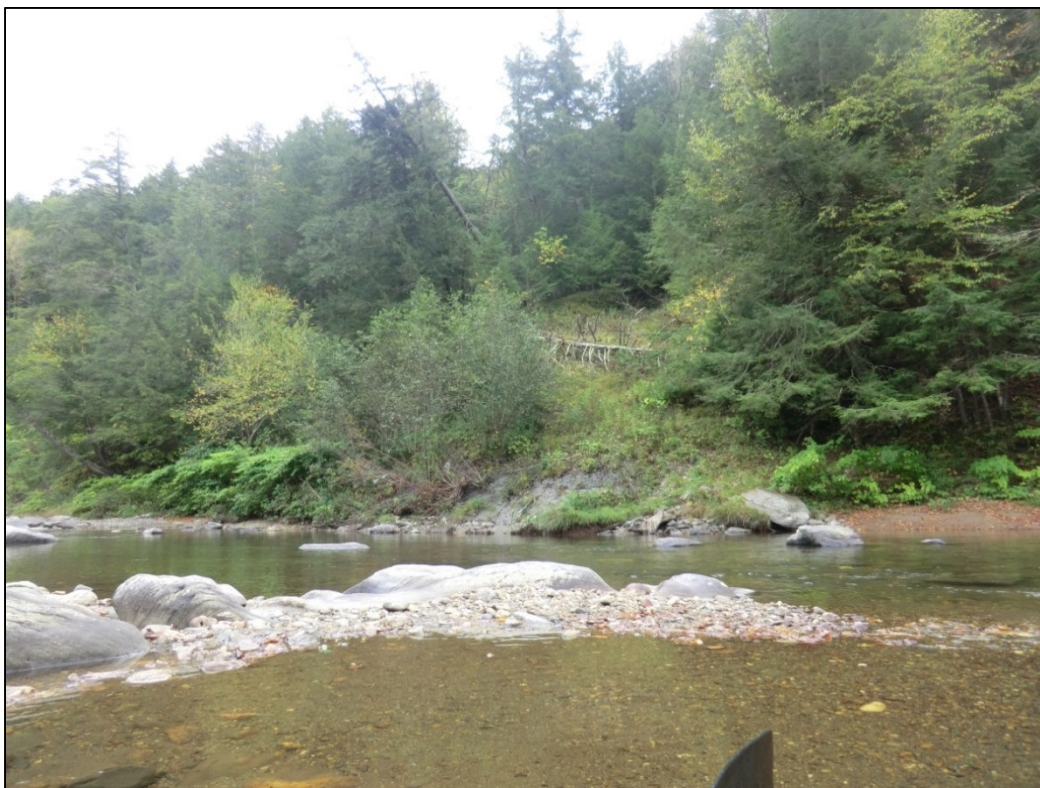
Reach 4 on the Mad River starts downstream at Kenneth Ward Park and continues upstream to just below the bridge on Bridge Road in Moretown (Appendix C, Map 2). The river flows along VT-100B, Spillway Road, as well as farms, houses, and forest for just over 9,000 feet. The river valley within M04 is semi-confined. This reach was not segmented during the Phase 2 assessment. The majority of the reach appears to have been historically straightened due to the presence of Route 100B and adjacent residential and agricultural land uses. This straightening led to minor historic incision; widening is possibly being prevented by bank armoring. Additional impacts in M04 include lacking buffer vegetation along the west side of the river due to the presence of VT-100B, houses, and farms, and several mass failures along the eastern valley wall. Bedrock is common on the bed in this reach, which may provide some vertical stability. M04 is in **good** geomorphic condition for these reasons. The reach is in **fair** habitat condition due to lacking large woody debris and bank and buffer vegetation on one bank.

Figure 5.2. Mass failures and bedrock are common in reach M04.

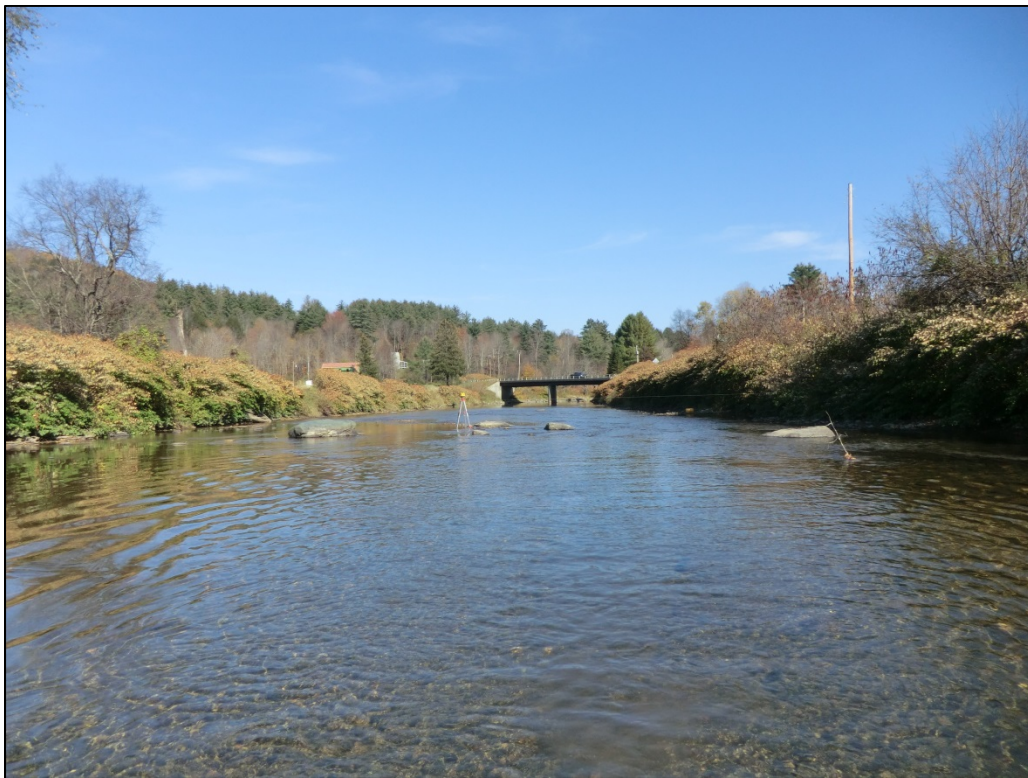
M06 is a 2,600 foot reach on the Mad River that begins roughly 600 feet downstream of the VT-100B bridge near Dickerson Road and ends 450 feet downstream of the Fletcher Road bridge (Appendix C, Map 3). This short reach flows through a broad valley, but due to the presence of 100B in the middle of the valley, the phase 2 valley type is semi-confined. The river for almost the entirety of this reach has been historically straightened due to the road and adjacent residential/agricultural land uses. Vegetation is lacking in the riparian buffers on both banks for most of the reach, and bank vegetation is dominated by invasive Japanese knotweed. Armoring is common along the east bank of the river, especially where it flows along 100B. Due to historic channel alterations, the river has undergone major incision in this reach, which has led to a stream type departure and loss of floodplain access. For this reason, M06 is in **fair** geomorphic condition. Similarly, M06 is in **fair** habitat condition, which is due to lacking large woody debris, poor instream cover for fish, and reduced/impacted bank and buffer vegetation.

Figure 5.3. M06 flows along VT-100B and was extensively historically straightened.

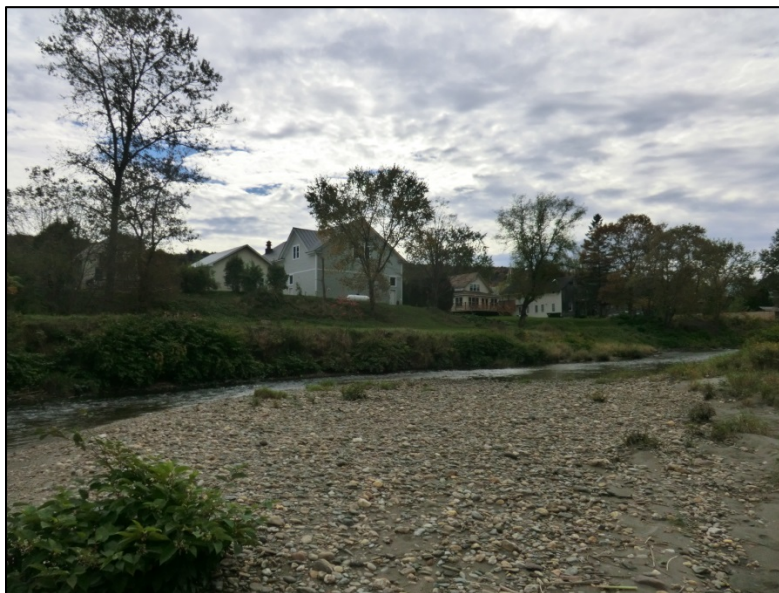
Reach 8 on the Mad River flows through the village of Moretown. It is approximately 1,500 feet long, beginning just above the Fletcher Road bridge at the confluence with Doctors Brook downstream and ending upstream approximately 1,200 feet below the Route 100B bridge near Old Gulf Road (Appendix C, Map 3). The river valley in this reach is naturally very broad, but Route 100B bisects it, creating a semi-confined phase 2 valley. Adjacent lands to the west of the river in this reach are primarily forested, while lands to the east are primarily residential, with several homes along Route 100B, as well as the Moretown library, firehouse, and elementary school. Riparian buffer vegetation is lacking for the entirety of the reach on the eastern side of the river due to several lawns. Japanese knotweed is prevalent along both banks of the river in this reach. There is a high terrace along the east side of the river. Bedrock gorges exist both immediately upstream and downstream of this reach, which provides vertical stability to M08. Further vertical adjustments of the river bed are unlikely due to these upstream and downstream grade controls. M08 is in **good** geomorphic condition as a result of this stability. The reach is in **fair** habitat condition because it is lacking large woody debris, and bank and buffer vegetation are either lacking or dominated by invasive species.

Figure 5.4. Residential land use adjacent to the river in M08 has resulted in poor riparian buffer vegetation.

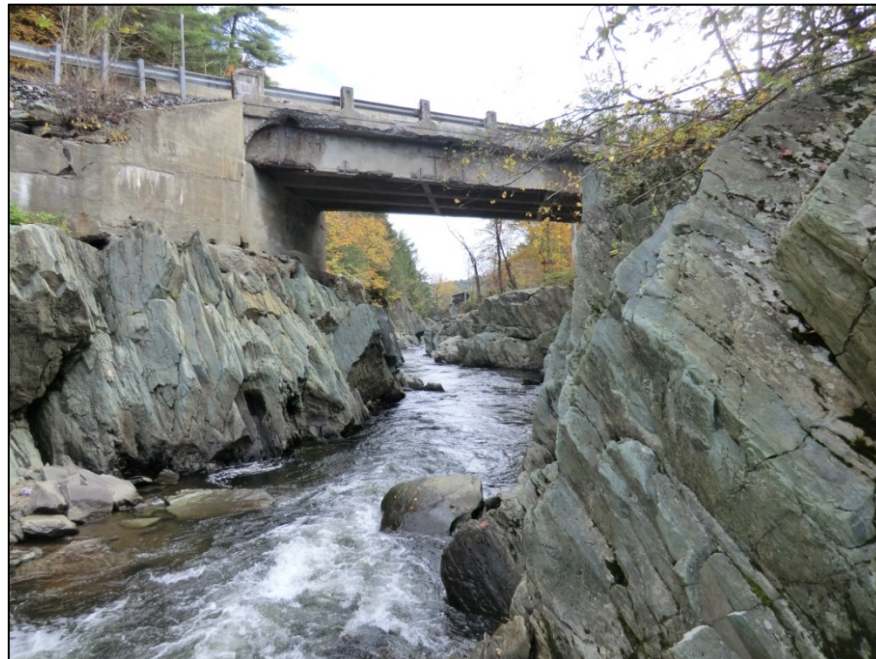
The downstream most segment on reach 9 is nearly 1,400 feet in length, and begins just upstream of the Moretown library and continues upstream to just above the Route 100B bridge near Old Gulf Road (Appendix C, Map 3). The Mad River flows through a bedrock gorge in segment A, and thus a full Phase 2 assessment could not be completed on this segment. It was unsafe to walk in the river within this segment; however, limited observations and impacts were recorded from the river bank. Bedrock is abundant both on the river bed and on the banks throughout this segment, providing both vertical and horizontal control for river adjustments. There is an old mill located on the south bank of the river within this segment. It was unsafe to assess the Route 100B bridge within this segment, but it was noted as being in poor condition. Administrative judgement data were collected for the segment, placing it in **good** geomorphic condition.

Figure 5.5. The Mad River flows through a bedrock gorge in M09-A.

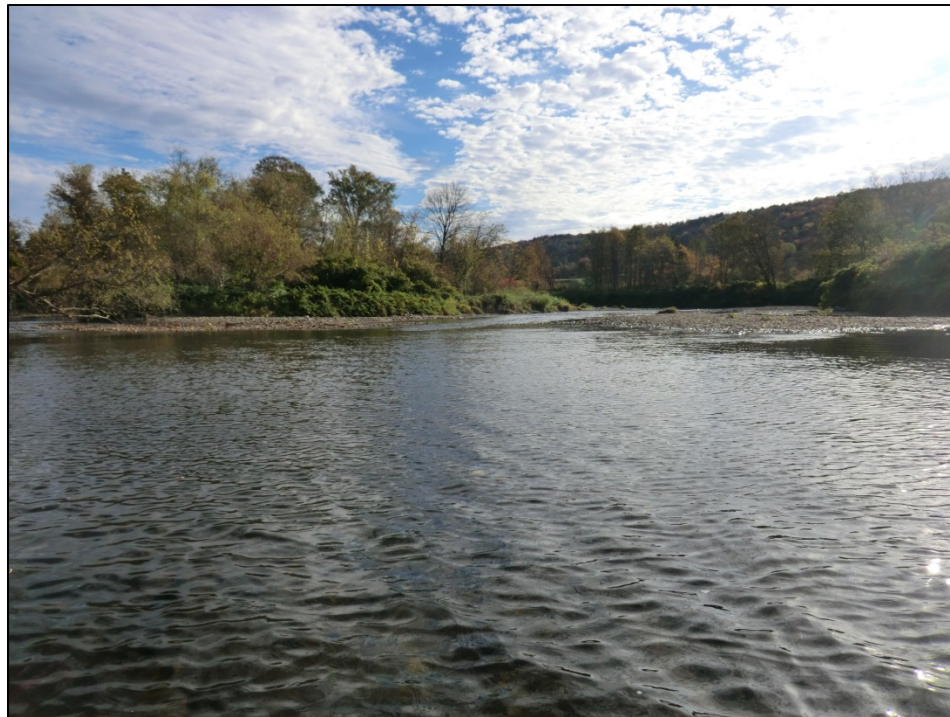
The upstream segment on reach M09 of the Mad River is roughly 1,800 feet in length, beginning just above the Route 100B bridge near Old Gulf Road and ending immediately upstream of the confluence of Dowsville Brook with the Mad River (Appendix C, Map 3). The river flows through a broad valley in this segment with adjacent agricultural and residential lands. This section of the Mad River is moderately sinuous and has several large aggradational features. Additionally, the river is exhibiting planform change in this segment via a flood chute and an impending *neck cutoff*. There is major erosion on both banks throughout the reach, especially on the outside of meander bends. Both streambanks are blanketed in Japanese knotweed. Major historic incision has occurred in this segment, which has resulted in a loss of floodplain access and a stream type departure. The river appears to be building a juvenile floodplain at a lower elevation. Due to these adjustments, M09-B was placed in **fair** geomorphic condition. The morphological characteristics of the river in this segment, as well as impacted banks and buffers, led to its placement in **fair** habitat condition.

Figure 5.6. Overly wide channel with abundant aggradation in M09-B.

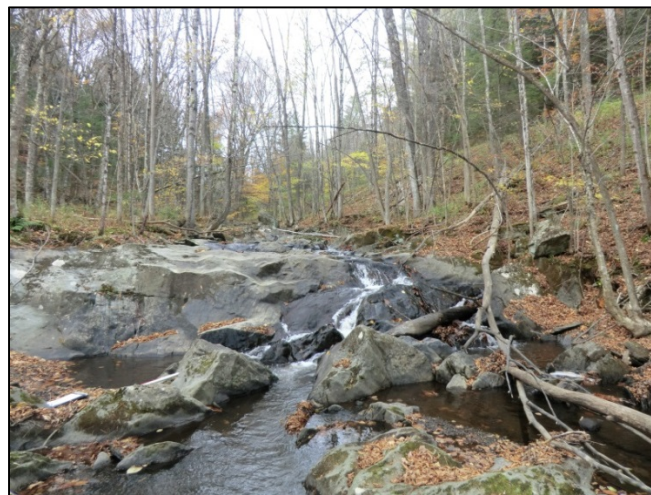
The downstream segment on reach 1 of Welder Brook begins at the confluence with the Mad River and continues upstream for roughly 2,500 feet to behind 445 Stevens Brook Road (Appendix C, Map 4). The segment is characterized by a step-pool bedform and abundant bedrock grade controls. Impacts within this segment are minimal and mostly relate to the presence of Stevens Brook Road along the north side of the stream channel. There are short sections of the brook that appear to have been straightened along the road, but for the most part, channel planform is natural. The abundant bedrock on the streambed in T1.01-A provides stability to the brook, which has not undergone incision or widening. T1.01-A is in **good** geomorphic condition for this stability and lack of impacts. Similarly, the segment is in **good** habitat condition, as it has a diversity of bed features, good instream cover, and mostly well forested buffers.

Figure 5.7. Bedrock grade controls are abundant in T1.01-A.

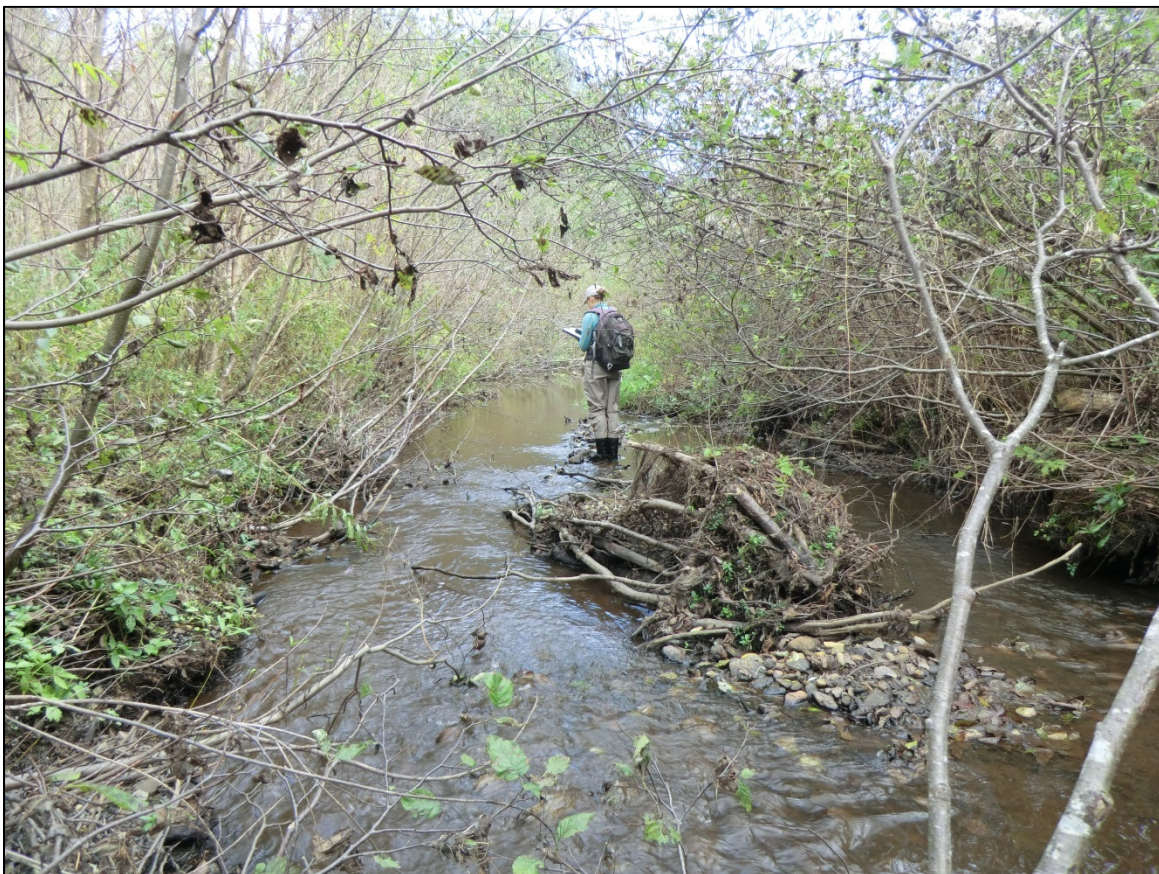
Segment B on reach one of Welder Brook is just over 1,200 feet in length and flows through a very broad valley (Appendix C, Map 4). This segment is within a large wetland complex and the brook has a low gradient, sinuous channel. The riparian buffers are well vegetated with shrub/sapling and herbaceous vegetation. There are multiple side channels and flood chutes throughout this segment where water spreads out as flows rise. Bank erosion is common, especially on outside meander bends, as are steep riffles. The brook has not incised in this segment, and human alteration is minimal. The planform is natural and floodplain connectivity is excellent. For these reasons, T1.01-B is in **good** geomorphic condition. The segment is also in **good** habitat condition, with its abundant large woody debris, diverse bed features, and well vegetated banks and buffers.

Figure 5.8. T1.01-B has a narrow, sinuous wetland channel.

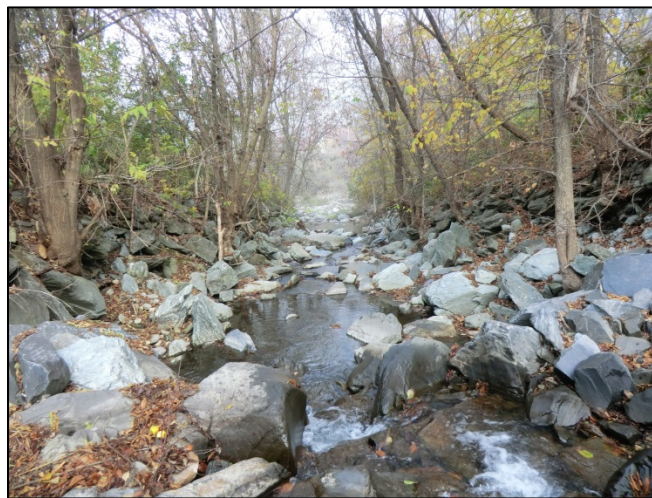
The lower segment on reach one of Doctors Brook is roughly 1,200 feet in length, ending just upstream of a private bridge (Appendix C, Map 3). The entirety of this segment appears to have been historically straightened due to the presence of houses and roads along its banks. This extensive straightening has led to major historic channel incision, a stream type departure, and a loss of floodplain access. Abundant bank armoring is preventing channel widening for much of this segment; however, areas that are not armored have severely eroding banks. Riparian buffers are lacking on both banks for most of the segment. For the aforementioned reasons, T1.01-A was placed in **poor** geomorphic condition. The segment is in **fair** habitat condition as a result of lacking large woody debris, altered channel planform, and impacted banks and buffers.

Figure 5.9. T2.01-A has been extensively straightened and riprapped.

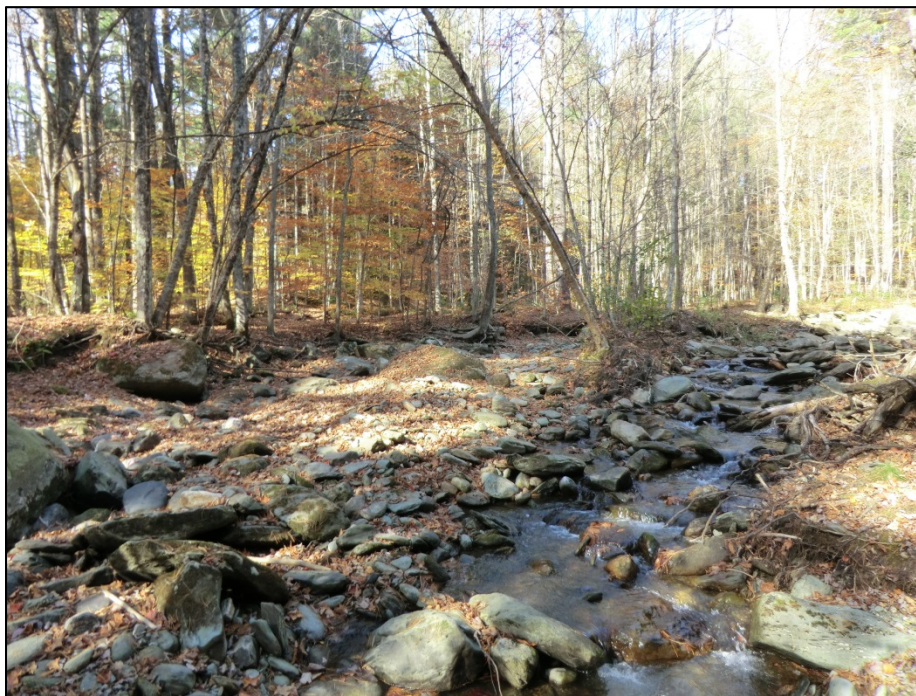
The upper segment on reach one of Doctors Brook is nearly 1,400 feet in length and flows through a forested, very broad valley (Appendix C, Map 3). The brook has a natural planform in this segment and minimal human alteration. A small section of historic channel straightening was observed at the downstream end of the segment, and another small area of channel alteration exists in the vicinity of a stream ford. Severe bank erosion was noted in this segment, especially on outside meander bends. Three mass failures were documented, the largest of which is located on the western bank of the brook toward the downstream end of the segment and is underlain by clay and sand. BCE observed one channel avulsion toward the upstream end of the segment where the brook appears to have formed a new primary flow path fairly recently. Severe historic incision was noted in this segment, which likely stems from the extensive historic channel alteration downstream in segment A. A stream type departure has occurred in T2.01-B, along with some loss of floodplain access. For these reasons, T2.01-B was placed in **fair** geomorphic condition. Despite channel adjustments and instability, there is abundant large woody debris and abundant pool features in this segment, as well as well forested banks and buffers. T2.01-B received a ranking of **good** for habitat condition.

Figure 5.10. Channel avulsion in T2.01-B.

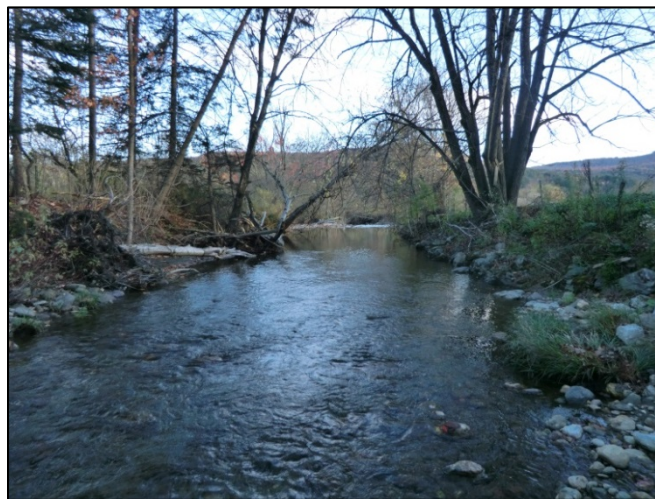
The downstream-most segment on reach one of Dowsville Brook is nearly 1,400 feet in length, extending from roughly 500 feet upstream of the Route 100B bridge downstream to the confluence with the Mad River (Appendix C, Map 5). Adjacent lands to this segment of the brook are primarily agricultural. Because of this, riparian buffer vegetation is lacking on both sides of the brook for much of the segment. The majority of T3.01-A appears to have been historically straightened due to the presence of the Route 100B crossing and surrounding agricultural lands. This historic straightening has led to channel incision, widening, and a departure from reference stream type. Due to these impacts and adjustments, T3.01-A is in **fair** geomorphic condition. Channel alterations and reduced bank and buffer vegetation led to the placement of T3.01-A in in **fair** habitat condition.

Figure 5.11. Straightened channel in T3.01-A.

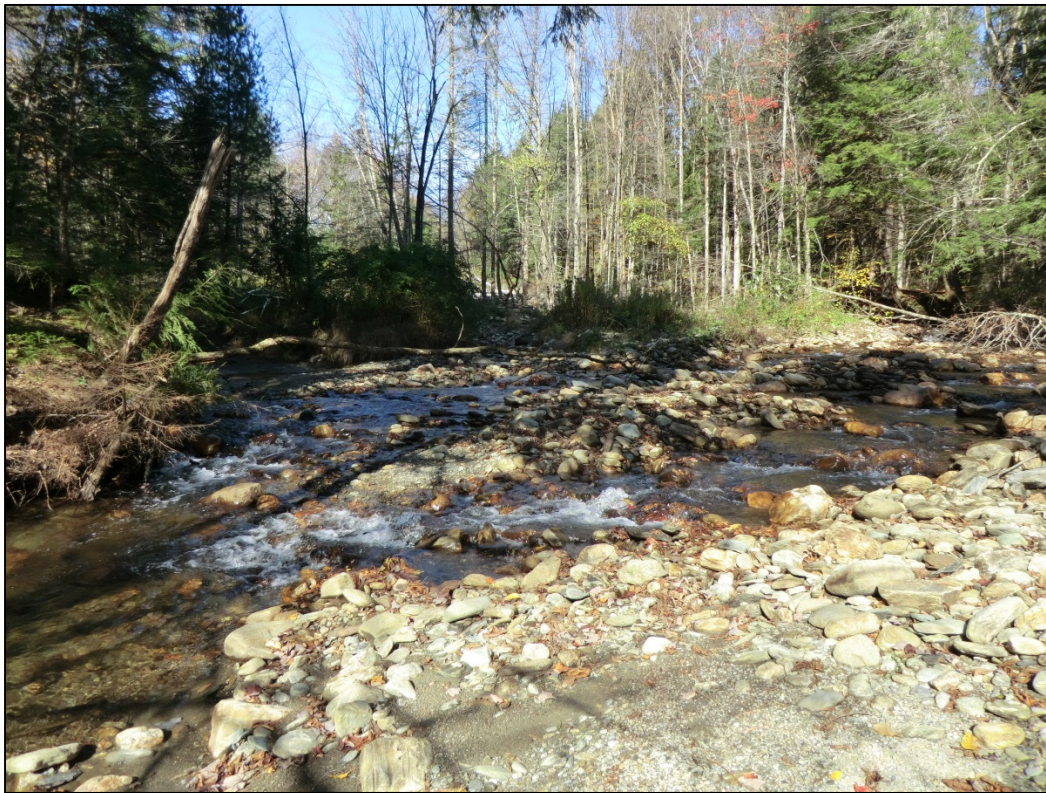
Segment B on reach one of Dowsville Brook is nearly 3,600 feet in length, beginning about 500 feet above the Route 100B bridge and ending upstream about 500 feet below the Route 100 bridge (Appendix C, Map 5). The brook flows through forested land in this segment and has minimal channel alteration. T3.01-B has undergone major aggradation and channel widening, leading to planform change. The channel is braided at low flows at some locations in this segment, but there are side channels and flood chutes throughout the segment, creating braiding at higher flows as well. Bank erosion is common on the outside of meander bends. Debris jams are abundant and are also contributing to planform change within T3.01-B. This segment is in **fair** geomorphic condition due to the major adjustments it is undergoing. The brook has abundant large woody debris and pools, as well as well forested banks and buffers. T3.01-B is in **good** habitat condition.

Figure 5.12. Aggradation and low flow braiding in T3.01-B.

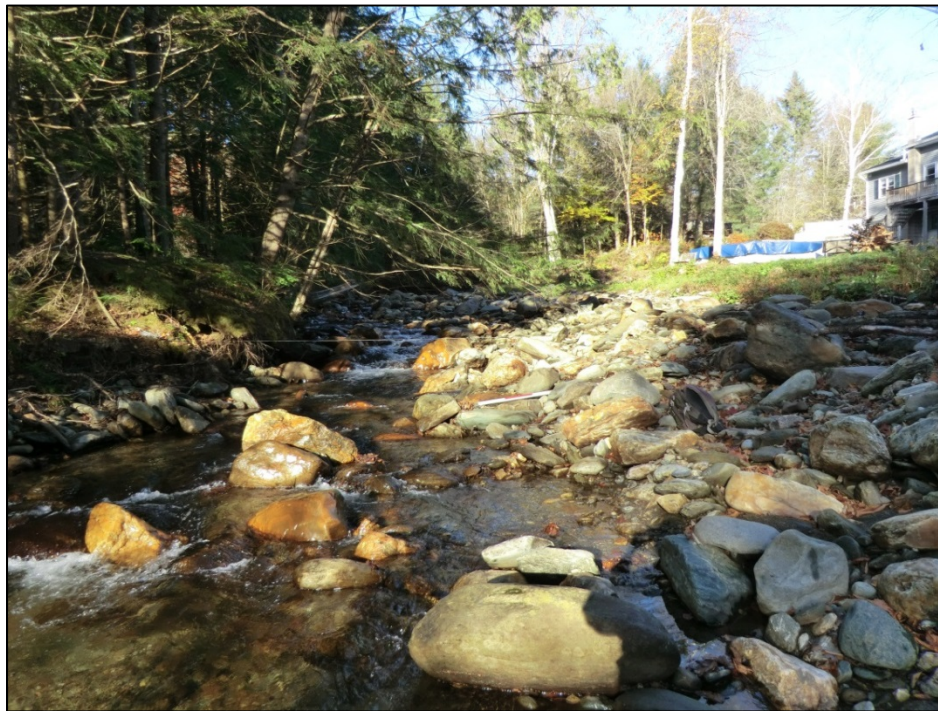
The upstream most segment on reach one of Dowsville Brook is characterized as having a higher slope than the downstream segments. This nearly 2,500 foot segment is located in Duxbury and flows through forested and residential land from just downstream of the Route 100 bridge upstream to near the cul-de-sac on Clark Road (Appendix C, Map 5). Historic and recent channel alterations were observed during the Phase 2 assessment, including channel straightening, dredging, windrowing, and berms. The uppermost portion of this segment has a higher slope than the rest of the segment, which is flatter and has large depositional features. Large flood chutes are present throughout the segment, contributing to planform adjustment. Sections of the brook appear to have been historically straightened behind several of the homes on Clark Road. Historic and recent berms, windrowing, and dredging were observed in the lower half of the segment above the Route 100 bridge. Major incision has occurred in this segment, though it has not led to a stream type departure. T3.01-C is in **fair** geomorphic condition and **fair** habitat condition due to the aforementioned alterations and adjustments, as well as impacted riparian buffers.

Figure 5.13. T3.01-C at cross section location.

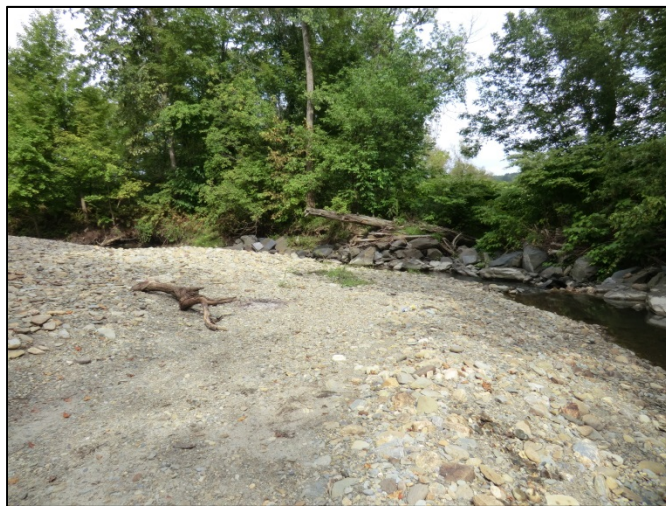
The downstream most segment on reach one of Jones Brook is approximately 2,300 feet in length, beginning roughly 700 feet above the Three Mile Bridge Road bridge at the upstream end and flowing downstream to the confluence with the Winooski River (Appendix C, Map 6). R16.S2.01-A flows through a very broad valley along several corn fields. Most of the segment appears to have been historically straightened due to the surrounding land use. Historic incision occurred within this segment and channel widening is actively occurring. Riprap is abundant along both banks, but bank erosion is occurring where riprap is not present. Some planform change was noted in the form of flood chutes. Lateral adjustments are being limited by bank armoring. R16.S2.01-A is in **fair** geomorphic condition for these reasons. The brook is also in **fair** habitat condition in this segment due to its altered planform, as well as lacking bank and buffer vegetation. Japanese knotweed is prevalent along both banks.

Figure 5.14. Large bar and riprapped bank in R16.S2.01-A.

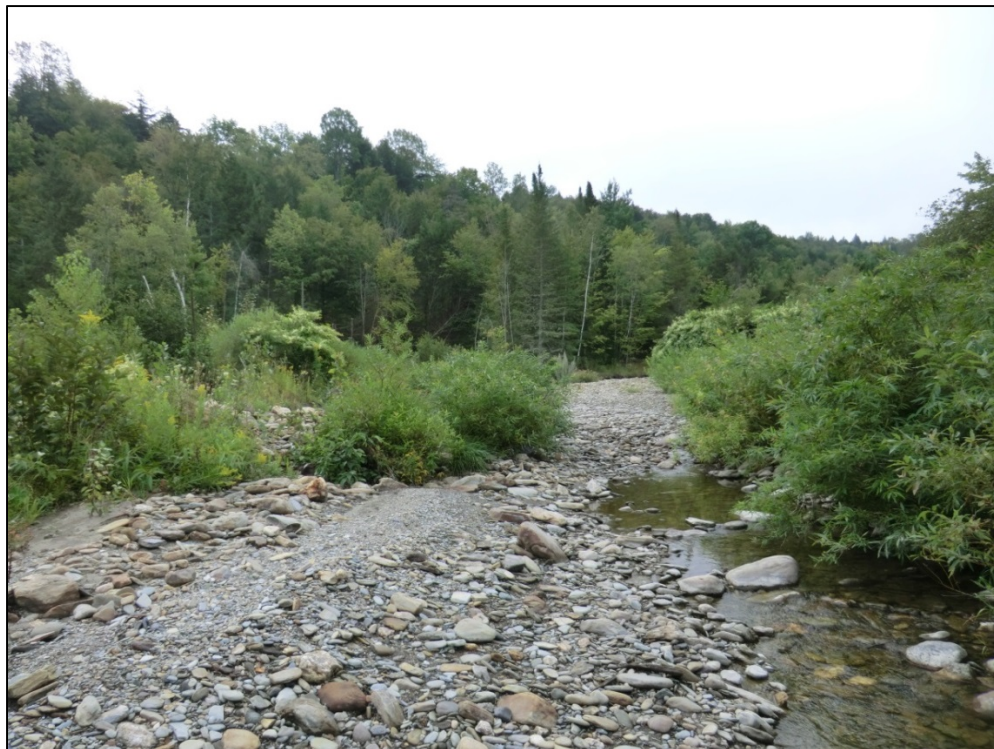
Segment B on reach one of Jones Brook is roughly 1,200 feet in length (Appendix C, Map 6). This segment differs from segments A and C primarily in channel planform and dimensions. R16.S2.01-B is characterized by abundant large depositional features, creating an extremely wide channel and low flow braiding conditions. There are several flood chutes and side channels that appear to be wetted at various flow conditions (including low flow). There are few human impacts to the brook within this segment, which include one stream ford and a very short section of minor windrowing just upstream of the ford. There is a major gully coming off of the east valley wall within this segment that may contribute large amounts of fine sediment to the brook. The source of the gully is unknown though it appears to originate in a clearing upslope and may be related to logging activities. The brook is part of a naturally very dynamic system. R16.S2.01-B is in **fair** geomorphic condition as a result of its abundant adjustments. Similarly, the brook is in **fair** habitat condition within this segment due to lacking instream cover and its hydrologic conditions that create a shallow channel without a diversity of bed features.

Figure 5.15. There is major aggradation and braiding in R16.S2.01-B.

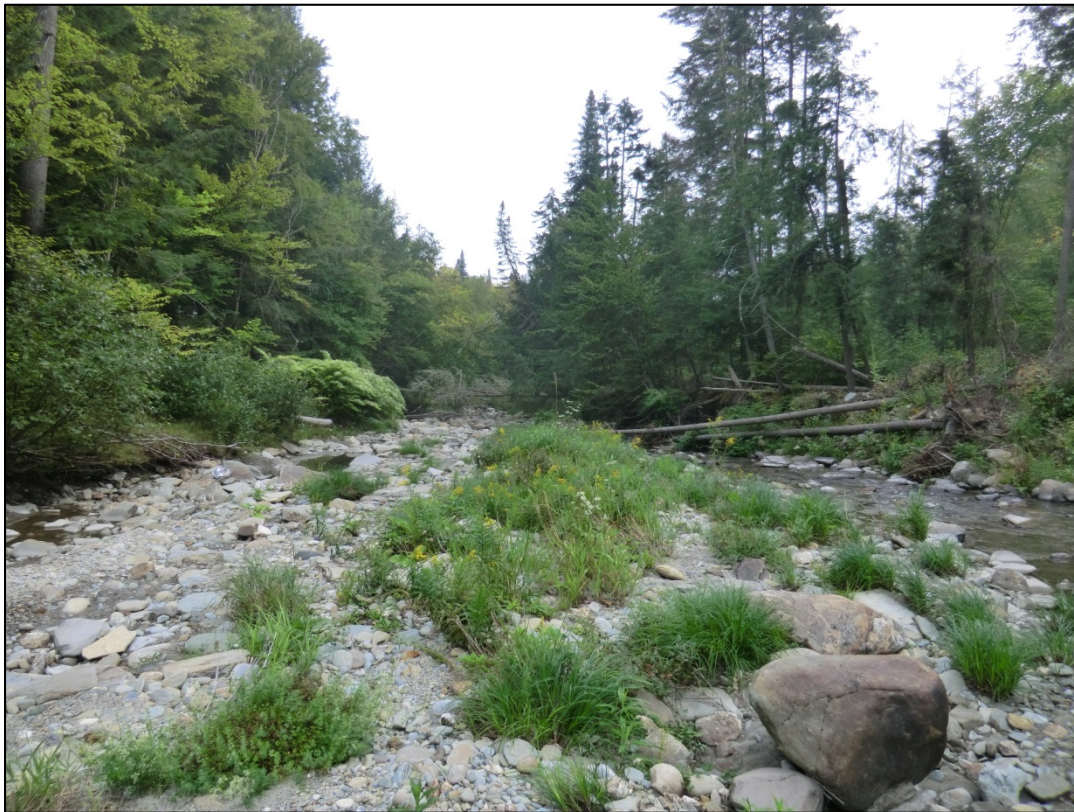
The upstream most segment on reach one of Jones Brook is just over 900 feet in length and flows through a narrower, steeper valley than the two downstream segments (Appendix C, Map 6). The brook is characterized by a naturally straight channel with large substrate. The brook has undergone historic incision and recent channel widening, which has led to a stream type departure. Large bars are present at the downstream end of the segment. It appears that the brook has been minimally altered, as it flows through the woods away from development along Jones Brook Road. R16.S2.01-C is in **fair** geomorphic condition as a result of historic and recent channel adjustments. The brook is also in **fair** habitat condition for many reasons, including lacking pool features, unstable banks, and a wide channel with mostly shallow water.

Figure 5.16. Wide, straight channel in R16.S2.01-C.

R16.S2.01-C Data Summary		Reference	Existing
Length:	945 ft	Broad	Broad
Drainage Area:	10.1 sq.mi.	C	B _C
Evolution Stage:	F-III	> 2.2	1.6
Sensitivity:	High	< 1.2	1.8
		Dominant Bed Material	Gravel
		Dominant Bedform	Riffle-Pool
Major Stressors:	Bank erosion, mass failures

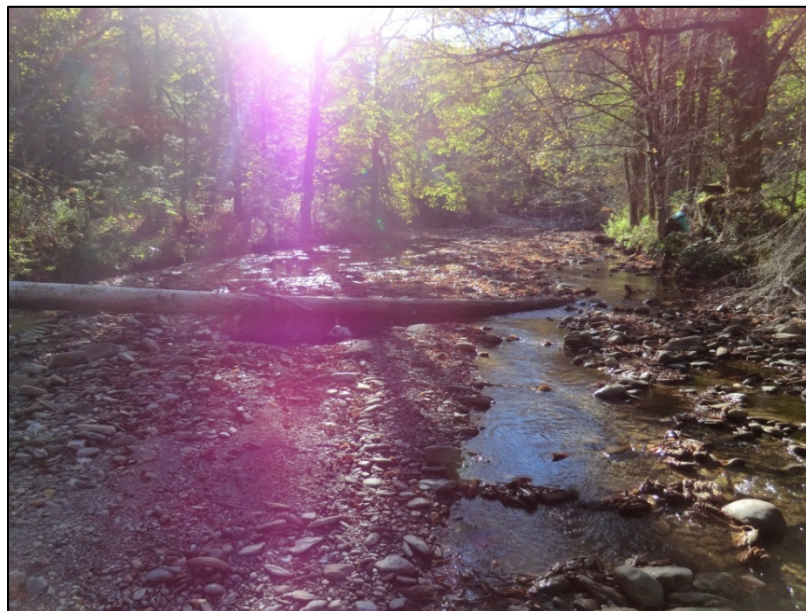
The downstream most segment on reach two of Jones Brook flows through a narrow valley in the Town of Berlin. The downstream half of the segment flows through the woods, while the upstream half flows through a residential area along the west bank of the brook (Appendix C, Map 6). Aggradation is a major process that is currently occurring within R16.S2.02-A. Numerous large bars are present throughout the segment causing the formation of steep riffles and channel widening. Although moderate historic incision has occurred within this segment, floodplain access is still mostly intact. Riparian buffers are lacking in the vicinity of two houses along the western bank of Jones Brook. Bank erosion is common along both banks within this segment, which provides further evidence that channel widening is occurring, and four mass failures are present. R16.S2.02-A is in **fair** geomorphic condition as a result of historic and active channel adjustments. This segment is also in **fair** habitat condition due to such factors as lacking instream cover, reduced bank and buffer vegetation, and lacking pool features.

Figure 5.17. Aggradation is a major process currently occurring within R16.S2.02-A.

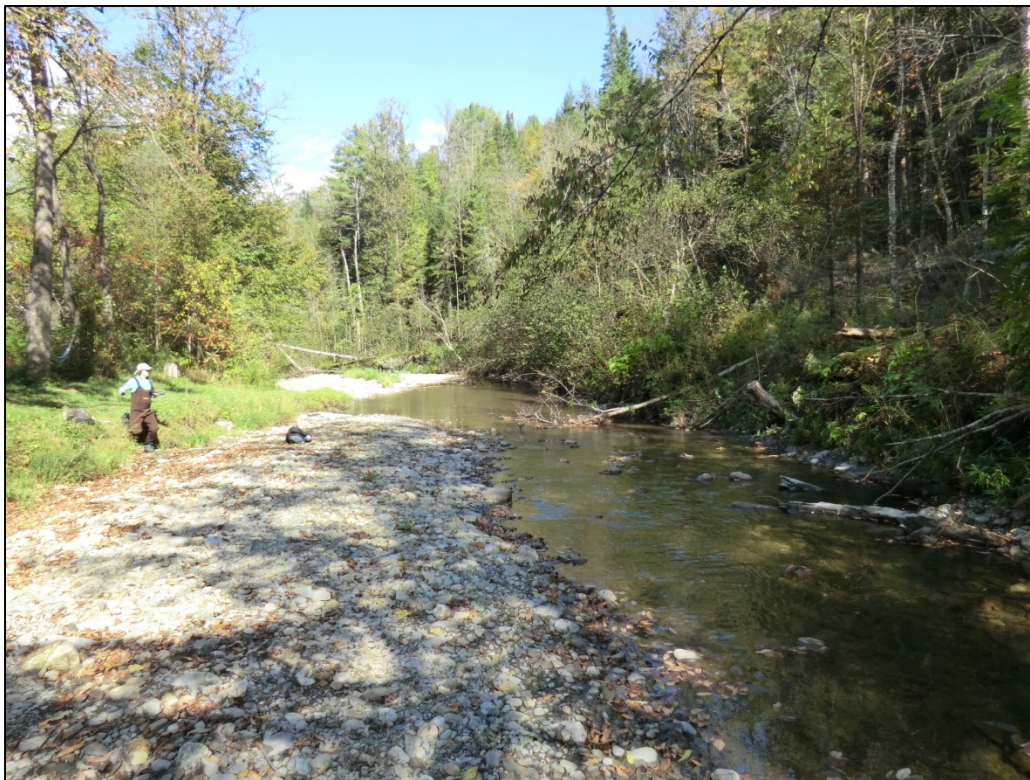
Segment B on reach two of Jones Brook is a short segment – only roughly 900 feet in length and is located in Berlin. The brook flows through a slightly wider valley in this segment than downstream and has more channel alteration due to the presence of residences on both sides of the brook (Appendix C, Map 6). Much of the segment appears to have been historically straightened up against the eastern valley wall due to residential land use on the west. Buffer vegetation is lacking for most of the segment on the western side of the brook, but also for a small section on the eastern side. The historic straightening in this segment appears to have led to major historic incision, resulting in a stream type departure and loss of floodplain access. Major aggradation has also occurred within this segment, as evidenced by several large bar features. For these reasons, R16.S2.02-B is in **fair** geomorphic condition. The segment is also in **fair** habitat condition as a result of lacking instream cover and pool habitat, channel adjustments that have created a wide, shallow channel, and lacking bank and buffer vegetation.

Figure 5.18. Wide, depositional channel in R16.S2.02-B.

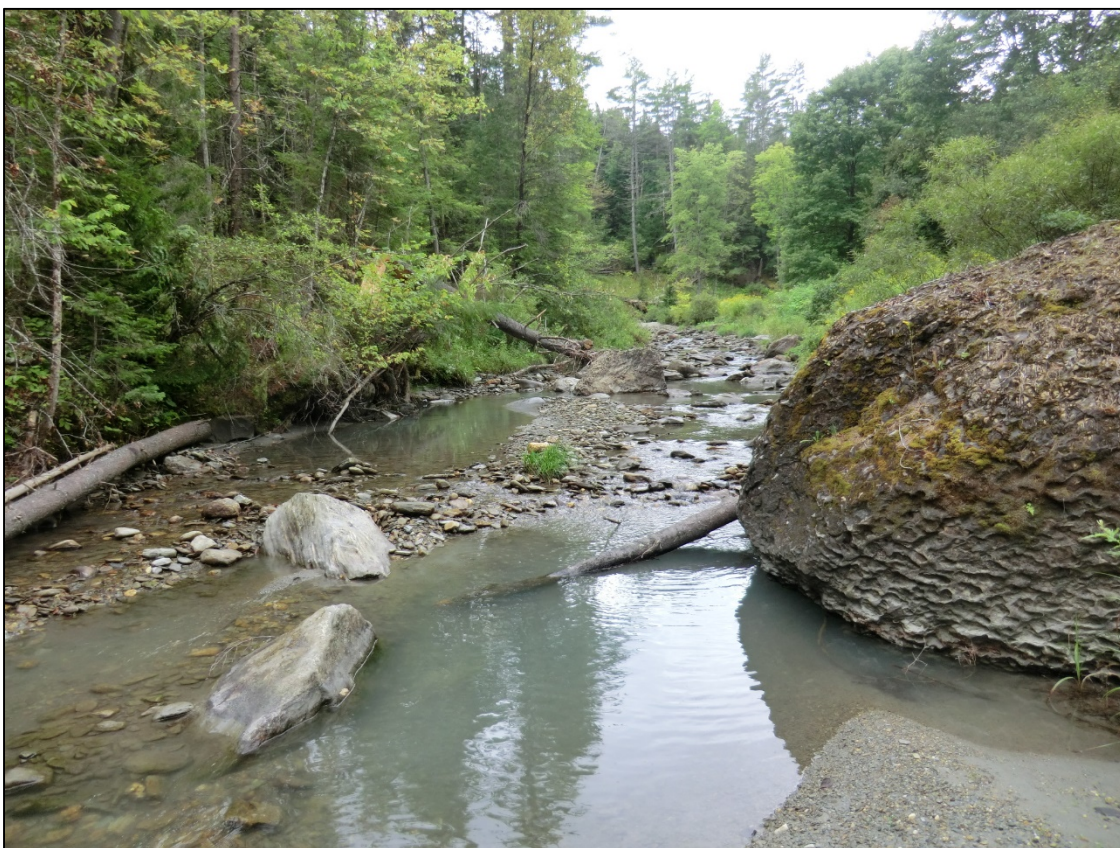
Segment C on reach two of Jones Brook flows through a narrower valley than the adjacent segments. It is roughly 1,200 feet in length and flows mostly through the woods along Jones Brook Road (Appendix C, Map 7). The lower end of the segment is in Berlin, while the upstream end is in Moretown. Very few channel alterations were observed within this segment, which has a mostly natural planform. Moderate historic incision was noted at the cross section for R16. S2.02-C, as well as minor widening. A few areas of bank erosion were noted in this segment, particularly on the eastern bank. Due to historic and recent channel adjustments, this segment was placed in **fair** geomorphic condition. R16.S2.02-C lacked large woody debris at the time of the assessment. Hydrologic characteristics and impacted bank and buffer vegetation on one side of the channel also contributed to the segment being placed in **fair** habitat condition.

Figure 5.19. R16.S2.02-C has a narrower valley and is naturally more entrenched than downstream segments.

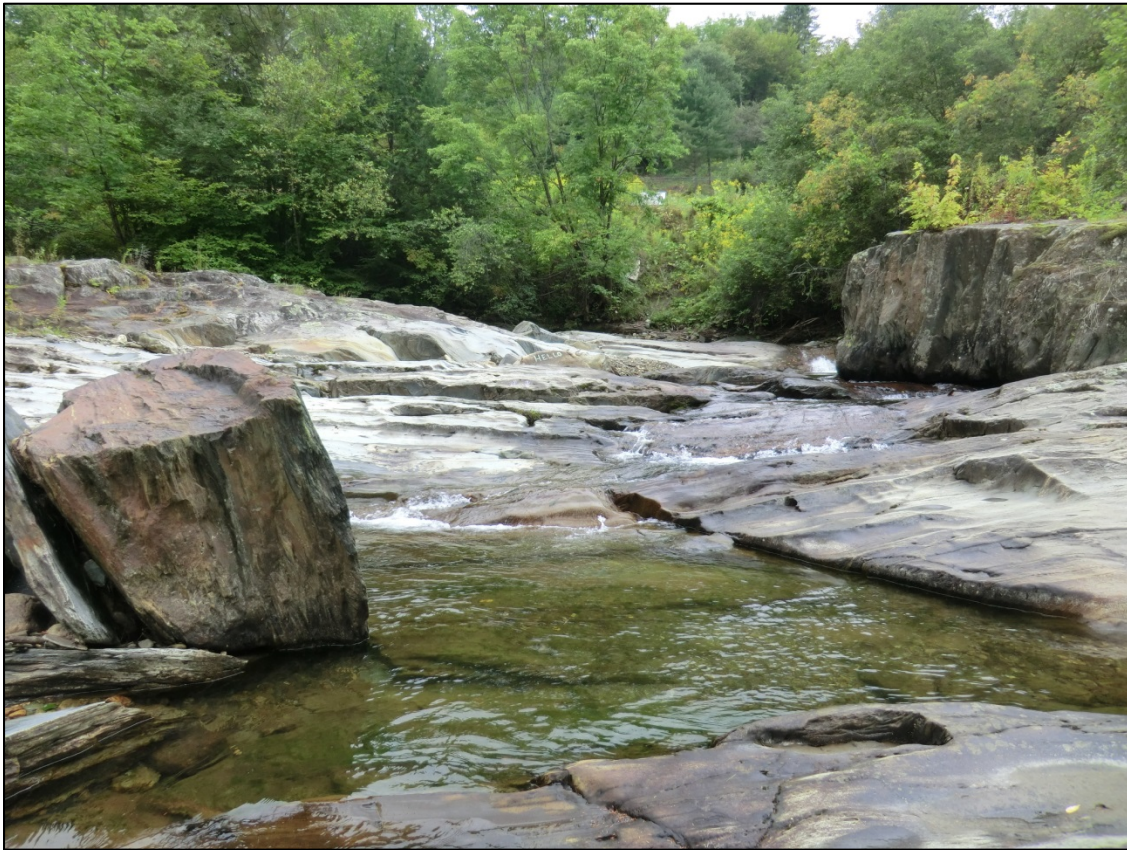
Segment D on R16.S2.02 is very short, only 584 feet in length. This segment flows through the woods and has a large bedrock grade control at its downstream end (Appendix C, Map 7). This grade control provides vertical stability to the channel within R16.S2.02-D, which has prevented major channel incision. Jones Brook upstream of the bedrock grade control appears to be undergoing minor channel widening with extensive bank erosion along the west bank. Overall, R16.S2.02-D was reported to be in **good** geomorphic condition due to only minor channel adjustments. Similarly, segment D was placed in **good** habitat condition, as it has good instream cover, a diversity of bed features, and mostly well vegetated banks and buffers.

Figure 5.20. Large bedrock grade control at the downstream end of R16.S2.02-D.

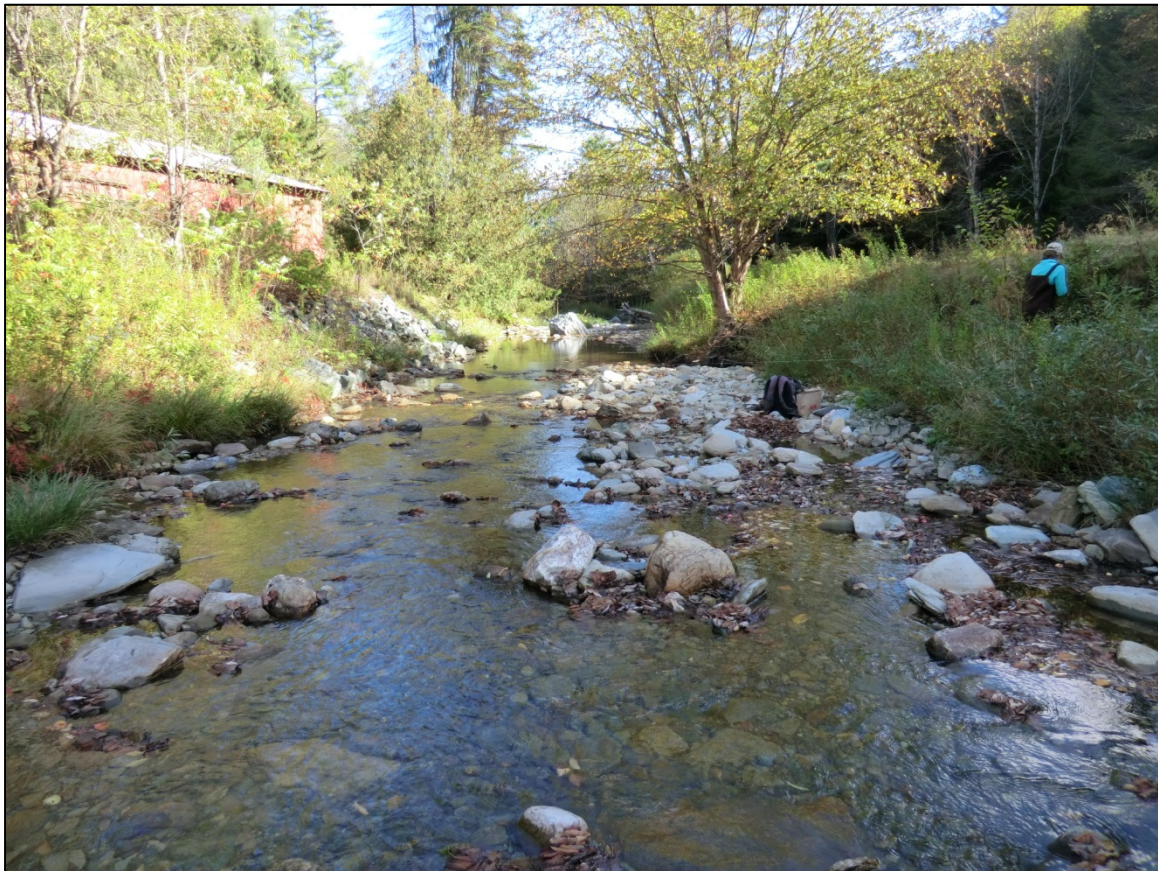
The upstream most segment on reach two of Jones Brook is nearly 700 feet in length, and flows through primarily residential land along Jones Brook Road (Appendix C, Map 7). This land use appears to have resulted in historic straightening for the entirety of this segment. Severe historic incision has occurred within R16.S2.02-E, causing a stream type departure and loss of floodplain access. Some channel widening is occurring, though it is limited in some locations due to riprap. Riparian buffer vegetation is lacking along the western side of Jones Brook for the whole segment. R16.S2.02-E is in **fair** geomorphic condition due to extensive historic channel alteration and severe historic incision. Large woody debris, bed features, and bank and buffer vegetation are lacking, which resulted in the placement of the segment in **fair** habitat condition.

Figure 5.21. Jones Brook has a straight and severely incised channel in R16.S2.02-E.

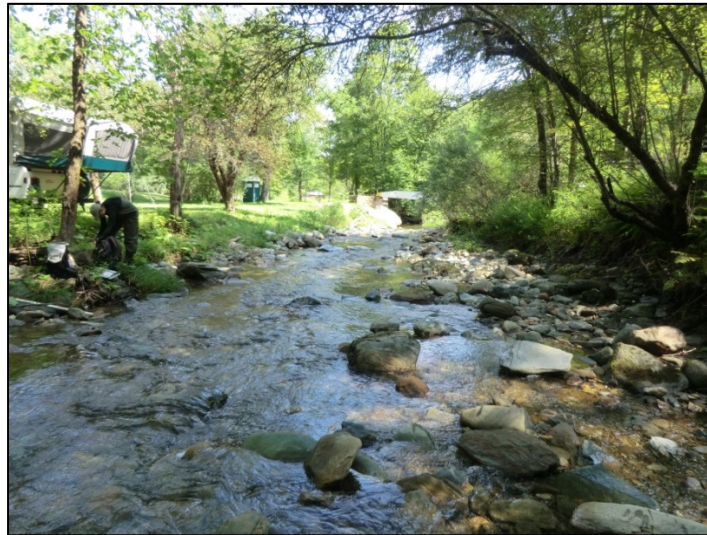
The downstream most segment on reach three of Jones Brook is just over 800 feet in length, beginning at the confluence with Kelley Brook downstream and ending upstream where the brook flows away from Jones Brook Road (Appendix C, Map 7). This segment has a very broad valley by reference; however, the valley is bisected by Jones Brook Road, which functionally narrows the valley. All of segment A appears to have been historically straightened due to the placement of Jones Brook Road in the western corridor and a house on the east of the brook. Despite this historic straightening, minimal channel incision has occurred within R16.S2.03-A. Bedrock grade controls exist both upstream and downstream of this segment, which may contribute to the vertical stability within the segment. Similarly, aggradation, widening, and planform change are minimal in this segment. A geomorphic condition of **good** was given to this segment for this lack of channel adjustments and the segment’s relative stability. R16.S2.03-A ranked **fair** for habitat condition for the brook’s lack of large woody debris, its altered planform, and lacking bank and buffer vegetation.

Figure 5.22. R16.S2.02-A looking downstream at the cross section location.
