Moretown, Vermont Phase 2 Stream Geomorphic Assessment & River Corridor Plan

April 20, 2018

Prepared by:
Bear Creek Environmental, LLC
149 State Street, Suite 3
Montpelier, Vermont 05602

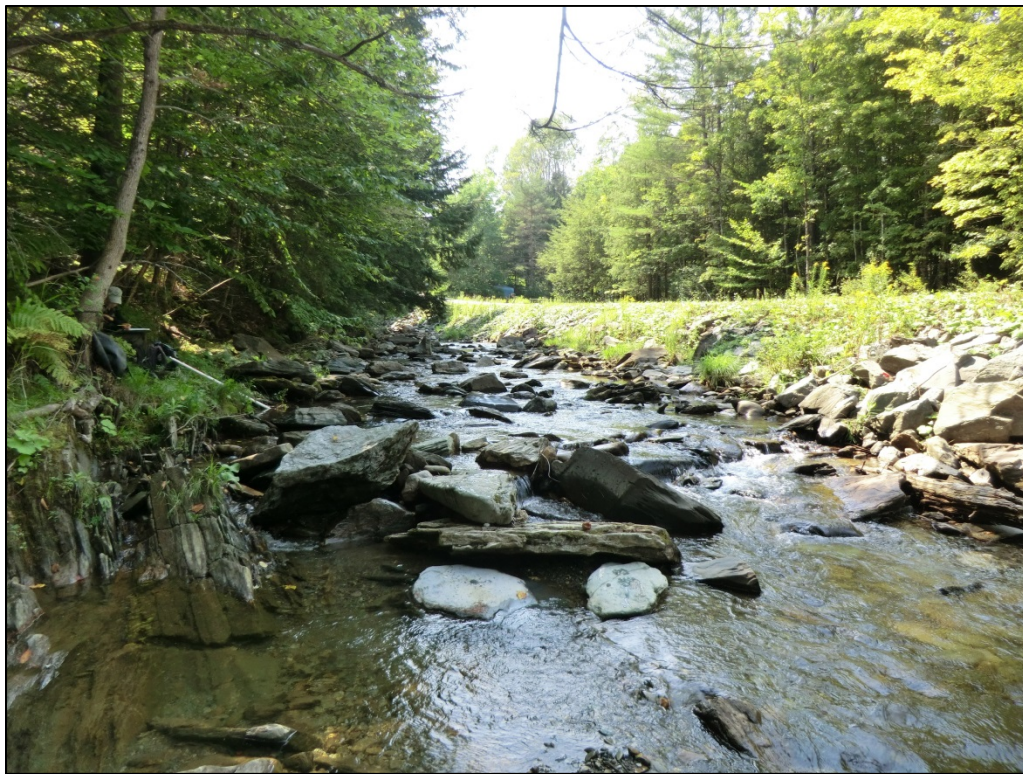
The second segment on reach three of Jones Brook is characterized by major channel encroachment by Jones Brook Road. This very short segment (just over 400 feet in length) flows directly along the road (Appendix C, Map 7). The brook has been straightened along the eastern valley wall for nearly the entire segment and is currently trapped between the road and valley wall. There is a major human caused change in valley width in this segment due to the presence of Jones Brook Road. Extensive bank armoring is present along the road. The road encroachment creates a human elevated floodplain and a high incision ratio, and has resulted in loss of floodplain access and a stream type departure. Lateral channel adjustments are being prevented by the bank armoring present on the west side of the channel and the valley wall immediately on the east. R16.S2.03-B is in **fair** geomorphic condition for these reasons. The straightened channel in this segment lacks large woody debris, pool features, and bank and buffer vegetation on one side. For these reasons, R16.S2.03-B is also in **fair** habitat condition.

Figure 5.23. R16.S2.03-B has been extensively straightened along Jones Brook Road.

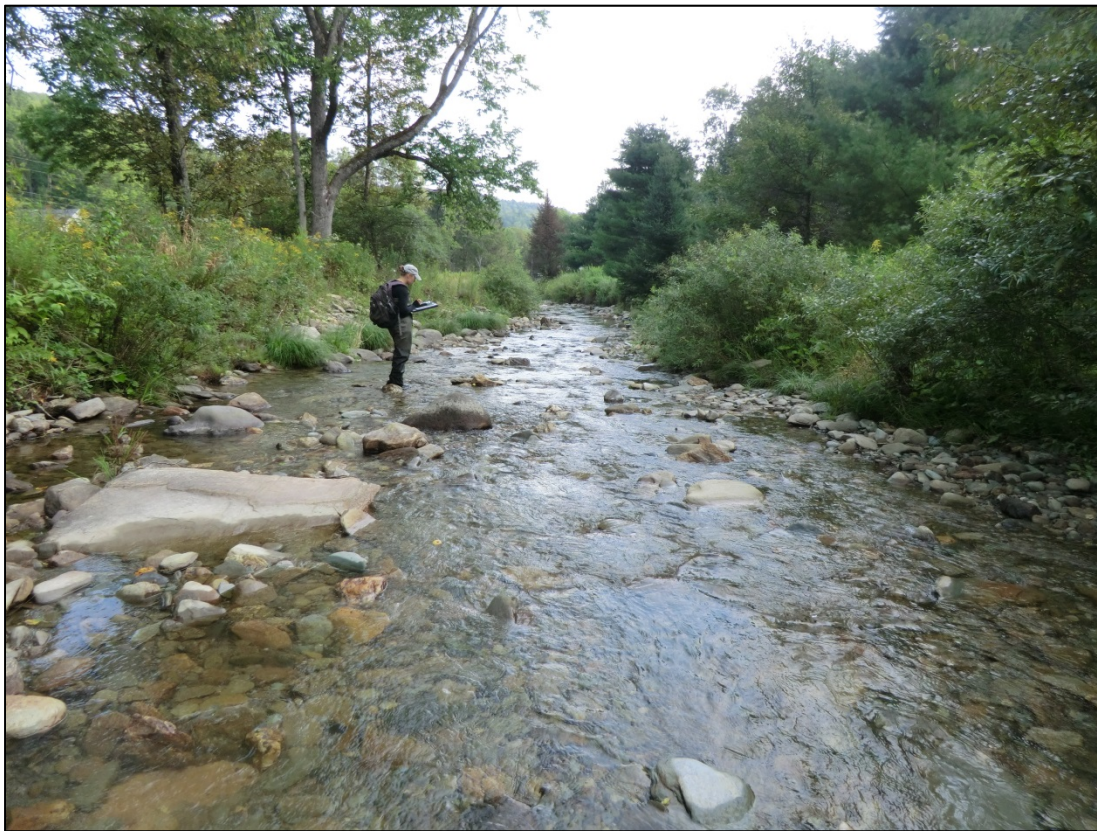
The upstream most segment on reach three of Jones Brook is the longest, at 2,100 feet. Jones Brook appears to have been historically straightened for the entire length of this segment due to several houses along Jones Brook Road (Appendix C, Map 7). Five ledge grade controls are present in the middle and at the downstream end of this segment, which afford the channel some vertical stability. Moderate historic incision has occurred within R16.S2.03-C likely as a result of channel alteration. Widening is currently occurring as evidenced through abundant bank erosion. Riparian buffer vegetation is lacking for about half of the segment. R16.S2.03-C is in **fair** geomorphic condition and **fair** habitat condition.

Figure 5.24. Straight channel in R16.S2.03-C.

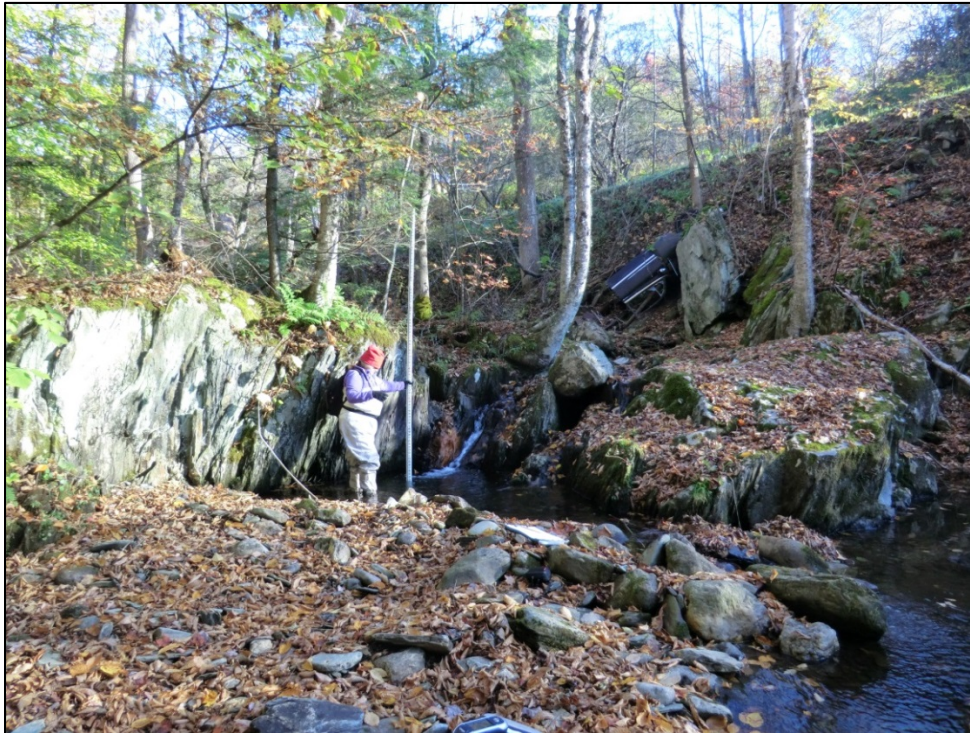
Figure 5.26. Bedrock grade controls are abundant in this segment.

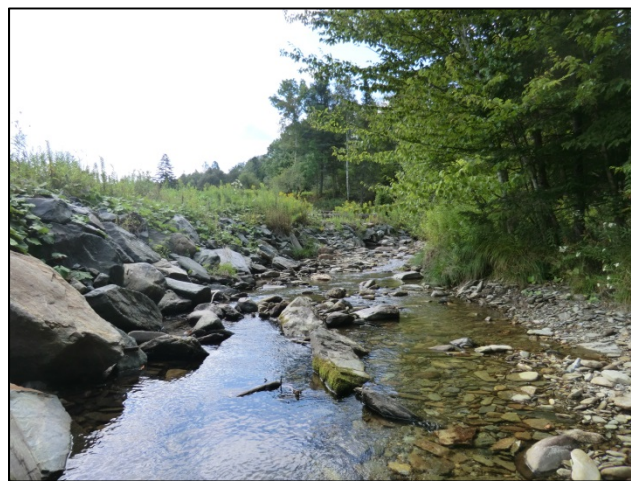
Figure 5.27. Extensive riprap and straightening in R16.S2.03-S1.01-A.

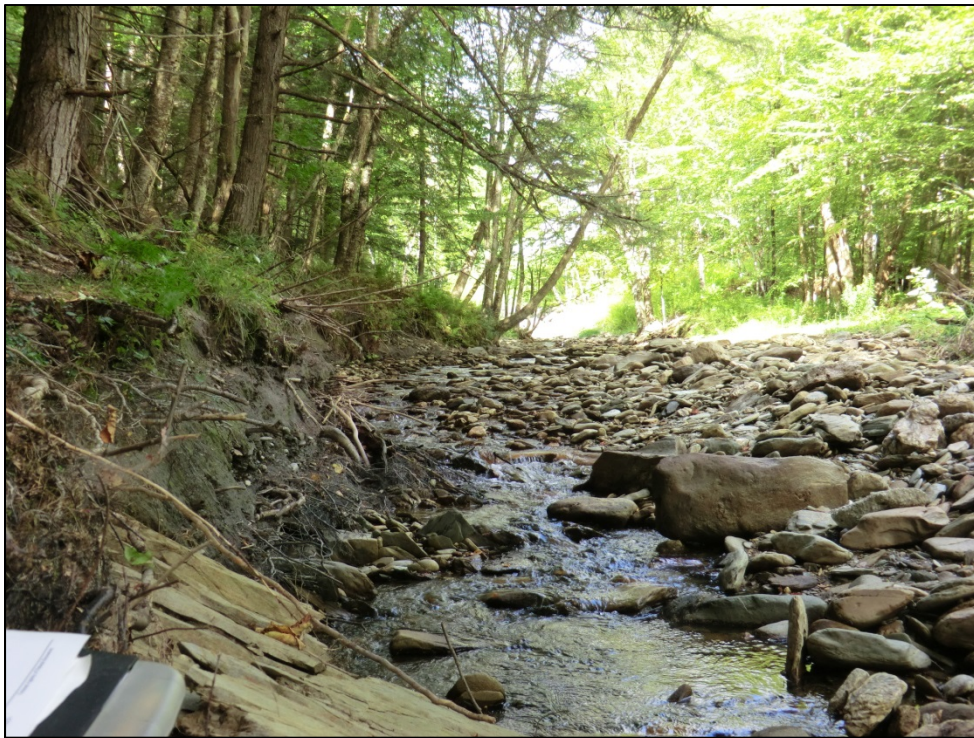
Figure 5.28. Headcut in R16.S2.03-S1.01-B.

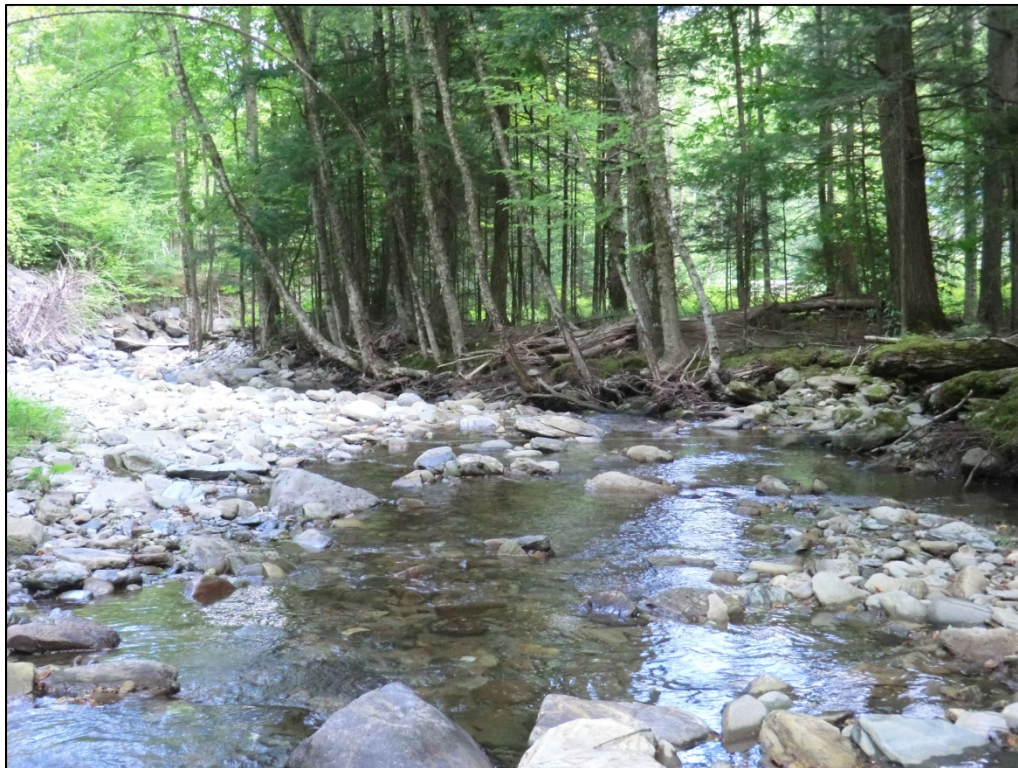
Figure 5.28. Downstream view at cross section in R16.S2.03-S1.01-C.
