Evan P. Fitzgerald
UVM/ANR Stream Geomorphic Assessment Project, Chittenden County, VT
Munroe Brook Phase II Documentation and QA/QC Notes
November 13, 2006

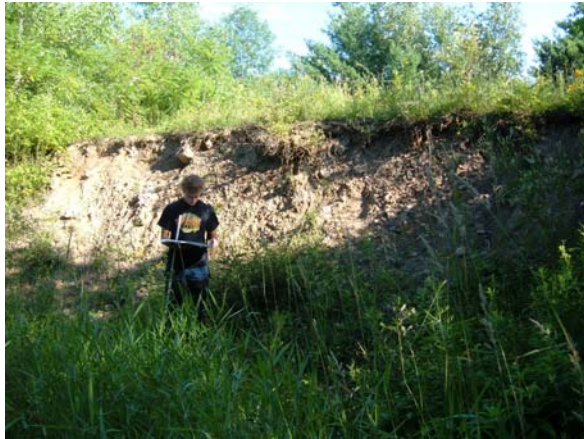
Figure 1. Mass failure on flood chute in reach M01

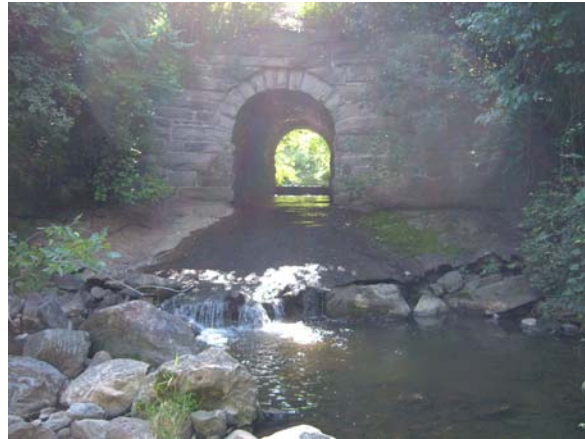
This reach is found from the Route 7 crossing down to the outlet at Shelburne Bay, and is a high-gradient channel with numerous impacts from surrounding urbanization. This reach has a length of 2500 feet, with a channel slope of approximately 2.0%. Observations of natural valley and slope characteristics suggest that reference conditions for this reach are riffle-pool bedform with a B-type channel. Due to apparent hydrologic impacts from upslope urban land use and stormwater outfalls, and the resulting changes in channel form, a stream type departure has been noted for bedform (see appendix 3). Six stormwater outfalls were noted along the reach, as well as one significant flood chute with a large mass failure within it (see figure 1). The grade control associated with the railroad crossing midway through the reach (see figure 2) is controlling some of the incision noted in the lower section of the reach near the mouth.

Figure 2. Railroad crossing grade control mid-reach

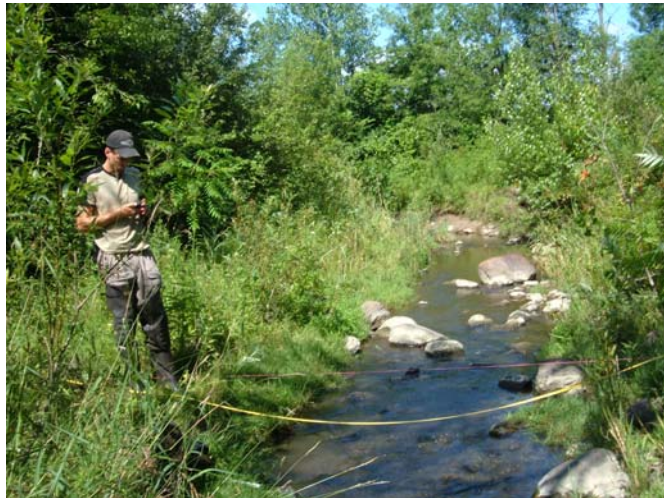
The natural form of the channel in the vicinity of the Route 7 crossing has been completely altered by the two box culverts and road construction carried out in summer 2005. While there are no opportunities for channel and floodplain remediation near Route 7 and Bay Road, there are significant planform changes and bank erosion immediately below the crossing that deserve consideration for restoration. Approximately 150 feet below the Bay Road crossing, there is a large flood chute on the left side of the channel. This flood chute cuts off the large bend to then north, and is accessed during flows at or near bankfull. When accessed, a large, exposed mass failure found half-way down the chute contributes large amounts of sediment to the reach where the flood chute rejoins main stem channel flowing south at the end the large bend. Stabilization of this failure and other sections of the flood chute, which could likely be done without significant machinery (ie, VYCC and revegetation), would control sediment inputs to the downstream channel and Shelburne Bay. In addition, further monitoring of the main channel below Bay Road (downstream of the flood chute inlet) should continue in the future, as areas of significant bank failure and incision (see figure 3) threaten connectivity to the floodplain.

Figure 3. Channel narrowing and bank failure below Bay Road crossing in M01

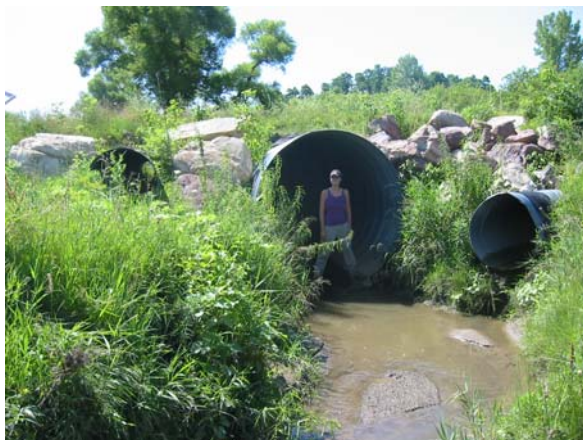
Figure 4. Culvert crossing midway through reach M02-A

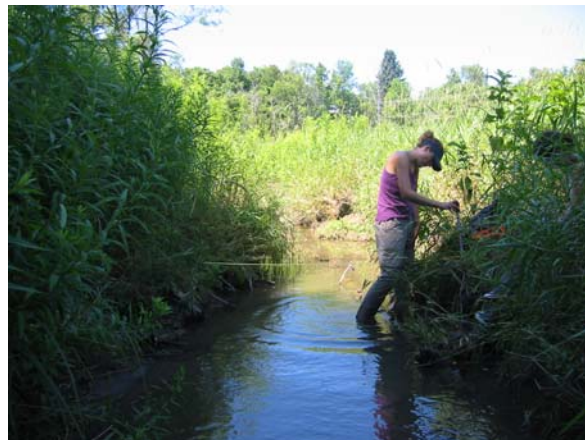
Figure 5. Cross-section in reach M04-A

The next upslope segment, M04-A, does not have significant human-induced alterations to channel, but historic beaver activity was observed. Incision observed in this segment may be resulting from the channel cutting down through aggraded sediment from historic beaver ponding (this was observed in many of the small Chittenden Co. streams throughout assessments). Some changes in planform are occurring as channel meanders through beaver meadow.

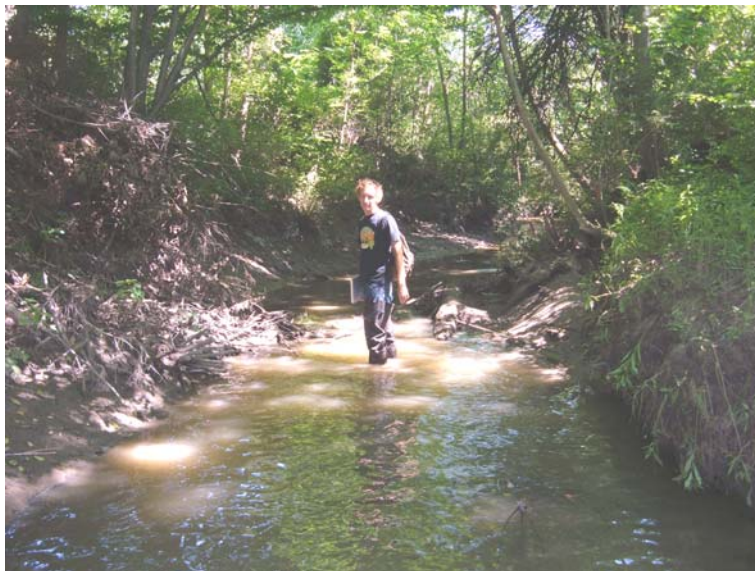
All of the low gradient reaches described above have a very high sensitivity to further watershed land use changes, as noted in the summary table in appendix 3, due to the inherent sensitivity associated with these stream types and the impacts affecting them. Both segments in reach M02 are being impacted by different stressors from adjacent land use which should be considered in future restoration efforts. In segment A, direct impacts associated with the pasture and animal fords are causing instability in the banks. Due to the inherent erodibility of the bank parent material, impacts from nearby grazing animals is causing significant sediment loading within the reach and to downstream reach M01. Segment B is currently in an extreme state of disequilibrium due to historic straightening and current impacts from urban runoff from adjacent neighborhoods on Deer Run Road. Berming (see figure 6), straightening, and altered hydrology has left little floodplain connectivity in this segment, and sediment transported from above reaches and within-reach stormwater outfalls is moved through and deposited in downstream reaches. Efforts to control stormwater runoff from the Deer Run Road and Longmeadow Road neighborhoods, in combination with the restoration of equilibrium channel geometry, would greatly reduce sediment transport through this segment.

Figure 6. Berming and entrenchment in M02-B

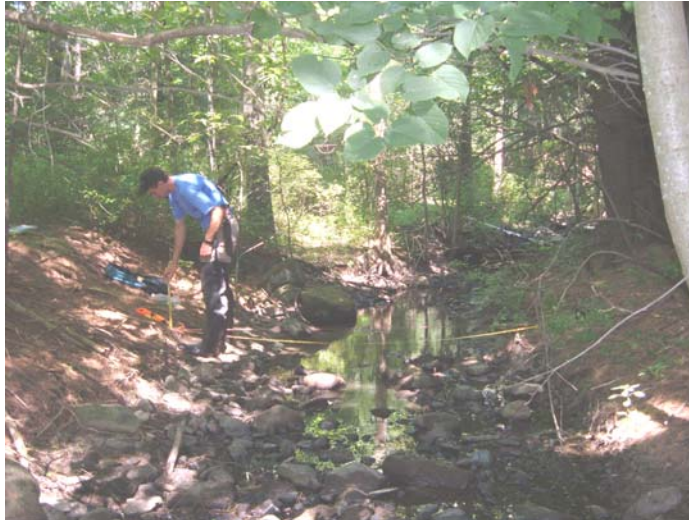
currently redeveloping sinuosity and aggrading with material transported from upstream high gradient reach T1.02. Reference channel conditions have been assessed as C-type with riffle-pool bedform, and a stream type departure has been noted due to the dominance of planebed features in the segment. This segment has been assessed at stage IV of channel evolution due to the aggradation and planform changes. One small beaver dam and one on-stream impoundment were noted (mid segment near the cul-de-sac on Executive Drive). The high degree of incision noted in the lower cross-section measurement (see figure 7 and maps in appendix 4) suggests that the aggradation and planform changes noted in the upper section of the segment may be ameliorated by these on-stream structures.

Figure 7. Lower cross-section on T1.01.B

This segment of Munroe Brook, and reaches M01 and T1.02 are experiencing extreme incision, widening, and bedform departure. Active restoration of stream channel geometry is likely not be feasible until the mitigation of the hydrologic regime of the entire watershed is addressed. This strategy, adopted by ANR, is consistent with research from other parts of the U.S. (Booth et al, 2002; Booth, 2005). In the T1.01.B corridor, there has recently been implementation of a stormwater control structure at Hullcrest Park. Since increases in stream power due to stormwater outfalls near the Pinehurst Road crossing are driving the current instability observed in this segment, this control structure should help reduce sediment production and transport in the segment and to downstream reaches. However, further monitoring of the ongoing adjustments and floodplain connectivity in this segment will be necessary as a basis for restoration efforts to reduce sediment loading in the watershed.

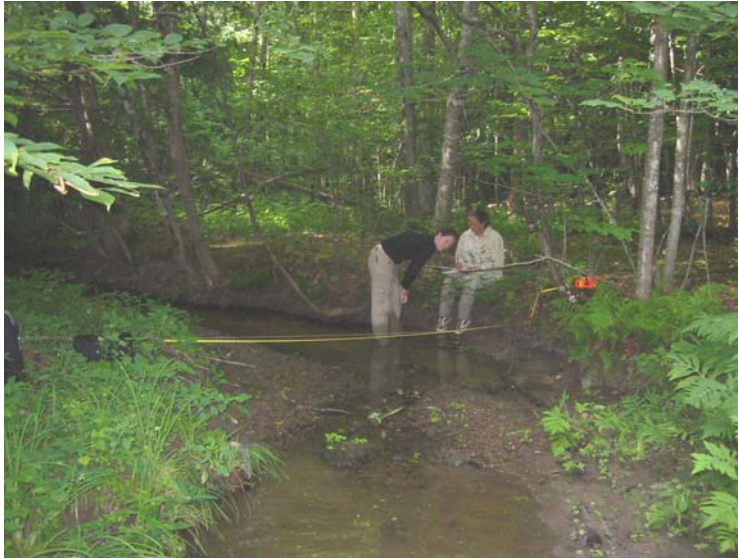
upper boundary of reach T1.02. The adjustments observed in this reach suggest that the on-stream pond found mid-reach is affecting the sediment regime below. Incision was noted directly below the structure, and severe aggradation was noted further downstream. Aggradation and widening are evident in the cross-section data in the lower reach (see figure 8), however further detailed field assessments and/or segmentation of the reach is warranted; the specific location of adjustments was not well described during the Phase II assessments. The reach has been given preliminary RGA and RHA scores of fair. No preliminary project identification has been made for either of these two reaches.

Figure 8. Cross-section on T1.03
