## **Sunderland Brook Tributary Report: Phase 2 Stream Geomorphic Assessment Summary**

**November 20, 2007**

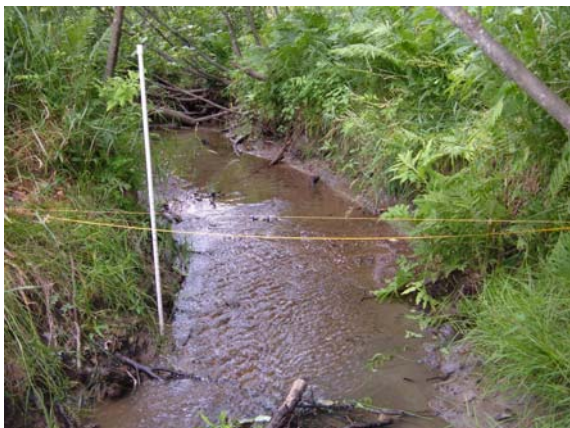
This segment has good geomorphic stability (stage I of channel evolution), but also has a very high sensitivity to future adjustments due to the propensity of E-type channels to undergo adjustments. Good pool variability and overall cover was observed throughout the segment resulting in an RHA score of good. The segment ends approximately 200 feet upstream of the Route 7 crossing where a tributary that originates in Camp Johnson enters from the southeast.

Figure 1. Cross section in lower T1.01-A

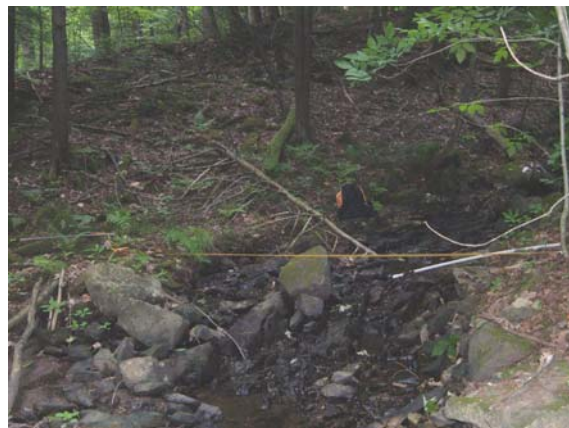
Figure 2. Cross section in lower T1.01-B

This segment begins 200 feet upstream of the Route 7 crossing and extends to the south along Route 7. At the segment break there is a sharp change in slope, and the channel geometry and bedform changes abruptly. This segment has B-type channel geometry with step-pool bedform. There are two significant grade controls in this segment which are controlling the migrating of adjustments along the channel network. A ledge is located near the lower segment break just upstream of a small flood chute. Upstream of this grade control, two significant flood chutes and a mass failure were noted, indicating that the channel is adjusting laterally in response to aggradation of sediment from an upstream source. Near the reach break with T1.02, an 8 foot waterfall is found that is preventing the downstream adjustments from moving upslope. A mass failure (8 feet high) is found just downstream of the waterfall on the left bank approximately 500 feet upstream of the Route 7 crossing. This failing slope may be the source of some of the sediment that has aggraded in between the grade controls.

The habitat conditions for this segment have been assessed as good overall, despite a low score for aggradation and a small wetted perimeter relative to the channel width. The geomorphic stability has been assessed as fair with a channel evolution stage of IV. The middle section of the reach is redeveloping a minor degree of sinuosity (naturally low in this setting) in response to previous aggradation and widening. The segment ends at the upstream reach break with T1.02 where there is a break in valley slope.

- Research on small watersheds of Chittenden County has shown that high-gradient reaches in urban watersheds which have limited natural floodplain access tend to undergo vertical adjustments more readily than low-gradient reaches (Fitzgerald, 2007). A similar pattern was noted for the two high gradient segments assessed in Tributary 1. Encroachment on the corridor in this segment and upstream segment T1.02-A may be unlikely due to the steep corridor topography. Nevertheless, due to the likelihood of future adjustments in both segments, protection of the stream corridor from future encroachment is highly recommended. Adequate protection of the stream corridor (6 times the channel width) is recommended to accommodate future stream channel adjustments towards equilibrium.

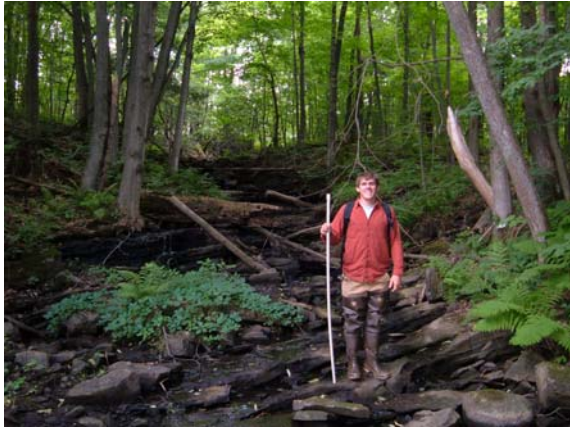
Figure 3. Ledge grade control in T2.02-A

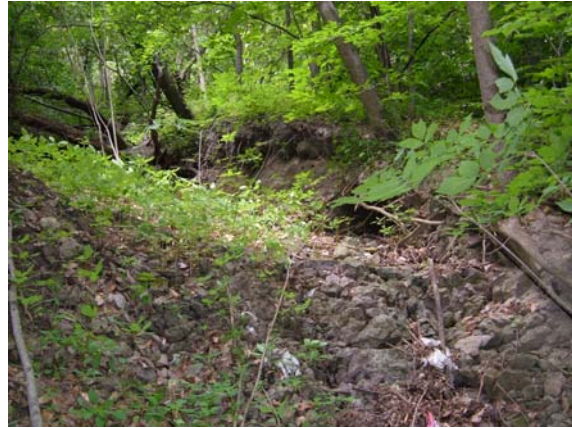
Figure 4. Gully in lower T2.02-A

- One large gully has formed below a stormwater outfall (18 inch diameter) originating from Sunderland Woods Drive. This 100 foot long gully is 17 feet wide and 5 feet deep. It has cut through the upper sand substrate, reaching a dense clay layer below. The sediment delivered to the channel from this gully is likely causing the planform changes noted in the downstream segment. The following remediation approaches should be considered for this gully: 1) installation of adequate stormwater controls for runoff from Sunderland Woods development; 2) application of rock weirs (or check dams) and side slope

- armoring in gully to prevent further export of sediment to the channel.
- A second, smaller gully is found below a stormwater ditch carrying Route 7 runoff, located south of Sunny Hollow Quick Stop. This 60 foot long gully is 7 feet wide and 3.5 feet deep. Like the larger downstream gully, it is likely exacerbating the planform changes noted in segment T1.01-B. The source of the runoff should be further investigated to determine if upslope controls along Route 7 are feasible.

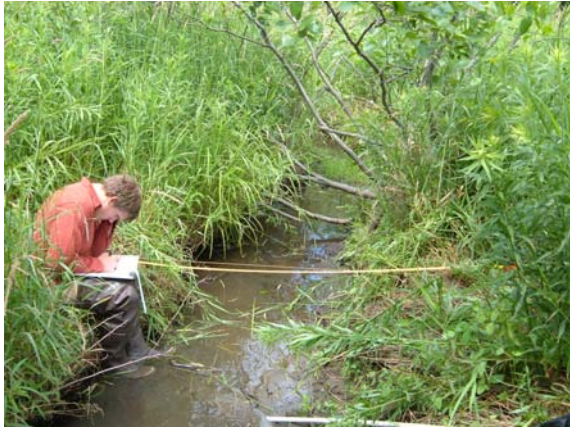
The habitat quality and geomorphic stability assessment for this segment was limited to the areas downstream of beaver ponding at Hercules Drive. The habitat conditions have been assessed as fair overall, with low scores noted for riparian buffers due to vegetation modifications in the middle and upper segment. The geomorphic stability has been assessed as good with a channel evolution stage of I. Only minor aggradation and changes in planform were noted in the areas below Hercules Drive.

Figure 5. Cross section in lower T1.02-B

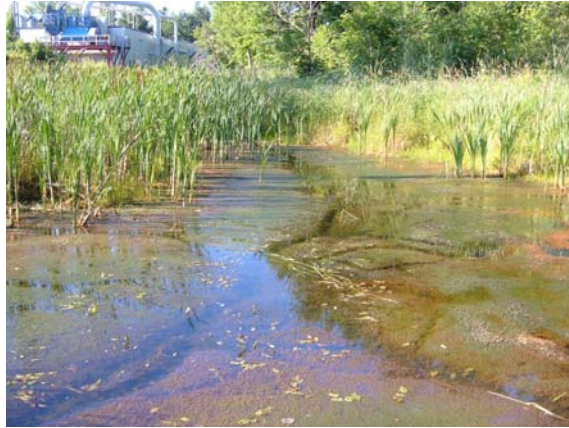
Figure 6. Beaver pond in upper T1.02-B
