Indian Brook Watershed Departure Analysis and Project Identification Summary

April 14, 2008

Fitzgerald Environmental Associates, LLC.

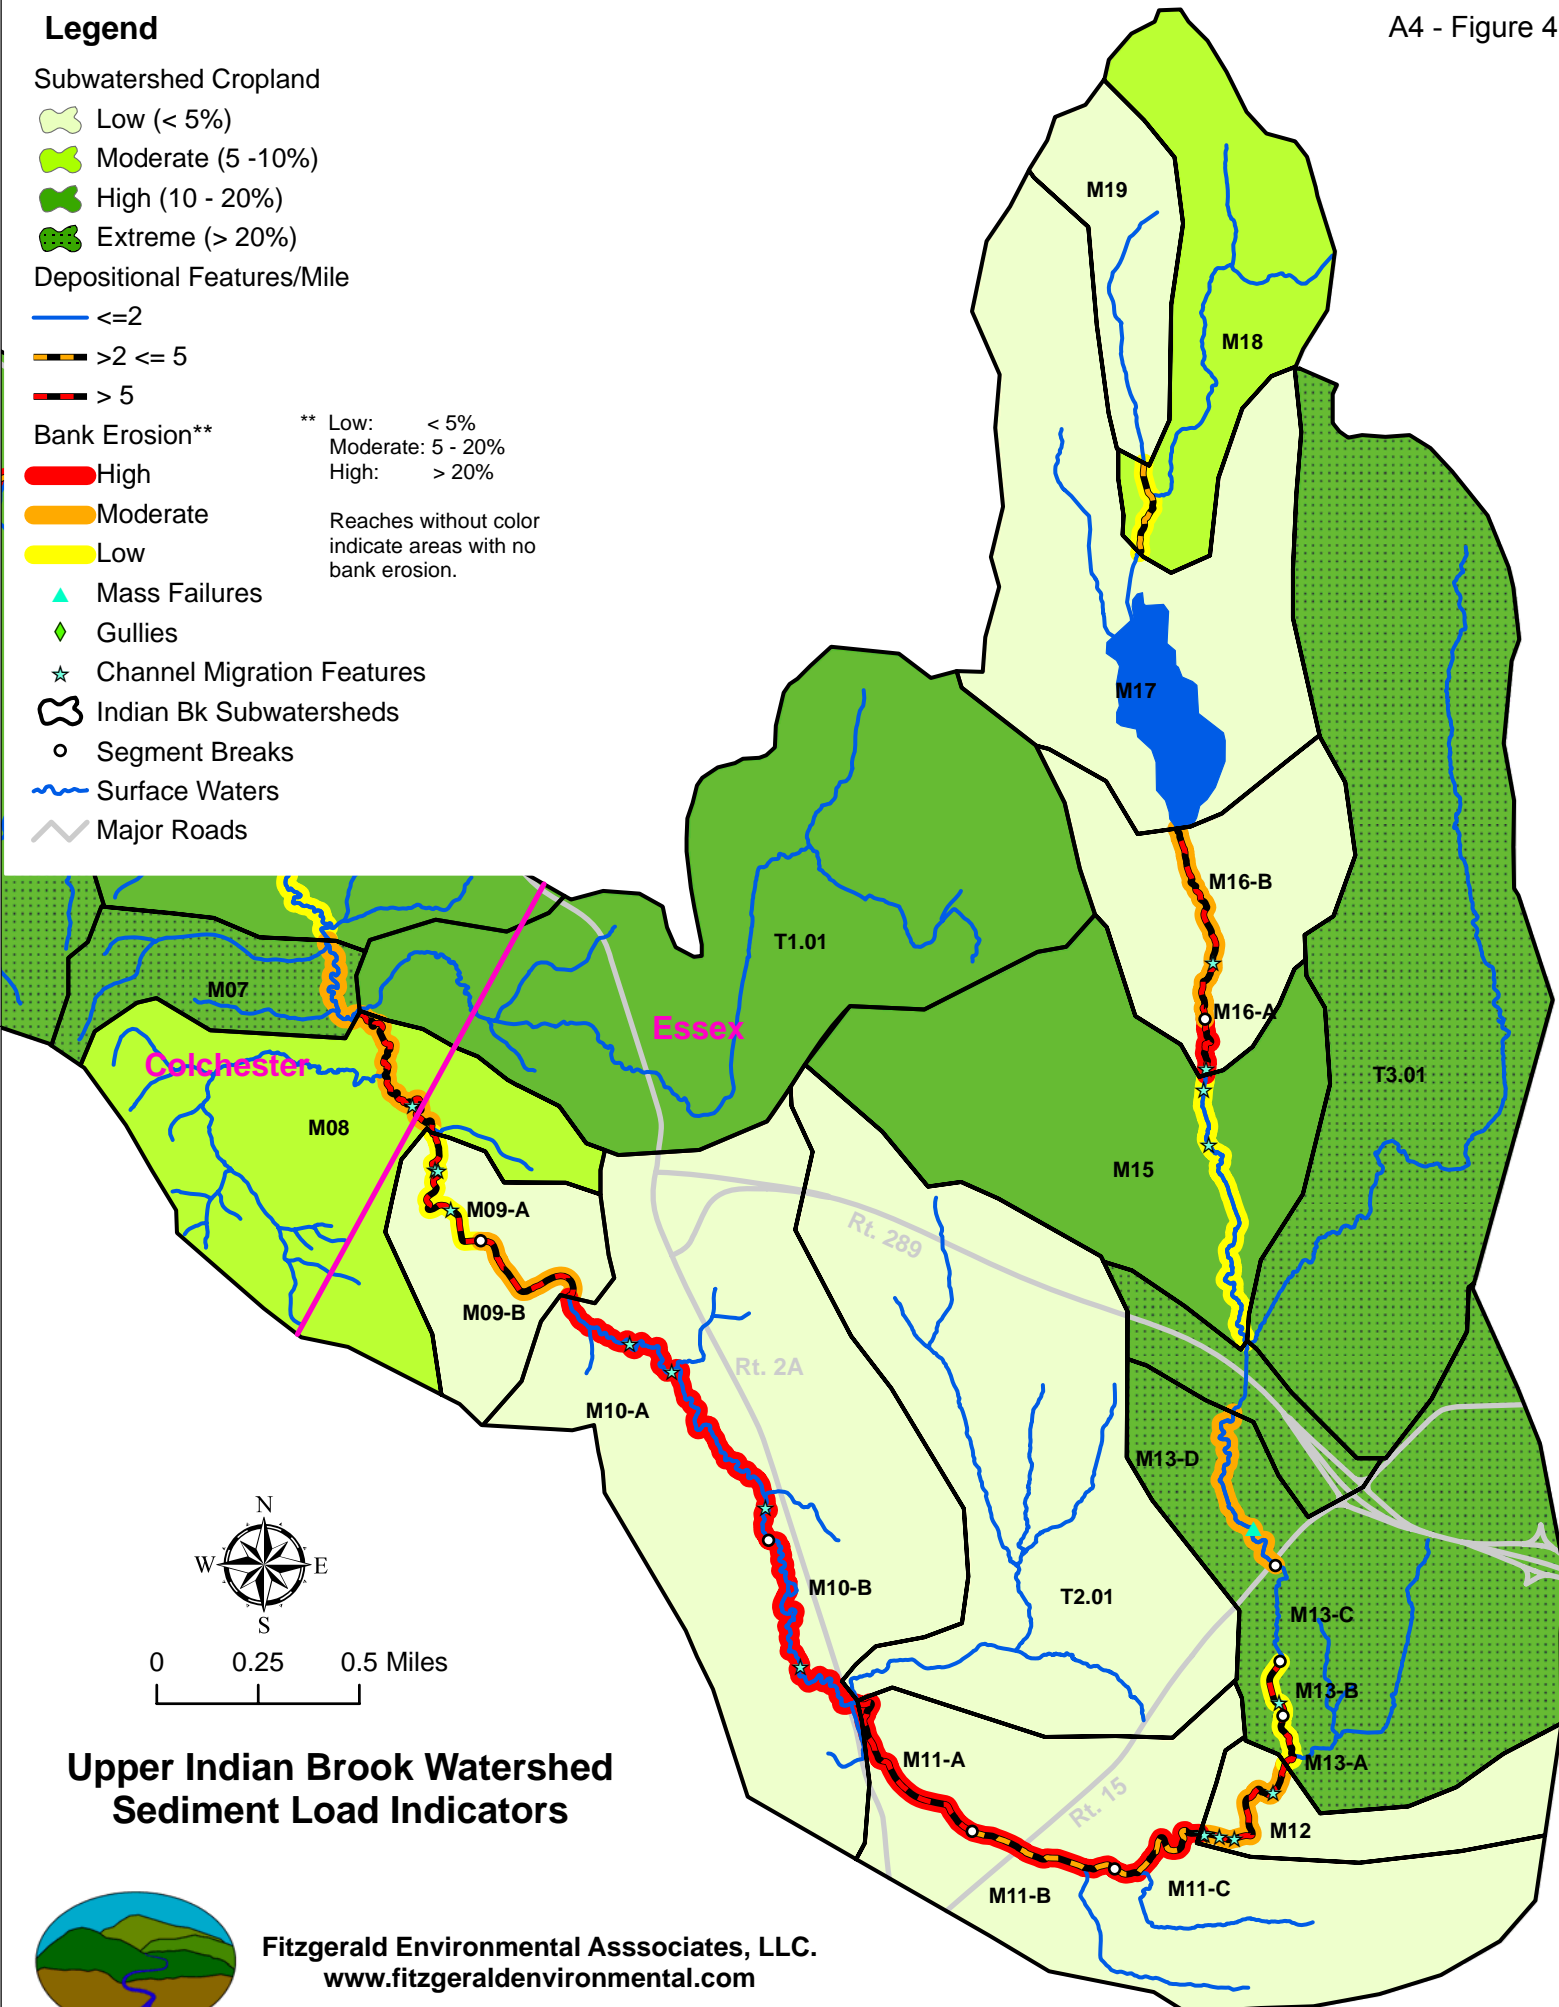
**Upper Indian Brook Watershed
 Sediment Load Indicators**

The current day stressors to the sediment regime have been mapped using the variables extracted from the Phase 2 field dataset, and the percent of agriculture within each subwatershed (Figures 3 and 4). Four classes of percent agriculture were mapped to depict the relative impact of sediment delivery from agricultural lands at the reach and watershed scales. In addition, depositional and migration features mapped during the Phase 2 assessments are included to depict areas of increased vertical and lateral channel adjustments due to aggradation. Mass failures, gullies and bank erosion depict where

sediment delivery from the channel boundaries is occurring. A summary of the local and upslope impacts to sediment loading for each main stem reach based on Figure 3 is provided in Table 5.

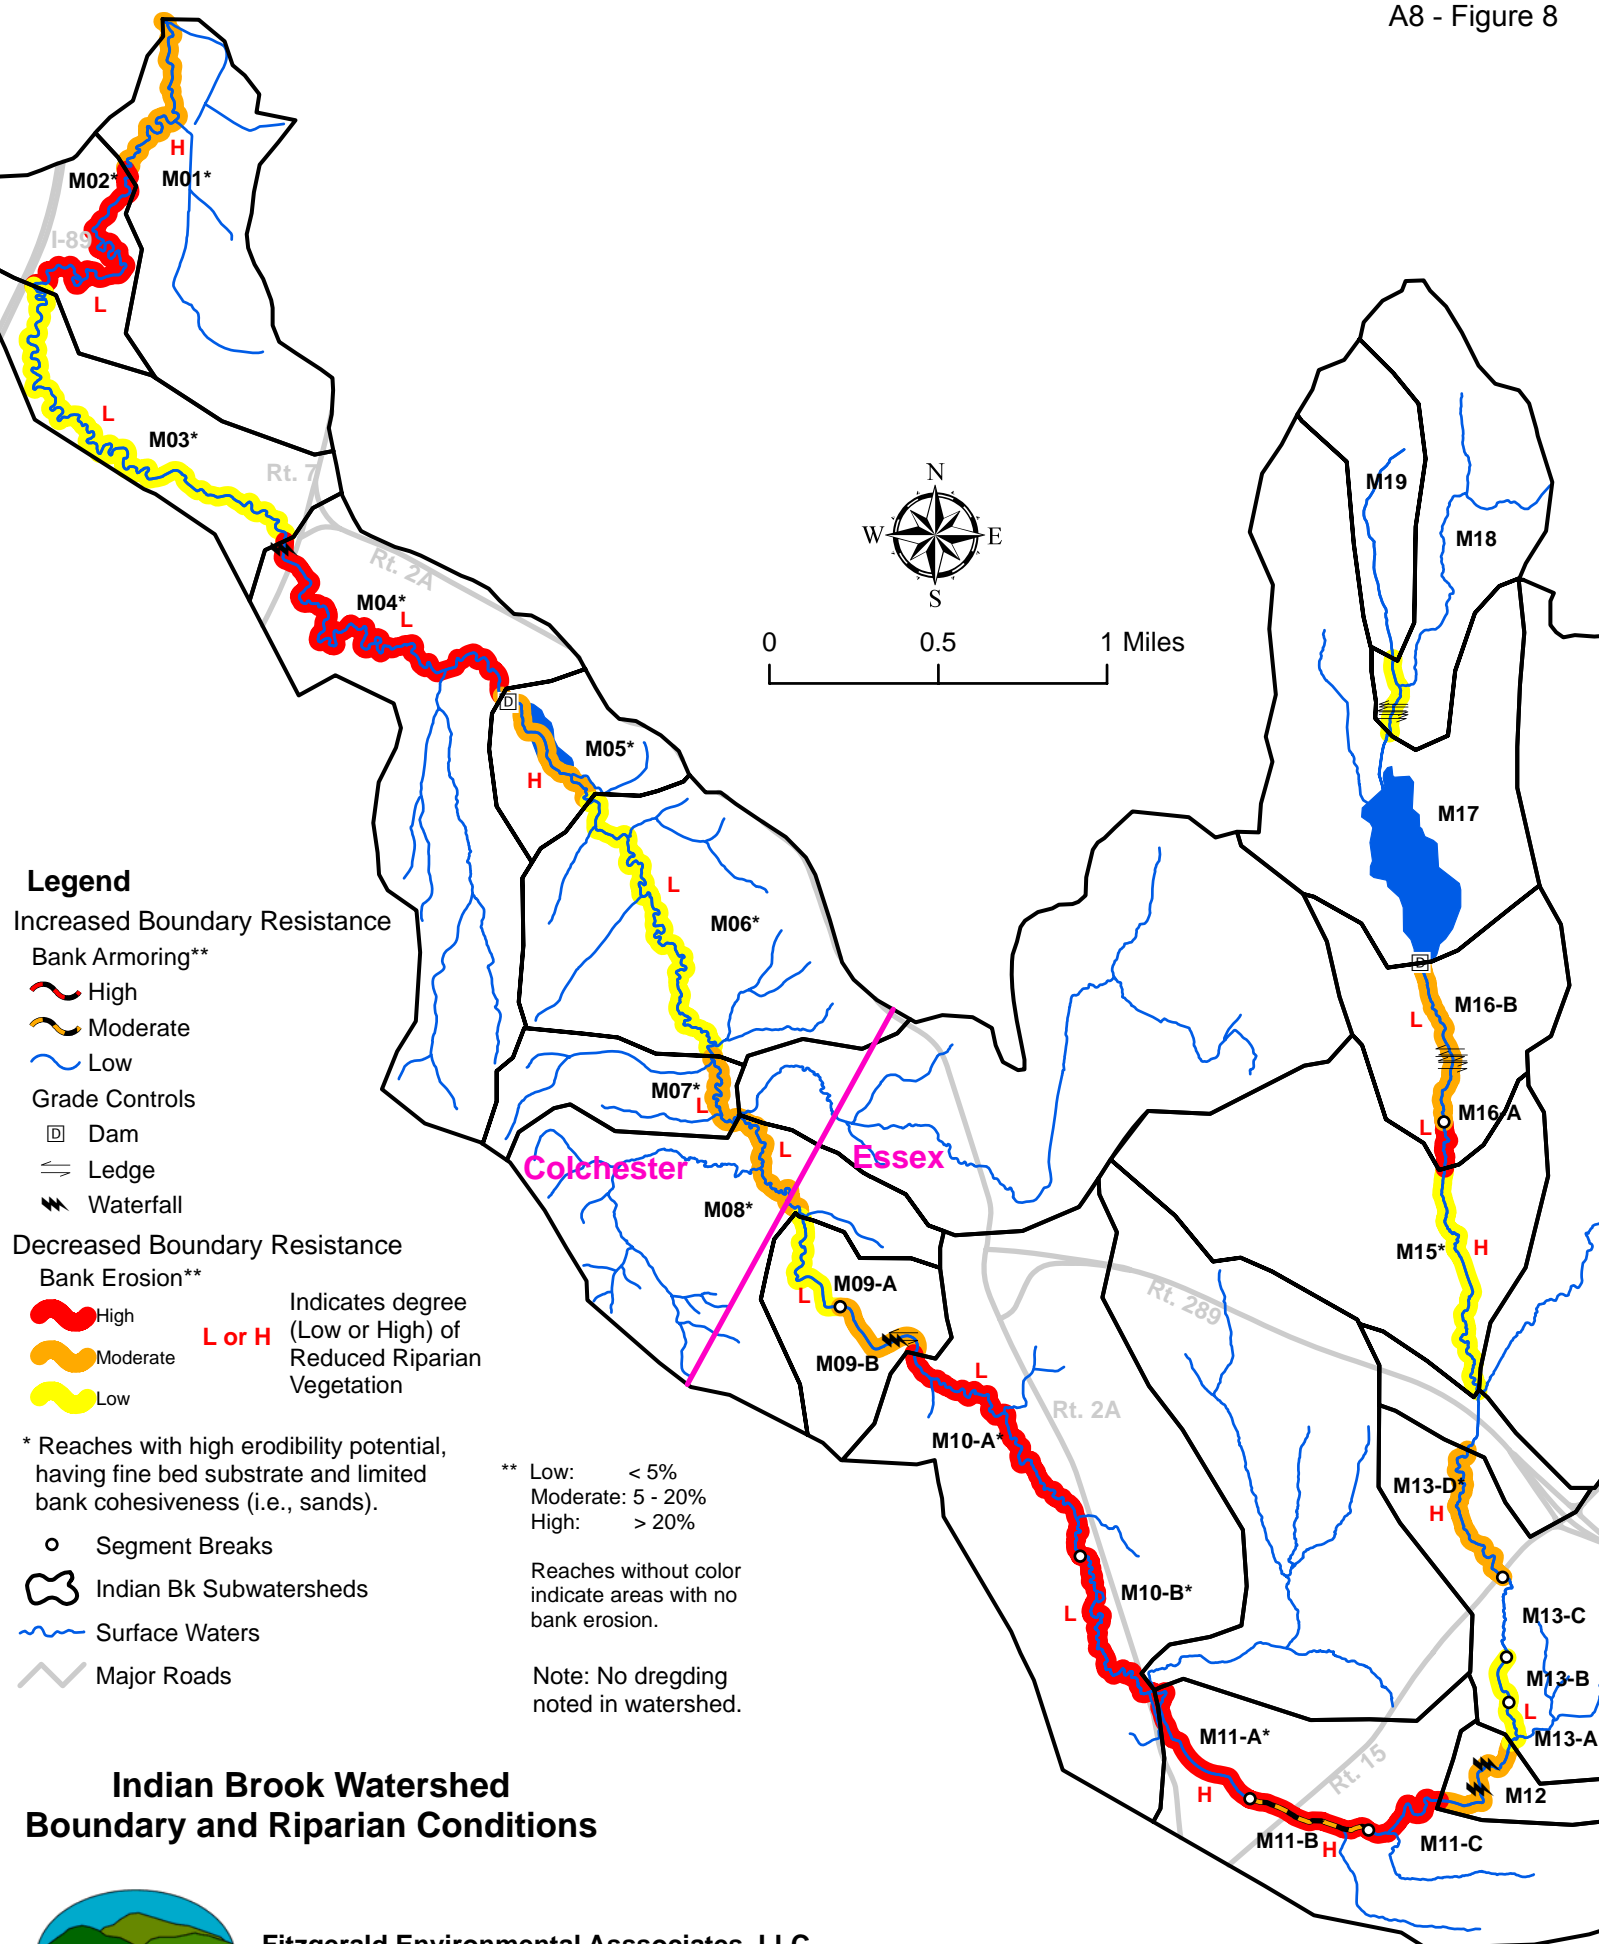
Indian Brook Watershed Boundary and Riparian Conditions

Alterations to the channel boundary conditions and riparian areas in the Indian Brook watershed have been mapped using the variables extracted from the Phase 2 field dataset (Figure 8). Relative bank armoring (e.g., rip-rap) highlights areas of increased resistance to lateral migration, whereas relative bank erosion highlights reaches where significant lateral adjustments are found. Additional data showing the location of natural channel features (e.g., ledges) depict areas that have a resistance to channel change. A summary of the local impacts to channel boundary conditions, including impacts to riparian vegetation, for each main stem reach based on Figure 8 is provided in Table 5.

In the Indian Brook watershed, many reaches along the main stem have a combination of fine bed substrate and limited bank cohesiveness. In the lower and middle watershed zones (where the greatest urbanization is found), only two natural grade controls (waterfalls) were noted during the field surveys. These conditions limit the amount of natural armoring within the remaining reaches (where no grade controls were noted), and allow for vertical adjustments (e.g., nickpoints) to migrate up the channel network. Channel armoring was found to be significant only in one area where corridor encroachments (e.g., berms and roads) are common around the Route 15 crossing. Many reaches had significant reductions in woody riparian vegetation, leading to decreased boundary resistance.

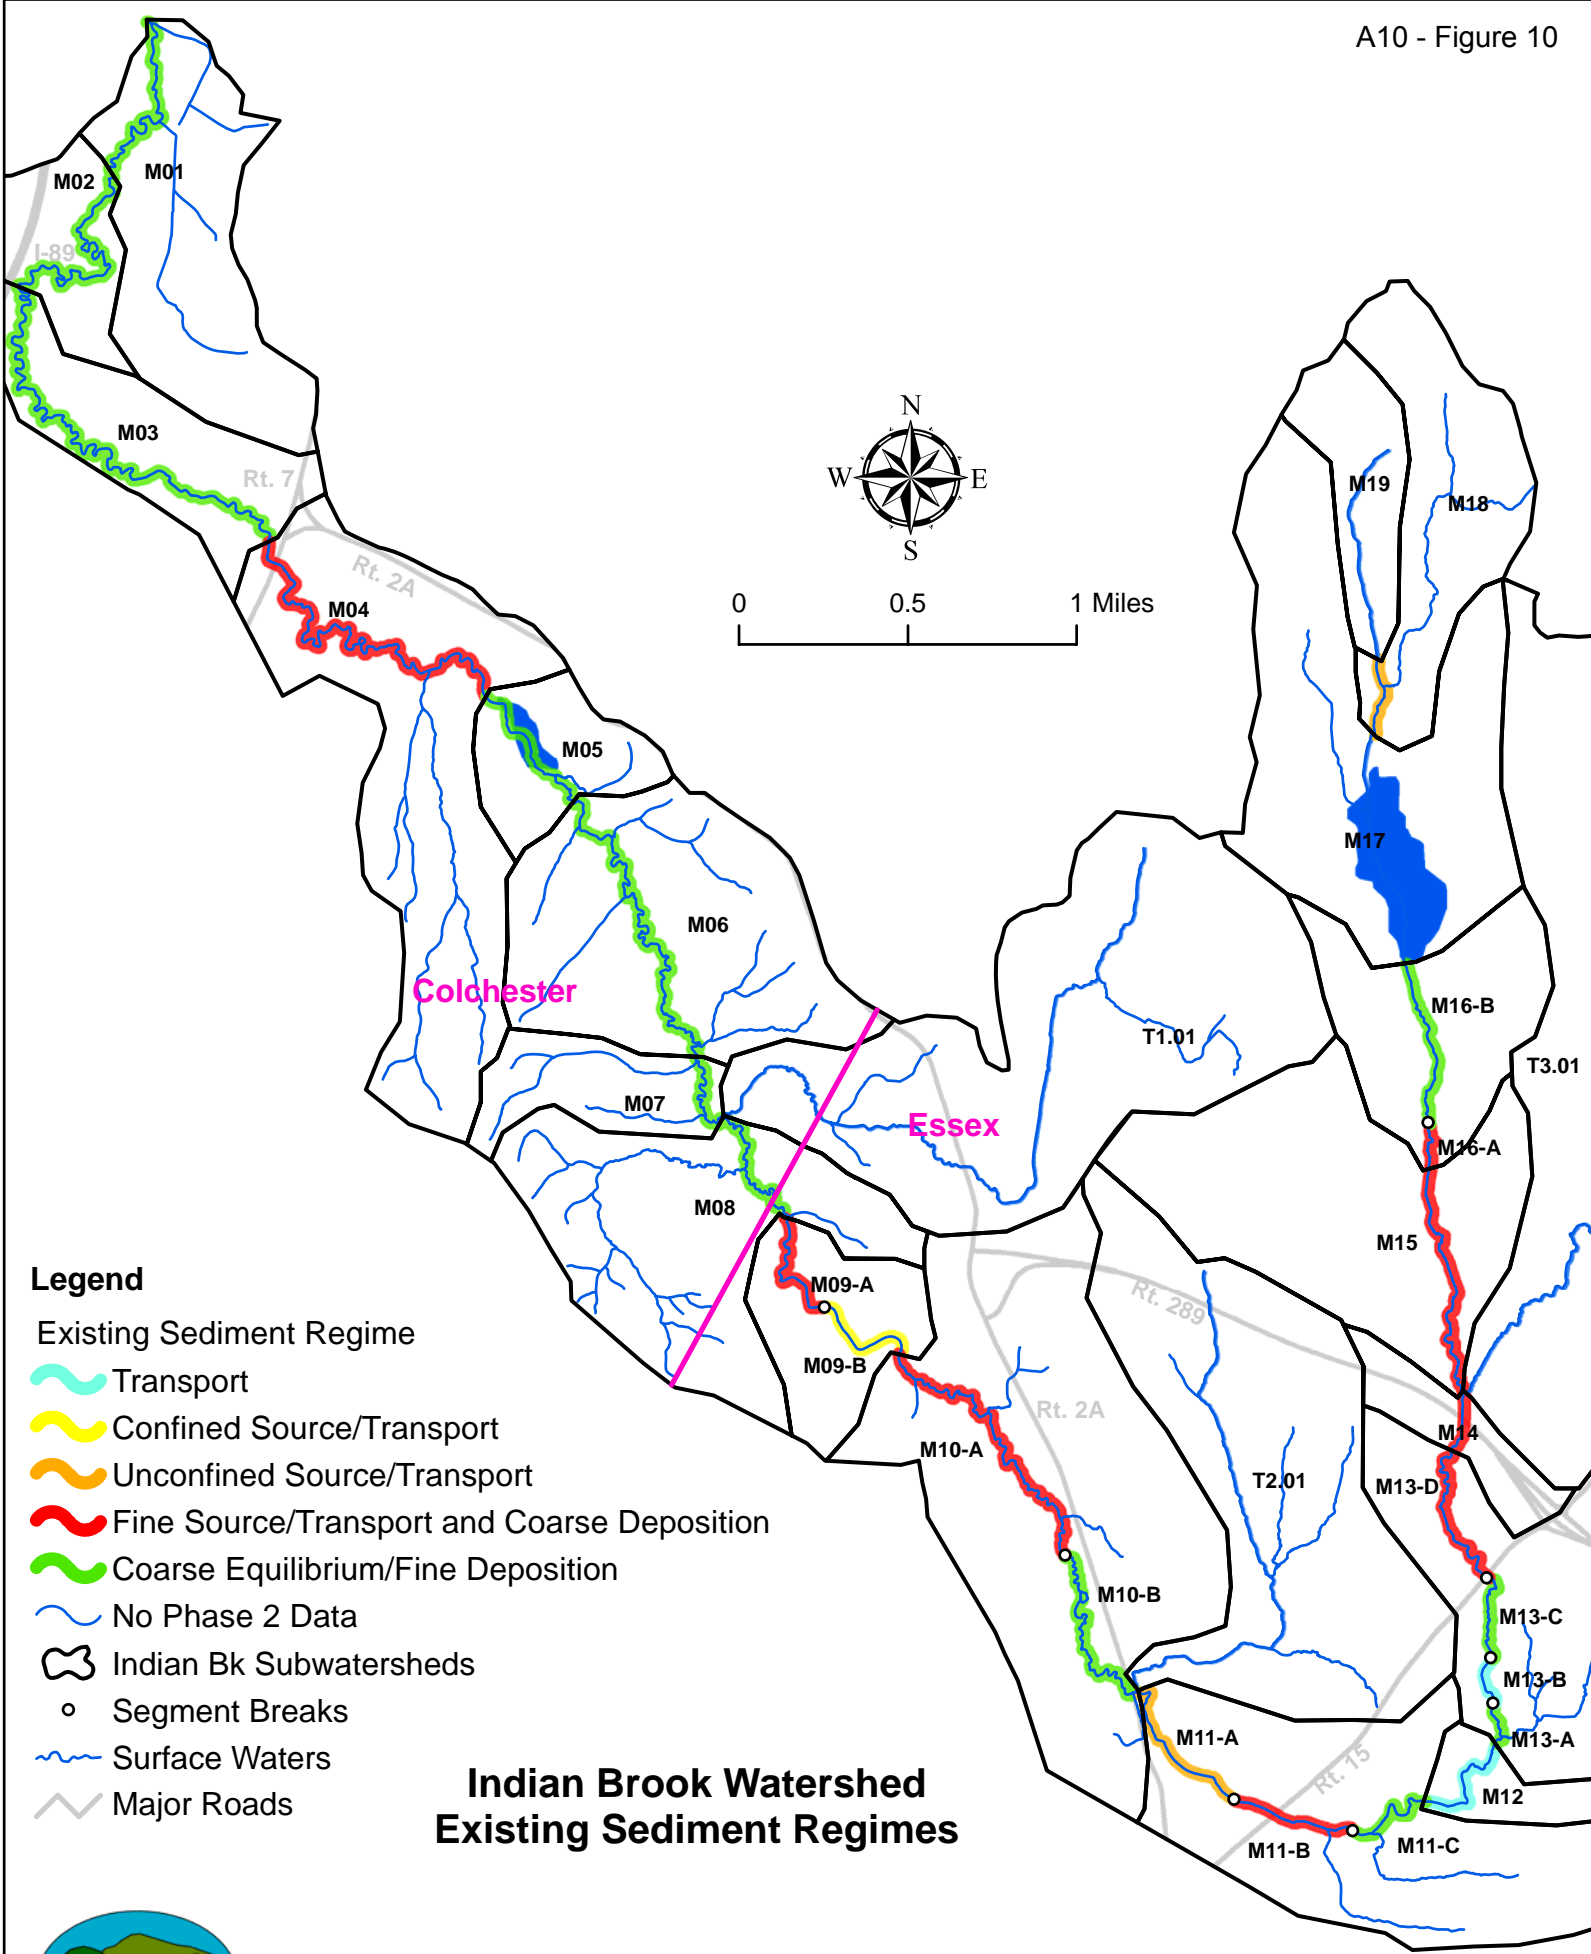
**Indian Brook Watershed
Existing Sediment Regimes**

The reference and existing sediment regime types have been mapped using data from the Phase 1 and 2 assessments. Figures 9 and 10 summarize the sediment regime types for reference and existing conditions for 23 main stem and 3 tributary segments. All of the reaches with slopes less than 2 percent are assumed to have been fine or coarse-bottomed streams in equilibrium, where there was a balance between sediment transport and supply. Only 5 of 23 main stem segments had sediment transport regimes under reference conditions where channel slopes were greater than 2 percent. The analysis of sediment regime types reveals that the main stem channel of Indian Brook has experienced many areas of departure from the reference regime conditions, especially in the middle watershed zone. Many of the reaches in the lower watersheds were determined to be in regime, protected from encroachment by steep valley side slopes and wide alluvial valleys with abundant wetlands. Five segments located in the middle watershed zone

were determined to have departed from their reference regime (Figure 8), resulting in areas with reduced floodplain deposition of fine sediments, and increased bank erosion.

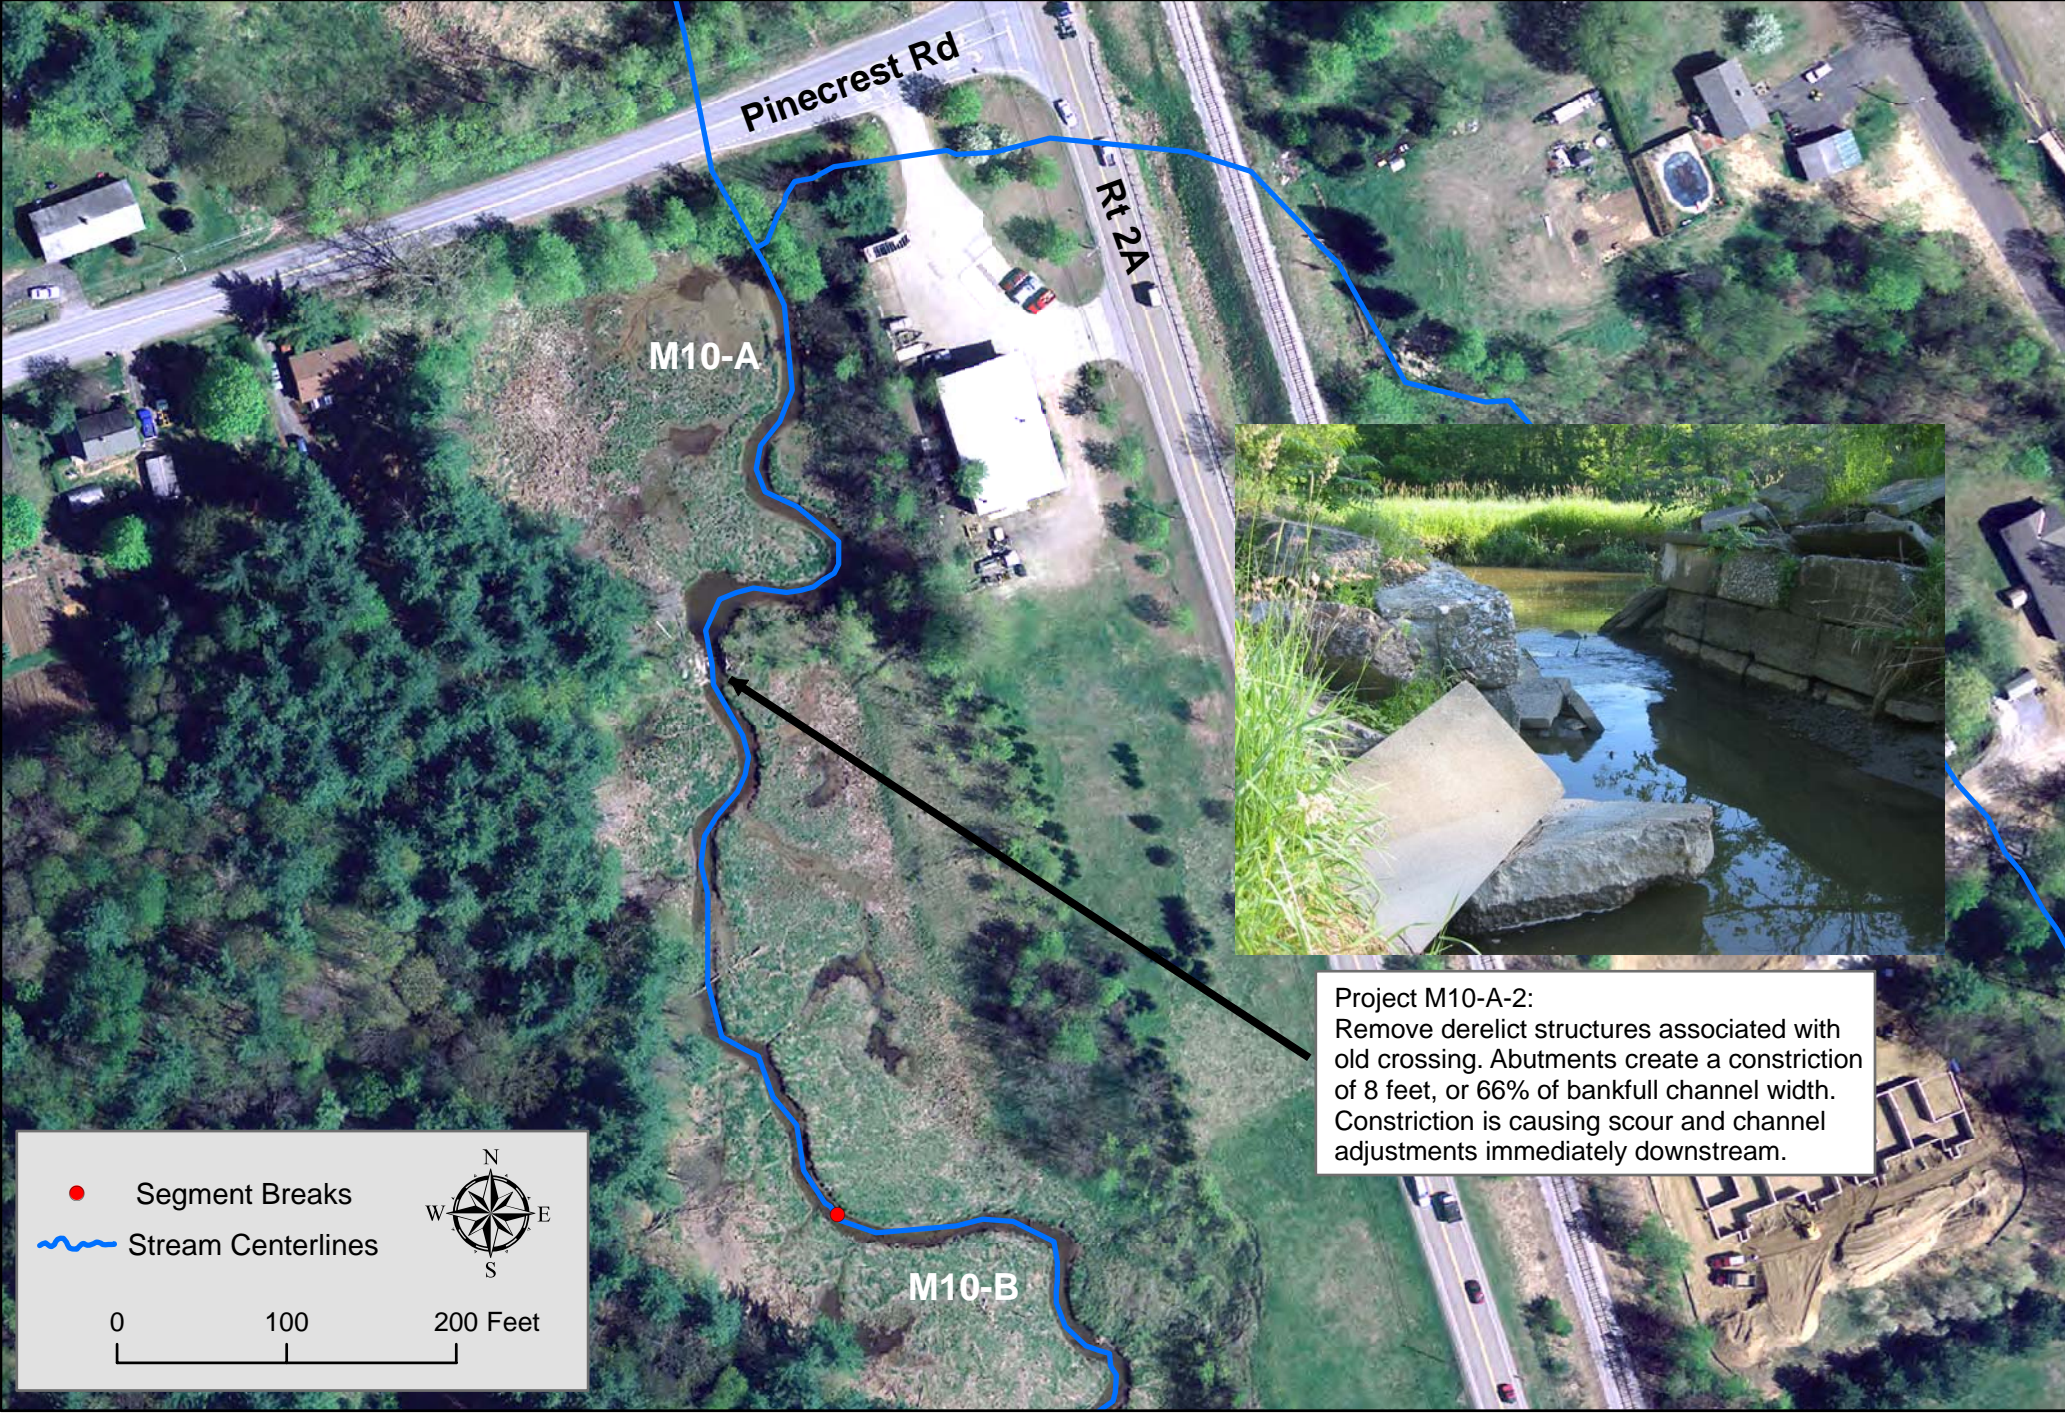
Figure 12
Segment M10-A Project Location

M10-A-2, E, II, Fair/Fair	See above for general segment description. One derelict crossing constricts the channel causing deposition upstream and changes in planform. See Figure 12 for a site map of project area.	Remove derelict structure (27) associated with old crossing. Abutments create a constriction of ~8', or 66% of bankfull channel width.	High priority because structure no longer functions as a stream crossing. Feasibility depends on parcel ownership (2 parcels) and cost of roadbed fill removal (likely high costs).	Reduced risk of erosion hazard in vicinity of structure. Increased continuity in the sediment regime, allowing for long-term equilibrium conditions.	Town of Essex; VTRANS; VTDEC
M10-B-1, E, I, Fair/Fair	Significant beaver activity throughout the reach causing changes in planform and decreased geomorphic	High priority stream corridor protection (3). Develop conservation easements for parcels	High priority because this segment is downstream of a highly channelized area of sediment transport in an urbanized area.	Attenuation of fine sediment will further protect WQ in Lake Champlain.	Town of Essex; VLT
